Appendix - Phase 1 Fish Passage Assessment Data and Photos

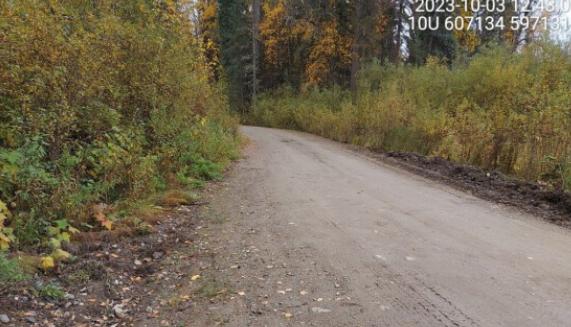
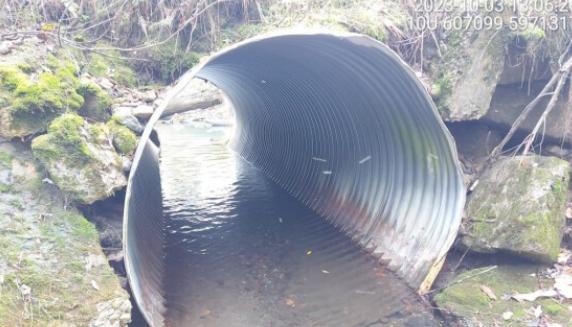
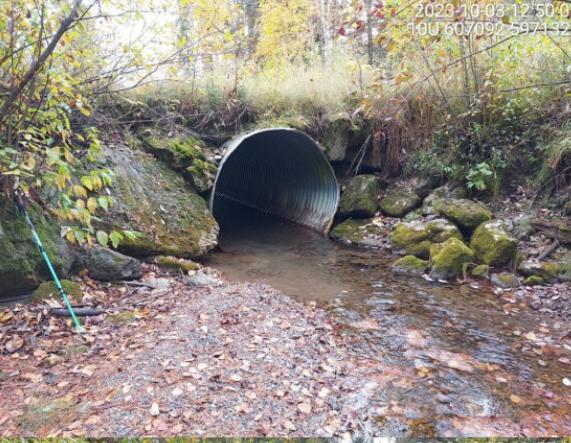
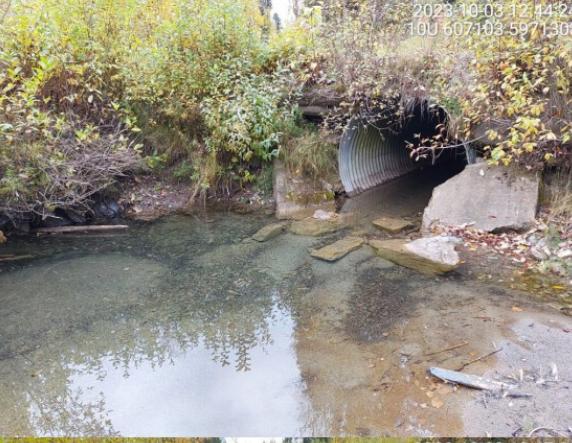
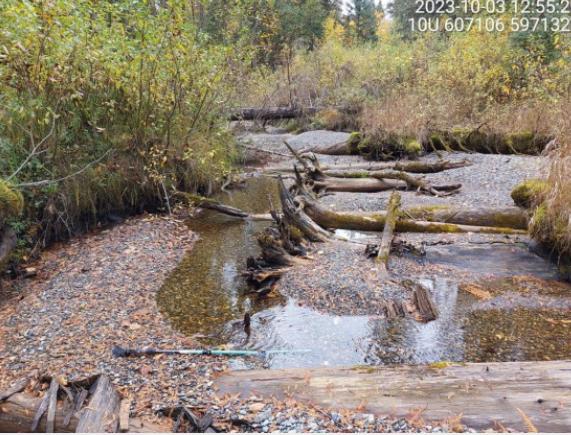
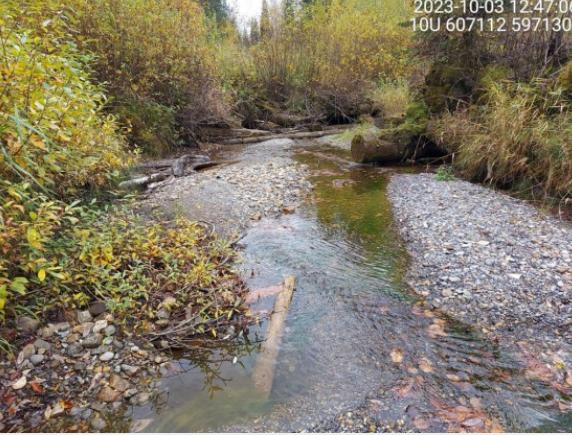
Location and Stream Data		Crossing Characteristics	
Date	2023-10-03	Crossing Sub Type	Round Culvert
PSCIS ID	199307	Diameter (m)	2
External ID	13900308	Length (m)	8
Crew	MW	Embedded	No
UTM Zone	10	Depth Embedded (m)	—
Easting	607110	Resemble Channel	No
Northing	5971294	Backwatered	Yes
Stream	Tributary to Fraser River	Percent Backwatered	100
Road	Penny Rd	Fill Depth (m)	0.7
Road Tenure	Unknown	Outlet Drop (m)	0
Channel Width (m)	5.9	Outlet Pool Depth (m)	0.6
Stream Slope (%)	3	Inlet Drop	No
Beaver Activity	No	Slope (%)	0
Habitat Value	High	Valley Fill	Deep Fill
Final score	16	Barrier Result	Potential
Fix type	Replace with New Open Bottom Structure	Fix Span / Diameter	15
Comments: Abundant gravels present downstream and upstream. Small fish seen in culvert and downstream. There's flow upstream and downstream but culvert is backwatered. Unassessed railway crossing ~900m upstream.. 12:52:51			
Photos: PSCIS ID 13900308. From top left clockwise: Road/Site Card, Barrel, Outlet, Downstream, Upstream, Inlet.

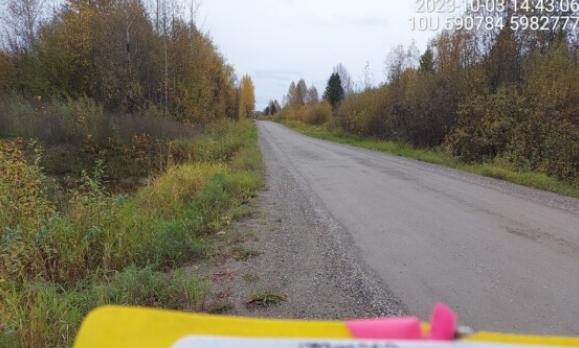
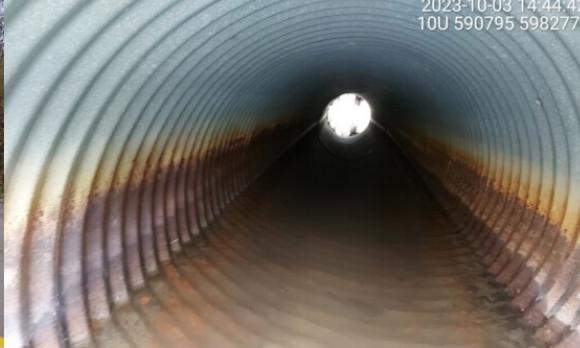
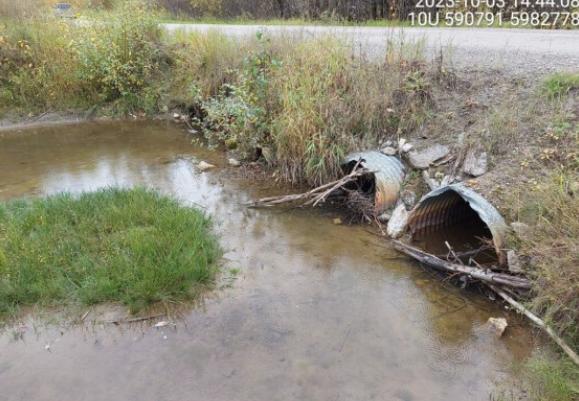
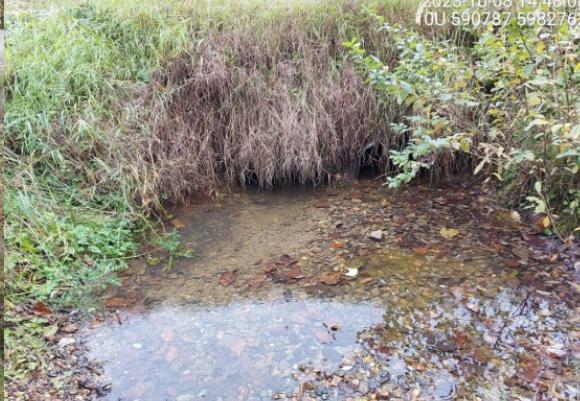
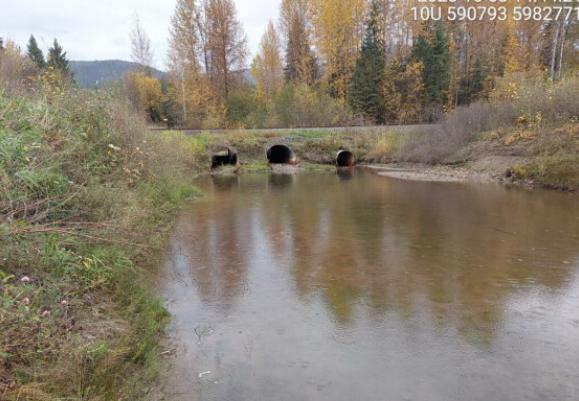
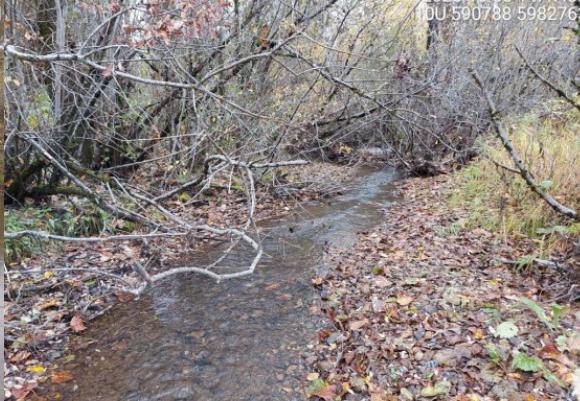
Photos: PSCIS ID 13900252. From top left clockwise: Road/Site Card, Barrel, Outlet, Downstream, Upstream, Inlet.

Location and Stream Data		Crossing Characteristics	
Date	2023-10-03	Crossing Sub Type	Round Culvert
PSCIS ID	199308	Diameter (m)	3.3
External ID	13900252	Length (m)	7
Crew	MW	Embedded	No
UTM Zone	10	Depth Embedded (m)	—
Easting	590794	Resemble Channel	No
Northing	5982763	Backwatered	Yes
Stream	Wolfe Creek	Percent Backwatered	100
Road	Upper Fraser Rd	Fill Depth (m)	1
Road Tenure	MOTI	Outlet Drop (m)	0
Channel Width (m)	4.1	Outlet Pool Depth (m)	0
Stream Slope (%)	2	Inlet Drop	No
Beaver Activity	No	Slope (%)	1
Habitat Value	High	Valley Fill	Deep Fill
Final score	18	Barrier Result	Potential
Fix type	Replace with New Open Bottom Structure	Fix Span / Diameter	15

Comments: Wide channel with four culverts. Culvert diameter totaled for all 4 culverts. Two are in good condition, other two are bent and look older. Railway crossing just upstream which consists of three culverts and appears likely passable for most species at most flows. Abundant gravels present downstream of road. This road is the only to access the town of Penny. MoTi chris_culvert_id: 1994890, 1994893, 1994894. 14:48:37

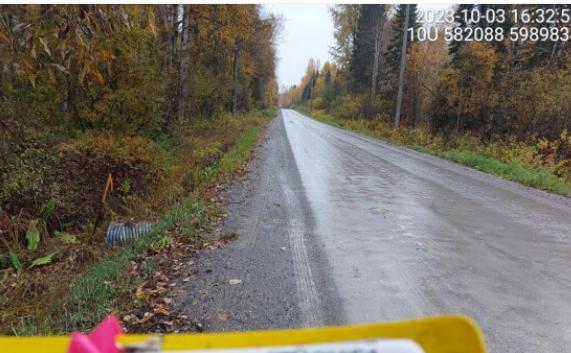
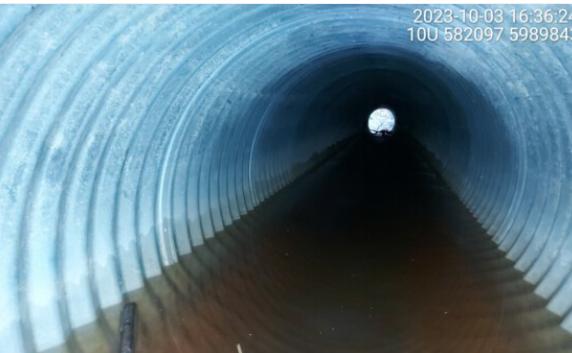
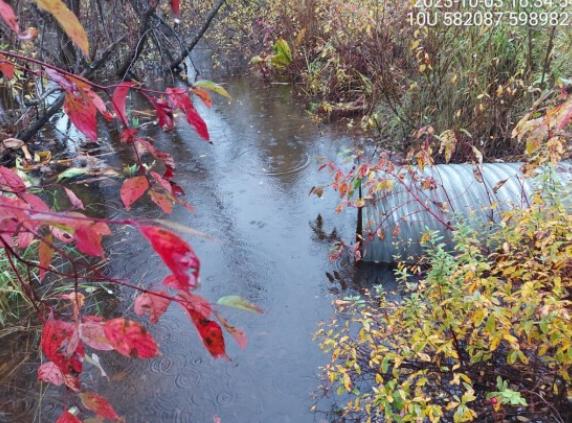
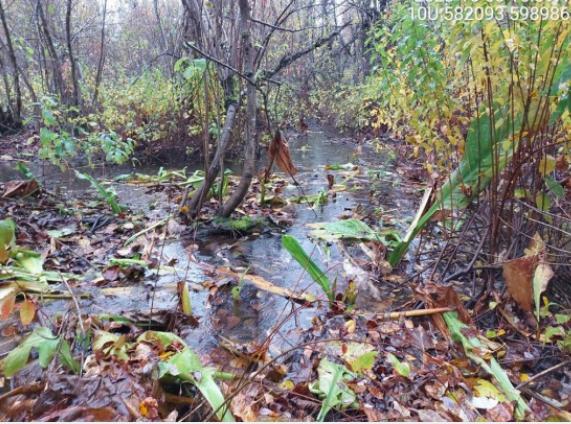
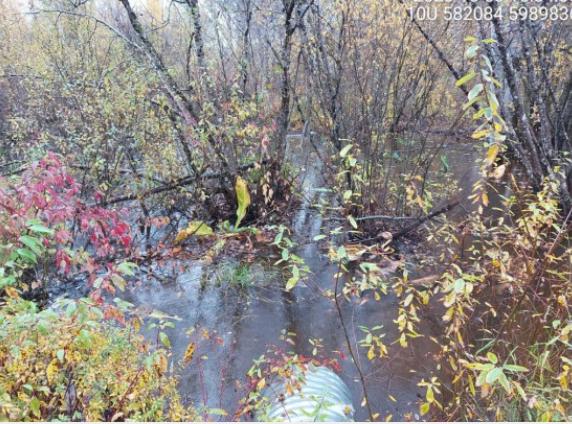
Photos: PSCIS ID 13900050. From top left clockwise: Road/Site Card, Barrel, Outlet, Downstream, Upstream, Inlet.

Location and Stream Data	.	Crossing Characteristics	–
Date	2023-10-03	Crossing Sub Type	Round Culvert
PSCIS ID	199309	Diameter (m)	0.8
External ID	13900050	Length (m)	12
Crew	MW	Embedded	No
UTM Zone	10	Depth Embedded (m)	–
Easting	582105	Resemble Channel	No
Northing	5989825	Backwatered	Yes
Stream	Tributary to Fraser River	Percent Backwatered	100
Road	Upper Fraser Rd	Fill Depth (m)	1.2
Road Tenure	MOTI	Outlet Drop (m)	0
Channel Width (m)	1.2	Outlet Pool Depth (m)	0
Stream Slope (%)	1.5	Inlet Drop	No
Beaver Activity	No	Slope (%)	2
Habitat Value	Low	Valley Fill	Deep Fill
Final score	21	Barrier Result	Barrier
Fix type	Replace Structure with Streambed Simulation CBS	Fix Span / Diameter	3

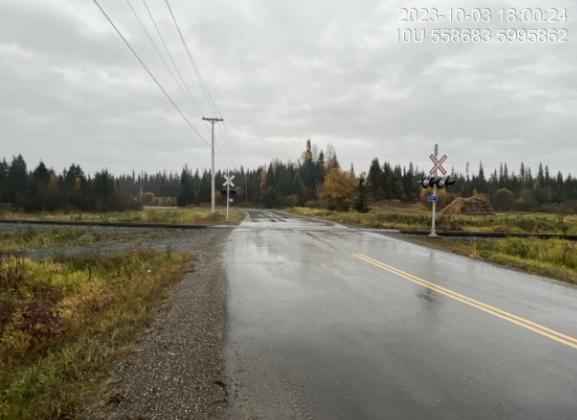
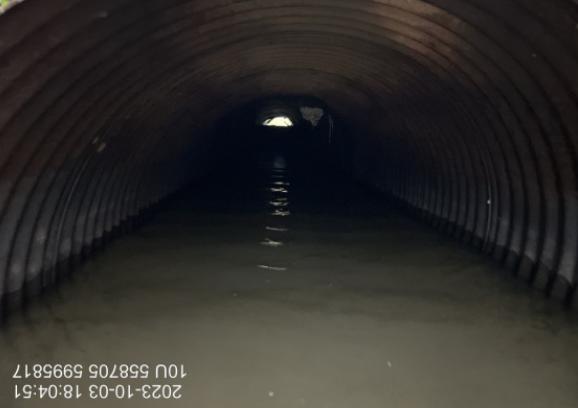
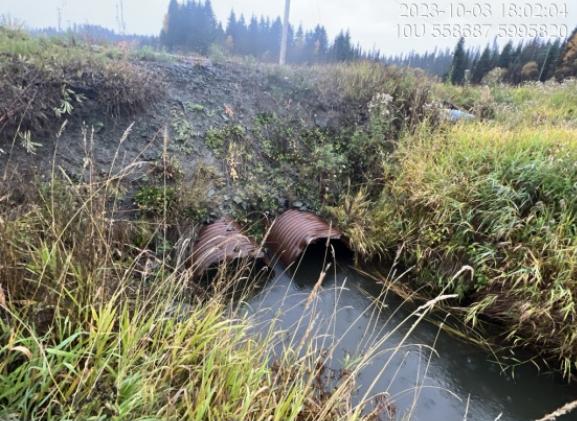
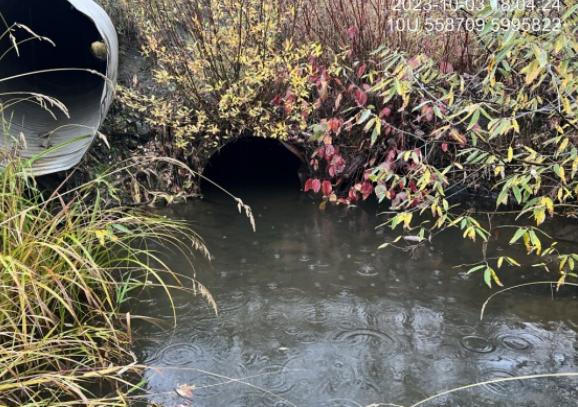
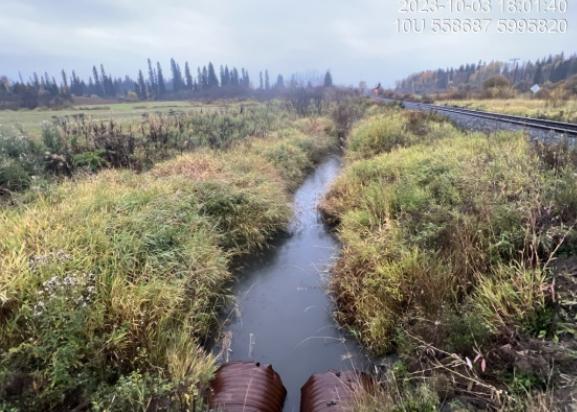
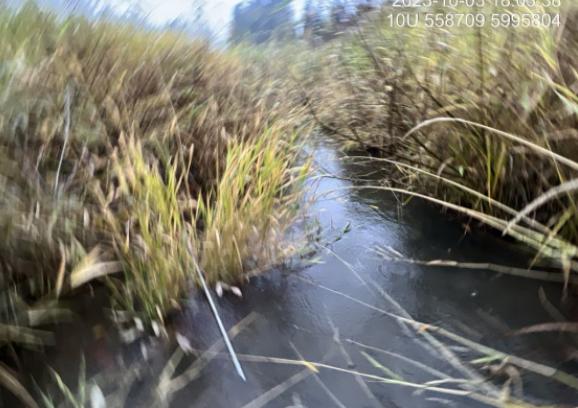
Photos: PSCIS ID 13900283. From top left clockwise: Road/Site Card, Barrel, Outlet, Downstream, Upstream, Inlet.

Location and Stream Data		.	Crossing Characteristics	–
Date	2023-10-03	Crossing Sub Type	Round Culvert	
PSCIS ID	199310	Diameter (m)	2	
External ID	13900283	Length (m)	14	
Crew	AI	Embedded	No	
UTM Zone	10	Depth Embedded (m)	–	
Easting	558697	Resemble Channel	No	
Northing	5995816	Backwatered	Yes	
Stream	Tributary to Aleza Lake	Percent Backwatered	100	
Road	Upper Fraser Rd	Fill Depth (m)	2.5	
Road Tenure	MOTI	Outlet Drop (m)	0	
Channel Width (m)	2.5	Outlet Pool Depth (m)	0.7	
Stream Slope (%)	0	Inlet Drop	No	
Beaver Activity	Yes	Slope (%)	0	
Habitat Value	Medium	Valley Fill	Deep Fill	
Final score	13	Barrier Result	Passable	
Fix type	–	Fix Span / Diameter	–	
Comments: Two pipes each with 1m diameter on the south side of the railway. It is not clear where the stream crosses under the railway upstream, this crossing still needs to be assessed. Agricultural field located upstream with what appears to be very minimal riparian buffer. Stream has been channelized beside the railway. A 1m overflow pipe has been installed above the level of the other 2 pipes. MoTi chris_culvert_id: 1994283, 1994682, 1994683. 18:08:11

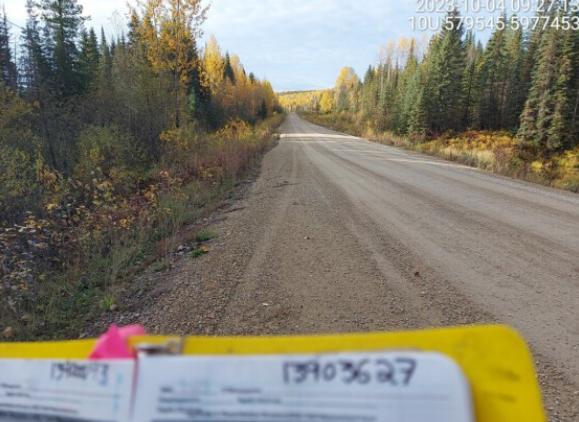
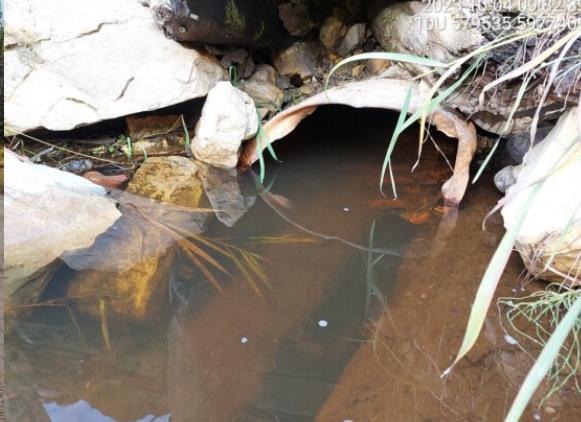
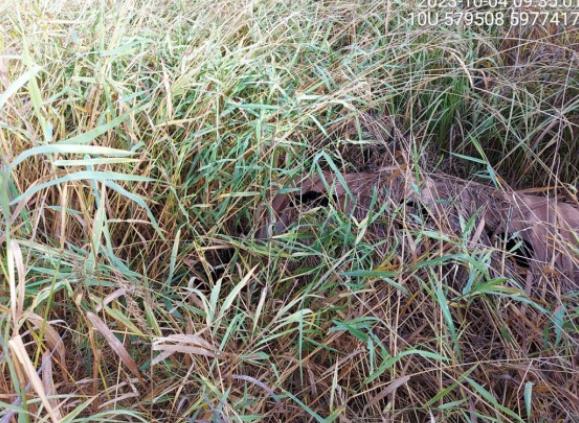
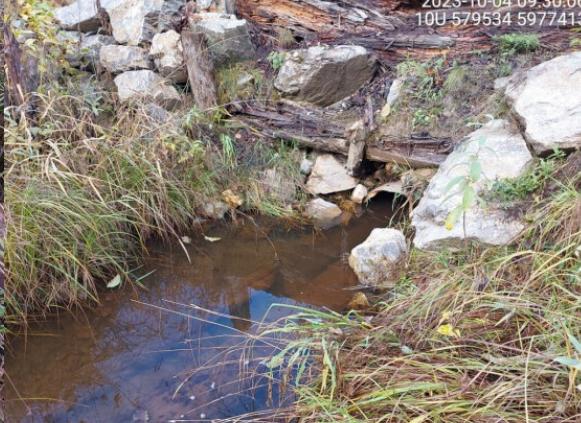
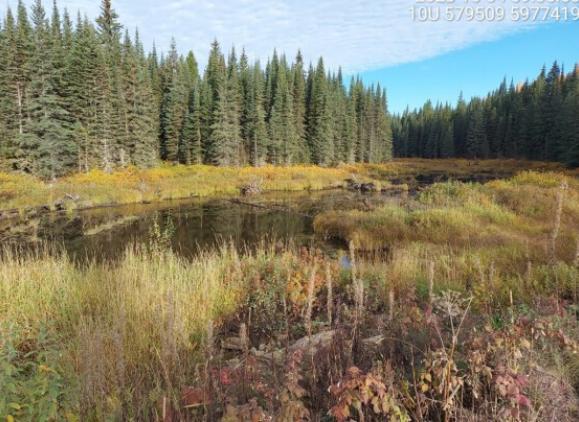
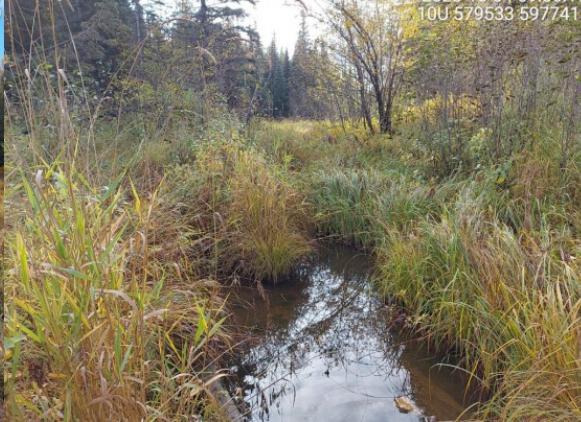
Photos: PSCIS ID 13903627. From top left clockwise: Road/Site Card, Barrel, Outlet, Downstream, Upstream, Inlet.

Location and Stream Data		.	Crossing Characteristics	-
Date	2023-10-04		Crossing Sub Type	Round Culvert
PSCIS ID	199311		Diameter (m)	0.7
External ID	13903627		Length (m)	16
Crew	MW		Embedded	No
UTM Zone	10		Depth Embedded (m)	-
Easting	579525		Resemble Channel	No
Northing	5977412		Backwatered	Yes
Stream	Tributary to Kenneth Creek		Percent Backwatered	100
Road	Bowron FSR		Fill Depth (m)	1.5
Road Tenure	MOF 7141		Outlet Drop (m)	0
Channel Width (m)	2.1		Outlet Pool Depth (m)	0
Stream Slope (%)	0		Inlet Drop	No
Beaver Activity	No		Slope (%)	1
Habitat Value	Low		Valley Fill	Deep Fill
Final score	24		Barrier Result	Barrier
Fix type	Replace with New Open Bottom Structure		Fix Span / Diameter	15

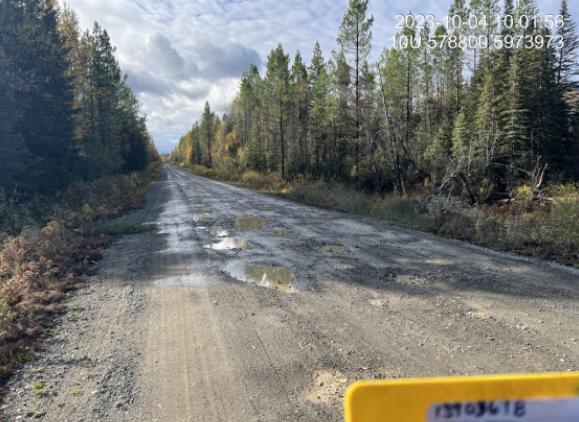
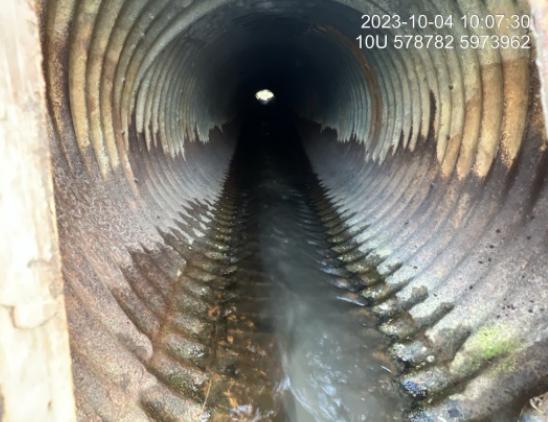
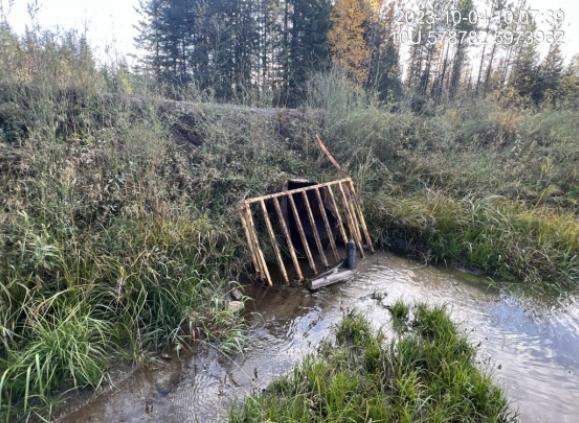
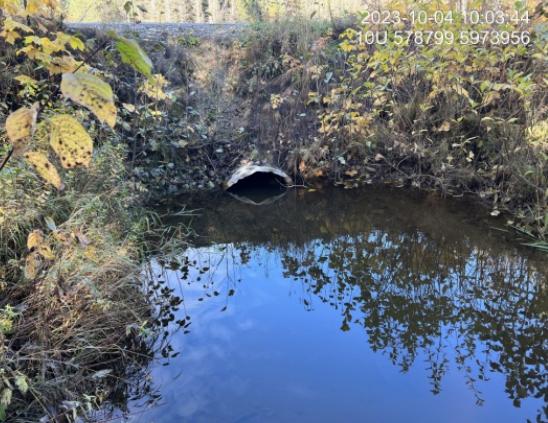
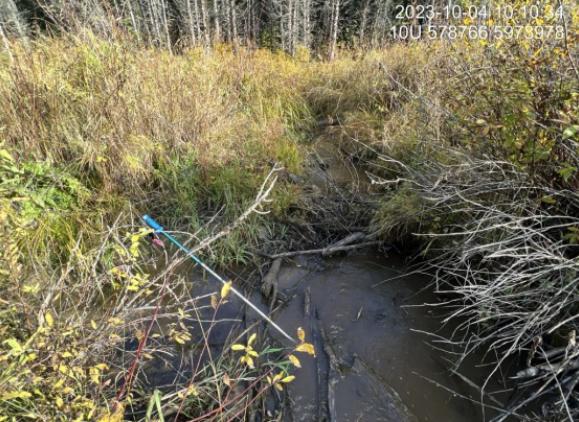
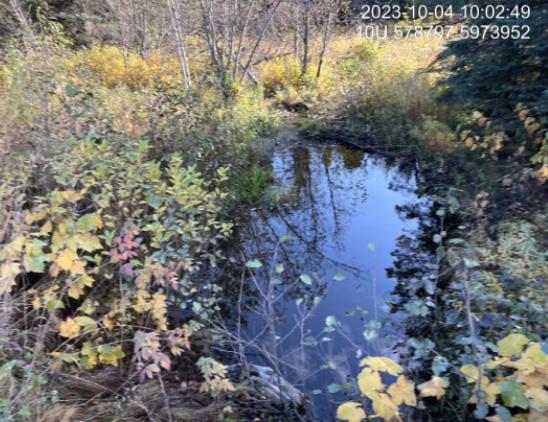
Photos: PSCIS ID 13903618. From top left clockwise: Road/Site Card, Barrel, Outlet, Downstream, Upstream, Inlet.

Location and Stream Data		Crossing Characteristics	
Date	2023-10-04	Crossing Sub Type	Round Culvert
PSCIS ID	199312	Diameter (m)	0.9
External ID	13903618	Length (m)	18
Crew	AI	Embedded	No
UTM Zone	10	Depth Embedded (m)	–
Easting	578804	Resemble Channel	No
Northing	5973956	Backwatered	Yes
Stream	Tributary to Kenneth Creek	Percent Backwatered	50
Road	Bowron FSR	Fill Depth (m)	1.4
Road Tenure	MOF 7141	Outlet Drop (m)	0
Channel Width (m)	1.8	Outlet Pool Depth (m)	0.5
Stream Slope (%)	1.5	Inlet Drop	No
Beaver Activity	Yes	Slope (%)	4
Habitat Value	Medium	Valley Fill	Deep Fill
Final score	29	Barrier Result	Barrier
Fix type	Replace Structure with Streambed Simulation CBS	Fix Span / Diameter	3

Comments: Wetland lake area upstream with small channels threaded through it. Beaver grate on culvert inlet and pipe is in poor shape as it is rusted and bent out of shape. Outlet backwater for 40%. Small stream with some flow.. 10:14:44

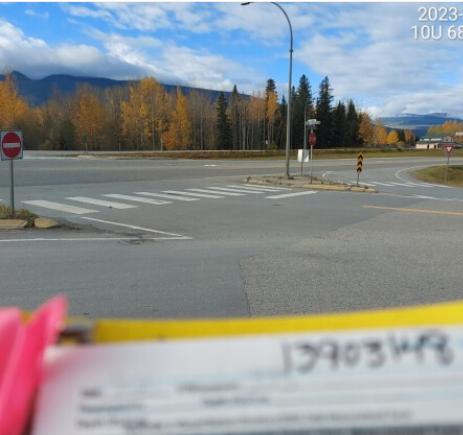
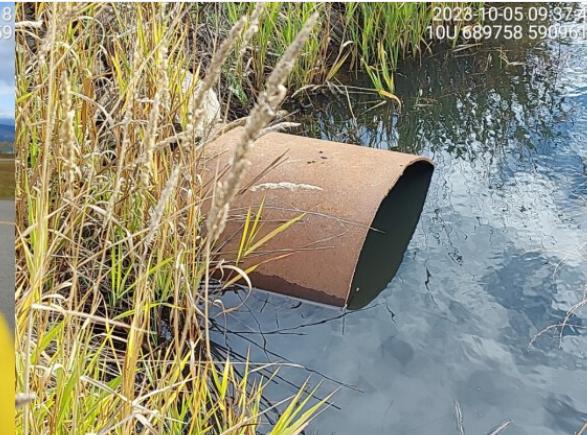
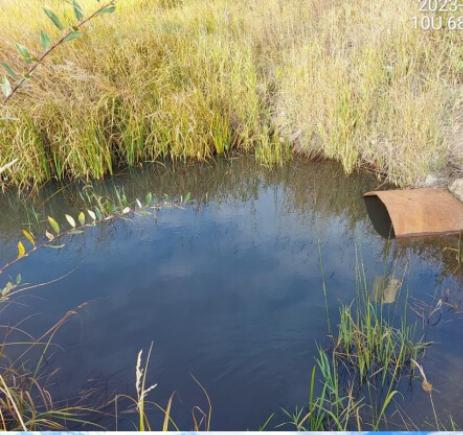
Photos: PSCIS ID 13903148. From top left clockwise: Road/Site Card, Barrel, Outlet, Downstream, Upstream, Inlet.

Location and Stream Data		Crossing Characteristics	
Date	2023-10-05	Crossing Sub Type	Round Culvert
PSCIS ID	199314	Diameter (m)	1.05
External ID	13903148	Length (m)	32
Crew	MW	Embedded	No
UTM Zone	10	Depth Embedded (m)	–
Easting	689760	Resemble Channel	No
Northing	5909638	Backwatered	Yes
Stream	Dominion Creek	Percent Backwatered	100
Road	Highway 16	Fill Depth (m)	1.3
Road Tenure	MOTI	Outlet Drop (m)	0
Channel Width (m)	2.9	Outlet Pool Depth (m)	0
Stream Slope (%)	0	Inlet Drop	No
Beaver Activity	No	Slope (%)	0
Habitat Value	Low	Valley Fill	Deep Fill
Final score	22	Barrier Result	Barrier
Fix type	Replace with New Open Bottom Structure	Fix Span / Diameter	15

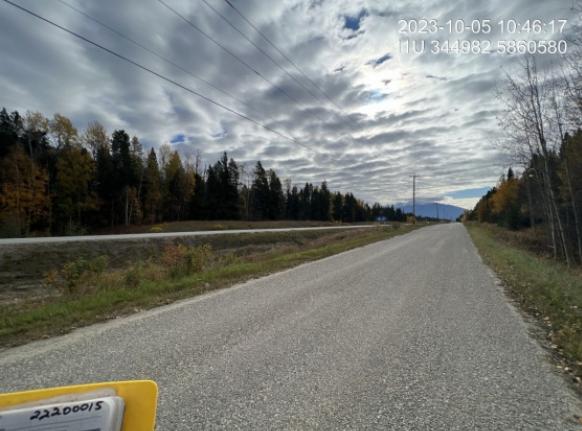
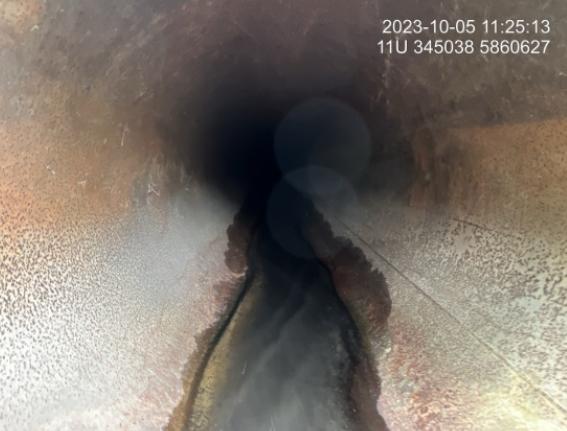
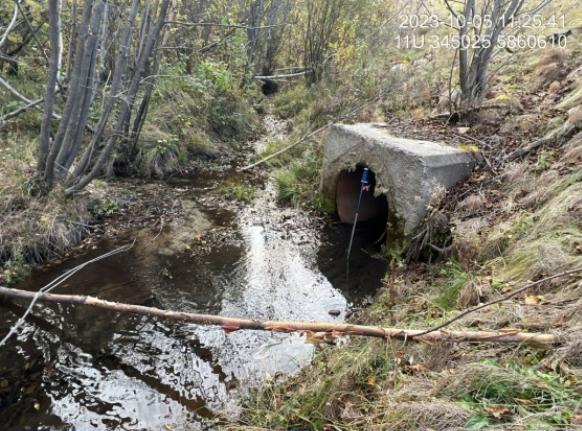
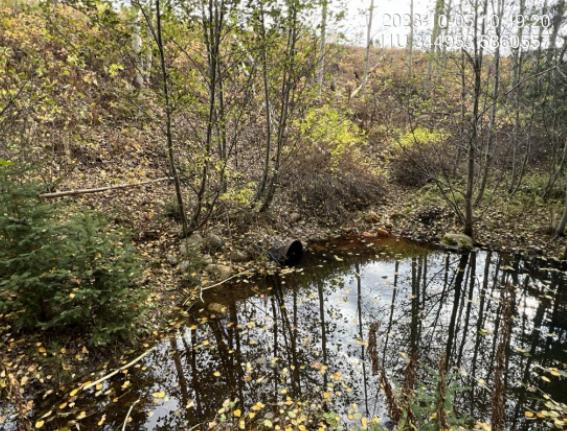
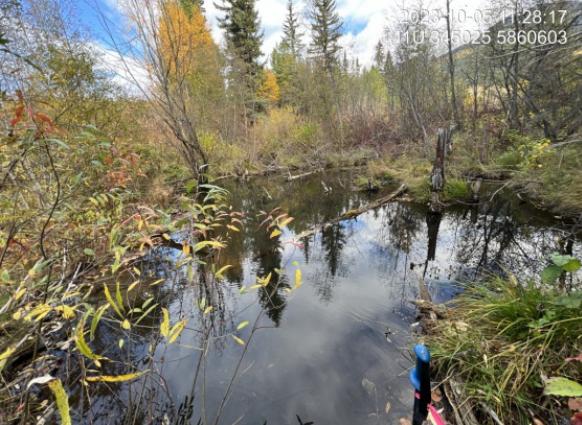
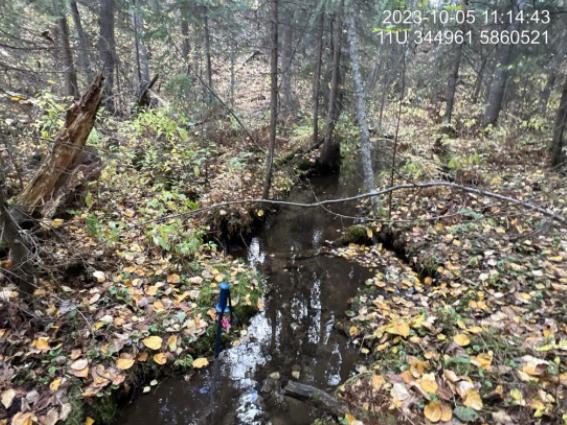
Location and Stream Data	.	Crossing Characteristics	-
Date	2023-10-05	Crossing Sub Type	Round Culvert
PSCIS ID	199315	Diameter (m)	0.9
External ID	22200015	Length (m)	67
Crew	AI	Embedded	No
UTM Zone	11	Depth Embedded (m)	-
Easting	345011	Resemble Channel	No
Northing	5860593	Backwatered	Yes
Stream	Crooked Creek	Percent Backwatered	10
Road	Highway 5	Fill Depth (m)	7.5
Road Tenure	MOTI	Outlet Drop (m)	0
Channel Width (m)	1.8	Outlet Pool Depth (m)	1
Stream Slope (%)	1.5	Inlet Drop	No
Beaver Activity	Yes	Slope (%)	3
Habitat Value	Medium	Valley Fill	Deep Fill
Final score	32	Barrier Result	Barrier
Fix type	Replace Structure with Streambed Simulation CBS	Fix Span / Diameter	3

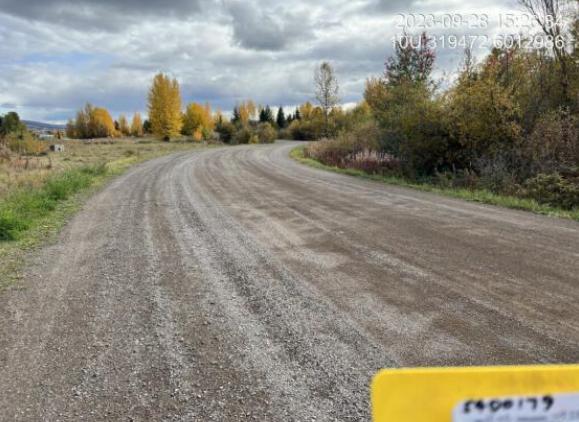
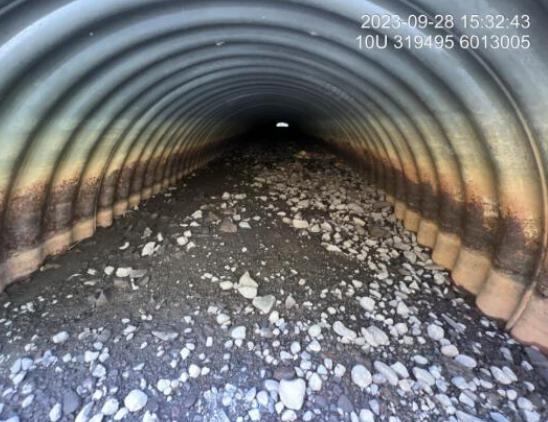
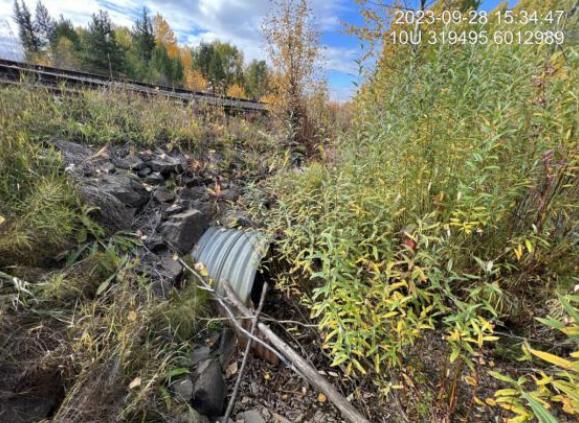
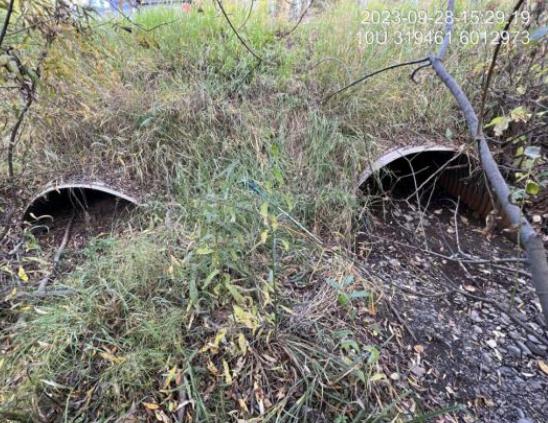
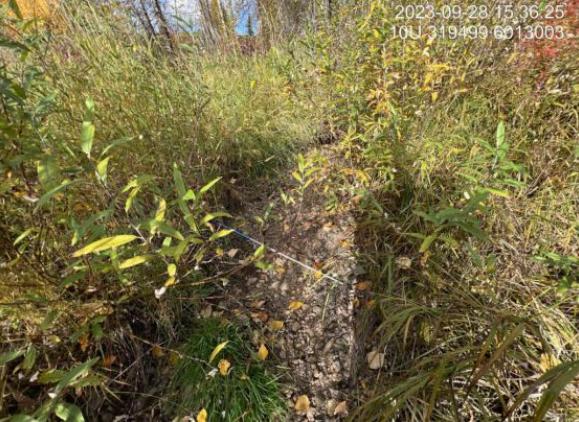
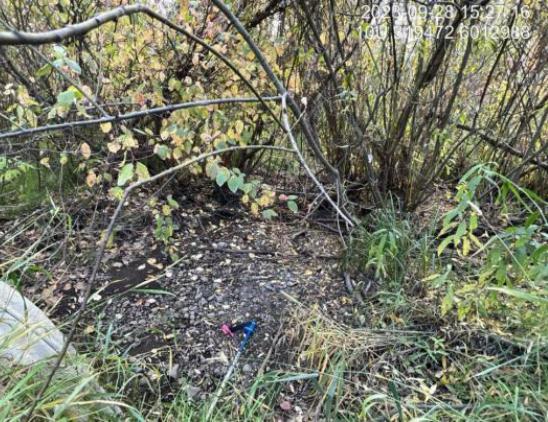
Photos: PSCIS ID 5400179. From top left clockwise: Road/Site Card, Barrel, Outlet, Downstream, Upstream, Inlet.

Location and Stream Data		•	Crossing Characteristics	–
Date	2023-09-28	Crossing Sub Type	Round Culvert	
PSCIS ID	199316	Diameter (m)	4.5	
External ID	5400179	Length (m)	38	
Crew	AI	Embedded	Yes	
UTM Zone	10	Depth Embedded (m)	0.75	
Easting	319471	Resemble Channel	Yes	
Northing	6012988	Backwatered	No	
Stream	Sauls Creek	Percent Backwatered	–	
Road	Railway Avenue	Fill Depth (m)	1.5	
Road Tenure	Burns Lake	Outlet Drop (m)	0	
Channel Width (m)	2.8	Outlet Pool Depth (m)	0	
Stream Slope (%)	0	Inlet Drop	No	
Beaver Activity	Yes	Slope (%)	0	
Habitat Value	Medium	Valley Fill	Deep Fill	
Final score	11	Barrier Result	Passable	
Fix type	–	Fix Span / Diameter	–	
Comments: There are three 1.5m pipes located under Railway Avenue continuing all the way under the railway line. Pipes are embedded at or more than 50% of their depth. Stream was dry at the time of assessment and scoured channels indicate a fairly small system.. 15:25:25

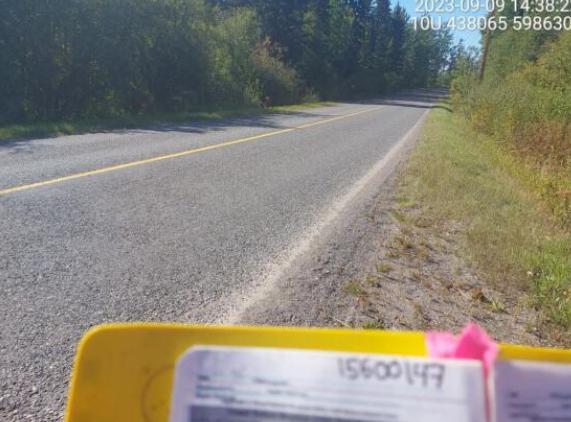
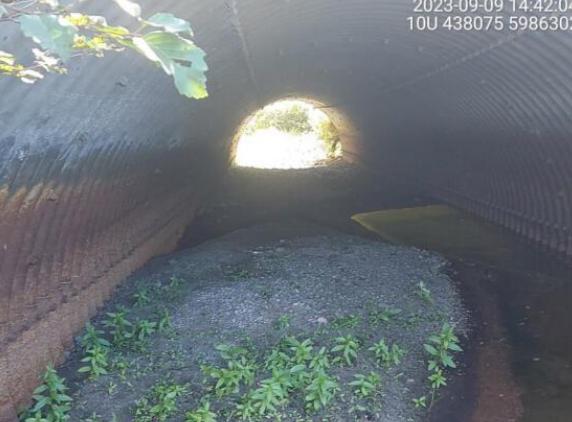
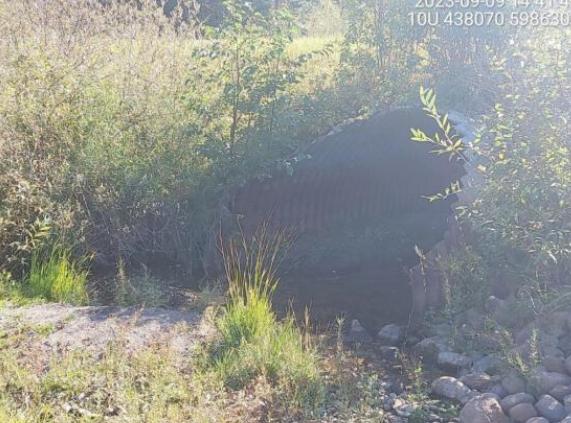
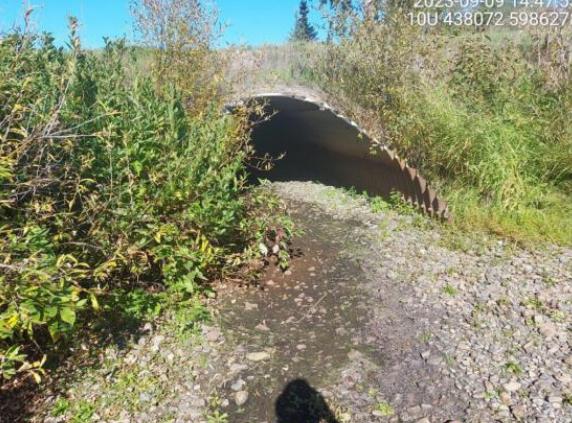
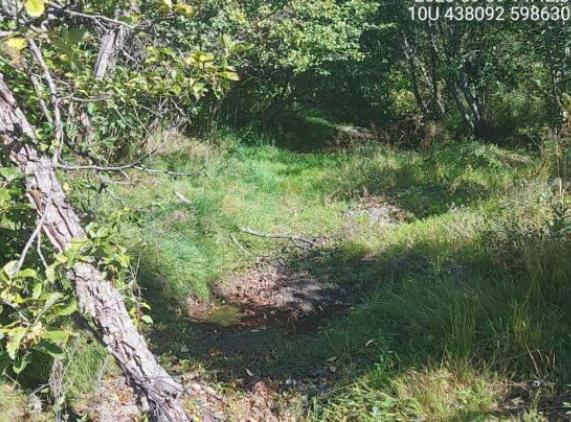
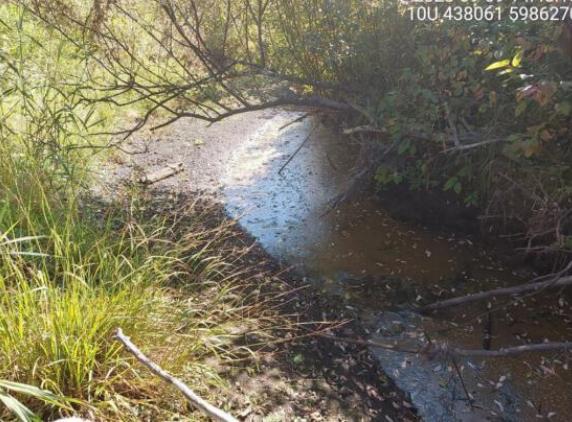
Photos: PSCIS ID 15600147. From top left clockwise: Road/Site Card, Barrel, Outlet, Downstream, Upstream, Inlet.

Location and Stream Data		.	Crossing Characteristics	-
Date	2023-09-09	Crossing Sub Type	Round Culvert	
PSCIS ID	199317	Diameter (m)	2.7	
External ID	15600147	Length (m)	16	
Crew	MW	Embedded	Yes	
UTM Zone	10	Depth Embedded (m)	0.3	
Easting	438071	Resemble Channel	No	
Northing	5986296	Backwatered	No	
Stream	Knight Creek	Percent Backwatered	-	
Road	Sickness Road	Fill Depth (m)	0.5	
Road Tenure	Vanderhoof	Outlet Drop (m)	0	
Channel Width (m)	1.9	Outlet Pool Depth (m)	0	
Stream Slope (%)	2	Inlet Drop	No	
Beaver Activity	No	Slope (%)	1	
Habitat Value	Medium	Valley Fill	Deep Fill	
Final score	13	Barrier Result	Passable	
Fix type	-	Fix Span / Diameter	-	
Comments: No water in pipe. Periodic pools of standing water upstream and downstream but no flowing water. NEWWS has completed restoration work for this site with sign posted at this location. Culvert appears fully embedded in photos so have changed inputs to reflect this.. 14:51:44

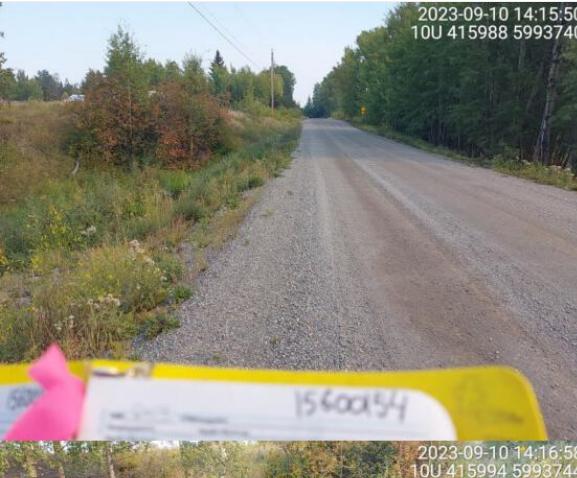
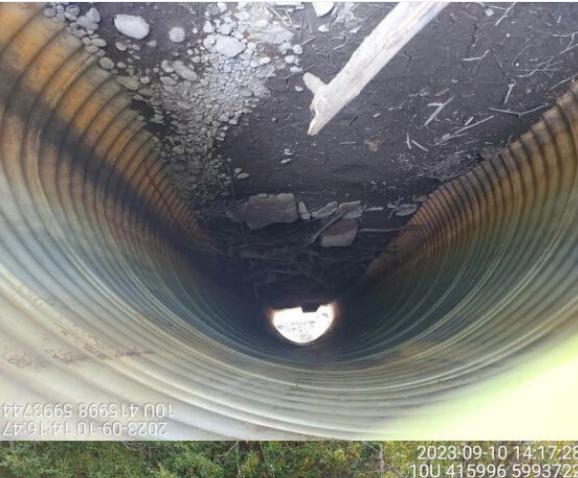
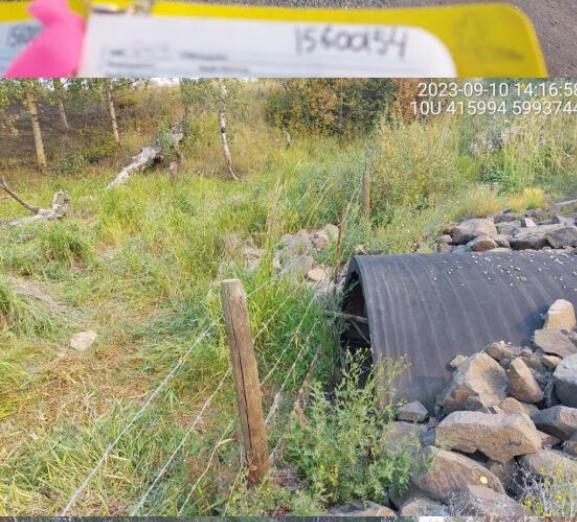
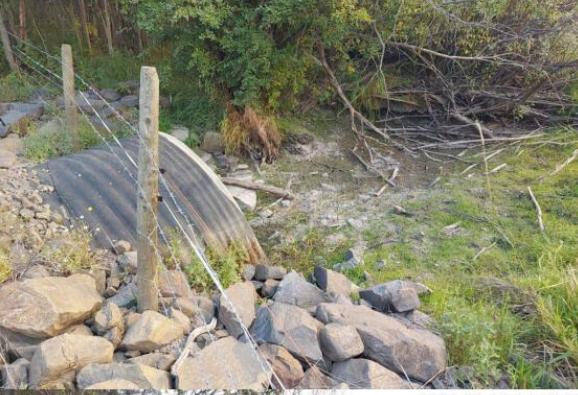
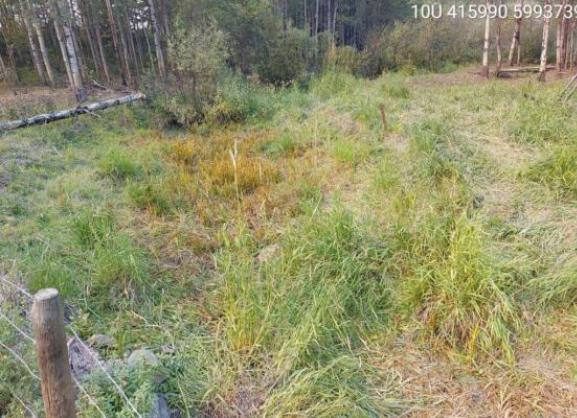
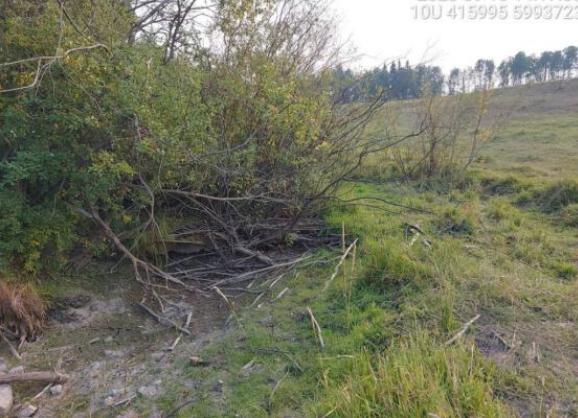
Photos: PSCIS ID 15600154. From top left clockwise: Road/Site Card, Barrel, Outlet, Downstream, Upstream, Inlet.

Location and Stream Data		Crossing Characteristics	
	.		-
Date	2023-09-10	Crossing Sub Type	Round Culvert
PSCIS ID	199318	Diameter (m)	1
External ID	15600154	Length (m)	16
Crew	MW	Embedded	Yes
UTM Zone	10	Depth Embedded (m)	0.1
Easting	416009	Resemble Channel	No
Northing	5993732	Backwatered	No
Stream	Trankle Creek	Percent Backwatered	-
Road	Braeside Rd	Fill Depth (m)	1
Road Tenure	MOTI	Outlet Drop (m)	0
Channel Width (m)	1	Outlet Pool Depth (m)	0
Stream Slope (%)	2	Inlet Drop	No
Beaver Activity	No	Slope (%)	1
Habitat Value	Low	Valley Fill	Deep Fill
Final score	16	Barrier Result	Potential
Fix type	Replace Structure with Streambed Simulation CBS	Fix Span / Diameter	3

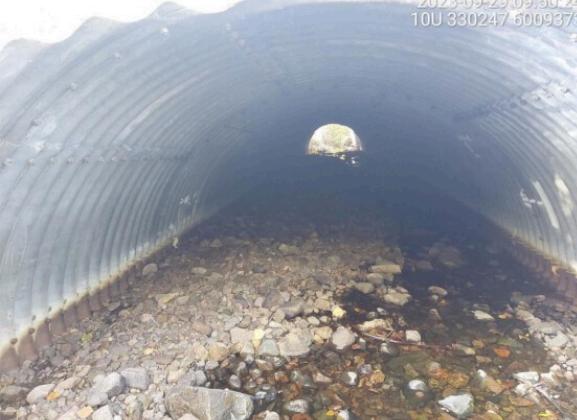
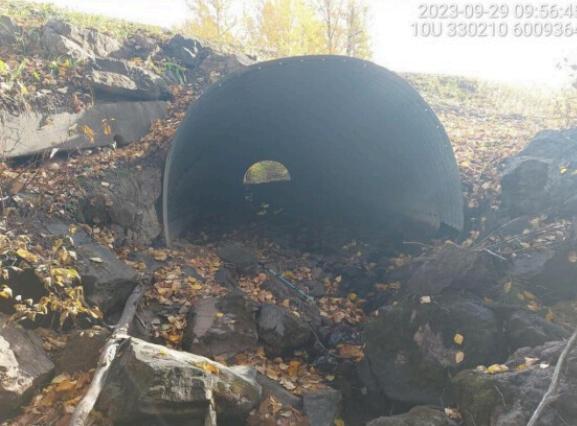
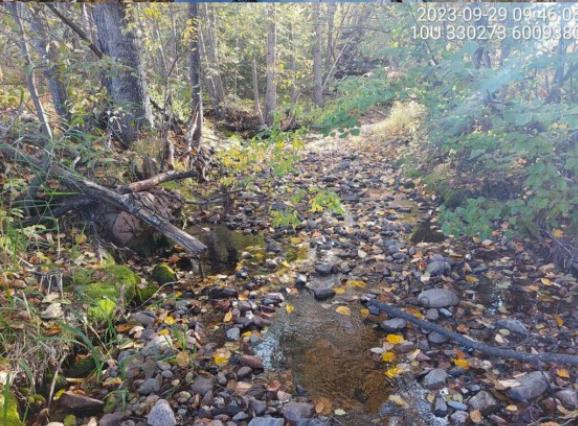
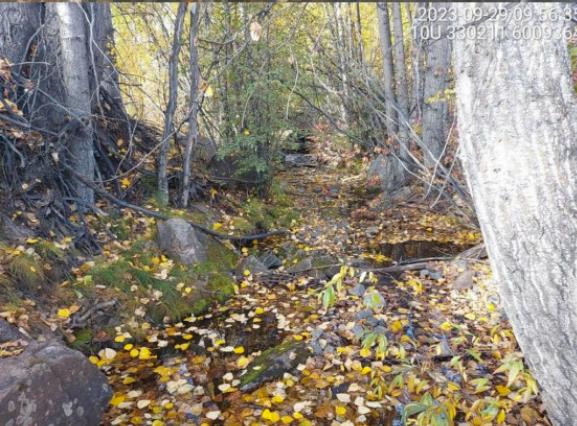
Photos: PSCIS ID 5400028. From top left clockwise: Road/Site Card, Barrel, Outlet, Downstream, Upstream, Inlet.

Comments: Wide channel, nicely installed moti major structure that appears passable as fully embedded. 3m falls noted in FISS as 1.3 km upstream. Railway crossing just downstream noted as passable in bcfishpass. MoTi chris_hwy_structure_road_id: 3811. 09:56:11

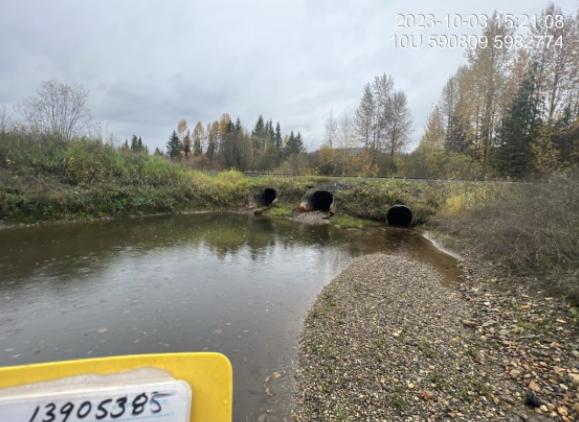
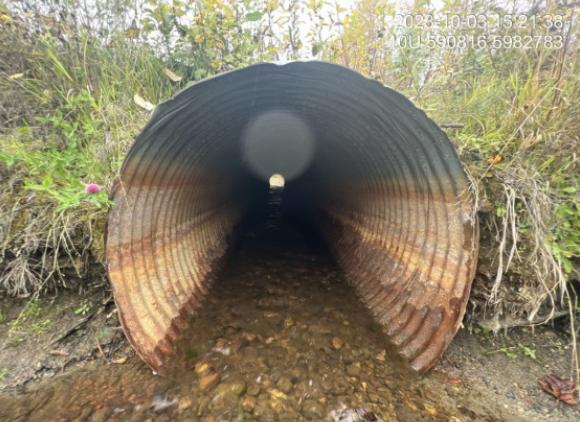
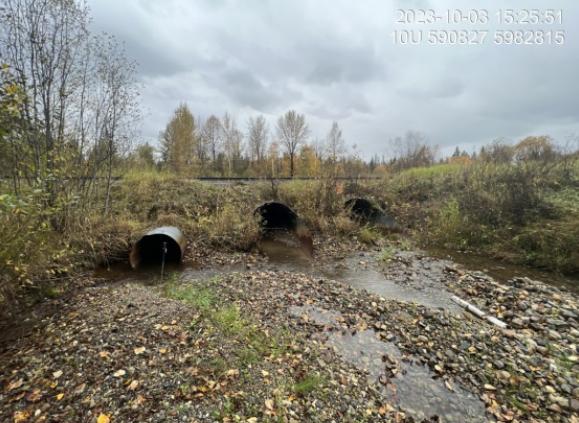
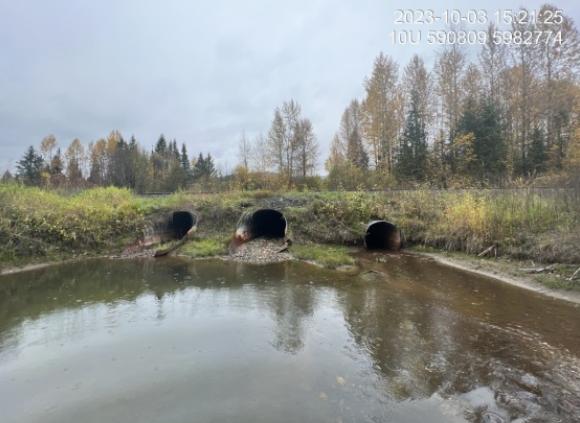
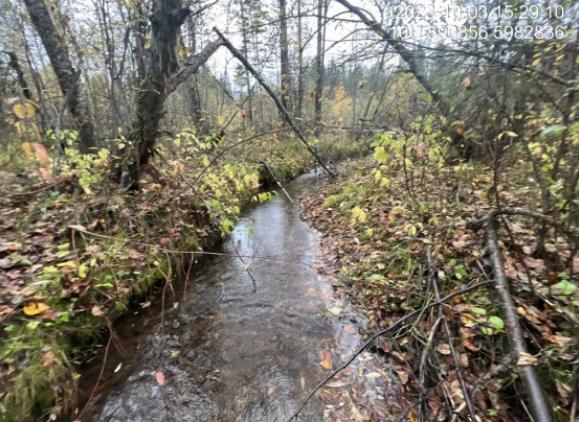
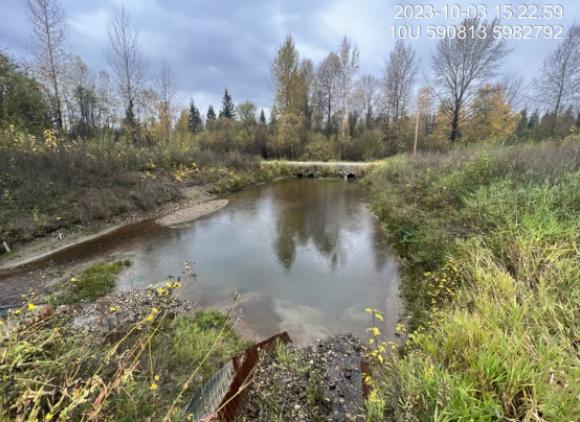
Location and Stream Data		•	Crossing Characteristics	–
Date	2023-10-03	Crossing Sub Type	Round Culvert	
PSCIS ID	199320	Diameter (m)	4.8	
External ID	13905385	Length (m)	18	
Crew	AI	Embedded	Yes	
UTM Zone	10	Depth Embedded (m)	0.25	
Easting	590814	Resemble Channel	Yes	
Northing	5982800	Backwatered	No	
Stream	Wolfe Creek	Percent Backwatered	–	
Road	Railway	Fill Depth (m)	2	
Road Tenure	CN Rail	Outlet Drop (m)	0	
Channel Width (m)	3.3	Outlet Pool Depth (m)	0.1	
Stream Slope (%)	1.5	Inlet Drop	No	
Beaver Activity	Yes	Slope (%)	0	
Habitat Value	High	Valley Fill	Deep Fill	
Final score	8	Barrier Result	Passable	
Fix type	–	Fix Span / Diameter	–	
Comments: Fully embedded pipes. Three pipes total, with two at 1.8 m and one at 1.2m in diameter. Nice habitat upstream with abundant gravels, some deeper pools and deeply undercut banks.. 15:31:23				
Photos: PSCIS ID 13905385. From top left clockwise: Road/Site Card, Barrel, Outlet, Downstream, Upstream, Inlet.

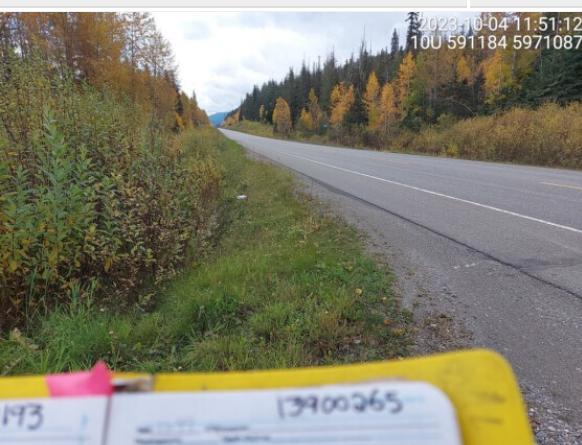
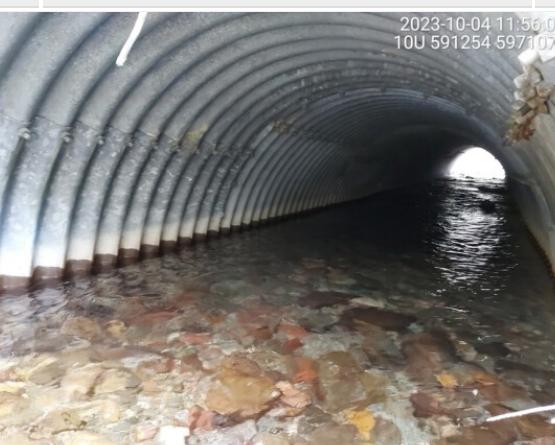
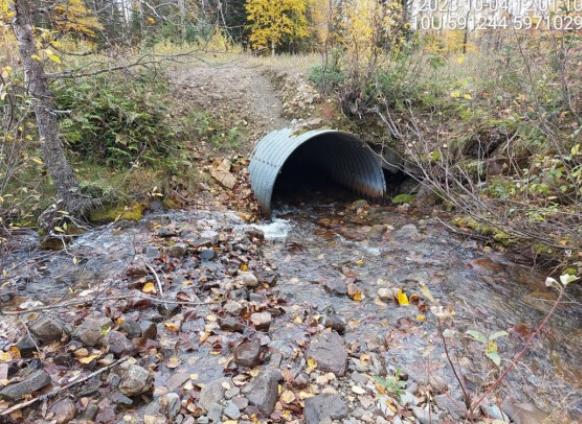
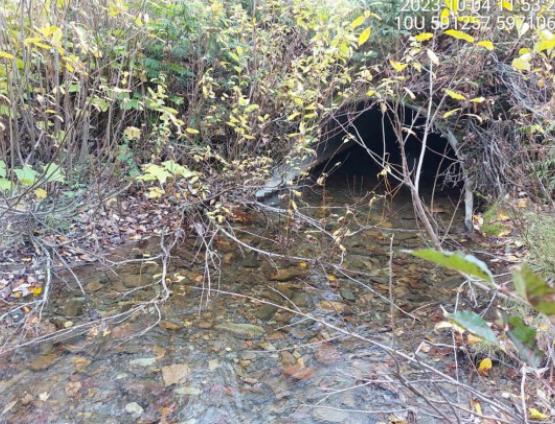
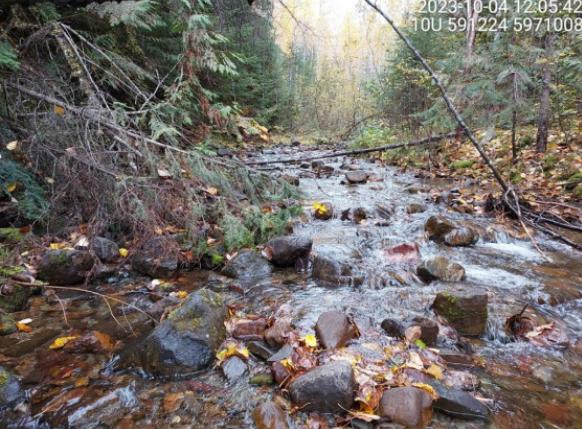
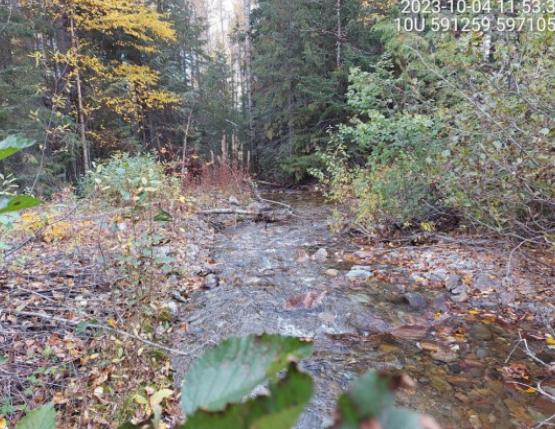
Photos: PSCIS ID 13900265. From top left clockwise: Road/Site Card, Barrel, Outlet, Downstream, Upstream, Inlet.

Location and Stream Data		Crossing Characteristics	
Date	2023-10-04	Crossing Sub Type	Round Culvert
PSCIS ID	199321	Diameter (m)	2
External ID	13900265	Length (m)	22
Crew	MW	Embedded	Yes
UTM Zone	10	Depth Embedded (m)	0.25
Easting	591253	Resemble Channel	No
Northing	5971048	Backwatered	No
Stream	Sugarbowl Creek	Percent Backwatered	—
Road	Highway 16	Fill Depth (m)	0.8
Road Tenure	MOTI	Outlet Drop (m)	0
Channel Width (m)	6.2	Outlet Pool Depth (m)	0
Stream Slope (%)	5.5	Inlet Drop	No
Beaver Activity	No	Slope (%)	1
Habitat Value	High	Valley Fill	Deep Fill
Final score	19	Barrier Result	Potential
Fix type	Replace with New Open Bottom Structure	Fix Span / Diameter	15
