Appendix - Phase 1 Fish Passage Assessment Data and Photos

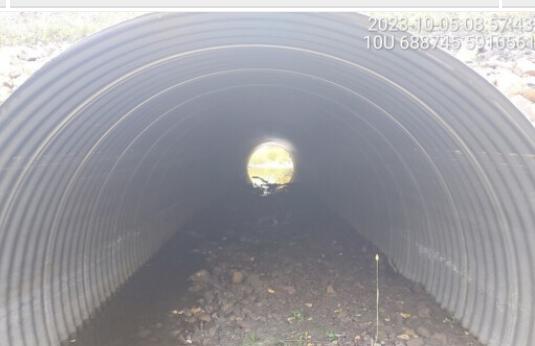
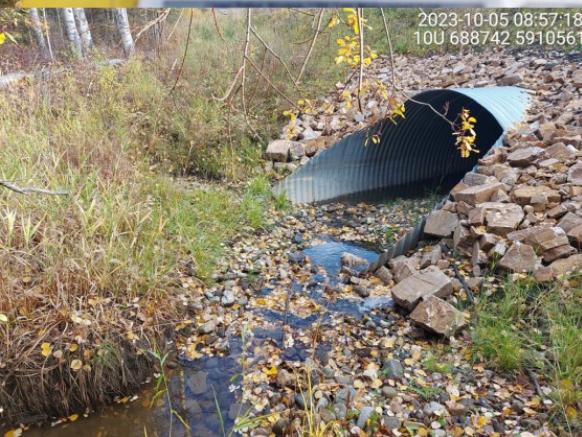
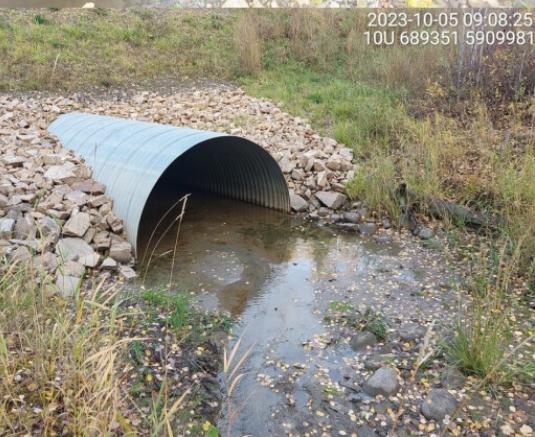
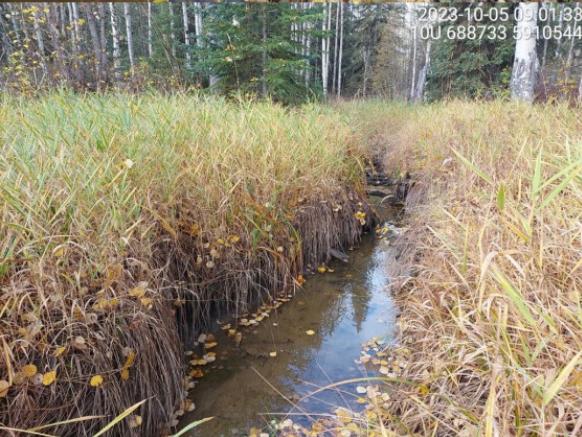
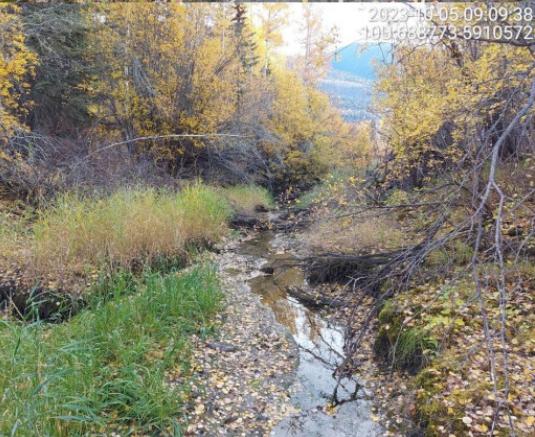
Photos: PSCIS ID 13900025. From top left clockwise: Road/Site Card, Barrel, Outlet, Downstream, Upstream, Inlet.

Location and Stream Data	.	Crossing Characteristics	—
Date	2023-10-05	Crossing Sub Type	Round Culvert
PSCIS ID	199322	Diameter (m)	3
External ID	13900025	Length (m)	27
Crew	MW	Embedded	Yes
UTM Zone	10	Depth Embedded (m)	0.15
Easting	688754	Resemble Channel	No
Northing	5910557	Backwatered	No
Stream	Shelby Creek	Percent Backwatered	—
Road	Airport Rd	Fill Depth (m)	2.2
Road Tenure	McBride	Outlet Drop (m)	0
Channel Width (m)	1.4	Outlet Pool Depth (m)	0
Stream Slope (%)	2	Inlet Drop	No
Beaver Activity	No	Slope (%)	3
Habitat Value	Medium	Valley Fill	Deep Fill
Final score	18	Barrier Result	Potential
Fix type	Replace Structure with Streambed Simulation CBS	Fix Span / Diameter	3

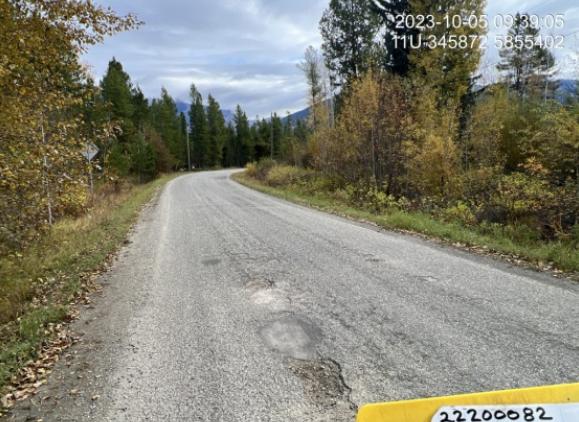
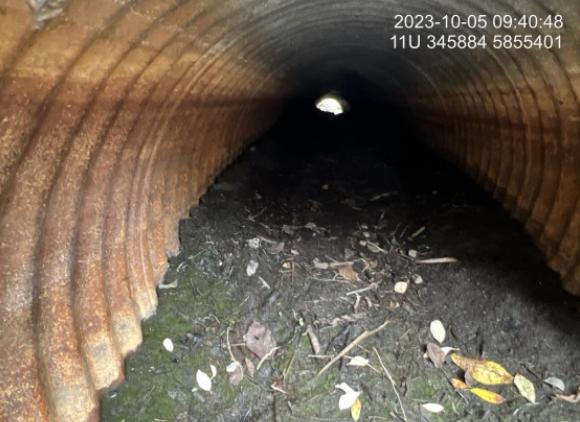
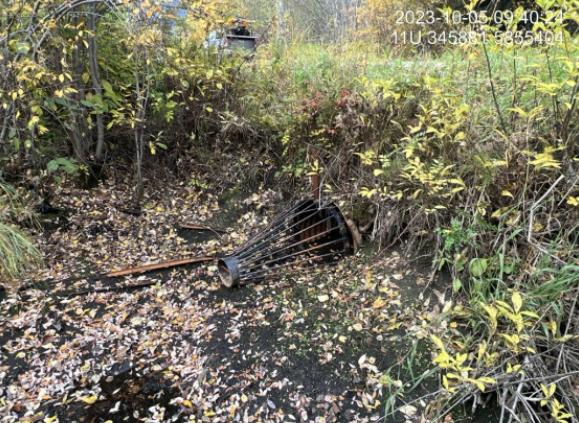
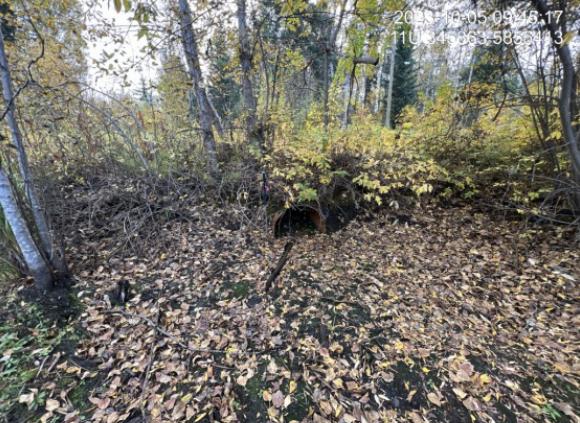
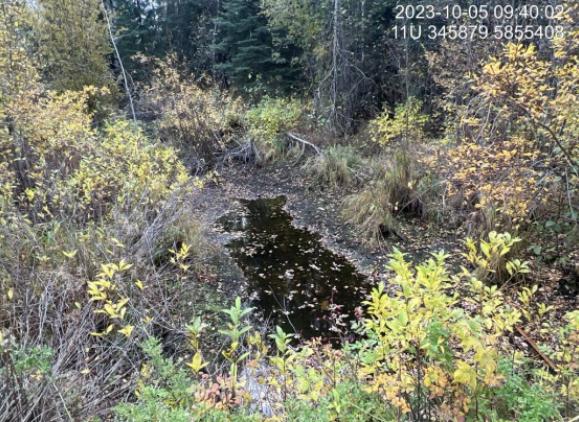
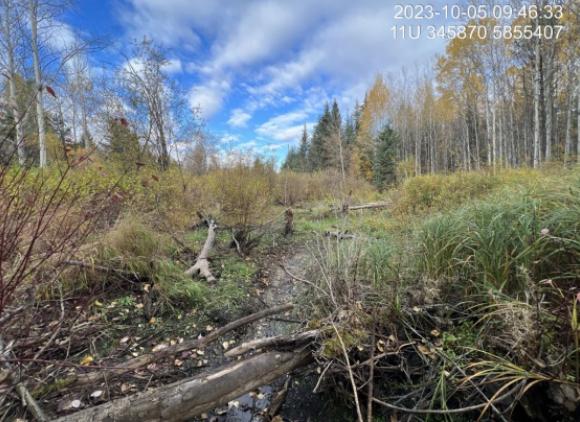
Photos: PSCIS ID 22200082. From top left clockwise: Road/Site Card, Barrel, Outlet, Downstream, Upstream, Inlet.

Location and Stream Data		•	Crossing Characteristics	–
Date	2023-10-05	Crossing Sub Type	Round Culvert	
PSCIS ID	199323	Diameter (m)	0.75	
External ID	22200082	Length (m)	12	
Crew	AI	Embedded	Yes	
UTM Zone	11	Depth Embedded (m)	0.18	
Easting	345873	Resemble Channel	Yes	
Northing	5855411	Backwatered	No	
Stream	Cranberry Creek	Percent Backwatered	–	
Road	Cranberry Lake Road	Fill Depth (m)	1	
Road Tenure	MOTI	Outlet Drop (m)	0	
Channel Width (m)	4	Outlet Pool Depth (m)	0	
Stream Slope (%)	0	Inlet Drop	No	
Beaver Activity	Yes	Slope (%)	0	
Habitat Value	Medium	Valley Fill	Deep Fill	
Final score	11	Barrier Result	Passable	
Fix type	–	Fix Span / Diameter	–	
Comments: Stream is mostly dewatered. Large beaver dam (1.7m high) located approximately 30m upstream. Fully embedded pipe with beaver grate on the inlet. Unassessed crossing on private driveway upstream from here. Adjacent landowner has concerns about the recent lack of water and says it is un-characteristic for the section of stream. They have concerns that recent pipeline construction just upstream of this crossing has potentially influenced beaver populations and water flow.. 09:47:05

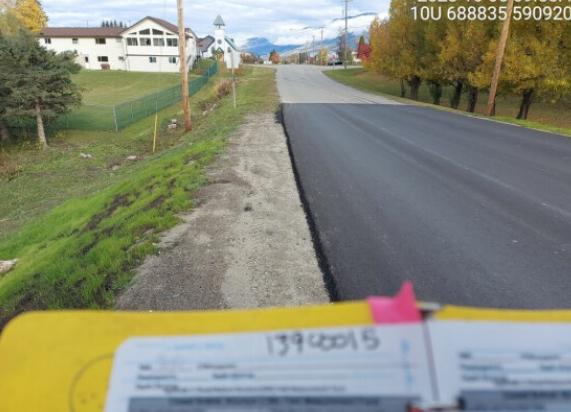
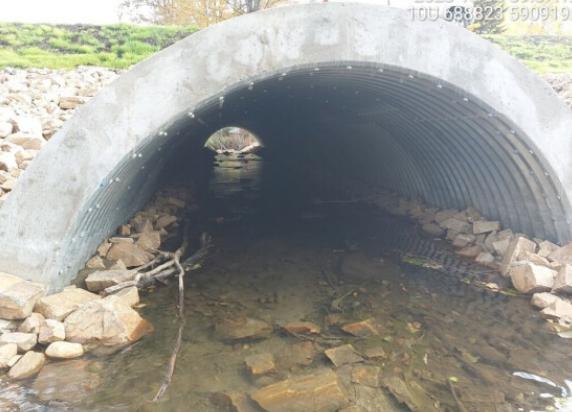
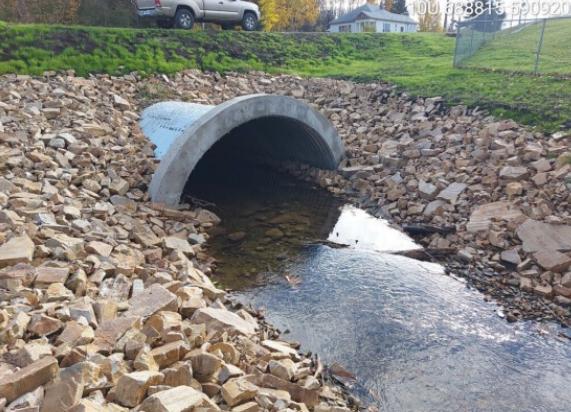
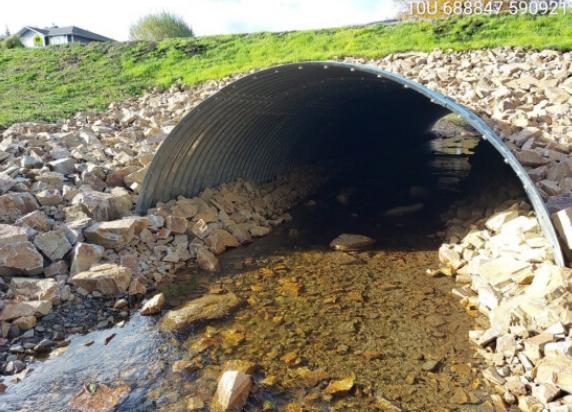
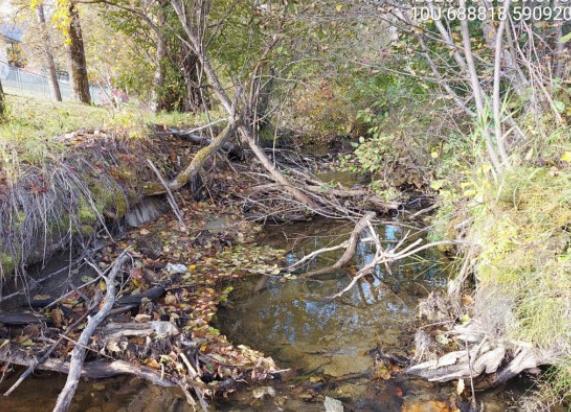
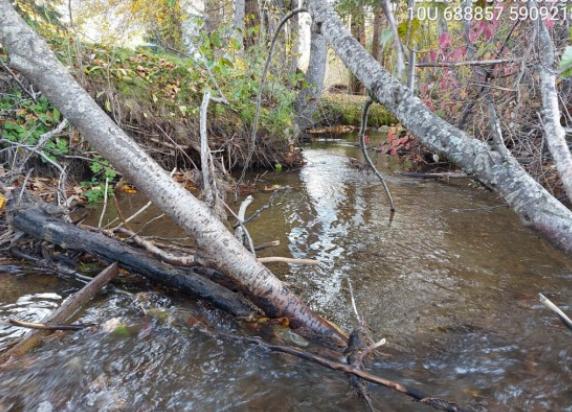
Location and Stream Data		Crossing Characteristics	
Date	2023-10-05	Crossing Sub Type	Round Culvert
PSCIS ID	199324	Diameter (m)	3.7
External ID	13900015	Length (m)	30
Crew	MW	Embedded	Yes
UTM Zone	10	Depth Embedded (m)	0.2
Easting	688844	Resemble Channel	Yes
Northing	5909209	Backwatered	No
Stream	Dominion Creek	Percent Backwatered	-
Road	2nd Ave	Fill Depth (m)	2
Road Tenure	McBride	Outlet Drop (m)	0
Channel Width (m)	3.4	Outlet Pool Depth (m)	0
Stream Slope (%)	0	Inlet Drop	No
Beaver Activity	No	Slope (%)	1
Habitat Value	High	Valley Fill	Deep Fill
Final score	16	Barrier Result	Potential
Fix type	Replace with New Open Bottom Structure	Fix Span / Diameter	15
Comments: Continuously embedded culvert. Wide channel with moderate flow. High value habitat. 10:09:03			
Photos: PSCIS ID 13900015. From top left clockwise: Road/Site Card, Barrel, Outlet, Downstream, Upstream, Inlet.

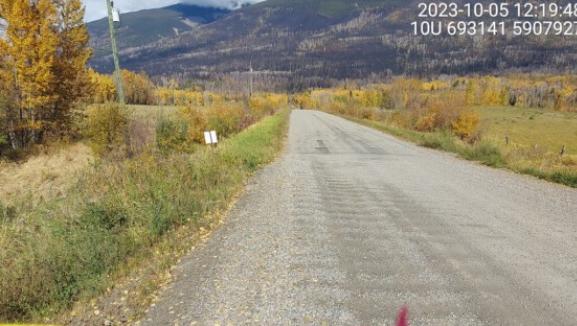
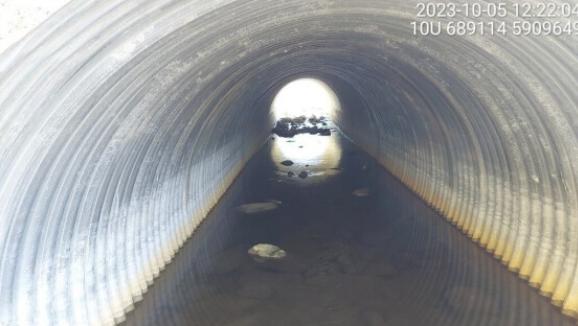
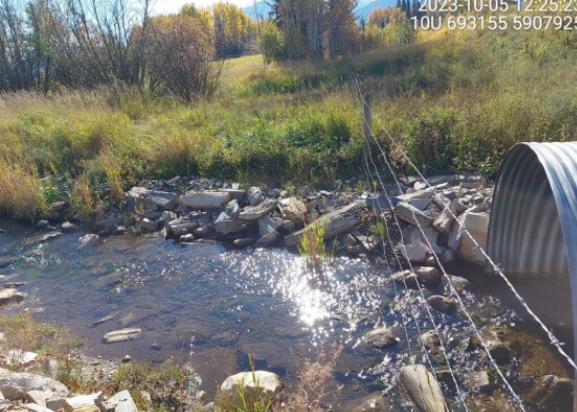
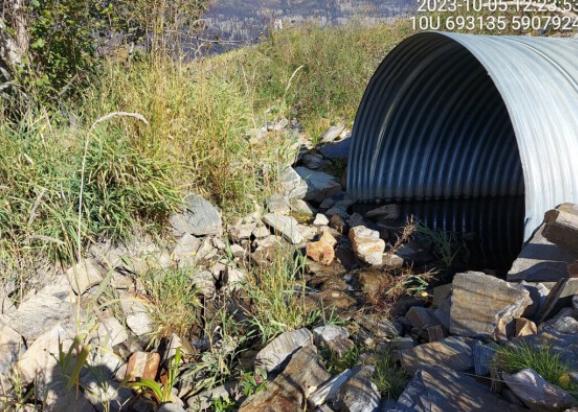
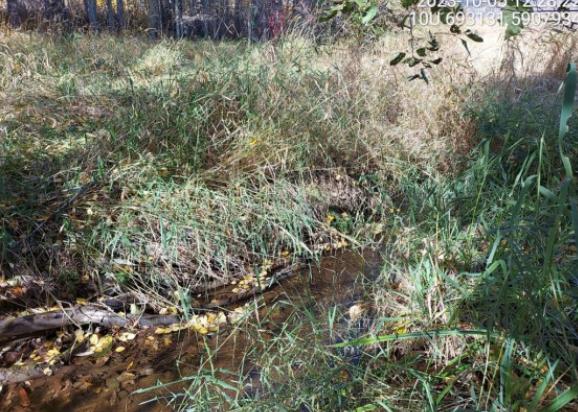
Photos: PSCIS ID 13900073. From top left clockwise: Road/Site Card, Barrel, Outlet, Downstream, Upstream, Inlet.

Location and Stream Data		Crossing Characteristics	
Date	2023-10-05	Crossing Sub Type	Round Culvert
PSCIS ID	199325	Diameter (m)	2.5
External ID	13900073	Length (m)	20
Crew	MW	Embedded	Yes
UTM Zone	10	Depth Embedded (m)	0.3
Easting	693145	Resemble Channel	Yes
Northing	5907919	Backwatered	No
Stream	Teare Creek	Percent Backwatered	—
Road	Jeck Rd	Fill Depth (m)	1.5
Road Tenure	MOTI Local	Outlet Drop (m)	0
Channel Width (m)	3.1	Outlet Pool Depth (m)	0.5
Stream Slope (%)	0	Inlet Drop	No
Beaver Activity	No	Slope (%)	1
Habitat Value	Medium	Valley Fill	Deep Fill
Final score	16	Barrier Result	Potential
Fix type	Replace with New Open Bottom Structure	Fix Span / Diameter	15

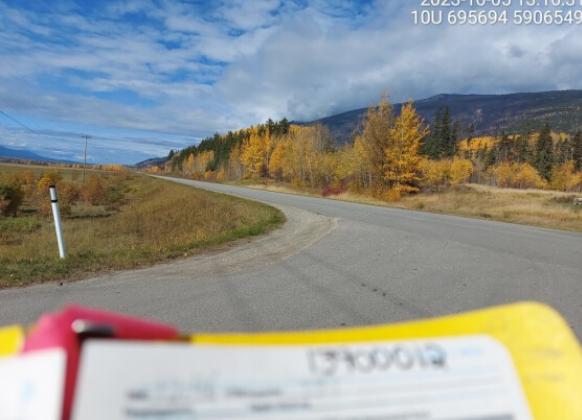
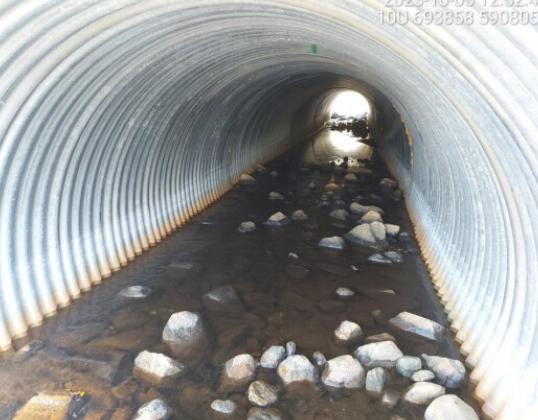
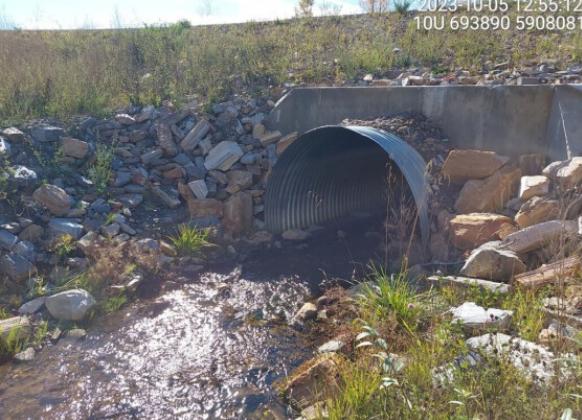
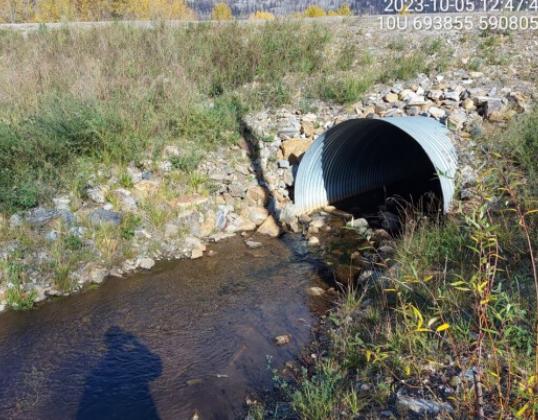
Photos: PSCIS ID 13900012. From top left clockwise: Road/Site Card, Barrel, Outlet, Downstream, Upstream, Inlet.

Location and Stream Data		Crossing Characteristics	
Date	2023-10-05	Crossing Sub Type	Round Culvert
PSCIS ID	199326	Diameter (m)	2.5
External ID	13900012	Length (m)	32
Crew	MW	Embedded	Yes
UTM Zone	10	Depth Embedded (m)	0.2
Easting	693878	Resemble Channel	Yes
Northing	5908064	Backwatered	No
Stream	Teare Creek	Percent Backwatered	—
Road	Highway 16	Fill Depth (m)	2.2
Road Tenure	MOTI	Outlet Drop (m)	0
Channel Width (m)	2.8	Outlet Pool Depth (m)	0
Stream Slope (%)	2	Inlet Drop	No
Beaver Activity	No	Slope (%)	1
Habitat Value	Medium	Valley Fill	Deep Fill
Final score	19	Barrier Result	Potential
Fix type	Replace with New Open Bottom Structure	Fix Span / Diameter	15

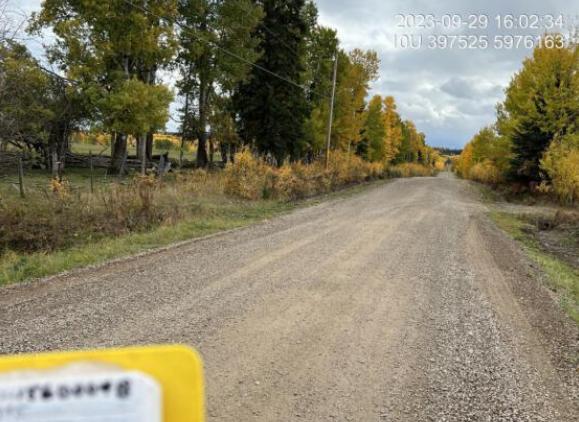
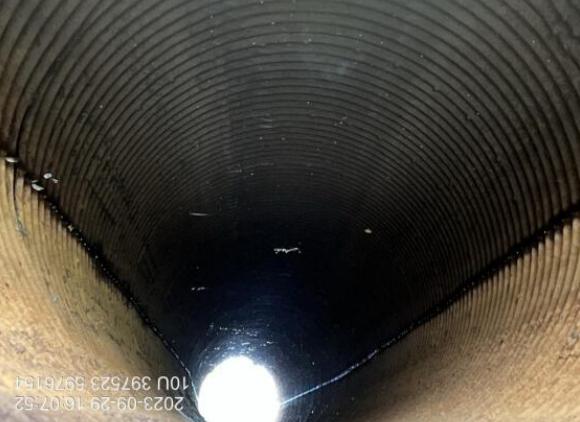
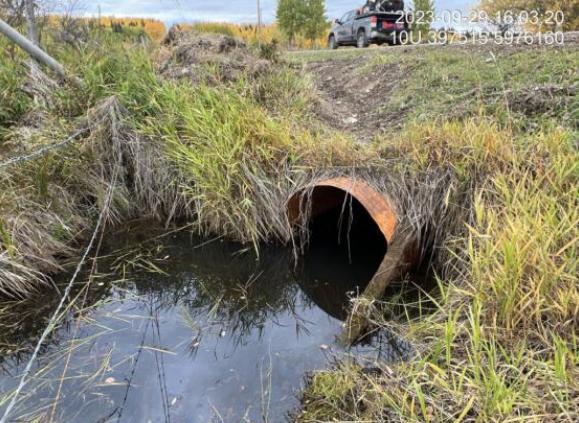
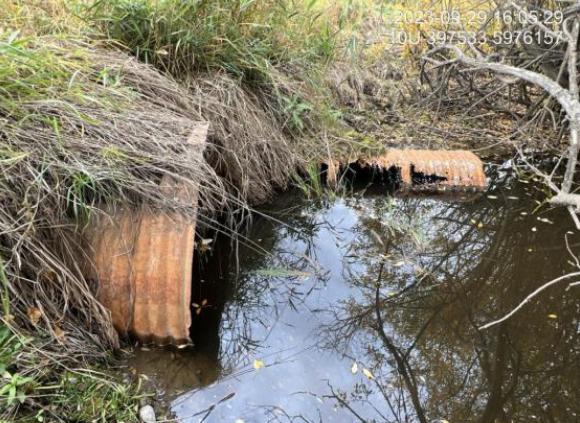
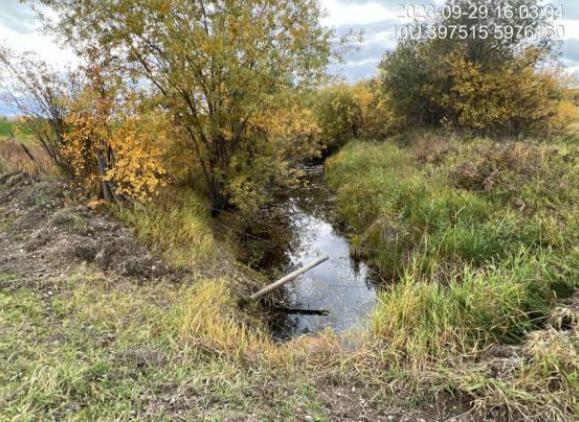
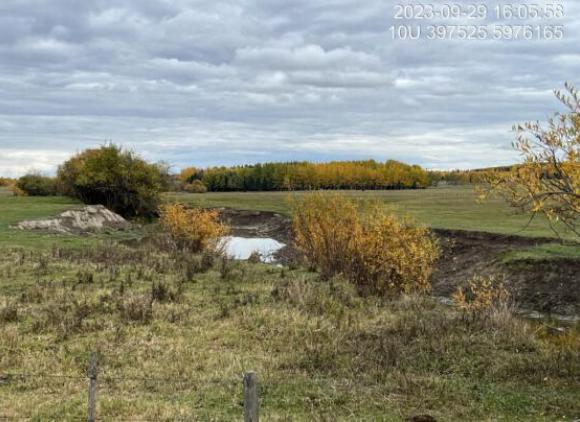
Photos: PSCIS ID 15600048. From top left clockwise: Road/Site Card, Barrel, Outlet, Downstream, Upstream, Inlet.

Location and Stream Data		•	Crossing Characteristics	–
Date	2023-09-29	Crossing Sub Type	Round Culvert	
PSCIS ID	199327	Diameter (m)	1.8	
External ID	15600048	Length (m)	17	
Crew	AI	Embedded	Yes	
UTM Zone	10	Depth Embedded (m)	0.2	
Easting	397528	Resemble Channel	Yes	
Northing	5976165	Backwatered	Yes	
Stream	Tahultzu Creek	Percent Backwatered	100	
Road	Lily Lake Road	Fill Depth (m)	1	
Road Tenure	MOTI	Outlet Drop (m)	0	
Channel Width (m)	3	Outlet Pool Depth (m)	0.3	
Stream Slope (%)	0	Inlet Drop	No	
Beaver Activity	No	Slope (%)	0	
Habitat Value	Medium	Valley Fill	Deep Fill	
Final score	14	Barrier Result	Passable	
Fix type	–	Fix Span / Diameter	–	
Comments: Two pipes (1.2m and 0.6m). 100% backwater. Guessing the pipes are embedded but cannot see due to poor water quality. This stream is extremely impacted by poor cattle ranching practices. There is no riparian fencing and cattle have completely trampled all the banks. There is no riparian vegetation and water quality is extremely poor. This stream could likely be very productive for chinook and other species if eventually restored. MoTi chris_culvert_id: 1795014, 1795015. 16:01:11

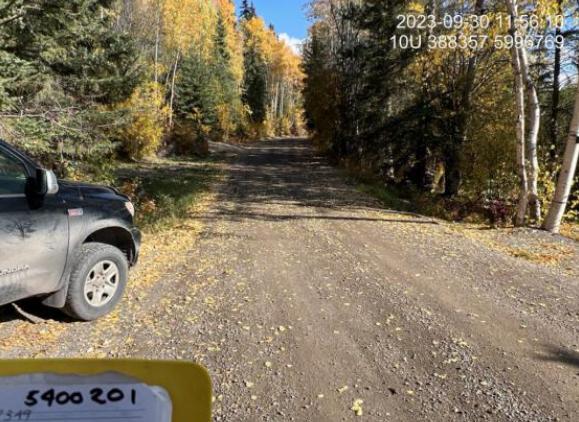
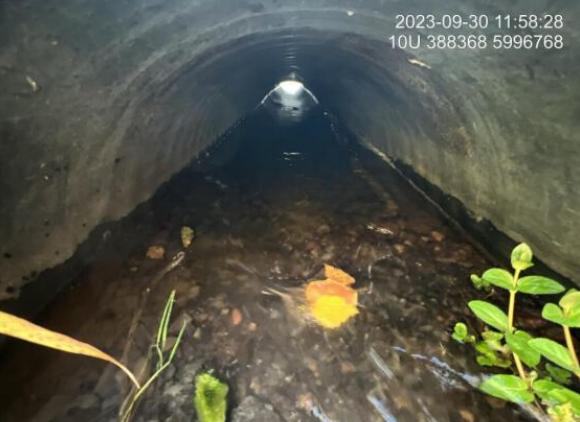
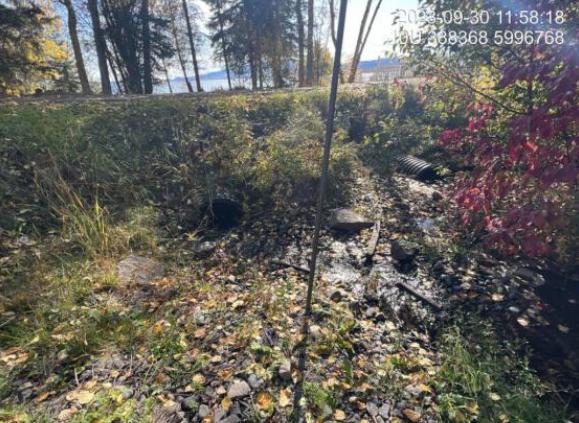
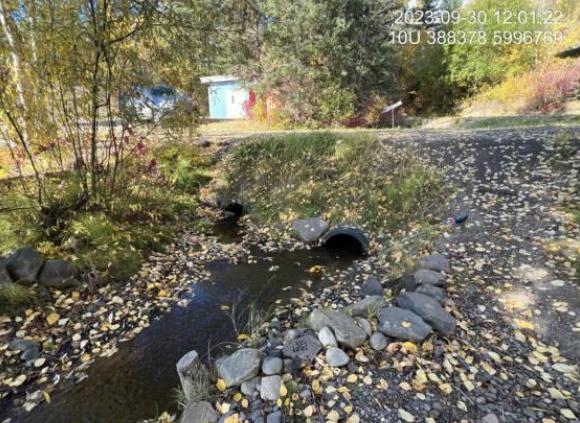
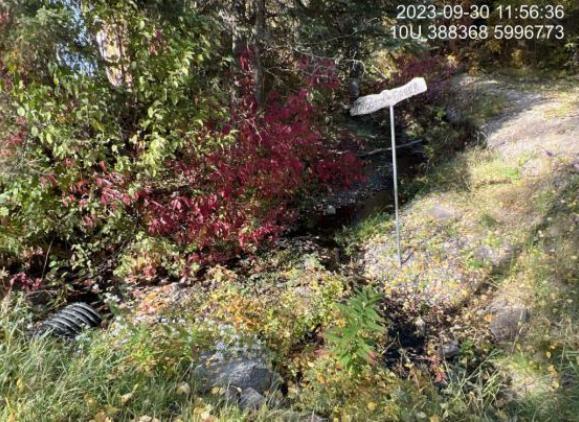
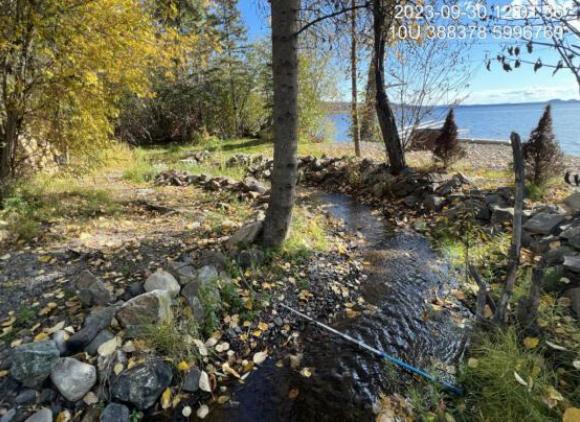
Photos: PSCIS ID 5400201. From top left clockwise: Road/Site Card, Barrel, Outlet, Downstream, Upstream, Inlet.

Location and Stream Data		•	Crossing Characteristics	–
Date	2023-09-30	Crossing Sub Type	Round Culvert	
PSCIS ID	199328	Diameter (m)	1.2	
External ID	5400201	Length (m)	11	
Crew	AI	Embedded	Yes	
UTM Zone	10	Depth Embedded (m)	0.5	
Easting	388367	Resemble Channel	Yes	
Northing	5996767	Backwatered	Yes	
Stream	Scotch Creek	Percent Backwatered	80	
Road	Gala Lake Road	Fill Depth (m)	1.5	
Road Tenure	MOTI	Outlet Drop (m)	0	
Channel Width (m)	1.7	Outlet Pool Depth (m)	0.05	
Stream Slope (%)	3	Inlet Drop	No	
Beaver Activity	No	Slope (%)	0.2	
Habitat Value	Medium	Valley Fill	Deep Fill	
Final score	6	Barrier Result	Passable	
Fix type	–	Fix Span / Diameter	–	
Comments: Good flow. Abundant gravel downstream and upstream. Pipes are both fully embedded with partial backwatering. Chinook point on the stream immediately adjacent to the site. Upstream left bank riparian has been cleared for what appears to be a parking space. Upstream crossing on Stella Road could be addressed by MoT. MoTi chris_culvert_id: 1790947, 3365573. 11:54:44

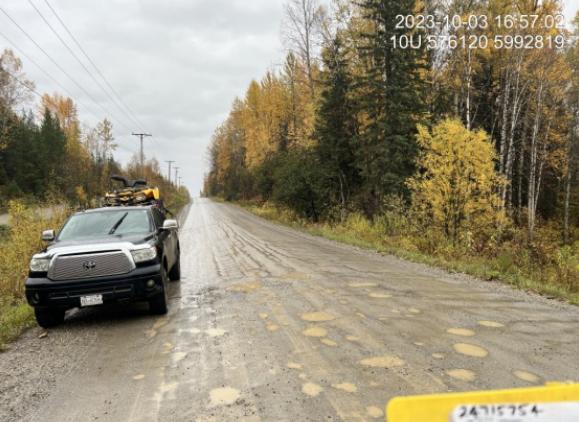
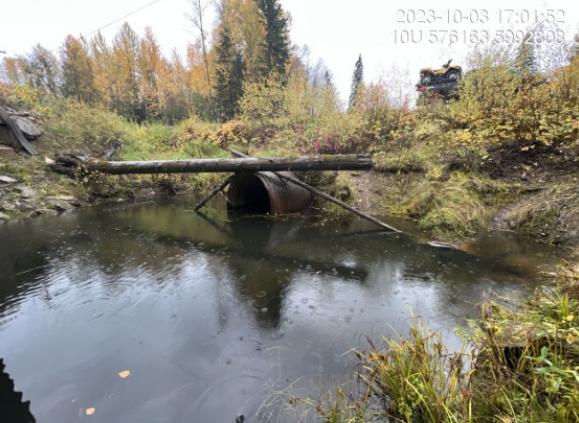
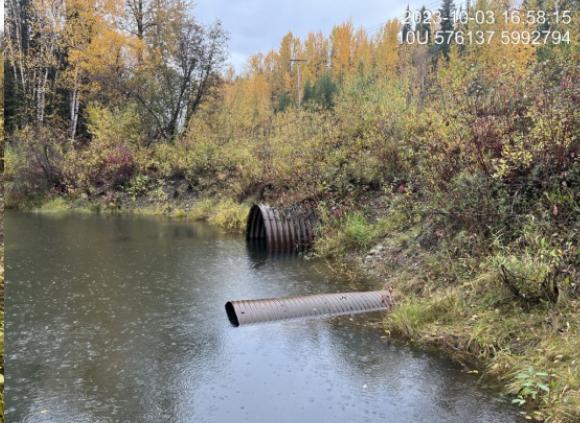
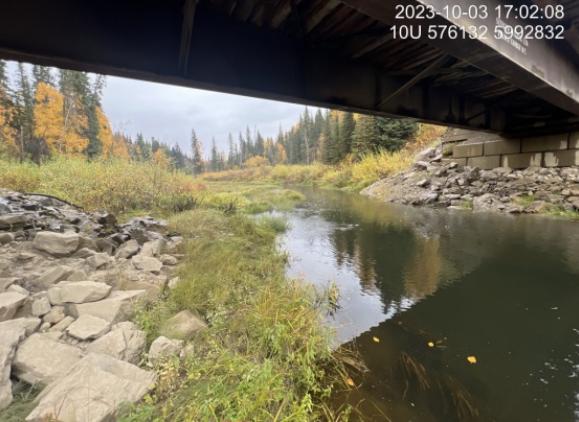
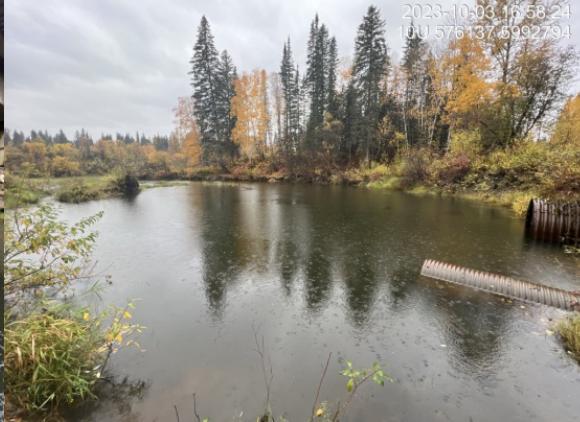
Photos: PSCIS ID 24715754. From top left clockwise: Road/Site Card, Barrel, Outlet, Downstream, Upstream, Inlet.

Location and Stream Data		•	Crossing Characteristics	–
Date	2023-10-03		Crossing Sub Type	Round Culvert
PSCIS ID	199329		Diameter (m)	4.4
External ID	24715754		Length (m)	35
Crew	AI		Embedded	Yes
UTM Zone	10		Depth Embedded (m)	1.3
Easting	576134		Resemble Channel	Yes
Northing	5992813		Backwatered	Yes
Stream	Tributary to Fraser River		Percent Backwatered	100
Road	Upper Fraser Road		Fill Depth (m)	2.5
Road Tenure	MOTI		Outlet Drop (m)	0
Channel Width (m)	12		Outlet Pool Depth (m)	2
Stream Slope (%)	0		Inlet Drop	No
Beaver Activity	Yes		Slope (%)	0
Habitat Value	High		Valley Fill	Deep Fill
Final score	12		Barrier Result	Passable
Fix type	–		Fix Span / Diameter	–
Comments: Three pipes total, two at 1.2m diameter which were completely submerged underwater and one at 2m diameter which was 100% backwatered. Assuming embedded due to the depth of the backwatering. Bridge located just upstream on River Road. Unassessed railway crossing located downstream which, based off satellite imagery, leads to a wetland area, but no modelled crossing present. There is a second unassessed crossing (24715896) downstream which should be assessed. Multiple non-salmonid FISS observations downstream. Chinook and sockeye salmon have been observed just upstream of the confluence of this creek with the Fraser River, roughly 1km downstream of the crossing. MoTi chris_culvert_id: 1994579, 1994580, 1994581. 17:04:42

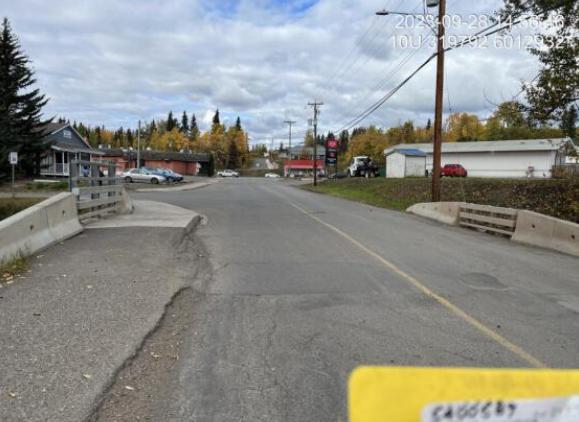
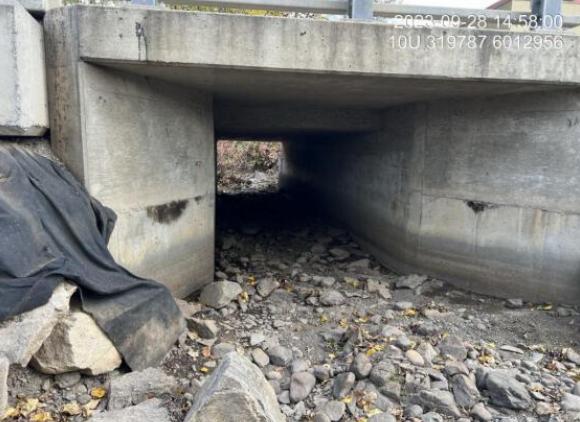
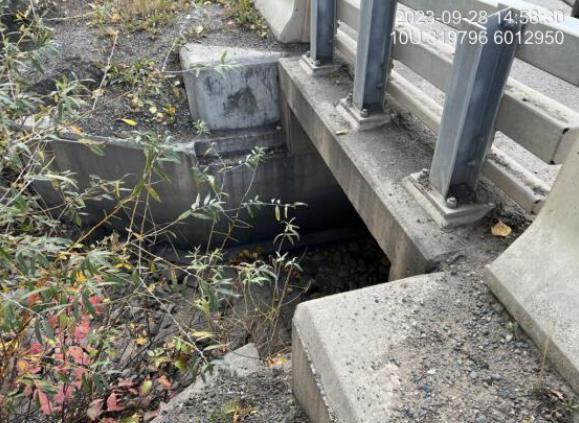
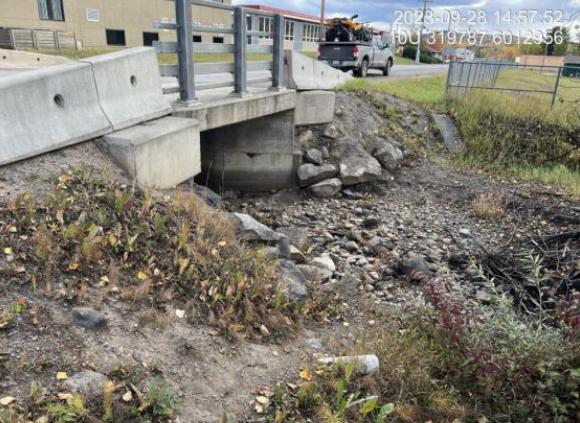
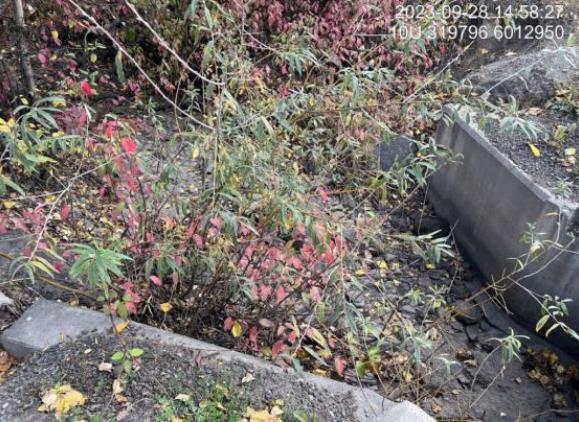
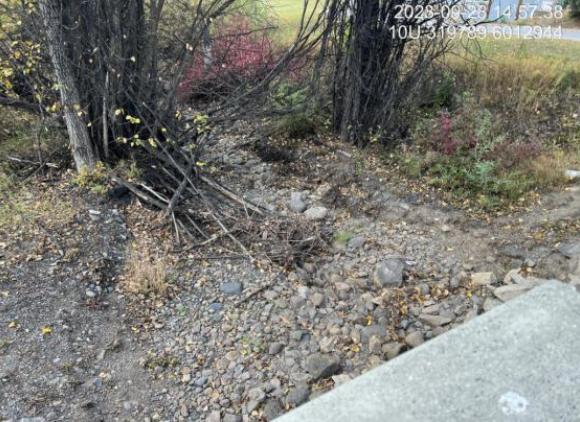
Location and Stream Data		.	Crossing Characteristics	-
Date	2023-09-28	Crossing Sub Type	Bridge	
PSCIS ID	199330	Diameter (m)	4	
External ID	5400159	Length (m)	11	
Crew	AI	Embedded	-	
UTM Zone	10	Depth Embedded (m)	-	
Easting	319797	Resemble Channel	-	
Northing	6012952	Backwatered	-	
Stream	Sauls Creek	Percent Backwatered	-	
Road	Government Rd	Fill Depth (m)	-	
Road Tenure	Burns Lake	Outlet Drop (m)	-	
Channel Width (m)	-	Outlet Pool Depth (m)	-	
Stream Slope (%)	-	Inlet Drop	-	
Beaver Activity	-	Slope (%)	-	
Habitat Value	-	Valley Fill	-	
Final score	0	Barrier Result	Passable	
Fix type	-	Fix Span / Diameter	-	
Comments: Dry channel. Bridge.. 14:56:53				
Photos: PSCIS ID 5400159. From top left clockwise: Road/Site Card, Barrel, Outlet, Downstream, Upstream, Inlet.

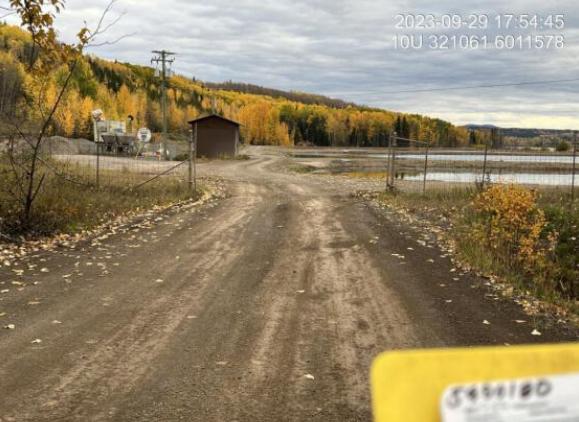
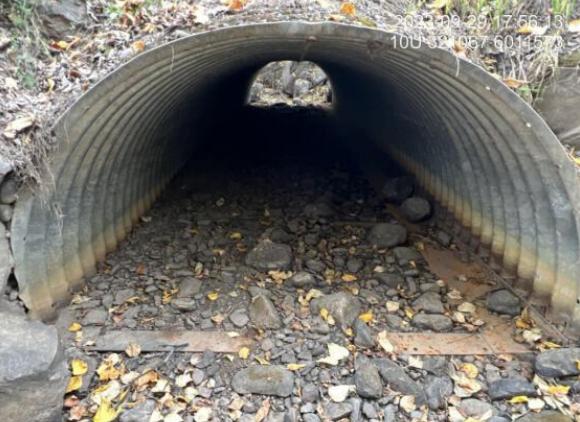
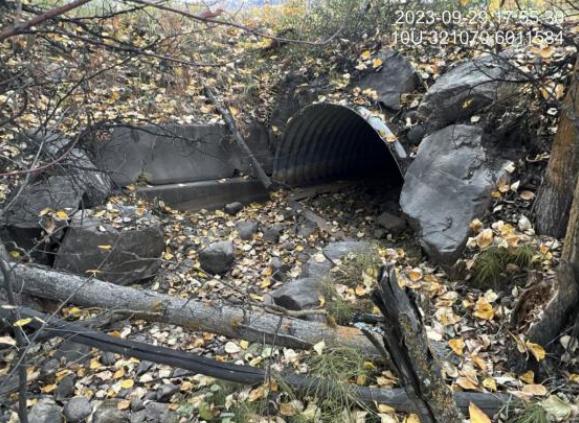
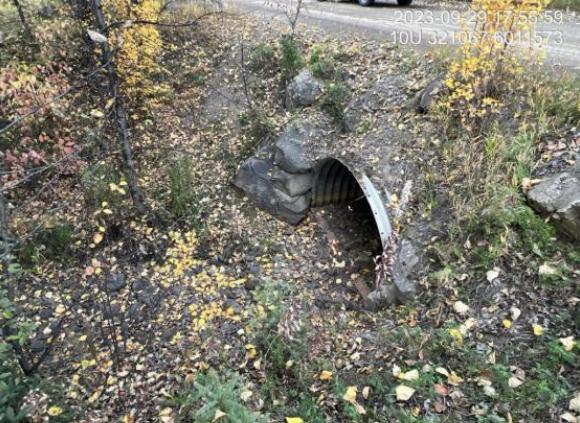
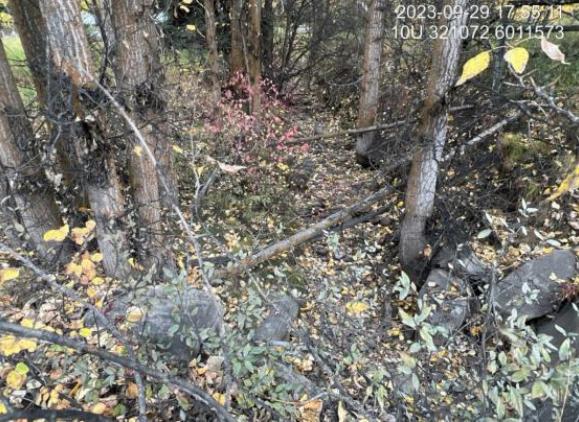
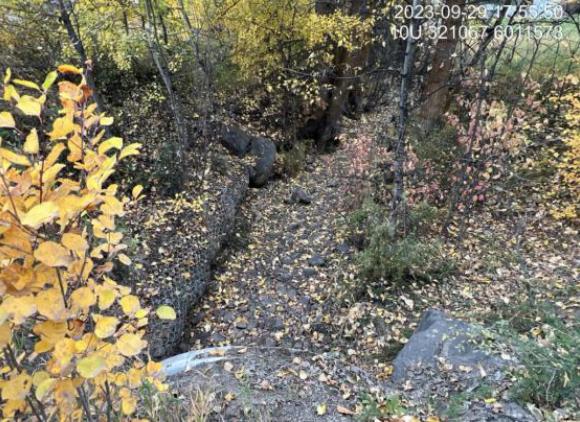
Location and Stream Data		.	Crossing Characteristics	-
Date	2023-09-29	Crossing Sub Type	Pipe Arch	
PSCIS ID	199331	Diameter (m)	2.65	
External ID	5400180	Length (m)	12	
Crew	AI	Embedded	-	
UTM Zone	10	Depth Embedded (m)	-	
Easting	321069	Resemble Channel	-	
Northing	6011579	Backwatered	-	
Stream	Wardrop Creek	Percent Backwatered	-	
Road	Glans Drive	Fill Depth (m)	-	
Road Tenure	Burns Lake	Outlet Drop (m)	-	
Channel Width (m)	-	Outlet Pool Depth (m)	-	
Stream Slope (%)	-	Inlet Drop	-	
Beaver Activity	-	Slope (%)	-	
Habitat Value	-	Valley Fill	-	
Final score	0	Barrier Result	Passable	
Fix type	-	Fix Span / Diameter	-	
Comments: Pipe arch. Passable. Modelled crossings 5406290 and 5400675 downstream adjacent to Burn's Lake shoreline have not been assessed.. 17:53:31				
Photos: PSCIS ID 5400180. From top left clockwise: Road/Site Card, Barrel, Outlet, Downstream, Upstream, Inlet.

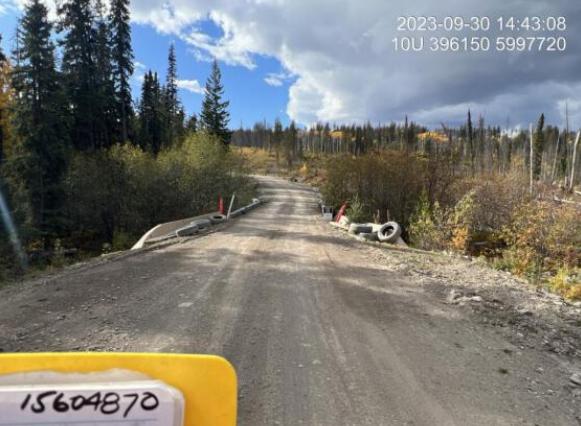
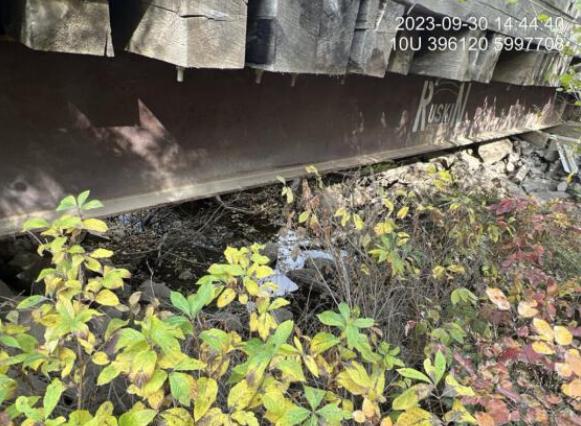
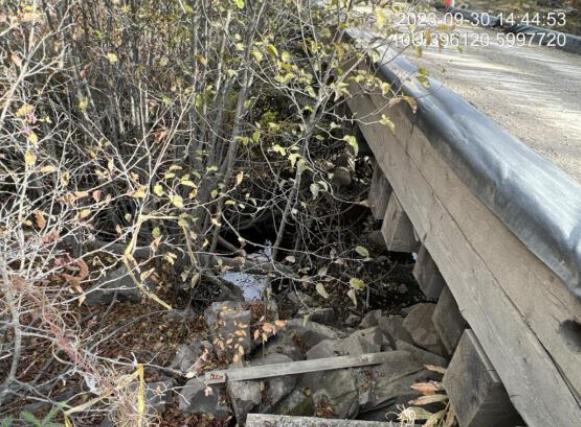
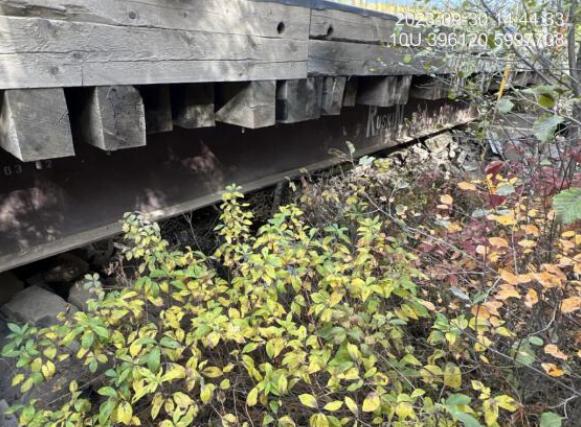
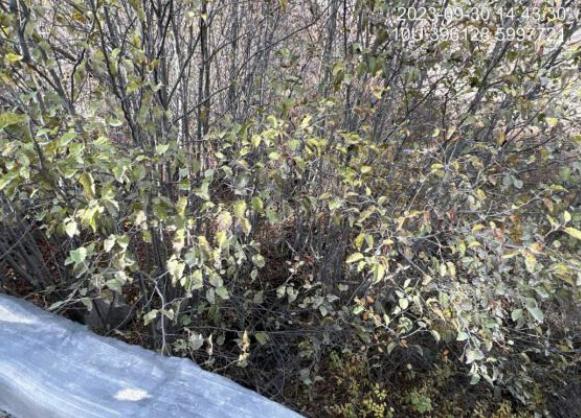
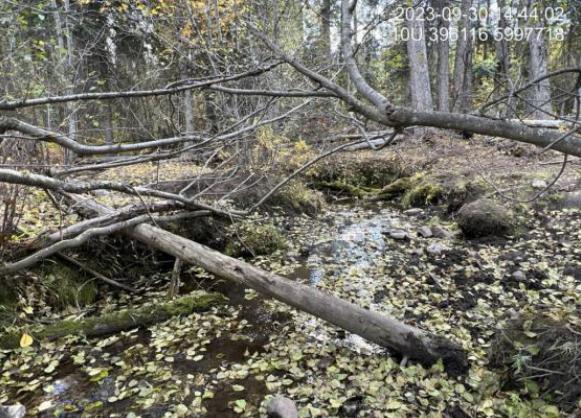
Location and Stream Data		•	Crossing Characteristics	–
Date	2023-09-30		Crossing Sub Type	Bridge
PSCIS ID	199332		Diameter (m)	13
External ID	15604870		Length (m)	5
Crew	AI		Embedded	–
UTM Zone	10		Depth Embedded (m)	–
Easting	396140		Resemble Channel	–
Northing	5997722		Backwatered	–
Stream	Tributary to Nechako River		Percent Backwatered	–
Road	Williams FSR		Fill Depth (m)	–
Road Tenure	West Fraser R09194 SE		Outlet Drop (m)	–
Channel Width (m)	–		Outlet Pool Depth (m)	–
Stream Slope (%)	–		Inlet Drop	–
Beaver Activity	–		Slope (%)	–
Habitat Value	–		Valley Fill	–
Final score	0		Barrier Result	Passable
Fix type	–		Fix Span / Diameter	–
Comments: Bridge with sign from Fraser lake sawmills. Extensive cattle trampling underneath the bridge, but some decent amount of water at this location.. 14:46:03				
Photos: PSCIS ID 15604870. From top left clockwise: Road/Site Card, Barrel, Outlet, Downstream, Upstream, Inlet.

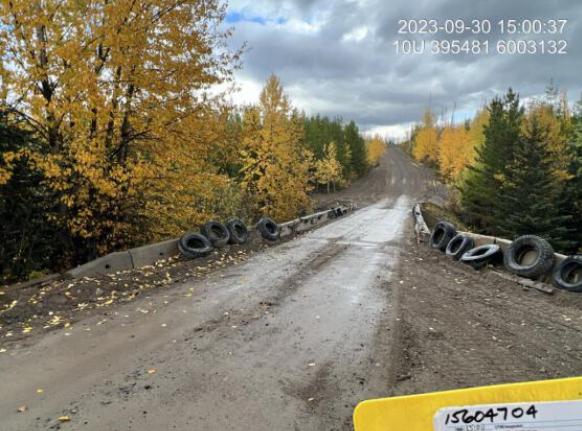
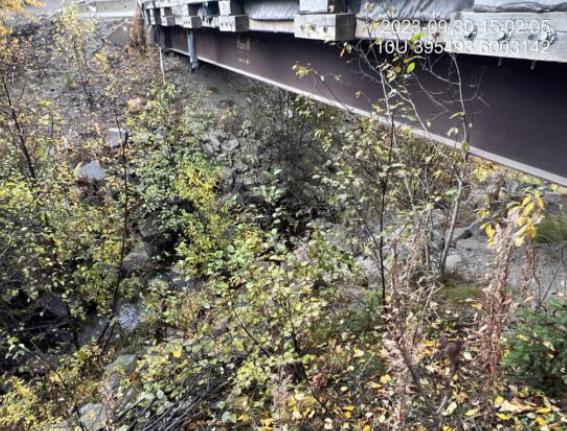
Location and Stream Data		.	Crossing Characteristics	-
Date	2023-09-30	Crossing Sub Type	Bridge	
PSCIS ID	199333	Diameter (m)	20	
External ID	15604704	Length (m)	5	
Crew	AI	Embedded	-	
UTM Zone	10	Depth Embedded (m)	-	
Easting	395496	Resemble Channel	-	
Northing	6003141	Backwatered	-	
Stream	Tatsutnai Creek	Percent Backwatered	-	
Road	Barlow FSR	Fill Depth (m)	-	
Road Tenure	Canfor R11286	Outlet Drop (m)	-	
Channel Width (m)	-	Outlet Pool Depth (m)	-	
Stream Slope (%)	-	Inlet Drop	-	
Beaver Activity	-	Slope (%)	-	
Habitat Value	-	Valley Fill	-	
Final score	0	Barrier Result	Passable	
Fix type	-	Fix Span / Diameter	-	
Comments: Bridge. Good flow. 15:02:17				
Photos: PSCIS ID 15604704. From top left clockwise: Road/Site Card, Barrel, Outlet, Downstream, Upstream, Inlet.

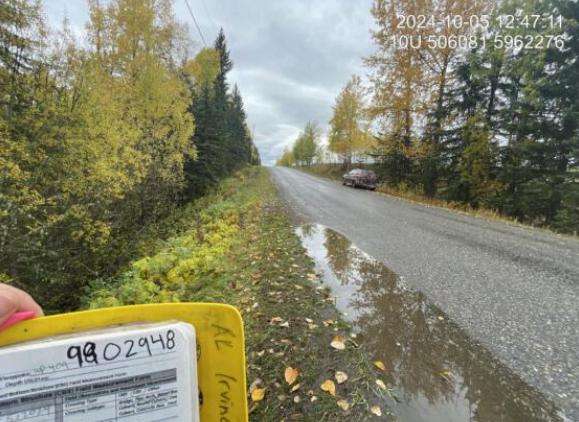
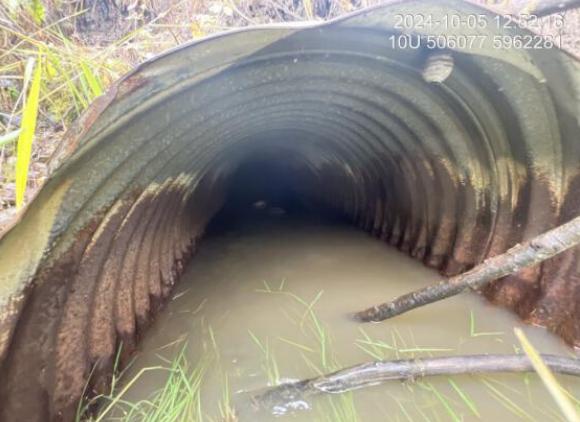
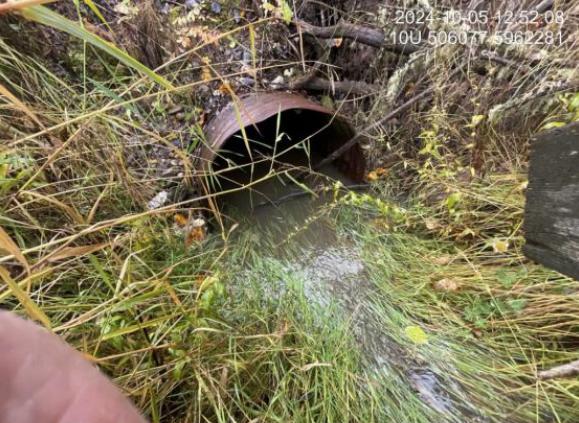
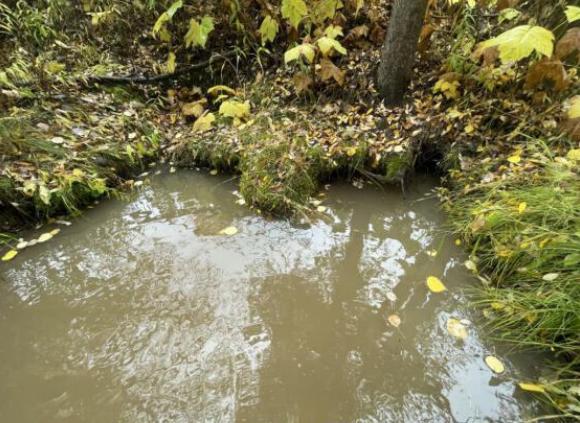
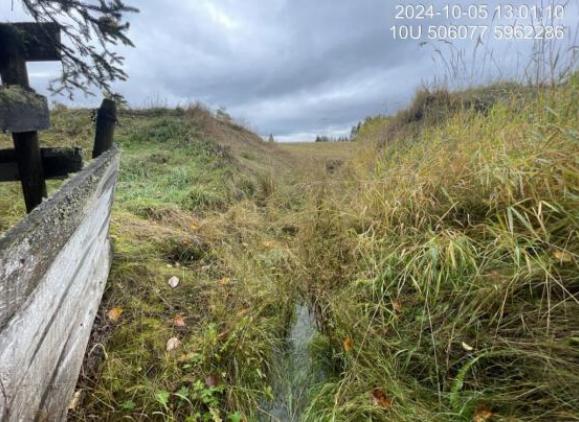
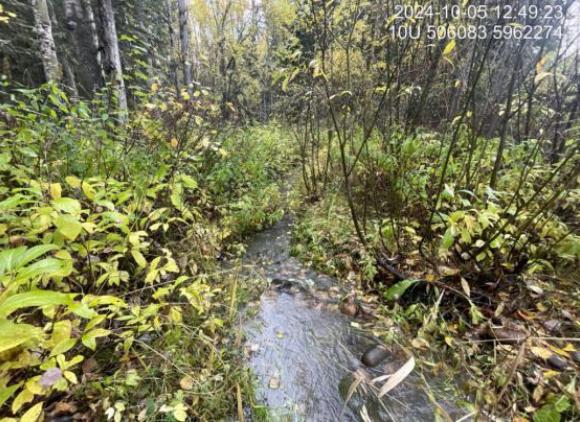
Photos: PSCIS ID 9902948. From top left clockwise: Road/Site Card, Barrel, Outlet, Downstream, Upstream, Inlet.

Comments: The culvert was fully backwatered, with the outlet completely submerged. The stream flowed through a grassy valley on private property upstream. The road column on the inlet side was eroding significantly. A V-shaped fence was positioned in front of the inlet for unknown reasons. Culvert slope and length were estimated, as the inlet was completely submerged and not visible. The culvert was embedded at the inlet and assumed to be fully embedded, though this could not be confirmed due to the submerged outlet. Just upstream of the inlet, remnants of a possible old dam were observed, with large piles of dirt on both sides and a dugout middle section allowing stream flow. See photos for details. MoTi chris_culvert_id: 1976182
