Appendix - Phase 1 Fish Passage Assessment Data and Photos

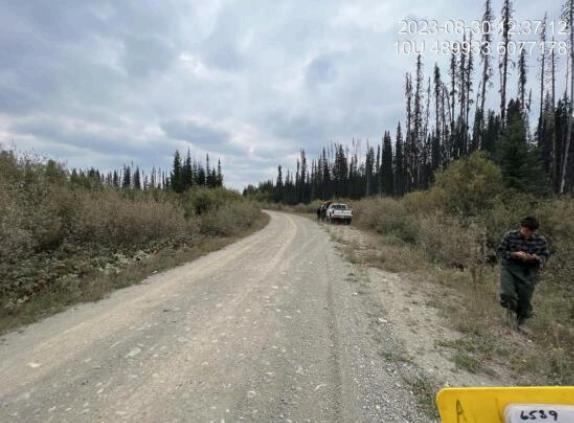
. From top left clockwise: Road/Site Card, Barrel, Outlet, Downstream, Upstream, Inlet.6539

Location and Stream Data	•	Crossing Characteristics	-
Comments: Public, beaver influenced wet land upstream. Fish observed at outlet. Nice flowing system downstream with pockets of gravel throughout. Two pipes at 1.55 m each. Beaver grate outlet cage dislodged and within stream approximately 5 m downstream of the pipes. 12:35:14			
Photos: PSCIS ID

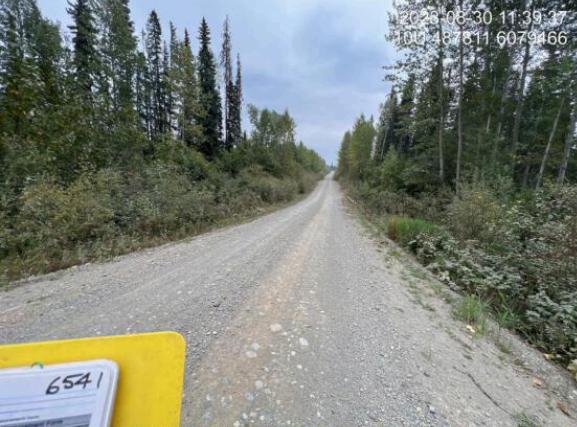
Location and Stream Data	•	Crossing Characteristics	-
Comments: Dry channel upstream and downstream except for fairly deep outlet pool with fish present. Culvert in poor shape with lots of rust. Road embankment fill failing on downstream side of road with large hole. Nice gravels available for spawning. Although outlet drop appears to be greater than 50 cm, it was actually estimated at 20 cm because the outlet pool has the water below the level of the stream bed on the downstream side. 11:40:56			
Photos: PSCIS ID

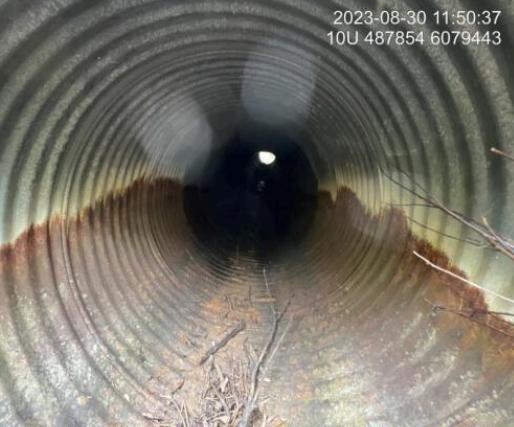
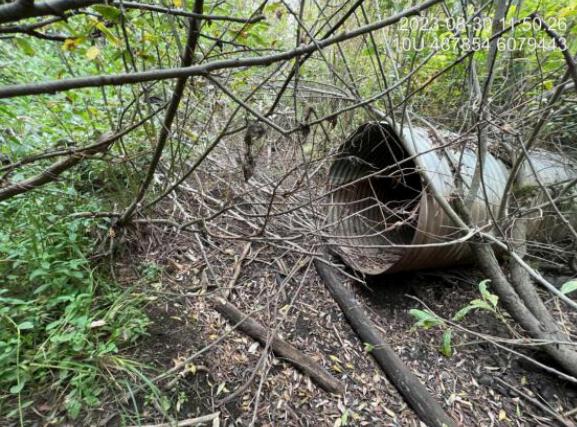
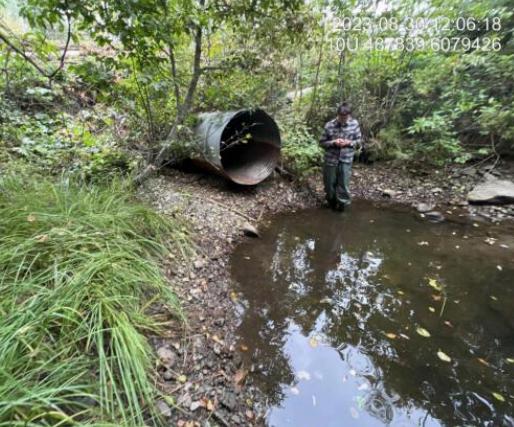
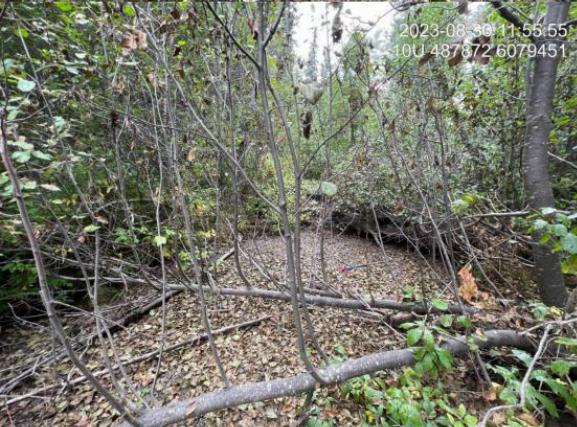
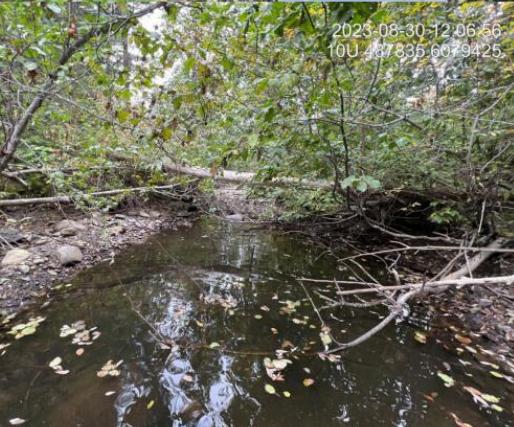
2023-08-30 12:06:56 10U 487835 6079425
. From top left clockwise: Road/Site Card, Barrel, Outlet, Downstream, Upstream, Inlet.6541

Location and Stream Data		Crossing Characteristics	
Date	2023-08-30	Crossing Sub Type	Round Culvert
PSCIS ID	6541	Diameter (m)	1.2
External ID	–	Length (m)	21
Crew	AI JD BP TS	Embedded	No
UTM Zone	10	Depth Embedded (m)	–
Easting	487842.4	Resemble Channel	No
Northing	6079435	Backwatered	No
Stream	Hammett Creek	Percent Backwatered	–
Road	Spur	Fill Depth (m)	2
Road Tenure	Canfor R07645	Outlet Drop (m)	0.2
Channel Width (m)	3.8	Outlet Pool Depth (m)	0.7
Stream Slope (%)	2.5	Inlet Drop	No
Beaver Activity	No	Slope (%)	3
Habitat Value	Medium	Valley Fill	Deep Fill
Final score	34	Barrier Result	Barrier
Fix type	Replace with New Open Bottom Structure	Fix Span / Diameter	10

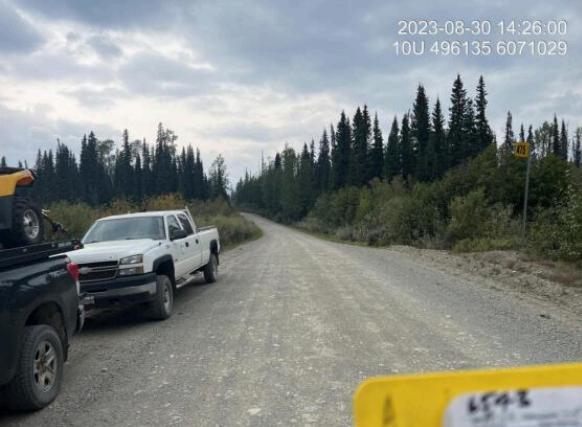
. From top left clockwise: Road/Site Card, Barrel, Outlet, Downstream, Upstream, Inlet.6543

Location and Stream Data	•	Crossing Characteristics	-
Comments: Large system with lots of water. 1.3 m high beaverdam 2 m above inlets. Two pipes at 2.0 m in size each. Beaver cage on west pipe inlet functioning to keep dam away from the actual inlet. Abundant gravel suitable for spawning downstream. Very nice stream and potential good candidate for replacement with a Bridge. 14:25:01			
Photos: PSCIS ID

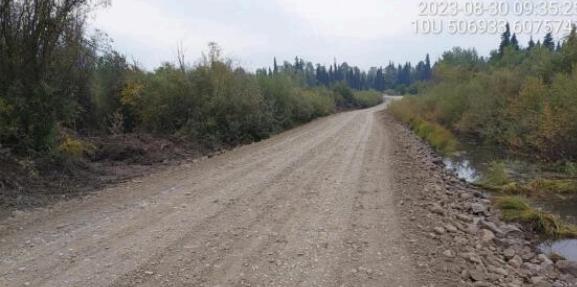
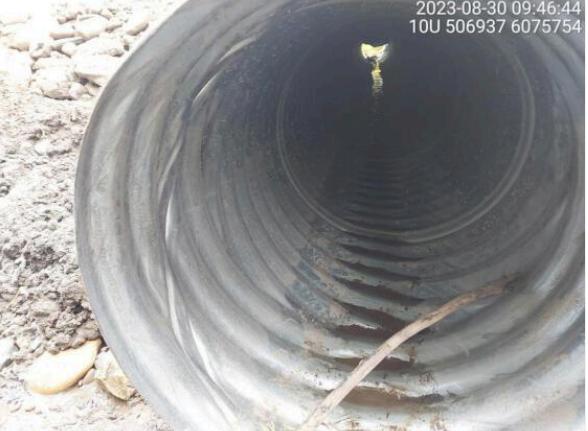
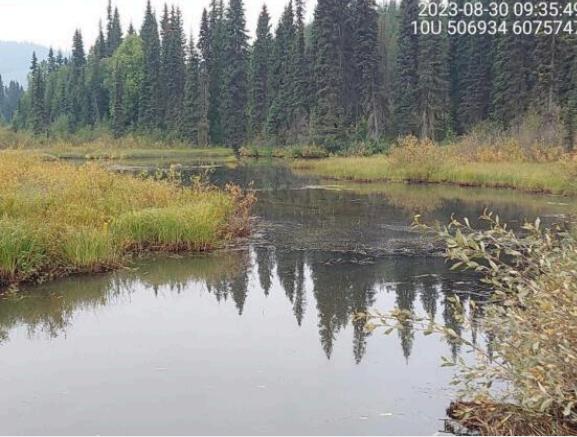
Location and Stream Data	•	Crossing Characteristics	-
Comments: Beaver activity at inlet side. Wetland upstream. Pipe is very small. Pipe is caved in near the inlet. Dewatered downstream. 09:32:45			
Photos: PSCIS ID

. From top left clockwise: Road/Site Card, Barrel, Outlet, Downstream, Upstream, Inlet.6544

Location and Stream Data		Crossing Characteristics	
Date	2023-08-30	Crossing Sub Type	Round Culvert
PSCIS ID	6544	Diameter (m)	0.5
External ID	–	Length (m)	8
Crew	MW MD	Embedded	No
UTM Zone	10	Depth Embedded (m)	–
Easting	506941	Resemble Channel	No
Northing	6075745	Backwatered	Yes
Stream	Tributary to Crooked River	Percent Backwatered	100
Road	Carp Lake FSR	Fill Depth (m)	0.3
Road Tenure	MOF 7731	Outlet Drop (m)	0
Channel Width (m)	2.7	Outlet Pool Depth (m)	0
Stream Slope (%)	1	Inlet Drop	No
Beaver Activity	Yes	Slope (%)	1
Habitat Value	Low	Valley Fill	Deep Fill
Final score	21	Barrier Result	Barrier
Fix type	Replace with New Open Bottom Structure	Fix Span / Diameter	10

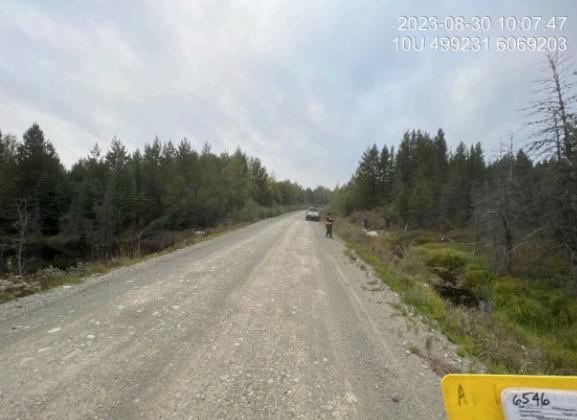
. From top left clockwise: Road/Site Card, Barrel, Outlet, Downstream, Upstream, Inlet.6546

Location and Stream Data	•	Crossing Characteristics	-
<p>Comments: Historic assessment from 2006 may not have measured the lowest elevation pipe. There are three pipes here. The main functioning pipe is 0.9 diameter and its 100% backwatered on the east side of the two larger 1.5 m pipes. Wetland, beaver influenced habitat, both upstream and downstream. Numerous fish (some RB) observed downstream and upstream. 10:03:49</p>			
<p>Photos: PSCIS ID</p>

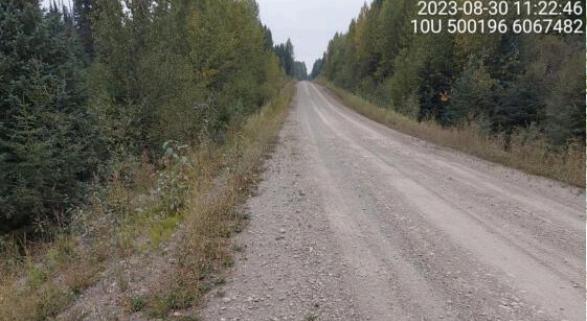
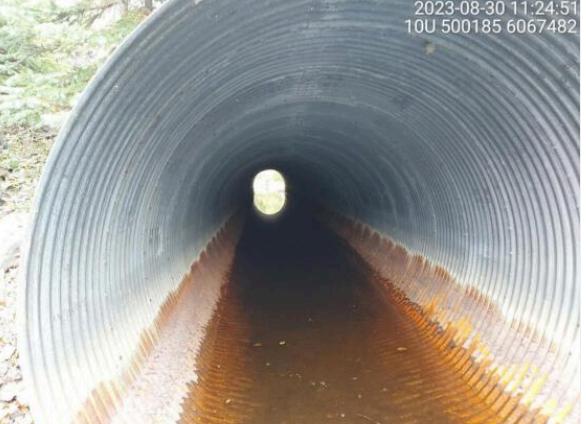
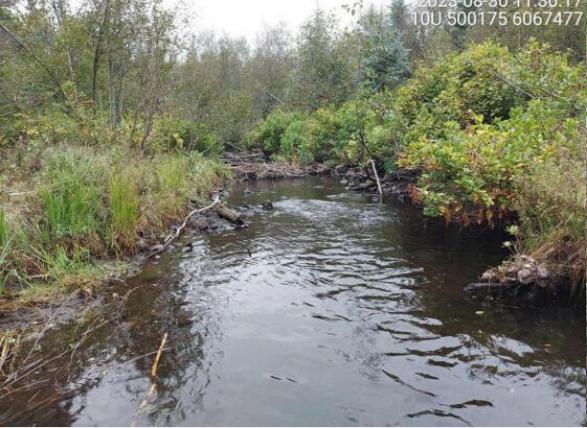
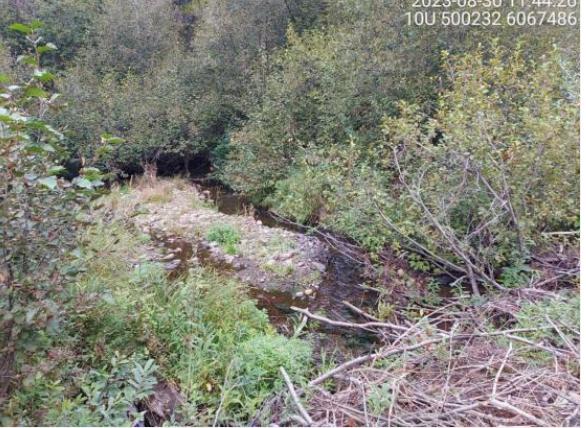
Location and Stream Data	•	Crossing Characteristics	-
Comments: Two pipes of similar diameter. Fully backwatered at outlet. Clear evidence of beaver activity near crossing. Dams upstream and downstream of crossing, creating big outlet pool. Fish spotted in culvert. 11:19:18			
Photos: PSCIS ID

2023-08-30 11:44:26 10U 500232 6067486	. From top left clockwise: Road/Site Card, Barrel, Outlet, Downstream, Upstream, Inlet.6621

Location and Stream Data		Crossing Characteristics	
Date	2023-08-30	Crossing Sub Type	Round Culvert
PSCIS ID	6621	Diameter (m)	4.1
External ID	–	Length (m)	28
Crew	MW MD	Embedded	No
UTM Zone	10	Depth Embedded (m)	–
Easting	500201.1	Resemble Channel	No
Northing	6067481	Backwatered	Yes
Stream	Tributary to Weedon Creek	Percent Backwatered	100
Road	Davie-War FSR	Fill Depth (m)	2.5
Road Tenure	Canfor R01860	Outlet Drop (m)	0
Channel Width (m)	5.6	Outlet Pool Depth (m)	1.3
Stream Slope (%)	1.5	Inlet Drop	No
Beaver Activity	Yes	Slope (%)	1
Habitat Value	Medium	Valley Fill	Deep Fill
Final score	24	Barrier Result	Barrier
Fix type	Replace with New Open Bottom Structure	Fix Span / Diameter	10

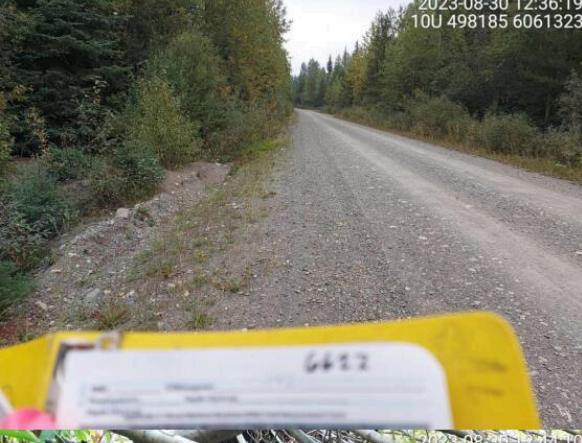
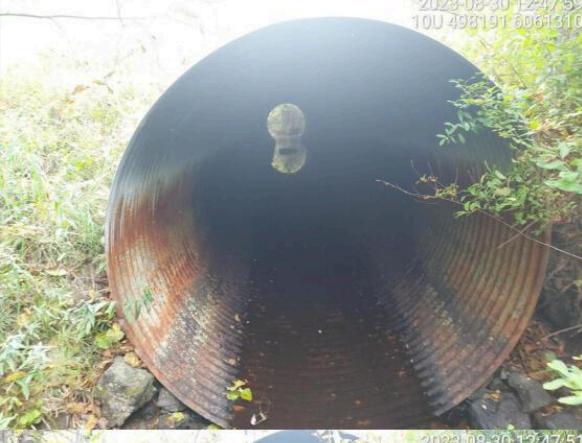
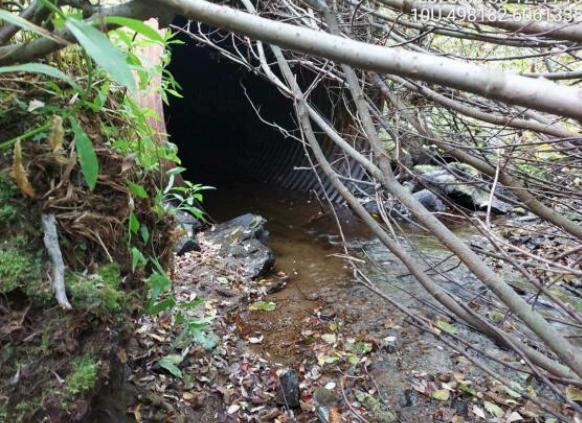
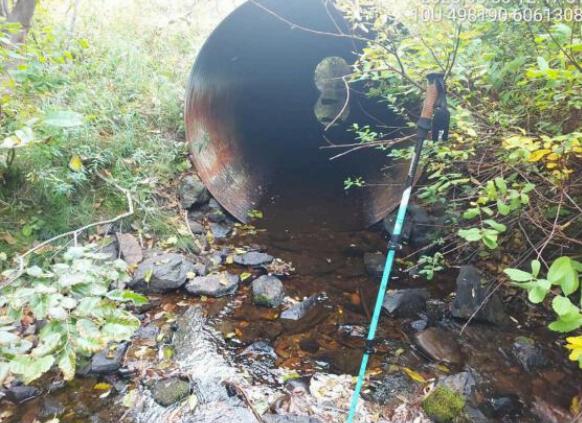
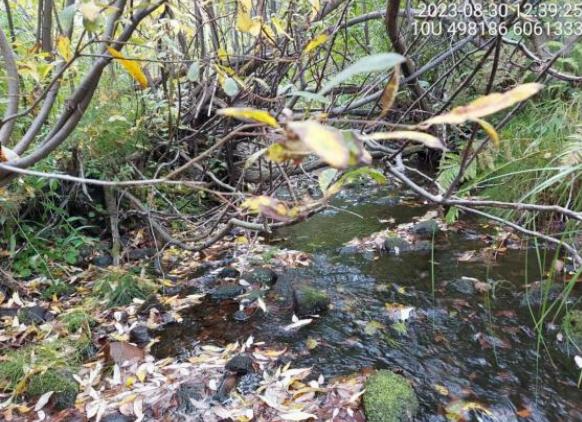
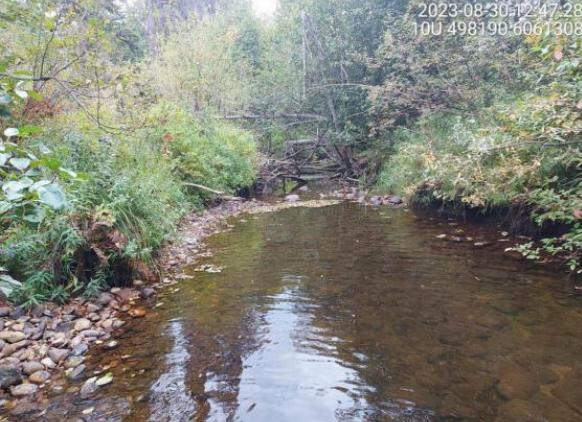
Location and Stream Data	•	Crossing Characteristics	-
Comments: Two pipes of equal width. High habitat value, good flowing stream. 12:33:15			
Photos: PSCIS ID

2023-08-30 12:47:28 10U 498190 6061308
From top left clockwise: Road/Site Card, Barrel, Outlet, Downstream, Upstream, Inlet.6622

Location and Stream Data		Crossing Characteristics	
Date	2023-08-30	Crossing Sub Type	Round Culvert
PSCIS ID	6622	Diameter (m)	3.5
External ID	–	Length (m)	18
Crew	MW MD	Embedded	No
UTM Zone	10	Depth Embedded (m)	–
Easting	498186	Resemble Channel	No
Northing	6061320	Backwatered	No
Stream	Tributary to Weedon Creek	Percent Backwatered	–
Road	Davie-Weedon Lake FSR	Fill Depth (m)	1
Road Tenure	MOF 7719	Outlet Drop (m)	0
Channel Width (m)	2.5	Outlet Pool Depth (m)	0.4
Stream Slope (%)	2.5	Inlet Drop	No
Beaver Activity	No	Slope (%)	3
Habitat Value	High	Valley Fill	Deep Fill
Final score	23	Barrier Result	Barrier
Fix type	Replace with New Open Bottom Structure	Fix Span / Diameter	10

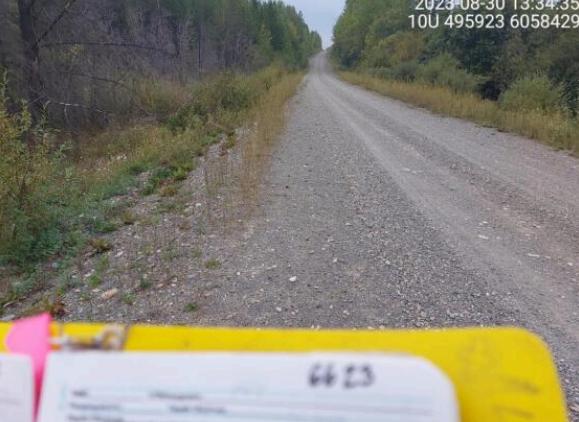
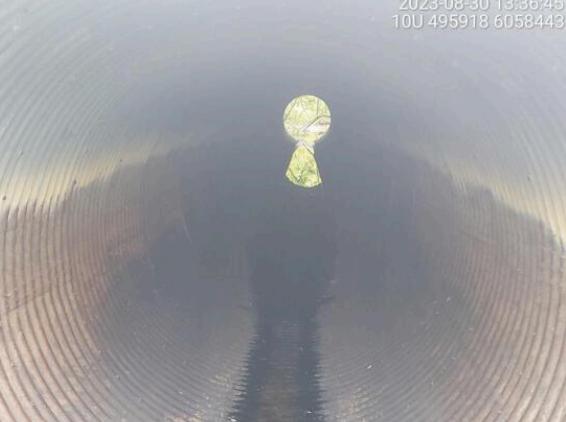
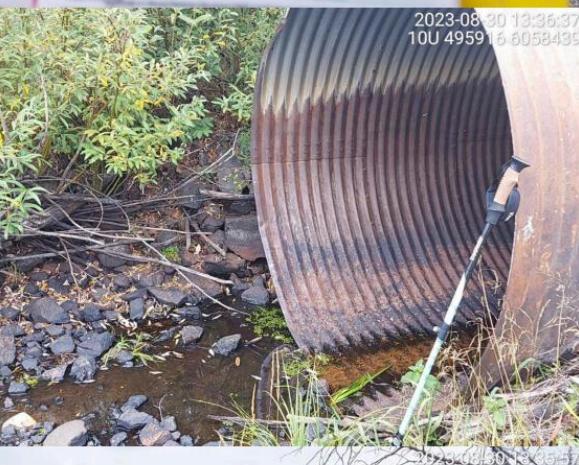
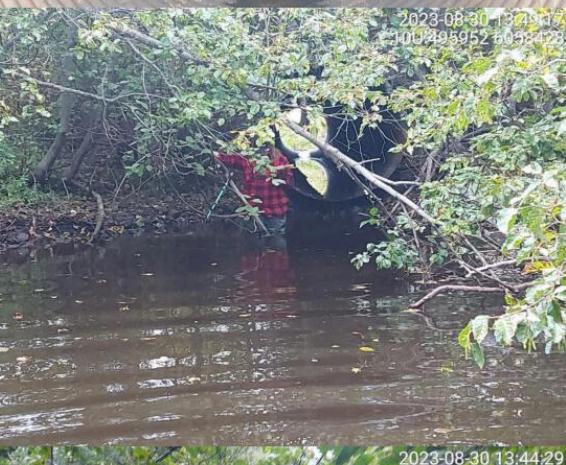
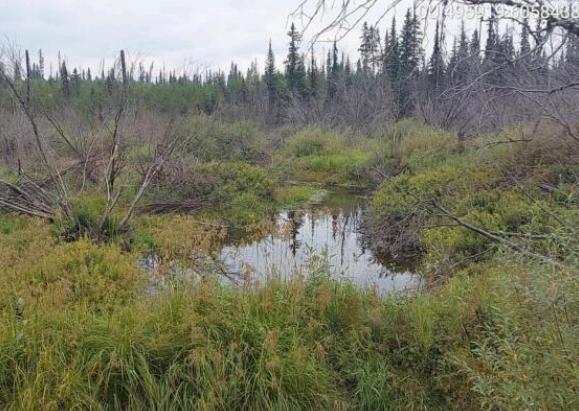
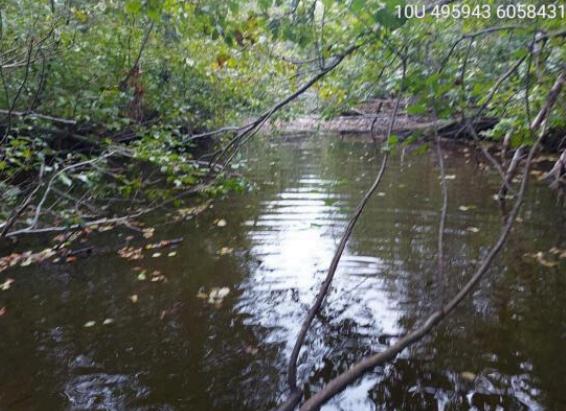
Location and Stream Data	•	Crossing Characteristics	-
Comments: Big pipe, backwatered and creating big outlet pool. Wetland upstream. Some flow downstream. 13:33:37			
Photos: PSCIS ID

. From top left clockwise: Road/Site Card, Barrel, Outlet, Downstream, Upstream, Inlet.6623

Location and Stream Data		Crossing Characteristics	
Date	2023-08-30	Crossing Sub Type	Round Culvert
PSCIS ID	6623	Diameter (m)	1.6
External ID	–	Length (m)	25
Crew	MW MD	Embedded	No
UTM Zone	10	Depth Embedded (m)	–
Easting	495931.2	Resemble Channel	No
Northing	6058430	Backwatered	No
Stream	Tributary to Weedon Lake	Percent Backwatered	–
Road	Davie-Weedon Lake FSR	Fill Depth (m)	1
Road Tenure	MOF 7719	Outlet Drop (m)	0.3
Channel Width (m)	2.6	Outlet Pool Depth (m)	0.7
Stream Slope (%)	1	Inlet Drop	No
Beaver Activity	No	Slope (%)	1.5
Habitat Value	Medium	Valley Fill	Deep Fill
Final score	34	Barrier Result	Barrier
Fix type	Replace with New Open Bottom Structure	Fix Span / Diameter	10

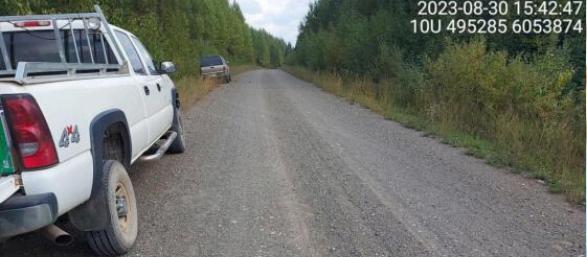
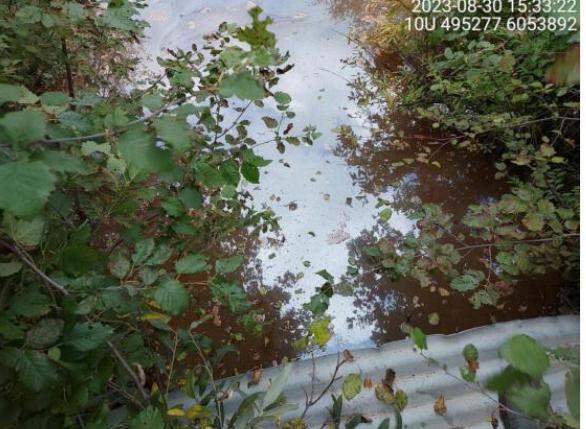
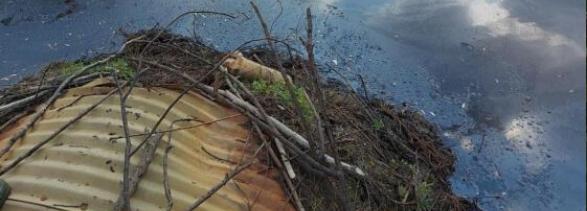
. From top left clockwise: Road/Site Card, Barrel, Outlet, Downstream, Upstream, Inlet.6624

Location and Stream Data	•	Crossing Characteristics	-
Comments: Big flooded wetland area. Beaver dam blocking inlet side. Massive outlet pool. Stream width and slope estimated. No defined channel. Culvert almost fully submerged on inlet side. 15:27:49			
Photos: PSCIS ID

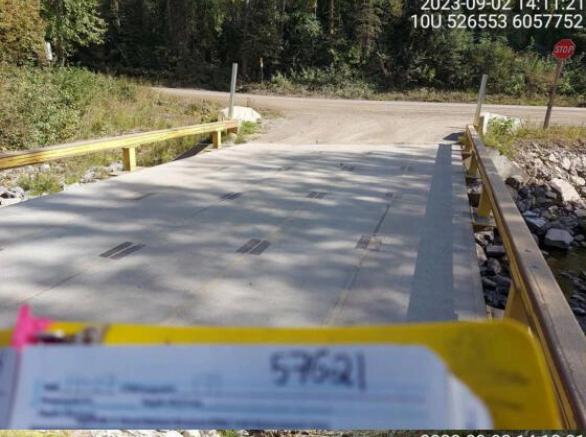
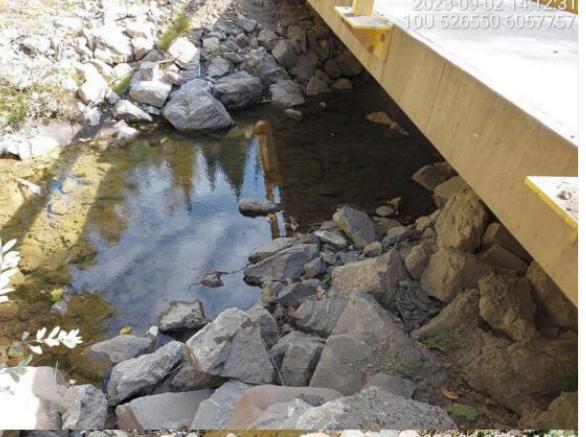
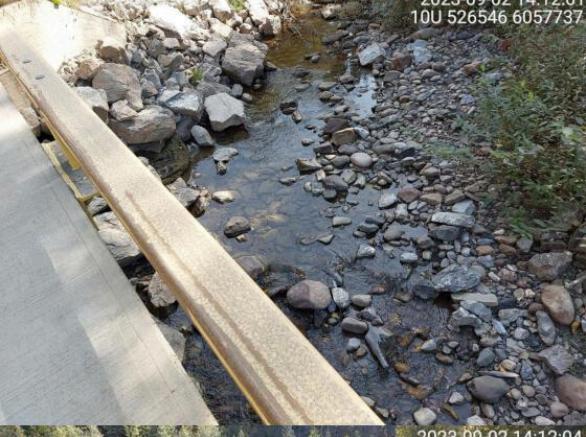
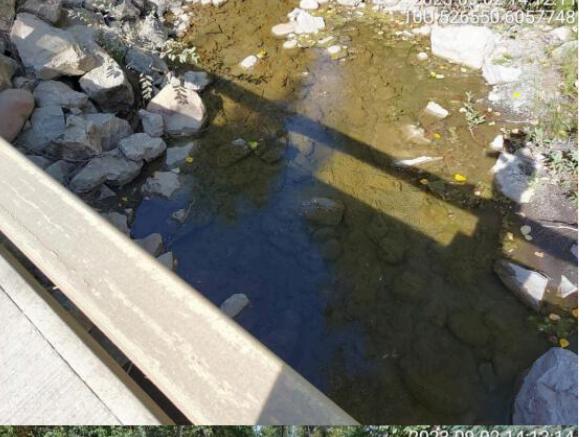
. From top left clockwise: Road/Site Card, Barrel, Outlet, Downstream, Upstream, Inlet.57621

Location and Stream Data	Crossing Characteristics
Comments: Near intersection of hambone and colbourne. Wide channel with good flow. 14:09:47	
Photos: PSCIS ID

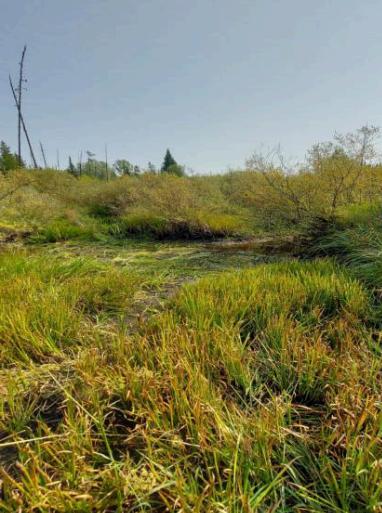
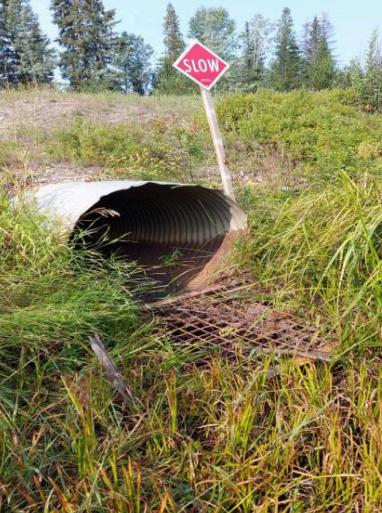
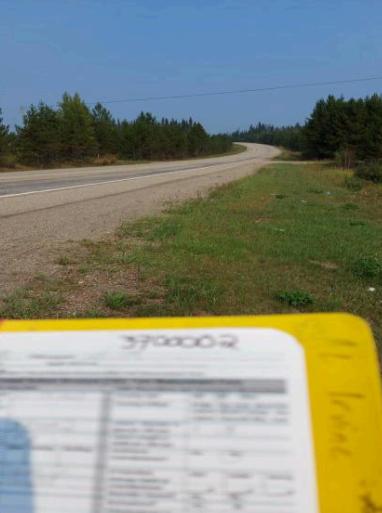
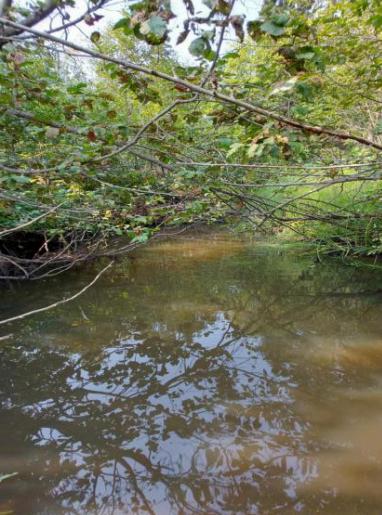
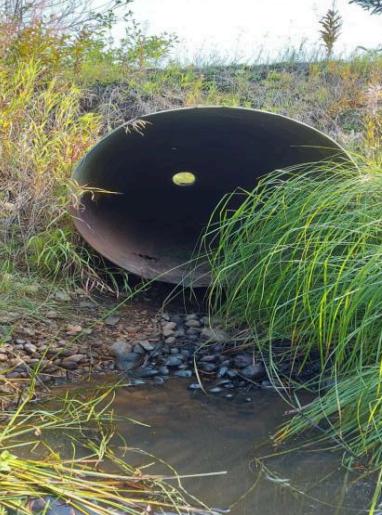
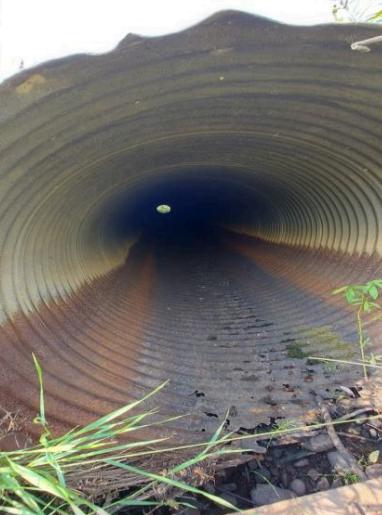
. From top left clockwise: Road/Site Card, Barrel, Outlet, Downstream, Upstream, Inlet.3700002

Location and Stream Data	•	Crossing Characteristics	-		
Comments: No water in culvert. Some water near inlet and outlet. Stream dewatered downstream again after ~20m. Burbot have been caught in the past approximately 700m upstream of the highway. Wide channel with small lakes and ponds upstream. Ministry of Transportation chris_culvert_id: 1997081. 11:52:21					
Photos: PSCIS ID

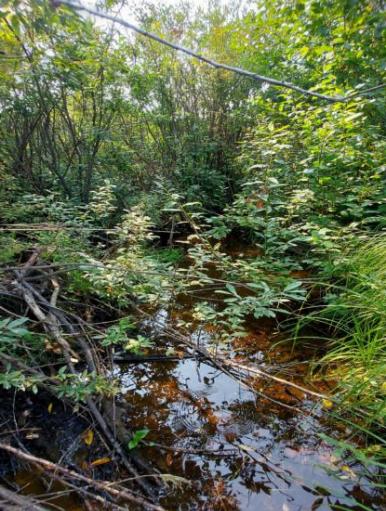
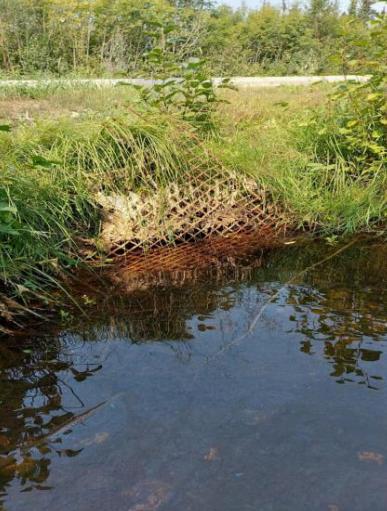
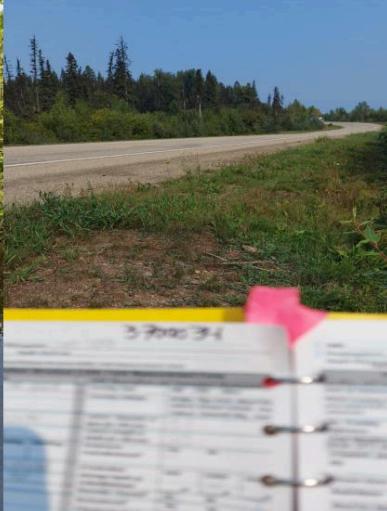
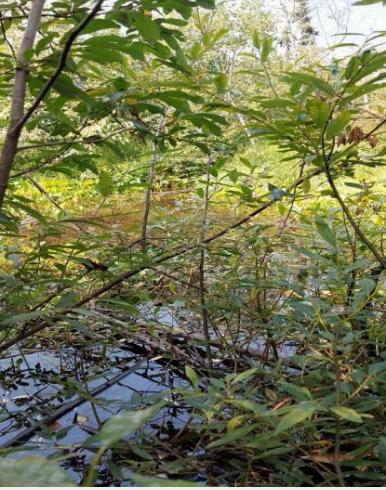
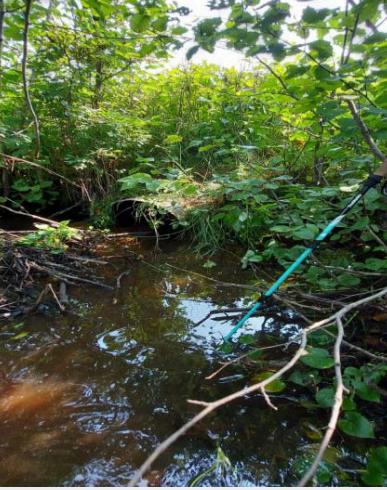
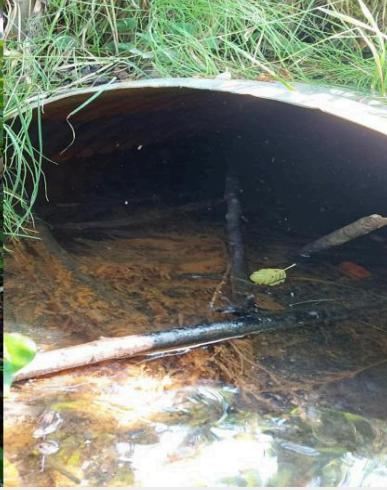
. From top left clockwise: Road/Site Card, Barrel, Outlet, Downstream, Upstream, Inlet.3700034

Location and Stream Data	•	Crossing Characteristics	-
Comments: Grate on inlet. Backwatered and big wetland area upstream. Difficult to determine where stream is, width and gradient estimated. Ministry of Transportation chris_culvert_id: 1997003. 12:41:10			
Photos: PSCIS ID

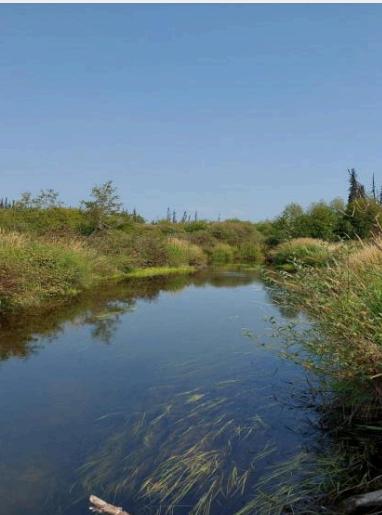
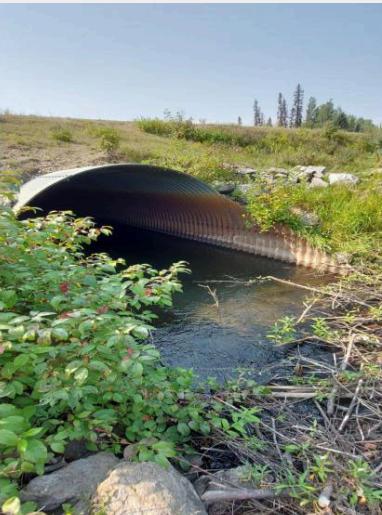
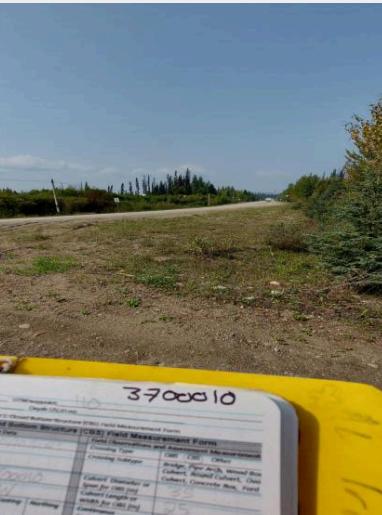
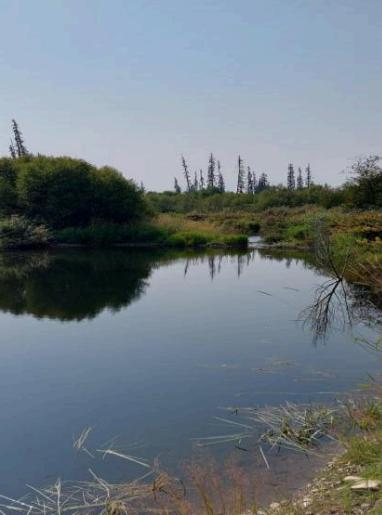
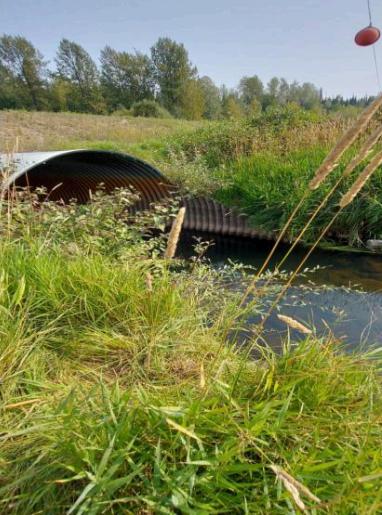
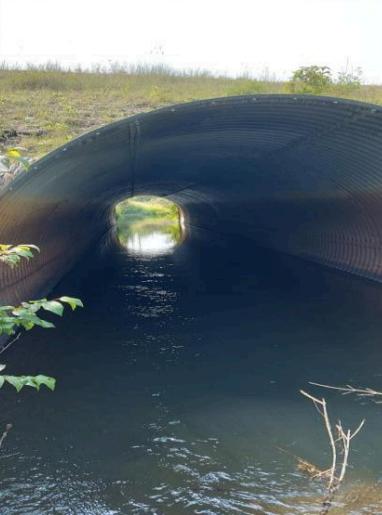
. From top left clockwise: Road/Site Card, Barrel, Outlet, Downstream, Upstream, Inlet.3700010

Location and Stream Data	•	Crossing Characteristics	-		
Comments: Enormous outlet pool indicating culvert may be undersized. Numerous fish spotted in outlet pool and inlet side. Debris jams covering entire stream channel at inlet and at outlet of outlet pool. Pool very deep, depth estimated. Ministry of Transportation chris_hwy_structure_road_id: 3759. 13:35:05					
Photos: PSCIS ID

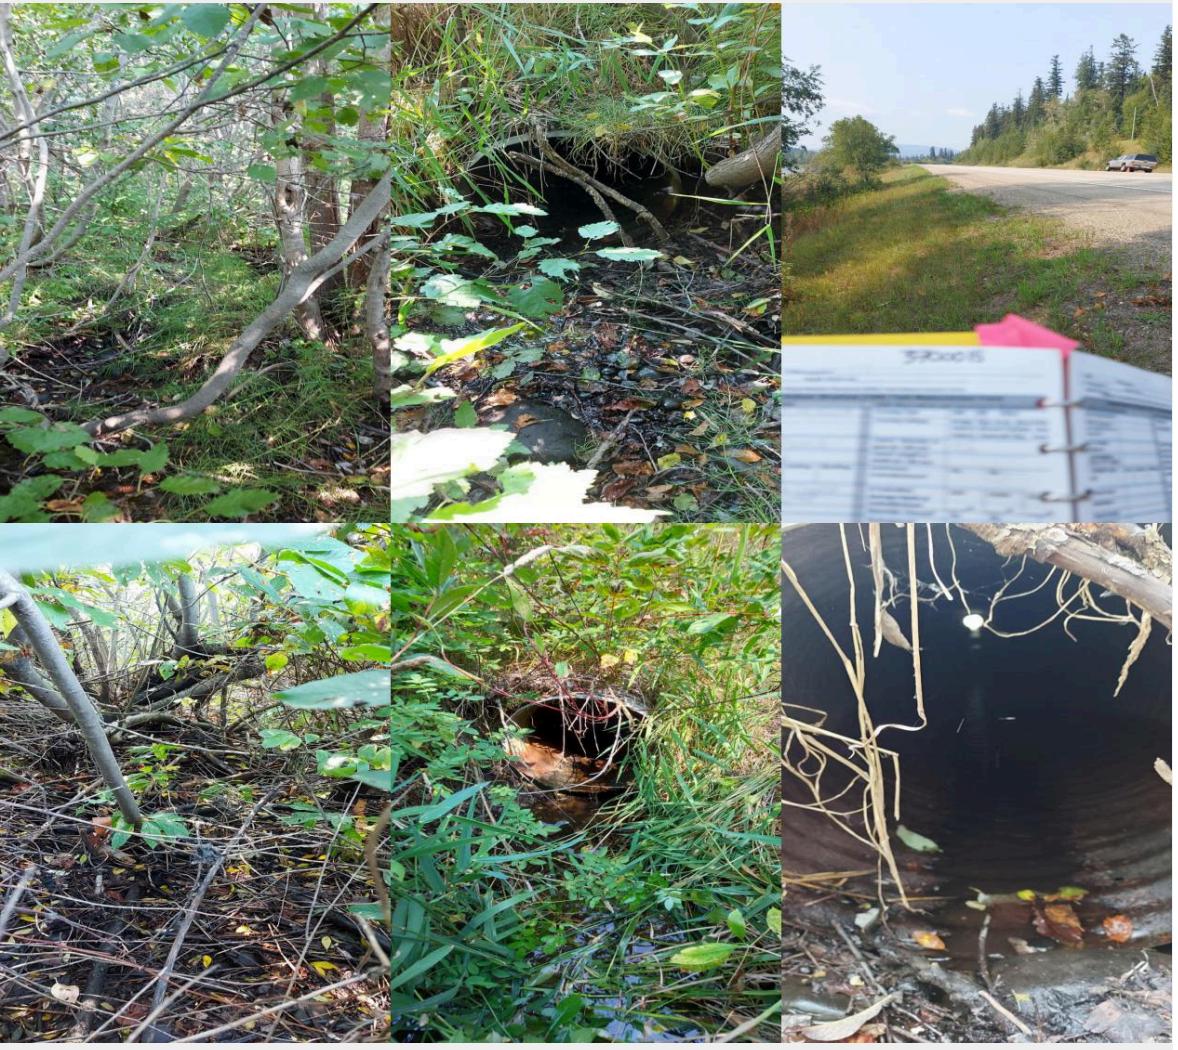
<p>. From top left clockwise: Road/Site Card, Barrel, Outlet, Downstream, Upstream, Inlet.3700015</p>

Location and Stream Data	•	Crossing Characteristics	-
Comments: Very little flow through culvert. Overgrown channel. Very little water in stream. Not likely fish bearing. Ministry of Transportation chris_culvert_id: 1996752. 14:05:09			
Photos: PSCIS ID

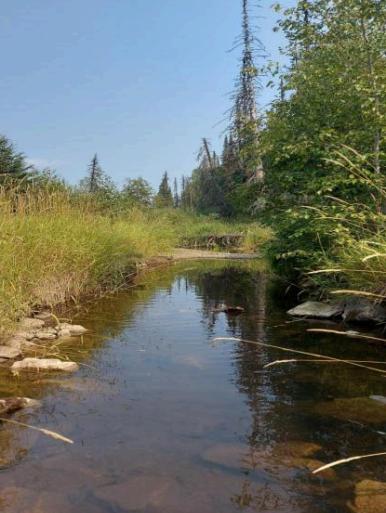
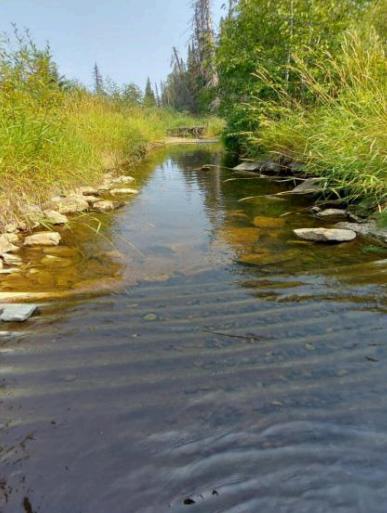
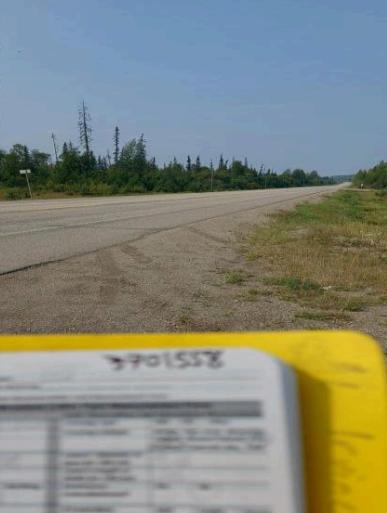
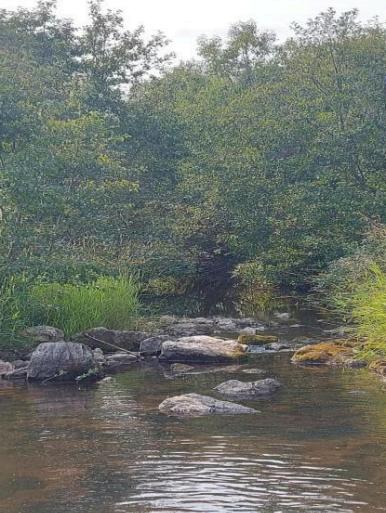
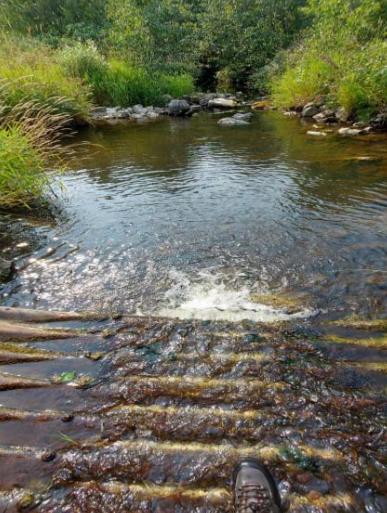
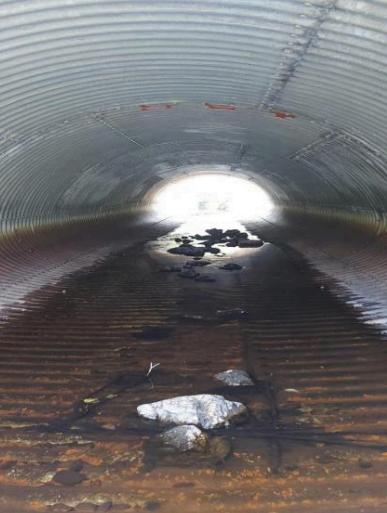
. From top left clockwise: Road/Site Card, Barrel, Outlet, Downstream, Upstream, Inlet.3701558

Location and Stream Data	•	Crossing Characteristics	-
Comments: Fish spotted in culvert and near inlet. Some substrate and cobbles in pipe. Ministry of Transportation chris_hwy_structure_road_id: 2434. 14:47:11			
Photos: PSCIS ID

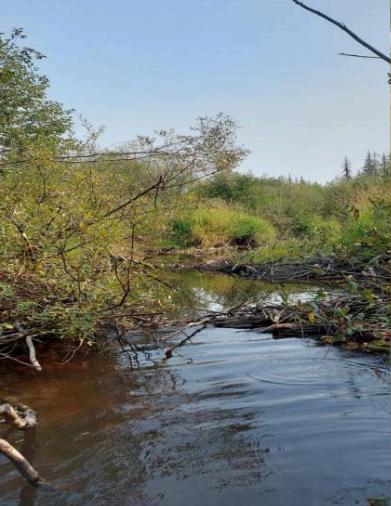
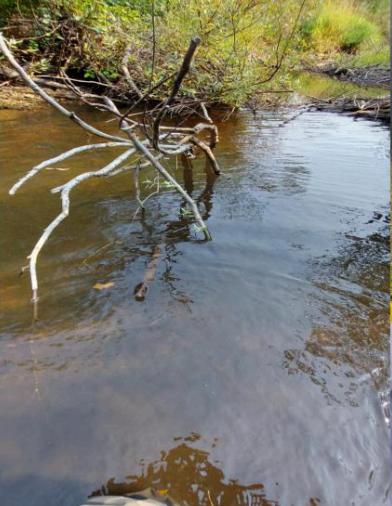
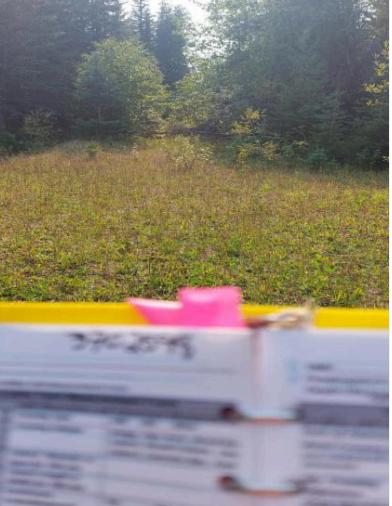
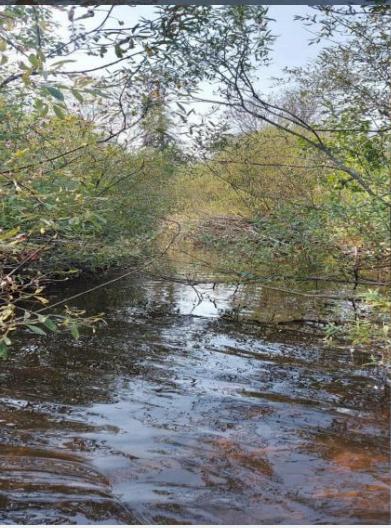
. From top left clockwise: Road/Site Card, Barrel, Outlet, Downstream, Upstream, Inlet.3702598

Location and Stream Data	.	Crossing Characteristics	-
Comments: High habitat quality. Old quad trail. Small trib flowing into creek from one side. 15:08:17			
Photos: PSCIS ID

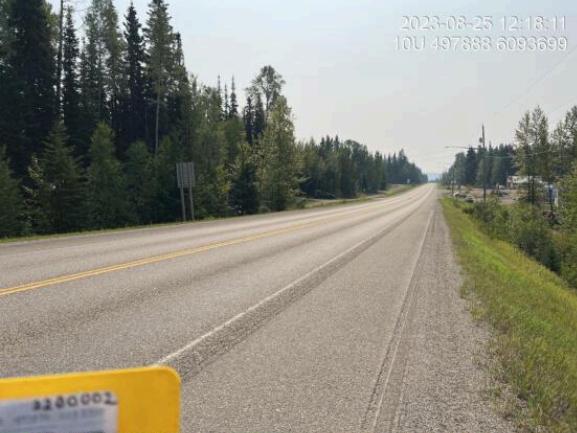
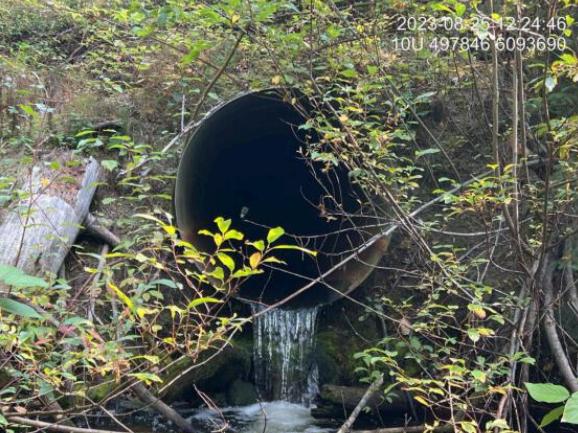
From top left clockwise: Road/Site Card, Barrel, Outlet, Downstream, Upstream, Inlet.2200002

Location and Stream Data	•	Crossing Characteristics
Comments: Stream is located between McLeod Lake Store on Highway and TseKhene food and fuel entrance. Most of the watershed drains reservation land. Could potentially be backwatered as an interim solution. Channel width estimated upstream in wetland type habitat so difficult to tell. Upstream end of the pipe is significantly sloped in the upstream direction. Ministry of Transportation chris_culvert_id: 1997114. 12:31:49		
Photos: PSCIS ID

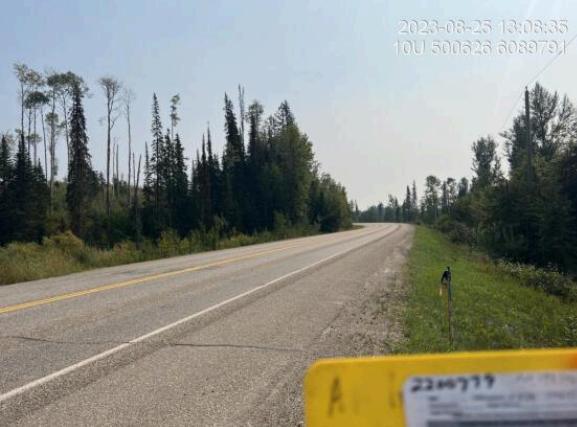
2023-08-25 13:08:35 10U 500626 608979;1

Location and Stream Data	•	Crossing Characteristics	-
Comments: Grate on inlet and beaver influenced wetland upstream. Inlet blocked by beaver debris with beaver trap on inlet. Potentially good candidate for leveler to maintain beaver activity without attempting to remove the animals. Ministry of Transportation chris_culvert_id: 1997066. 13:04:57			
Photos: PSCIS ID

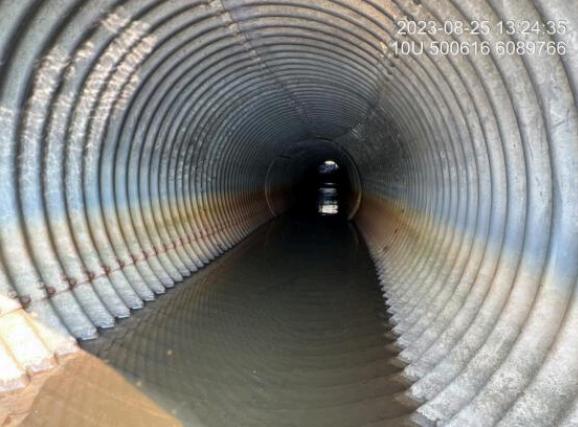
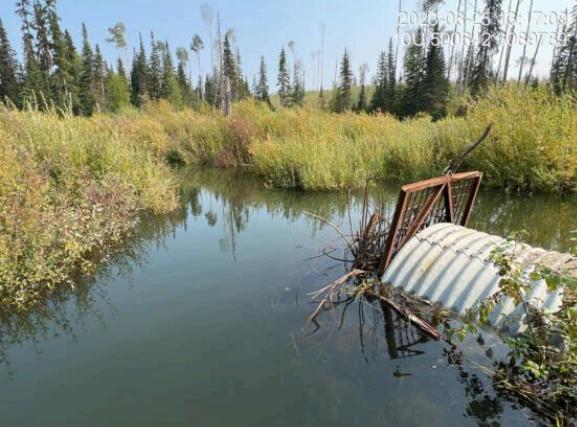
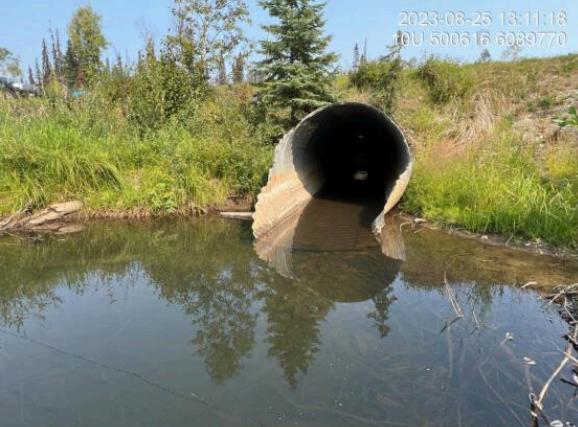
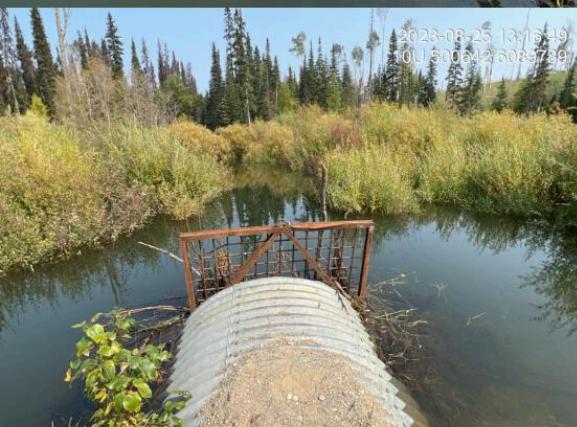
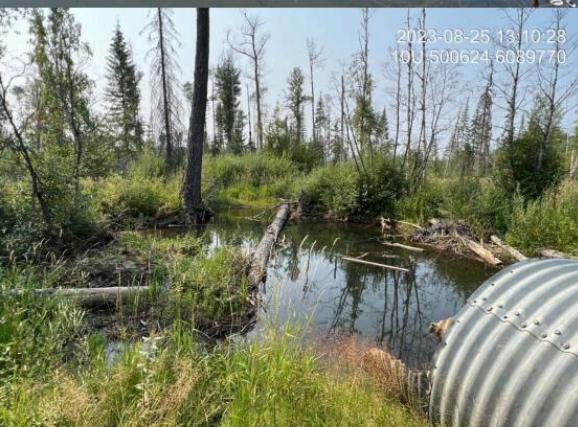
2023-08-25 13:10:28 10U 500624 6089770	
. From top left clockwise: Road/Site Card, Barrel, Outlet, Downstream, Upstream, Inlet.2200779

Location and Stream Data	•	Crossing Characteristics
Comments: Abundant gravels, suitable for spawning upstream. Although flows are minimal, the streams does still have water. Models as having over 3 km of habitat upstream below 5%. Although no fish are recorded as present upstream it seems highly likely that this would be a fish bearing stream. Outlet drop is 80cm. Steep section of pipe at the inlet recorded as inlet drop. Ministry of Transportation chris_culvert_id: 1996852. 13:40:04		
Photos: PSCIS ID

Location and Stream Data		Crossing Characteristics	
Date	2023-08-25	Crossing Sub Type	Round Culvert
PSCIS ID	198668	Diameter (m)	1.2
External ID	2200604	Length (m)	50
Crew	AI	Embedded	No
UTM Zone	10	Depth Embedded (m)	–
Easting	501962.9	Resemble Channel	No
Northing	6087826	Backwatered	No
Stream	Tributary to McLeod Lake	Percent Backwatered	–
Road	Highway 97	Fill Depth (m)	6
Road Tenure	MOTI	Outlet Drop (m)	0.8
Channel Width (m)	1.9	Outlet Pool Depth (m)	0.6
Stream Slope (%)	3	Inlet Drop	Yes
Beaver Activity	Yes	Slope (%)	1
Habitat Value	Medium	Valley Fill	Deep Fill
Final score	37	Barrier Result	Barrier
Fix type	Replace Structure with Streambed Simulation CBS	Fix Span / Diameter	3

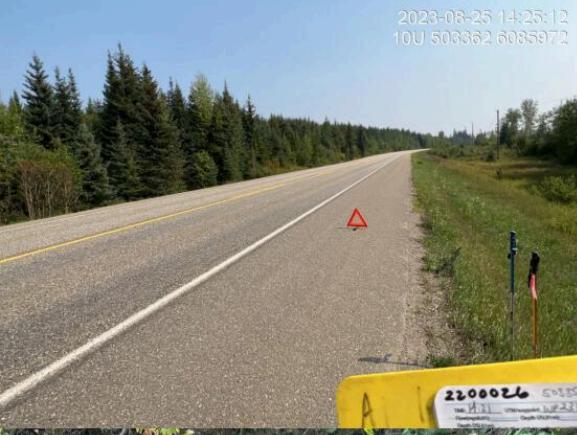
Location and Stream Data	•	Crossing Characteristics
Comments: Culvert is extremely under sized. Nice stream with pockets of gravel and good flow upstream. Rainbow known in the system. Culvert is literally unravelling at the downstream end with a very large outlet pool. Beaver activity noted downstream. Seems very unlikely that any fish can pass through the pipe. Ministry of Transportation chris_culvert_id: 1996861. 14:23:42		
Photos: PSCIS ID

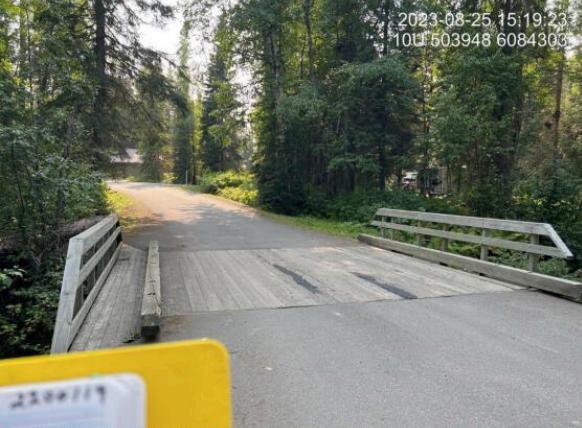
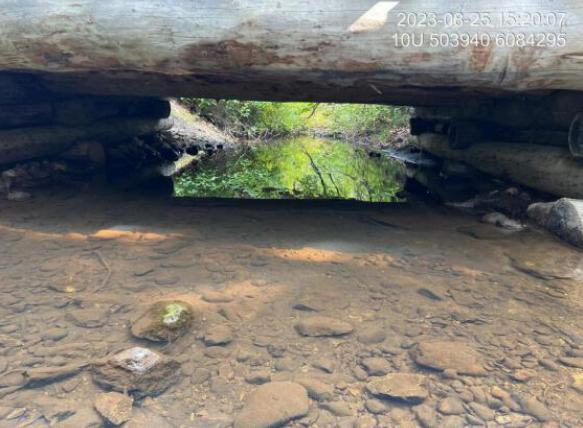
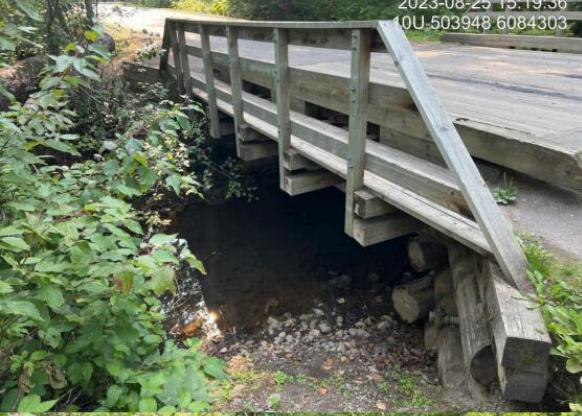
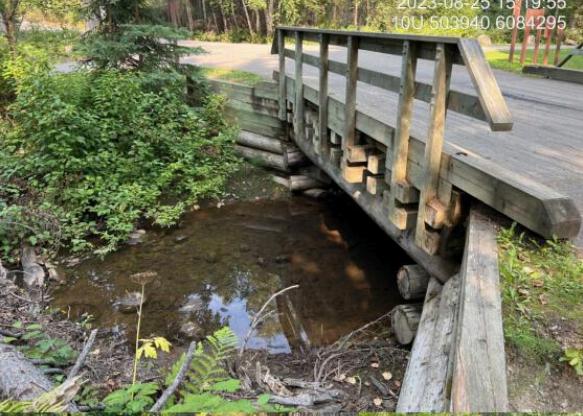
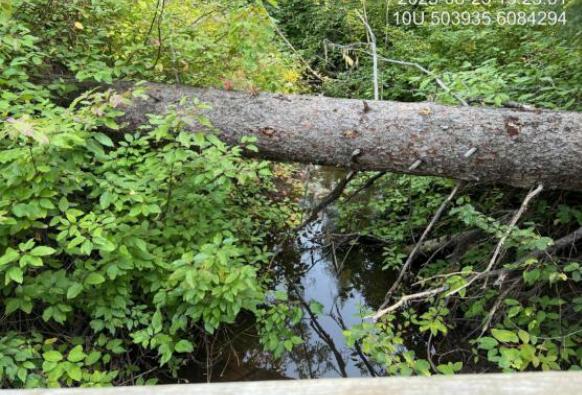
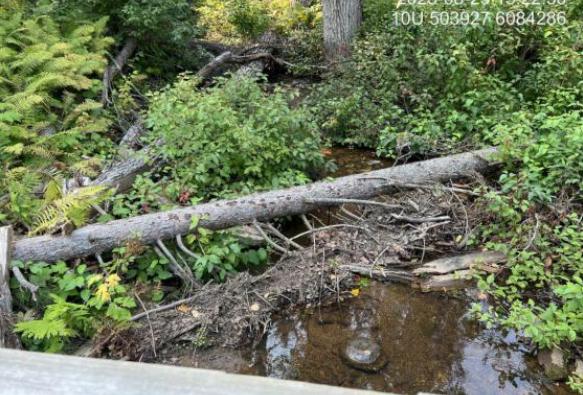
2023-08-25 15:22:50 10U 503927 6084286
. From top left clockwise: Road/Site Card, Barrel, Outlet, Downstream, Upstream, Inlet.2200119

Location and Stream Data	•	Crossing Characteristics	-
Comments: Nice little campground bridge. 15:20:36			
Photos: PSCIS ID
