Appendix - Phase 1 Fish Passage Assessment Data and Photos

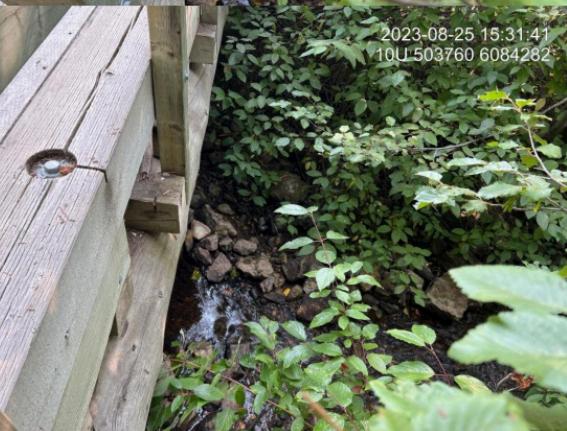
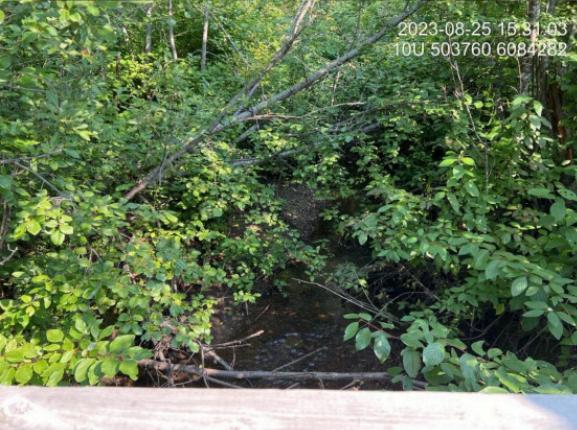
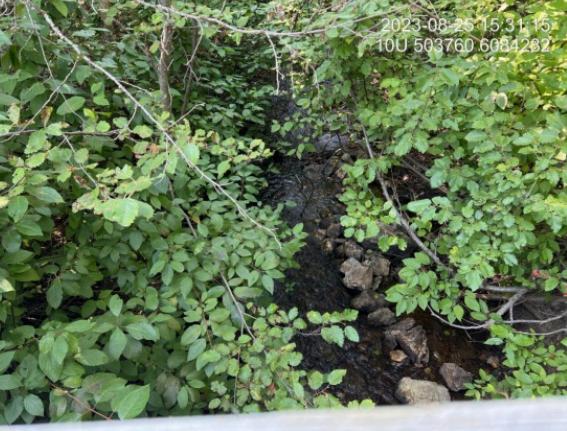
2023-08-25 15:31:15 10U 503760 6084282	
. From top left clockwise: Road/Site Card, Barrel, Outlet, Downstream, Upstream, Inlet.2200114

Location and Stream Data	•	Crossing Characteristics	-
Comments: There are four bridges in total within 200m, with 2 inventoried. 15:32:10			
Photos: PSCIS ID

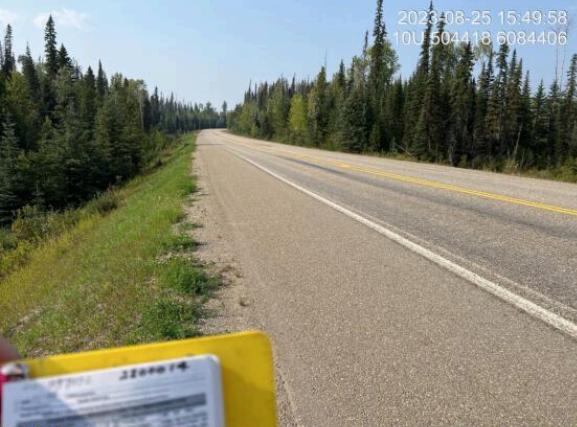
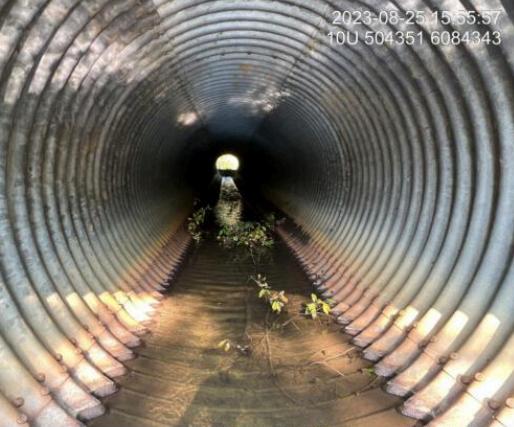
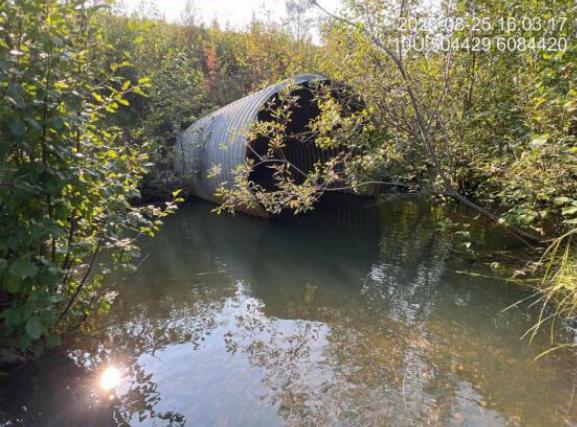
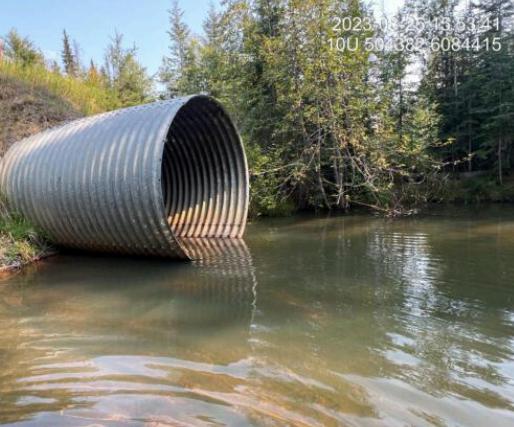
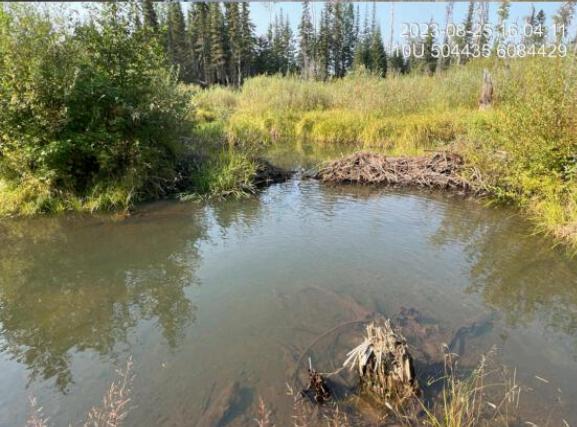
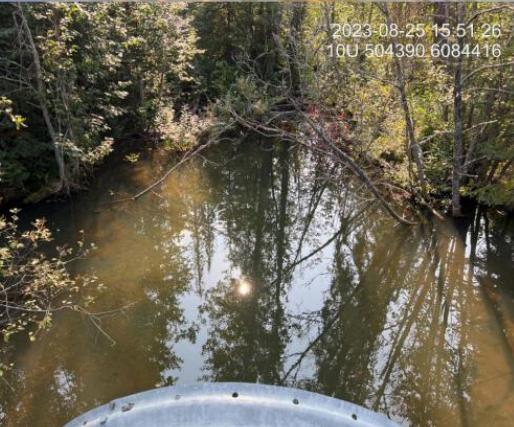
. From top left clockwise: Road/Site Card, Barrel, Outlet, Downstream, Upstream, Inlet.2200014

Location and Stream Data	•	Crossing Characteristics
Comments: Beaver activity downstream with extensive beaver influence wetlands upstream. 1 1/2 m high blockage at the inlet to beaver activity. Stream width difficult to estimate due to wetland nature of habitat upstream. This is the first road stream crossing on this stream to be an issue at all downstream, crossings or bridges within whiskers point provincial park campground. Ministry of Transportation chris_culvert_id: 1997172. 16:05:30		
Photos: PSCIS ID

Location and Stream Data		Crossing Characteristics –	
Date	2023-08-25	Crossing Sub Type	Round Culvert
PSCIS ID	198672	Diameter (m)	2.5
External ID	2200014	Length (m)	35
Crew	AI	Embedded	No
UTM Zone	10	Depth Embedded (m)	–
Easting	504410.8	Resemble Channel	No
Northing	6084420	Backwatered	No
Stream	Whiskers Creek	Percent Backwatered	–
Road	Highway 97	Fill Depth (m)	5
Road Tenure	MOTI	Outlet Drop (m)	0
Channel Width (m)	7	Outlet Pool Depth (m)	1.5
Stream Slope (%)	0	Inlet Drop	No
Beaver Activity	Yes	Slope (%)	2
Habitat Value	Medium	Valley Fill	Deep Fill
Final score	27	Barrier Result	Barrier
Fix type	Replace with New Open Bottom Structure	Fix Span / Diameter	16

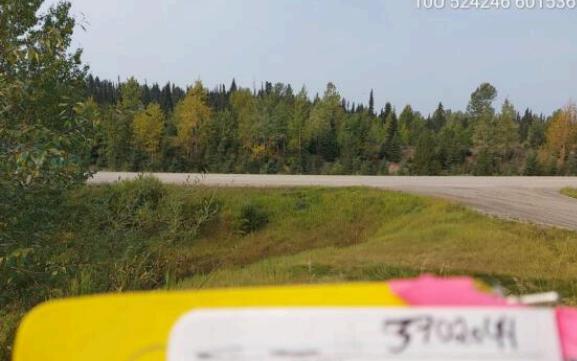
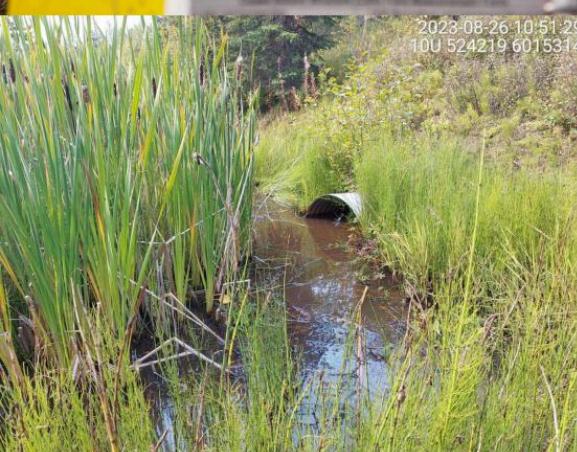
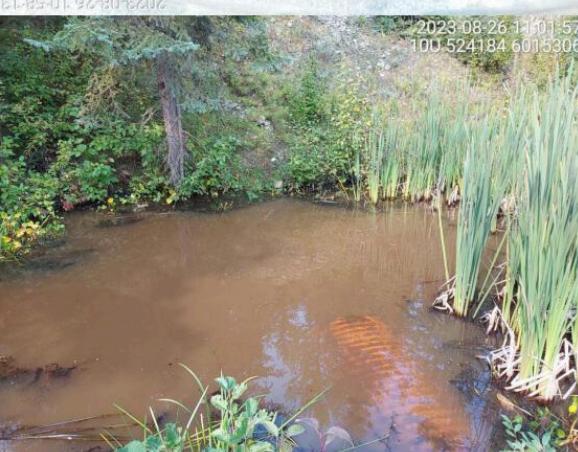
Location and Stream Data	•	Crossing Characteristics	-
Comments: Culvert is fully submerged on outlet side. No stream found beyond outlet pool. Big wetland complex on upstream side. No defined channel. Stream slope, channel width, and culvert slope were estimated. Ministry of Transportation chris_culvert_id: 1996888. 11:04:17			
Photos: PSCIS ID

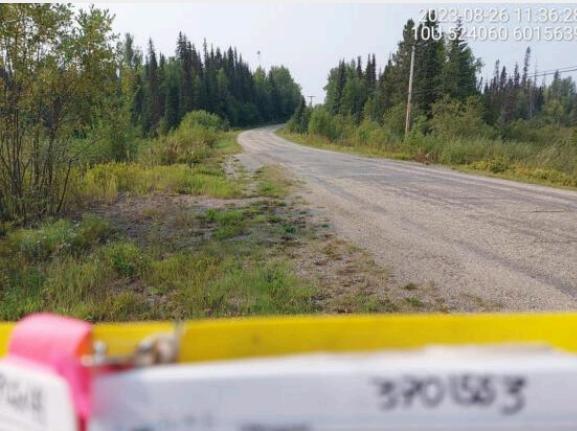
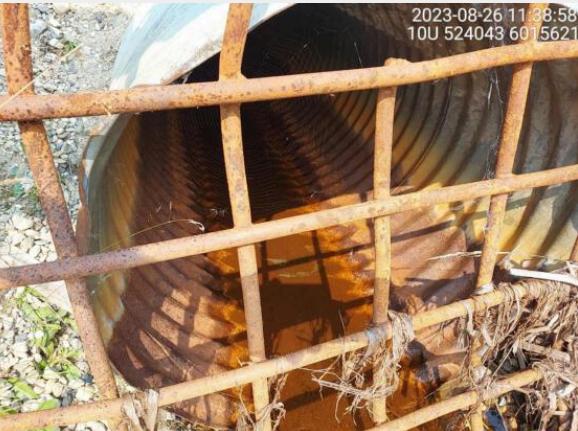
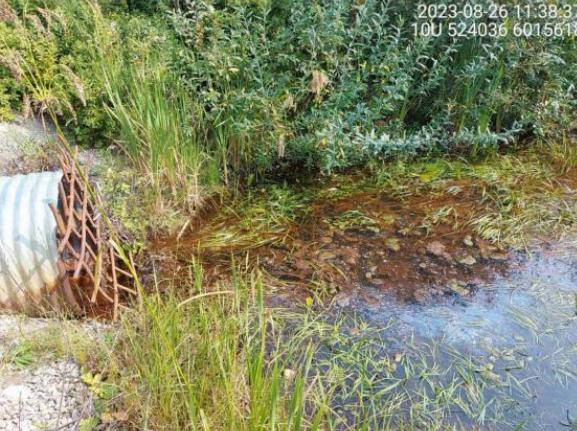
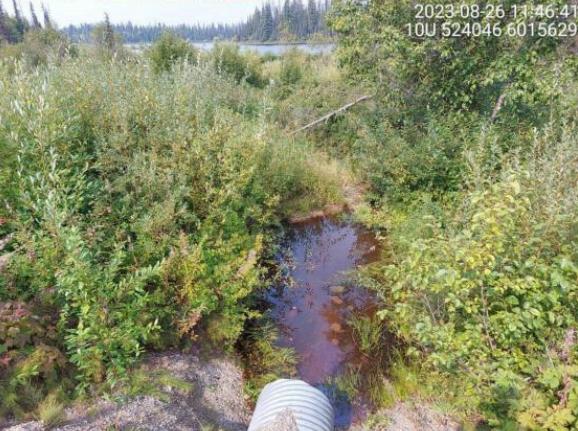
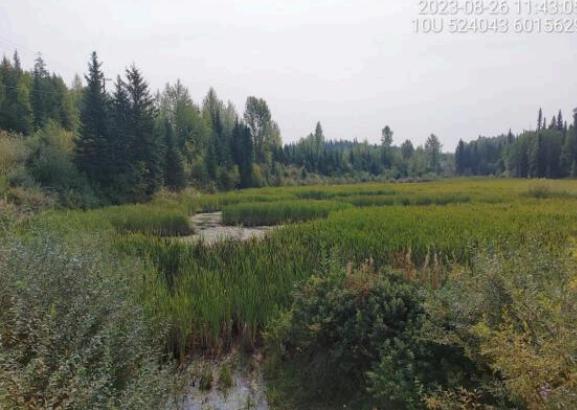
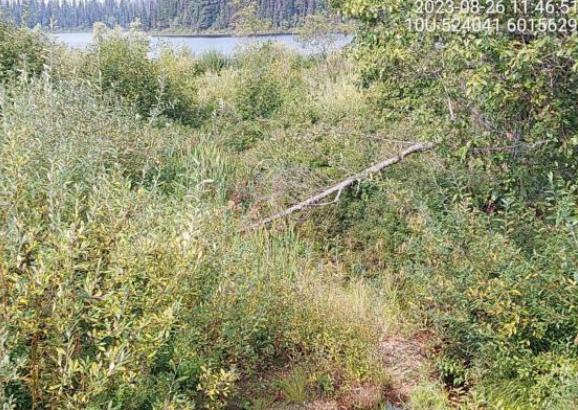
. From top left clockwise: Road/Site Card, Barrel, Outlet, Downstream, Upstream, Inlet.3701553

Location and Stream Data	•	Crossing Characteristics	-
Comments: Beaver grate on inlet side. Big wetland area upstream and no defined stream channel seen. Some flow downstream. Very little flow through pipe. There is an unassessed crossing upstream, on railway (modelled crossing id 3703407). Ministry of Transportation chris_culvert_id: 3440699. 11:56:39			
Photos: PSCIS ID

Location and Stream Data		Crossing Characteristics –	
Date	2023-08-26	Crossing Sub Type	Round Culvert
PSCIS ID	198674	Diameter (m)	0.8
External ID	3701553	Length (m)	12
Crew	MW	Embedded	No
UTM Zone	10	Depth Embedded (m)	–
Easting	524033.9	Resemble Channel	No
Northing	6015628	Backwatered	No
Stream	Miller Creek	Percent Backwatered	–
Road	Summit Lake Rd	Fill Depth (m)	1.5
Road Tenure	MOTI Local	Outlet Drop (m)	0
Channel Width (m)	2.4	Outlet Pool Depth (m)	0.6
Stream Slope (%)	2	Inlet Drop	No
Beaver Activity	No	Slope (%)	2.5
Habitat Value	Low	Valley Fill	Deep Fill
Final score	21	Barrier Result	Barrier
Fix type	Replace with New Open Bottom Structure	Fix Span / Diameter	14

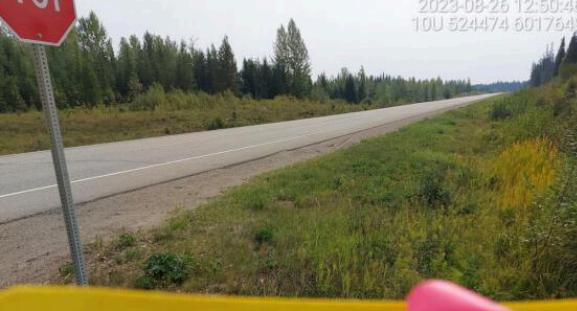
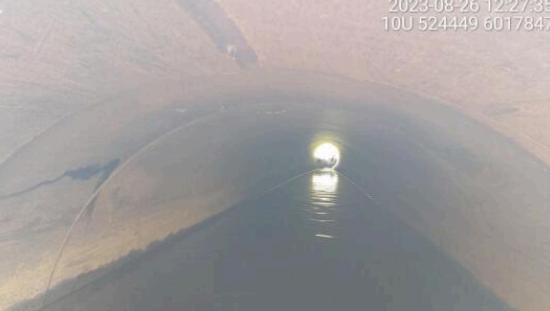
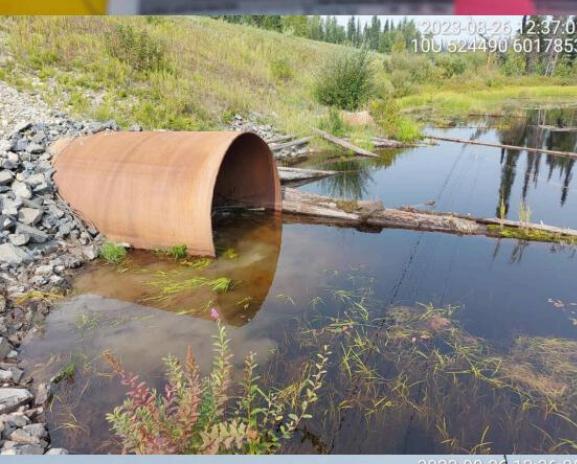
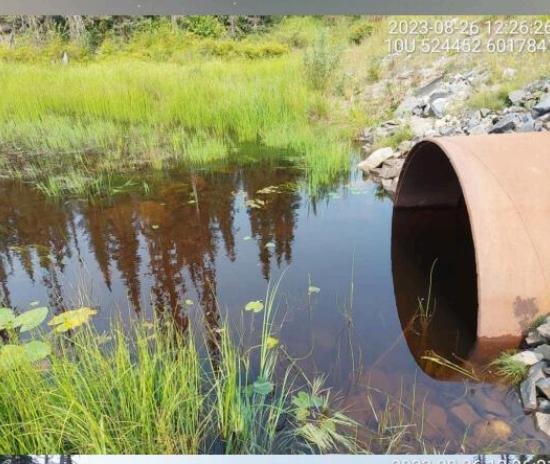
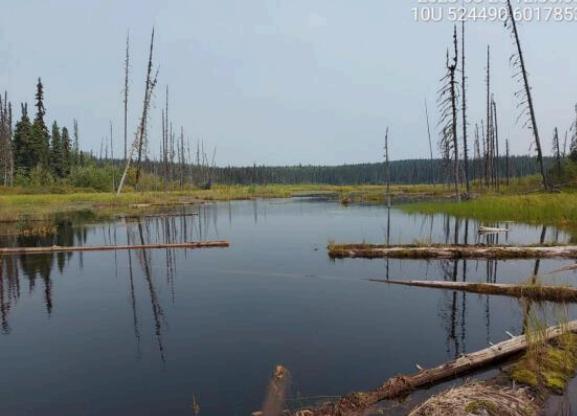
<p>3701554</p>

Location and Stream Data	•	Crossing Characteristics	-
Comments: Debris jam at inlet creating small drop. Large wetland area upstream and downstream. No well defined channel. Burbot confirmed just upstream in the past, as well as downstream near Summit Lake. Ministry of Transportation chris_culvert_id: 1996948. 12:35:23			
Photos: PSCIS ID

Location and Stream Data		Crossing Characteristics	
Date	2023-08-26	Crossing Sub Type	Round Culvert
PSCIS ID	198675	Diameter (m)	1.9
External ID	3701554	Length (m)	26
Crew	MW	Embedded	No
UTM Zone	10	Depth Embedded (m)	–
Easting	524469.3	Resemble Channel	No
Northing	6017855	Backwatered	Yes
Stream	O'Dell Creek	Percent Backwatered	100
Road	Highway 97	Fill Depth (m)	3
Road Tenure	MOTI	Outlet Drop (m)	0
Channel Width (m)	1.9	Outlet Pool Depth (m)	0.8
Stream Slope (%)	1.5	Inlet Drop	No
Beaver Activity	Yes	Slope (%)	4
Habitat Value	Medium	Valley Fill	Deep Fill
Final score	26	Barrier Result	Barrier
Fix type	Replace Structure with Streambed Simulation CBS	Fix Span / Diameter	3

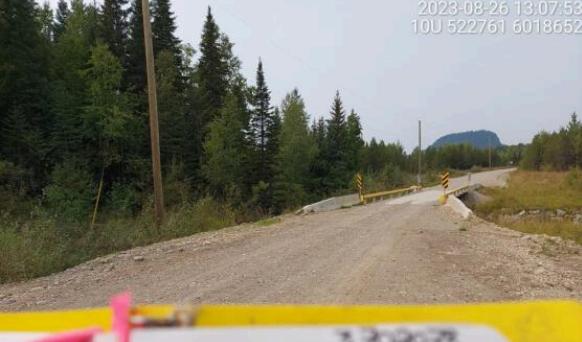
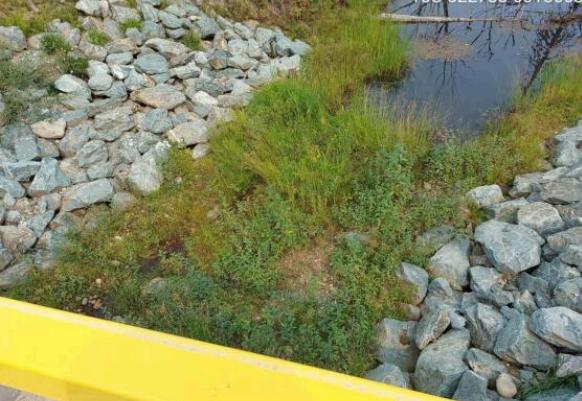
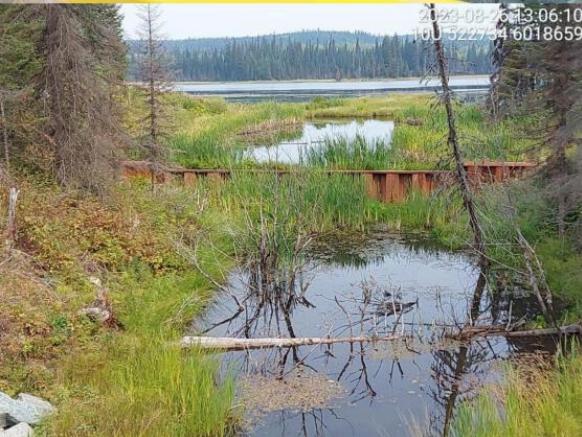
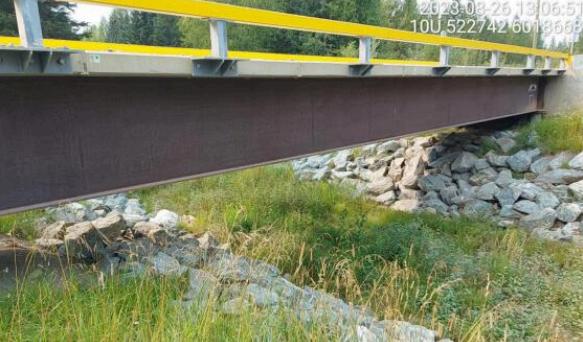
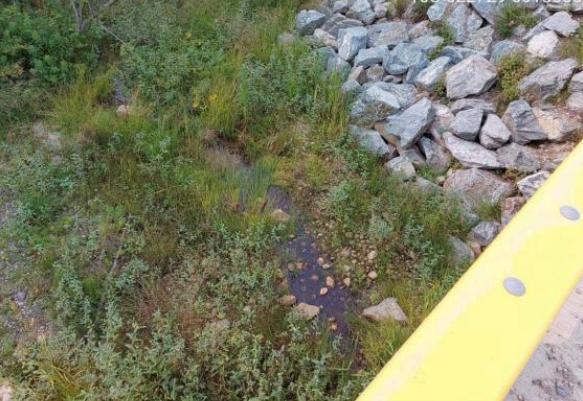
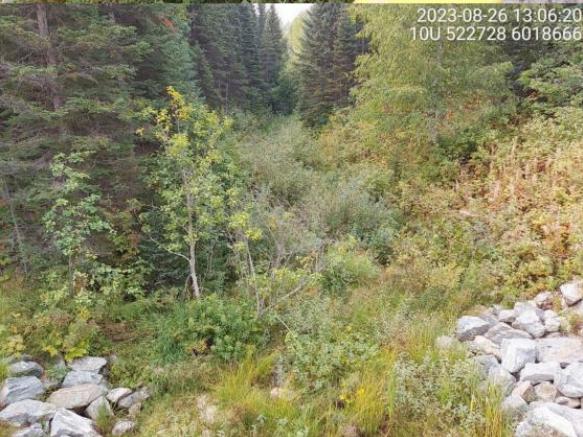
. From top left clockwise: Road/Site Card, Barrel, Outlet, Downstream, Upstream, Inlet.3702078

Location and Stream Data	•	Crossing Characteristics	-
Comments: Neilsen Lake dam located approximately 30m upstream of bridge, near outlet of lake. Metal dam 1.8m in height and owned by Ministry of Environment. 13:08:06			
Photos: PSCIS ID

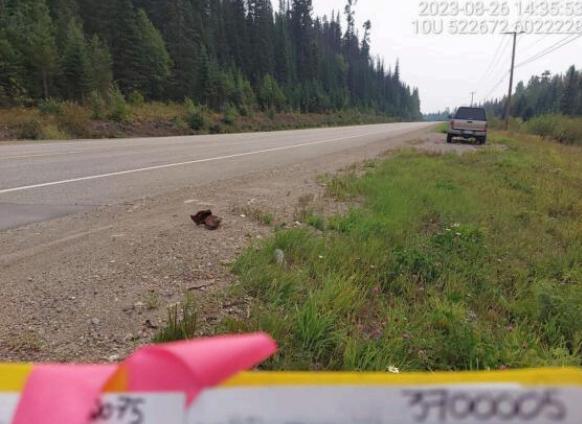
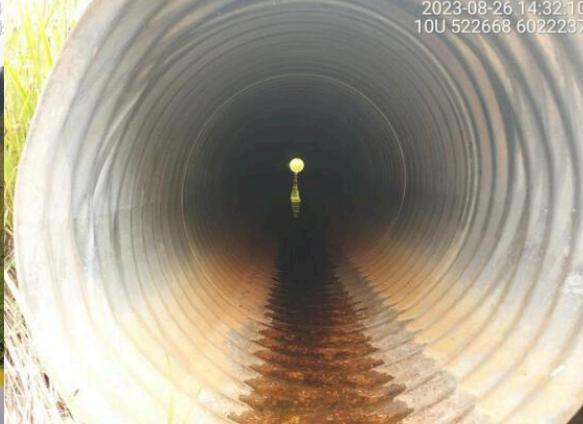
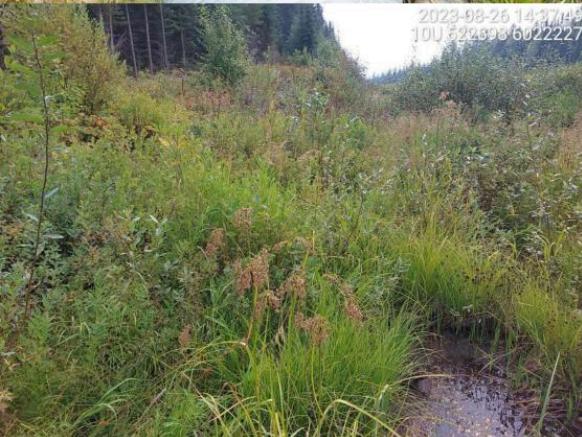
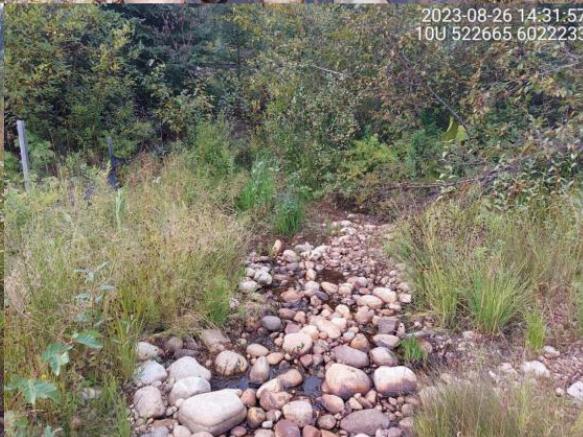
. From top left clockwise: Road/Site Card, Barrel, Outlet, Downstream, Upstream, Inlet.3700005

Location and Stream Data	•	Crossing Characteristics	-
Comments: No visible channel upstream. Very little flow through culvert. Some water and cobbles at outlet. Ministry of Transportation chris_culvert_id: 1997258. 14:42:45			
Photos: PSCIS ID

Location and Stream Data		Crossing Characteristics –	
Date	2023-08-26	Crossing Sub Type	Round Culvert
PSCIS ID	198678	Diameter (m)	0.75
External ID	3700005	Length (m)	23
Crew	MW	Embedded	No
UTM Zone	10	Depth Embedded (m)	–
Easting	522683.9	Resemble Channel	No
Northing	6022233	Backwatered	No
Stream	Witters Creek	Percent Backwatered	–
Road	Highway 97	Fill Depth (m)	1
Road Tenure	MOTI	Outlet Drop (m)	0
Channel Width (m)	2.3	Outlet Pool Depth (m)	0
Stream Slope (%)	2	Inlet Drop	No
Beaver Activity	No	Slope (%)	4
Habitat Value	Low	Valley Fill	Deep Fill
Final score	29	Barrier Result	Barrier
Fix type	Replace with New Open Bottom Structure	Fix Span / Diameter	14

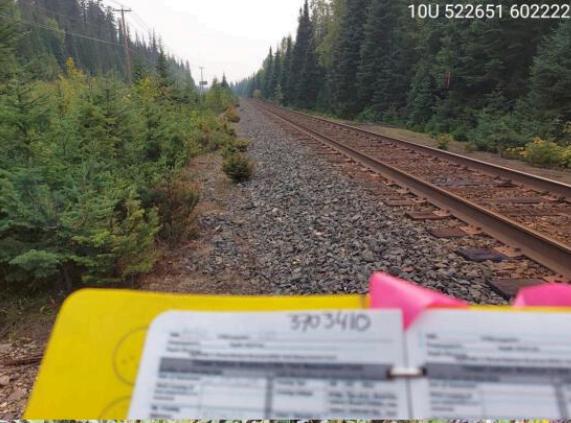
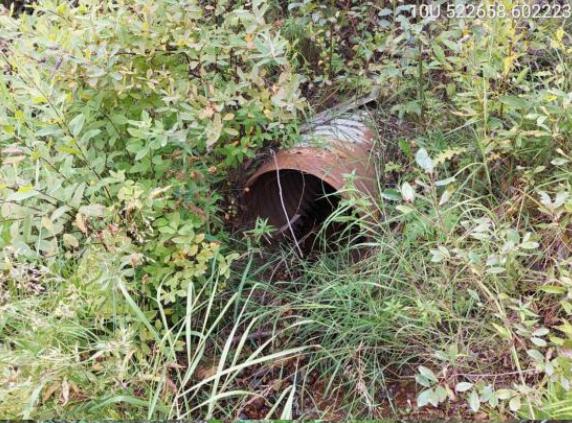
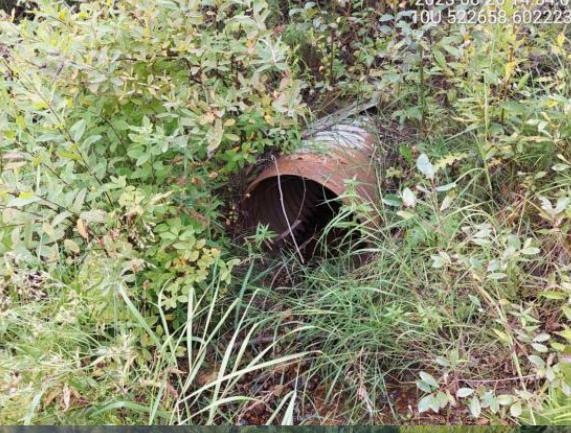
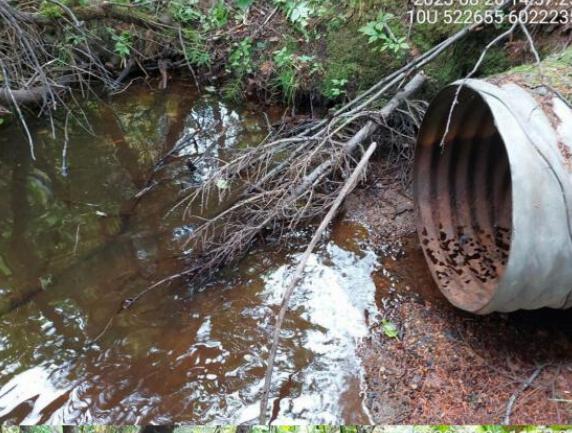
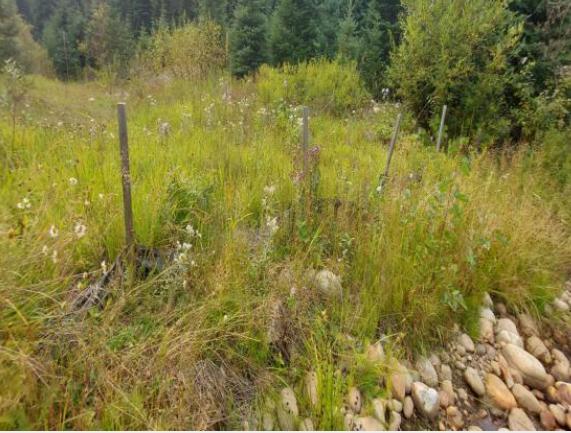
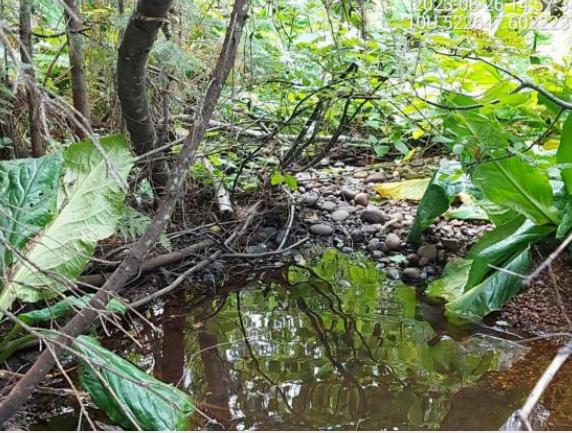
Location and Stream Data	•	Crossing Characteristics	-
Comments: Small amount of water in pipe. Channel is overgrown downstream. Almost no flow in stream. 15:01:34			
Photos: PSCIS ID

Location and Stream Data		Crossing Characteristics	
Date	2023-08-26	Crossing Sub Type	Round Culvert
PSCIS ID	198679	Diameter (m)	0.6
External ID	3703410	Length (m)	17
Crew	MW	Embedded	No
UTM Zone	10	Depth Embedded (m)	–
Easting	522653.6	Resemble Channel	No
Northing	6022232	Backwatered	No
Stream	Witters Creek	Percent Backwatered	–
Road	Railway	Fill Depth (m)	2
Road Tenure	CN Rail	Outlet Drop (m)	0.1
Channel Width (m)	1.9	Outlet Pool Depth (m)	0.4
Stream Slope (%)	1.5	Inlet Drop	No
Beaver Activity	No	Slope (%)	1
Habitat Value	Low	Valley Fill	Deep Fill
Final score	24	Barrier Result	Barrier
Fix type	Replace Structure with Streambed Simulation CBS	Fix Span / Diameter	3

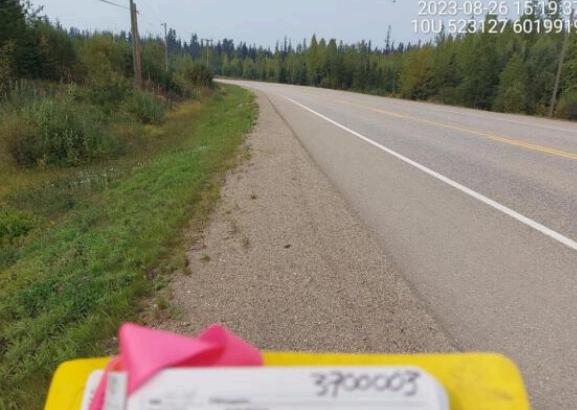
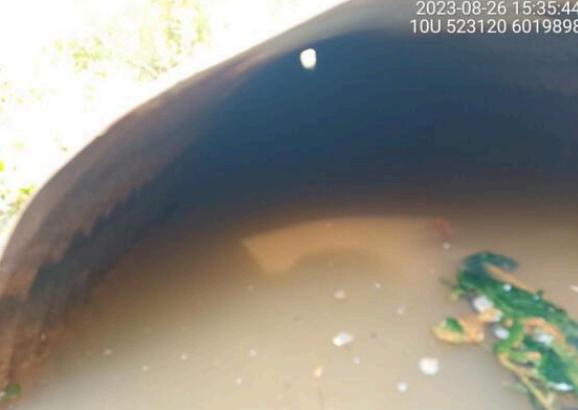
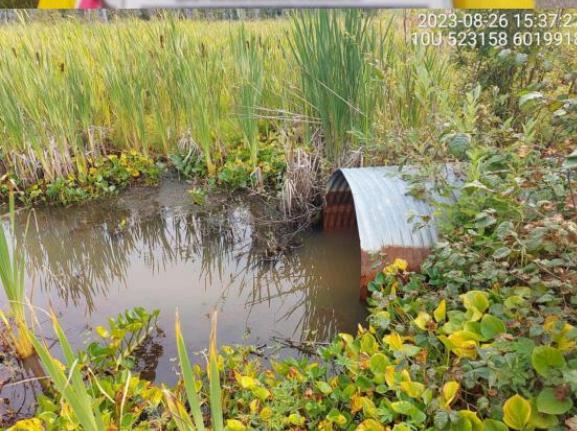
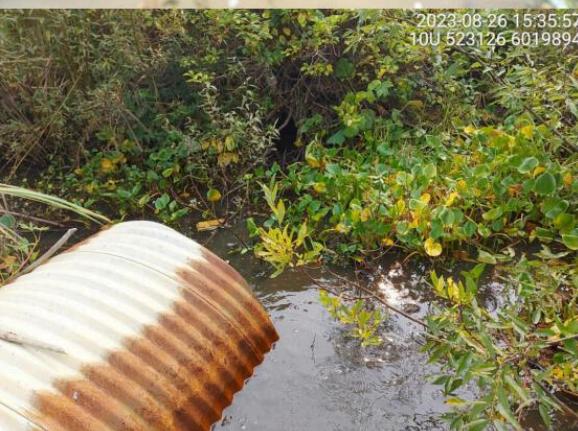
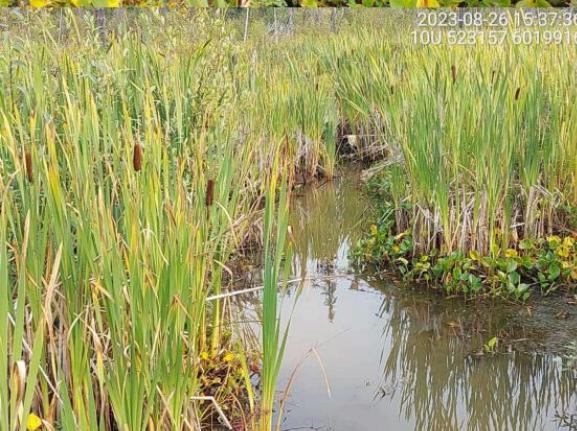
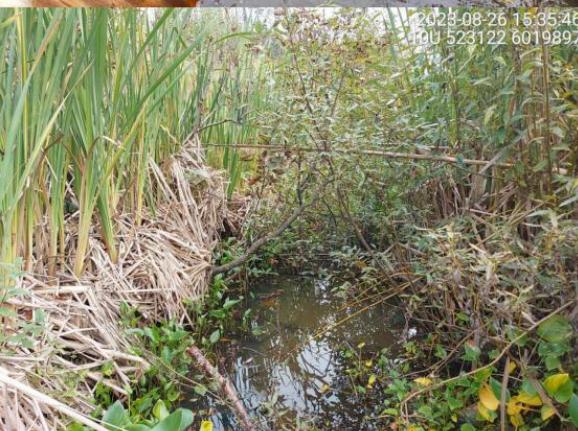
Location and Stream Data	•	Crossing Characteristics	-
Comments: Wetland habitat, no flow. No culvert found south where modelled crossing is supposed to be on map. Unassessed railway crossing downstream. Ministry of Transportation chris_culvert_id: 1997273. 15:40:25			
Photos: PSCIS ID

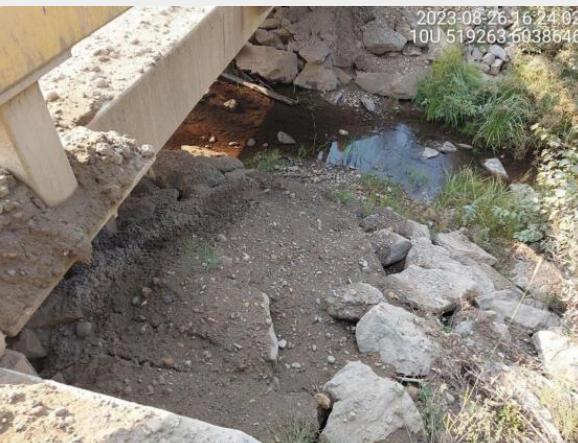
Location and Stream Data	•	Crossing Characteristics
Comments: Burbot and bull trout confirmed upstream in past. Wetland upstream. 16:24:42		
Photos: PSCIS ID

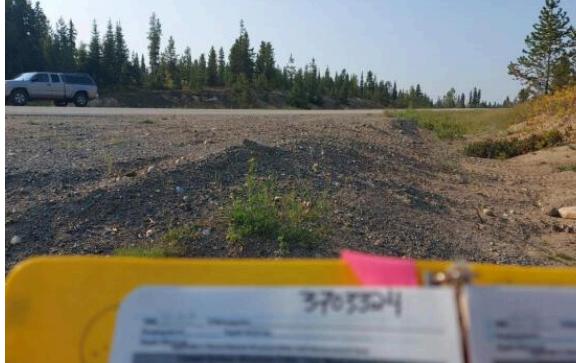
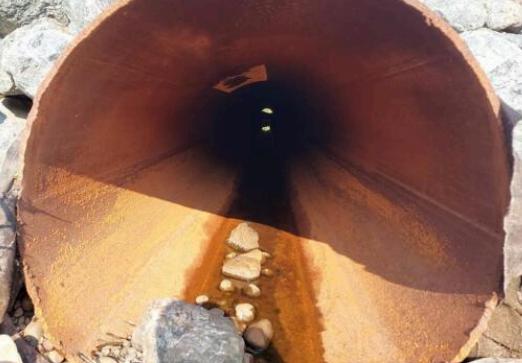
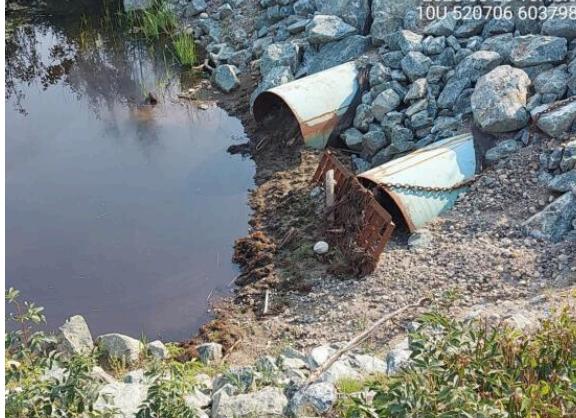
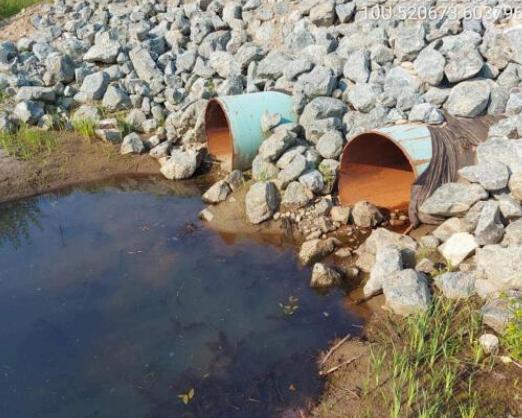
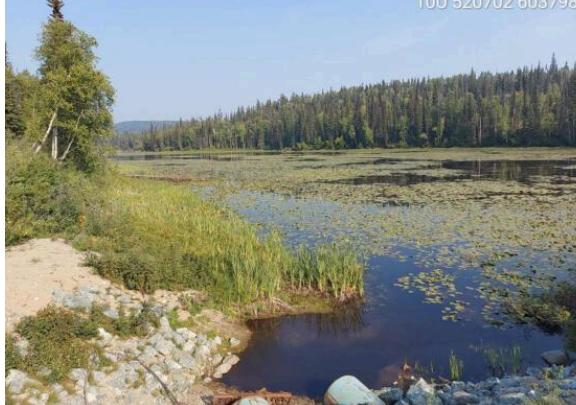
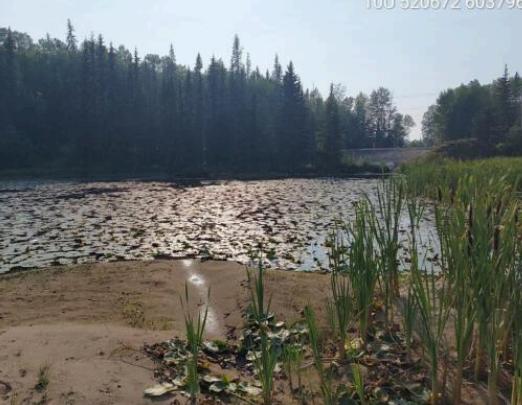
. From top left clockwise: Road/Site Card, Barrel, Outlet, Downstream, Upstream, Inlet.3700007

Location and Stream Data	•	Crossing Characteristics	-
Comments: Two pipes. Big wetland upstream and downstream. No well defined channel. Ministry of Transportation chris_culvert_id: 1997232. 16:47:59			
Photos: PSCIS ID			
2023-08-26 16:52:25 10U 520696 6037985	•	2023-08-26 16:39:45 10U 520674 6037967	-

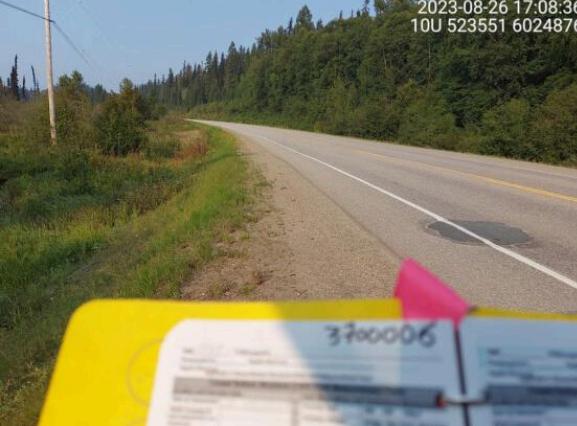
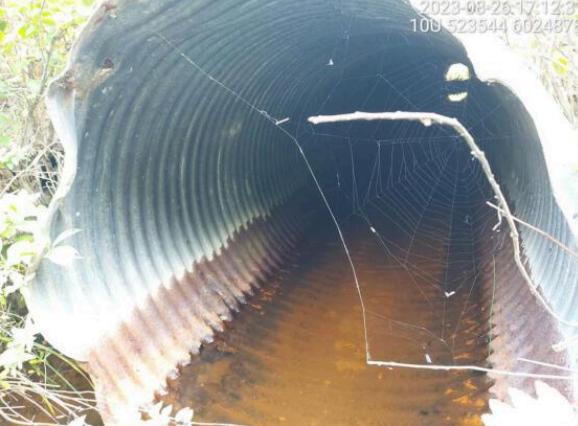
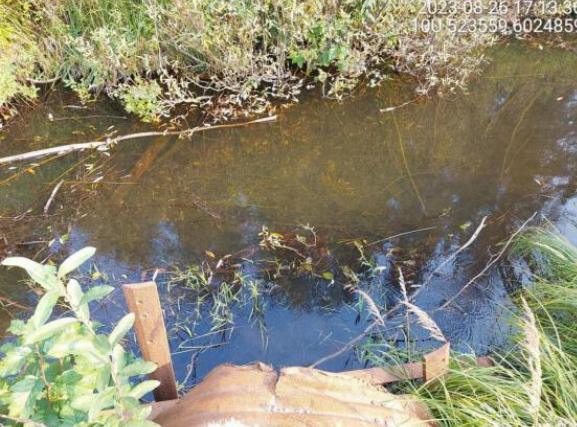
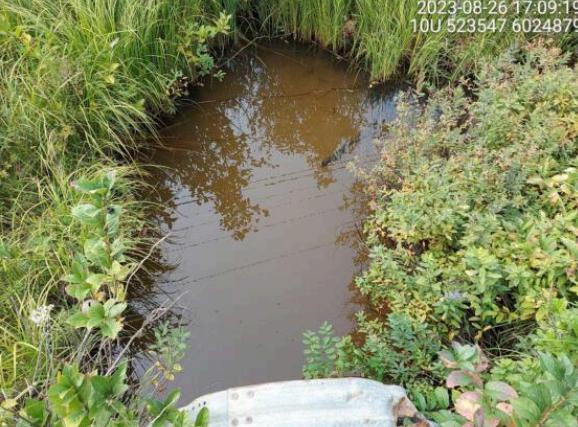
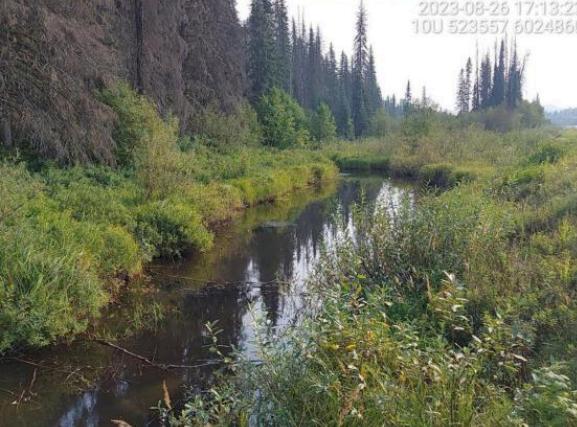
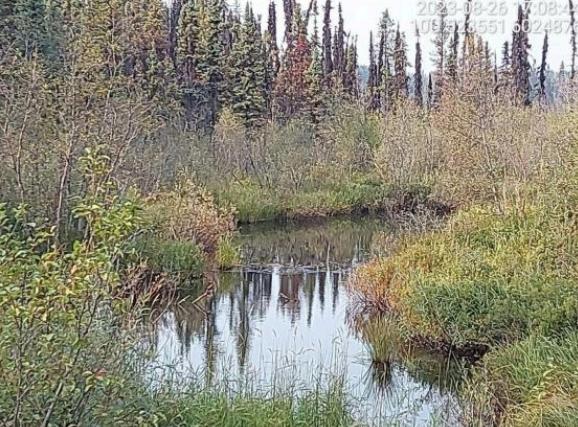
From top left clockwise: Road/Site Card, Barrel, Outlet, Downstream, Upstream, Inlet.3700006

Location and Stream Data	•	Crossing Characteristics
Comments: Backwatered, wetland downstream. Culvert is rusted. Four small lakes upstream, including Augustine, Log, and Cloud Lake. Fish presence confirmed in Augustine Lake (RB, SU, NSC and RSC). Unassessed crossing (modelled id 3703412) located downstream of highway on railway, near the confluence with Crooked River. Ministry of Transportation chris_culvert_id: 1997146. 17:17:30		
Photos: PSCIS ID

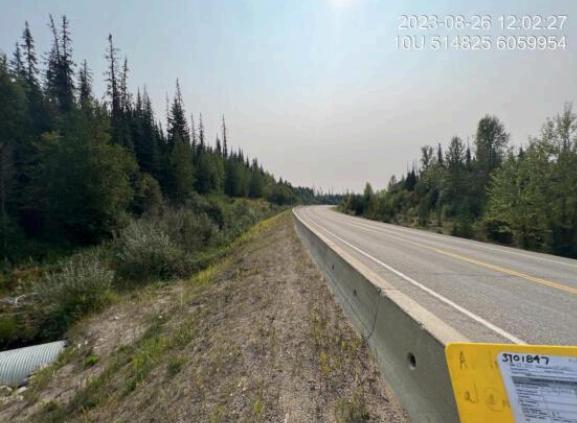
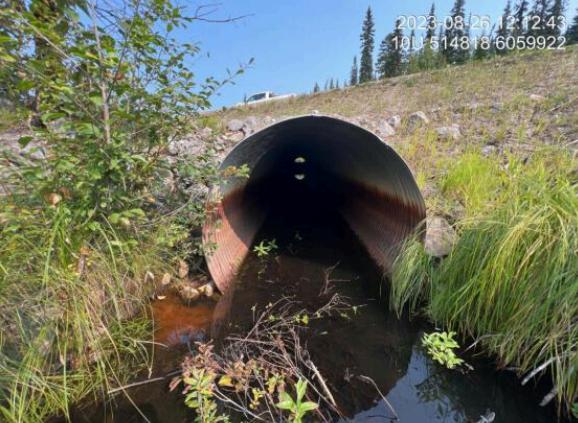
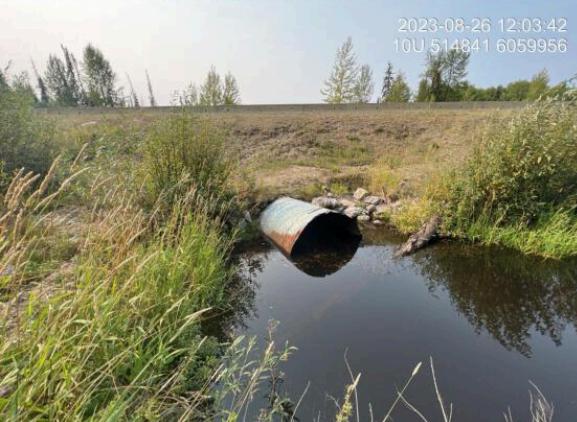
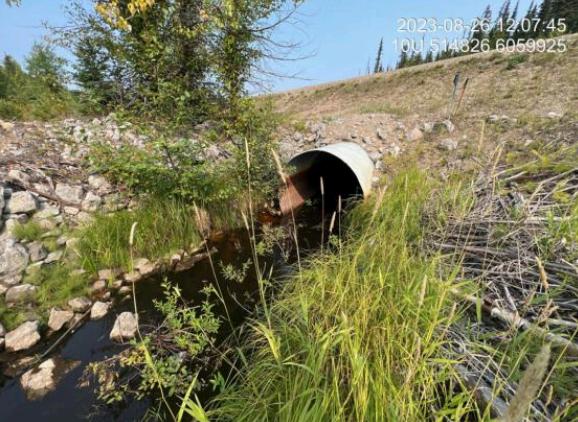
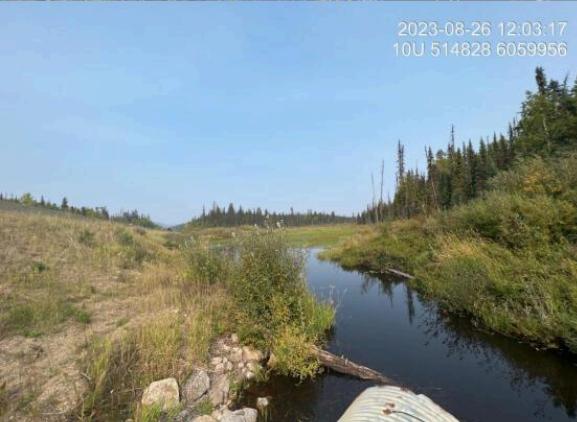
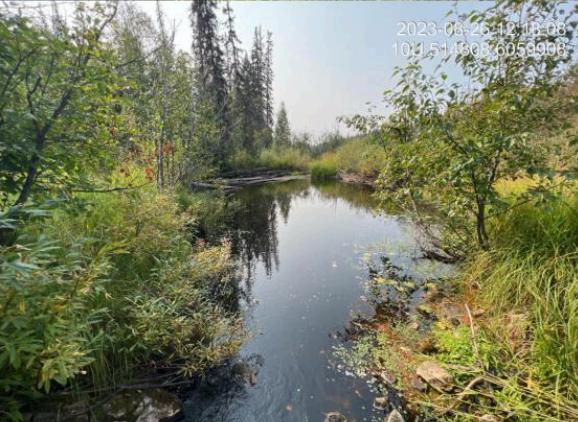
. From top left clockwise: Road/Site Card, Barrel, Outlet, Downstream, Upstream, Inlet.3700019

Location and Stream Data	•	Crossing Characteristics
Comments: 100% backwatered culvert with lots of beaver activity and wetland area upstream. Inlet drop is created by beaver generated shrub material so backwatering is happening. However, there is a step of approximately 0.6 m at the top end of the pipe. Black algae throughout channel downstream. Downstream channel appears to be constructed of rock at approximately 3.8 m wide before entering more beaverdam influenced wetland habitat. Ministry of Transportation chris_culvert_id: 1996976. 12:08:15		
Photos: PSCIS ID

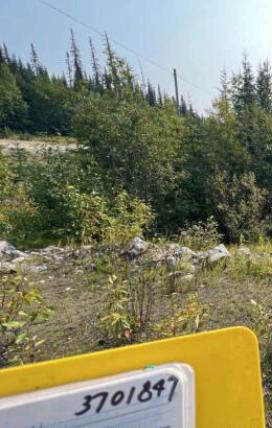
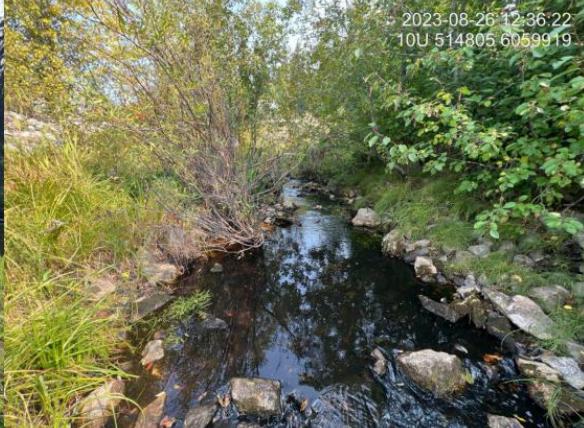
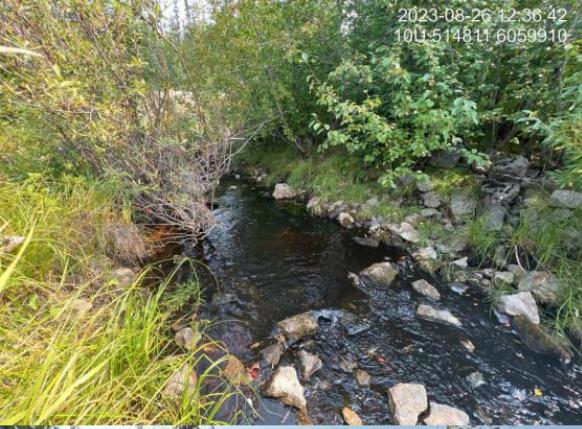
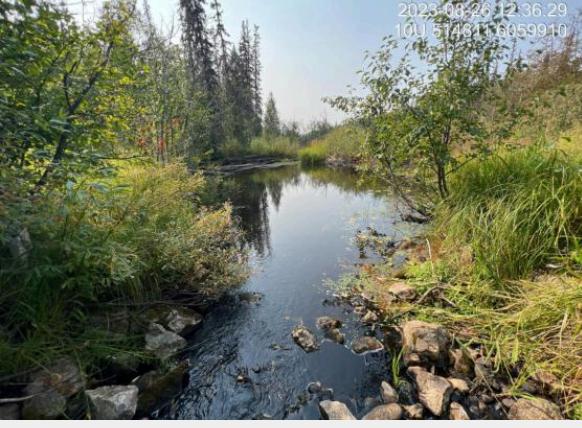
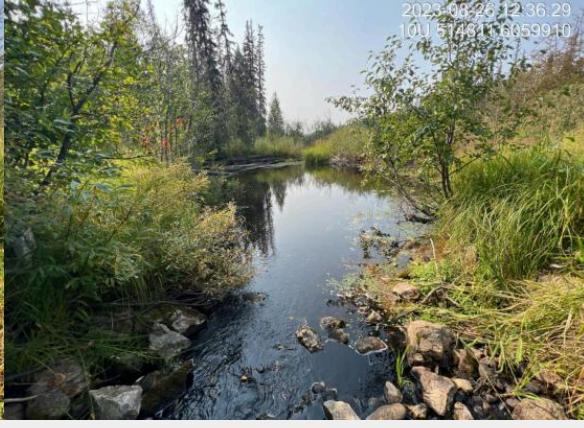
2023-08-26 12:36:29 10U 514811 6059910
. From top left clockwise: Road/Site Card, Barrel, Outlet, Downstream, Upstream, Inlet.3701847

Location and Stream Data	•	Crossing Characteristics	-
Comments: Armoured ford on pipeline. Immediately downstream of highway. 12:36:50			
Photos: PSCIS ID

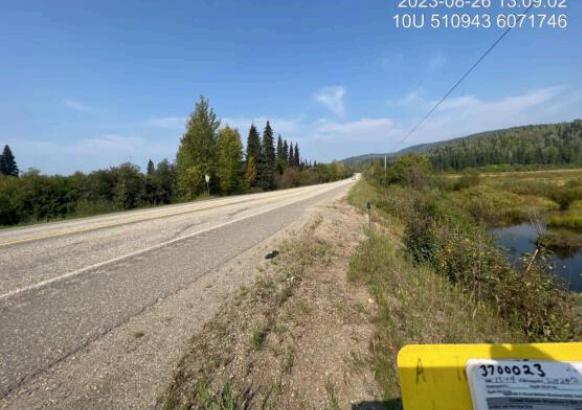
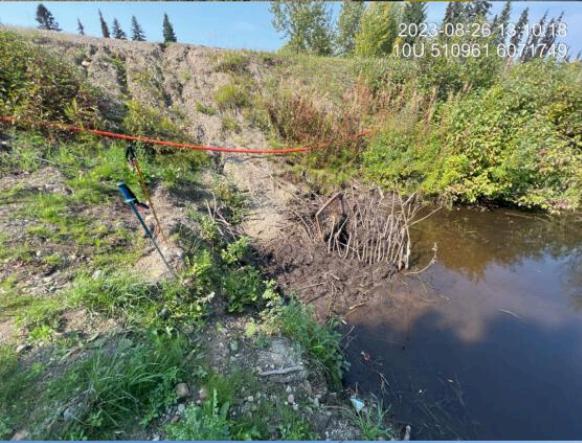
Location and Stream Data	•	Crossing Characteristics
Comments: 0.5 m pipe is stuffed inside of the sleeve of a larger older pipe. Beaver trap located at inlet. Burbot have been observed upstream in the past. Inlet almost completely blocked by beaver debris, as well as human placed sticks and beaver trap. Significant road prism erosion on upstream side of pipe as well as immediately adjacent to outlet. Ministry of Transportation chris_culvert_id: 1997085. 13:05:45		
Photos: PSCIS ID

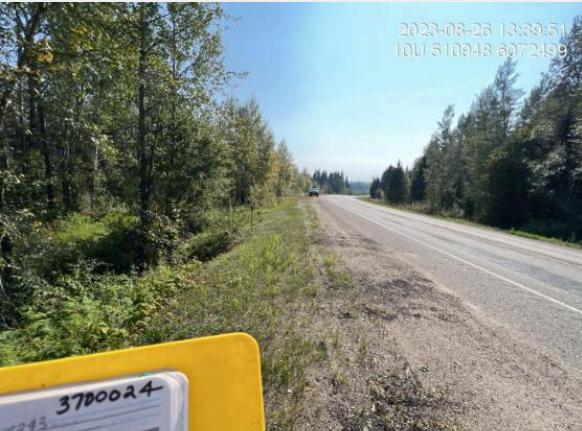
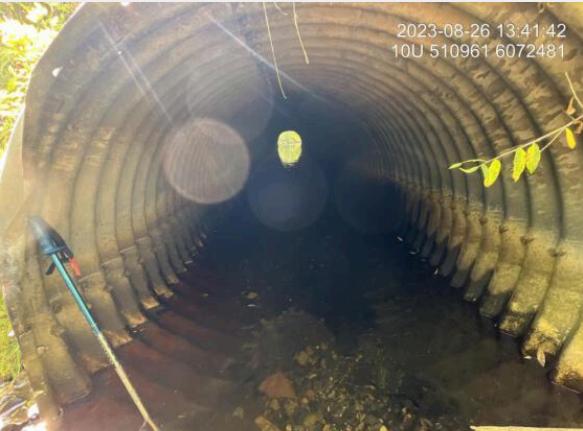
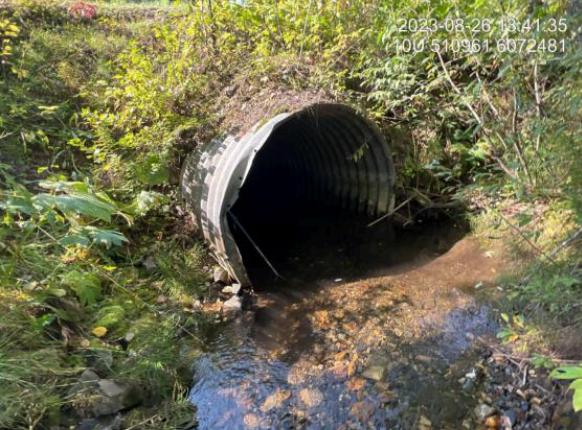
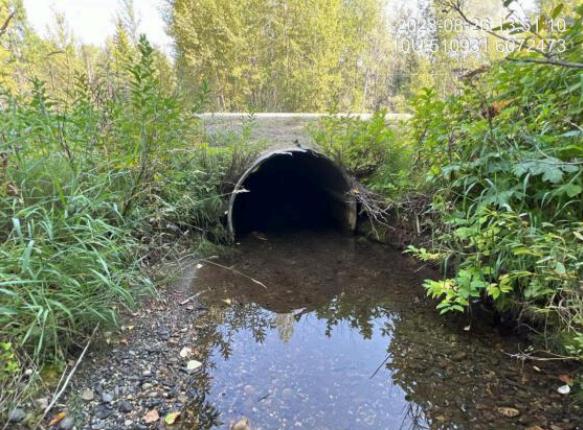
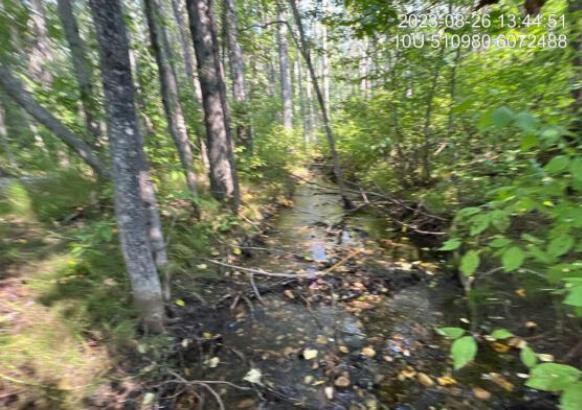
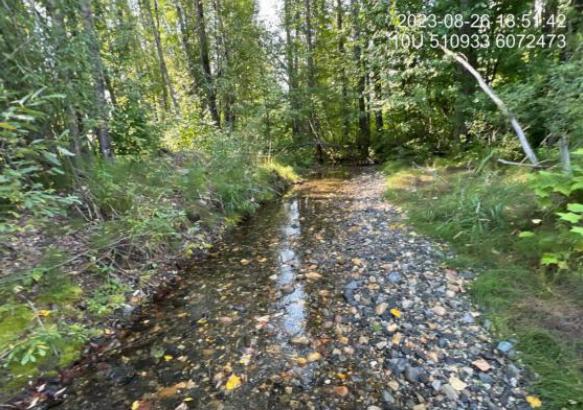
<p>2023-08-26 13:51:42 10U 510961 6072473</p>	<p>. From top left clockwise: Road/Site Card, Barrel, Outlet, Downstream, Upstream, Inlet.3700024</p>

Location and Stream Data	•	Crossing Characteristics	-
<p>Comments: Nice stream with good flow and abundant gravel, suitably sized for spawning. Culvert is 100% backwatered and fully embedded. It appears as though there have been some very high flow events that have moved significant amounts of gravel, substrate, upstream and downstream. See photos. Channel seems overly straight and deep so suspect machine work has been done to dredge out the crossing, upstream and downstream. Ministry of Transportation chris_culvert_id: 1997302. 13:37:33</p>			
<p>Photos: PSCIS ID</p>

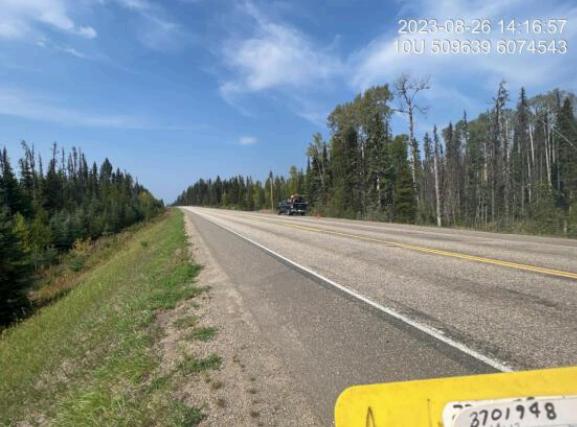
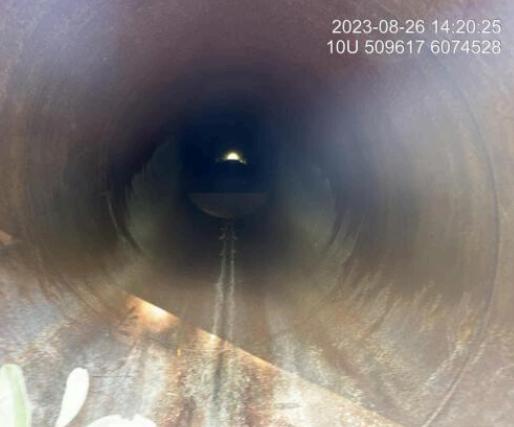
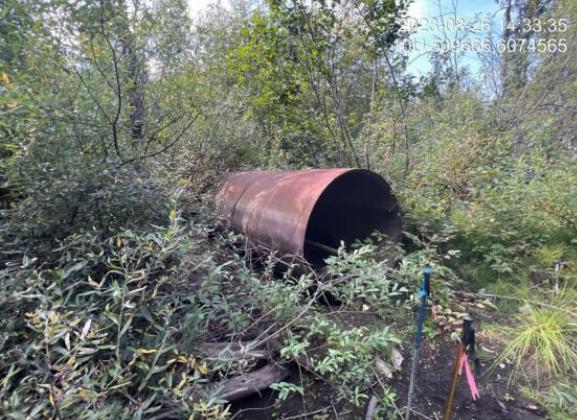
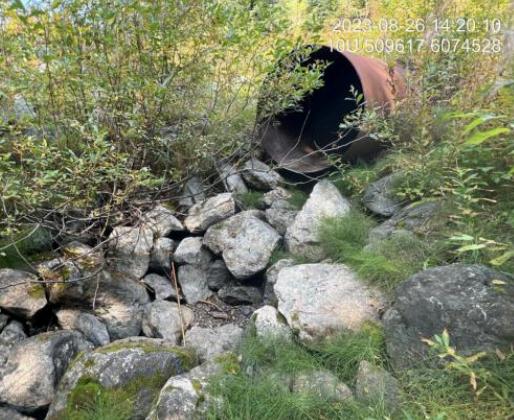
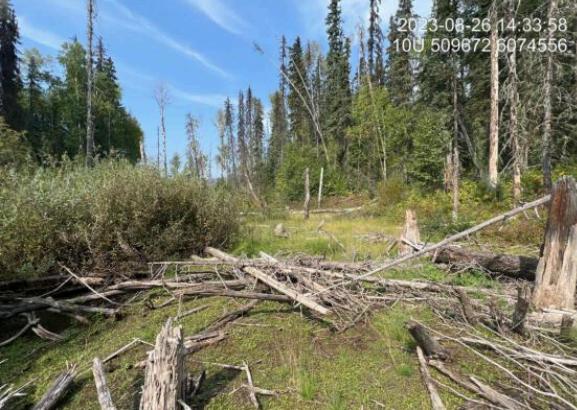
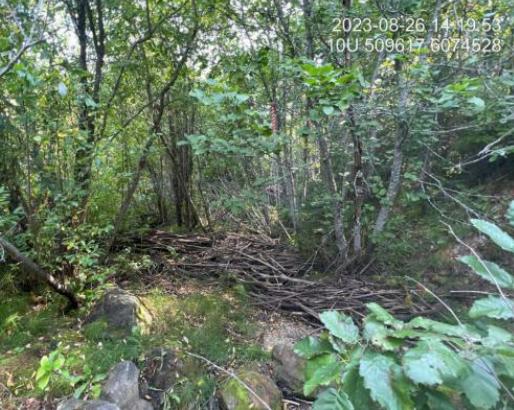
. From top left clockwise: Road/Site Card, Barrel, Outlet, Downstream, Upstream, Inlet.3701948

Location and Stream Data	•	Crossing Characteristics	-
Comments: Newly installed horizontally drilled culvert. Stream dry at the time of assessment. Partially vegetated channel upstream, and downstream indicates that the system has not flowed heavily perennially for some time. Wetland type habitat upstream with nice gravels and classic stream character downstream. Baffles installed within the pipe. Approximately 1/3 of the pipe is blocked from beaver debris near inlet. Ministry of Transportation chris_culvert_id: 1997288. 14:12:18			
Photos: PSCIS ID
