Appendix - Phase 1 Fish Passage Assessment Data and Photos

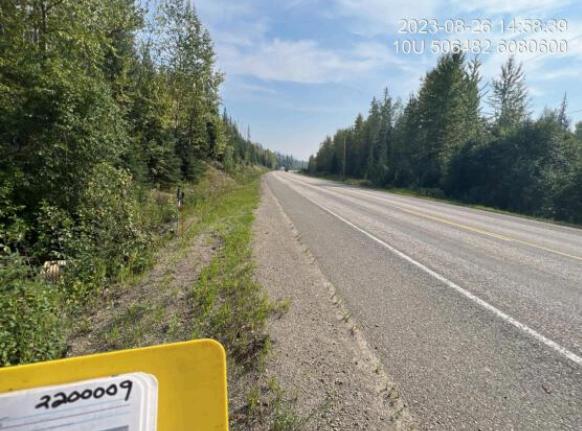
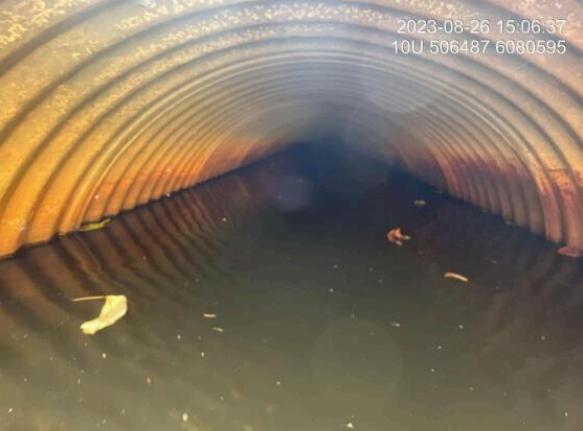
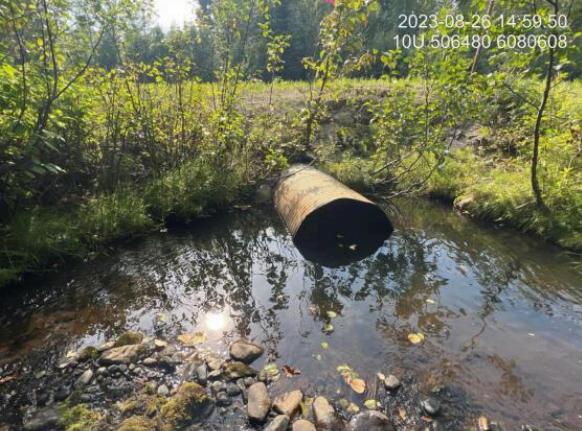
Location and Stream Data	•	Crossing Characteristics	-
Comments: Very nice stream with good flows and abundant gravel. Healthy riparian with evidence of beaver activity, including dam, approximately 5 m downstream of outlet which has backwatered the entire structure, including the outlet of the pipe, which is approximately 10 cm below the surface. It appears as though the crossing has been dredged with a machine recently, both upstream and downstream to deal with substrate deposition. There is pavement armouring the inlet area of the road prism. Ministry of Transportation chris_culvert_id: 1997018. 15:14:21			
Photos: PSCIS ID

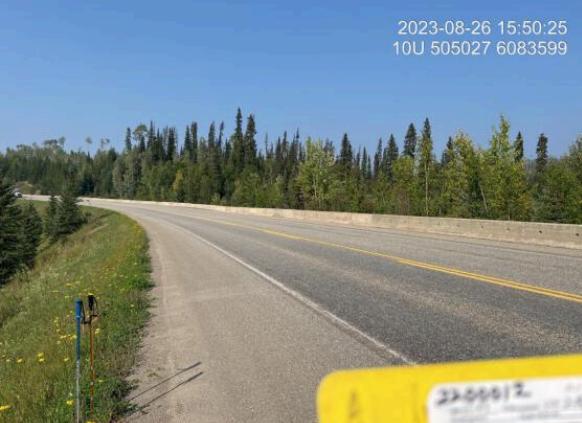
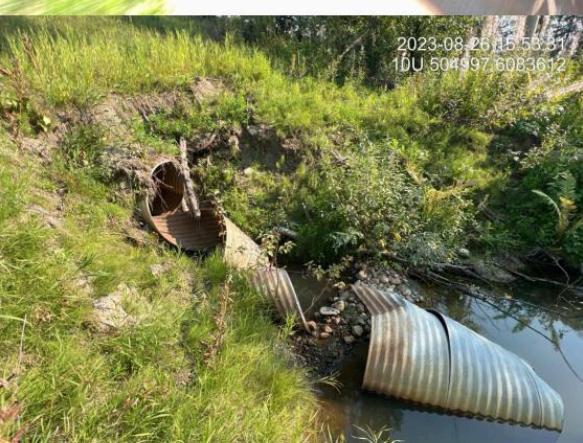
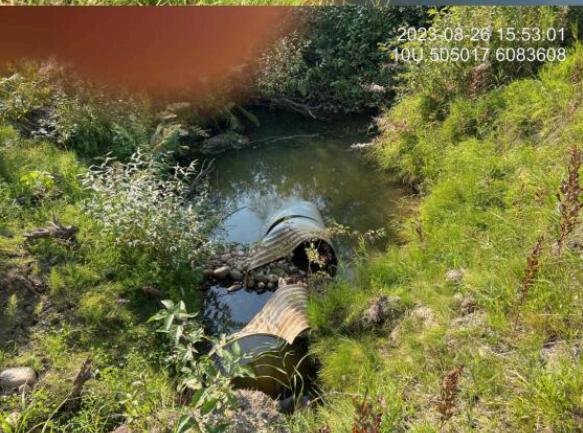
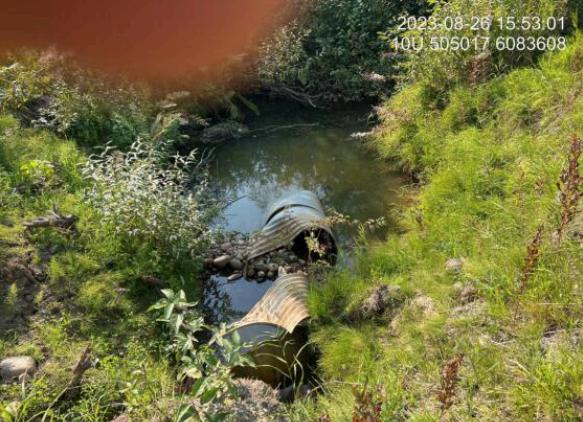
. From top left clockwise: Road/Site Card, Barrel, Outlet, Downstream, Upstream, Inlet.2200012

Location and Stream Data	•	Crossing Characteristics
Comments: Small stream with extremely long pipe, in very bad shape. End of pipe is unravelling with evidence of machine work at the outlet. Grate on inlet is off of pipe. Appears there has been dredging both upstream and downstream. Large area of clear-cut land upstream. Ministry of Transportation chris_culvert_id: 1997177. 15:50:45		
Photos: PSCIS ID

Location and Stream Data		Crossing Characteristics	
Date	2023-08-26	Crossing Sub Type	Round Culvert
PSCIS ID	198690	Diameter (m)	0.9
External ID	2200012	Length (m)	55
Crew	AI	Embedded	No
UTM Zone	10	Depth Embedded (m)	–
Easting	505029	Resemble Channel	No
Northing	6083597	Backwatered	No
Stream	Tributary to McLeod lake	Percent Backwatered	–
Road	Highway 97	Fill Depth (m)	8
Road Tenure	MOTI	Outlet Drop (m)	0.6
Channel Width (m)	2.5	Outlet Pool Depth (m)	0.1
Stream Slope (%)	3	Inlet Drop	No
Beaver Activity	No	Slope (%)	0
Habitat Value	Low	Valley Fill	Deep Fill
Final score	32	Barrier Result	Barrier
Fix type	Replace Structure with Streambed Simulation CBS	Fix Span / Diameter	4.5

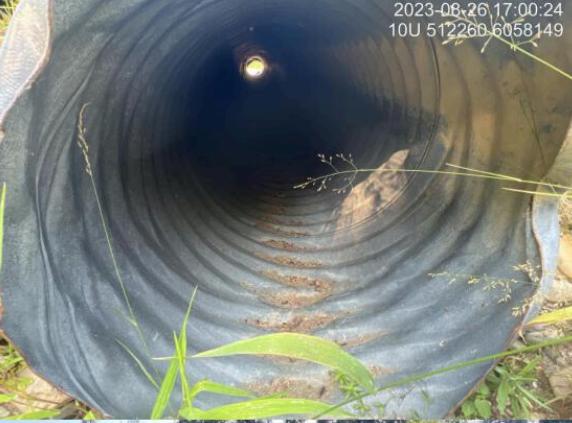
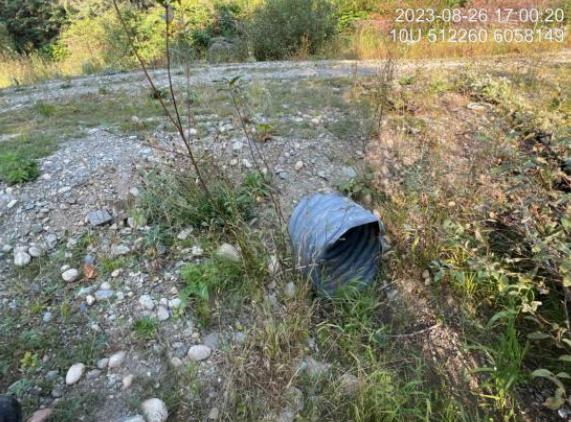
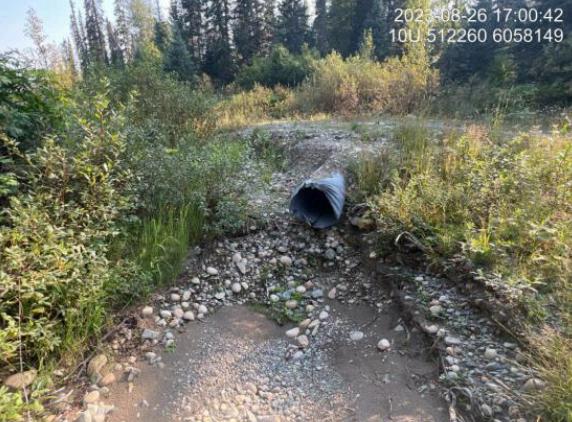
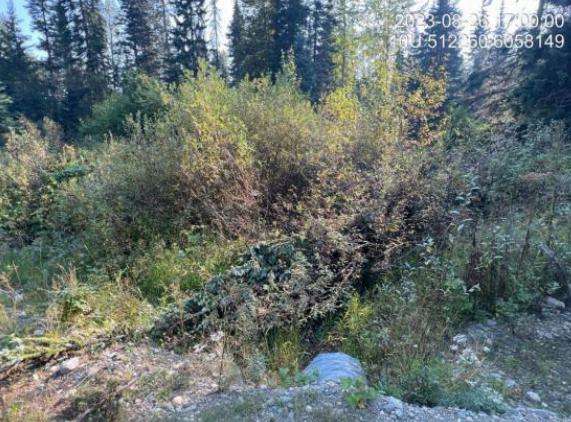
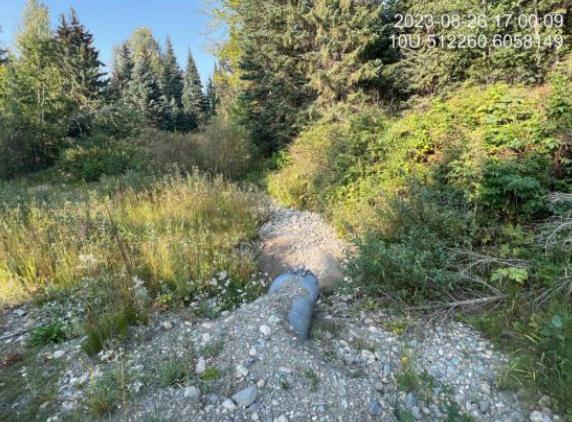
. From top left clockwise: Road/Site Card, Barrel, Outlet, Downstream, Upstream, Inlet.3702657

Location and Stream Data	•	Crossing Characteristics	-
Comments: Unlikely a fish bearing stream. Dry at the time of assessment. 17:02:49			
Photos: PSCIS ID

Location and Stream Data		Crossing Characteristics	
Date	2023-08-26	Crossing Sub Type	Round Culvert
PSCIS ID	198691	Diameter (m)	0.7
External ID	3702657	Length (m)	14
Crew	AI	Embedded	No
UTM Zone	10	Depth Embedded (m)	–
Easting	512259.6	Resemble Channel	No
Northing	6058147	Backwatered	No
Stream	Tributary to Kerry Lake	Percent Backwatered	–
Road	Kerry FSR	Fill Depth (m)	0.5
Road Tenure	MOF 8270	Outlet Drop (m)	0.3
Channel Width (m)	1	Outlet Pool Depth (m)	0
Stream Slope (%)	5	Inlet Drop	No
Beaver Activity	No	Slope (%)	3
Habitat Value	Low	Valley Fill	Deep Fill
Final score	36	Barrier Result	Barrier
Fix type	Replace Structure with Streambed Simulation CBS	Fix Span / Diameter	3

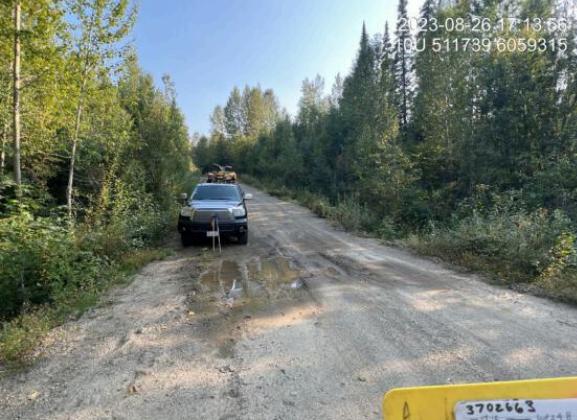
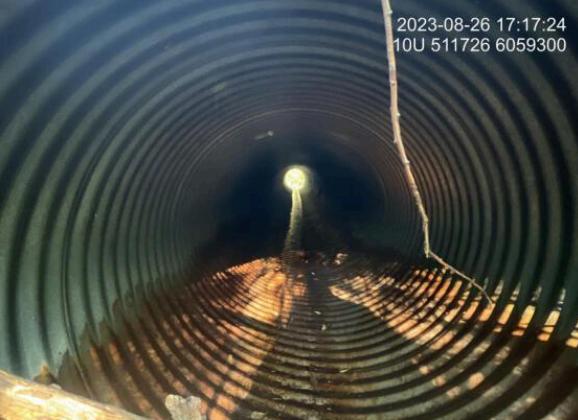
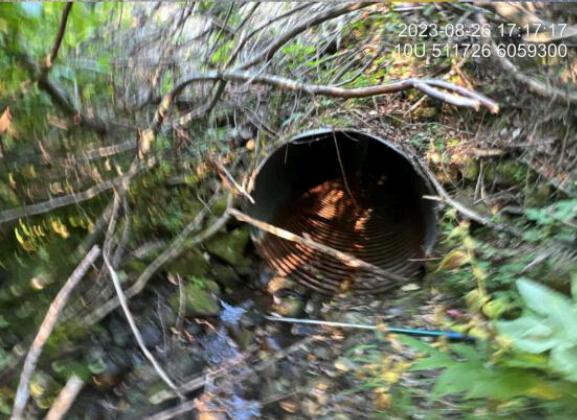
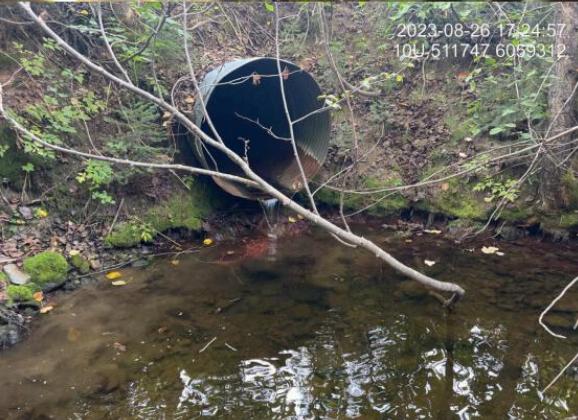
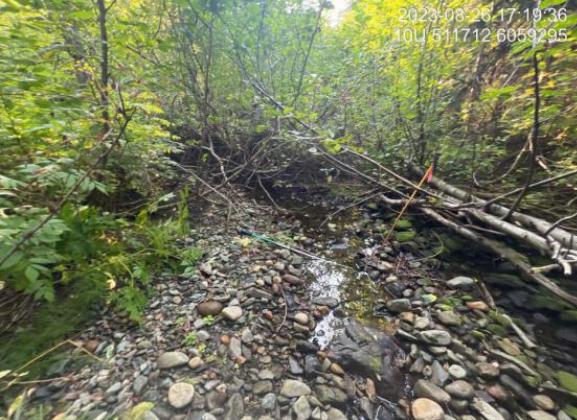
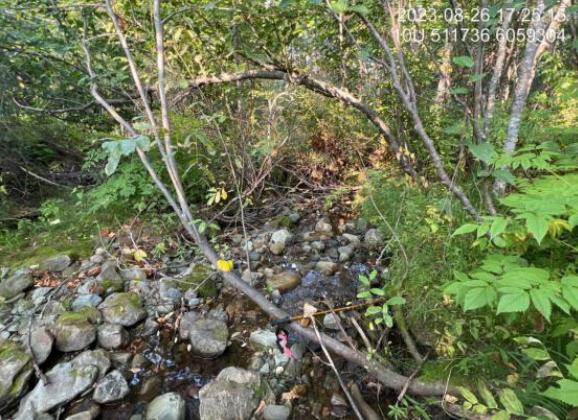
2023-08-26 17:25:15 10U 511736 6059304	. From top left clockwise: Road/Site Card, Barrel, Outlet, Downstream, Upstream, Inlet.3702663

Location and Stream Data	•	Crossing Characteristics	-
Comments: Nice little stream with decent flow for this time of year. Pockets of gravel throughout and healthy shrub and mixed riparian. Fish presence unknown, but seems likely due to proximity to Kerry lake with low gradients. 17:14:13			
Photos: PSCIS ID

Location and Stream Data		Crossing Characteristics –	
Date	2023-08-26	Crossing Sub Type	Round Culvert
PSCIS ID	198692	Diameter (m)	1.2
External ID	3702663	Length (m)	17
Crew	AI	Embedded	No
UTM Zone	10	Depth Embedded (m)	–
Easting	511738.8	Resemble Channel	No
Northing	6059303	Backwatered	No
Stream	Tributary to Kerry Lake	Percent Backwatered	–
Road	Kerry FSR	Fill Depth (m)	4
Road Tenure	MOF 8270	Outlet Drop (m)	0.3
Channel Width (m)	3.6	Outlet Pool Depth (m)	1
Stream Slope (%)	4	Inlet Drop	No
Beaver Activity	No	Slope (%)	3
Habitat Value	Medium	Valley Fill	Deep Fill
Final score	39	Barrier Result	Barrier
Fix type	Replace with New Open Bottom Structure	Fix Span / Diameter	13

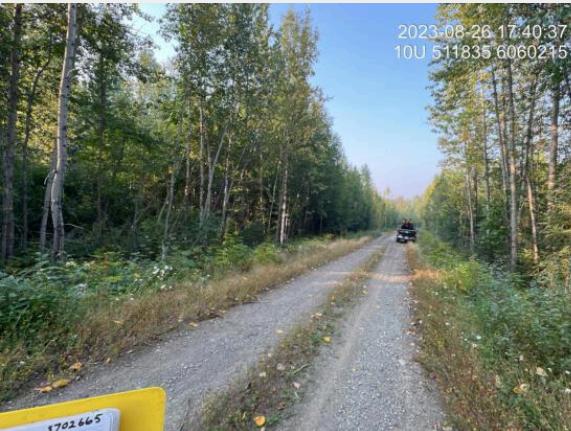
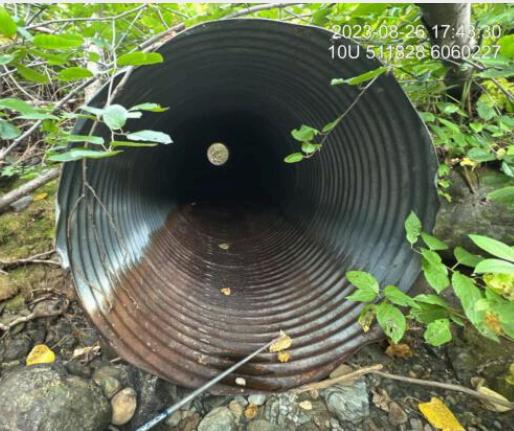
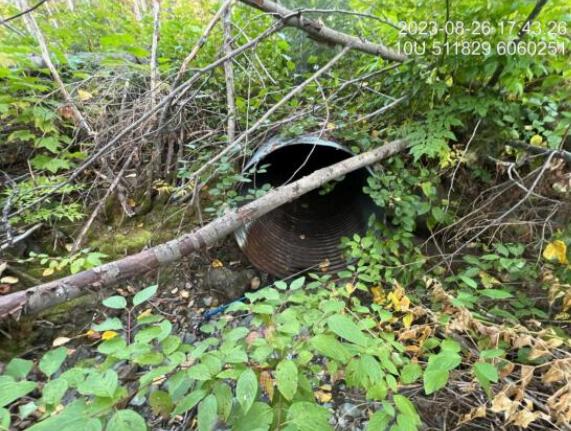
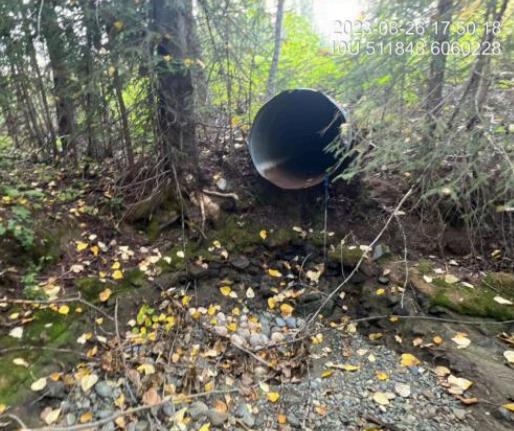
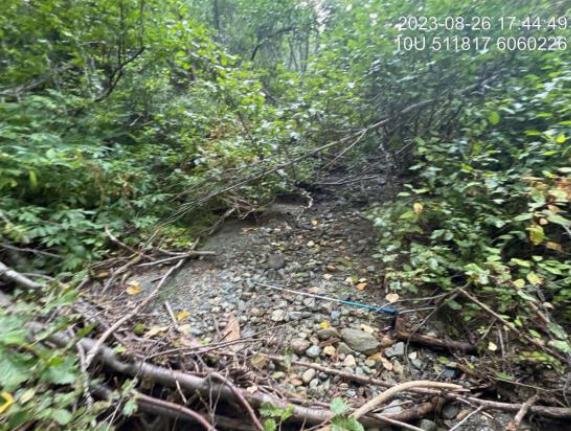
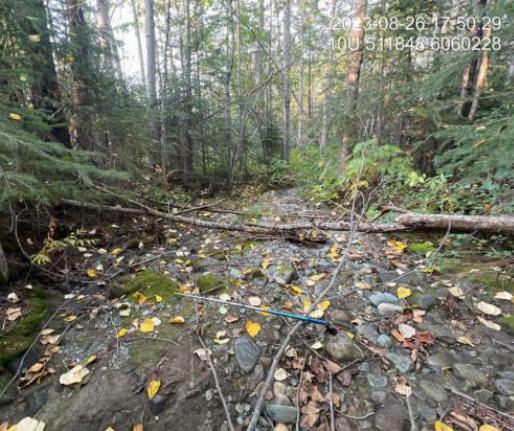
. From top left clockwise: Road/Site Card, Barrel, Outlet, Downstream, Upstream, Inlet.3702665

Location and Stream Data	•	Crossing Characteristics	-
Comments: Stream dry at time of survey. Appears to be a fairly large system with abundant gravels present throughout. Estimated 200 to 300 m of lower gradient habitat upstream that could be useful for downstream populations in the spring. Huge outlet drop and very large dry pool indicating pipe is undersized. 17:40:54			
Photos: PSCIS ID

Location and Stream Data		Crossing Characteristics –	
Date	2023-08-26	Crossing Sub Type	Round Culvert
PSCIS ID	198693	Diameter (m)	1.2
External ID	3702665	Length (m)	20
Crew	AI	Embedded	No
UTM Zone	10	Depth Embedded (m)	–
Easting	511840.8	Resemble Channel	No
Northing	6060225	Backwatered	No
Stream	Tributary to Kerry Lake	Percent Backwatered	–
Road	Kerry FSR	Fill Depth (m)	2
Road Tenure	MOF 8270	Outlet Drop (m)	1
Channel Width (m)	3.5	Outlet Pool Depth (m)	0.7
Stream Slope (%)	3.5	Inlet Drop	Yes
Beaver Activity	No	Slope (%)	3
Habitat Value	Low	Valley Fill	Deep Fill
Final score	39	Barrier Result	Barrier
Fix type	Replace with New Open Bottom Structure	Fix Span / Diameter	14

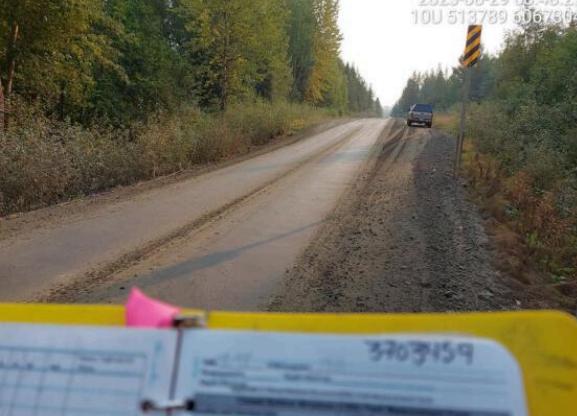
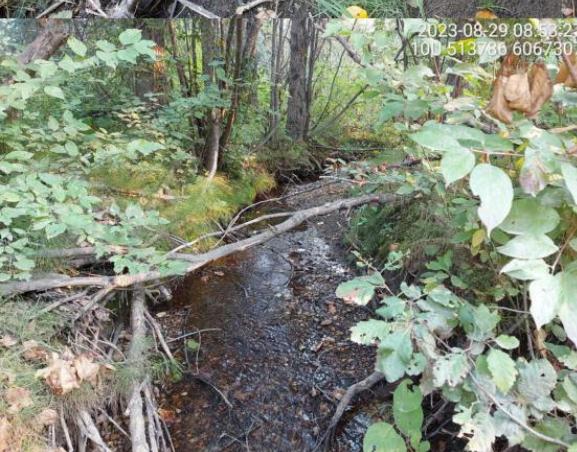
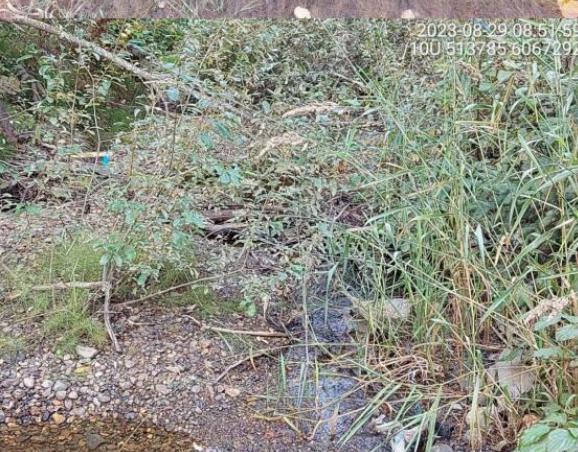
Location and Stream Data	•	Crossing Characteristics	-
Comments: High habitat value upstream. Many fish spotted in outlet pool. Tributary to big system. Culvert old and not in great shape. Needs to be replaced. Debris jam at inlet blocking small section of flow. 08:57:52			
Photos: PSCIS ID

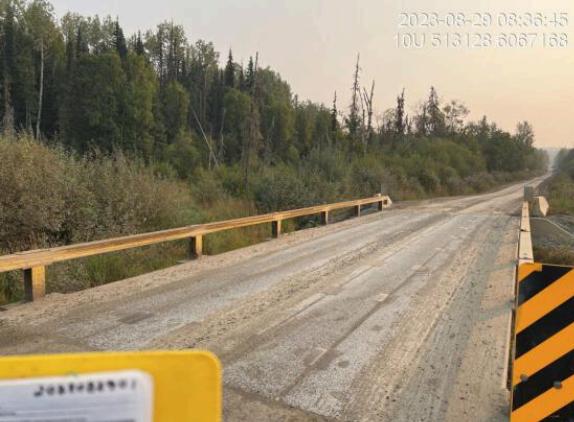
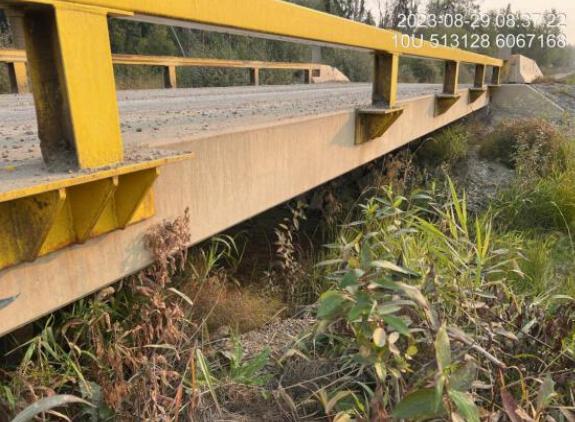
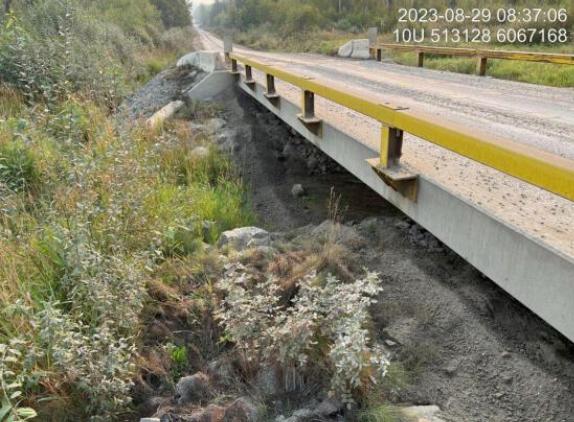
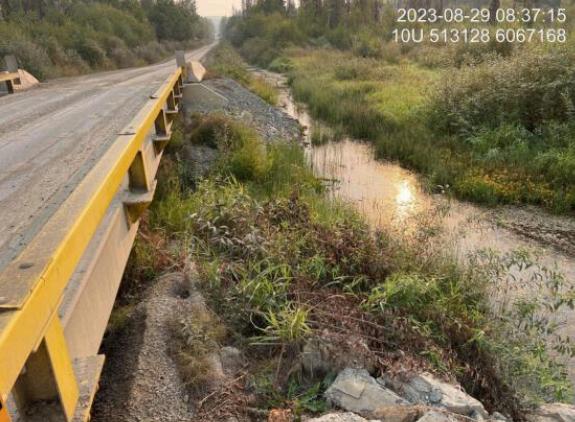
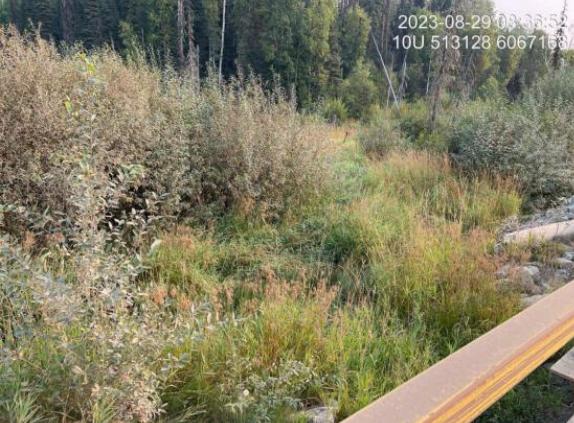
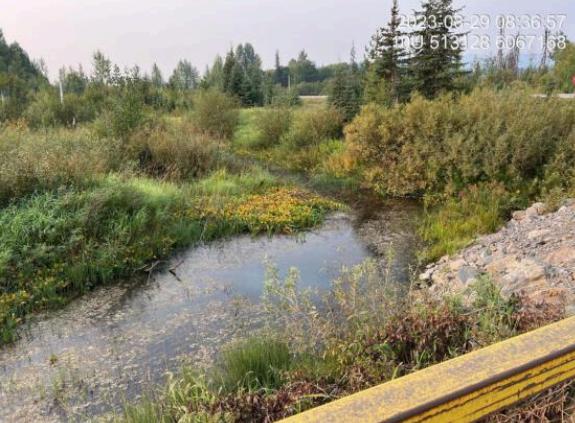
Location and Stream Data	•	Crossing Characteristics	-
Comments: Bridge over wetland drainage area. Channel dry at time of assessment. Not a mapped stream but a wetland area upstream of the highway. 08:39:05			
Photos: PSCIS ID

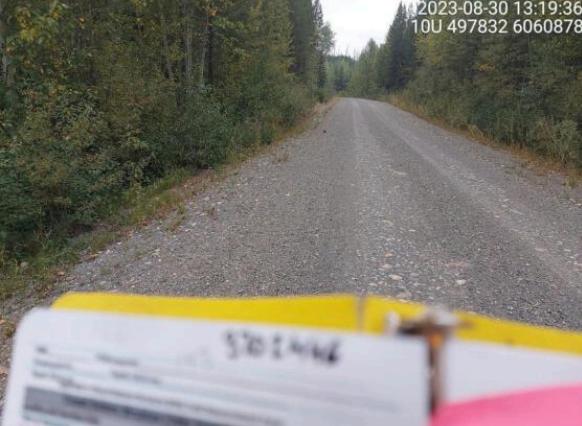
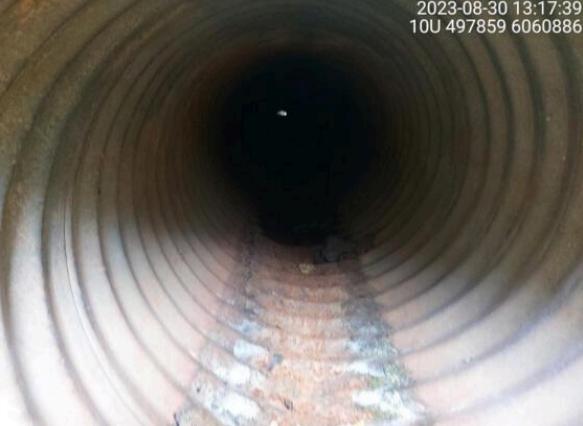
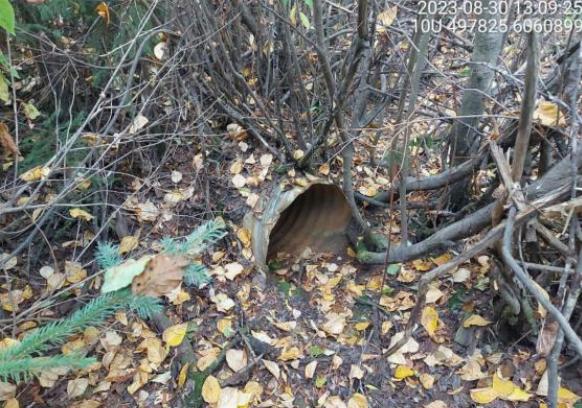
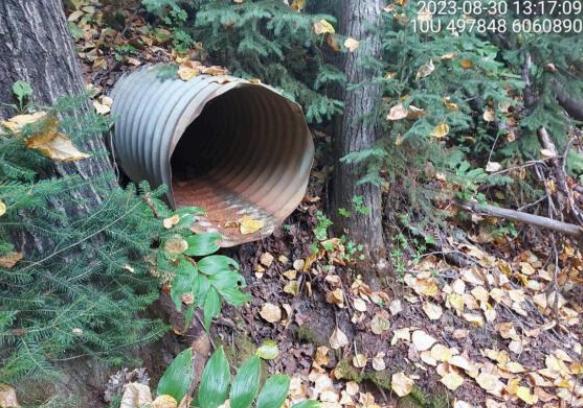
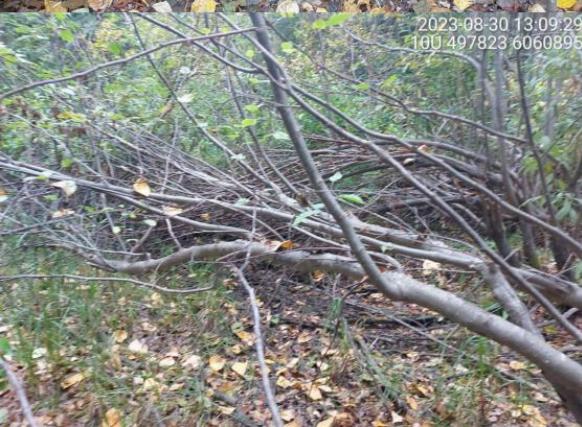
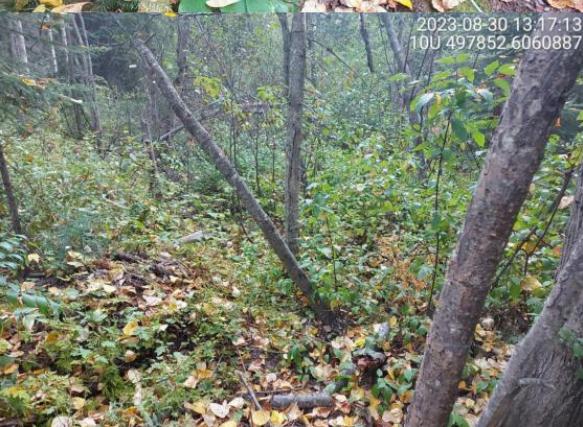
Location and Stream Data	•	Crossing Characteristics	-
Comments: No clear defined channel. Gradient and channel width could not be determined. Dewatered stream. Small, old culvert. 13:07:58			
Photos: PSCIS ID

Location and Stream Data		Crossing Characteristics	
Date	2023-08-30	Crossing Sub Type	Round Culvert
PSCIS ID	198696	Diameter (m)	0.6
External ID	3702446	Length (m)	15
Crew	MW MD	Embedded	No
UTM Zone	10	Depth Embedded (m)	–
Easting	497845.7	Resemble Channel	No
Northing	6060884	Backwatered	No
Stream	Tributary to Weedon Lake	Percent Backwatered	–
Road	Davie-Weedon Lake FSR	Fill Depth (m)	2.5
Road Tenure	Canfor R02875	Outlet Drop (m)	0.5
Channel Width (m)	0	Outlet Pool Depth (m)	0
Stream Slope (%)	0	Inlet Drop	Yes
Beaver Activity	No	Slope (%)	6
Habitat Value	Low	Valley Fill	Deep Fill
Final score	33	Barrier Result	Barrier
Fix type	Replace Structure with Streambed Simulation CBS	Fix Span / Diameter	3

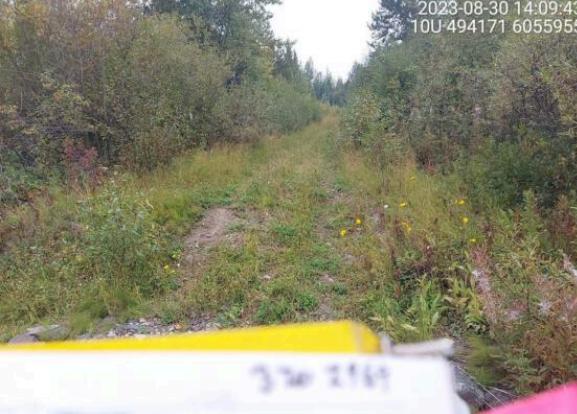
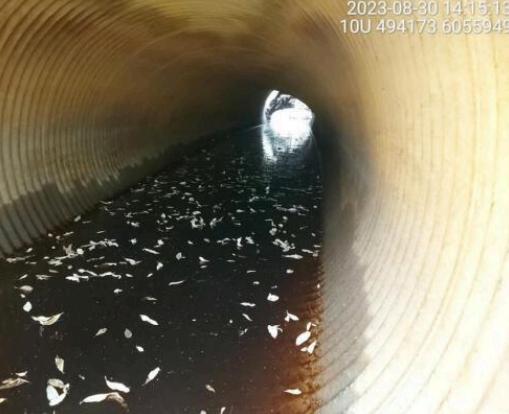
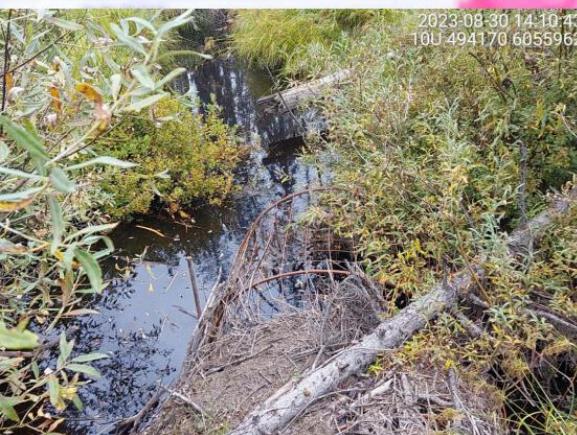
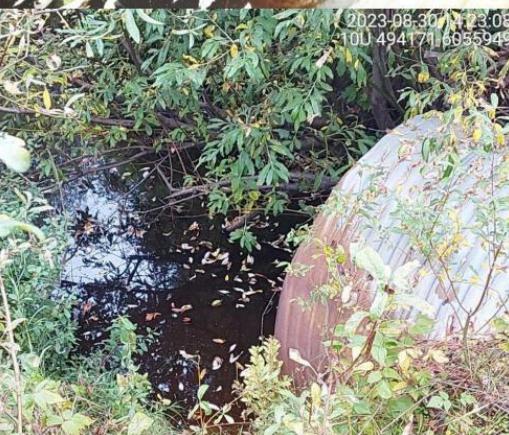
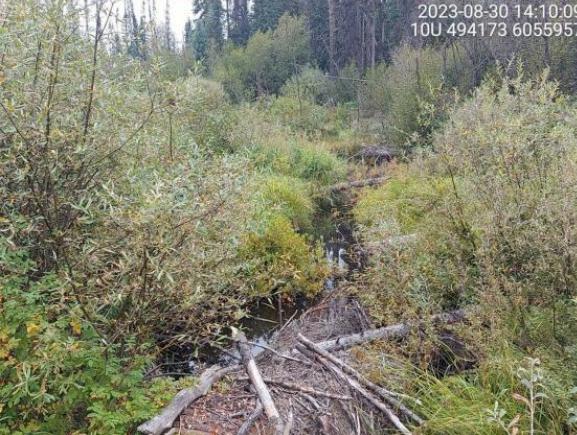
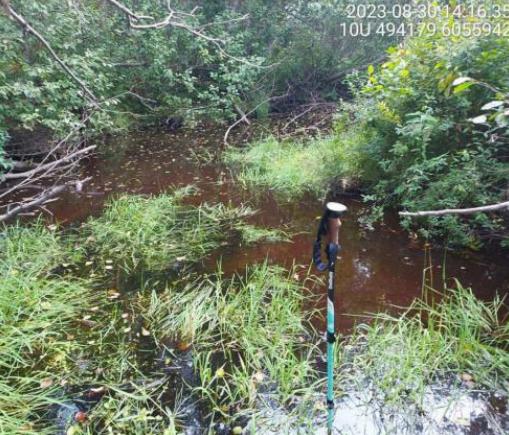
<p>2023-08-30 14:16:35 10U 494179 6055942</p>	
<p>. From top left clockwise: Road/Site Card, Barrel, Outlet, Downstream, Upstream, Inlet.3702959</p>

Location and Stream Data	•	Crossing Characteristics	-
Comments: Big beaver dam directly on inlet side, with beaver cage in front of dam (on upstream side). Wetland habitat downstream. Road is caved in on top of culvert. 14:07:02			
Photos: PSCIS ID

Location and Stream Data		Crossing Characteristics	
Date	2023-08-30	Crossing Sub Type	Round Culvert
PSCIS ID	198697	Diameter (m)	1.5
External ID	3702959	Length (m)	12
Crew	MW MD	Embedded	No
UTM Zone	10	Depth Embedded (m)	—
Easting	494175.8	Resemble Channel	No
Northing	6055953	Backwatered	Yes
Stream	Tributary to Weedon Creek	Percent Backwatered	100
Road	Davie-Weedon Lake FSR	Fill Depth (m)	0.5
Road Tenure	Canfor R01860	Outlet Drop (m)	0
Channel Width (m)	3.4	Outlet Pool Depth (m)	1
Stream Slope (%)	1	Inlet Drop	No
Beaver Activity	Yes	Slope (%)	1
Habitat Value	Medium	Valley Fill	Deep Fill
Final score	21	Barrier Result	Barrier
Fix type	Replace with New Open Bottom Structure	Fix Span / Diameter	14

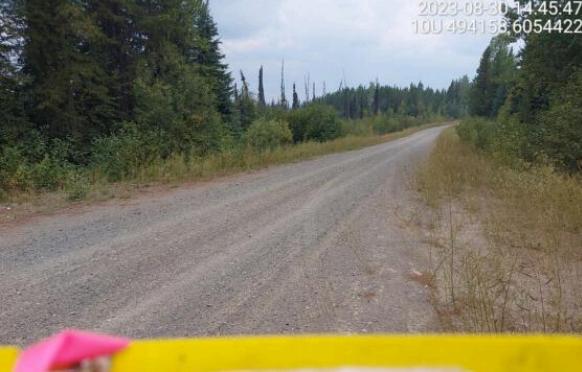
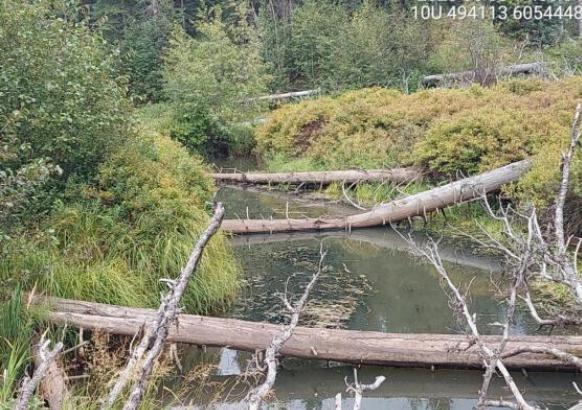
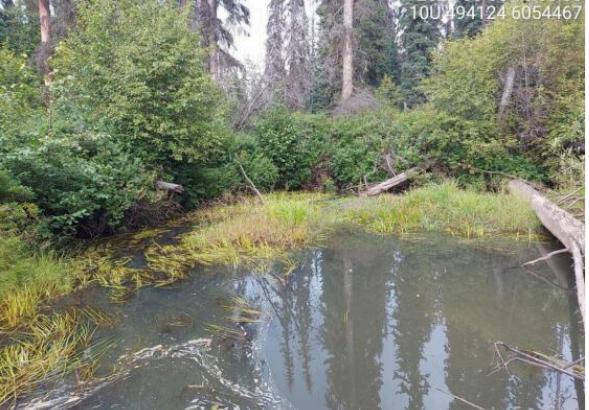
. From top left clockwise: Road/Site Card, Barrel, Outlet, Downstream, Upstream, Inlet.3702445

Location and Stream Data	•	Crossing Characteristics	-
Comments: Two culverts of equal length. Debris blockage on inlet side of both pipes. Some flow through culvert. Right culvert is caved in near inlet. 14:48:50			
Photos: PSCIS ID

Location and Stream Data		Crossing Characteristics	
Date	2023-08-30	Crossing Sub Type	Round Culvert
PSCIS ID	198698	Diameter (m)	3.5
External ID	3702445	Length (m)	25
Crew	MW MD	Embedded	No
UTM Zone	10	Depth Embedded (m)	—
Easting	494123.6	Resemble Channel	No
Northing	6054452	Backwatered	No
Stream	Tributary to Weedon Lake	Percent Backwatered	—
Road	Davie-Weedon Lake FSR	Fill Depth (m)	1
Road Tenure	Canfor R01859	Outlet Drop (m)	0.5
Channel Width (m)	3.5	Outlet Pool Depth (m)	0.4
Stream Slope (%)	1.5	Inlet Drop	No
Beaver Activity	Yes	Slope (%)	2.5
Habitat Value	Medium	Valley Fill	Deep Fill
Final score	31	Barrier Result	Barrier
Fix type	Replace with New Open Bottom Structure	Fix Span / Diameter	14

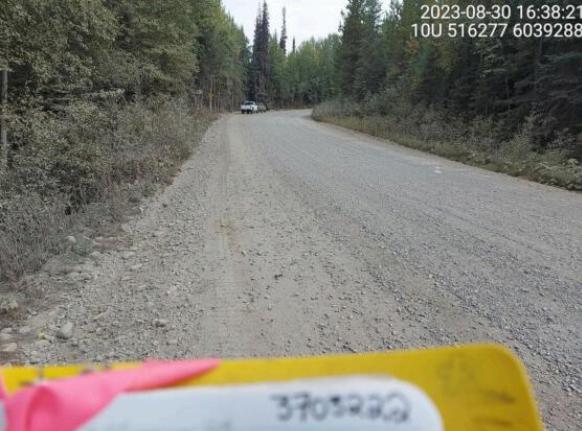
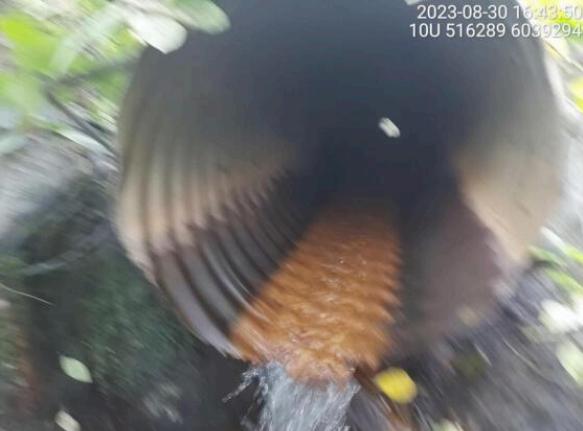
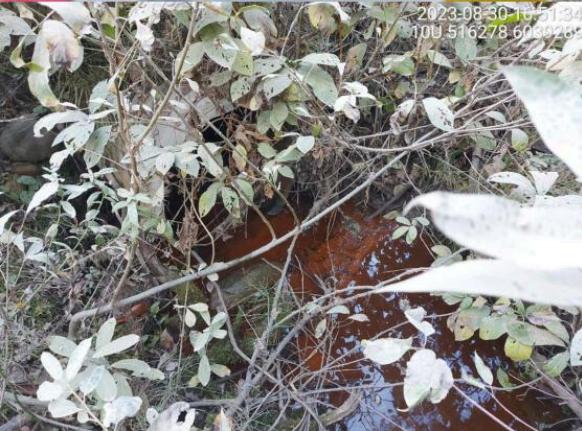
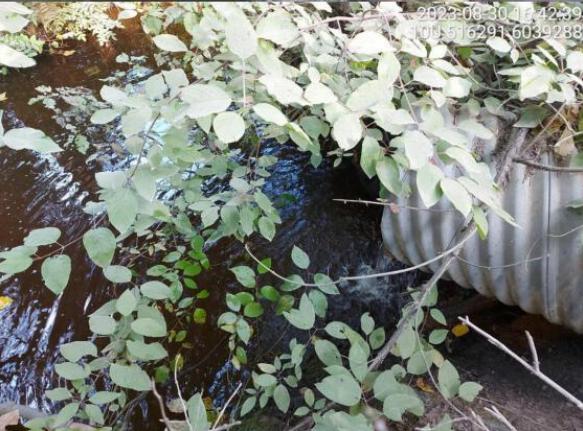
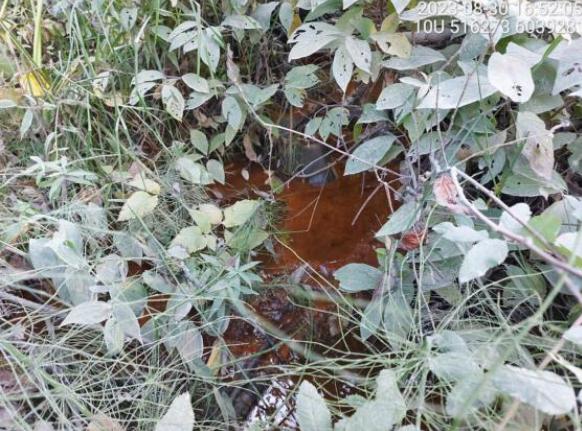
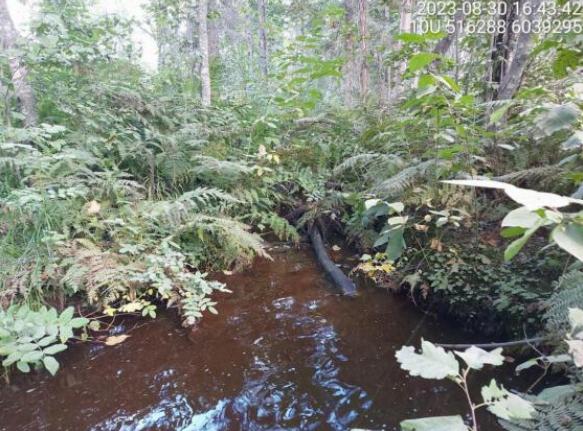
. From top left clockwise: Road/Site Card, Barrel, Outlet, Downstream, Upstream, Inlet.3703222

Location and Stream Data	•	Crossing Characteristics	-
Comments: Big outlet drop with big outlet pool. Perched culvert, small, overgrown stream channel. 16:40:11			
Photos: PSCIS ID

Location and Stream Data		Crossing Characteristics –	
Date	2023-08-30	Crossing Sub Type	Round Culvert
PSCIS ID	198699	Diameter (m)	0.6
External ID	3703222	Length (m)	15
Crew	MW MD JD BD	Embedded	No
UTM Zone	10	Depth Embedded (m)	–
Easting	516272.8	Resemble Channel	No
Northing	6039291	Backwatered	No
Stream	Tributary to Davie Lake	Percent Backwatered	–
Road	Davie Lake FSR	Fill Depth (m)	2
Road Tenure	MOF 7719	Outlet Drop (m)	0.6
Channel Width (m)	2.3	Outlet Pool Depth (m)	0.4
Stream Slope (%)	3.5	Inlet Drop	No
Beaver Activity	No	Slope (%)	3
Habitat Value	Medium	Valley Fill	Deep Fill
Final score	39	Barrier Result	Barrier
Fix type	Replace with New Open Bottom Structure	Fix Span / Diameter	14

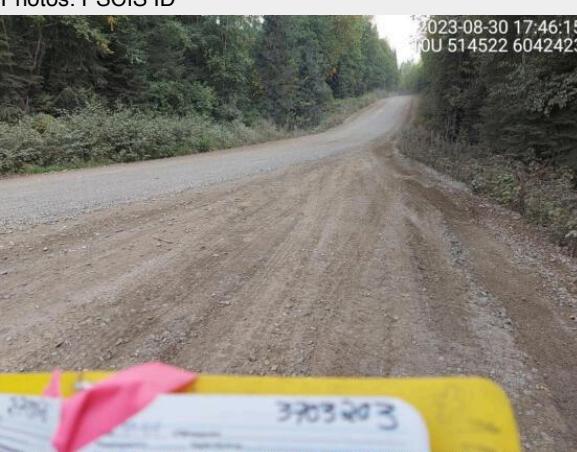
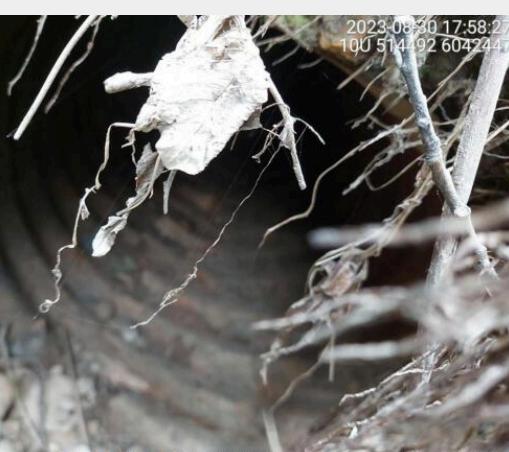
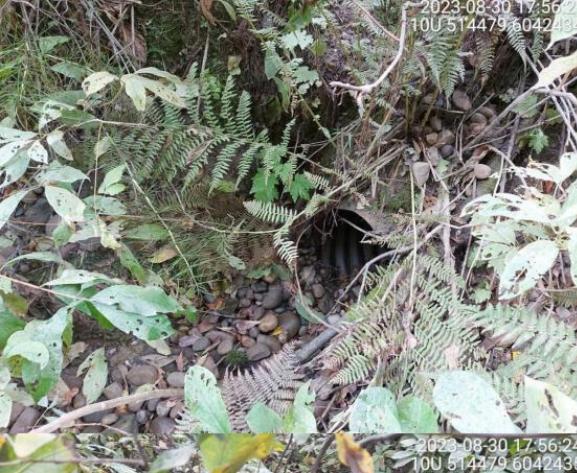
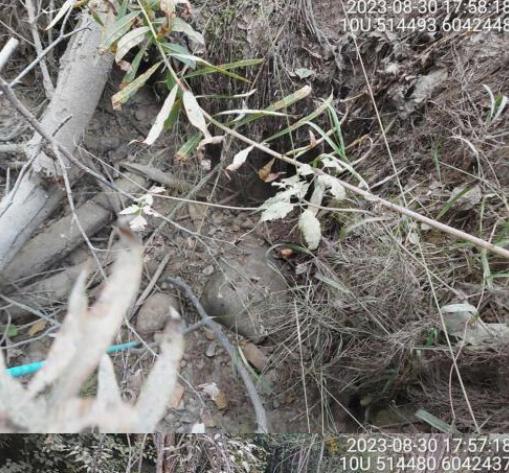
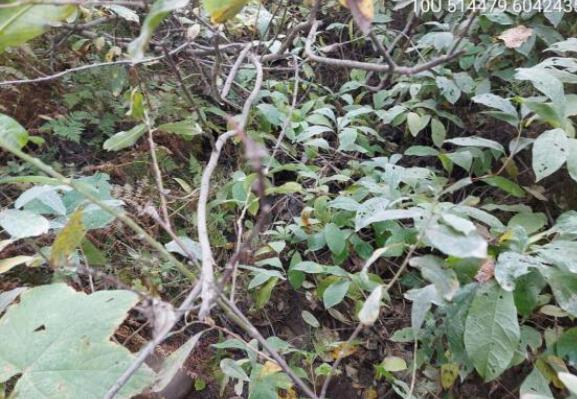
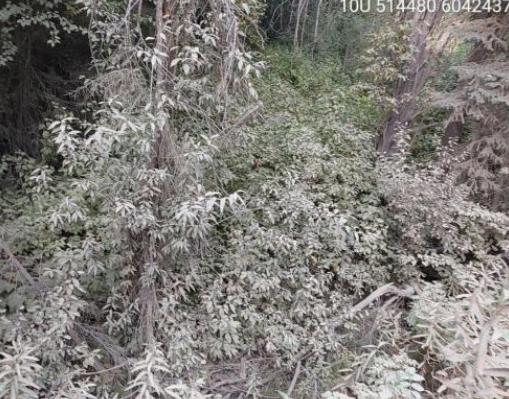
. From top left clockwise: Road/Site Card, Barrel, Outlet, Downstream, Upstream, Inlet.3703203

Location and Stream Data	•	Crossing Characteristics	-
Comments: Dewatered channel. Very overgrown and no clear channel. Channel width and gradient estimated. 17:53:54			
Photos: PSCIS ID

Location and Stream Data		Crossing Characteristics	
Date	2023-08-30	Crossing Sub Type	Round Culvert
PSCIS ID	198701	Diameter (m)	0.5
External ID	3703203	Length (m)	15
Crew	MW	Embedded	No
UTM Zone	10	Depth Embedded (m)	–
Easting	514487	Resemble Channel	No
Northing	6042441	Backwatered	No
Stream	Tributary to Davie Lake	Percent Backwatered	–
Road	Davie Lake FSR	Fill Depth (m)	3.5
Road Tenure	MOF 7719	Outlet Drop (m)	0
Channel Width (m)	1.2	Outlet Pool Depth (m)	0
Stream Slope (%)	1	Inlet Drop	No
Beaver Activity	No	Slope (%)	3
Habitat Value	Low	Valley Fill	Deep Fill
Final score	29	Barrier Result	Barrier
Fix type	Replace Structure with Streambed Simulation CBS	Fix Span / Diameter	3

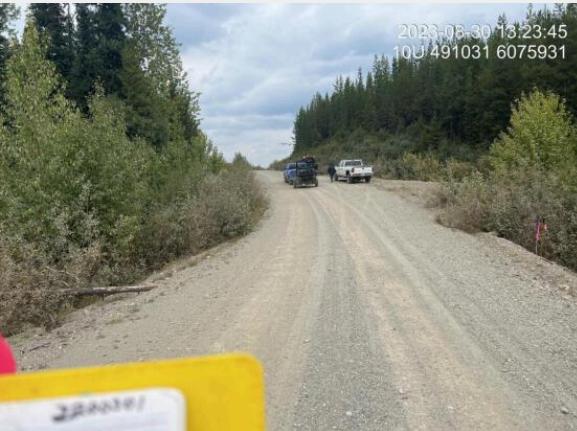
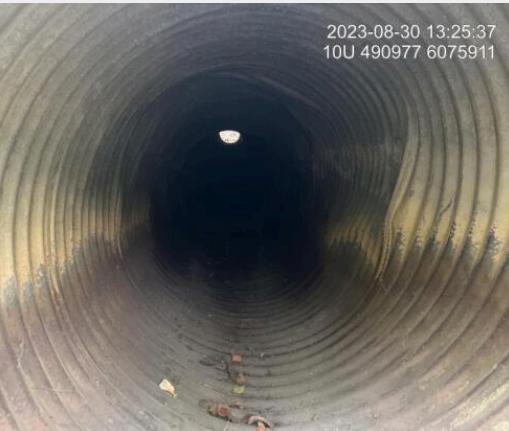
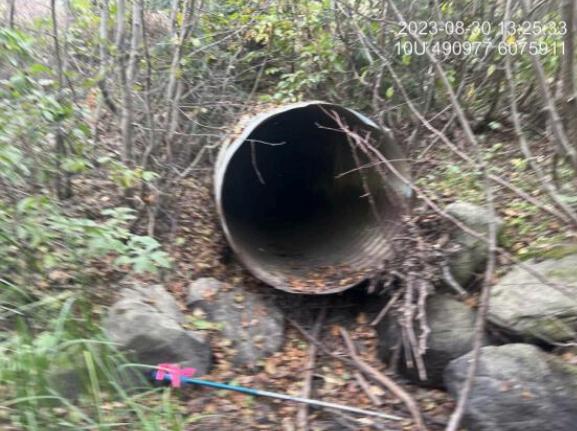
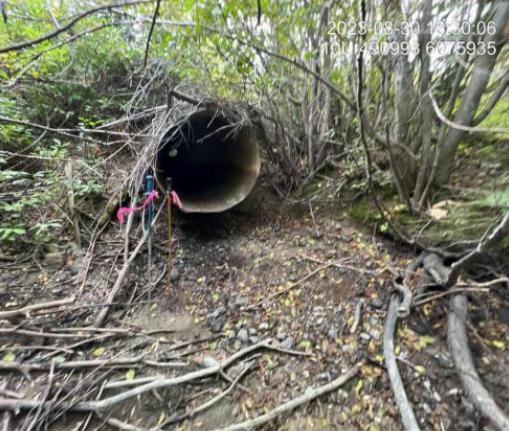
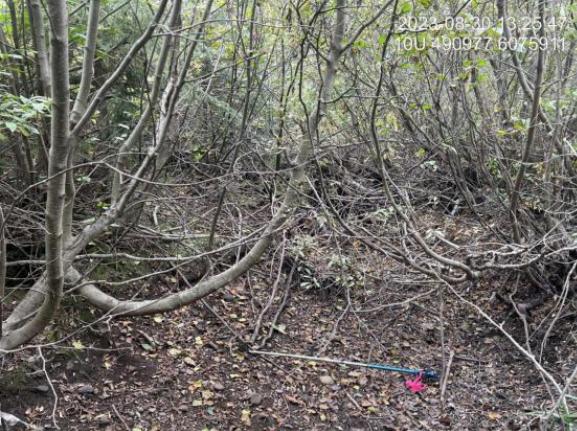
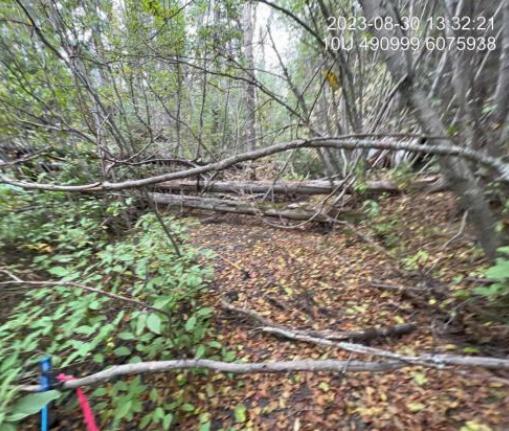
. From top left clockwise: Road/Site Card, Barrel, Outlet, Downstream, Upstream, Inlet.2200301

Location and Stream Data	•	Crossing Characteristics	-
Comments: Stream dry at the time of assessment. This is a larger system during runoff with abundant gravels present suitable for rainbow spawning. Old pipe located downstream of the crossing proximately 20 m. Healthy riparian mixed forest. 13:18:06			
Photos: PSCIS ID

Location and Stream Data		Crossing Characteristics	
Date	2023-08-30	Crossing Sub Type	Round Culvert
PSCIS ID	198702	Diameter (m)	1
External ID	2200301	Length (m)	26
Crew	AI JD TS BP	Embedded	No
UTM Zone	10	Depth Embedded (m)	—
Easting	490978.8	Resemble Channel	No
Northing	6075927	Backwatered	No
Stream	Tributary to Hammett Creek	Percent Backwatered	—
Road	Carp Lake FSR	Fill Depth (m)	2.5
Road Tenure	Canfor R01860	Outlet Drop (m)	0.55
Channel Width (m)	3	Outlet Pool Depth (m)	0.6
Stream Slope (%)	1.5	Inlet Drop	No
Beaver Activity	No	Slope (%)	4
Habitat Value	Medium	Valley Fill	Deep Fill
Final score	39	Barrier Result	Barrier
Fix type	Replace with New Open Bottom Structure	Fix Span / Diameter	14

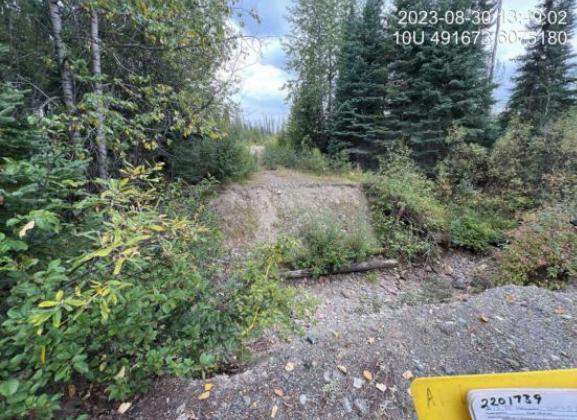
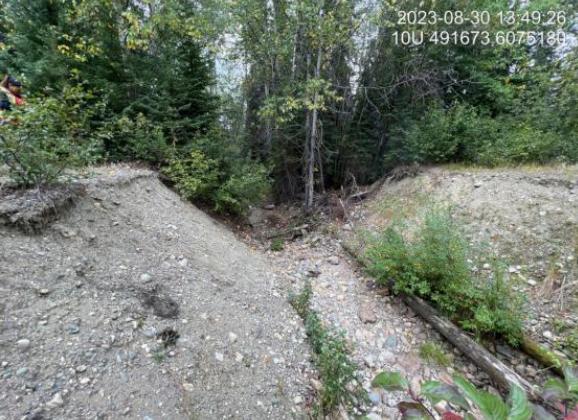
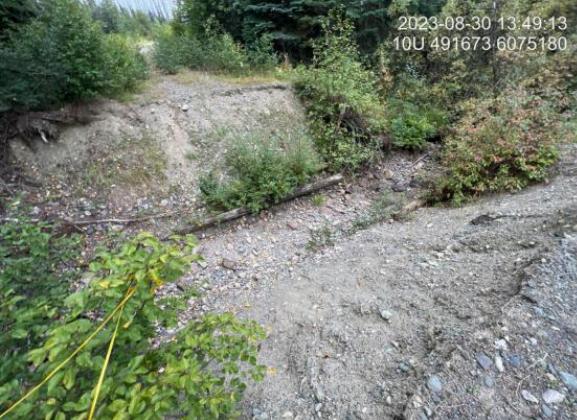
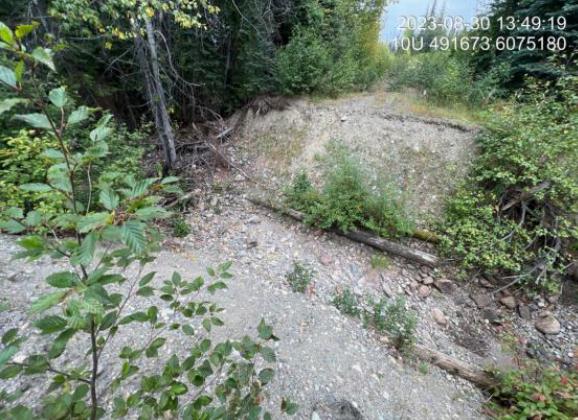
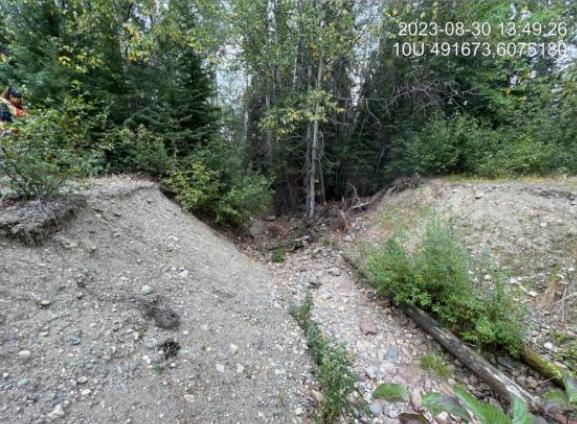
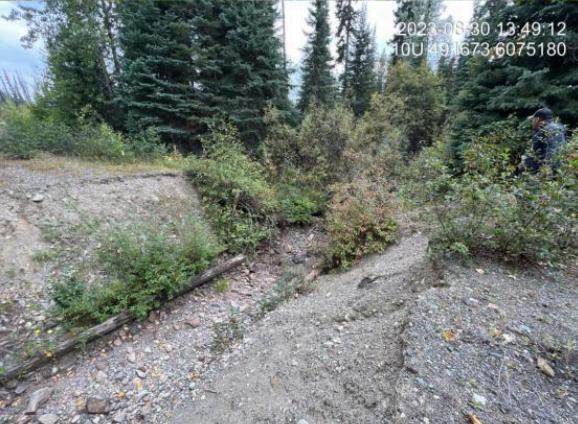
<p>2023-08-30 13:49:12 10U 491673.6075180</p>	<p>. From top left clockwise: Road/Site Card, Barrel, Outlet, Downstream, Upstream, Inlet.2201739</p>

Location and Stream Data	•	Crossing Characteristics	-
Comments: Ford. Deep deactivation will block all ATV access. 13:47:04			
Photos: PSCIS ID

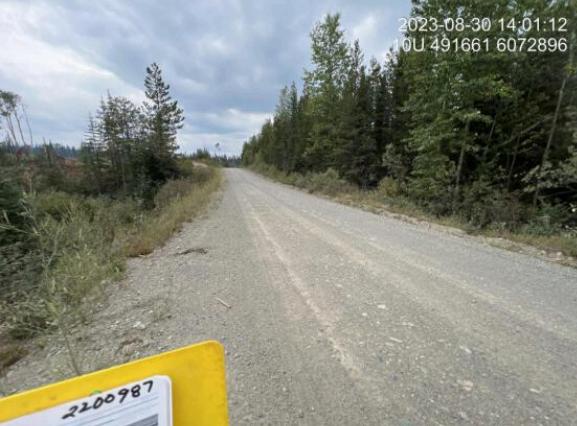
Location and Stream Data	•	Crossing Characteristics	-
Comments: Small stream with dry, mostly vegetated channel indicating stream rarely flows. Very unlikely that fish try to access upstream of the road. 14:08:49			
Photos: PSCIS ID

Location and Stream Data		Crossing Characteristics	
Date	2023-08-30	Crossing Sub Type	Round Culvert
PSCIS ID	198704	Diameter (m)	1.2
External ID	2200987	Length (m)	22
Crew	AI	Embedded	No
UTM Zone	10	Depth Embedded (m)	–
Easting	491638.9	Resemble Channel	No
Northing	6072901	Backwatered	No
Stream	Tributary to Hammett Creek	Percent Backwatered	–
Road	Davie-War FSR	Fill Depth (m)	2
Road Tenure	Canfor R01860	Outlet Drop (m)	0
Channel Width (m)	1	Outlet Pool Depth (m)	0
Stream Slope (%)	5.5	Inlet Drop	Yes
Beaver Activity	No	Slope (%)	4
Habitat Value	Low	Valley Fill	Deep Fill
Final score	23	Barrier Result	Barrier
Fix type	Replace Structure with Streambed Simulation CBS	Fix Span / Diameter	3

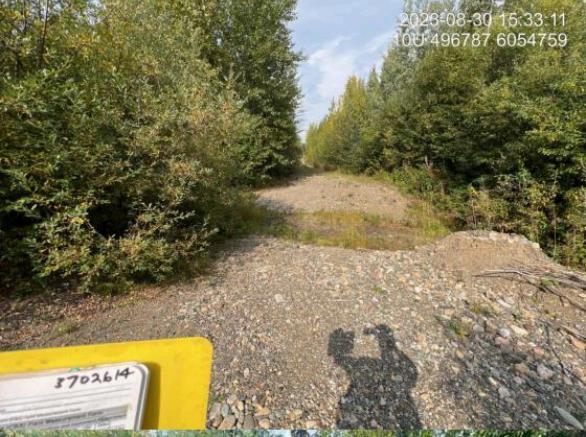
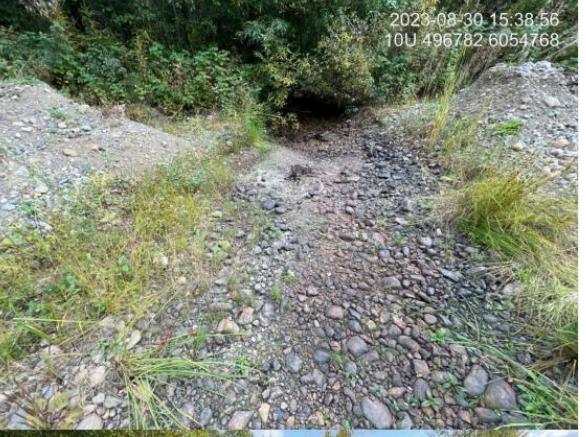
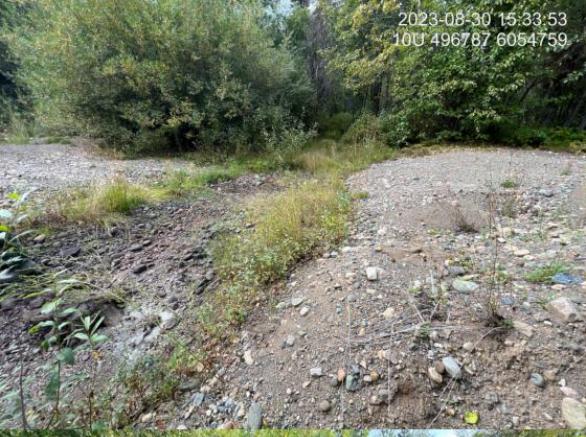
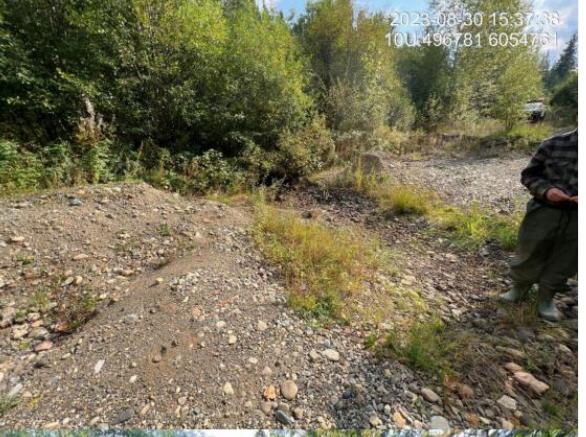
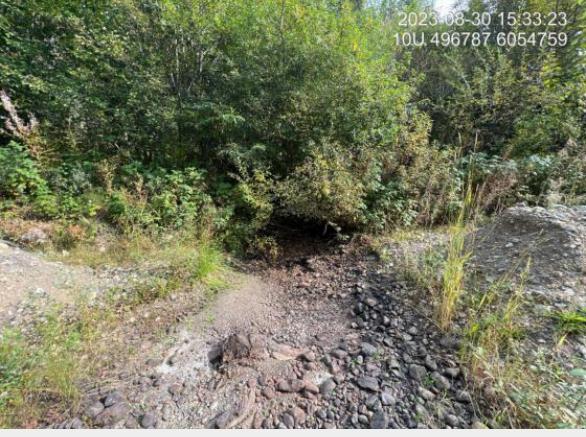
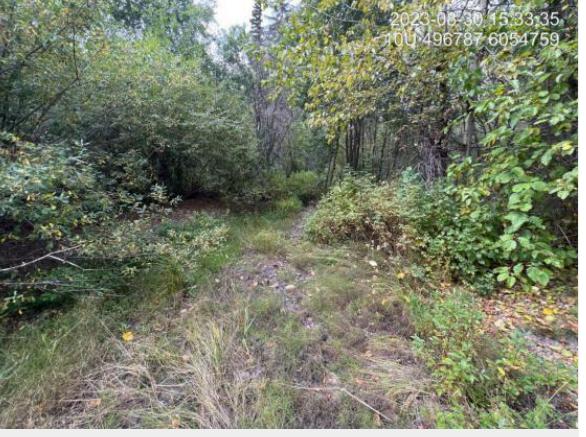
2023-08-30 15:33:35 10U 496787 6054759
From top left clockwise: Road/Site Card, Barrel, Outlet, Downstream, Upstream, Inlet.3702614

Location and Stream Data	•	Crossing Characteristics	-
Comments: Ford. Deactivated road with ATV drive around. 15:39:47			
Photos: PSCIS ID
