Appendix - Phase 1 Fish Passage Assessment Data and Photos

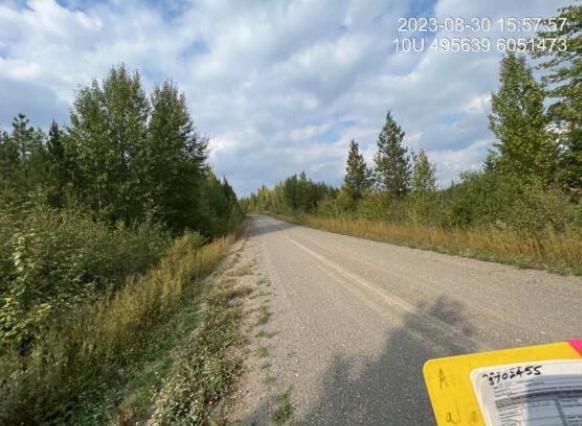
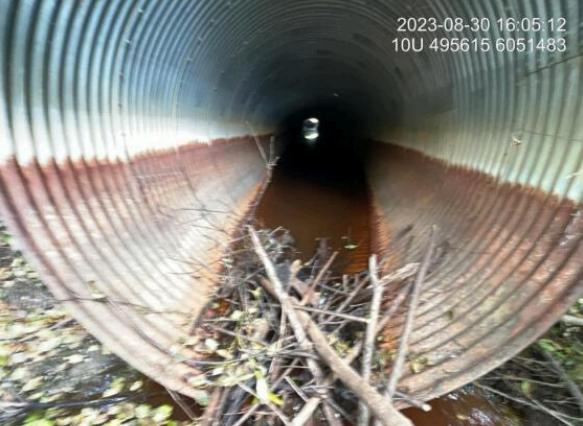
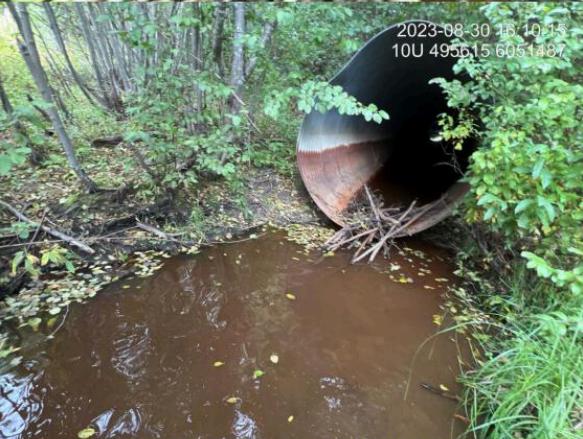
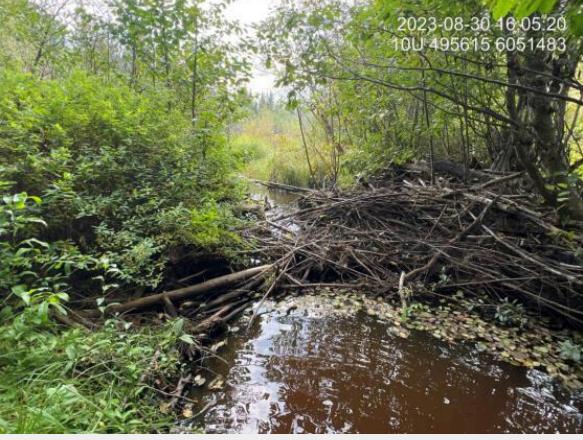
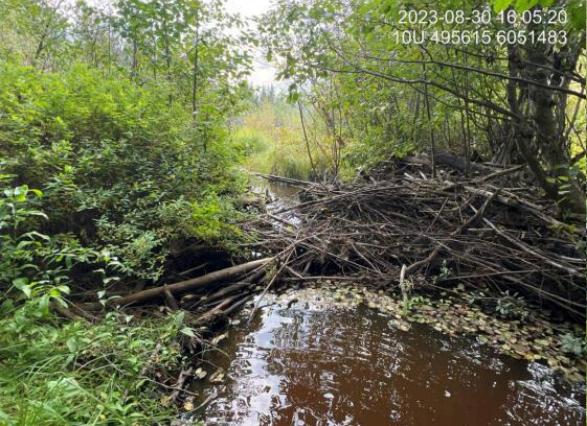
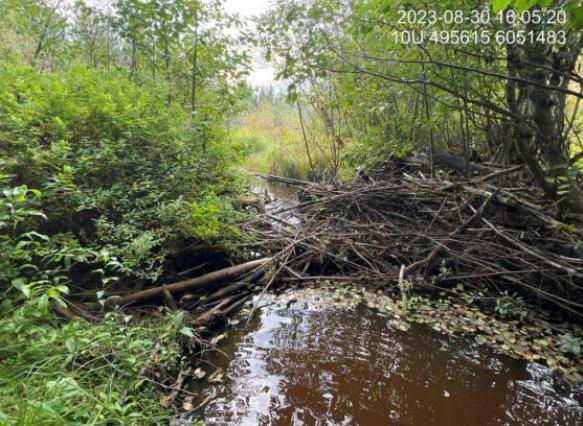
. From top left clockwise: Road/Site Card, Barrel, Outlet, Downstream, Upstream, Inlet.3702455

Location and Stream Data	•	Crossing Characteristics	-
Comments: Large wetland areas, upstream and downstream. Culvert appears to have settled in the middle with raised inlet and outlet. Beaverdam over 1 m high located just upstream of inlet. 16:05:32			
Photos: PSCIS ID

Location and Stream Data		Crossing Characteristics –	
Date	2023-08-30	Crossing Sub Type	Round Culvert
PSCIS ID	198706	Diameter (m)	1.75
External ID	3702455	Length (m)	55
Crew	AI	Embedded	No
UTM Zone	10	Depth Embedded (m)	–
Easting	495632.4	Resemble Channel	No
Northing	6051512	Backwatered	No
Stream	Tributary to Weedon Lake	Percent Backwatered	–
Road	David-Weedon Lake FSR	Fill Depth (m)	5
Road Tenure	Winton R02864	Outlet Drop (m)	0.25
Channel Width (m)	10	Outlet Pool Depth (m)	0.4
Stream Slope (%)	0	Inlet Drop	Yes
Beaver Activity	Yes	Slope (%)	0
Habitat Value	Medium	Valley Fill	Deep Fill
Final score	27	Barrier Result	Barrier
Fix type	Replace with New Open Bottom Structure	Fix Span / Diameter	16

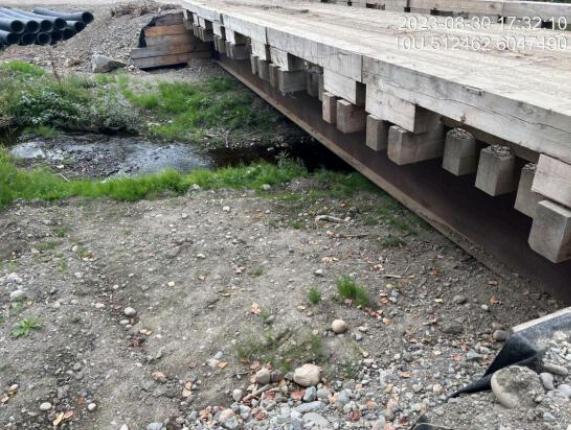
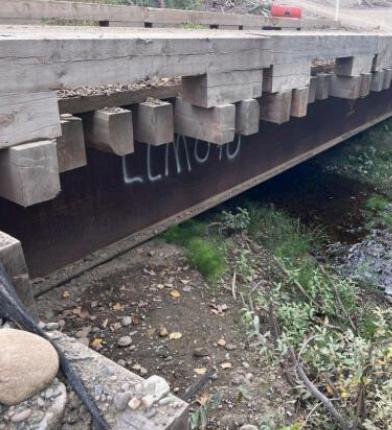
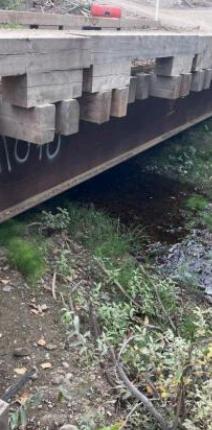
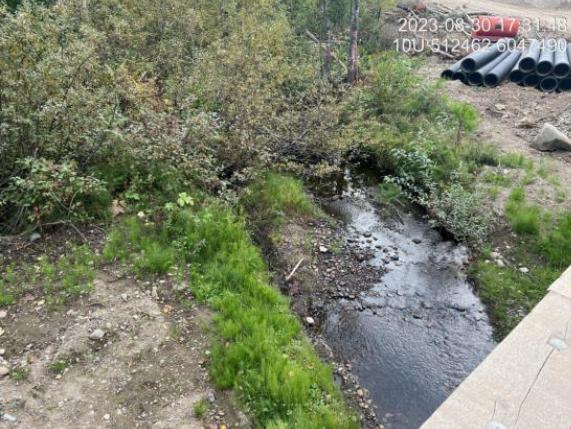
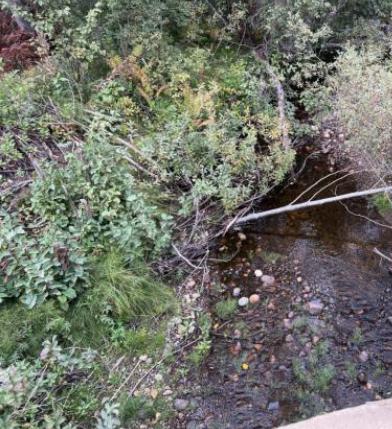
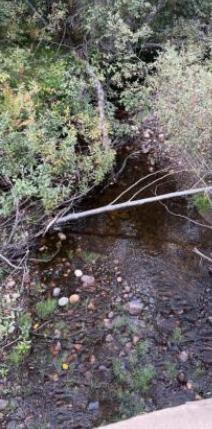
. From top left clockwise: Road/Site Card, Barrel, Outlet, Downstream, Upstream, Inlet.3700783

Location and Stream Data	•	Crossing Characteristics	-
Comments: Good flowing stream with abundant gravels. 17:30:20			
Photos: PSCIS ID

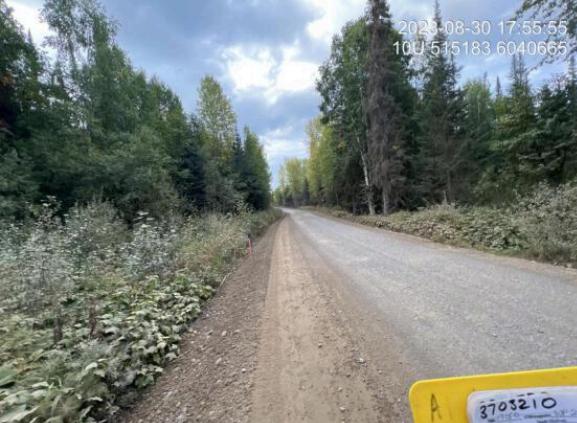
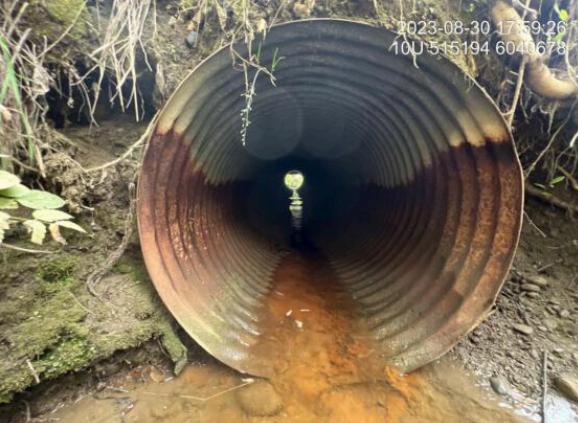
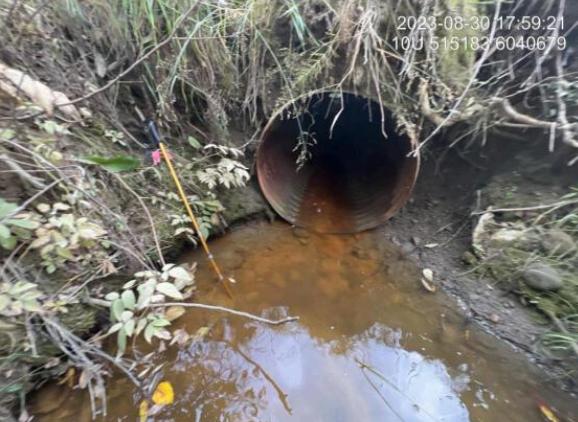
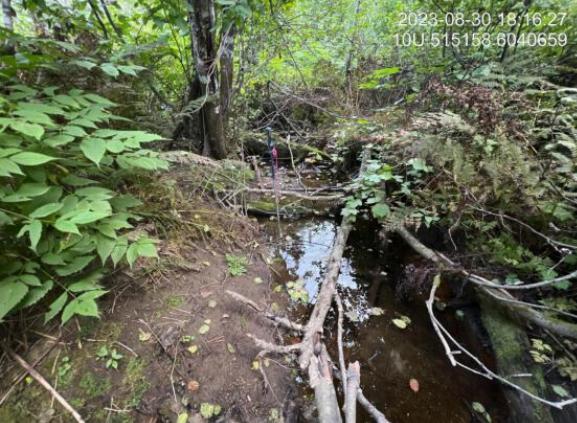
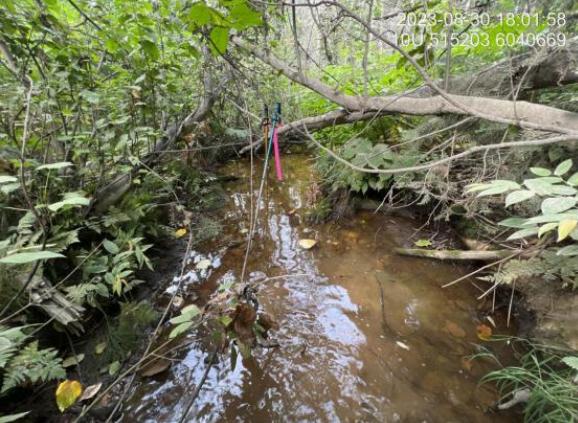
<p>2023-08-30 18:01:58 10U 515203 6040669</p>	<p>. From top left clockwise: Road/Site Card, Barrel, Outlet, Downstream, Upstream, Inlet.3703210</p>

Location and Stream Data	•	Crossing Characteristics	-		
Comments: Abundant gravel downstream. Minimal flow but channel is well defined indicating it flows for most of the year. Crossing modelled as just upstream a couple hundred metres does not exist, and should be entered into bcfishpass. 17:53:50					
Photos: PSCIS ID

Location and Stream Data		Crossing Characteristics –	
Date	2023-08-30	Crossing Sub Type	Round Culvert
PSCIS ID	198708	Diameter (m)	1
External ID	3703210	Length (m)	13
Crew	AI	Embedded	No
UTM Zone	10	Depth Embedded (m)	–
Easting	515195.7	Resemble Channel	No
Northing	6040682	Backwatered	No
Stream	Tributary to Davie Lake	Percent Backwatered	–
Road	David Lake FSR	Fill Depth (m)	1
Road Tenure	MOF 7719	Outlet Drop (m)	0
Channel Width (m)	2.4	Outlet Pool Depth (m)	0.3
Stream Slope (%)	0.5	Inlet Drop	No
Beaver Activity	No	Slope (%)	1.5
Habitat Value	Medium	Valley Fill	Deep Fill
Final score	21	Barrier Result	Barrier
Fix type	Replace with New Open Bottom Structure	Fix Span / Diameter	14

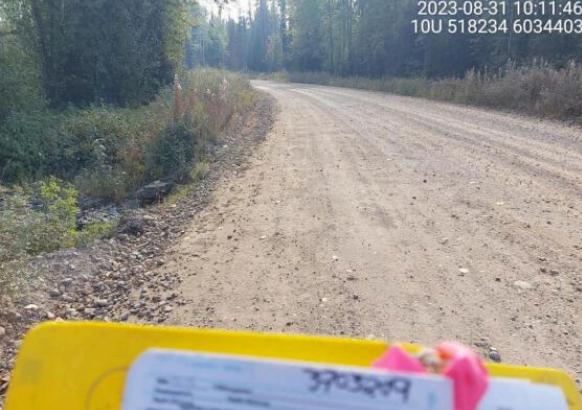
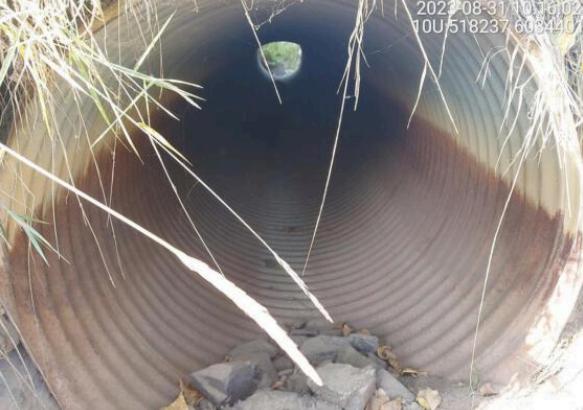
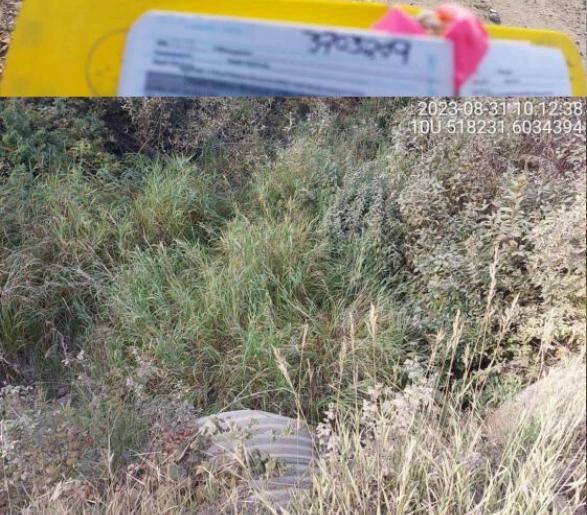
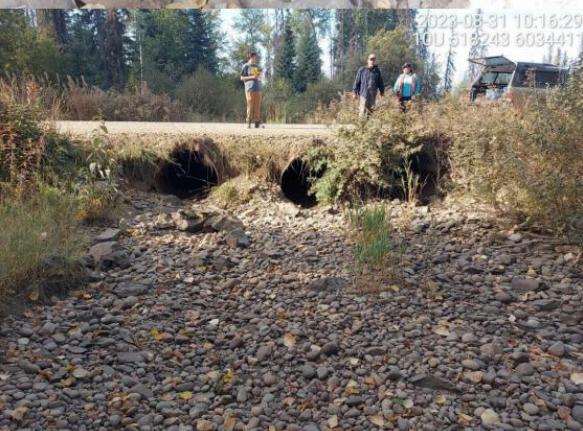
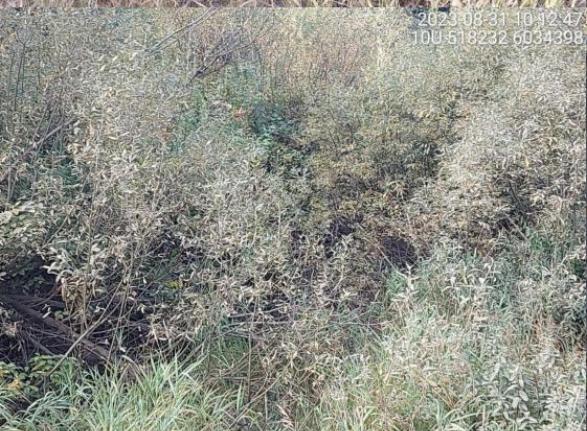
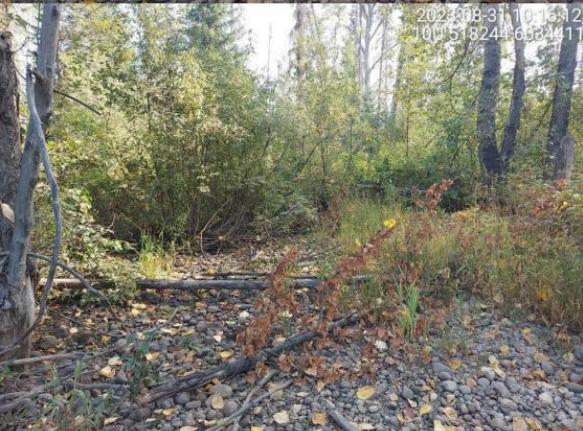
<p>2023-08-31 10:16:12 10U 518244 6034411</p>
<p>. From top left clockwise: Road/Site Card, Barrel, Outlet, Downstream, Upstream, Inlet.3703209</p>

Location and Stream Data	•	Crossing Characteristics
Comments: Three pipes. Stream is completely dewatered. No water flowing through culvert. Culvert diameter totaled between three. 10:20:43		
Photos: PSCIS ID

Location and Stream Data		Crossing Characteristics –	
Date	2023-08-31	Crossing Sub Type	Round Culvert
PSCIS ID	198709	Diameter (m)	3.6
External ID	3703209	Length (m)	12
Crew	MW TS JD BP	Embedded	No
UTM Zone	10	Depth Embedded (m)	–
Easting	518240.9	Resemble Channel	No
Northing	6034399	Backwatered	No
Stream	Tributary to Crooked River	Percent Backwatered	–
Road	Davie Lake FSR	Fill Depth (m)	0.6
Road Tenure	MOF 7719	Outlet Drop (m)	0
Channel Width (m)	4	Outlet Pool Depth (m)	0
Stream Slope (%)	1.5	Inlet Drop	No
Beaver Activity	No	Slope (%)	2
Habitat Value	Low	Valley Fill	Deep Fill
Final score	18	Barrier Result	Potential
Fix type	Replace with New Open Bottom Structure	Fix Span / Diameter	14

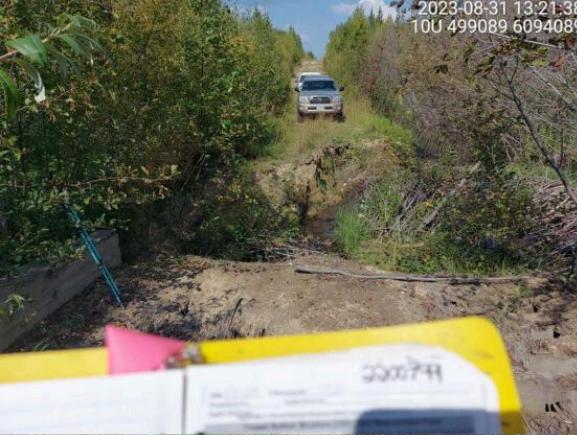
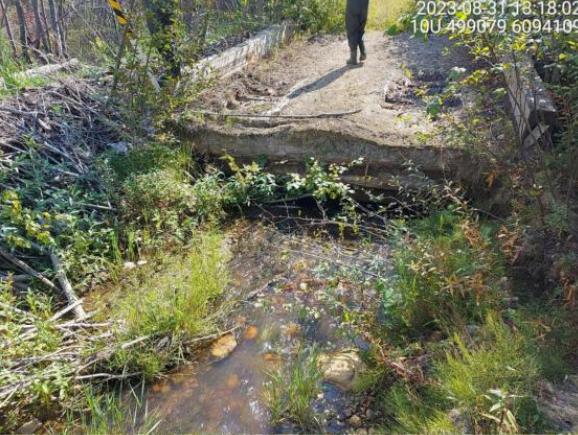
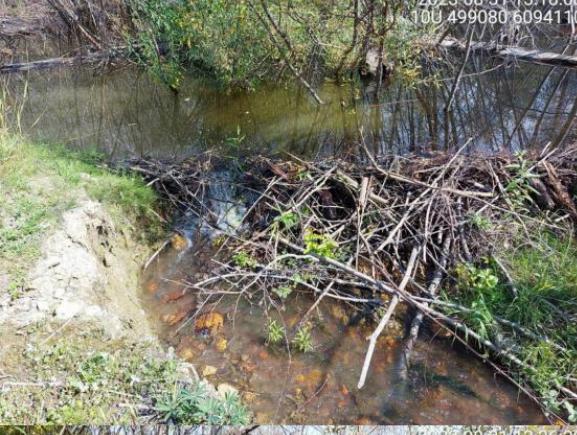
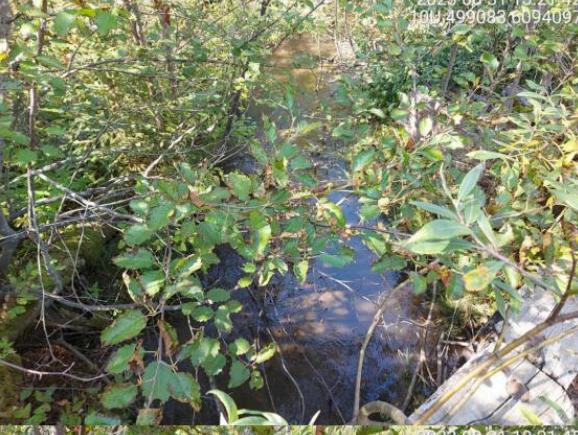
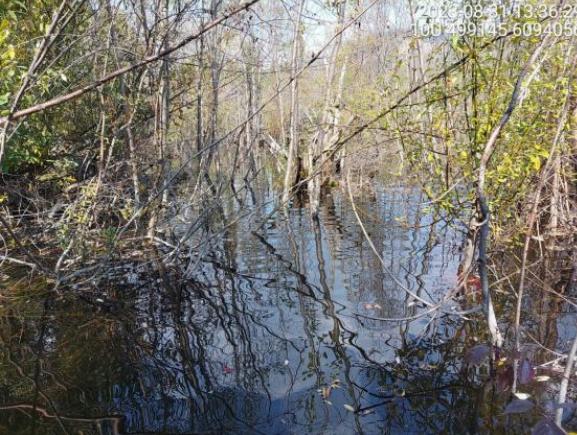
Location and Stream Data	•	Crossing Characteristics	-
Comments: Huge beaver wetland complex just upstream of crossing. Dams on both sides of crossing. Old bridge that is separated in the middle, impassable by vehicle. 14:09:51			
Photos: PSCIS ID

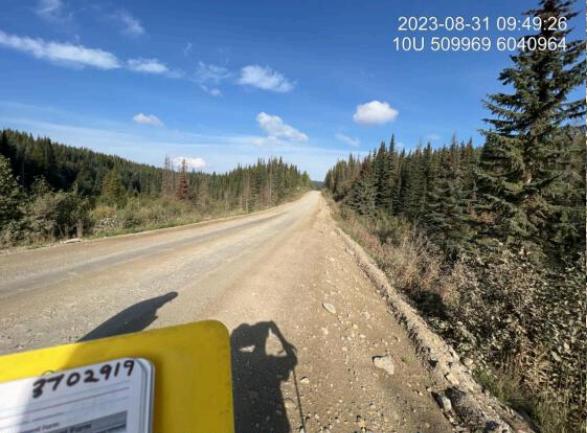
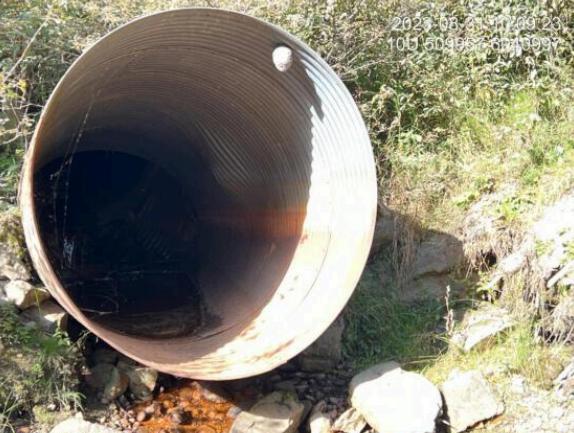
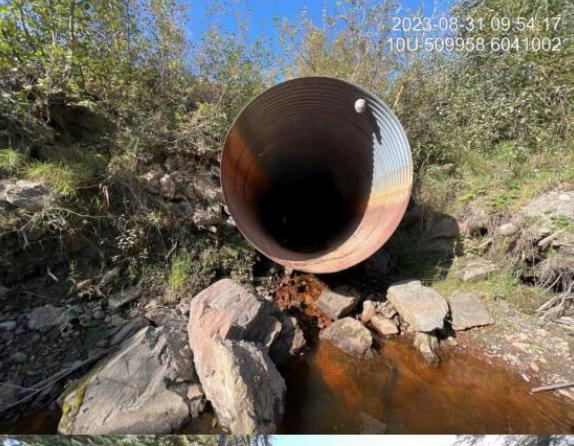
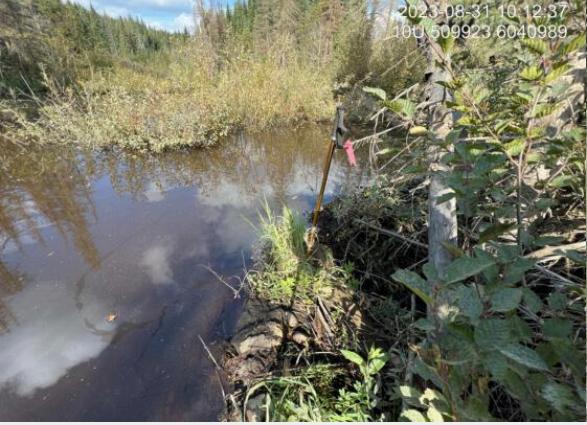
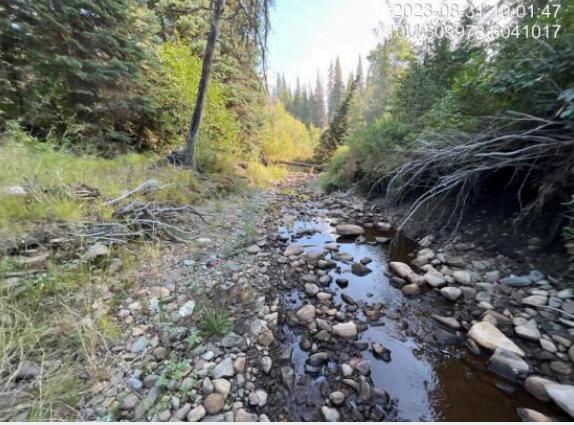
<p>2023-08-31 10:12:37 10U 509923 6040989</p>	<p>. From top left clockwise: Road/Site Card, Barrel, Outlet, Downstream, Upstream, Inlet.3702919</p>

Location and Stream Data	•	Crossing Characteristics
Comments: Surprisingly large drainage with good flow. Huge outlet drop and pipe is in very bad shape. Extra 3 m of culvert has been added to the downstream side and is sloping the opposite direction to draining. Large amounts of algae in the channel downstream. Massive amounts of erosion in the downstream channel indicating there are very high flows during runoff. Upstream side of pipe is completely blocked by a beaver dam, creating a wetland upstream. 09:51:08		
Photos: PSCIS ID

Location and Stream Data		Crossing Characteristics –	
Date	2023-08-31	Crossing Sub Type	Round Culvert
PSCIS ID	198711	Diameter (m)	1.75
External ID	3702919	Length (m)	30
Crew	AI MD	Embedded	No
UTM Zone	10	Depth Embedded (m)	–
Easting	509951.7	Resemble Channel	No
Northing	6040984	Backwatered	No
Stream	Tributary to Crooked River	Percent Backwatered	–
Road	Davie-Muskeg FSR	Fill Depth (m)	4
Road Tenure	Winton R02864	Outlet Drop (m)	1.1
Channel Width (m)	4.3	Outlet Pool Depth (m)	0.65
Stream Slope (%)	2.5	Inlet Drop	Yes
Beaver Activity	No	Slope (%)	3
Habitat Value	Medium	Valley Fill	Deep Fill
Final score	42	Barrier Result	Barrier
Fix type	Replace with New Open Bottom Structure	Fix Span / Diameter	13

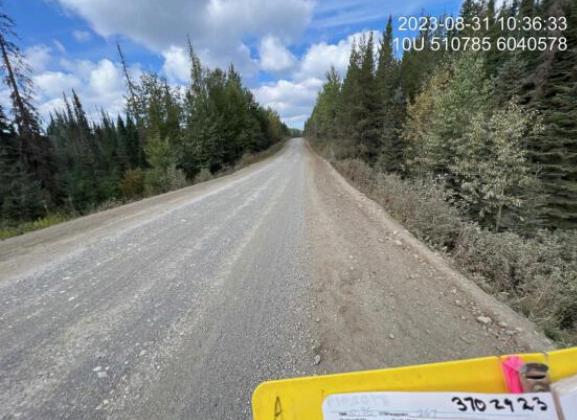
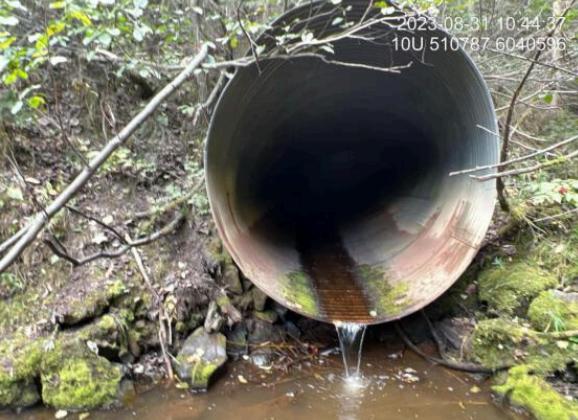
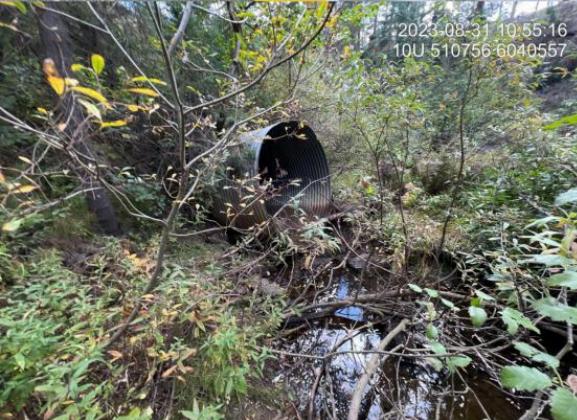
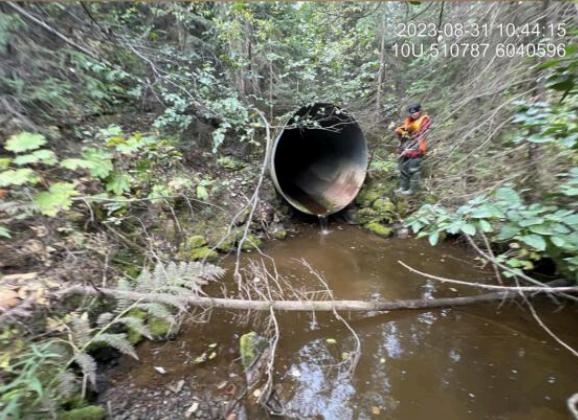
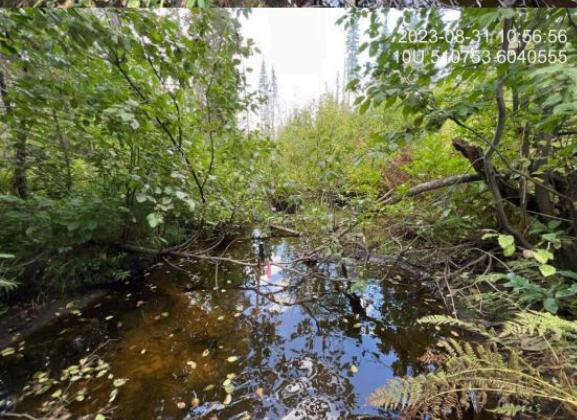
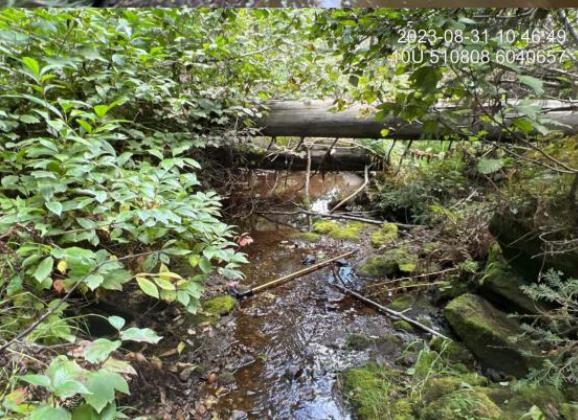
. From top left clockwise: Road/Site Card, Barrel, Outlet, Downstream, Upstream, Inlet.3702923

Location and Stream Data	•	Crossing Characteristics
Comments: Pipe is in extremely bad condition. There are collapsed sections at the edge of the road prism both upstream and downstream. The inlet of the pipe is elevated well above the stream surface as the centre of the pipe has been pressed down by the road fill overtime. Lots of flow must be going underneath the pipe. Large system with decent flow. Some gravels suitable for spawning downstream. 10:35:13		
Photos: PSCIS ID

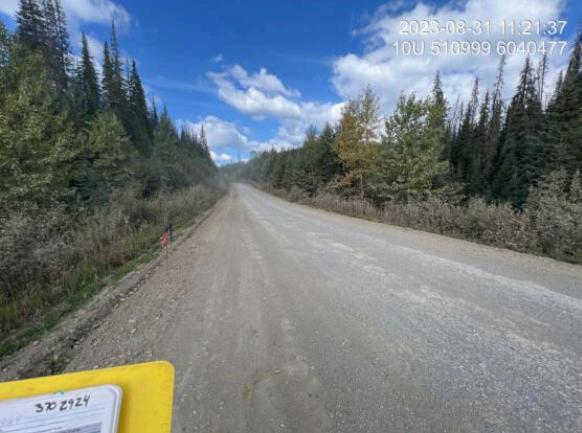
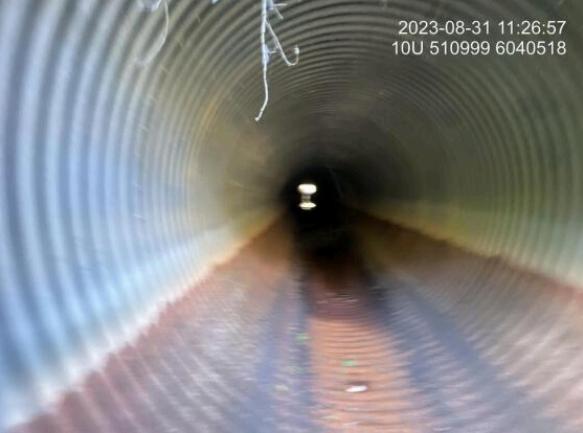
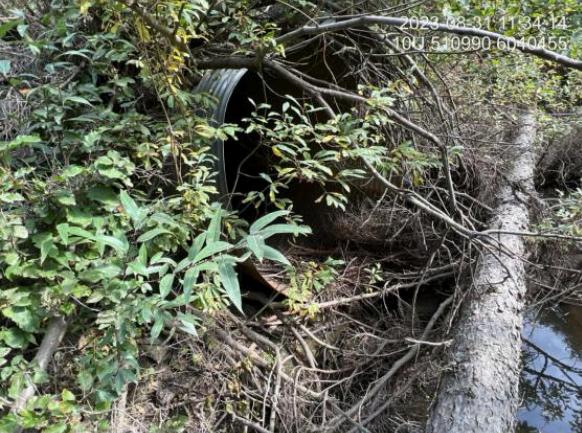
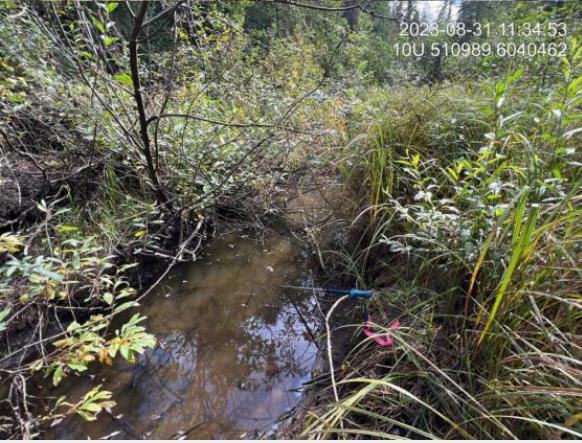
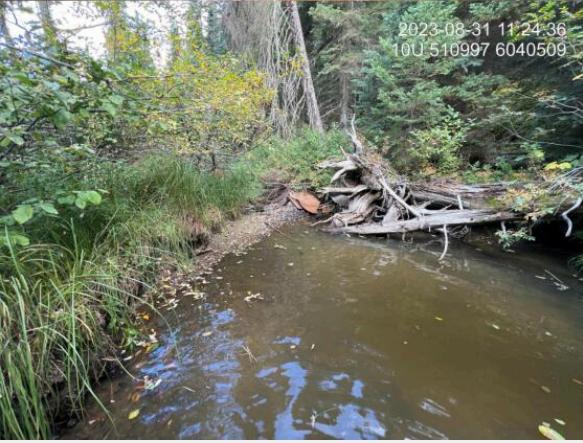
<p>2023-08-31 11:24:36 10U 510997 6040509</p>	<p>. From top left clockwise: Road/Site Card, Barrel, Outlet, Downstream, Upstream, Inlet.3702924</p>

Location and Stream Data	•	Crossing Characteristics	-
Comments: Low gradient wetland type habitat with fine substrates upstream. Decent size drainage with some water in the channel but no actual flow. Some gravels downstream. Pipe is separating approximately 5 m downstream from the inlet. 11:20:00			
Photos: PSCIS ID

Location and Stream Data		Crossing Characteristics	
Date	2023-08-31	Crossing Sub Type	Round Culvert
PSCIS ID	198713	Diameter (m)	2.1
External ID	3702924	Length (m)	47
Crew	AI MD	Embedded	No
UTM Zone	10	Depth Embedded (m)	–
Easting	511000.5	Resemble Channel	No
Northing	6040479	Backwatered	No
Stream	Tributary to Crooked River	Percent Backwatered	–
Road	Davie-Muskeg FSR	Fill Depth (m)	9
Road Tenure	Winton R02864	Outlet Drop (m)	0.2
Channel Width (m)	3.4	Outlet Pool Depth (m)	0.3
Stream Slope (%)	2	Inlet Drop	No
Beaver Activity	No	Slope (%)	3
Habitat Value	Medium	Valley Fill	Deep Fill
Final score	37	Barrier Result	Barrier
Fix type	Replace Structure with Streambed Simulation CBS	Fix Span / Diameter	4.5

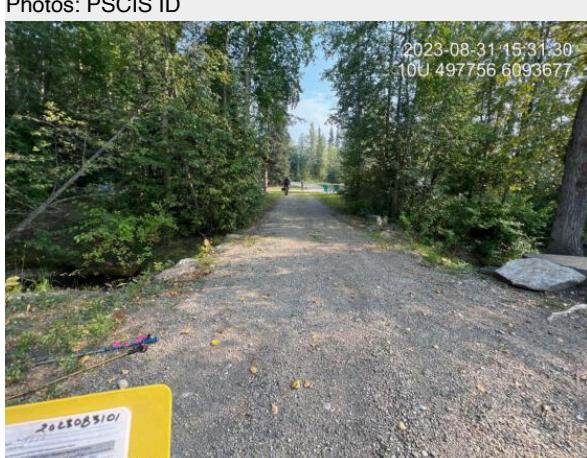
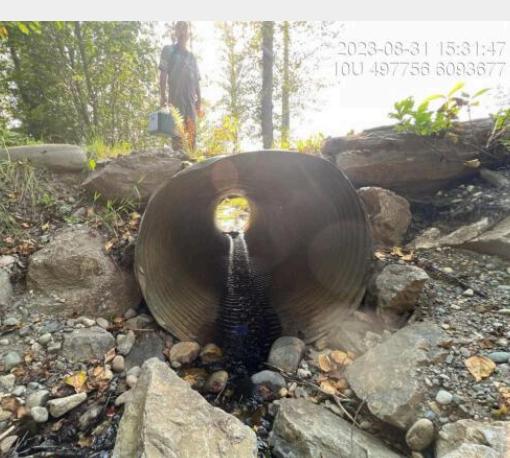
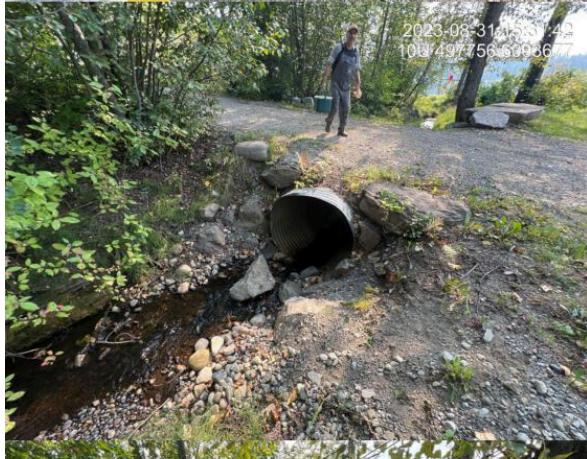
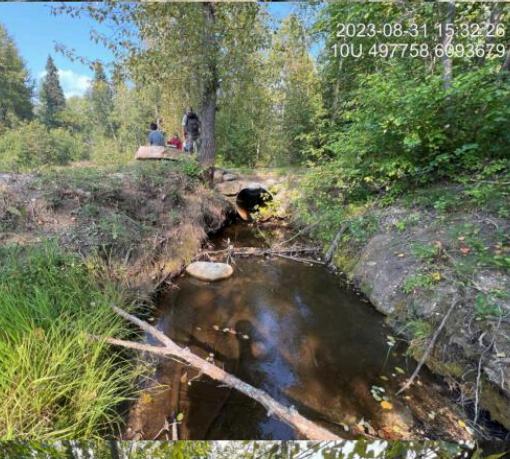
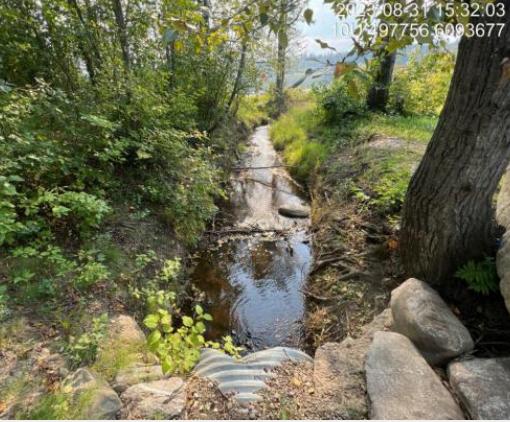
. From top left clockwise: Road/Site Card, Barrel, Outlet, Downstream, Upstream, Inlet.2023083101

Location and Stream Data	•	Crossing Characteristics	-
Comments: Small culvert within the campground area. Approximately 40 m upstream of the mouth of the lake. 15:29:22			
Photos: PSCIS ID

Location and Stream Data		Crossing Characteristics –	
Date	2023-08-31	Crossing Sub Type	Round Culvert
PSCIS ID	198714	Diameter (m)	1.2
External ID	2023083101	Length (m)	8
Crew	AI MD	Embedded	No
UTM Zone	10	Depth Embedded (m)	–
Easting	497758.4	Resemble Channel	No
Northing	6093674	Backwatered	No
Stream	Tributary to McLeod Lake	Percent Backwatered	–
Road	Campground Rd	Fill Depth (m)	0.5
Road Tenure	MOE	Outlet Drop (m)	0
Channel Width (m)	2.3	Outlet Pool Depth (m)	0.3
Stream Slope (%)	2	Inlet Drop	Yes
Beaver Activity	Yes	Slope (%)	5
Habitat Value	Medium	Valley Fill	Deep Fill
Final score	26	Barrier Result	Barrier
Fix type	Replace with New Open Bottom Structure	Fix Span / Diameter	10

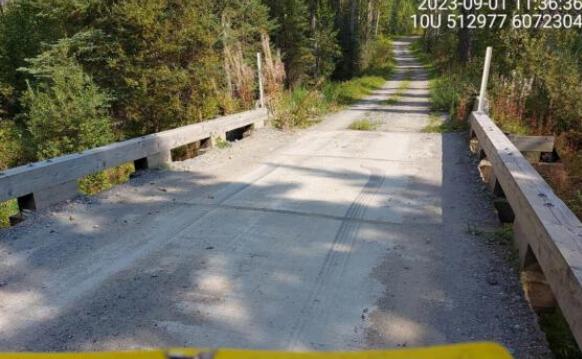
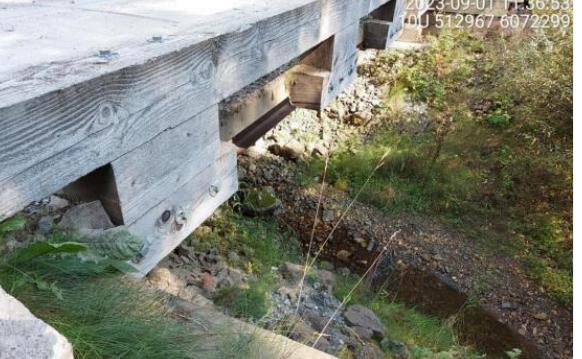
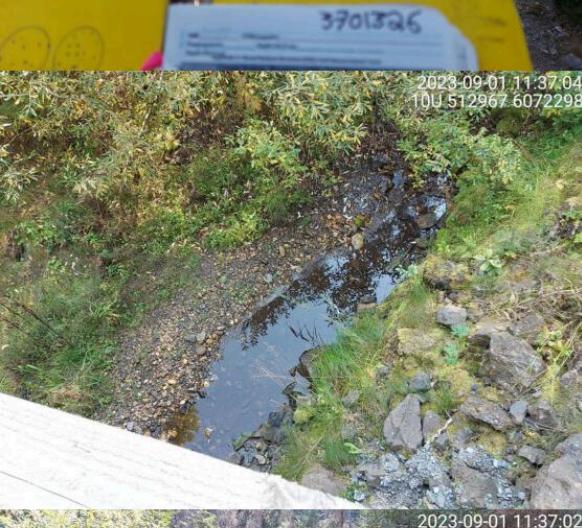
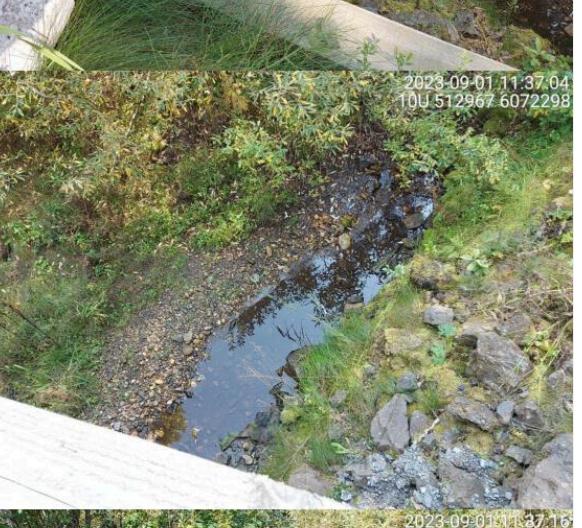
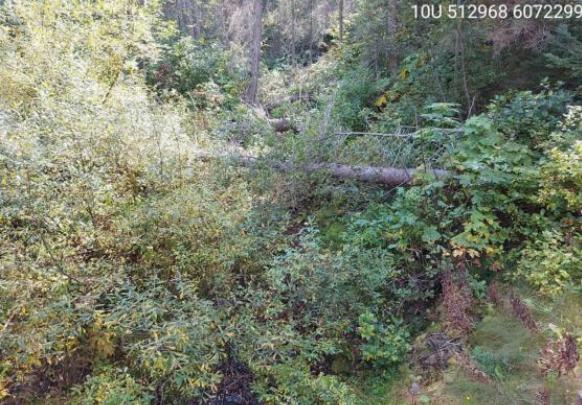
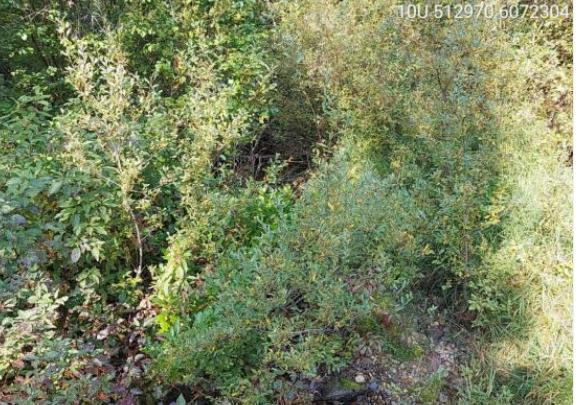
. From top left clockwise: Road/Site Card, Barrel, Outlet, Downstream, Upstream, Inlet.3701326

Location and Stream Data	•	Crossing Characteristics	-
Comments: Small stream with some flow. 11:37:53			
Photos: PSCIS ID

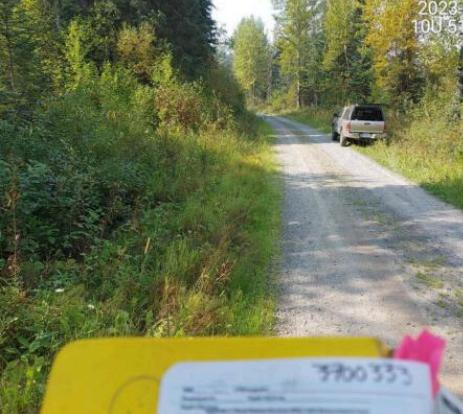
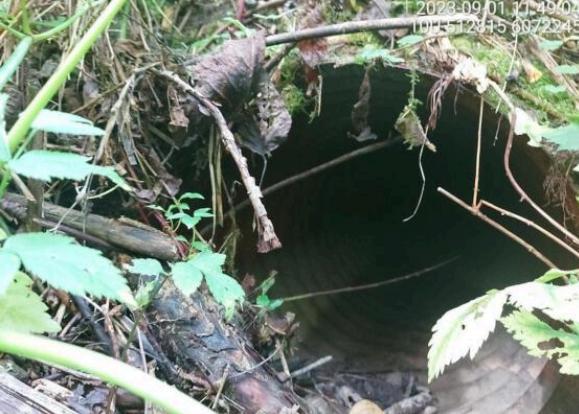
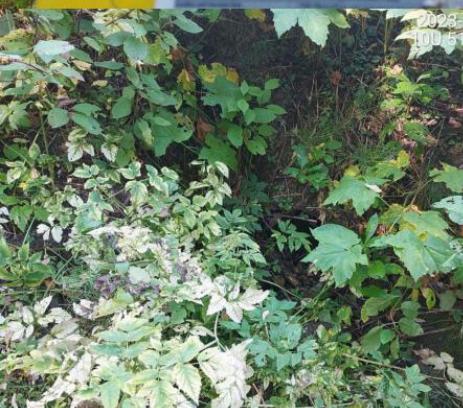
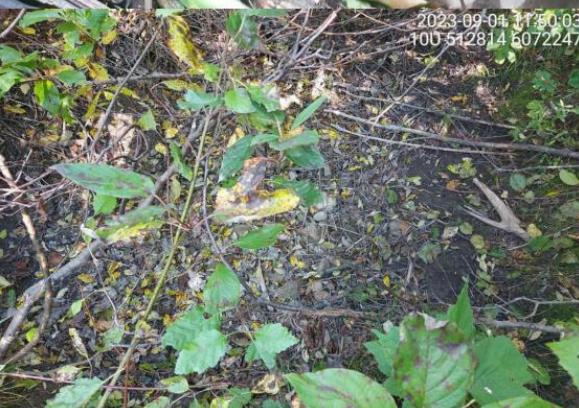
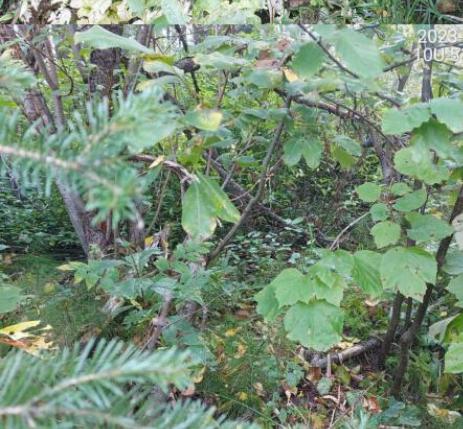
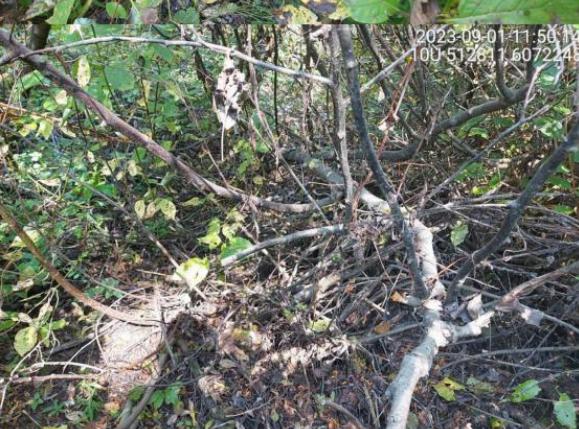
. From top left clockwise: Road/Site Card, Barrel, Outlet, Downstream, Upstream, Inlet.3700333

Location and Stream Data	•	Crossing Characteristics	-
Comments: Very small culvert, dewatered. No well defined channel present. Channel width and slope estimated. Main flow of stream likely goes under bridge nearby. 11:52:39			
Photos: PSCIS ID

Location and Stream Data		Crossing Characteristics	
Date	2023-09-01	Crossing Sub Type	Round Culvert
PSCIS ID	198716	Diameter (m)	0.5
External ID	3700333	Length (m)	7
Crew	MW	Embedded	No
UTM Zone	10	Depth Embedded (m)	–
Easting	512837.1	Resemble Channel	No
Northing	6072245	Backwatered	No
Stream	42 Mile Creek	Percent Backwatered	–
Road	Unnamed	Fill Depth (m)	1.5
Road Tenure	B.C. Custom Timber Products Ltd.	Outlet Drop (m)	0
Channel Width (m)	1.6	Outlet Pool Depth (m)	0
Stream Slope (%)	2.5	Inlet Drop	No
Beaver Activity	No	Slope (%)	2
Habitat Value	Low	Valley Fill	Deep Fill
Final score	21	Barrier Result	Barrier
Fix type	Replace Structure with Streambed Simulation CBS	Fix Span / Diameter	3

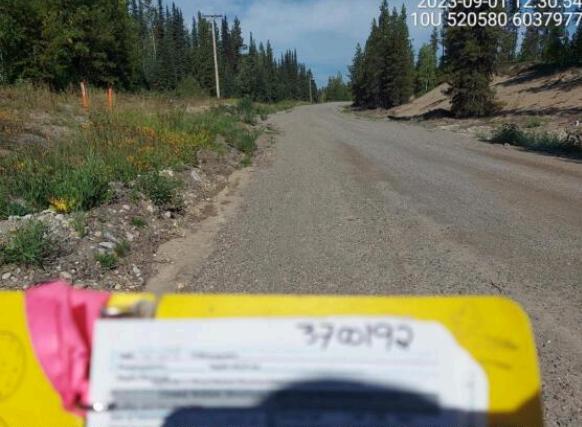
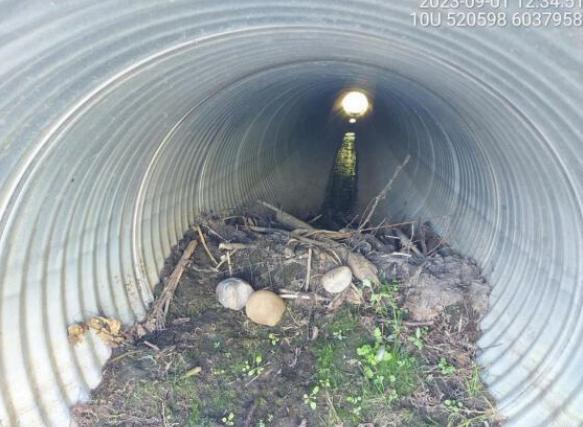
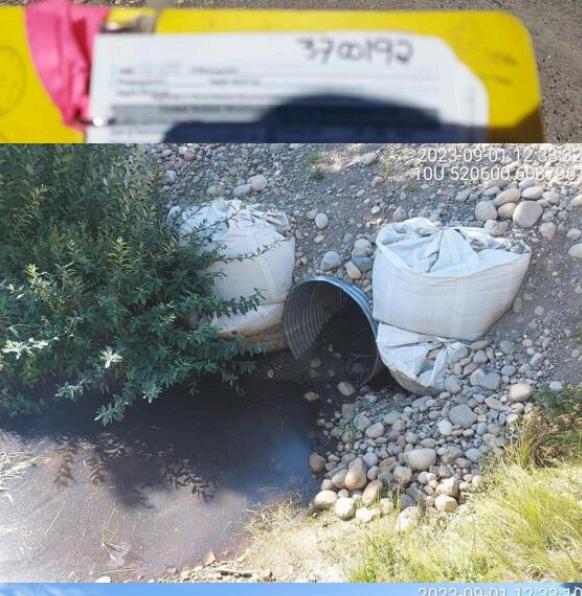
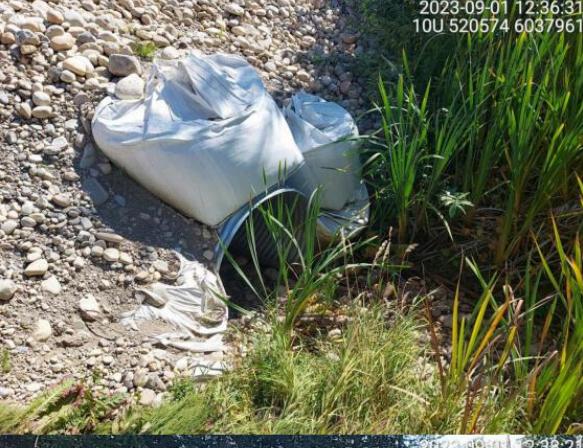
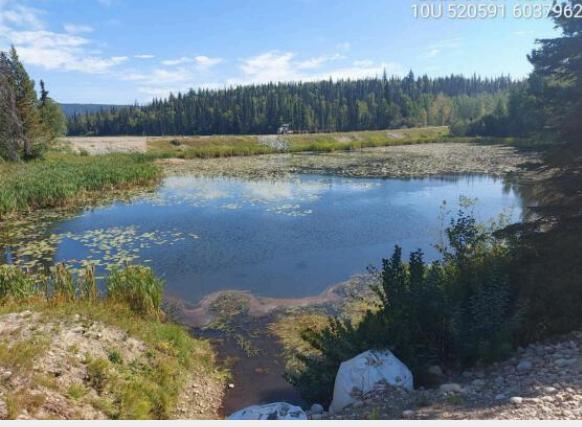
<p>2023-09-01 12:38:21 10U 520570 6037957</p>
. From top left clockwise: Road/Site Card, Barrel, Outlet, Downstream, Upstream, Inlet.3700192

Location and Stream Data	•	Crossing Characteristics
Comments: Wetland upstream and downstream. Stream gradient estimated. No water in culvert, dewatered downstream near crossing. Blockage at inlet from beaver mud dam. Steep embankment above culvert, risk of rockslide high. Big sacks on inlet and outlet holding embankment in place. Lake chub and brassy minnow confirmed in the past near highway. 12:31:41		
Photos: PSCIS ID

Location and Stream Data		Crossing Characteristics	
Date	2023-09-01	Crossing Sub Type	Round Culvert
PSCIS ID	198717	Diameter (m)	1.2
External ID	3700192	Length (m)	15
Crew	MW	Embedded	No
UTM Zone	10	Depth Embedded (m)	–
Easting	520582.7	Resemble Channel	No
Northing	6037949	Backwatered	No
Stream	Tributary to Crooked River	Percent Backwatered	–
Road	Spur	Fill Depth (m)	3.5
Road Tenure	Unclassified	Outlet Drop (m)	0
Channel Width (m)	1.2	Outlet Pool Depth (m)	0
Stream Slope (%)	1.5	Inlet Drop	No
Beaver Activity	Yes	Slope (%)	1
Habitat Value	Low	Valley Fill	Deep Fill
Final score	21	Barrier Result	Barrier
Fix type	Replace Structure with Streambed Simulation CBS	Fix Span / Diameter	3

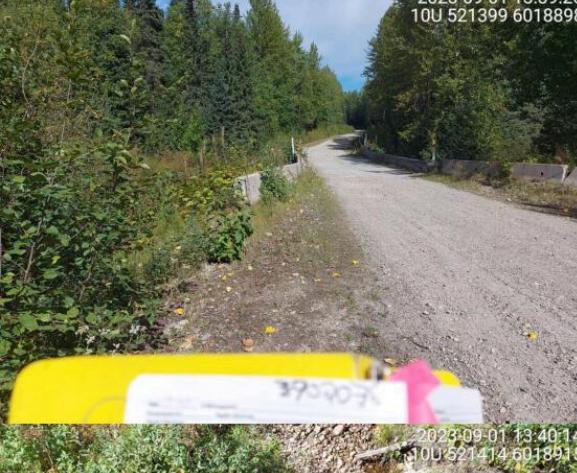
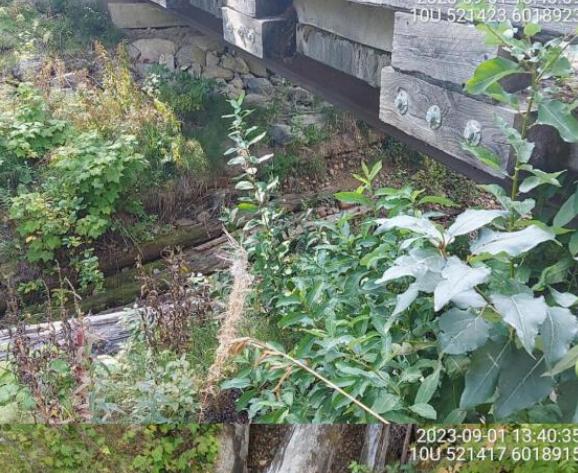
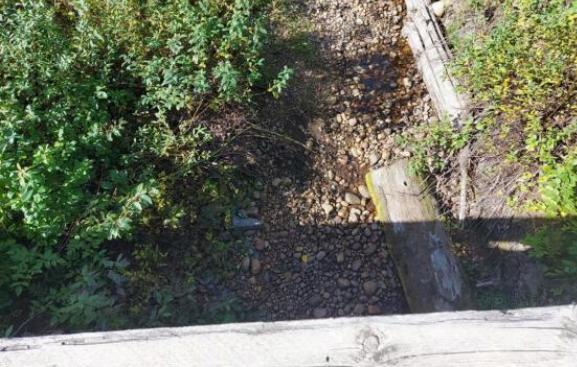
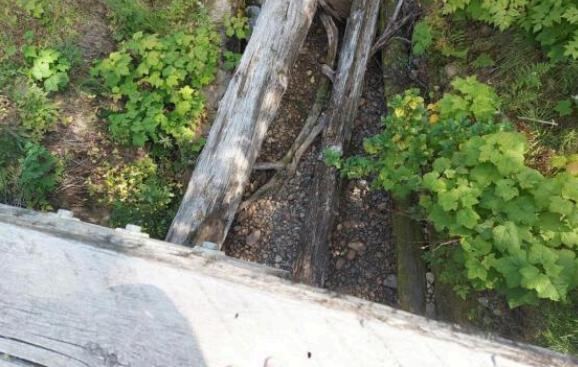
Location and Stream Data	•	Crossing Characteristics	-
Comments: Very little flow and water at time of survey. Huge downed trees on downstream side. 13:41:31			
Photos: PSCIS ID

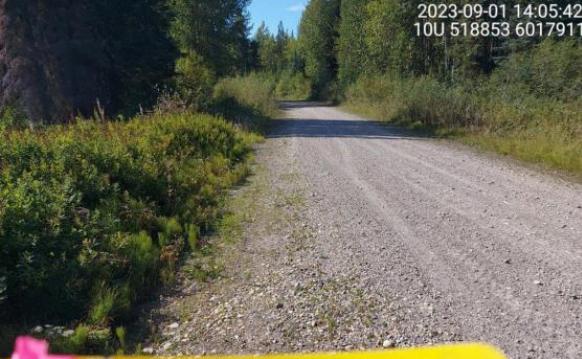
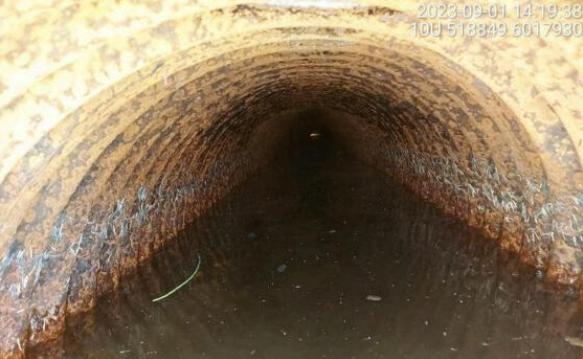
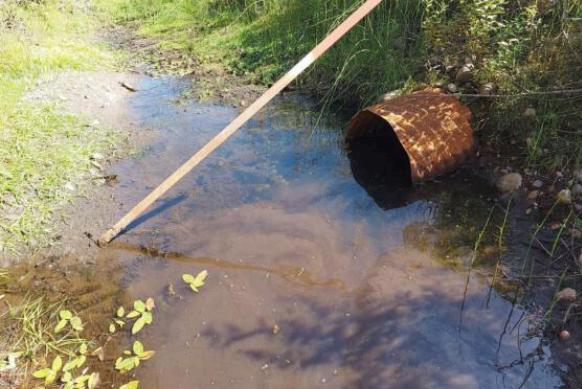
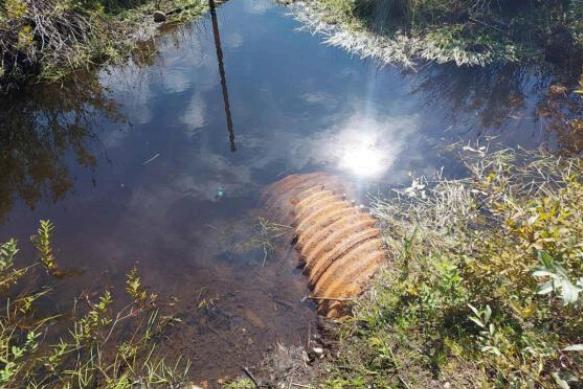
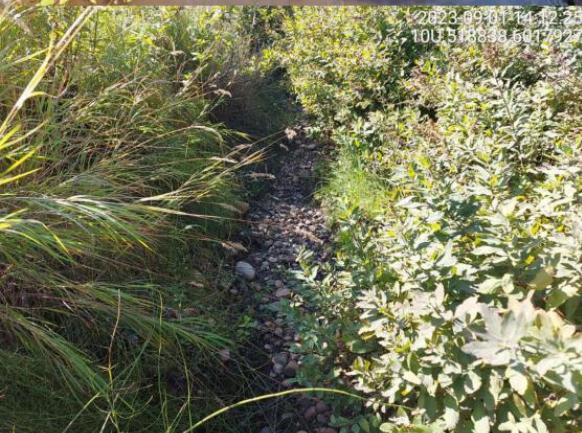
. From top left clockwise: Road/Site Card, Barrel, Outlet, Downstream, Upstream, Inlet.3702074

Location and Stream Data	•	Crossing Characteristics	-
Comments: Culvert was in wrong location on map. It is actually located on road approximately 95m east of modelled crossing location. A lot of fry fish spotted near outlet. Culvert very rusted and near the end of its life. Small channel upstream running along road for 20m but no defined channel after that. 14:02:57			
Photos: PSCIS ID

Location and Stream Data		Crossing Characteristics	
Date	2023-09-01	Crossing Sub Type	Round Culvert
PSCIS ID	198719	Diameter (m)	0.6
External ID	3702074	Length (m)	13
Crew	MW	Embedded	No
UTM Zone	10	Depth Embedded (m)	–
Easting	518848	Resemble Channel	No
Northing	6017917	Backwatered	Yes
Stream	Balsam Creek	Percent Backwatered	100
Road	Caine Creek FSR	Fill Depth (m)	1
Road Tenure	MOF 7694	Outlet Drop (m)	0
Channel Width (m)	1.2	Outlet Pool Depth (m)	0.7
Stream Slope (%)	1.5	Inlet Drop	No
Beaver Activity	No	Slope (%)	4
Habitat Value	Low	Valley Fill	Deep Fill
Final score	26	Barrier Result	Barrier
Fix type	Replace Structure with Streambed Simulation CBS	Fix Span / Diameter	3

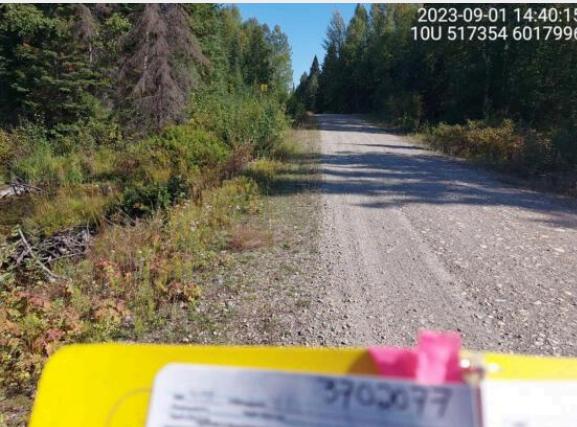
Location and Stream Data	•	Crossing Characteristics
Comments: Fry and parr spotted upstream and downstream of crossing. Culvert very rusted on inlet side. Wetland habitat upstream. Channel narrows downstream and is a little overgrown but has moderate flow. Enquist Lake located upstream. 14:41:51		
Photos: PSCIS ID
