Appendix - Phase 1 Fish Passage Assessment Data and Photos

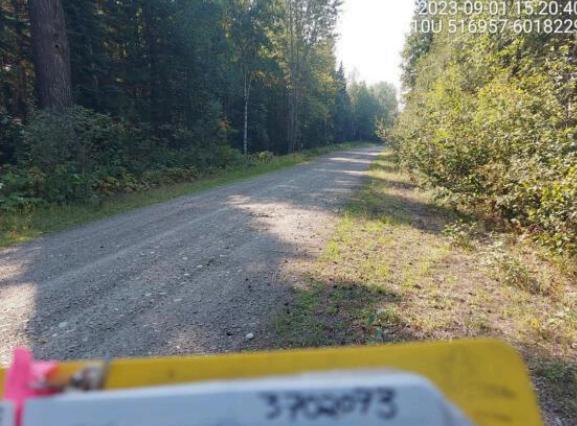
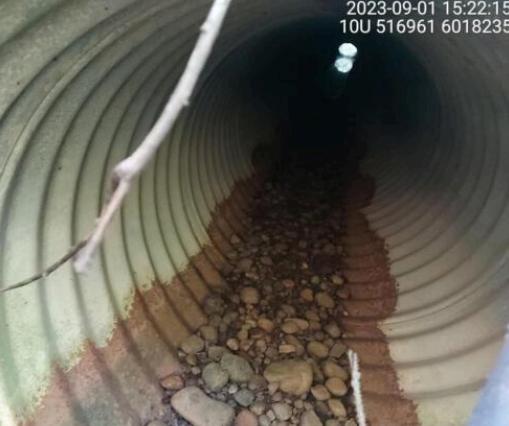
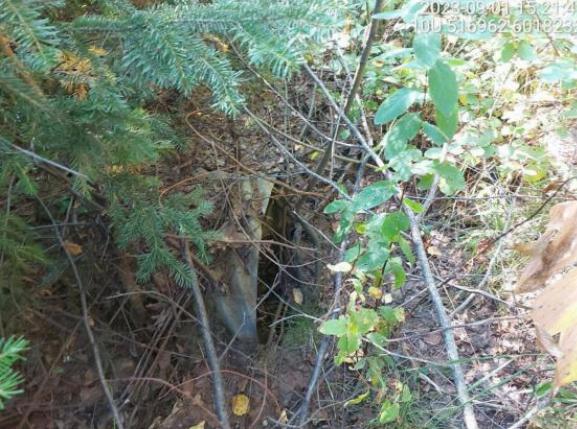
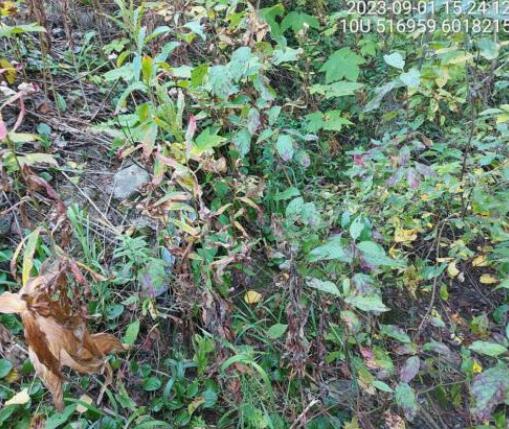
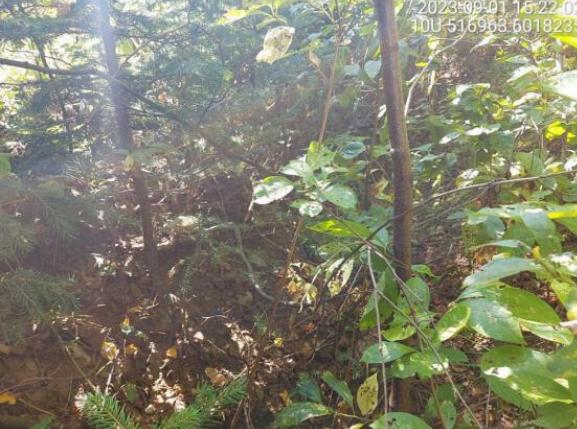
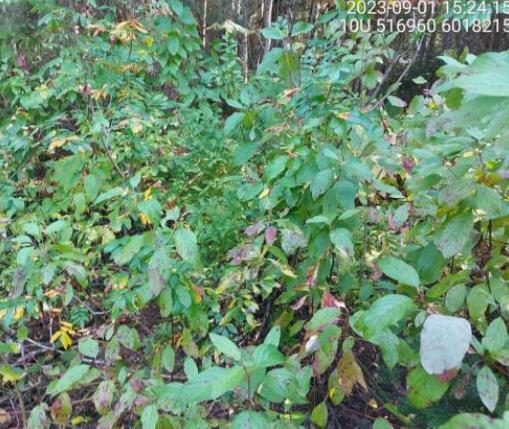
. From top left clockwise: Road/Site Card, Barrel, Outlet, Downstream, Upstream, Inlet.3702073

Location and Stream Data	•	Crossing Characteristics	-
Comments: Stream is dewatered. No clearly defined channel up or downstream. Small tree growing on inlet side, sign that there hasn't been water flowing in a long time. Channel width and slope estimated. 15:19:23			
Photos: PSCIS ID

Location and Stream Data		Crossing Characteristics	
Date	2023-09-01	Crossing Sub Type	Round Culvert
PSCIS ID	198721	Diameter (m)	0.6
External ID	3702073	Length (m)	13
Crew	MW	Embedded	No
UTM Zone	10	Depth Embedded (m)	–
Easting	516959.5	Resemble Channel	No
Northing	6018229	Backwatered	No
Stream	Tributary to Summit Lake	Percent Backwatered	–
Road	Caine Creek FSR	Fill Depth (m)	0.5
Road Tenure	MOF 7694	Outlet Drop (m)	0
Channel Width (m)	1.7	Outlet Pool Depth (m)	0
Stream Slope (%)	1.5	Inlet Drop	No
Beaver Activity	No	Slope (%)	2
Habitat Value	Low	Valley Fill	Deep Fill
Final score	21	Barrier Result	Barrier
Fix type	Replace Structure with Streambed Simulation CBS	Fix Span / Diameter	3

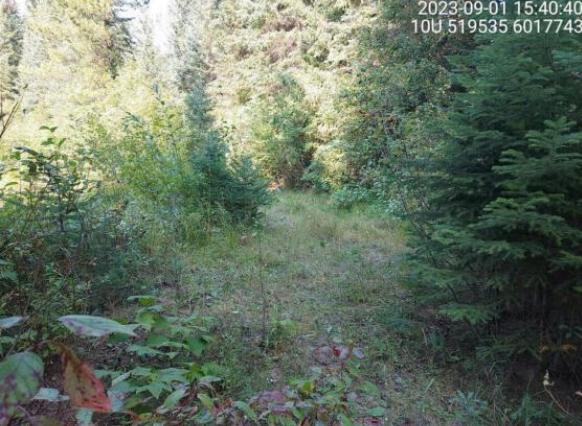
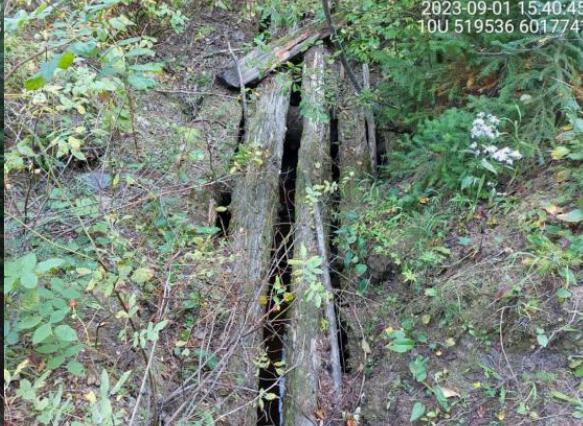
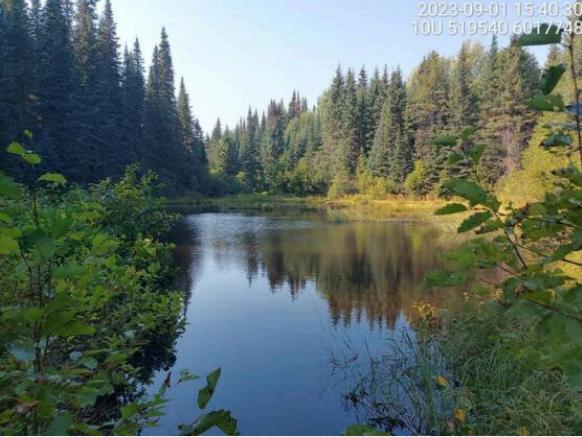
. From top left clockwise: Road/Site Card, Barrel, Outlet, Downstream, Upstream, Inlet.3700931

Location and Stream Data	•	Crossing Characteristics	-
Comments: Looks like there was once a very old bridge here. Very overgrown and rotten. Water passing underneath but not flowing. Not a fish passage issue. 15:38:42			
Photos: PSCIS ID

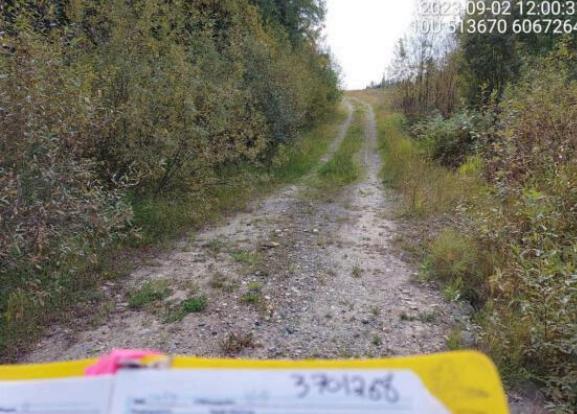
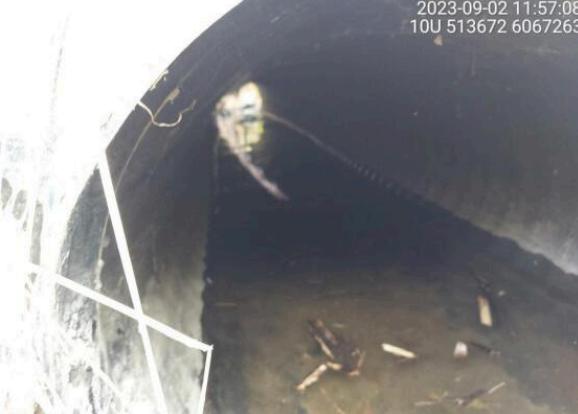
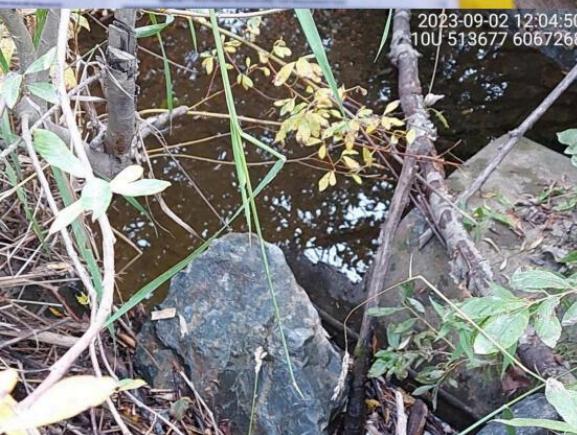
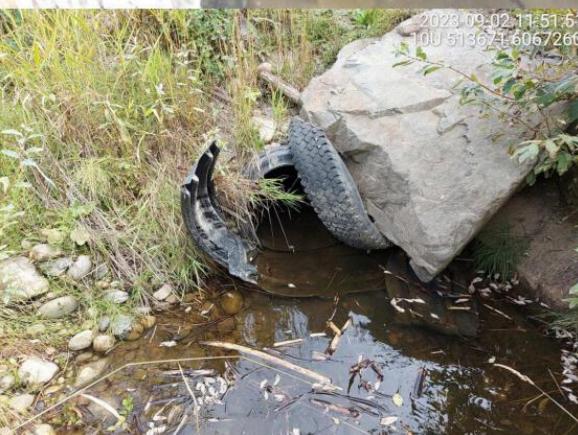
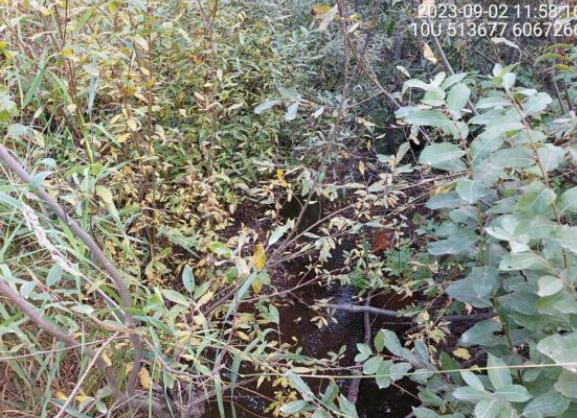
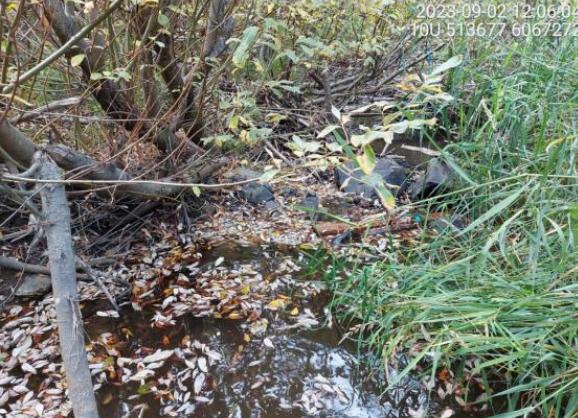
<p>2023-09-02 12:06:04 10U 513677 6067272</p>	<p>. From top left clockwise: Road/Site Card, Barrel, Outlet, Downstream, Upstream, Inlet.3701268</p>

Location and Stream Data	•	Crossing Characteristics	-
Comments: Two culverts, one plastic pipe and one really old metal pipe. Metal pipe is longer, outlets are at different spots. 11:58:55			
Photos: PSCIS ID

Location and Stream Data		Crossing Characteristics –	
Date	2023-09-02	Crossing Sub Type	Round Culvert
PSCIS ID	198723	Diameter (m)	1.4
External ID	3701268	Length (m)	5
Crew	MW	Embedded	No
UTM Zone	10	Depth Embedded (m)	–
Easting	513674	Resemble Channel	No
Northing	6067268	Backwatered	Yes
Stream	Tributary to Altezega Creek	Percent Backwatered	75
Road	Spur	Fill Depth (m)	0.5
Road Tenure	Unclassified	Outlet Drop (m)	0
Channel Width (m)	2.2	Outlet Pool Depth (m)	0.4
Stream Slope (%)	1	Inlet Drop	No
Beaver Activity	No	Slope (%)	1
Habitat Value	High	Valley Fill	Deep Fill
Final score	21	Barrier Result	Barrier
Fix type	Replace with New Open Bottom Structure	Fix Span / Diameter	14

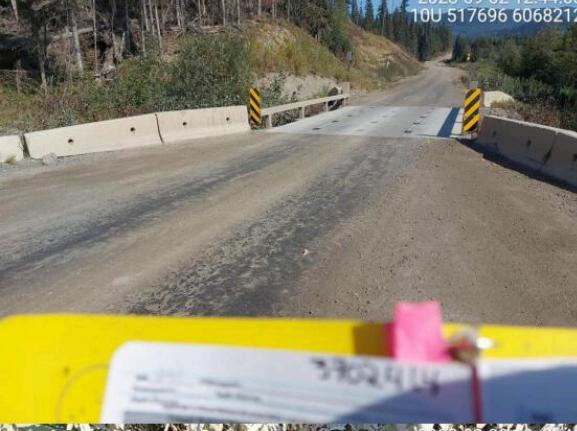
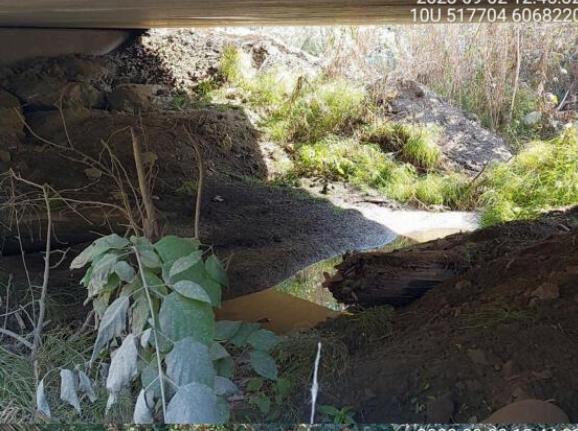
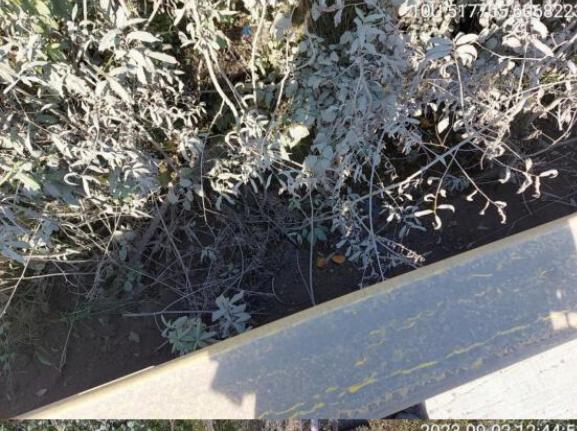
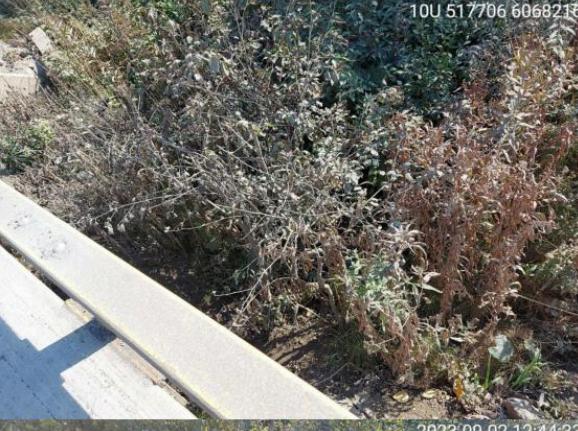
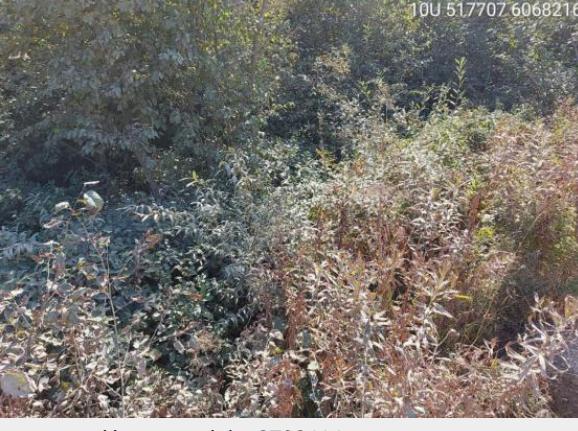
2023-09-02 12:44:33 10U 517707 6068216	. From top left clockwise: Road/Site Card, Barrel, Outlet, Downstream, Upstream, Inlet.3702414

Location and Stream Data	•	Crossing Characteristics	-		
Comments: No water flowing under bridge at time of survey. Dewatered downstream. 12:46:41					
Photos: PSCIS ID

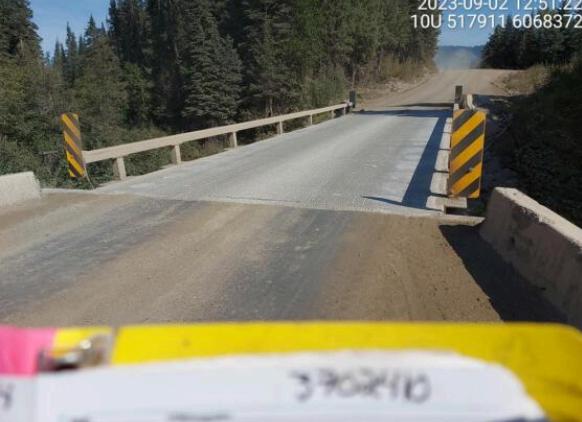
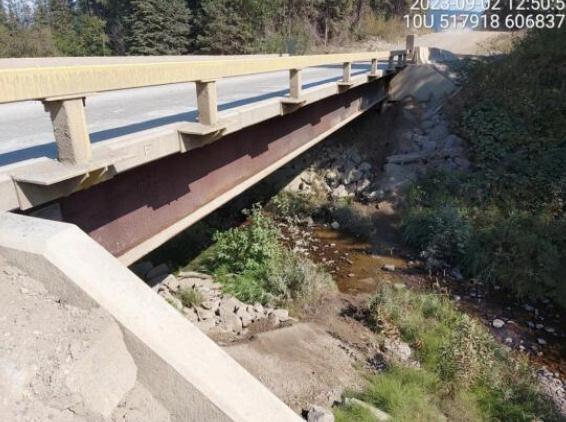
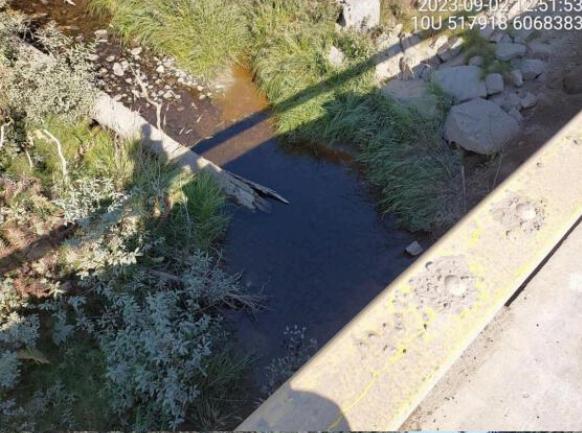
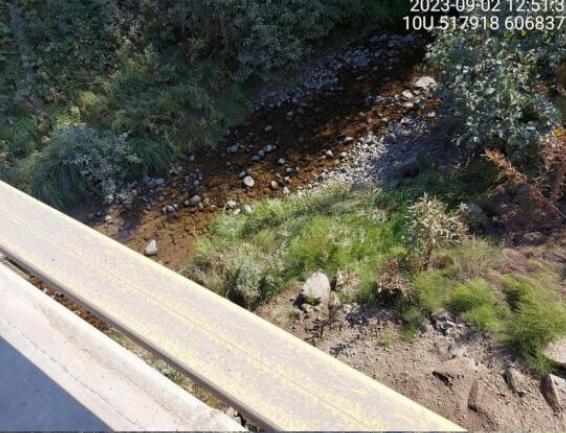
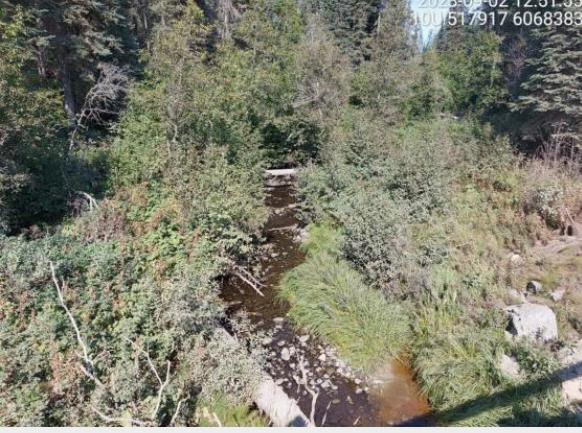
. From top left clockwise: Road/Site Card, Barrel, Outlet, Downstream, Upstream, Inlet.3702410

Location and Stream Data	•	Crossing Characteristics	-
Comments: Nice looking stream with good flow. 12:52:35			
Photos: PSCIS ID

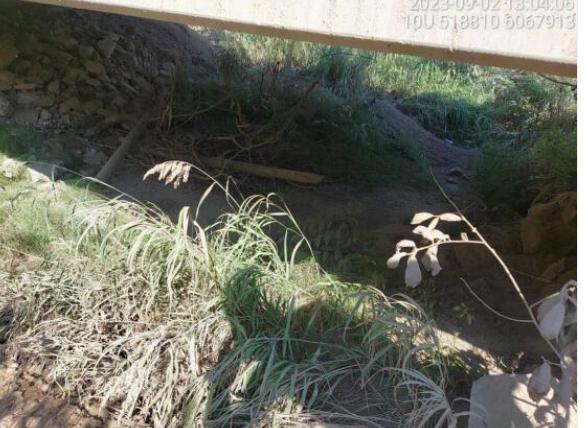
Location and Stream Data	.	Crossing Characteristics	-
Comments: Dewatered stream at time of survey. 13:05:36			
Photos: PSCIS ID

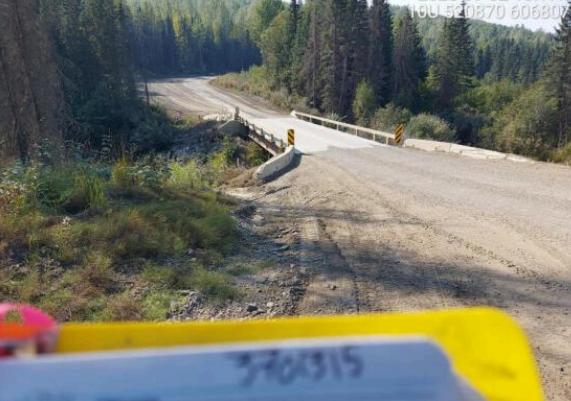
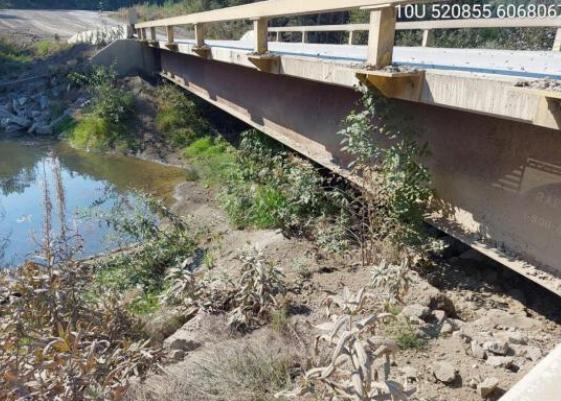
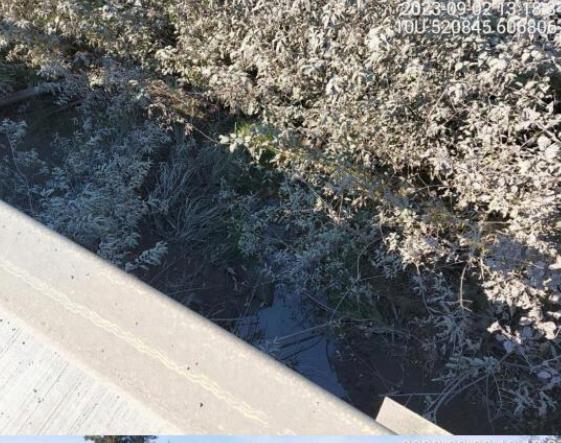
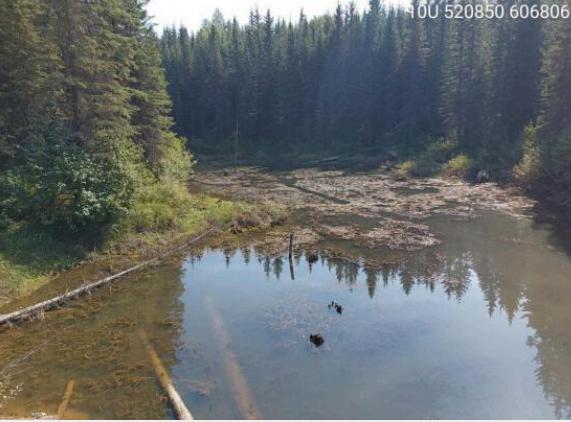
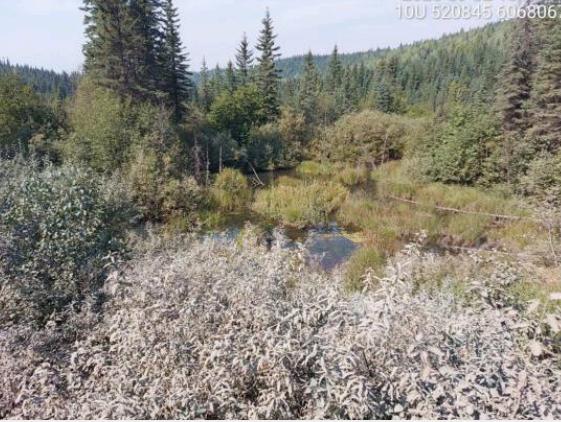
-
. From top left clockwise: Road/Site Card, Barrel, Outlet, Downstream, Upstream, Inlet.3701315

Location and Stream Data		Crossing Characteristics –	
Date	2023-09-02	Crossing Sub Type	Bridge
PSCIS ID	198727	Diameter (m)	17
External ID	3701315	Length (m)	4
Crew	MW	Embedded	–
UTM Zone	10	Depth Embedded (m)	–
Easting	520855.7	Resemble Channel	–
Northing	6068064	Backwatered	–
Stream	Tributary to Altezega Creek	Percent Backwatered	–
Road	Firth Lake FSR	Fill Depth (m)	–
Road Tenure	Canfor R01860	Outlet Drop (m)	–
Channel Width (m)	–	Outlet Pool Depth (m)	–
Stream Slope (%)	–	Inlet Drop	–
Beaver Activity	No	Slope (%)	–
Habitat Value	–	Valley Fill	–
Final score	0	Barrier Result	Passable
Fix type	–	Fix Span / Diameter	–

Location and Stream Data	•	Crossing Characteristics	-
Comments: Wetland upstream and downstream. No flowing water under bridge. 13:15:29			
Photos: PSCIS ID

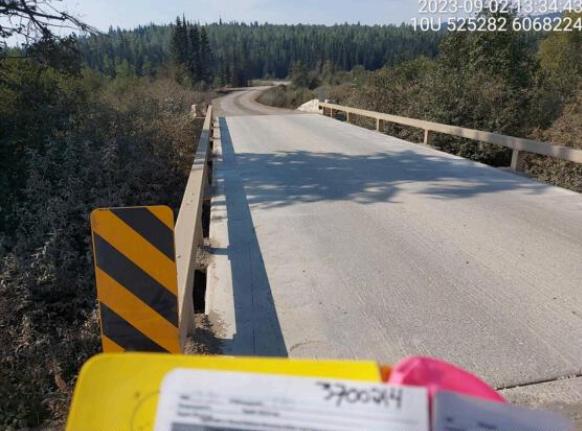
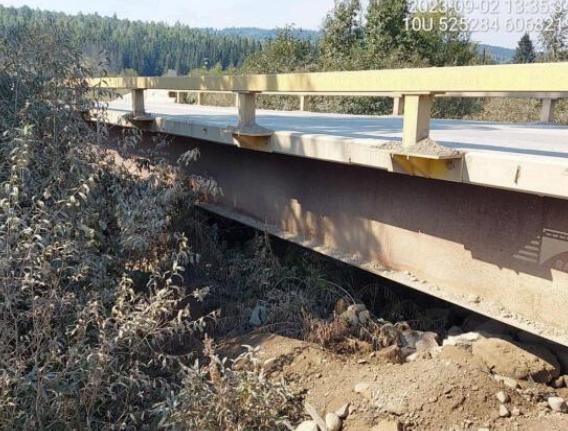
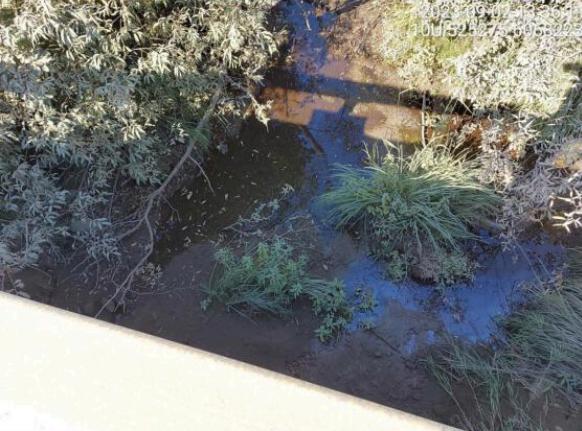
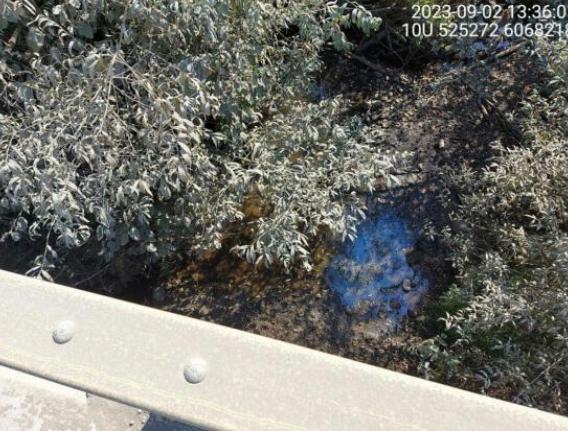
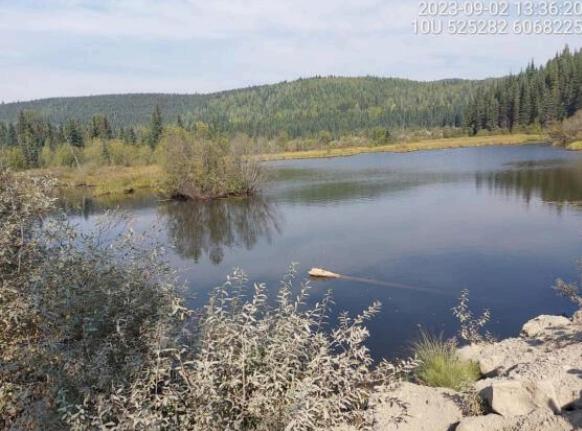
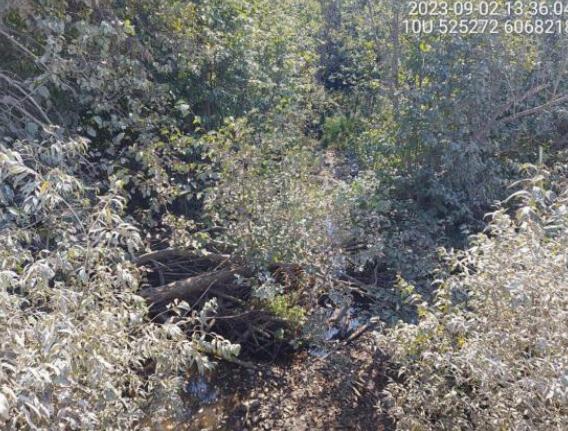
Location and Stream Data		Crossing Characteristics –	
Date	2023-09-02	Crossing Sub Type	Bridge
PSCIS ID	198728	Diameter (m)	16
External ID	3700214	Length (m)	4
Crew	MW	Embedded	–
UTM Zone	10	Depth Embedded (m)	–
Easting	525275.5	Resemble Channel	–
Northing	6068222	Backwatered	–
Stream	Redrocky Creek	Percent Backwatered	–
Road	Firth Lake FSR	Fill Depth (m)	–
Road Tenure	Canfor R01860	Outlet Drop (m)	–
Channel Width (m)	–	Outlet Pool Depth (m)	–
Stream Slope (%)	–	Inlet Drop	–
Beaver Activity	No	Slope (%)	–
Habitat Value	–	Valley Fill	–
Final score	0	Barrier Result	Passable
Fix type	–	Fix Span / Diameter	–

Location and Stream Data	•	Crossing Characteristics
Comments: Small lake upstream. Modelled crossing was in wrong location. 13:32:39		
Photos: PSCIS ID

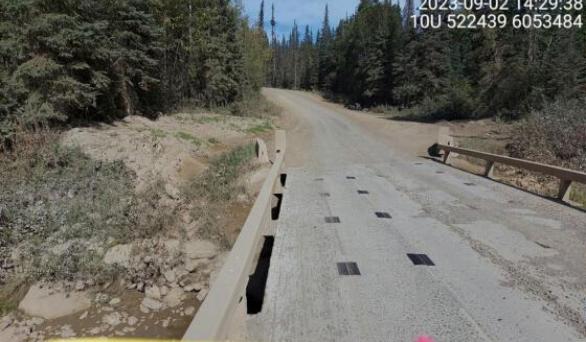
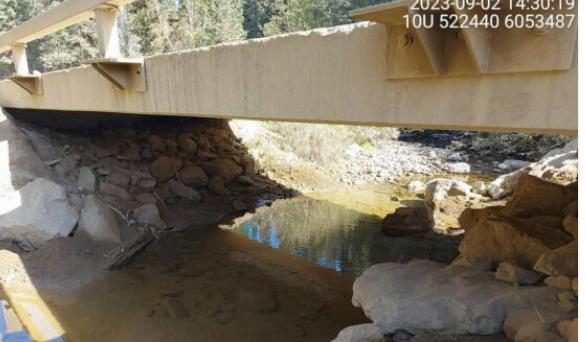
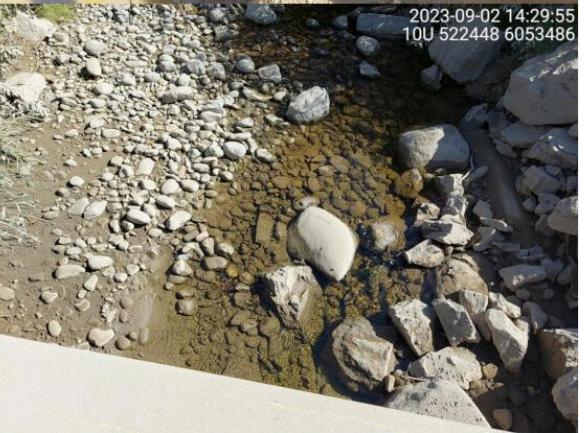
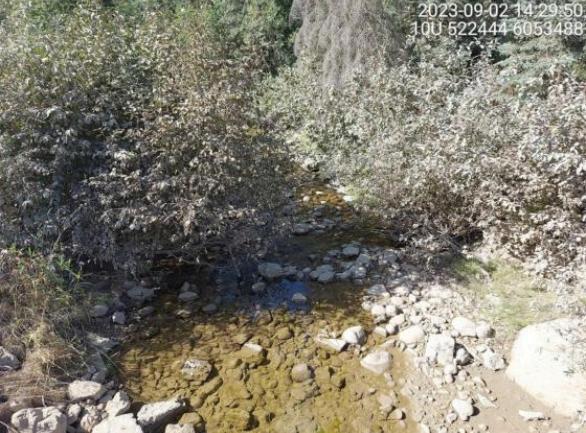
Location and Stream Data		Crossing Characteristics –	
Date	2023-09-02	Crossing Sub Type	Bridge
PSCIS ID	198729	Diameter (m)	10
External ID	3702575	Length (m)	4
Crew	MW	Embedded	–
UTM Zone	10	Depth Embedded (m)	–
Easting	522445.5	Resemble Channel	–
Northing	6053489	Backwatered	–
Stream	Lincoln Creek	Percent Backwatered	–
Road	Chuchinka-Red Rocky FSR	Fill Depth (m)	–
Road Tenure	MOF 5506	Outlet Drop (m)	–
Channel Width (m)	–	Outlet Pool Depth (m)	–
Stream Slope (%)	–	Inlet Drop	–
Beaver Activity	No	Slope (%)	–
Habitat Value	–	Valley Fill	–
Final score	0	Barrier Result	Passable
Fix type	–	Fix Span / Diameter	–

Location and Stream Data	•	Crossing Characteristics	-
Comments: Nice stream with lots of water at time of survey. 14:30:26			
Photos: PSCIS ID
