SOCIETY FOR ECOSYSTEM RESTORATION  
IN NORTHERN BRITISH COLUMBIA

## Restoring Fish Passage in the Peace Region - 2022 - PEA-F23-F- 3761-DCA

Prepared for  
Fish and Wildlife Compensation Program  
and  
Fish Passage Technical Working Group

Version 0.1.3 2023-08-16

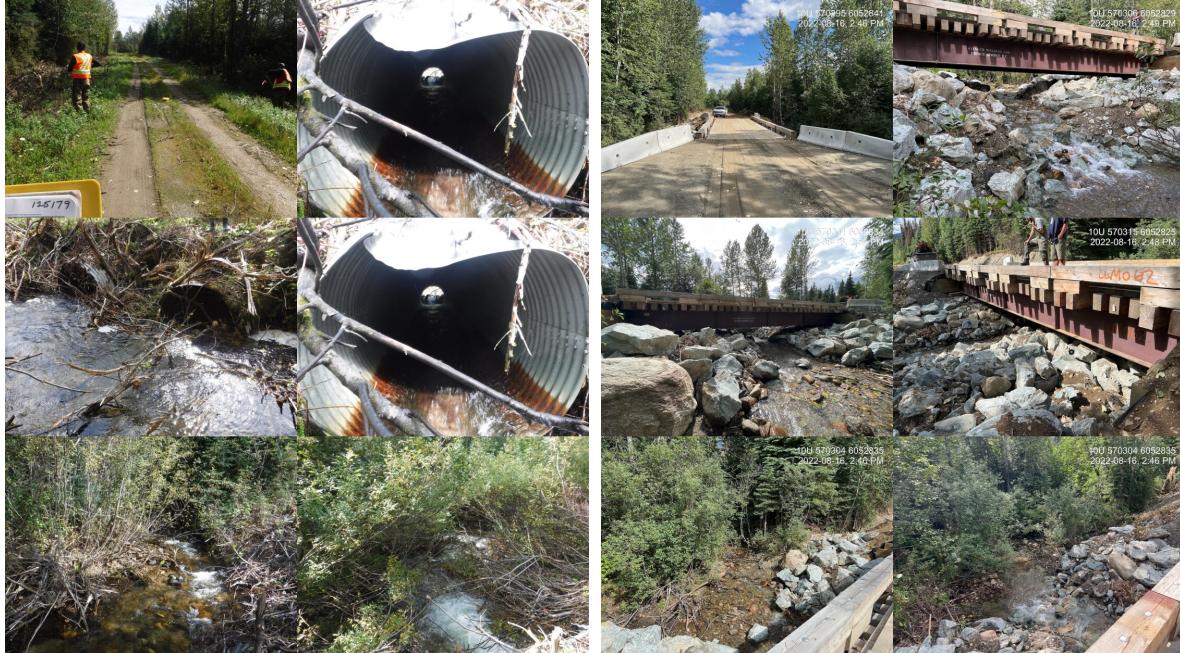
PSCIS crossing 125179 is located on a tributary to Missinka River, 1km upstream of the confluence, on the Chuchinka-Missinka FSR. This crossing is located approximately 660m east of PSCIS crossing 125180 and joins this adjacent stream just before emptying into the Missinka River. A map of the watershed is provided in map attachment [931.116](#). The twin culverts were replaced with a clear-span bridge in the summer of 2022.

Figure 3.1: Left: Photos of crossing 125179 in 2019. Right: Photos of crossing 125179 in 2022.

It is recommended that future monitoring be conducted at this location to track the stream morphological changes and provide insight into fish migration within the system. Electrofishing with tagging of target species is recommended along with photo documentation of stream morphology near the bridge. Fish sampling in the adjacent similar sized stream ([PSCIS crossing 125180](#)) containing culverts ranked as barriers would provide reference site data for comparison.

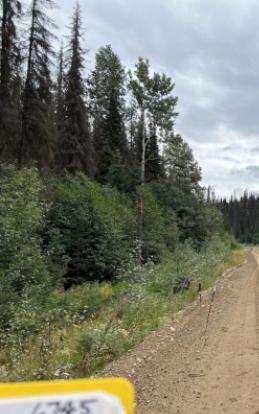
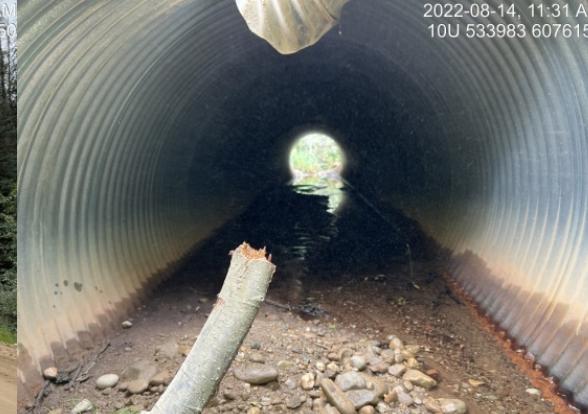
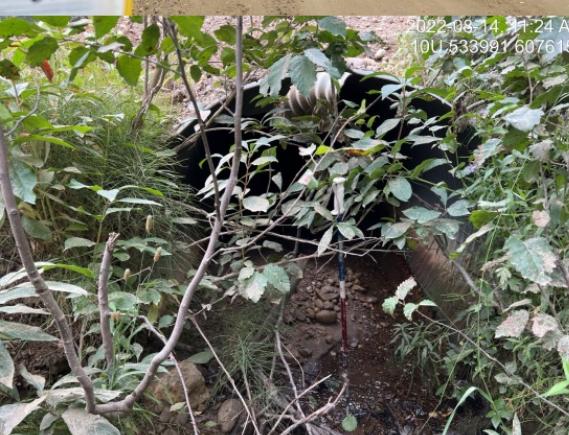
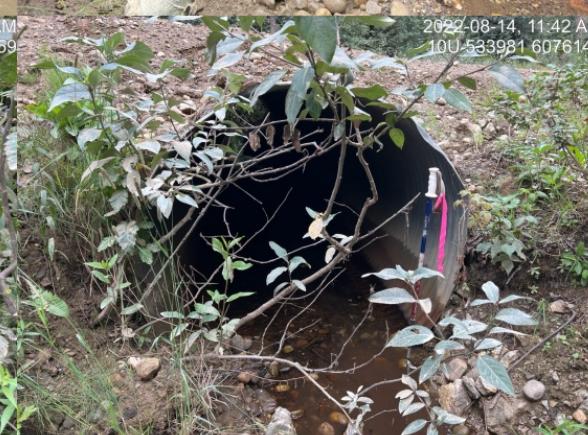
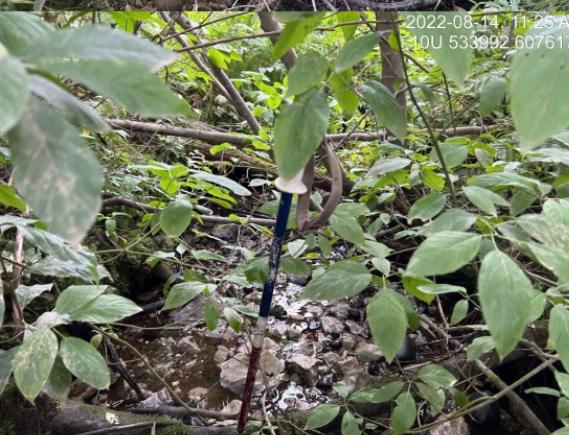
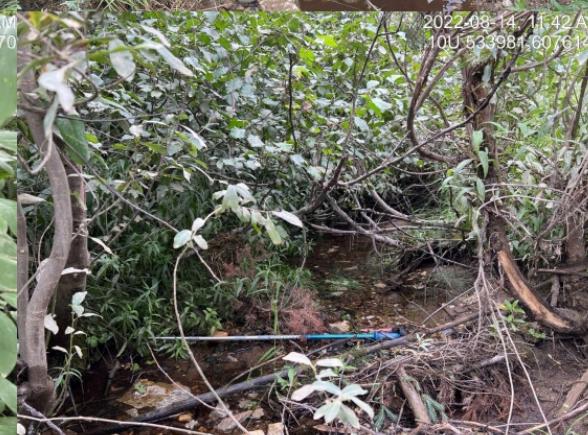
| Location and Stream Data | • | Crossing Characteristics | - |
|--|--|--|--|
| Comments: Damaged near outlet. Small stream but flowing. Middle of pipe filled with fines. 11:18 | | | |

| Location and Stream Data | . | Crossing Characteristics | - |
|---|--|---|---|
| Fix type | Replace Structure with Streambed Simulation<br>CBS | Fix Span / Diameter | 3 |

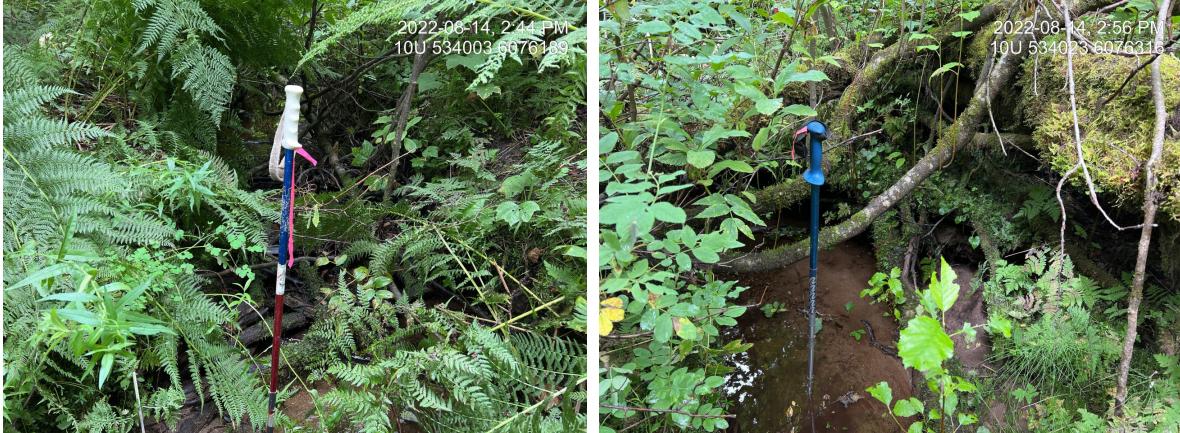
Figure 3.2: Left: Typical habitat downstream of PSCIS crossing 6745. Right: Typical habitat downstream of PSCIS crossing 6745.

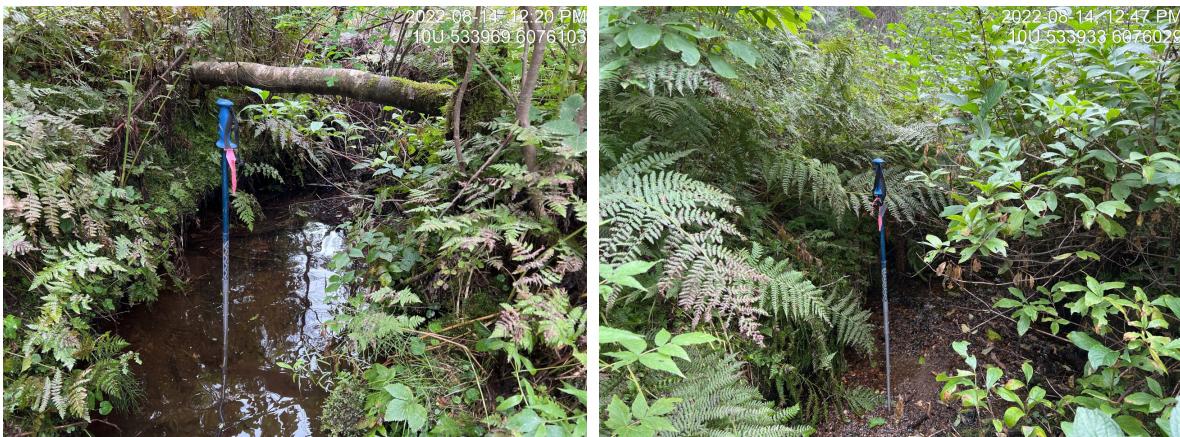
Figure 3.3: Left: Typical habitat upstream of PSCIS crossing 6745. Right: Typical habitat upstream of PSCIS crossing 6745.

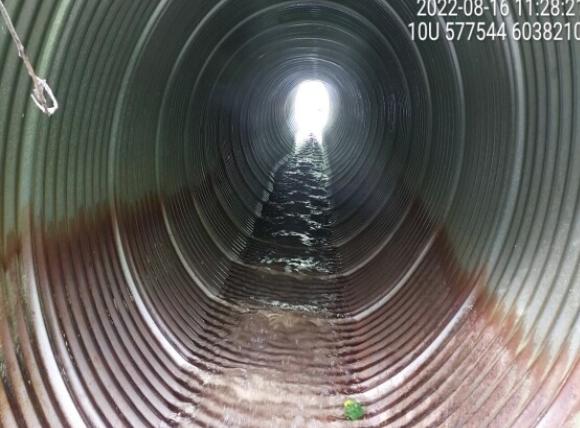
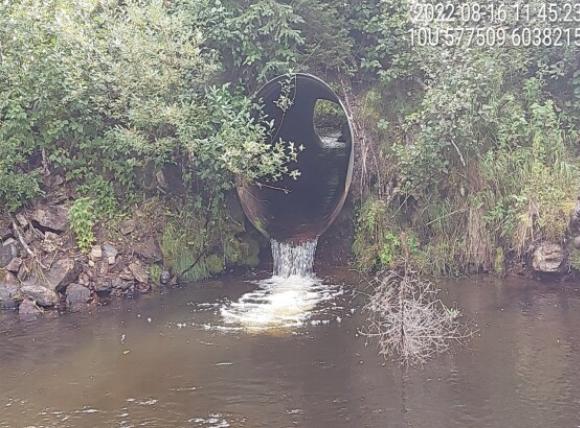
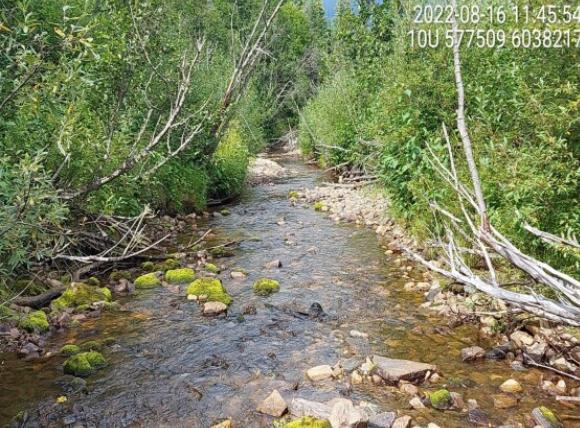
This site was reassessed in 2022, with drone survey and fish sampling conducted. At the time of survey the crossing was un-embedded, non-backwatered and ranked as a barrier to upstream fish passage. The culvert was undersized - evidenced by the large outlet drop of 0.6m and outlet pool depth of 2m (MoE 2011) (Table 3.5).

| Location and Stream Data | • | Crossing Characteristics | - |
|---|--|--|---|
| Comments: Habitat survey done with drone. 11:15:00 AM | | | |

| Location and Stream Data | | Crossing Characteristics – | |
|---|--|---|---|
| Fix type | Replace with New Open Bottom Structure | Fix Span / Diameter | 15 |

Although at the time of reporting plans for replacement of this site had been delayed, future removal (or replacement) of the crossing is still recommended. Preliminary cost estimates for the work were estimated at /\$350,000 to /\$400,000. Additionally, re-assessment of the site with electrofishing in the 2023 and/or 2024 will provide valuable information regarding fish health and migration at the site.

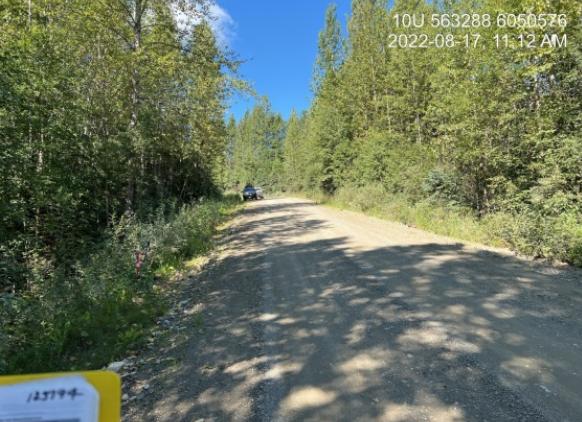
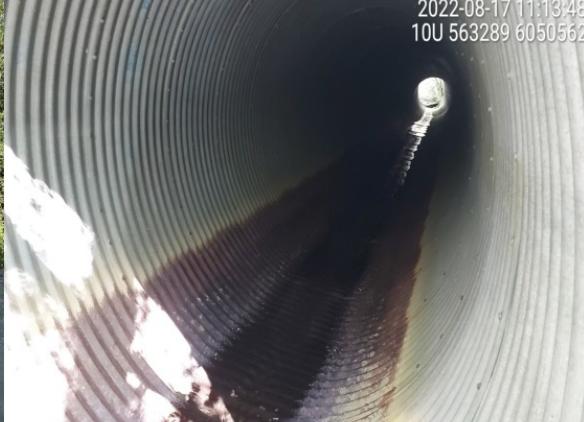
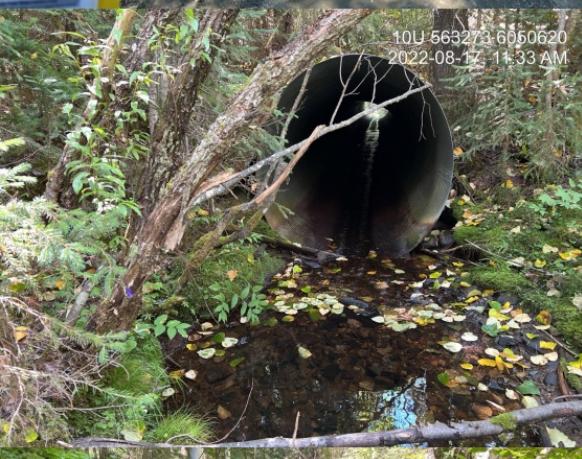
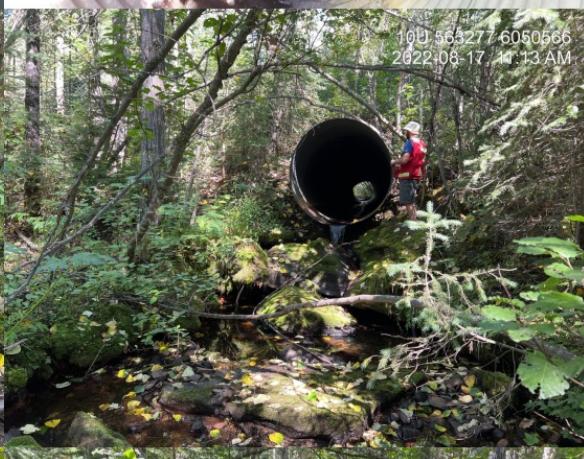
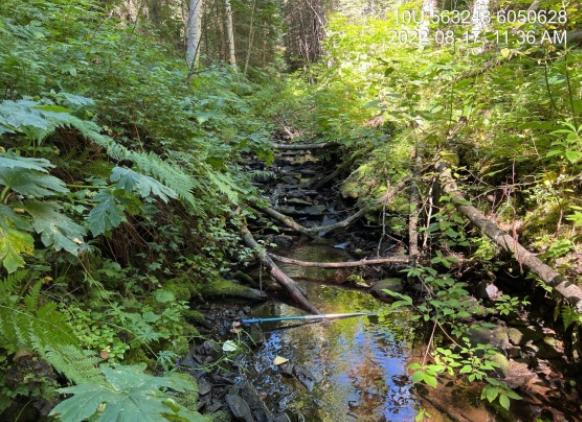
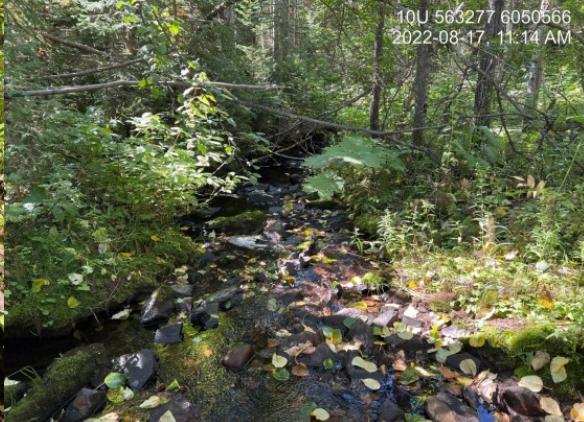
| Location and Stream Data | • | Crossing Characteristics | - |
|--|---|---|---|
| <p>Comments: Very narrow cascade at outlet, big outlet drop. Good size pools downstream. Upstream has evenly distributed shale. Lots of functional woody debris. 11:09</p> | | | |

| Location and Stream Data | | Crossing Characteristics – | |
|---|--|---|---|
| Fix type | Replace with New Open Bottom Structure | Fix Span / Diameter | 15 |

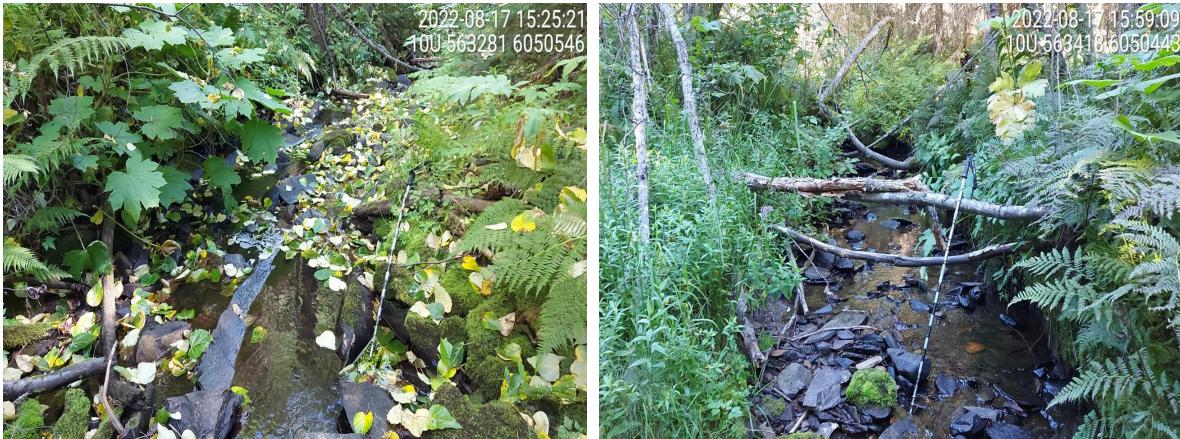
The stream was surveyed downstream from crossing 125194 for 250m (Figure 3.6). The dominant substrate was gravels with fines sub-dominant. Total cover amount was rated as moderate with small woody debris dominant. Cover was also present as large woody debris and overhanging vegetation. The average channel width was 2.8m, the average wetted width was 2.5m, and the average gradient was 2.8%. There were trace amounts of undercut banks and pools that were suitable for rearing. Abundant gravels were present that would be suitable for resident rainbow spawning. Habitat was reasonably complex due to abundant woody debris and rated as medium value for salmonid rearing and spawning.

Figure 3.6: Left: Typical habitat downstream of PSCIS crossing 125194. Right: Example of typical stream substrate downstream of PSCIS crossing 125194.

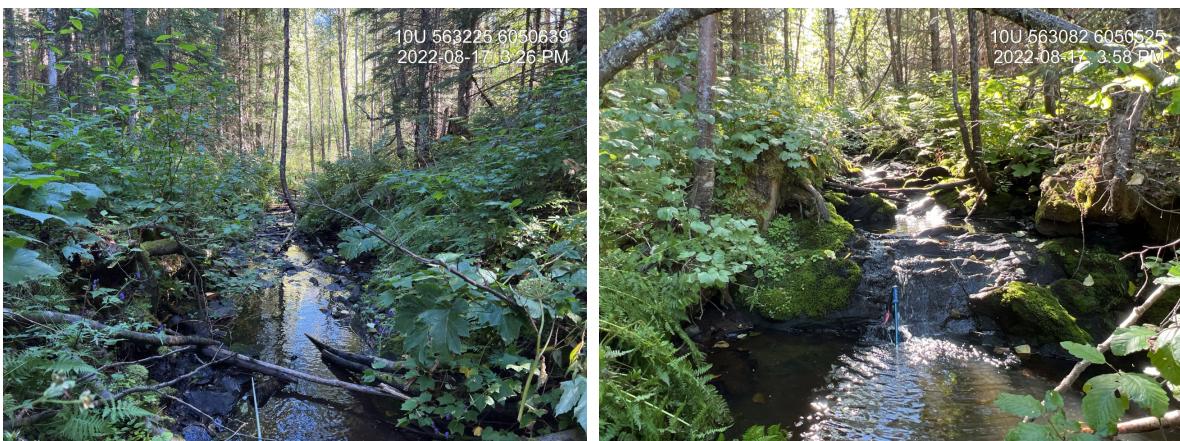
Figure 3.7: Left: Typical habitat upstream of PSCIS crossing 125194. Right: Small rock step approximately 0.6m in height, upstream of PSCIS crossing 125194.

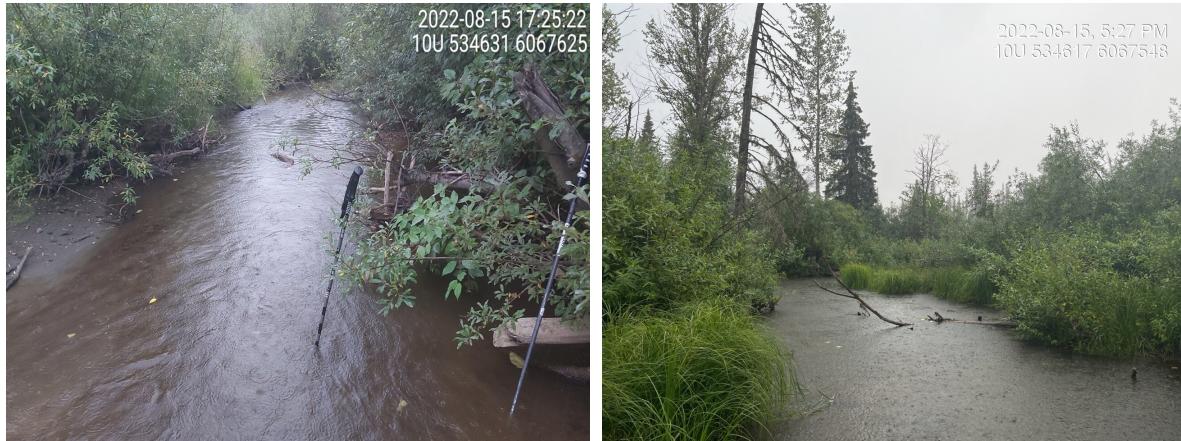
Figure 3.9: Left: Habitat downstream of PSCIS crossing 125261. Right: Transition to wetland type habitat, downstream of PSCIS crossing 125261.

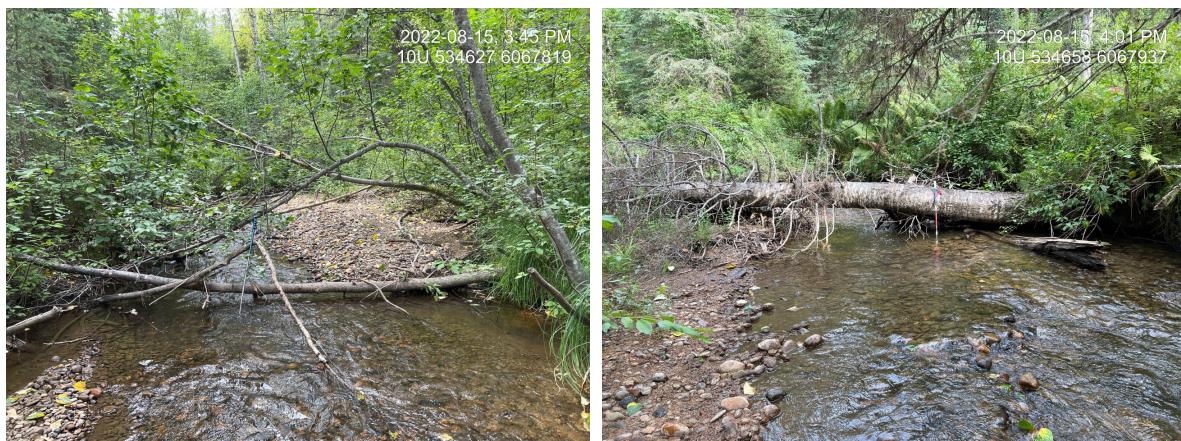
The stream was surveyed upstream from crossing 125261 for 700m (Figure 3.10). The average channel width was 6.2m, the average wetted width was 2.4m, and the average gradient was 2.3%. Total cover amount was rated as moderate with deep pools dominant. Cover was also present as small woody debris, large woody debris, undercut banks, and overhanging vegetation. The dominant substrate was gravels with cobbles sub-dominant. This is a large stream with abundant gravel suitable for spawning and deep pools for overwintering. Numerous fish were observed, with complex habitat due to abundant large woody debris and deeply undercut banks. At the top end of the survey, the location of modelled crossing 16601271 was assessed. The crossing was not present as the road had been deactivated (Figure 3.12). Overall, the habitat surveyed upstream of crossing 125261 was rated as high value as an important migration corridor containing habitat suitable spawning habitat and high rearing potential.

Figure 3.10: Left: Habitat upstream of PSCIS crossing 125261. Right: Habitat upstream of PSCIS crossing 125261.

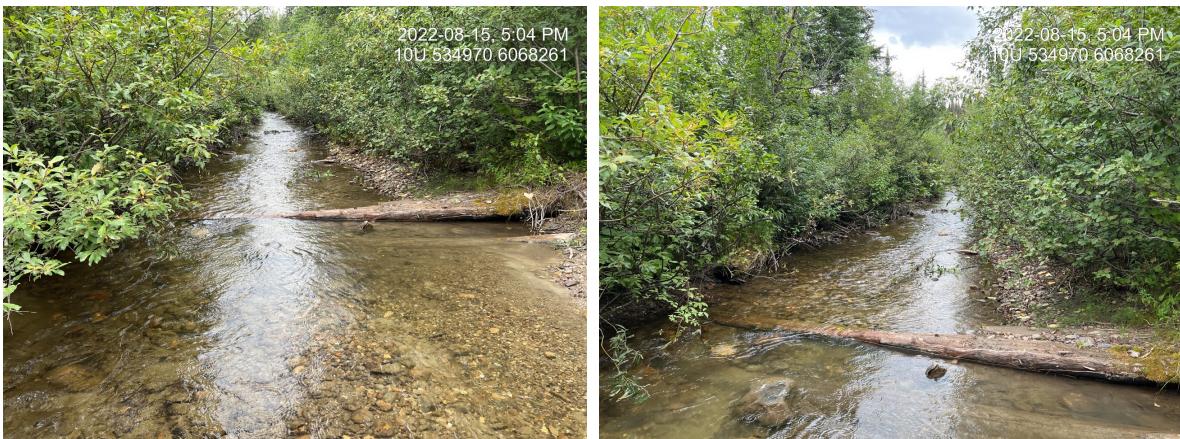
Figure 3.12: Left: Downstream view at end of survey, at location of PSCIS crossing 198321. Right: Upstream view at end of survey, at location of PSCIS crossing 198321.

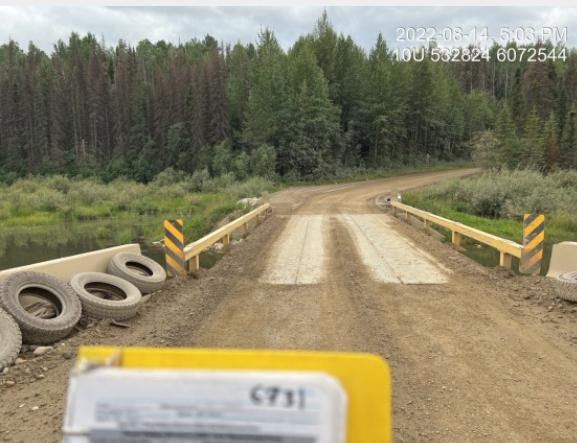
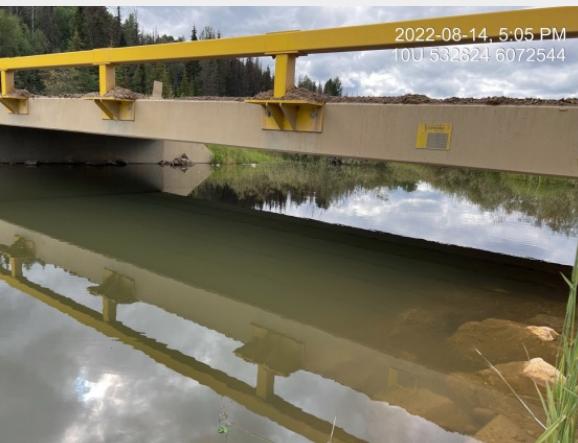
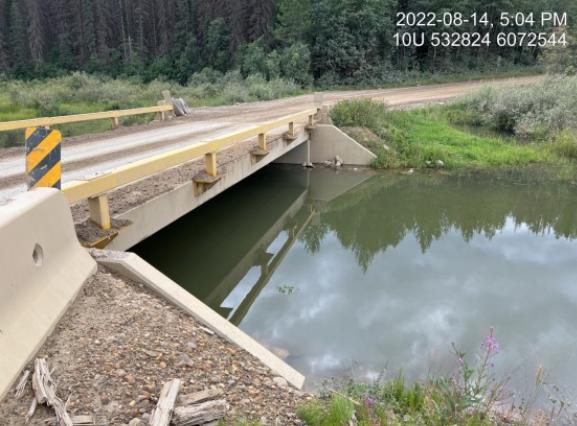
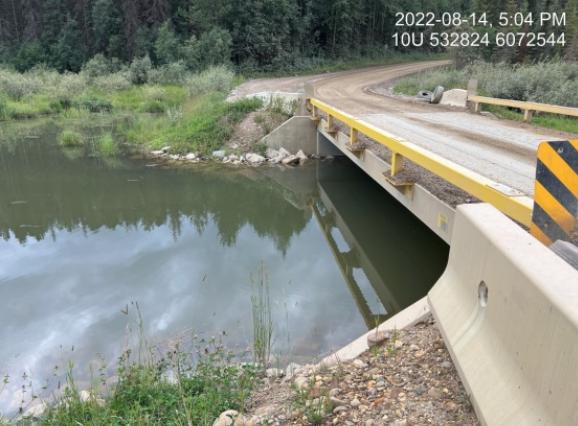
| Location and Stream Data | • | Crossing Characteristics |
|--|---|---|
| Comments: Bridge was recently installed since 2019. 16:57 | | |

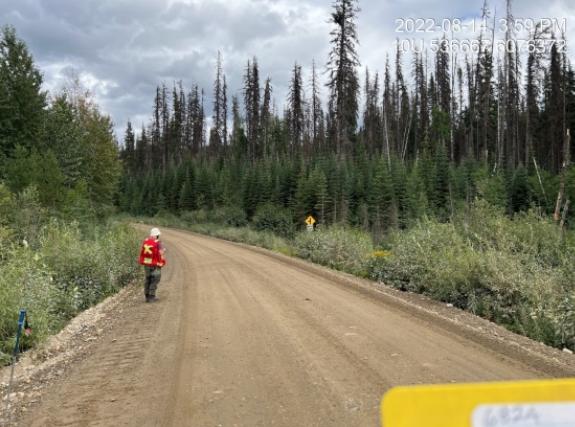
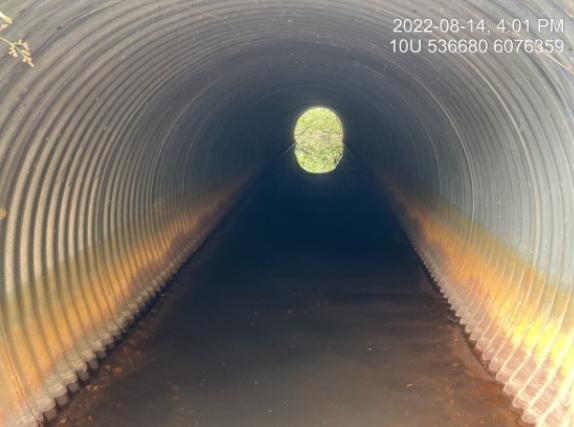
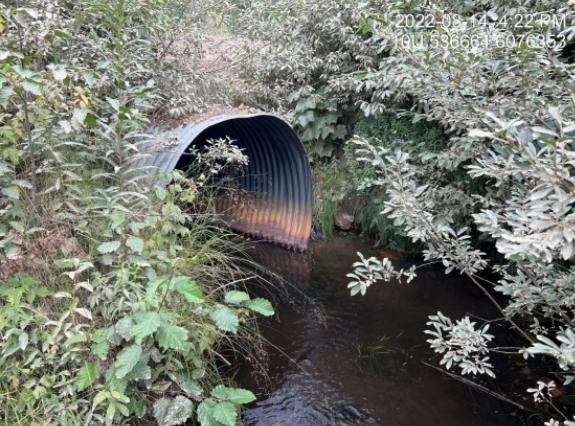
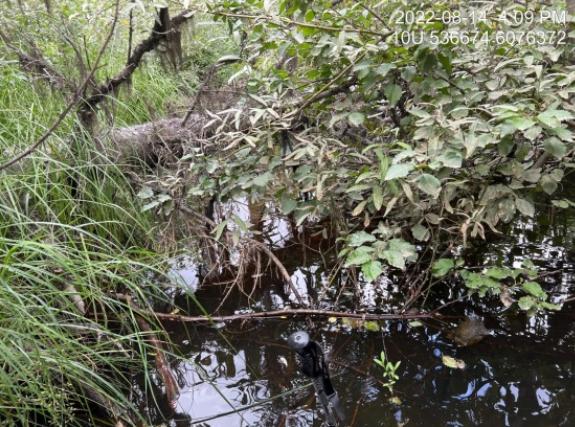
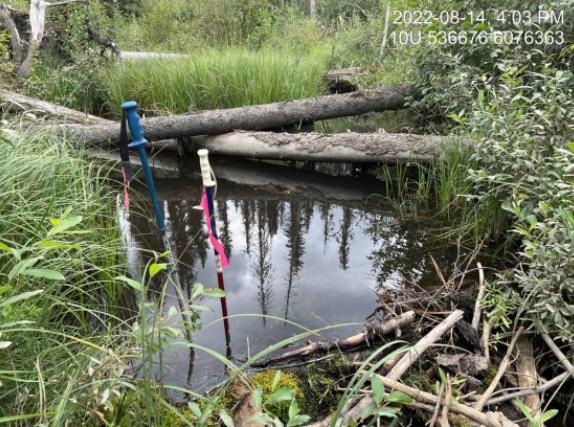
| Location and Stream Data | • | Crossing Characteristics |
|--|---|--|
| . From top left clockwise: Road/Site Card, Barrel, Outlet, Downstream, Upstream, Inlet.6824 | | |

| Location and Stream Data | • | Crossing Characteristics |
|--|---|--|
| Comments: Channel with gradient estimated. Culvert is fully backwatered due to beaver dams at this time and passable but might be a good idea to assess flow velocities in the spring at higher flows. Habitat confirmation could be conducted to get an idea of fish values and habitat values to inform if are an issue. 15:54 | | |

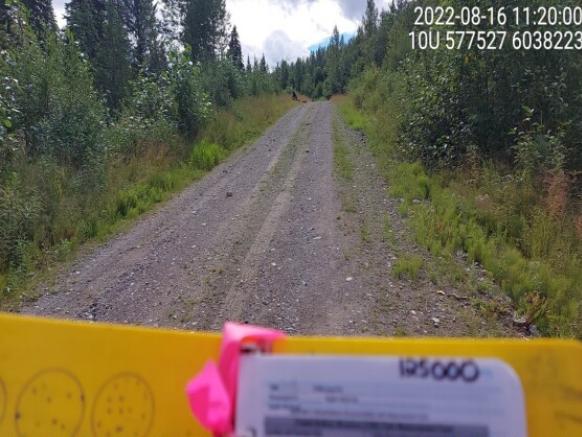
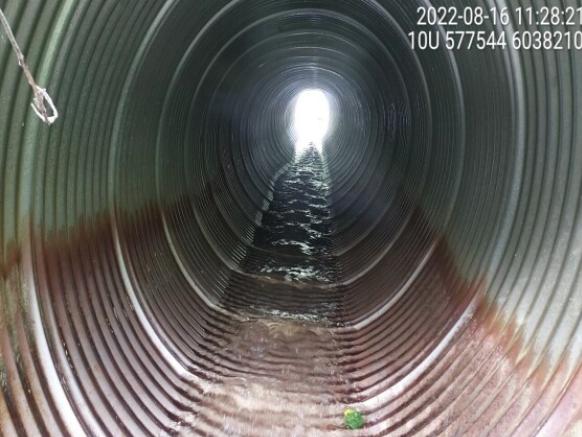
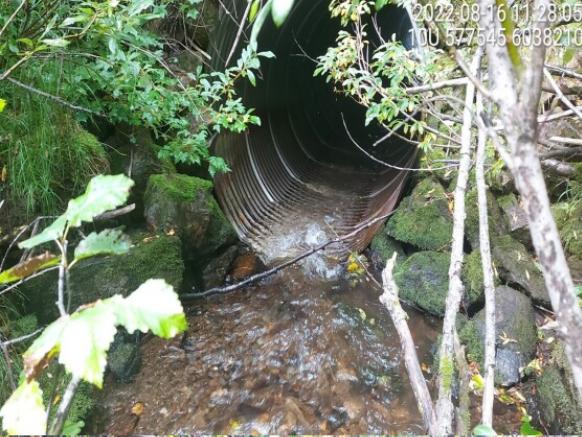
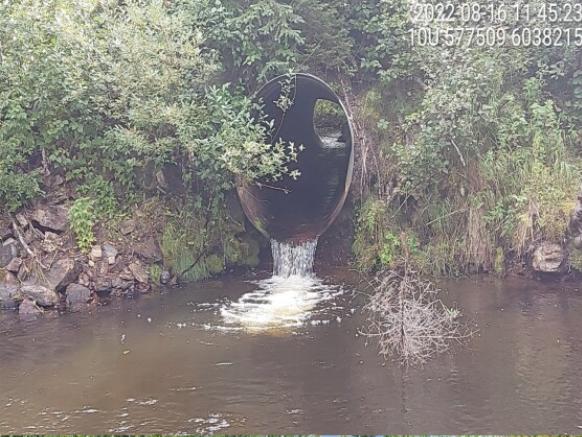
. From top left clockwise: Road/Site Card, Barrel, Outlet, Downstream, Upstream, Inlet.125000

| Location and Stream Data | • | Crossing Characteristics | - |
|---|---|--|---|
| Comments: Habitat survey done with drone. 11:15:00 AM | | | |

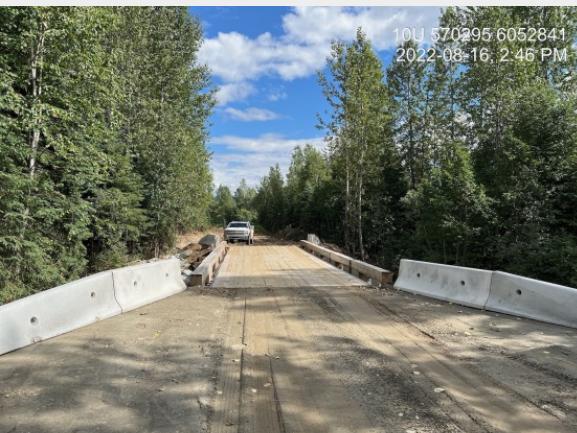
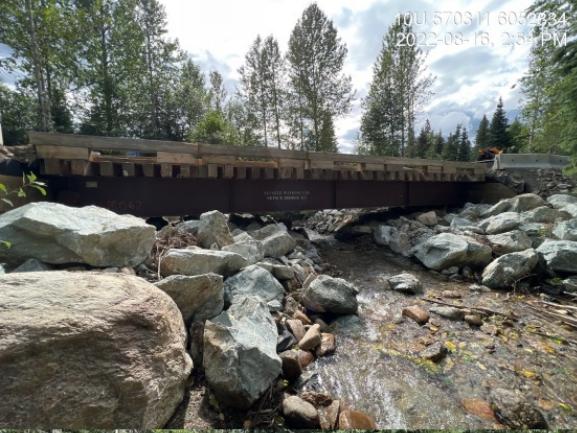
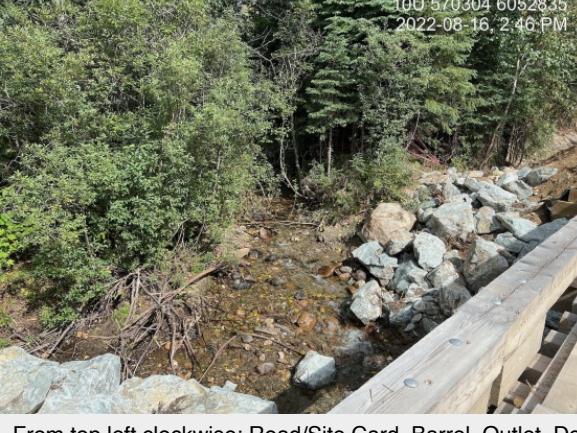
| Location and Stream Data | • | Crossing Characteristics | - |
|--|---|---|---|
| Comments: Riprap is 6.7m wide on east and 4.7m wide on west. Riprap cascade downstream of structure ~5m. | | | |

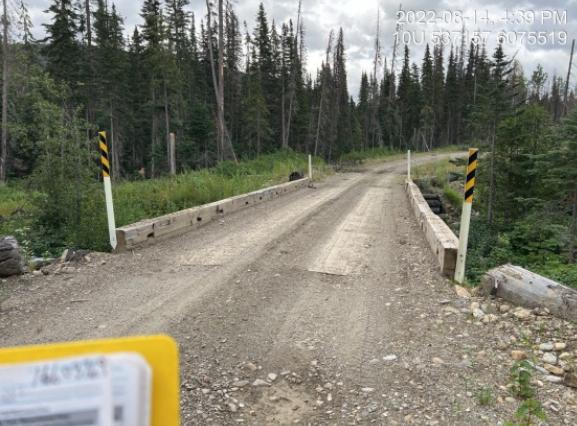
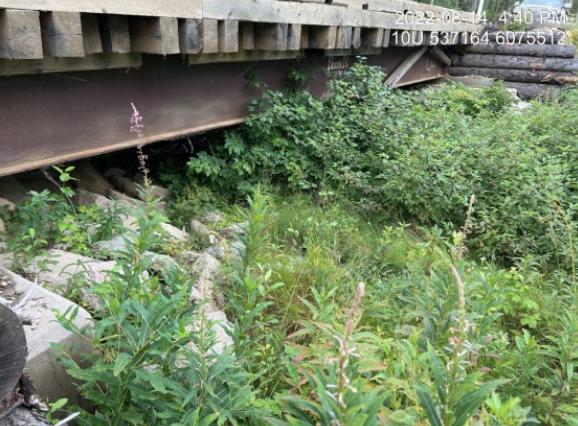
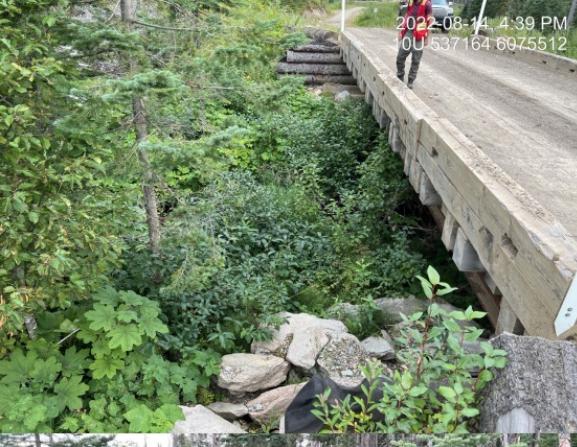
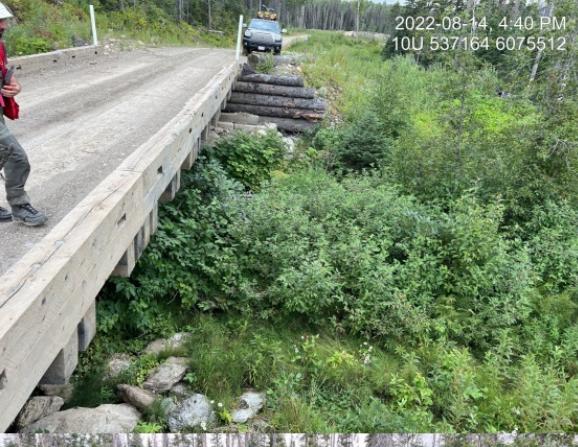
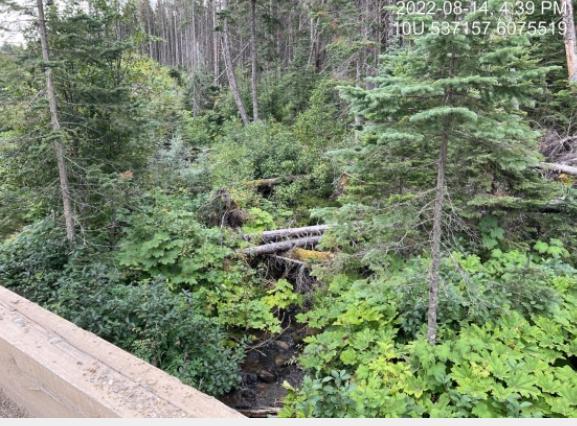
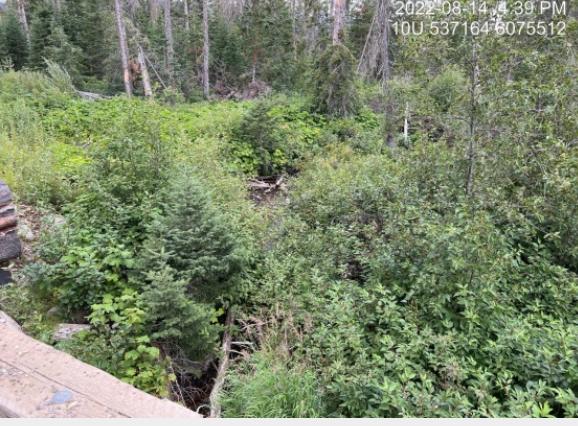
| Location and Stream Data | • Crossing Characteristics |
|---|--|
| Comments: Bridge, overgrown vegetation at inlet and outlet. 16:35:00 | |

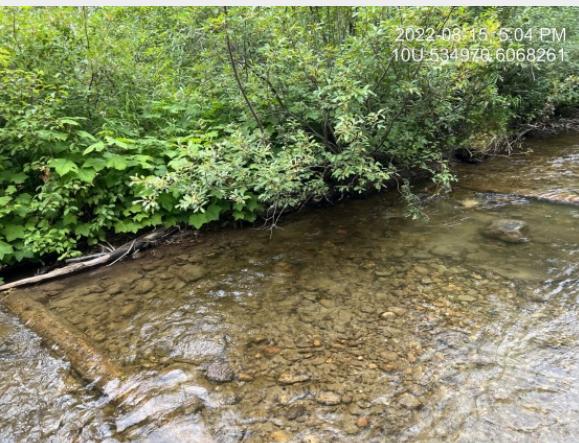
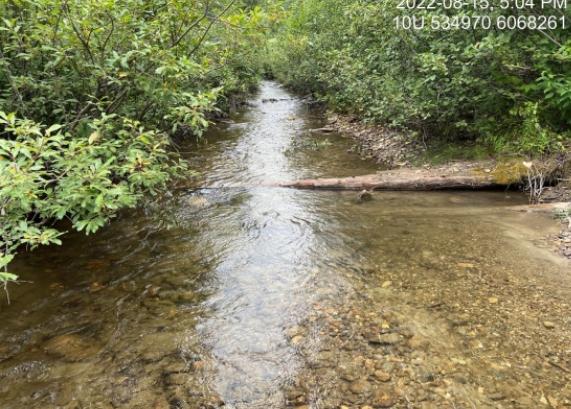
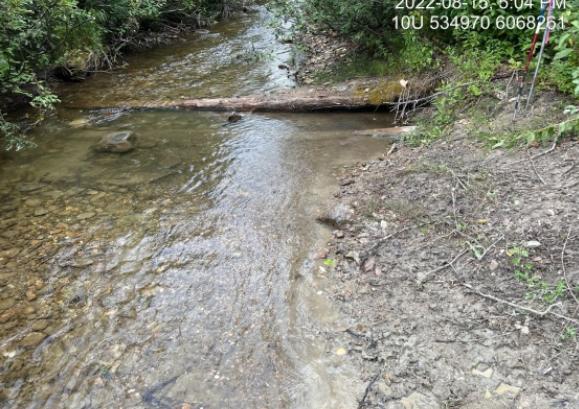
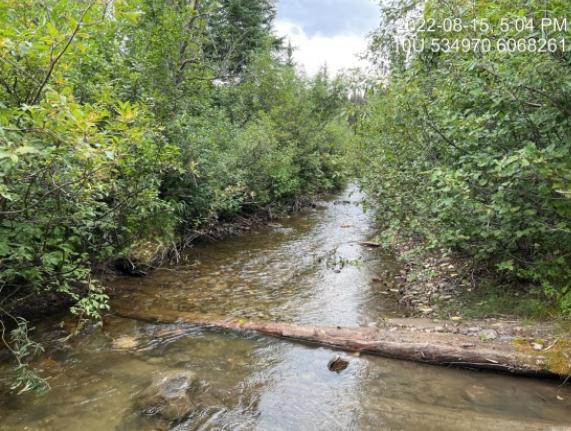
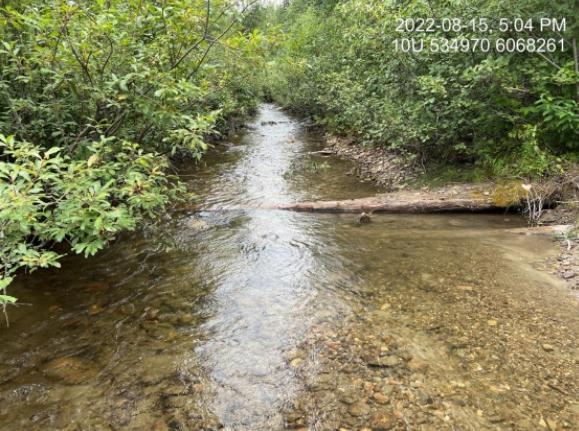
| Location and Stream Data | • | Crossing Characteristics | - |
|--|---|---|---|
| . From top left clockwise: Road/Site Card, Barrel, Outlet, Downstream, Upstream, Inlet.16601271 | | | |

| Location and Stream Data | • | Crossing Characteristics | - |
|--|---|---|---|
| Comments: No ford or crossing. This appears to be the end of the accessible remnants of this rough ATV road. 17:06 | | | |

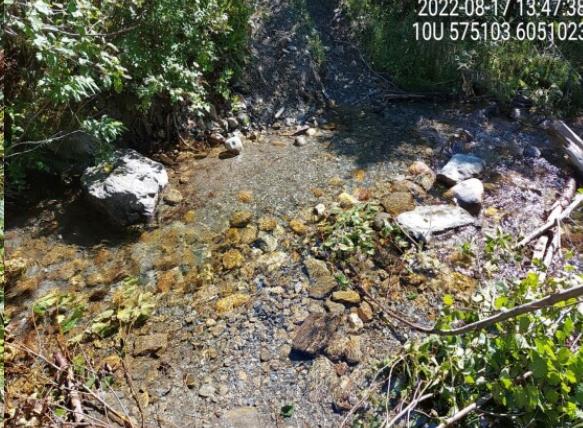
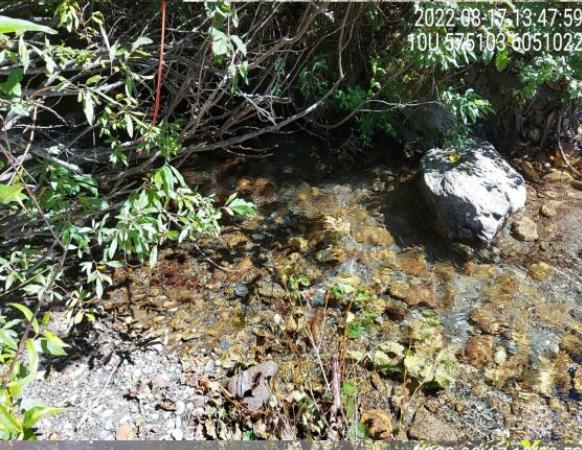
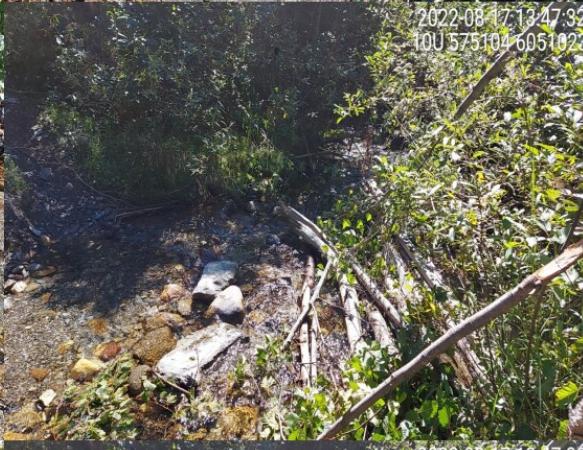
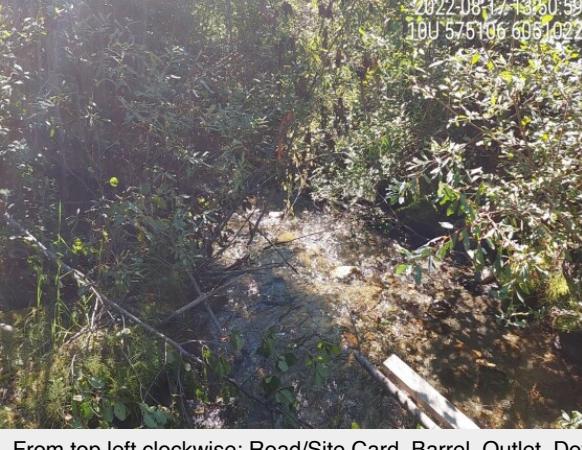
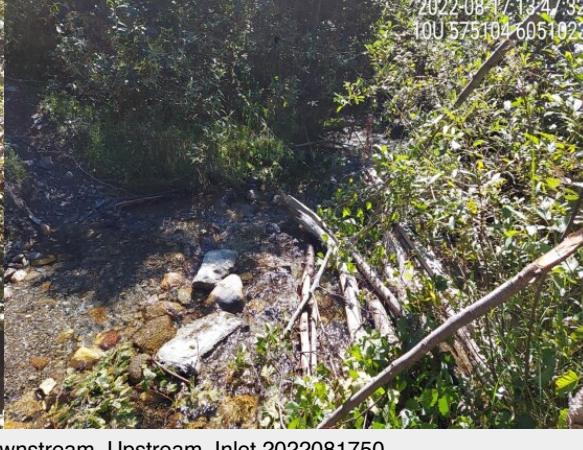
. From top left clockwise: Road/Site Card, Barrel, Outlet, Downstream, Upstream, Inlet.2022081750

| Location and Stream Data | • | Crossing Characteristics | - |
|--|---|---|---|
| Comments: Located at a quad trail. 13:53 | | | |
