# Post Construction Report

## Table FSR 21 km - Culvert Replacement and Streambed Reconstruction

Date: 26.07.2024 | DWB file: 2308-133 (PB) | Rev: 0

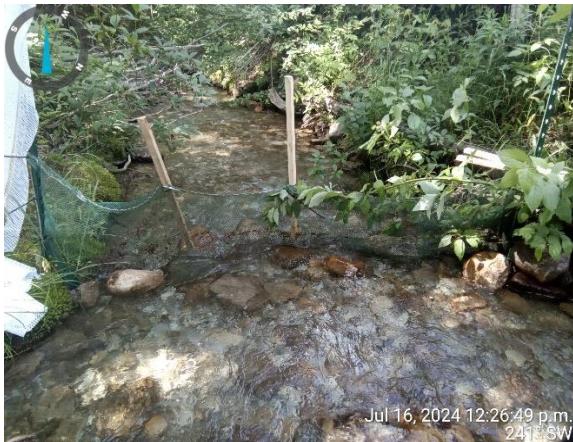
**Photo 1.** Fish exclusion netting setup for salvage (July 16, 2024).

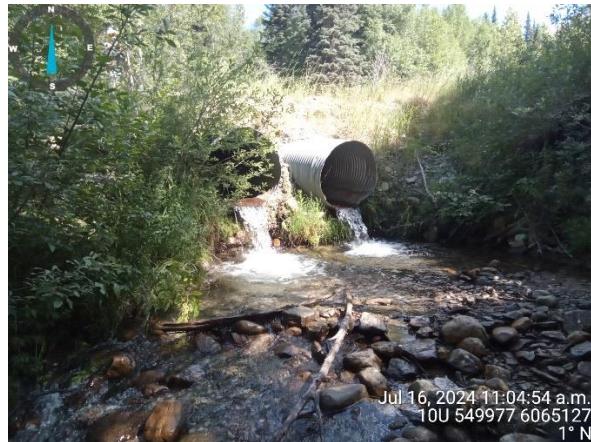
**Photo 2.** Perched, downstream culverts, view of outlet. (July 16, 2024).

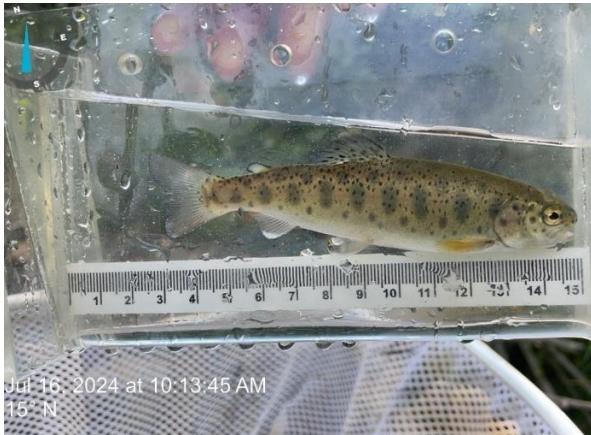
**Photo 3.** Rainbow trout captured during salvage. (July 16, 2024).

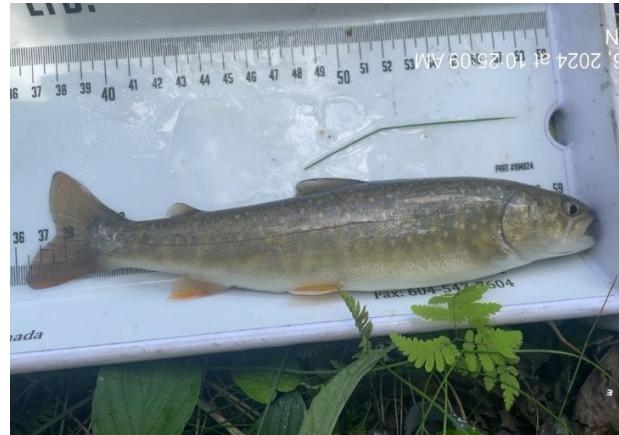
**Photo 4.** Bull trout captured during salvage. (July 16, 2024).

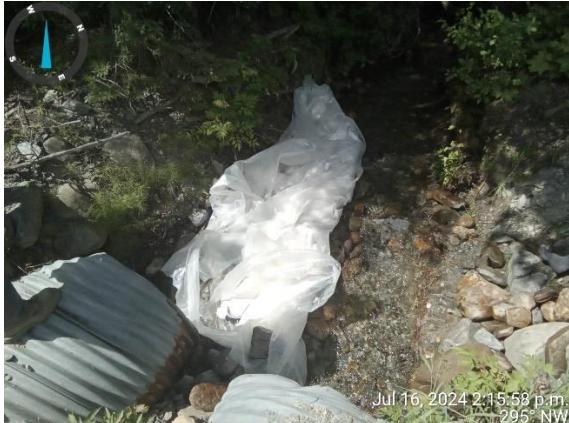
Works began on July 16<sup>th</sup>, when materials and equipment were hauled to site. In order to remove the western culvert, crews first installed a diversion that directed flow into the eastern culvert (**Photo 5**). Road material was pulled back from culvert, then removed. On July 17<sup>th</sup>, the excavator placed six large boulders on the downstream end according to the engineering drawings, and filled in the eastern pool with fill (**Photos 9, 10**). The eastern key was excavated and the banks were shaped, and geotextile cloth was added prior to riprap placement (**Photos 11-13**). On July 18<sup>th</sup>, a lowbed delivered the remaining bridge components to the staging site (**Photo 14**). Due to the large amount of excess fill excavated from site, a rock truck was brought in to transport it offsite. Welding, painting, and compaction activities were conducted throughout the day for bridge piling installation. On July 19<sup>th</sup>, grouting activities were performed in the morning while the weather remained cool. Grouting presented a very low risk to impacting the water course, as the works were completed several meters away (**Photo 16**). For 20-minute intervals, crews washed the partially reconstructed stream bed on the eastern side to aid in sealing the channel (**Photos 17, 18**). On July 20<sup>th</sup>, the remaining boulders were added to the stream bed in preparation for switching over the diversion. The diversion was directed into the stream bed to allow for the removal of the second culvert on the east side (**Photos 22, 28**). Sandbags were added to the sides of the reconstructed channel to prevent seepage into the western key. The bottom half of the second culvert

**Photo 5.** Diversion of stream into single culvert. (July 16, 2024).

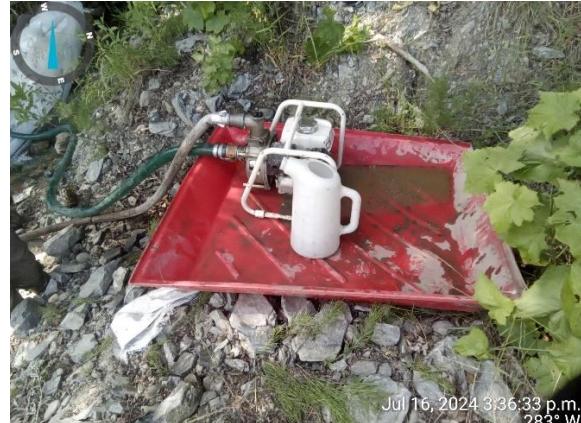
**Photo 6.** Pump with spill tray used. (July 16, 2024).

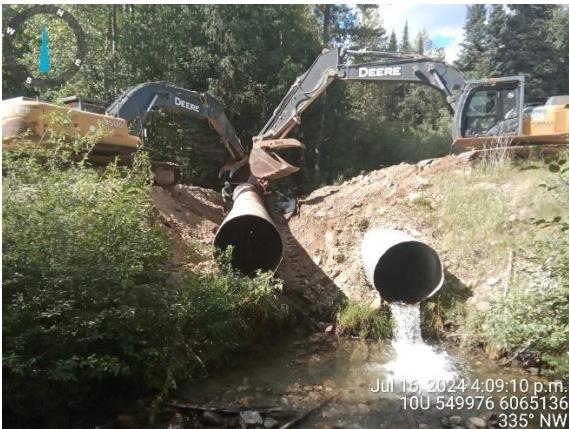
**Photo 7.** Removal of western culvert. (July 16, 2024).

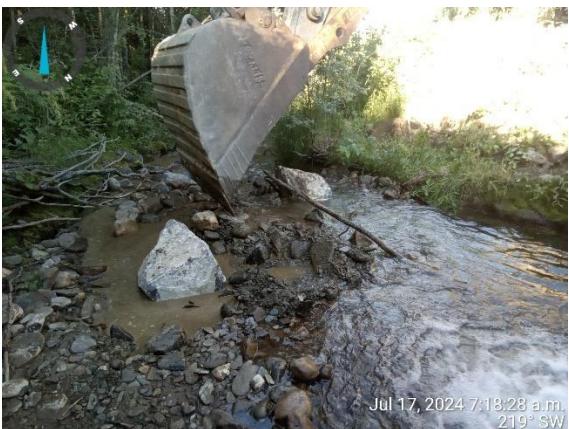
**Photo 9.** Addition of rock features to western side of stream. (July 17, 2024).

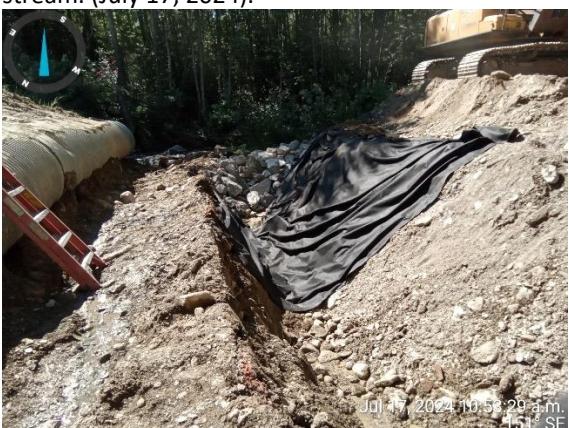
Site isolation was employed during the Project, since excavation below the wetted perimeter of the creek was required by design. Throughout the Project, sediment fences were kept on site as contingent erosion and sediment control (ESC) measures. Post construction, the exposed cut slopes of the new crossing will be seeded and mulched with straw by Canfor (or delegate) to mitigate erosion and sedimentation. No additional erosion and sediment control measures were required at the time of construction, due to the favourable weather conditions (i.e., dry) and clear span bridge design (**Photos 11, 33**. Appendix A).

**Photo 11.** Fabric laid down prior to riprap placement in key. (July 17, 2024).

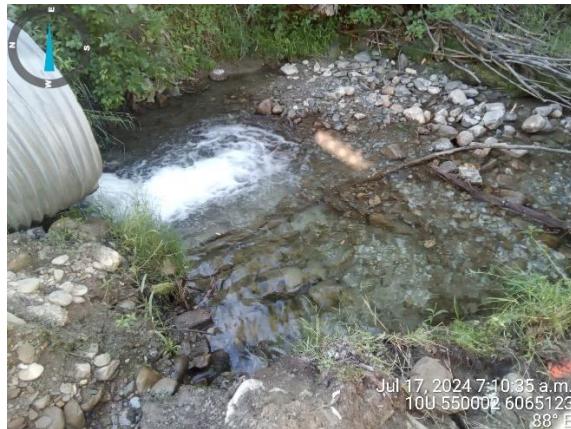
**Photo 8.** One of two downstream pools to be filled with substrate. (July 17, 2024).

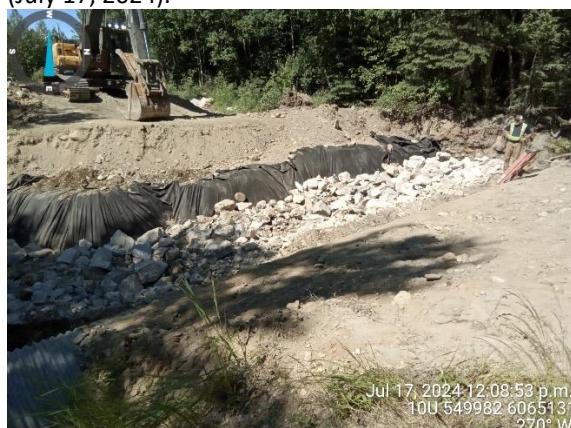
**Photo 12.** Riprap placement on western bank. (July 17, 2024).

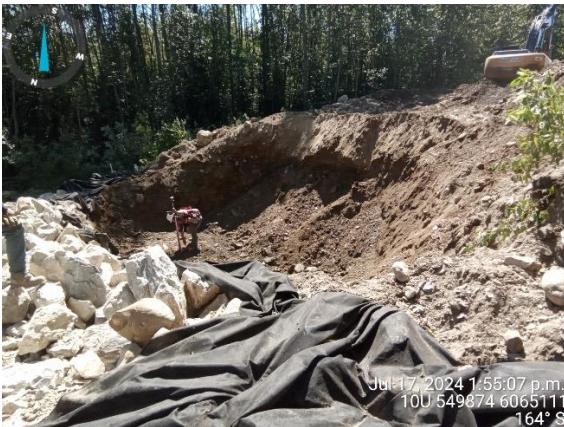
**Photo 13.** Excavation of material for bridge piling placement. (July 17, 2024).

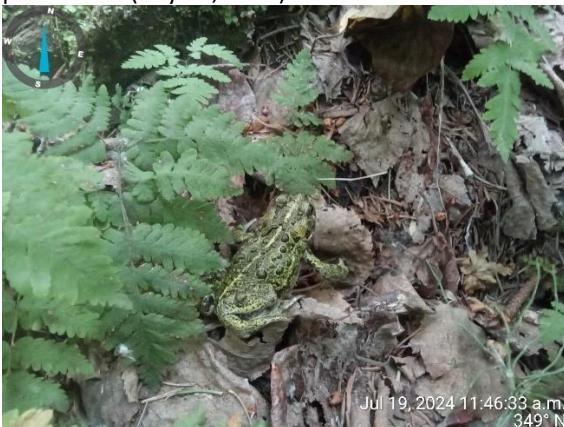
**Photo 15.** Western toad relocated from site. (July 18, 2024).

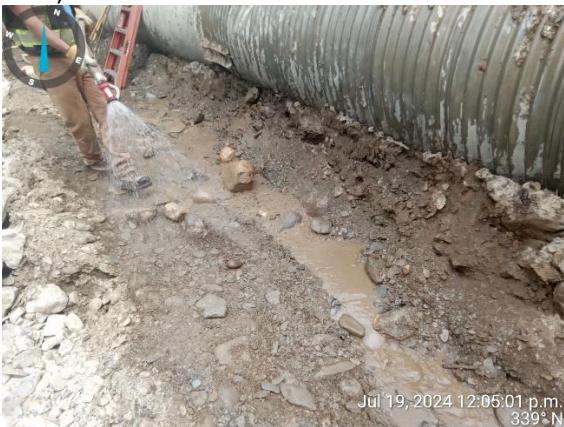
**Photo 17.** Washing stream bed prior to flushing. (July 19, 2024).

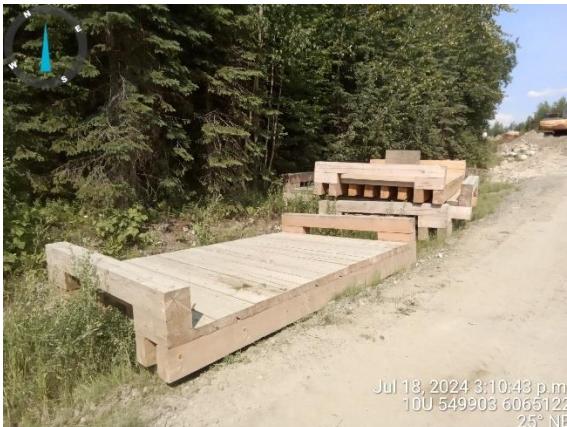
**Photo 14.** Staging of materials delivered to site. (July 18, 2024).

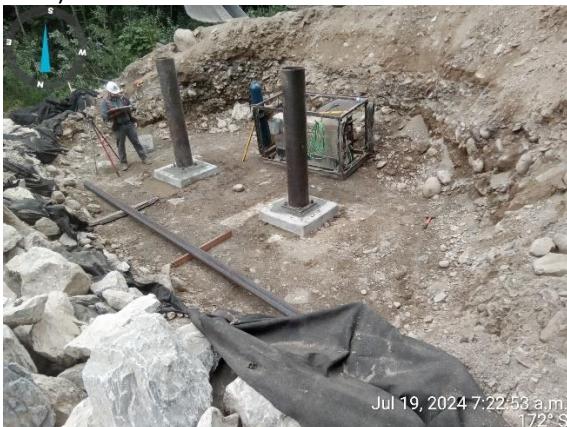
**Photo 16.** Installation of piles/footings, with welding and grouting completed. (July 19, 2024).

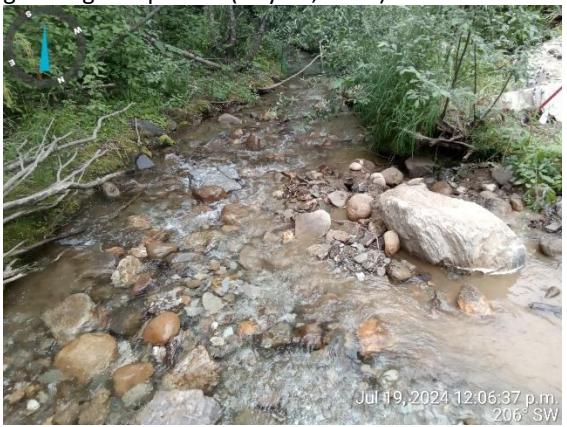
There were spikes in turbidity on July 16<sup>th</sup>, downstream of site works, that were caused by the installation of the upstream culvert diversion. Turbidity readings reached 38.1 NTU, but was non-persisting and returned to within threshold (>8 NTU). On July 17<sup>th</sup>, boulders and fill was added to the downstream area below the culverts, causing a spike in turbidity of 45.7 NTU, dropping to 20.6 NTU, and within an hour, levels were back within threshold. On July 18<sup>th</sup>, no instream works were conducted, and all turbidity levels remained within threshold. On July 19<sup>th</sup>, removal of fill around the remaining culvert presented low risk for introducing turbidity to site. The reconstructed stream bed beside the remaining culvert was washed in 20-minute intervals, followed by a period of rest to allow turbidity spikes to return back to within threshold. Turbidity was at its peak reading 32.7 NTU, and another reading of 24.8 NTU. No further instream works occurred that day, and site remained within threshold with a final reading of 1.12 NTU. On July 20<sup>th</sup>, crews diverted stream flow into the reconstructed streambed. High readings of turbidity were expected during this event, reading at 208 NTU. Within three hours, turbidity returned to within threshold, at 6.86 NTU. Another spike in turbidity occurred in the afternoon, but returned to threshold within the hour. No further instream works were conducted. On July 21<sup>st</sup>, no instream works occurred, and all readings remained within threshold throughout construction activities. On July 22<sup>nd</sup>, a spike in turbidity was recorded at 77.2 NTU during the removal of the remaining half of culvert. Another series of turbidity spikes occurred as crews filled in the scour pool at the lower end of site, reconstructed the stream bed, and added boulder features. The levels were recorded at its highest at 237 NTU. The site returned within threshold at 12:45 pm, and no further spikes in turbidity were recorded.

**Photo 18.** Turbidity entering stream during washing. (July 19, 2024).

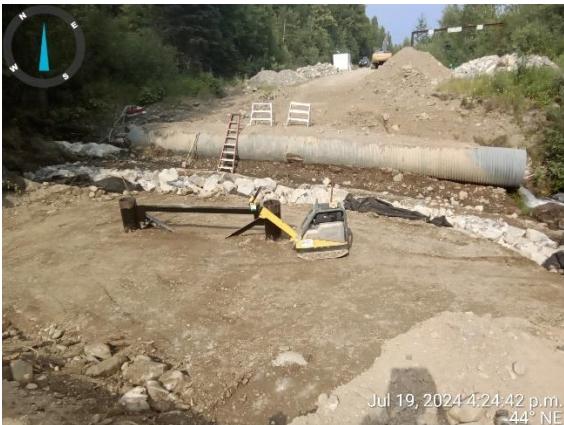
**Photo 19.** Overview of site works. (July 19, 2024).

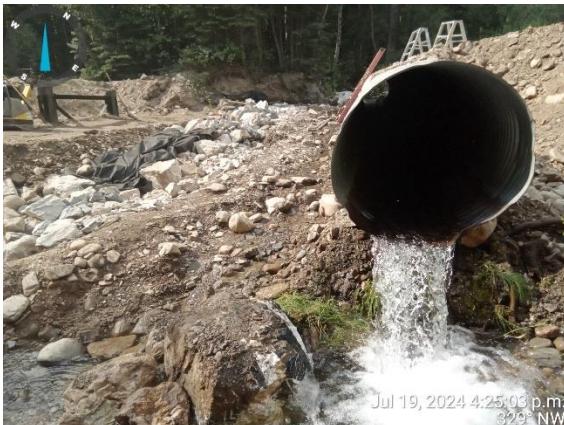
**Photo 20.** Flow diversion and partially reconstructed right bank. (July 19, 2024).

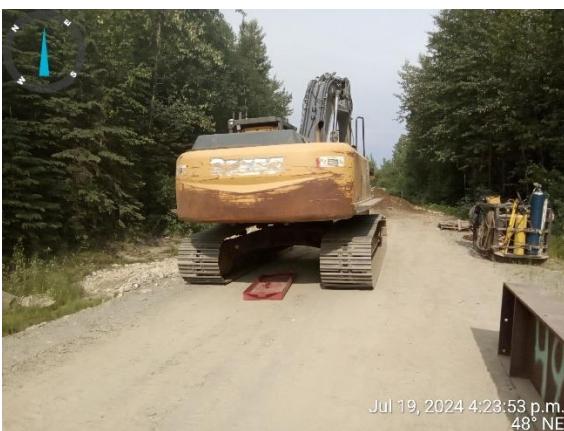
**Photo 21.** Equipment staged with spill tray. (July 19, 2024).

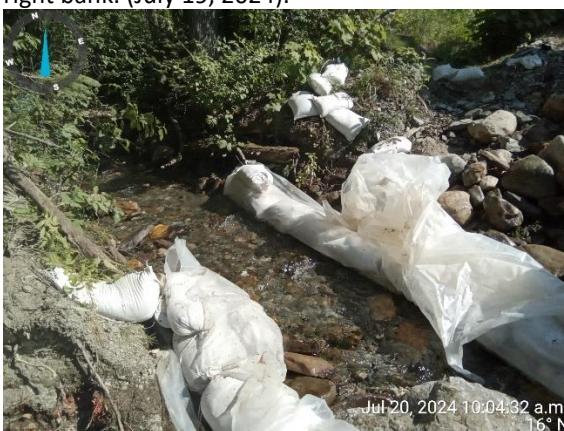
**Photo 22.** Diversion to reconstructed stream bed at inlet side of crossing. (July 20, 2024).

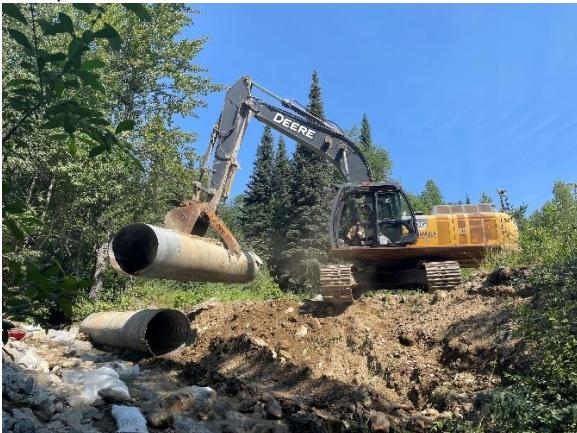
was removed, and the excavation of the eastern key commenced (**Photo 23**). Geotextile fabric was placed, and riprap was added overtop (**Photo 24, 25**). On July 21<sup>st</sup>, welding, painting, and compaction activities were conducted throughout the day (**Photo 30**). Grouting occurred in a very low risk location, with the EM on standby to measure pH. Some backfilling also occurred. On July 22<sup>nd</sup>, the final section of culvert was removed by excavator (**Photo 32**). Both excavators completed streambed restoration activities from both sides of the banks. Remaining rock material was used to ensure the correct gradient and width was applied to the reconstruction (**Photos 35, 36**).

**Photo 23.** Removal of the lower half of the eastern culvert. (July 20, 2024).

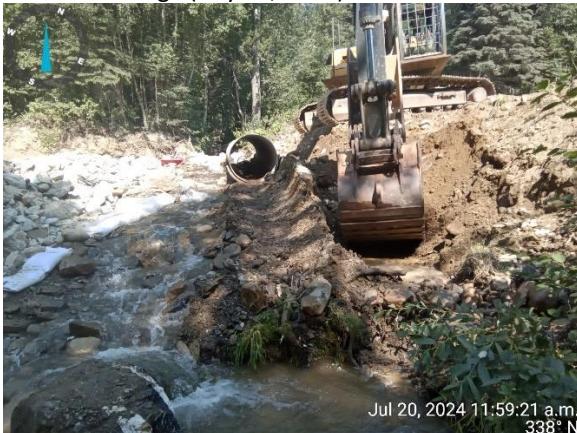
**Photo 24.** Commencement of the eastern key excavation. (July 20, 2024).

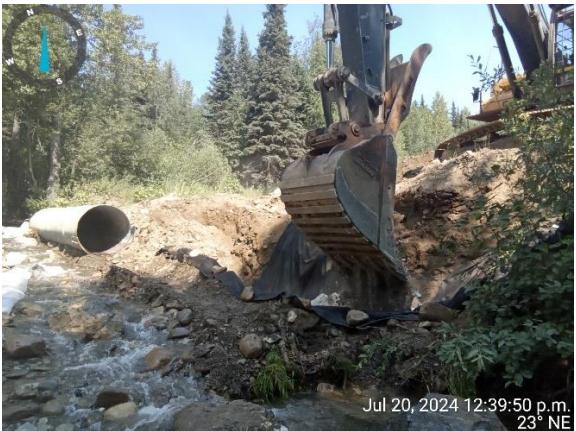
**Photo 25.** Excavator adding fill into key. (July 20, 2024).

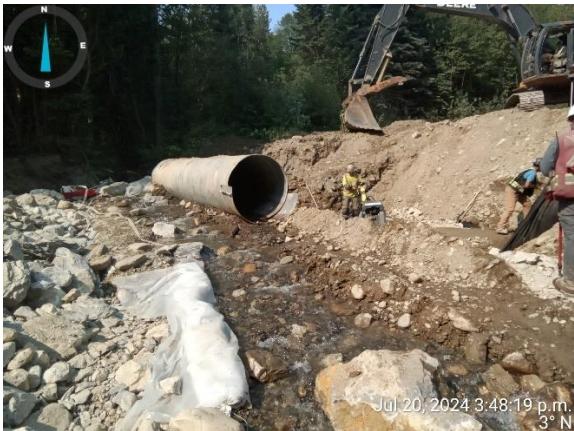
**Photo 26.** Clear flow through stream bed after flushing. (July 20, 2024).

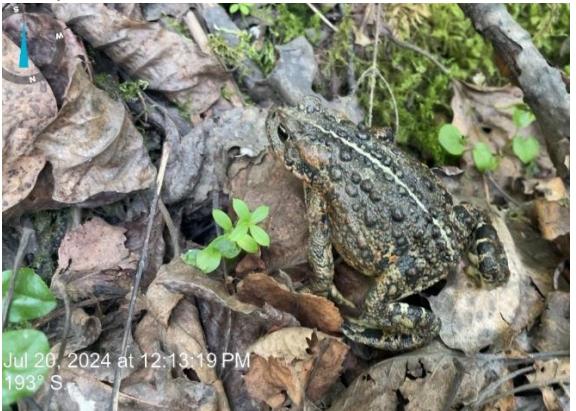
**Photo 27.** Western toad salvaged from area of riprap. (July 20, 2024).

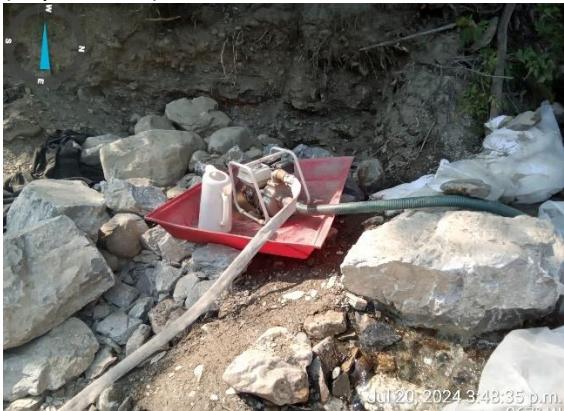
**Photo 28.** Pump with spill tray at diversion. (July 20, 2024).

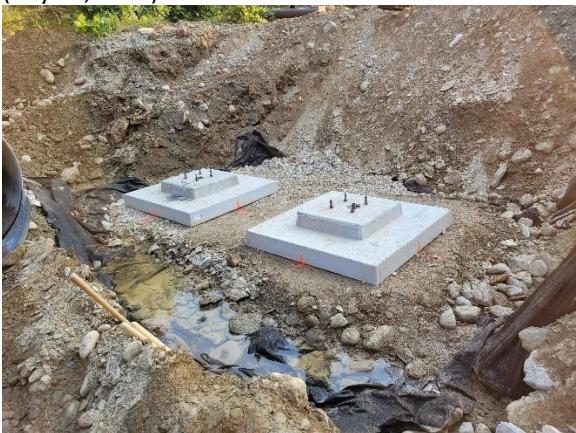
**Photo 29.** Footing placement in key. (July 21, 2024).

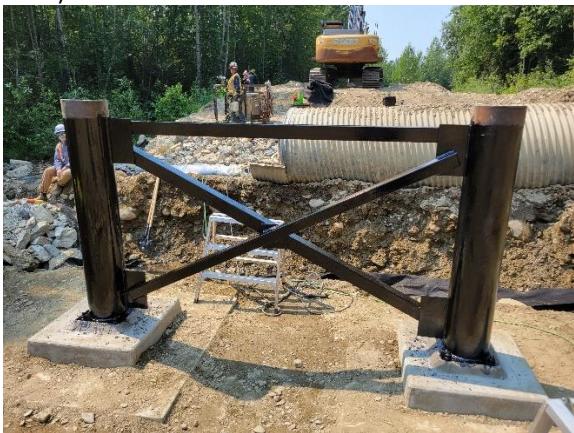
**Photo 30.** Installation of piles/footings, with welding and grouting completed. (July 21, 2024).

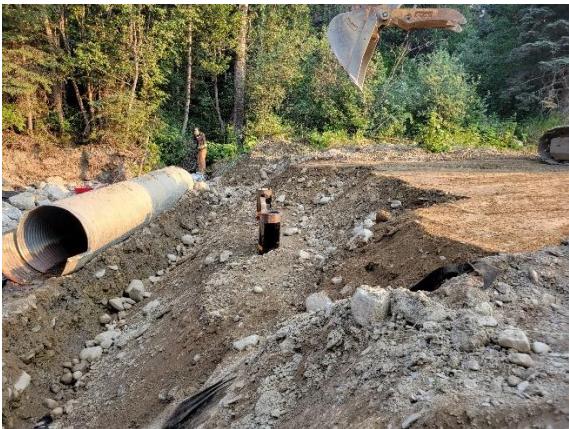
**Photo 31.** Backfilling of spread footings. (July 22, 2024).

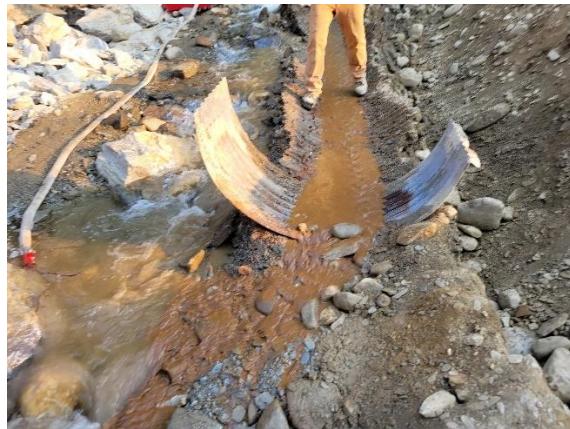
**Photo 32.** Temporary turbidity spike upon removal of culvert and flushing of stagnant water. (July 22, 2024).

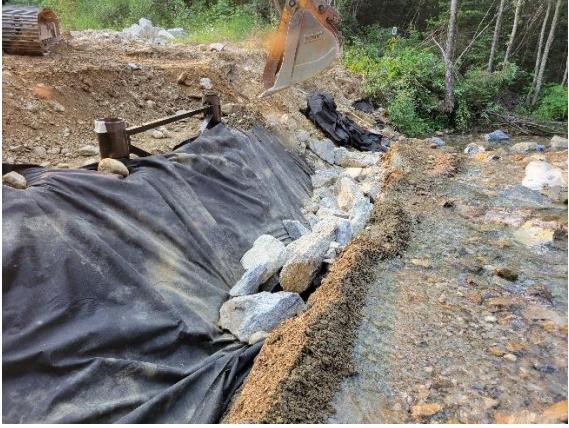
**Photo 33.** Riprap placement over geotextile fabric. (July 22, 2024).

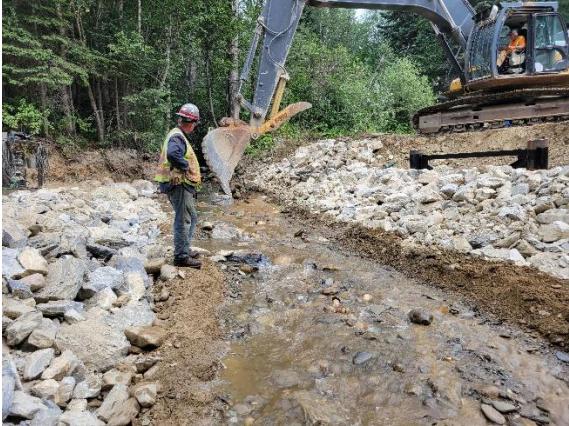
**Photo 35.** Streambed reconstruction with boulder placement. (July 22, 2024).

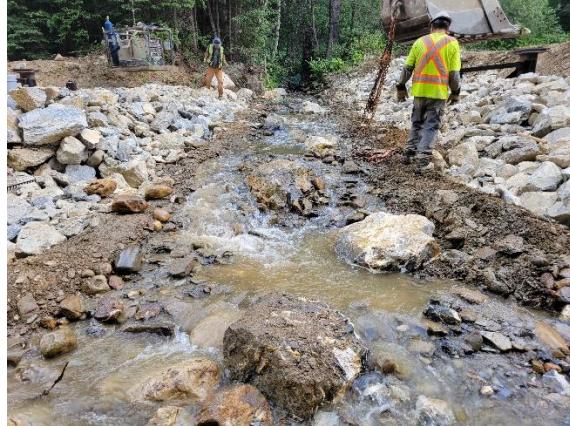
**Photo 36.** Reconstructed stream bed. (July 22, 2024).

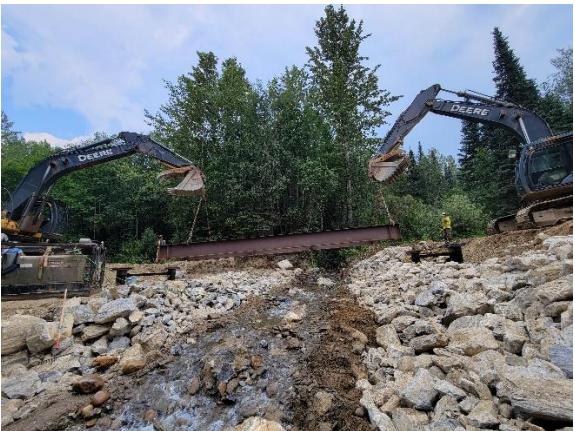
**Photo 37.** Placement of steel girder. (July 22, 2024).

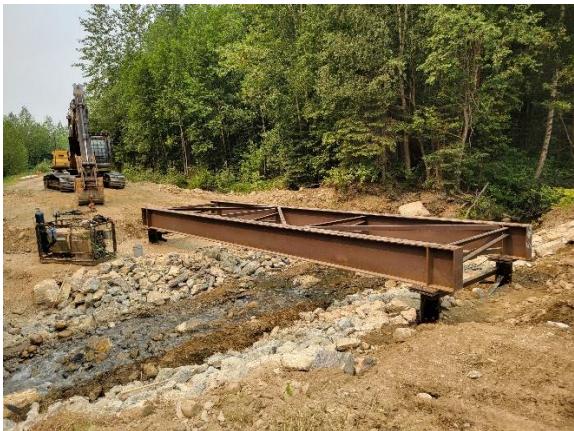
**Photo 38.** Girder launch. (July 22, 2024).

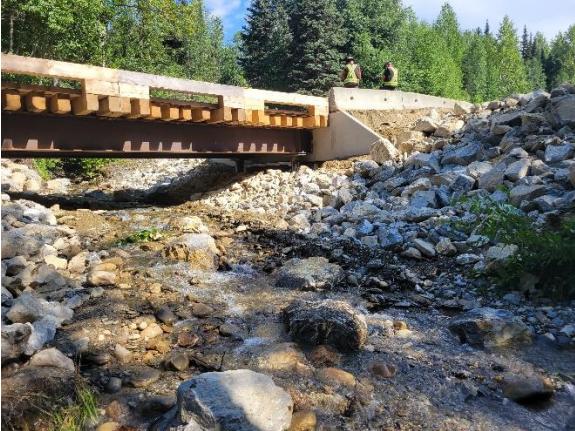
**Photo 39.** Bridge deck installation and final inspection. (July 24, 2024).

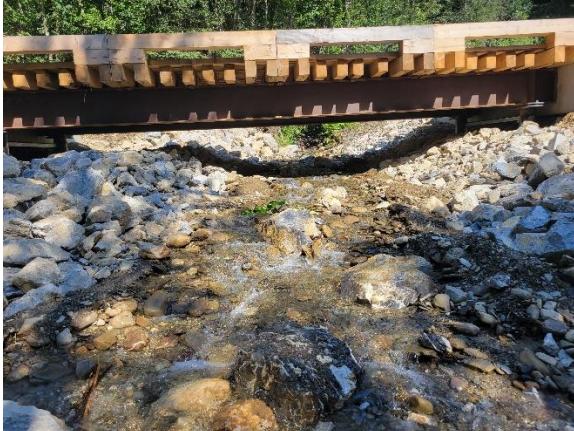
**Photo 40.** Reconstructed channel under bridge. (July 24, 2024).

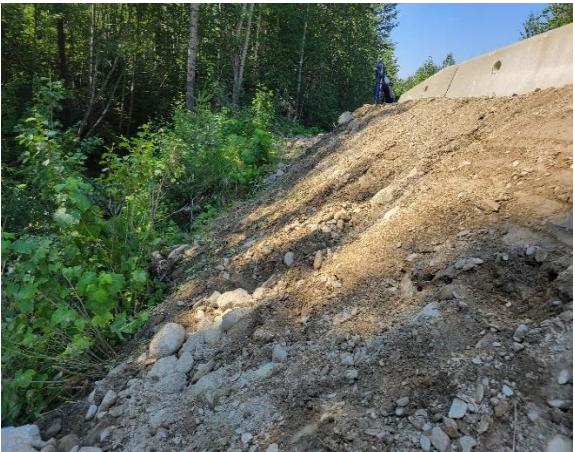
**Photo 41.** Area of site to be seeded and mulched. (July 24, 2024).

Canfor (or their delegate) will seed the exposed soil areas along the new cut slopes of the crossing with a regionally appropriate seed mix and cover them with straw mulch.
