## Bulkley River and Morice River Watershed Groups Fish Passage Restoration Planning 2021

Prepared for  
Habitat Conservation Trust Foundation - CAT21-6-288  
BC Fish Passage Remediation Program  
Canadian Wildlife Federation

Prepared by  
Al Irvine, B.Sc., R.P.Bio.  
New Graph Environment Ltd.  
on behalf of  
Society for Ecosystem Restoration in Northern British Columbia

Version 0.1.0  
2022-05-13

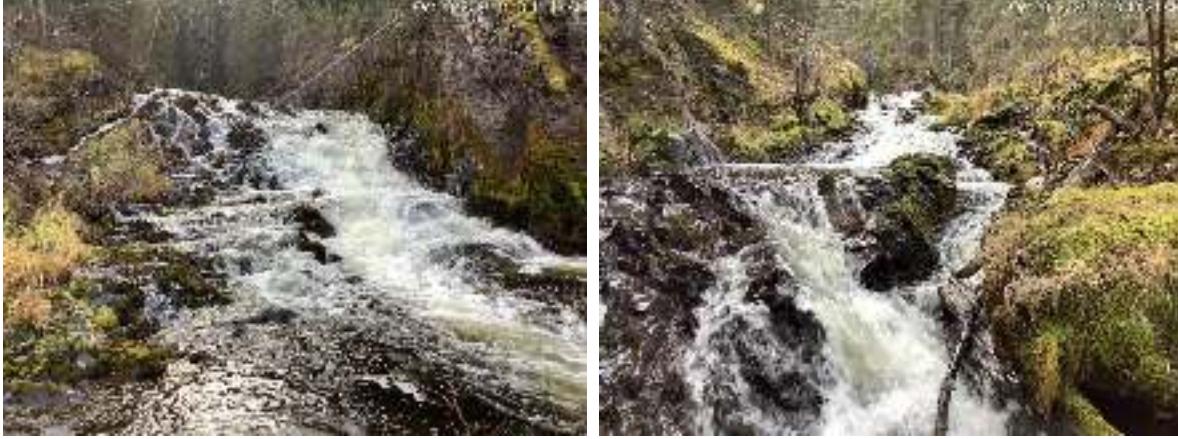
Dyson (1949) and Stokes (1956) report substantial use of habitat above Bulkley Falls by steelhead, chinook, coho and sockeye utilization in the past (pre-1950) based on spawning reports. Both authors concluded that the Bulkley Falls pose a partial obstruction to migrating fish based on flow levels. Chinook, which migrate early in the summer when water levels are high, have been noted as able to ascend the falls in normal to high water years and in high water years it was thought that coho and steelhead could ascend. A. Gottesfeld and Rabnett (2007) report that the falls are almost completely impassable to all salmon during low water flows. Stokes (1956) reports that there was high value spawning habitat located within the first 3km of the Bulkley River from the outlet of Bulkley Lake.

Figure 4.1: Left: Bulkley Falls main channel. Right: Bulkley Falls side channel.

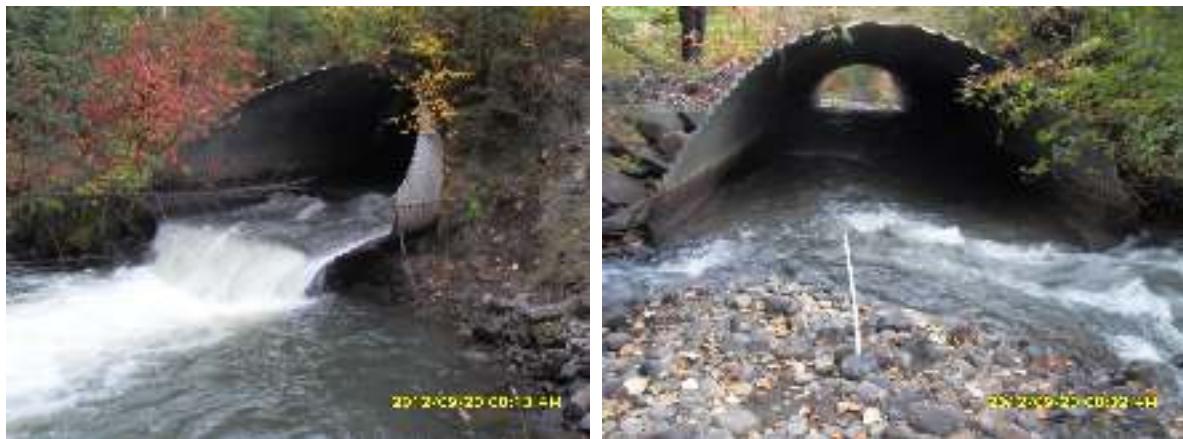
Figure 5.4: Left: Outlet of PSCIS crossing 57944 in 2012. Photo from PSCIS. Right: Inlet of PSCIS crossing 57944 in 2012. Photo from PSCIS.

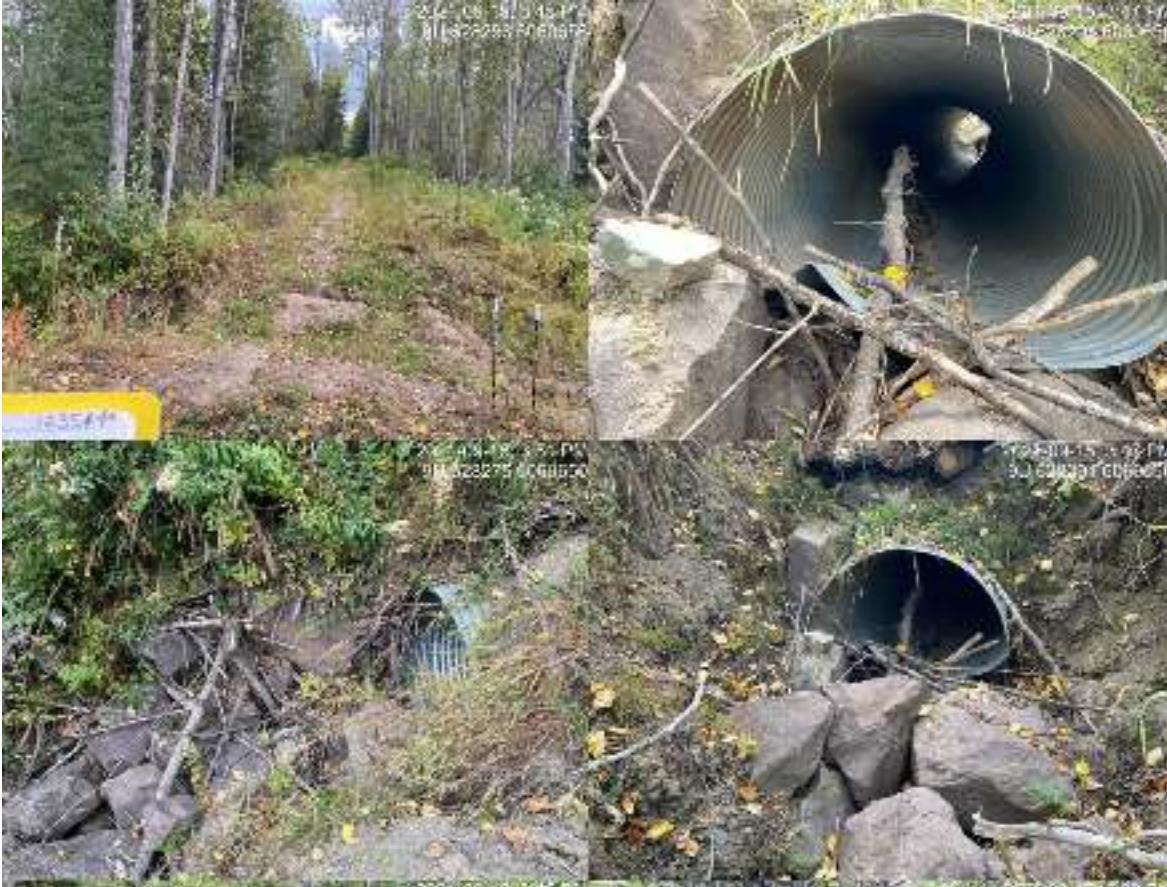
Location and Stream Data	•	Crossing Characteristics	-
Comments: Inlet of culvert is ~5m elevation more than upstream channel. Road has filled in the creek. 15:44

Photos: From top left clockwise: Road/Site Card, Barrel, Outlet, Downstream, Upstream, Inlet.

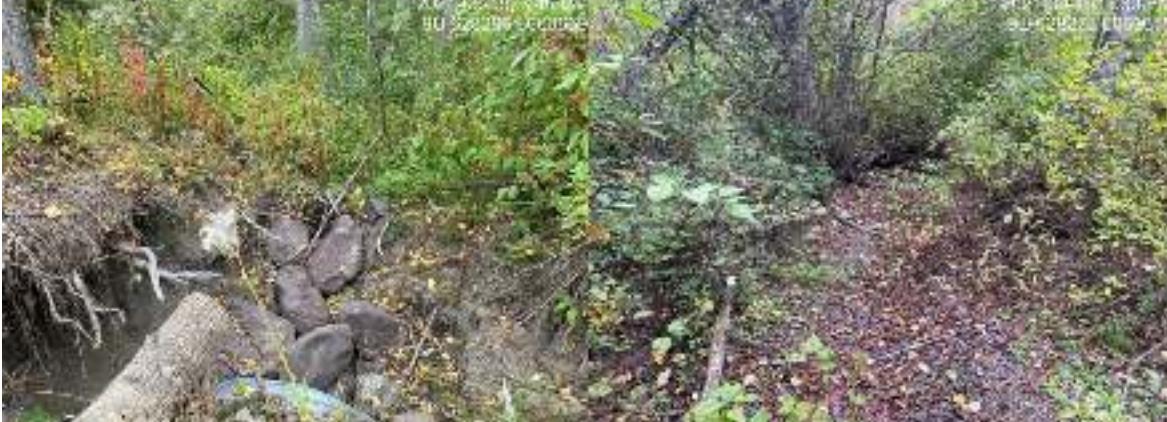
Location and Stream Data		Crossing Characteristics	
Date	2021-09-15	Crossing Sub Type	Round Culvert
PSCIS ID	58151	Diameter (m)	1
External ID	–	Length (m)	14
Crew	KP	Embedded	No
UTM Zone	9	Depth Embedded (m)	–
Easting	629753.3	Resemble Channel	No
Northing	6061126	Backwatered	No
Stream	McDowell Creek	Percent Backwatered	–
Road	Woodmere Road	Fill Depth (m)	0.5
Road Tenure	MoTi Local	Outlet Drop (m)	0.25
Channel Width (m)	1.8	Outlet Pool Depth (m)	0.64
Stream Slope (%)	1.5	Inlet Drop	No
Beaver Activity	No	Slope (%)	5
Habitat Value	Medium	Valley Fill	Deep Fill
Final score	31	Barrier Result	Barrier
Fix type	Replace Structure with Streambed Simulation CBS	Fix Span / Diameter	3

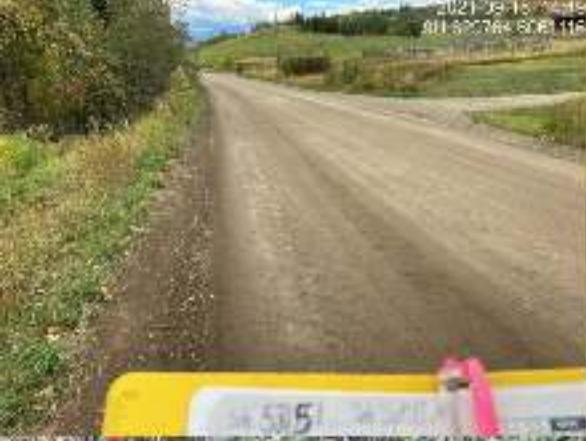
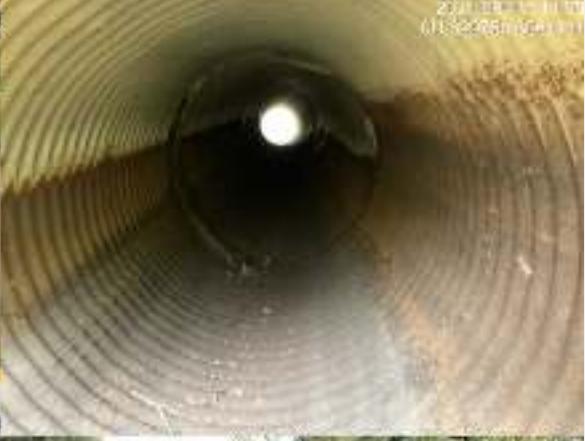
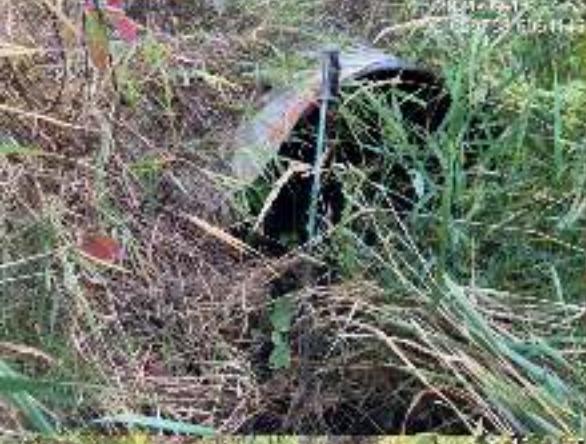
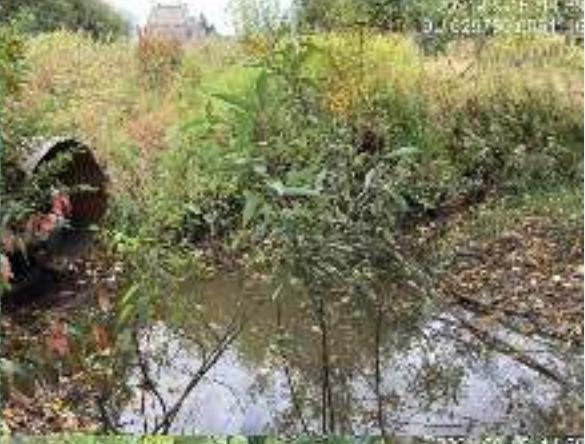
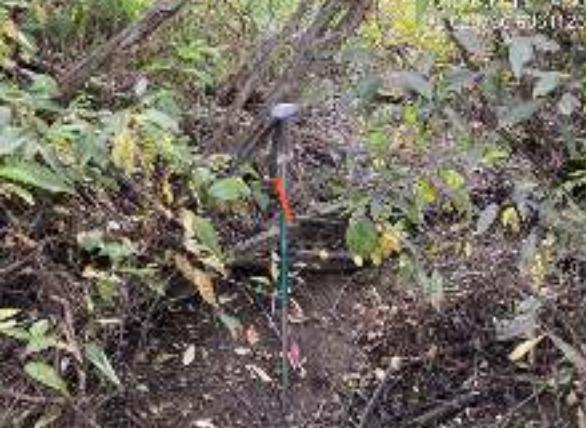
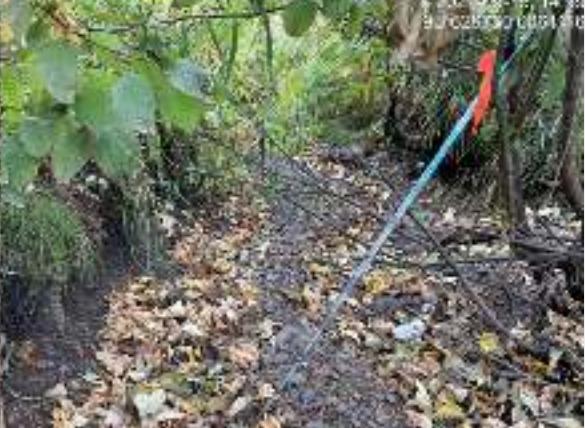
Location and Stream Data	•	Crossing Characteristics	-
Comments: Channel dry. Current pool water depth is 0.31, outlet drop measured using long tape to simulate riffle crest height. 14:48

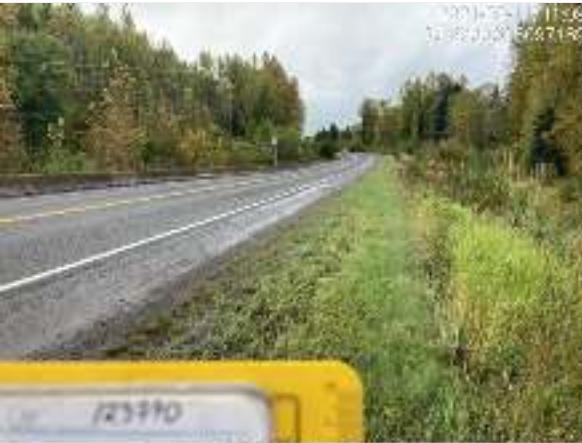
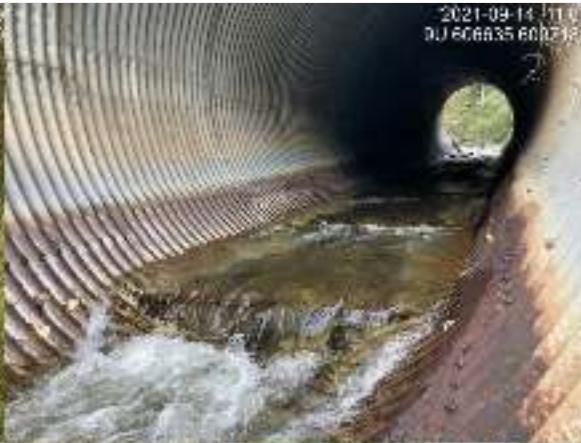
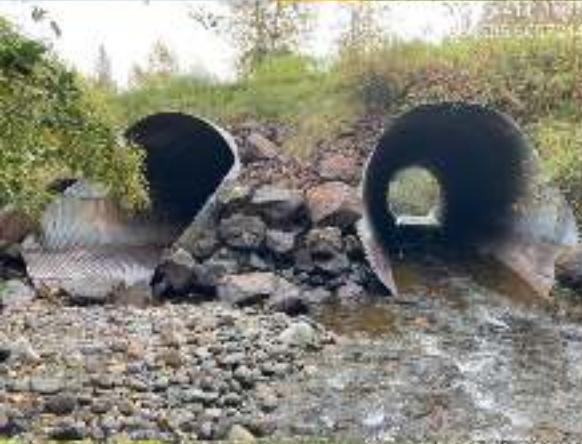
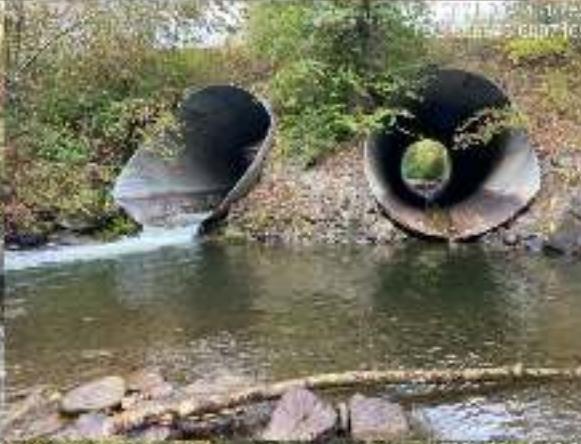
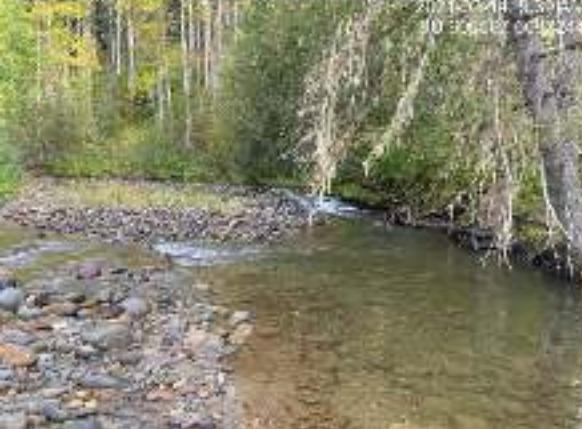
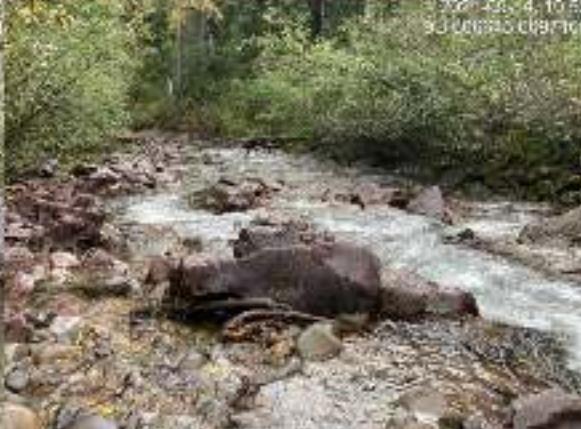
Photos: From top left clockwise: Road/Site Card, Barrel, Outlet, Downstream, Upstream, Inlet.

Location and Stream Data	•	Crossing Characteristics	-
Comments: Both pipes have outlet drop and water flowing through. Water depth in left pipe is 0.01m, left pipe no embeddment. Inlet drop only on right one. Also has baffling with substrate but baffling not in place for downstream ~3m, so not continuous. Estimated pool depth. 10:52

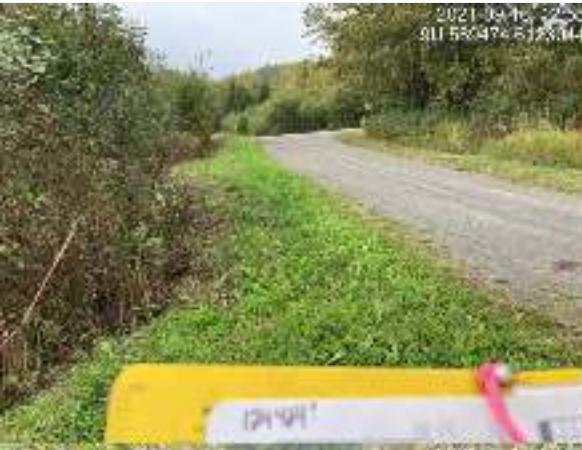
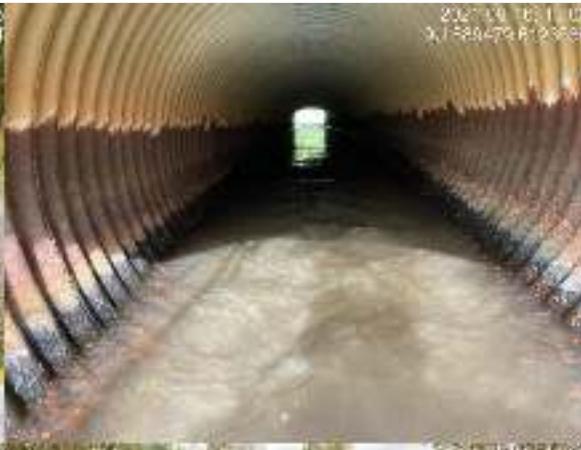
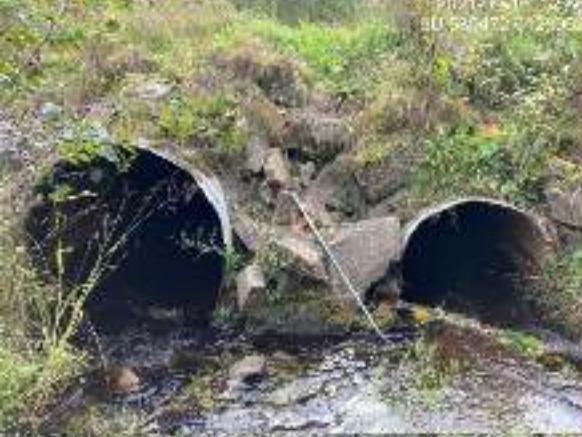
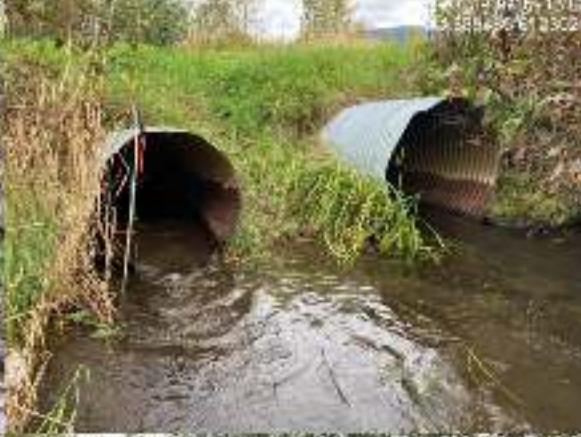
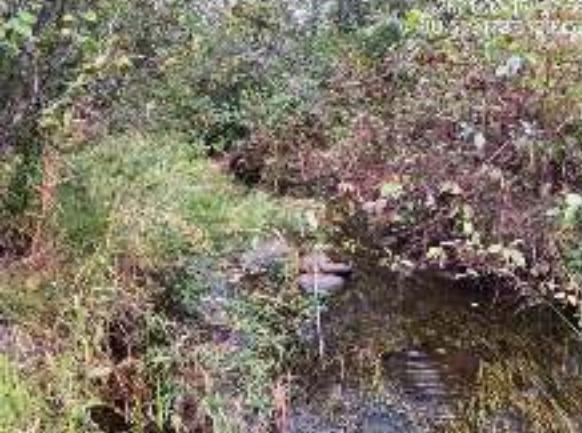
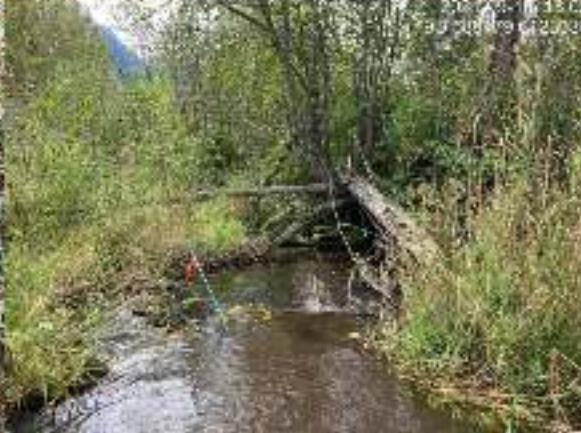
Location and Stream Data	•	Crossing Characteristics	-
Comments: Bent in middle from road weight. Inlet drop of 0.10 for both pipes. Slow steady flow almost wetland habitat above and below. Water is high. 12:54

Location and Stream Data		Crossing Characteristics –	
Date	2021-09-16	Crossing Sub Type	Round Culvert
PSCIS ID	124422	Diameter (m)	1.2
External ID	–	Length (m)	45
Crew	KP	Embedded	No
UTM Zone	9	Depth Embedded (m)	–
Easting	589499.9	Resemble Channel	No
Northing	6123162	Backwatered	Yes
Stream	Tributary to Waterfall Creek	Percent Backwatered	25
Road	Highway 16	Fill Depth (m)	6
Road Tenure	New Hazelton Arterial	Outlet Drop (m)	0
Channel Width (m)	5.2	Outlet Pool Depth (m)	0
Stream Slope (%)	5.2	Inlet Drop	Yes
Beaver Activity	Yes	Slope (%)	1.5
Habitat Value	Medium	Valley Fill	Deep Fill
Final score	27	Barrier Result	Barrier
Fix type	Replace with New Open Bottom Structure	Fix Span / Diameter	19

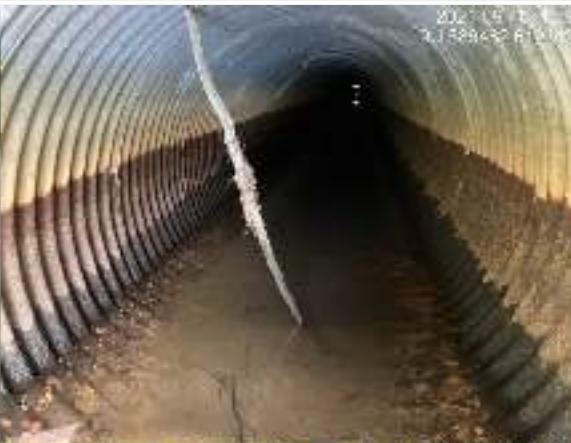
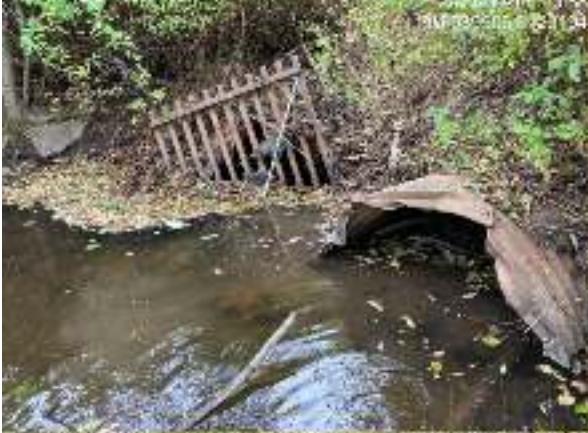
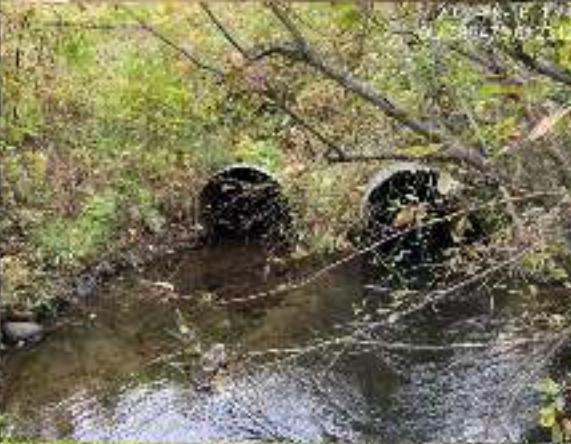
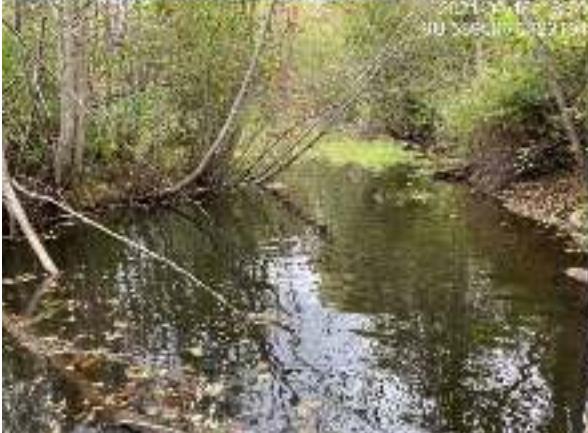
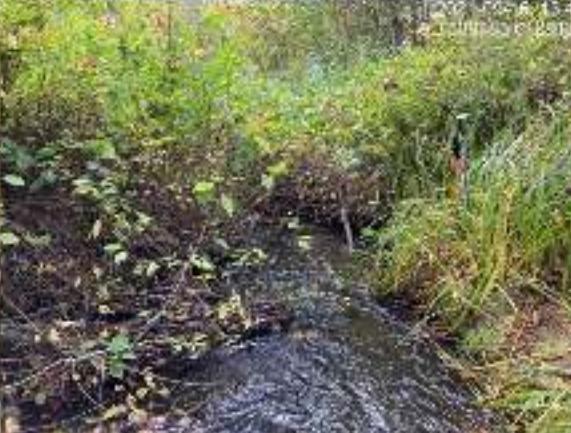
Location and Stream Data	•	Crossing Characteristics	-
Comments: 2 pipes. Both have water, left bank one is flowing. Assessment comments indicate right bank pipe is backwatered 100% but changed to 25% based on photos and past PSCIS data and photos which also indicated not backwatered. Suspect blockage due to debris. Outlet water depth, fish sighted in outlet of right barrel. 13:42

Should restoration/maintenance activities proceed, replacement of PSCIS crossing 124420 with a bridge (30m span) is recommended. The cost of the work is estimated at \$18,000,000 for a cost benefit of 0.5 linear m/\$1000 and 2.9 m<sup>2</sup>/\$1000. These cost benefit estimates assume that adult coho spawner passage through 124420 will result in passage through upstream crossings which rank as barriers according to the provincial metric but are likely to be passable to adult coho.

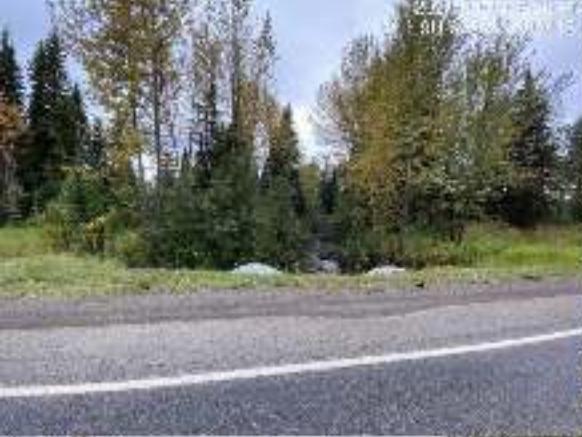
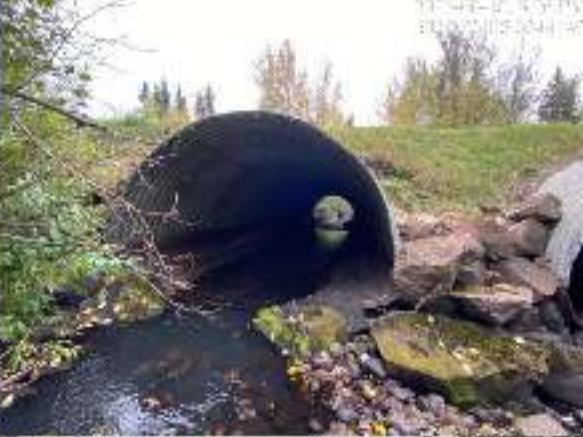
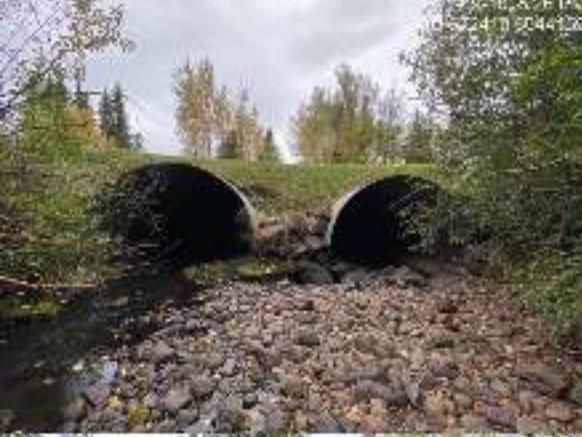
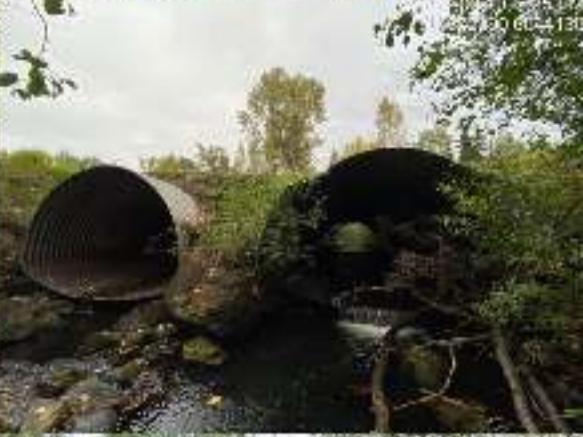
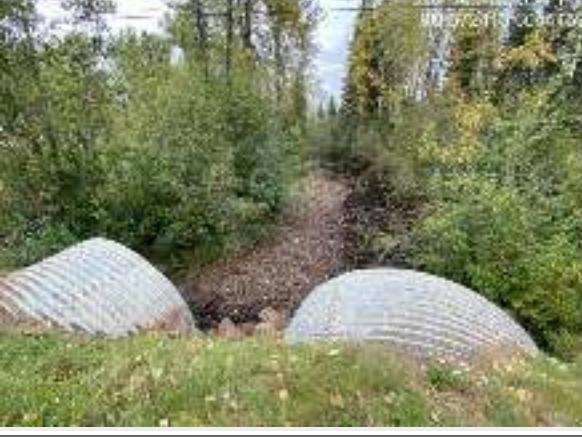
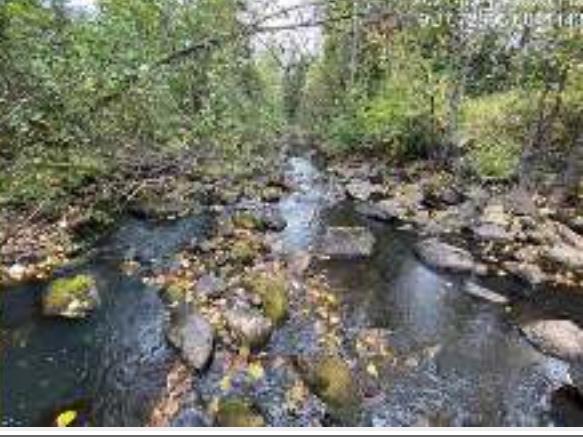
Location and Stream Data		Crossing Characteristics –	
Road	Highway 16	Fill Depth (m)	1
Road Tenure	MoTi highway	Outlet Drop (m)	0.2
Channel Width (m)	12.5	Outlet Pool Depth (m)	1
Stream Slope (%)	1.5	Inlet Drop	No
Beaver Activity	No	Slope (%)	2
Habitat Value	High	Valley Fill	Deep Fill
Final score	29	Barrier Result	Barrier
Fix type	Replace with New Open Bottom Structure	Fix Span / Diameter	16.5
Photos: From top left clockwise: Road/Site Card, Barrel, Outlet, Downstream, Upstream, Inlet.

Location and Stream Data	•	Crossing Characteristics	-
Comments: Culvert and habitat measurements taken in 2020. Multipass closed site electorfishing conducted in 2021 upstream and downstream of highway. 17:25

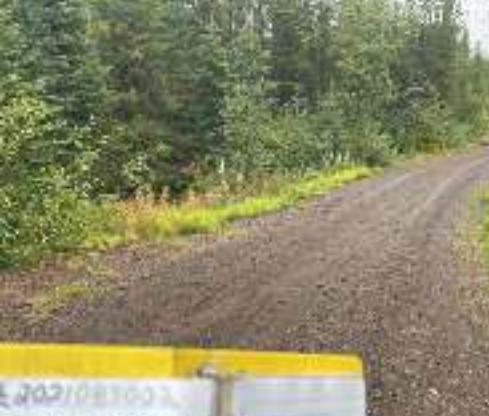
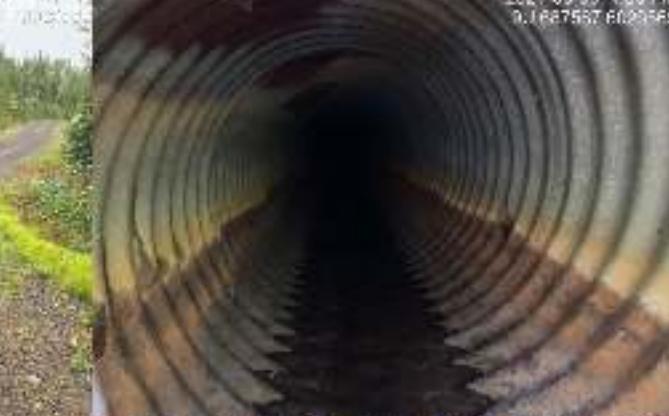
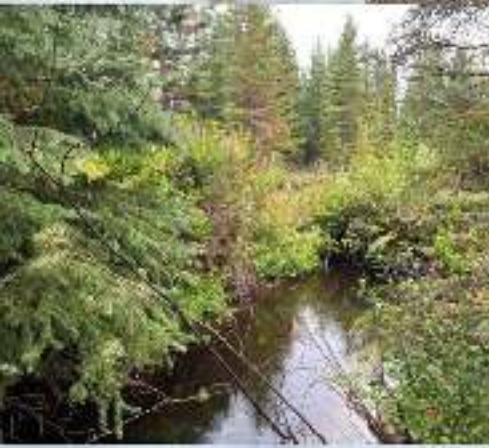
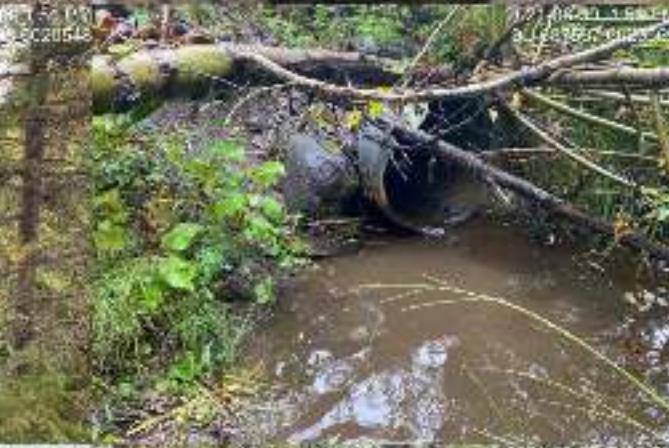
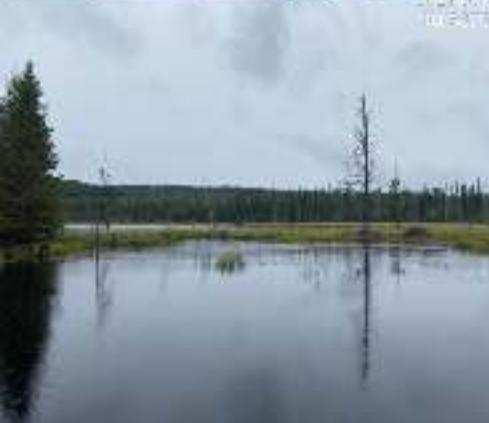
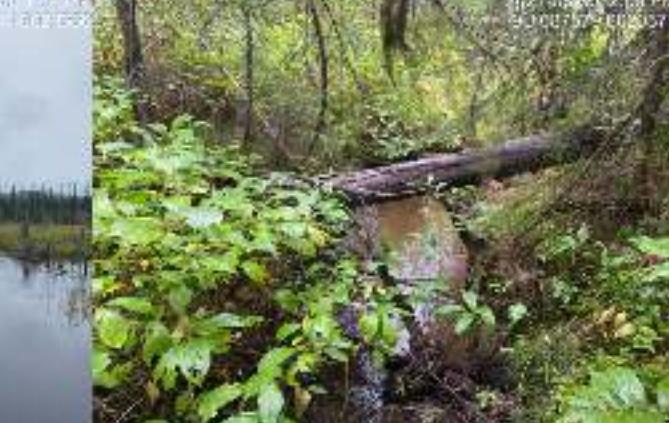
Location and Stream Data	• Crossing Characteristics
<p>Comments: Habitat value is low to medium. Large beaver influenced lake upstream with two dams ~1.5m high at 10m and 30m upstream. Inlet blocked. Water at inlet is level with the top of the culvert. At 4m downstream is a 1m high beaver dam. 13:23</p>

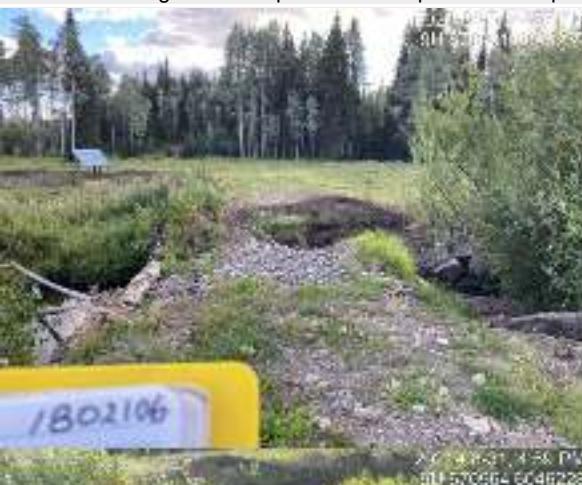
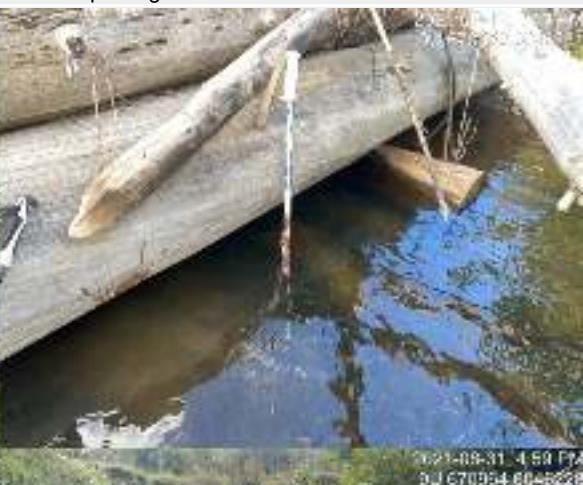
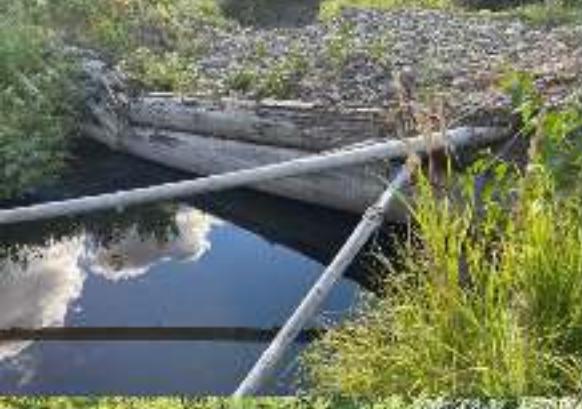
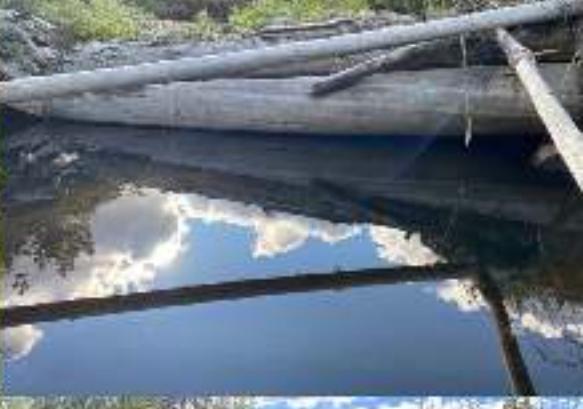
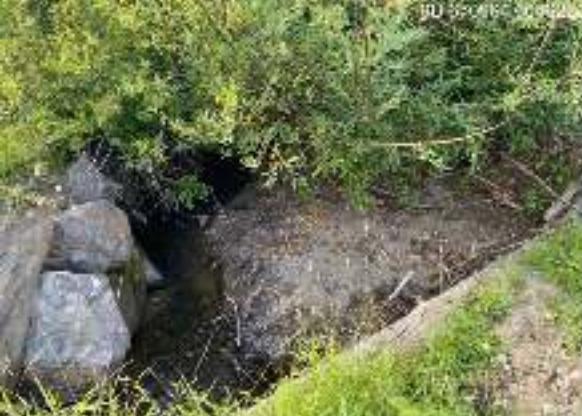
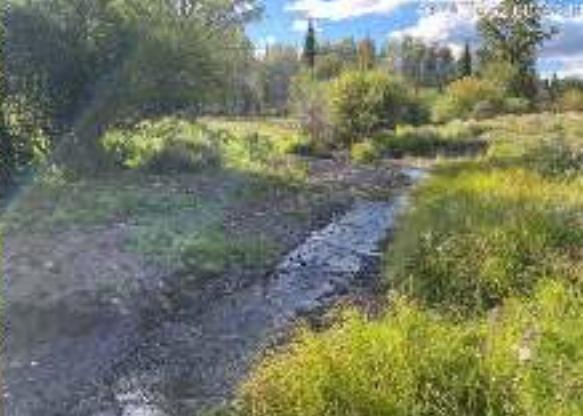
Location and Stream Data	•	Crossing Characteristics	-
Comments: Bridge has collapsed and is impediment to upstream fish passage. Habitat confirmation conducted. 16:56

Should restoration/maintenance activities proceed at the site, removal of PSCIS crossing 197912 is recommended. In addition to removal of the collapsed bridge, resloping of banks and the installation of live cuttings/pegboarding is recommended in three areas downstream where cattle trampling is resulting in significant erosion. A map of the erosion areas and associated prescriptions for rehabilitation of the downstream corners is provided as Figure [5.22](#). The cost of the work is estimated at \$30,000 for a cost benefit of 924 linear m/\$1000 and 3973.2 m<sup>2</sup>/\$1000.

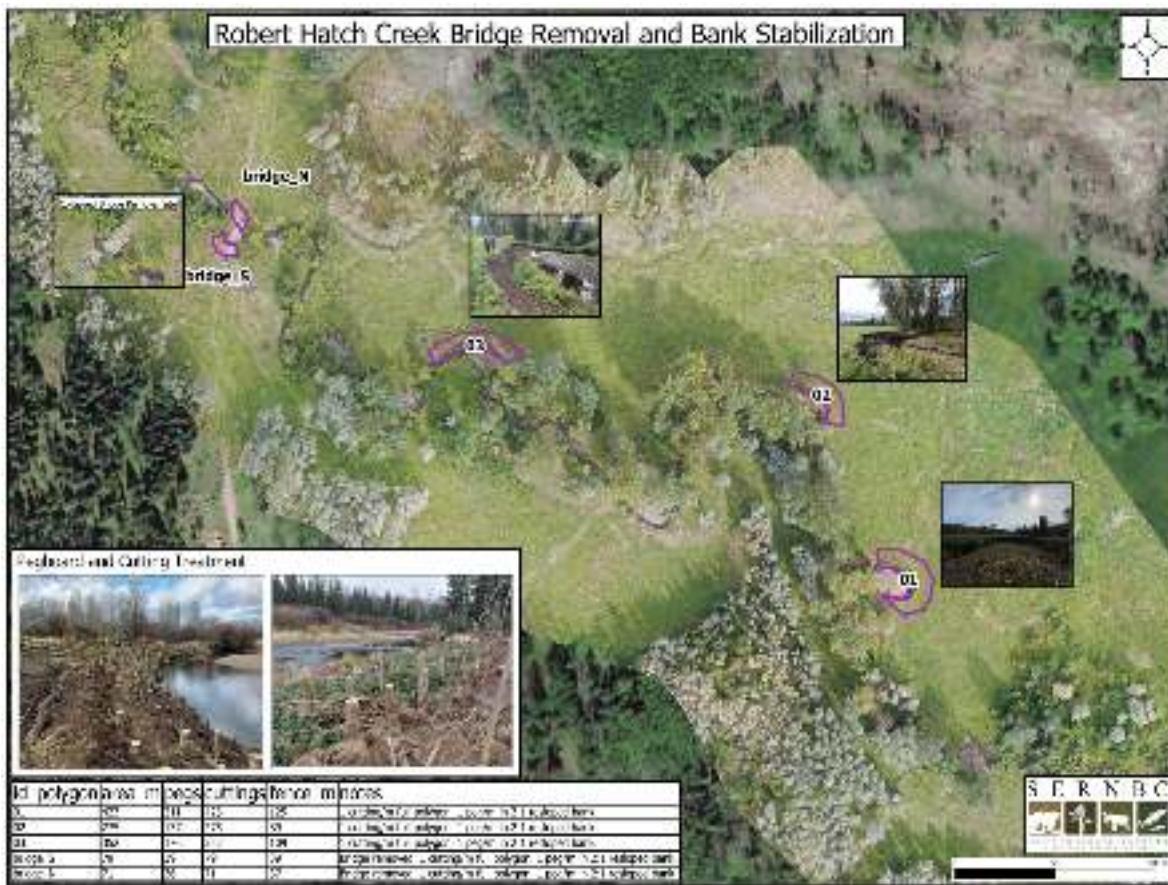
Figure 5.22: Restoration plan for Robert Hatch Creek including removal of collapsed bridge, resloping of banks and the installation of live cuttings/pegboarding

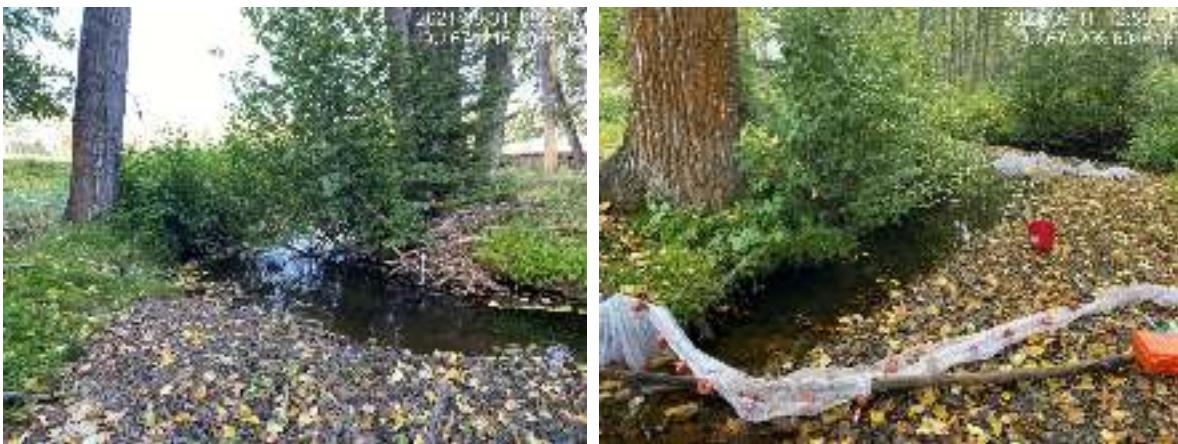
The stream was surveyed downstream from the culvert for 300m (Figure [5.24](#)). Total cover amount was rated as with deep pools dominant. Cover was also present as small woody debris, large woody debris, undercut banks, and overhanging vegetation (Table [5.35](#)). The average channel width was 4.7m, the average wetted width was 3.2m and the average gradient was 1.2%. The dominant substrate was gravels with fines subdominant. The habitat was rated as medium value for salmonid rearing and spawning.

Figure 5.24: Left: Typical habitat downstream of PSCIS crossing 197912. Right: Typical habitat downstream of PSCIS crossing 197912.

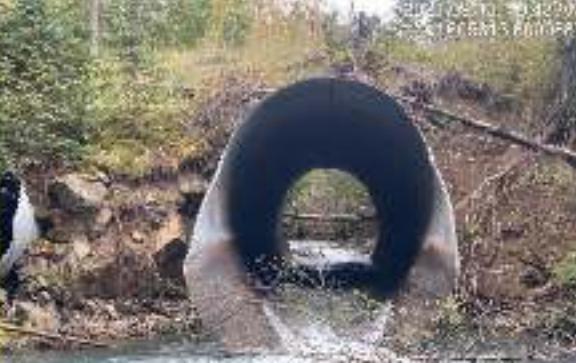
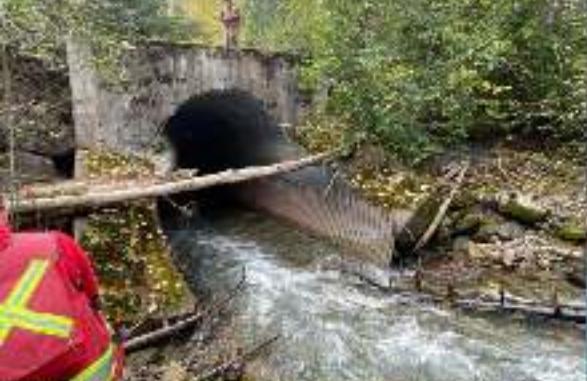
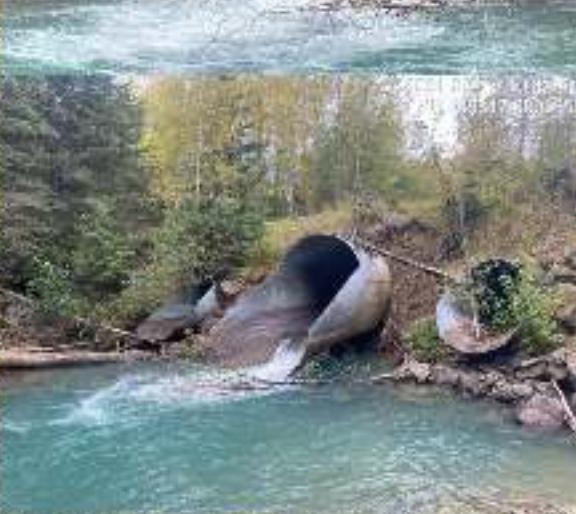
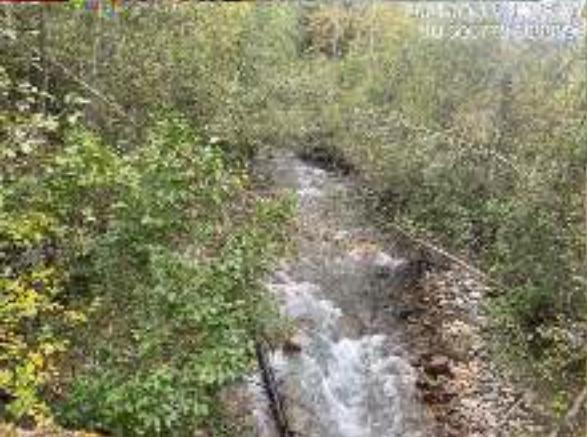
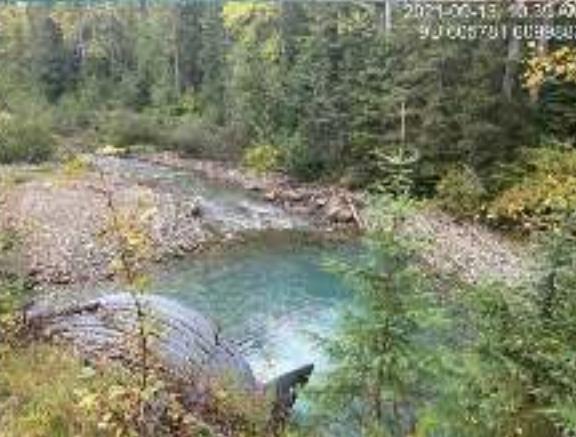
Location and Stream Data	•	Crossing Characteristics	-
Comments: Outlet is cracked and drops. Inlet embedded to 2/3 way. 10:33

Photos: From top left clockwise: Road/Site Card, Barrel, Outlet, Downstream, Upstream, Inlet.

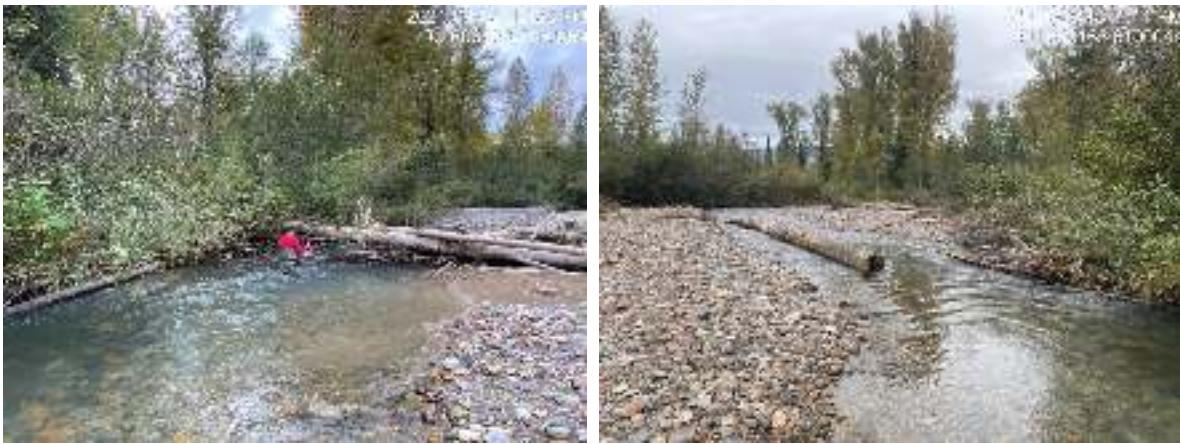
The stream was surveyed downstream from crossing 197960 for 450m (Figure 5.27). Total cover amount was rated as moderate with overhanging vegetation dominant. Cover was also present as small woody debris, large woody debris, undercut banks, and deep pools. The average channel

width was 25.4m, the average wetted width was 8.9m and the average gradient was 1.7%. The dominant substrate was cobbles with gravels subdominant. The stream was moderately turbid due to glacial flour with abundant quantities of gravels suitably sized for trout and salmon species present. The stream channel was noted as riffle dominated with a lack of complexity due to adjacent riparian clearing and dyke installation. The habitat was rated as medium value for salmonid rearing and spawning.

Figure 5.27: Left: Typical habitat downstream of PSCIS crossing 197960. Right: Typical habitat downstream of PSCIS crossing 197960.

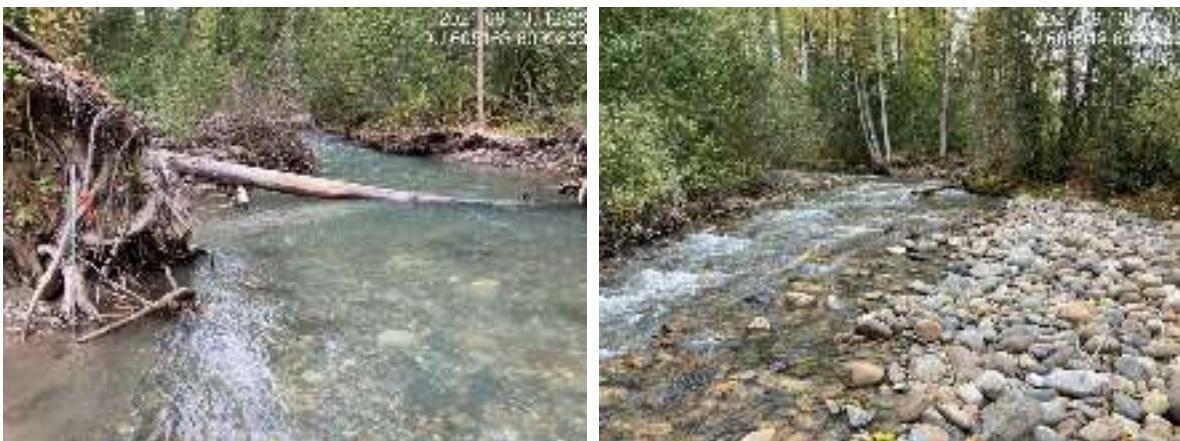
The stream was surveyed upstream from crossing 197960 for 1000m (Figure [5.28](#)). Total cover amount was rated as moderate with overhanging vegetation dominant. Cover was also present as small woody debris, large woody debris, boulders, and undercut banks. The average channel width was 18m, the average wetted width was 8.9m and the average gradient was 2.8%. The dominant substrate was cobbles with gravels subdominant. The first 50 - 100m upstream of crossing channel and banks were noted as armoured with riprap. Abundant gravels suitable for resident and anadromous salmonids were noted throughout. The habitat was rated as medium value as an important migration corridor containing suitable spawning habitat and having moderate rearing potential.

Figure 5.28: Left: Typical habitat upstream of PSCIS crossing 197960. Right: Typical habitat upstream of PSCIS crossing 197960.

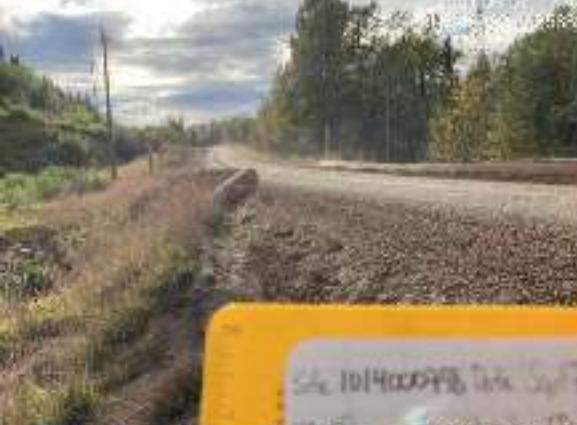
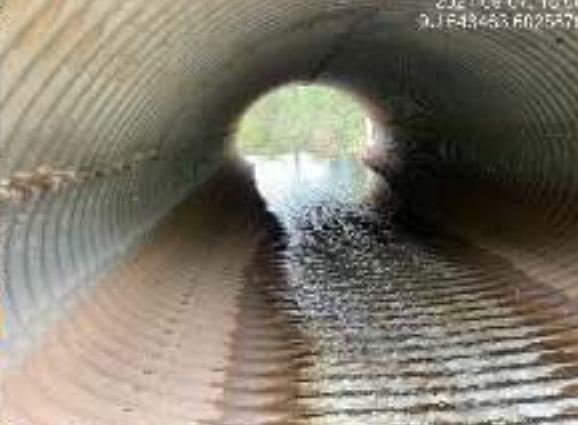
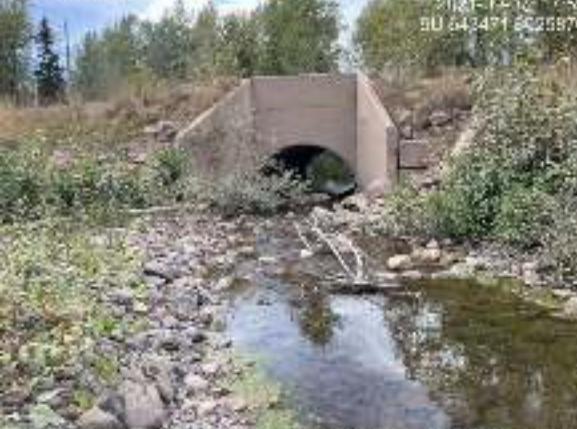
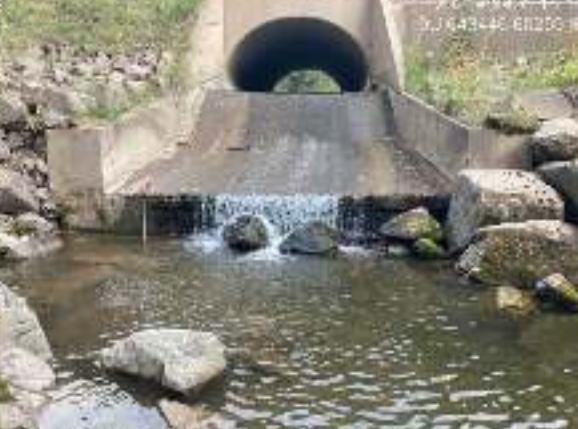
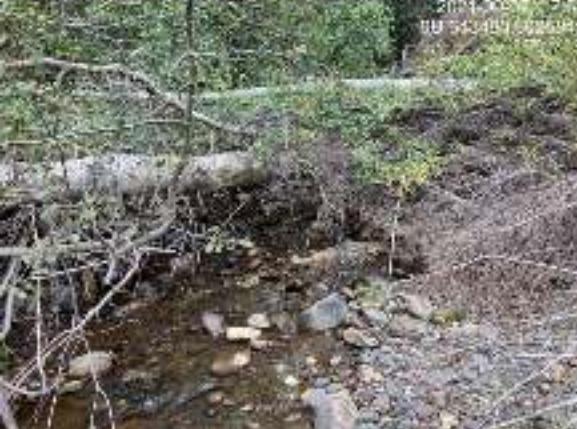
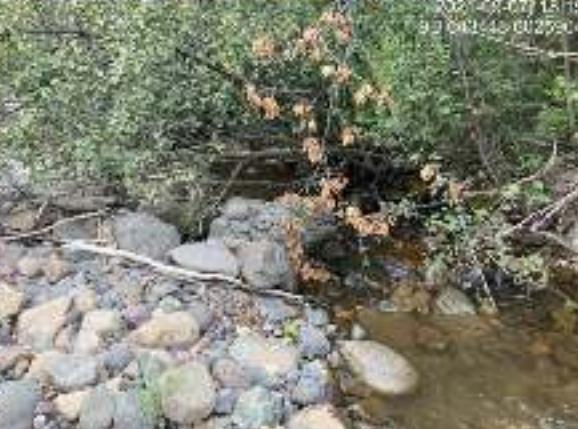
Location and Stream Data	• Crossing Characteristics
Comments: Partial inlet drop of varying height due to large woody debris and boulders. Side channel dry, must be seasonal use only. 17:47

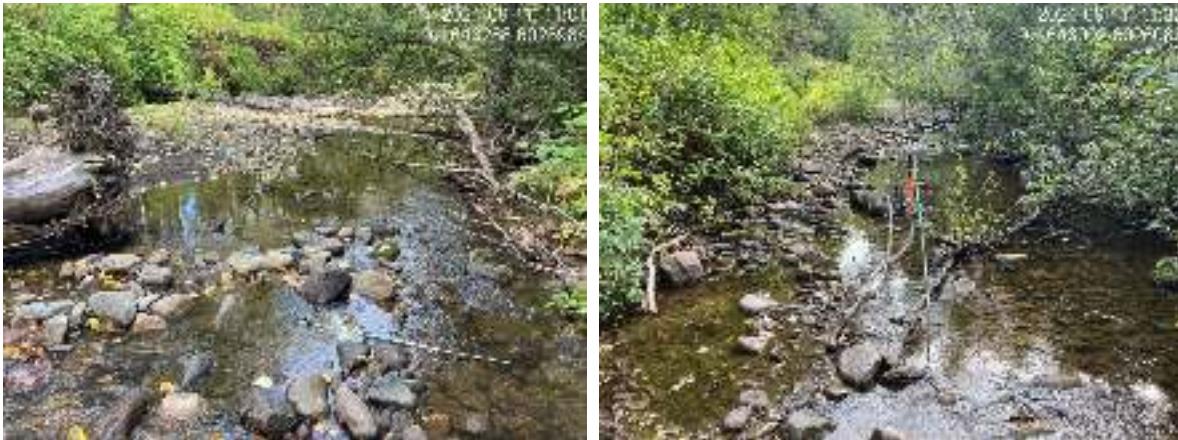
The stream was surveyed downstream from crossing 197962 for 600m (Figure 5.30). Total cover amount was rated as moderate with undercut banks dominant. Cover was also present as small

woody debris, large woody debris, boulders, deep pools, and overhanging vegetation. The average channel width was 8.1m, the average wetted width was 4.2m, and the average gradient was 2.6%. The dominant substrate was cobbles with boulders sub-dominant. Multiple areas of side channels and small braided sections were noted with intermittent sections of aggraded cobbles / gravels moved in high flows. There were pockets of gravel present suitable for spawning resident and anadromous salmonids.

Figure 5.30: Left: Habitat downstream of PSCIS crossing 197962. Right: Habitat downstream of PSCIS crossing 197962.
