## Bulkley River and Morice River Watershed Groups Fish Passage Restoration Planning 2021

Prepared for  
Habitat Conservation Trust Foundation - CAT21-6-288  
BC Fish Passage Remediation Program  
Canadian Wildlife Federation

Prepared by  
Al Irvine, B.Sc., R.P.Bio.  
New Graph Environment Ltd.  
on behalf of  
Society for Ecosystem Restoration in Northern British Columbia

Version 0.1.0  
2022-05-13

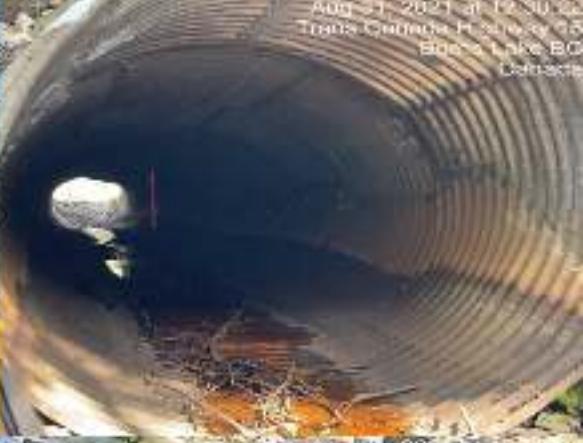
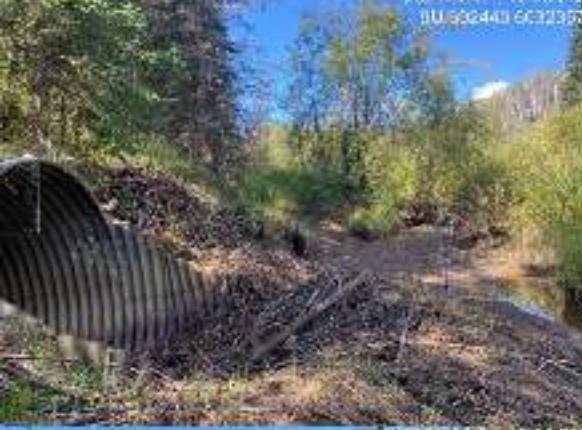
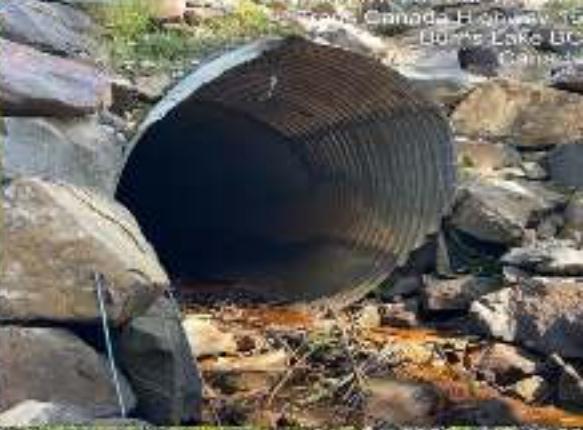
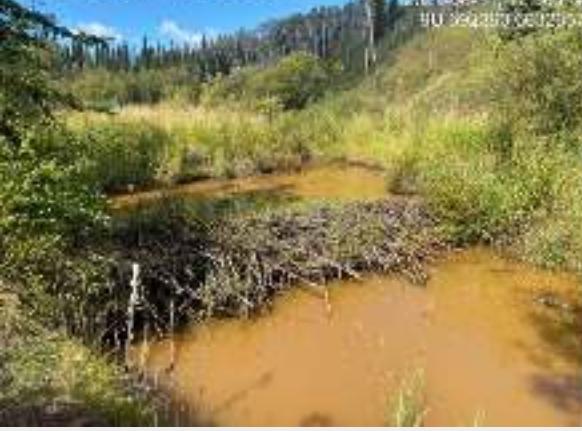
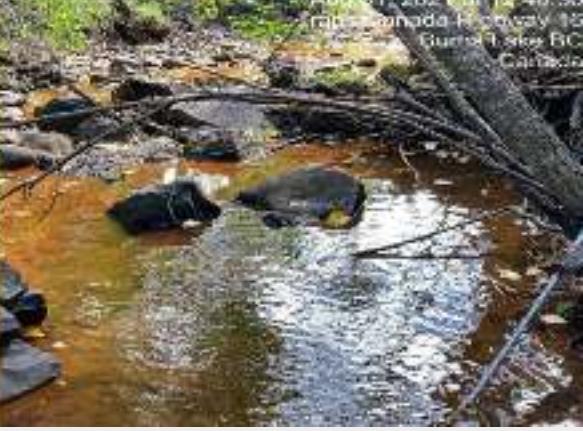
At the time of the survey, PSCIS crossing 197967 was non-backwatered and ranked as a barrier to upstream fish passage according to the provincial protocol (MoE 2011b) (Table 5.53). Water temperature was 12°C, pH was 7.2 and conductivity was 359uS/cm. A beaver dam was noted just upstream of the culvert inlet (~1.5m high).

Location and Stream Data	•	Crossing Characteristics	-
Comments: Beaver dam at inlet ~1.5m high. Rocks placed at outlet reducing drop to 0, rocks about long, and have staggered drop of 0.7m. 12:20

Should restoration/maintenance activities proceed, replacement of PSCIS crossing 197967 with a bridge (31m span) is recommended. The cost of the work is estimated at \$18,600,000 for a cost benefit of 2.8 linear m/\$1000 and 14.8 m<sup>2</sup>/\$1000.

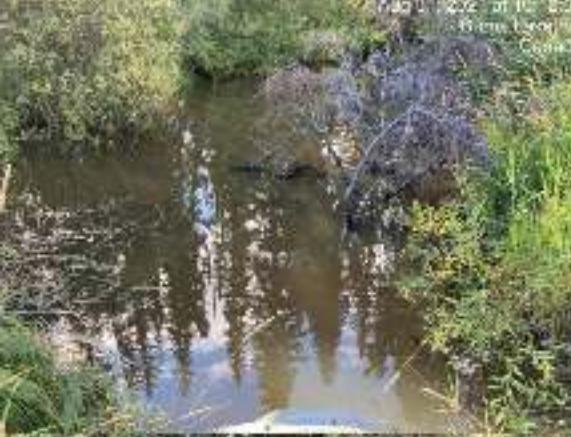
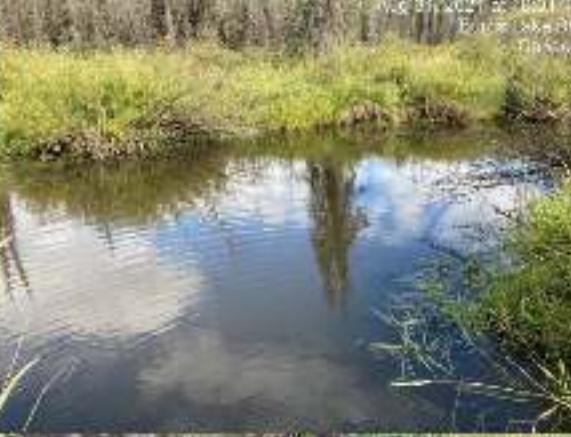
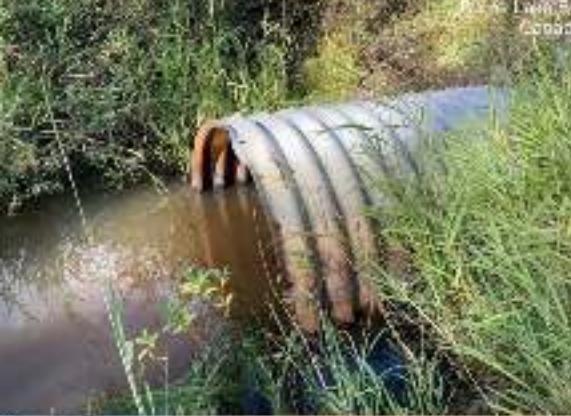
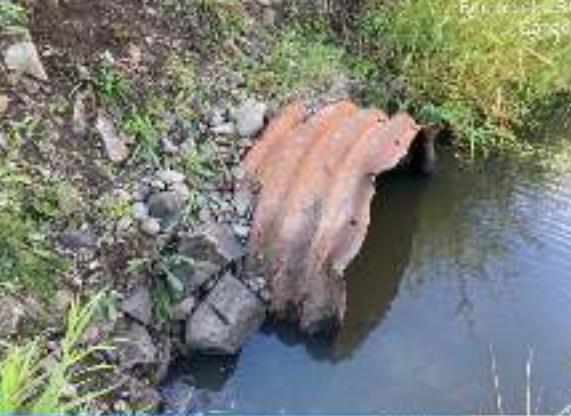
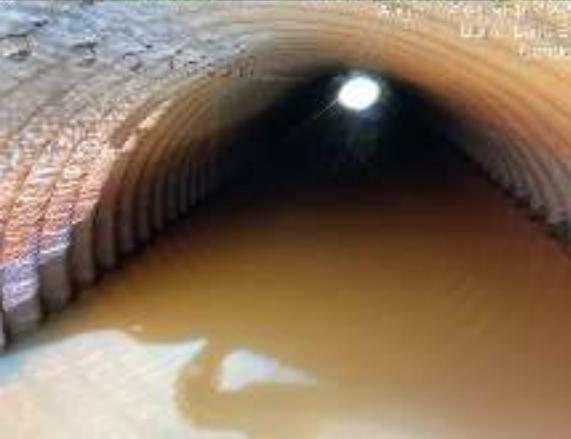
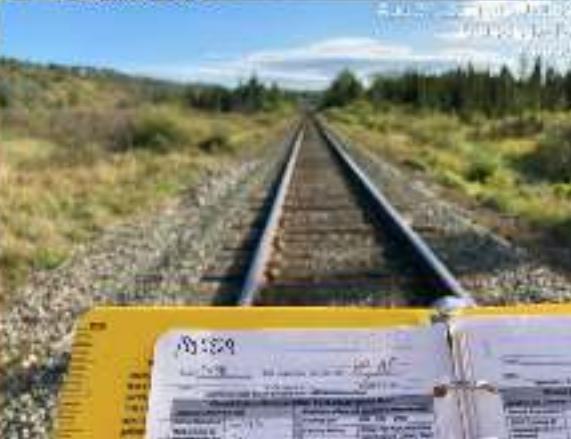
Location and Stream Data	•	Crossing Characteristics	-
Comments: Backwatered fully, appears fully passable. Fish sighted at outlet. Distance from water surface to top of culvert is 70cm. 9:58

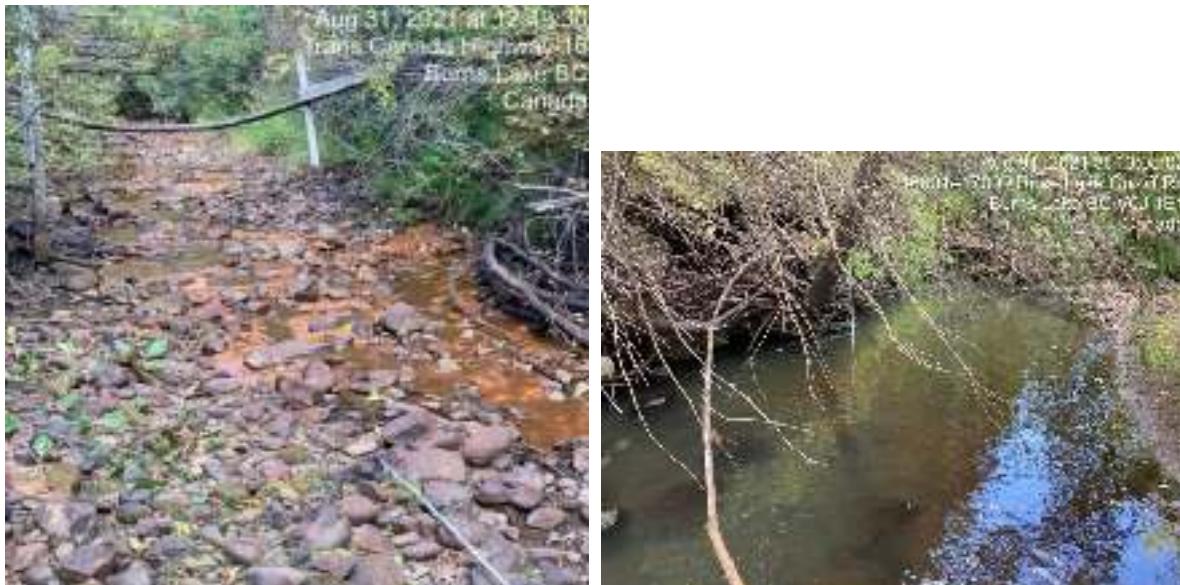
The stream was surveyed downstream from crossing 197967 for 375m to the bridge (PSCIS 197966) located on Ross Lake Cutoff Rd (Figure 5.32). The average channel width was 5.7m, the

average wetted width was 3.1m, and the average gradient was 2.5%. Total cover amount was rated as trace with overhanging vegetation dominant. Cover was also present as deep pools and instream vegetation. The dominant substrate was cobbles with fines sub-dominant. The site was noted as having significant amounts of thick red colored algae for the majority of survey. Flow was very low with uncommon pools. Fence material was noted in or across channel in two locations and riparian vegetation had been removed where an agricultural field and fence line were close. Although considered an important migration corridor, the habitat was rated as medium value for salmonid rearing and spawning due to limited complexity resulting from adjacent agricultural activities.

Figure 5.32: Left: Habitat downstream of PSCIS crossing 197967. Right: Habitat downstream of PSCIS crossing 197967.

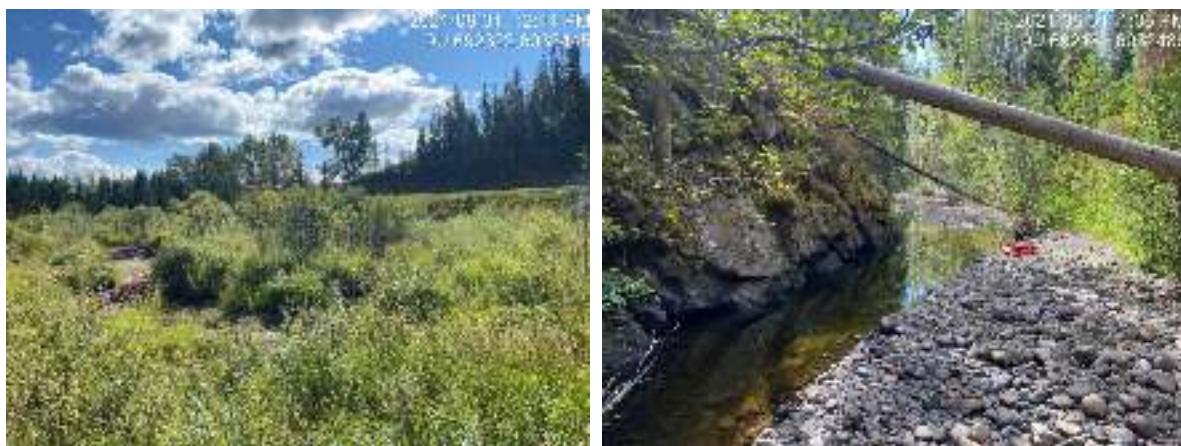
The stream was surveyed upstream from crossing 197967 for 800m (Figure 5.33). Total cover amount was rated as moderate with deep pools dominant. Cover was also present as large woody

debris and overhanging vegetation. The average channel width was 5.3m, the average wetted width was 2.3m, and the average gradient was 2.5%. The dominant substrate was gravels with cobbles sub-dominant. The first ~250m of channel upstream of the highway were noted as beaver influenced wetland with extensive dry sections at the time of the survey. Frequent pockets of gravels and small cobbles suitable for rainbow trout and coho salmon spawning were noted throughout the area surveyed. A canyon section of stream was located upstream of the crossing approximately 300m contained deep bedrock pools with small fish present and no large woody debris. One deep pool upstream of the canyon section contained likely 2-3 year old juveniles (coloring indicated rainbow trout, unverified). The habitat was rated as medium value as an important migration corridor containing suitable spawning habitat and having moderate rearing potential.

Figure 5.33: Left: Habitat upstream of PSCIS crossing 197967. Right: Habitat upstream of PSCIS crossing 197967.

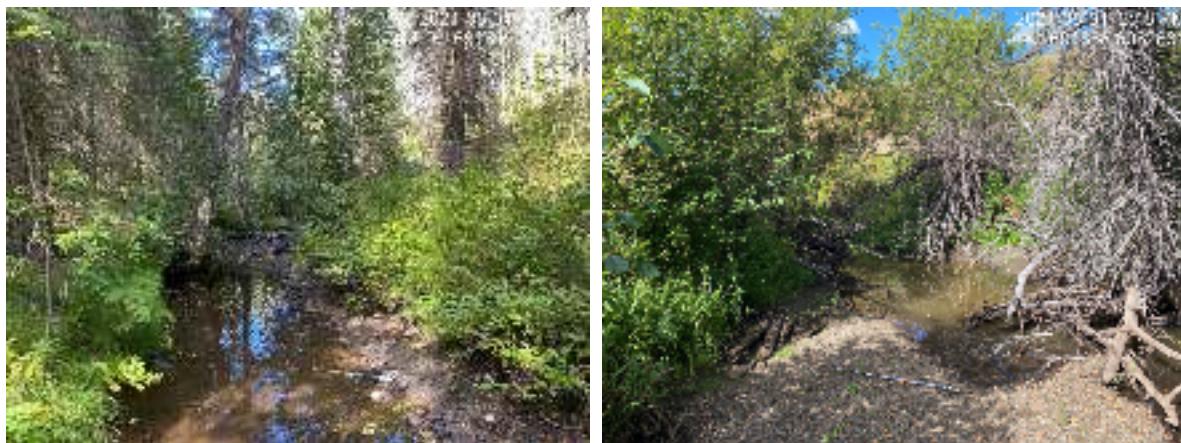
Taman Creek was surveyed for 400m above where it joins the Bulkley River mainstem upstream of PSCIS crossing 197967 (Figure [5.34](#)). The average channel width was 3.8m, the average wetted width was 2.2m, and the average gradient was 2.5%. The dominant substrate was gravels with cobbles sub-dominant. Total cover amount was rated as moderate with deep pools dominant. Cover was also present as small woody debris, large woody debris, undercut banks, and overhanging vegetation. The water in Taman Creek during the survey was noted as turbid with numerous salmonid fry present at the downstream end of the site. Algae was abundant throughout the system and eroding banks were common. Abundant gravels suitable for resident rainbow trout and coho salmon spawning were present and habitat was rated as medium value for salmon rearing and spawning.

Figure 5.34: Left: Habitat upstream of PSCIS crossing 197967. Right: Habitat upstream of PSCIS crossing 197967.

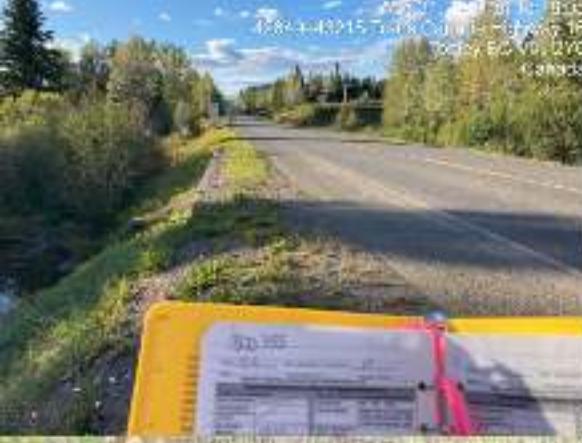
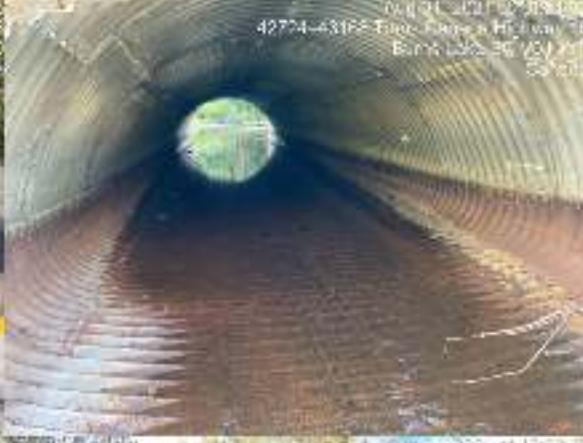
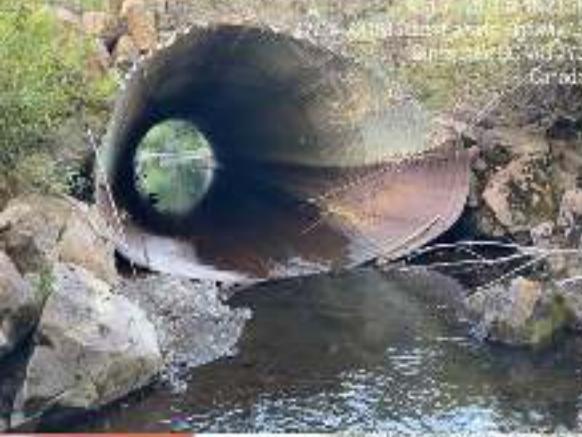
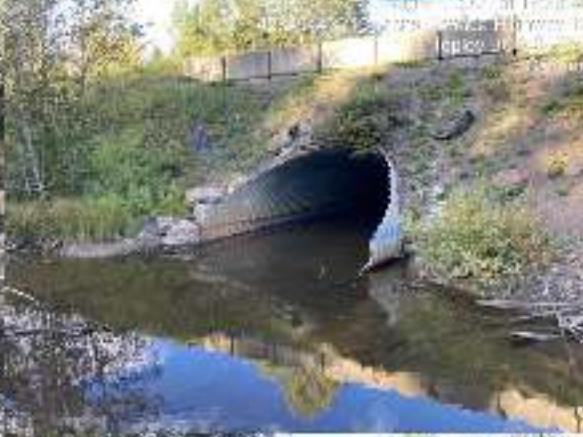
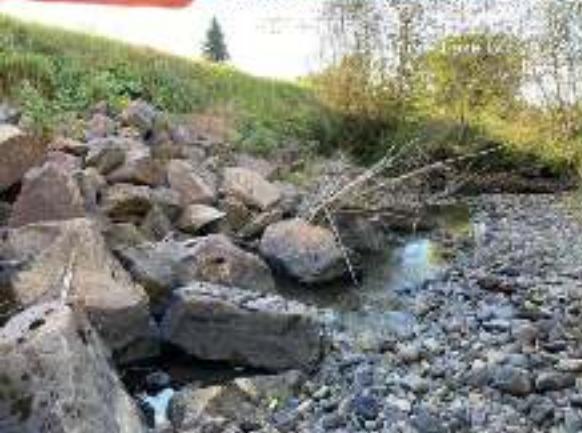
Location and Stream Data	•	Crossing Characteristics	-
Comments: Fish sighted upstream, not aligned with stream, channel runs into rip rap berm of highway then over to closed bottom structure. Pool (40cn) on upstream inlet. Fish sighted in downstream pool. 18:16

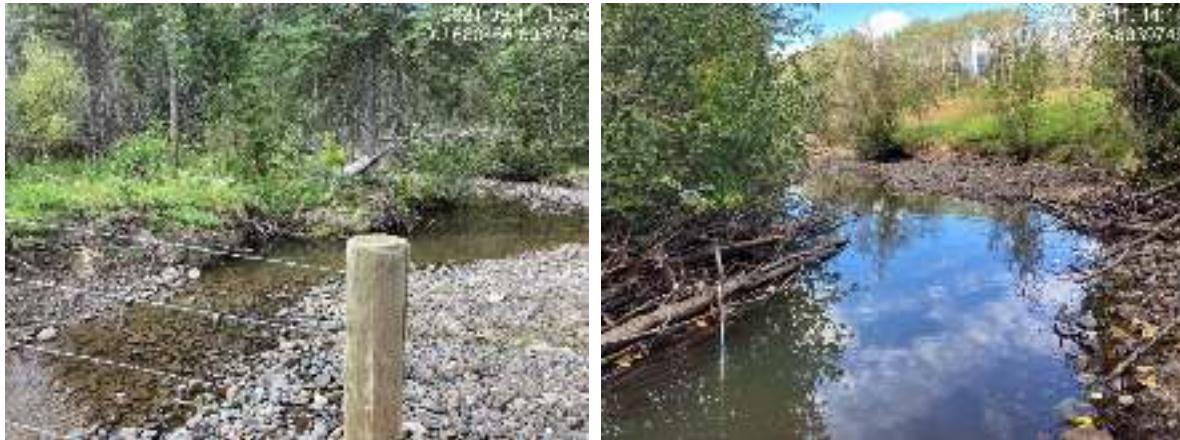
Figure 5.36: Left: Typical habitat downstream of PSCIS crossing 197976. Right: Typical habitat downstream of PSCIS crossing 197976.

At the time of the survey, PSCIS crossing 197976 was 50% backwatered, un-embedded and ranked as a barrier to upstream fish passage according to the provincial protocol (MoE 2011b) (Table 5.59). A juvenile fish (~140 cm) was noted as easily swimming upstream through the culvert during the survey. PSCIS crossing 197976 was not backwatered, not embedded and ranked as a barrier to upstream fish passage according to the provincial protocol (Table 5.60). Water temperature was 11° C, pH was 7 and conductivity was 248uS/cm.

Should restoration/maintenance activities proceed, replacement of PSCIS crossing 197976 with a bridge (12.5m span) is recommended. The cost of the work is estimated at \$7,500,000 for a cost benefit of 3.3 linear m/\$1000 and 27.1 m<sup>2</sup>/\$1000. As the crossing partially backwaters naturally, a plan to backwater the crossing could also be of consideration in the short term with a rough cost estimate to complete of \$25,000.

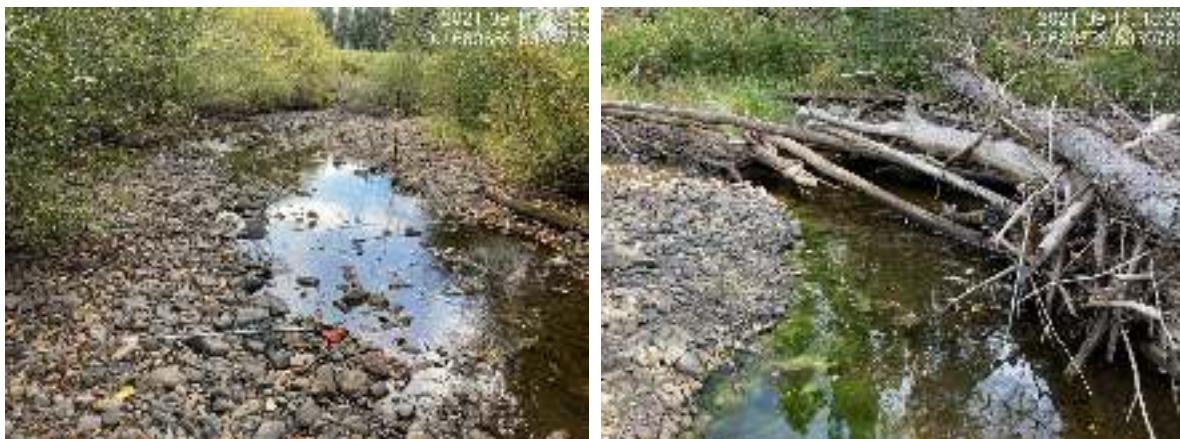
Figure 5.37: Left: Typical habitat upstream of PSCIS crossing 197976. Right: Typical habitat upstream of PSCIS crossing 197976.

The stream was surveyed upstream from crossing 197976 for 345m (Figure [5.37](#)). The dominant substrate was cobbles with gravels sub-dominant. The average channel width was 8.1m, the average wetted width was 4.2m, and the average gradient was 1%. Total cover amount was rated as moderate with deep pools dominant. Cover was also present as small woody debris, undercut banks, and overhanging vegetation. Fish were observed throughout the area surveyed and extensive algae growth was present on stream substrates. Large woody debris was rare and riparian/bank damage due to livestock was minimal and located at what appeared to be watering sites. Fencing was located across the stream in multiple locations. Patches of gravels suitable for spawning were present. Habitat value was rated as medium as the surveyed area was considered an important migration corridor containing suitable spawning habitat and having moderate rearing potential.

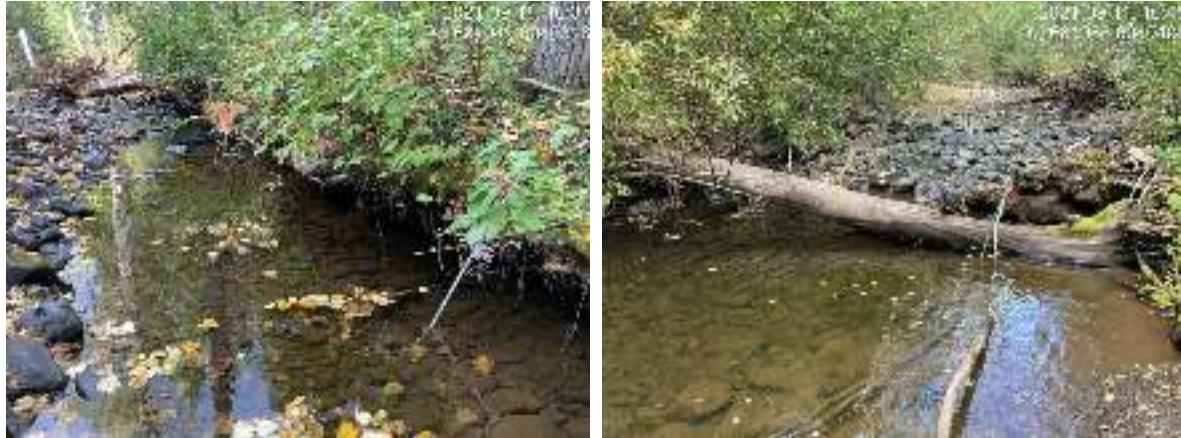
Figure 5.38: Left: Typical habitat upstream of PSCIS crossing 197975. Right: Typical habitat upstream of PSCIS crossing 197975.

The stream was surveyed upstream from crossing 197975 for 550m (Figure [5.38](#)). The dominant substrate was cobbles with gravels sub-dominant. Total cover amount was rated as moderate with deep pools dominant. Cover was also present as small woody debris, boulders, undercut banks, and overhanging vegetation. The average channel width was 7.7m, the average wetted width was 3.5m, and the average gradient was 1%. Immediately upstream of the crossing for ~80m, extensive anthropogenic damage was noted due to dredging of the channel. Heavy cattle grazing was also observed on the left bank. Juvenile salmonids were observed occasionally throughout the area surveyed. Fencing was located across the stream approximately 250m upstream of the culvert. Patches of gravels suitable for spawning were present. Habitat value was rated as medium as the surveyed area was considered an important migration corridor containing suitable spawning habitat and having moderate rearing potential.

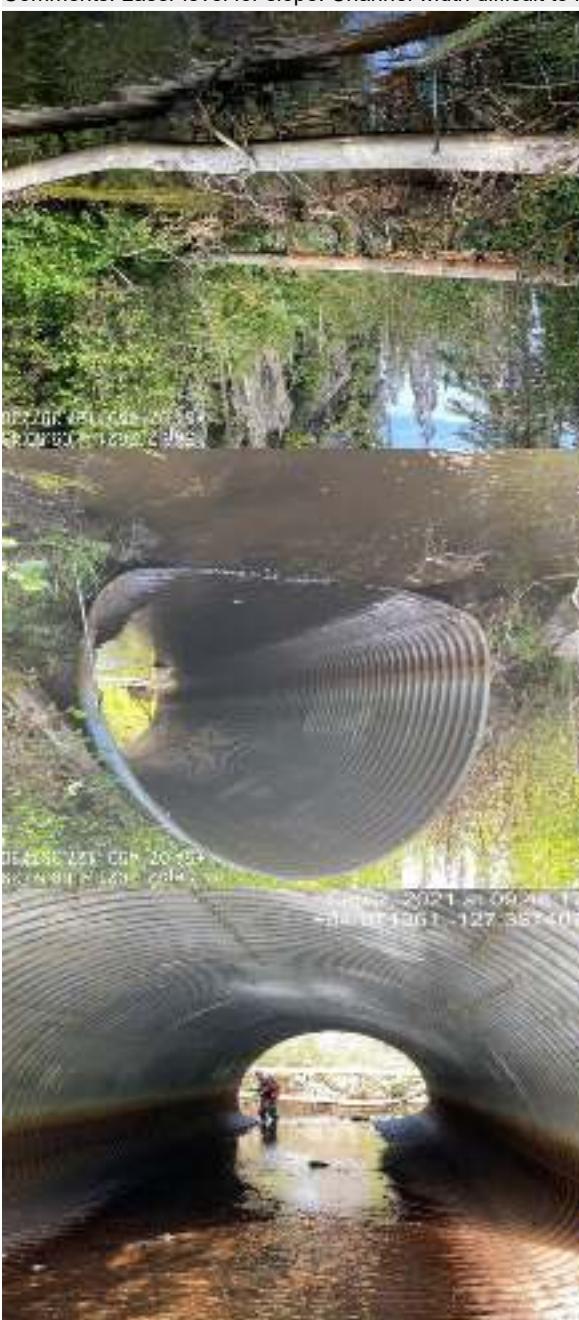
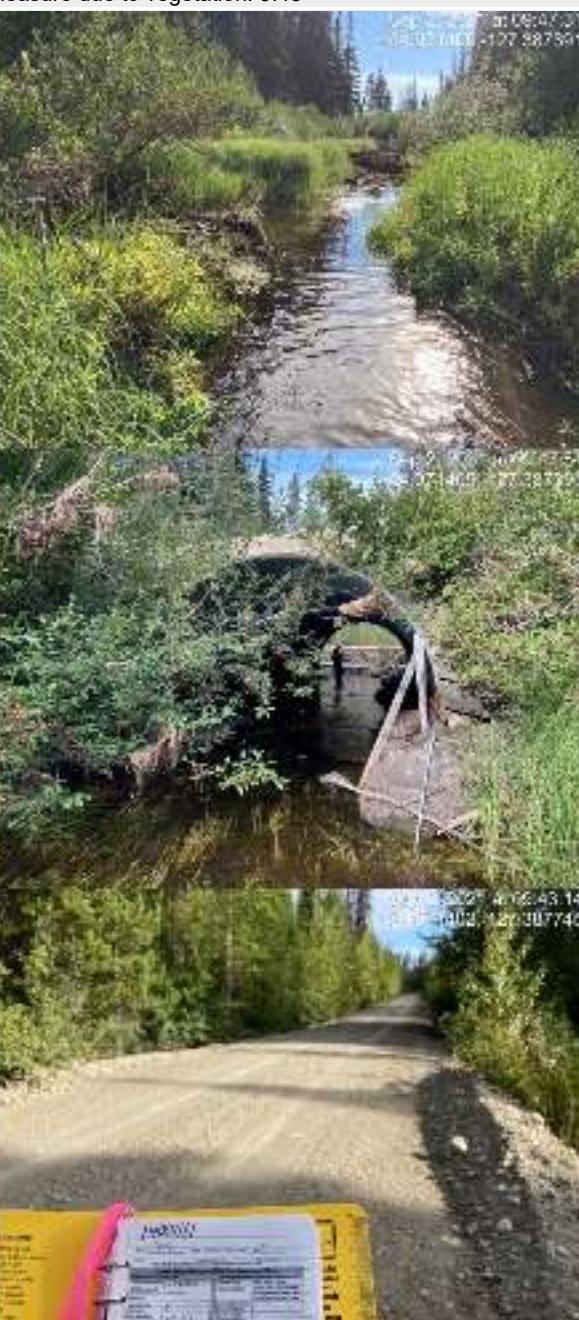
Location and Stream Data	•	Crossing Characteristics	-
Comments: Laser level for slope. Channel width difficult to measure due to vegetation. 9:43

Should restoration/maintenance activities proceed at the site, replacement of PSCIS crossing 198000 with a bridge (14m span) is recommended.

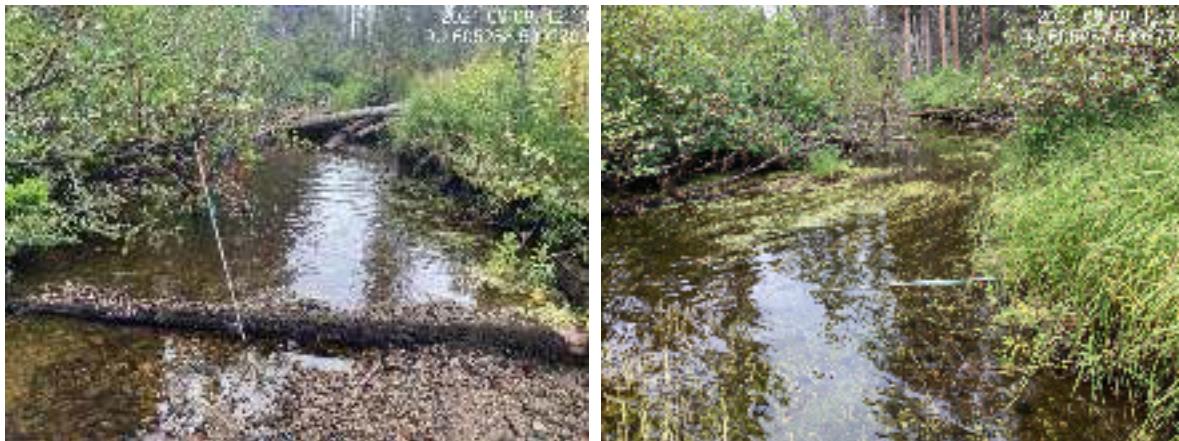
Figure 5.39: Left: Typical habitat downstream of PSCIS crossing 198000. Right: Typical habitat downstream of PSCIS crossing 198000.

The stream was surveyed downstream from the culvert for 300m (Figure [5.39](#)). Total cover amount was rated as with instream vegetation dominant. Cover was also present as small woody debris, large woody debris, and overhanging vegetation (Table [5.67](#)). The average channel width was 6.2m, the average wetted width was 5.1m and the average gradient was 1.2%. The dominant substrate was gravels with cobbles subdominant. The habitat was rated as high value for salmonid rearing and spawning.

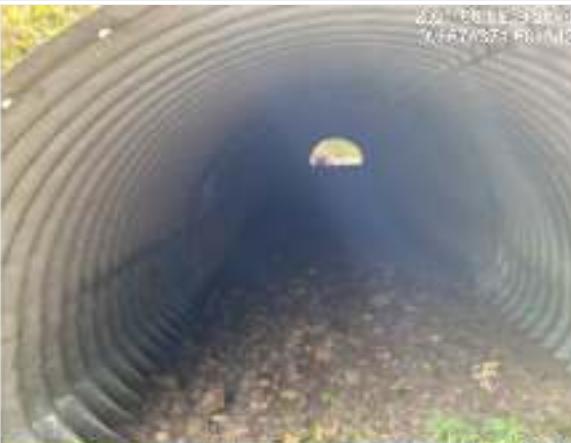
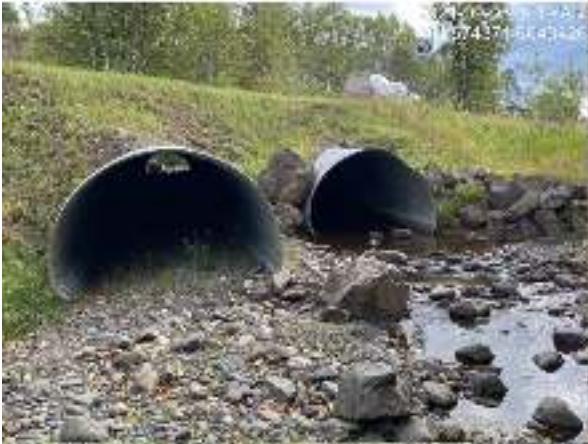
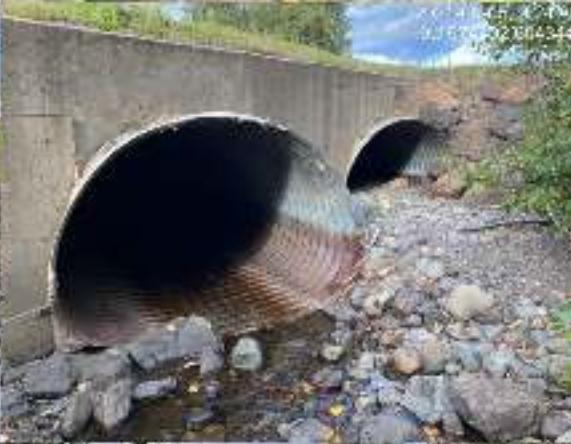
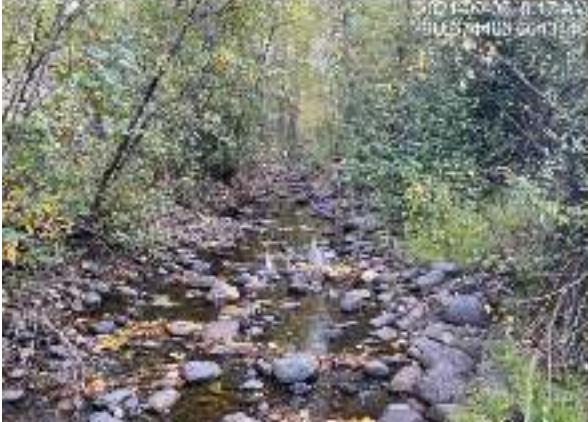
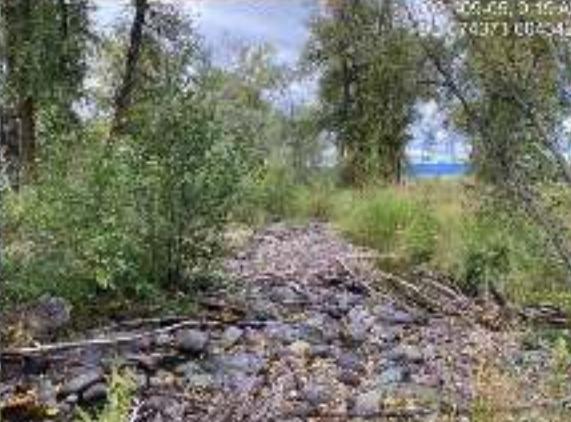
Location and Stream Data	•	Crossing Characteristics	-
Comments: Habitat confirmation conducted. Two pipes (2.5m x 2.5m). Culvert slope measured with lazel level. Fish observed. Could not locate downstream crossing on railway. Garmin backroads mapbook shows stream connecting with side channel of the Bulkley. 9:17			
NO IMAGE AVAILABLE

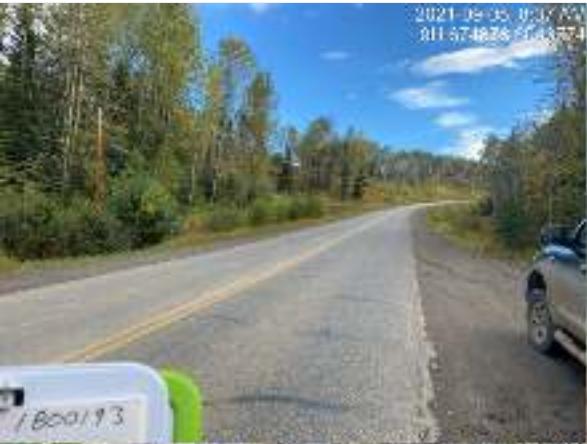
Location and Stream Data	•	Crossing Characteristics	-
Comments: Habitat confirmation conducted. ~110mm fish observed in outlet pool. Culvert slope surveyed with lazer level. 8:37

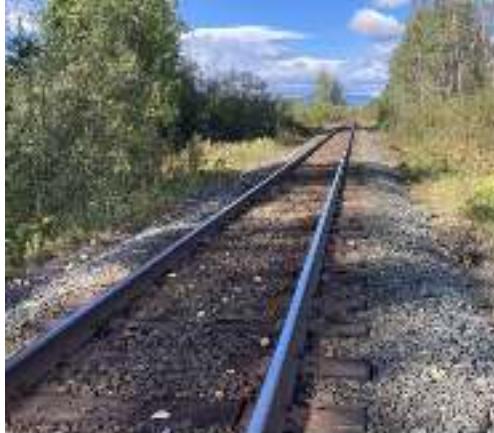
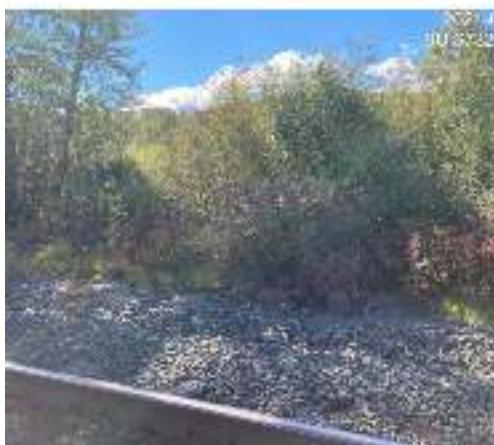
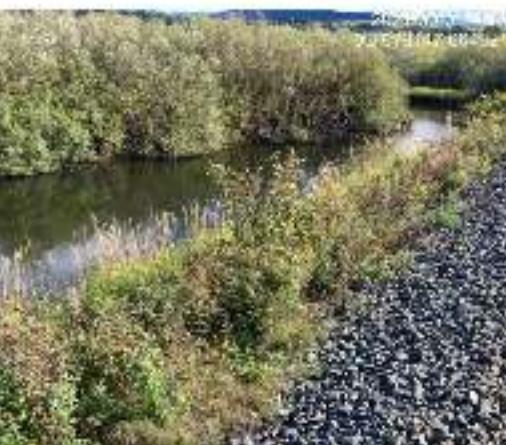
Location and Stream Data	•	Crossing Characteristics	-
<p>Comments: No crossing actually exists in the field however site entered as a placeholder because there should be connection between Bulkley and Cesford at this location. Survey found no culvert and landowner reported none present. Large man-made ditch through adjacent field may be draining some water. Lower section of stream dry at time of survey. 11:22</p>

For PSCIS crossing 198090 it is recommended some sort of fish passable structure be installed under the railway to reconnect Cesford Creek with the Bulkley River. The cost of the work is roughly estimated at \$6,000,000.

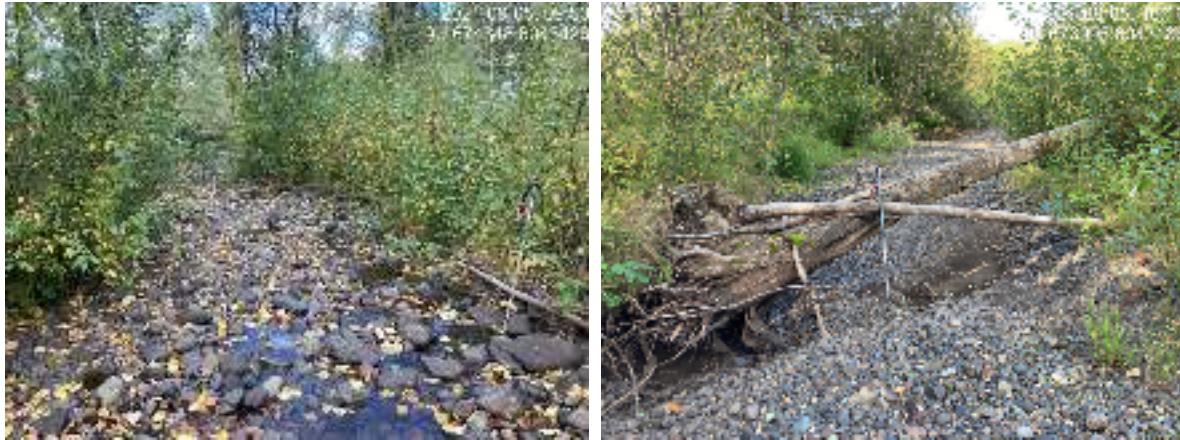
Figure 5.42: Left: Typical habitat downstream of PSCIS crossing 198048. Right: Typical habitat downstream of PSCIS crossing 198048.

The stream was surveyed downstream from crossing 198048 at Highway 16 for 1400m to the mainstem of the Bulkley River (Figure [5.42](#)). Total cover amount was rated as with overhanging vegetation dominant. Cover was also present as small woody debris and undercut banks (Table [5.73](#)). The average channel width was 5.5m, the average wetted width was 1.5m and the average gradient was 3.5%. The dominant substrate was cobbles with gravels subdominant. The habitat was rated as medium value for salmonid rearing and spawning.

Should restoration/maintenance activities proceed, replacement of PSCIS crossing 198048 with a bridge (10m span) is recommended. The cost of the work is estimated at \$6,000,000 for a cost benefit of 1.8 linear m/\$1000 and 9.1 m<sup>2</sup>/\$1000.

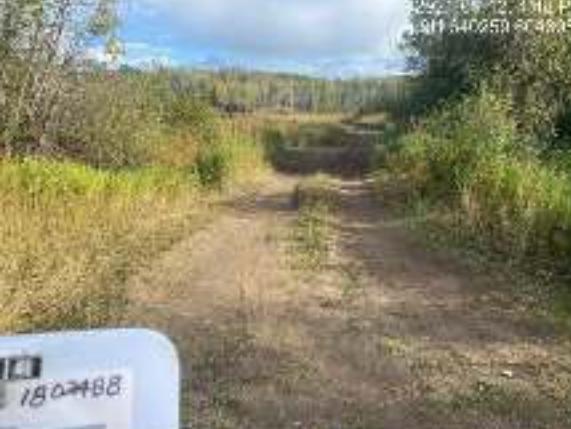
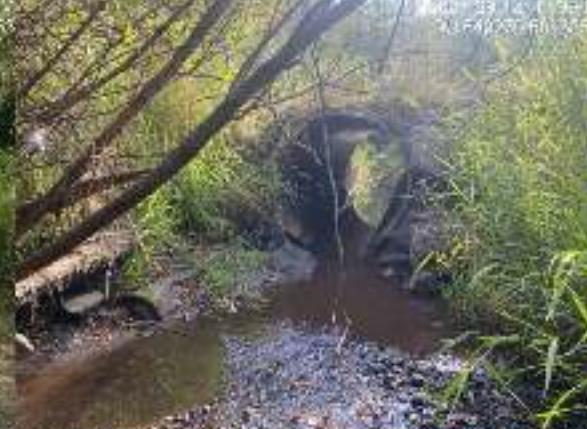
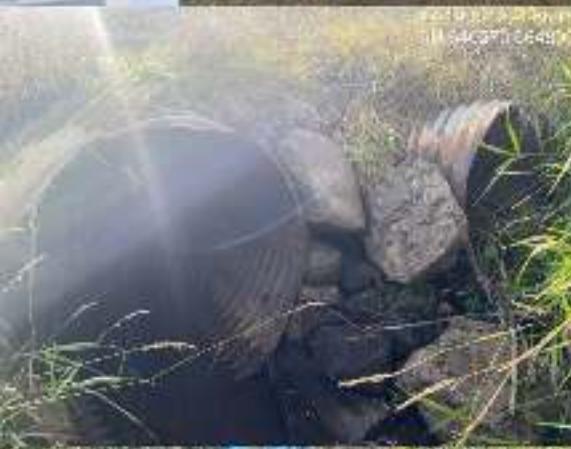
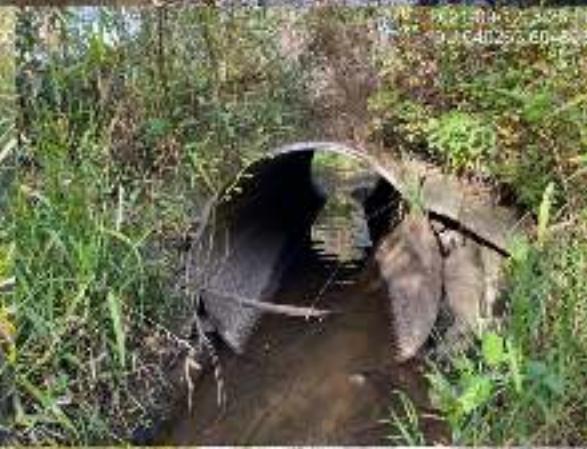
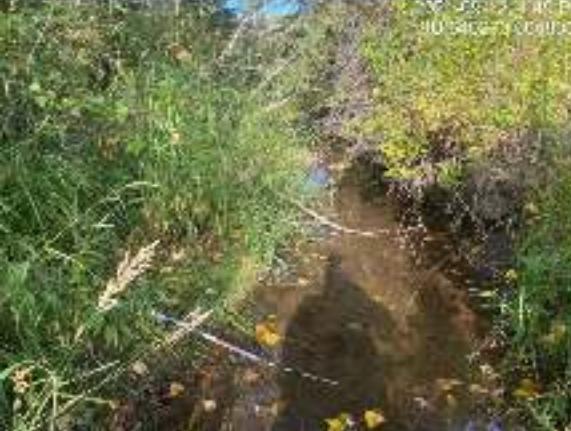
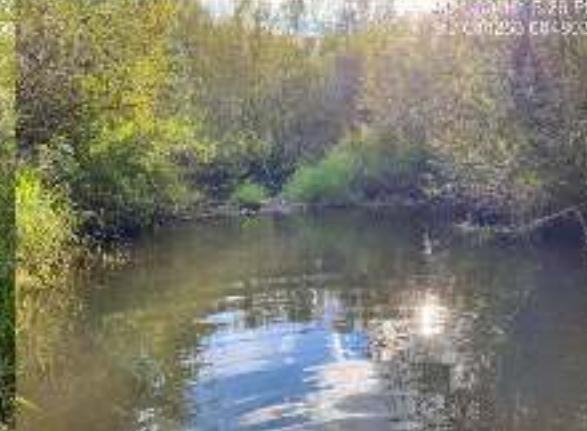
Location and Stream Data	•	Crossing Characteristics	-
Comments: Udder View Farm. Currently appears passable for all life stages and species but may present slight barrier at time of year when flow are high. Large outlet pool indicates that culvert is undersized. Landowners adjacent to the stream report that the channel was historically relocated through the fields near the river and they would like to work together to relocate. 16:48

Should restoration/maintenance activities proceed at the site, replacement of PSCIS crossing 198066 with a bridge (10m span) is recommended.

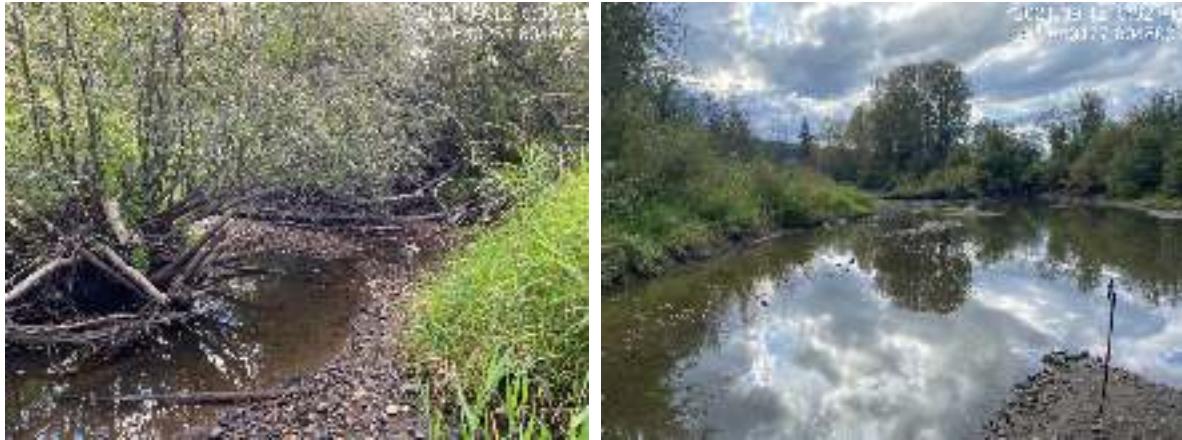
Figure 5.44: Left: Typical habitat downstream of PSCIS crossing 198066. Right: Habitat on side channel of Bulkley River downstream of crossing 198066.

The stream was surveyed downstream from the culvert for 100m (Figure 5.44). Total cover amount was rated as with overhanging vegetation dominant. Cover was also present as (Table 5.78). The

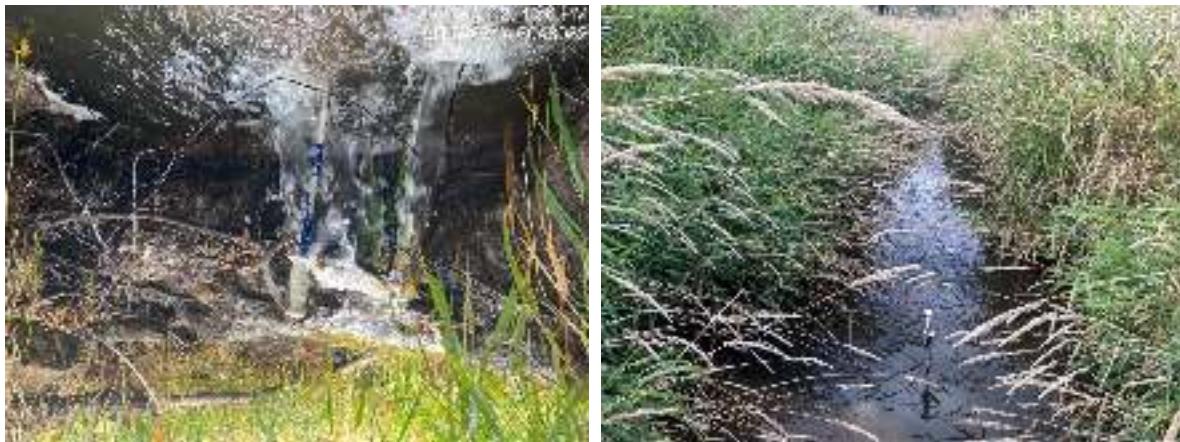
Figure 5.45: Left: Small drop (50cm high) located ~20m upstream of PSCIS crossing 198066. Right: Habitat immediately upstream of PSCIS crossing 198066 that flows through a hay field within an excavated trench for approximately 350m.
