## Bulkley River and Morice River Watershed Groups Fish Passage Restoration Planning 2021 - DRAFT

Prepared for  
Habitat Conservation Trust Foundation - CAT21-6-288  
BC Fish Passage Remediation Program  
Canadian Wildlife Federation

Prepared by  
Al Irvine, B.Sc., R.P.Bio.  
New Graph Environment Ltd.  
on behalf of  
Society for Ecosystem Restoration in Northern British Columbia

Version 0.0.9.1 - DRAFT  
2022-05-02

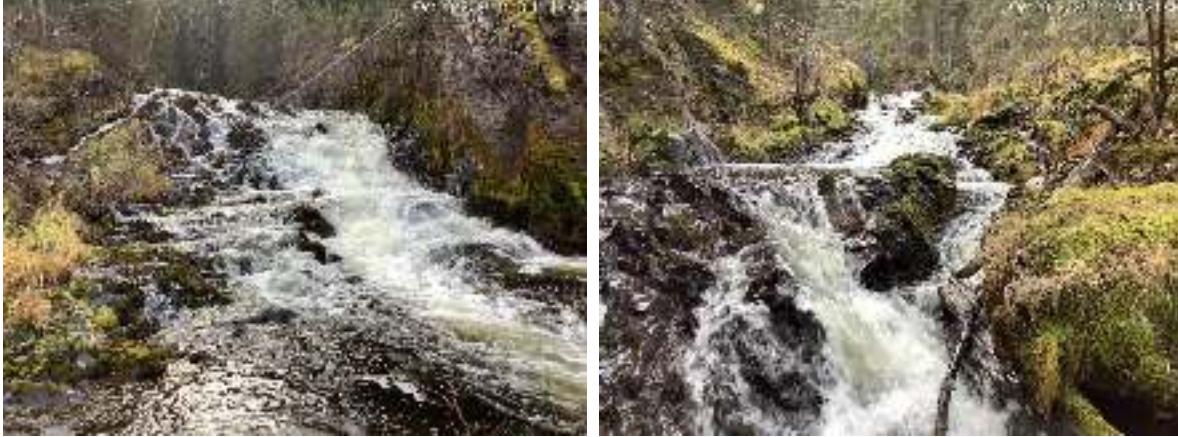
Figure 4.1: Left: Bulkley Falls main channel. Right: Bulkley Falls side channel.

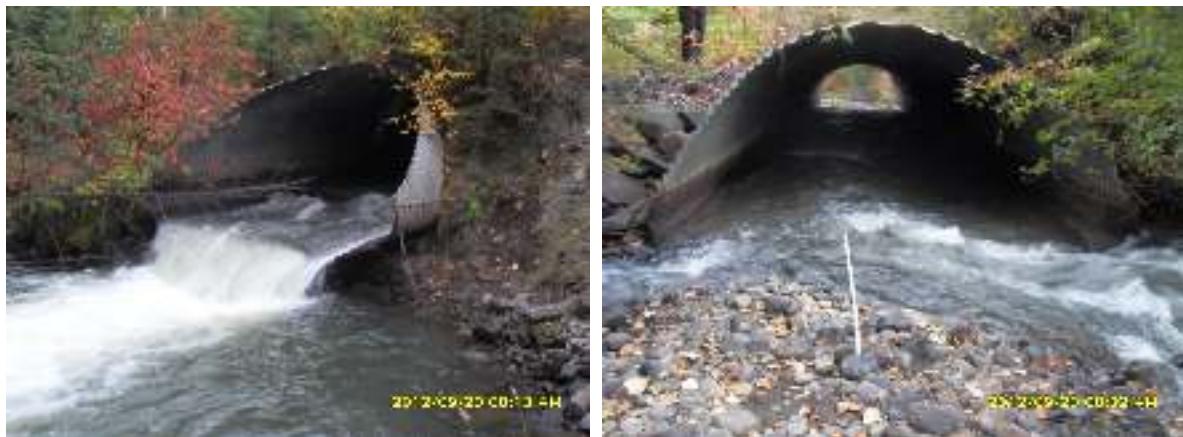
Figure 5.4: Left: Outlet of PSCIS crossing 57944 in 2012. Photo from PSCIS. Right: Inlet of PSCIS crossing 57944 in 2012. Photo from PSCIS.

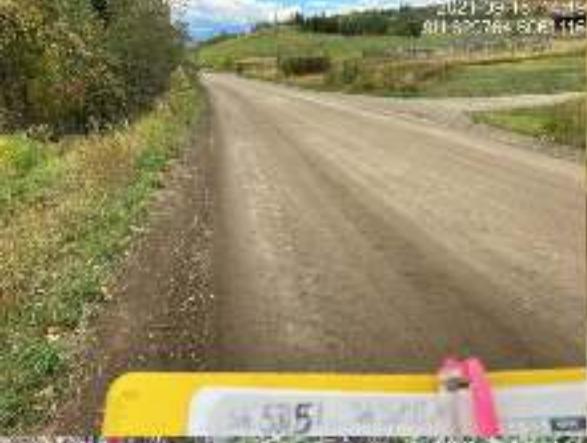
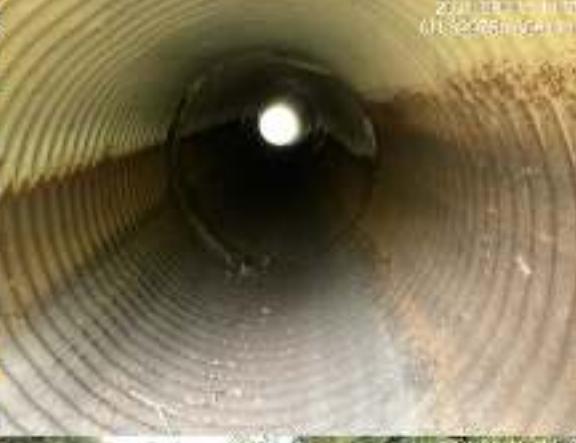
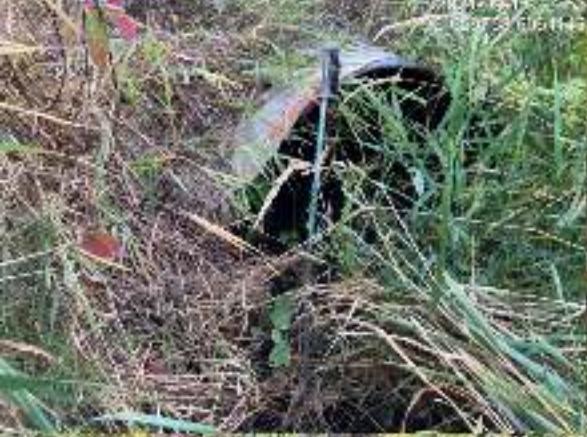
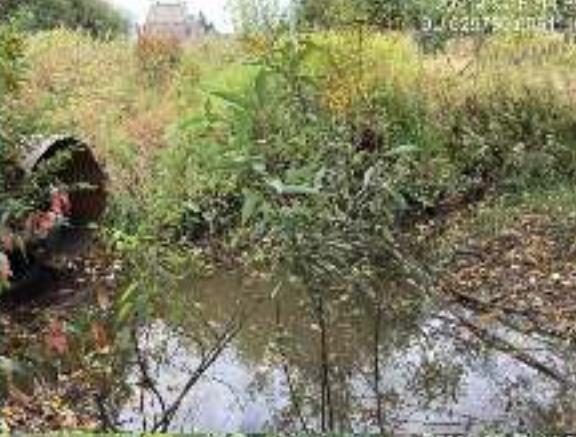
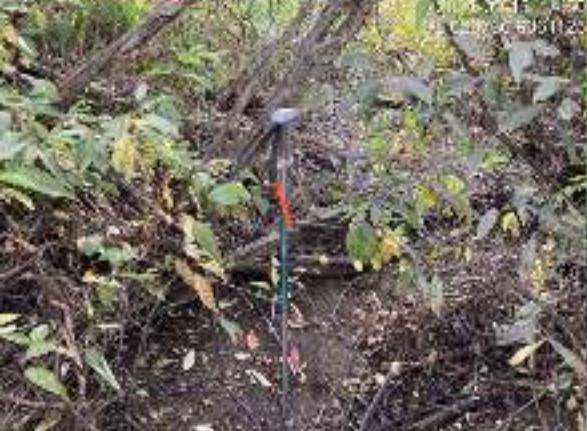
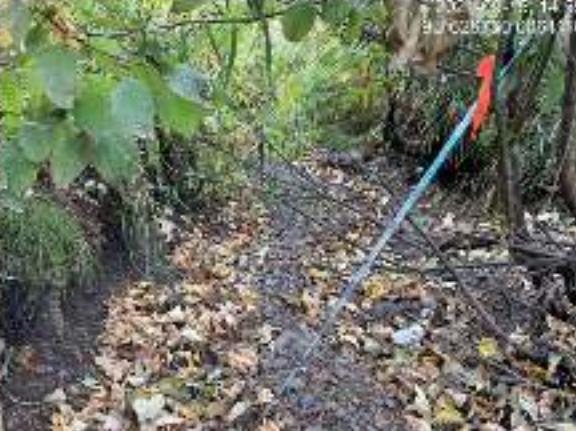
Location and Stream Data	•	Crossing Characteristics	-
Comments: Channel dry. Current pool water depth is 0.31, outlet drop measured using long tape to simulate riffle crest height. 14:48

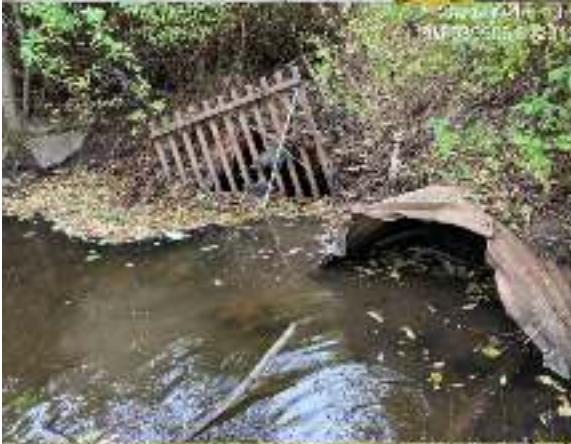
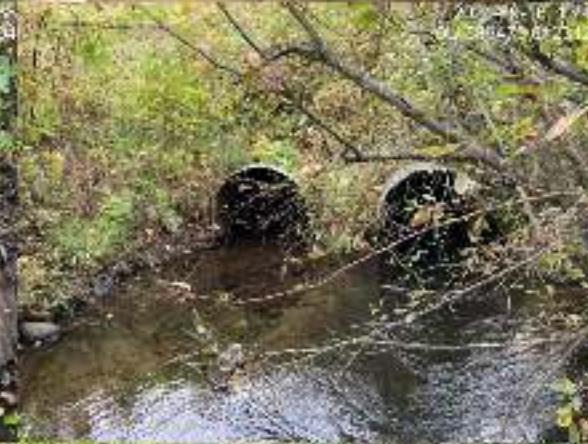
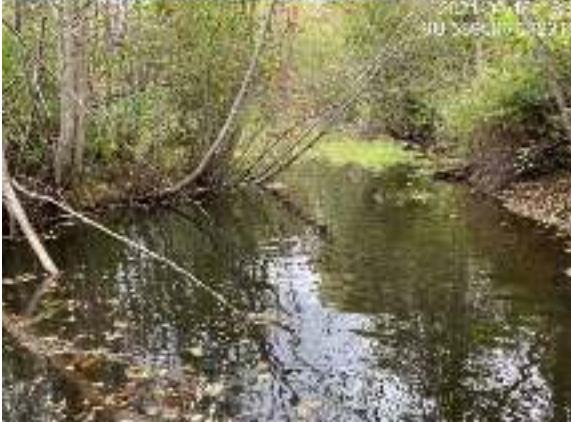
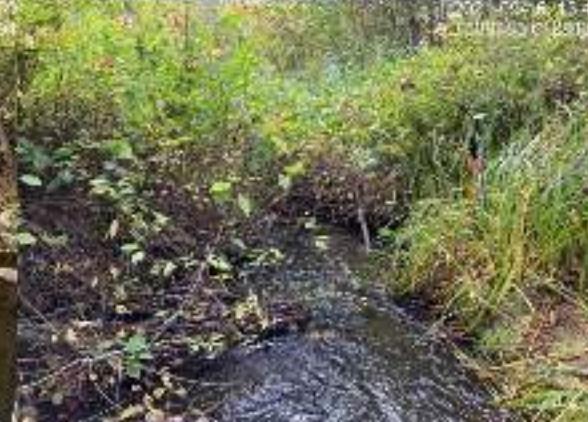
Location and Stream Data	•	Crossing Characteristics	-
Comments: 2 pipes. Both have water, left bank one is flowing. Assessment comments indicate right bank pipe is backwatered 100% but changed to 25% based on photos and past PSCIS data and photos which also indicated not backwatered. Suspect blockage due to debris. Outlet water depth, fish sighted in outlet of right barrel. 13:42

Should restoration/maintenance activities proceed, replacement of PSCIS crossing 124420 with a bridge (30m span) is recommended. The cost of the work is estimated at \$18,000,000 for a cost benefit of 0.5 linear m/\$1000 and 2.9 m<sup>2</sup>/\$1000. These cost benefit estimates assume that adult coho spawner passage through 124420 will result in passage through upstream crossings which rank as barriers according to the provincial metric but are likely to be passable to adult coho.

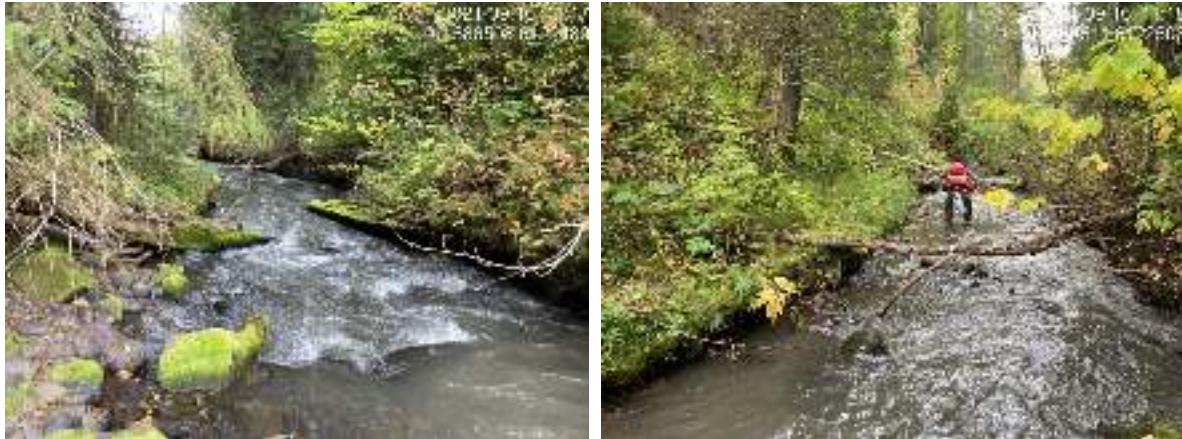
Figure 5.12: Left: Typical habitat downstream of PSCIS crossing 124420. Right: Typical habitat downstream of PSCIS crossing 124420.

The stream was surveyed downstream from the culvert for 375m (Figure [5.12](#)). Total cover amount was rated as with large woody debris dominant. Cover was also present as small woody debris, boulders, and overhanging vegetation (Table [5.22](#)). The average channel width was 6.1m, the average wetted width was 4.6m and the average gradient was 2.1%. The dominant substrate was gravels with cobbles subdominant. Survey notes indicate a complex system with deeply undercut banks with steep sections and confined areas. Segments of stream showed signs of erosion and deposition of fine sediments. Multiple areas with braided channels around woody debris and evidence of large fluctuations in flow were noted. The habitat was rated as high value for salmonid rearing and spawning. The reader is referred to Newman and England (2018) for addition information on habitat containing more detail.

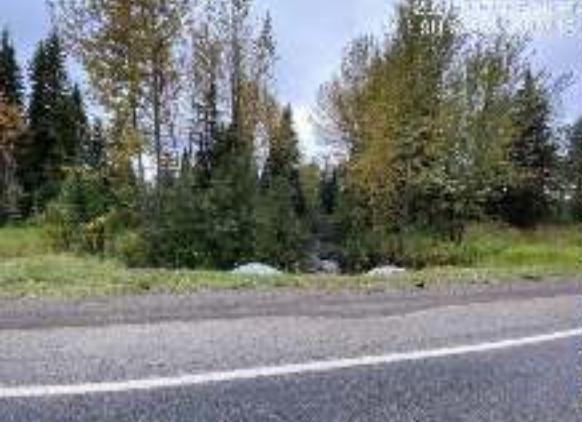
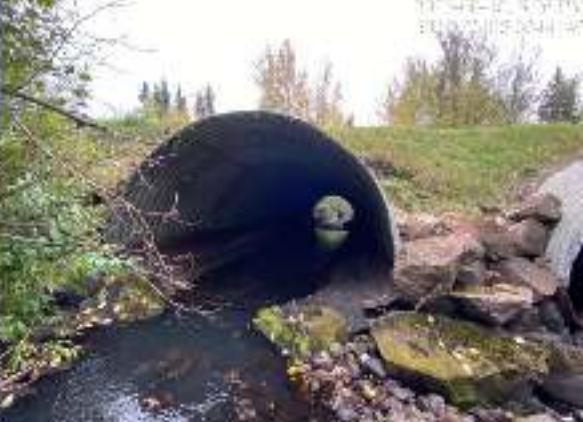
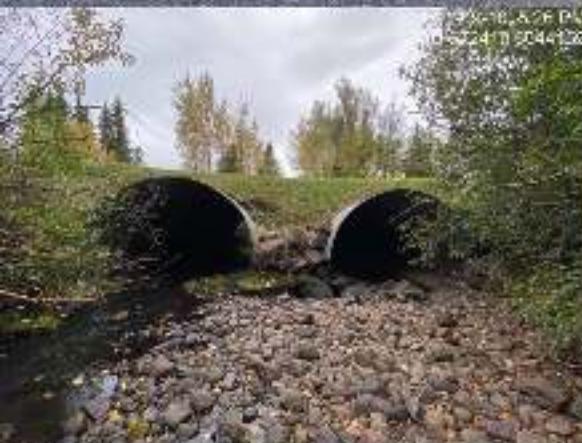
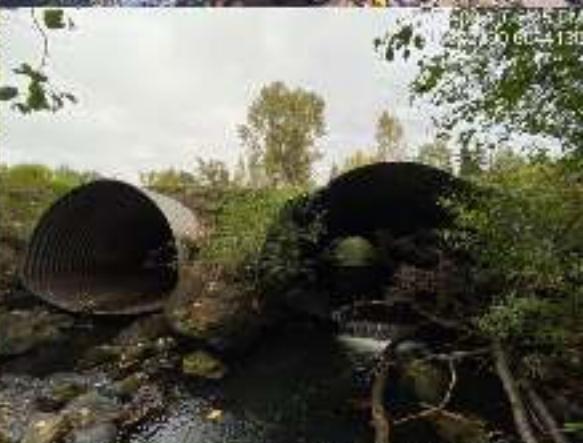
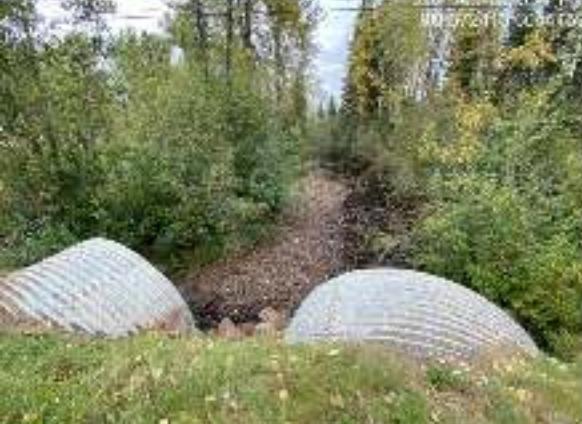
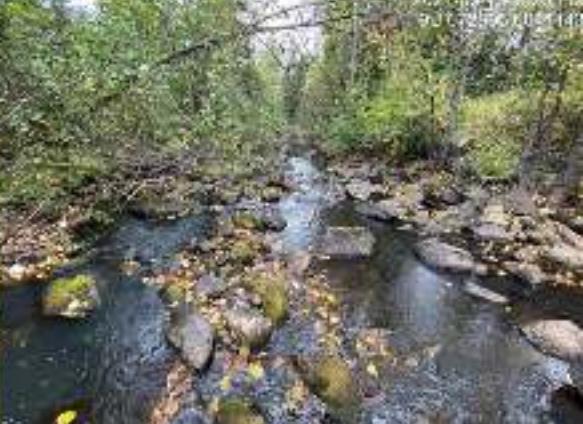
Location and Stream Data	•	Crossing Characteristics	-
Comments: Culvert and habitat measurements taken in 2020. Multipass closed site electorfishing conducted in 2021 upstream and downstream of highway. 17:25

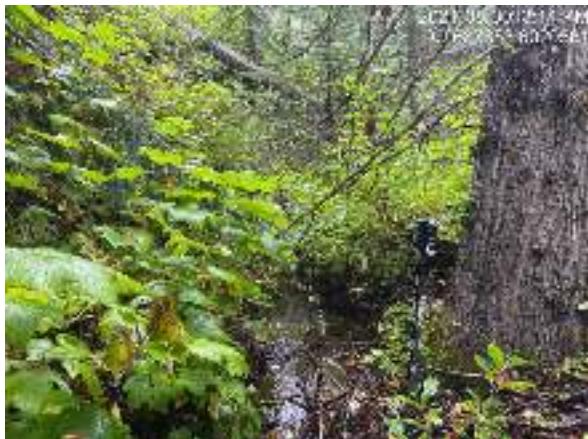
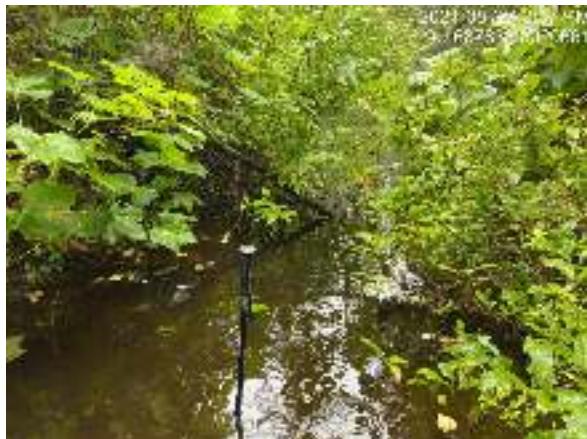
Figure 5.20: Left: Habitat downstream of PSCIS crossing 197909. Right: Habitat downstream of PSCIS crossing 197909.

The stream was surveyed downstream from crossing 197909 for 400m (Figure [5.20](#)). The dominant substrate was fines with NA sub-dominant., Total cover amount was rated as abundant with dominant. Cover was also present as ., The average channel width was 1.3m, the average wetted width was 1.3m, and the average gradient was 3.2%. At approximately 300m downstream of the culvert the stream became wider with glide habitat to ~50cm in depth resulting from sediments deposited by a failure on the steep north canyon wall. Habitat was rated as low value for salmonid rearing and spawning due to the small size of the stream, low flows and fine substrate.

Should restoration/maintenance activities proceed at the site, replacement of PSCIS crossing 197909 with a clear span bridge is recommended. The cost of the work is estimated at \$40,000 for a cost benefit of 5.6 linear m/\$1000 and 7.3 m<sup>2</sup>/\$1000.

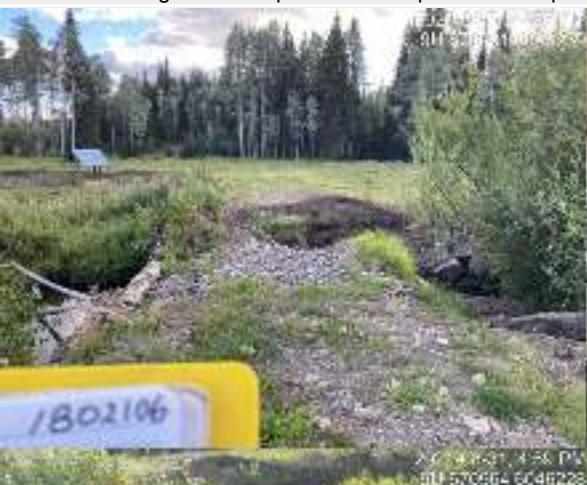
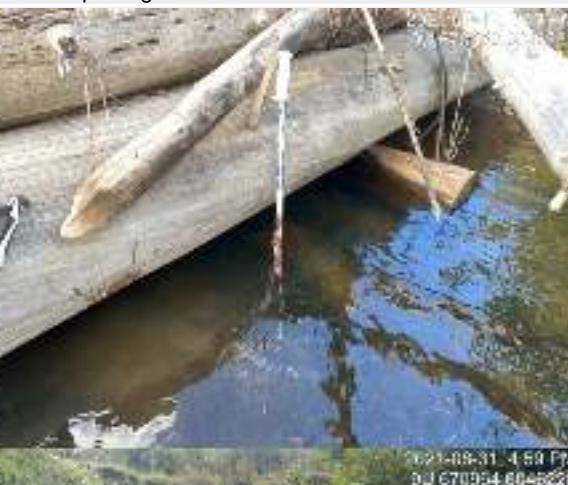
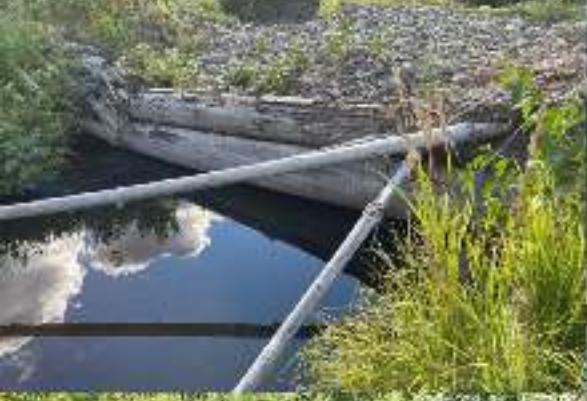
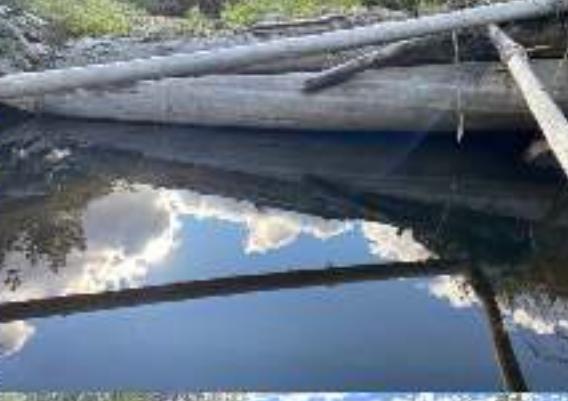
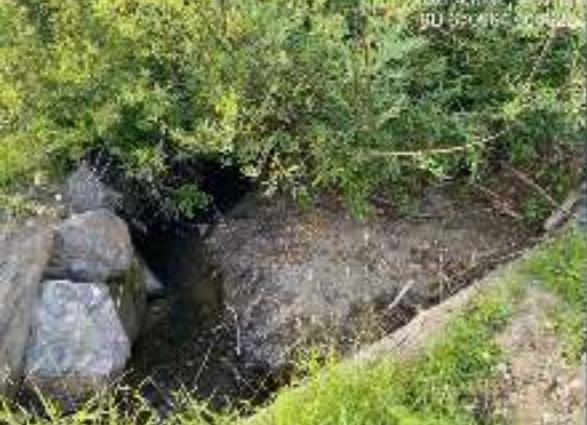
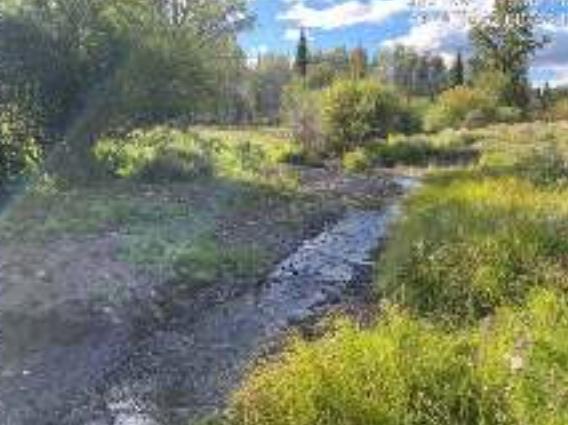
Photos: From top left clockwise: Road/Site Card, Barrel, Outlet, Downstream, Upstream, Inlet.

Location and Stream Data	•	Crossing Characteristics	-
Comments: Bridge has collapsed and is impediment to upstream fish passage. Habitat confirmation conducted. 16:56

Should restoration/maintenance activities proceed at the site, removal of PSCIS crossing 197912 is recommended. In addition to removal of the collapsed bridge, resloping of banks and the installation of live cuttings/pegboarding is recommended in three areas downstream where cattle trampling is resulting in significant erosion. A map of the erosion areas and associated prescriptions for rehabilitation of the downstream corners is provided as Figure [??](#). The cost of the work is estimated at \$30,000 for a cost benefit of 924 linear m/\$1000 and 3973.2 m<sup>2</sup>/\$1000.

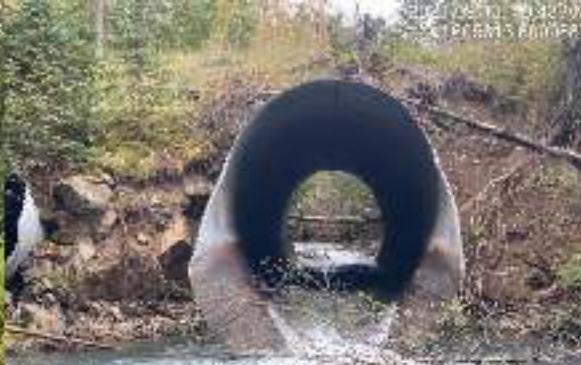
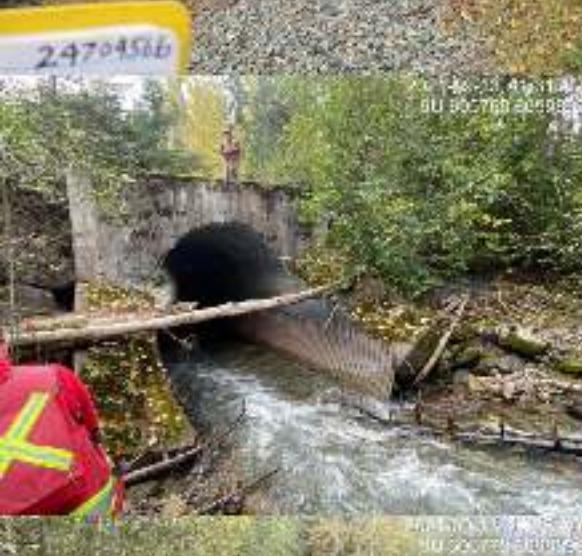
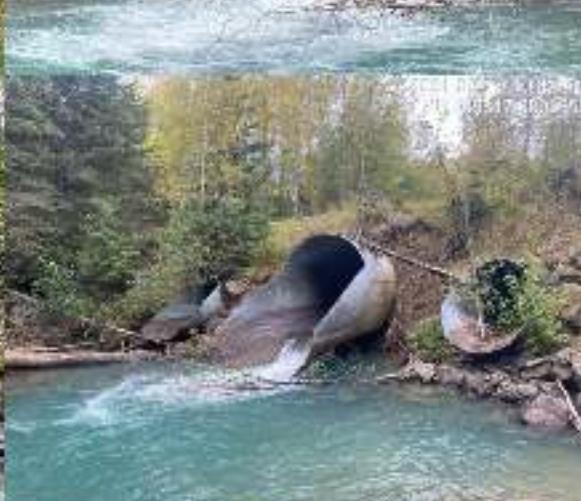
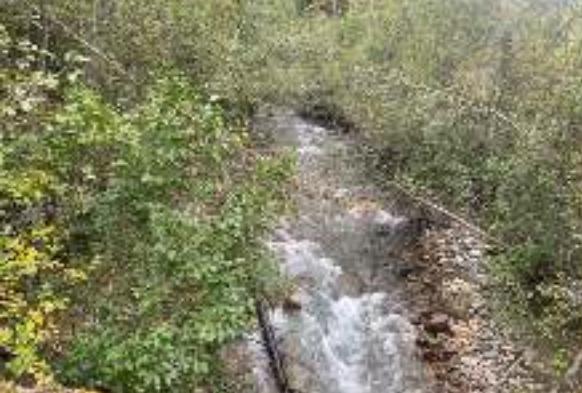
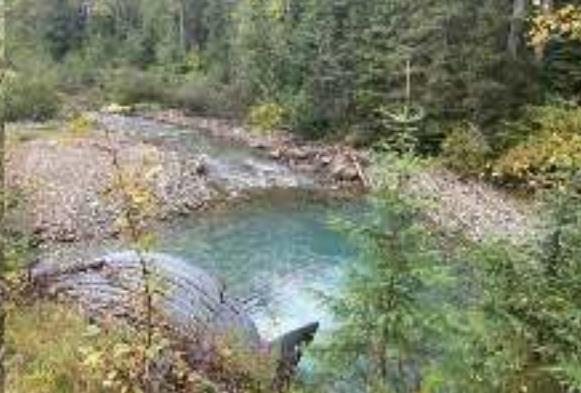
Location and Stream Data	•	Crossing Characteristics	-
Comments: Outlet is cracked and drops. Inlet embedded to 2/3 way. 10:33

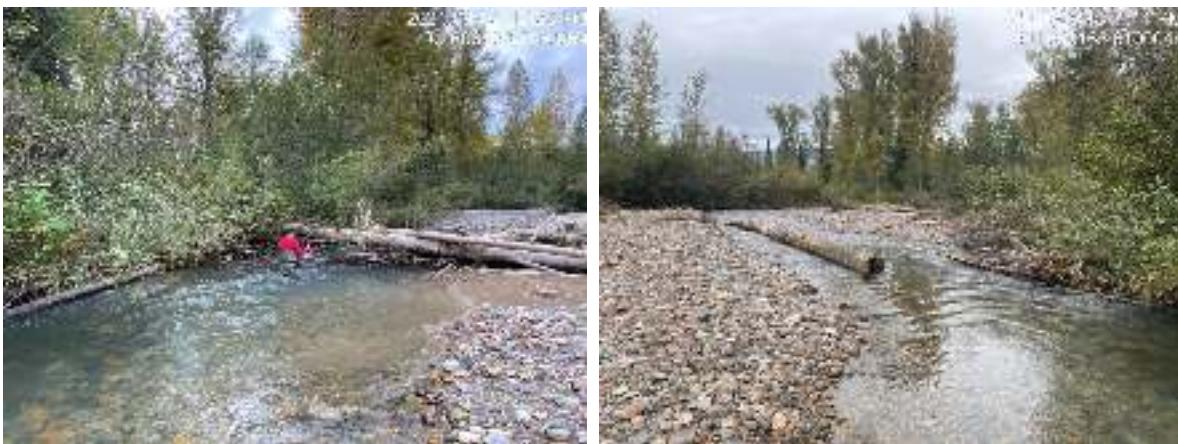
The stream was surveyed downstream from crossing 197960 for 450m (Figure 5.26). Total cover amount was rated as moderate with overhanging vegetation dominant. Cover was also present as small woody debris, large woody debris, undercut banks, and deep pools. The average channel

width was 25.4m, the average wetted width was 8.9m and the average gradient was 1.7%. The dominant substrate was cobbles with gravels subdominant. The stream was moderately turbid due to glacial flour with abundant quantities of gravels suitably sized for trout and salmon species present. The stream channel was noted as riffle dominated with a lack of complexity due to adjacent riparian clearing and dyke installation. The habitat was rated as medium value for salmonid rearing and spawning.

Figure 5.26: Left: Typical habitat downstream of PSCIS crossing 197960. Right: Typical habitat downstream of PSCIS crossing 197960.

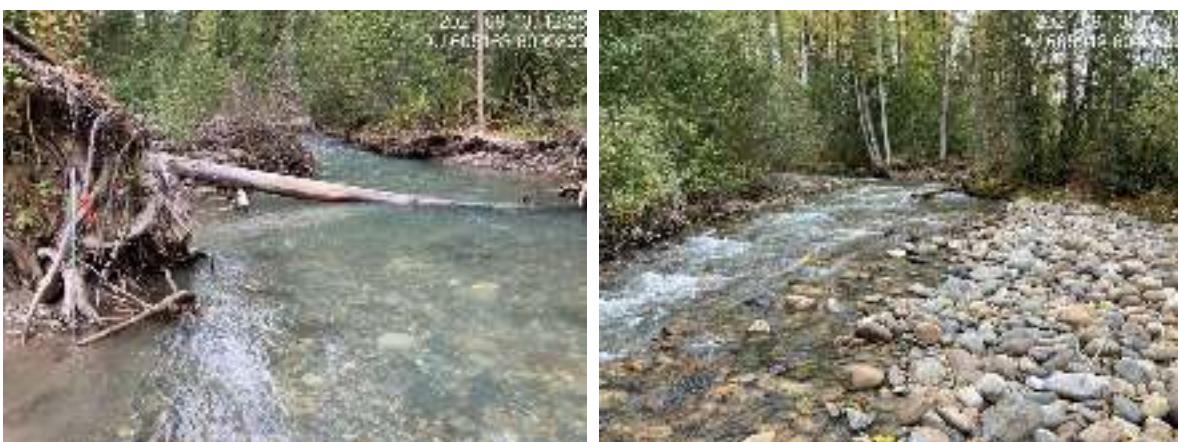
The stream was surveyed upstream from crossing 197960 for 1000m (Figure [5.27](#)). Total cover amount was rated as moderate with overhanging vegetation dominant. Cover was also present as small woody debris, large woody debris, boulders, and undercut banks. The average channel width was 18m, the average wetted width was 8.9m and the average gradient was 2.8%. The dominant substrate was cobbles with gravels subdominant. The first 50 - 100m upstream of crossing channel and banks were noted as armoured with riprap. Abundant gravels suitable for resident and anadromous salmonids were noted throughout. The habitat was rated as medium value as an important migration corridor containing suitable spawning habitat and having moderate rearing potential.

Figure 5.27: Left: Typical habitat upstream of PSCIS crossing 197960. Right: Typical habitat upstream of PSCIS crossing 197960.

Should restoration/maintenance activities proceed, replacement of PSCIS crossing 197960 with a bridge (23m span) is recommended. The cost of the work is estimated at \$13,800,000 for a cost benefit of 0.7 linear m/\$1000 and 13 m<sup>2</sup>/\$1000.

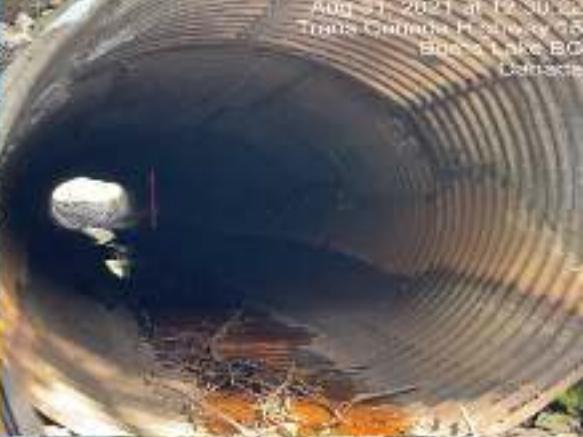
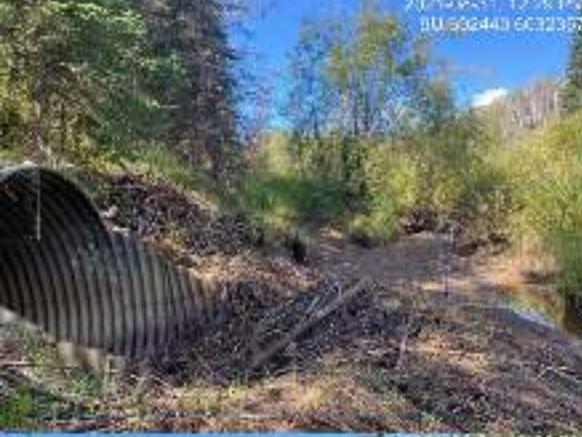
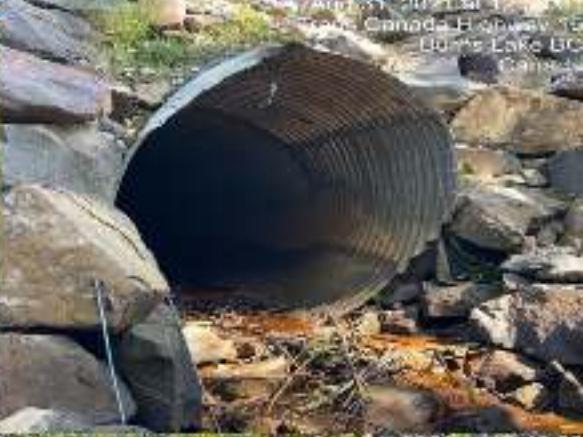
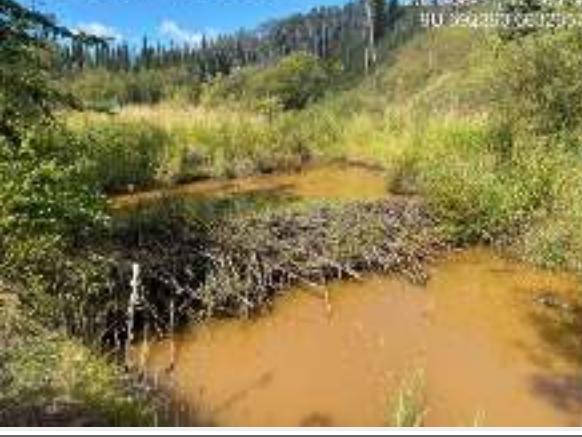
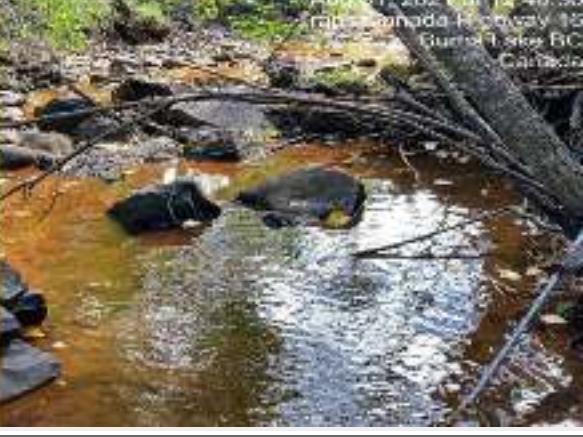
At the time of the survey, PSCIS crossing 197967 was non-backwatered and ranked as a barrier to upstream fish passage according to the provincial protocol (MoE 2011b) (Table 5.47). Water temperature was 12°C, pH was 7.2 and conductivity was 359uS/cm. A beaver dam was noted just upstream of the culvert inlet (~1.5m high).

Location and Stream Data	•	Crossing Characteristics	-
Comments: Beaver dam at inlet ~1.5m high. Rocks placed at outlet reducing drop to 0, rocks about long, and have staggered drop of 0.7m. 12:20

Should restoration/maintenance activities proceed, replacement of PSCIS crossing 197967 with a bridge (31m span) is recommended. The cost of the work is estimated at \$18,600,000 for a cost benefit of 2.8 linear m/\$1000 and 14.8 m<sup>2</sup>/\$1000.

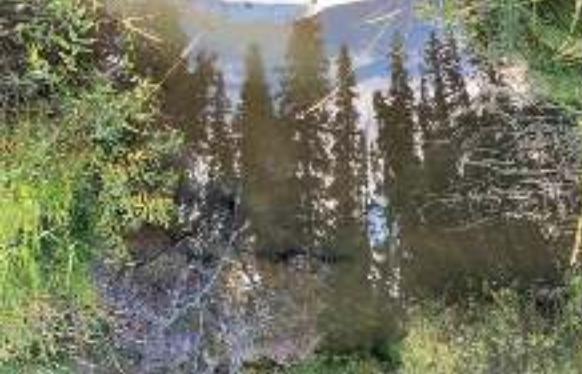
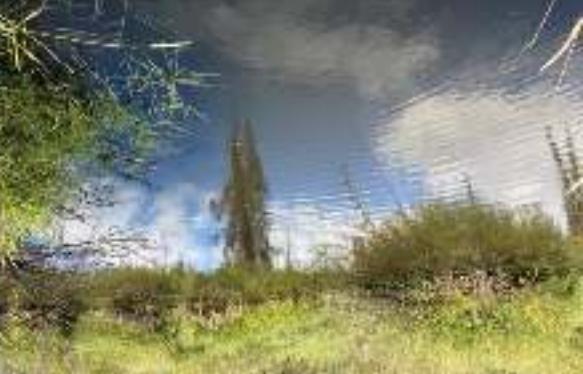
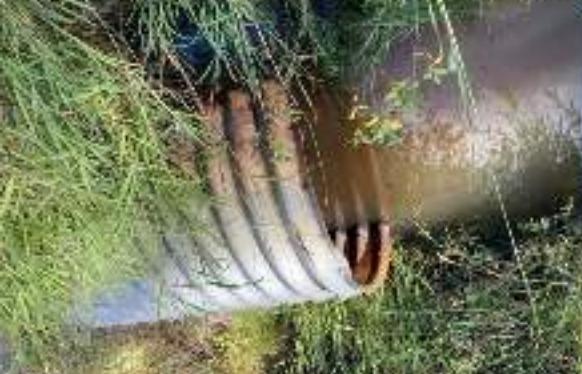
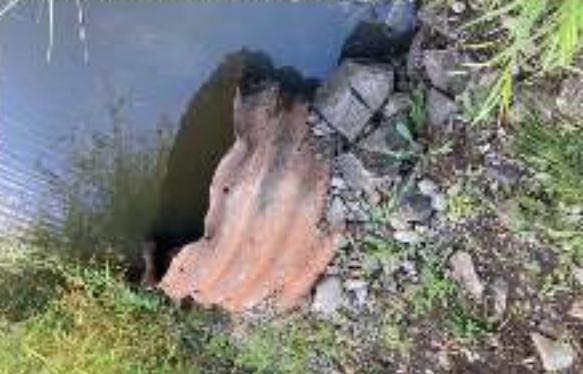
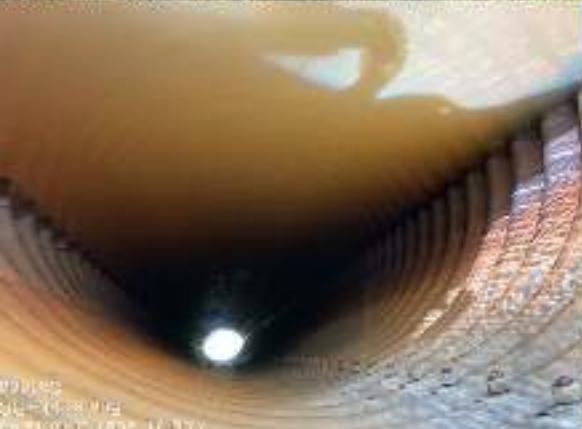
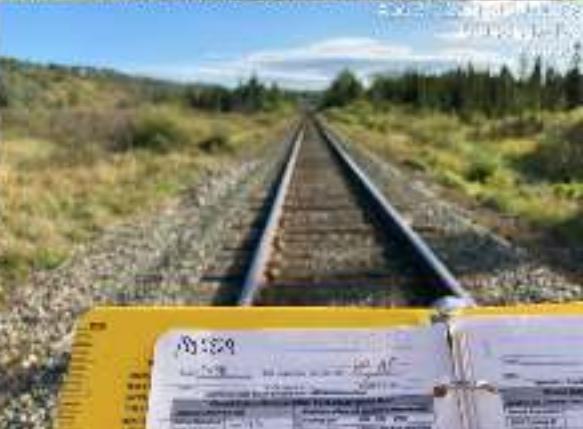
Location and Stream Data	•	Crossing Characteristics	-
Comments: Backwatered fully, appears fully passable. Fish sighted at outlet. Distance from water surface to top of culvert is 70cm. 9:58

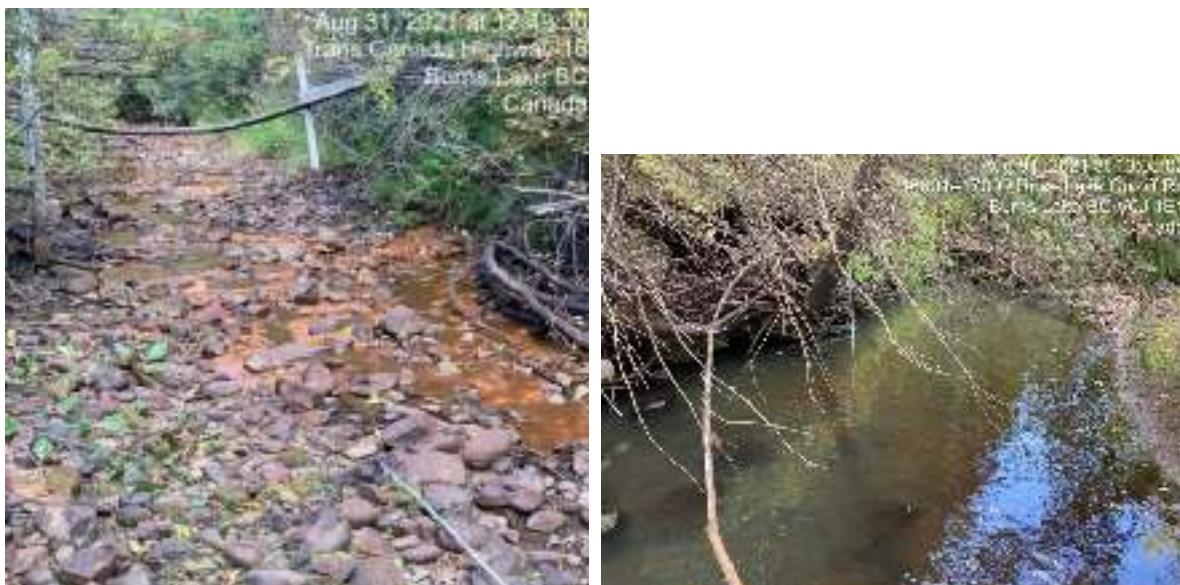
The stream was surveyed downstream from crossing 197967 for 375m to the bridge (PSCIS 197966) located on Ross Lake Cutoff Rd (Figure 5.28). The dominant substrate was cobbles with

fines sub-dominant., The average channel width was 5.7m, the average wetted width was 3.1m, and the average gradient was 2.5%., Total cover amount was rated as trace with overhanging vegetation dominant. Cover was also present as deep pools and instream vegetation. The site was noted as having significant amounts of thick red colored algae for the majority of survey. Flow was very low with uncommon pools. Fence material was noted in or across channel in two locations and riparian vegetation had been removed where an agricultural field and fence line were close. Although considered an important migration corridor, the habitat was rated as medium value for salmonid rearing and spawning due to limited complexity resulting from adjacent agricultural activities.

Figure 5.28: Left: Habitat downstream of PSCIS crossing 197967. Right: Habitat downstream of PSCIS crossing 197967.

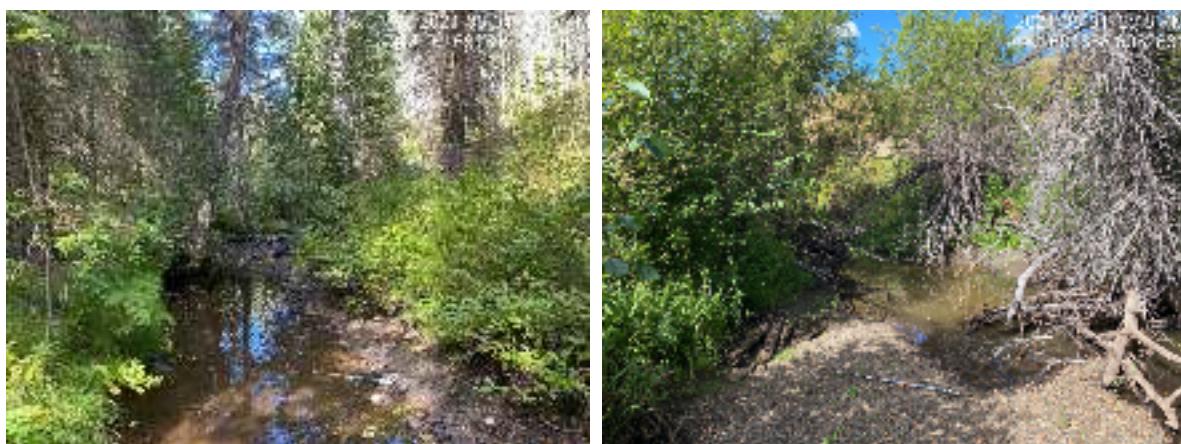
Taman Creek was surveyed for 400m above where it joins the Bulkley River mainstem upstream of PSCIS crossing 197967 (Figure [5.30](#)). The average channel width was 3.8m, the average wetted width was 2.2m, and the average gradient was 2.5%,. The dominant substrate was gravels with cobbles sub-dominant., Total cover amount was rated as moderate with deep pools dominant. Cover was also present as small woody debris, large woody debris, undercut banks, and overhanging vegetation. The water in Taman Creek during the survey was noted as turbid with numerous salmonid fry present at the downstream end of the site. Algae was abundant throughout the system and eroding banks were common. Abundant gravels suitable for resident rainbow trout and coho salmon spawning were present and habitat was rated as medium value for salmon rearing and spawning.

Figure 5.30: Left: Habitat upstream of PSCIS crossing 197967. Right: Habitat upstream of PSCIS crossing 197967.

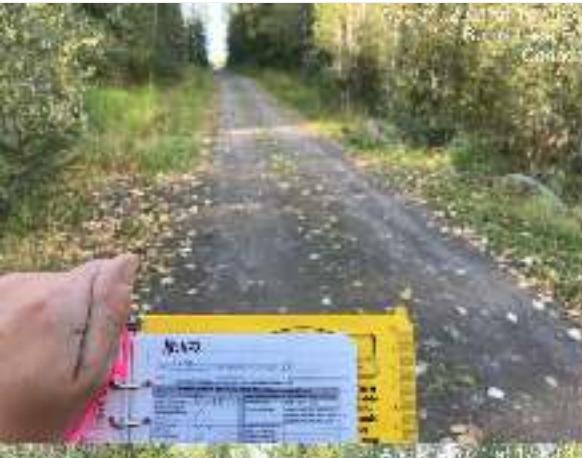
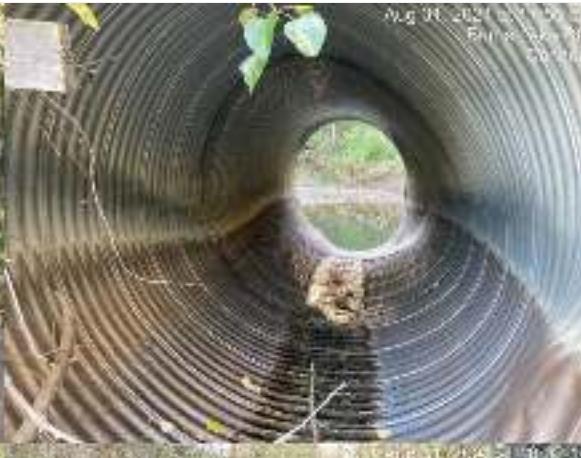
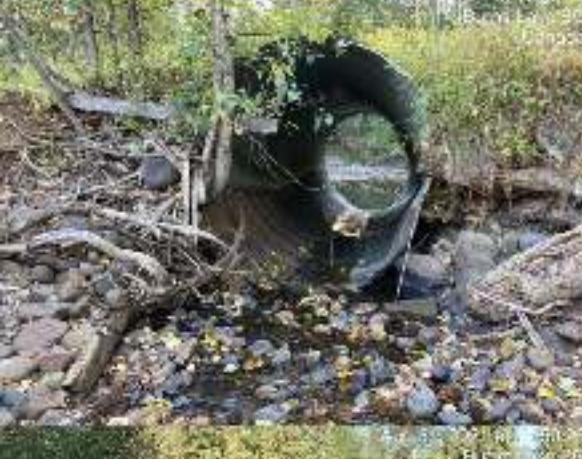
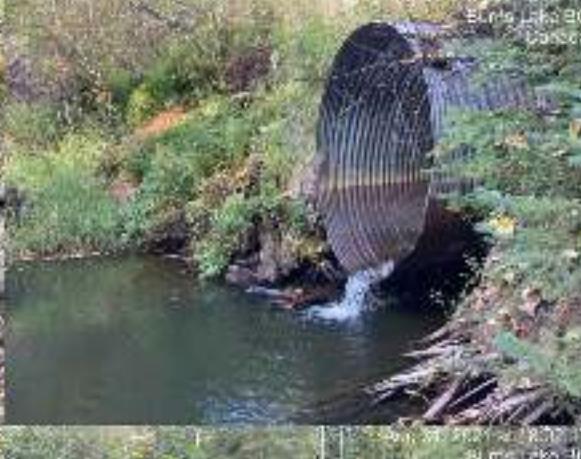
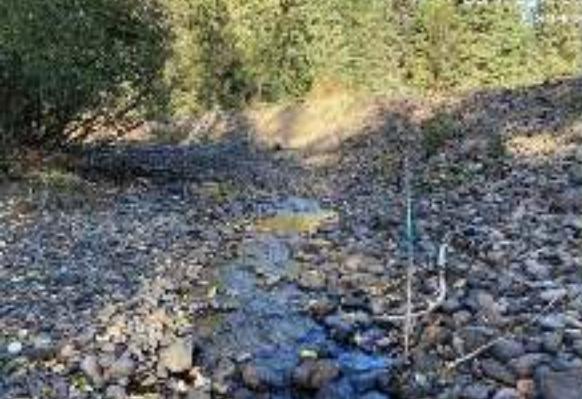
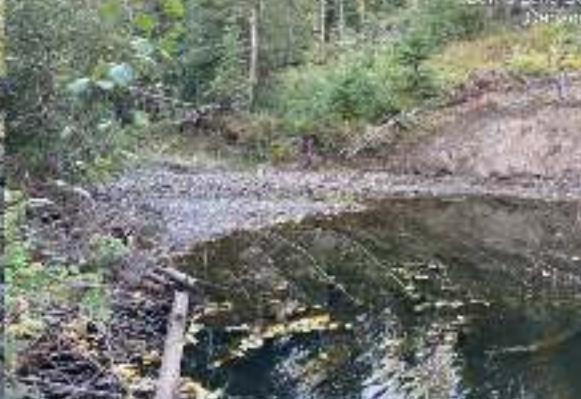
Location and Stream Data	•	Crossing Characteristics	-
Comments: Dredging upstream, channel width not natural. Signs of major flooding including wear on upstream sides of culvert. No riparian zone on river left upstream. Culvert 4% but has bend at last 2m outlet drop and outlet pool depth are estimates. This stream could use some restoration. 17:46

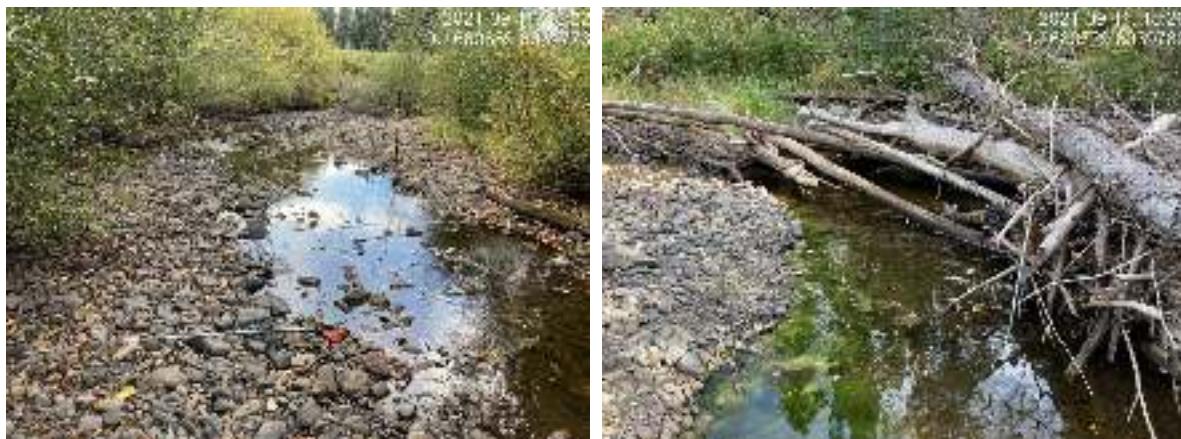
The stream was surveyed upstream from crossing 197976 for 345m (Figure [5.33](#)). Total cover amount was rated as moderate with deep pools dominant. Cover was also present as small woody debris, undercut banks, and overhanging vegetation. The dominant substrate was cobbles with gravels sub-dominant. The average channel width was 8.1m, the average wetted width was 4.2m, and the average gradient was 1%. Fish were observed throughout the area surveyed and extensive algae growth was present on stream substrates. Large woody debris was rare and riparian/bank damage due to livestock was minimal and located at what appeared to be watering sites. Fencing was located across the stream in multiple locations. Patches of gravels suitable for spawning were present. Habitat value was rated as medium as the surveyed area was considered an important migration corridor containing suitable spawning habitat and having moderate rearing potential.

Figure 5.33: Left: Typical habitat upstream of PSCIS crossing 197976. Right: Typical habitat upstream of PSCIS crossing 197976.

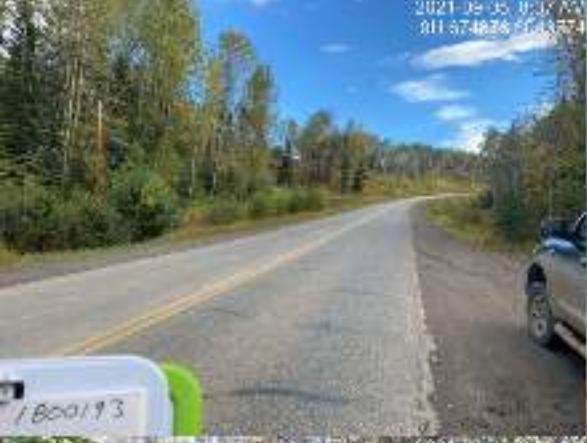
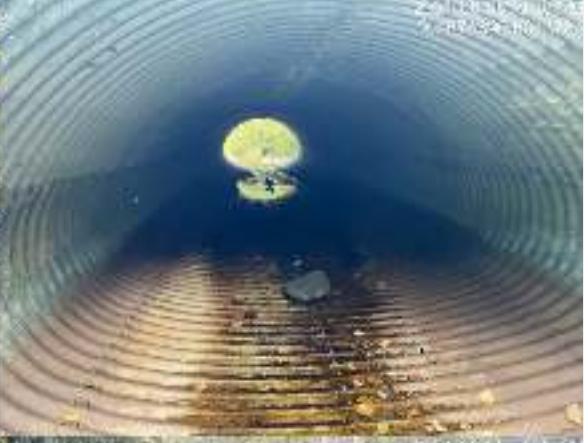
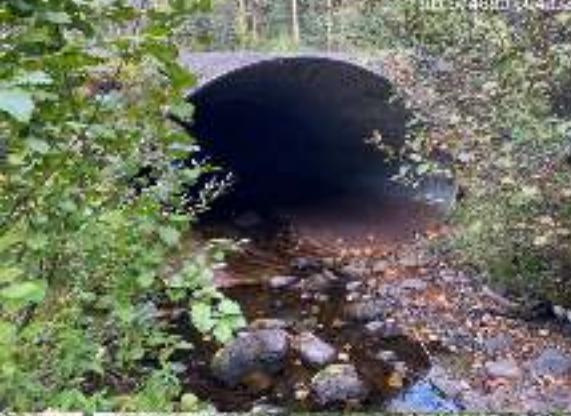
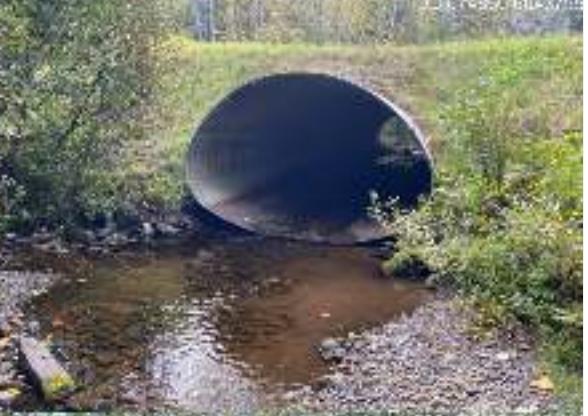
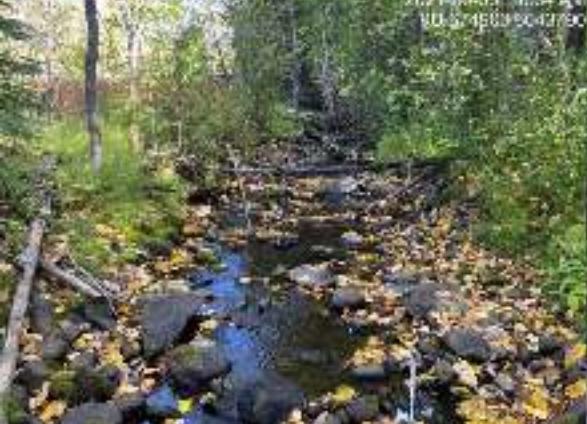
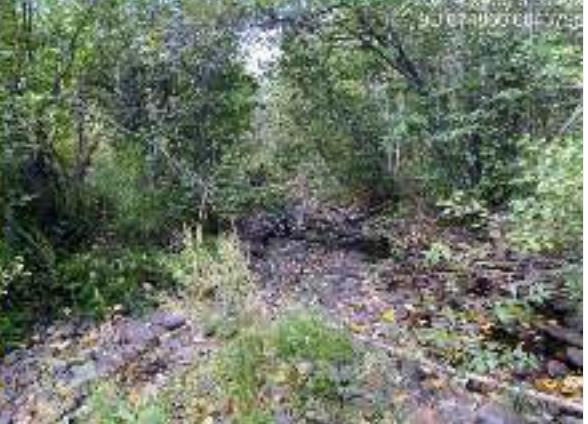
Location and Stream Data	•	Crossing Characteristics	-
Comments: Habitat confirmation conducted. ~110mm fish observed in outlet pool. Culvert slope surveyed with lazer level. 8:37

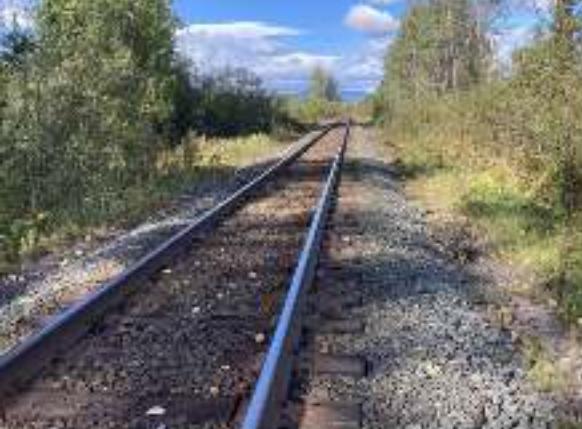
Location and Stream Data	•	Crossing Characteristics	-
Comments: No crossing actually exists in the field however site entered as a placeholder because there should be connection between Bulkley and Cesford at this location. Survey found no culvert and landowner reported none present. Large man-made ditch through adjacent field may be draining some water. Lower section of stream dry at time of survey. 11:22

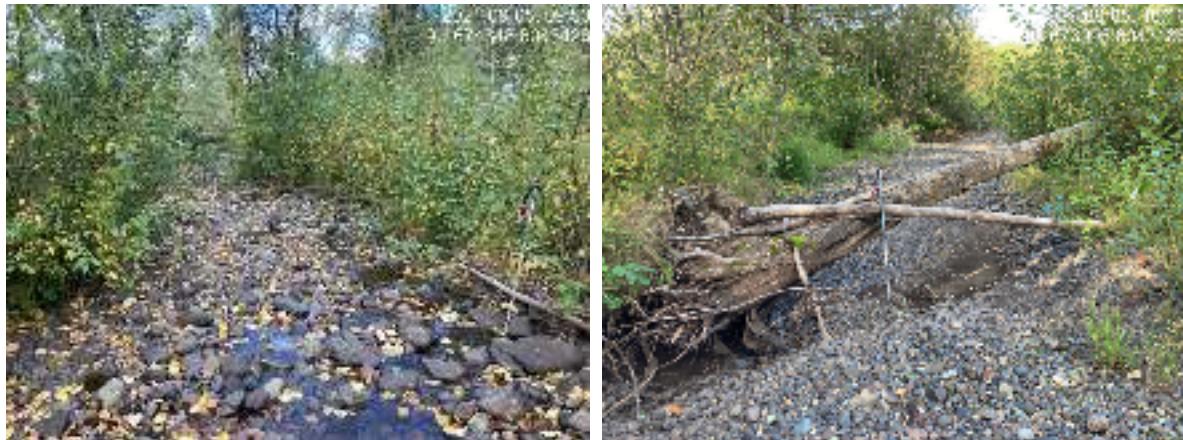
The stream was surveyed downstream from the culvert for 1400m (Figure [5.38](#)). Total cover amount was rated as with overhanging vegetation dominant. Cover was also present as small woody debris and undercut banks (Table [5.67](#)). The average channel width was 5.5m, the average wetted width was 1.5m and the average gradient was 3.5%. The dominant substrate was cobbles with gravels subdominant. The habitat was rated as medium value for salmonid rearing and spawning.

Figure 5.38: Left: Typical habitat downstream of PSCIS crossing 198048. Right: Typical habitat downstream of PSCIS crossing 198048.

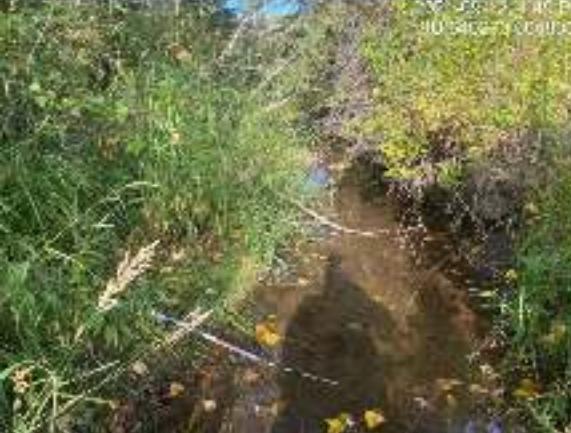
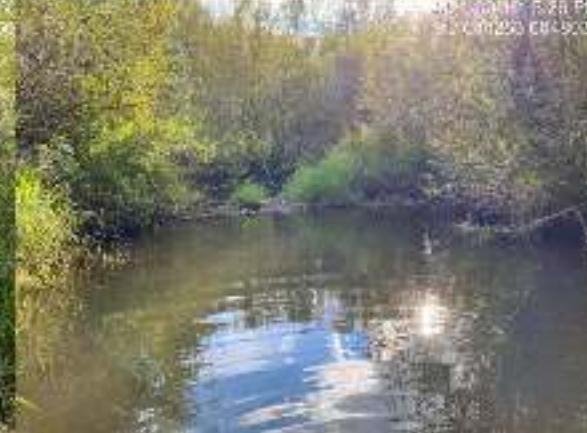
Table 5.71: Summary of fish passage assessment for PSCIS crossing 123377.

<b>Location and Stream Data</b>		<b>Crossing Characteristics –</b>	
<b>Location and Stream Data</b>		<b>Crossing Characteristics –</b>	
Date	2021-09-05	Crossing Sub Type	Round Culvert
PSCIS ID	123377	Diameter (m)	1.05
External ID	–	Length (m)	29
Crew	AI	Embedded	No
UTM Zone	9	Depth Embedded (m)	–
Easting	641632.6	Resemble Channel	No
Northing	6049398	Backwatered	No
Stream	Thompson Creek	Percent Backwatered	–
Road	Walcott Road	Fill Depth (m)	1.5
Road Tenure	MoTi Local	Outlet Drop (m)	0.25
Channel Width (m)	4.8	Outlet Pool Depth (m)	0.3
Stream Slope (%)	2.7	Inlet Drop	No
Beaver Activity	No	Slope (%)	3
Habitat Value	High	Valley Fill	Deep Fill
Final score	34	Barrier Result	Barrier
Fix type	Replace with New Open Bottom Structure	Fix Span / Diameter	10
Photos: From top left clockwise: Road/Site Card, Barrel, Outlet, Downstream, Upstream, Inlet.

There was 123377 is 12.3km of habitat upstream of crossing rated as high value for salmonid rearing and spawning. Crossing 123377 was ranked as a high priority for proceeding to design for replacement.
