Bulkley River and Morice River Watershed Groups Fish Passage Restoration Planning 2021 - DRAFT

Prepared for
Habitat Conservation Trust Foundation - CAT21-6-288
BC Fish Passage Remediation Program
Canadian Wildlife Federation

Prepared by
Al Irvine, B.Sc., R.P.Bio.
New Graph Environment Ltd.
on behalf of
Society for Ecosystem Restoration in Northern British Columbia

Version 0.0.9.2 - DRAFT
2022-05-06

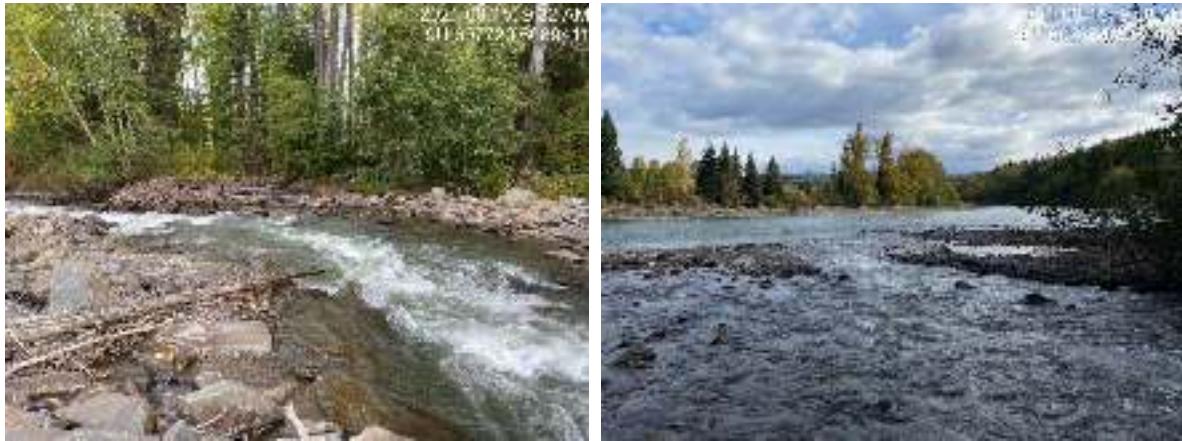
Figure 5.1: Left: Typical habitat downstream of PSCIS crossing 57944. Right: Typical habitat downstream of PSCIS crossing 57944.

The stream was surveyed downstream from crossing 57944 for 140m to the confluence with the Bulkley River (Figure 5.1). Total cover amount was rated as moderate with undercut banks dominant. Cover was also present as small woody debris, large woody debris, boulders, and

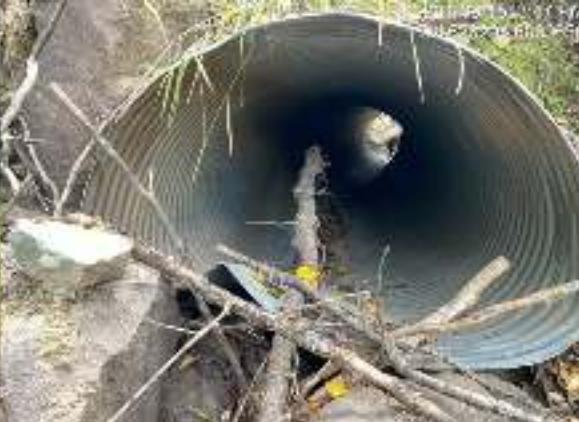
Photos: From top left clockwise: Road/Site Card, Barrel, Outlet, Downstream, Upstream, Inlet.

Location and Stream Data	•	Crossing Characteristics	-
Comments: Inlet of culvert is ~5m elevation more than upstream channel. Road has filled in the creek. 15:44

Location and Stream Data		Crossing Characteristics	
Date	2021-09-15	Crossing Sub Type	Round Culvert
PSCIS ID	58151	Diameter (m)	1
External ID	–	Length (m)	14
Crew	KP	Embedded	No
UTM Zone	9	Depth Embedded (m)	–
Easting	629753.3	Resemble Channel	No
Northing	6061126	Backwatered	No
Stream	McDowell Creek	Percent Backwatered	–
Road	Woodmere Road	Fill Depth (m)	0.5
Road Tenure	MoTi Local	Outlet Drop (m)	0.25
Channel Width (m)	1.8	Outlet Pool Depth (m)	0.64
Stream Slope (%)	1.5	Inlet Drop	No
Beaver Activity	No	Slope (%)	5
Habitat Value	Medium	Valley Fill	Deep Fill
Final score	31	Barrier Result	Barrier
Fix type	Replace Structure with Streambed Simulation CBS	Fix Span / Diameter	3

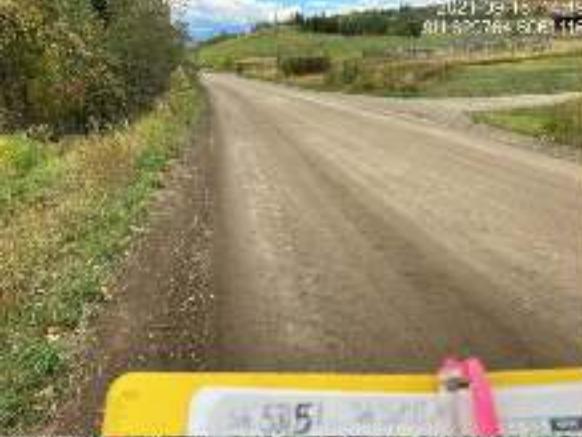
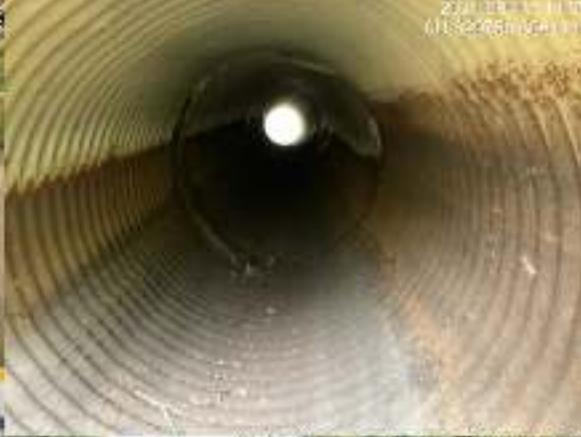
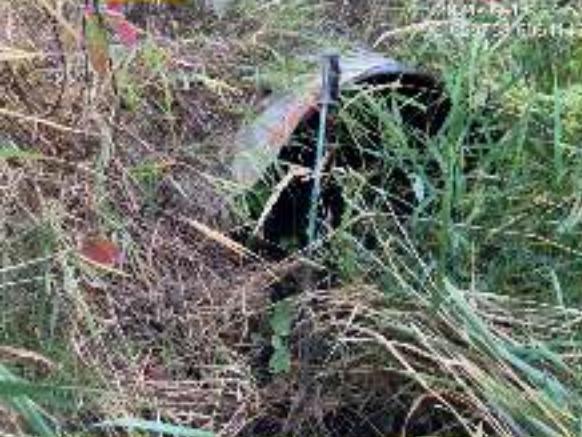
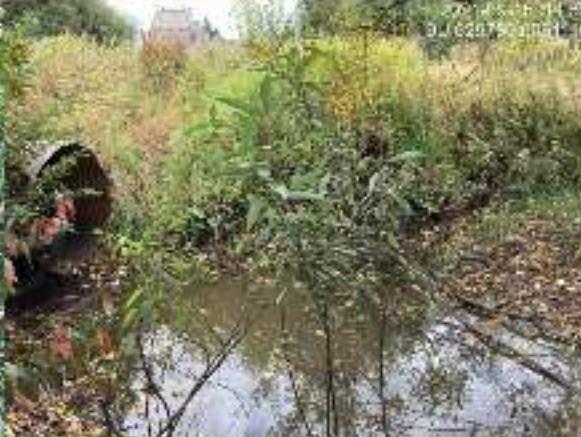
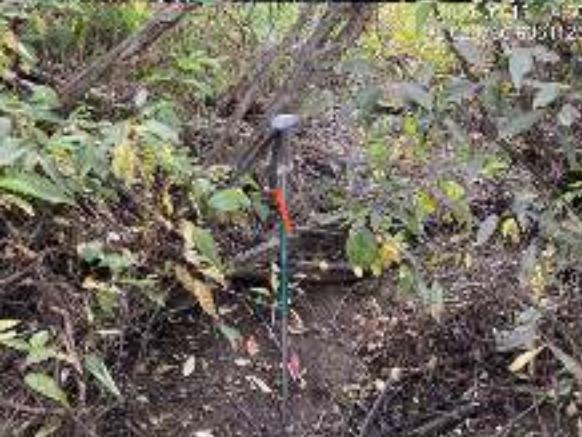
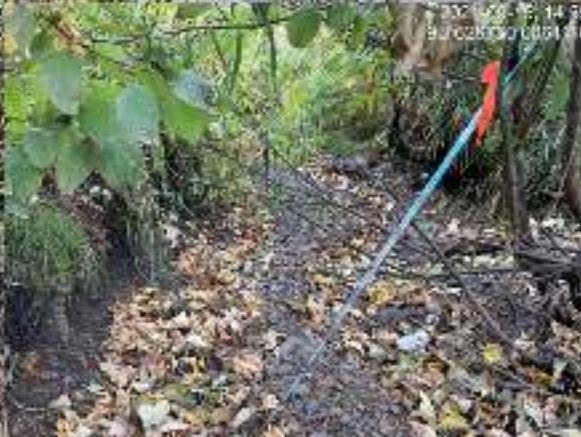
Location and Stream Data	•	Crossing Characteristics	-
Comments: Channel dry. Current pool water depth is 0.31, outlet drop measured using long tape to simulate riffle crest height. 14:48

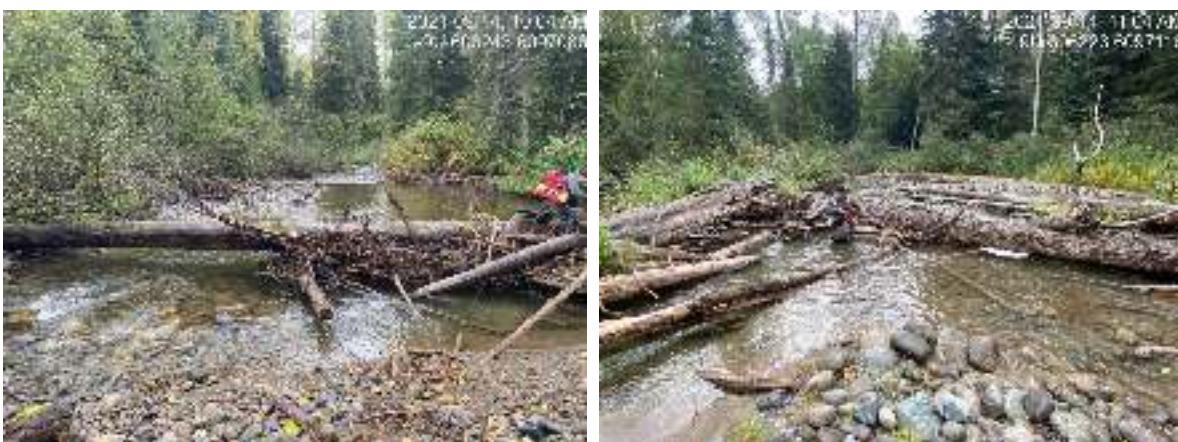
The stream was surveyed upstream from crossing 123770 for 1000m (Figure [5.10](#)). Total cover amount was rated as moderate with undercut banks dominant. Cover was also present as small woody debris, large woody debris, boulders, deep pools, and overhanging vegetation. The average channel width was 12.2m, the average wetted width was 8.3m and the average gradient was 2.9%. The dominant substrate was cobbles with gravels subdominant. The first 50 - 100m upstream of crossing channel and banks were noted as armoured with riprap. Abundant gravels suitable for resident and anadromous salmonids were noted throughout. The habitat was rated as high value as an important migration corridor containing suitable spawning habitat and having moderate rearing potential.

Figure 5.10: Left: Typical habitat upstream of PSCIS crossing 123770. Right: Typical habitat upstream of PSCIS crossing 123770.

Should restoration/maintenance activities proceed, replacement of PSCIS crossing 123770 with a bridge (19m span) is recommended. The cost of the work is estimated at \$11,400,000 for a cost benefit of 1 linear m/\$1000 and 12.5 m²/\$1000.

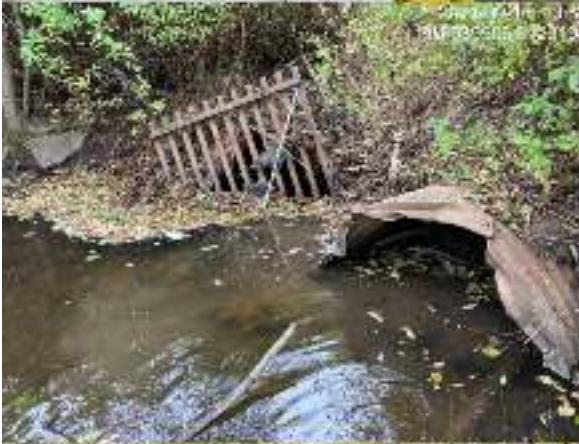
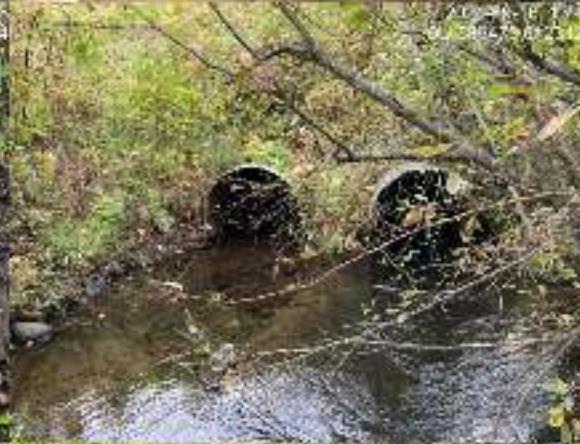
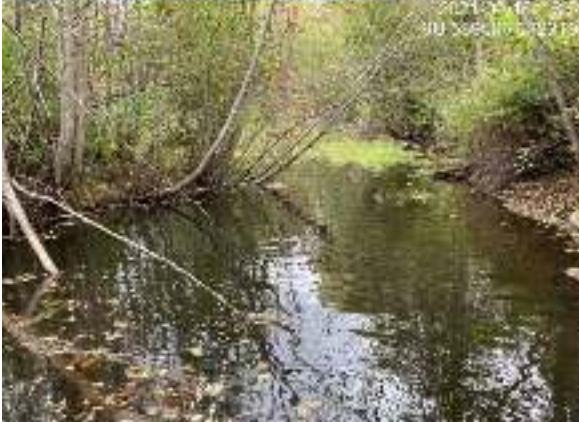
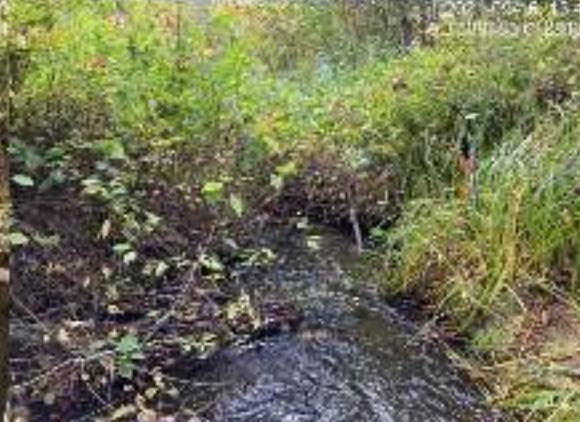
Location and Stream Data	•	Crossing Characteristics	-
Comments: 2 pipes. Both have water, left bank one is flowing. Assessment comments indicate right bank pipe is backwatered 100% but changed to 25% based on photos and past PSCIS data and photos which also indicated not backwatered. Suspect blockage due to debris. Outlet water depth, fish sighted in outlet of right barrel. 13:42

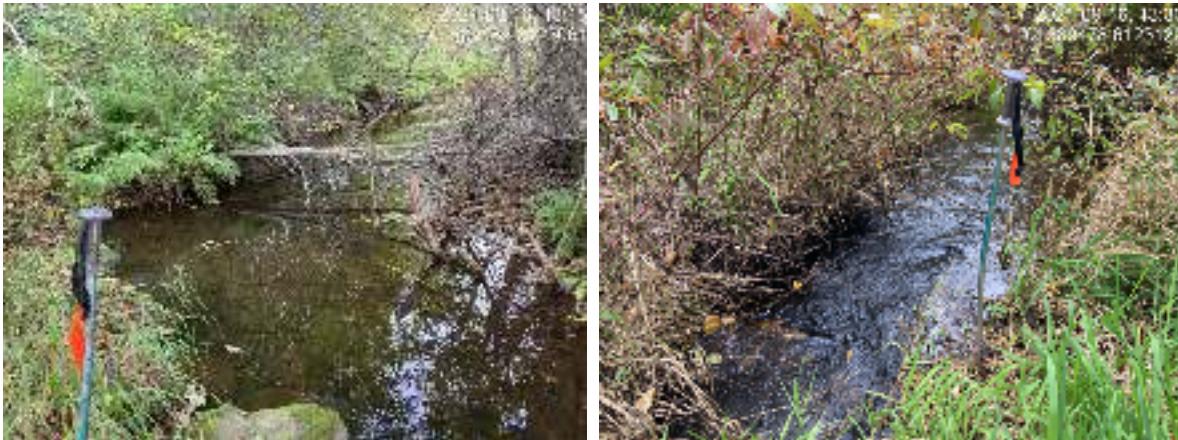
The stream was surveyed upstream from crossing 124421 for 120m to 124422 (Figure 5.15). Total cover amount was rated as abundant with instream vegetation dominant. Cover was also present as small woody debris, undercut banks, and overhanging vegetation. The average channel width was 2.6m, the average wetted width was 2.5m, and the average gradient was 2.1%. The dominant substrate was fines with gravels sub-dominant. Survey notes indicate a slow moving wetland like stream with deep glides throughout. Instream vegetation was abundant with somewhat stagnant water often smelling of sulfur. Near top of the survey, the gradient increased slightly and the substrate transitioned from primarily fines to small gravel. Within the riparian area shrubs and sedges were thick and vigorous. Habitat value was rated as moderate as this section of stream was considered an important migration corridor.

Figure 5.15: Left: Typical habitat upstream of PSCIS crossing 124420. Right: Typical habitat upstream of PSCIS crossing 124420.

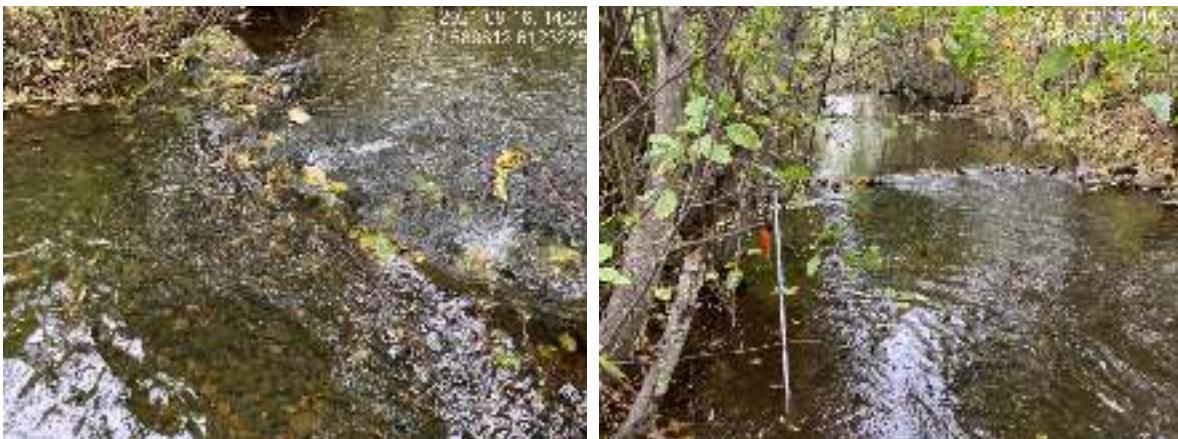
The stream was surveyed upstream from crossing 124422 for 350m (Figure 5.16). The dominant substrate was fines with gravels sub-dominant. Total cover amount was rated as abundant with instream vegetation dominant. Cover was also present as small woody debris, undercut banks, and overhanging vegetation. The average channel width was 6.7m, the average wetted width was 6.6m, and the average gradient was 2.1%. Within this section of stream there appears to have been restorative efforts involving the placement of logs to provide riffle pool breaks and retain gravel suitable for coho spawning. Gravels were abundant in this area and its location within a residential area of New Hazelton provides an important connection between the stream and the surrounding community. Habitat value was rated as moderate as this section of stream was considered critical for coho spawning.

Figure 5.16: Left: Typical habitat upstream of PSCIS crossing 124420. Right: Typical habitat upstream of PSCIS crossing 124420.

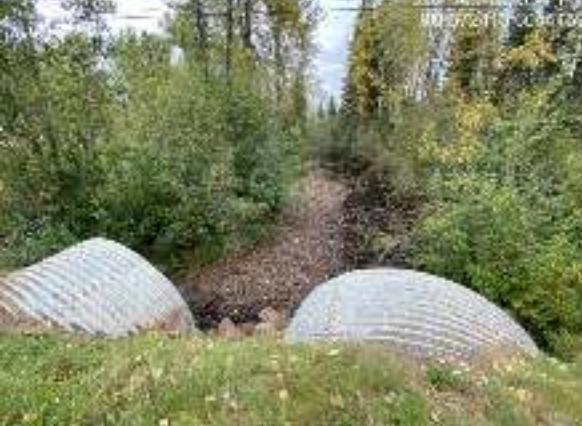
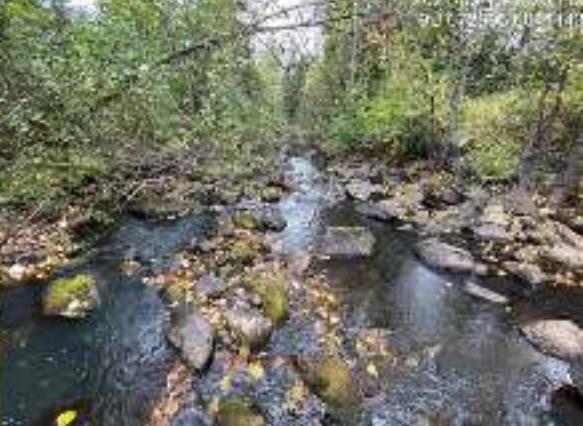
Location and Stream Data		Crossing Characteristics –	
Road	Highway 16	Fill Depth (m)	1
Road Tenure	MoTi highway	Outlet Drop (m)	0.2
Channel Width (m)	12.5	Outlet Pool Depth (m)	1
Stream Slope (%)	1.5	Inlet Drop	No
Beaver Activity	No	Slope (%)	2
Habitat Value	High	Valley Fill	Deep Fill
Final score	29	Barrier Result	Barrier
Fix type	Replace with New Open Bottom Structure	Fix Span / Diameter	16.5
Photos: From top left clockwise: Road/Site Card, Barrel, Outlet, Downstream, Upstream, Inlet.

Location and Stream Data	•	Crossing Characteristics	-
Comments: Culvert and habitat measurements taken in 2020. Multipass closed site electorfishing conducted in 2021 upstream and downstream of highway. 17:25

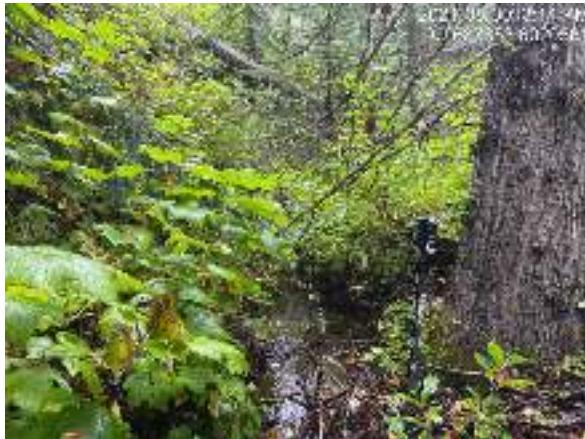
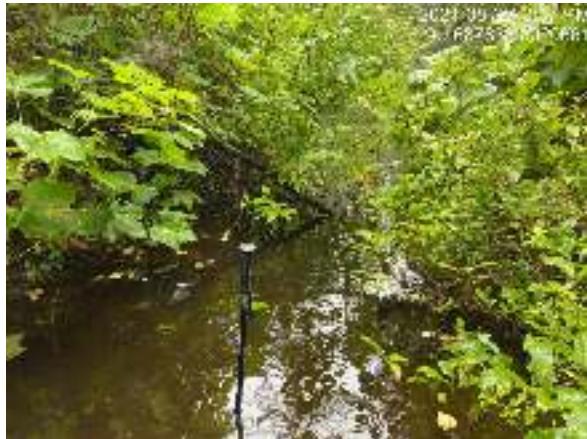
The stream was surveyed downstream from crossing 197909 for 400m (Figure [5.20](#)). The average channel width was 1.3m, the average wetted width was 1.3m, and the average gradient was 3.2%. Total cover amount was rated as abundant with dominant. Cover was also present as . The dominant substrate was fines with NA sub-dominant. At approximately 300m downstream of the culvert the stream became wider with glide habitat to ~50cm in depth resulting from sediments deposited by a failure on the steep north canyon wall. Habitat was rated as low value for salmonid rearing and spawning due to the small size of the stream, low flows and fine substrate.

Figure 5.20: Left: Habitat downstream of PSCIS crossing 197909. Right: Habitat downstream of PSCIS crossing 197909.

Should restoration/maintenance activities proceed at the site, replacement of PSCIS crossing 197909 with a clear span bridge is recommended. The cost of the work is estimated at \$40,000 for a cost benefit of 5.6 linear m/\$1000 and 7.3 m²/\$1000.

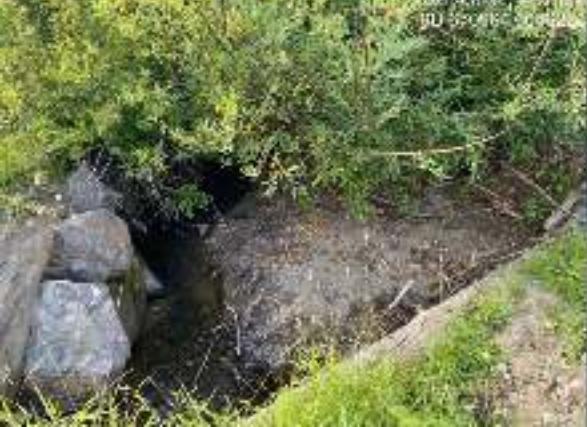
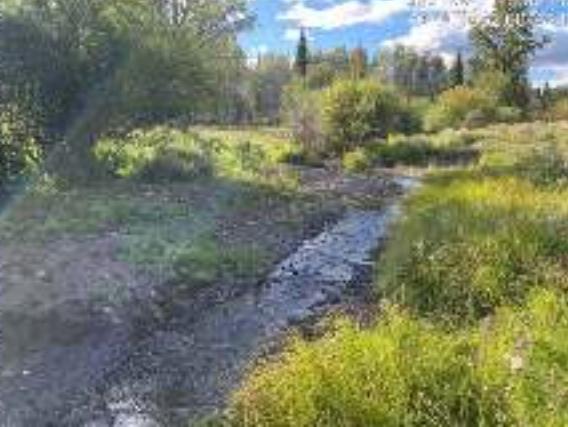
Location and Stream Data	•	Crossing Characteristics	-
Comments: Bridge has collapsed and is impediment to upstream fish passage. Habitat confirmation conducted. 16:56

Should restoration/maintenance activities proceed at the site, removal of PSCIS crossing 197912 is recommended. In addition to removal of the collapsed bridge, resloping of banks and the installation of live cuttings/pegboarding is recommended in three areas downstream where cattle trampling is resulting in significant erosion. A map of the erosion areas and associated prescriptions for rehabilitation of the downstream corners is provided as Figure [5.22](#). The cost of the work is estimated at \$30,000 for a cost benefit of 924 linear m/\$1000 and 3973.2 m²/\$1000.

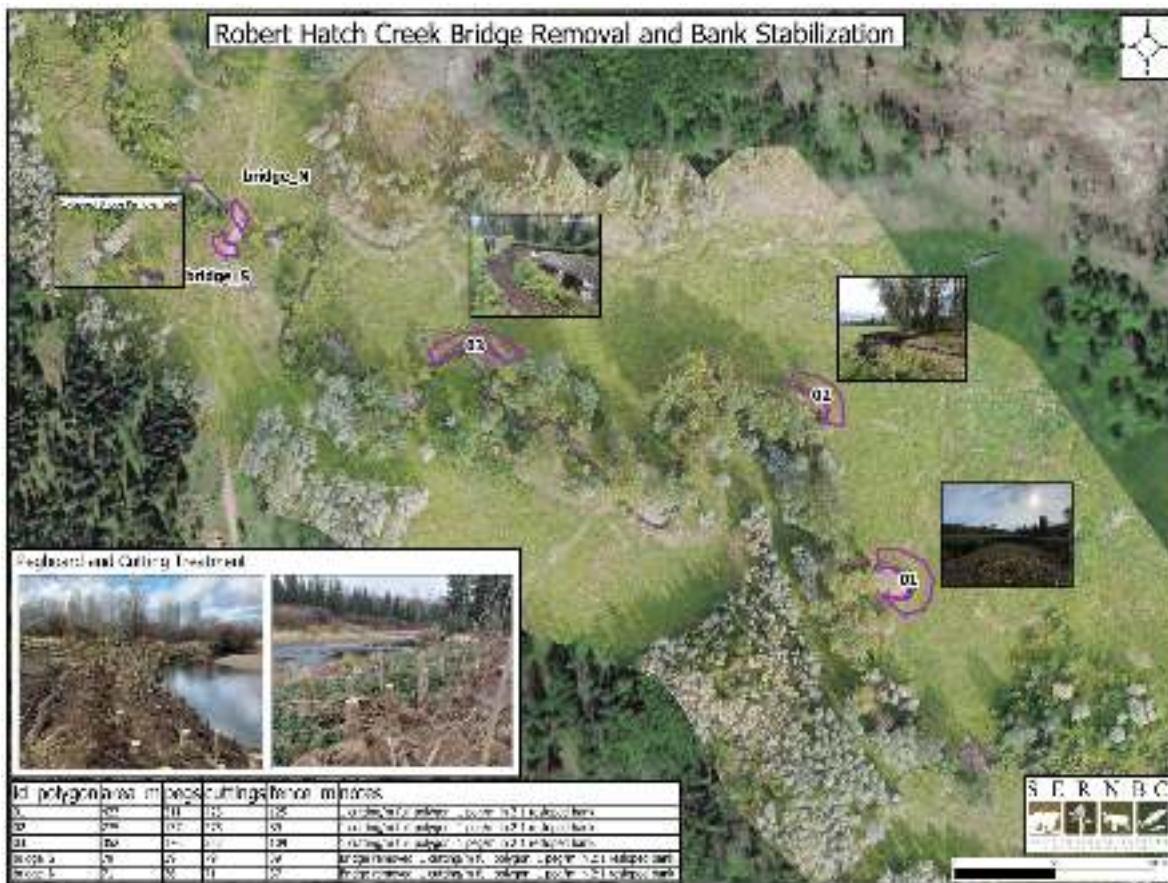
Figure 5.22: Restoration plan for Robert Hatch Creek including removal of collapsed bridge, resloping of banks and the installation of live cuttings/pegboarding

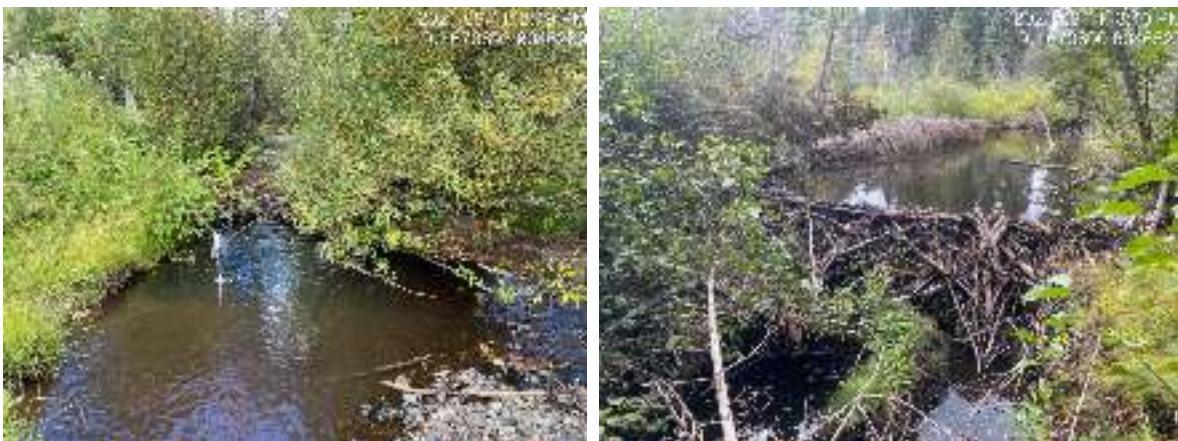
Figure 5.25: Left: Typical habitat upstream of PSCIS crossing 197912. Right: Typical habitat upstream of PSCIS crossing 197912.

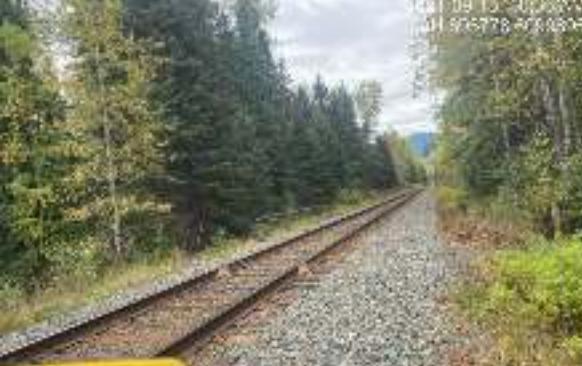
Location and Stream Data	•	Crossing Characteristics	-
Comments: Outlet is cracked and drops. Inlet embedded to 2/3 way. 10:33

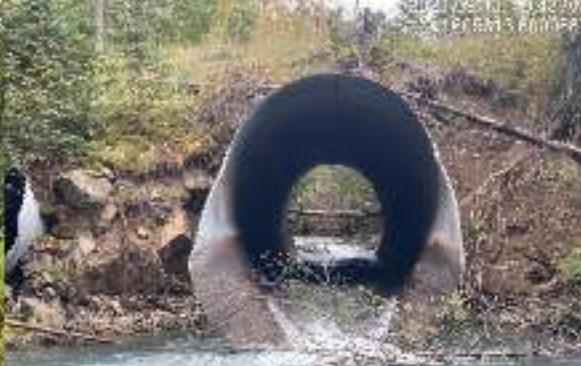
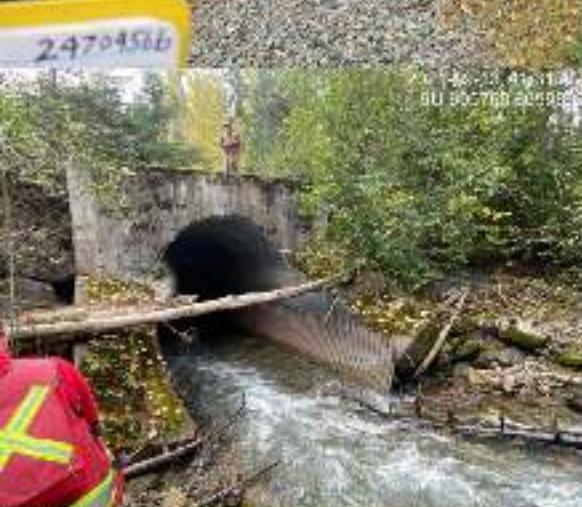
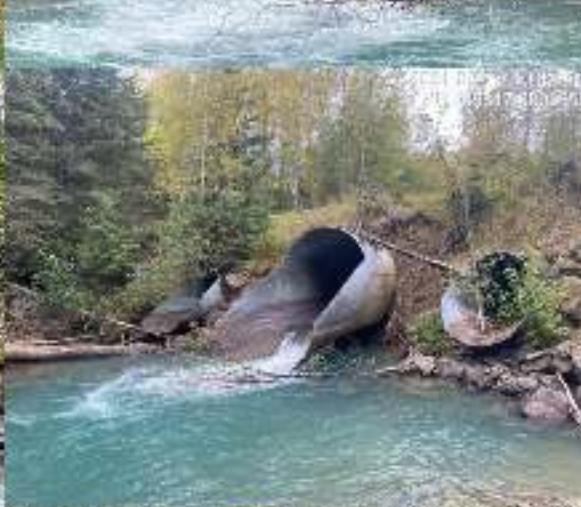
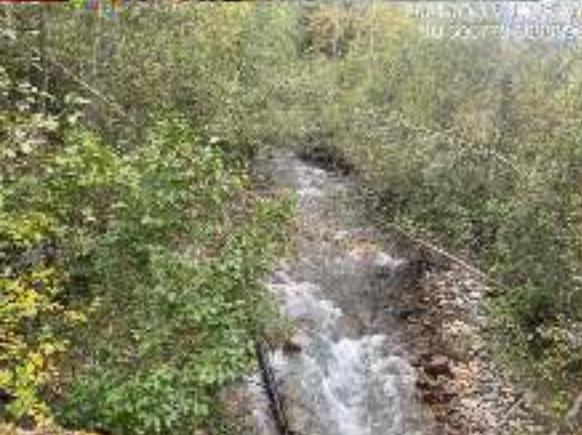
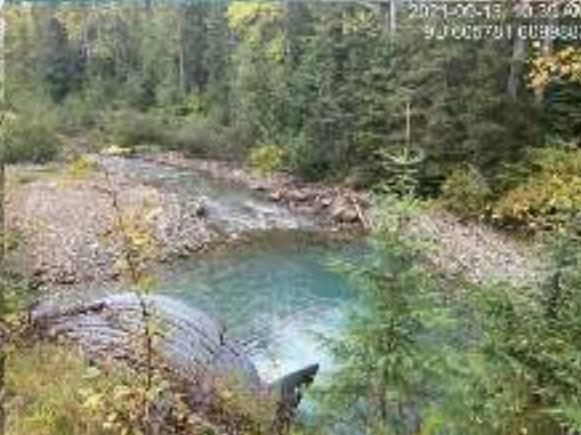
Location and Stream Data		•	Crossing Characteristics	-
Date	2021-09-15		Crossing Sub Type	Round Culvert
PSCIS ID	123775		Diameter (m)	1.22
External ID	-		Length (m)	32
Crew	DN AN		Embedded	No
UTM Zone	9		Depth Embedded (m)	-
Easting	606445.5		Resemble Channel	No
Northing	6099726		Backwatered	No
Stream	Witset Creek		Percent Backwatered	-
Road	Highway 16		Fill Depth (m)	0.3
Road Tenure	MoTi Arterial		Outlet Drop (m)	0
Channel Width (m)	0.5		Outlet Pool Depth (m)	0
Stream Slope (%)	1		Inlet Drop	No
Beaver Activity	No		Slope (%)	0.5
Habitat Value	Low		Valley Fill	Deep Fill
Final score	16		Barrier Result	Potential
Fix type	Replace Structure with Streambed Simulation CBS		Fix Span / Diameter	3

Should restoration/maintenance activities proceed, replacement of PSCIS crossing 197960 with a bridge (23m span) is recommended. The cost of the work is estimated at \$13,800,000 for a cost benefit of 0.7 linear m/\$1000 and 13 m²/\$1000.

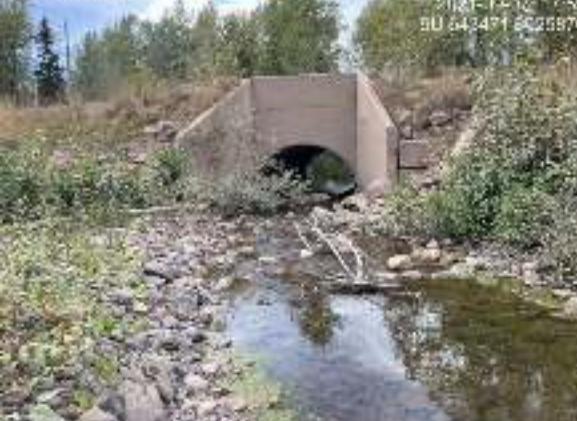
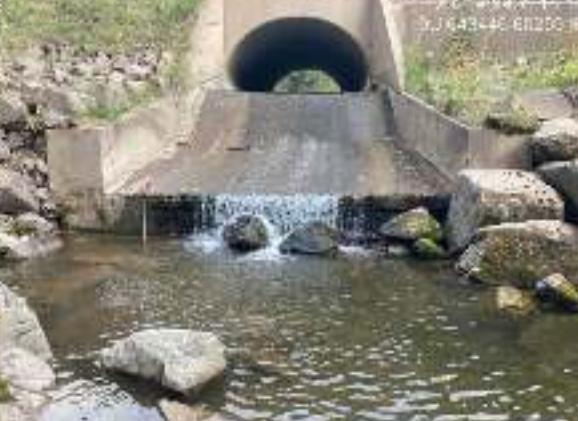
Location and Stream Data		Crossing Characteristics –	
Stream	Peacock Creek	Percent Backwatered	–
Road	Morice FSR	Fill Depth (m)	3.5
Road Tenure	FLNR DND 4656	Outlet Drop (m)	0.5
Channel Width (m)	9.3	Outlet Pool Depth (m)	1.05
Stream Slope (%)	4	Inlet Drop	Yes
Beaver Activity	No	Slope (%)	3.5
Habitat Value	Medium	Valley Fill	Deep Fill
Final score	39	Barrier Result	Barrier
Fix type	Replace with New Open Bottom Structure	Fix Span / Diameter	16

Location and Stream Data	• Crossing Characteristics
Comments: Partial inlet drop of varying height due to large woody debris and boulders. Side channel dry, must be seasonal use only. 17:47

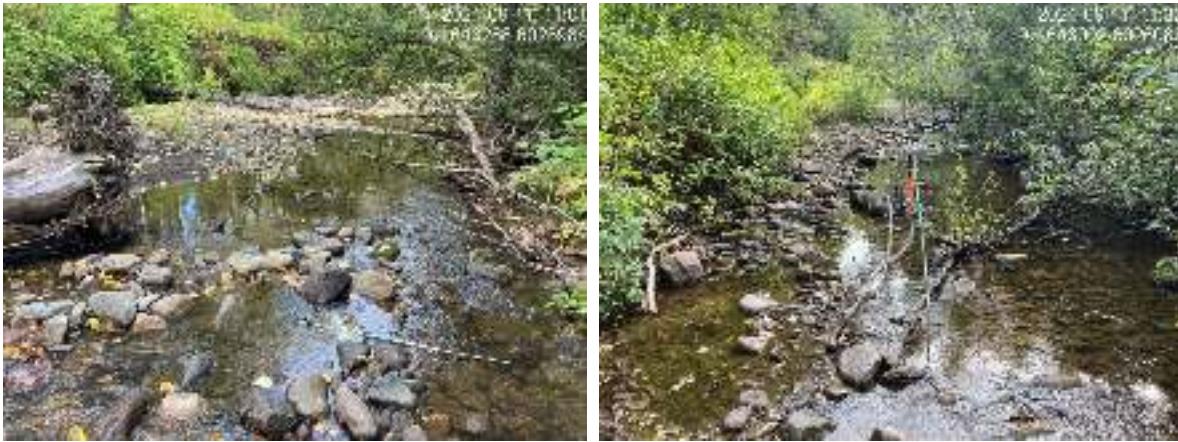
The stream was surveyed downstream from crossing 197962 for 600m (Figure 5.30). The average channel width was 8.1m, the average wetted width was 4.2m, and the average gradient was 2.6%.

Total cover amount was rated as moderate with undercut banks dominant. Cover was also present as small woody debris, large woody debris, boulders, deep pools, and overhanging vegetation. The dominant substrate was cobbles with boulders sub-dominant. Multiple areas of side channels and small braided sections were noted with intermittent sections of aggraded cobbles / gravels moved in high flows. There were pockets of gravel present suitable for spawning resident and anadromous salmonids.

Figure 5.30: Left: Habitat downstream of PSCIS crossing 197962. Right: Habitat downstream of PSCIS crossing 197962.

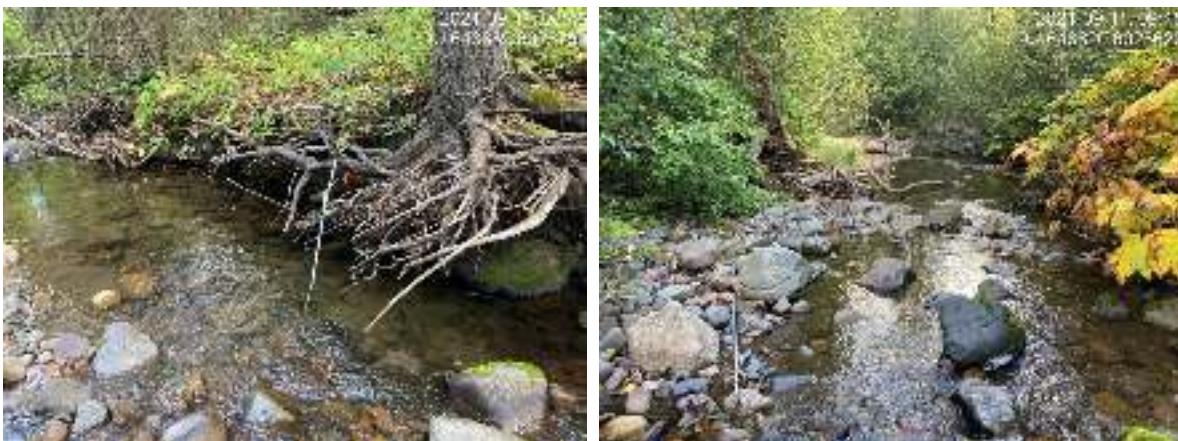
Figure 5.31: Left: Habitat upstream of PSCIS crossing 197962. Right: Habitat upstream of PSCIS crossing 197962.

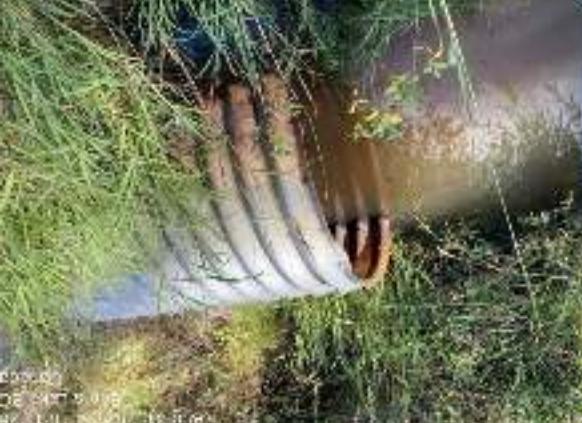
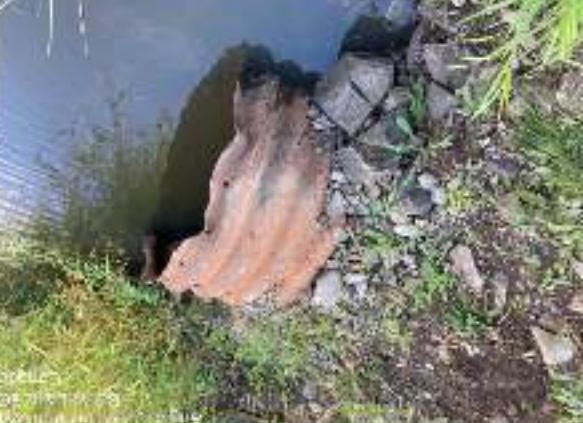
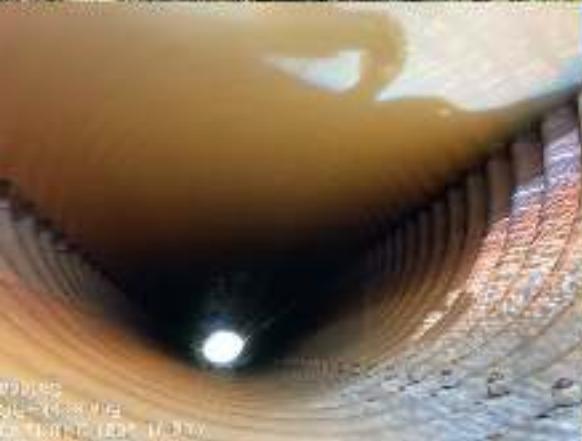
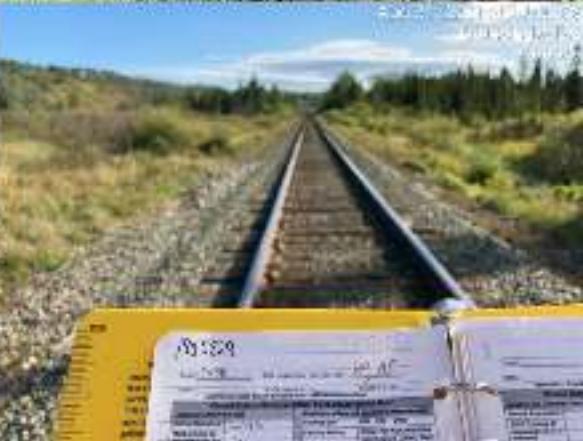
Location and Stream Data	•	Crossing Characteristics	-
Comments: Backwatered fully, appears fully passable. Fish sighted at outlet. Distance from water surface to top of culvert is 70cm. 9:58

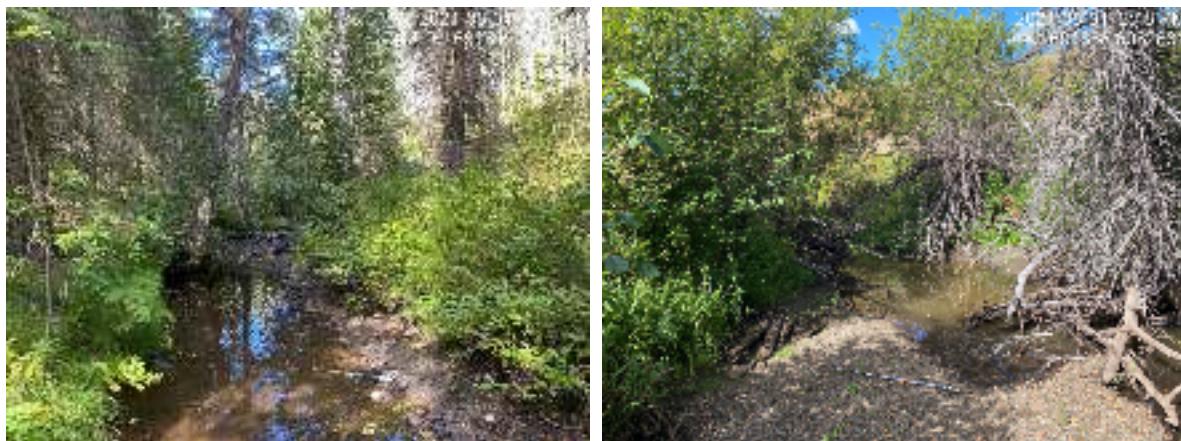
Taman Creek was surveyed for 400m above where it joins the Bulkley River mainstem upstream of PSCIS crossing 197967 (Figure [5.34](#)). The dominant substrate was gravels with cobbles sub-dominant. Total cover amount was rated as moderate with deep pools dominant. Cover was also present as small woody debris, large woody debris, undercut banks, and overhanging vegetation. The average channel width was 3.8m, the average wetted width was 2.2m, and the average gradient was 2.5%. The water in Taman Creek during the survey was noted as turbid with numerous salmonid fry present at the downstream end of the site. Algae was abundant throughout the system and eroding banks were common. Abundant gravels suitable for resident rainbow trout and coho salmon spawning were present and habitat was rated as medium value for salmon rearing and spawning.

Figure 5.34: Left: Habitat upstream of PSCIS crossing 197967. Right: Habitat upstream of PSCIS crossing 197967.

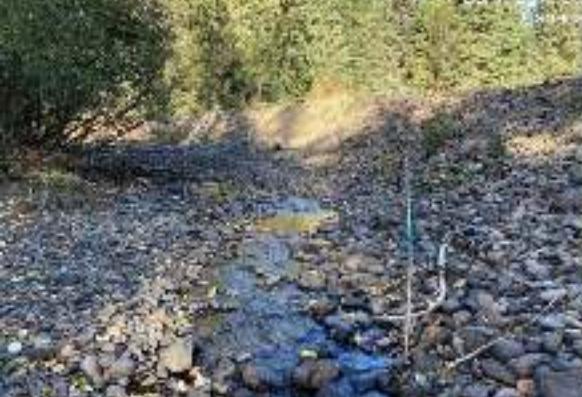
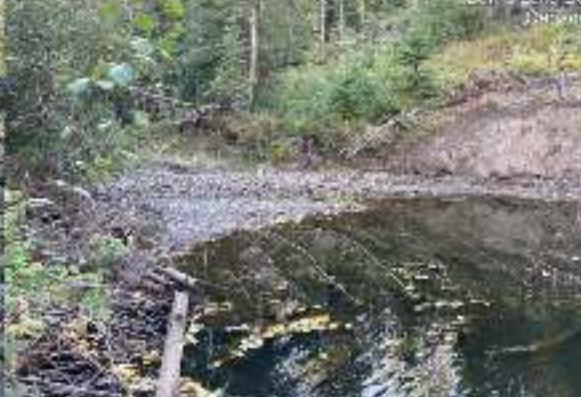
Location and Stream Data	•	Crossing Characteristics	-
Comments: Dredging upstream, channel width not natural. Signs of major flooding including wear on upstream sides of culvert. No riparian zone on river left upstream. Culvert 4% but has bend at last 2m outlet drop and outlet pool depth are estimates. This stream could use some restoration. 17:46

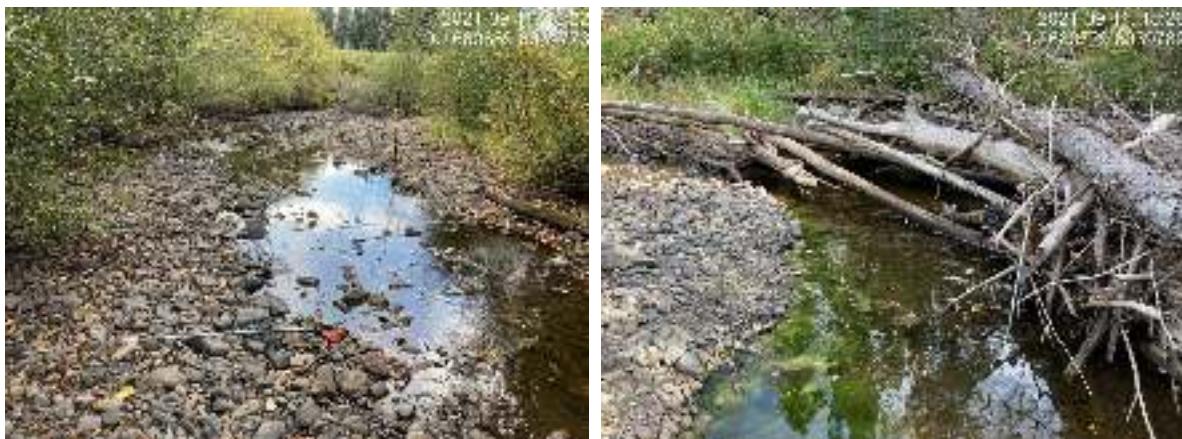
Figure 5.37: Left: Typical habitat upstream of PSCIS crossing 197976. Right: Typical habitat upstream of PSCIS crossing 197976.

The stream was surveyed upstream from crossing 197976 for 345m (Figure [5.37](#)). The dominant substrate was cobbles with gravels sub-dominant. The average channel width was 8.1m, the average wetted width was 4.2m, and the average gradient was 1%. Total cover amount was rated as moderate with deep pools dominant. Cover was also present as small woody debris, undercut banks, and overhanging vegetation. Fish were observed throughout the area surveyed and extensive algae growth was present on stream substrates. Large woody debris was rare and riparian/bank damage due to livestock was minimal and located at what appeared to be watering sites. Fencing was located across the stream in multiple locations. Patches of gravels suitable for spawning were present. Habitat value was rated as medium as the surveyed area was considered an important migration corridor containing suitable spawning habitat and having moderate rearing potential.

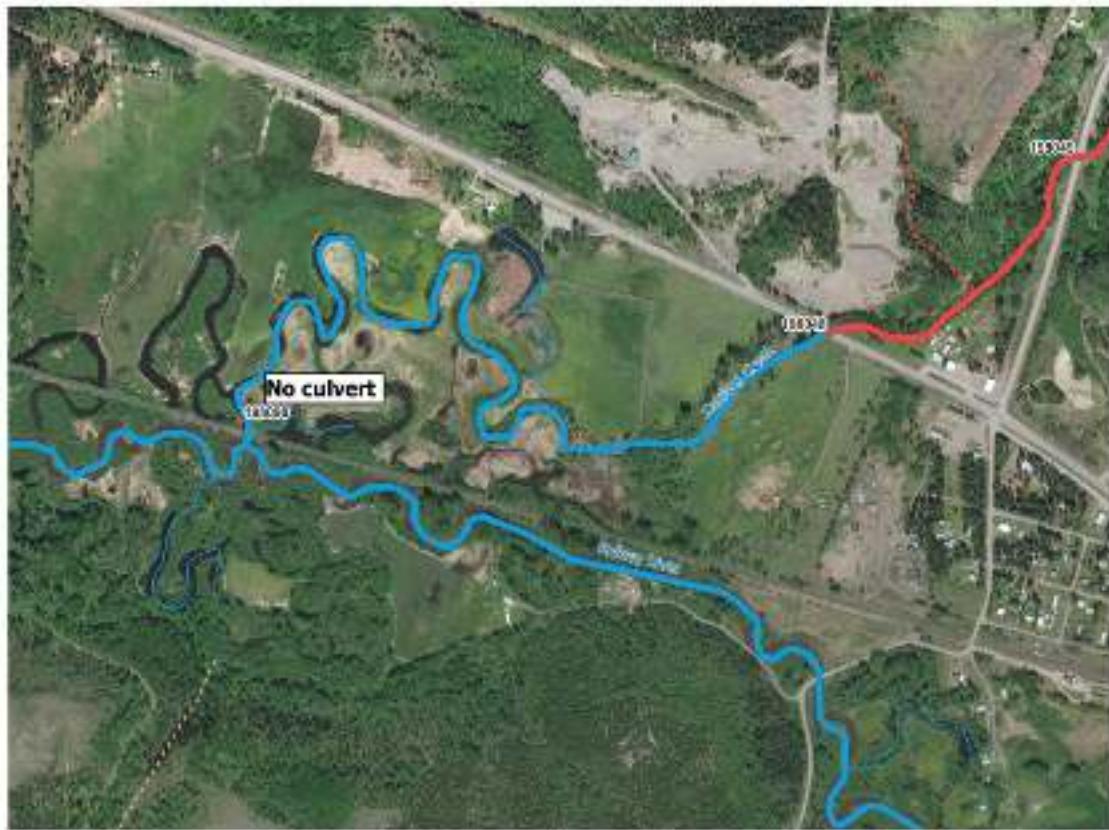
Figure 5.41: Location of potential location of crossing 198090 which was not present in the field.

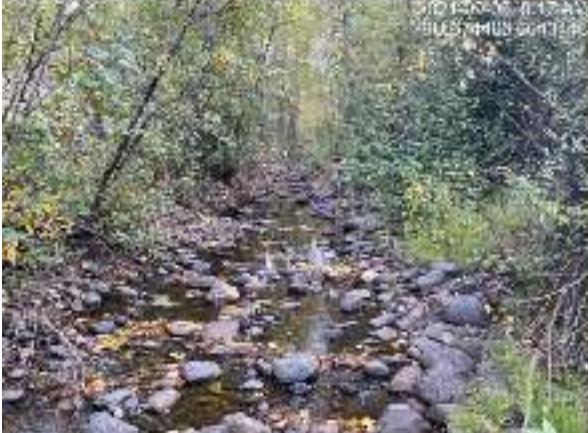
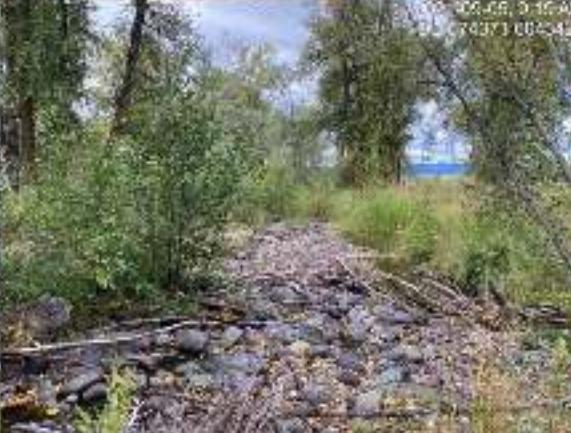
Location and Stream Data	•	Crossing Characteristics	-
Comments: Habitat confirmation conducted. Two pipes (2.5m x 2.5m). Culvert slope measured with lazel level. Fish observed. Could not locate downstream crossing on railway. Garmin backroads mapbook shows stream connecting with side channel of the Bulkley. 9:17			
NO IMAGE AVAILABLE

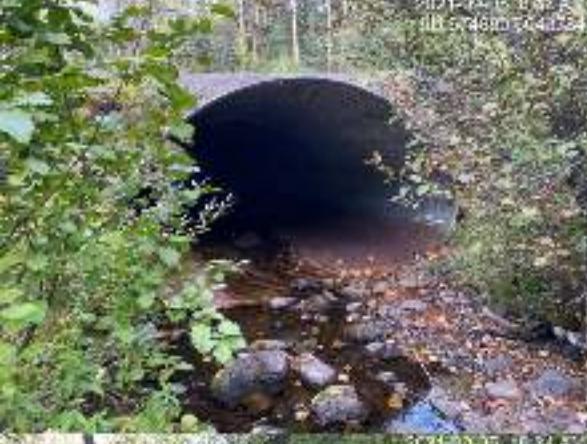
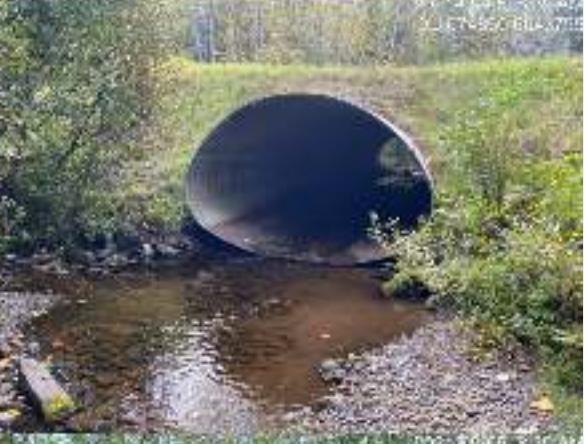
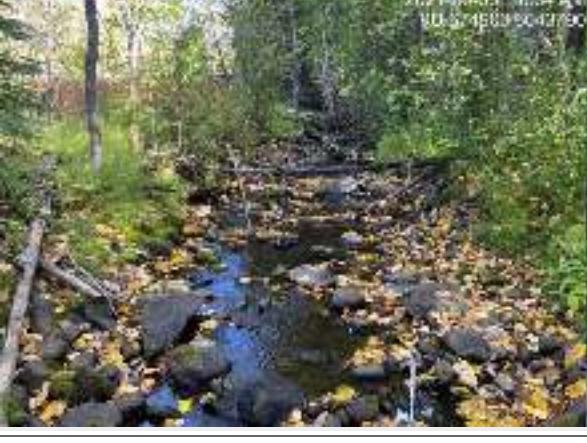
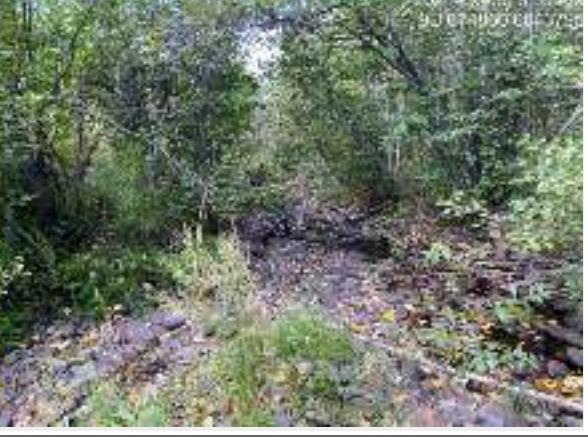
Location and Stream Data	•	Crossing Characteristics	-
Comments: Habitat confirmation conducted. ~110mm fish observed in outlet pool. Culvert slope surveyed with lazer level. 8:37

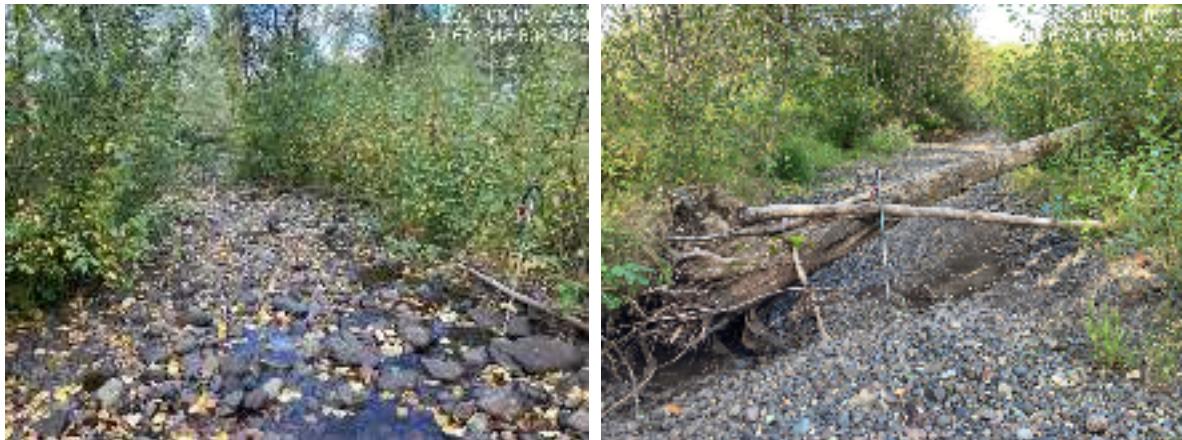
Figure 5.42: Left: Typical habitat downstream of PSCIS crossing 198048. Right: Typical habitat downstream of PSCIS crossing 198048.

The stream was surveyed downstream from the culvert for 1400m (Figure [5.42](#)). Total cover amount was rated as with overhanging vegetation dominant. Cover was also present as small woody debris and undercut banks (Table [5.73](#)). The average channel width was 5.5m, the average wetted width was 1.5m and the average gradient was 3.5%. The dominant substrate was cobbles with gravels subdominant. The habitat was rated as medium value for salmonid rearing and spawning.

Should restoration/maintenance activities proceed at the site, replacement of PSCIS crossing 198048 with a bridge (10m span) is recommended.
