## Bulkley River and Morice River Watershed Groups Fish Passage Restoration Planning 2021

Prepared for  
Habitat Conservation Trust Foundation - CAT21-6-288  
BC Fish Passage Remediation Program  
Canadian Wildlife Federation

Prepared by  
Al Irvine, B.Sc., R.P.Bio.  
New Graph Environment Ltd.  
on behalf of  
Society for Ecosystem Restoration in Northern British Columbia

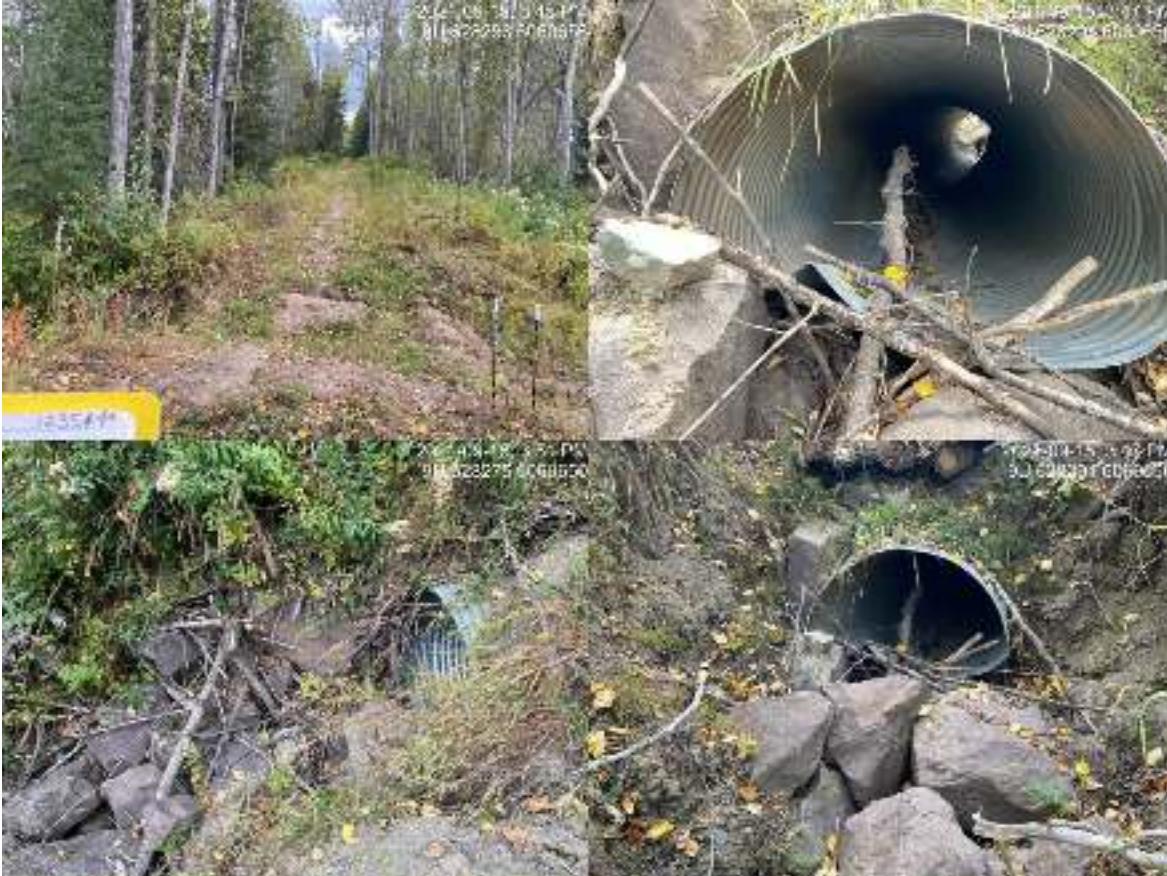
Location and Stream Data	•	Crossing Characteristics	-
Comments: Inlet of culvert is ~5m elevation more than upstream channel. Road has filled in the creek. 15:44

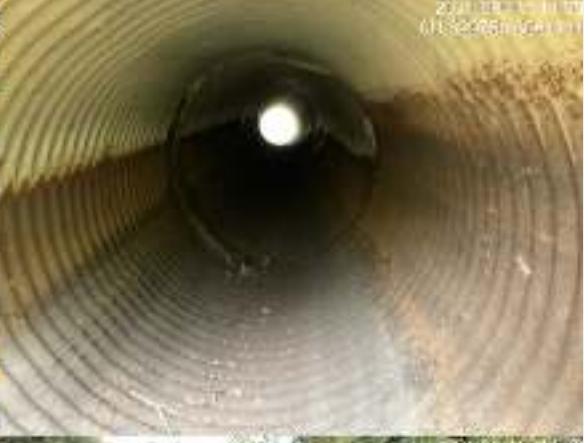
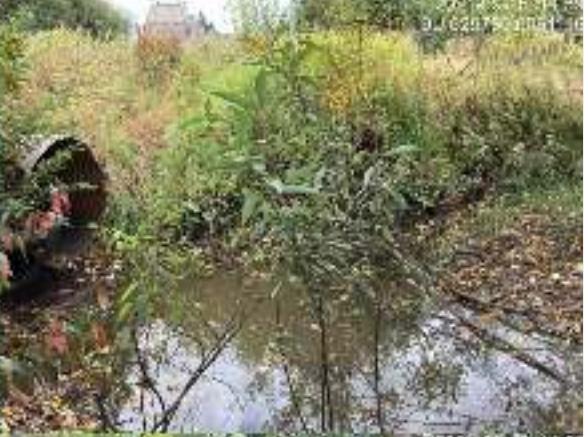
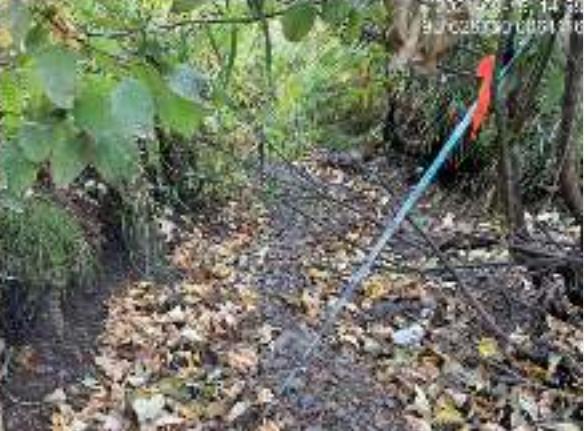
Location and Stream Data	•	Crossing Characteristics	-
Comments: Channel dry. Current pool water depth is 0.31, outlet drop measured using long tape to simulate riffle crest height. 14:48

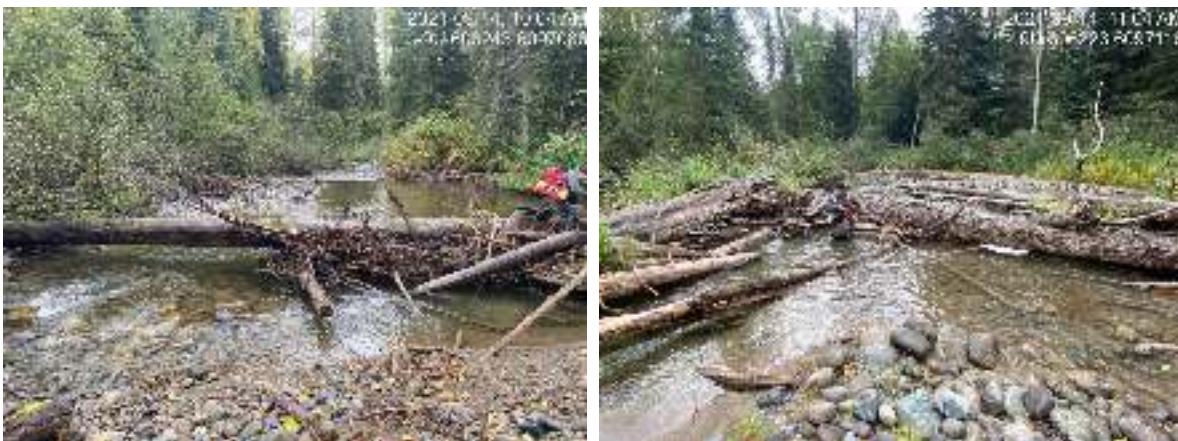
Figure 5.10: Left: Typical habitat upstream of PSCIS crossing 123770. Right: Typical habitat upstream of PSCIS crossing 123770.

The stream was surveyed upstream from crossing 123770 for 1000m (Figure [5.10](#)). Total cover amount was rated as moderate with undercut banks dominant. Cover was also present as small woody debris, large woody debris, boulders, deep pools, and overhanging vegetation. The average channel width was 12.2m, the average wetted width was 8.3m and the average gradient was 2.9%. The dominant substrate was cobbles with gravels subdominant. The first 50 - 100m upstream of crossing channel and banks were noted as armoured with riprap. Abundant gravels suitable for resident and anadromous salmonids were noted throughout. The habitat was rated as high value as an important migration corridor containing suitable spawning habitat and having moderate rearing potential.

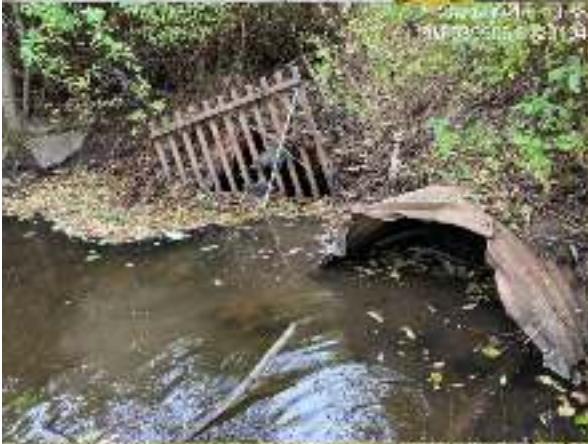
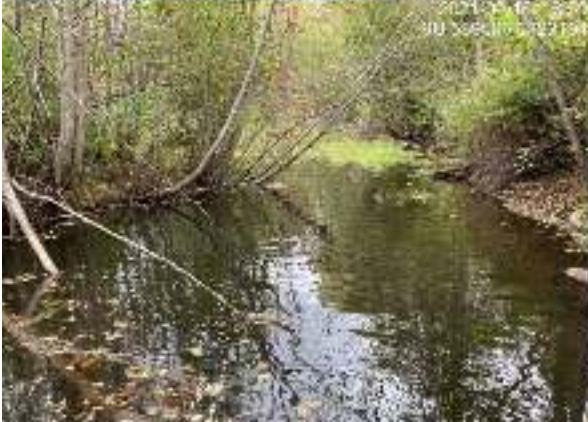
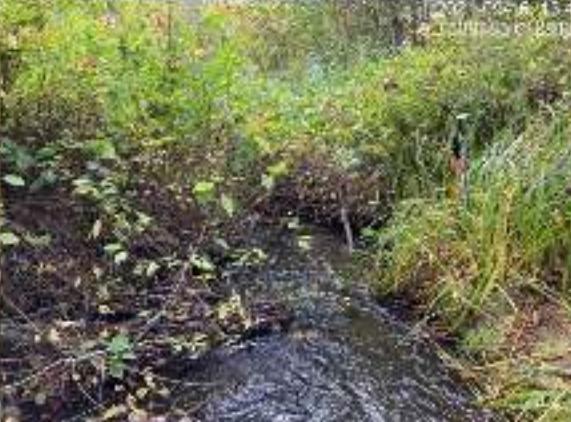
Location and Stream Data	•	Crossing Characteristics	-
Comments: 2 pipes. Both have water, left bank one is flowing. Assessment comments indicate right bank pipe is backwatered 100% but changed to 25% based on photos and past PSCIS data and photos which also indicated not backwatered. Suspect blockage due to debris. Outlet water depth, fish sighted in outlet of right barrel. 13:42

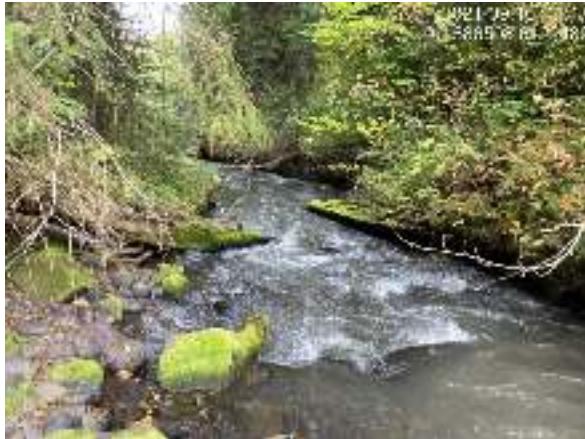
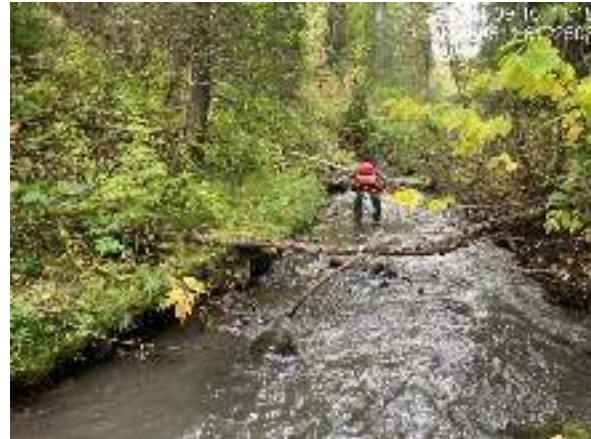
Figure 5.12: Left: Typical habitat downstream of PSCIS crossing 124420. Right: Typical habitat downstream of PSCIS crossing 124420.

The stream was surveyed downstream from the culvert for 375m (Figure [5.12](#)). Total cover amount was rated as with large woody debris dominant. Cover was also present as small woody debris, boulders, and overhanging vegetation (Table [5.22](#)). The average channel width was 6.1m, the average wetted width was 4.6m and the average gradient was 2.1%. The dominant substrate was gravels with cobbles subdominant. Survey notes indicate a complex system with deeply undercut banks with steep sections and confined areas. Segments of stream showed signs of erosion and deposition of fine sediments. Multiple areas with braided channels around woody debris and evidence of large fluctuations in flow were noted. The habitat was rated as high value for salmonid rearing and spawning. The reader is referred to Newman and England (2018) for addition information on habitat containing more detail.

Should restoration/maintenance activities proceed, replacement of PSCIS crossing 124420 with a bridge (30m span) is recommended. The cost of the work is estimated at \$18,000,000 for a cost benefit of 0.5 linear m/\$1000 and 2.9 m<sup>2</sup>/\$1000. These cost benefit estimates assume that adult coho spawner passage through 124420 will result in passage through upstream crossings which rank as barriers according to the provincial metric but are likely to be passable to adult coho.

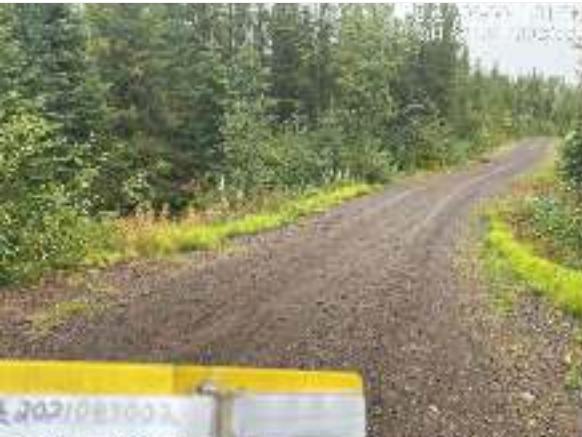
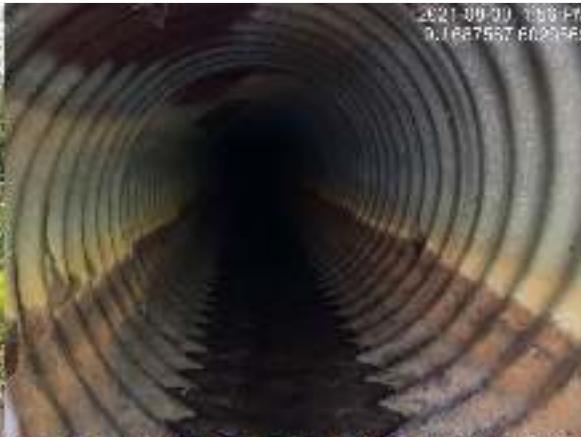
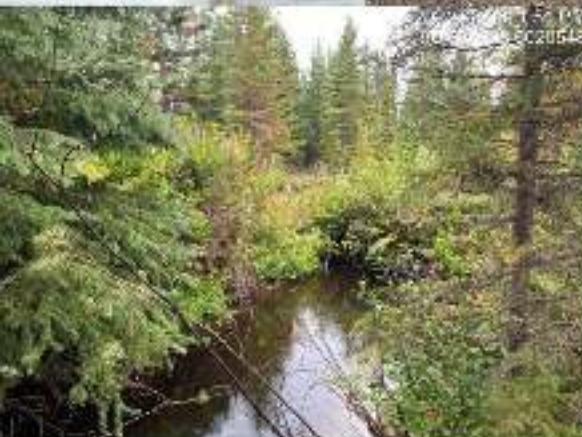
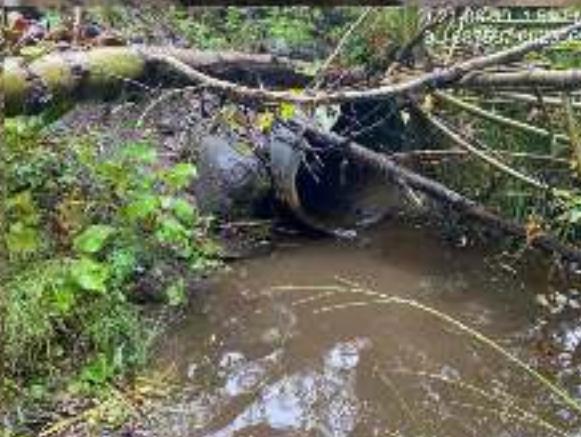
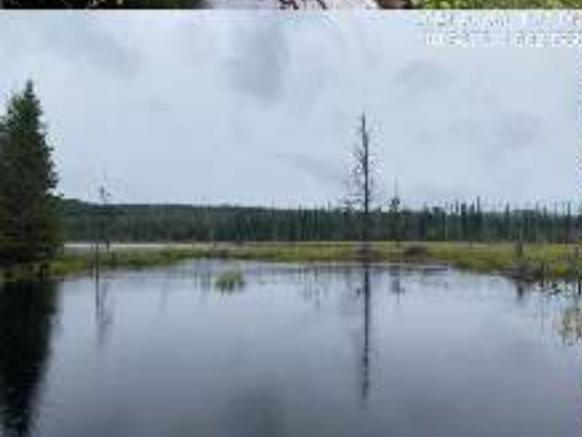
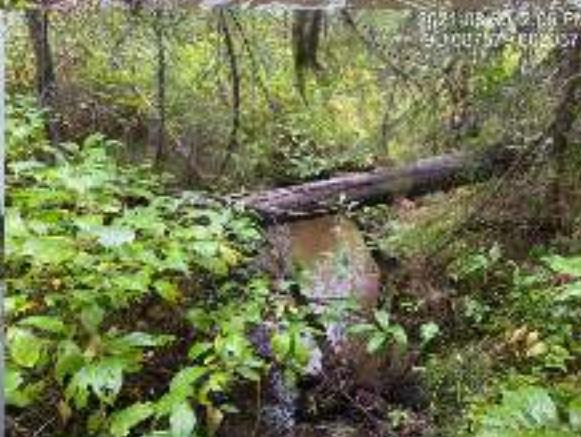
Location and Stream Data	•	Crossing Characteristics	-
Comments: Habitat value is low to medium. Large beaver influenced lake upstream with two dams ~1.5m high at 10m and 30m upstream. Inlet blocked. Water at inlet is level with the top of the culvert. At 4m downstream is a 1m high beaver dam. 13:23

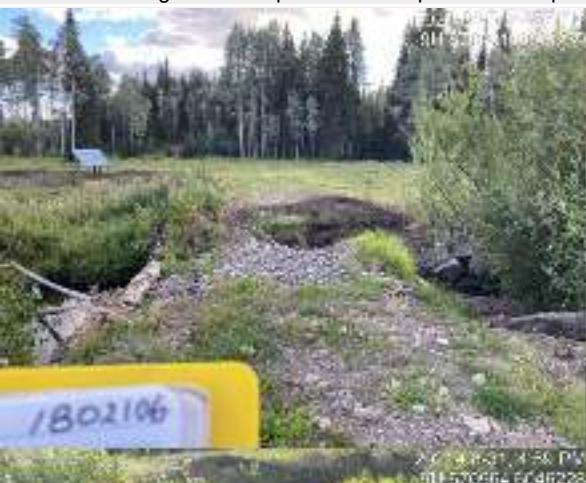
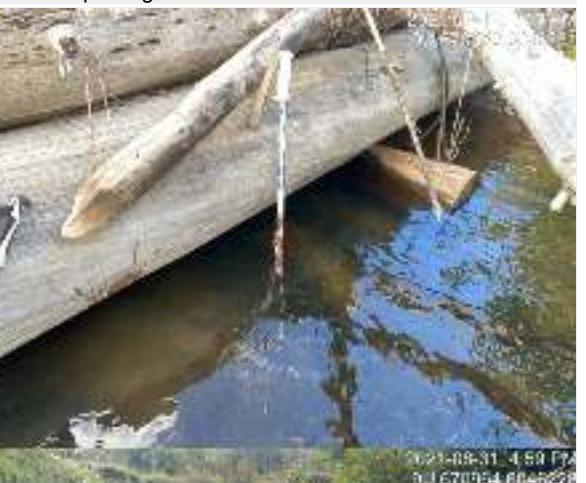
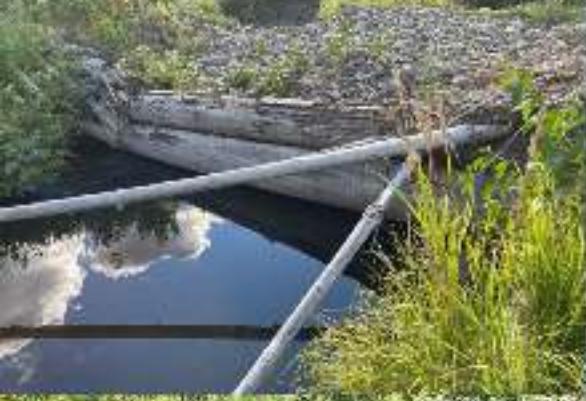
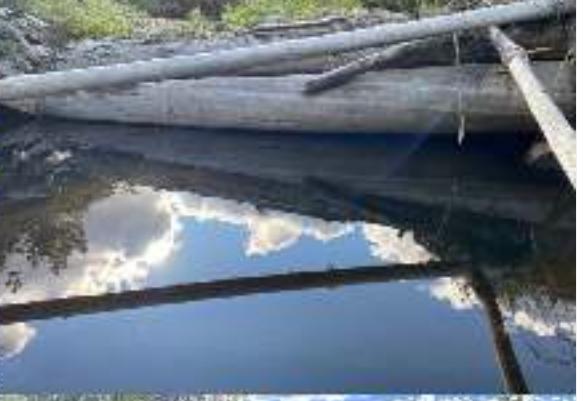
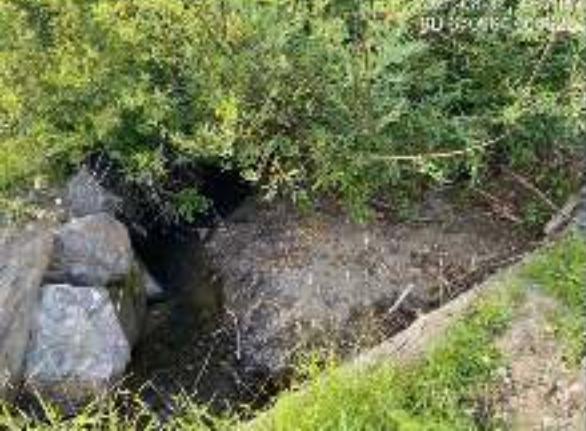
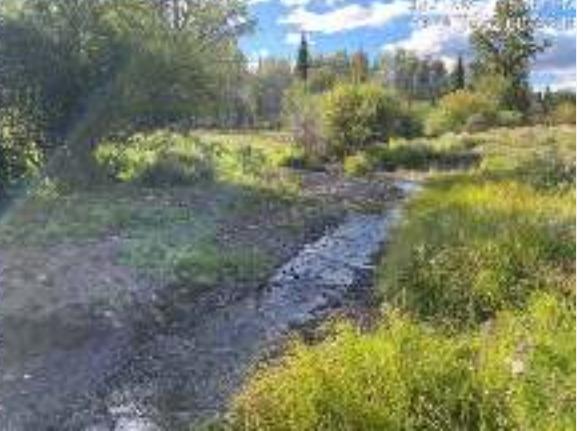
Photos: From top left clockwise: Road/Site Card, Barrel, Outlet, Downstream, Upstream, Inlet.

Location and Stream Data	•	Crossing Characteristics	-
Comments: Bridge has collapsed and is impediment to upstream fish passage. Habitat confirmation conducted. 16:56

Should restoration/maintenance activities proceed at the site, removal of PSCIS crossing 197912 is recommended. In addition to removal of the collapsed bridge, resloping of banks and the installation of live cuttings/pegboarding is recommended in three areas downstream where cattle trampling is resulting in significant erosion. A map of the erosion areas and associated prescriptions for rehabilitation of the downstream corners is provided as Figure [5.22](#). The cost of the work is estimated at \$30,000 for a cost benefit of 924 linear m/\$1000 and 3973.2 m<sup>2</sup>/\$1000.

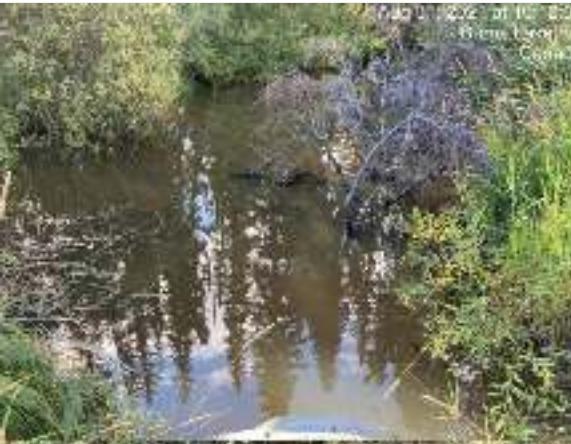
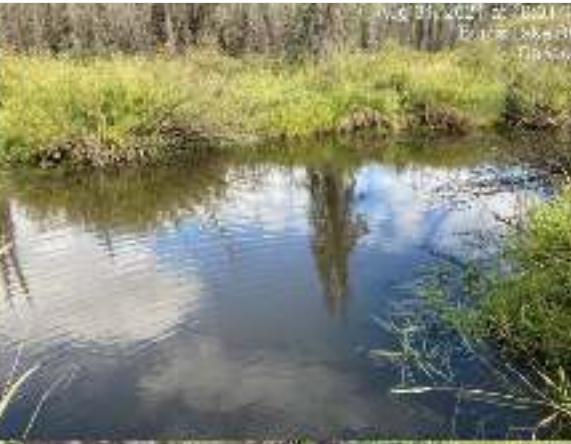
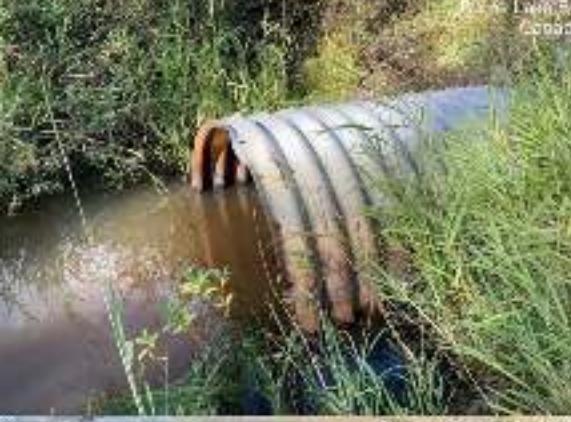
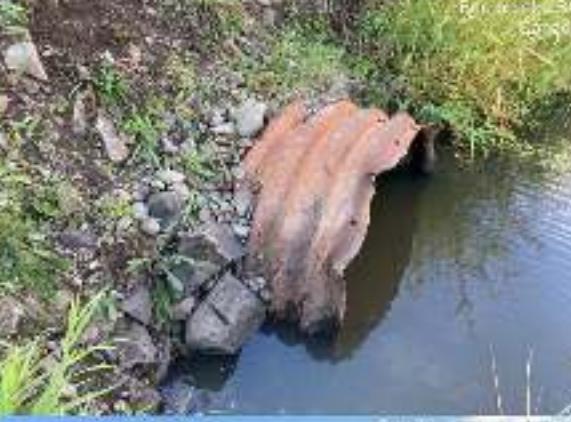
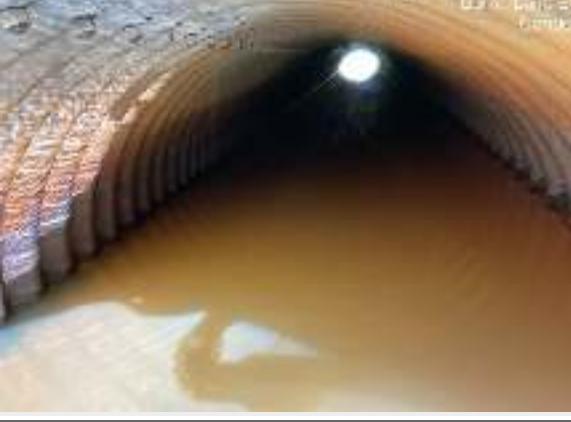
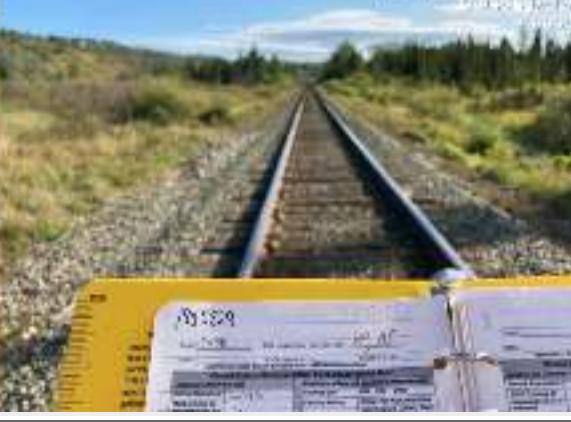
Location and Stream Data	•	Crossing Characteristics	-
Comments: Backwatered fully, appears fully passable. Fish sighted at outlet. Distance from water surface to top of culvert is 70cm. 9:58

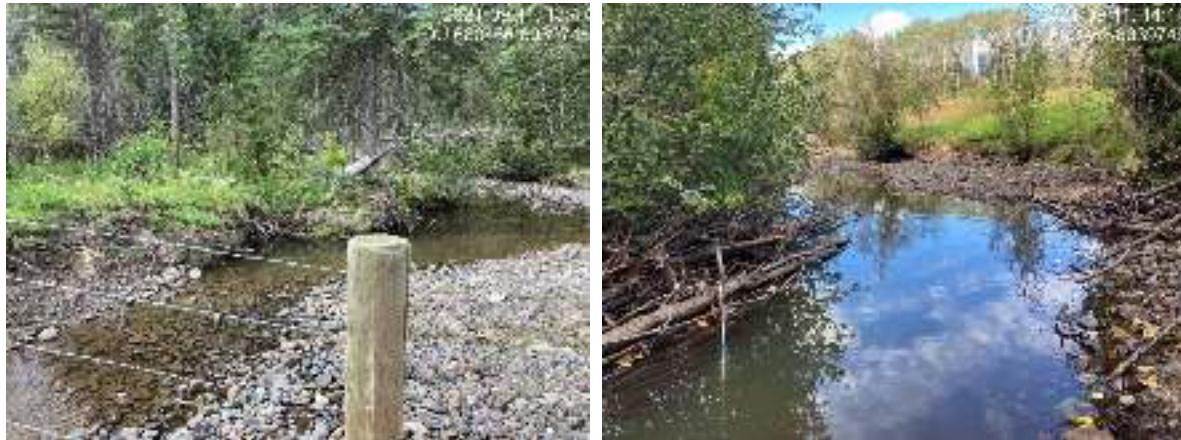
Figure 5.36: Left: Typical habitat downstream of PSCIS crossing 197976. Right: Typical habitat downstream of PSCIS crossing 197976.

At the time of the survey, PSCIS crossing 197976 was 50% backwatered, un-embedded and ranked as a barrier to upstream fish passage according to the provincial protocol (MoE 2011b) (Table 5.59). A juvenile fish (~140 cm) was noted as easily swimming upstream through the culvert during the survey. PSCIS crossing 197976 was not backwatered, not embedded and ranked as a barrier to upstream fish passage according to the provincial protocol (Table 5.60). Water temperature was 11° C, pH was 7 and conductivity was 248uS/cm.

Should restoration/maintenance activities proceed, replacement of PSCIS crossing 197976 with a bridge (12.5m span) is recommended. The cost of the work is estimated at \$7,500,000 for a cost benefit of 3.3 linear m/\$1000 and 27.1 m<sup>2</sup>/\$1000. As the crossing partially backwaters naturally, a plan to backwater the crossing could also be of consideration in the short term with a rough cost estimate to complete of \$25,000.

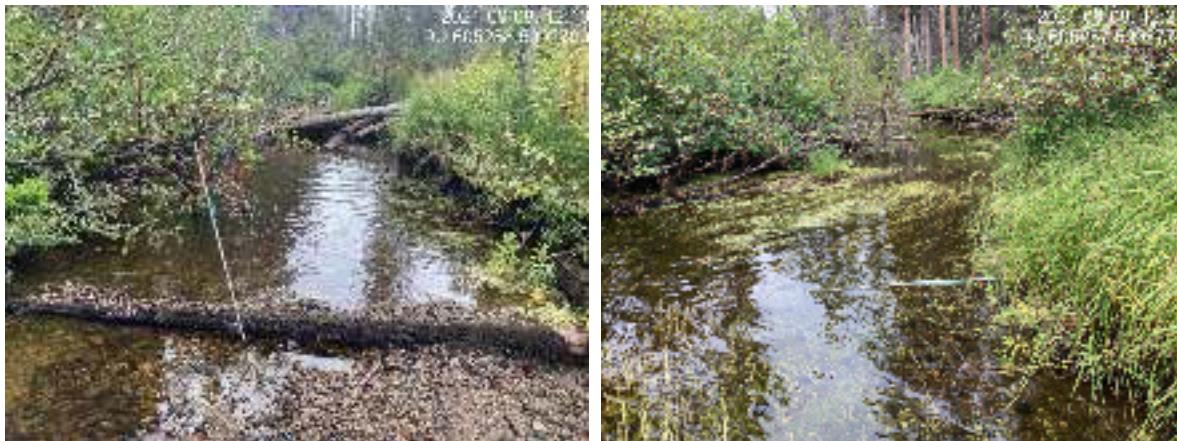
Figure 5.39: Left: Typical habitat downstream of PSCIS crossing 198000. Right: Typical habitat downstream of PSCIS crossing 198000.

The stream was surveyed downstream from the culvert for 300m (Figure [5.39](#)). Total cover amount was rated as with instream vegetation dominant. Cover was also present as small woody debris, large woody debris, and overhanging vegetation (Table [5.67](#)). The average channel width was 6.2m, the average wetted width was 5.1m and the average gradient was 1.2%. The dominant substrate was gravels with cobbles subdominant. The habitat was rated as high value for salmonid rearing and spawning.

Should restoration/maintenance activities proceed at the site, replacement of PSCIS crossing 198000 with a bridge (14m span) is recommended.

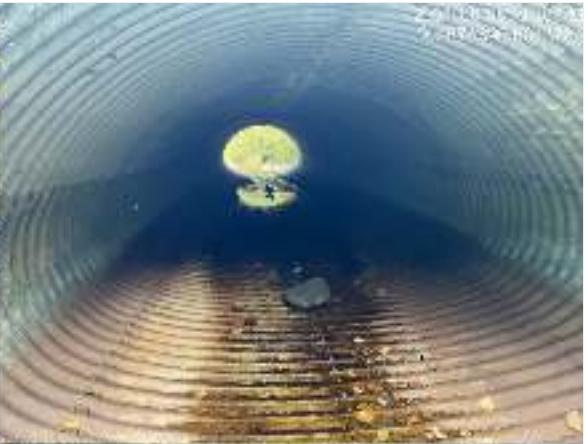
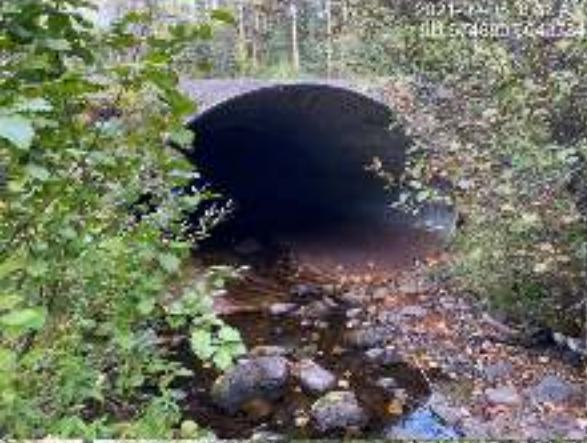
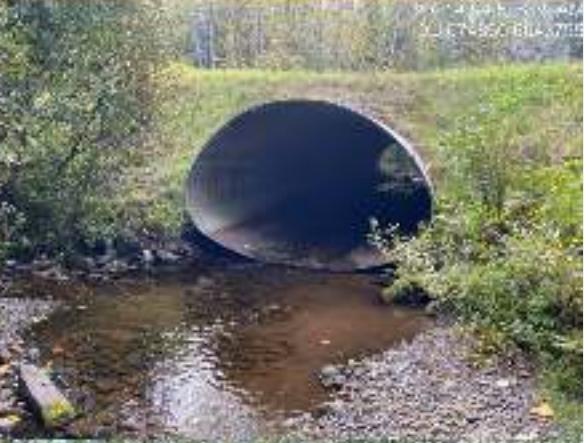
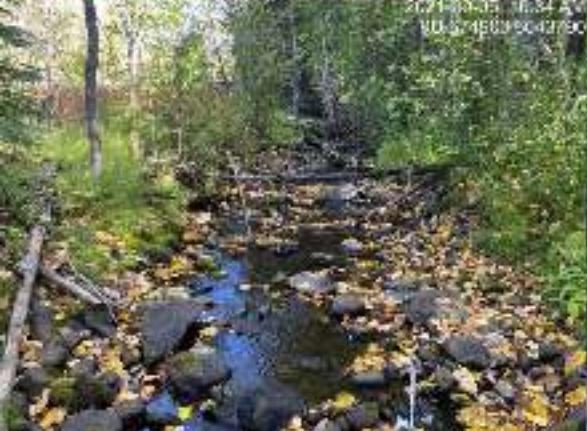
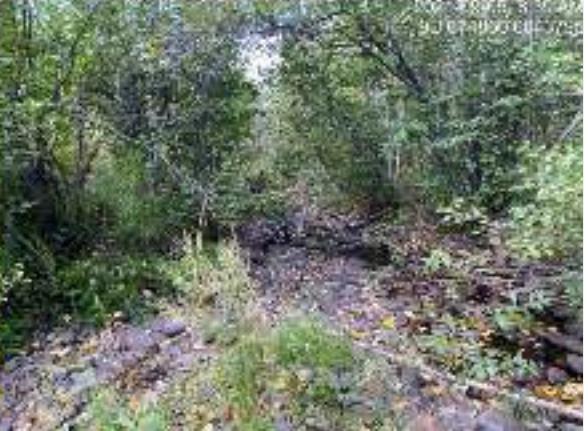
Location and Stream Data		Crossing Characteristics –	
Date	2021-09-05	Crossing Sub Type	Round Culvert
PSCIS ID	198049	Diameter (m)	3.7
External ID	–	Length (m)	21
Crew	AI	Embedded	No
UTM Zone	9	Depth Embedded (m)	–
Easting	674875.4	Resemble Channel	No
Northing	6043782	Backwatered	No
Stream	Cesford Creek	Percent Backwatered	–
Road	Highway 118	Fill Depth (m)	1
Road Tenure	MoTi Arterial	Outlet Drop (m)	0.5
Channel Width (m)	4.9	Outlet Pool Depth (m)	0.25
Stream Slope (%)	2.83	Inlet Drop	No
Beaver Activity	No	Slope (%)	1.5
Habitat Value	High	Valley Fill	Deep Fill
Final score	34	Barrier Result	Barrier
Fix type	Replace with New Open Bottom Structure	Fix Span / Diameter	10
Photos: From top left clockwise: Road/Site Card, Barrel, Outlet, Downstream, Upstream, Inlet.

Location and Stream Data	•	Crossing Characteristics	-
Comments: Habitat confirmation conducted. ~110mm fish observed in outlet pool. Culvert slope surveyed with lazer level. 8:37

Should restoration/maintenance activities proceed, replacement of PSCIS crossing 198049 with a bridge (10m span) is recommended. The cost of the work is estimated at \$6,000,000 for a cost benefit of 1.7 linear m/\$1000 and 8.4 m<sup>2</sup>/\$1000. Relocation of the driveway accessing the private land from the other side of the stream and removal of the crossing could also be considered.

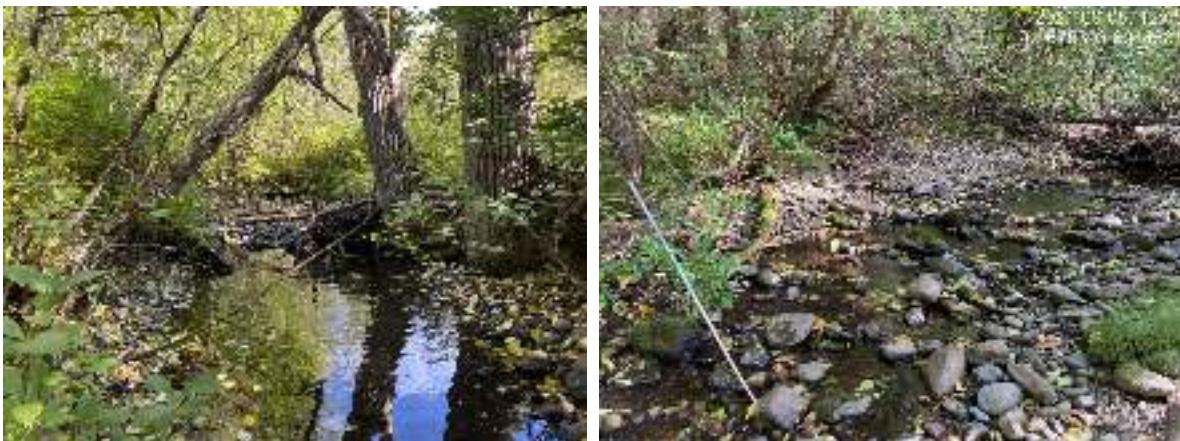
Figure 5.44: Left: Habitat upstream of PSCIS crossing 198049. Right: Habitat upstream of PSCIS crossing 198049.

The stream was surveyed upstream from crossing 198049 for 600m (Figure [5.44](#)). The average channel width was 5m, the average wetted width was 2.8m, and the average gradient was 3.5%. The dominant substrate was cobbles with boulders sub-dominant. Total cover amount was rated as moderate with large woody debris dominant. Cover was also present as deep pools and overhanging vegetation. The stream had good flow and moderate complexity due to mature cottonwood riparian and frequent large woody debris. Occasional pool and frequent gravel sections were also noted. Habitat value was rated as medium as the surveyed area was considered an important migration corridor containing suitable spawning habitat and having moderate rearing potential.

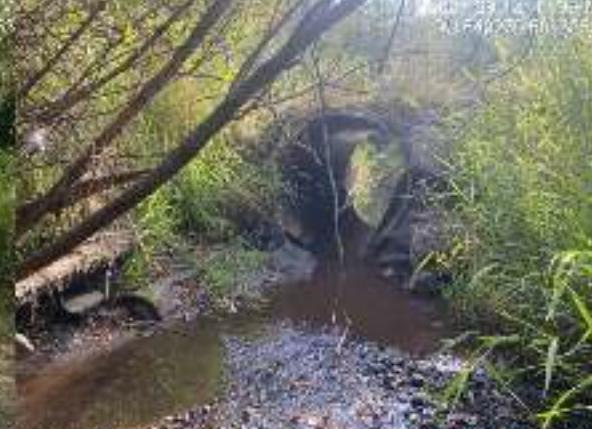
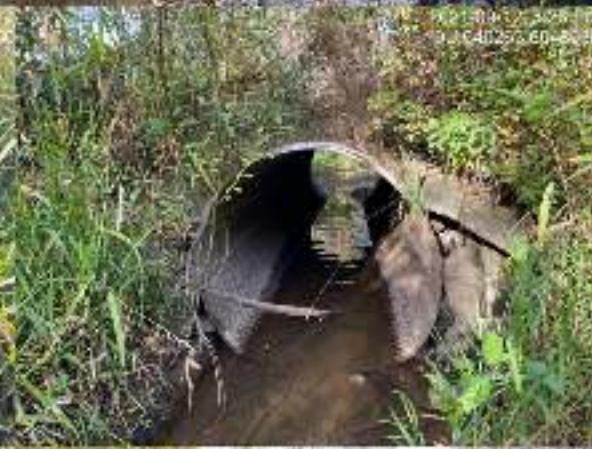
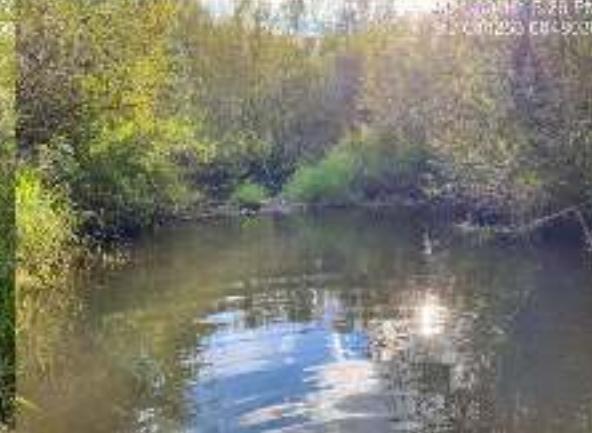
Location and Stream Data		Crossing Characteristics –	
Northing	6048061	Backwatered	Yes
Stream	Thompson Creek	Percent Backwatered	95
Road	Private Road	Fill Depth (m)	0.2
Road Tenure	Unclassified	Outlet Drop (m)	0
Channel Width (m)	2.77	Outlet Pool Depth (m)	0.1
Stream Slope (%)	0.5	Inlet Drop	No
Beaver Activity	No	Slope (%)	0.4
Habitat Value	High	Valley Fill	Deep Fill
Final score	16	Barrier Result	Potential
Fix type	Replace with New Open Bottom Structure	Fix Span / Diameter	10
Photos: From top left clockwise: Road/Site Card, Barrel, Outlet, Downstream, Upstream, Inlet.

Location and Stream Data	•	Crossing Characteristics	-
Comments: Udder View Farm. Currently appears passable for all life stages and species but may present slight barrier at time of year when flow are high. Large outlet pool indicates that culvert is undersized. Landowners adjacent to the stream report that the channel was historically relocated through the fields near the river and they would like to work together to relocate. 16:48

Should restoration/maintenance activities proceed at the site, replacement of PSCIS crossing 198066 with a bridge (10m span) is recommended.
