Appendix - Phase 1 Fish Passage Assessment Data and Photos

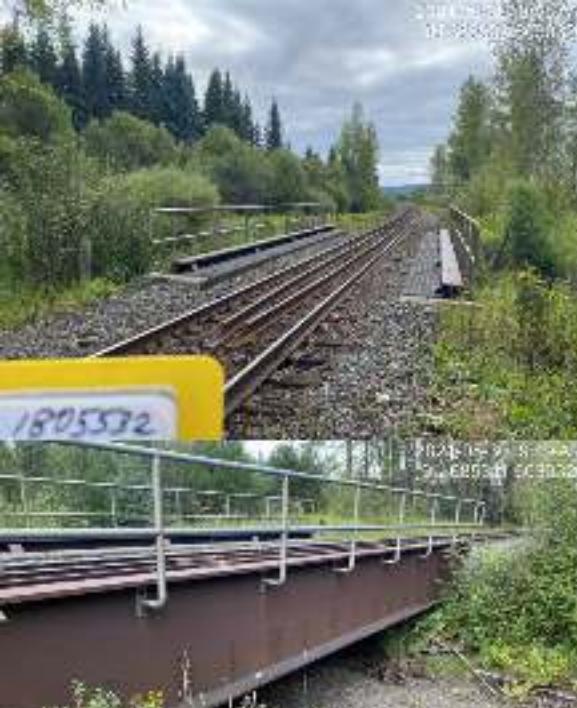
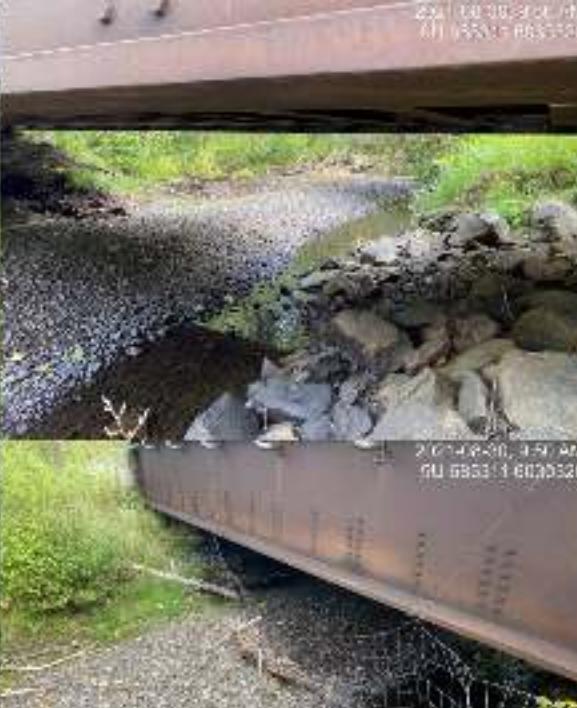
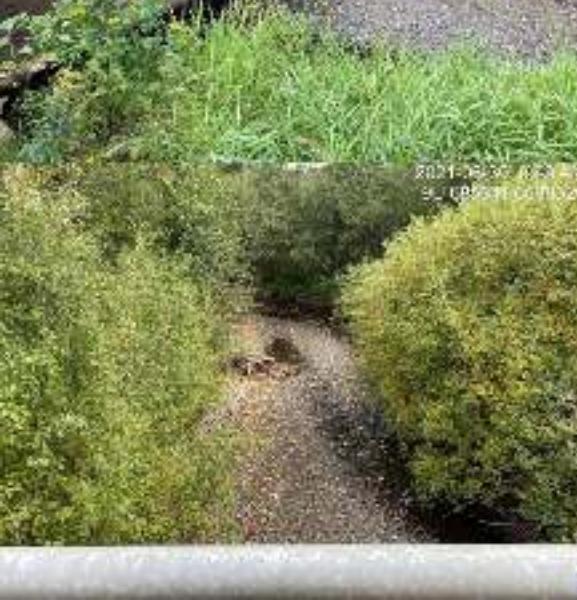
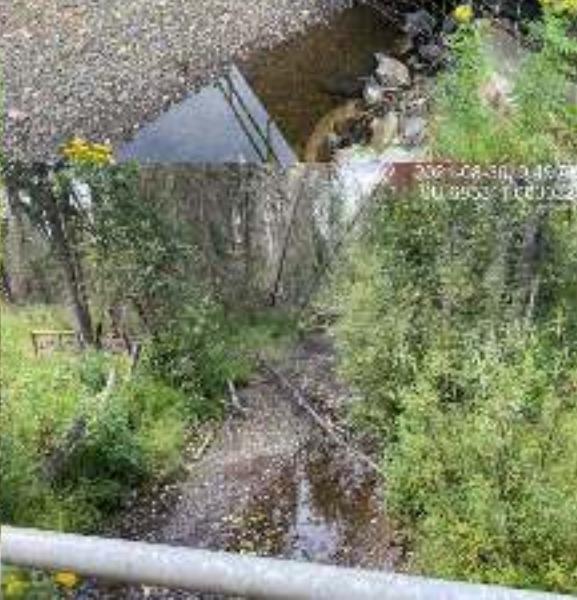
Photos: PSCIS ID 197900. From top left clockwise: Road/Site Card, Barrel, Outlet, Downstream, Upstream, Inlet.

Location and Stream Data	.	Crossing Characteristics	-
Date	2021-08-30	Crossing Sub Type	Bridge
PSCIS ID	197900	Diameter (m)	13.5
External ID	1805532	Length (m)	6
Crew	AI	Embedded	-
UTM Zone	9	Depth Embedded (m)	-
Easting	685314.1	Resemble Channel	-
Northing	6030317	Backwatered	-
Stream	Crow Creek	Percent Backwatered	-
Road	CN Railway	Fill Depth (m)	-
Road Tenure	Canadian National	Outlet Drop (m)	-
Channel Width (m)	-	Outlet Pool Depth (m)	-
Stream Slope (%)	-	Inlet Drop	-
Beaver Activity	-	Slope (%)	-
Habitat Value	-	Valley Fill	-
Final score	0	Barrier Result	Passable
Fix type	-	Fix Span / Diameter	-

Location and Stream Data	•	Crossing Characteristics	-
Comments: Bridge. 9:46

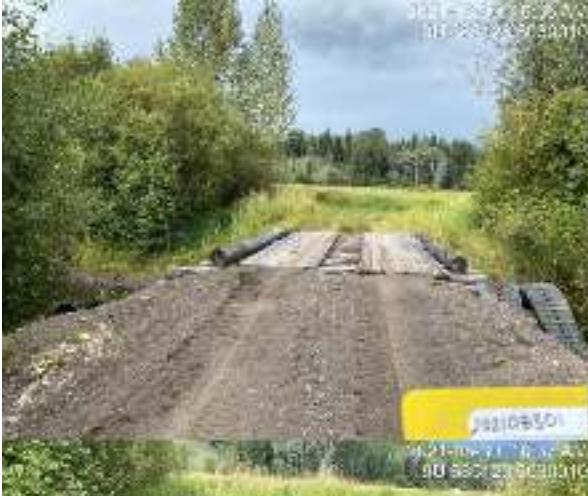
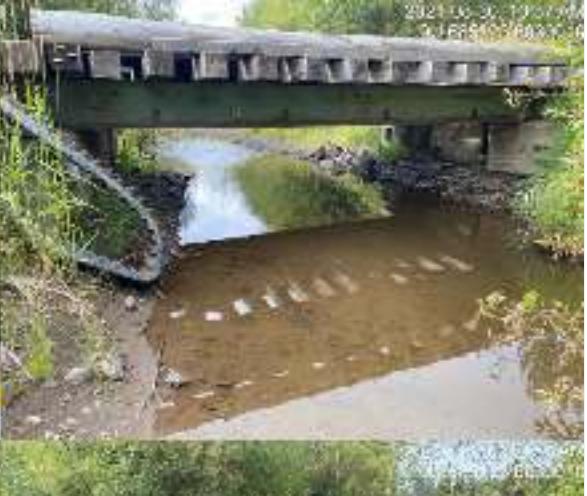
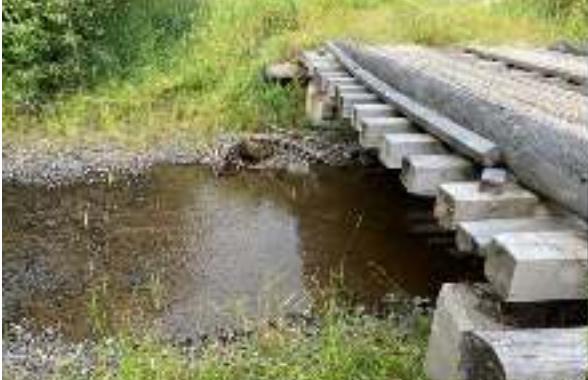
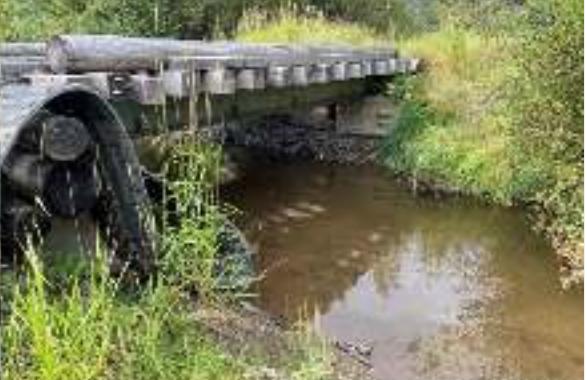
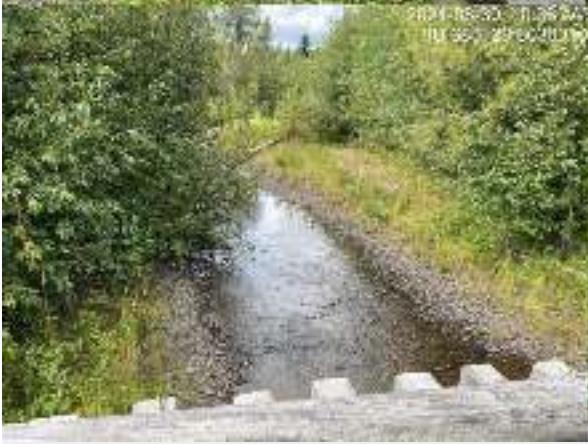
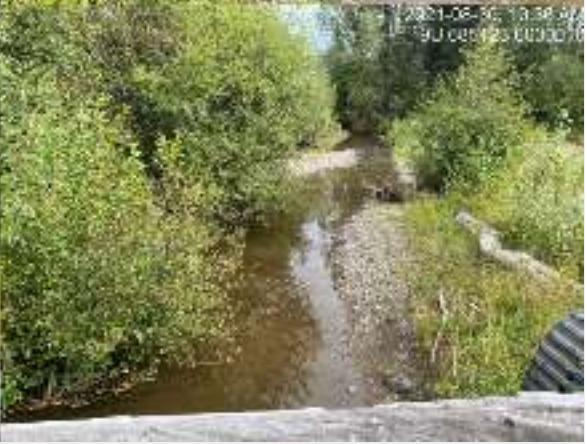
Photos: PSCIS ID 197901. From top left clockwise: Road/Site Card, Barrel, Outlet, Downstream, Upstream, Inlet.

Location and Stream Data		•	Crossing Characteristics	-
Date	2021-08-30	Crossing Sub Type	Bridge	
PSCIS ID	197901	Diameter (m)	8	
External ID	1801185	Length (m)	4	
Crew	AI KP	Embedded	-	
UTM Zone	9	Depth Embedded (m)	-	
Easting	684767	Resemble Channel	-	
Northing	6029867	Backwatered	-	
Stream	Crow Creek	Percent Backwatered	-	
Road	Private	Fill Depth (m)	-	
Road Tenure	Unclassified	Outlet Drop (m)	-	
Channel Width (m)	-	Outlet Pool Depth (m)	-	
Stream Slope (%)	-	Inlet Drop	-	
Beaver Activity	-	Slope (%)	-	
Habitat Value	-	Valley Fill	-	
Final score	0	Barrier Result	Passable	
Fix type	-	Fix Span / Diameter	-

Location and Stream Data	•	Crossing Characteristics	-
Comments: Bridge. 10:36

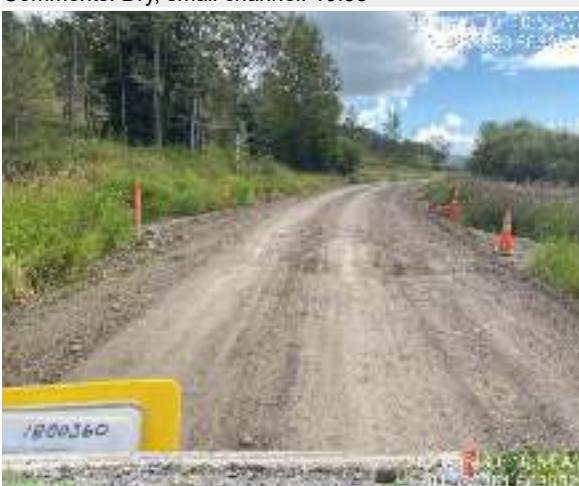
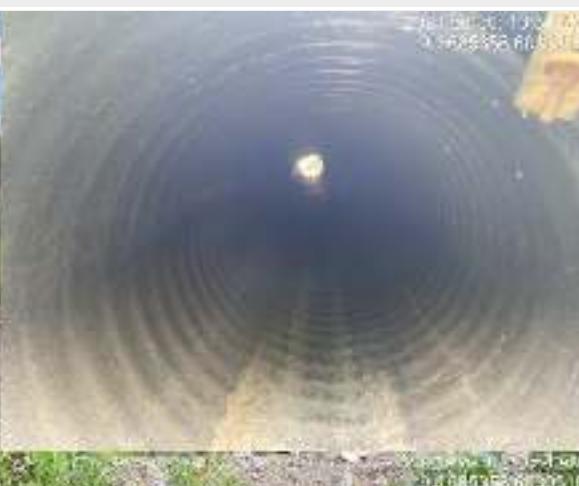
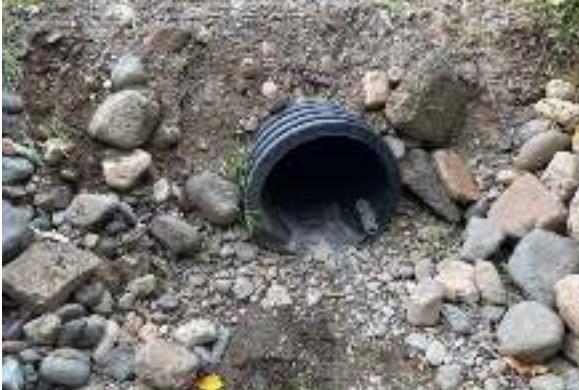
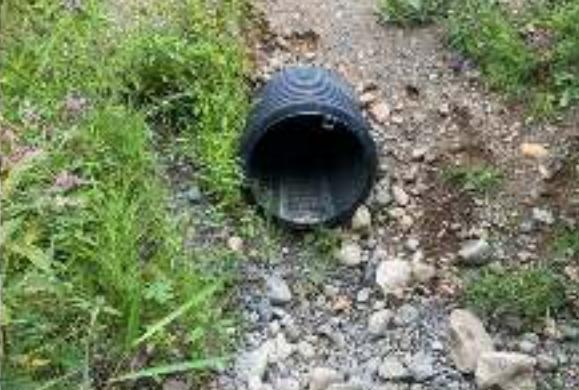
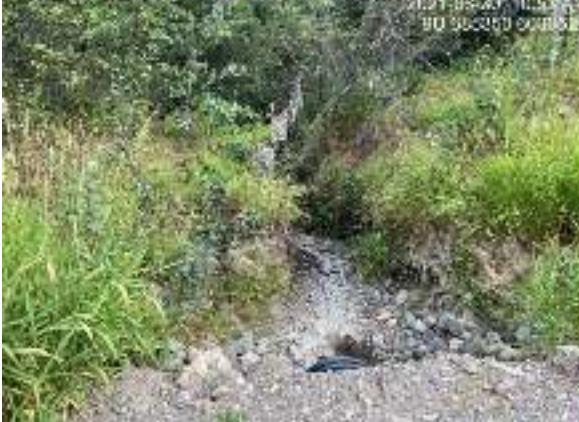
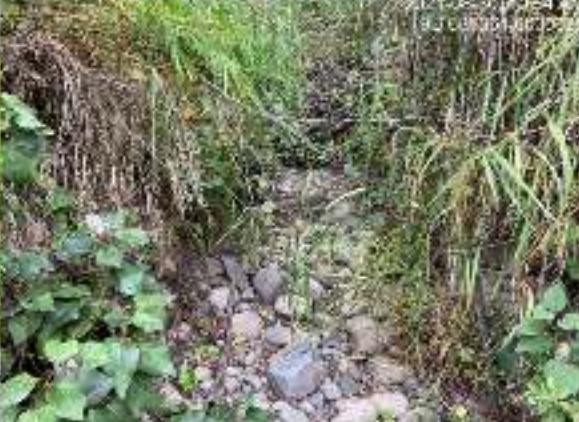
Photos: PSCIS ID 197902. From top left clockwise: Road/Site Card, Barrel, Outlet, Downstream, Upstream, Inlet.

Location and Stream Data		Crossing Characteristics	
Date	2021-08-30	Crossing Sub Type	Round Culvert
PSCIS ID	197902	Diameter (m)	0.6
External ID	1800360	Length (m)	14
Crew	AI KP	Embedded	No
UTM Zone	9	Depth Embedded (m)	—
Easting	685353.3	Resemble Channel	No
Northing	6030520	Backwatered	No
Stream	Tributary to Bulkley River	Percent Backwatered	—
Road	Rose Lake Cutoff Road	Fill Depth (m)	1
Road Tenure	MoTi Local	Outlet Drop (m)	0.1
Channel Width (m)	1.5	Outlet Pool Depth (m)	0.1
Stream Slope (%)	7	Inlet Drop	No
Beaver Activity	No	Slope (%)	3.5
Habitat Value	Low	Valley Fill	Deep Fill
Final score	26	Barrier Result	Barrier
Fix type	Replace Structure with Streambed Simulation CBS	Fix Span / Diameter	3

Location and Stream Data	.	Crossing Characteristics	-
Comments: Dry, small channel. 10:53

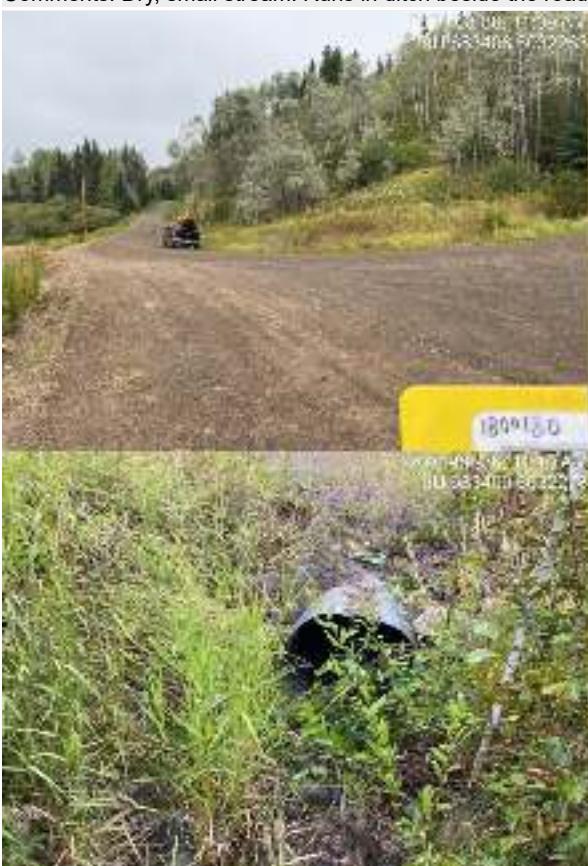
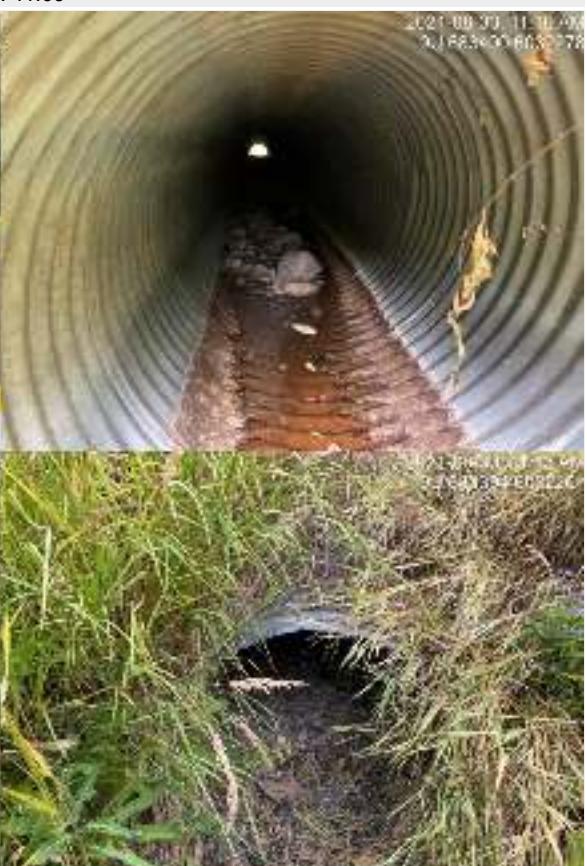
Photos: PSCIS ID 197903. From top left clockwise: Road/Site Card, Barrel, Outlet, Downstream, Upstream, Inlet.

Location and Stream Data		Crossing Characteristics	
Date	2021-08-30	Crossing Sub Type	Round Culvert
PSCIS ID	197903	Diameter (m)	0.9
External ID	1800180	Length (m)	23
Crew	AI KP	Embedded	No
UTM Zone	9	Depth Embedded (m)	–
Easting	683420.7	Resemble Channel	No
Northing	6032258	Backwatered	No
Stream	Tributary to Bulkley River	Percent Backwatered	–
Road	Rose Lake Cutoff Road	Fill Depth (m)	1
Road Tenure	MoTi Local	Outlet Drop (m)	0
Channel Width (m)	1.5	Outlet Pool Depth (m)	0
Stream Slope (%)	12	Inlet Drop	Yes
Beaver Activity	No	Slope (%)	3.5
Habitat Value	Low	Valley Fill	Deep Fill
Final score	29	Barrier Result	Barrier
Fix type	Replace Structure with Streambed Simulation CBS	Fix Span / Diameter	3

Location and Stream Data	•	Crossing Characteristics	-
Comments: Dry, small stream. Runs in ditch beside the road. 11:09

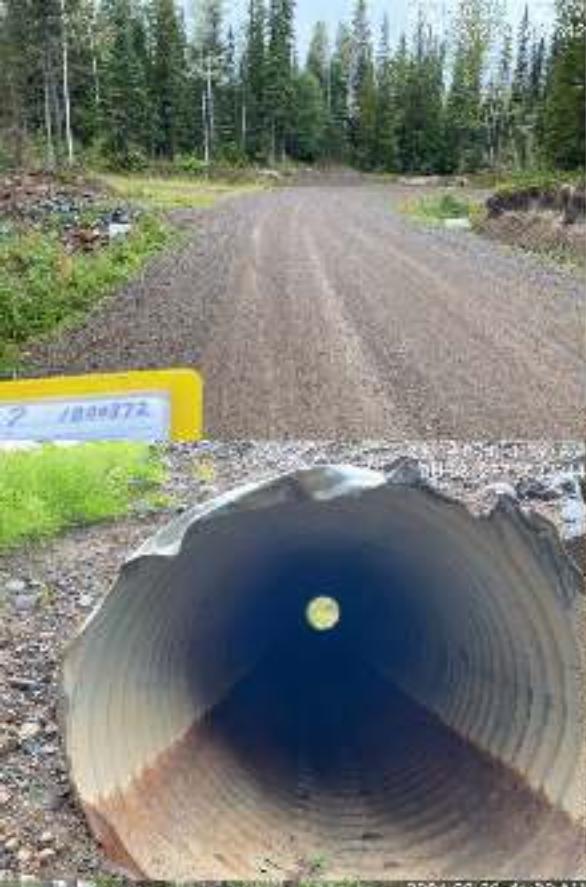
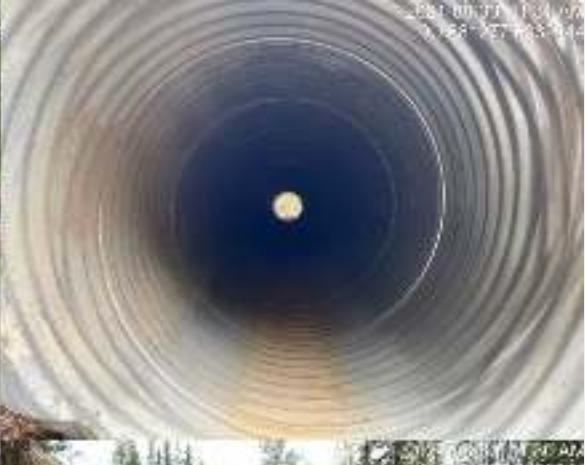
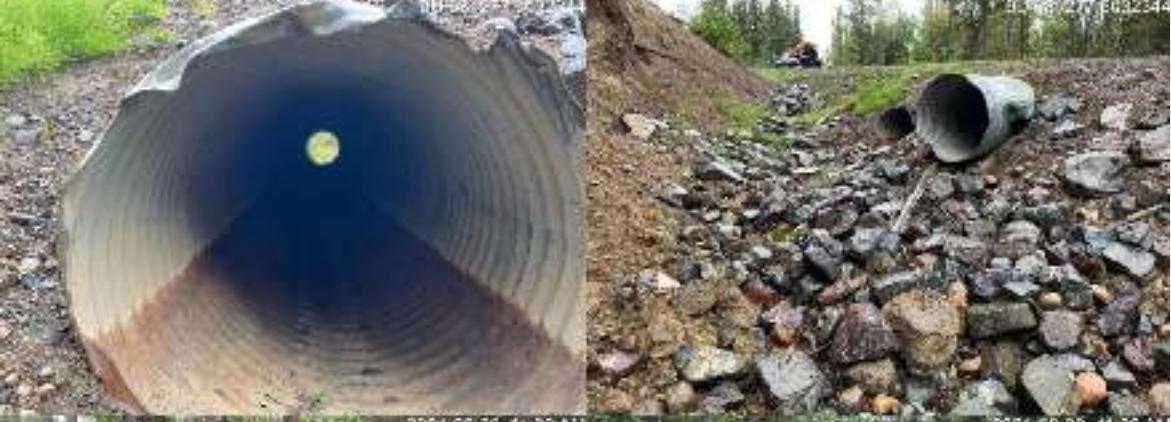
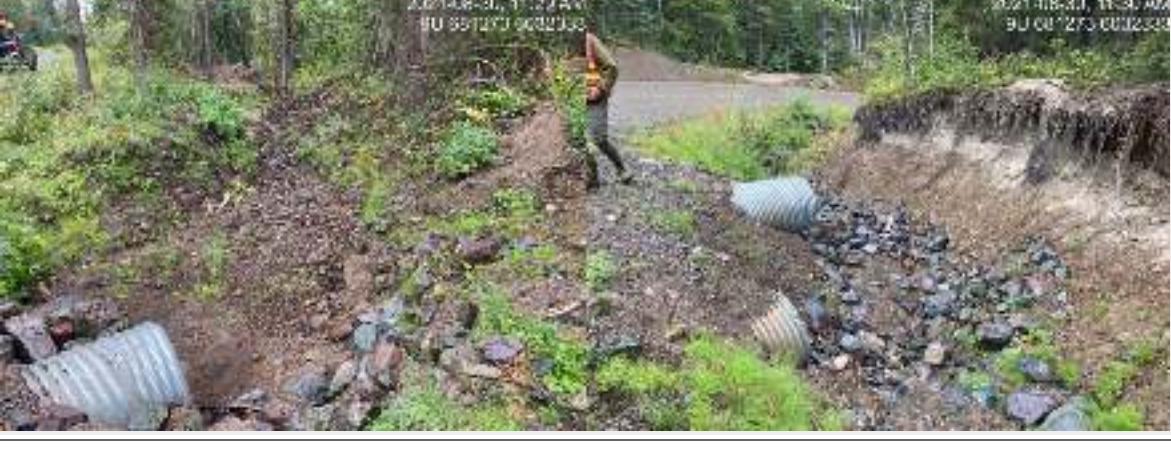
Photos: PSCIS ID 197904. From top left clockwise: Road/Site Card, Barrel, Outlet, Downstream, Upstream, Inlet.

Location and Stream Data		Crossing Characteristics –	
Date	2021-08-30	Crossing Sub Type	Round Culvert
PSCIS ID	197904	Diameter (m)	0.9
External ID	1800372	Length (m)	15
Crew	AI	Embedded	No
UTM Zone	9	Depth Embedded (m)	–
Easting	681279	Resemble Channel	No
Northing	6032345	Backwatered	No
Stream	Tributary to Bulkley River	Percent Backwatered	–
Road	Crow Creek Road	Fill Depth (m)	1.5
Road Tenure	Resource	Outlet Drop (m)	0
Channel Width (m)	2	Outlet Pool Depth (m)	0
Stream Slope (%)	4	Inlet Drop	No
Beaver Activity	No	Slope (%)	8
Habitat Value	Low	Valley Fill	Deep Fill
Final score	29	Barrier Result	Barrier
Fix type	Replace with New Open Bottom Structure	Fix Span / Diameter	10

Location and Stream Data	•	Crossing Characteristics	-
Comments: Dry with dredged channel. Double pipe (0.9 x 0.9). 11:26

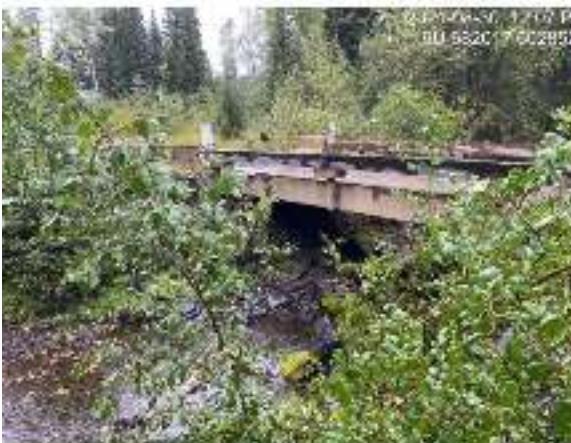
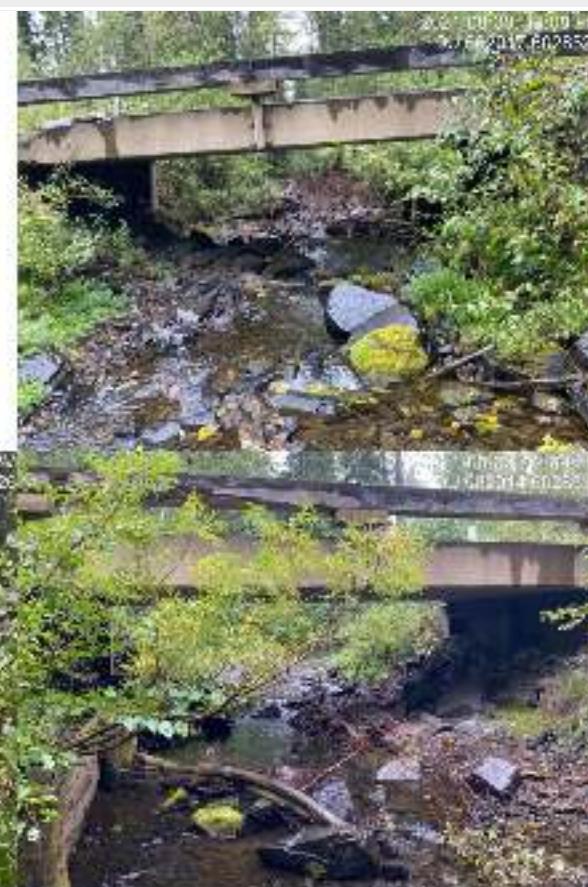
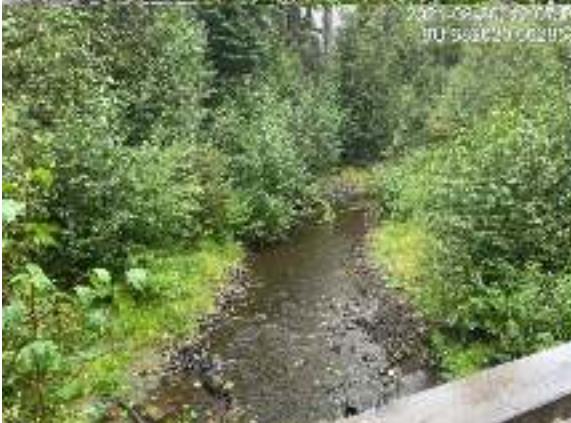
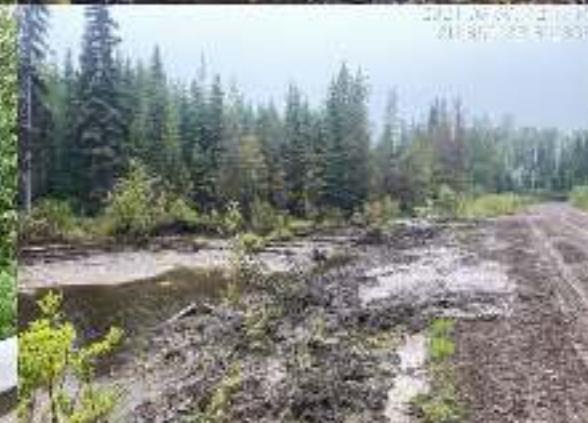
Photos: PSCIS ID 197905. From top left clockwise: Road/Site Card, Barrel, Outlet, Downstream, Upstream, Inlet.

Location and Stream Data	.	Crossing Characteristics	-
Date	2021-08-30	Crossing Sub Type	Bridge
PSCIS ID	197905	Diameter (m)	10
External ID	1803682	Length (m)	5
Crew	AI KP	Embedded	-
UTM Zone	9	Depth Embedded (m)	-
Easting	682026.1	Resemble Channel	-
Northing	6028531	Backwatered	-
Stream	Crow Creek	Percent Backwatered	-
Road	Maxan Creek FSR	Fill Depth (m)	-
Road Tenure	FLNR DND 7735	Outlet Drop (m)	-
Channel Width (m)	-	Outlet Pool Depth (m)	-
Stream Slope (%)	-	Inlet Drop	-
Beaver Activity	-	Slope (%)	-
Habitat Value	-	Valley Fill	-
Final score	0	Barrier Result	Passable
Fix type	-	Fix Span / Diameter	-

Location and Stream Data	•	Crossing Characteristics	-
Comments: Bridge. 12:05			
NO IMAGE AVAILABLE

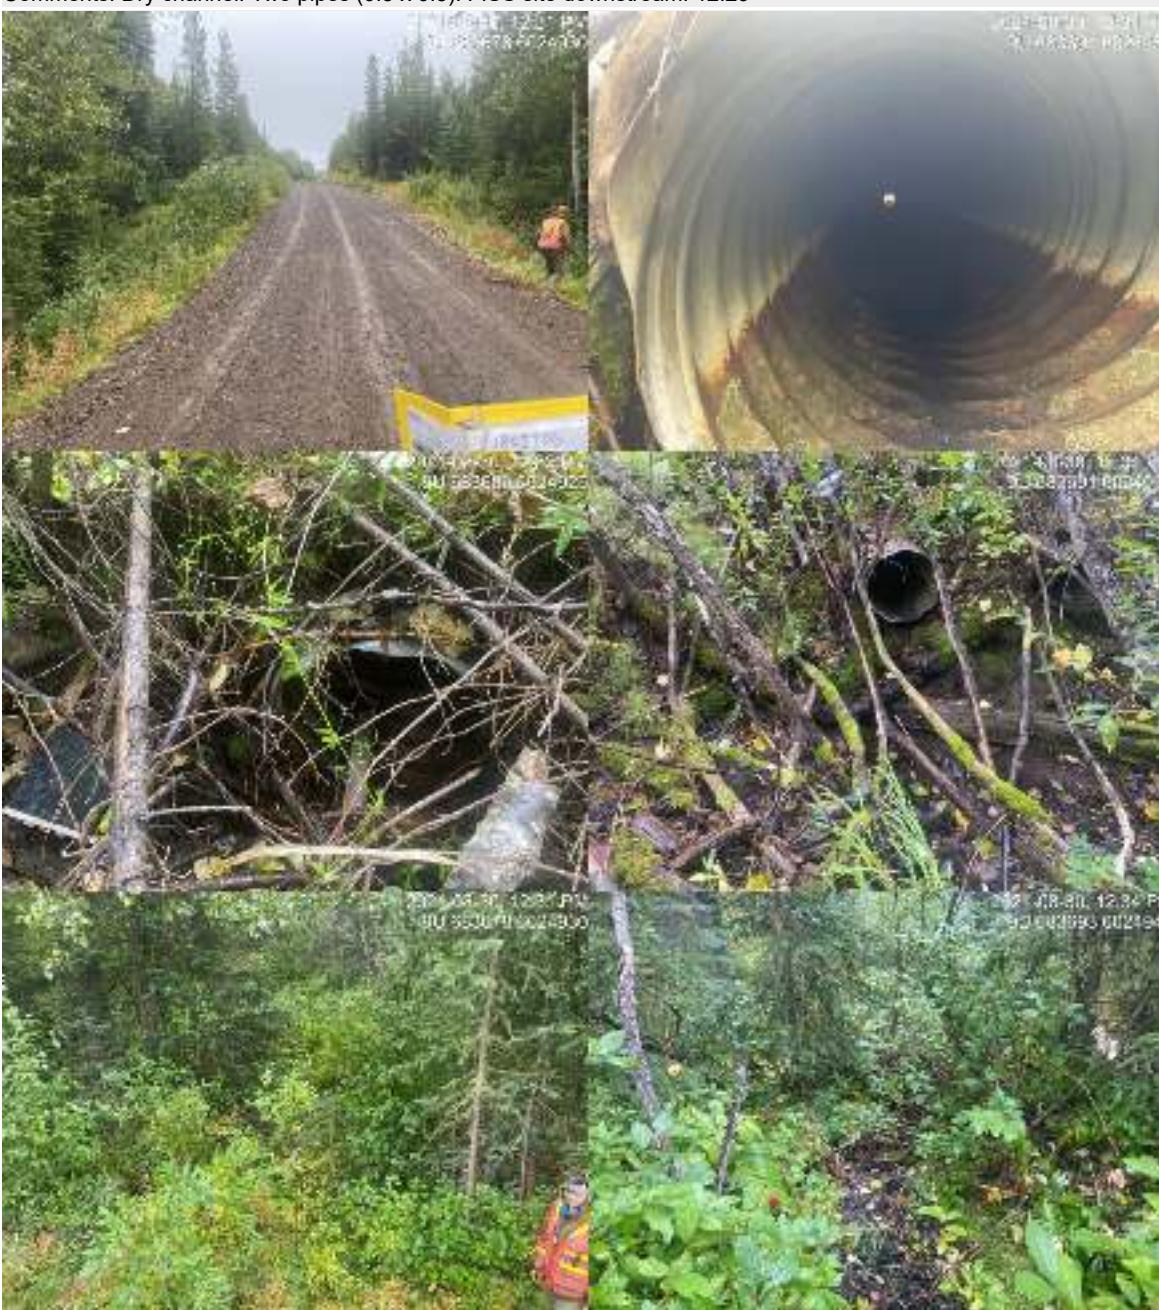
Photos: PSCIS ID 197906. From top left clockwise: Road/Site Card, Barrel, Outlet, Downstream, Upstream, Inlet.

Location and Stream Data		Crossing Characteristics	
Date	2021-08-30	Crossing Sub Type	Round Culvert
PSCIS ID	197906	Diameter (m)	0.5
External ID	1803706	Length (m)	30
Crew	AI KP	Embedded	No
UTM Zone	9	Depth Embedded (m)	—
Easting	683683.9	Resemble Channel	No
Northing	6024930	Backwatered	No
Stream	Tributary to Maxan Creek	Percent Backwatered	—
Road	Maxan Creek FSR	Fill Depth (m)	3
Road Tenure	FLNR DND 7735	Outlet Drop (m)	0.6
Channel Width (m)	1.2	Outlet Pool Depth (m)	0.3
Stream Slope (%)	3	Inlet Drop	No
Beaver Activity	No	Slope (%)	3.5
Habitat Value	Low	Valley Fill	Deep Fill
Final score	42	Barrier Result	Barrier
Fix type	Replace Structure with Streambed Simulation CBS	Fix Span / Diameter	3

Location and Stream Data	•	Crossing Characteristics	-
Comments: Dry channel. Two pipes (0.5 x 0.5). FISS site downstream. 12:29

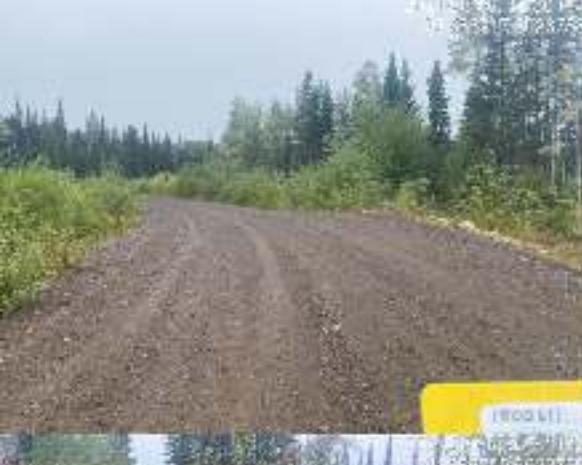
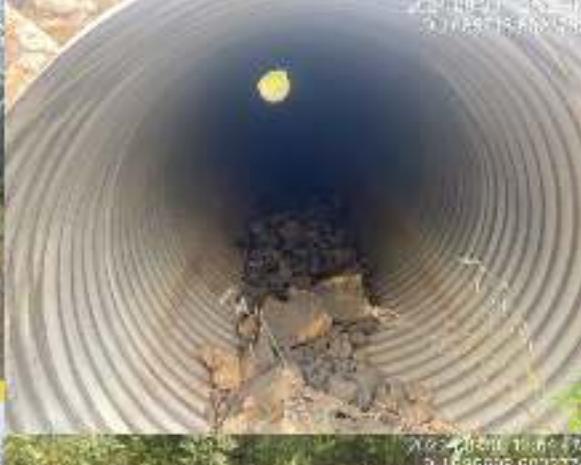
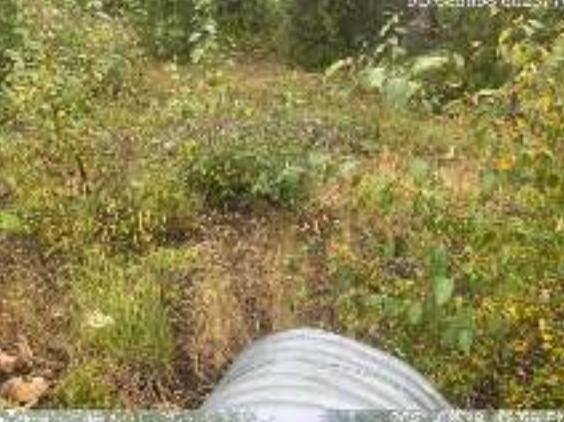
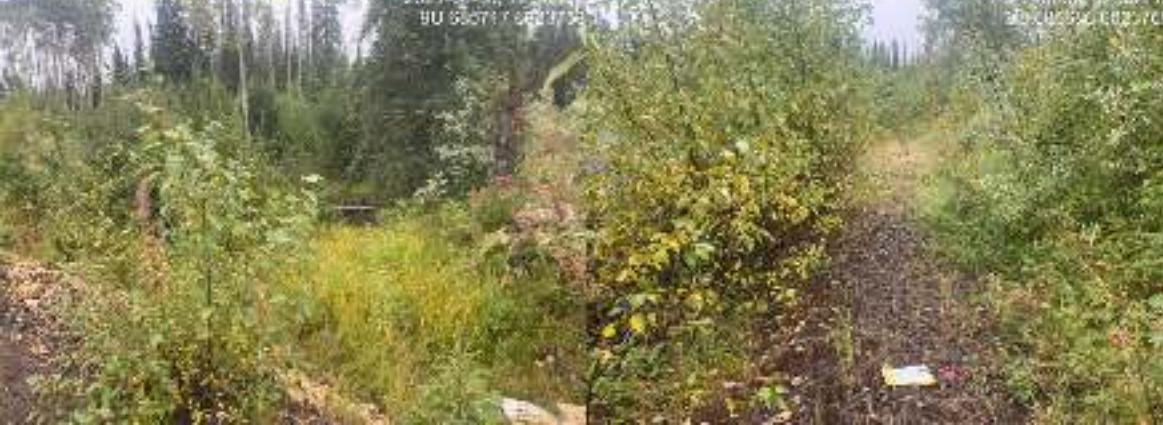
Photos: PSCIS ID 197907. From top left clockwise: Road/Site Card, Barrel, Outlet, Downstream, Upstream, Inlet.

Location and Stream Data	•	Crossing Characteristics	-
Comments: Dry channel at time of survey. Runs in ditch on low side of road. Recently replaces. 12:49

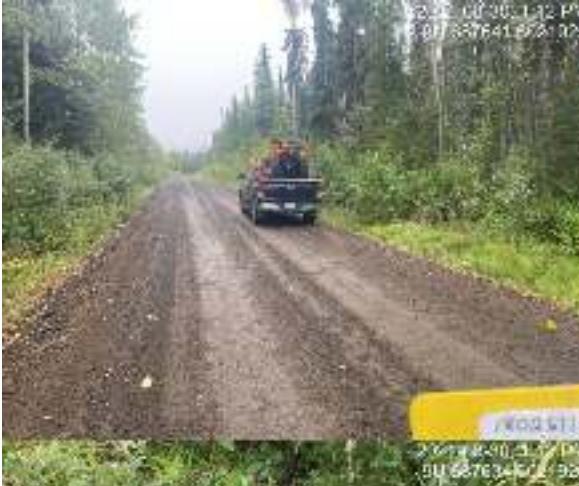
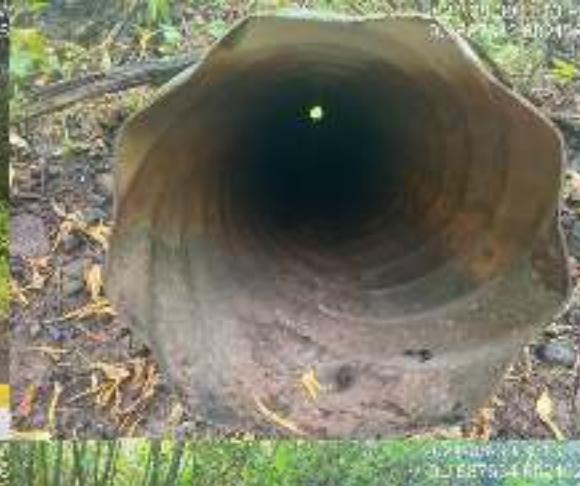
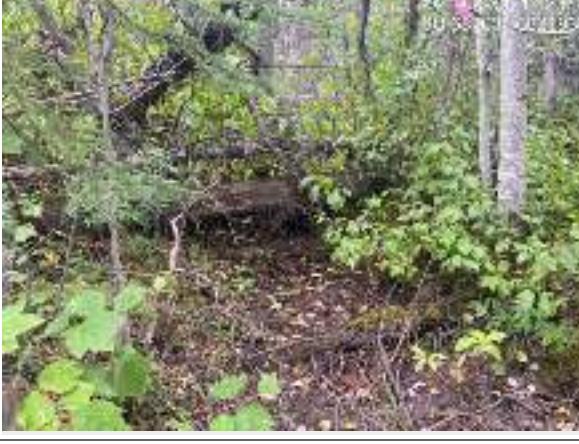
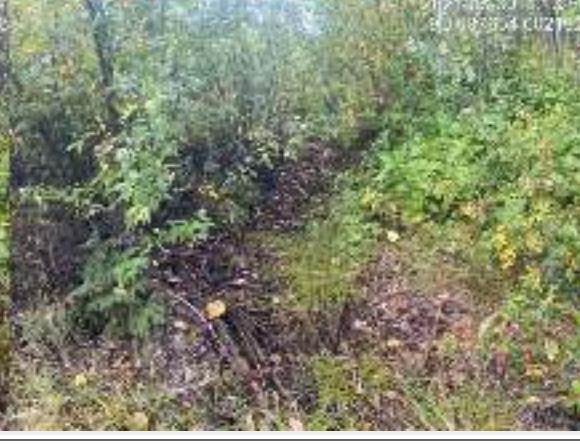
Photos: PSCIS ID 197908. From top left clockwise: Road/Site Card, Barrel, Outlet, Downstream, Upstream, Inlet.

Location and Stream Data		Crossing Characteristics	
Date	2021-08-30	Crossing Sub Type	Round Culvert
PSCIS ID	197908	Diameter (m)	0.3
External ID	1803697	Length (m)	15
Crew	AI KP	Embedded	No
UTM Zone	9	Depth Embedded (m)	–
Easting	687646.9	Resemble Channel	No
Northing	6021923	Backwatered	No
Stream	Tributary to Maxan Creek	Percent Backwatered	–
Road	Maxan Creek FSR	Fill Depth (m)	1
Road Tenure	FLNR DND 7735	Outlet Drop (m)	0.1
Channel Width (m)	1	Outlet Pool Depth (m)	0
Stream Slope (%)	2	Inlet Drop	No
Beaver Activity	No	Slope (%)	1.5
Habitat Value	Low	Valley Fill	Deep Fill
Final score	24	Barrier Result	Barrier
Fix type	Replace Structure with Streambed Simulation CBS	Fix Span / Diameter	3

Location and Stream Data	•	Crossing Characteristics	-
Comments: Dry channel at time of survey. Very small stream. ID # on card in road photo is incorrect. 13:10

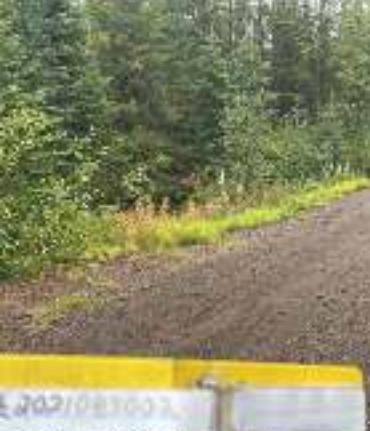
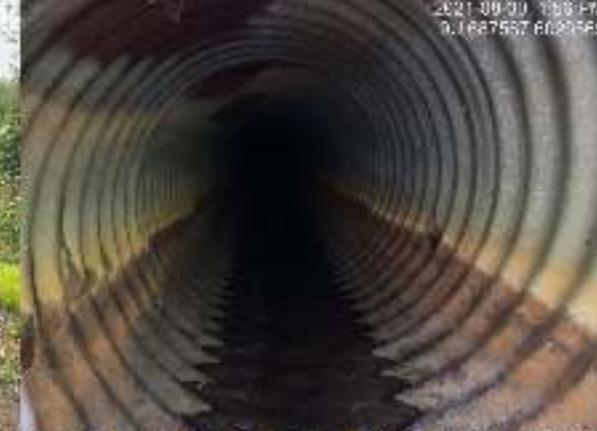
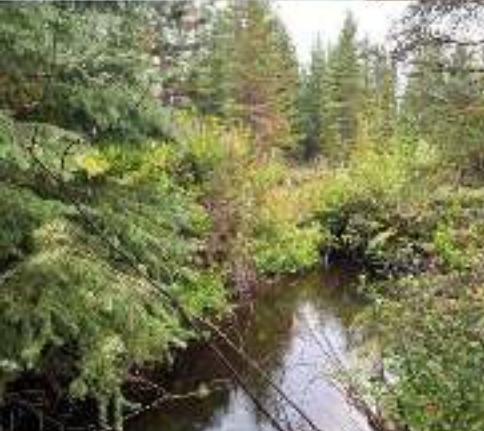
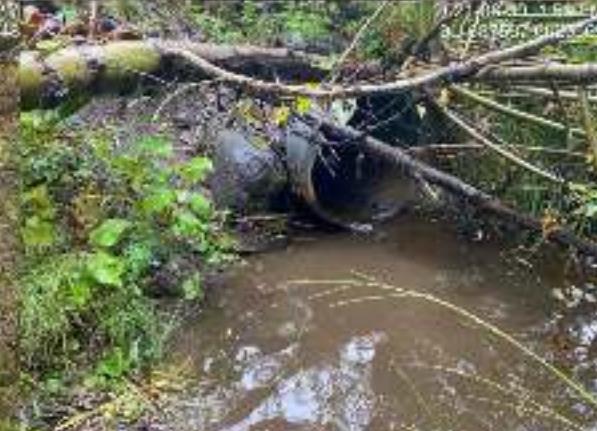
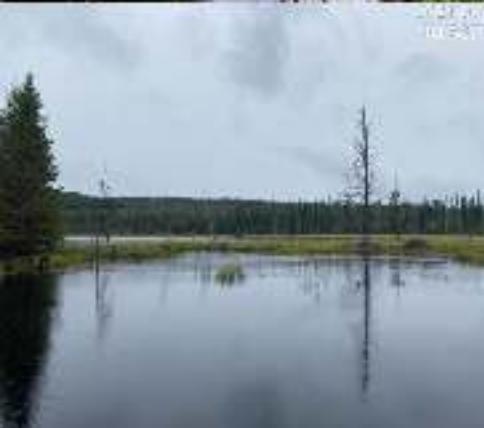
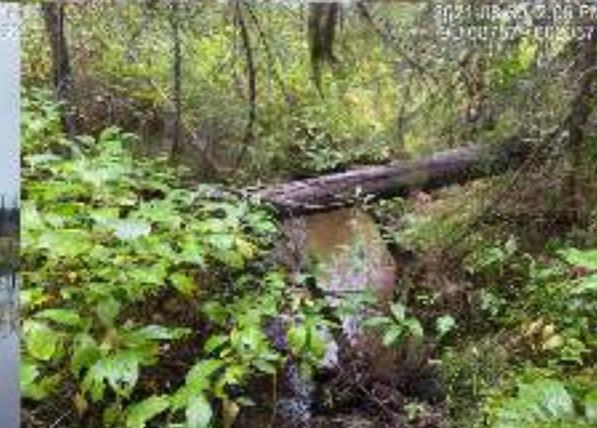
Photos: PSCIS ID 197909. From top left clockwise: Road/Site Card, Barrel, Outlet, Downstream, Upstream, Inlet.

Location and Stream Data		Crossing Characteristics	
Date	2021-08-30	Crossing Sub Type	Round Culvert
PSCIS ID	197909	Diameter (m)	0.6
External ID	1804693	Length (m)	16
Crew	AI KP	Embedded	No
UTM Zone	9	Depth Embedded (m)	–
Easting	687557	Resemble Channel	No
Northing	6020572	Backwatered	No
Stream	Tributary to Maxan Creek	Percent Backwatered	–
Road	Maxan Creek FSR	Fill Depth (m)	2.5
Road Tenure	FLNR DND 7735	Outlet Drop (m)	0
Channel Width (m)	0.9	Outlet Pool Depth (m)	0.65
Stream Slope (%)	4	Inlet Drop	Yes
Beaver Activity	Yes	Slope (%)	3
Habitat Value	Medium	Valley Fill	Deep Fill
Final score	29	Barrier Result	Barrier
Fix type	Replace Structure with Streambed Simulation CBS	Fix Span / Diameter	3

Location and Stream Data	• Crossing Characteristics
<p>Comments: Habitat value is low to medium. Large beaver influenced lake upstream with two dams ~1.5m high at 10m and 30m upstream. Inlet blocked. Water at inlet is level with the top of the culvert. At 4m downstream is a 1m high beaver dam. 13:23</p>

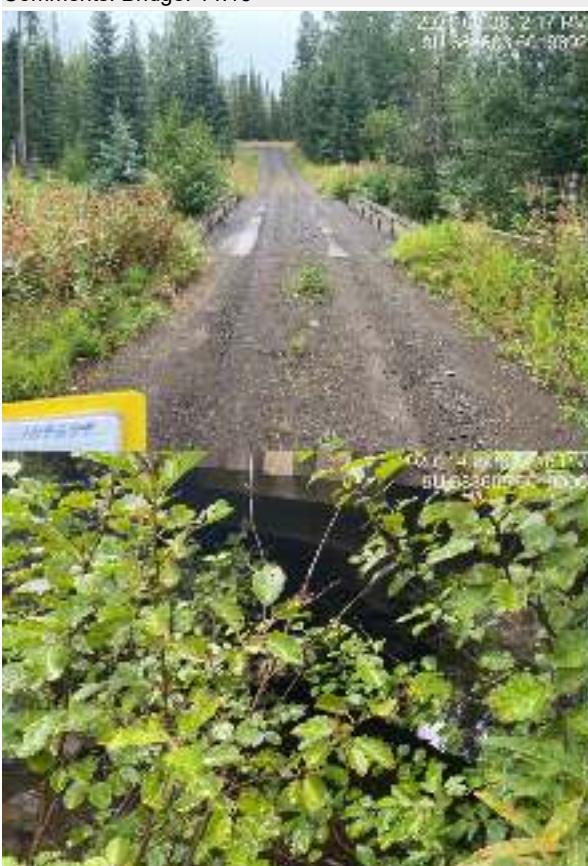
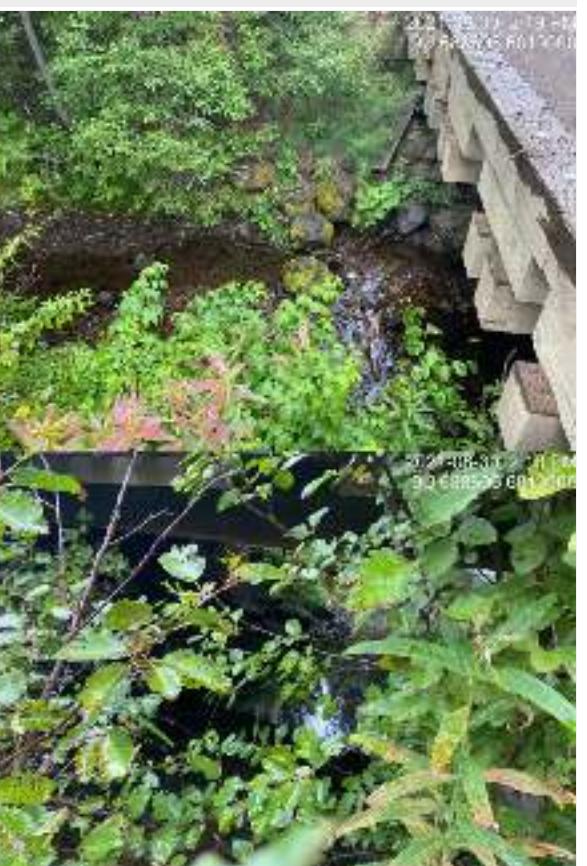
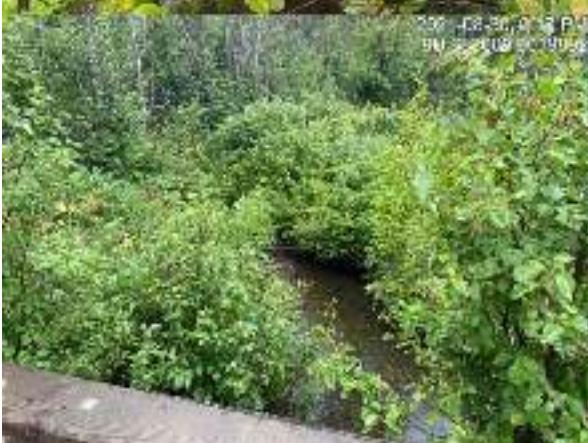
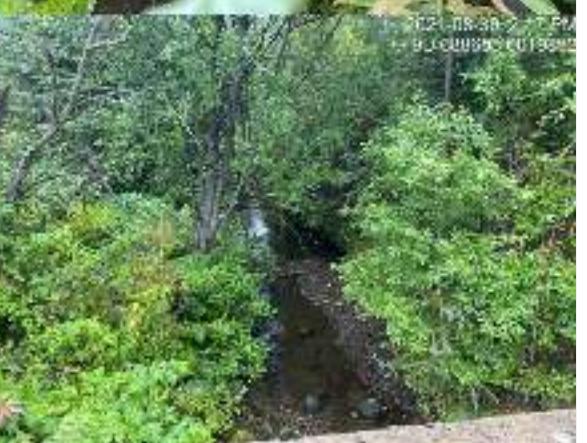
Photos: PSCIS ID 197911. From top left clockwise: Road/Site Card, Barrel, Outlet, Downstream, Upstream, Inlet.

Location and Stream Data	•	Crossing Characteristics	-
Comments: Ford. 15:55

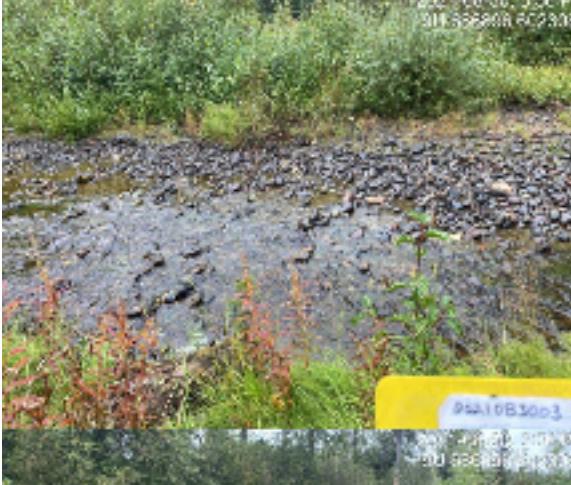
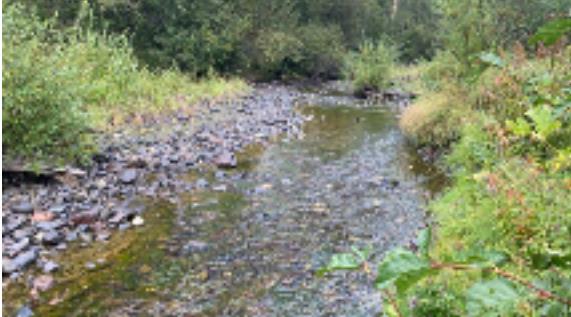
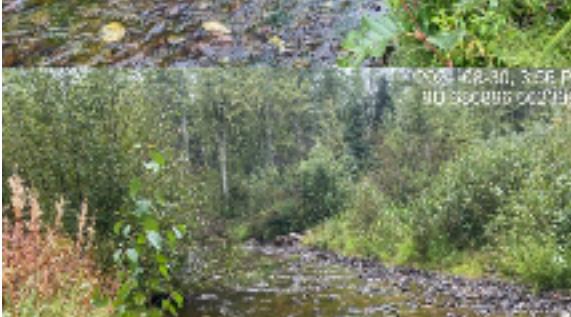
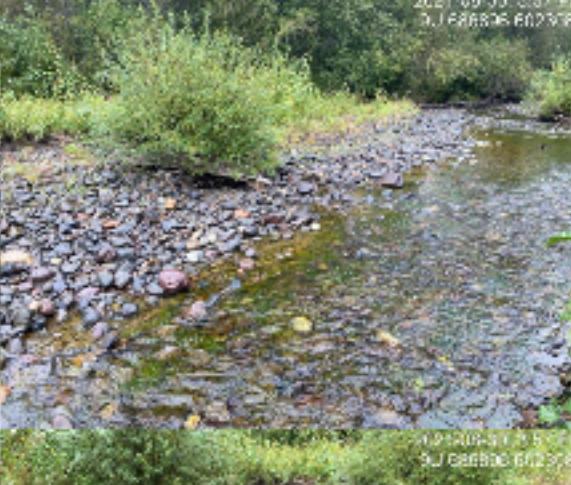
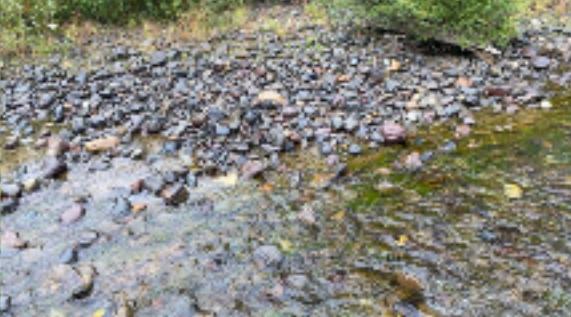
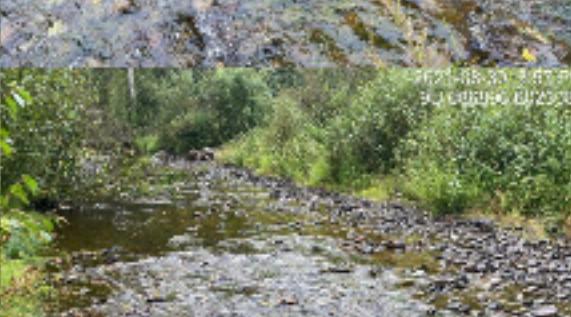
Photos: PSCIS ID 197912. From top left clockwise: Road/Site Card, Barrel, Outlet, Downstream, Upstream, Inlet.

Location and Stream Data	•	Crossing Characteristics	-
Comments: Bridge has collapsed and is impediment to upstream fish passage. Habitat confirmation conducted. 16:56

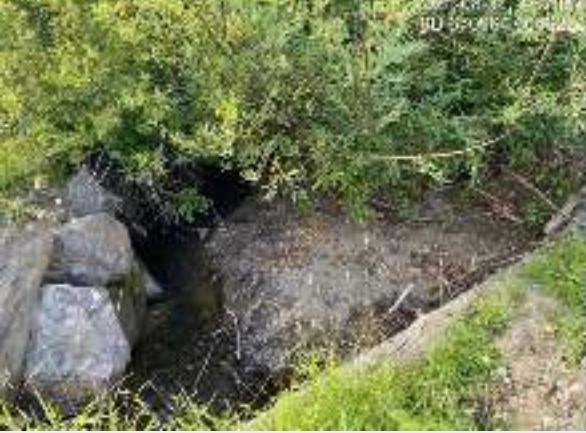
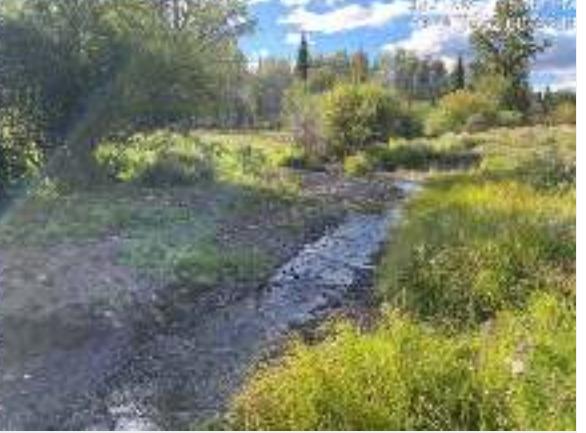
Photos: PSCIS ID 197913. From top left clockwise: Road/Site Card, Barrel, Outlet, Downstream, Upstream, Inlet.

Location and Stream Data	•	Crossing Characteristics	-
Comments: Ford. 17:46

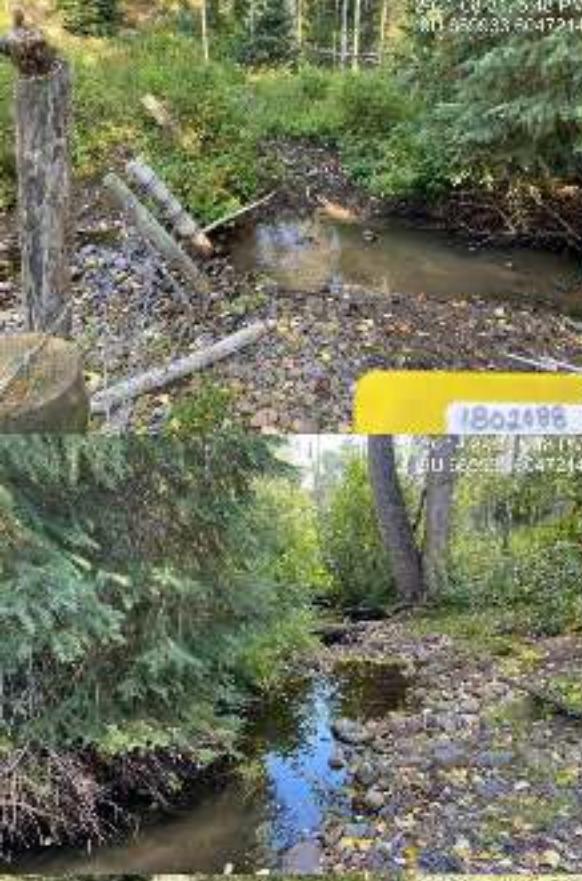
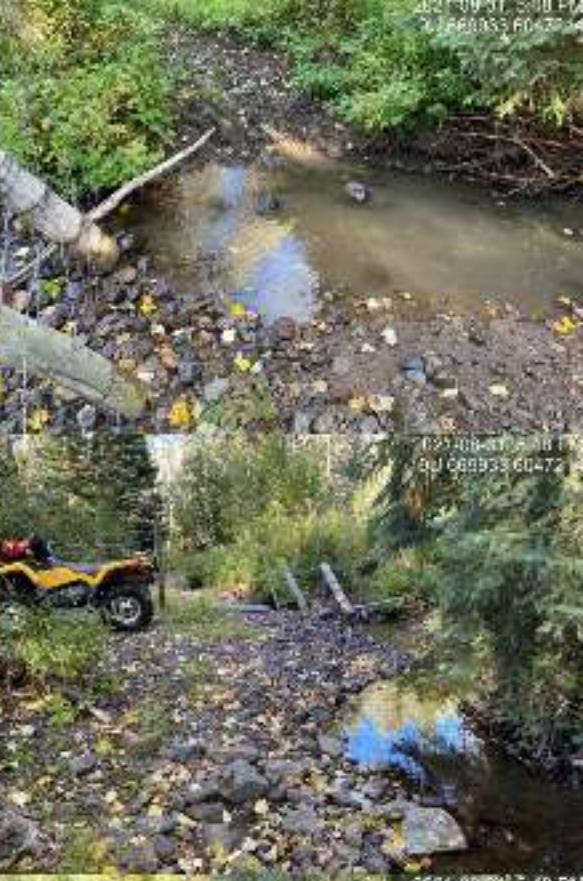
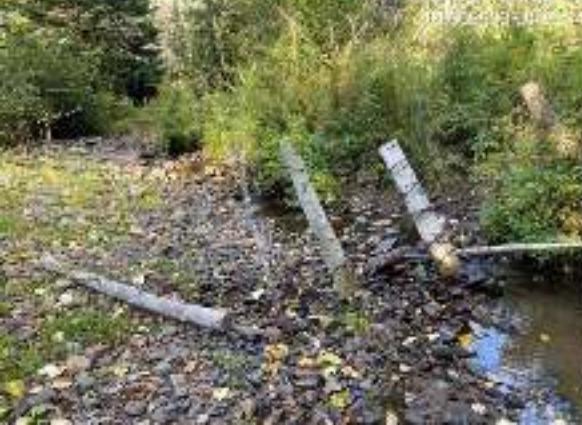
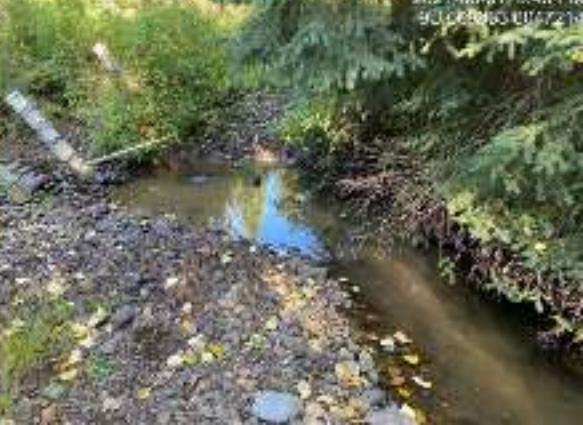
Photos: PSCIS ID 197914. From top left clockwise: Road/Site Card, Barrel, Outlet, Downstream, Upstream, Inlet.

Location and Stream Data	•	Crossing Characteristics	-
Comments: Ford. Area is extensively impacted by cattle trampling of banks. 17:56

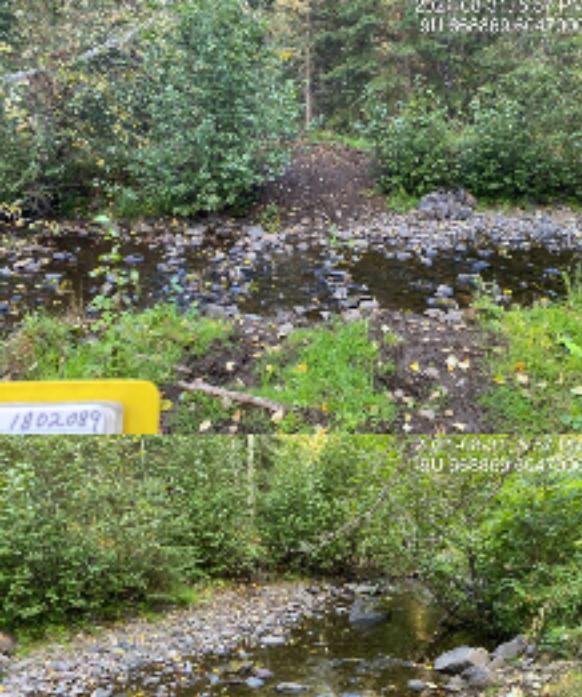
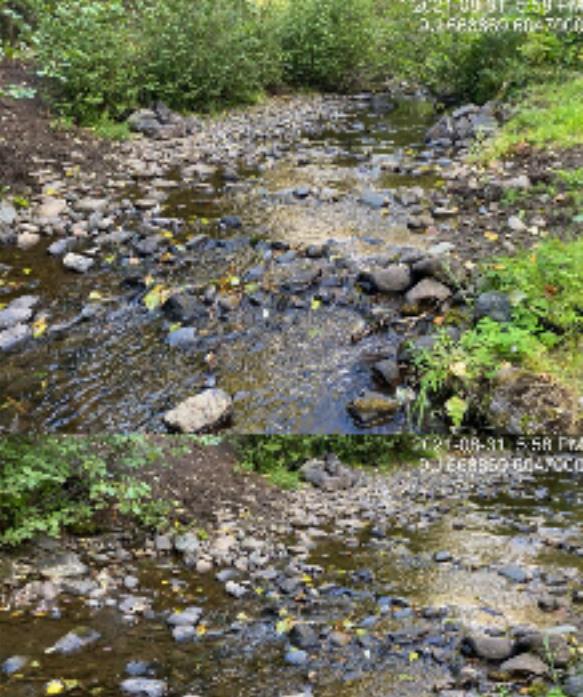
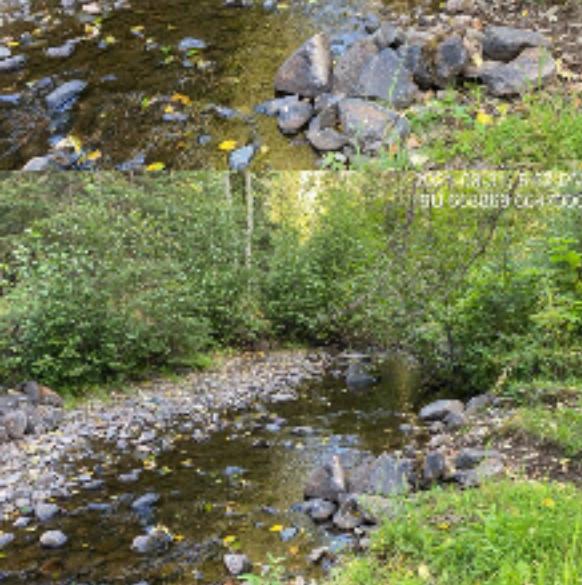
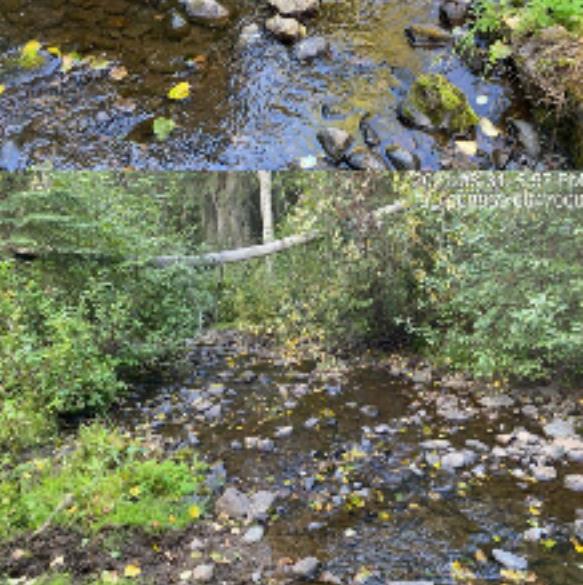
Photos: PSCIS ID 197915. From top left clockwise: Road/Site Card, Barrel, Outlet, Downstream, Upstream, Inlet.

Location and Stream Data	•	Crossing Characteristics	-
Comments: Ford. Road deactivated and grown in. Not ATV accessible beyond this point. 12:15
