Appendix - Phase 1 Fish Passage Assessment Data and Photos

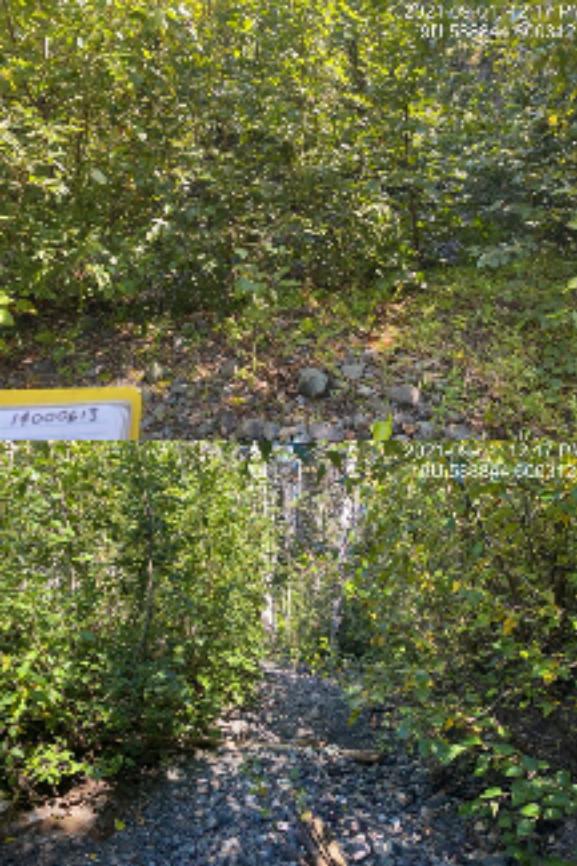
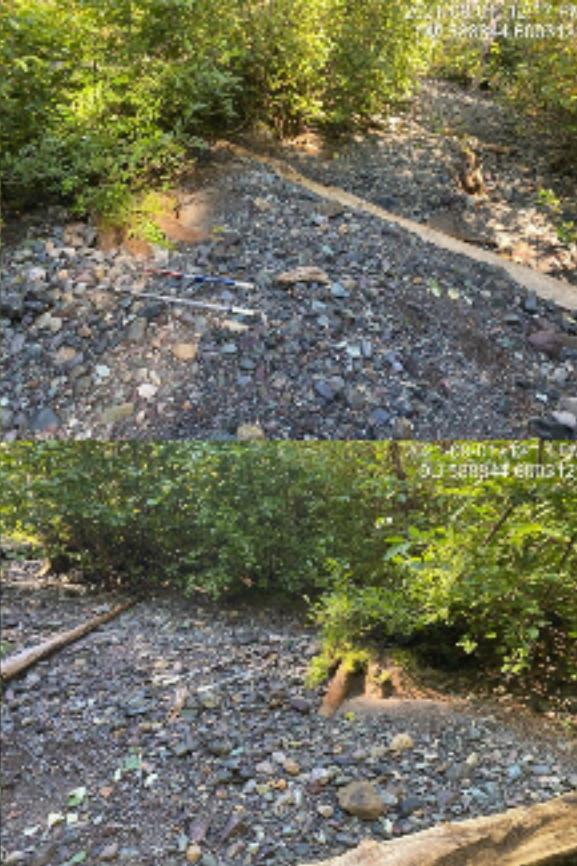
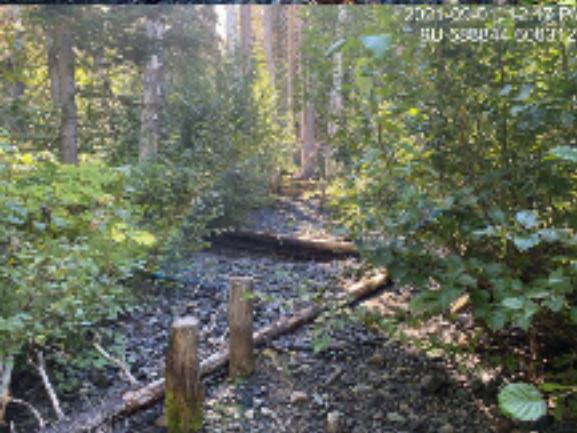
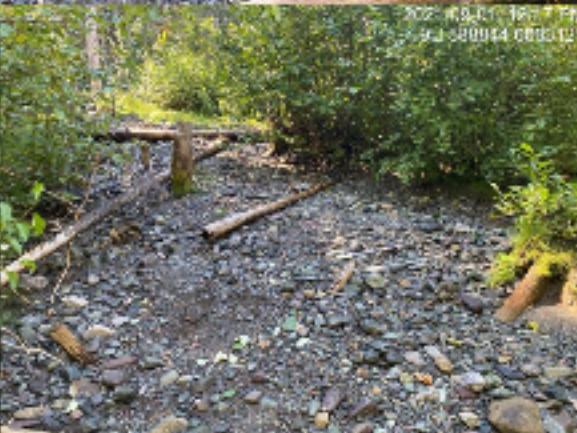
Photos: PSCIS ID 197916. From top left clockwise: Road/Site Card, Barrel, Outlet, Downstream, Upstream, Inlet.

Location and Stream Data	•	Crossing Characteristics	-
Comments: Old Crystal Ck FSR. Flat bottom structure. Good flow with abundant gravels and LWD. Nice stream. Appears passable to all life stages. Culvert slope was estimated with clinometer so may be slightly off. If slope was entered as 1% this crossing would rank as a "potential" barrier. 12:26

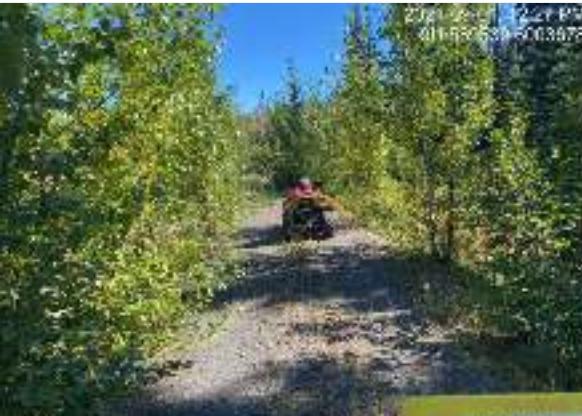
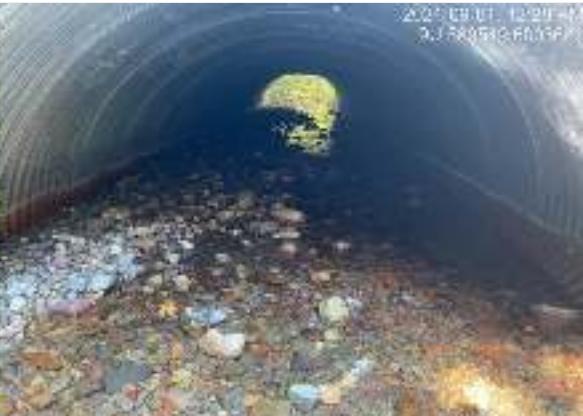
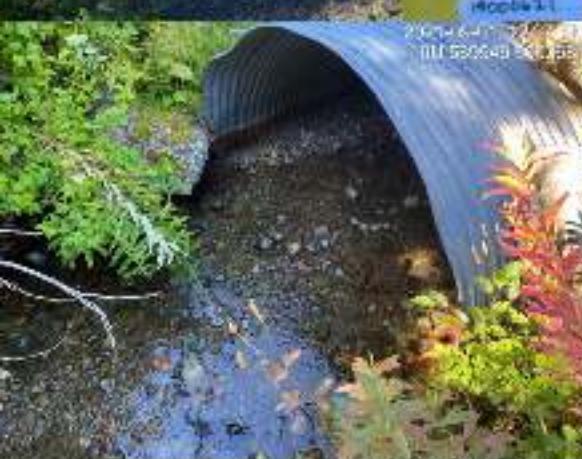
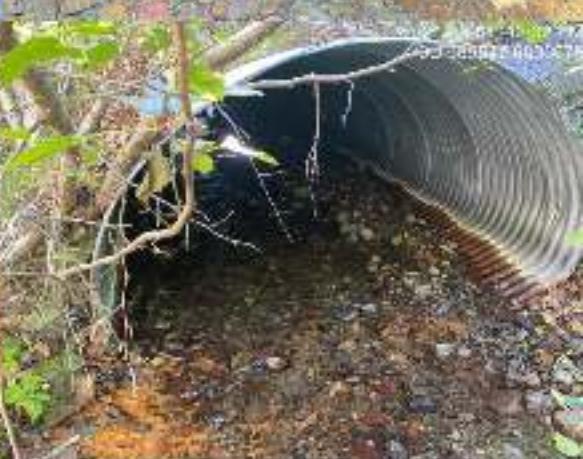
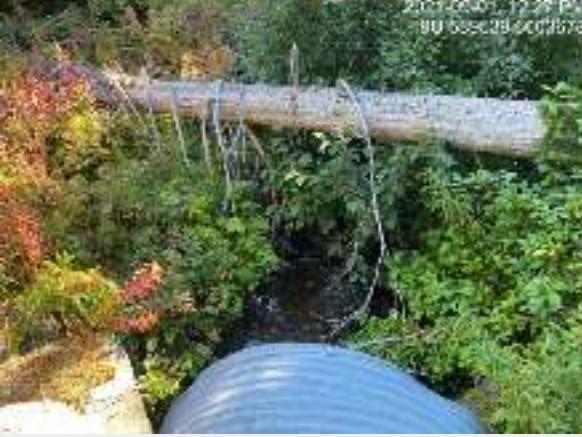
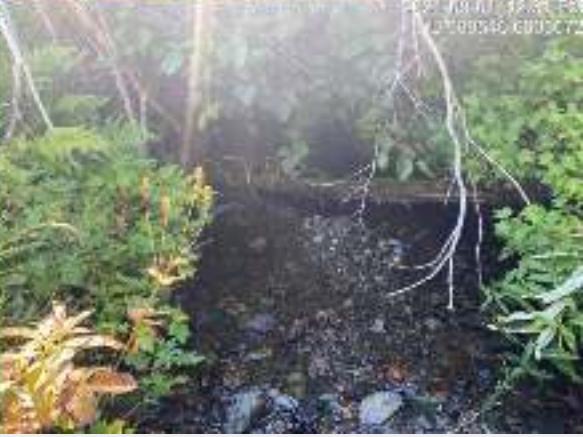
Photos: PSCIS ID 197917. From top left clockwise: Road/Site Card, Barrel, Outlet, Downstream, Upstream, Inlet.

Location and Stream Data	•	Crossing Characteristics	-
Comments: Dry channel at time of survey. Should this bridge be removed and girders salvaged? 13:05

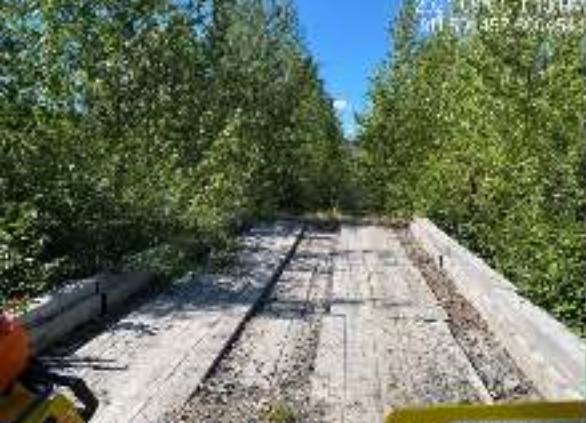
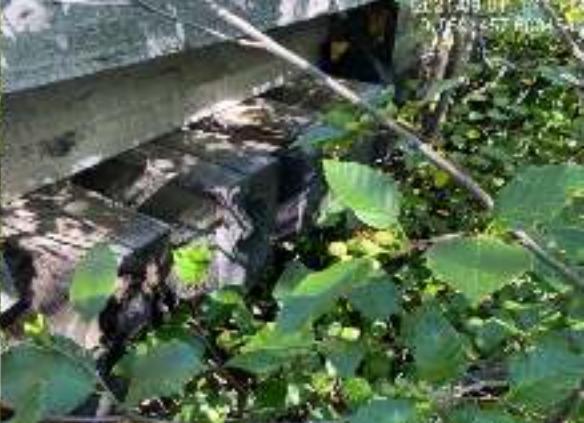
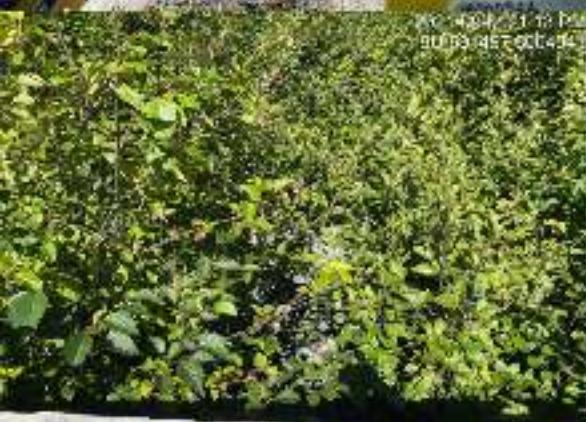
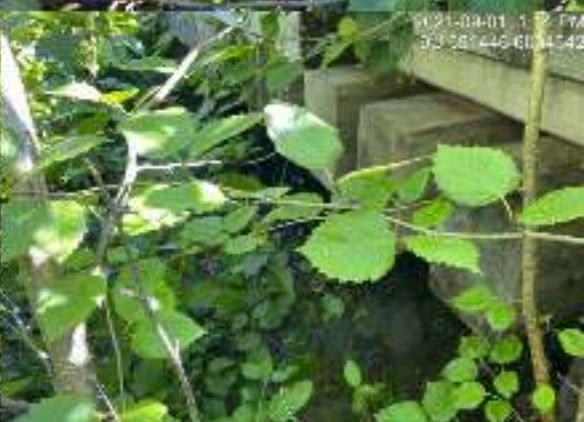
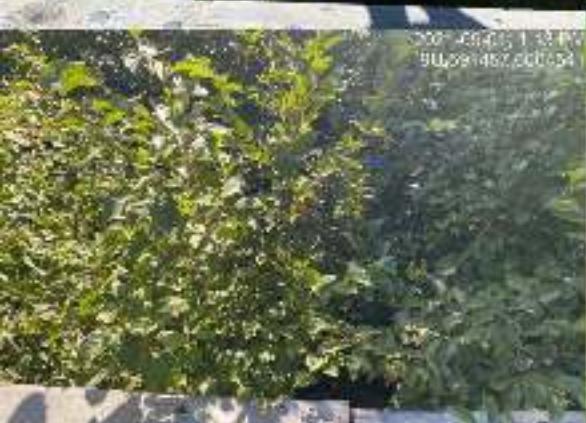
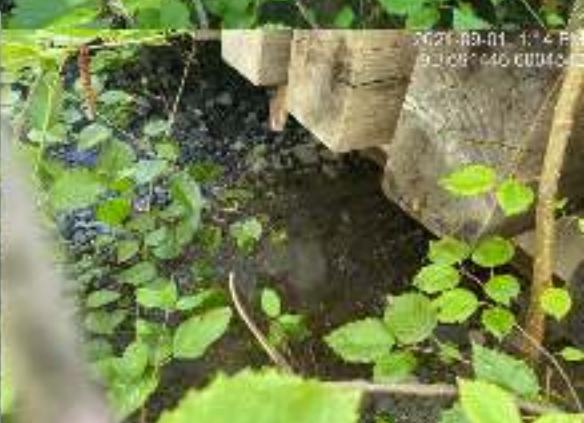
Photos: PSCIS ID 197918. From top left clockwise: Road/Site Card, Barrel, Outlet, Downstream, Upstream, Inlet.

Location and Stream Data	•	Crossing Characteristics	-
Comments: Bridge. Wood abutments and girders. 13:12

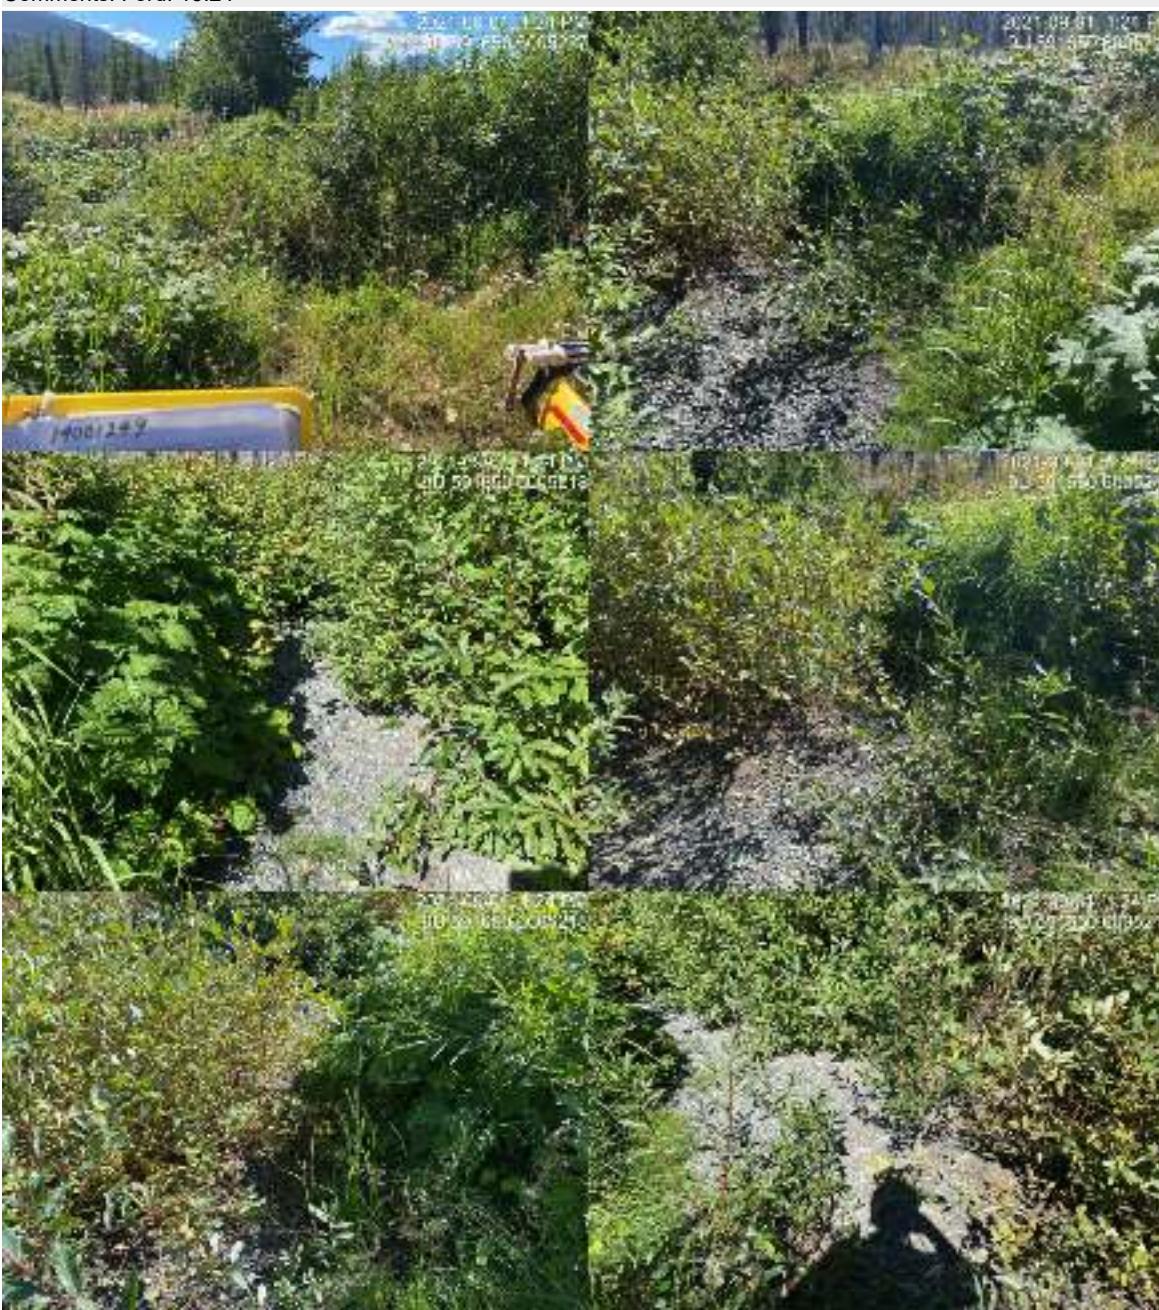
Photos: PSCIS ID 197919. From top left clockwise: Road/Site Card, Barrel, Outlet, Downstream, Upstream, Inlet.

Location and Stream Data	•	Crossing Characteristics	-
Comments: Ford. 13:24

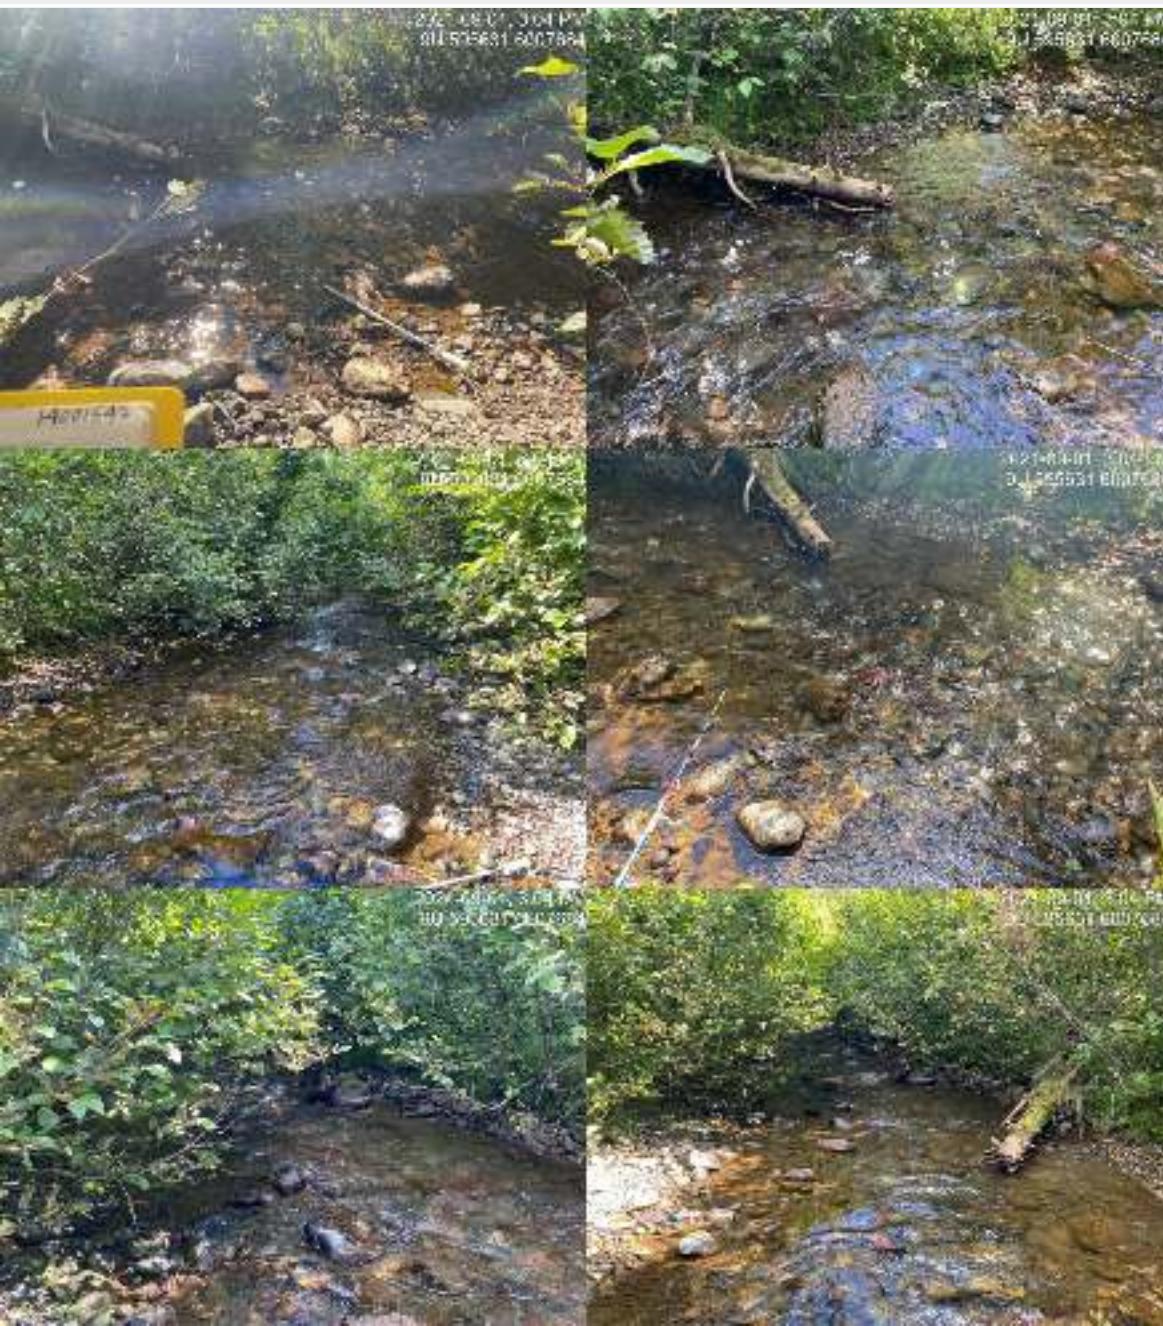
Photos: PSCIS ID 197921. From top left clockwise: Road/Site Card, Barrel, Outlet, Downstream, Upstream, Inlet.

Location and Stream Data	.	Crossing Characteristics	-
Comments: Road deactivated. 15:02

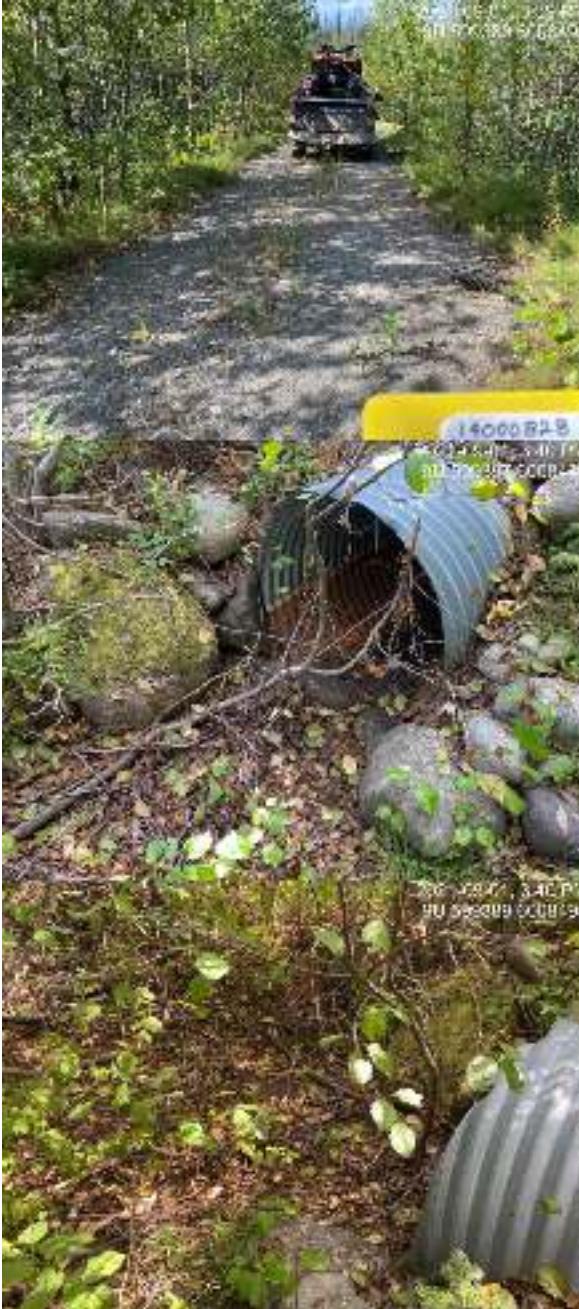
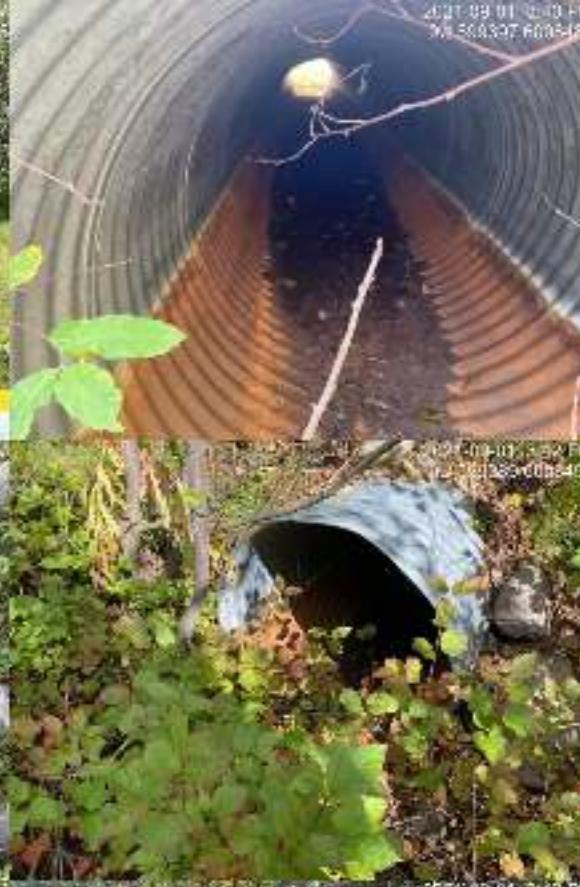
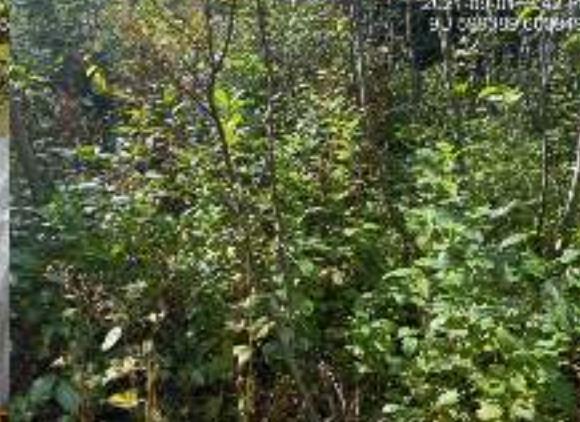
Photos: PSCIS ID 197922. From top left clockwise: Road/Site Card, Barrel, Outlet, Downstream, Upstream, Inlet.

Location and Stream Data	•	Crossing Characteristics	-
Comments: Dry at time of survey. Channel poorly defined. Likely flows for only short periods. 15:40

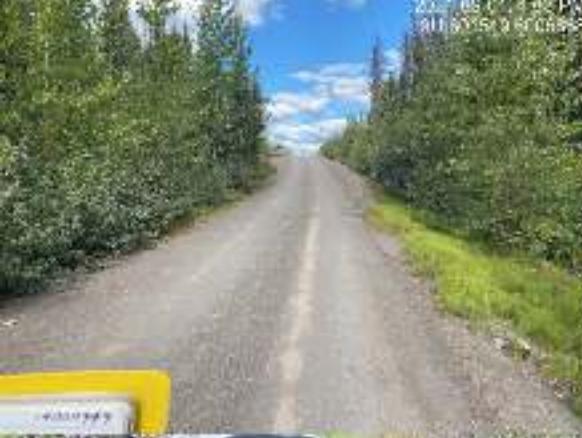
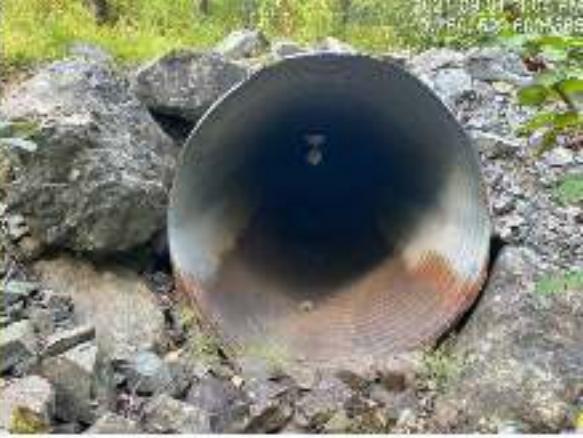
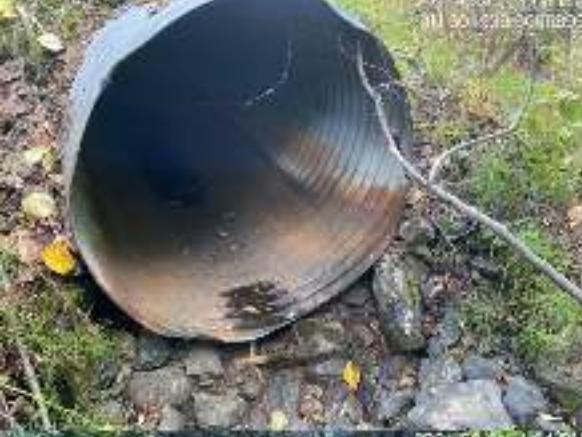
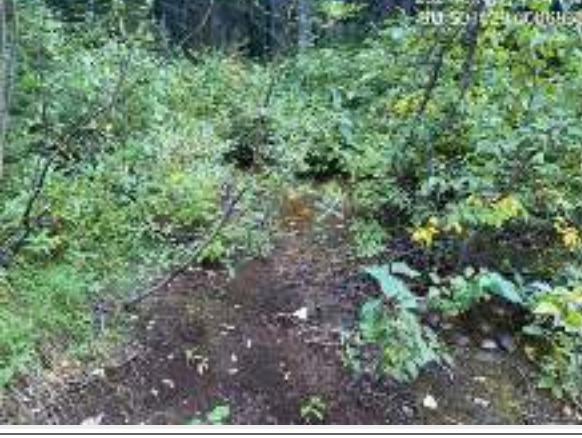
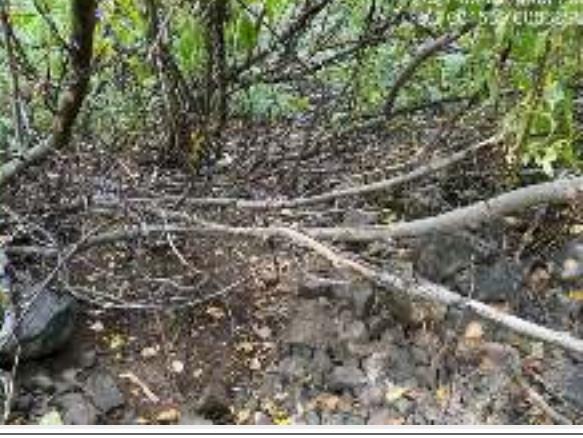
Photos: PSCIS ID 197923. From top left clockwise: Road/Site Card, Barrel, Outlet, Downstream, Upstream, Inlet.

Location and Stream Data		Crossing Characteristics	
Date	2021-09-01	Crossing Sub Type	Round Culvert
PSCIS ID	197923	Diameter (m)	1.2
External ID	14000949	Length (m)	28
Crew	AI	Embedded	No
UTM Zone	9	Depth Embedded (m)	–
Easting	601529	Resemble Channel	No
Northing	6006865	Backwatered	No
Stream	Tributary to Gosnell Creek	Percent Backwatered	–
Road	Crystal Creek FSR	Fill Depth (m)	1
Road Tenure	FLNR DND 9785	Outlet Drop (m)	0.5
Channel Width (m)	0.9	Outlet Pool Depth (m)	0.1
Stream Slope (%)	0.5	Inlet Drop	No
Beaver Activity	No	Slope (%)	0.5
Habitat Value	Low	Valley Fill	Deep Fill
Final score	23	Barrier Result	Barrier
Fix type	Replace Structure with Streambed Simulation CBS	Fix Span / Diameter	3

Location and Stream Data	•	Crossing Characteristics	-
Comments: Fill depth estimated. 16:02

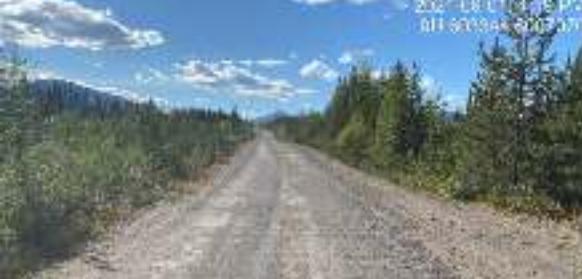
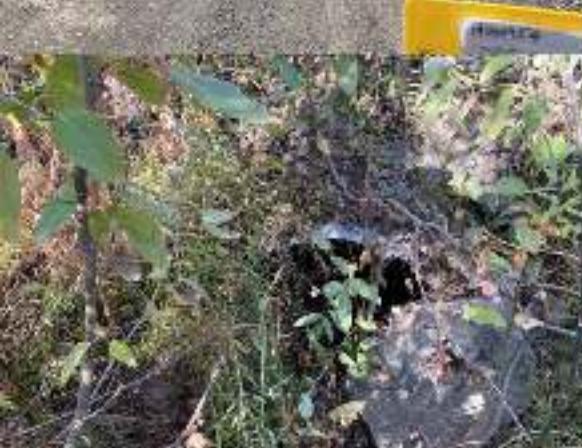
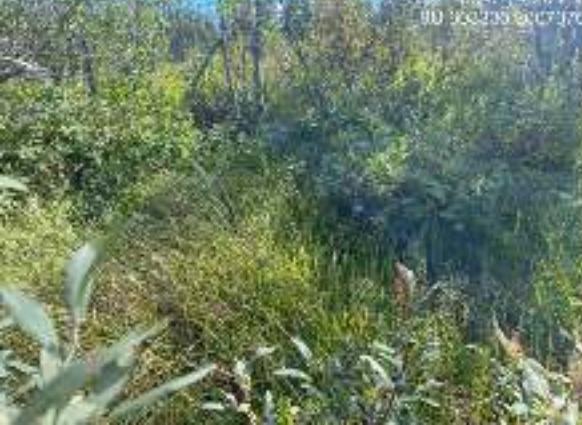
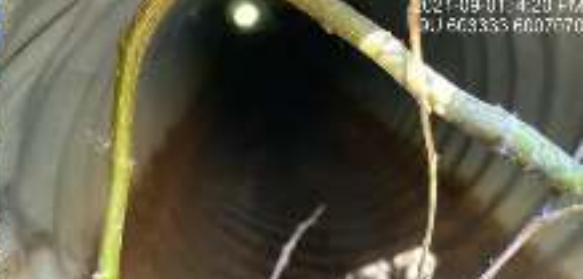
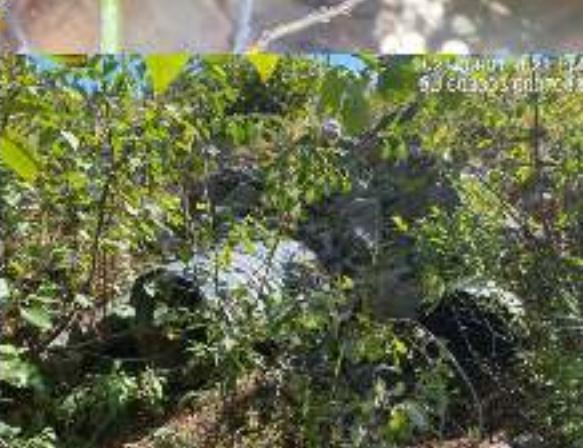
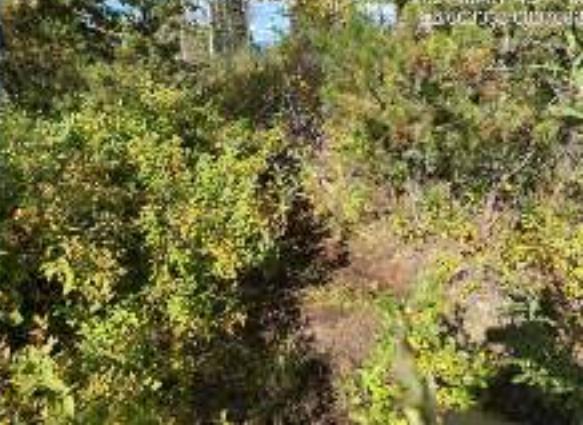
Photos: PSCIS ID 197924. From top left clockwise: Road/Site Card, Barrel, Outlet, Downstream, Upstream, Inlet.

Location and Stream Data		Crossing Characteristics	
Date	2021-09-01	Crossing Sub Type	Round Culvert
PSCIS ID	197924	Diameter (m)	0.5
External ID	14000954	Length (m)	18
Crew	AI	Embedded	No
UTM Zone	9	Depth Embedded (m)	–
Easting	603333.1	Resemble Channel	No
Northing	6007072	Backwatered	No
Stream	Tributary to Gosnell Creek	Percent Backwatered	–
Road	Crystal Creek FSR	Fill Depth (m)	1.5
Road Tenure	FLNR DND 9785	Outlet Drop (m)	0
Channel Width (m)	1.3	Outlet Pool Depth (m)	0
Stream Slope (%)	0.5	Inlet Drop	No
Beaver Activity	No	Slope (%)	1
Habitat Value	Low	Valley Fill	Deep Fill
Final score	24	Barrier Result	Barrier
Fix type	Replace Structure with Streambed Simulation CBS	Fix Span / Diameter	3

Location and Stream Data	•	Crossing Characteristics	-
Comments: Dry. Channel partially covered in moss. Very like flows for only short periods of the year. 16:18

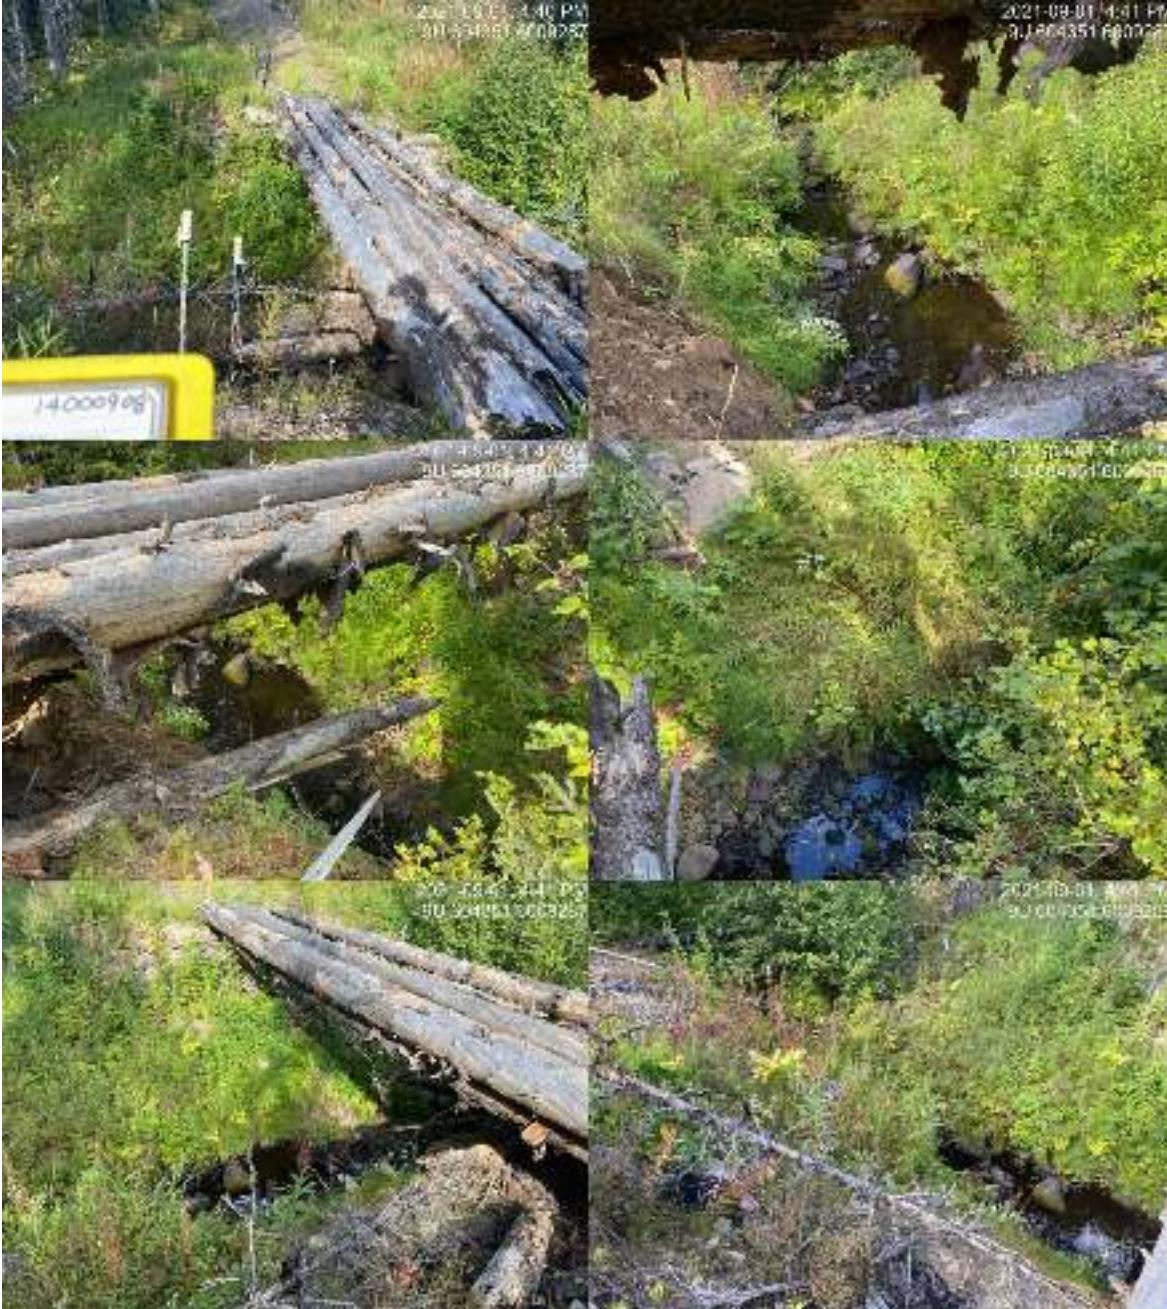
Photos: PSCIS ID 197925. From top left clockwise: Road/Site Card, Barrel, Outlet, Downstream, Upstream, Inlet.

Location and Stream Data	•	Crossing Characteristics	-
Comments: Ford. Quad bridge in place made from logs. 16:38

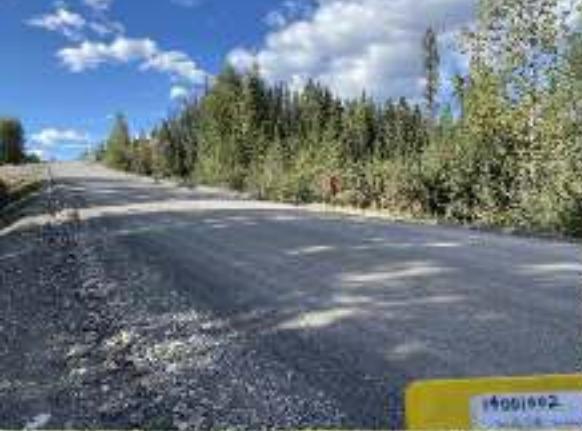
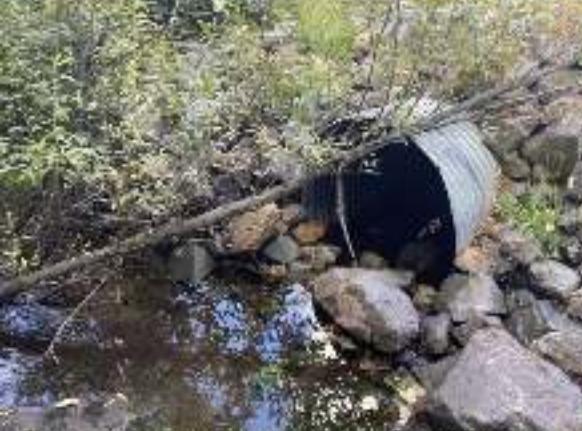
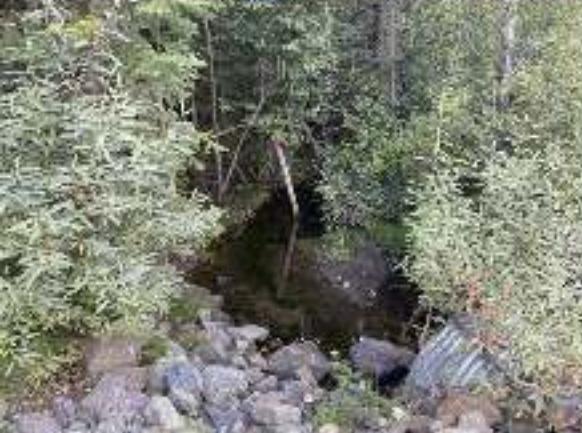
Photos: PSCIS ID 197926. From top left clockwise: Road/Site Card, Barrel, Outlet, Downstream, Upstream, Inlet.

Location and Stream Data	•	Crossing Characteristics	-
Comments: Observed 60mm fish swimming into the outlet. Nicely embedded. Inlet drop of large cobbles may be issue for smaller fish. 16:54

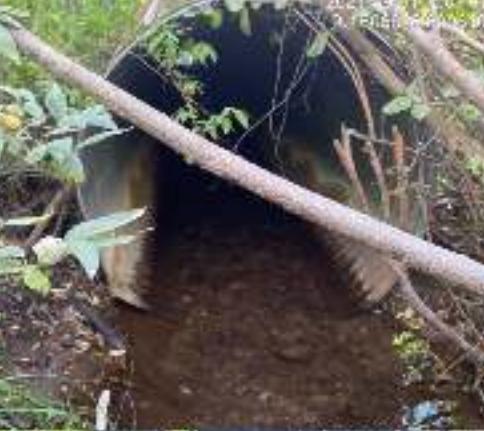
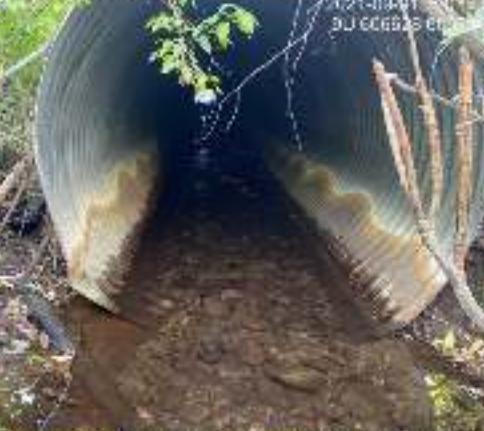
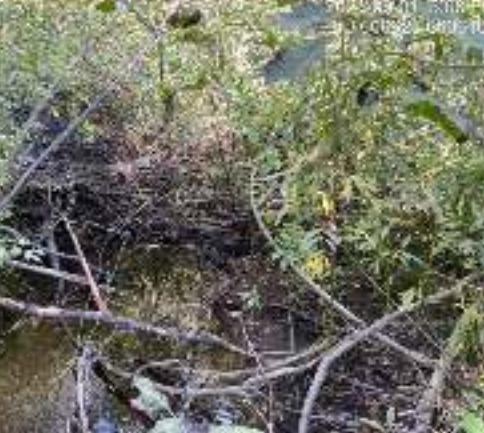
Location and Stream Data		Crossing Characteristics –	
Date	2021-09-01	Crossing Sub Type	Round Culvert
PSCIS ID	197926	Diameter (m)	1.1
External ID	14001002	Length (m)	30
Crew	AI	Embedded	Yes
UTM Zone	9	Depth Embedded (m)	0.15
Easting	606615	Resemble Channel	Yes
Northing	6006104	Backwatered	No
Stream	Tributary to Morice River	Percent Backwatered	—
Road	Morice West FSR	Fill Depth (m)	2
Road Tenure	FLNR DND 9785	Outlet Drop (m)	0
Channel Width (m)	2	Outlet Pool Depth (m)	0.1
Stream Slope (%)	5	Inlet Drop	Yes
Beaver Activity	No	Slope (%)	1
Habitat Value	Medium	Valley Fill	Deep Fill
Final score	22	Barrier Result	Barrier
Fix type	Replace with New Open Bottom Structure	Fix Span / Diameter	10

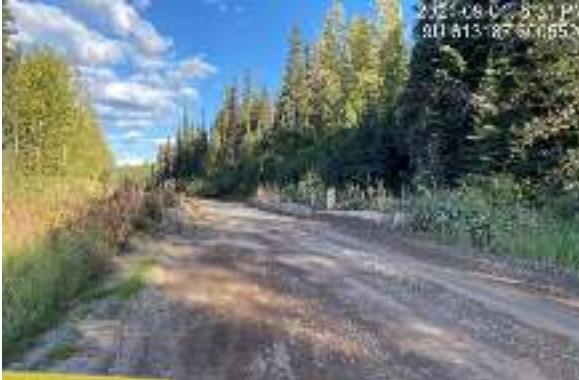
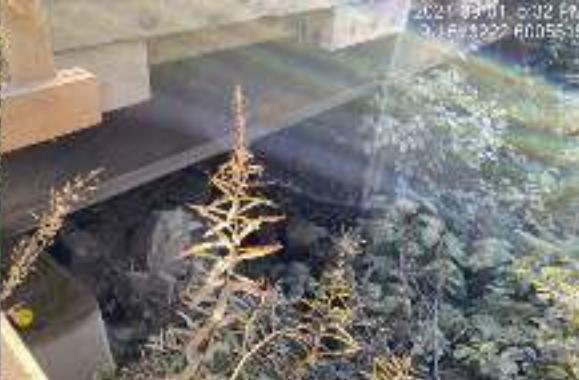
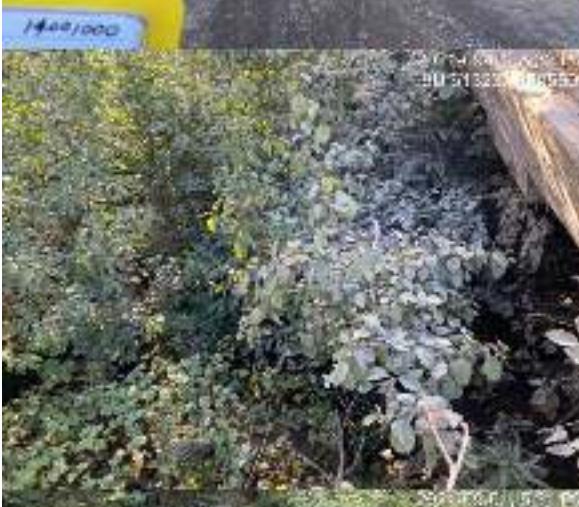
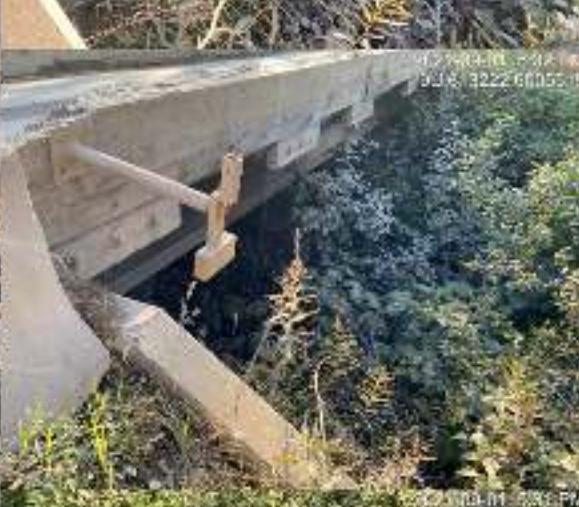
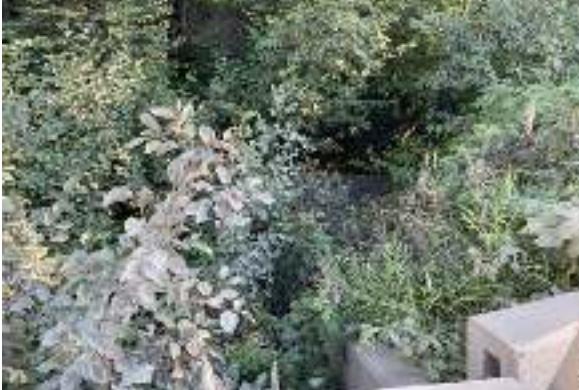
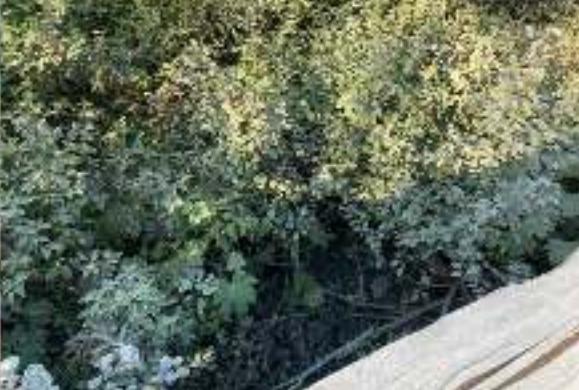
Photos: PSCIS ID 197927. From top left clockwise: Road/Site Card, Barrel, Outlet, Downstream, Upstream, Inlet.

Location and Stream Data	•	Crossing Characteristics	-
Comments: Bridge. 17:30

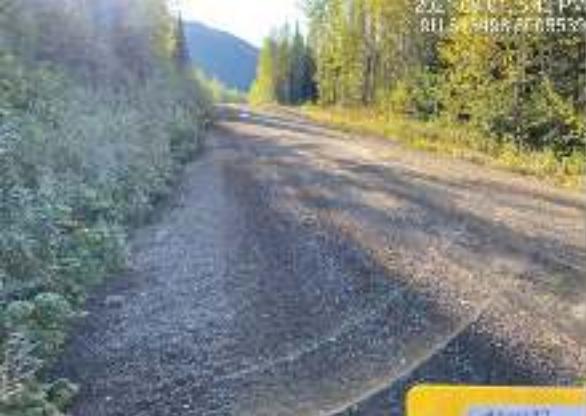
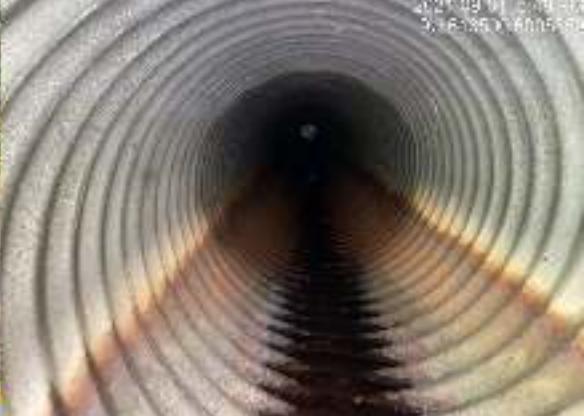
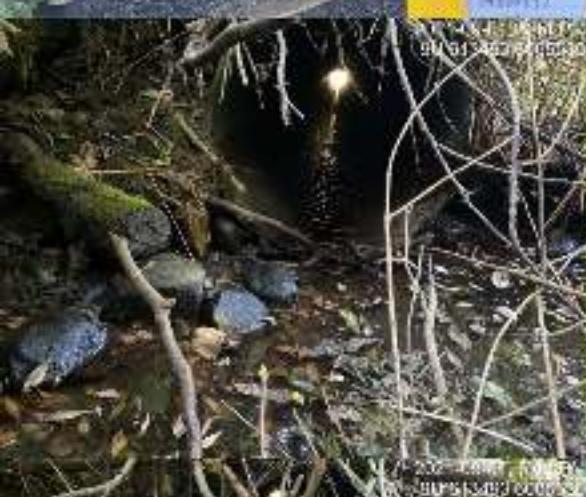
Photos: PSCIS ID 197928. From top left clockwise: Road/Site Card, Barrel, Outlet, Downstream, Upstream, Inlet.

Location and Stream Data		Crossing Characteristics	
Date	2021-09-01	Crossing Sub Type	Round Culvert
PSCIS ID	197928	Diameter (m)	0.6
External ID	14000997	Length (m)	20
Crew	AI	Embedded	No
UTM Zone	9	Depth Embedded (m)	–
Easting	613579	Resemble Channel	No
Northing	6005551	Backwatered	No
Stream	Tributary to Morice River	Percent Backwatered	–
Road	Morice West FSR	Fill Depth (m)	2.5
Road Tenure	FLNR DND 9785	Outlet Drop (m)	0.5
Channel Width (m)	1.2	Outlet Pool Depth (m)	0
Stream Slope (%)	5	Inlet Drop	No
Beaver Activity	No	Slope (%)	3.5
Habitat Value	Low	Valley Fill	Deep Fill
Final score	39	Barrier Result	Barrier
Fix type	Replace Structure with Streambed Simulation CBS	Fix Span / Diameter	3

Location and Stream Data	•	Crossing Characteristics	-
Comments: Dry. Small stream. DV point upstream in FISS. May be flowing at point upstream. 17:41

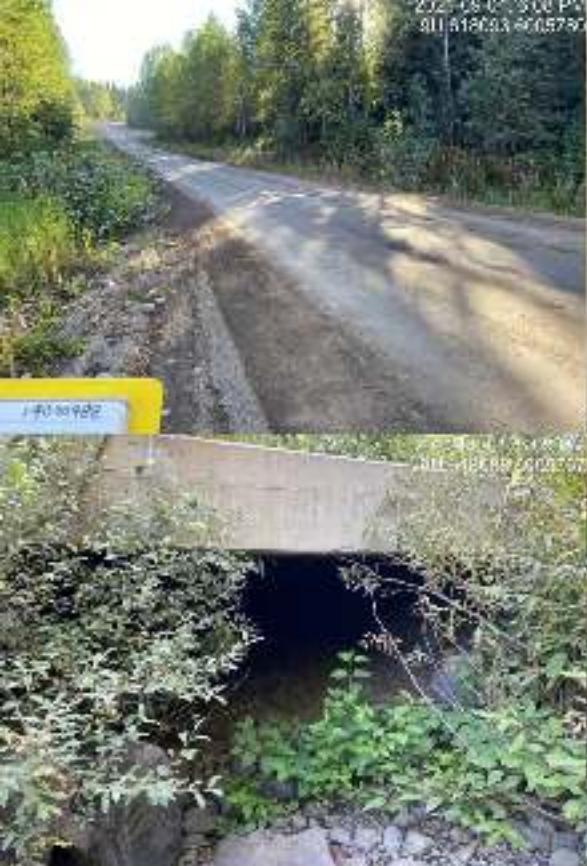
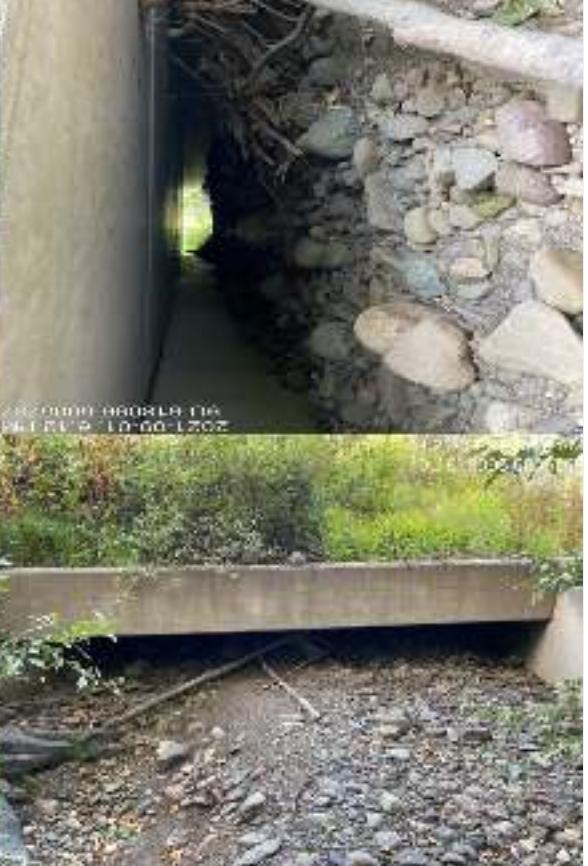
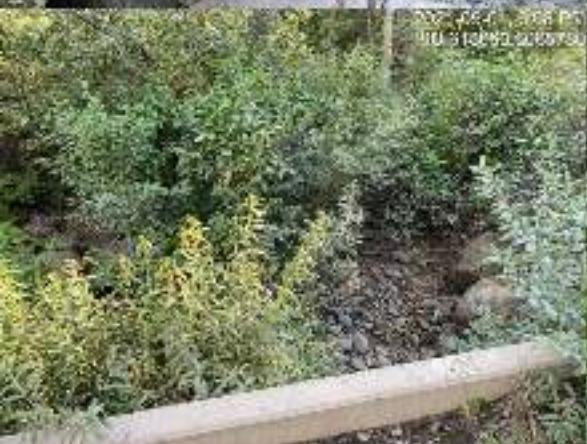
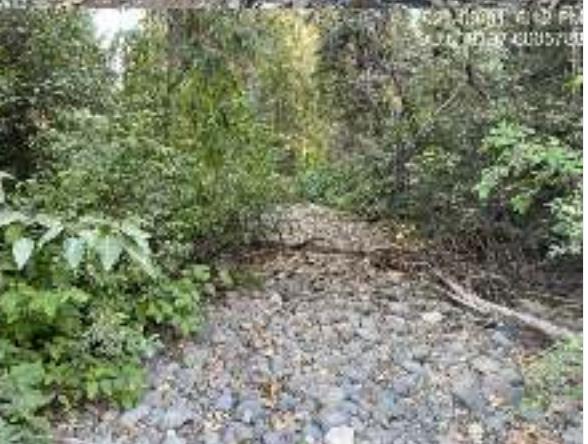
Photos: PSCIS ID 197929. From top left clockwise: Road/Site Card, Barrel, Outlet, Downstream, Upstream, Inlet.

Location and Stream Data	•	Crossing Characteristics	-
Comments: Bridge with only 0.7 clearance at outlet. 18:07

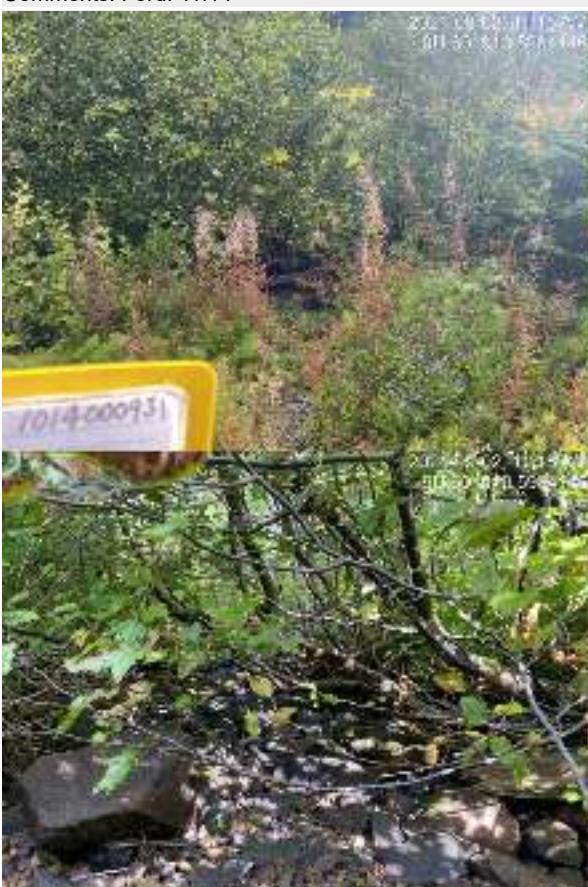
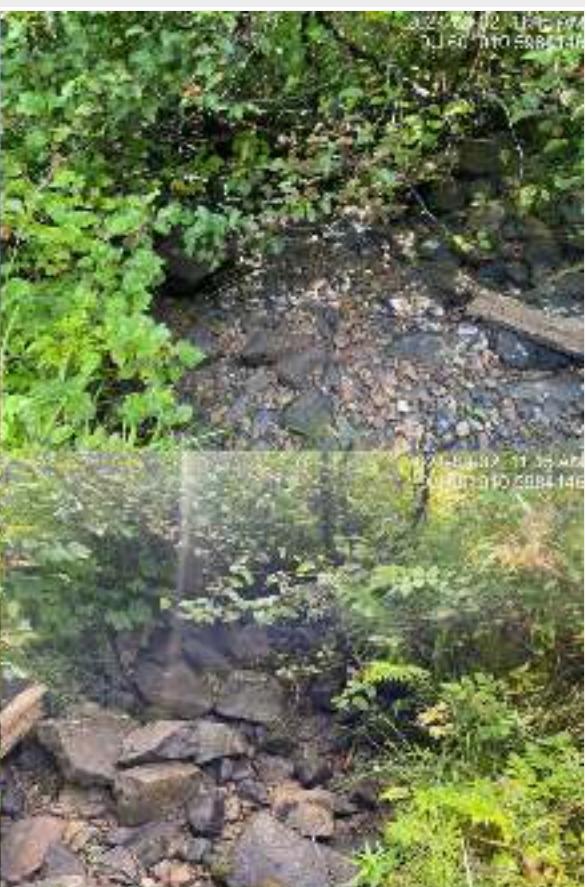
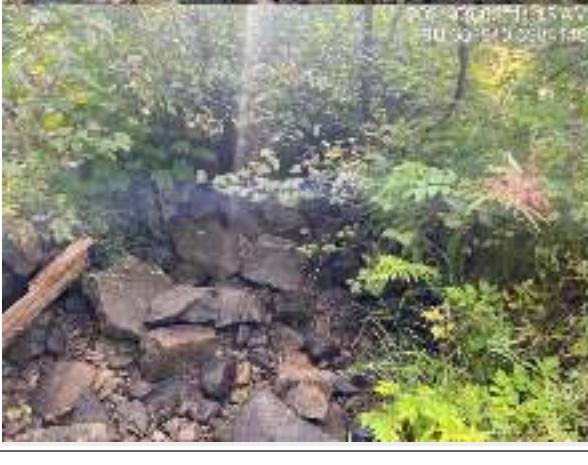
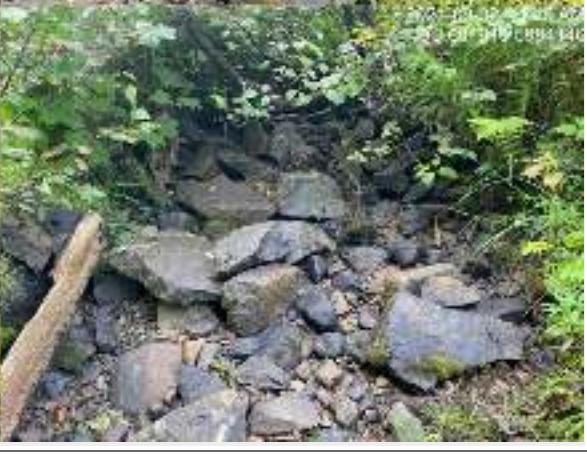
Location and Stream Data	•	Crossing Characteristics	-
Comments: Ford. 11:14

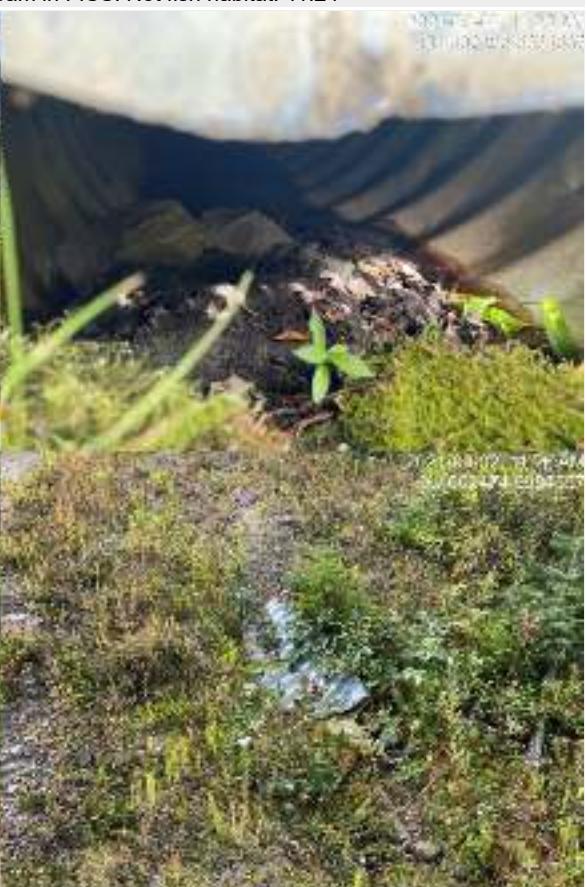
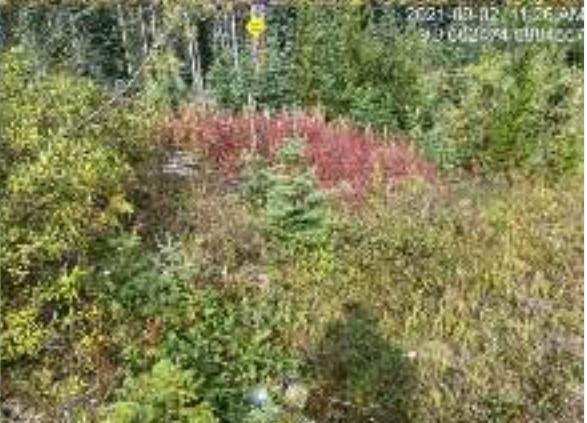
Photos: PSCIS ID 197931. From top left clockwise: Road/Site Card, Barrel, Outlet, Downstream, Upstream, Inlet.

Location and Stream Data		Crossing Characteristics	
Date	2021-09-02	Crossing Sub Type	Round Culvert
PSCIS ID	197931	Diameter (m)	0.5
External ID	14000932	Length (m)	17
Crew	AI	Embedded	No
UTM Zone	9	Depth Embedded (m)	—
Easting	602457.8	Resemble Channel	No
Northing	5984532	Backwatered	No
Stream	Tributary to Nanika River	Percent Backwatered	—
Road	Spur	Fill Depth (m)	0.3
Road Tenure	Canfor R06951	Outlet Drop (m)	0
Channel Width (m)	0.4	Outlet Pool Depth (m)	0
Stream Slope (%)	7	Inlet Drop	No
Beaver Activity	No	Slope (%)	5
Habitat Value	Low	Valley Fill	Deep Fill
Final score	23	Barrier Result	Barrier
Fix type	Replace Structure with Streambed Simulation CBS	Fix Span / Diameter	3

Location and Stream Data	•	Crossing Characteristics	-
Comments: Cross ditch. Questioning fish point. Noted upstream in FISS. Not fish habitat. 11:24
