Appendix - Phase 1 Fish Passage Assessment Data and Photos

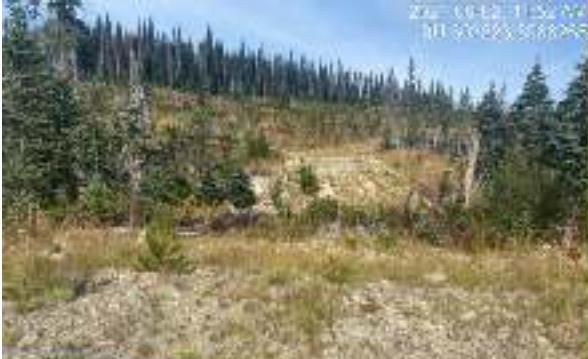
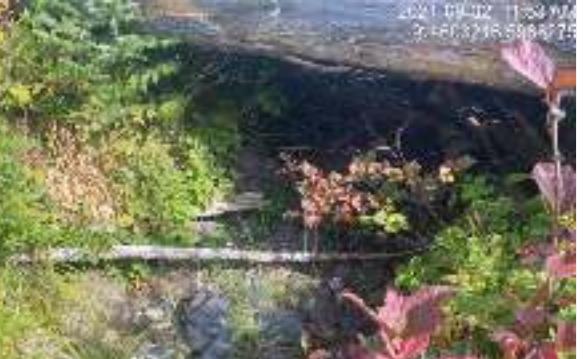
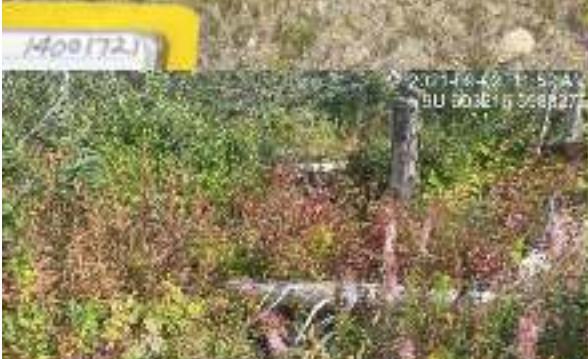
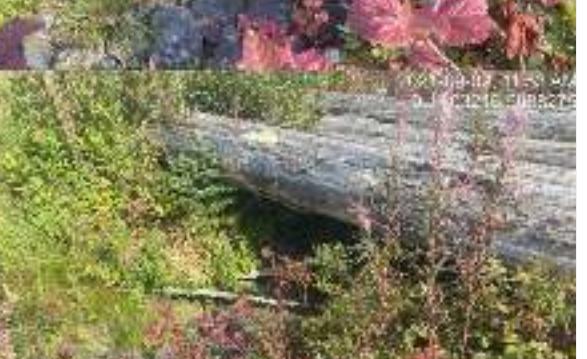
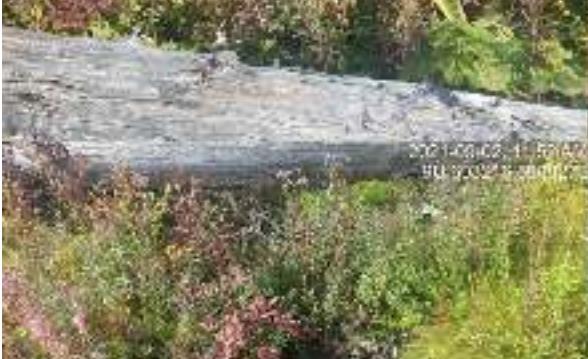
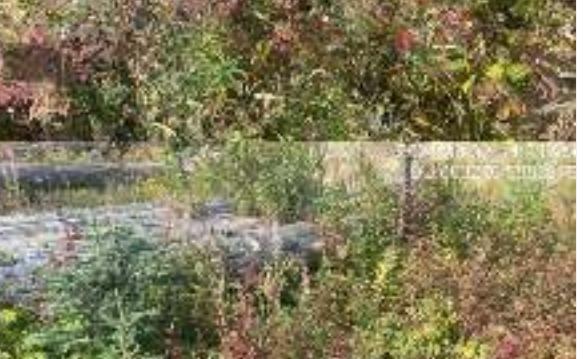
Photos: PSCIS ID 197932. From top left clockwise: Road/Site Card, Barrel, Outlet, Downstream, Upstream, Inlet.

Location and Stream Data	•	Crossing Characteristics	-
Comments: Temporary log bridge for ATVs. Within young cutblock. 11:51

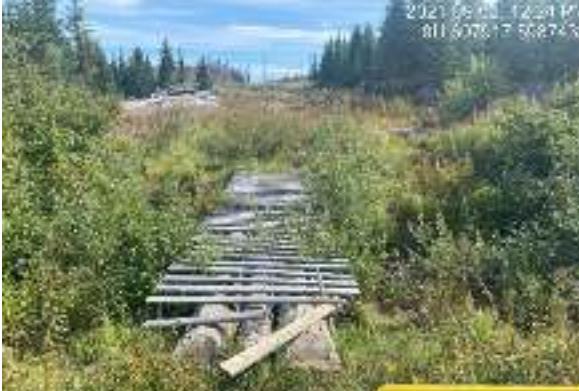
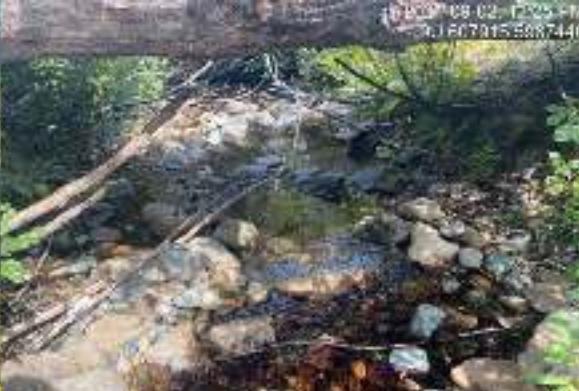
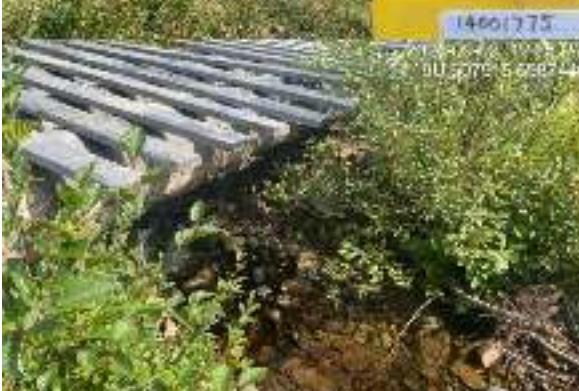
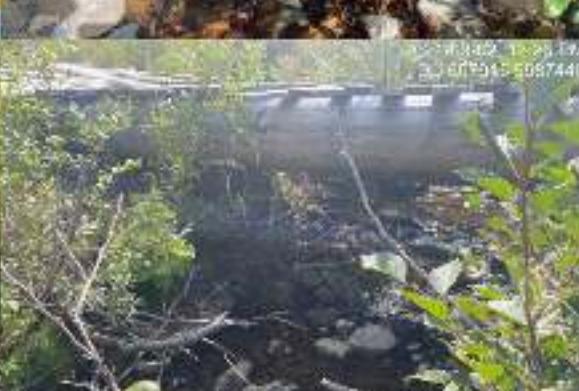
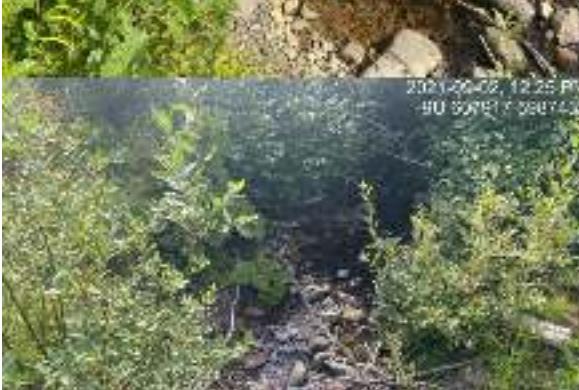
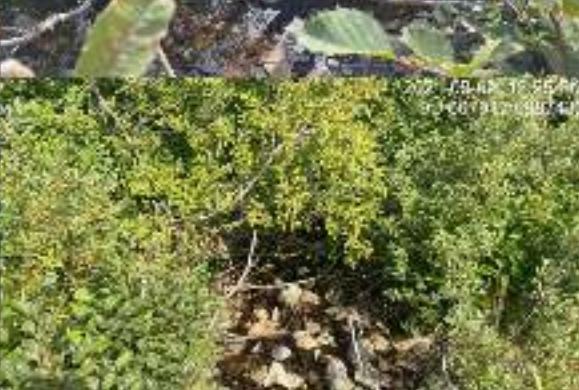
Photos: PSCIS ID 197933. From top left clockwise: Road/Site Card, Barrel, Outlet, Downstream, Upstream, Inlet.

Location and Stream Data	•	Crossing Characteristics	-
Comments: Quad bridge of logs and 2x6. 12:23

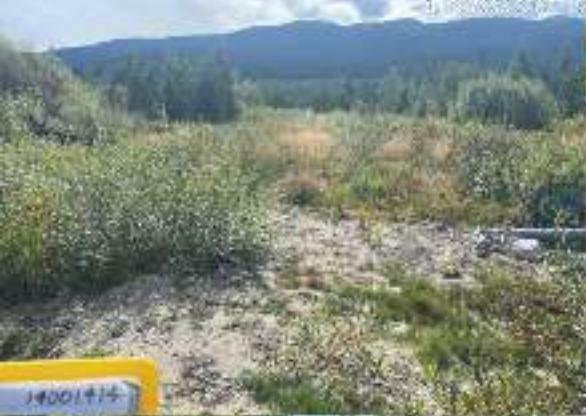
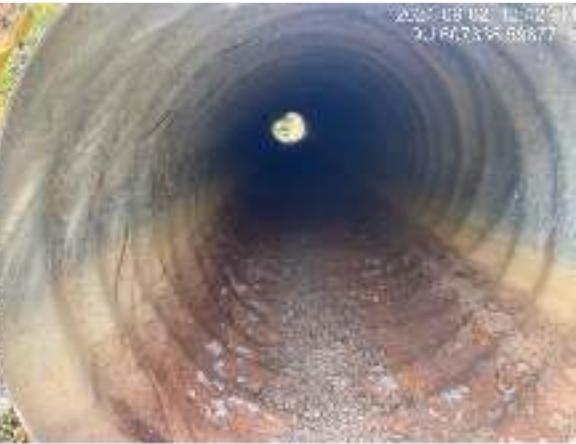
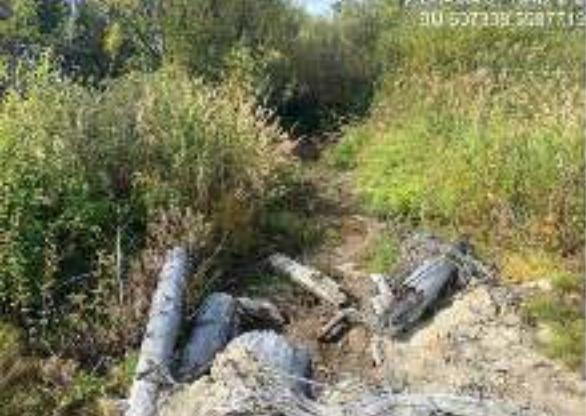
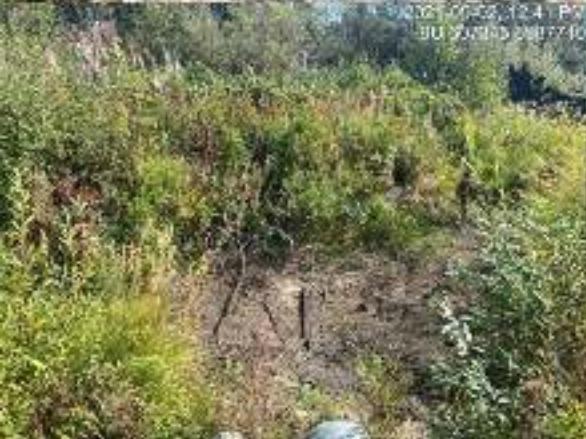
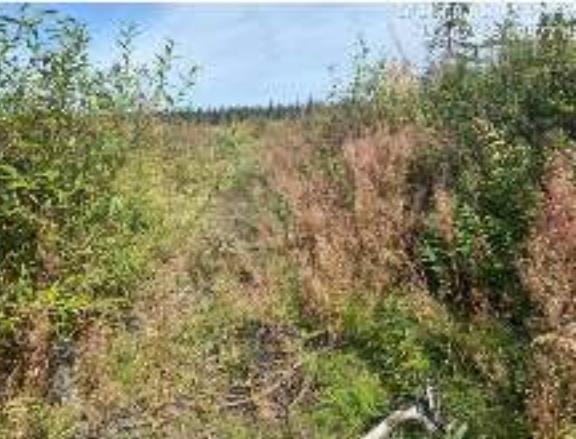
Photos: PSCIS ID 197934. From top left clockwise: Road/Site Card, Barrel, Outlet, Downstream, Upstream, Inlet.

Location and Stream Data		Crossing Characteristics	
Date	2021-09-02	Crossing Sub Type	Round Culvert
PSCIS ID	197934	Diameter (m)	0.4
External ID	14001414	Length (m)	6
Crew	AI	Embedded	No
UTM Zone	9	Depth Embedded (m)	—
Easting	607342.9	Resemble Channel	No
Northing	5987705	Backwatered	No
Stream	Tributary to Nanika River	Percent Backwatered	—
Road	Spur	Fill Depth (m)	0.2
Road Tenure	Canfor R10644	Outlet Drop (m)	0
Channel Width (m)	1	Outlet Pool Depth (m)	0.2
Stream Slope (%)	0	Inlet Drop	No
Beaver Activity	No	Slope (%)	0
Habitat Value	Low	Valley Fill	Deep Fill
Final score	16	Barrier Result	Potential
Fix type	Replace Structure with Streambed Simulation CBS	Fix Span / Diameter	3

Location and Stream Data	•	Crossing Characteristics	-
Comments: Temporary road to cutblock. Suspect main stream flows elsewhere. This is dry currently but wetland type depression. Channel poorly defined. Drains to ground. 12:40

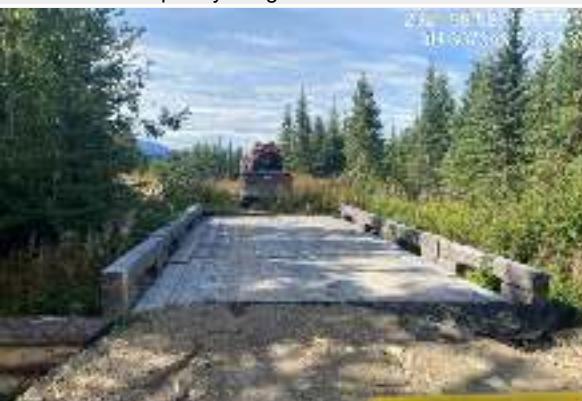
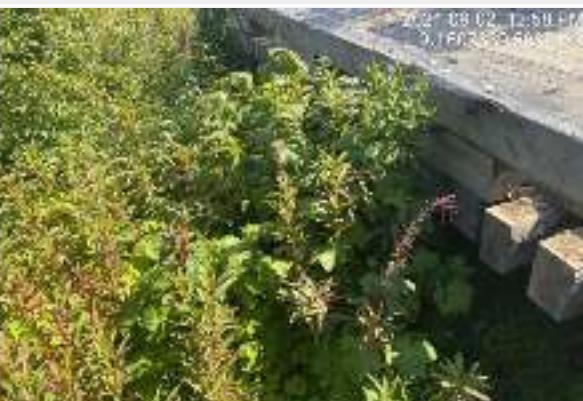
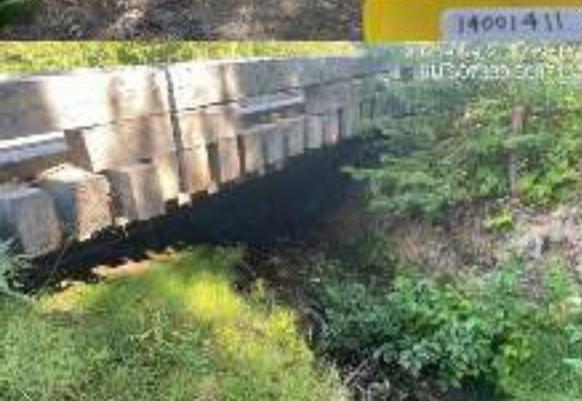
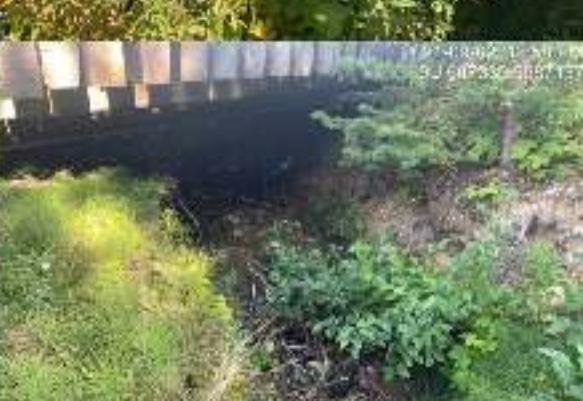
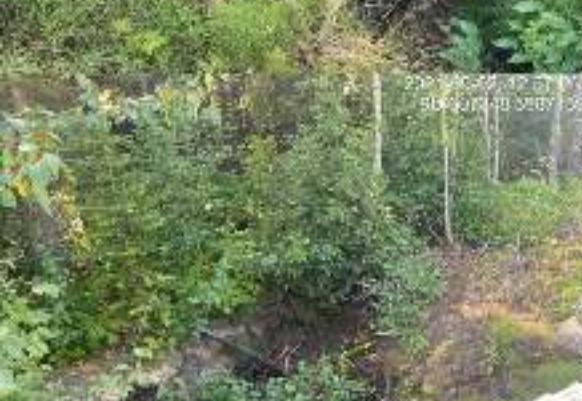
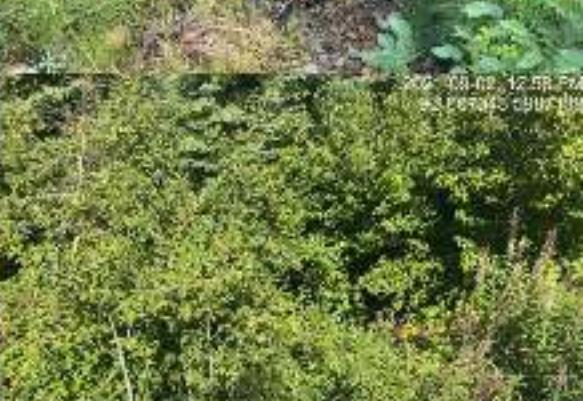
Photos: PSCIS ID 197935. From top left clockwise: Road/Site Card, Barrel, Outlet, Downstream, Upstream, Inlet.

Location and Stream Data	•	Crossing Characteristics	-
Comments: Temporary bridge with wood abutments. 12:56

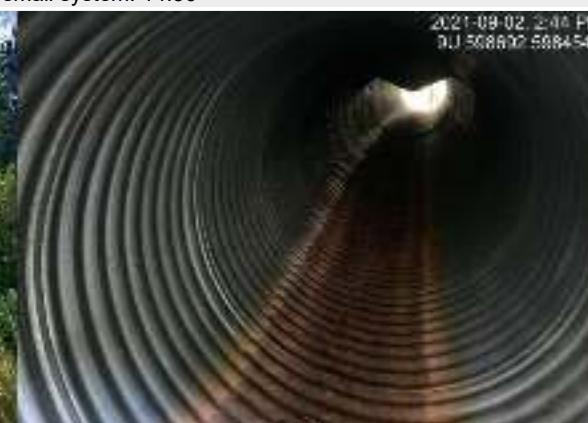
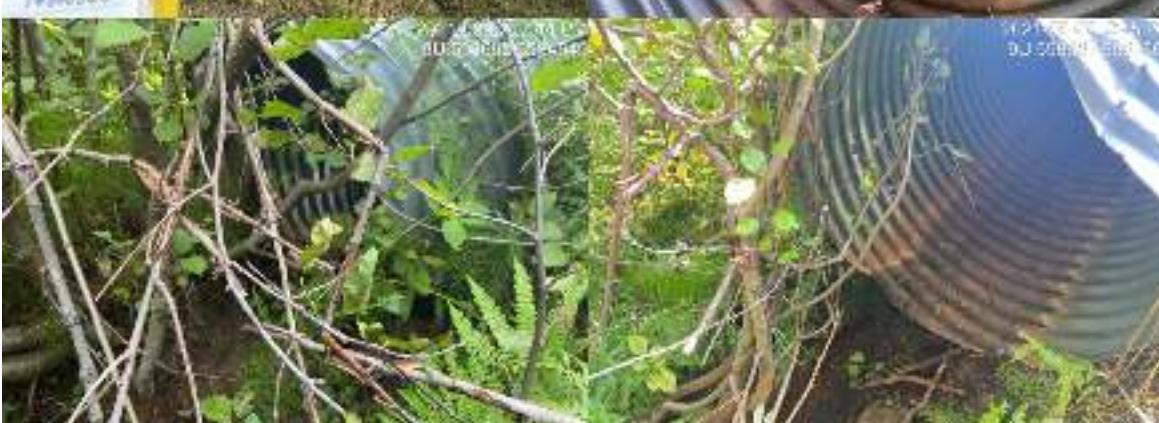
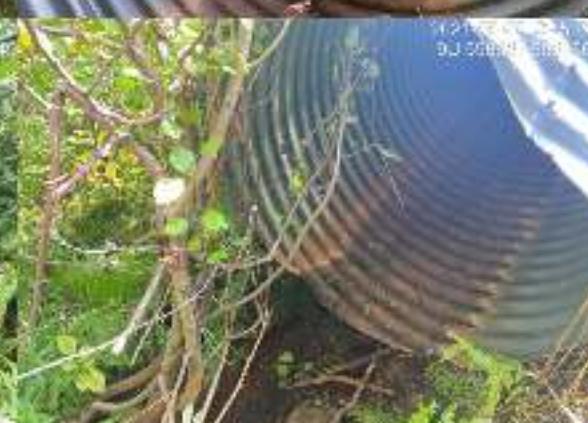
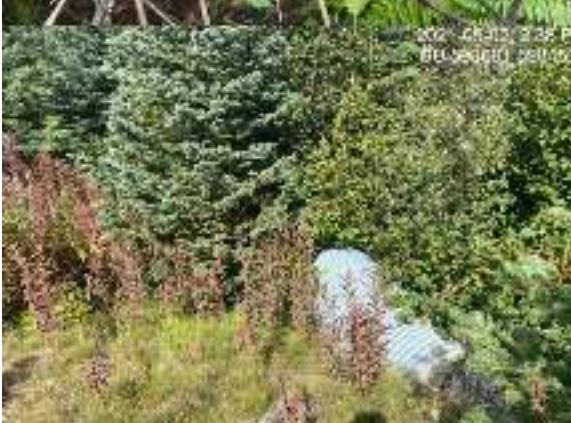
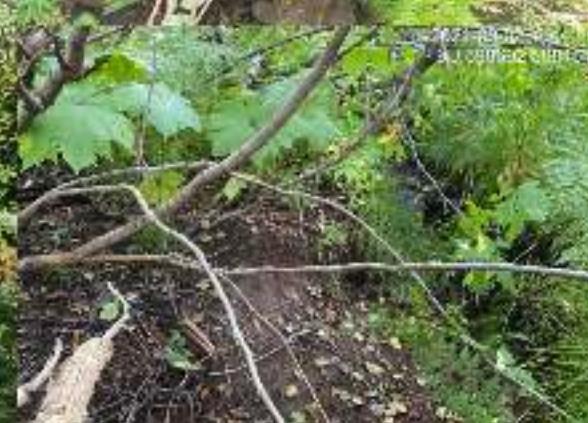
Photos: PSCIS ID 197936. From top left clockwise: Road/Site Card, Barrel, Outlet, Downstream, Upstream, Inlet.

Location and Stream Data		Crossing Characteristics	
Date	2021-09-02	Crossing Sub Type	Round Culvert
PSCIS ID	197936	Diameter (m)	1
External ID	2021090299	Length (m)	15
Crew	AI	Embedded	No
UTM Zone	9	Depth Embedded (m)	–
Easting	598684	Resemble Channel	No
Northing	5984563	Backwatered	No
Stream	–	Percent Backwatered	–
Road	Spur	Fill Depth (m)	0.3
Road Tenure	Canfor R08817	Outlet Drop (m)	0.1
Channel Width (m)	0.9	Outlet Pool Depth (m)	0.25
Stream Slope (%)	10	Inlet Drop	No
Beaver Activity	No	Slope (%)	3.5
Habitat Value	Low	Valley Fill	Deep Fill
Final score	23	Barrier Result	Barrier
Fix type	Replace Structure with Streambed Simulation CBS	Fix Span / Diameter	3

Location and Stream Data	•	Crossing Characteristics	-
Comments: Quad access. Dry. Fish points upstream. Very small system. 14:36

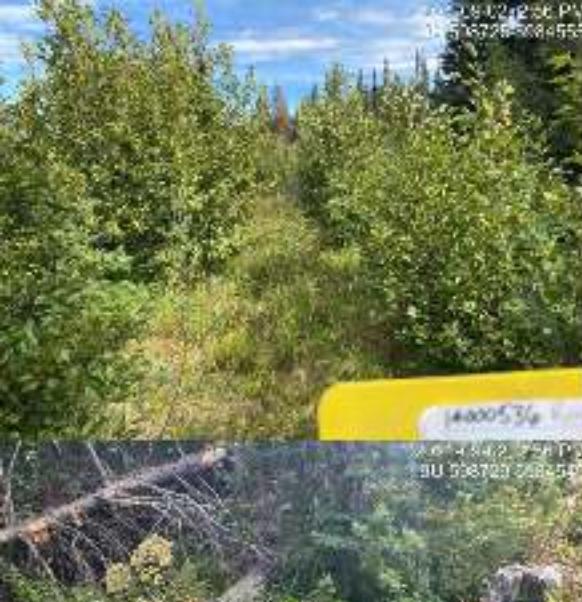
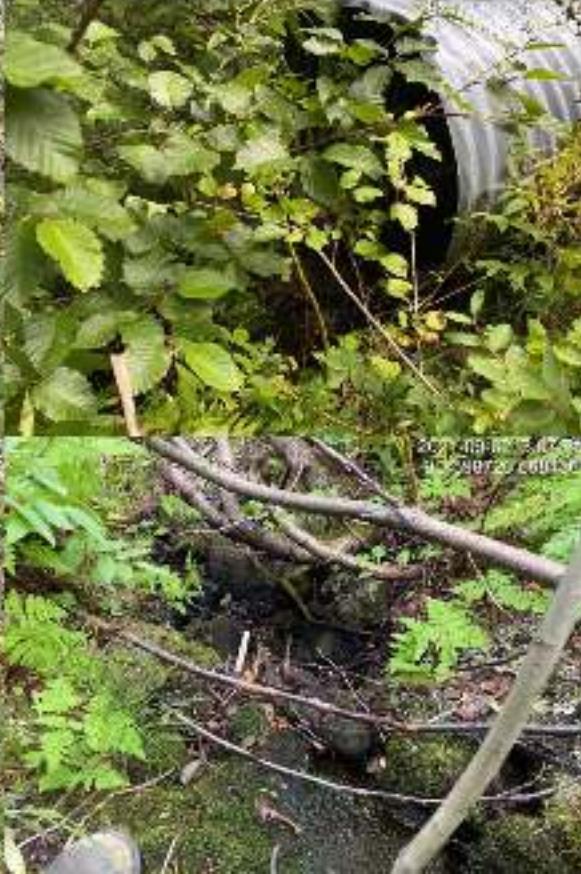
Photos: PSCIS ID 197937. From top left clockwise: Road/Site Card, Barrel, Outlet, Downstream, Upstream, Inlet.

Location and Stream Data		Crossing Characteristics	
Date	2021-09-02	Crossing Sub Type	Round Culvert
PSCIS ID	197937	Diameter (m)	1
External ID	14000536	Length (m)	16
Crew	AI	Embedded	No
UTM Zone	9	Depth Embedded (m)	—
Easting	598400.6	Resemble Channel	No
Northing	5984485	Backwatered	No
Stream	Tributary to Nanika River	Percent Backwatered	—
Road	Spur	Fill Depth (m)	1
Road Tenure	Canfor R08817	Outlet Drop (m)	0.2
Channel Width (m)	0.8	Outlet Pool Depth (m)	0.01
Stream Slope (%)	5	Inlet Drop	No
Beaver Activity	No	Slope (%)	2.5
Habitat Value	Low	Valley Fill	Deep Fill
Final score	23	Barrier Result	Barrier
Fix type	Replace Structure with Streambed Simulation CBS	Fix Span / Diameter	3

Location and Stream Data	•	Crossing Characteristics	-
Comments: Quad road (remove?). Some flow. Fish points upstream. 14:55

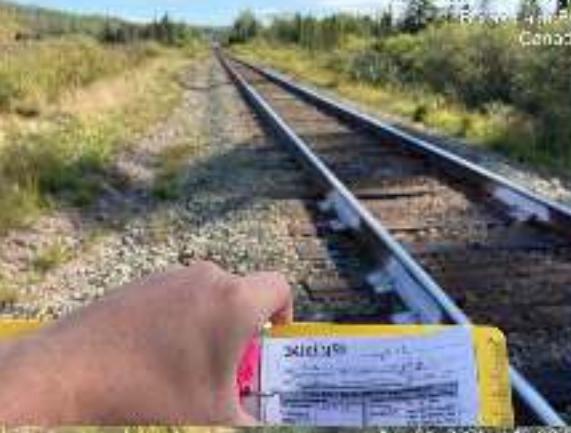
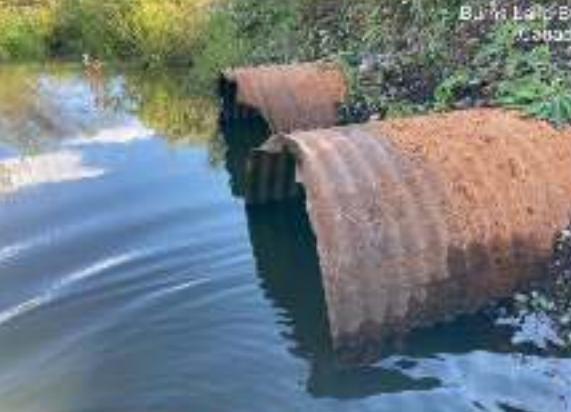
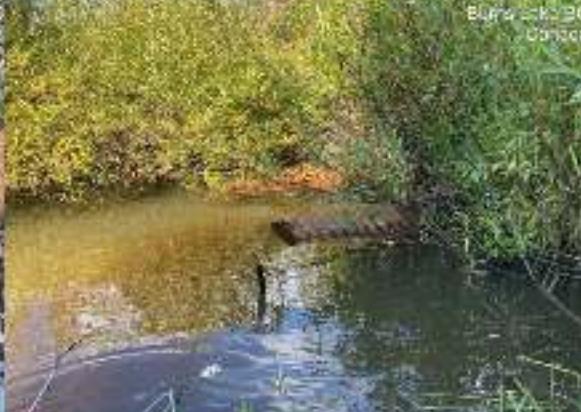
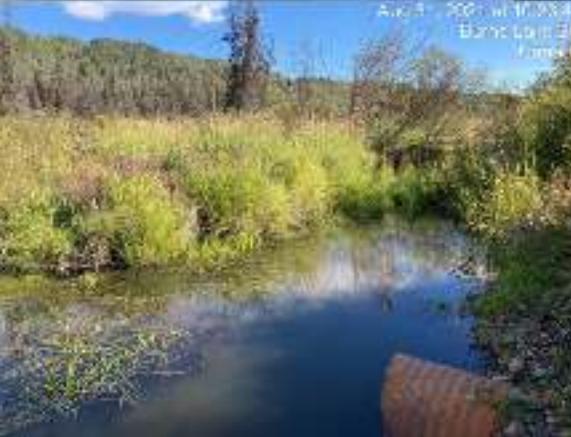
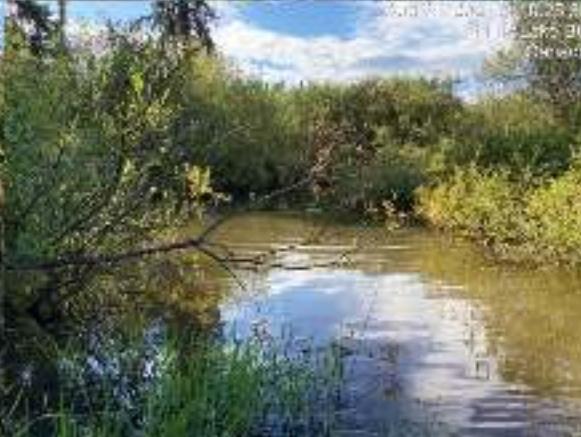
Photos: PSCIS ID 197939. From top left clockwise: Road/Site Card, Barrel, Outlet, Downstream, Upstream, Inlet.

Location and Stream Data	Crossing Characteristics
Comments: Good flow. Nice stream. Not sure why it didn't map. 15:57

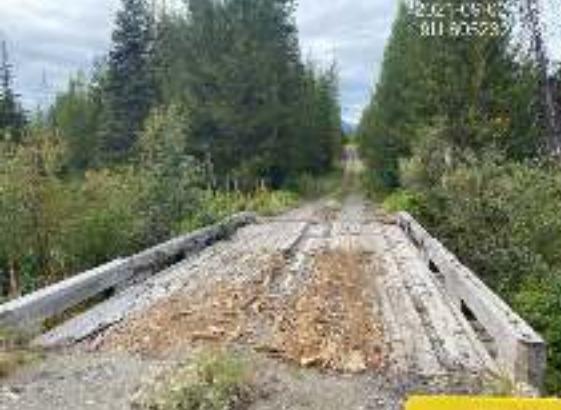
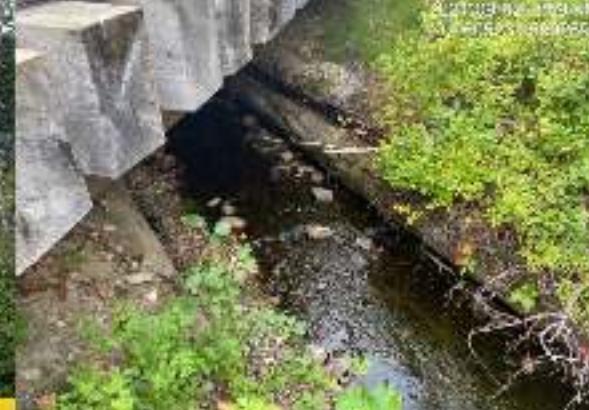
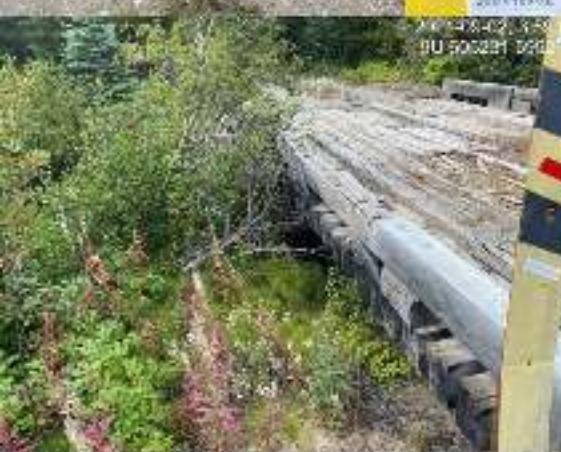
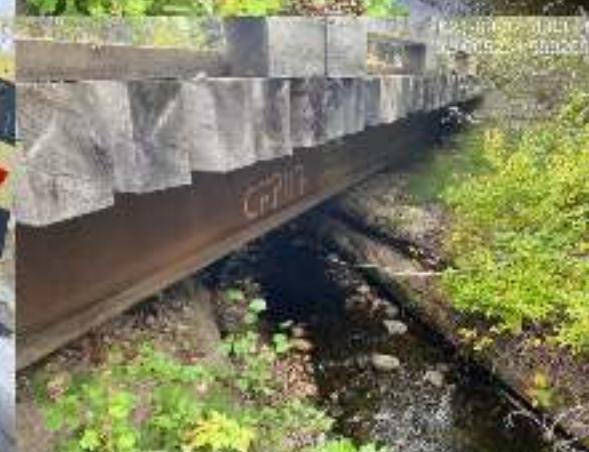
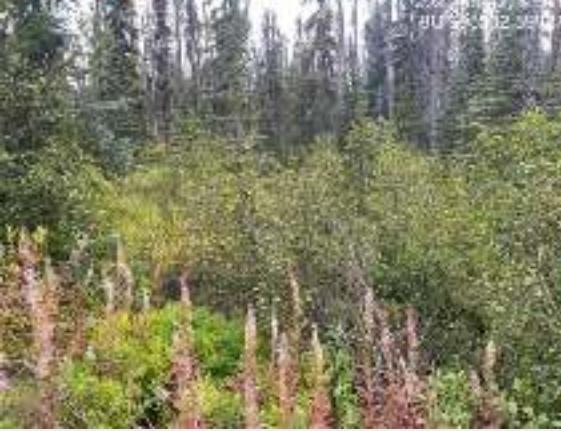
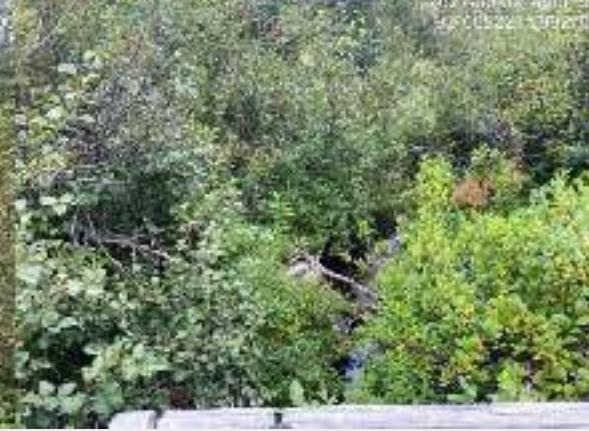
Photos: PSCIS ID 197940. From top left clockwise: Road/Site Card, Barrel, Outlet, Downstream, Upstream, Inlet.

Location and Stream Data	•	Crossing Characteristics	-
Comments: Road deactivated. No visible channel. 17:02

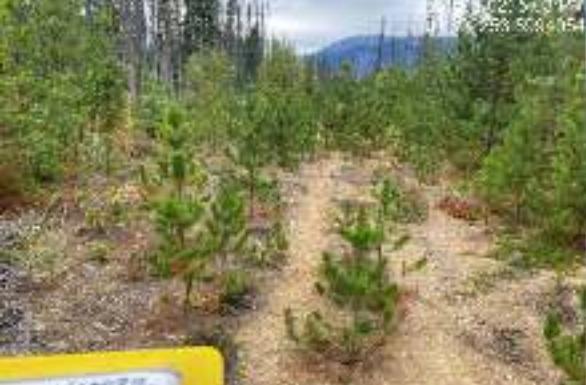
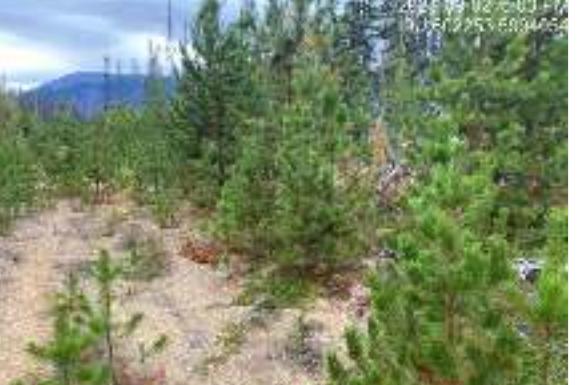
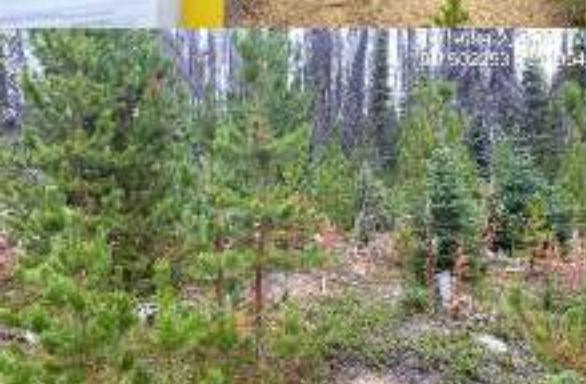
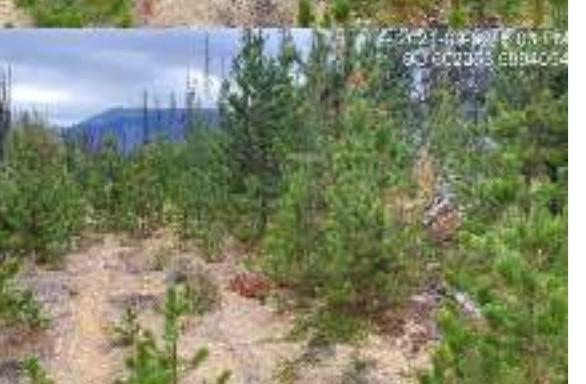
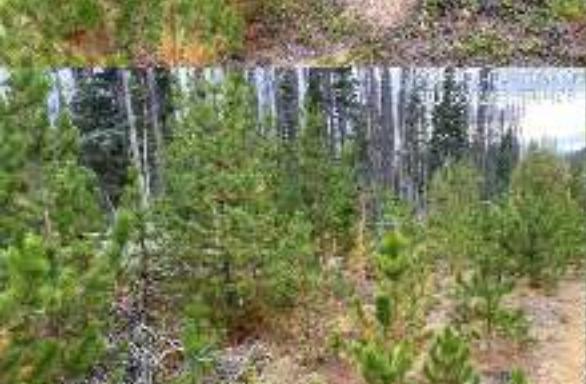
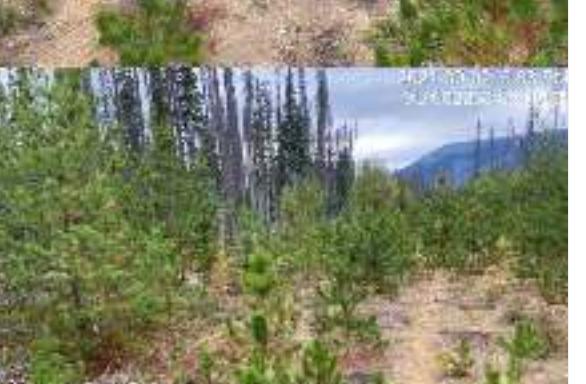
Photos: PSCIS ID 197941. From top left clockwise: Road/Site Card, Barrel, Outlet, Downstream, Upstream, Inlet.

Location and Stream Data	.	Crossing Characteristics	-
Comments: Road deactivated. Channel moist. 17:06

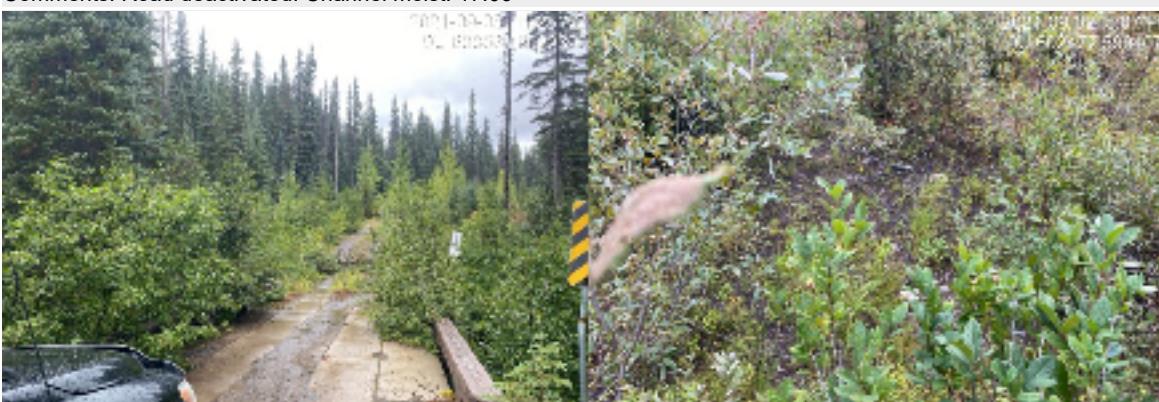
Photos: PSCIS ID 197942. From top left clockwise: Road/Site Card, Barrel, Outlet, Downstream, Upstream, Inlet.

Location and Stream Data	•	Crossing Characteristics	-
Comments: Thault River. 11:34

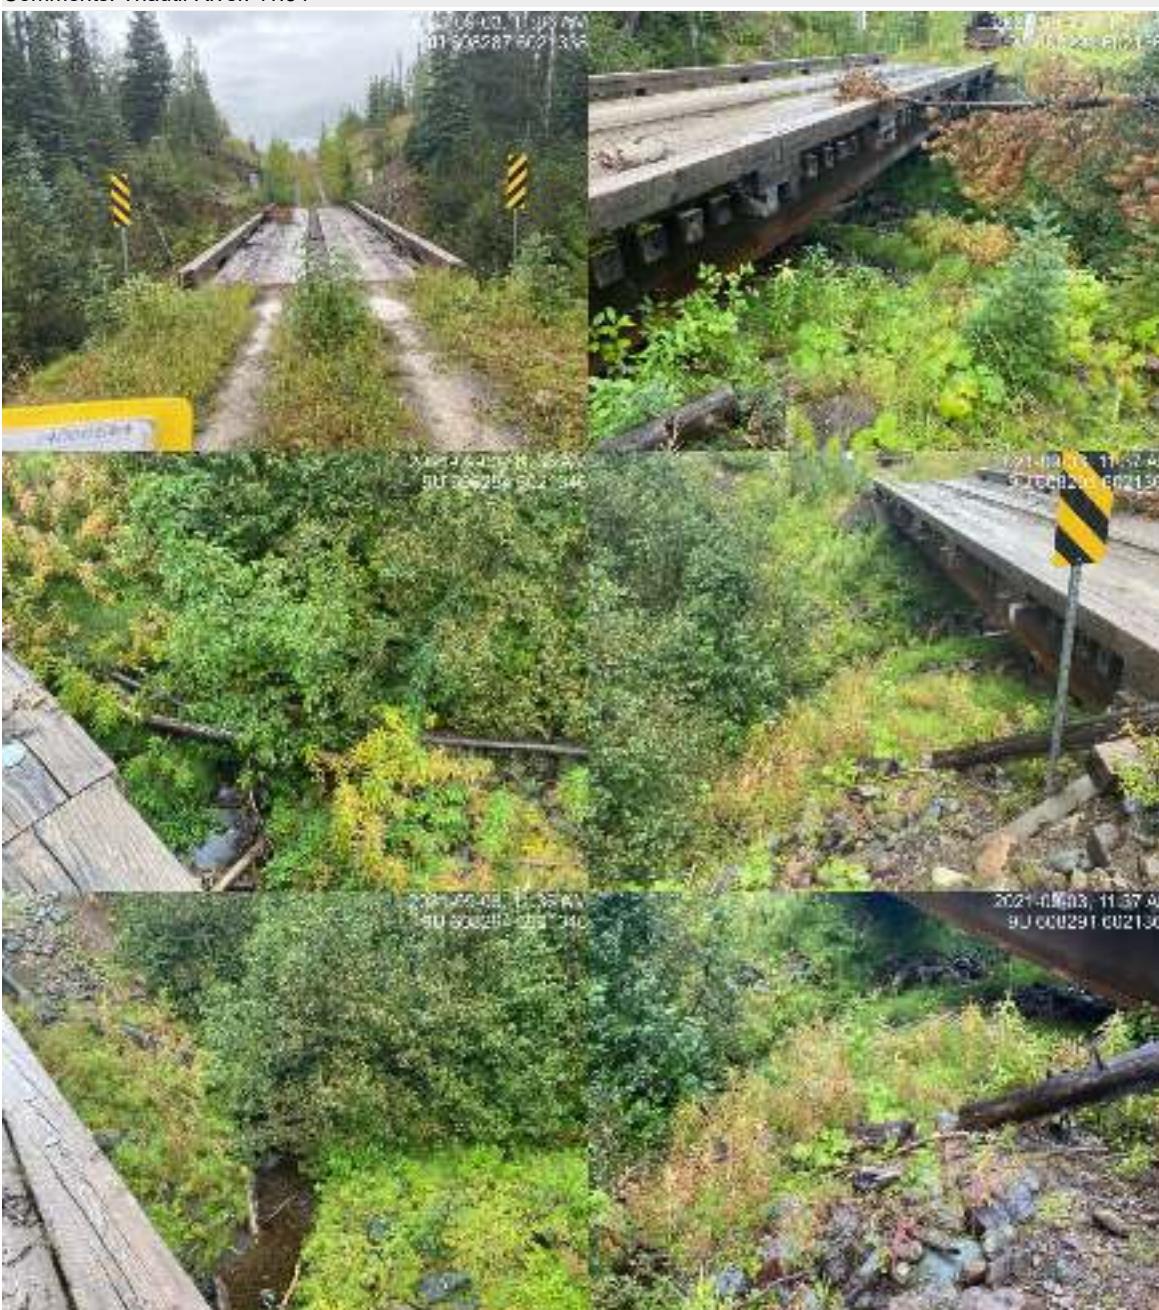
Photos: PSCIS ID 197943. From top left clockwise: Road/Site Card, Barrel, Outlet, Downstream, Upstream, Inlet.

Location and Stream Data	•	Crossing Characteristics	-
Comments: Bridge. 13:40

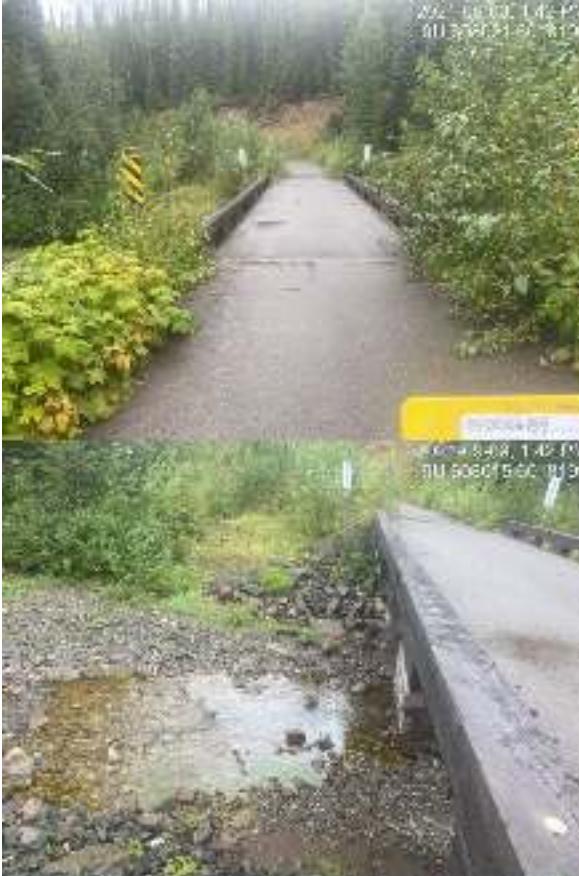
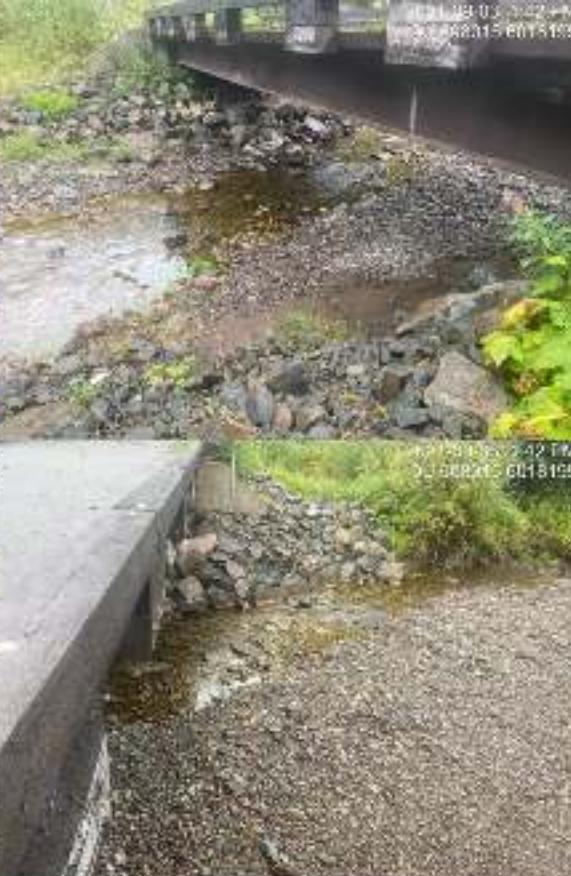
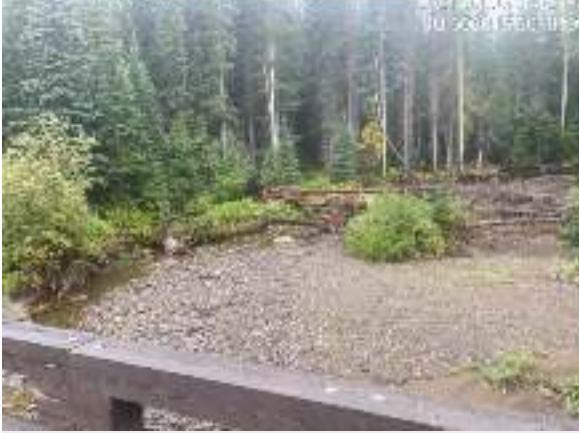
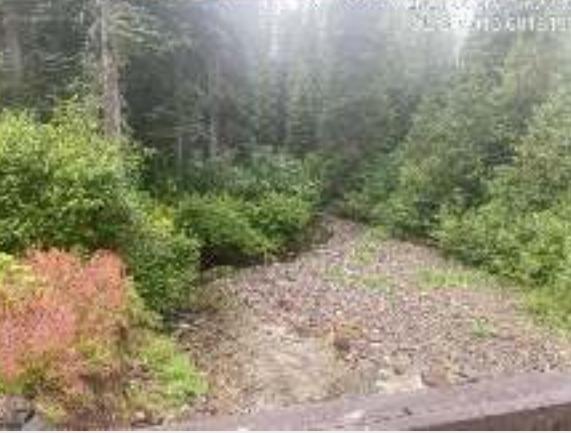
Photos: PSCIS ID 197944. From top left clockwise: Road/Site Card, Barrel, Outlet, Downstream, Upstream, Inlet.

Location and Stream Data		Crossing Characteristics –	
Date	2021-09-03	Crossing Sub Type	Round Culvert
PSCIS ID	197944	Diameter (m)	0.5
External ID	14000695	Length (m)	16
Crew	AI	Embedded	No
UTM Zone	9	Depth Embedded (m)	—
Easting	607829	Resemble Channel	No
Northing	6016958	Backwatered	No
Stream	Tributary to Thaulit River	Percent Backwatered	—
Road	Chisholm FSR	Fill Depth (m)	2.5
Road Tenure	FLNR DND 9946	Outlet Drop (m)	0.7
Channel Width (m)	2.2	Outlet Pool Depth (m)	0.3
Stream Slope (%)	6.5	Inlet Drop	No
Beaver Activity	No	Slope (%)	4.5
Habitat Value	Medium	Valley Fill	Deep Fill
Final score	39	Barrier Result	Barrier
Fix type	Replace with New Open Bottom Structure	Fix Span / Diameter	10

Location and Stream Data	.	Crossing Characteristics	-
Comments: Models as non-fish but DV below. 13:55

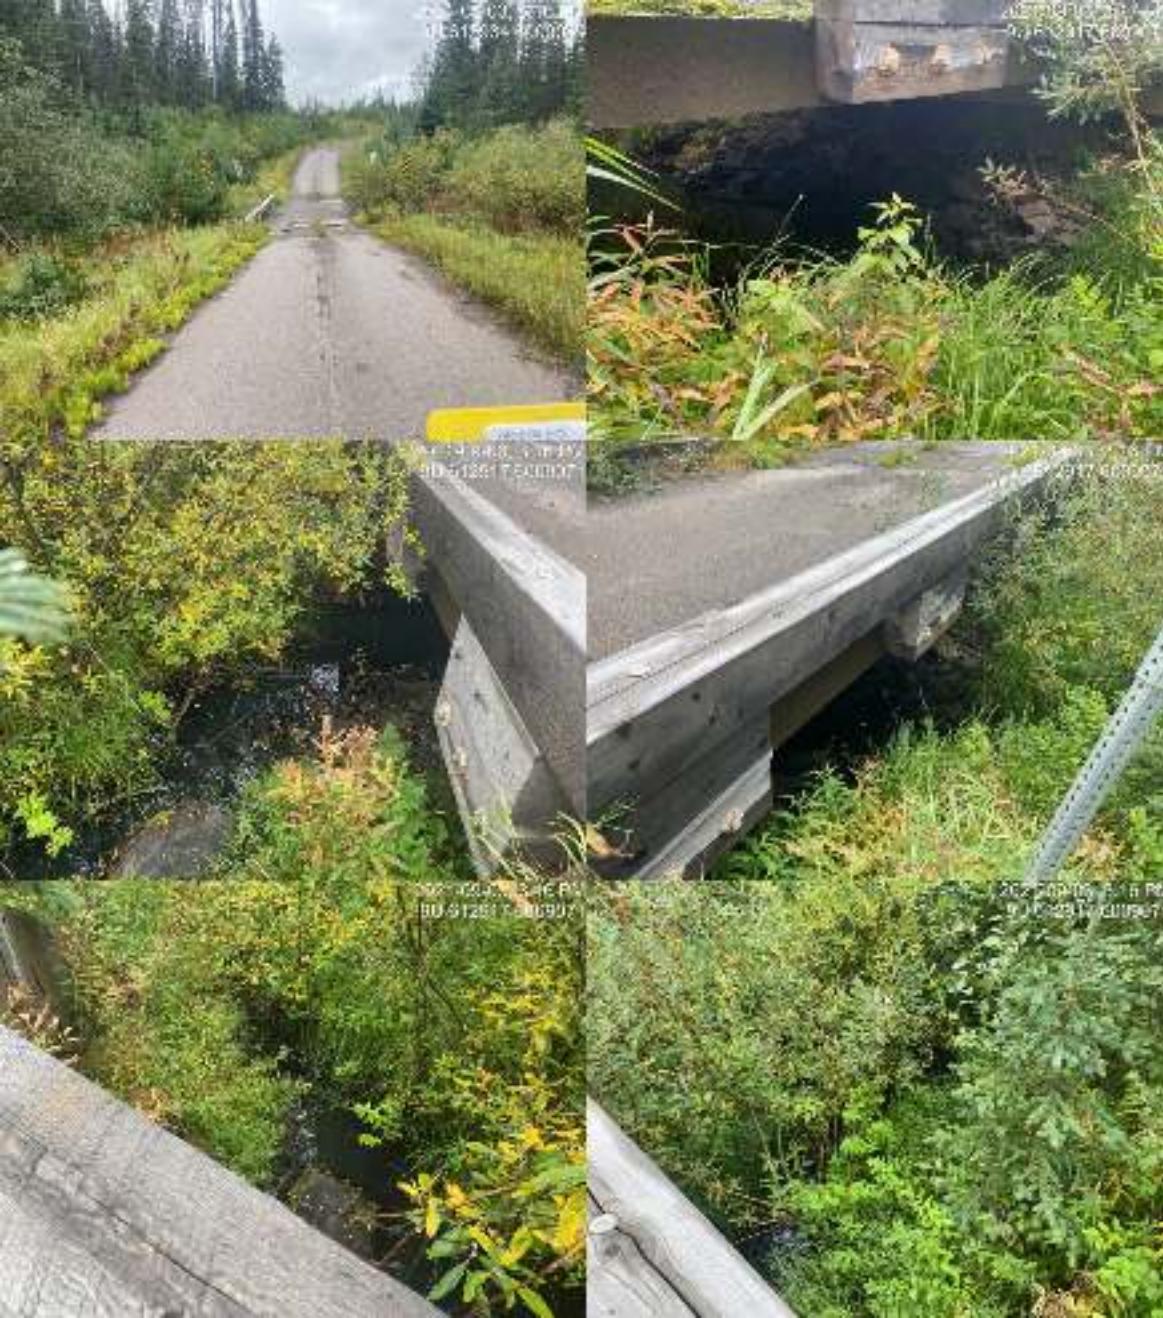
Photos: PSCIS ID 197948. From top left clockwise: Road/Site Card, Barrel, Outlet, Downstream, Upstream, Inlet.

Location and Stream Data	•	Crossing Characteristics	-
Comments: Deactivated road. ATV could get through. 15:40

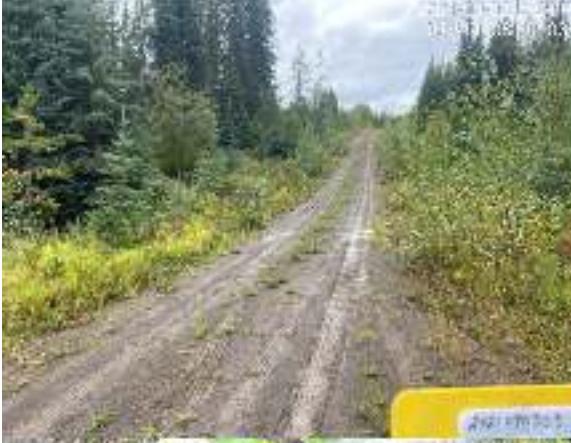
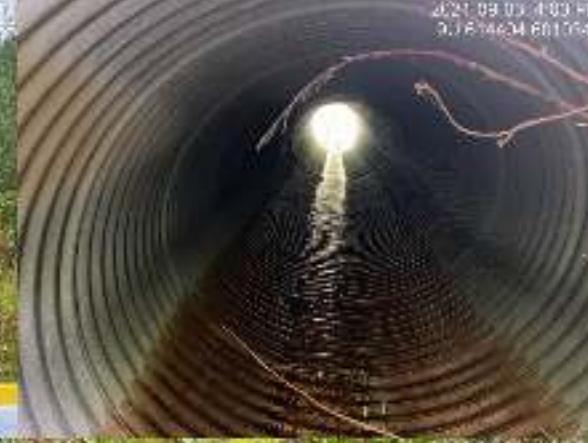
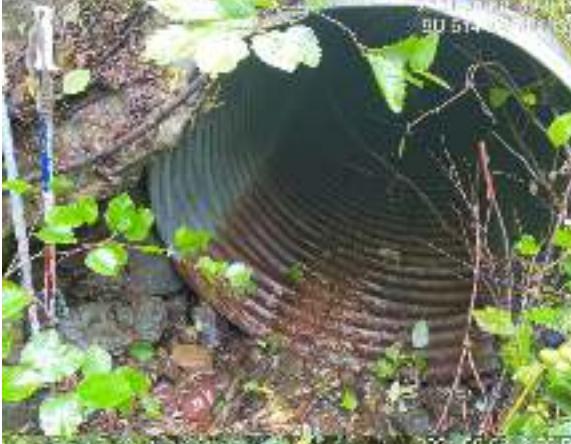
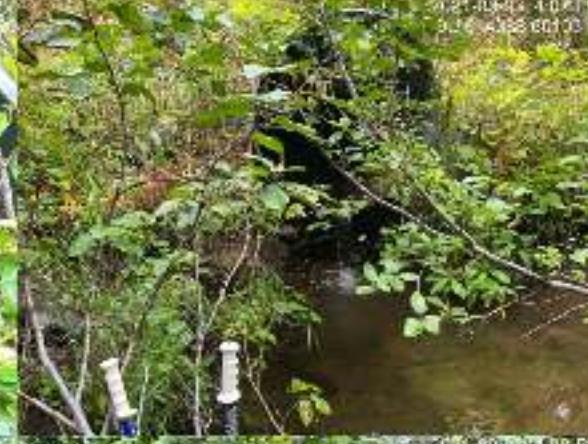
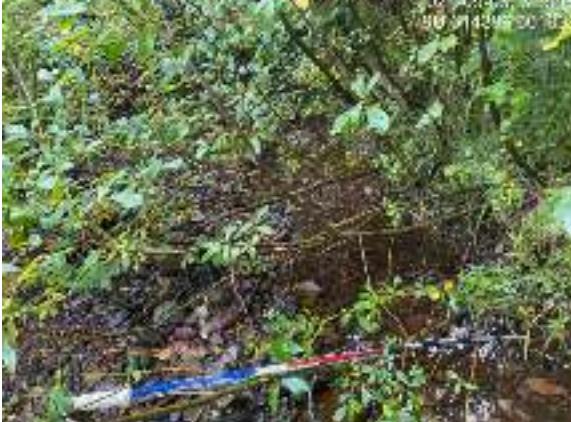
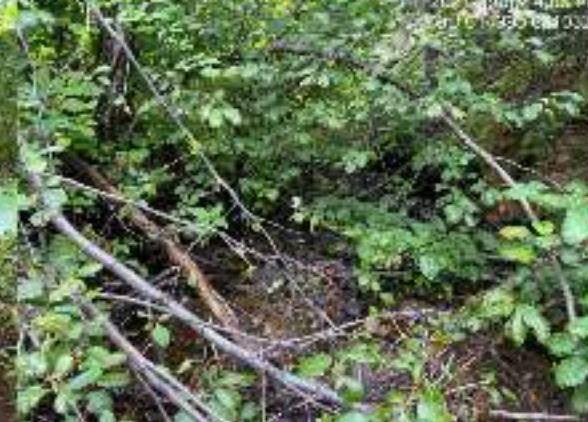
Location and Stream Data	•	Crossing Characteristics	-
Comments: Good flow. Nice gravels. Deep undercut banks. CT upstream and downstream in FISS. ~40mm fish upstream. 15:52

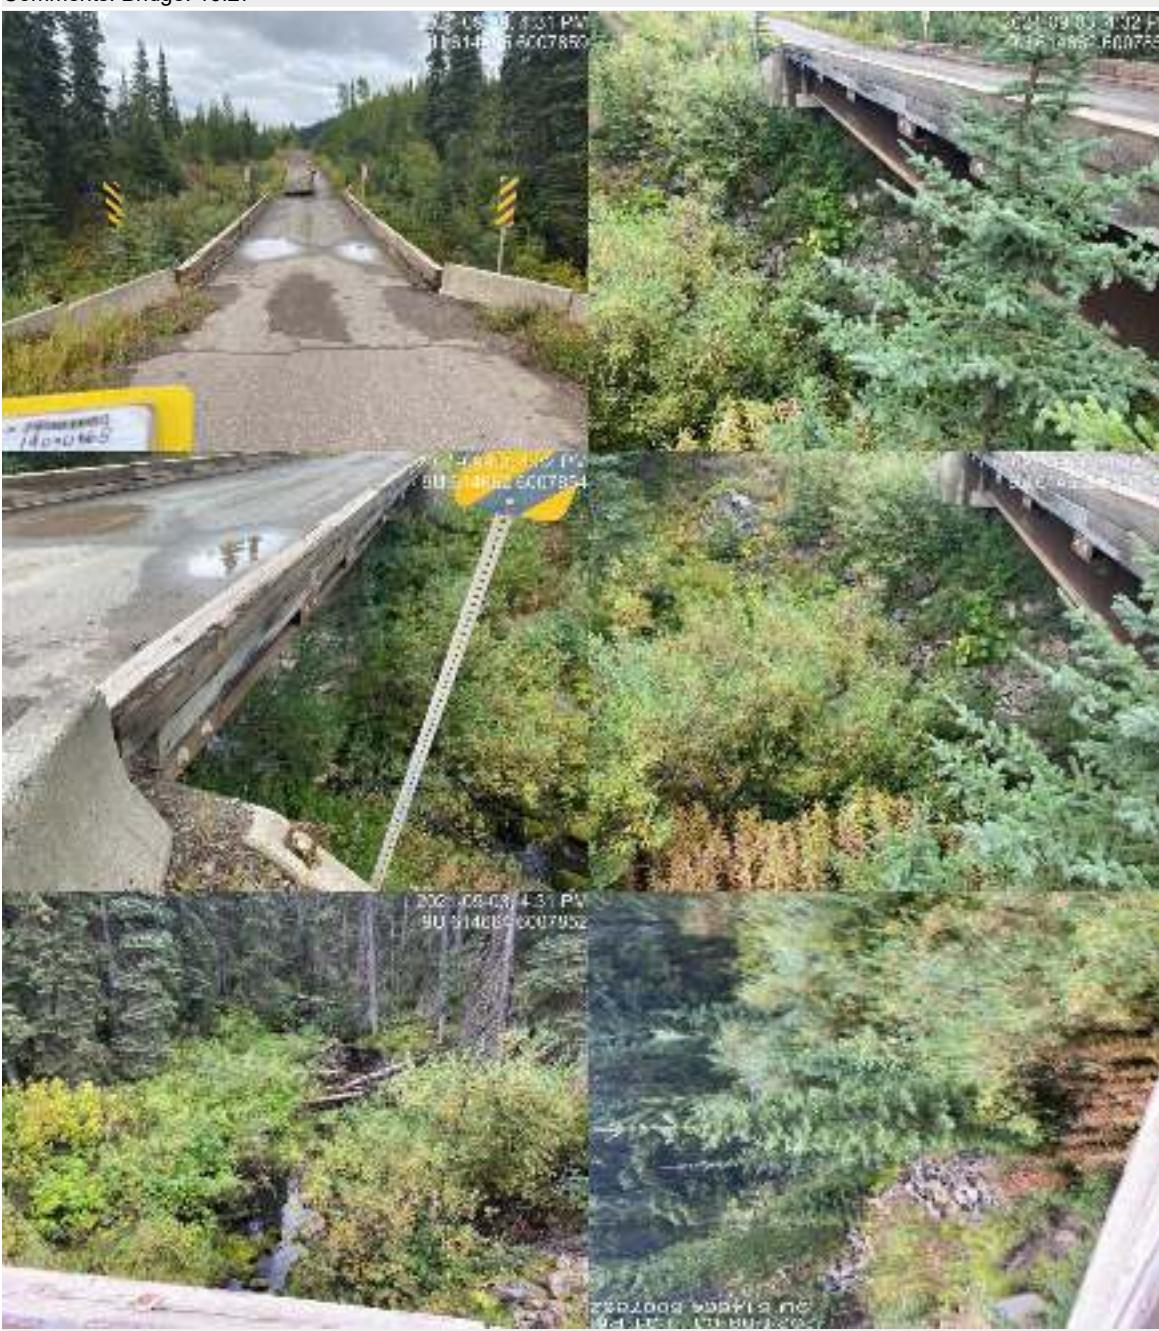
Photos: PSCIS ID 197950. From top left clockwise: Road/Site Card, Barrel, Outlet, Downstream, Upstream, Inlet.

Location and Stream Data	•	Crossing Characteristics	-
Comments: Bridge. 16:27

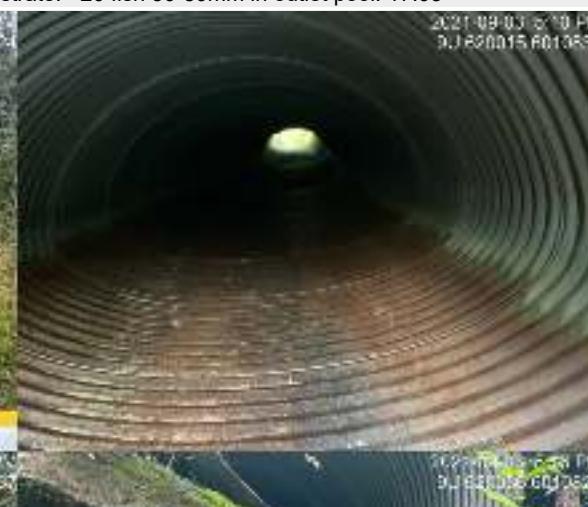
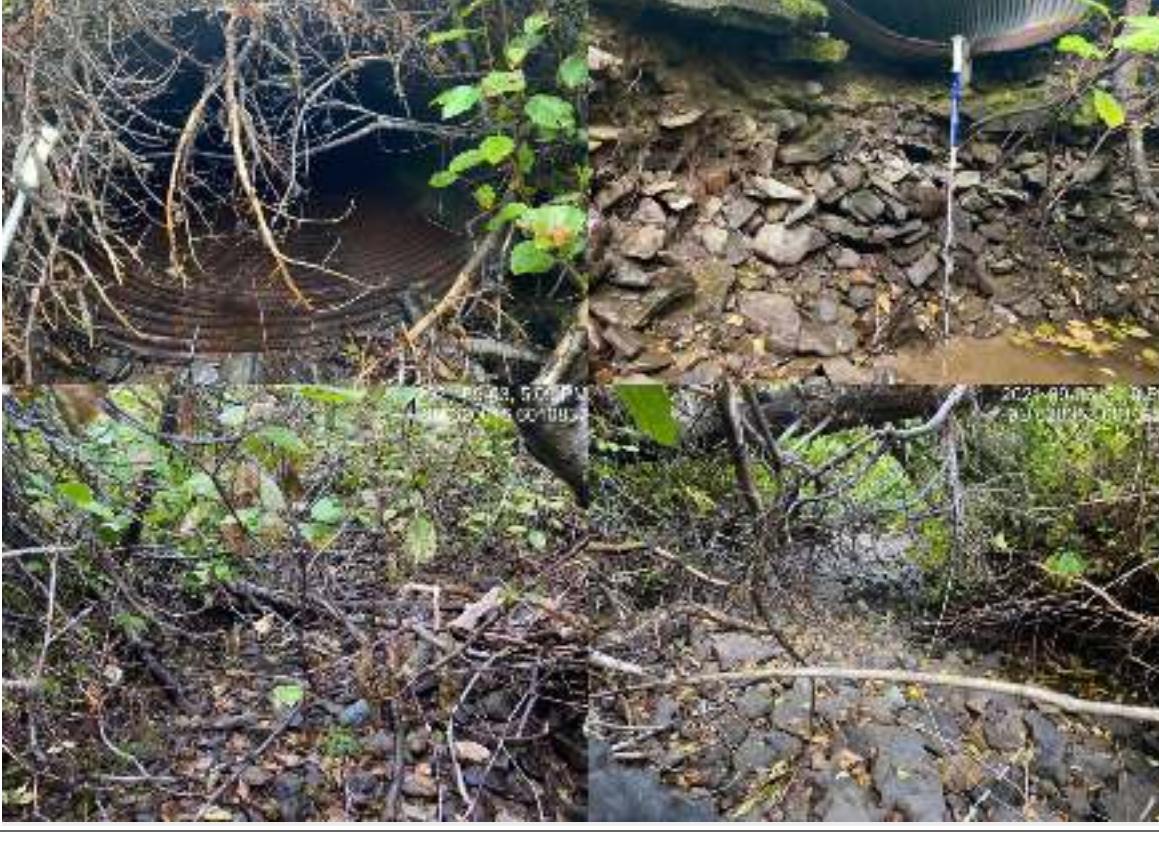
Photos: PSCIS ID 197951. From top left clockwise: Road/Site Card, Barrel, Outlet, Downstream, Upstream, Inlet.

Location and Stream Data		Crossing Characteristics –	
Date	2021-09-03	Crossing Sub Type	Oval Culvert
PSCIS ID	197951	Diameter (m)	1.6
External ID	14001177	Length (m)	22
Crew	AI	Embedded	No
UTM Zone	9	Depth Embedded (m)	–
Easting	620026.2	Resemble Channel	No
Northing	6010831	Backwatered	No
Stream	Tributary to Morice River	Percent Backwatered	–
Road	False Tagit FSR	Fill Depth (m)	1.5
Road Tenure	FLNR DND 9946	Outlet Drop (m)	1.1
Channel Width (m)	3	Outlet Pool Depth (m)	0.6
Stream Slope (%)	1	Inlet Drop	No
Beaver Activity	No	Slope (%)	4.5
Habitat Value	Medium	Valley Fill	Deep Fill
Final score	39	Barrier Result	Barrier
Fix type	Replace with New Open Bottom Structure	Fix Span / Diameter	10

Location and Stream Data	•	Crossing Characteristics	-
Comments: Dry upstream but sizable channel. Cobble substrate. ~20 fish 50-80mm in outlet pool. 17:05
