Appendix - Phase 1 Fish Passage Assessment Data and Photos

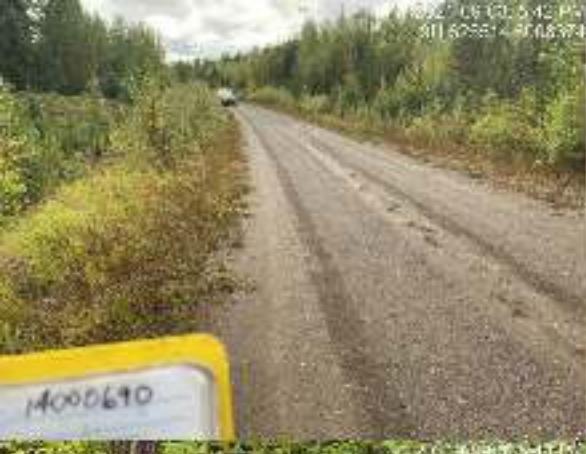
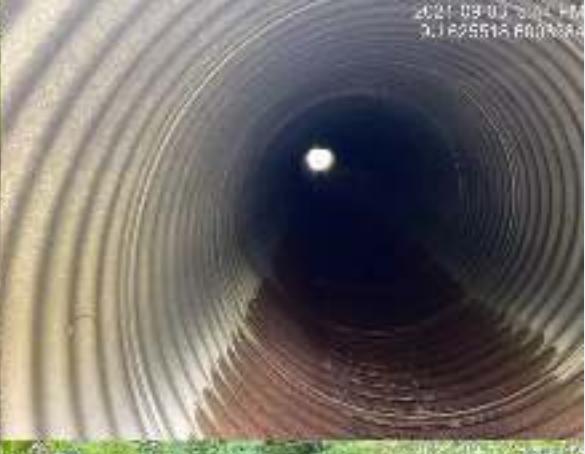
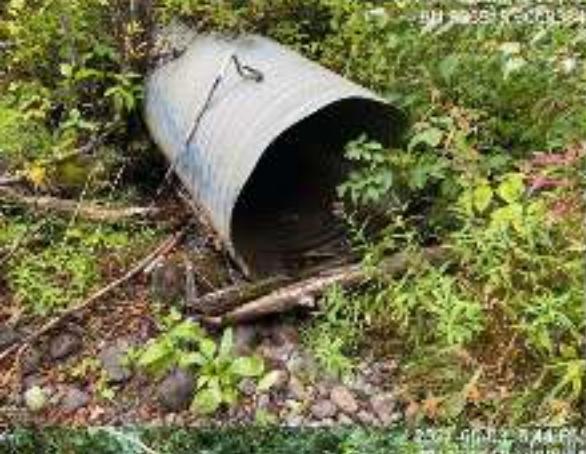
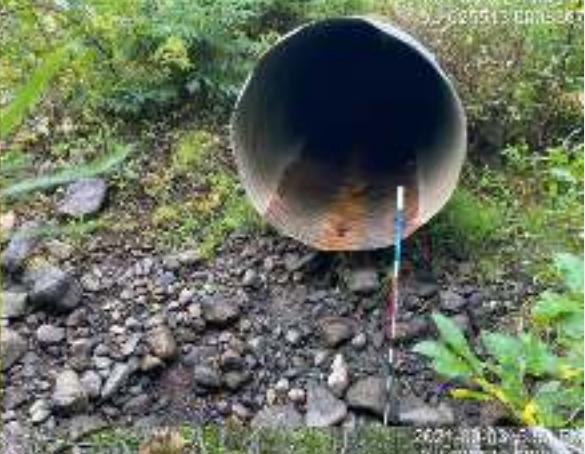
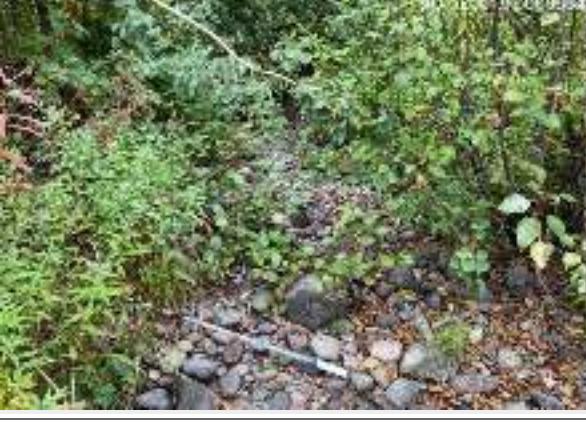
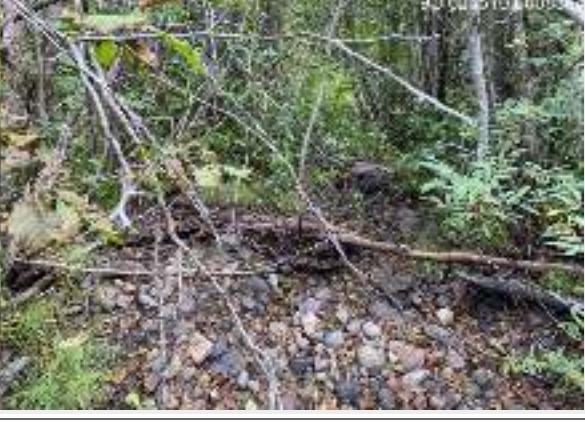
Photos: PSCIS ID 197952. From top left clockwise: Road/Site Card, Barrel, Outlet, Downstream, Upstream, Inlet.

Location and Stream Data		Crossing Characteristics –	
Date	2021-09-03	Crossing Sub Type	Round Culvert
PSCIS ID	197952	Diameter (m)	1
External ID	14000690	Length (m)	24
Crew	AI	Embedded	No
UTM Zone	9	Depth Embedded (m)	–
Easting	625491.4	Resemble Channel	No
Northing	6008365	Backwatered	No
Stream	Tributary to Morice River	Percent Backwatered	–
Road	Chisholm FSR	Fill Depth (m)	1
Road Tenure	FLNR DND 9946	Outlet Drop (m)	0.35
Channel Width (m)	2.1	Outlet Pool Depth (m)	0.5
Stream Slope (%)	6	Inlet Drop	Yes
Beaver Activity	No	Slope (%)	4.5
Habitat Value	Low	Valley Fill	Deep Fill
Final score	39	Barrier Result	Barrier
Fix type	Replace with New Open Bottom Structure	Fix Span / Diameter	10

Location and Stream Data	•	Crossing Characteristics	-
Comments: Dry except small outlet pool. Cobble substrate. Some gravels present. 17:41

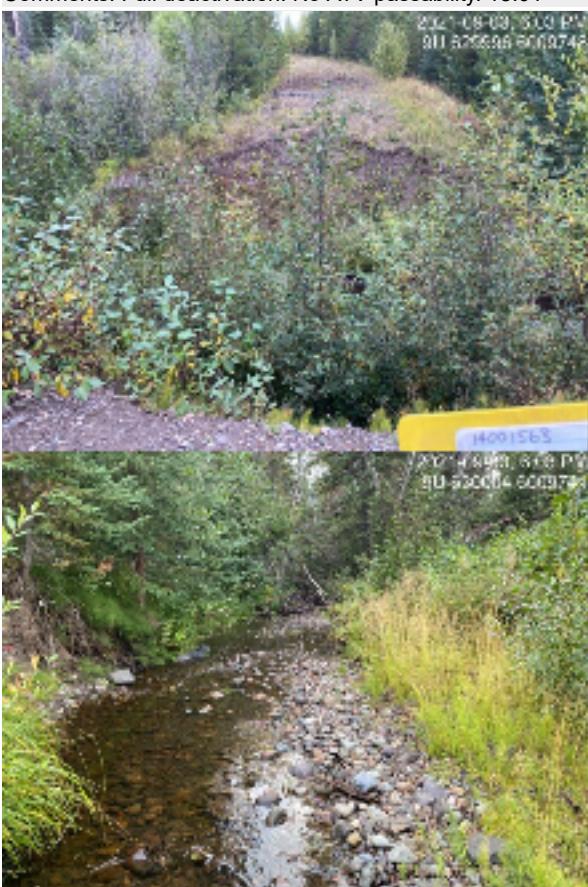
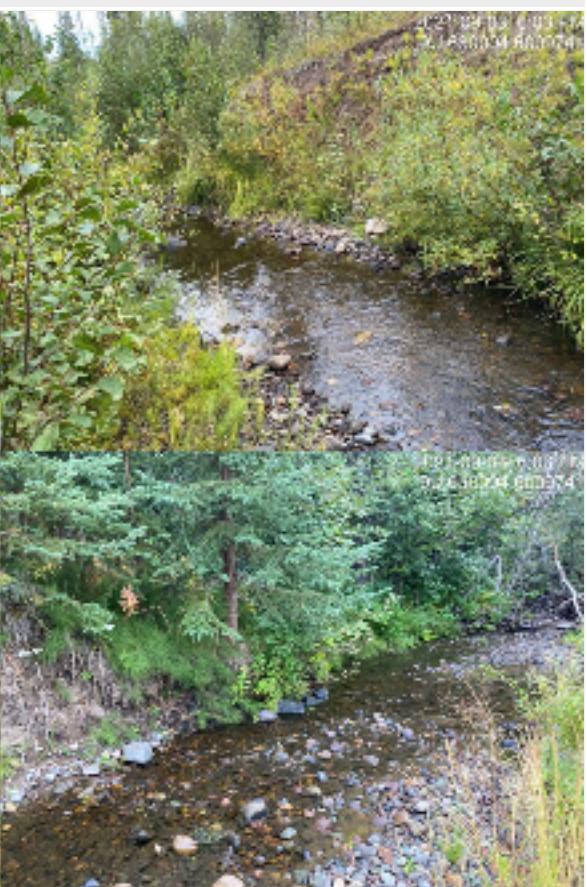
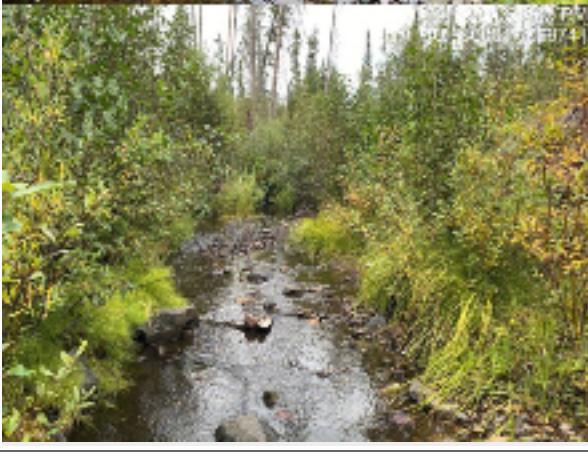
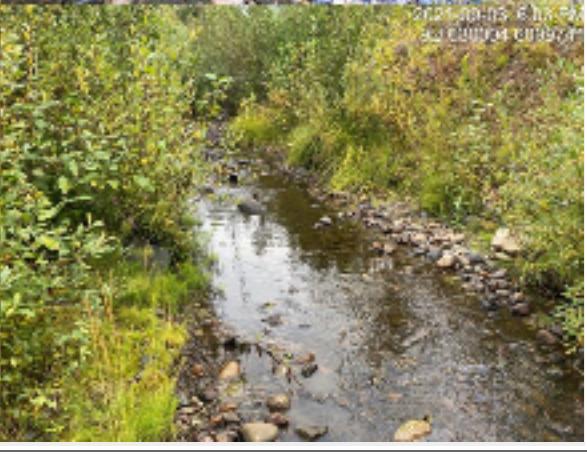
Photos: PSCIS ID 197953. From top left clockwise: Road/Site Card, Barrel, Outlet, Downstream, Upstream, Inlet.

Location and Stream Data	•	Crossing Characteristics	-
Comments: Full deactivation. No ATV passability. 18:01

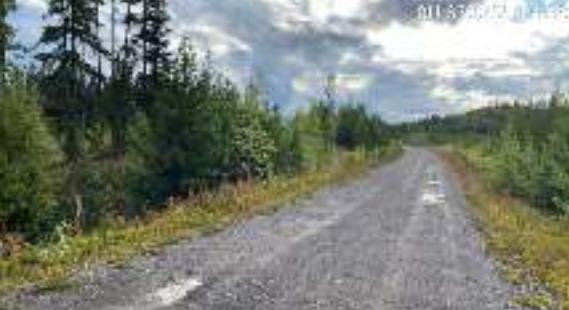
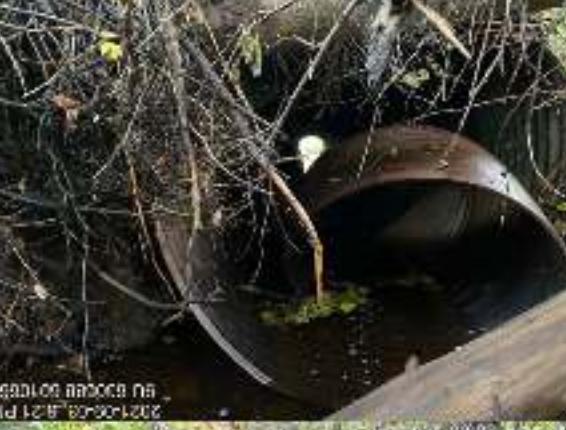
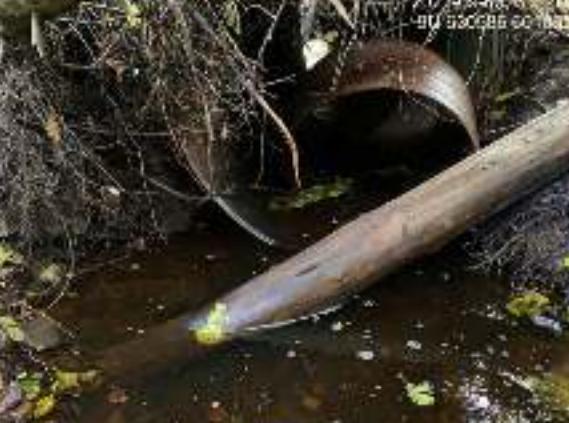
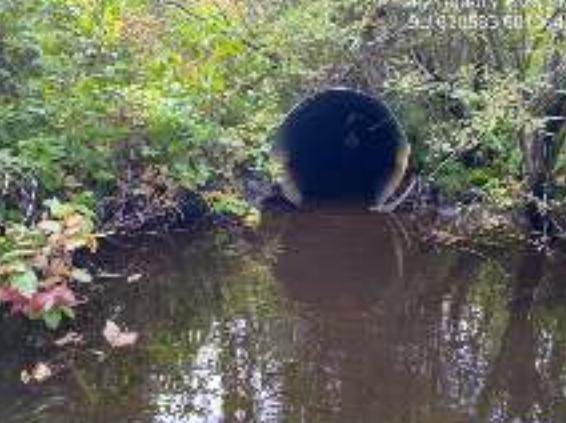
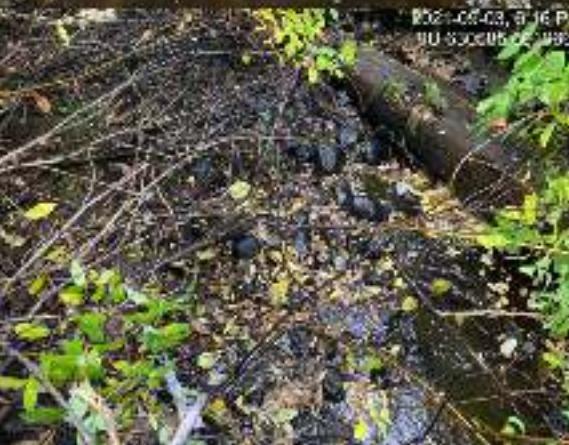
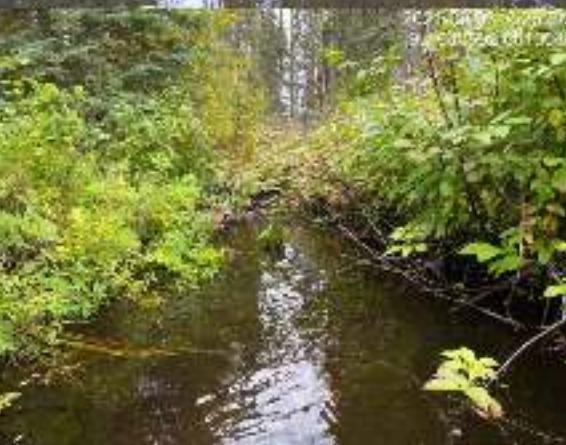
Photos: PSCIS ID 197954. From top left clockwise: Road/Site Card, Barrel, Outlet, Downstream, Upstream, Inlet.

Location and Stream Data		Crossing Characteristics –	
Date	2021-09-03	Crossing Sub Type	Round Culvert
PSCIS ID	197954	Diameter (m)	1.25
External ID	14000696	Length (m)	30
Crew	AI	Embedded	No
UTM Zone	9	Depth Embedded (m)	–
Easting	630596.4	Resemble Channel	No
Northing	6010650	Backwatered	Yes
Stream	Tributary to Morice River	Percent Backwatered	25
Road	Chisholm FSR	Fill Depth (m)	3
Road Tenure	FLNR DND 9946	Outlet Drop (m)	0
Channel Width (m)	1.7	Outlet Pool Depth (m)	0.6
Stream Slope (%)	3	Inlet Drop	No
Beaver Activity	No	Slope (%)	0.5
Habitat Value	Medium	Valley Fill	Deep Fill
Final score	22	Barrier Result	Barrier
Fix type	Replace with New Open Bottom Structure	Fix Span / Diameter	10

Location and Stream Data	Crossing Characteristics
<p>Comments: Nice stream downstream at deactivated crossing. Riparian shrub cover is extremely thick. Difficult to get width and gradient. Stream may be bigger. 18:13</p>

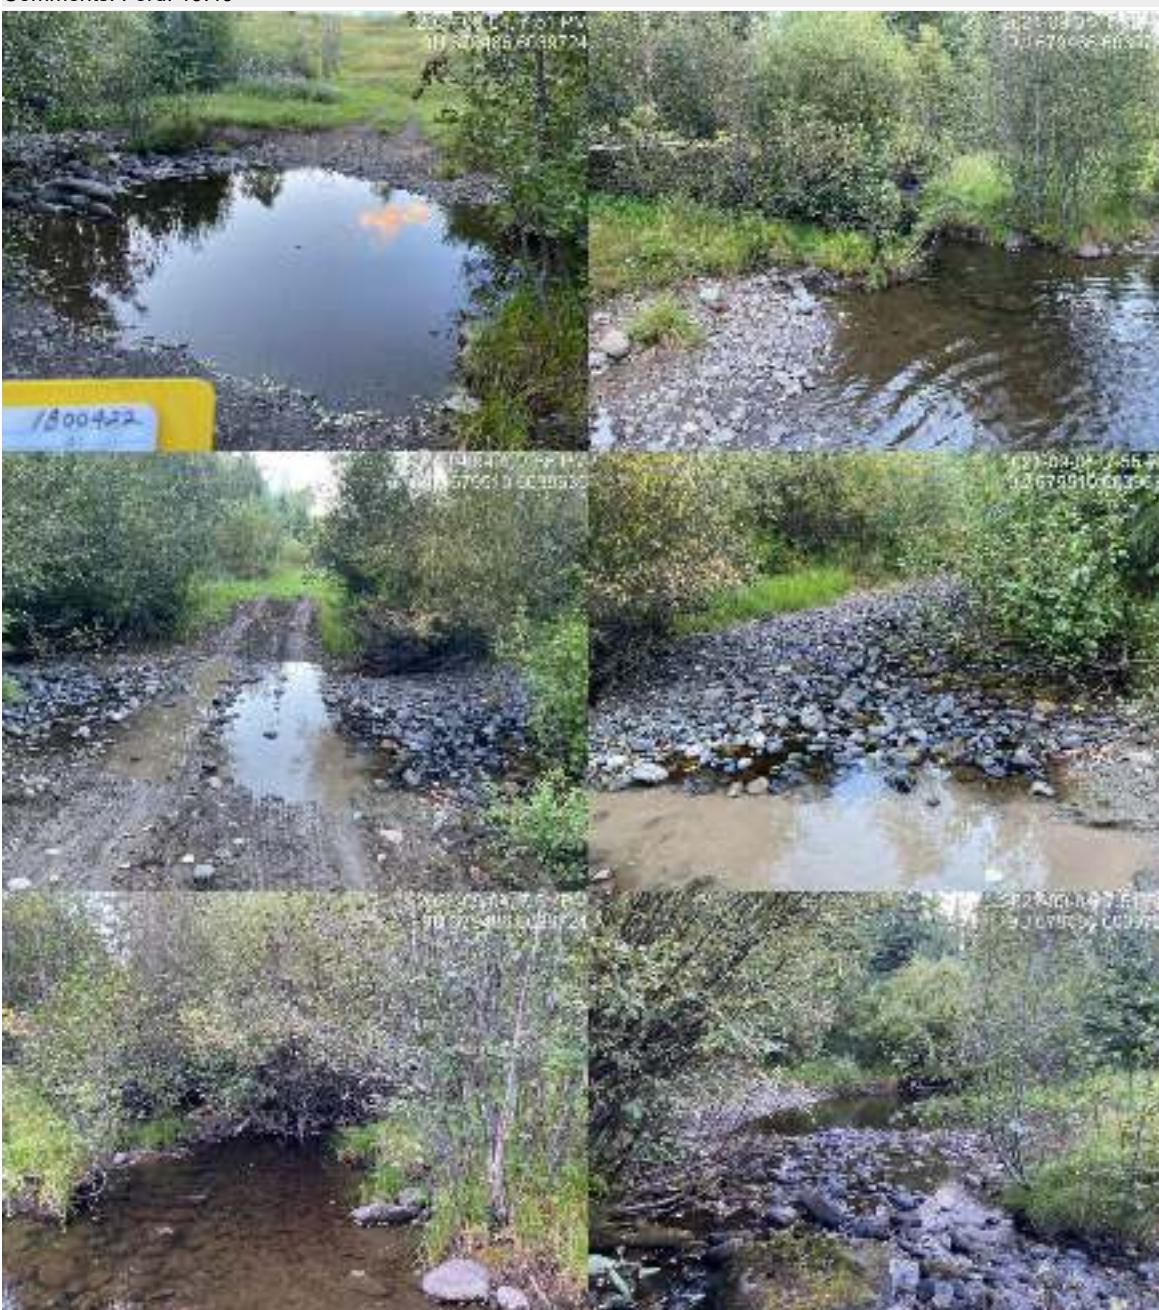
Photos: PSCIS ID 197955. From top left clockwise: Road/Site Card, Barrel, Outlet, Downstream, Upstream, Inlet.

Location and Stream Data	•	Crossing Characteristics	-
Comments: Ford. 19:49

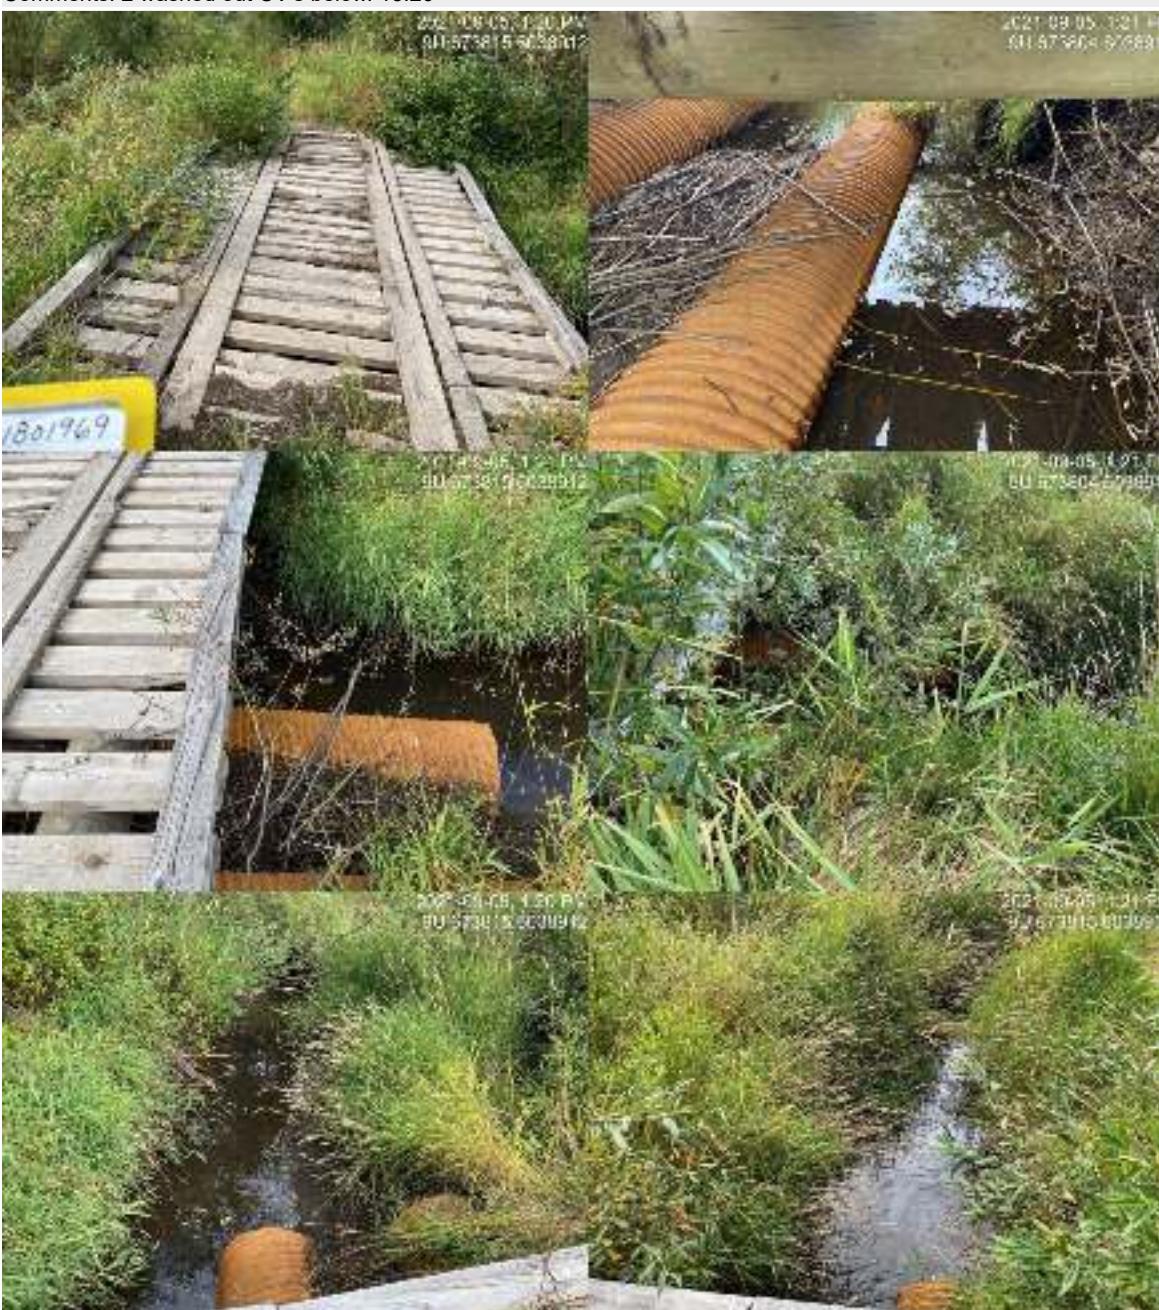
Photos: PSCIS ID 197957. From top left clockwise: Road/Site Card, Barrel, Outlet, Downstream, Upstream, Inlet.

Location and Stream Data	•	Crossing Characteristics	-
Comments: 2 washed out CV's below. 13:20

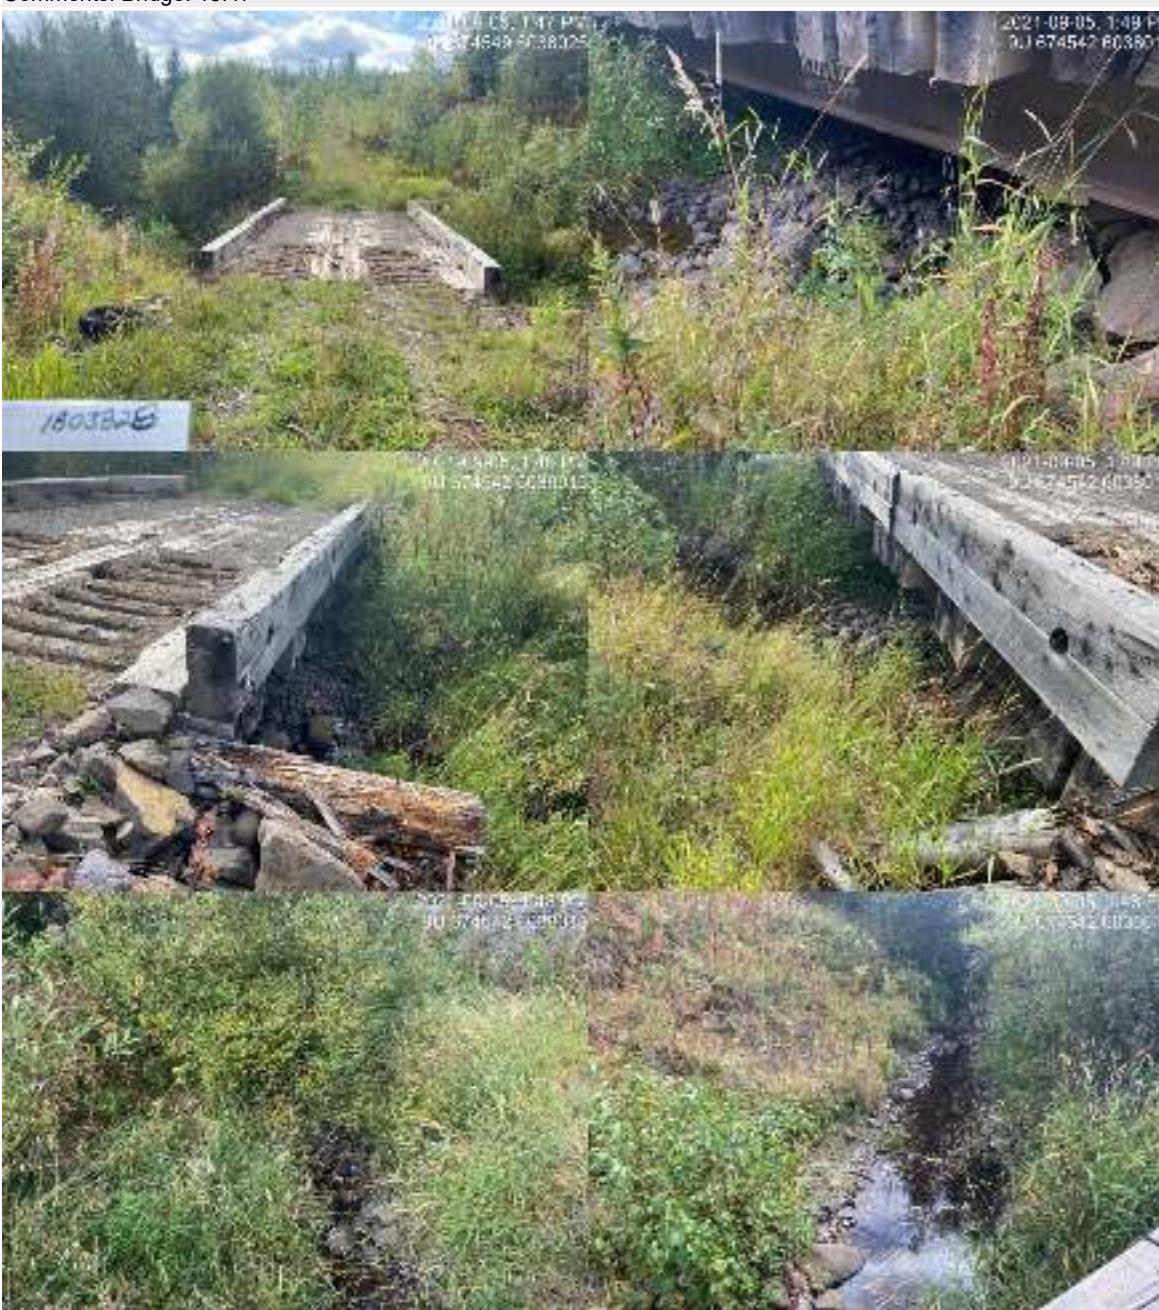
Photos: PSCIS ID 197958. From top left clockwise: Road/Site Card, Barrel, Outlet, Downstream, Upstream, Inlet.

Location and Stream Data	•	Crossing Characteristics	-
Comments: Bridge. 13:47

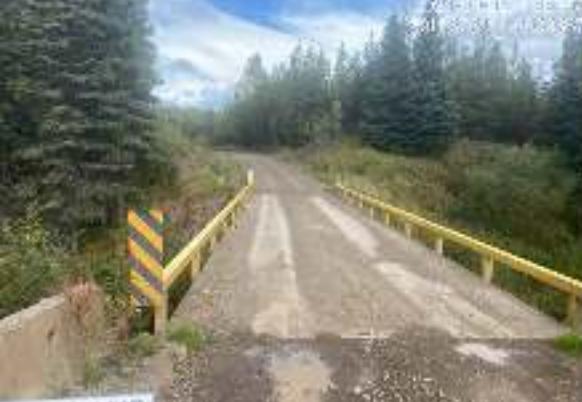
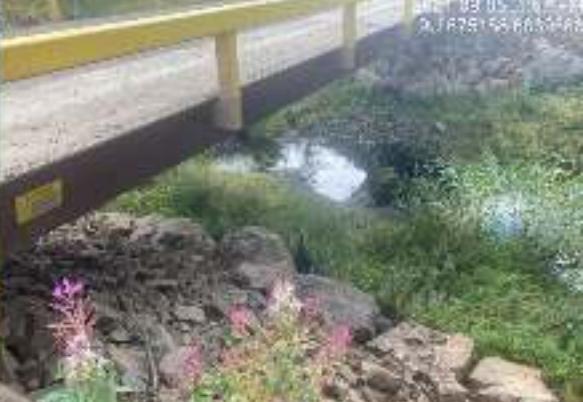
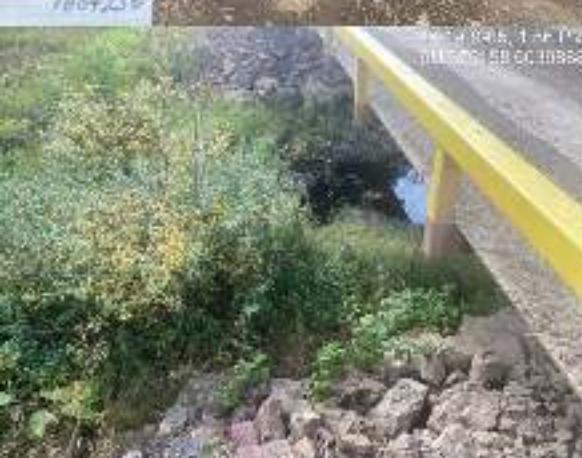
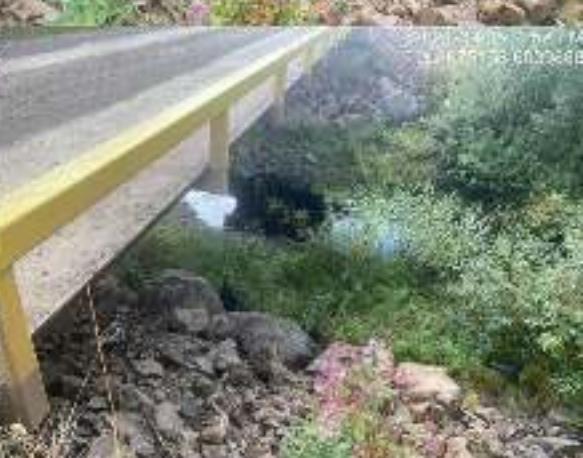
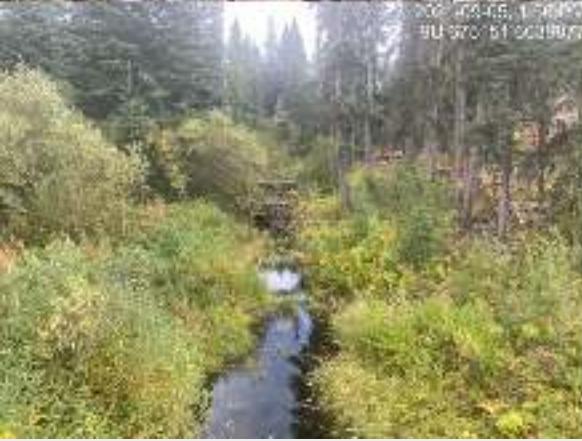
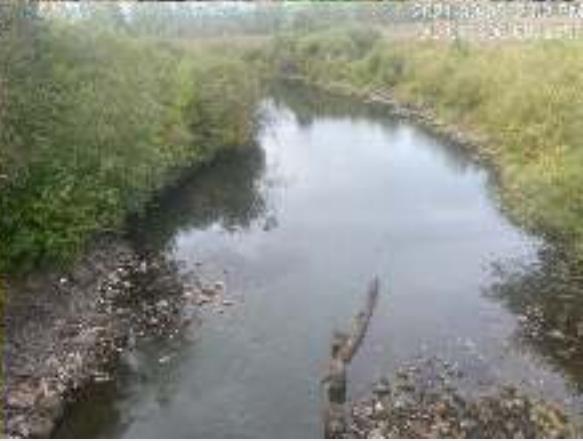
Photos: PSCIS ID 197959. From top left clockwise: Road/Site Card, Barrel, Outlet, Downstream, Upstream, Inlet.

Location and Stream Data	•	Crossing Characteristics	-
Comments: Newer, 13:55

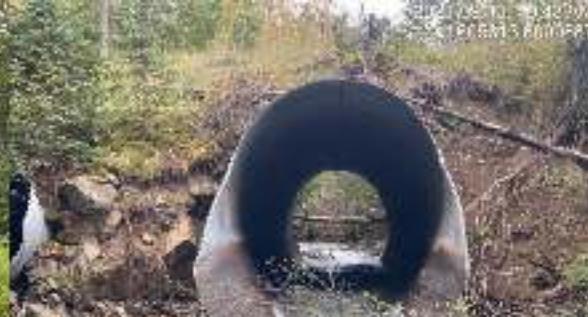
Photos: PSCIS ID 197960. From top left clockwise: Road/Site Card, Barrel, Outlet, Downstream, Upstream, Inlet.

Location and Stream Data		Crossing Characteristics –	
Date	2021-09-13	Crossing Sub Type	Round Culvert
PSCIS ID	197960	Diameter (m)	3.4
External ID	24704566	Length (m)	24
Crew	AI KP	Embedded	No
UTM Zone	9	Depth Embedded (m)	—
Easting	605785.6	Resemble Channel	No
Northing	6099884	Backwatered	No
Stream	Corya Creek	Percent Backwatered	—
Road	Railway	Fill Depth (m)	1.5
Road Tenure	Unknown	Outlet Drop (m)	0.65
Channel Width (m)	18	Outlet Pool Depth (m)	3
Stream Slope (%)	2.8	Inlet Drop	No
Beaver Activity	Yes	Slope (%)	2.5
Habitat Value	High	Valley Fill	Deep Fill
Final score	34	Barrier Result	Barrier
Fix type	Replace with New Open Bottom Structure	Fix Span / Diameter	23

Location and Stream Data	•	Crossing Characteristics	-
Comments: Outlet is cracked and drops. Inlet embedded to 2/3 way. 10:33

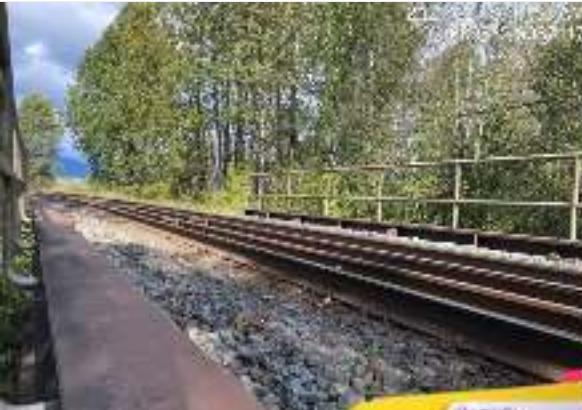
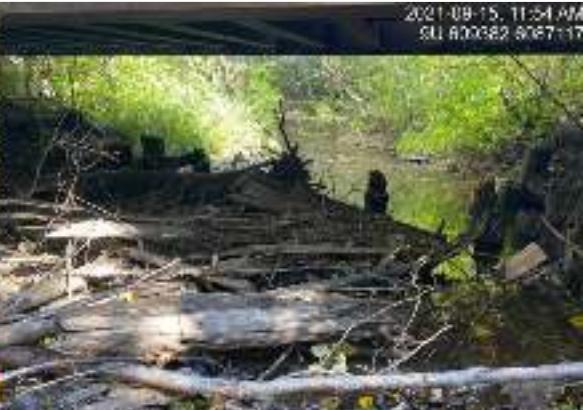
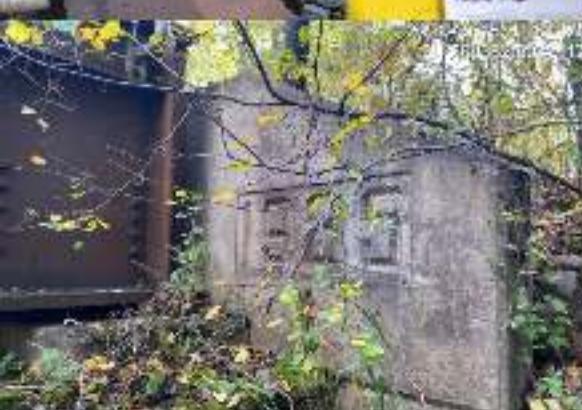
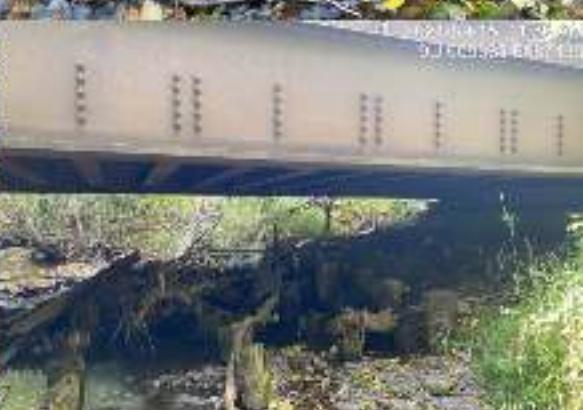
Photos: PSCIS ID 197961. From top left clockwise: Road/Site Card, Barrel, Outlet, Downstream, Upstream, Inlet.

Location and Stream Data	•	Crossing Characteristics	-
Comments: Bridge. 11:50	•		-

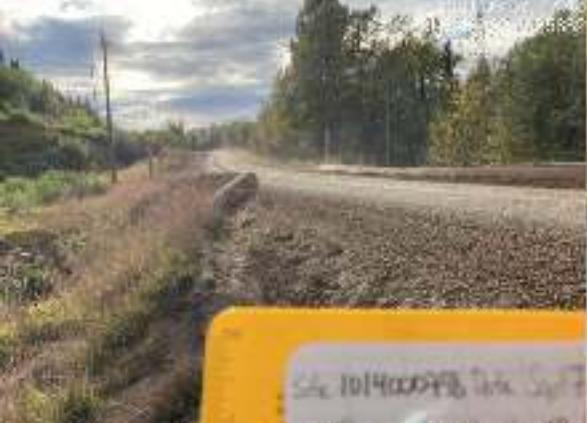
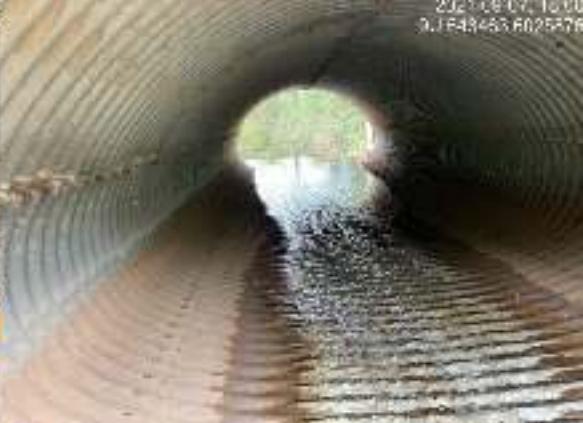
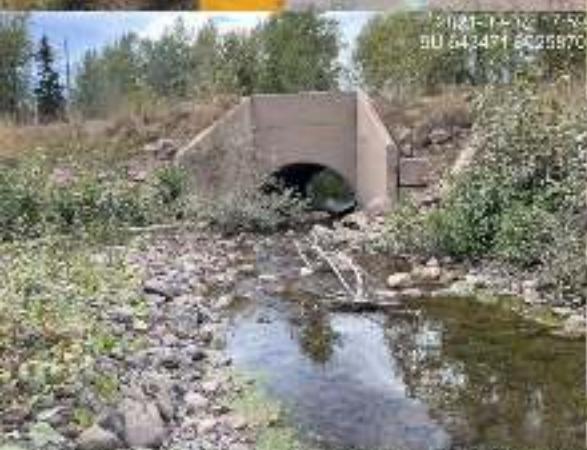
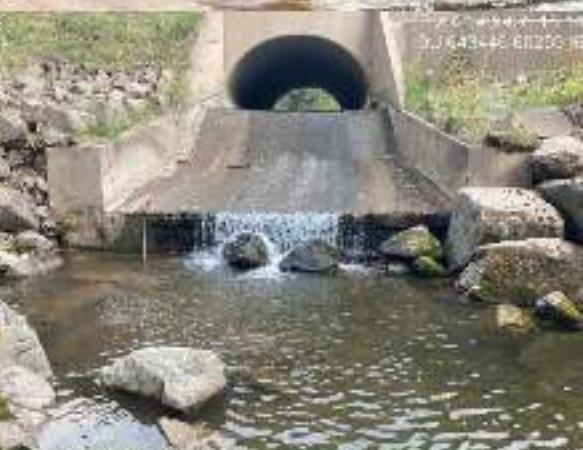
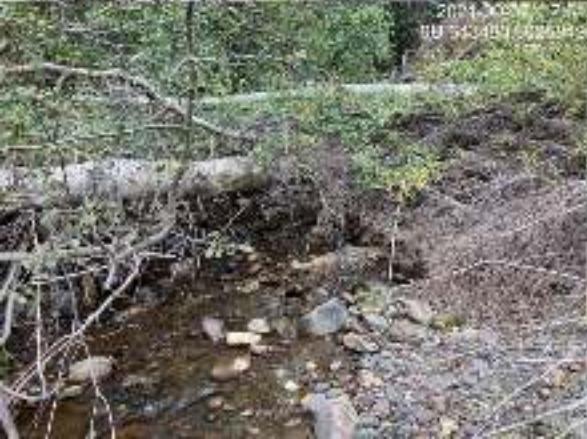
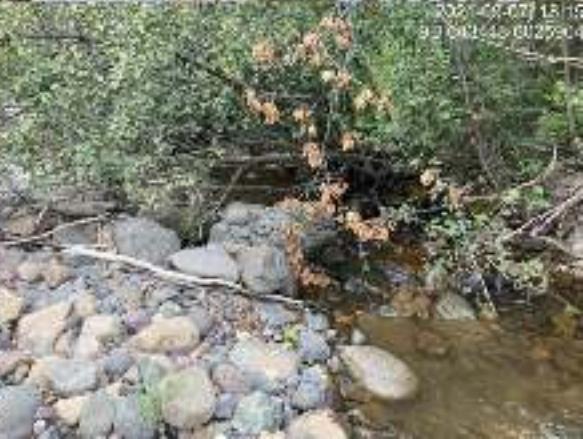
Photos: PSCIS ID 197962. From top left clockwise: Road/Site Card, Barrel, Outlet, Downstream, Upstream, Inlet.

Location and Stream Data		Crossing Characteristics	
Date	2021-09-07	Crossing Sub Type	Oval Culvert
PSCIS ID	197962	Diameter (m)	3.6
External ID	14000798	Length (m)	15
Crew	KP	Embedded	No
UTM Zone	9	Depth Embedded (m)	—
Easting	643460.3	Resemble Channel	No
Northing	6025890	Backwatered	No
Stream	Peacock Creek	Percent Backwatered	—
Road	Morice FSR	Fill Depth (m)	3.5
Road Tenure	FLNR DND 4656	Outlet Drop (m)	1.2
Channel Width (m)	9.3	Outlet Pool Depth (m)	0
Stream Slope (%)	4	Inlet Drop	No
Beaver Activity	No	Slope (%)	3.5
Habitat Value	High	Valley Fill	Deep Fill
Final score	39	Barrier Result	Barrier
Fix type	Replace with New Open Bottom Structure	Fix Span / Diameter	15.8

Location and Stream Data	•	Crossing Characteristics	-
Comments: Historic side channel for fish passage not functioning. 17:47

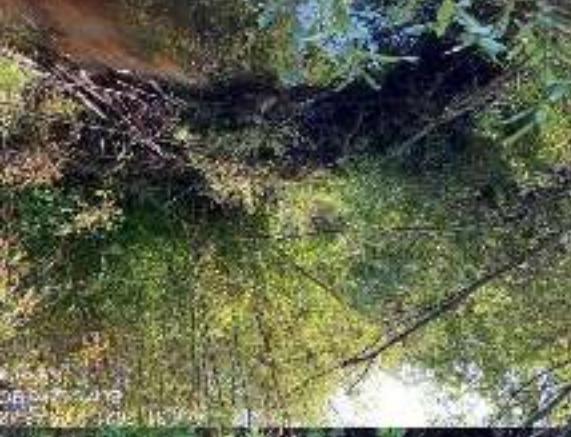
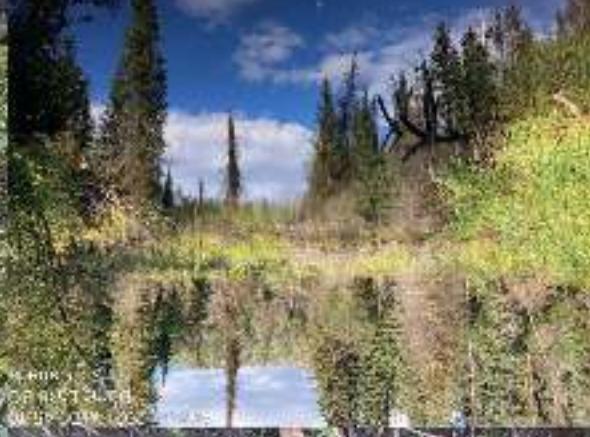
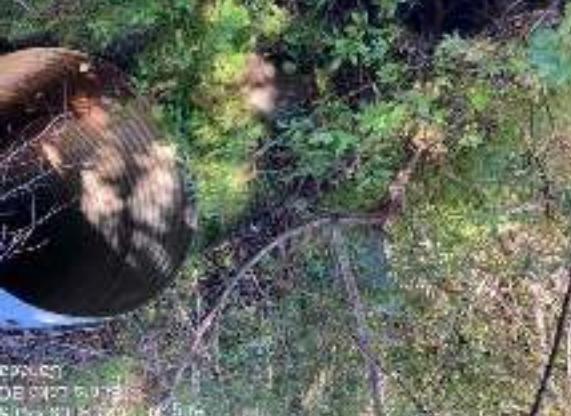
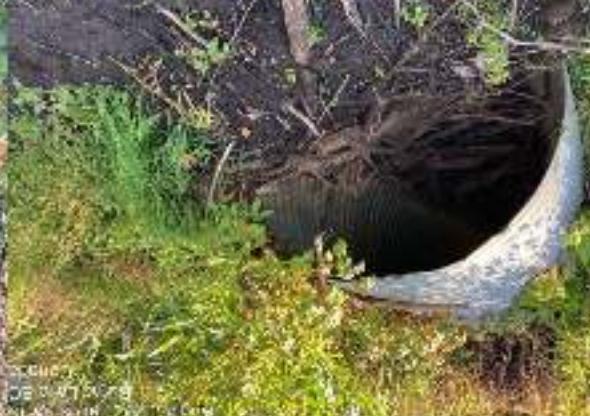
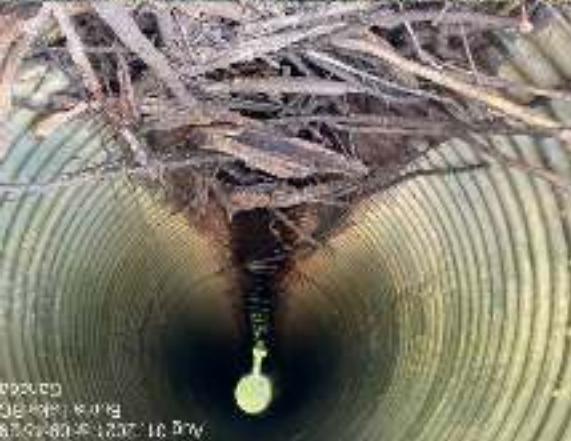
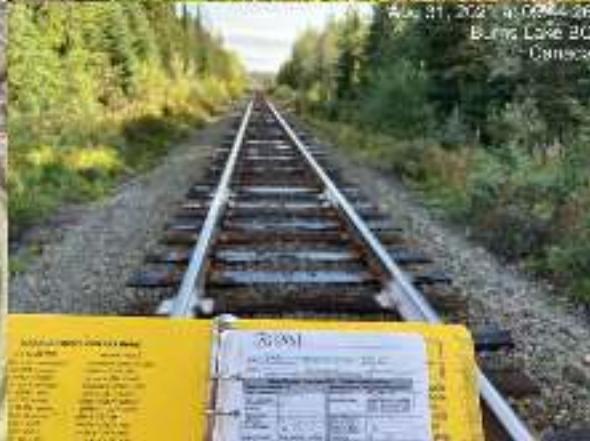
Photos: PSCIS ID 197963. From top left clockwise: Road/Site Card, Barrel, Outlet, Downstream, Upstream, Inlet.

Location and Stream Data	• Crossing Characteristics
<p>Comments: Beavers have clogged both inlets (double barrel). Significant sized marsh ~40m upstream with beaver dam 1.5 - 2m high on outlet of wetland. 9:40</p>

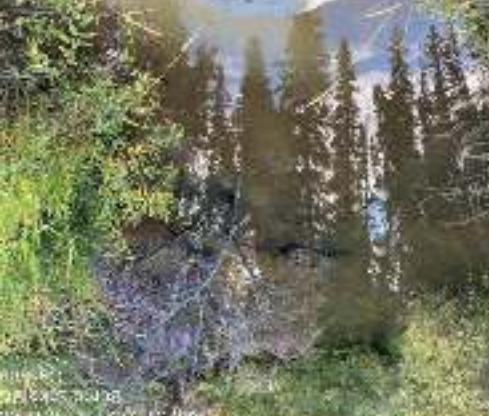
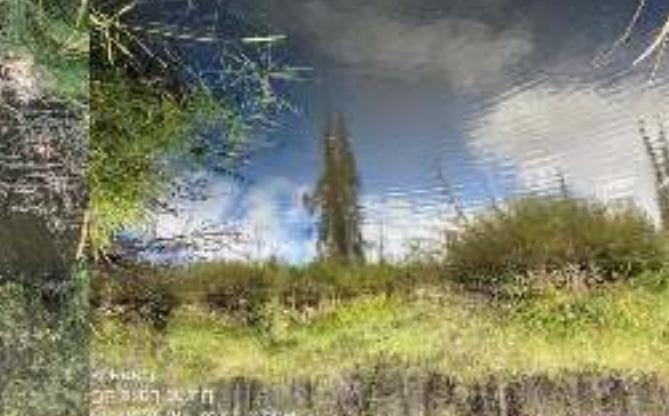
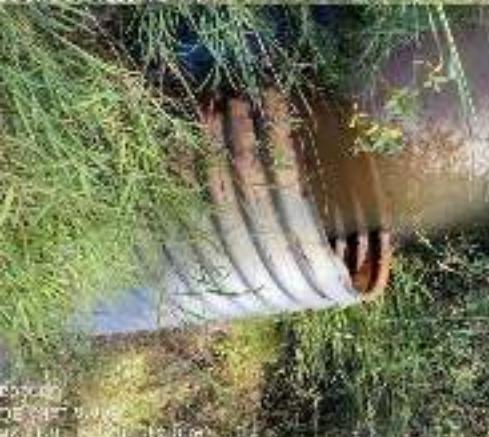
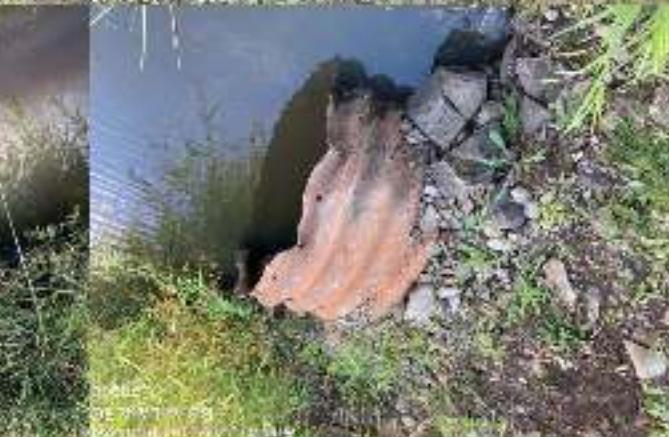
Photos: PSCIS ID 197964. From top left clockwise: Road/Site Card, Barrel, Outlet, Downstream, Upstream, Inlet.

Location and Stream Data	Crossing Characteristics
<p>Comments: Backwatered fully, appears fully passable. Fish sighted at outlet. Distance from water surface to top of culvert is 70cm. 9:58</p>

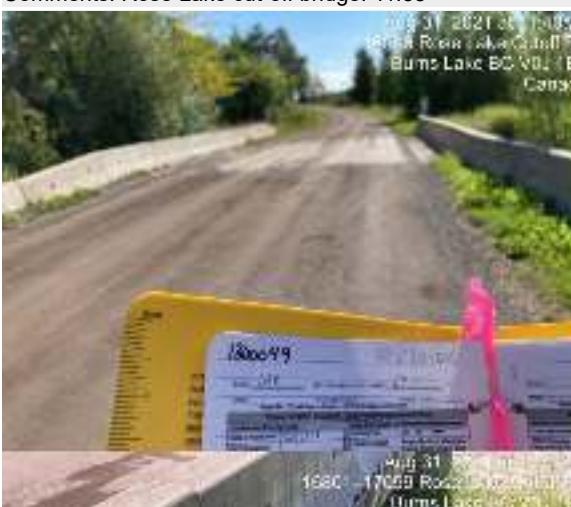
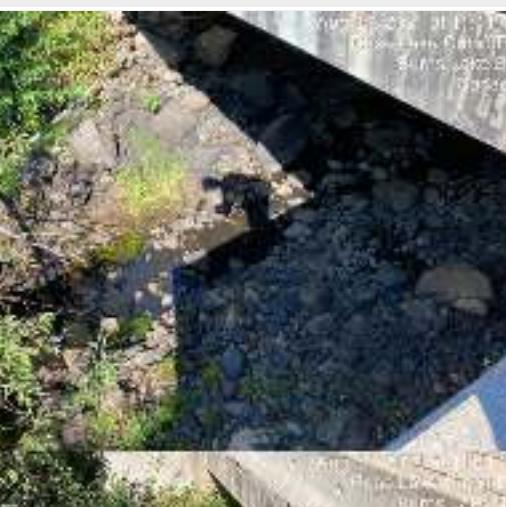
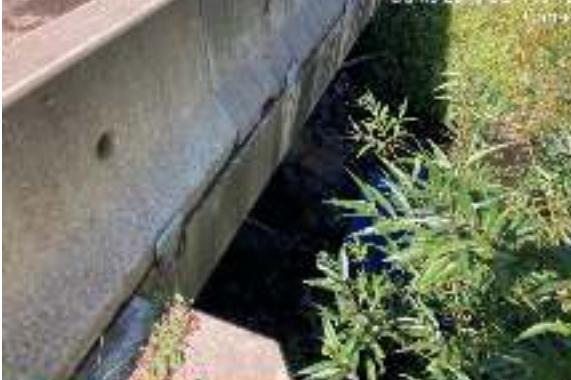
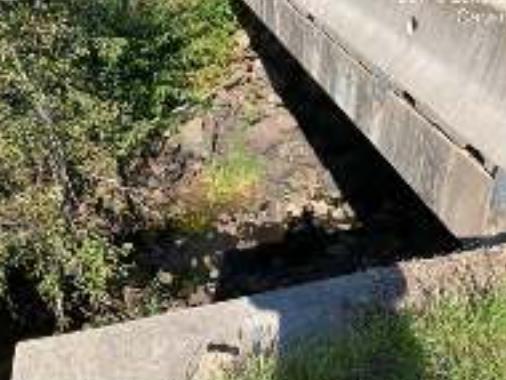
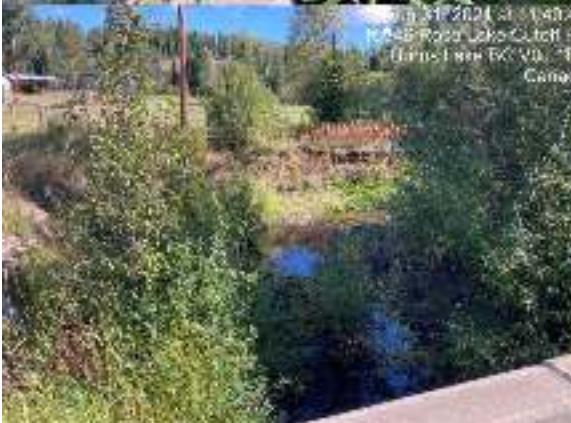
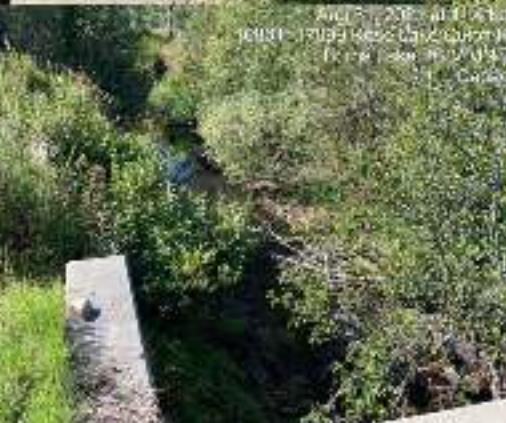
Photos: PSCIS ID 197966. From top left clockwise: Road/Site Card, Barrel, Outlet, Downstream, Upstream, Inlet.

Location and Stream Data	•	Crossing Characteristics	-
Comments: Rose Lake cut-off bridge. 11:38

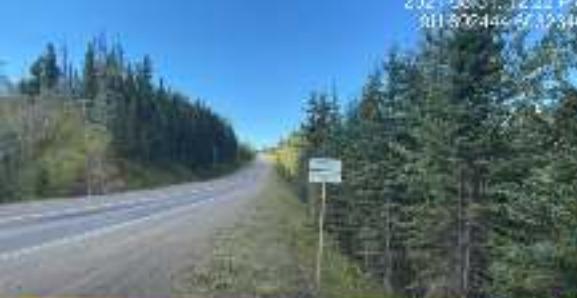
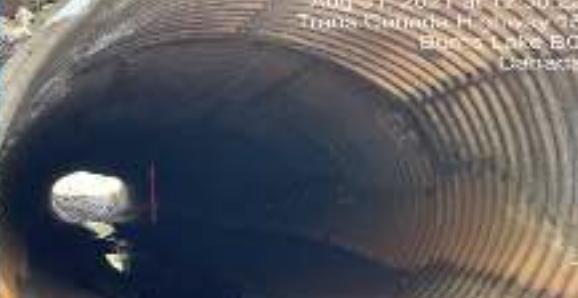
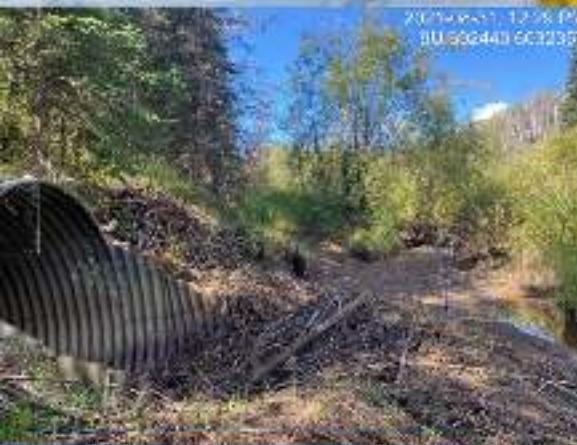
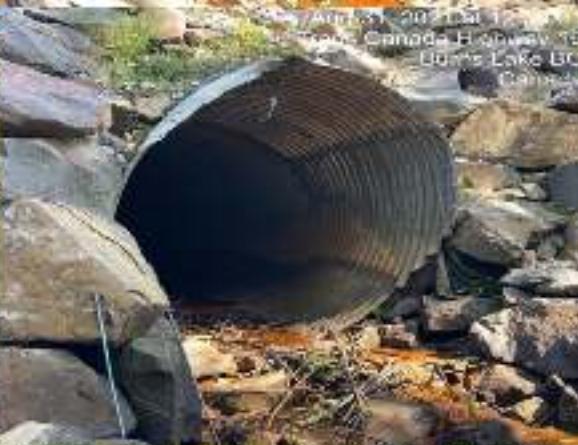
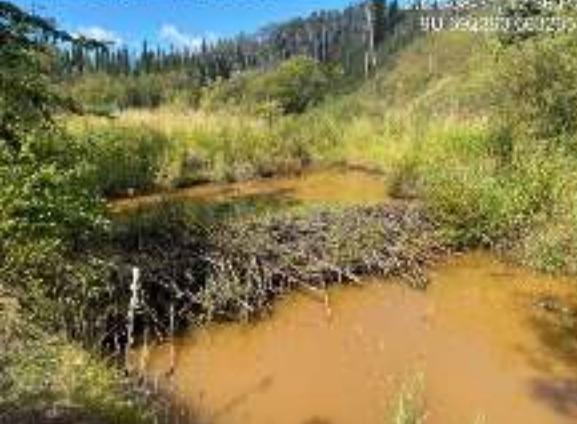
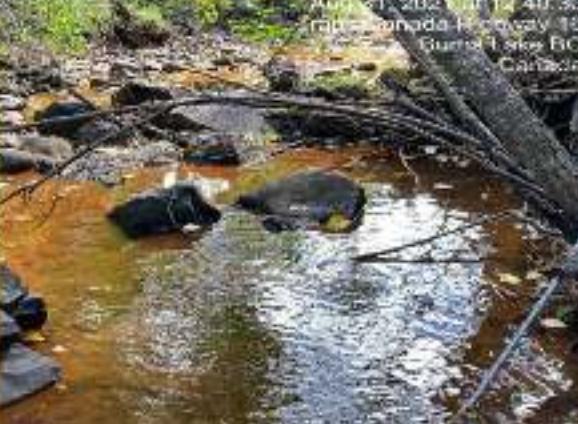
Photos: PSCIS ID 197967. From top left clockwise: Road/Site Card, Barrel, Outlet, Downstream, Upstream, Inlet.

Location and Stream Data		Crossing Characteristics –	
Date	2021-08-31	Crossing Sub Type	Round Culvert
PSCIS ID	197967	Diameter (m)	3
External ID	1800050	Length (m)	30
Crew	KP AI	Embedded	No
UTM Zone	9	Depth Embedded (m)	—
Easting	692434.6	Resemble Channel	No
Northing	6032331	Backwatered	No
Stream	Taman Creek	Percent Backwatered	—
Road	Highway 16	Fill Depth (m)	9.99
Road Tenure	Highway	Outlet Drop (m)	0
Channel Width (m)	5.3	Outlet Pool Depth (m)	0.4
Stream Slope (%)	1.7	Inlet Drop	Yes
Beaver Activity	Yes	Slope (%)	2.5
Habitat Value	Medium	Valley Fill	Deep Fill
Final score	27	Barrier Result	Barrier
Fix type	Replace with New Open Bottom Structure	Fix Span / Diameter	31

Location and Stream Data	• Crossing Characteristics
Comments: Beaver dam at inlet ~1.5m high. Rocks placed at outlet reducing drop to 0, rocks about long, and have staggered drop of 0.7m. 12:20

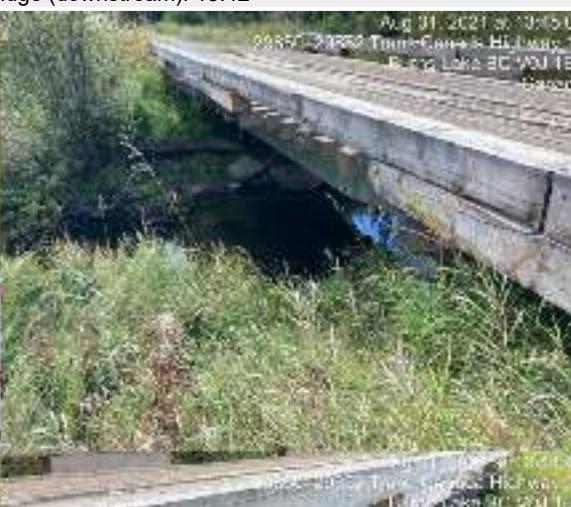
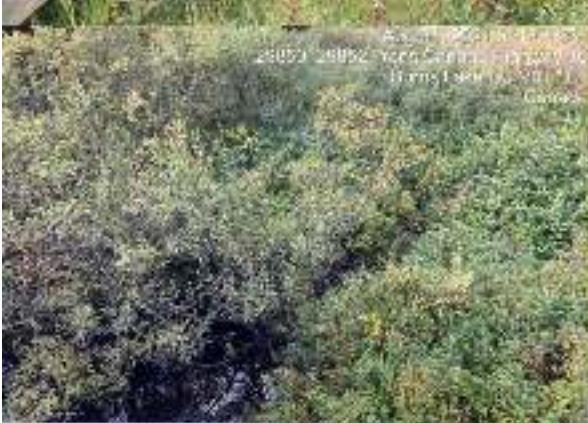
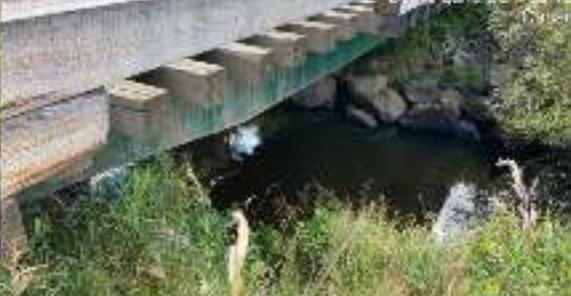
Photos: PSCIS ID 197968. From top left clockwise: Road/Site Card, Barrel, Outlet, Downstream, Upstream, Inlet.

Location and Stream Data	•	Crossing Characteristics	-
Comments: Observed water pump and intake hose below bridge (downstream). 13:42

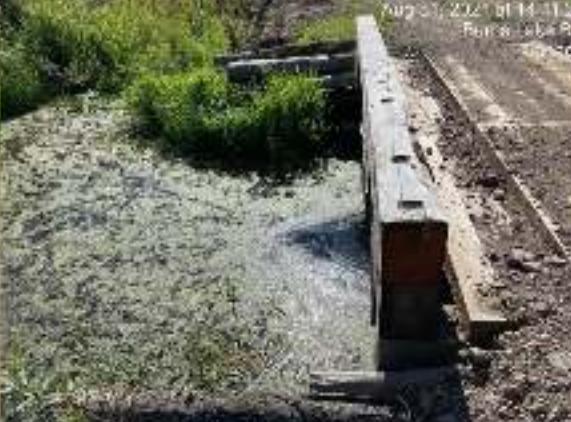
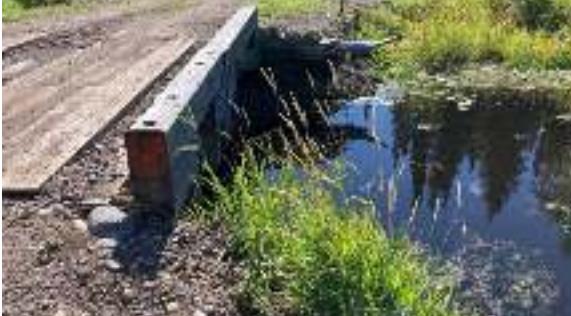
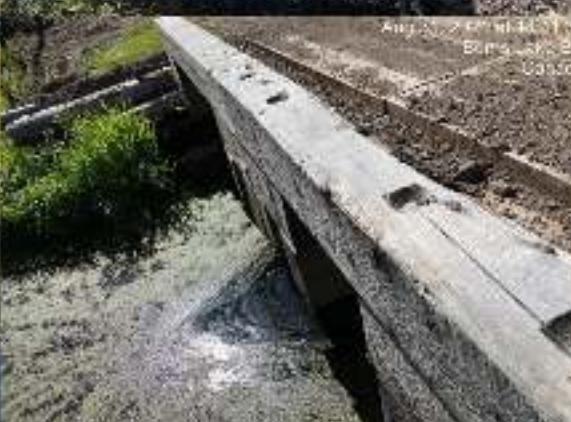
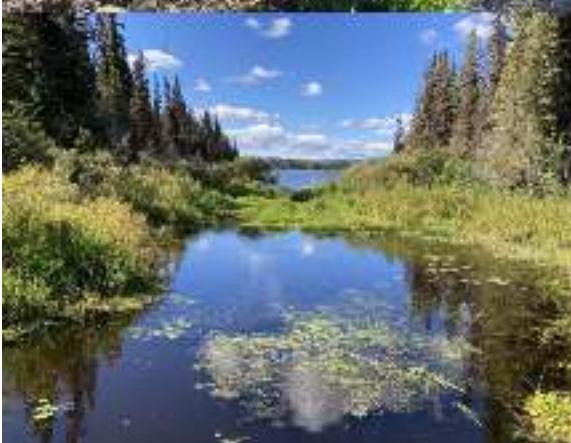
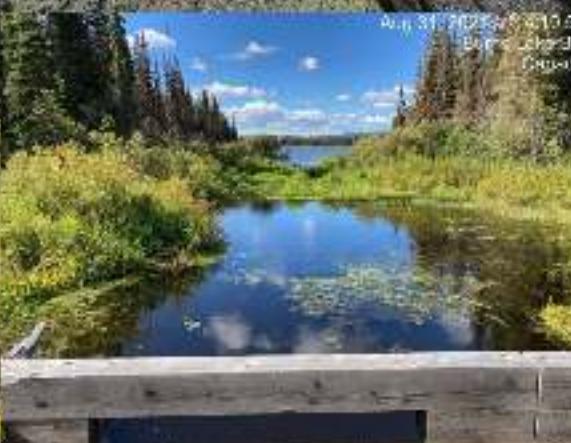
Photos: PSCIS ID 197969. From top left clockwise: Road/Site Card, Barrel, Outlet, Downstream, Upstream, Inlet.

Location and Stream Data	•	Crossing Characteristics	-
Comments: Bridge at outflow of Conrad Lake, on Bulkley River. Access via Mulligan road, then start of Raymond Road. 14:08
