Appendix - Phase 1 Fish Passage Assessment Data and Photos

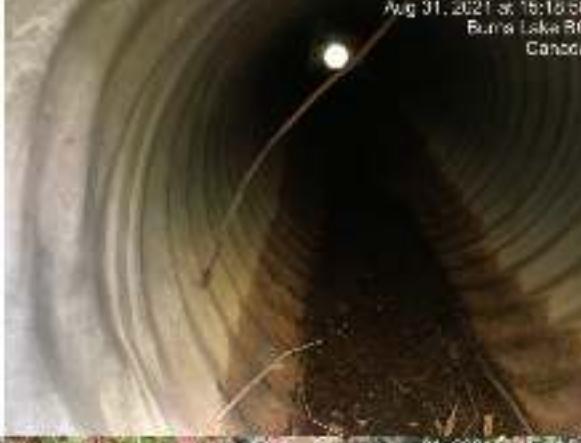
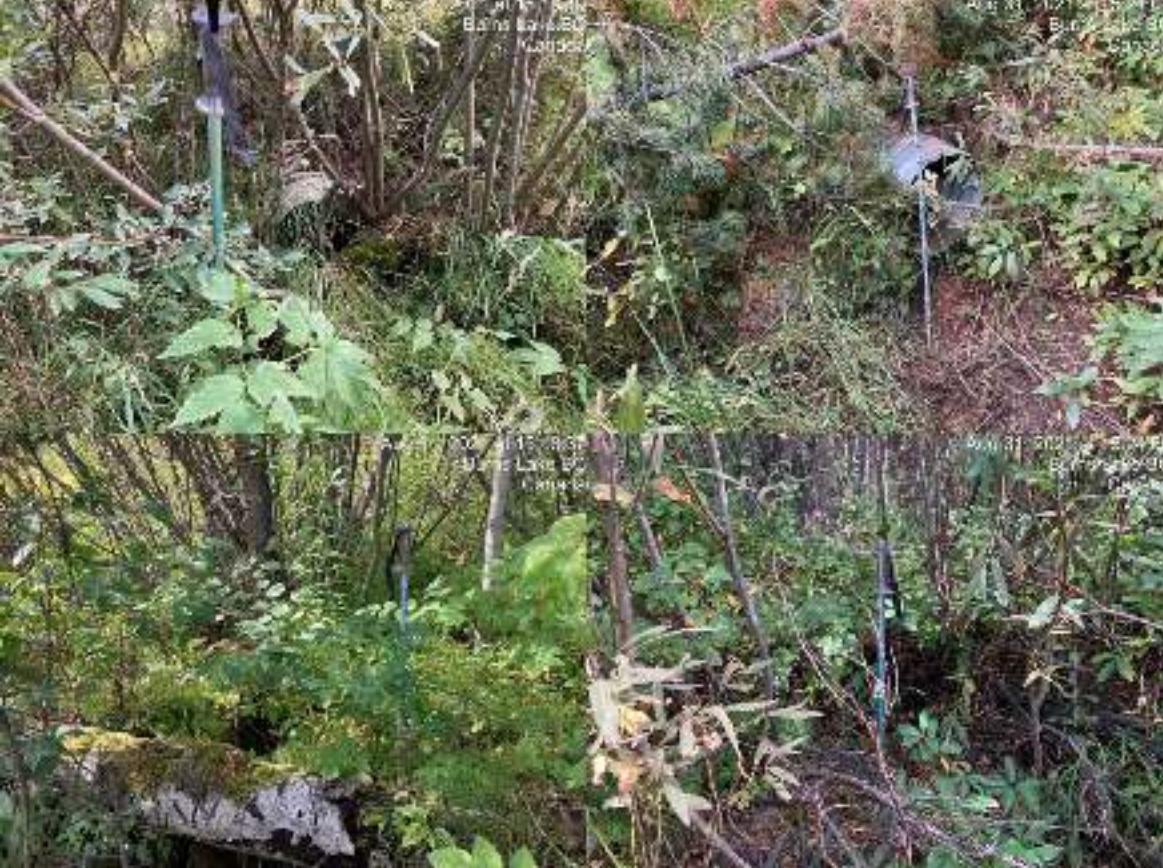
Photos: PSCIS ID 197970. From top left clockwise: Road/Site Card, Barrel, Outlet, Downstream, Upstream, Inlet.

Location and Stream Data		Crossing Characteristics	
Date	2021-08-31	Crossing Sub Type	Round Culvert
PSCIS ID	197970	Diameter (m)	0.6
External ID	1803813	Length (m)	13
Crew	KP	Embedded	No
UTM Zone	9	Depth Embedded (m)	—
Easting	684415	Resemble Channel	No
Northing	6035809	Backwatered	No
Stream	Tributary to Broman Lake	Percent Backwatered	—
Road	Broman Lake FSR	Fill Depth (m)	0.5
Road Tenure	Chinook Comfor R21201	Outlet Drop (m)	0.18
Channel Width (m)	0.7	Outlet Pool Depth (m)	0.5
Stream Slope (%)	5	Inlet Drop	Yes
Beaver Activity	No	Slope (%)	4
Habitat Value	Low	Valley Fill	Deep Fill
Final score	28	Barrier Result	Barrier
Fix type	Replace Structure with Streambed Simulation CBS	Fix Span / Diameter	3

Location and Stream Data	•	Crossing Characteristics	-
Comments: Just before km 3. Inlet embedded with vegetation ~0.2m. Channel dry, small amount of water in pool downstream. ~5cm. Hard to see channel downstream. 15:14

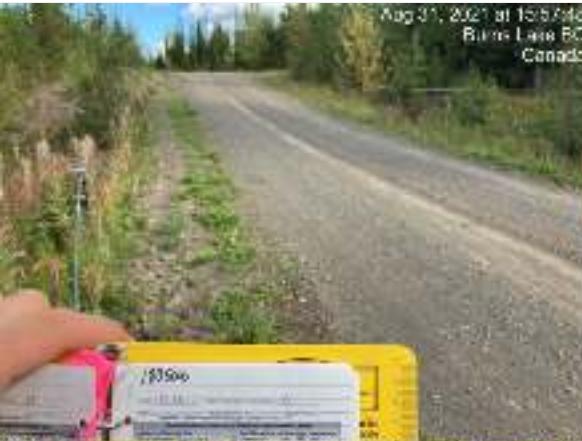
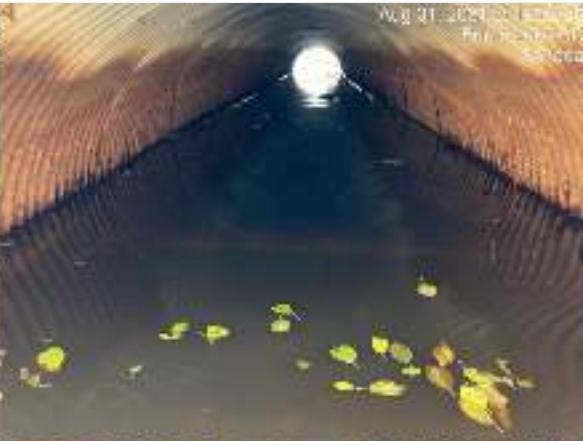
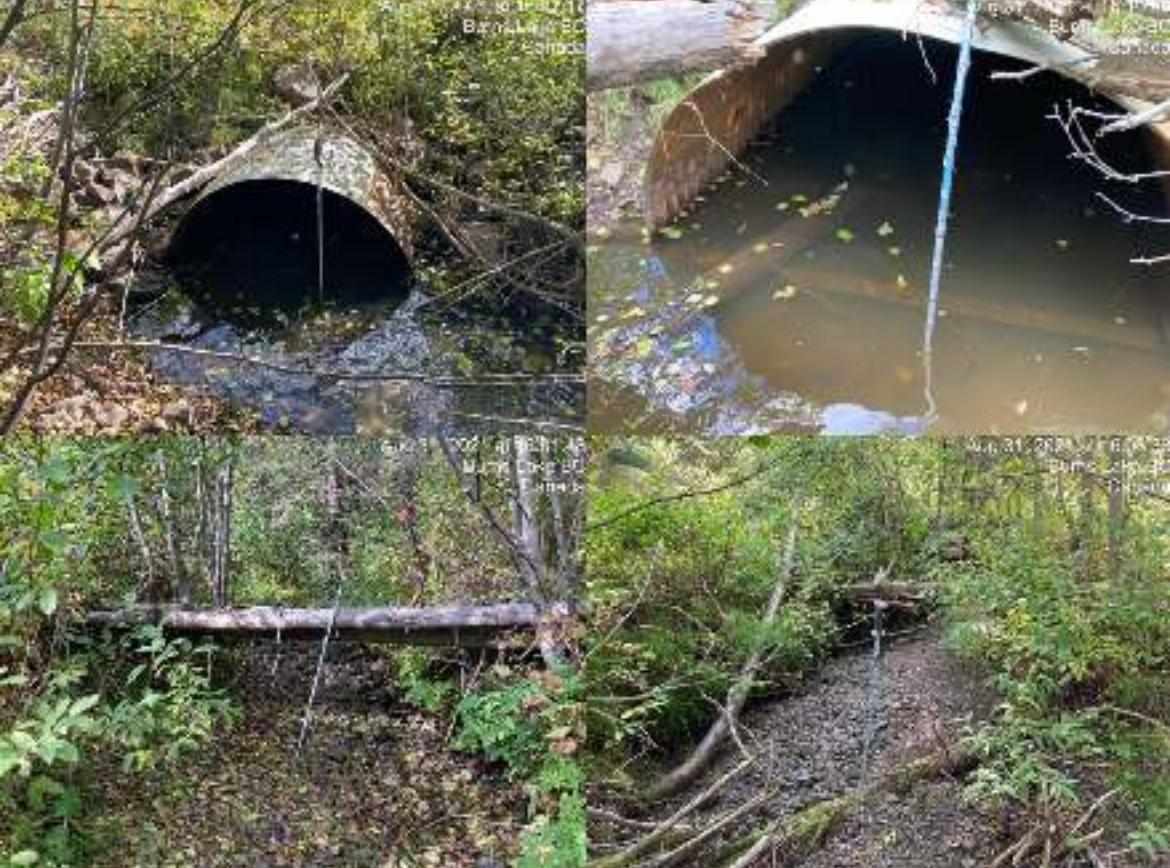
Photos: PSCIS ID 197971. From top left clockwise: Road/Site Card, Barrel, Outlet, Downstream, Upstream, Inlet.

Location and Stream Data	•	Crossing Characteristics	-
Comments: Channel mostly dry. Pool at inlet and another 30m upstream. Water depth 22cm at inlet. Pool at outlet and water throughout culvert. Open bottomed pipe arch. Looks very passable. Additional closed bottom structure higher and beside (river right), doesn't appear to get use. 15:56

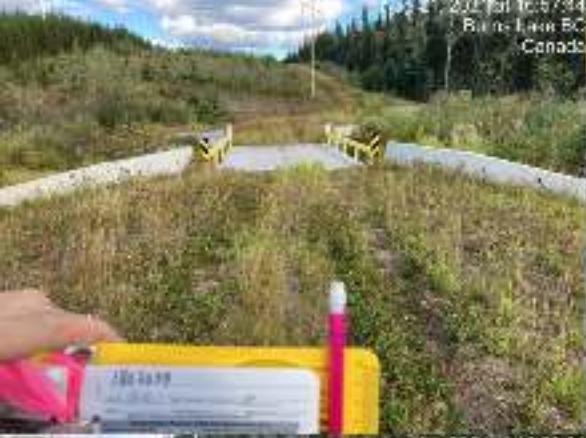
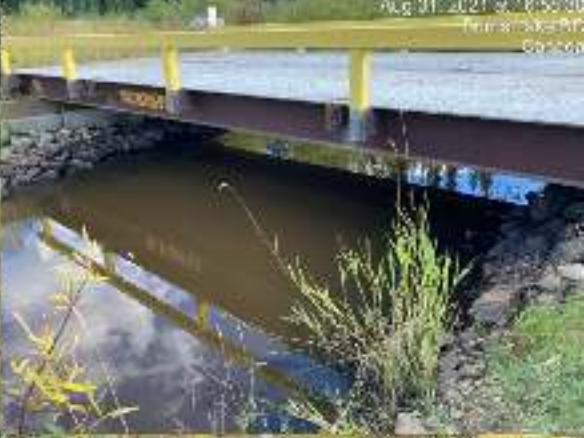
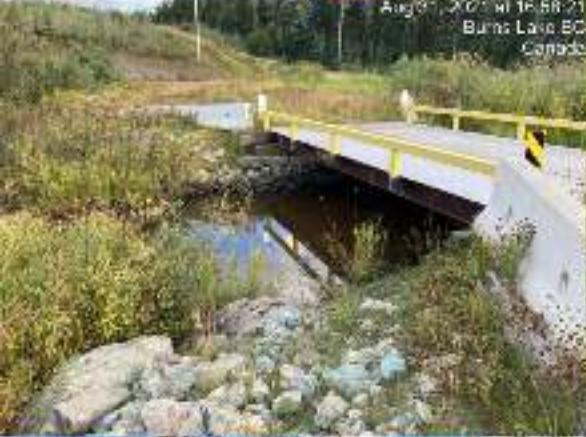
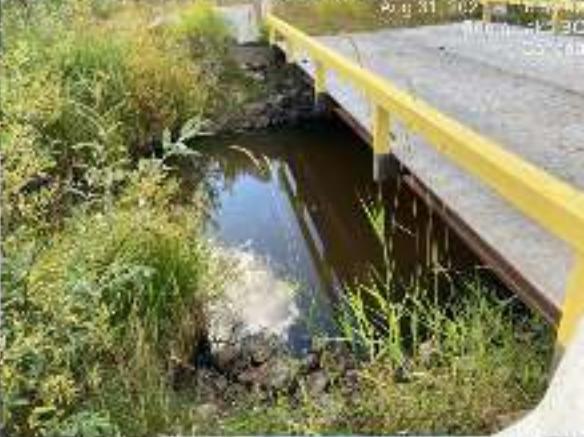
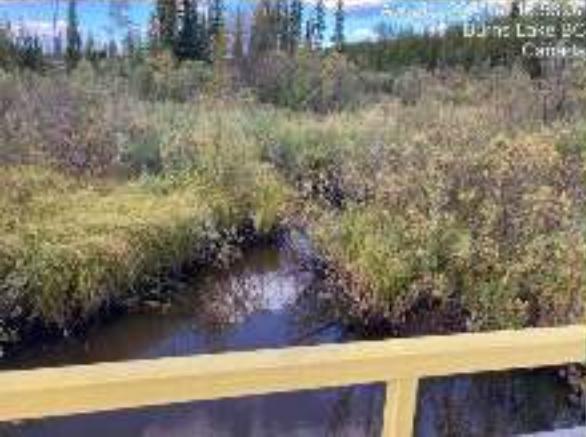
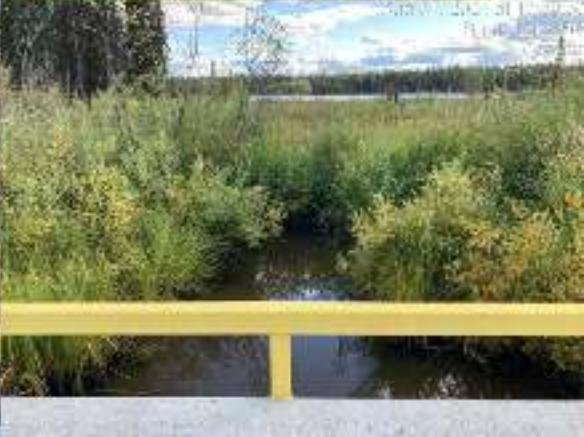
Photos: PSCIS ID 197974. From top left clockwise: Road/Site Card, Barrel, Outlet, Downstream, Upstream, Inlet.

Location and Stream Data		Crossing Characteristics –	
Date	2021-08-31	Crossing Sub Type	Round Culvert
PSCIS ID	197974	Diameter (m)	0.9
External ID	1800356	Length (m)	33
Crew	KP	Embedded	No
UTM Zone	9	Depth Embedded (m)	—
Easting	680383.2	Resemble Channel	No
Northing	6040056	Backwatered	No
Stream	Watson Creek	Percent Backwatered	—
Road	Highway 16	Fill Depth (m)	3
Road Tenure	Highway	Outlet Drop (m)	0.93
Channel Width (m)	2.2	Outlet Pool Depth (m)	0.92
Stream Slope (%)	2	Inlet Drop	No
Beaver Activity	No	Slope (%)	3
Habitat Value	Low	Valley Fill	Deep Fill
Final score	42	Barrier Result	Barrier
Fix type	Replace with New Open Bottom Structure	Fix Span / Diameter	10

Location and Stream Data	•	Crossing Characteristics	-
Comments: Channel dry. Small pool at inlet. Inlet perched above water 3cm and substrate 17cm. Channel upstream is not aligned with culvert at all. 17:24

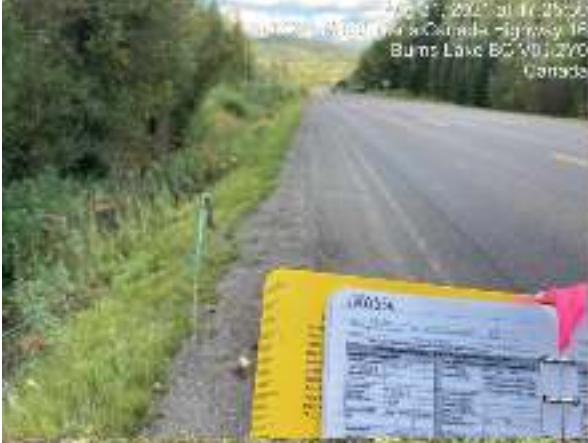
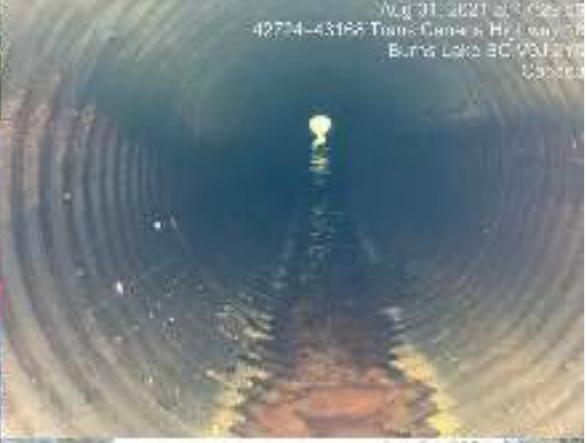
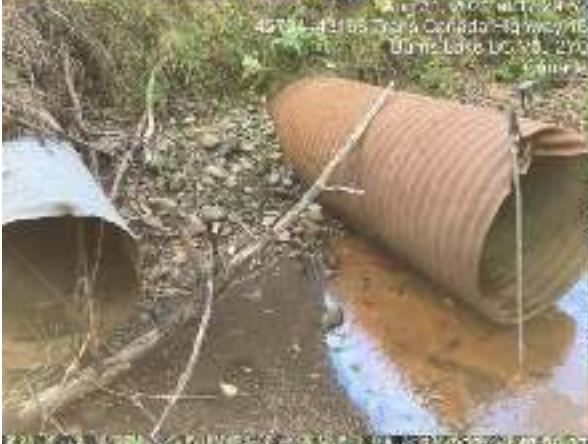
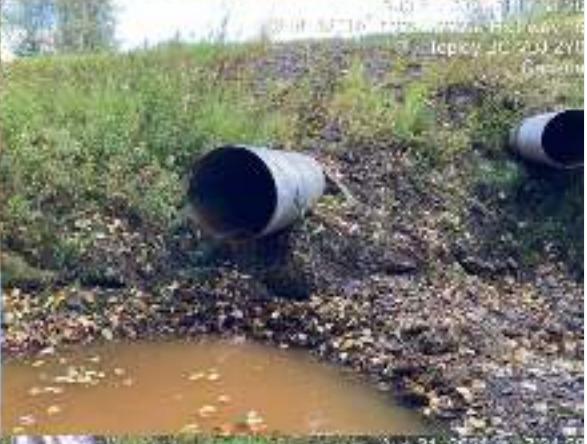
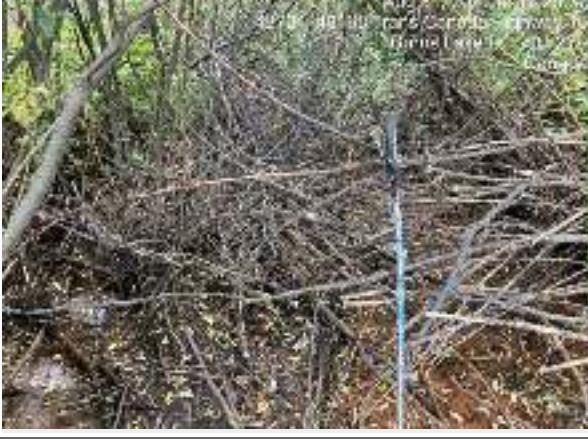
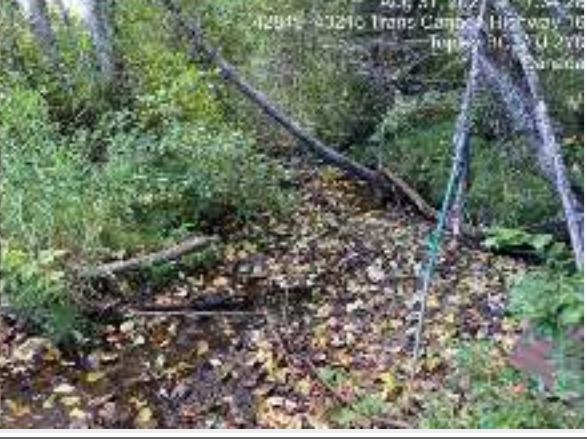
Photos: PSCIS ID 197975. From top left clockwise: Road/Site Card, Barrel, Outlet, Downstream, Upstream, Inlet.

Location and Stream Data		Crossing Characteristics –	
Date	2021-08-31	Crossing Sub Type	Round Culvert
PSCIS ID	197975	Diameter (m)	3
External ID	1801122	Length (m)	10
Crew	KP	Embedded	No
UTM Zone	9	Depth Embedded (m)	—
Easting	680832	Resemble Channel	No
Northing	6040045	Backwatered	No
Stream	Ailport Creek	Percent Backwatered	—
Road	Private Driveway	Fill Depth (m)	0.5
Road Tenure	Unclassified	Outlet Drop (m)	0.3
Channel Width (m)	6.5	Outlet Pool Depth (m)	1.45
Stream Slope (%)	3	Inlet Drop	No
Beaver Activity	No	Slope (%)	4
Habitat Value	Medium	Valley Fill	Deep Fill
Final score	36	Barrier Result	Barrier
Fix type	Replace with New Open Bottom Structure	Fix Span / Diameter	11.5

Location and Stream Data	•	Crossing Characteristics	-
Comments: Dredging upstream, channel width not natural. Signs of major flooding including wear on upstream sides of culvert. No riparian zone on river left upstream. Culvert 4% but has bend at last 2m outlet drop and outlet pool depth are estimates. This stream could use some restoration. 17:46

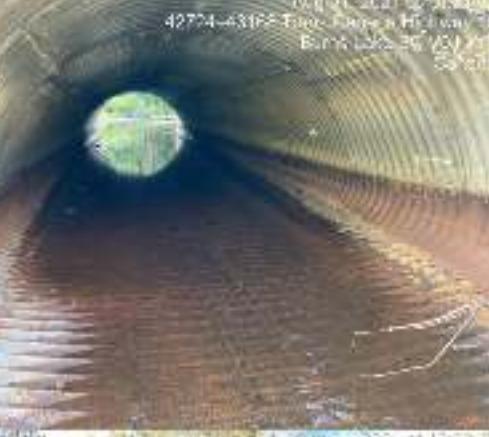
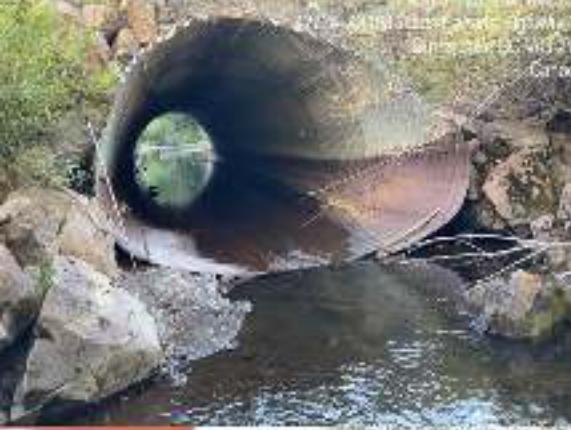
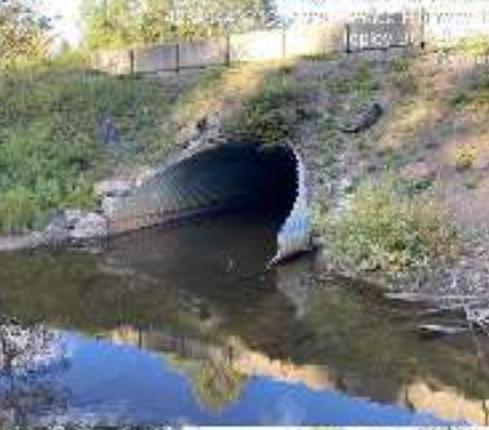
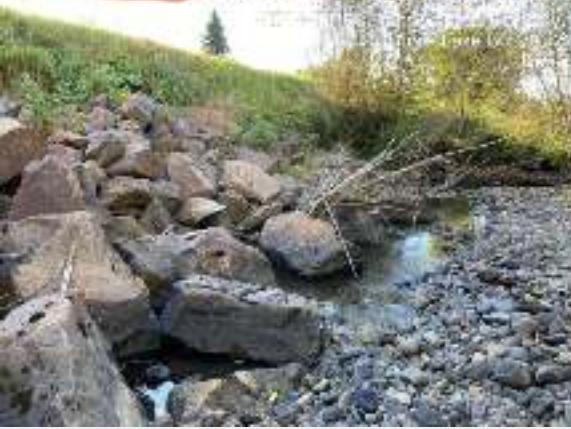
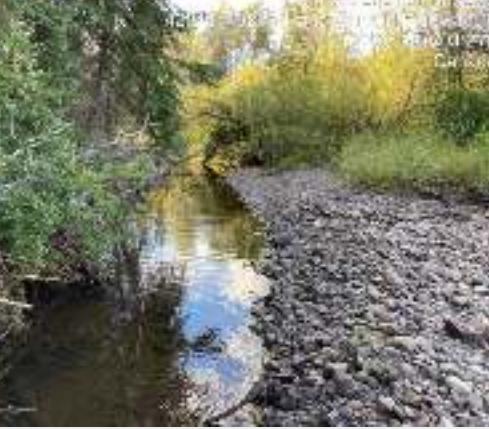
Photos: PSCIS ID 197976. From top left clockwise: Road/Site Card, Barrel, Outlet, Downstream, Upstream, Inlet.

Location and Stream Data	•	Crossing Characteristics	-
<p>Comments: Fish sighted upstream, not aligned with stream, channel runs into rip rap berm of highway then over to closed bottom structure. Pool (40cn) on upstream inlet. Fish sighted in downstream pool. 18:16</p>

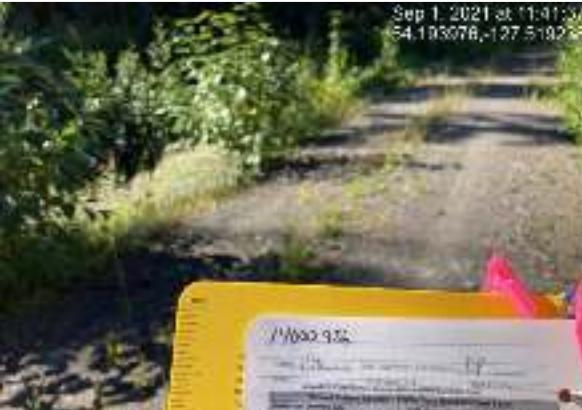
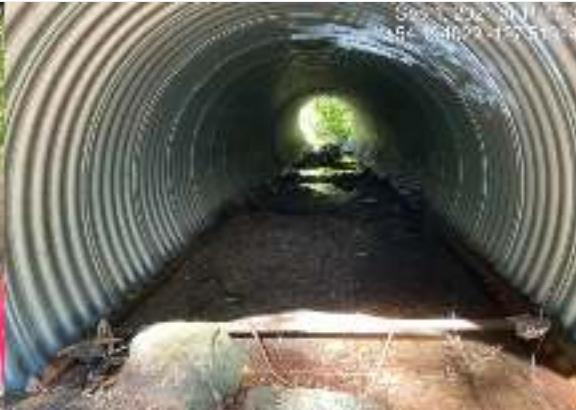
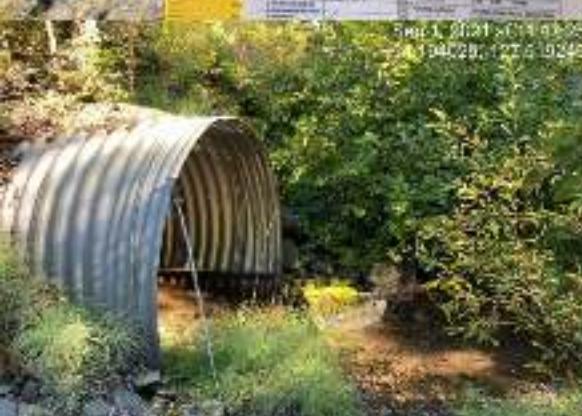
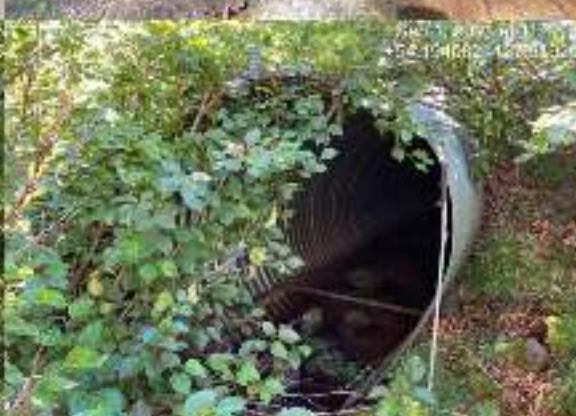
Photos: PSCIS ID 197980. From top left clockwise: Road/Site Card, Barrel, Outlet, Downstream, Upstream, Inlet.

Location and Stream Data		•	Crossing Characteristics	-
Date	2021-09-01		Crossing Sub Type	Round Culvert
PSCIS ID	197980		Diameter (m)	2
External ID	14000956		Length (m)	23
Crew	KP		Embedded	Yes
UTM Zone	9		Depth Embedded (m)	0.3
Easting	596610.5		Resemble Channel	Yes
Northing	6006123		Backwatered	No
Stream	Tributary to Gosnell Creek		Percent Backwatered	-
Road	Crystal Creek FSR		Fill Depth (m)	2.5
Road Tenure	FLNR DND 9785		Outlet Drop (m)	0
Channel Width (m)	0.9		Outlet Pool Depth (m)	0.1
Stream Slope (%)	6		Inlet Drop	No
Beaver Activity	No		Slope (%)	2
Habitat Value	Medium		Valley Fill	Deep Fill
Final score	13		Barrier Result	Passable
Fix type	-		Fix Span / Diameter	-

Location and Stream Data	Crossing Characteristics
Comments: Appears passable. Nice little stream with plenty of gravel. 11:38

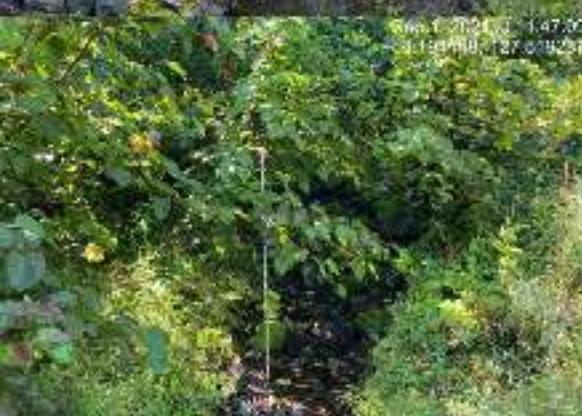
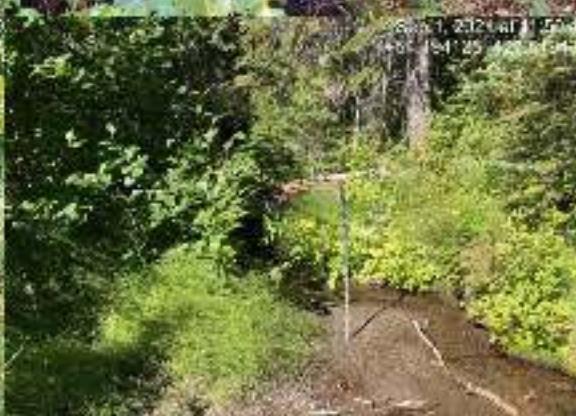
Photos: PSCIS ID 197981. From top left clockwise: Road/Site Card, Barrel, Outlet, Downstream, Upstream, Inlet.

Location and Stream Data	•	Crossing Characteristics	-
Comments: Appears passable. Similar to previous but bigger stream. Nice gravels on both sides. 11:55

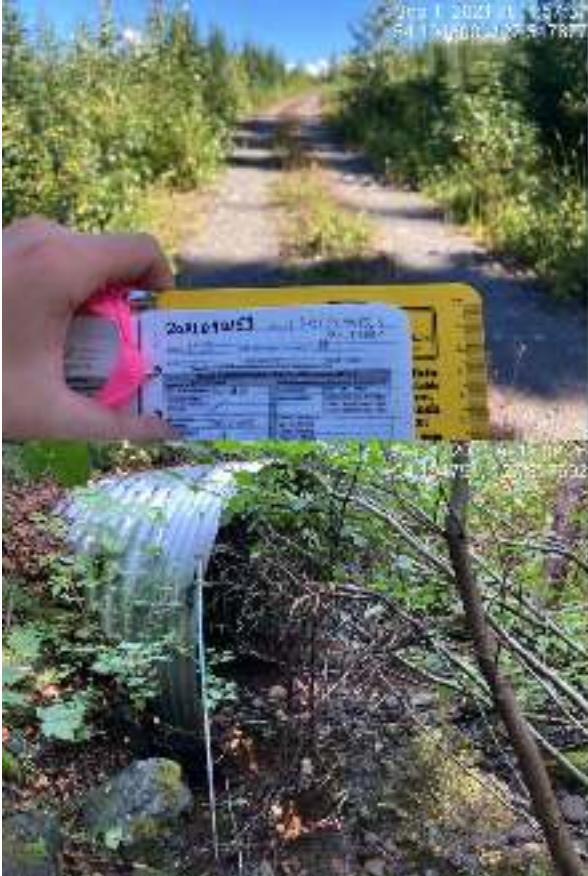
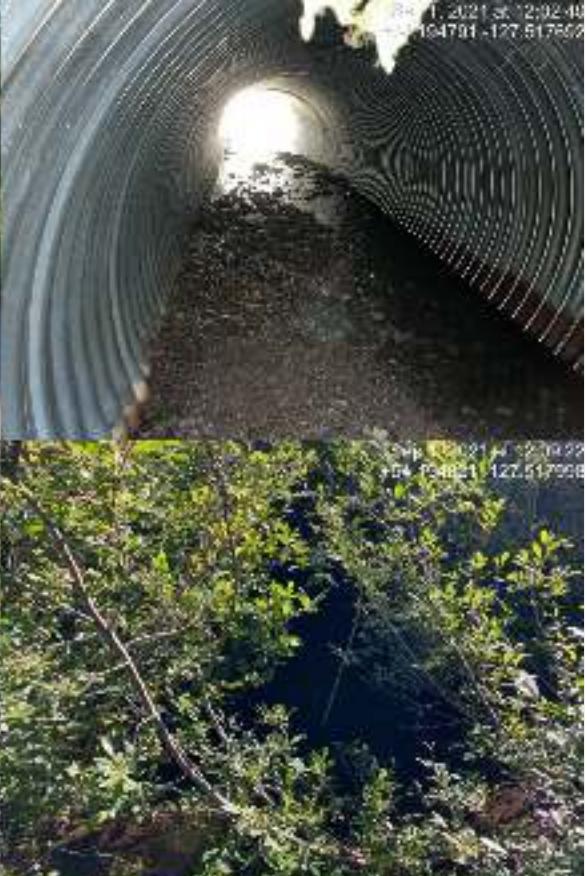
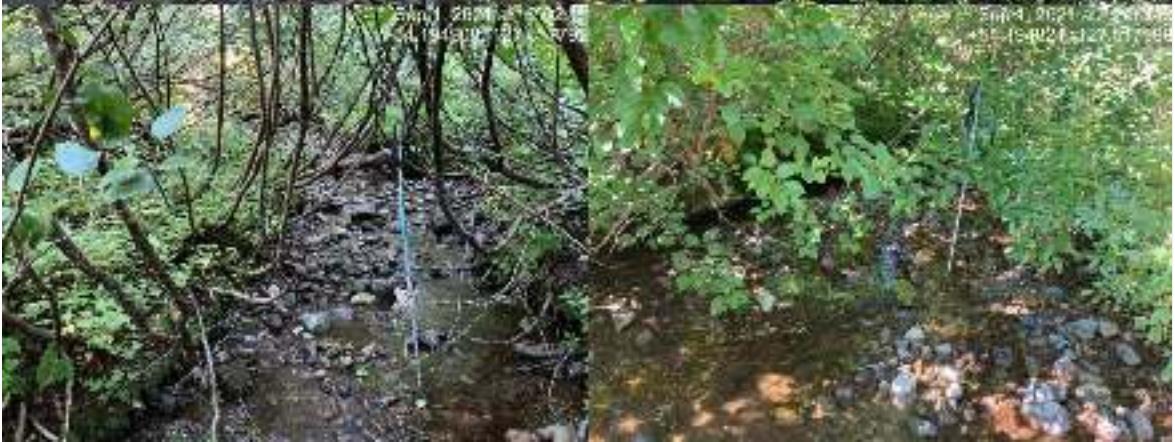
Photos: PSCIS ID 197982. From top left clockwise: Road/Site Card, Barrel, Outlet, Downstream, Upstream, Inlet.

Location and Stream Data		Crossing Characteristics –	
Date	2021-09-01	Crossing Sub Type	Round Culvert
PSCIS ID	197982	Diameter (m)	1.8
External ID	14000941	Length (m)	24
Crew	KP	Embedded	Yes
UTM Zone	9	Depth Embedded (m)	0.3
Easting	598157.4	Resemble Channel	Yes
Northing	6006329	Backwatered	Yes
Stream	Tributary to Gosnell Creek	Percent Backwatered	25
Road	Crystal Creek FSR	Fill Depth (m)	1
Road Tenure	FLNR DND 9785	Outlet Drop (m)	0
Channel Width (m)	2.2	Outlet Pool Depth (m)	0.2
Stream Slope (%)	4	Inlet Drop	No
Beaver Activity	No	Slope (%)	3.5
Habitat Value	Medium	Valley Fill	Deep Fill
Final score	21	Barrier Result	Barrier
Fix type	Replace with New Open Bottom Structure	Fix Span / Diameter	10

Location and Stream Data	Crossing Characteristics
<p>Comments: Only left (facing downstream) is embedded, right one backwatered 25%. Nice gravel on upstream and downstream side. 12:23</p>

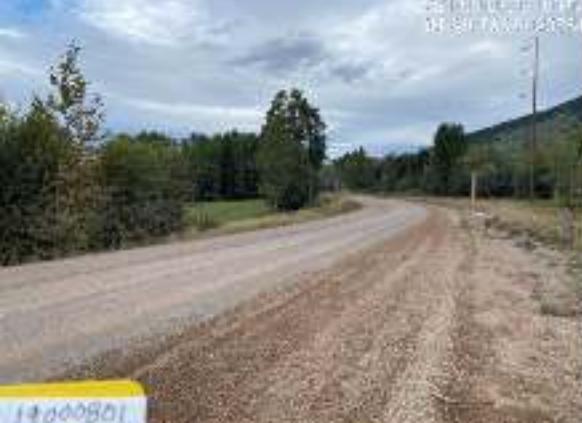
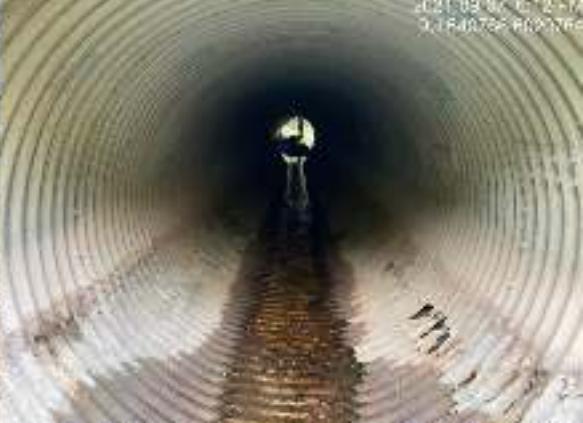
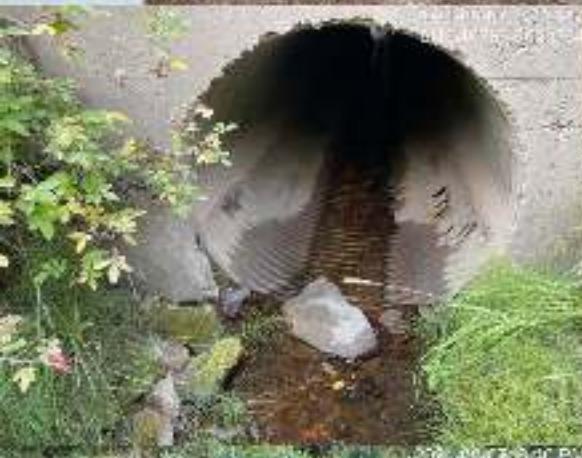
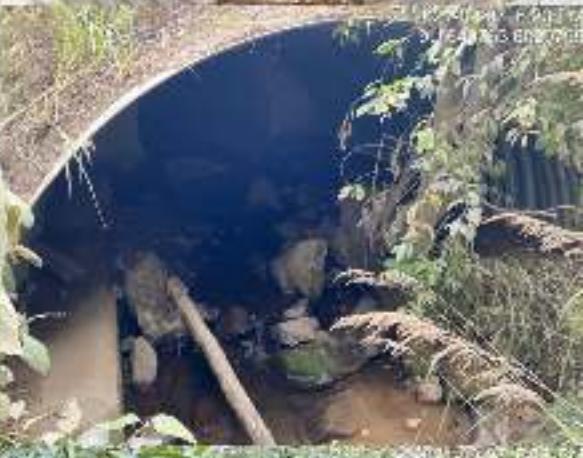
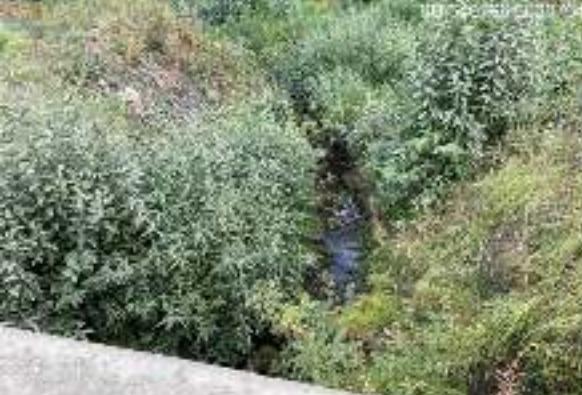
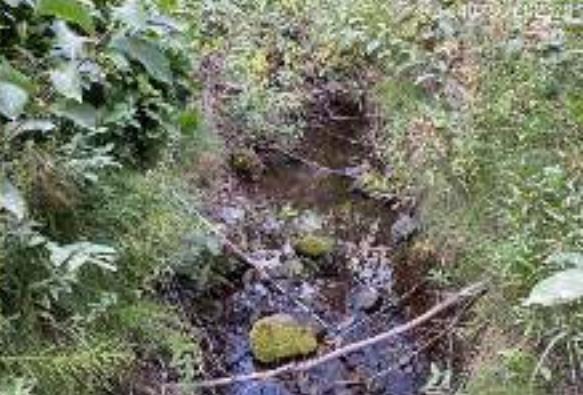
Photos: PSCIS ID 197989. From top left clockwise: Road/Site Card, Barrel, Outlet, Downstream, Upstream, Inlet.

Location and Stream Data		Crossing Characteristics –	
Date	2021-09-07	Crossing Sub Type	Round Culvert
PSCIS ID	197989	Diameter (m)	1.35
External ID	14000801	Length (m)	19
Crew	AI	Embedded	No
UTM Zone	9	Depth Embedded (m)	–
Easting	640778	Resemble Channel	No
Northing	6020795	Backwatered	No
Stream	Tributary to Morice River	Percent Backwatered	–
Road	Morice FSR	Fill Depth (m)	2
Road Tenure	FLNR DND 4656	Outlet Drop (m)	0
Channel Width (m)	2.2	Outlet Pool Depth (m)	0
Stream Slope (%)	1.5	Inlet Drop	Yes
Beaver Activity	No	Slope (%)	3
Habitat Value	Medium	Valley Fill	Deep Fill
Final score	29	Barrier Result	Barrier
Fix type	Replace with New Open Bottom Structure	Fix Span / Diameter	10

Location and Stream Data	•	Crossing Characteristics	-
Comments: Concrete structure. Many 30-40mm fry. 2.5m open bottom structure end or pipe. 18:08

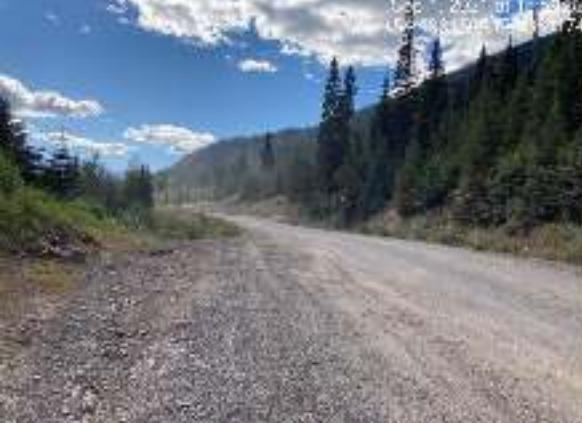
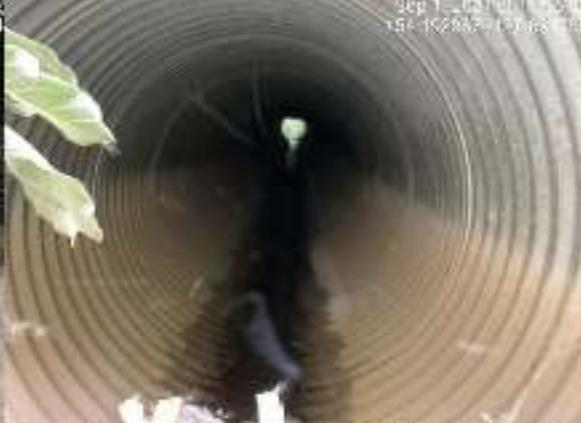
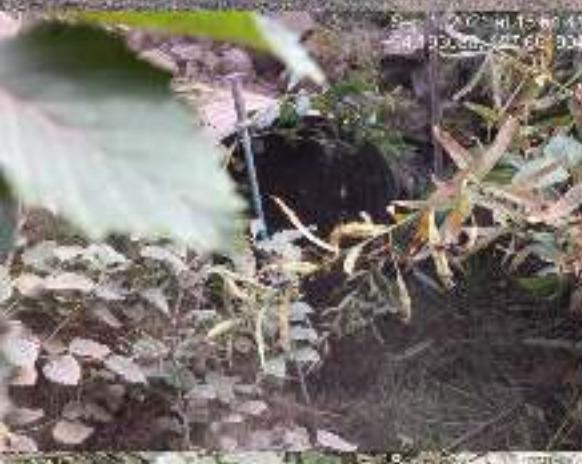
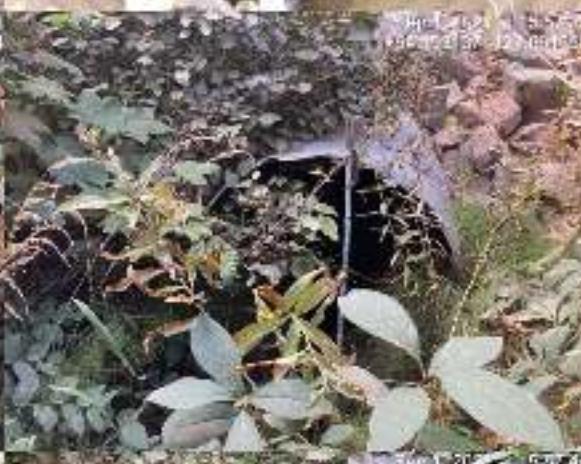
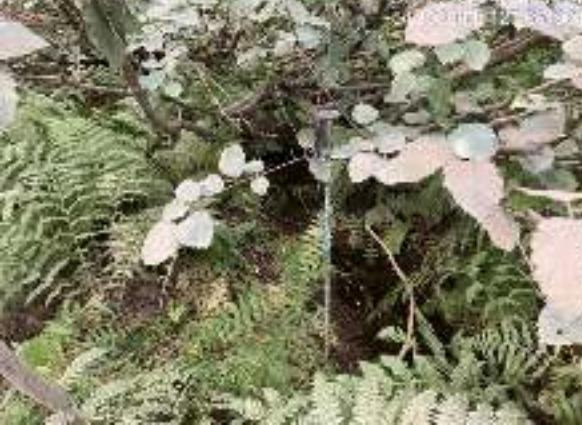
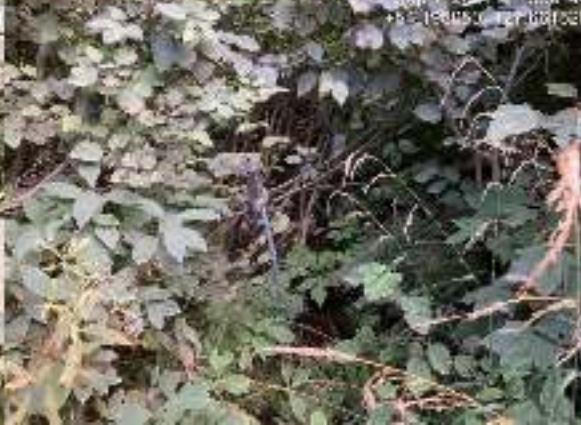
Photos: PSCIS ID 197992. From top left clockwise: Road/Site Card, Barrel, Outlet, Downstream, Upstream, Inlet.

Location and Stream Data	•	Crossing Characteristics	-
Comments: Very close to previous. Very small channelled stream, trickling. 15:51

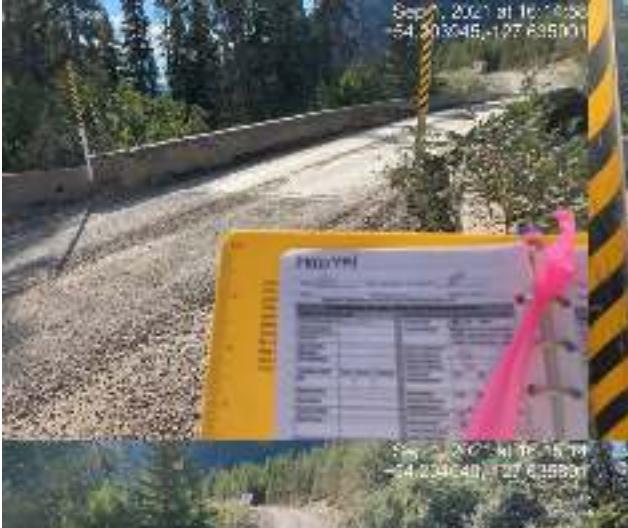
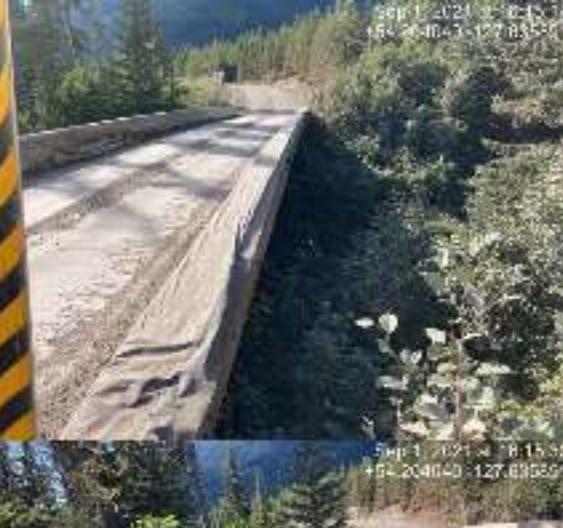
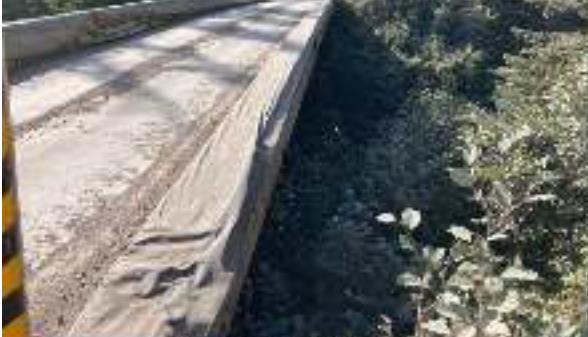
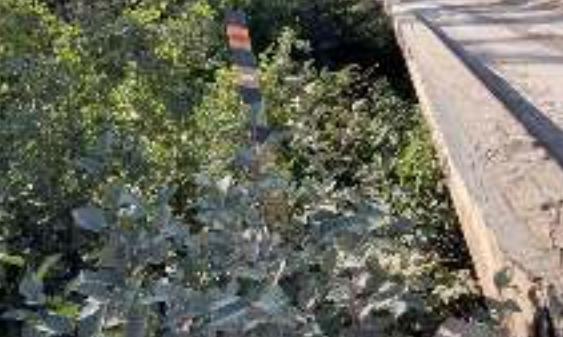
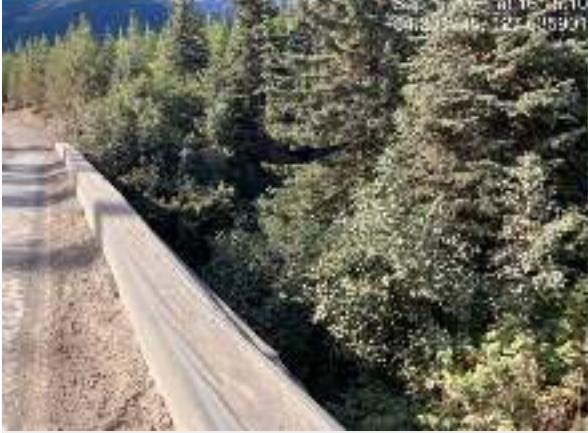
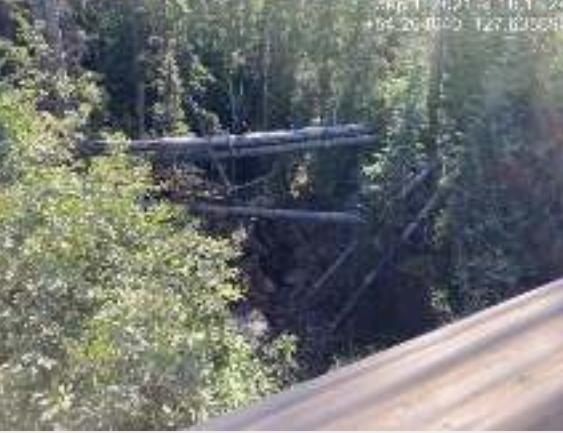
Photos: PSCIS ID 197993. From top left clockwise: Road/Site Card, Barrel, Outlet, Downstream, Upstream, Inlet.

Location and Stream Data		•	Crossing Characteristics	-
Date	2021-09-01		Crossing Sub Type	Bridge
PSCIS ID	197993		Diameter (m)	28
External ID	14000494		Length (m)	7
Crew	KP		Embedded	-
UTM Zone	9		Depth Embedded (m)	-
Easting	588957.4		Resemble Channel	-
Northing	6007081		Backwatered	-
Stream	Tributary to Gosnell Creek		Percent Backwatered	-
Road	6 Road		Fill Depth (m)	-
Road Tenure	Canfor R07593		Outlet Drop (m)	-
Channel Width (m)	-		Outlet Pool Depth (m)	-
Stream Slope (%)	-		Inlet Drop	-
Beaver Activity	-		Slope (%)	-
Habitat Value	-		Valley Fill	-
Final score	0		Barrier Result	Passable
Fix type	-		Fix Span / Diameter	-

Location and Stream Data	•	Crossing Characteristics	-
Comments: Bridge. 16:13

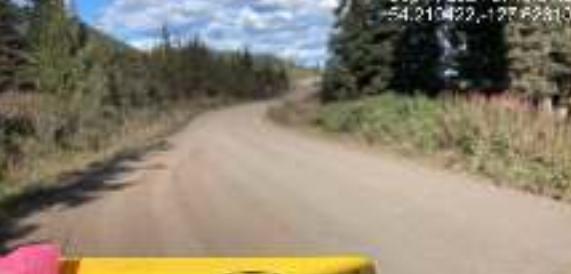
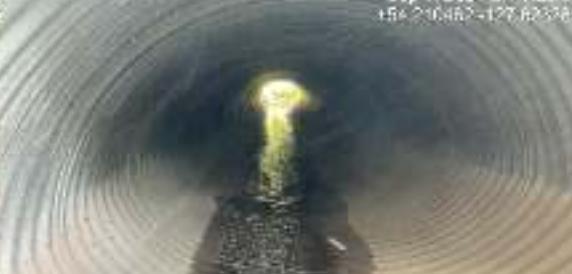
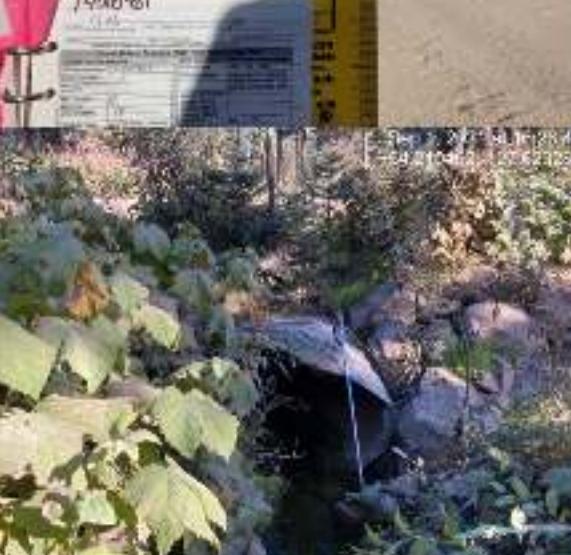
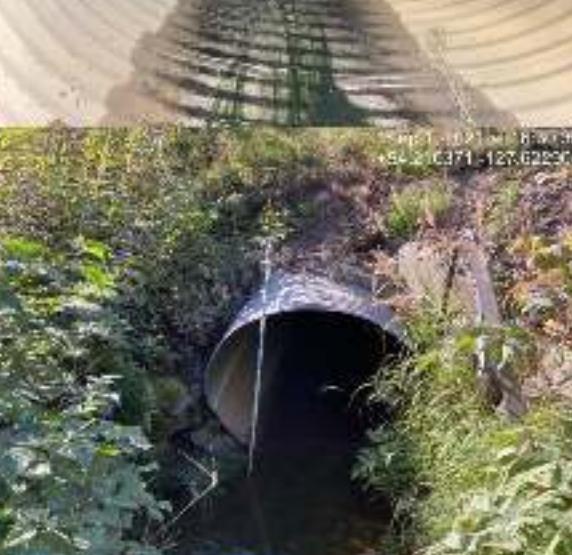
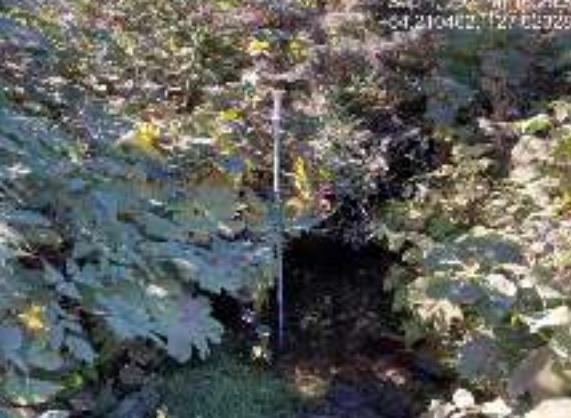
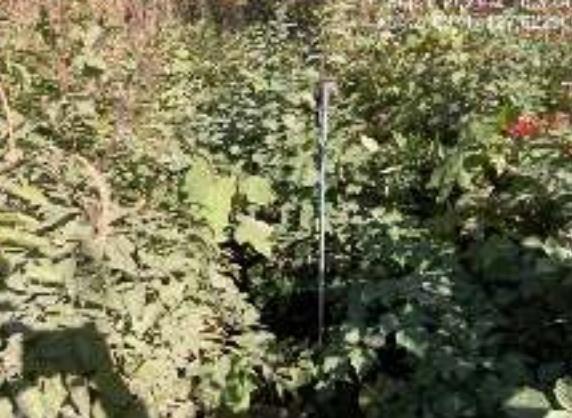
Photos: PSCIS ID 197994. From top left clockwise: Road/Site Card, Barrel, Outlet, Downstream, Upstream, Inlet.

Location and Stream Data		Crossing Characteristics	
Date	2021-09-01	Crossing Sub Type	Round Culvert
PSCIS ID	197994	Diameter (m)	0.9
External ID	14000481	Length (m)	16
Crew	KP	Embedded	No
UTM Zone	9	Depth Embedded (m)	–
Easting	589783.6	Resemble Channel	No
Northing	6007798	Backwatered	Yes
Stream	Tributary to Gosnell Creek	Percent Backwatered	10
Road	6 Road	Fill Depth (m)	1
Road Tenure	Canfor R07593	Outlet Drop (m)	0
Channel Width (m)	1.1	Outlet Pool Depth (m)	0.15
Stream Slope (%)	6	Inlet Drop	No
Beaver Activity	No	Slope (%)	5
Habitat Value	Medium	Valley Fill	Deep Fill
Final score	26	Barrier Result	Barrier
Fix type	Replace Structure with Streambed Simulation CBS	Fix Span / Diameter	3

Location and Stream Data	Crossing Characteristics
Comments: Very recently logged upstream and downstream. 16:23

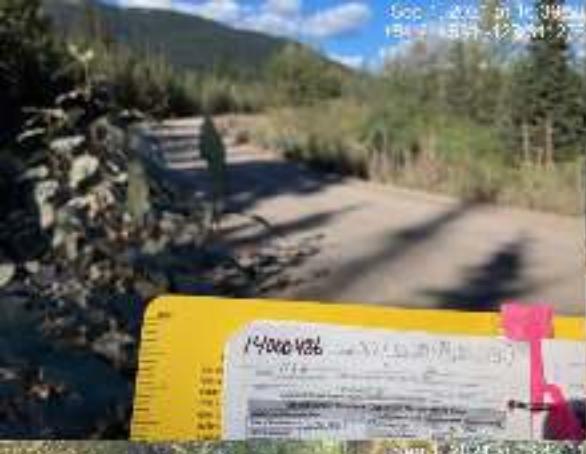
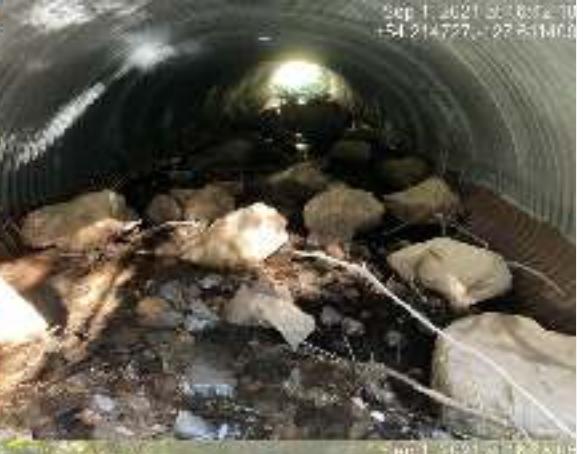
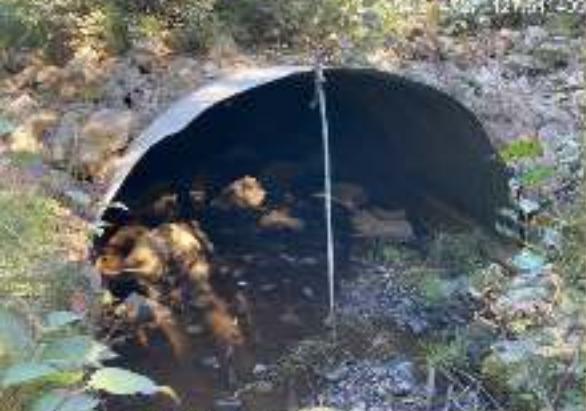
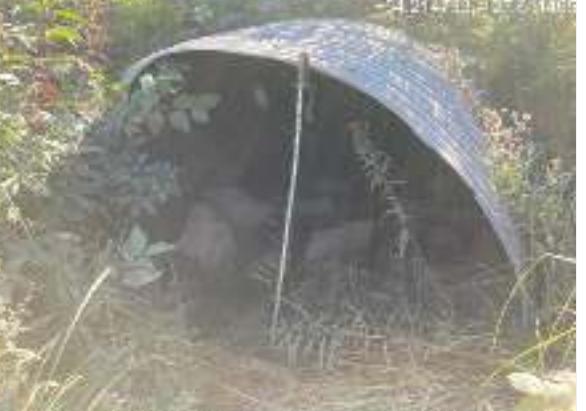
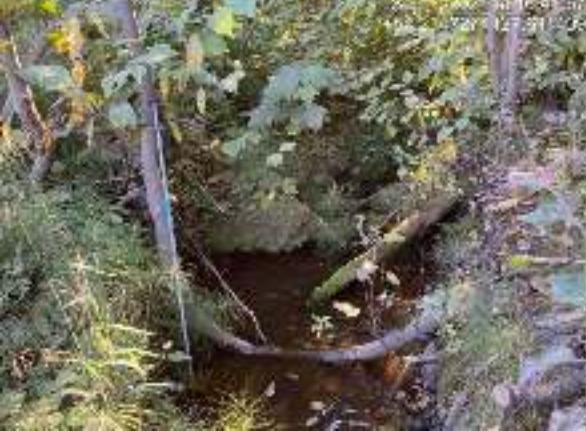
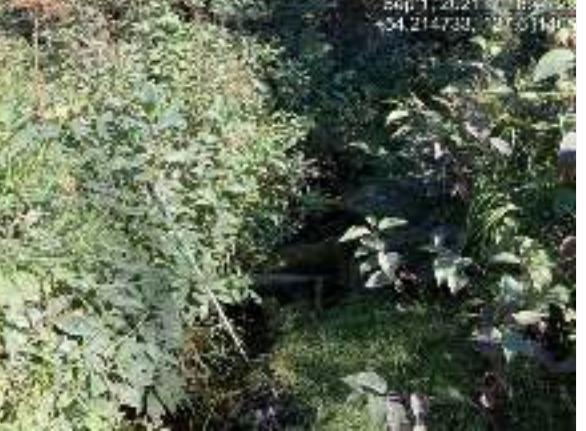
Photos: PSCIS ID 197995. From top left clockwise: Road/Site Card, Barrel, Outlet, Downstream, Upstream, Inlet.

Location and Stream Data		•	Crossing Characteristics	-
Date	2021-09-01		Crossing Sub Type	Round Culvert
PSCIS ID	197995		Diameter (m)	2.2
External ID	14000486		Length (m)	25
Crew	KP		Embedded	Yes
UTM Zone	9		Depth Embedded (m)	0.75
Easting	590552.1		Resemble Channel	Yes
Northing	6008295		Backwatered	No
Stream	Tributary to Gosnell Creek		Percent Backwatered	-
Road	6 Road		Fill Depth (m)	1.5
Road Tenure	Canfor R07593		Outlet Drop (m)	0
Channel Width (m)	0.8		Outlet Pool Depth (m)	0.2
Stream Slope (%)	6.5		Inlet Drop	No
Beaver Activity	No		Slope (%)	3
Habitat Value	Medium		Valley Fill	Deep Fill
Final score	13		Barrier Result	Passable
Fix type	-		Fix Span / Diameter	-

Location and Stream Data	•	Crossing Characteristics	-
Comments: Estimated length, missed in field. All culverts on road were >20m due to size of road. 16:37

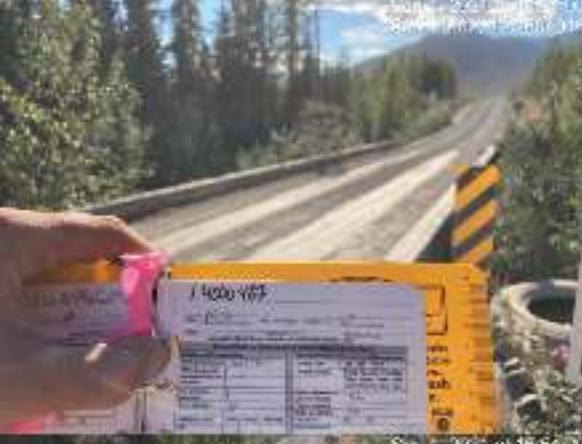
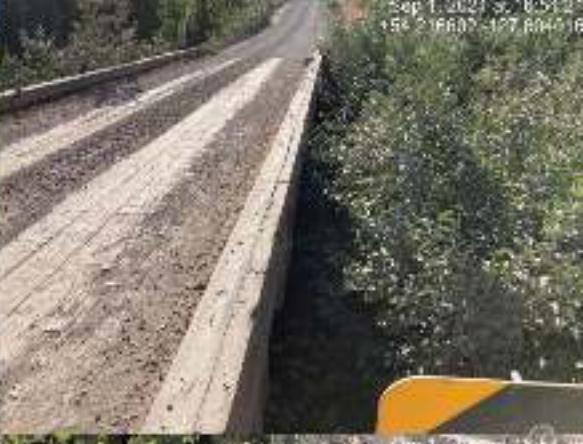
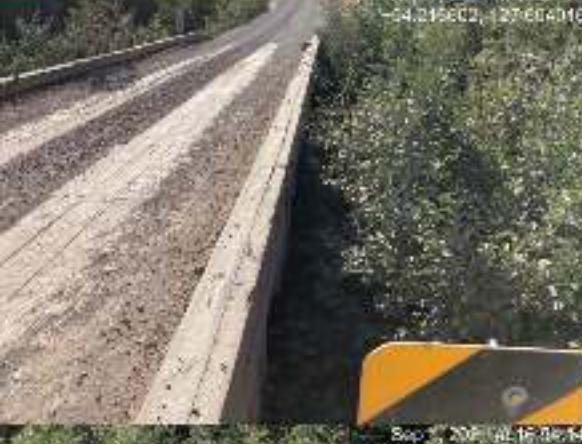
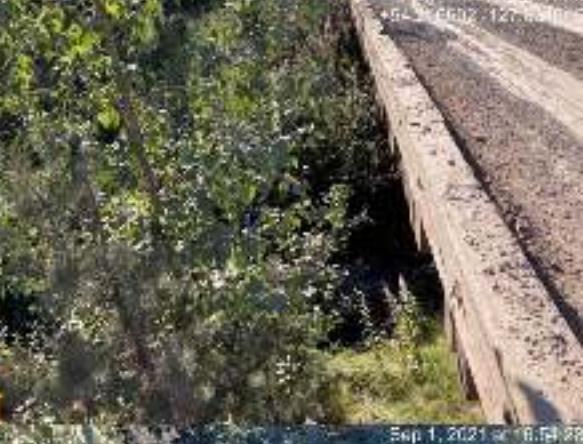
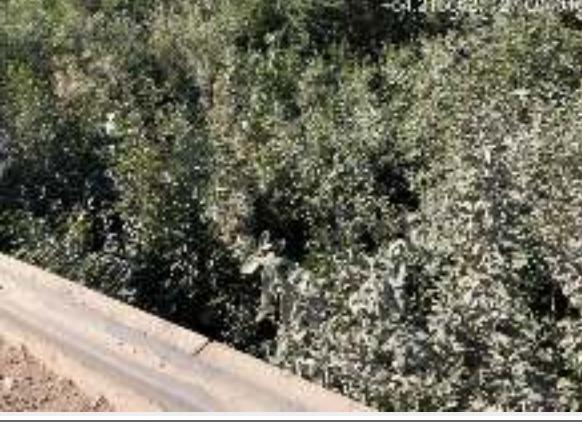
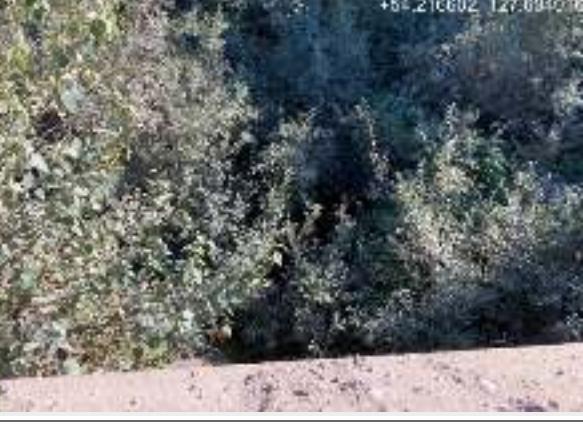
Photos: PSCIS ID 197996. From top left clockwise: Road/Site Card, Barrel, Outlet, Downstream, Upstream, Inlet.

Location and Stream Data		•	Crossing Characteristics	-
Date	2021-09-01		Crossing Sub Type	Bridge
PSCIS ID	197996		Diameter (m)	22
External ID	14000487		Length (m)	6
Crew	KP		Embedded	-
UTM Zone	9		Depth Embedded (m)	-
Easting	590985		Resemble Channel	-
Northing	6008508		Backwatered	-
Stream	Tributary to Gosnell Creek		Percent Backwatered	-
Road	6 Road		Fill Depth (m)	-
Road Tenure	Canfor R07593		Outlet Drop (m)	-
Channel Width (m)	-		Outlet Pool Depth (m)	-
Stream Slope (%)	-		Inlet Drop	-
Beaver Activity	-		Slope (%)	-
Habitat Value	-		Valley Fill	-
Final score	0		Barrier Result	Passable
Fix type	-		Fix Span / Diameter	-

Location and Stream Data	•	Crossing Characteristics	-
Comments: Check utm. 16:52
