Appendix - Phase 1 Fish Passage Assessment Data and Photos

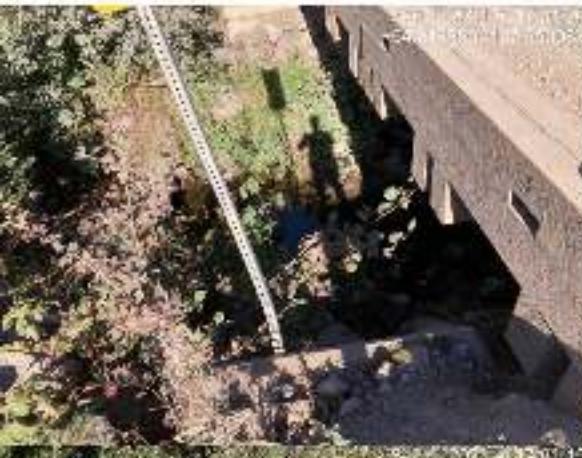
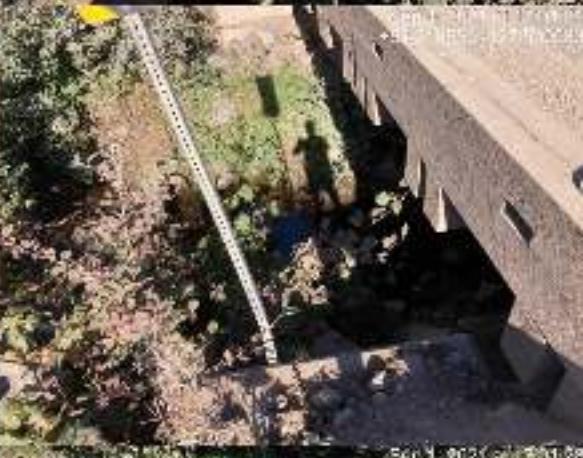
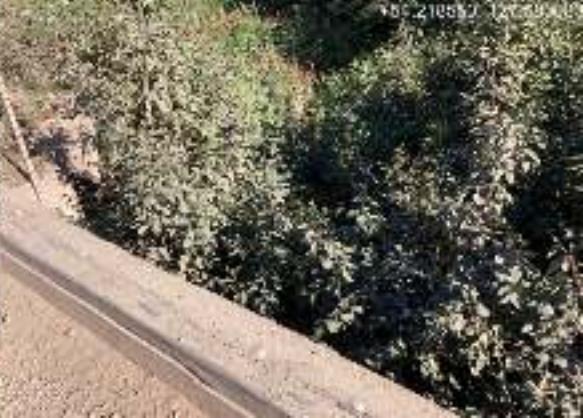
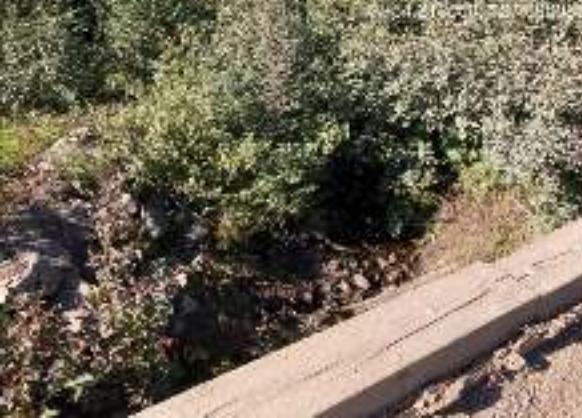
Photos: PSCIS ID 197997. From top left clockwise: Road/Site Card, Barrel, Outlet, Downstream, Upstream, Inlet.

Location and Stream Data		•	Crossing Characteristics	-
Date	2021-09-01		Crossing Sub Type	Bridge
PSCIS ID	197997		Diameter (m)	11
External ID	14000492		Length (m)	6
Crew	KP		Embedded	-
UTM Zone	9		Depth Embedded (m)	-
Easting	591945.7		Resemble Channel	-
Northing	6008758		Backwatered	-
Stream	Tributary to Gosnell Creek		Percent Backwatered	-
Road	6 Road		Fill Depth (m)	-
Road Tenure	Canfor R07593		Outlet Drop (m)	-
Channel Width (m)	-		Outlet Pool Depth (m)	-
Stream Slope (%)	-		Inlet Drop	-
Beaver Activity	-		Slope (%)	-
Habitat Value	-		Valley Fill	-
Final score	0		Barrier Result	Passable
Fix type	-		Fix Span / Diameter	-

Location and Stream Data	•	Crossing Characteristics	-
Comments: Bridge. 17:00			
NO IMAGE AVAILABLE

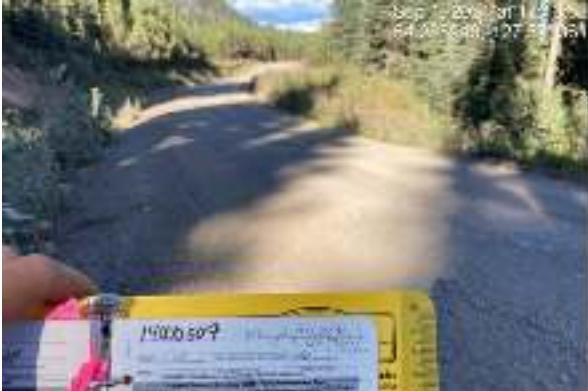
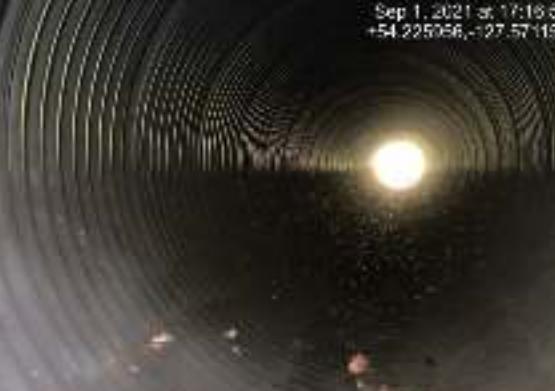
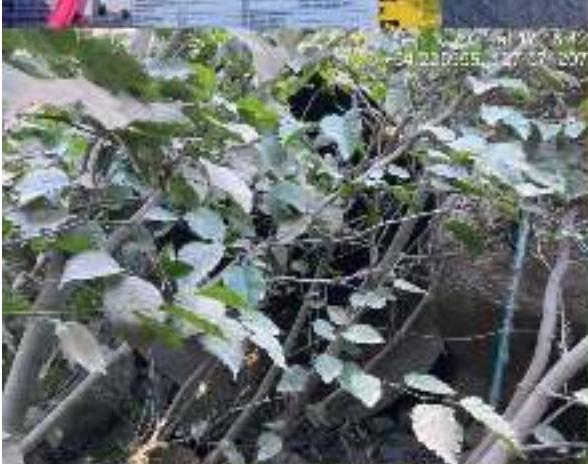
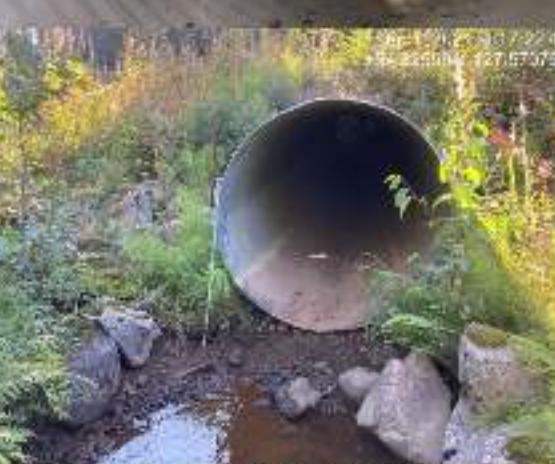
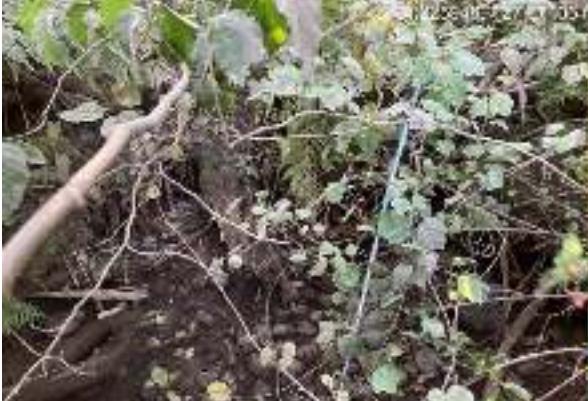
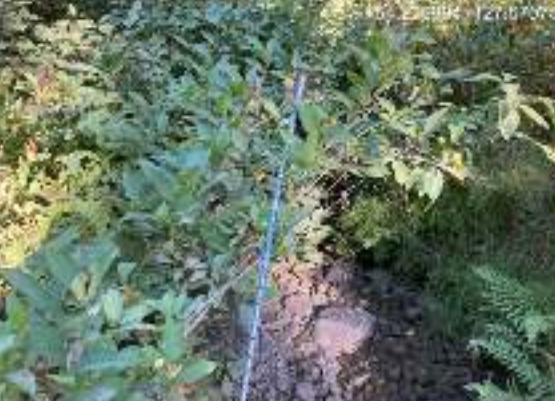
Photos: PSCIS ID 197998. From top left clockwise: Road/Site Card, Barrel, Outlet, Downstream, Upstream, Inlet.

Location and Stream Data		Crossing Characteristics	
Date	2021-09-01	Crossing Sub Type	Round Culvert
PSCIS ID	197998	Diameter (m)	1.5
External ID	14000507	Length (m)	24
Crew	KP	Embedded	No
UTM Zone	9	Depth Embedded (m)	—
Easting	593237.3	Resemble Channel	No
Northing	6009679	Backwatered	No
Stream	Tributary to Gosnell Creek	Percent Backwatered	—
Road	6 Road	Fill Depth (m)	1
Road Tenure	Canfor R07593	Outlet Drop (m)	0
Channel Width (m)	1.8	Outlet Pool Depth (m)	0.15
Stream Slope (%)	7	Inlet Drop	No
Beaver Activity	No	Slope (%)	5
Habitat Value	Medium	Valley Fill	Deep Fill
Final score	26	Barrier Result	Barrier
Fix type	Replace Structure with Streambed Simulation CBS	Fix Span / Diameter	3

Location and Stream Data	•	Crossing Characteristics	-
Comments: Channel dry upstream. 3 toads in outlet pool. 17:12

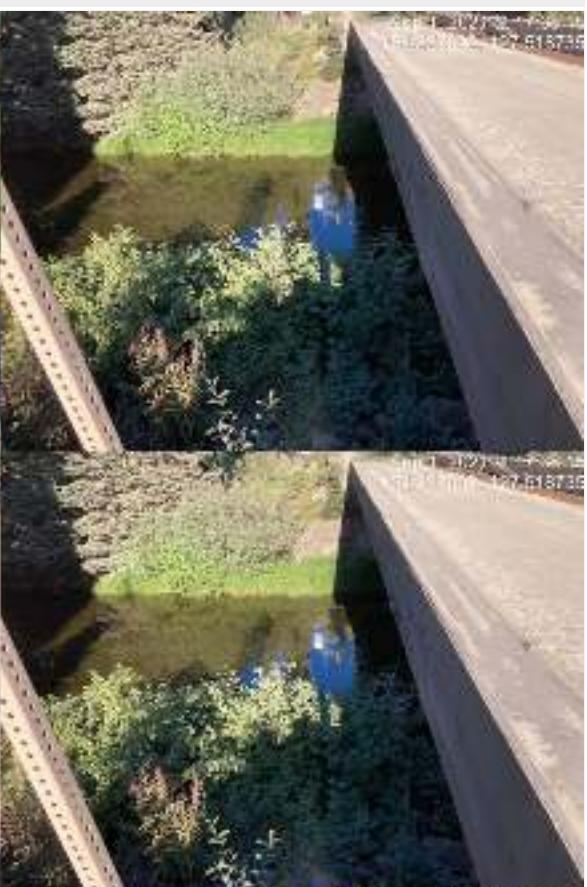
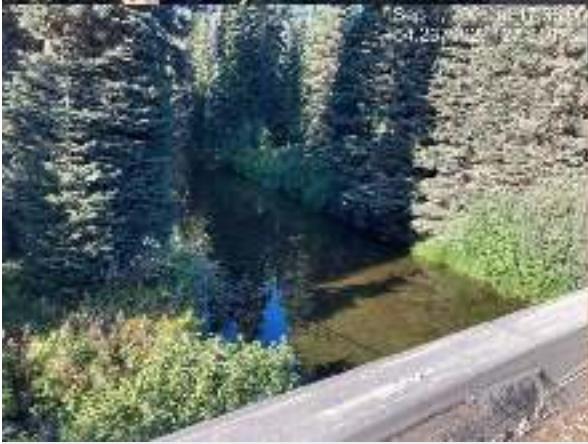
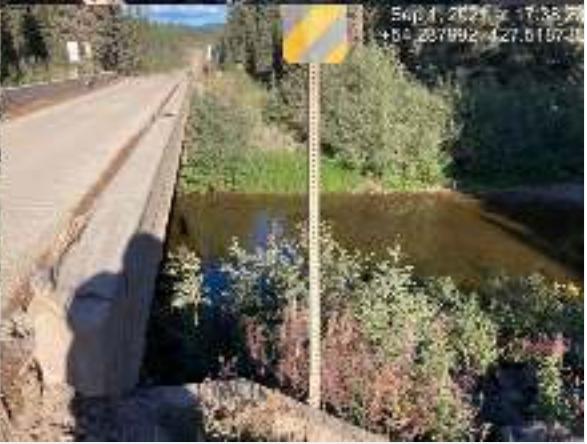
Photos: PSCIS ID 197999. From top left clockwise: Road/Site Card, Barrel, Outlet, Downstream, Upstream, Inlet.

Location and Stream Data	•	Crossing Characteristics	-
Comments: Bridge. 17:36

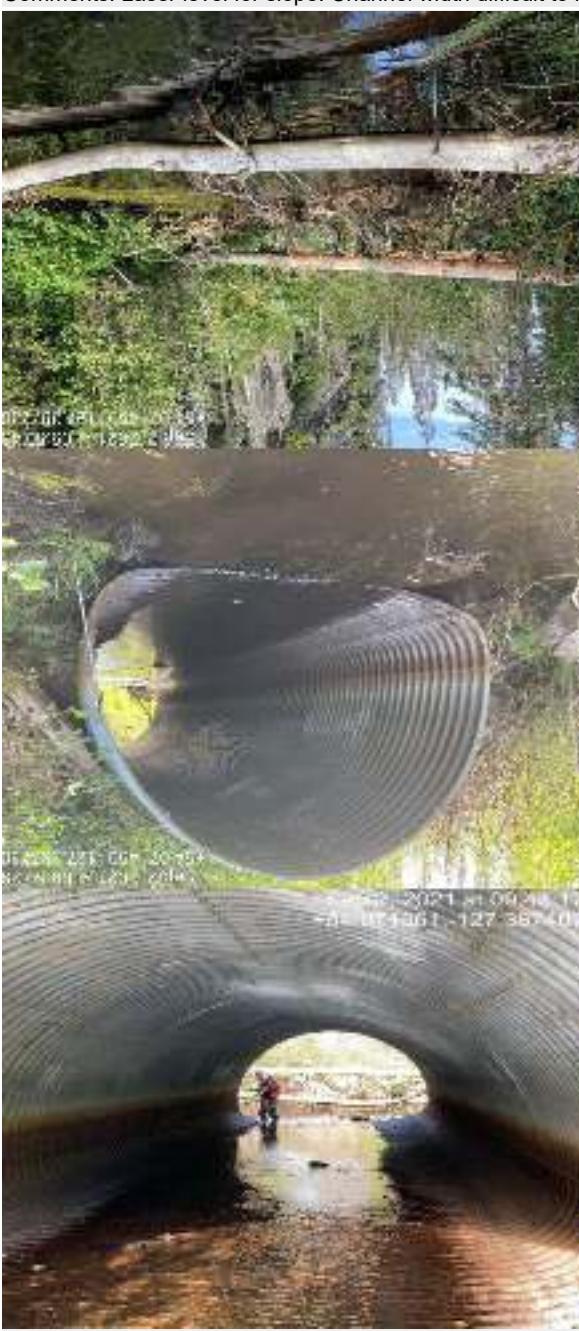
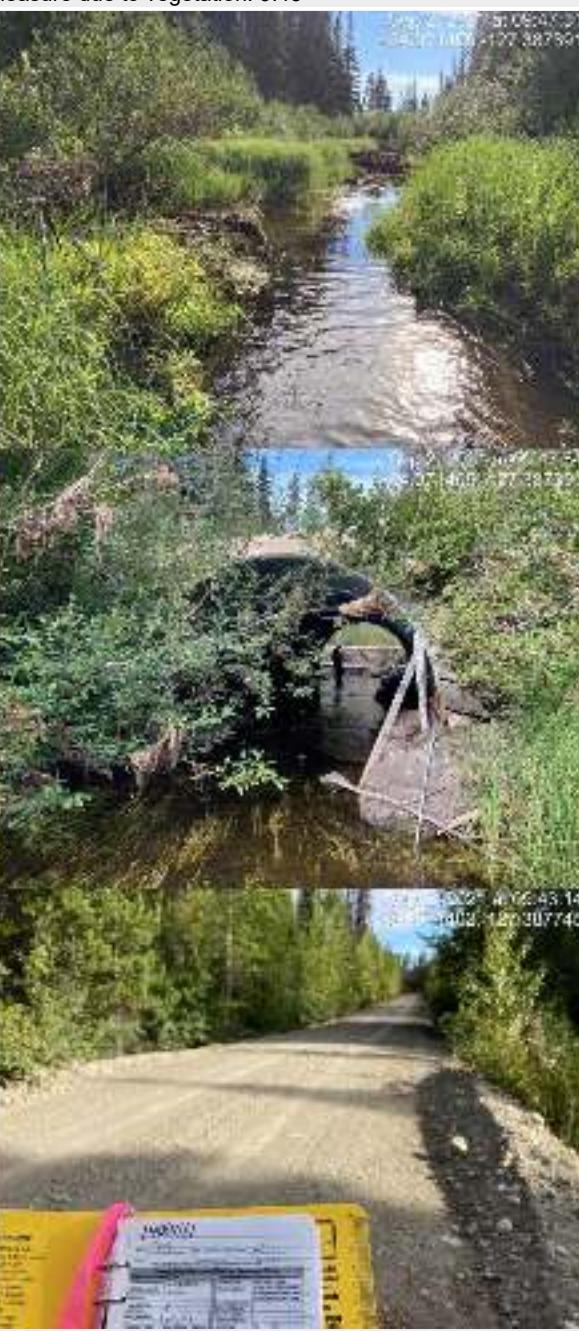
Photos: PSCIS ID 198000. From top left clockwise: Road/Site Card, Barrel, Outlet, Downstream, Upstream, Inlet.

Location and Stream Data		Crossing Characteristics	
Date	2021-09-02	Crossing Sub Type	Oval Culvert
PSCIS ID	198000	Diameter (m)	3.9
External ID	14001161	Length (m)	16
Crew	KP AI	Embedded	No
UTM Zone	9	Depth Embedded (m)	—
Easting	605511	Resemble Channel	No
Northing	5992667	Backwatered	No
Stream	McBride Creek	Percent Backwatered	—
Road	Nanika FSR	Fill Depth (m)	0.8
Road Tenure	FLNR DND 4656	Outlet Drop (m)	0.05
Channel Width (m)	9	Outlet Pool Depth (m)	0.8
Stream Slope (%)	2	Inlet Drop	No
Beaver Activity	No	Slope (%)	0.5
Habitat Value	High	Valley Fill	Deep Fill
Final score	19	Barrier Result	Potential
Fix type	Replace with New Open Bottom Structure	Fix Span / Diameter	14

Location and Stream Data	•	Crossing Characteristics	-
Comments: Laser level for slope. Channel width difficult to measure due to vegetation. 9:43

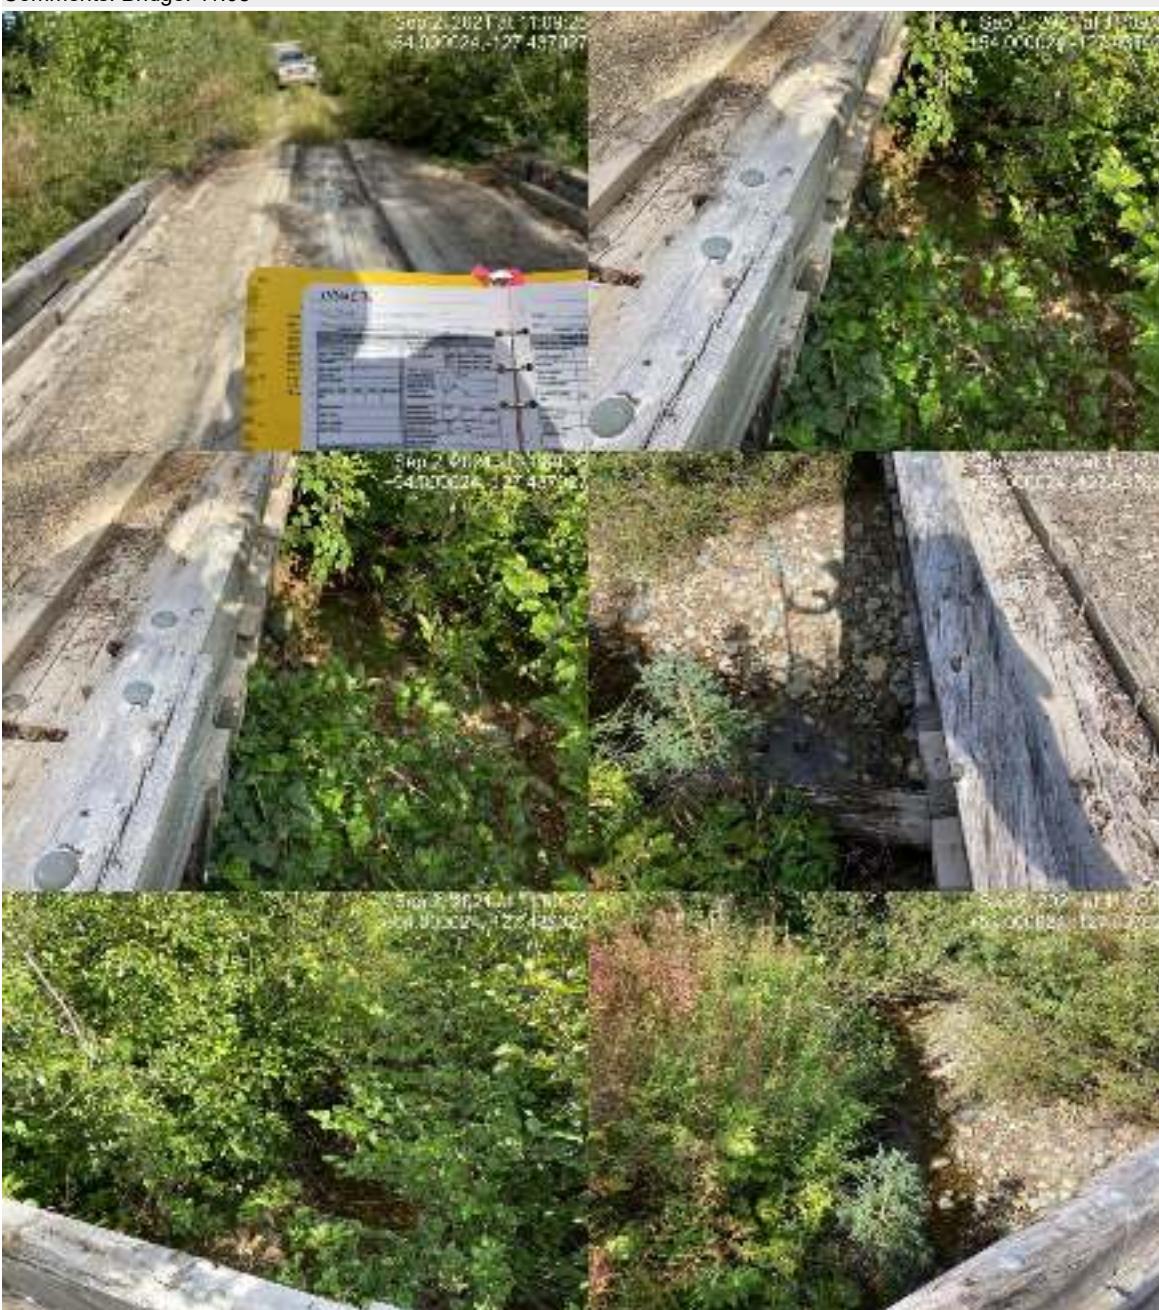
Photos: PSCIS ID 198001. From top left clockwise: Road/Site Card, Barrel, Outlet, Downstream, Upstream, Inlet.

Location and Stream Data	•	Crossing Characteristics	-
Comments: Bridge. 11:08

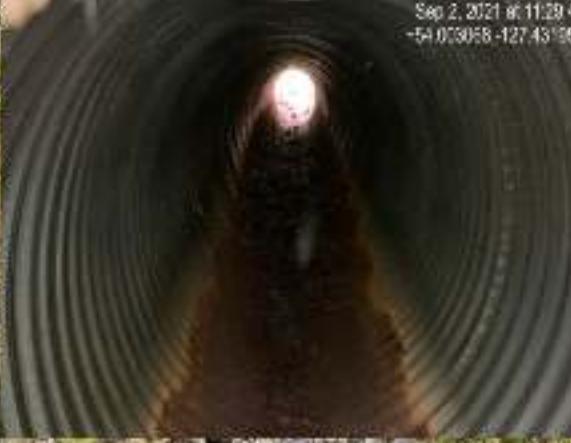
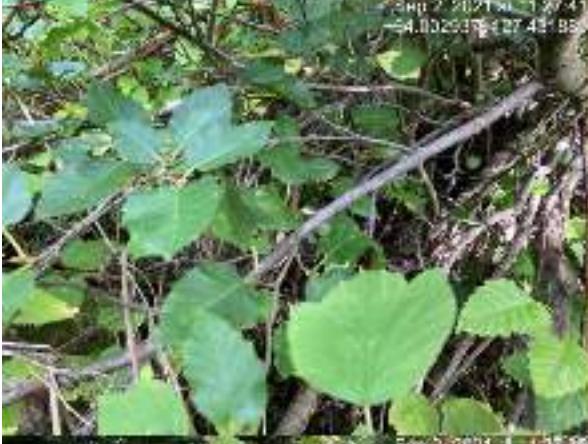
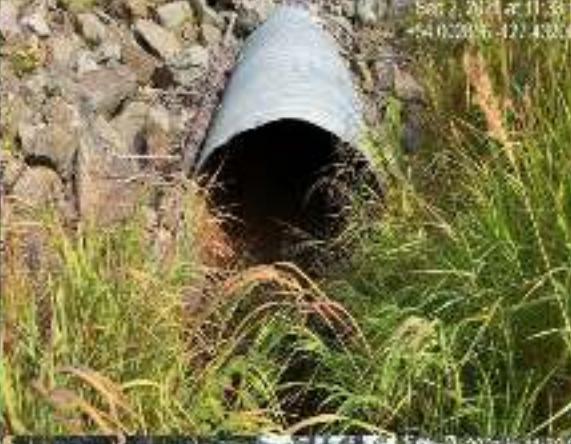
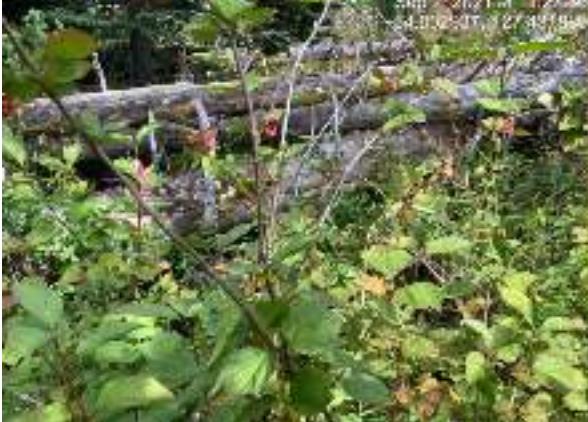
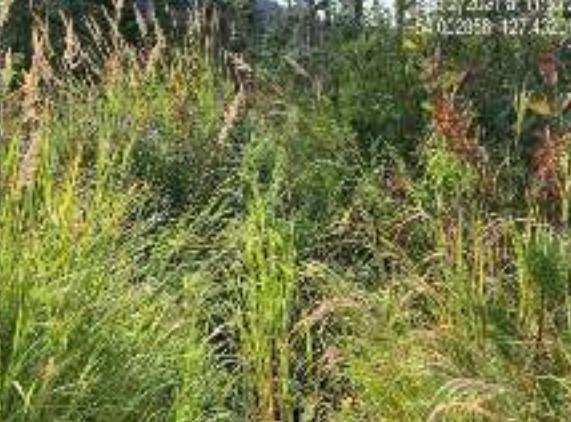
Photos: PSCIS ID 198002. From top left clockwise: Road/Site Card, Barrel, Outlet, Downstream, Upstream, Inlet.

Location and Stream Data		Crossing Characteristics	
Date	2021-09-02	Crossing Sub Type	Round Culvert
PSCIS ID	198002	Diameter (m)	1
External ID	14001009	Length (m)	16
Crew	KP	Embedded	No
UTM Zone	9	Depth Embedded (m)	–
Easting	602775.8	Resemble Channel	No
Northing	5984983	Backwatered	No
Stream	Tributary to Nanika River	Percent Backwatered	–
Road	9 Road	Fill Depth (m)	1
Road Tenure	Canfor R06951	Outlet Drop (m)	0
Channel Width (m)	0.5	Outlet Pool Depth (m)	0.22
Stream Slope (%)	8	Inlet Drop	Yes
Beaver Activity	No	Slope (%)	5
Habitat Value	Low	Valley Fill	Deep Fill
Final score	23	Barrier Result	Barrier
Fix type	Replace Structure with Streambed Simulation CBS	Fix Span / Diameter	3

Location and Stream Data	•	Crossing Characteristics	-
Comments: Dry channel, difficult to locate channel upstream. Inlet drop 0.3m. Appears it could be backwatered when there is flow. Outlet partially embedded on <3m in. 11:22

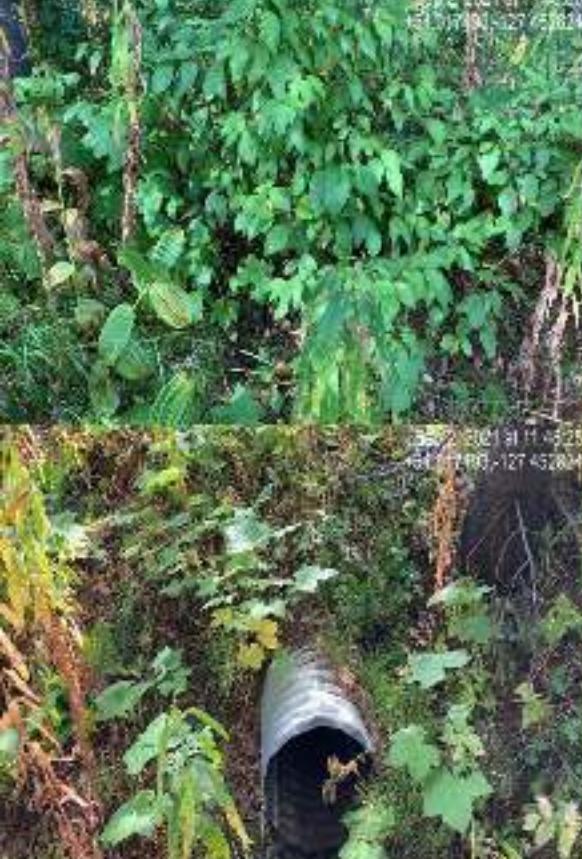
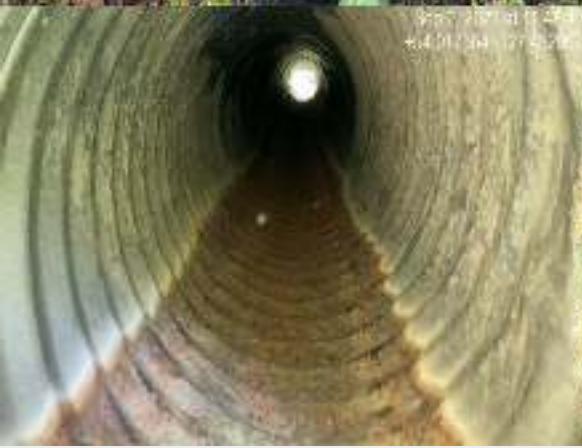
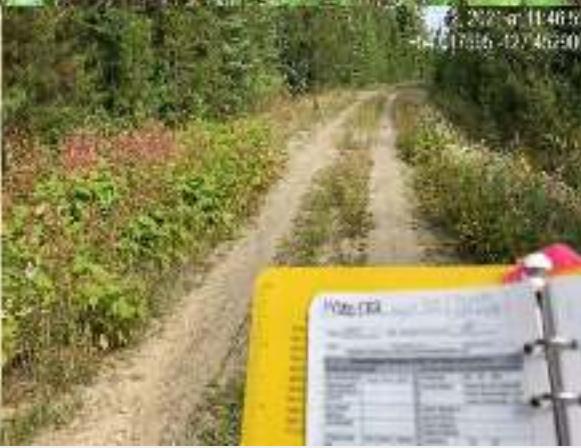
Photos: PSCIS ID 198003. From top left clockwise: Road/Site Card, Barrel, Outlet, Downstream, Upstream, Inlet.

Location and Stream Data		Crossing Characteristics	
Date	2021-09-02	Crossing Sub Type	Round Culvert
PSCIS ID	198003	Diameter (m)	0.6
External ID	14000582	Length (m)	20
Crew	KP	Embedded	No
UTM Zone	9	Depth Embedded (m)	–
Easting	601366.6	Resemble Channel	No
Northing	5986580	Backwatered	No
Stream	Tributary to Nanika River	Percent Backwatered	–
Road	Nanika FSR	Fill Depth (m)	1
Road Tenure	Canfor R06951	Outlet Drop (m)	0.1
Channel Width (m)	0.5	Outlet Pool Depth (m)	0.2
Stream Slope (%)	5	Inlet Drop	No
Beaver Activity	No	Slope (%)	5
Habitat Value	Low	Valley Fill	Deep Fill
Final score	23	Barrier Result	Barrier
Fix type	Replace Structure with Streambed Simulation CBS	Fix Span / Diameter	3

Location and Stream Data	•	Crossing Characteristics	-
Comments: Poorly defined channel unlikely fish habitat. Dry. 11:45

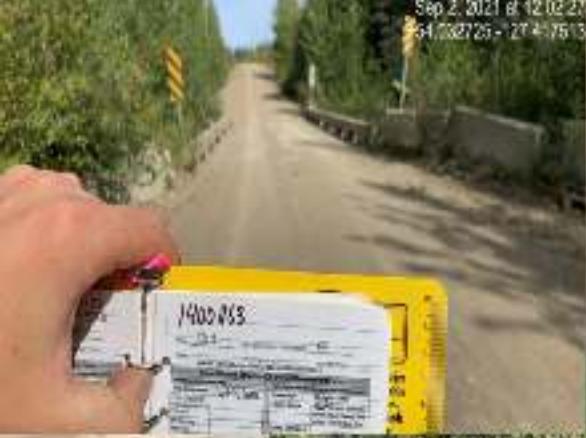
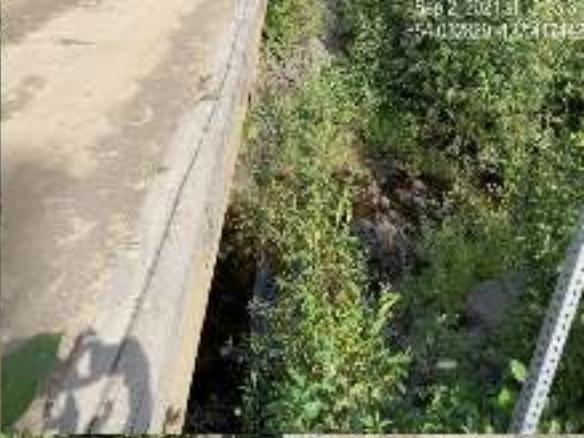
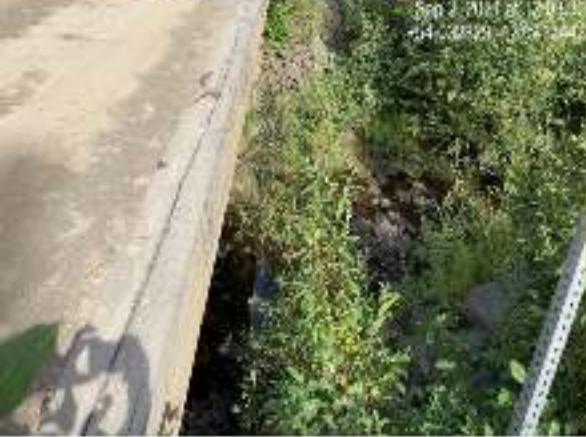
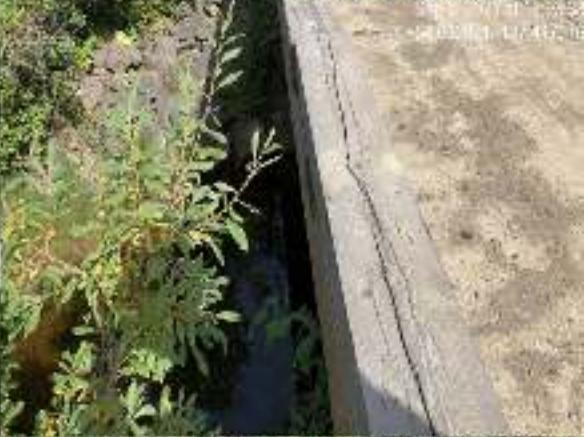
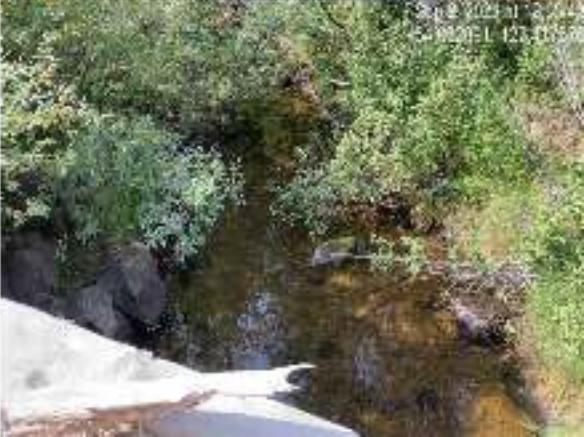
Photos: PSCIS ID 198004. From top left clockwise: Road/Site Card, Barrel, Outlet, Downstream, Upstream, Inlet.

Location and Stream Data	•	Crossing Characteristics	-
Comments: Bridge. 12:02

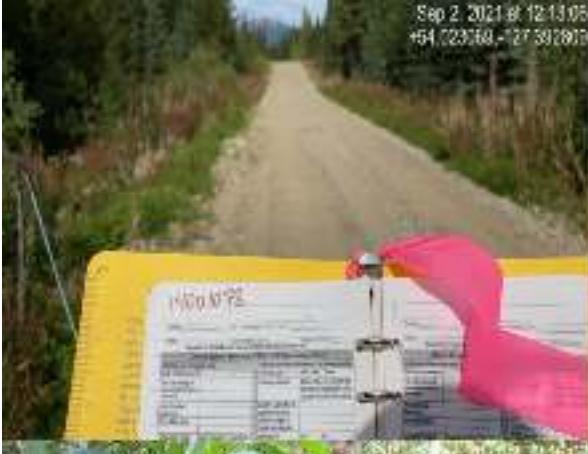
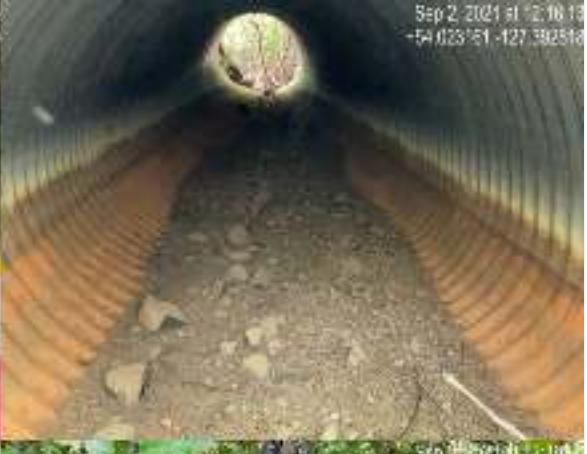
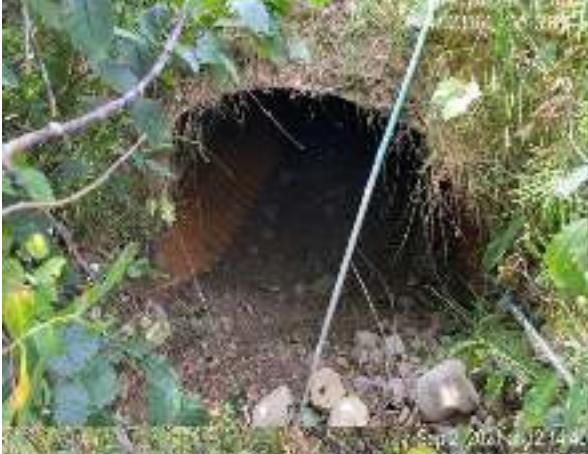
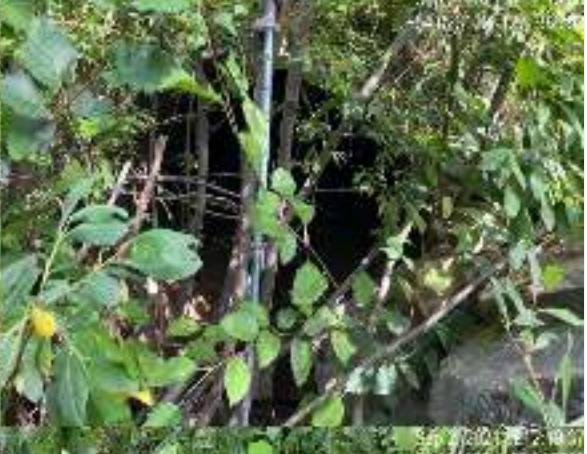
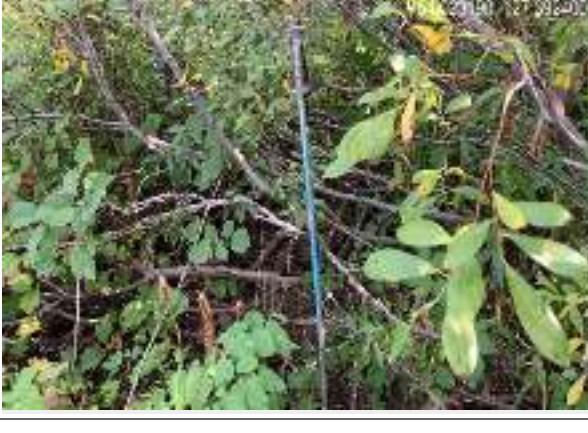
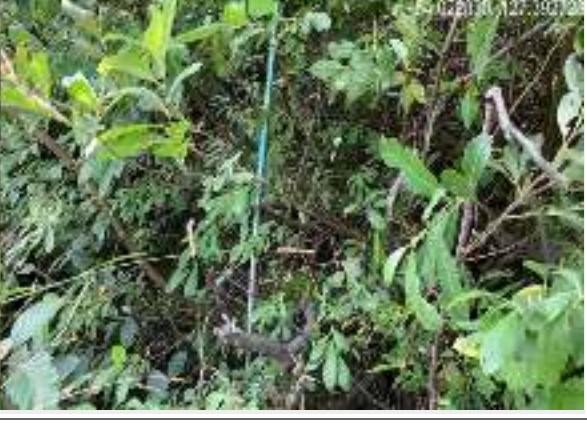
Photos: PSCIS ID 198005. From top left clockwise: Road/Site Card, Barrel, Outlet, Downstream, Upstream, Inlet.

Location and Stream Data		Crossing Characteristics	
Date	2021-09-02	Crossing Sub Type	Round Culvert
PSCIS ID	198005	Diameter (m)	1.2
External ID	14001078	Length (m)	10
Crew	KP	Embedded	No
UTM Zone	9	Depth Embedded (m)	–
Easting	605308	Resemble Channel	No
Northing	5987254	Backwatered	No
Stream	Tributary to Nanika River	Percent Backwatered	–
Road	Spur	Fill Depth (m)	0.5
Road Tenure	Canfor R06951	Outlet Drop (m)	0
Channel Width (m)	0.8	Outlet Pool Depth (m)	0
Stream Slope (%)	4	Inlet Drop	Yes
Beaver Activity	No	Slope (%)	3
Habitat Value	Low	Valley Fill	Deep Fill
Final score	20	Barrier Result	Barrier
Fix type	Replace Structure with Streambed Simulation CBS	Fix Span / Diameter	3

Location and Stream Data	•	Crossing Characteristics	-
Comments: Dry channel, stream slope estimated. Outlet drop .15m. 12:12

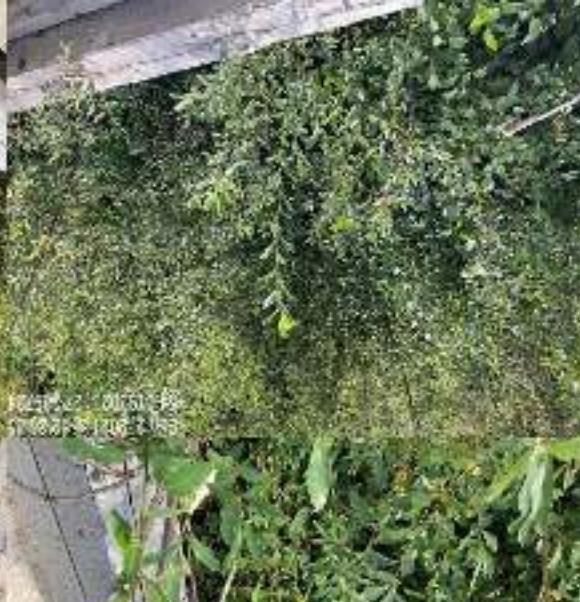
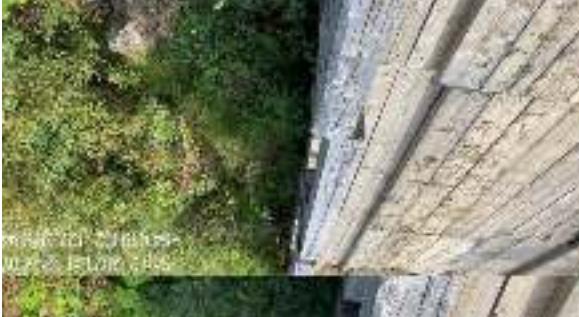
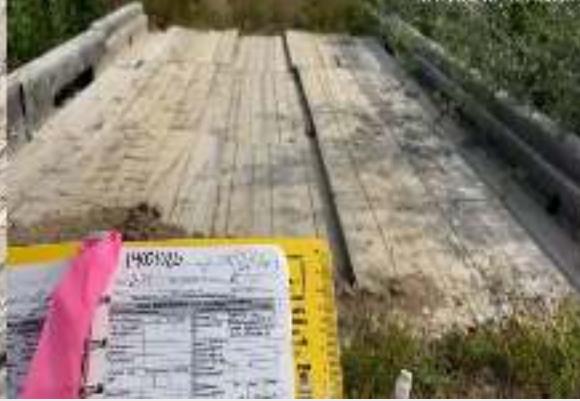
Photos: PSCIS ID 198006. From top left clockwise: Road/Site Card, Barrel, Outlet, Downstream, Upstream, Inlet.

Location and Stream Data	.	Crossing Characteristics	-
Comments: Location much different than map. 12:25

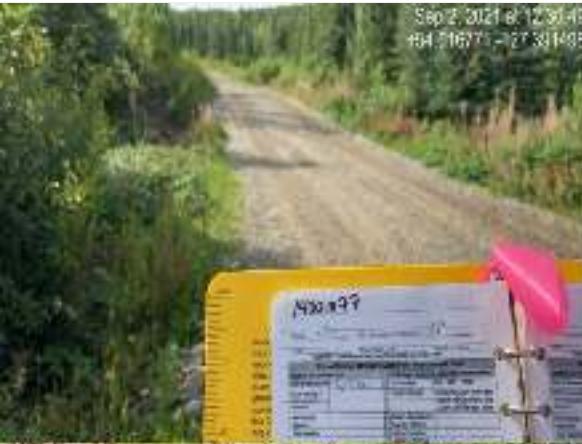
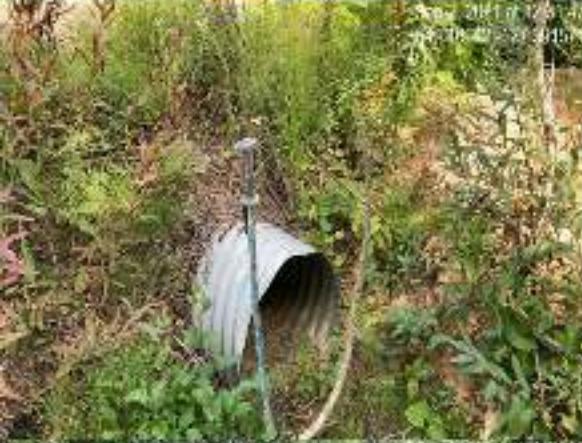
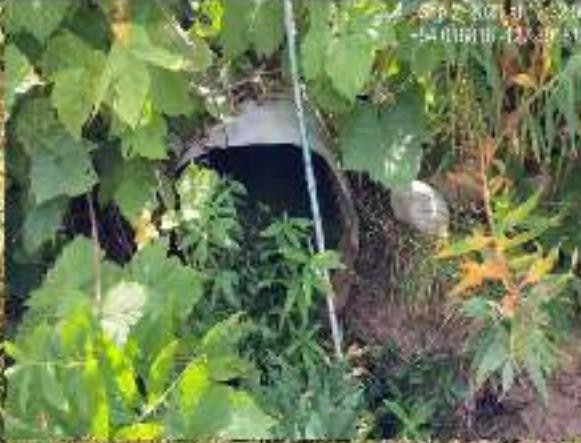
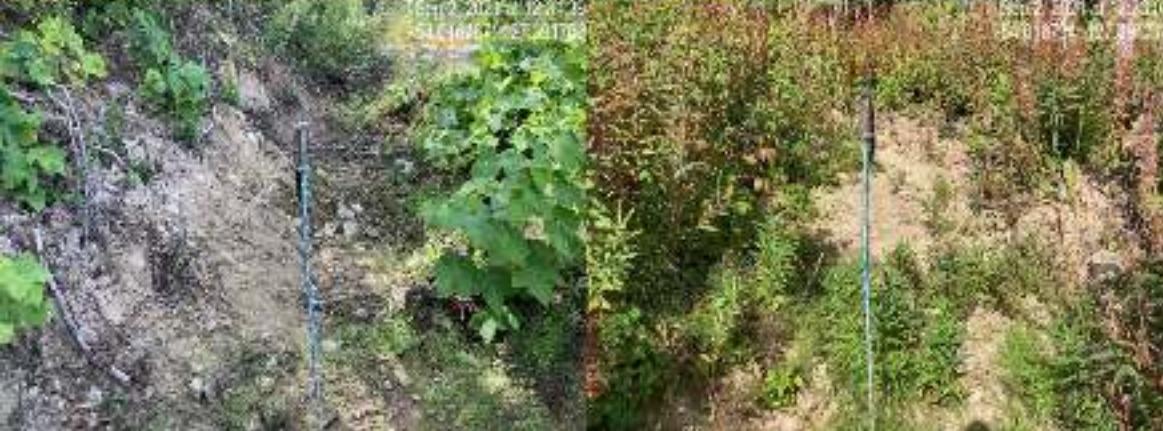
Photos: PSCIS ID 198007. From top left clockwise: Road/Site Card, Barrel, Outlet, Downstream, Upstream, Inlet.

Location and Stream Data		Crossing Characteristics	
Date	2021-09-02	Crossing Sub Type	Round Culvert
PSCIS ID	198007	Diameter (m)	0.6
External ID	14001077	Length (m)	10
Crew	KP	Embedded	Yes
UTM Zone	9	Depth Embedded (m)	0.2
Easting	605389	Resemble Channel	No
Northing	5986595	Backwatered	No
Stream	Tributary to Nanika River	Percent Backwatered	–
Road	Spur	Fill Depth (m)	0.5
Road Tenure	Canfor R06951	Outlet Drop (m)	0.1
Channel Width (m)	1	Outlet Pool Depth (m)	0.15
Stream Slope (%)	7	Inlet Drop	No
Beaver Activity	No	Slope (%)	4
Habitat Value	Low	Valley Fill	Deep Fill
Final score	21	Barrier Result	Barrier
Fix type	Replace Structure with Streambed Simulation CBS	Fix Span / Diameter	3

Location and Stream Data	•	Crossing Characteristics	-
Comments: Dry, hard to see channel. More of a maintenance culvert, completed due to fish data upstream. No real channel. Embedment is fines more erosional deposit. 12:30

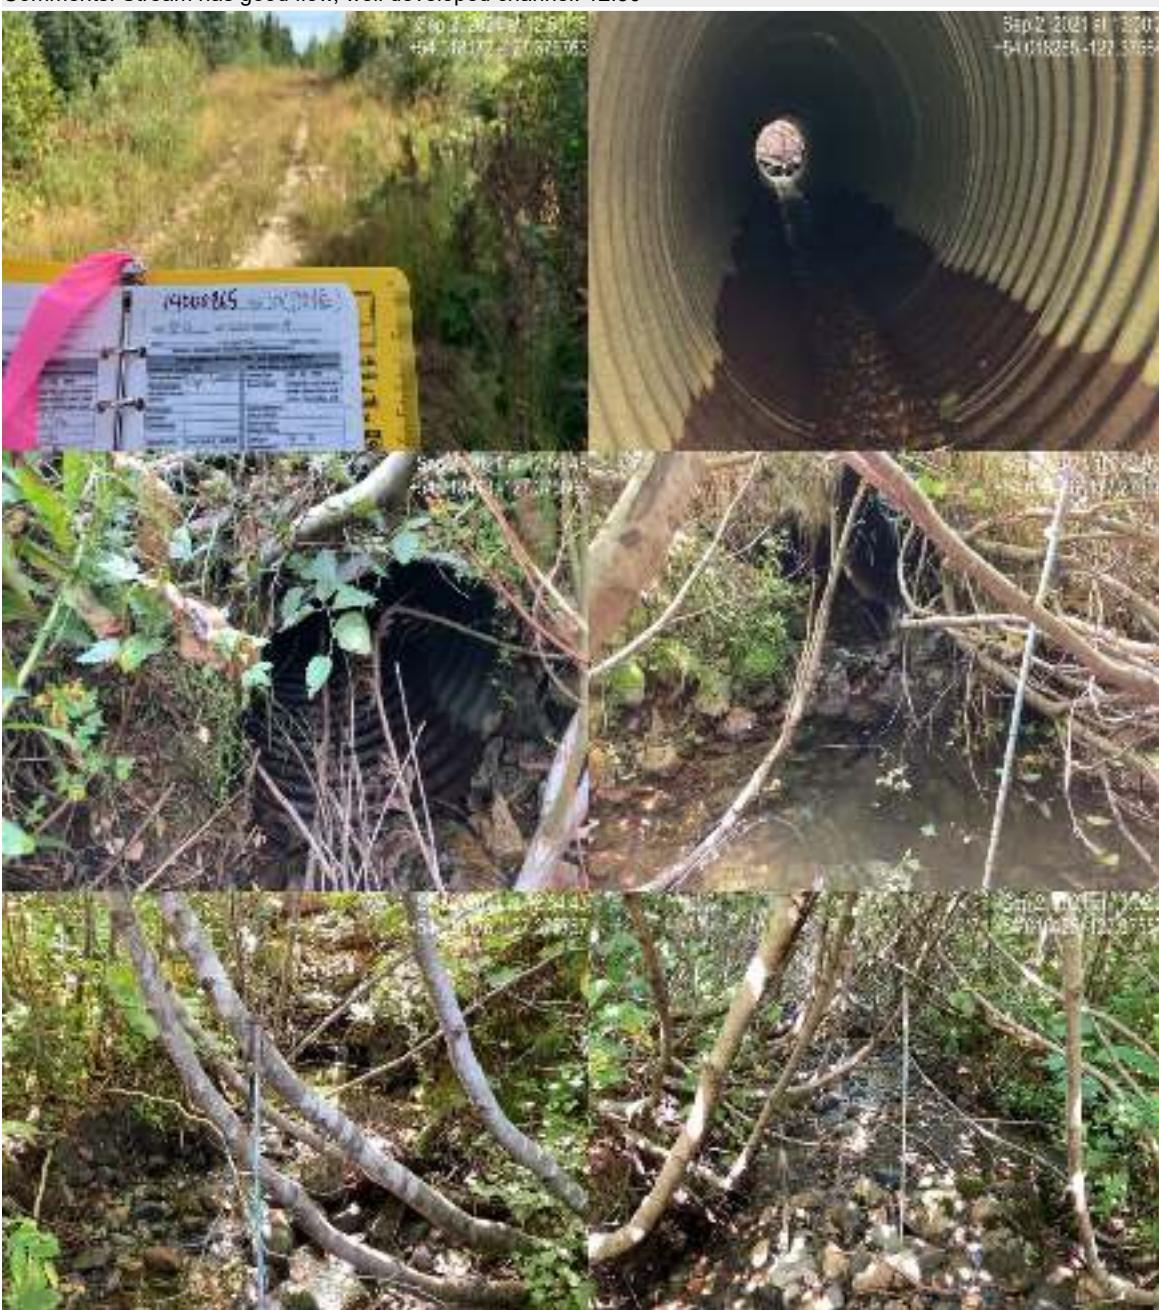
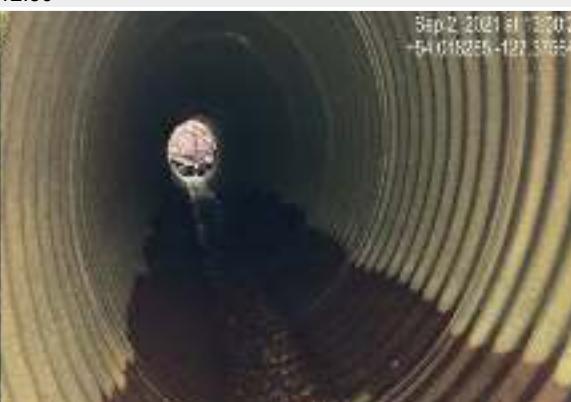
Photos: PSCIS ID 198008. From top left clockwise: Road/Site Card, Barrel, Outlet, Downstream, Upstream, Inlet.

Location and Stream Data		Crossing Characteristics	
Date	2021-09-02	Crossing Sub Type	Round Culvert
PSCIS ID	198008	Diameter (m)	0.9
External ID	14000865	Length (m)	11
Crew	KP	Embedded	No
UTM Zone	9	Depth Embedded (m)	–
Easting	606426.2	Resemble Channel	No
Northing	5986782	Backwatered	No
Stream	Tributary to Nanika River	Percent Backwatered	–
Road	Spur	Fill Depth (m)	0.2
Road Tenure	Canfor R10644	Outlet Drop (m)	0.18
Channel Width (m)	1.8	Outlet Pool Depth (m)	0.6
Stream Slope (%)	7	Inlet Drop	Yes
Beaver Activity	No	Slope (%)	6
Habitat Value	Medium	Valley Fill	Deep Fill
Final score	31	Barrier Result	Barrier
Fix type	Replace Structure with Streambed Simulation CBS	Fix Span / Diameter	3

Location and Stream Data	•	Crossing Characteristics	-
Comments: Stream has good flow, well developed channel. 12:50

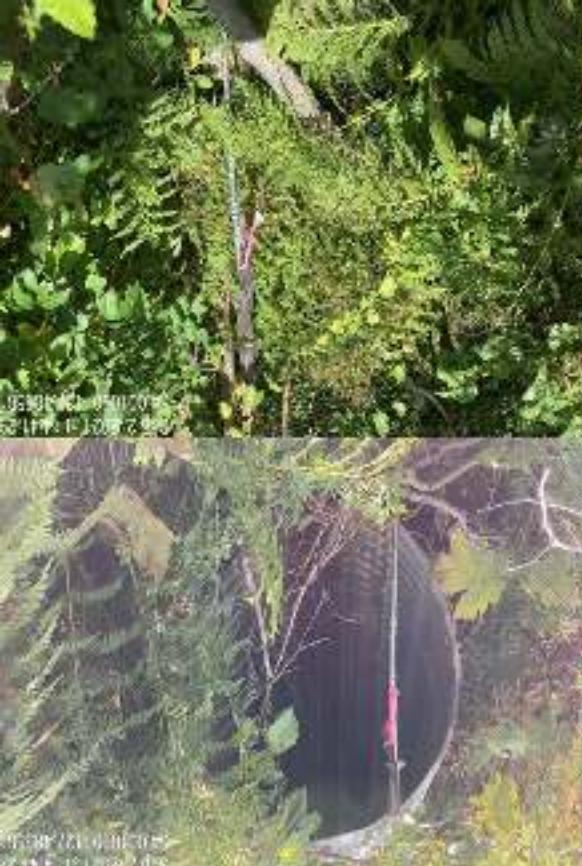
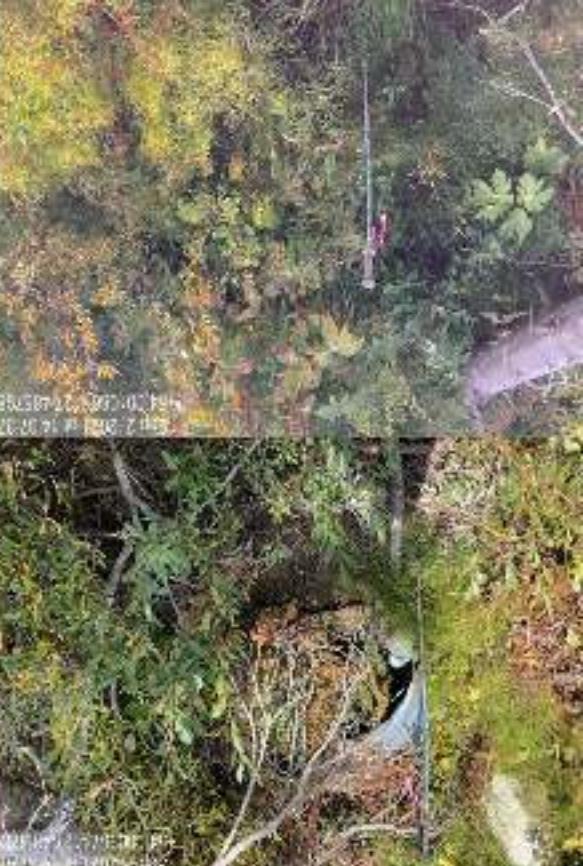
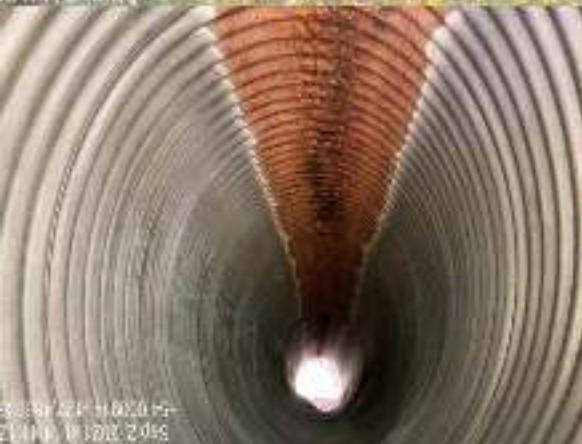
Photos: PSCIS ID 198009. From top left clockwise: Road/Site Card, Barrel, Outlet, Downstream, Upstream, Inlet.

Location and Stream Data		Crossing Characteristics	
Date	2021-09-02	Crossing Sub Type	Round Culvert
PSCIS ID	198009	Diameter (m)	0.9
External ID	14000535	Length (m)	14
Crew	KP	Embedded	No
UTM Zone	9	Depth Embedded (m)	—
Easting	599263.7	Resemble Channel	No
Northing	5984699	Backwatered	No
Stream	Tributary to Nanika River	Percent Backwatered	—
Road	1 Road	Fill Depth (m)	0.75
Road Tenure	Canfor R08817	Outlet Drop (m)	0.8
Channel Width (m)	1	Outlet Pool Depth (m)	0.15
Stream Slope (%)	8	Inlet Drop	No
Beaver Activity	No	Slope (%)	5
Habitat Value	Low	Valley Fill	Deep Fill
Final score	33	Barrier Result	Barrier
Fix type	Replace Structure with Streambed Simulation CBS	Fix Span / Diameter	3

Location and Stream Data	Crossing Characteristics
Comments: Channel dry , hard to find. Unlikely fish habitat. Culvert deformed. 14:35

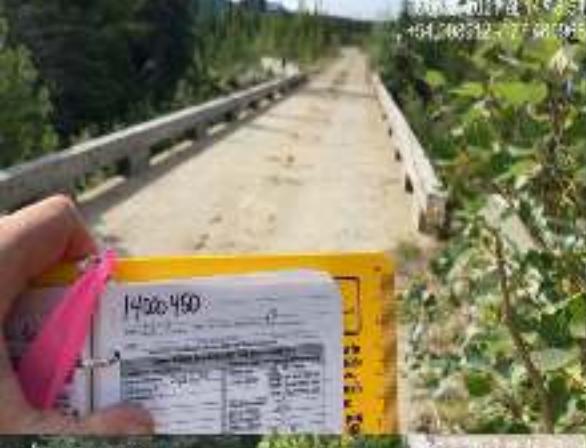
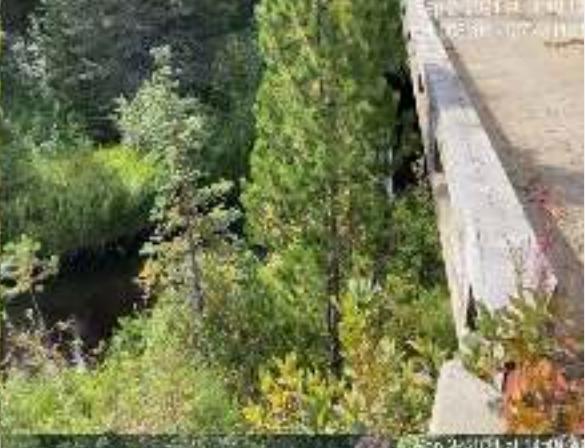
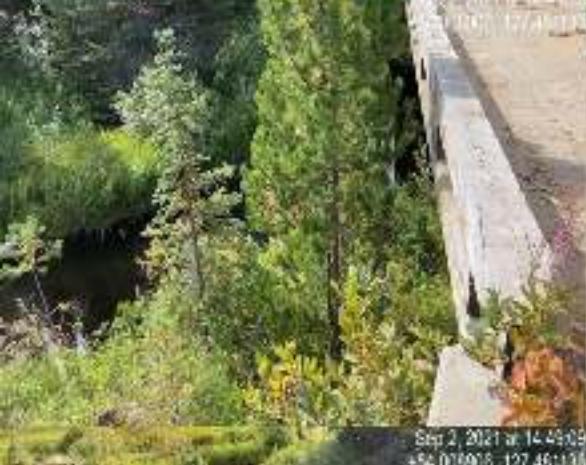
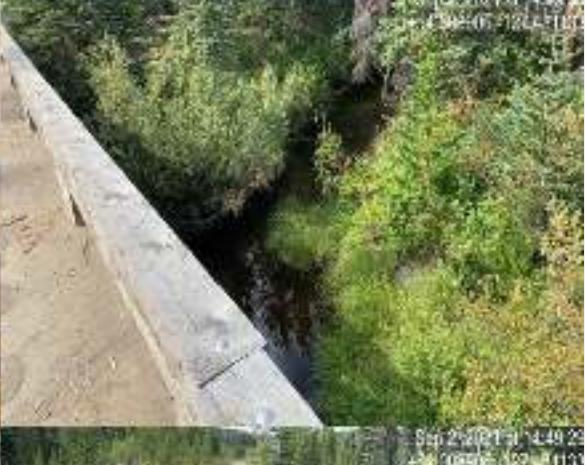
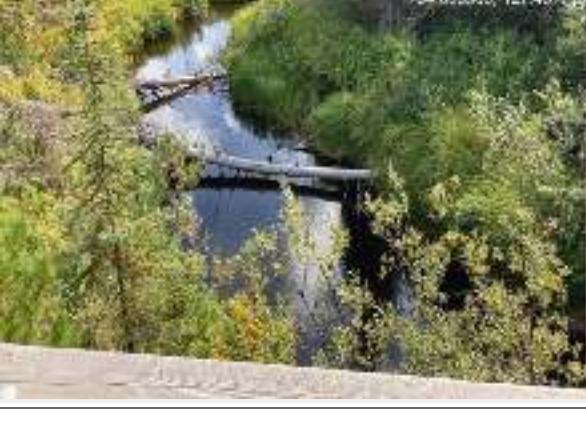
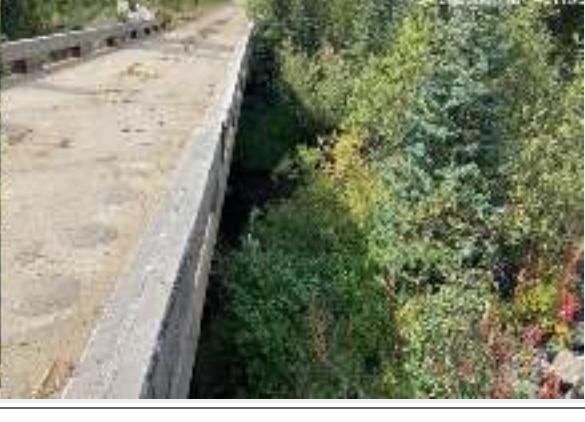
Photos: PSCIS ID 198010. From top left clockwise: Road/Site Card, Barrel, Outlet, Downstream, Upstream, Inlet.

Location and Stream Data	.	Crossing Characteristics	-
Date	2021-09-02	Crossing Sub Type	Bridge
PSCIS ID	198010	Diameter (m)	26
External ID	14000450	Length (m)	5
Crew	KP	Embedded	-
UTM Zone	9	Depth Embedded (m)	-
Easting	599516.3	Resemble Channel	-
Northing	5985582	Backwatered	-
Stream	Tributary to Nanika River	Percent Backwatered	-
Road	4 Road	Fill Depth (m)	-
Road Tenure	FLNR DND 4656	Outlet Drop (m)	-
Channel Width (m)	-	Outlet Pool Depth (m)	-
Stream Slope (%)	-	Inlet Drop	-
Beaver Activity	-	Slope (%)	-
Habitat Value	-	Valley Fill	-
Final score	0	Barrier Result	Passable
Fix type	-	Fix Span / Diameter	-

Location and Stream Data	•	Crossing Characteristics	-
Comments: Bridge. 14:47
