Appendix - Phase 1 Fish Passage Assessment Data and Photos

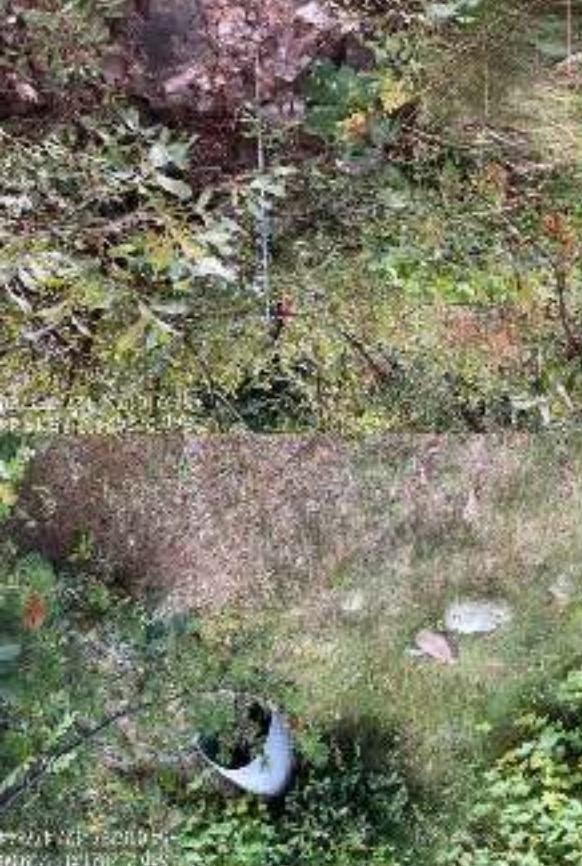
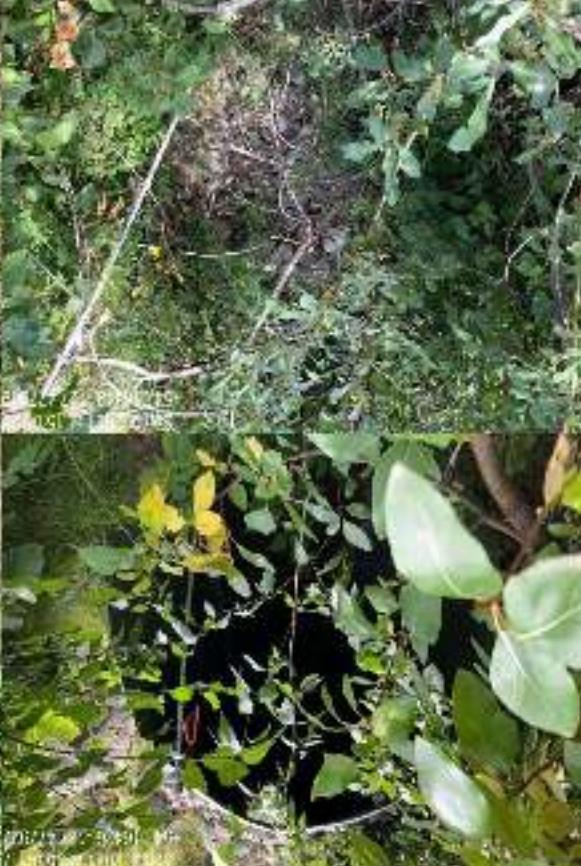
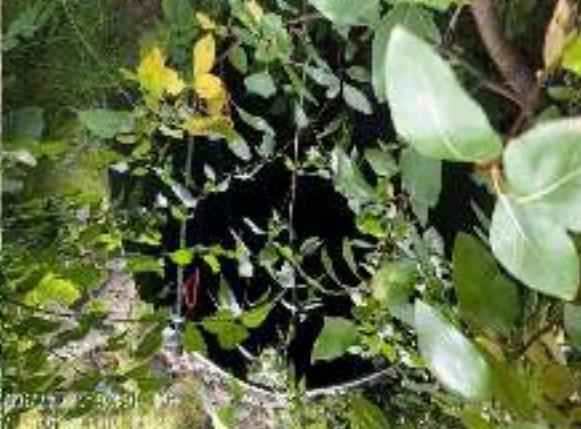
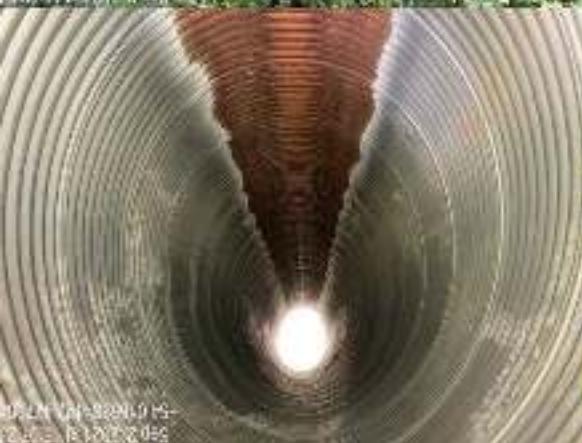
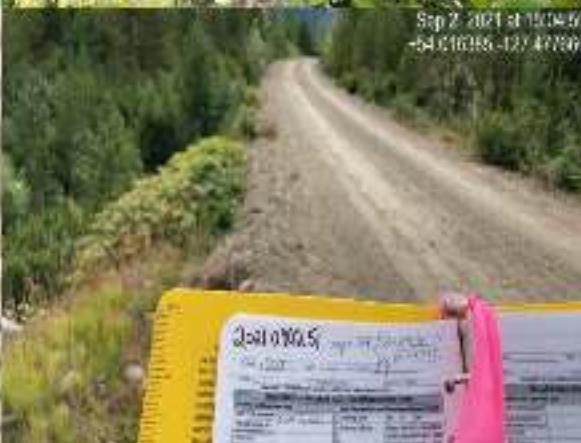
Photos: PSCIS ID 198011. From top left clockwise: Road/Site Card, Barrel, Outlet, Downstream, Upstream, Inlet.

Location and Stream Data		Crossing Characteristics –	
Date	2021-09-02	Crossing Sub Type	Round Culvert
PSCIS ID	198011	Diameter (m)	1.6
External ID	14000443	Length (m)	22
Crew	KP	Embedded	No
UTM Zone	9	Depth Embedded (m)	—
Easting	599738.2	Resemble Channel	No
Northing	5986409	Backwatered	No
Stream	Tributary to Nanika River	Percent Backwatered	—
Road	4 Road	Fill Depth (m)	2.5
Road Tenure	FLNR DND 4656	Outlet Drop (m)	0.4
Channel Width (m)	2.2	Outlet Pool Depth (m)	0.7
Stream Slope (%)	7	Inlet Drop	No
Beaver Activity	No	Slope (%)	6
Habitat Value	Low	Valley Fill	Deep Fill
Final score	39	Barrier Result	Barrier
Fix type	Replace with New Open Bottom Structure	Fix Span / Diameter	10

Location and Stream Data	•	Crossing Characteristics	-
Comments: Dry channel. Another culvert ~5m away, higher and smaller for flood or overflow. Outlet pool big, stream experiences high seasonal variation. 15:03

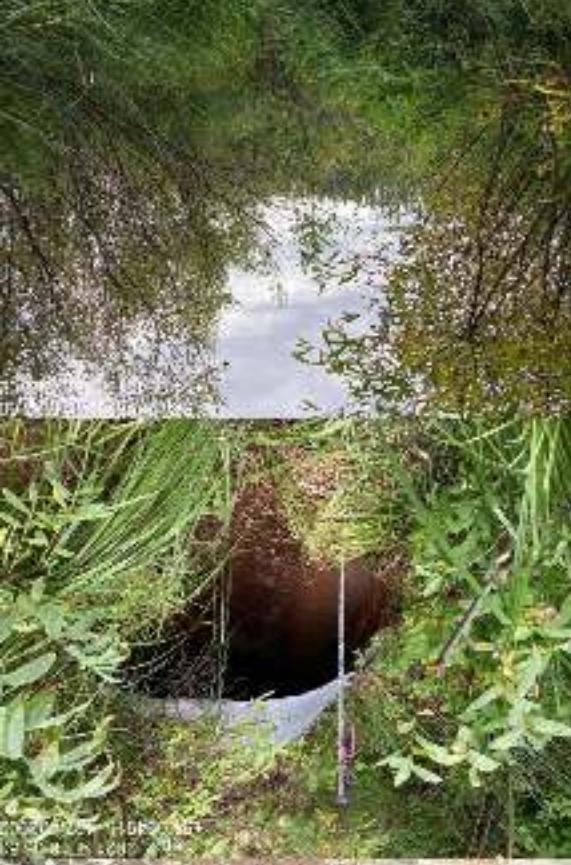
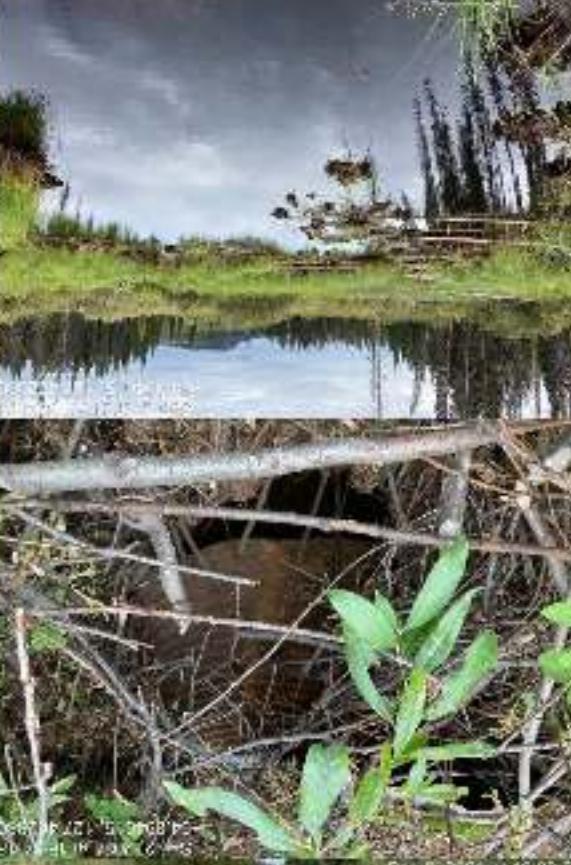
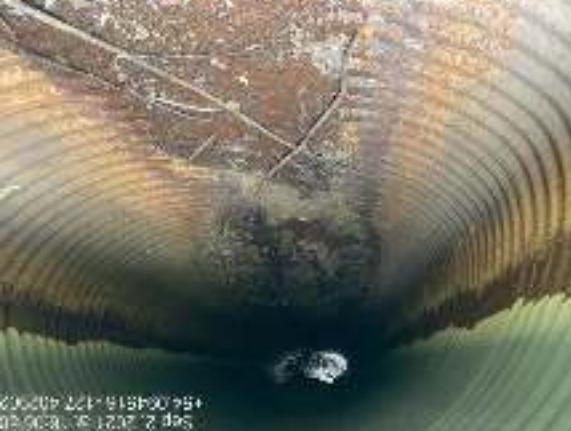
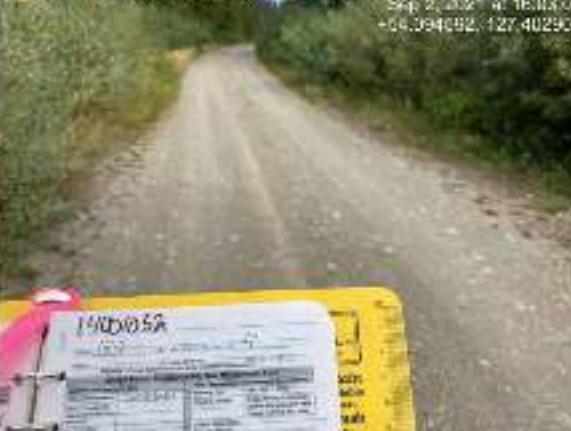
Location and Stream Data	•	Crossing Characteristics	-
Comments: Beaver clogged inlet, with potentially a beaver lodge built on it. No water flowing through. Culvert broken in several places. Looks like old beaver fence on inlet, not effective. Large wetland upstream and downstream. 16:02

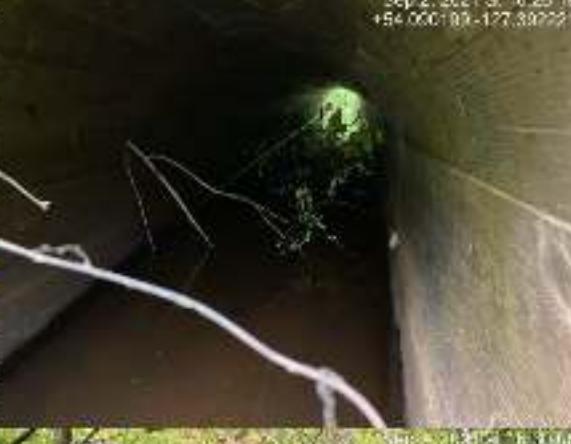
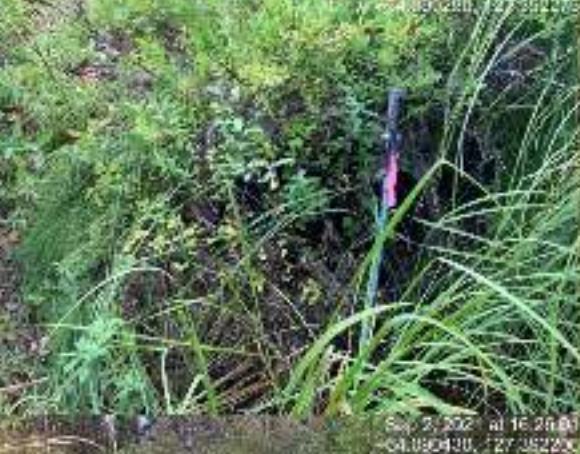
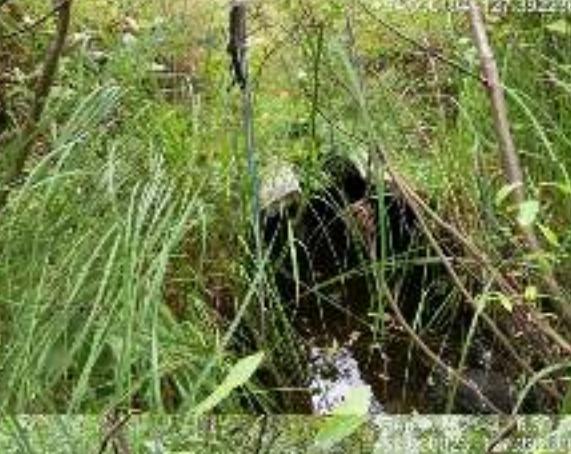
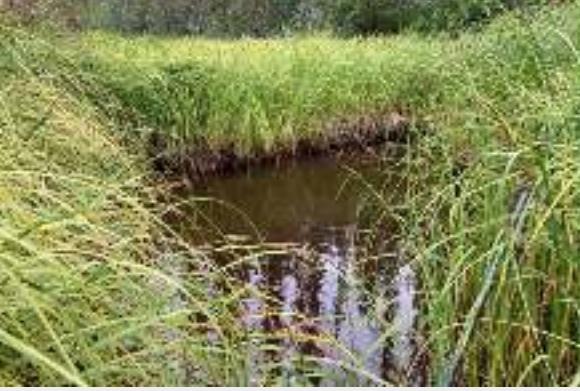
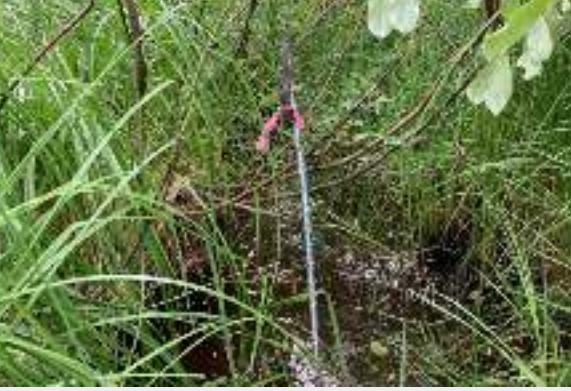
Photos: PSCIS ID 198013. From top left clockwise: Road/Site Card, Barrel, Outlet, Downstream, Upstream, Inlet.

Location and Stream Data		•	Crossing Characteristics	–
Date	2021-09-02		Crossing Sub Type	Round Culvert
PSCIS ID	198013		Diameter (m)	0.7
External ID	14000777		Length (m)	13
Crew	KP		Embedded	No
UTM Zone	9		Depth Embedded (m)	–
Easting	605157		Resemble Channel	Yes
Northing	5994783		Backwatered	Yes
Stream	Tributary to McBride River		Percent Backwatered	100
Road	Morice FSR		Fill Depth (m)	0.5
Road Tenure	FLNR DND 4656		Outlet Drop (m)	0
Channel Width (m)	0.7		Outlet Pool Depth (m)	0
Stream Slope (%)	0.5		Inlet Drop	No
Beaver Activity	No		Slope (%)	0.5
Habitat Value	Medium		Valley Fill	Deep Fill
Final score	13		Barrier Result	Passable
Fix type	–		Fix Span / Diameter	–

Location and Stream Data	•	Crossing Characteristics	-
Comments: Wetland like habitat above and below, culvert is made of wood but intact. Damage on top of culvert on outlet (missing plank). 16:24

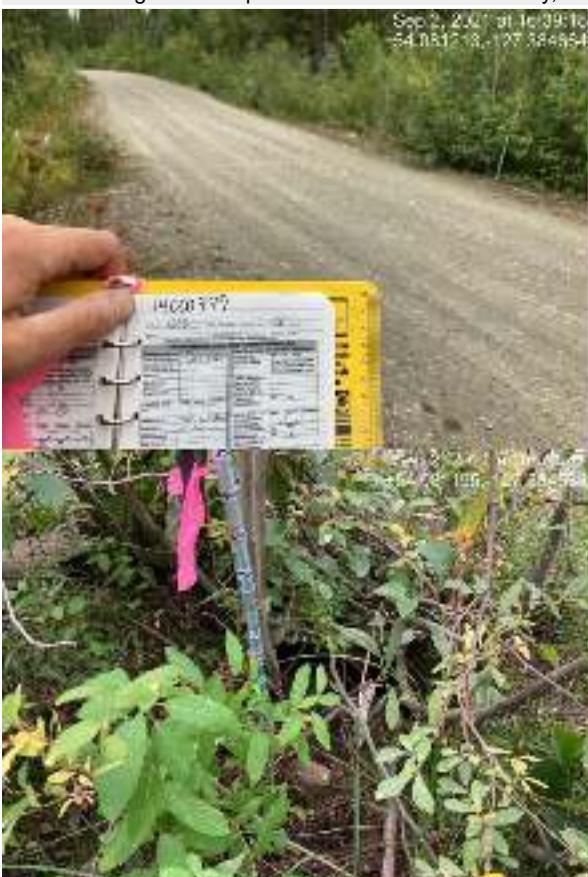
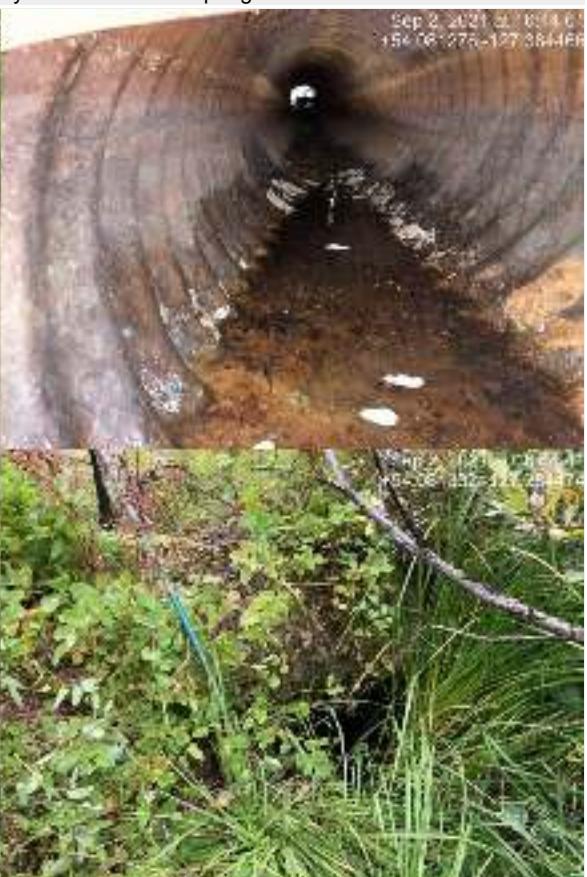
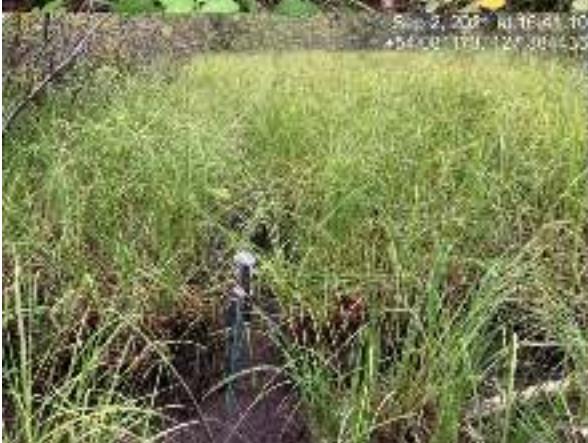
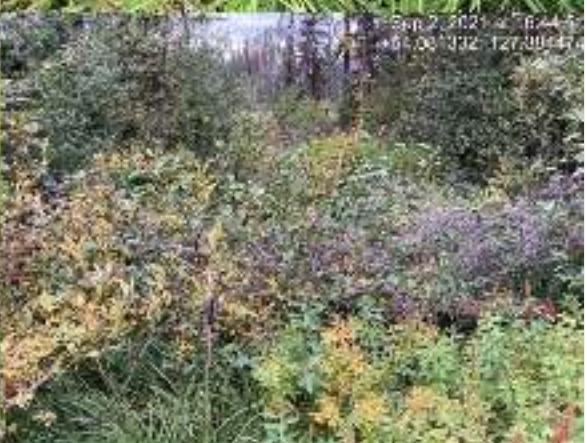
Photos: PSCIS ID 198014. From top left clockwise: Road/Site Card, Barrel, Outlet, Downstream, Upstream, Inlet.

Location and Stream Data		•	Crossing Characteristics	-
Date	2021-09-02		Crossing Sub Type	Round Culvert
PSCIS ID	198014		Diameter (m)	0.9
External ID	14000779		Length (m)	10
Crew	KP		Embedded	No
UTM Zone	9		Depth Embedded (m)	-
Easting	605675		Resemble Channel	Yes
Northing	5993744		Backwatered	No
Stream	Tributary to McBride River		Percent Backwatered	-
Road	Morice FSR		Fill Depth (m)	0.3
Road Tenure	FLNR DND 4656		Outlet Drop (m)	0
Channel Width (m)	0.9		Outlet Pool Depth (m)	0
Stream Slope (%)	0.5		Inlet Drop	No
Beaver Activity	No		Slope (%)	0.5
Habitat Value	Medium		Valley Fill	Deep Fill
Final score	13		Barrier Result	Passable
Fix type	-		Fix Span / Diameter	-

Location and Stream Data	•	Crossing Characteristics	-
Comments: Wetland habitat on both sides of crossing. Inlet hard to find, has major vegetation growth coming out of it and is ~1m higher than upstream substrate. Channel dry, likely backwatered for spring flow. 16:38

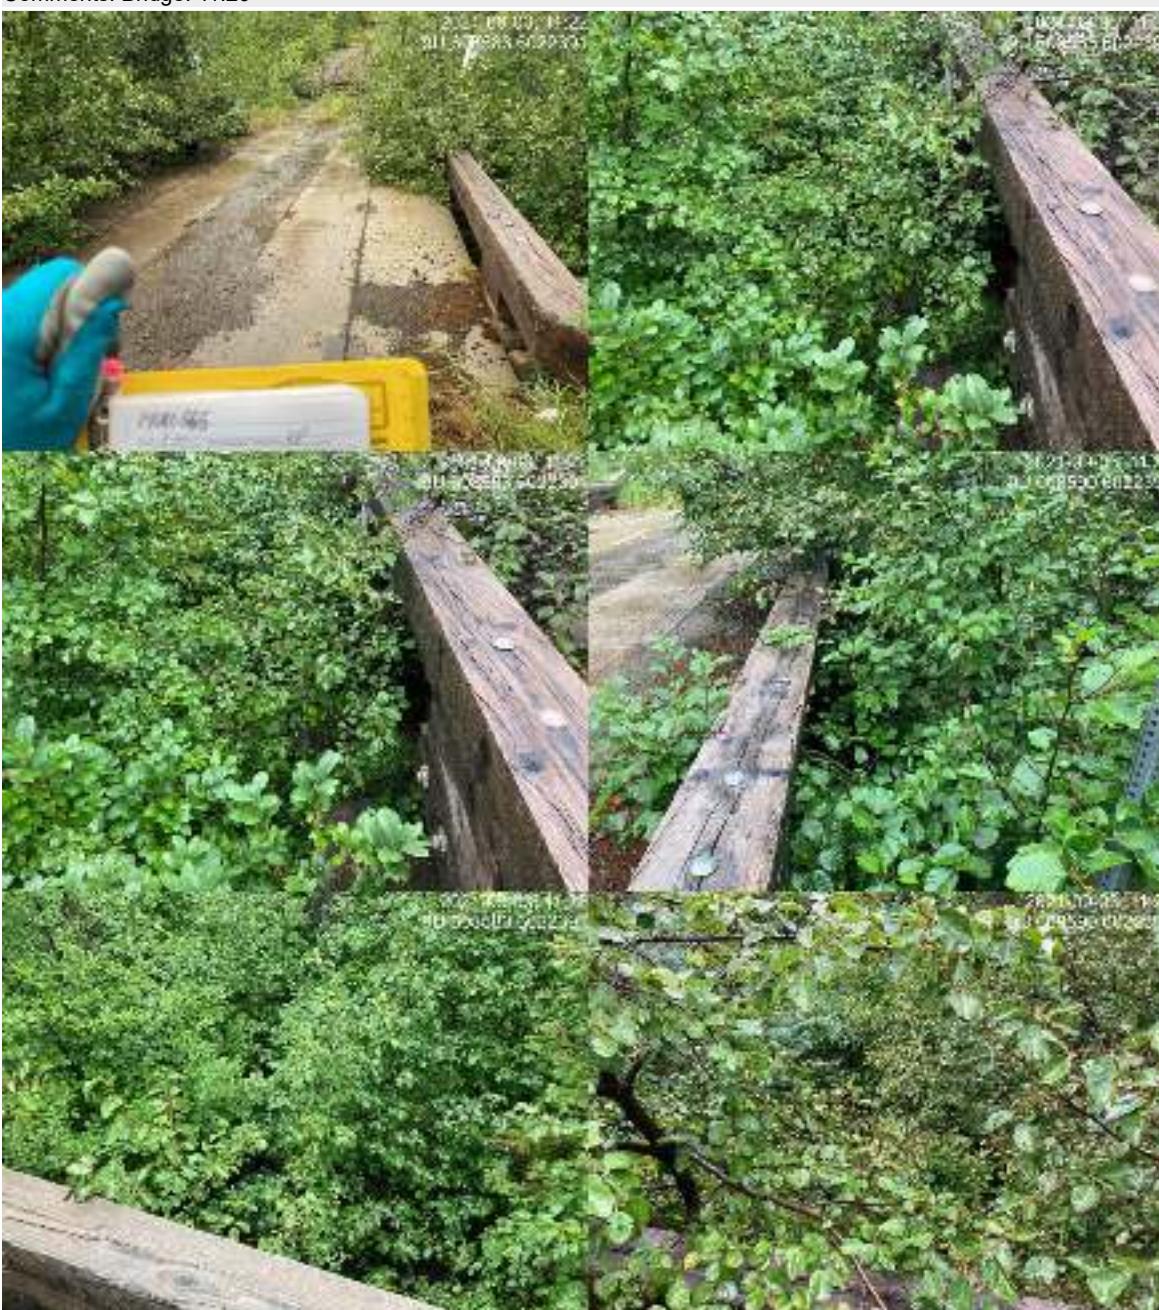
Photos: PSCIS ID 198015. From top left clockwise: Road/Site Card, Barrel, Outlet, Downstream, Upstream, Inlet.

Location and Stream Data	.	Crossing Characteristics	-
Date	2021-09-03	Crossing Sub Type	Bridge
PSCIS ID	198015	Diameter (m)	13
External ID	14000565	Length (m)	4
Crew	KP	Embedded	-
UTM Zone	9	Depth Embedded (m)	-
Easting	608574.3	Resemble Channel	-
Northing	6022389	Backwatered	-
Stream	Tributary to Thautil River	Percent Backwatered	-
Road	Chisholm FSR	Fill Depth (m)	-
Road Tenure	West Fraser R05232	Outlet Drop (m)	-
Channel Width (m)	-	Outlet Pool Depth (m)	-
Stream Slope (%)	-	Inlet Drop	-
Beaver Activity	-	Slope (%)	-
Habitat Value	-	Valley Fill	-
Final score	0	Barrier Result	Passable
Fix type	-	Fix Span / Diameter	-

Location and Stream Data	•	Crossing Characteristics	-
Comments: Bridge. 11:20

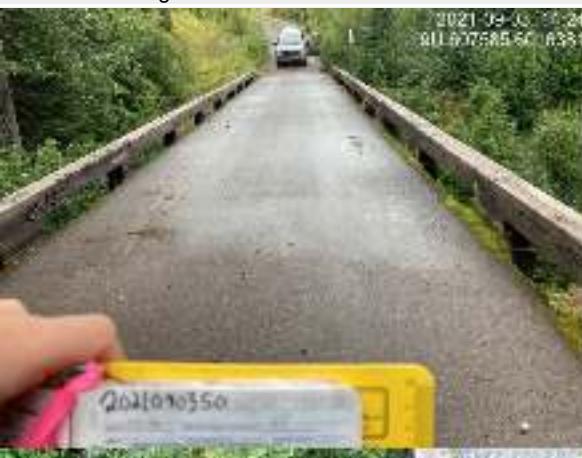
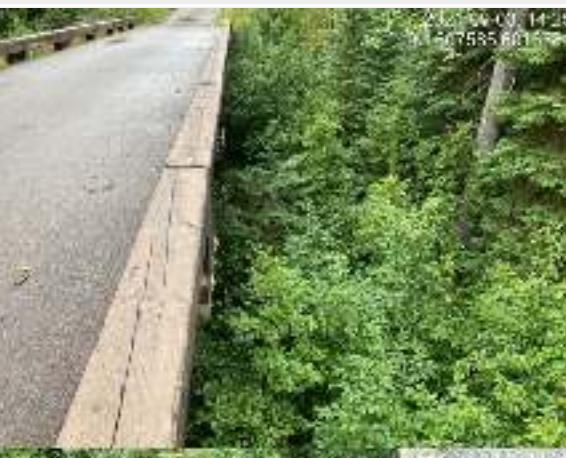
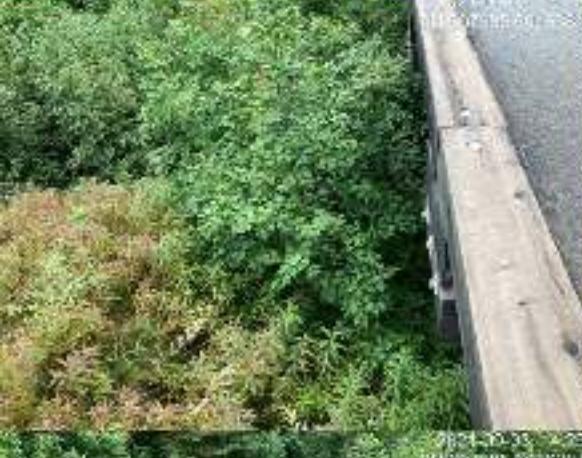
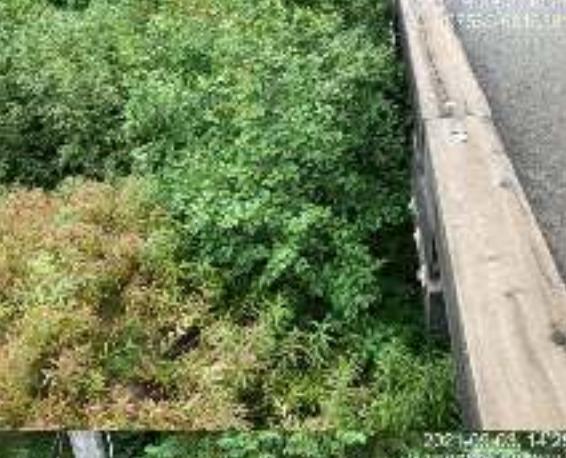
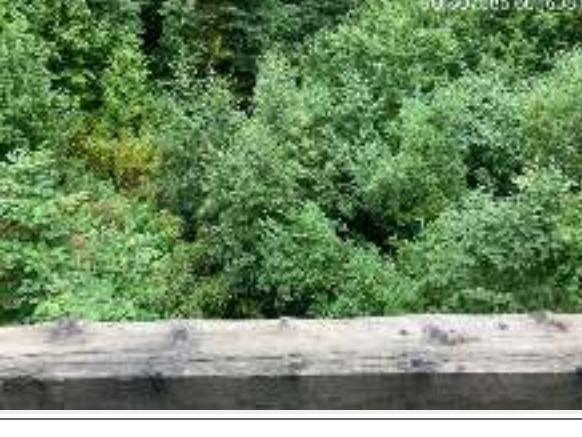
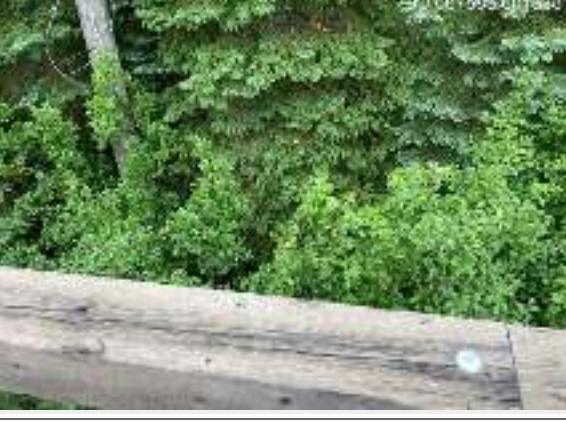
Photos: PSCIS ID 198017. From top left clockwise: Road/Site Card, Barrel, Outlet, Downstream, Upstream, Inlet.

Location and Stream Data	.	Crossing Characteristics	-
Date	2021-09-03	Crossing Sub Type	Bridge
PSCIS ID	198017	Diameter (m)	25
External ID	14000702	Length (m)	5
Crew	KP	Embedded	-
UTM Zone	9	Depth Embedded (m)	-
Easting	607585	Resemble Channel	-
Northing	6016381	Backwatered	-
Stream	Tributary to Thautil River	Percent Backwatered	-
Road	Chisholm FSR	Fill Depth (m)	-
Road Tenure	FLNR DND 9946	Outlet Drop (m)	-
Channel Width (m)	-	Outlet Pool Depth (m)	-
Stream Slope (%)	-	Inlet Drop	-
Beaver Activity	-	Slope (%)	-
Habitat Value	-	Valley Fill	-
Final score	0	Barrier Result	Passable
Fix type	-	Fix Span / Diameter	-

Location and Stream Data	•	Crossing Characteristics	-
Comments: Bridge. 14:22

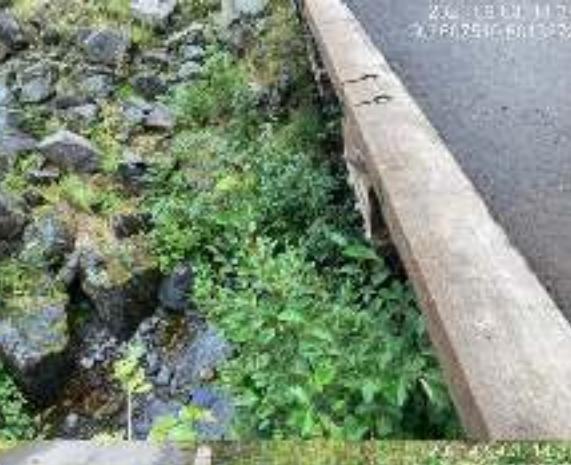
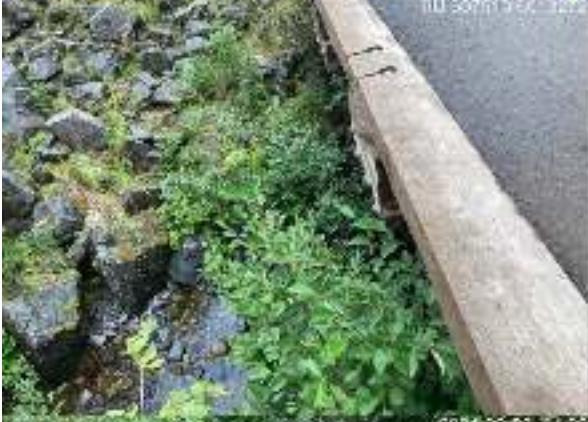
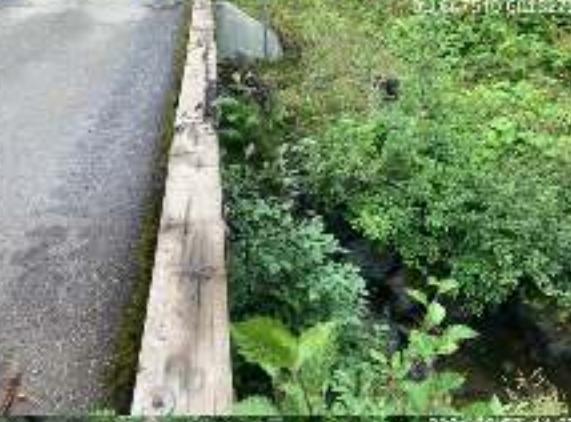
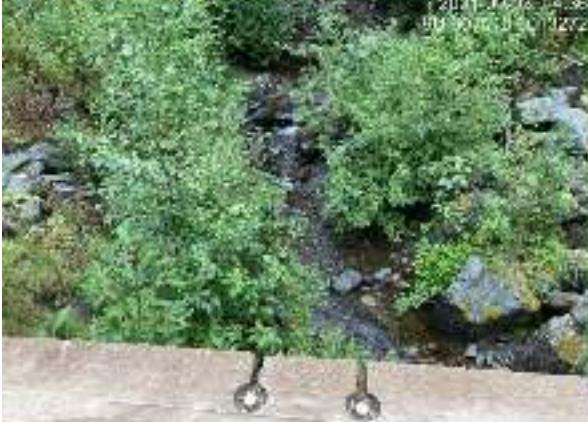
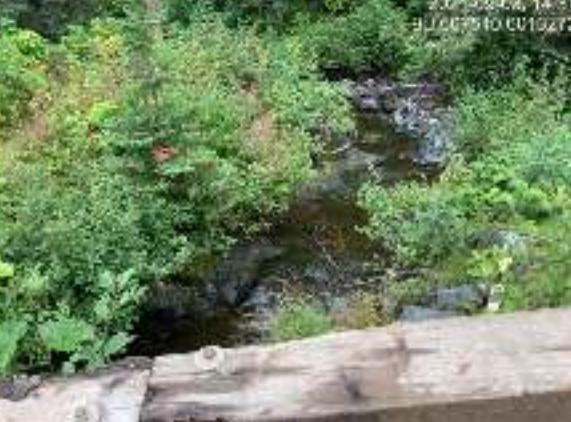
Photos: PSCIS ID 198018. From top left clockwise: Road/Site Card, Barrel, Outlet, Downstream, Upstream, Inlet.

Location and Stream Data	.	Crossing Characteristics	-
Date	2021-09-03	Crossing Sub Type	Bridge
PSCIS ID	198018	Diameter (m)	11
External ID	14000685	Length (m)	4
Crew	KP	Embedded	-
UTM Zone	9	Depth Embedded (m)	-
Easting	607509	Resemble Channel	-
Northing	6013247	Backwatered	-
Stream	Tributary to Thautil River	Percent Backwatered	-
Road	Chisholm FSR	Fill Depth (m)	-
Road Tenure	FLNR DND 9946	Outlet Drop (m)	-
Channel Width (m)	-	Outlet Pool Depth (m)	-
Stream Slope (%)	-	Inlet Drop	-
Beaver Activity	-	Slope (%)	-
Habitat Value	-	Valley Fill	-
Final score	0	Barrier Result	Passable
Fix type	-	Fix Span / Diameter	-

Location and Stream Data	•	Crossing Characteristics	-
Comments: Bridge. 14:33

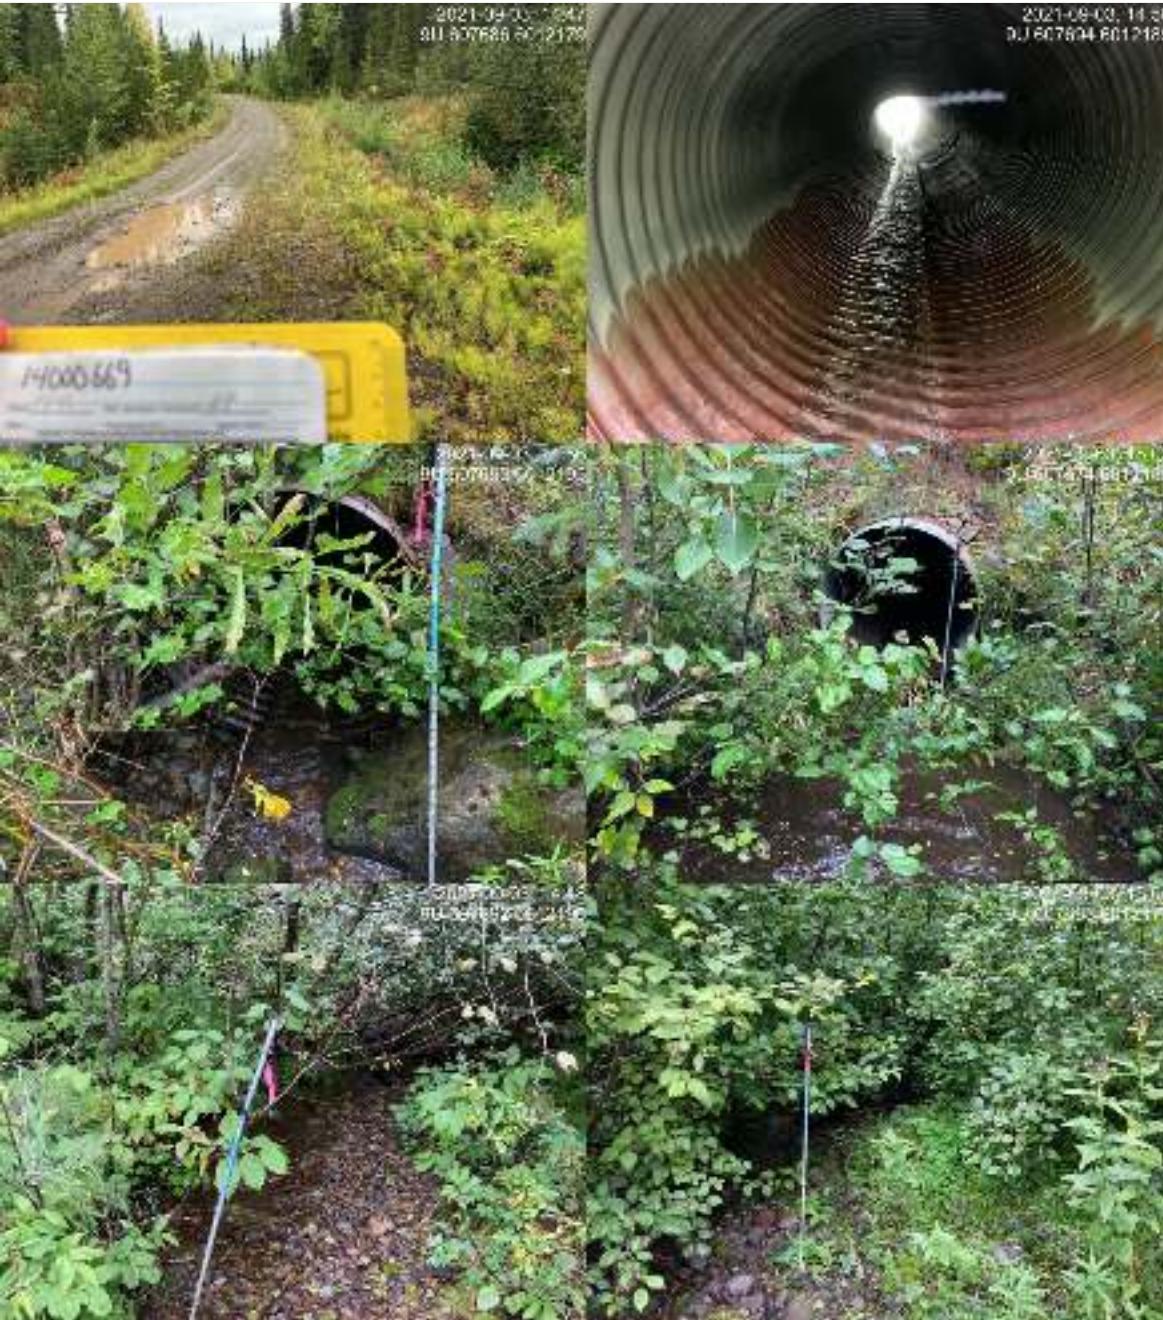
Photos: PSCIS ID 198019. From top left clockwise: Road/Site Card, Barrel, Outlet, Downstream, Upstream, Inlet.

Location and Stream Data		Crossing Characteristics	
Date	2021-09-03	Crossing Sub Type	Round Culvert
PSCIS ID	198019	Diameter (m)	1
External ID	14000669	Length (m)	12
Crew	KP	Embedded	No
UTM Zone	9	Depth Embedded (m)	–
Easting	607690.2	Resemble Channel	No
Northing	6012189	Backwatered	No
Stream	Tributary to Thautil River	Percent Backwatered	–
Road	Chisholm FSR	Fill Depth (m)	2.5
Road Tenure	FLNR DND 9946	Outlet Drop (m)	0.12
Channel Width (m)	1.6	Outlet Pool Depth (m)	0.5
Stream Slope (%)	5	Inlet Drop	Yes
Beaver Activity	No	Slope (%)	4.5
Habitat Value	Medium	Valley Fill	Deep Fill
Final score	26	Barrier Result	Barrier
Fix type	Replace Structure with Streambed Simulation CBS	Fix Span / Diameter	3

Location and Stream Data	•	Crossing Characteristics	-
Comments: Initially ~1.6m channel, then ~40m upstream goes underground and channel down to 1.1 or 0.9m. Inlet drop ~0.25m in front of inlet. Culvert slope challenging due to angle and deformed middle of culvert. 14:46

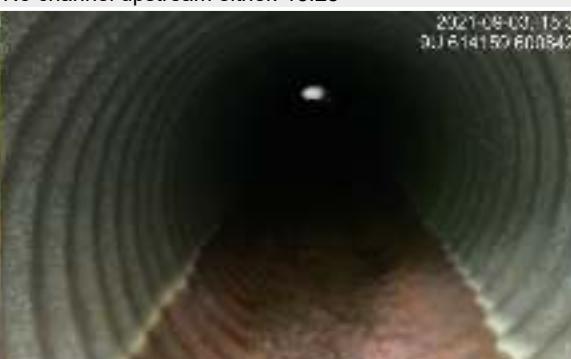
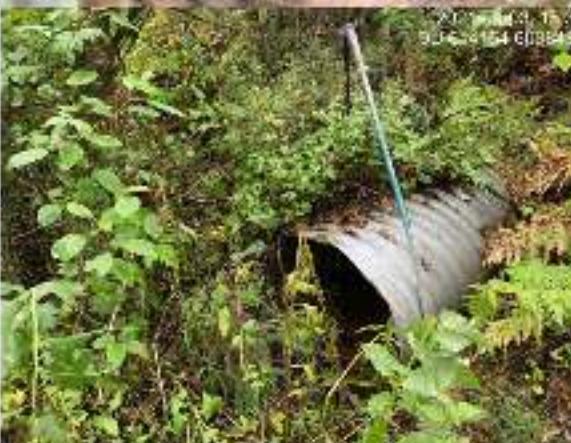
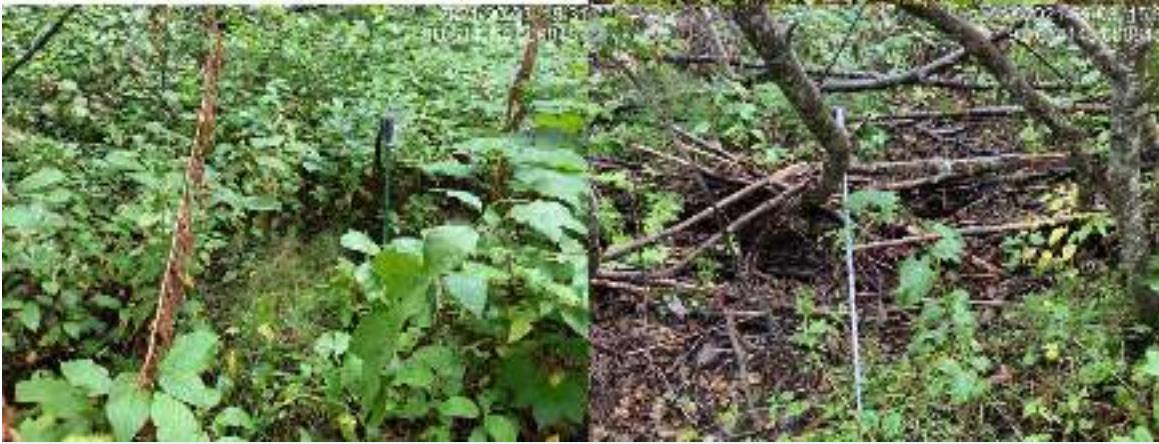
Photos: PSCIS ID 198020. From top left clockwise: Road/Site Card, Barrel, Outlet, Downstream, Upstream, Inlet.

Location and Stream Data		Crossing Characteristics	
Date	2021-09-03	Crossing Sub Type	Round Culvert
PSCIS ID	198020	Diameter (m)	0.6
External ID	14000688	Length (m)	16
Crew	KP	Embedded	No
UTM Zone	9	Depth Embedded (m)	—
Easting	614148.2	Resemble Channel	No
Northing	6008425	Backwatered	No
Stream	Tributary to Thault River	Percent Backwatered	—
Road	Chisholm FSR	Fill Depth (m)	2.5
Road Tenure	FLNR DND 9946	Outlet Drop (m)	0
Channel Width (m)	0	Outlet Pool Depth (m)	0
Stream Slope (%)	4	Inlet Drop	No
Beaver Activity	No	Slope (%)	5
Habitat Value	Low	Valley Fill	Deep Fill
Final score	23	Barrier Result	Barrier
Fix type	Replace Structure with Streambed Simulation CBS	Fix Span / Diameter	3

Location and Stream Data	•	Crossing Characteristics	-
Comments: No channel found downstream. Not fish habitat. No channel upstream either. 15:28

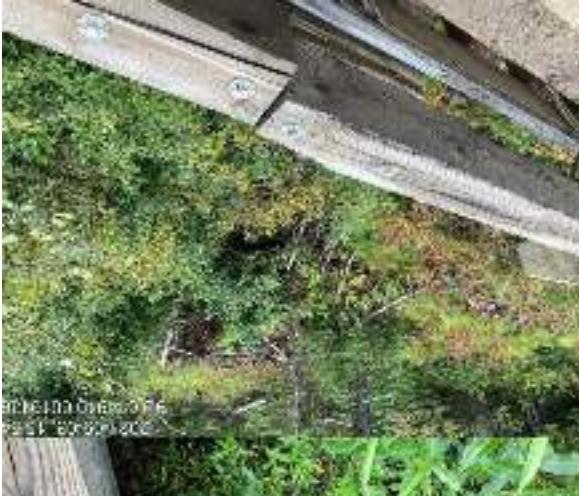
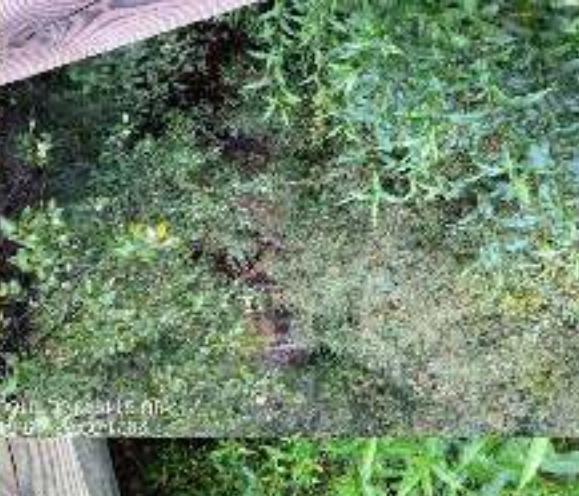
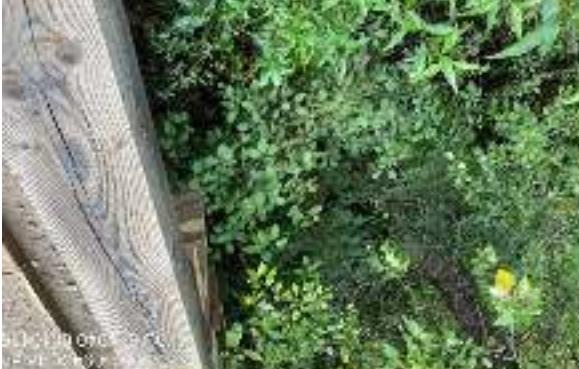
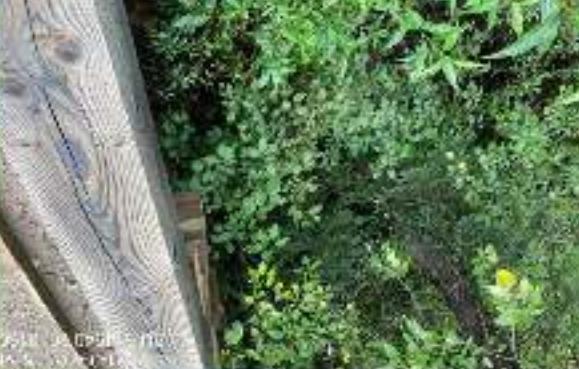
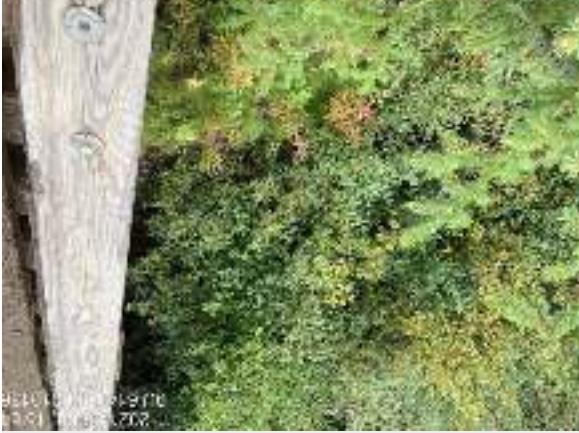
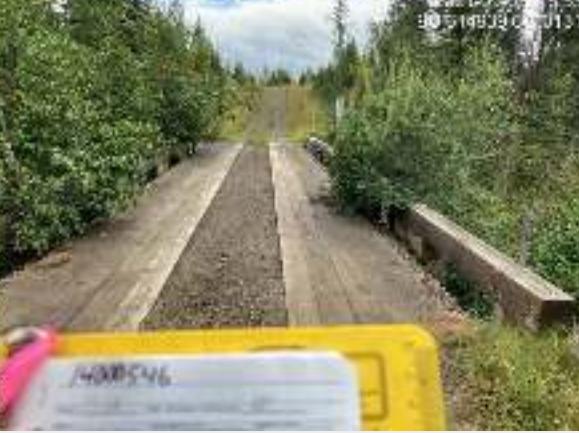
Photos: PSCIS ID 198021. From top left clockwise: Road/Site Card, Barrel, Outlet, Downstream, Upstream, Inlet.

Location and Stream Data	•	Crossing Characteristics	-
Comments: Bridge. 15:52

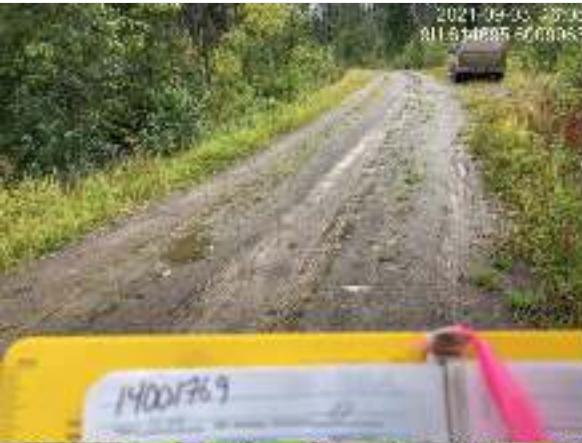
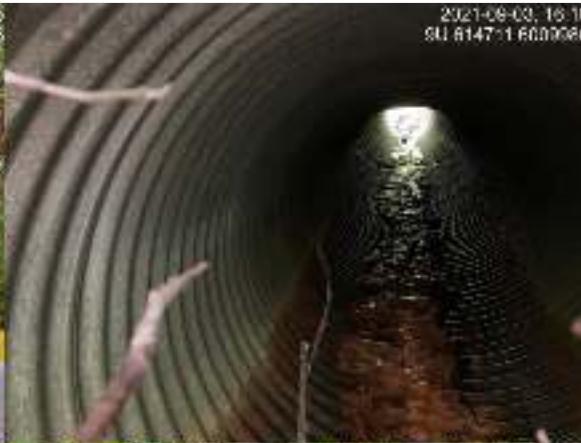
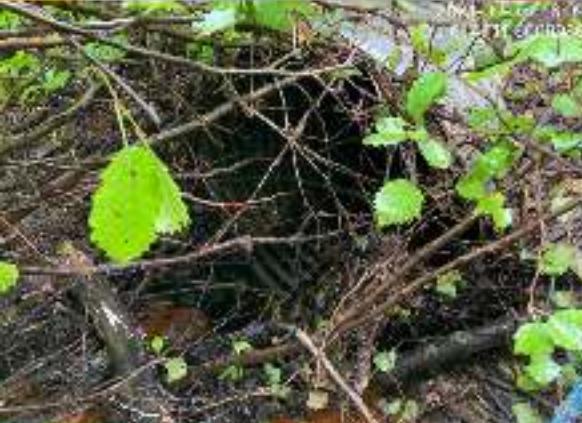
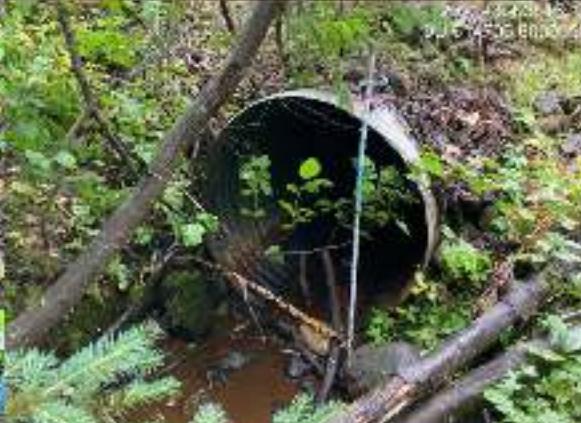
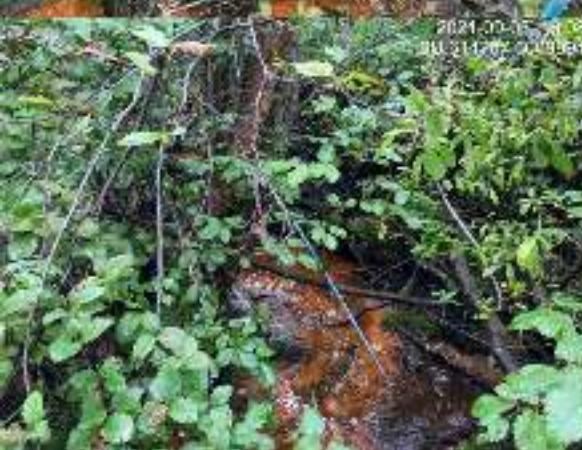
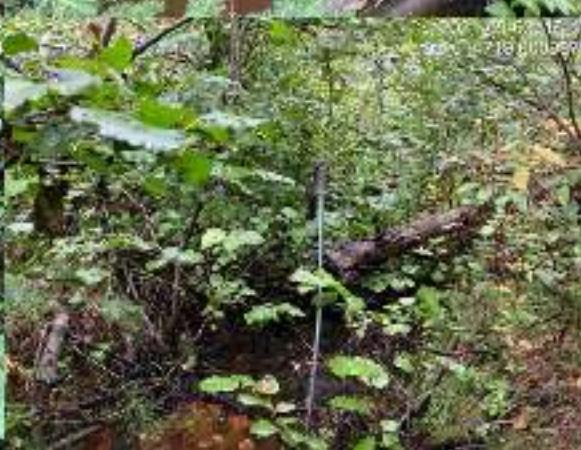
Photos: PSCIS ID 198022. From top left clockwise: Road/Site Card, Barrel, Outlet, Downstream, Upstream, Inlet.

Location and Stream Data		Crossing Characteristics	
Date	2021-09-03	Crossing Sub Type	Round Culvert
PSCIS ID	198022	Diameter (m)	1
External ID	14001769	Length (m)	11
Crew	KP	Embedded	No
UTM Zone	9	Depth Embedded (m)	–
Easting	614711.5	Resemble Channel	No
Northing	6009971	Backwatered	Yes
Stream	Tributary to Tagit Creek	Percent Backwatered	10
Road	5 Road	Fill Depth (m)	2
Road Tenure	Resource	Outlet Drop (m)	0
Channel Width (m)	1.4	Outlet Pool Depth (m)	0.3
Stream Slope (%)	4.5	Inlet Drop	Yes
Beaver Activity	No	Slope (%)	3.5
Habitat Value	Medium	Valley Fill	Deep Fill
Final score	26	Barrier Result	Barrier
Fix type	Replace Structure with Streambed Simulation CBS	Fix Span / Diameter	3

Location and Stream Data	•	Crossing Characteristics	-
Comments: No beaver activity observed but suspected beaver dam upstream due to slow/low flow, and reddish brown algae observed at other beaver site. Inlet drop 0.27. Backwatered a little with pool downstream. Slope tough due to big bend in middle of culvert. 16:04

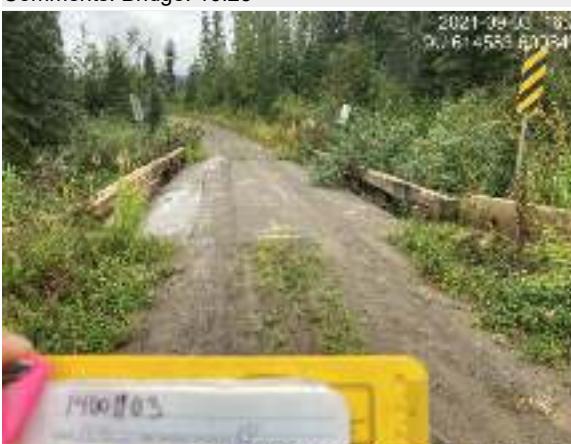
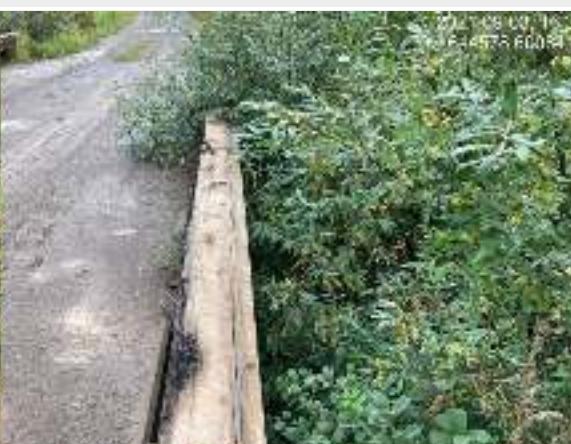
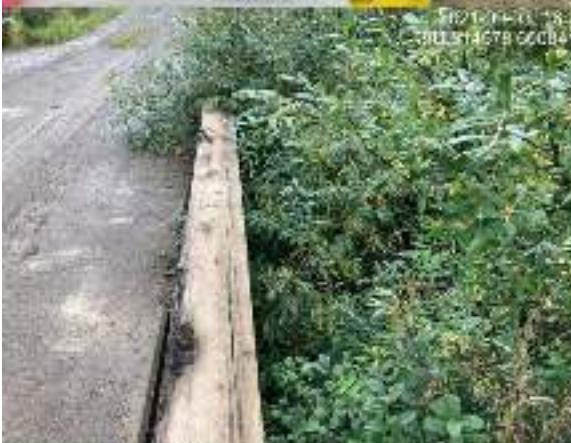
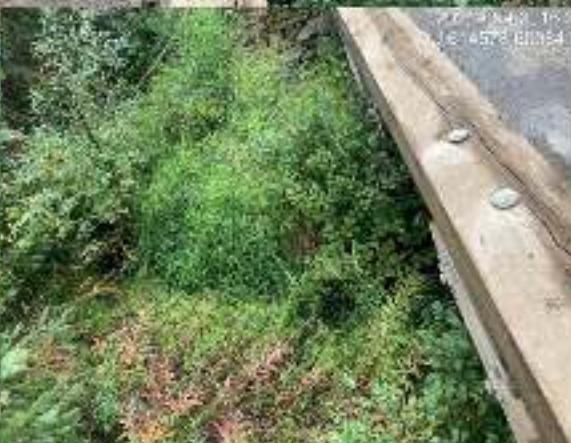
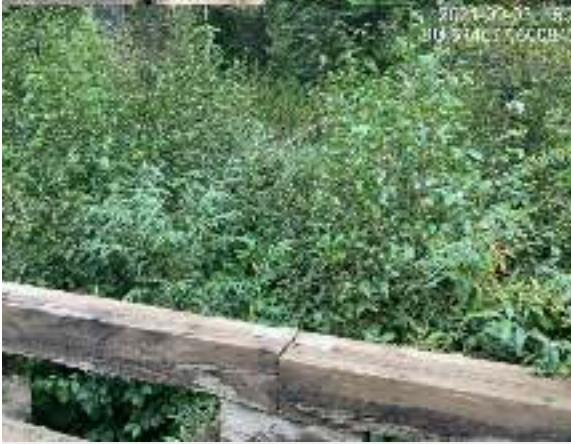
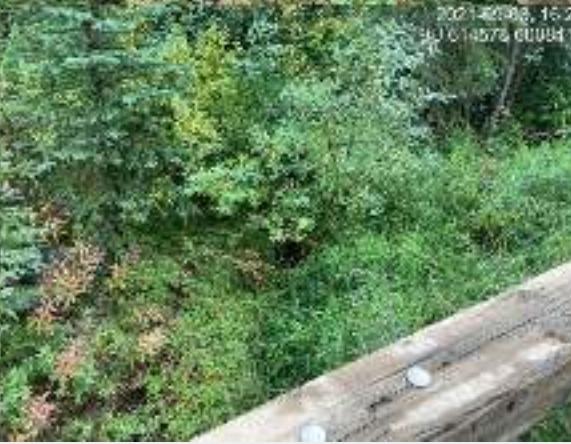
Photos: PSCIS ID 198023. From top left clockwise: Road/Site Card, Barrel, Outlet, Downstream, Upstream, Inlet.

Location and Stream Data	•	Crossing Characteristics	-
Comments: Bridge. 16:25

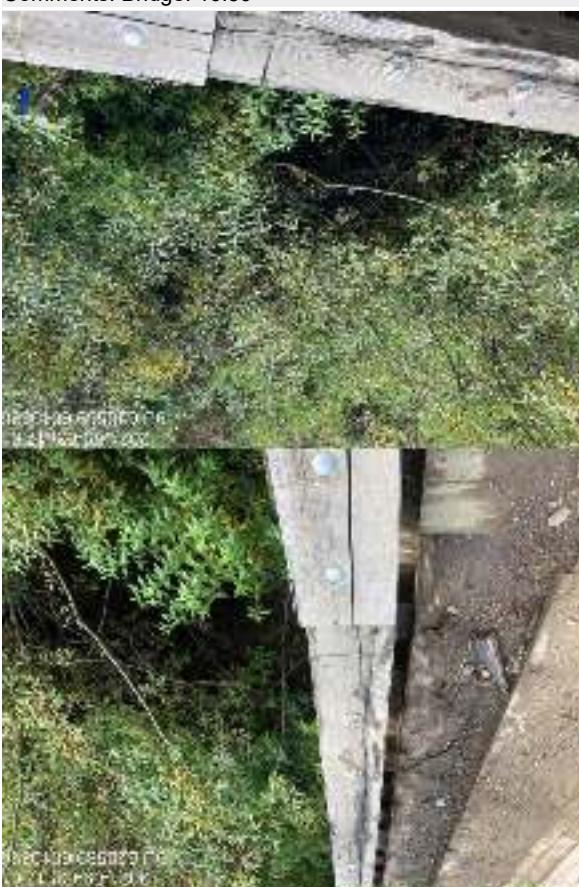
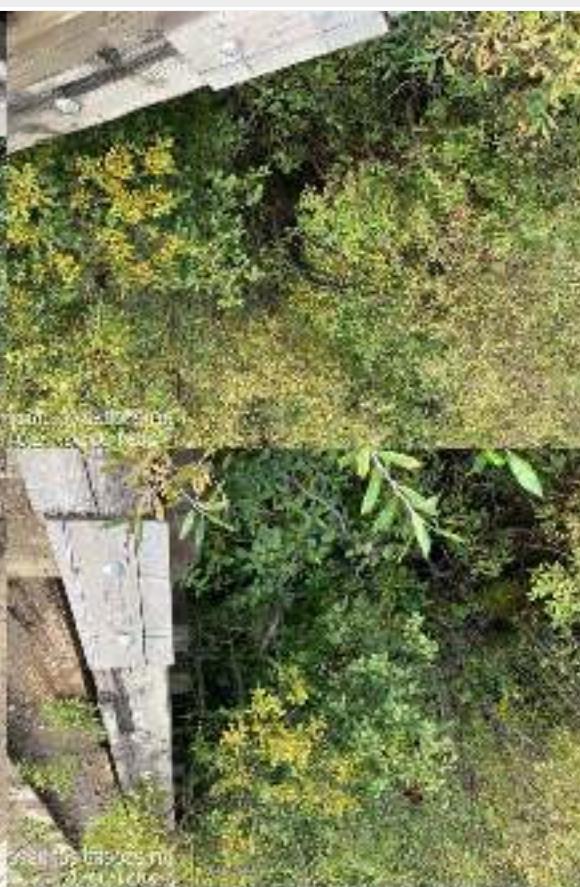
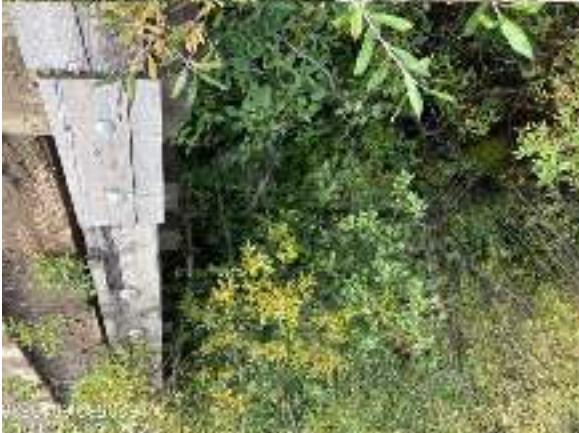
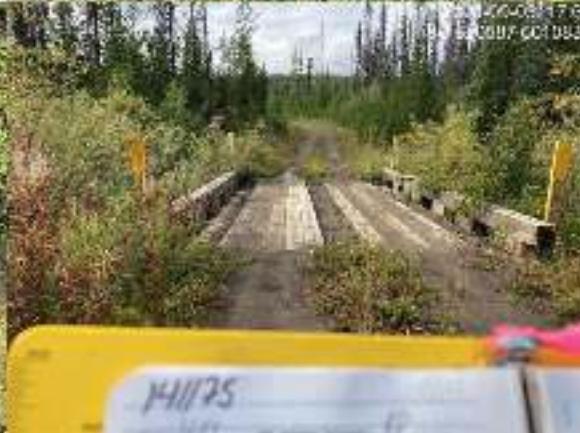
Photos: PSCIS ID 198024. From top left clockwise: Road/Site Card, Barrel, Outlet, Downstream, Upstream, Inlet.

Location and Stream Data	•	Crossing Characteristics	-
Comments: Bridge. 16:59
