Appendix - Phase 1 Fish Passage Assessment Data and Photos

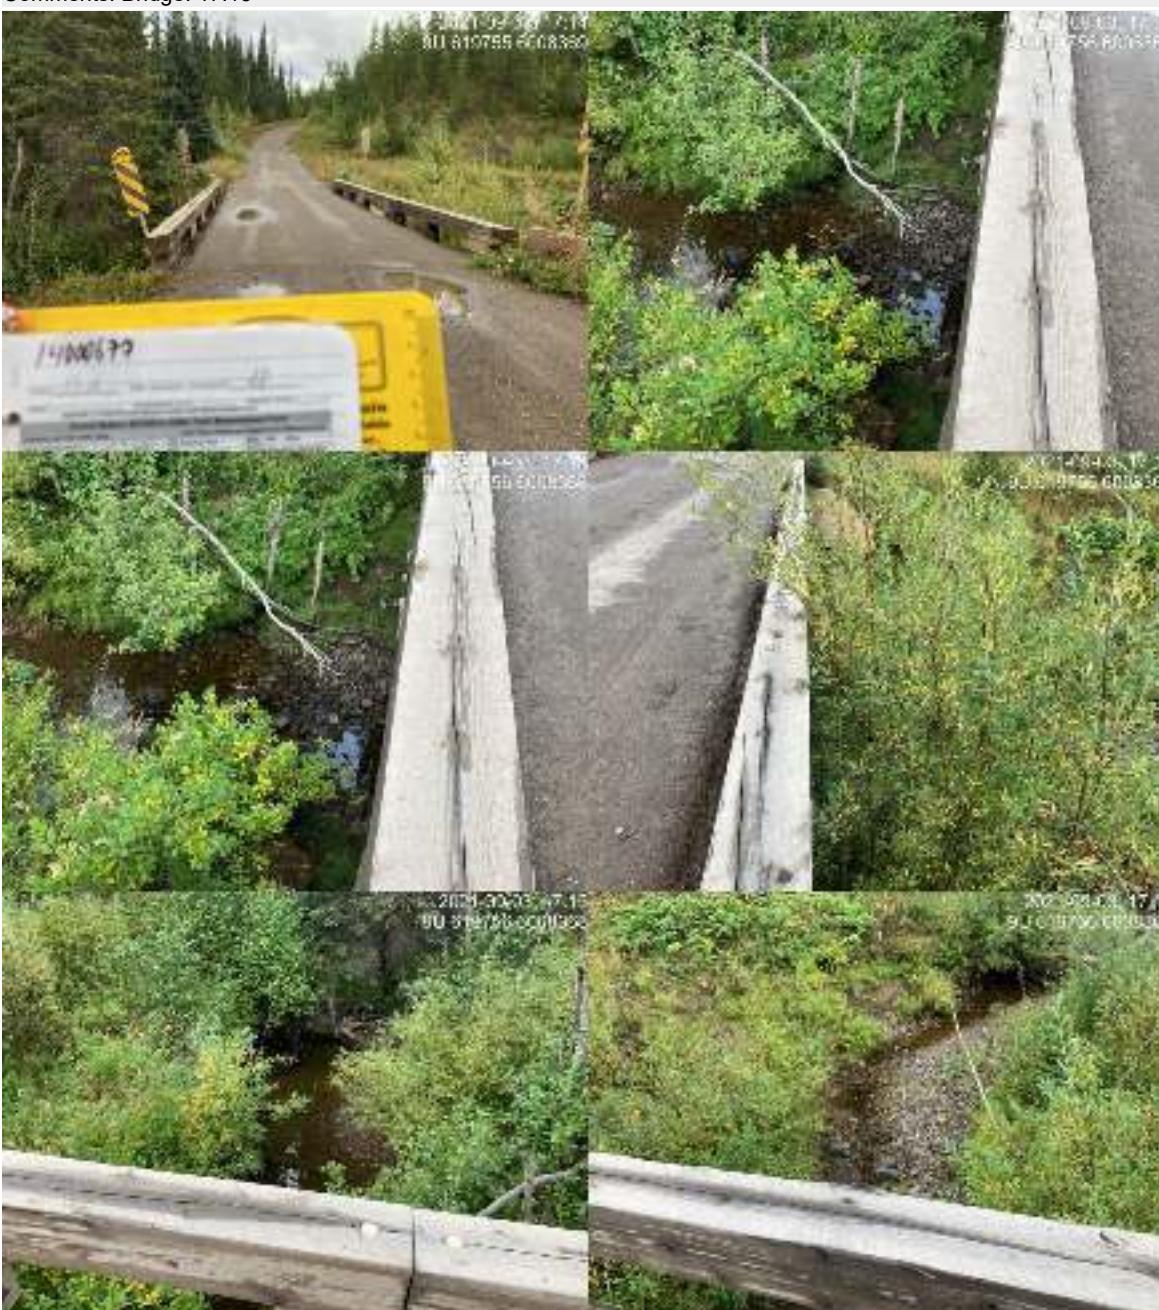
Photos: PSCIS ID 198025. From top left clockwise: Road/Site Card, Barrel, Outlet, Downstream, Upstream, Inlet.

Location and Stream Data	•	Crossing Characteristics	-
Comments: Bridge. 17:13

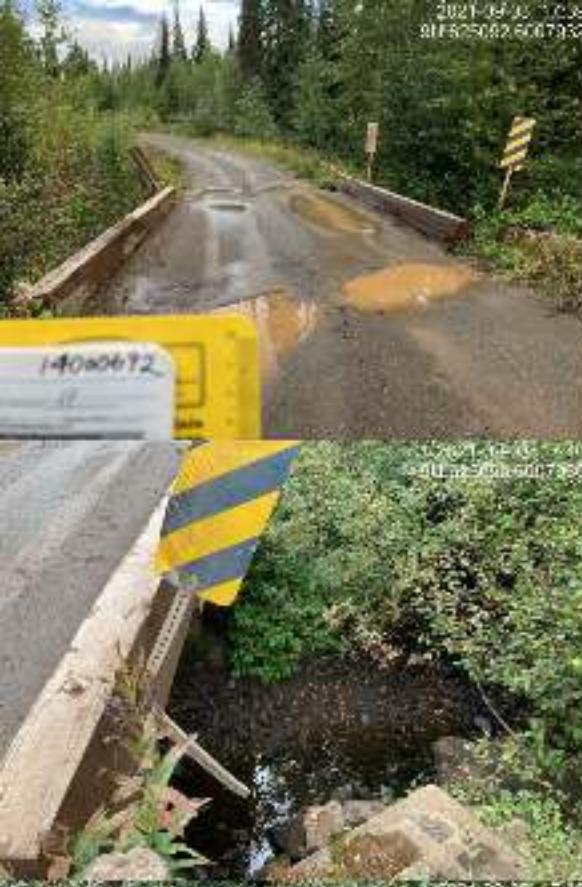
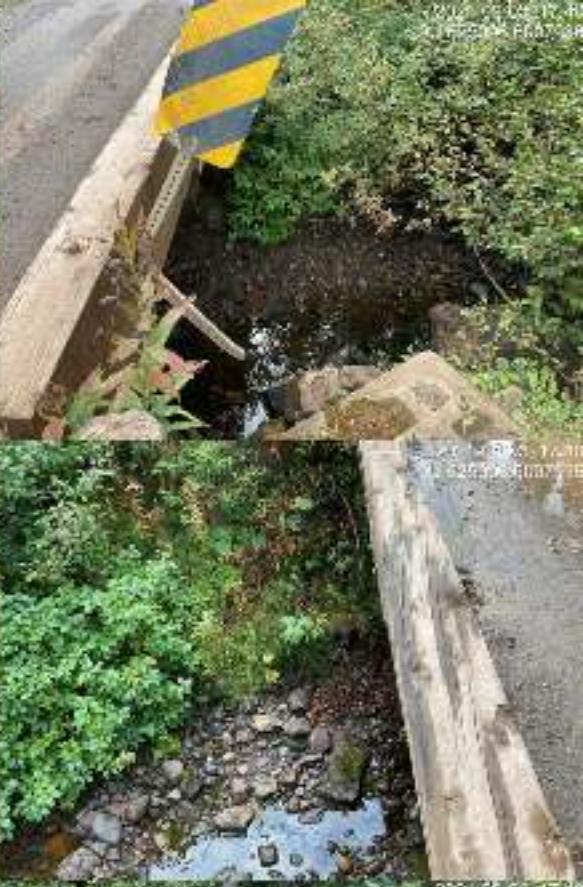
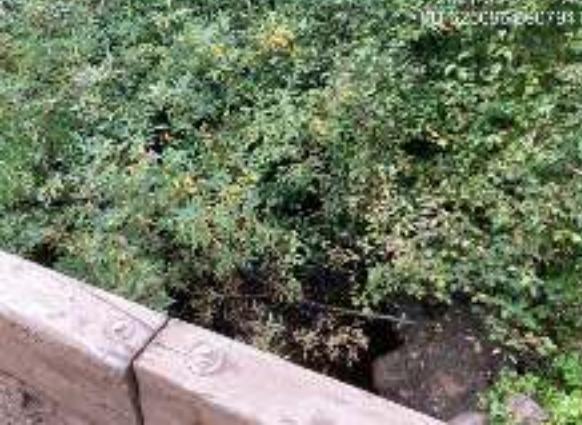
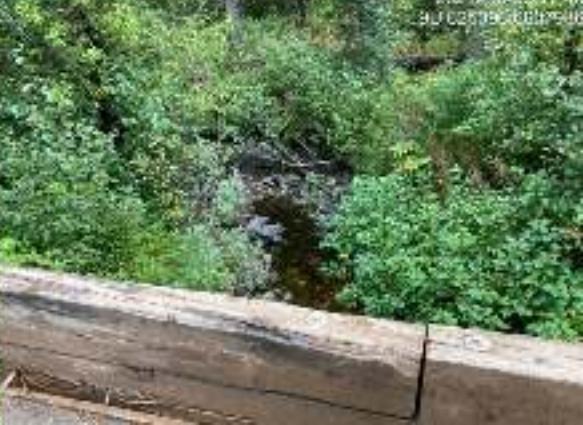
Photos: PSCIS ID 198027. From top left clockwise: Road/Site Card, Barrel, Outlet, Downstream, Upstream, Inlet.

Location and Stream Data	•	Crossing Characteristics	-
Comments: Bridge. 17:38

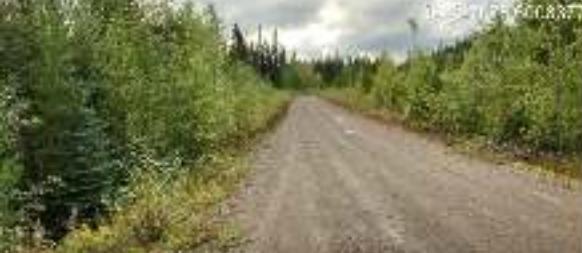
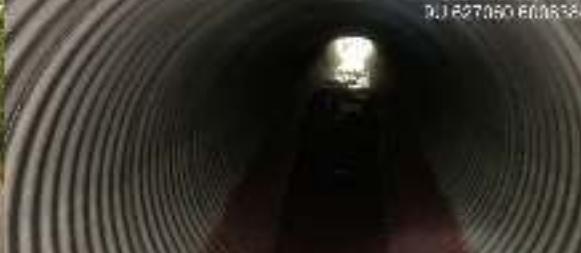
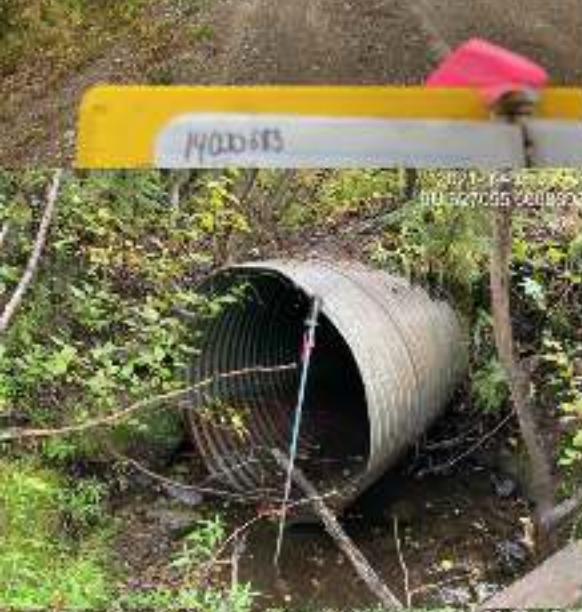
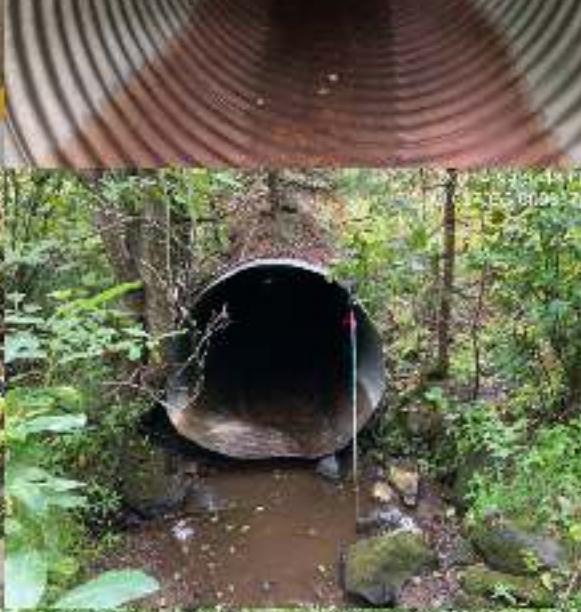
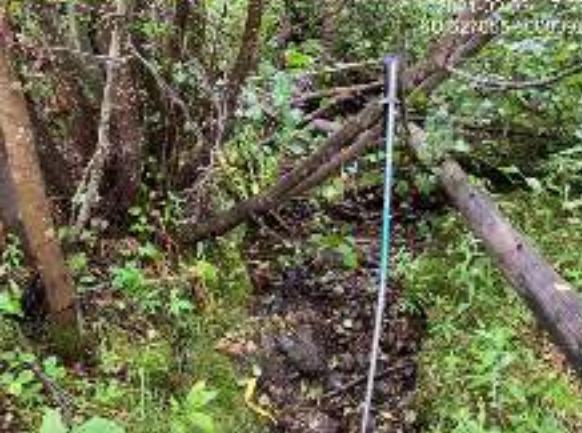
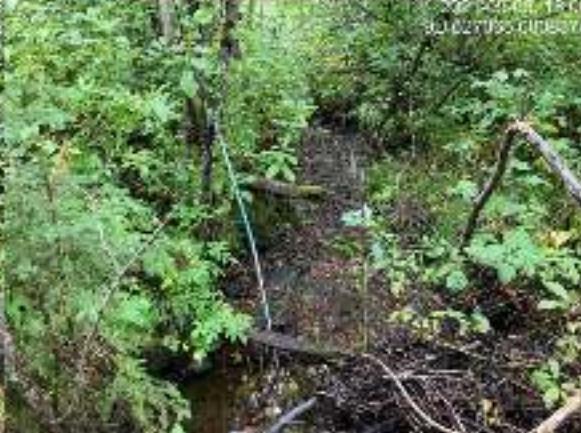
Photos: PSCIS ID 198028. From top left clockwise: Road/Site Card, Barrel, Outlet, Downstream, Upstream, Inlet.

Location and Stream Data		Crossing Characteristics	
Date	2021-09-03	Crossing Sub Type	Round Culvert
PSCIS ID	198028	Diameter (m)	1.2
External ID	14000683	Length (m)	17
Crew	KP	Embedded	No
UTM Zone	9	Depth Embedded (m)	—
Easting	627065	Resemble Channel	No
Northing	6008380	Backwatered	No
Stream	Tributary to Thautil River	Percent Backwatered	—
Road	Chisholm FSR	Fill Depth (m)	2
Road Tenure	FLNR DND 9946	Outlet Drop (m)	0.12
Channel Width (m)	1.1	Outlet Pool Depth (m)	0.17
Stream Slope (%)	5	Inlet Drop	No
Beaver Activity	No	Slope (%)	3.5
Habitat Value	Low	Valley Fill	Deep Fill
Final score	23	Barrier Result	Barrier
Fix type	Replace Structure with Streambed Simulation CBS	Fix Span / Diameter	3

Location and Stream Data	•	Crossing Characteristics	-
Comments: No water flowing however pools of stagnant water throughout. Culvert bent in the middle and appears to have some substrate and stagnant water in the middle. 17:49

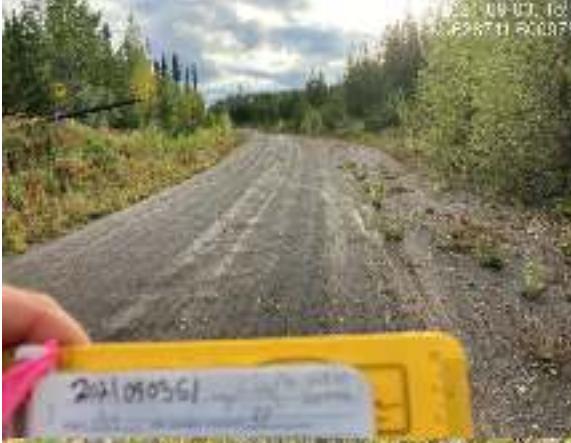
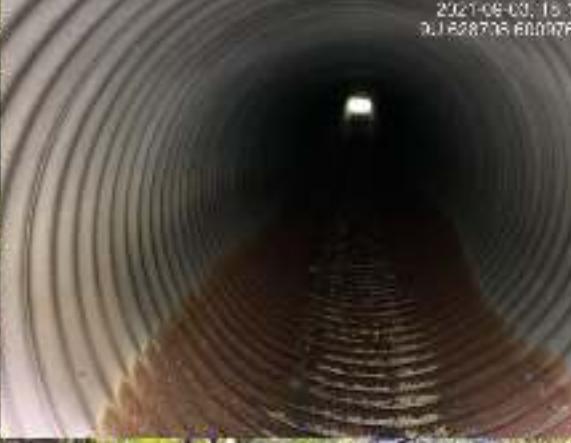
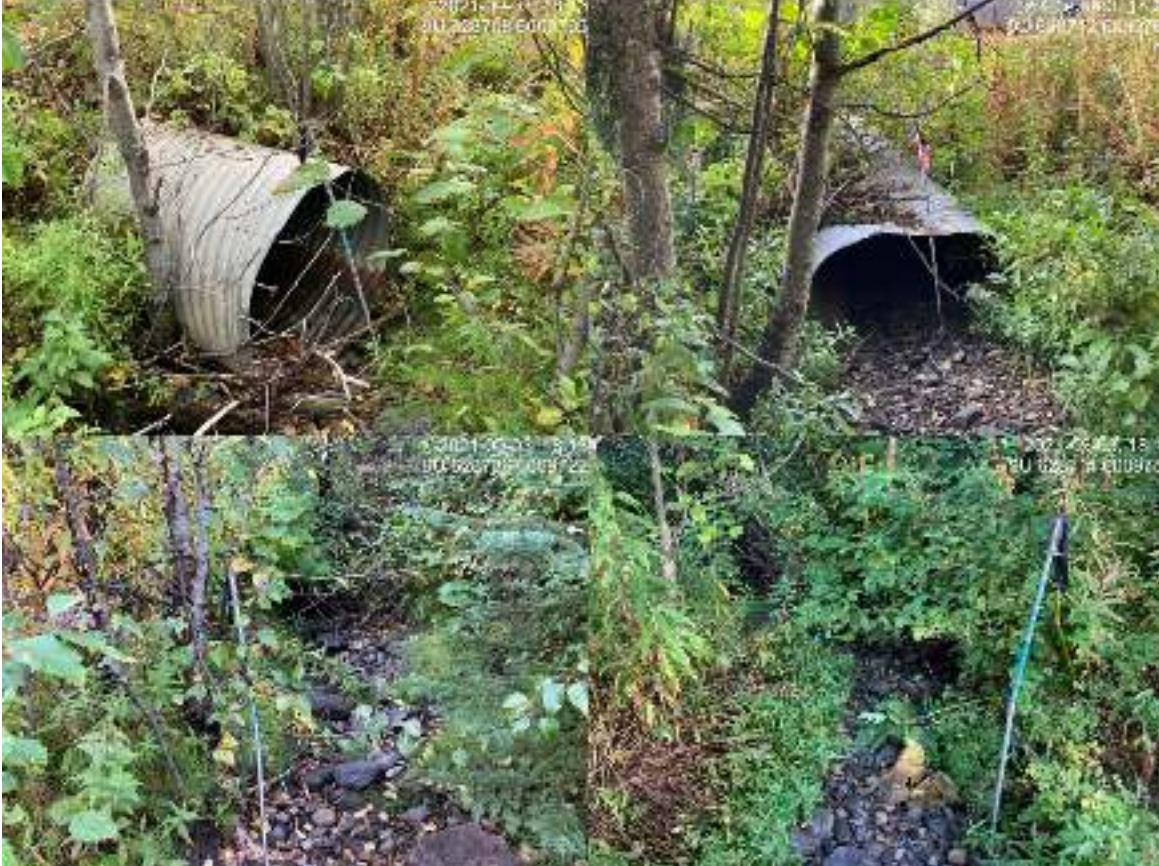
Photos: PSCIS ID 198029. From top left clockwise: Road/Site Card, Barrel, Outlet, Downstream, Upstream, Inlet.

Location and Stream Data		Crossing Characteristics	
Date	2021-09-03	Crossing Sub Type	Round Culvert
PSCIS ID	198029	Diameter (m)	1
External ID	14000694	Length (m)	21
Crew	KP	Embedded	No
UTM Zone	9	Depth Embedded (m)	–
Easting	628708	Resemble Channel	No
Northing	6009766	Backwatered	No
Stream	Tributary to Thautil River	Percent Backwatered	–
Road	Chisholm FSR	Fill Depth (m)	1
Road Tenure	FLNR DND 9946	Outlet Drop (m)	0
Channel Width (m)	0.9	Outlet Pool Depth (m)	0
Stream Slope (%)	7	Inlet Drop	Yes
Beaver Activity	No	Slope (%)	5
Habitat Value	Low	Valley Fill	Deep Fill
Final score	23	Barrier Result	Barrier
Fix type	Replace Structure with Streambed Simulation CBS	Fix Span / Diameter	3

Location and Stream Data	•	Crossing Characteristics	-
Comments: Dry channel, upstream slope estimated. Inlet drop 0.2m. Culvert slope difficult to get due to misshapen structure. Outlet embedded a little bit. 18:09

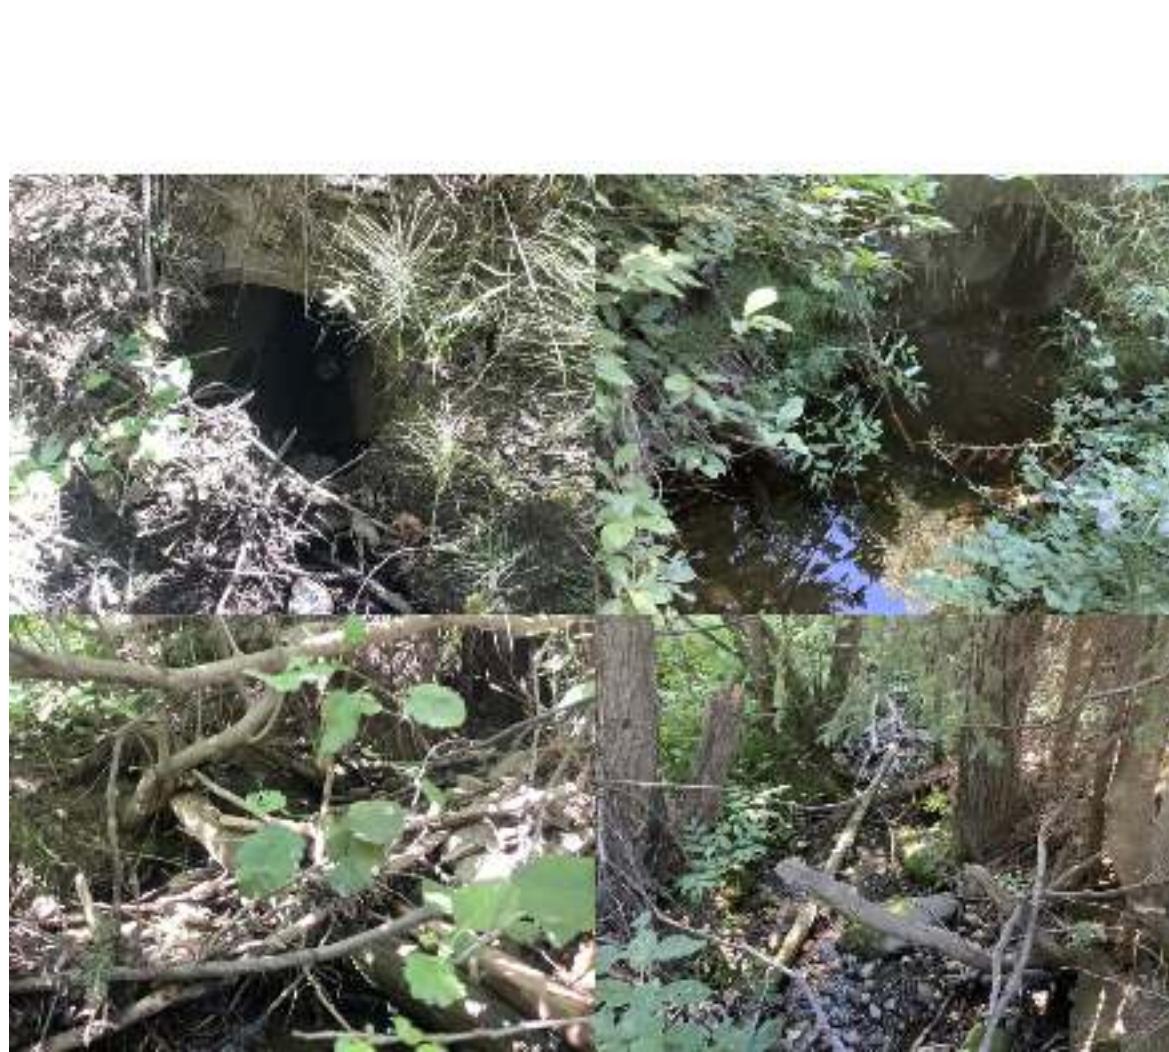
Photos: PSCIS ID 198030. From top left clockwise: Road/Site Card, Barrel, Outlet, Downstream, Upstream, Inlet.

Location and Stream Data		Crossing Characteristics	
	•		-
Date	2021-08-11	Crossing Sub Type	Round Culvert
PSCIS ID	198030	Diameter (m)	0.7
External ID	14000823	Length (m)	12
Crew	LRH DM	Embedded	No
UTM Zone	9	Depth Embedded (m)	-
Easting	623571	Resemble Channel	No
Northing	6001711	Backwatered	No
Stream	Tributary to Lamprey Creek	Percent Backwatered	-
Road	Morice FSR	Fill Depth (m)	1.5
Road Tenure	FLNR DND 4656	Outlet Drop (m)	0.05
Channel Width (m)	1	Outlet Pool Depth (m)	0.45
Stream Slope (%)	15	Inlet Drop	Yes
Beaver Activity	No	Slope (%)	2
Habitat Value	Low	Valley Fill	Deep Fill
Final score	21	Barrier Result	Barrier
Fix type	Replace Structure with Streambed Simulation CBS	Fix Span / Diameter	3

Location and Stream Data	•	Crossing Characteristics	-
Comments: Water flowing in channel up and down stream.			
NO IMAGE AVAILABLE		NO IMAGE AVAILABLE

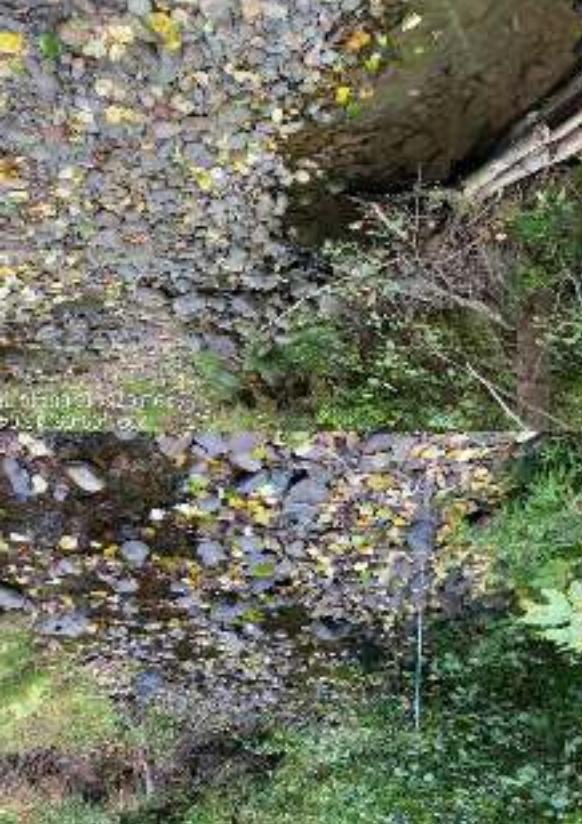
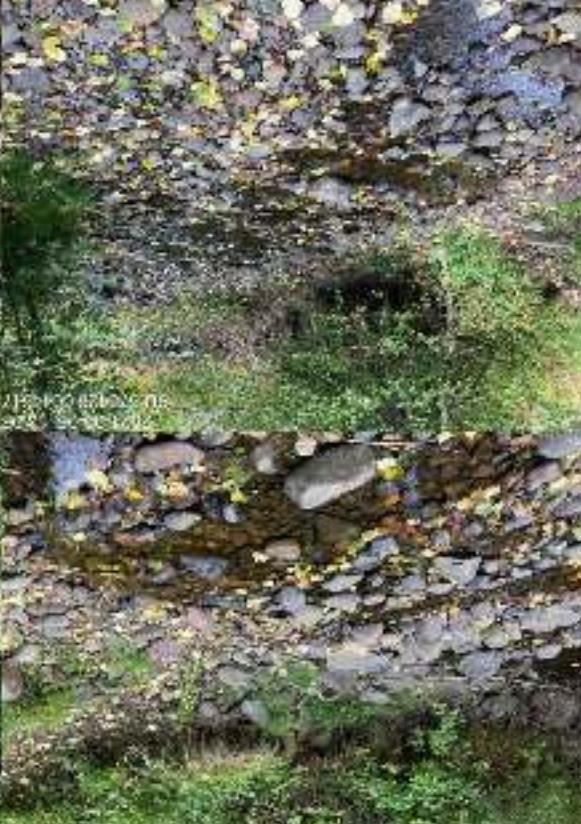
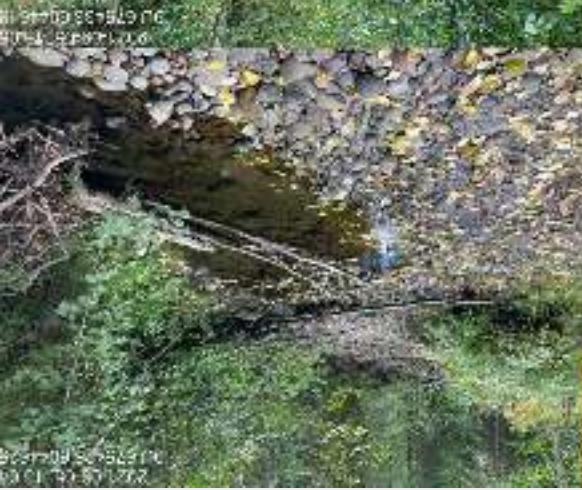
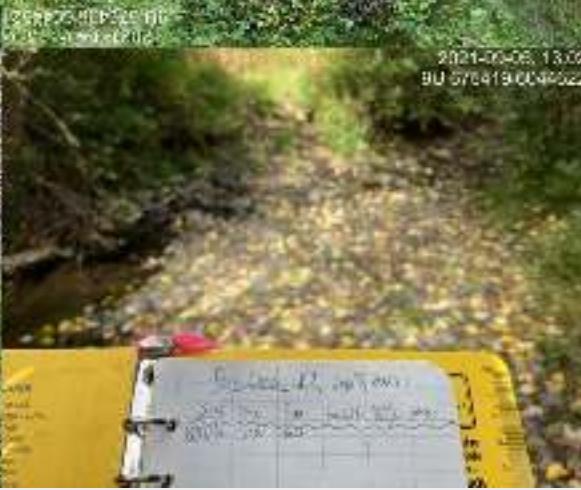
Photos: PSCIS ID 198032. From top left clockwise: Road/Site Card, Barrel, Outlet, Downstream, Upstream, Inlet.

Location and Stream Data	•	Crossing Characteristics	-
Comments: Ford. 13:01

Location and Stream Data	•	Crossing Characteristics	–
Date	2021-09-05	Crossing Sub Type	Ford
PSCIS ID	198032	Diameter (m)	–
External ID	1801165	Length (m)	–
Crew	KP	Embedded	–
UTM Zone	9	Depth Embedded (m)	–
Easting	675402	Resemble Channel	–
Northing	6044909	Backwatered	–
Stream	McRea Creek	Percent Backwatered	–
Road	Spur	Fill Depth (m)	–
Road Tenure	Unclassified	Outlet Drop (m)	–
Channel Width (m)	–	Outlet Pool Depth (m)	–
Stream Slope (%)	–	Inlet Drop	–
Beaver Activity	–	Slope (%)	–
Habitat Value	–	Valley Fill	–
Final score	0	Barrier Result	Unknown
Fix type	–	Fix Span / Diameter	–

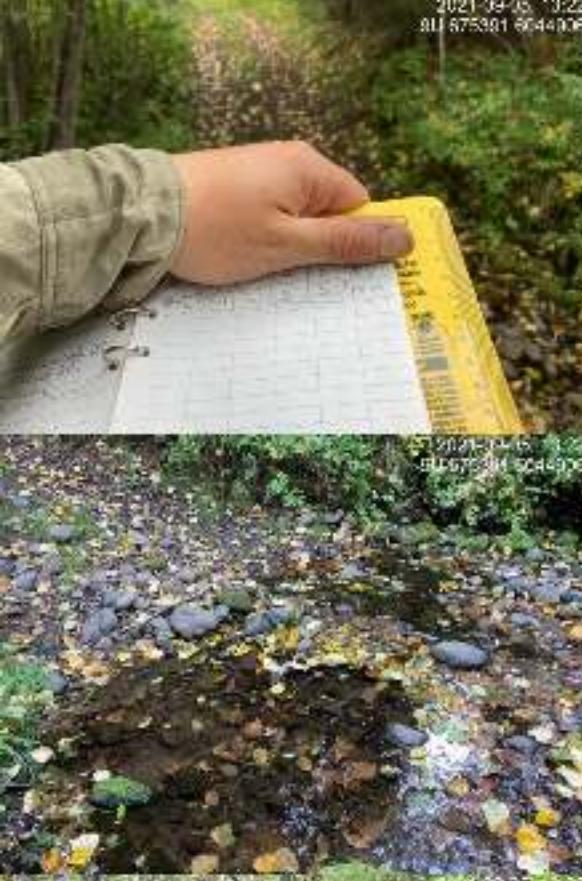
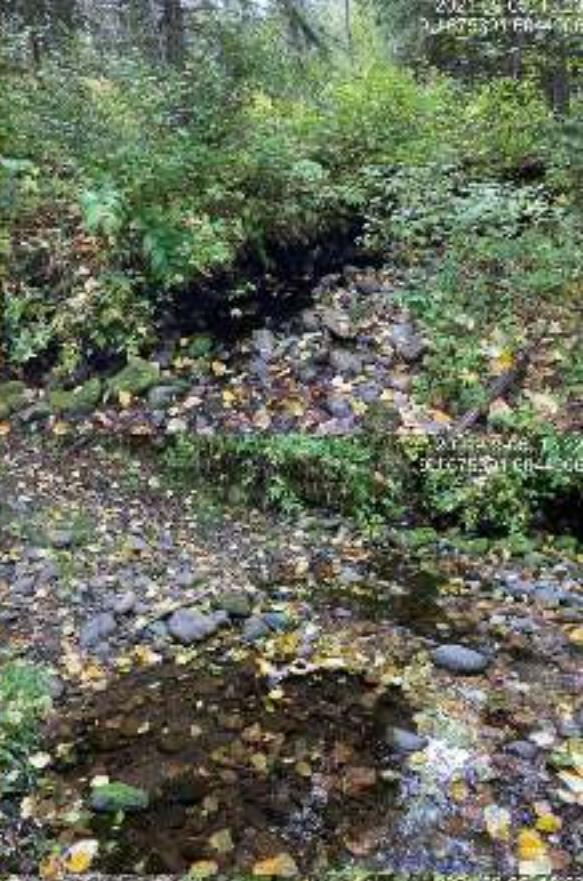
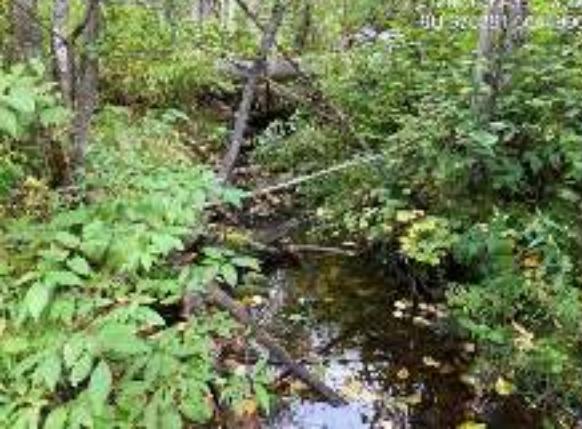
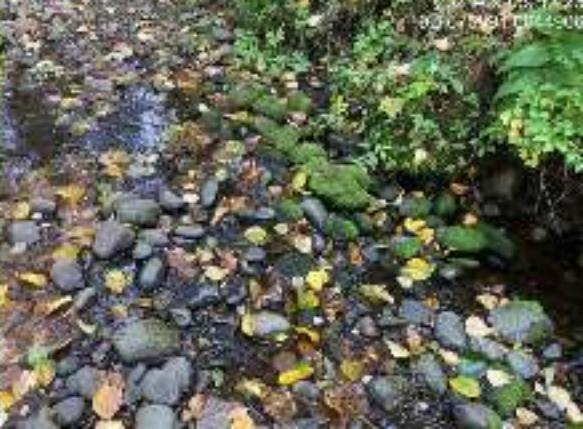
Photos: PSCIS ID 198033. From top left clockwise: Road/Site Card, Barrel, Outlet, Downstream, Upstream, Inlet.

Location and Stream Data	•	Crossing Characteristics	-
Comments: Ford. 13:21

Location and Stream Data		Crossing Characteristics	
Date	2021-09-06	Crossing Sub Type	Round Culvert
PSCIS ID	198033	Diameter (m)	0.4
External ID	14000395	Length (m)	11
Crew	KP AI VJ TP	Embedded	No
UTM Zone	9	Depth Embedded (m)	—
Easting	605863.8	Resemble Channel	No
Northing	6023574	Backwatered	Yes
Stream	Tributary to Gabriel Creek	Percent Backwatered	50
Road	Thautil FSR	Fill Depth (m)	1.5
Road Tenure	West Fraser R03753	Outlet Drop (m)	0
Channel Width (m)	0.67	Outlet Pool Depth (m)	0
Stream Slope (%)	4	Inlet Drop	No
Beaver Activity	No	Slope (%)	1.5
Habitat Value	Low	Valley Fill	Deep Fill
Final score	21	Barrier Result	Barrier
Fix type	Replace Structure with Streambed Simulation CBS	Fix Span / Diameter	3

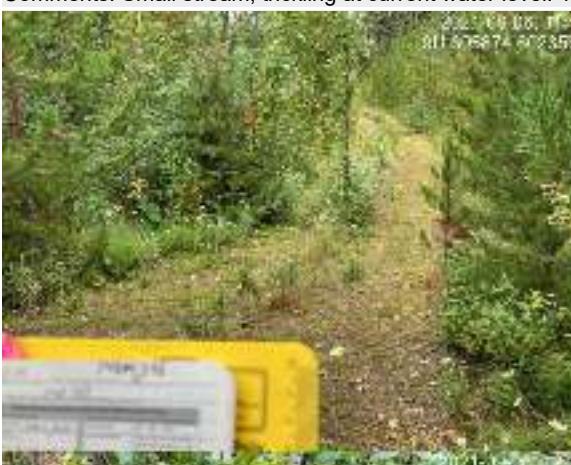
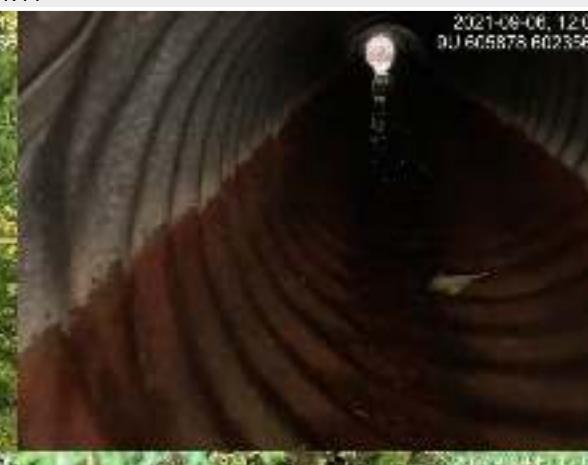
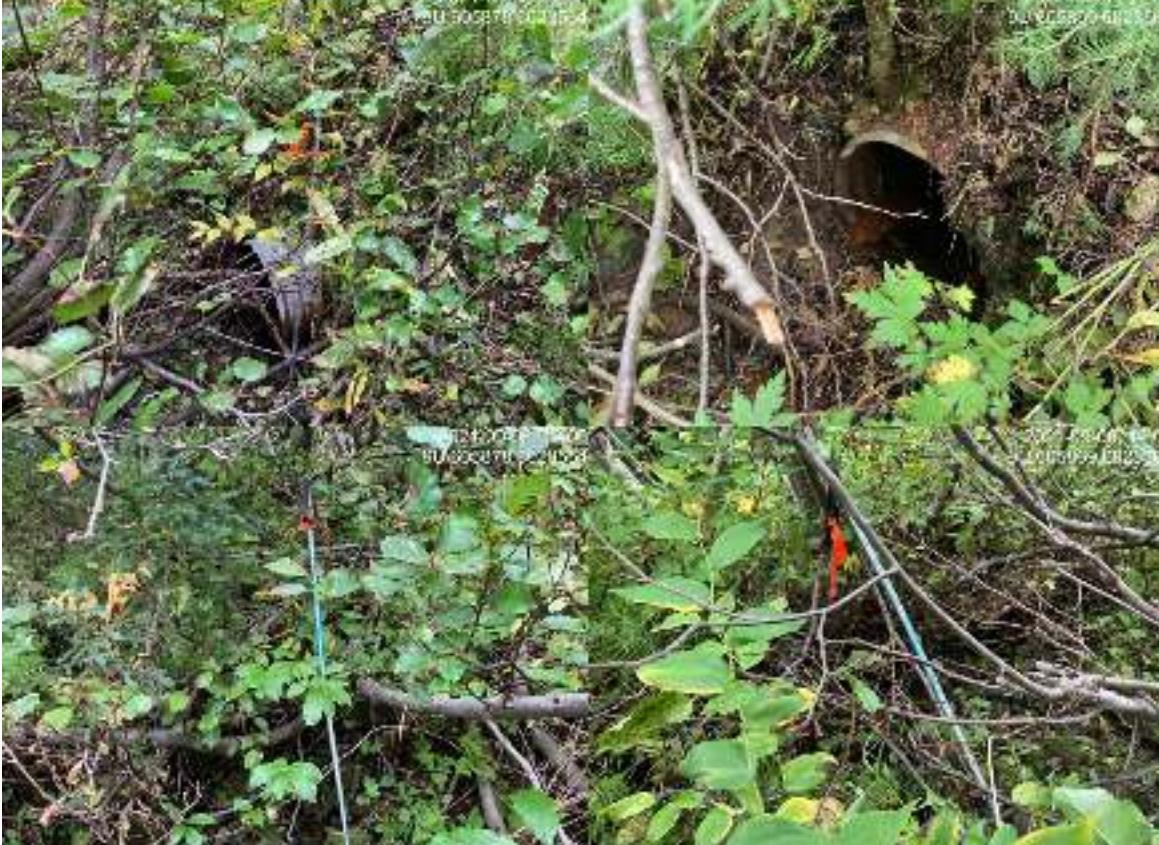
Photos: PSCIS ID 198034. From top left clockwise: Road/Site Card, Barrel, Outlet, Downstream, Upstream, Inlet.

Location and Stream Data	•	Crossing Characteristics	-
Comments: Small stream, trickling at current water level. 11:44

Location and Stream Data		Crossing Characteristics	
Date	2021-09-06	Crossing Sub Type	Round Culvert
PSCIS ID	198034	Diameter (m)	0.9
External ID	14000994	Length (m)	17
Crew	KP AI VJ TP	Embedded	No
UTM Zone	9	Depth Embedded (m)	—
Easting	603815	Resemble Channel	No
Northing	6009562	Backwatered	No
Stream	Tributary to Thaultil River	Percent Backwatered	—
Road	Thaultil FSR	Fill Depth (m)	4
Road Tenure	FLNR DND 9785	Outlet Drop (m)	0.34
Channel Width (m)	0.6	Outlet Pool Depth (m)	0.31
Stream Slope (%)	1	Inlet Drop	No
Beaver Activity	No	Slope (%)	2
Habitat Value	Medium	Valley Fill	Deep Fill
Final score	28	Barrier Result	Barrier
Fix type	Replace Structure with Streambed Simulation CBS	Fix Span / Diameter	3

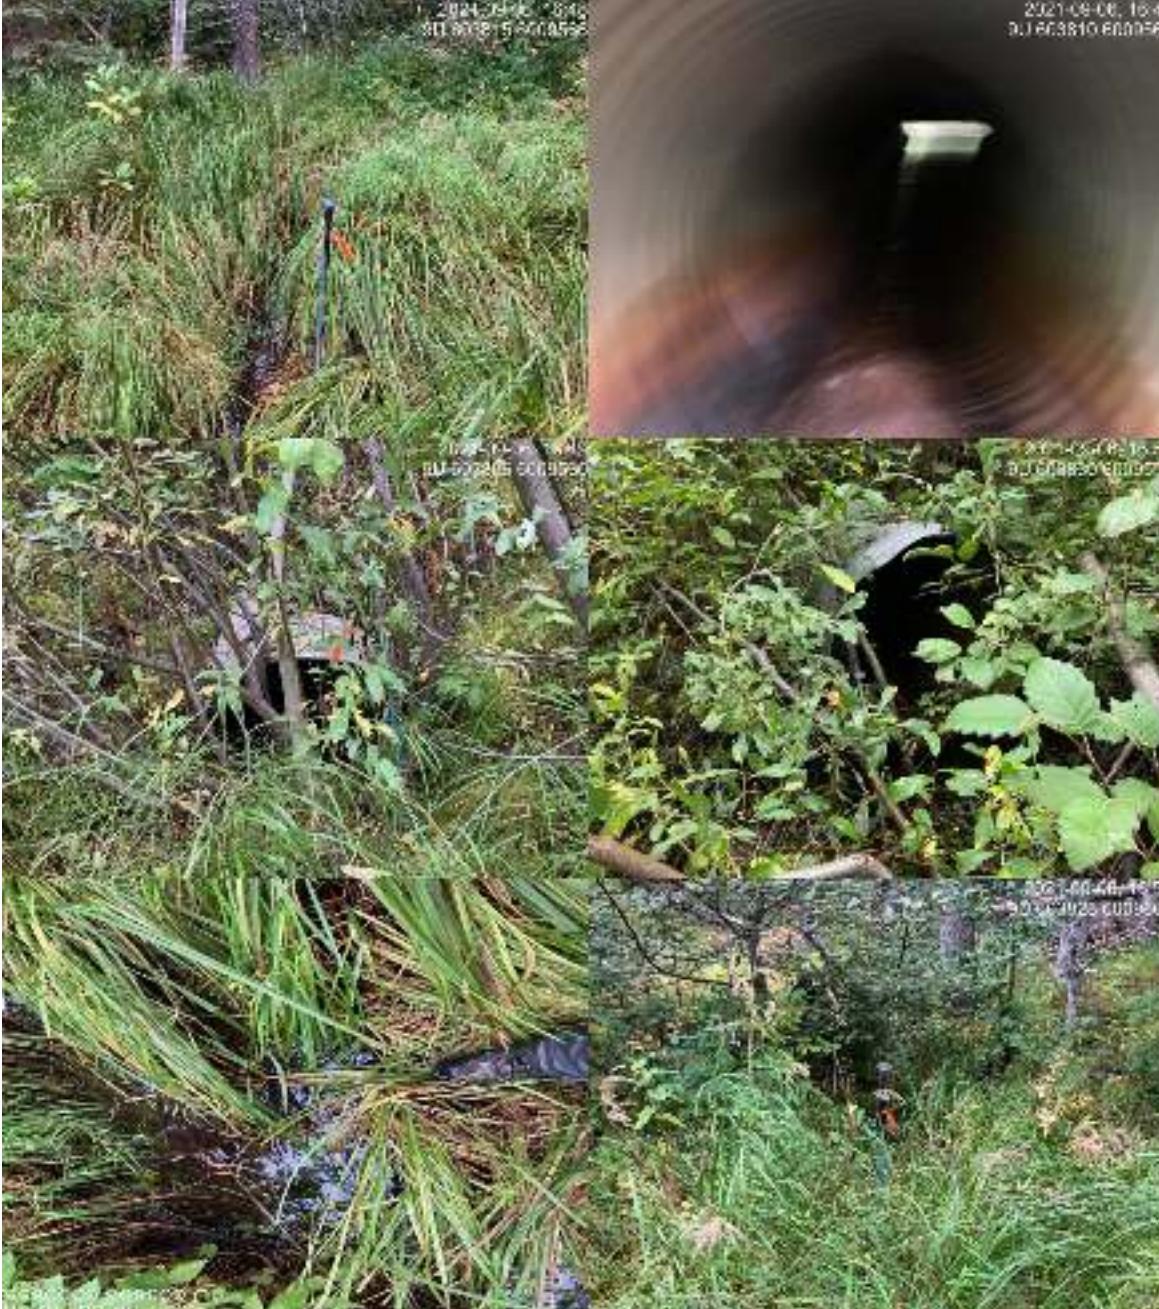
Photos: PSCIS ID 198035. From top left clockwise: Road/Site Card, Barrel, Outlet, Downstream, Upstream, Inlet.

Location and Stream Data	•	Crossing Characteristics	-
Comments: Upstream sedge wetland looking habitat with distinct narrow channel. Outlet drop, and small pool. Small vegetation embedment. Stream trickling. Similar sedge / wetland habitat downstream. 16:46

Location and Stream Data		Crossing Characteristics	
Date	2021-09-06	Crossing Sub Type	Round Culvert
PSCIS ID	198035	Diameter (m)	1
External ID	14000398	Length (m)	13
Crew	KP	Embedded	No
UTM Zone	9	Depth Embedded (m)	—
Easting	605437	Resemble Channel	No
Northing	6021867	Backwatered	No
Stream	Tributary to Gabriel Creek	Percent Backwatered	—
Road	Thautil FSR	Fill Depth (m)	2
Road Tenure	West Fraser R03753	Outlet Drop (m)	0.18
Channel Width (m)	1.17	Outlet Pool Depth (m)	0.26
Stream Slope (%)	6	Inlet Drop	Yes
Beaver Activity	No	Slope (%)	5
Habitat Value	Low	Valley Fill	Deep Fill
Final score	28	Barrier Result	Barrier
Fix type	Replace Structure with Streambed Simulation CBS	Fix Span / Diameter	3

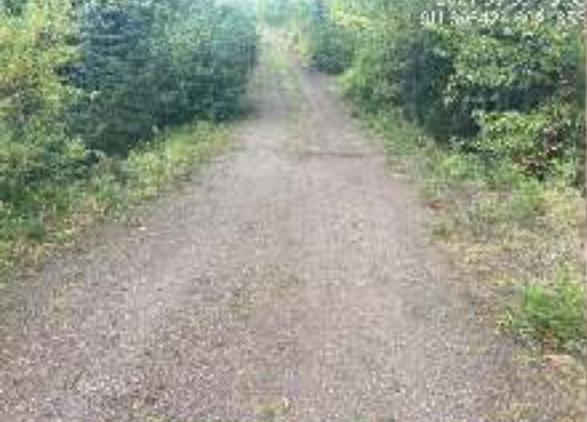
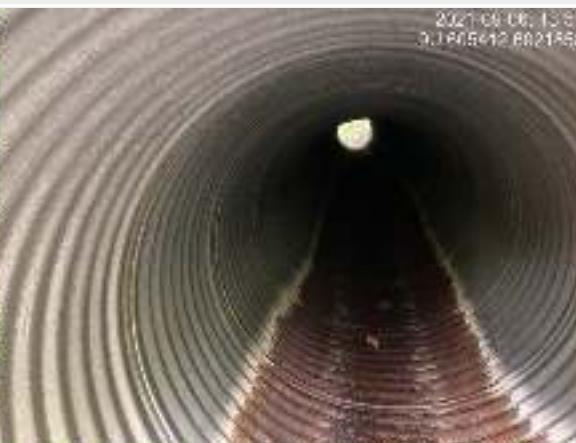
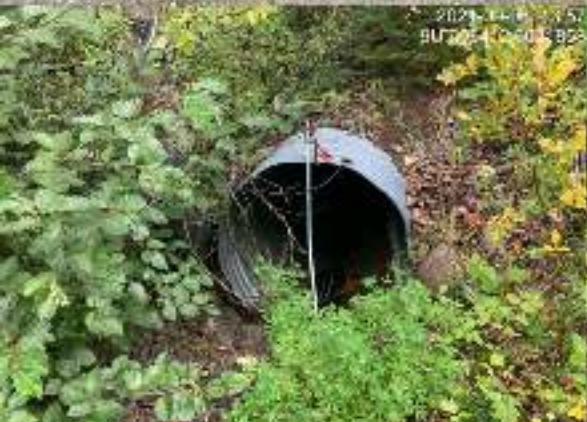
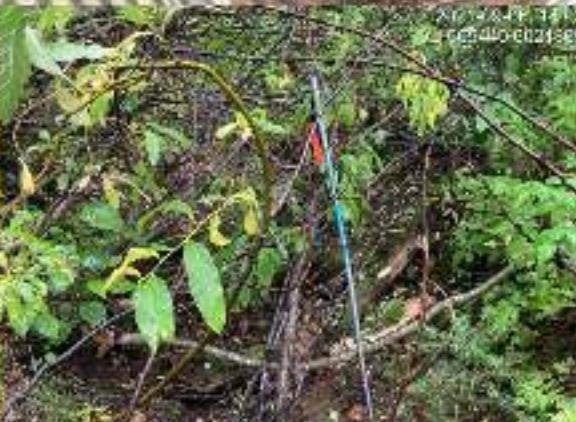
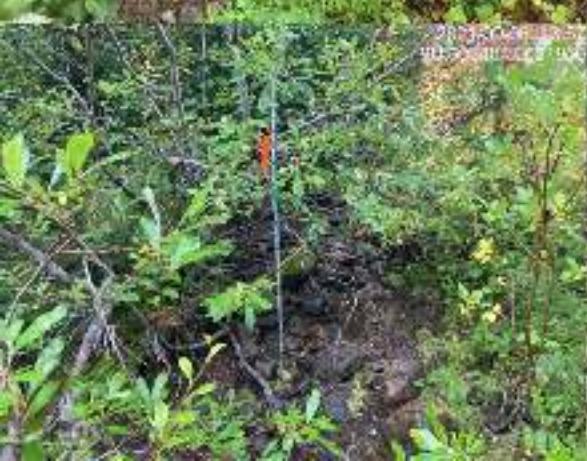
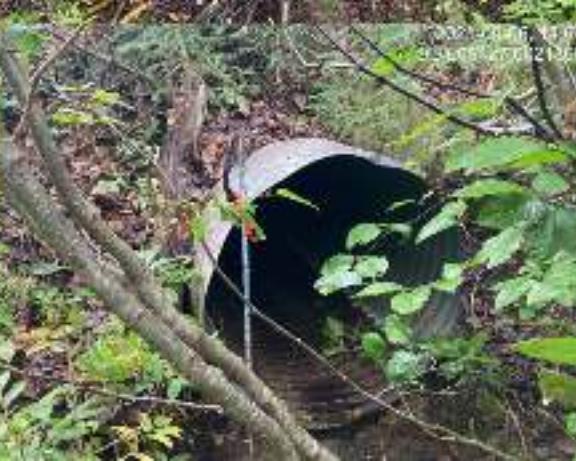
Photos: PSCIS ID 198036. From top left clockwise: Road/Site Card, Barrel, Outlet, Downstream, Upstream, Inlet.

Location and Stream Data	•	Crossing Characteristics	-
Comments: Dry channel. 13:53

Location and Stream Data		Crossing Characteristics	
Date	2021-09-06	Crossing Sub Type	Round Culvert
PSCIS ID	198036	Diameter (m)	0.9
External ID	14000377	Length (m)	24
Crew	KP	Embedded	No
UTM Zone	9	Depth Embedded (m)	—
Easting	606924.1	Resemble Channel	No
Northing	6020704	Backwatered	No
Stream	Tributary to Thaultil River	Percent Backwatered	—
Road	Thaultil FSR	Fill Depth (m)	4.5
Road Tenure	West Fraser R03753	Outlet Drop (m)	1.1
Channel Width (m)	1.9	Outlet Pool Depth (m)	0.55
Stream Slope (%)	8	Inlet Drop	Yes
Beaver Activity	No	Slope (%)	6
Habitat Value	Medium	Valley Fill	Deep Fill
Final score	39	Barrier Result	Barrier
Fix type	Replace Structure with Streambed Simulation CBS	Fix Span / Diameter	3

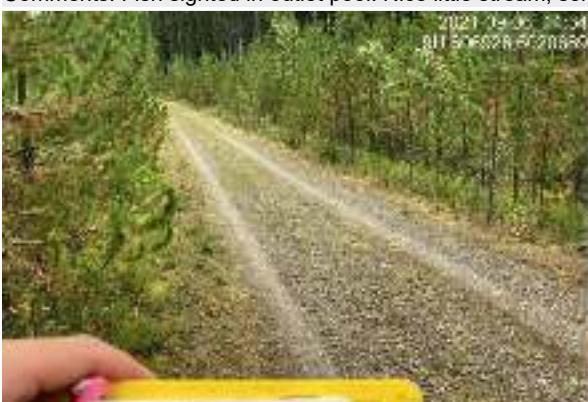
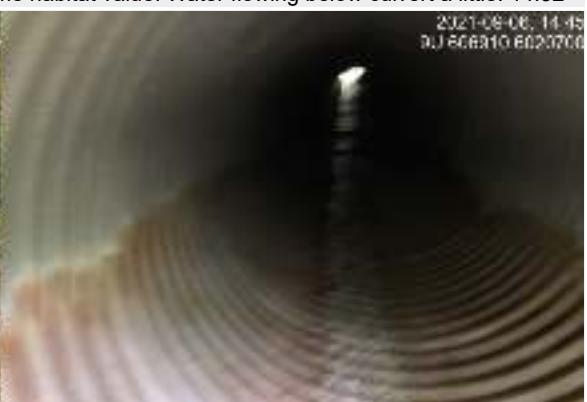
Photos: PSCIS ID 198037. From top left clockwise: Road/Site Card, Barrel, Outlet, Downstream, Upstream, Inlet.

Location and Stream Data	•	Crossing Characteristics	-
Comments: Fish sighted in outlet pool. Nice little stream, some habitat value. Water flowing below culvert a little. 14:32

Location and Stream Data		Crossing Characteristics	
Date	2021-09-06	Crossing Sub Type	Round Culvert
PSCIS ID	198037	Diameter (m)	0.6
External ID	14000375	Length (m)	12
Crew	KP	Embedded	No
UTM Zone	9	Depth Embedded (m)	–
Easting	605796.6	Resemble Channel	No
Northing	6016997	Backwatered	No
Stream	Tributary to Thautil River	Percent Backwatered	–
Road	Thautil FSR	Fill Depth (m)	0.3
Road Tenure	West Fraser R03753	Outlet Drop (m)	0
Channel Width (m)	0.65	Outlet Pool Depth (m)	0
Stream Slope (%)	4.5	Inlet Drop	No
Beaver Activity	No	Slope (%)	2
Habitat Value	Low	Valley Fill	Deep Fill
Final score	18	Barrier Result	Potential
Fix type	Replace Structure with Streambed Simulation CBS	Fix Span / Diameter	3

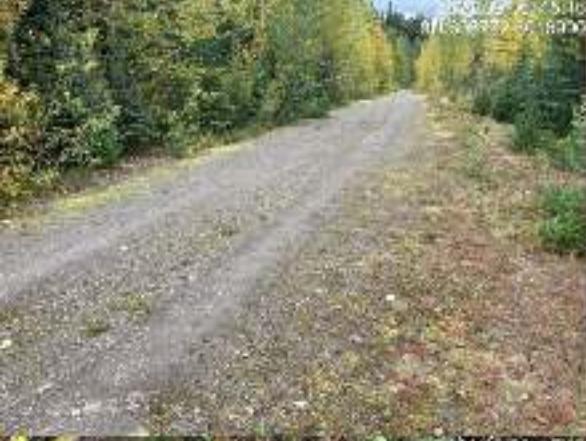
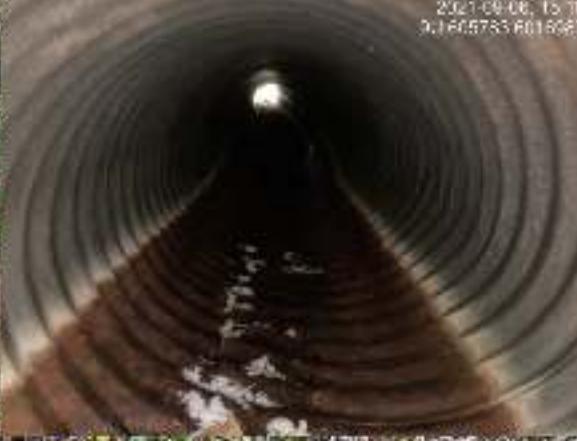
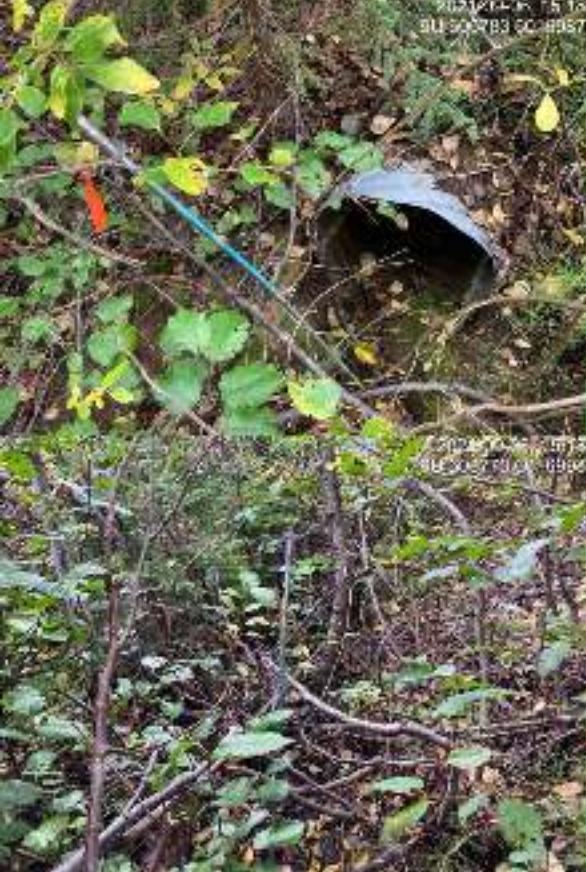
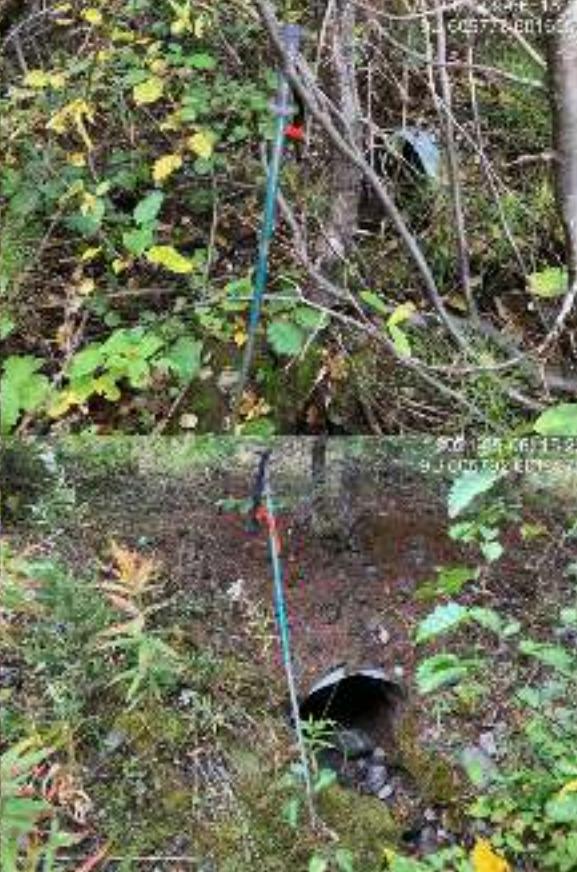
Photos: PSCIS ID 198038. From top left clockwise: Road/Site Card, Barrel, Outlet, Downstream, Upstream, Inlet.

Location and Stream Data	•	Crossing Characteristics	-
Comments: Dry channel. Upstream channel runs parallel to road, not well defined channel, appears very ephemeral. Downstream channel much more defined. Outlet partially embedded. 15:16

Location and Stream Data		Crossing Characteristics	
Date	2021-09-06	Crossing Sub Type	Round Culvert
PSCIS ID	198038	Diameter (m)	0.6
External ID	14000382	Length (m)	11
Crew	KP	Embedded	No
UTM Zone	9	Depth Embedded (m)	—
Easting	604924	Resemble Channel	No
Northing	6014325	Backwatered	No
Stream	Tributary to Thaultil River	Percent Backwatered	—
Road	Thaultil FSR	Fill Depth (m)	1
Road Tenure	West Fraser R03753	Outlet Drop (m)	0.17
Channel Width (m)	0.7	Outlet Pool Depth (m)	0.48
Stream Slope (%)	4	Inlet Drop	No
Beaver Activity	No	Slope (%)	3
Habitat Value	Low	Valley Fill	Deep Fill
Final score	28	Barrier Result	Barrier
Fix type	Replace Structure with Streambed Simulation CBS	Fix Span / Diameter	3

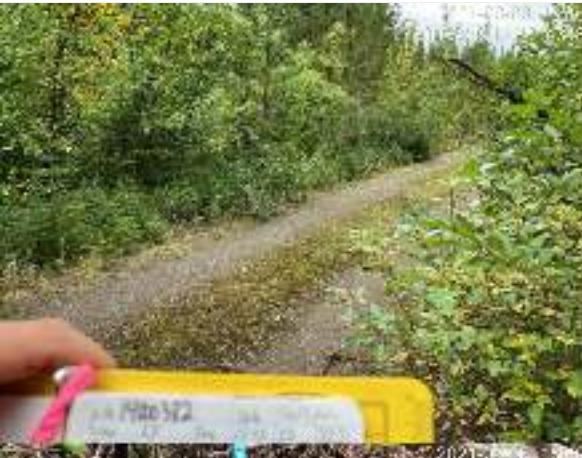
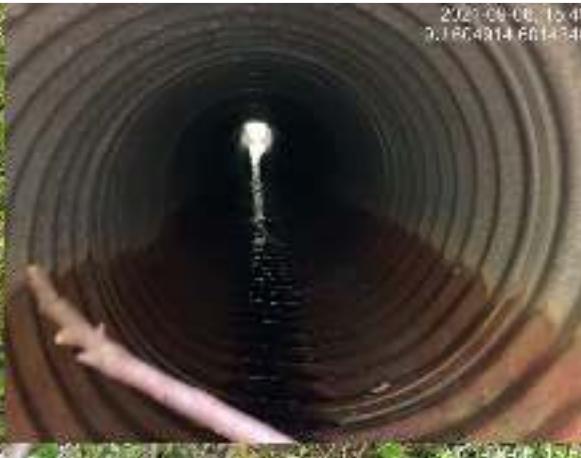
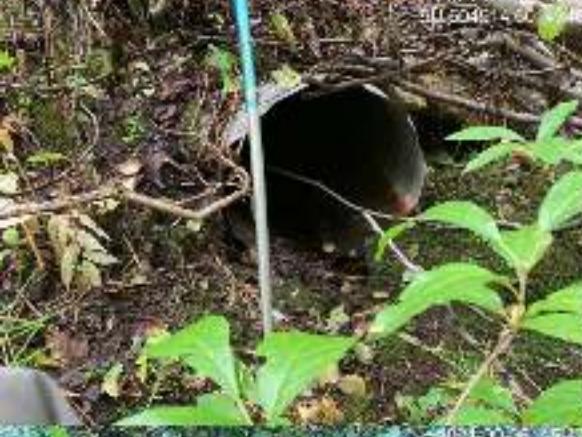
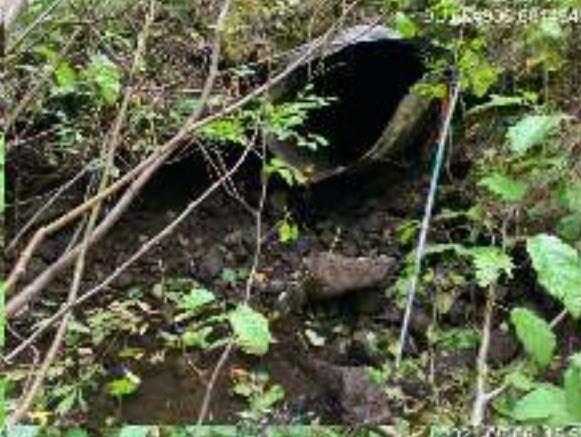
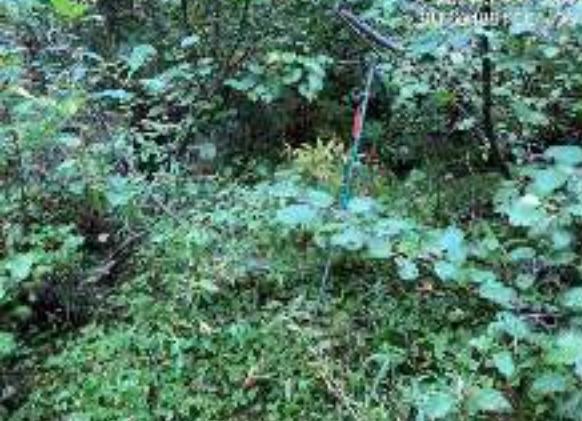
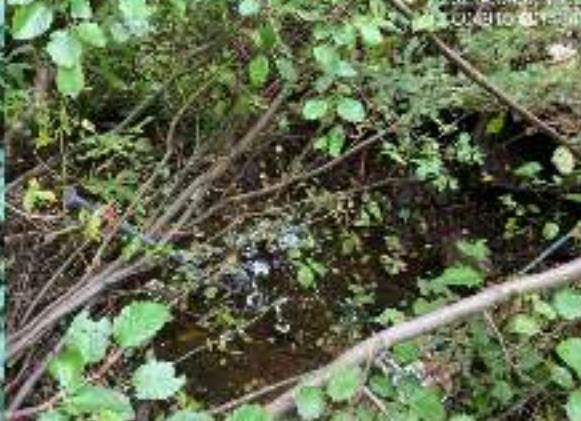
Location and Stream Data	•	Crossing Characteristics	-
Comments: Dry channel. Upstream channel heavily vegetated and goes below mossy structure 5m towards inlet. Outlet damaged and slightly misshapen. Large outlet pool but still minimal channel downstream that is partially vegetated, and goes under moss. Culvert slope estimated afterwards as not recorded in field. 15:45
