Appendix - Phase 1 Fish Passage Assessment Data and Photos

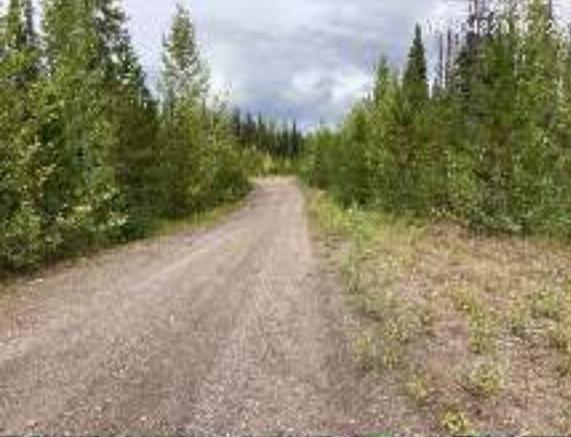
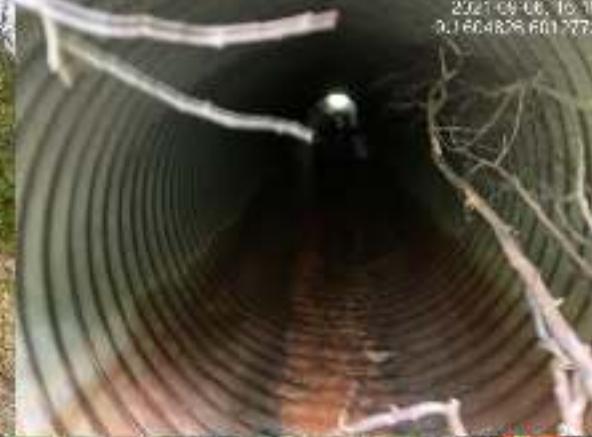
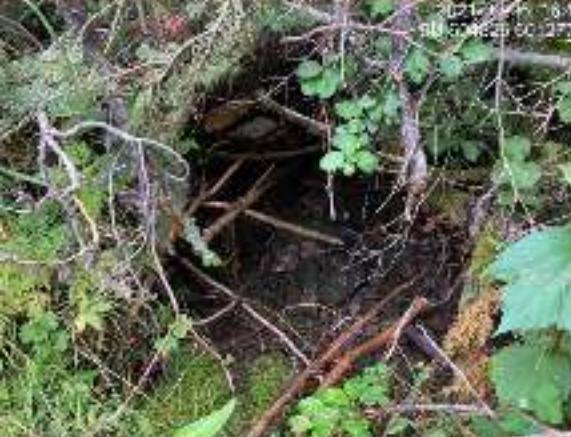
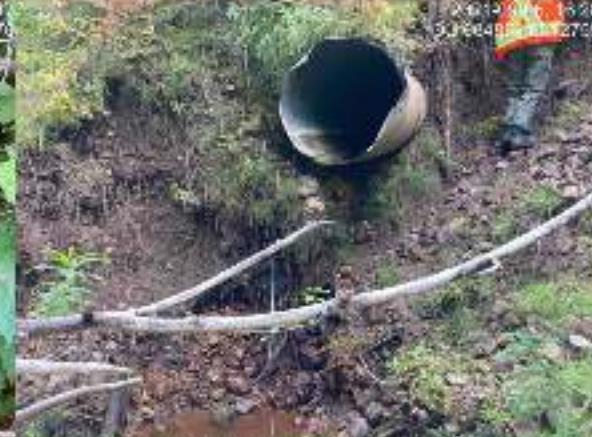
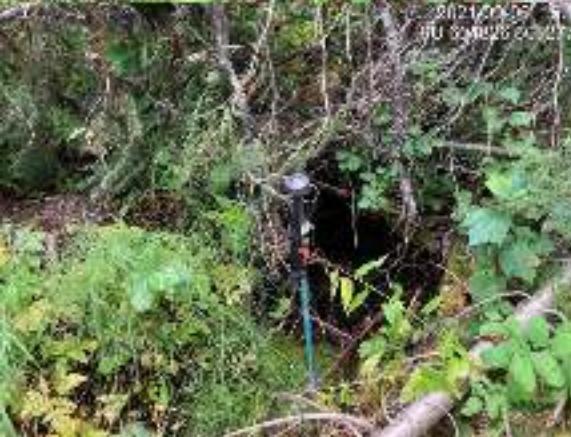
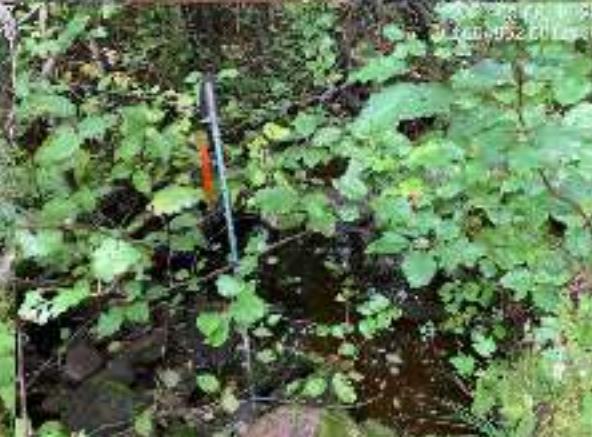
Photos: PSCIS ID 198040. From top left clockwise: Road/Site Card, Barrel, Outlet, Downstream, Upstream, Inlet.

Location and Stream Data	•	Crossing Characteristics	-
Comments: Upstream channel is partially subsurface below mossy vegetation. Mostly dry with powder pools, huge OD. Downstream channel a bit bigger with larger pools. Creek not flowing. 16:11

Location and Stream Data		Crossing Characteristics	
Date	2021-09-08	Crossing Sub Type	Round Culvert
PSCIS ID	198040	Diameter (m)	0.9
External ID	14000882	Length (m)	14
Crew	KP	Embedded	No
UTM Zone	9	Depth Embedded (m)	–
Easting	607215.9	Resemble Channel	No
Northing	5997194	Backwatered	Yes
Stream	Tributary to Morice River	Percent Backwatered	100
Road	Spur	Fill Depth (m)	0.5
Road Tenure	Canfor R08826	Outlet Drop (m)	0
Channel Width (m)	0.9	Outlet Pool Depth (m)	0
Stream Slope (%)	0.5	Inlet Drop	No
Beaver Activity	Yes	Slope (%)	1
Habitat Value	Medium	Valley Fill	Deep Fill
Final score	18	Barrier Result	Potential
Fix type	Replace Structure with Streambed Simulation CBS	Fix Span / Diameter	3

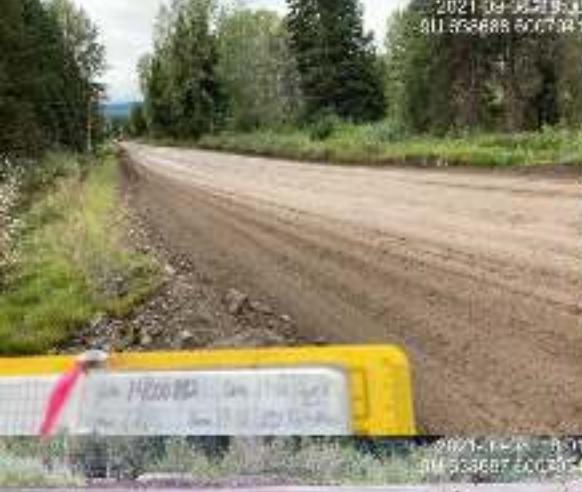
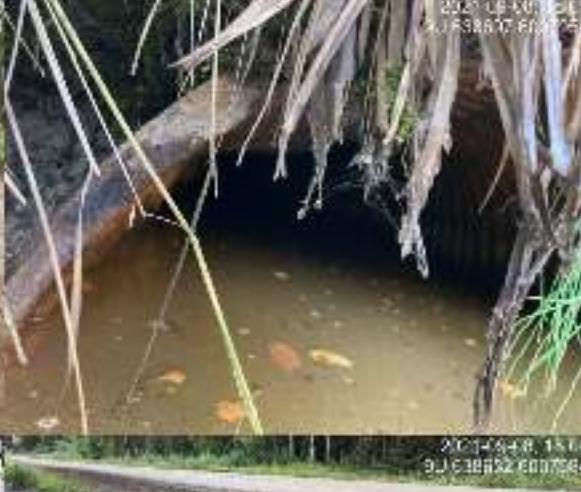
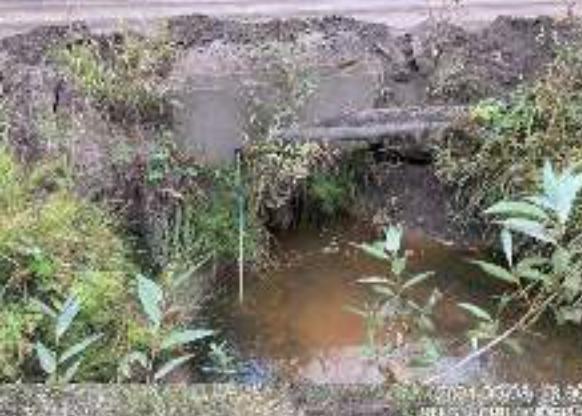
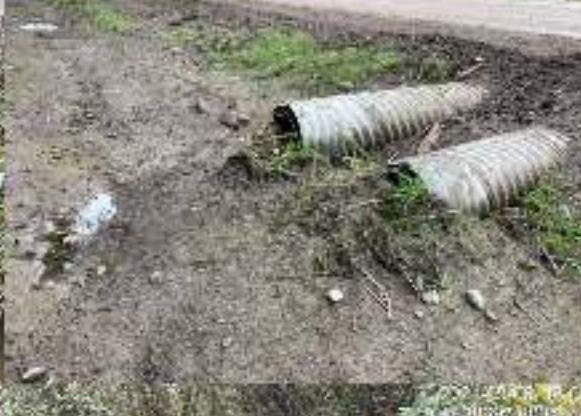
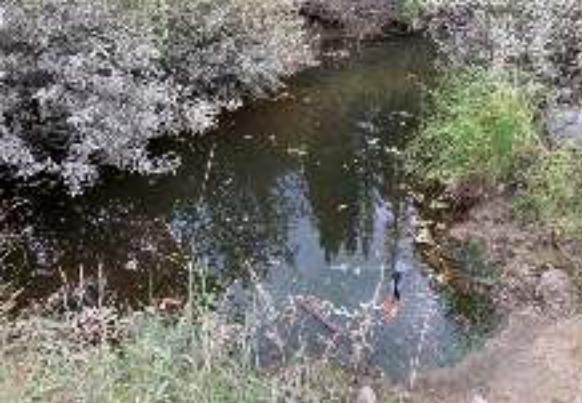
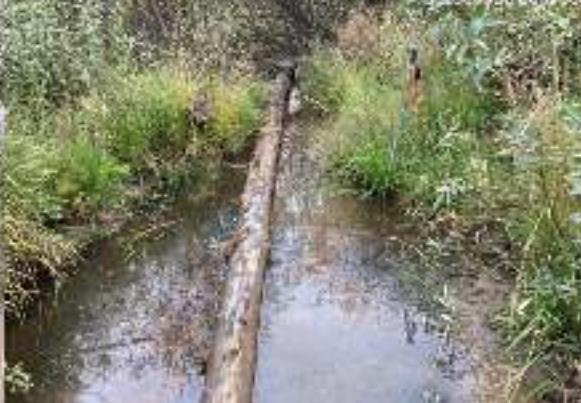
Photos: PSCIS ID 198041. From top left clockwise: Road/Site Card, Barrel, Outlet, Downstream, Upstream, Inlet.

Location and Stream Data	•	Crossing Characteristics	-
Comments: Culvert 100% covered by mud from beaver activity, otherwise would be flowing through backwatered. Outlet 100% backwatered almost covering culvert in water. Large wetland complex upstream. Infrastructure looks old and in poor shape, retaining wall / cement block tipping over on outlet. Slope estimated based on backwatered status. Additional culvert ~75m down the road to deal with flooding. 17:53

Location and Stream Data	.	Crossing Characteristics	-
Date	2021-09-12	Crossing Sub Type	Bridge
PSCIS ID	198041	Diameter (m)	11
External ID	1802760	Length (m)	3
Crew	KP	Embedded	-
UTM Zone	9	Depth Embedded (m)	-
Easting	640551.2	Resemble Channel	-
Northing	6053250	Backwatered	-
Stream	Deep Creek	Percent Backwatered	-
Road	Spur	Fill Depth (m)	-
Road Tenure	Unclassified	Outlet Drop (m)	-
Channel Width (m)	-	Outlet Pool Depth (m)	-
Stream Slope (%)	-	Inlet Drop	-
Beaver Activity	-	Slope (%)	-
Habitat Value	-	Valley Fill	-
Final score	0	Barrier Result	Passable
Fix type	-	Fix Span / Diameter	-

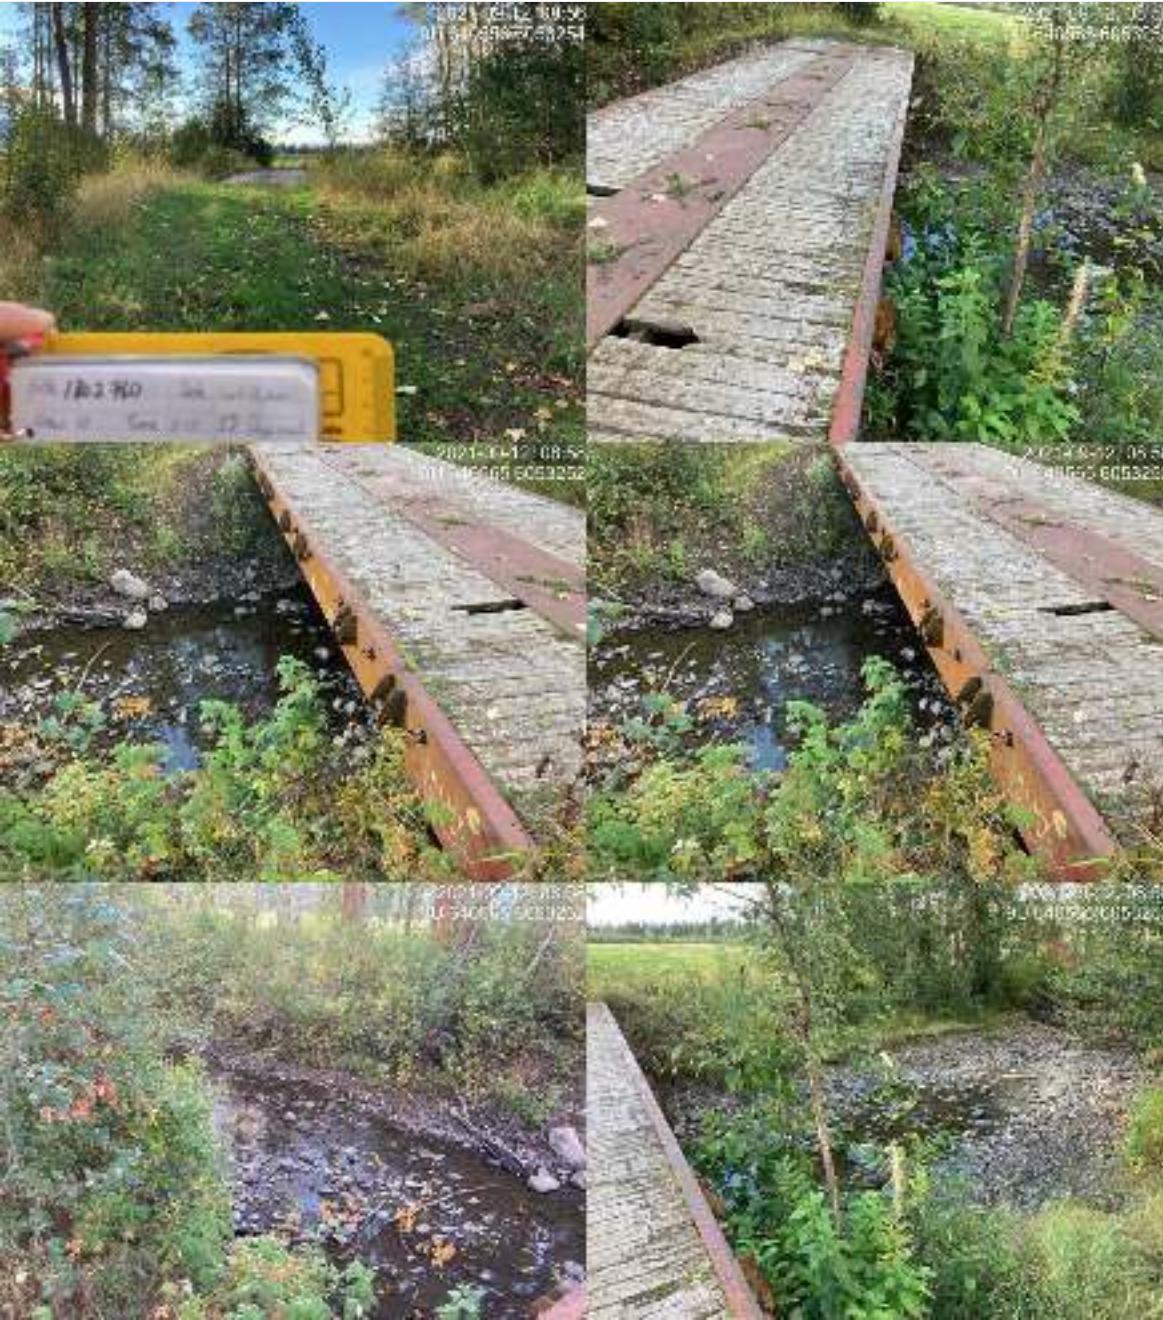
Photos: PSCIS ID 198042. From top left clockwise: Road/Site Card, Barrel, Outlet, Downstream, Upstream, Inlet.

Location and Stream Data	Crossing Characteristics
Comments: Old rail can deck, now bridge. Owner says nothing else downstream. 8:55

Location and Stream Data	•	Crossing Characteristics	–
Date	2021-09-12	Crossing Sub Type	Concrete Box
PSCIS ID	198042	Diameter (m)	2.8
External ID	1805553	Length (m)	14
Crew	KP	Embedded	Yes
UTM Zone	9	Depth Embedded (m)	0.1
Easting	611695.8	Resemble Channel	Yes
Northing	6082109	Backwatered	No
Stream	Toboggan Creek	Percent Backwatered	–
Road	CN Railway	Fill Depth (m)	0.5
Road Tenure	Canadian National	Outlet Drop (m)	0
Channel Width (m)	11.5	Outlet Pool Depth (m)	0
Stream Slope (%)	0.25	Inlet Drop	No
Beaver Activity	Yes	Slope (%)	0.2
Habitat Value	High	Valley Fill	Deep Fill
Final score	11	Barrier Result	Passable
Fix type	–	Fix Span / Diameter	–

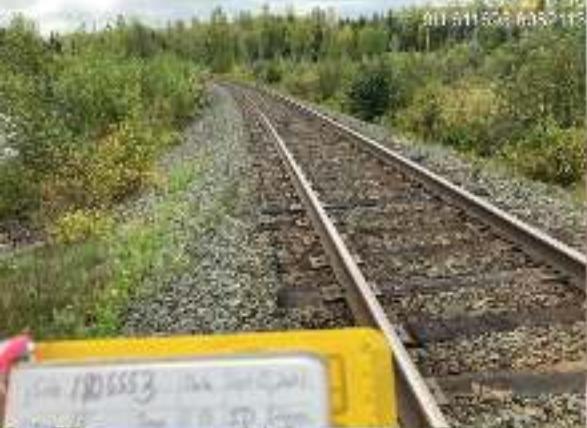
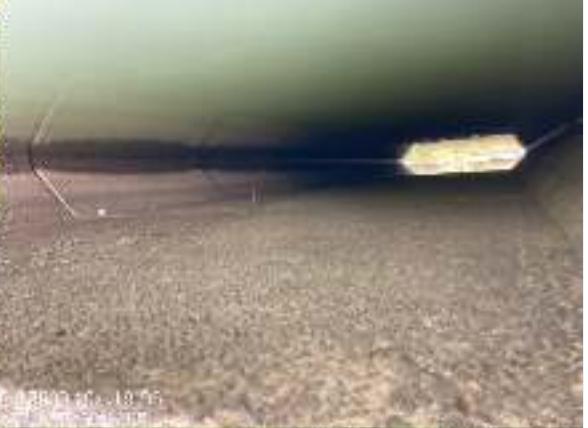
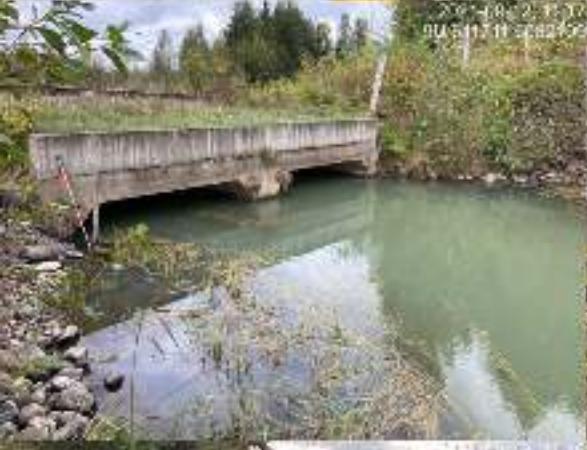
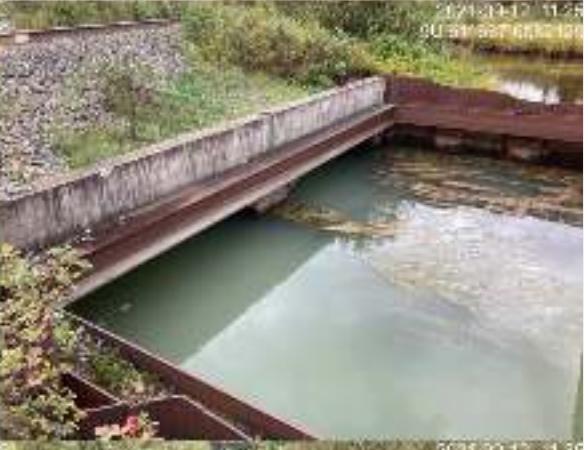
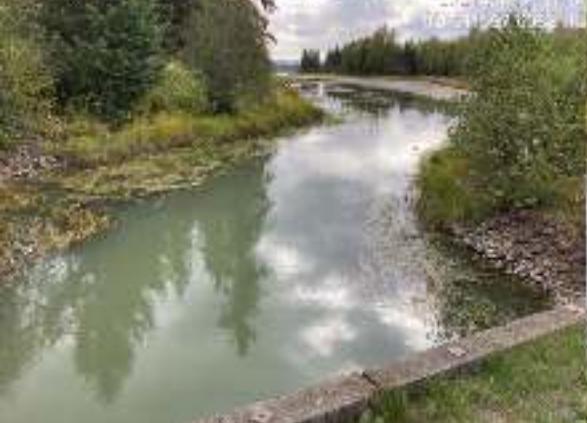
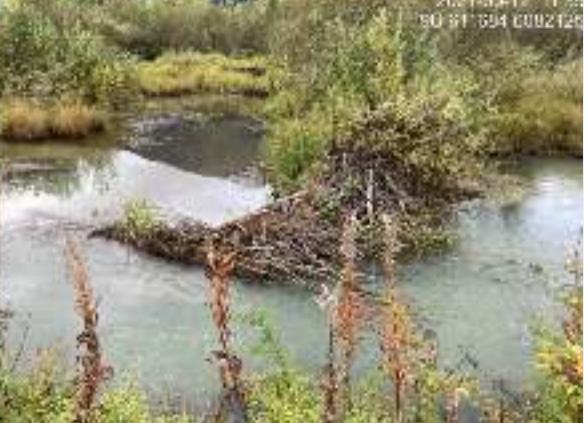
Location and Stream Data	•	Crossing Characteristics	-
Comments: 2 concrete box. Not backwatered but fully wetted due to slow flowing water. Stream slope estimated. Lake/wetland habitat upstream, flowing very slowly through, assuming the crossing is embedded or an open bottom. Appears to be fish friendly. Length was taken with rangefinder. 11:1

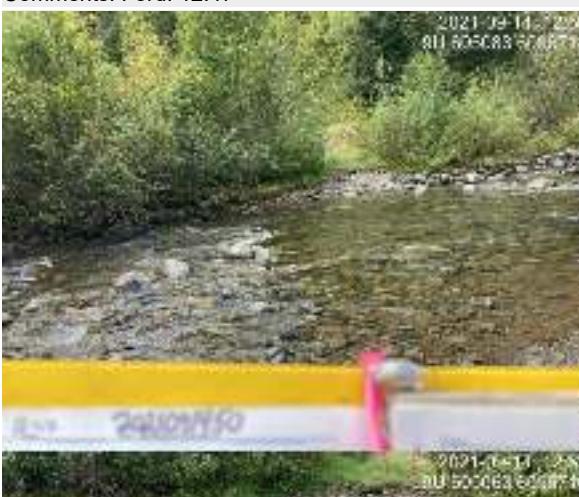
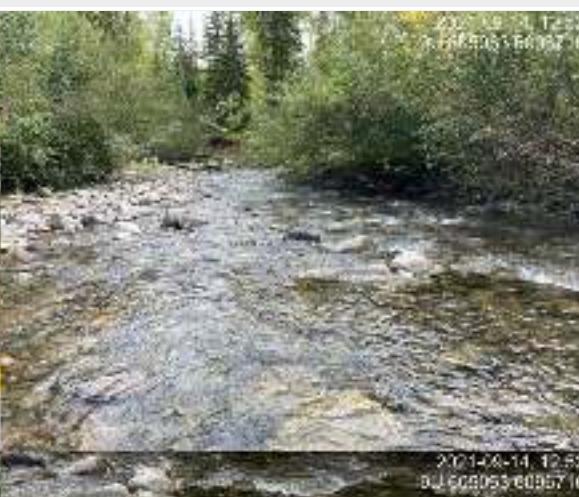
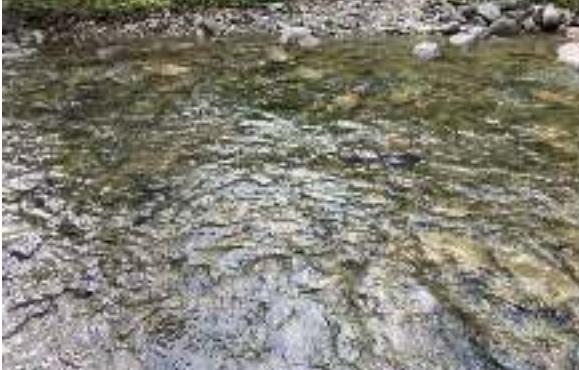
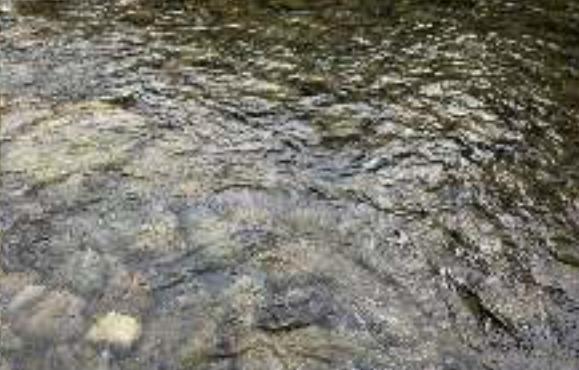
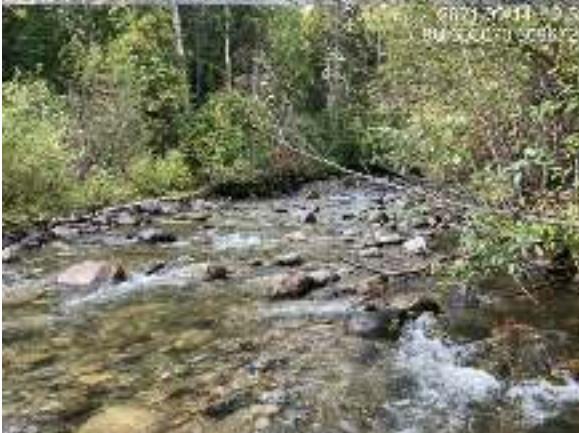
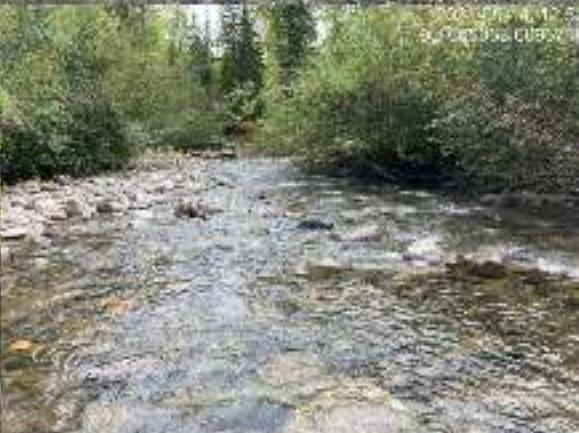
Photos: PSCIS ID 198043. From top left clockwise: Road/Site Card, Barrel, Outlet, Downstream, Upstream, Inlet.

Location and Stream Data	•	Crossing Characteristics	-
Comments: Ford. 12:47			
2021-09-14, 12:47 011-605083-07487-10		2021-09-14, 12:47 011-605083-07487-10

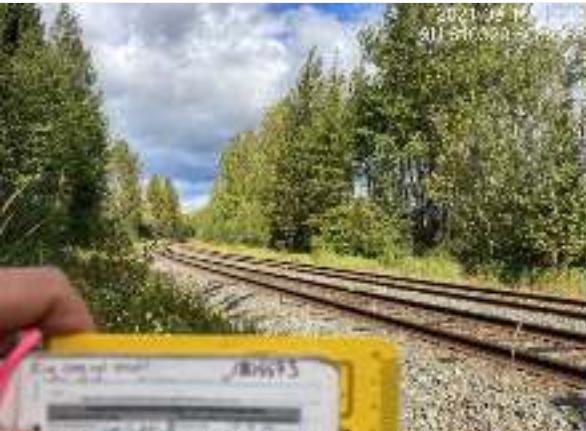
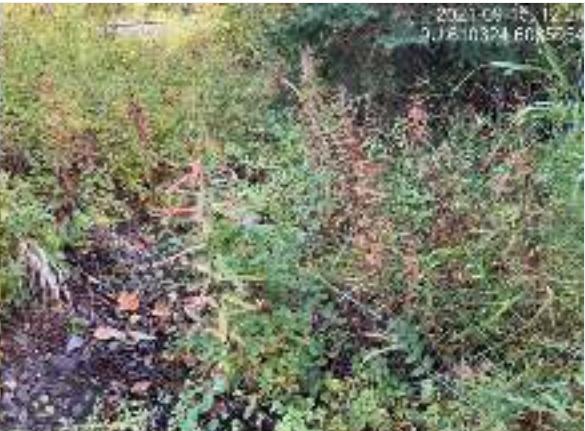
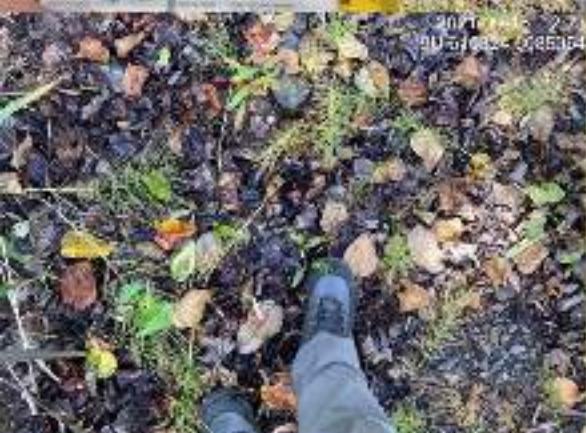
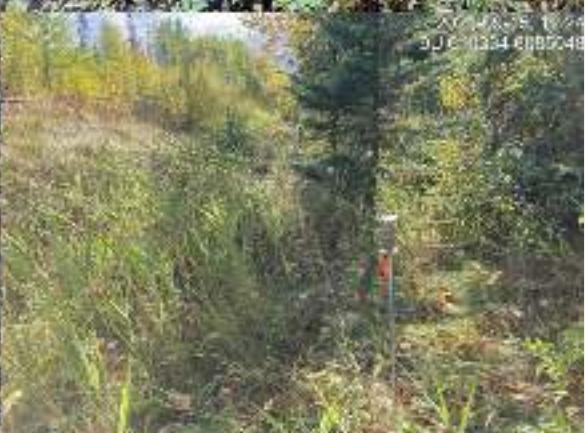
Photos: PSCIS ID 198044. From top left clockwise: Road/Site Card, Barrel, Outlet, Downstream, Upstream, Inlet.

Location and Stream Data		Crossing Characteristics	
Date	2021-09-15	Crossing Sub Type	Round Culvert
PSCIS ID	198044	Diameter (m)	0.1
External ID	1805573	Length (m)	15
Crew	KP	Embedded	No
UTM Zone	9	Depth Embedded (m)	—
Easting	610392.9	Resemble Channel	No
Northing	6084973	Backwatered	No
Stream	Tributary to Toboggan Creek	Percent Backwatered	—
Road	Railway	Fill Depth (m)	2
Road Tenure	Canadian National	Outlet Drop (m)	0
Channel Width (m)	2	Outlet Pool Depth (m)	0
Stream Slope (%)	1	Inlet Drop	No
Beaver Activity	No	Slope (%)	3
Habitat Value	Low	Valley Fill	Deep Fill
Final score	29	Barrier Result	Barrier
Fix type	Replace Structure with Streambed Simulation CBS	Fix Span / Diameter	3

Location and Stream Data	•	Crossing Characteristics	-
Comments: Crossing does not exist on railway. Site entered as a placeholder because there should be connection. Surveyed above and below modelled crossing. There is ephemeral channel upstream of the railway that is directed to go along the railway in ditch and quickly dissipates into shrubs and grasses. 12:19

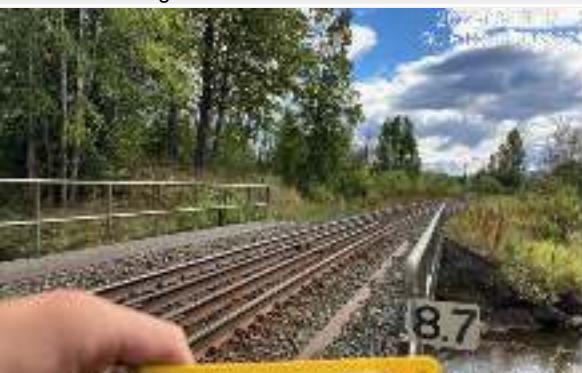
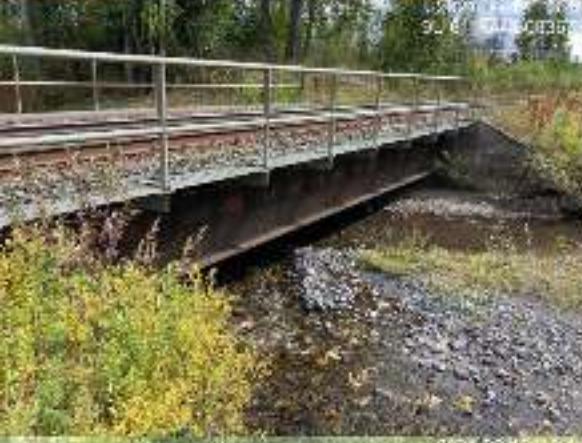
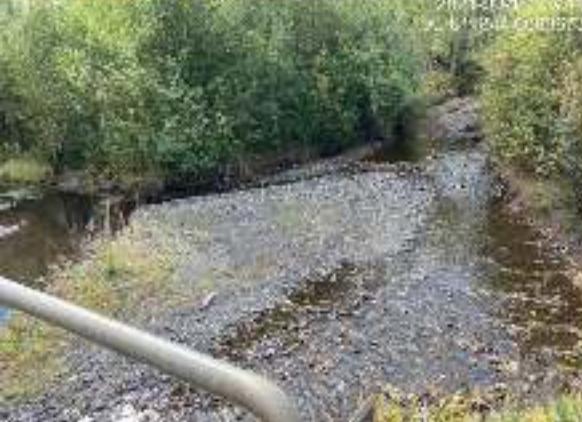
Photos: PSCIS ID 198045. From top left clockwise: Road/Site Card, Barrel, Outlet, Downstream, Upstream, Inlet.

Location and Stream Data	.	Crossing Characteristics	-
Comments: Bridge. 13:40

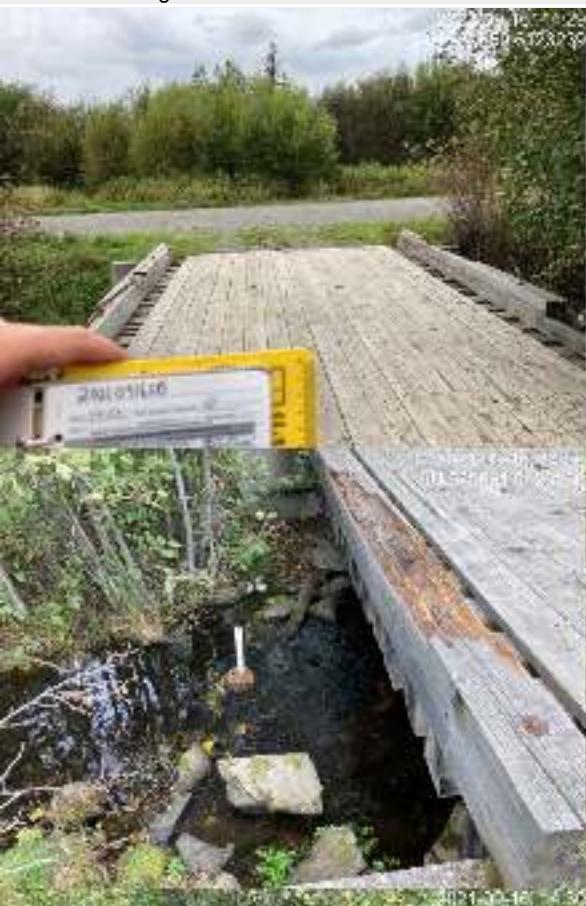
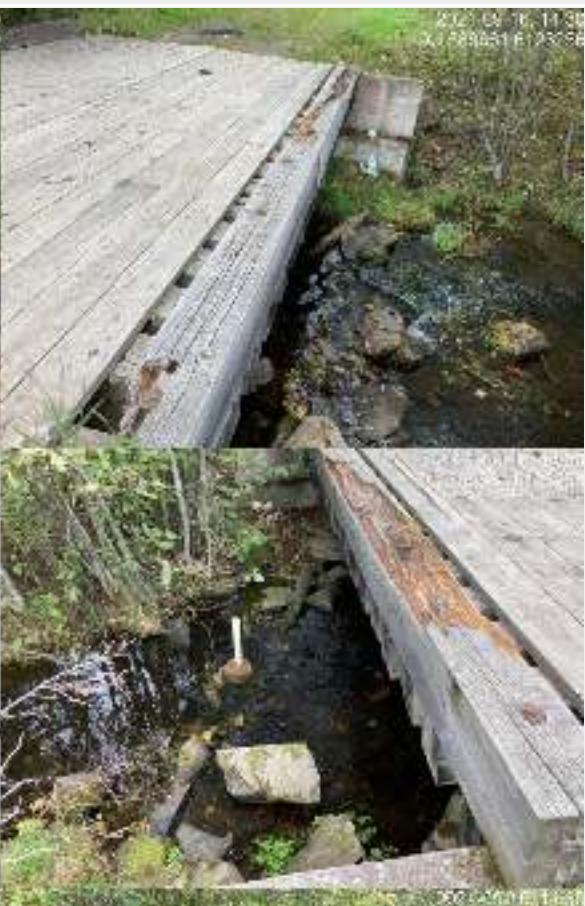
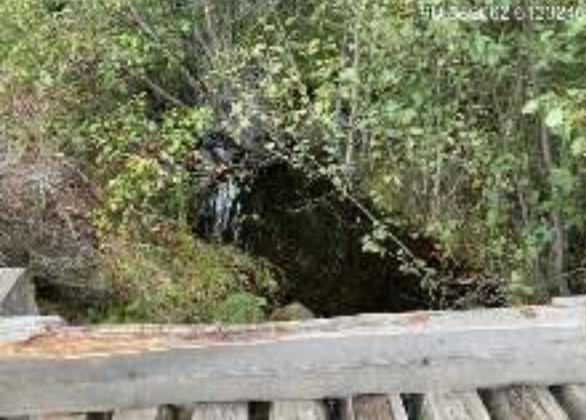
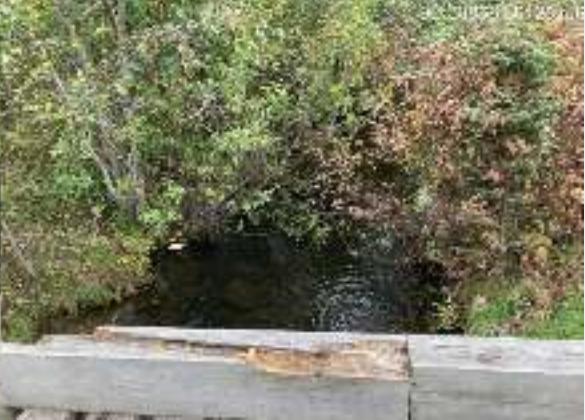
Photos: PSCIS ID 198046. From top left clockwise: Road/Site Card, Barrel, Outlet, Downstream, Upstream, Inlet.

Location and Stream Data	•	Crossing Characteristics	-
Comments: Bridge. 14:27

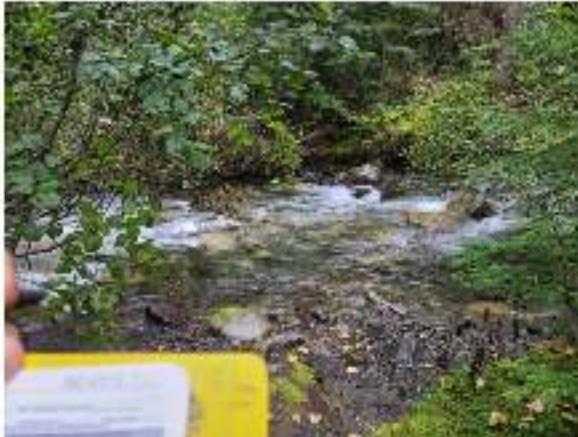
Photos: PSCIS ID 198047. From top left clockwise: Road/Site Card, Barrel, Outlet, Downstream, Upstream, Inlet.

Location and Stream Data	•	Crossing Characteristics	-
Comments: No structure present.			
NO IMAGE AVAILABLE	NO IMAGE AVAILABLE	NO IMAGE AVAILABLE	NO IMAGE AVAILABLE

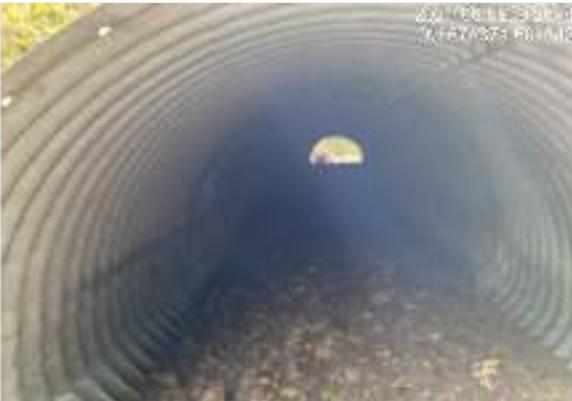
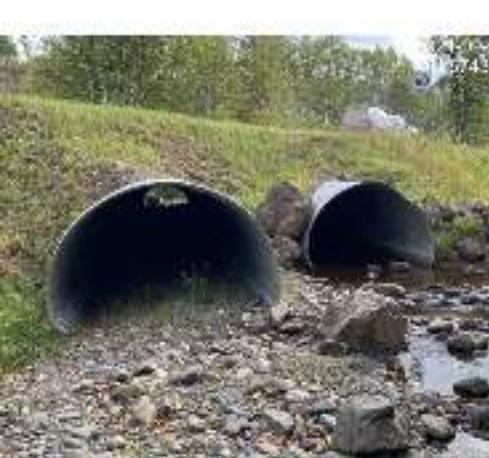
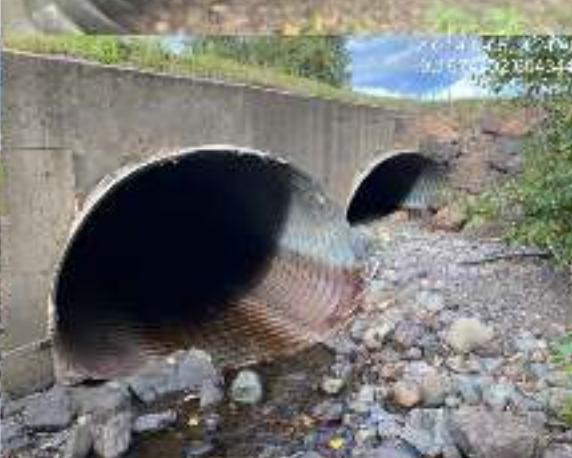
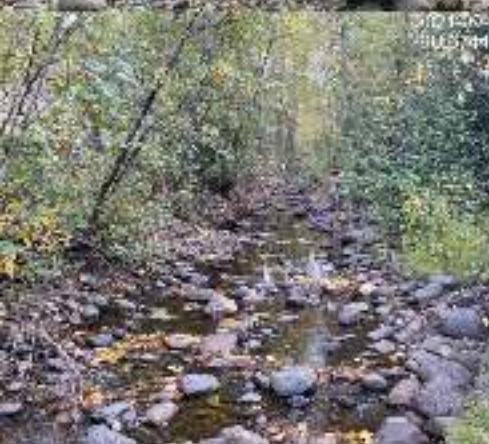
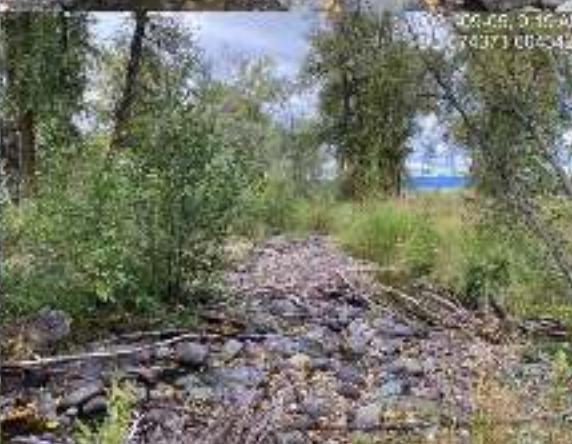
Photos: PSCIS ID 198048. From top left clockwise: Road/Site Card, Barrel, Outlet, Downstream, Upstream, Inlet.

Location and Stream Data		Crossing Characteristics –	
Date	2021-09-05	Crossing Sub Type	Round Culvert
PSCIS ID	198048	Diameter (m)	2.5
External ID	1800048	Length (m)	25
Crew	KP AI	Embedded	No
UTM Zone	9	Depth Embedded (m)	–
Easting	674397.1	Resemble Channel	No
Northing	6043433	Backwatered	Yes
Stream	Cesford Creek	Percent Backwatered	30
Road	Highway 16	Fill Depth (m)	1
Road Tenure	MoTi Arterial	Outlet Drop (m)	0
Channel Width (m)	5.48	Outlet Pool Depth (m)	0.09
Stream Slope (%)	3.5	Inlet Drop	Yes
Beaver Activity	No	Slope (%)	1.5
Habitat Value	High	Valley Fill	Deep Fill
Final score	24	Barrier Result	Barrier
Fix type	Replace with New Open Bottom Structure	Fix Span / Diameter	10

Location and Stream Data	•	Crossing Characteristics	-
Comments: Habitat confirmation conducted. Two pipes (2.5m x 2.5m). Culvert slope measured with lazel level. Fish observed. Could not locate downstream crossing on railway. Garmin backroads mapbook shows stream connecting with side channel of the Bulkley. 9:17			
NO IMAGE AVAILABLE

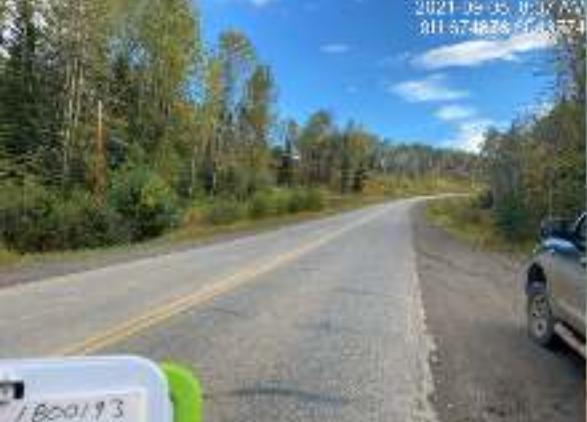
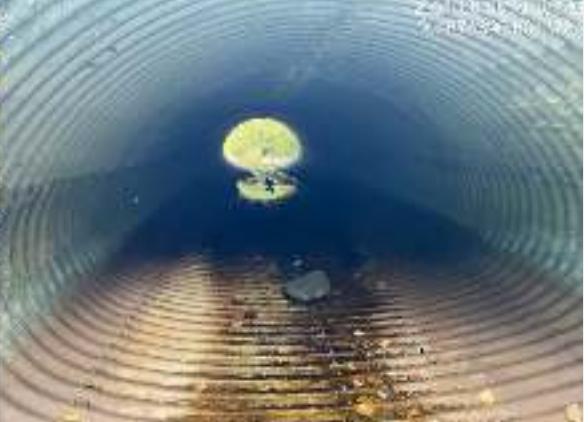
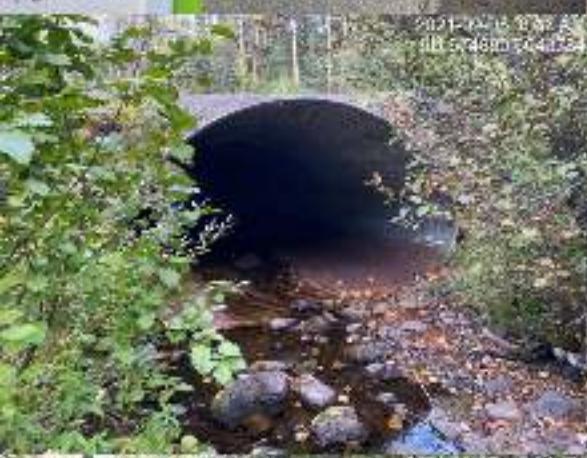
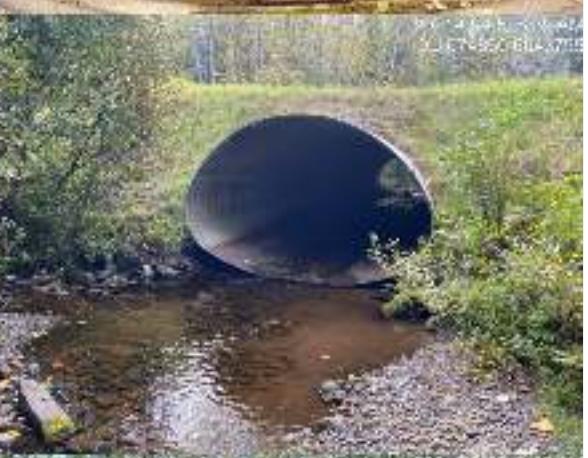
Photos: PSCIS ID 198049. From top left clockwise: Road/Site Card, Barrel, Outlet, Downstream, Upstream, Inlet.

Location and Stream Data		Crossing Characteristics –	
Date	2021-09-05	Crossing Sub Type	Round Culvert
PSCIS ID	198049	Diameter (m)	3.7
External ID	1800193	Length (m)	21
Crew	AI KP	Embedded	No
UTM Zone	9	Depth Embedded (m)	—
Easting	674875.4	Resemble Channel	No
Northing	6043782	Backwatered	No
Stream	Cesford Creek	Percent Backwatered	—
Road	Highway 118	Fill Depth (m)	1
Road Tenure	MoTi Arterial	Outlet Drop (m)	0.5
Channel Width (m)	4.9	Outlet Pool Depth (m)	0.25
Stream Slope (%)	2.83	Inlet Drop	No
Beaver Activity	No	Slope (%)	1.5
Habitat Value	High	Valley Fill	Deep Fill
Final score	34	Barrier Result	Barrier
Fix type	Replace with New Open Bottom Structure	Fix Span / Diameter	10

Location and Stream Data	•	Crossing Characteristics	-
Comments: Habitat confirmation conducted. ~110mm fish observed in outlet pool. Culvert slope surveyed with lazer level. 8:37

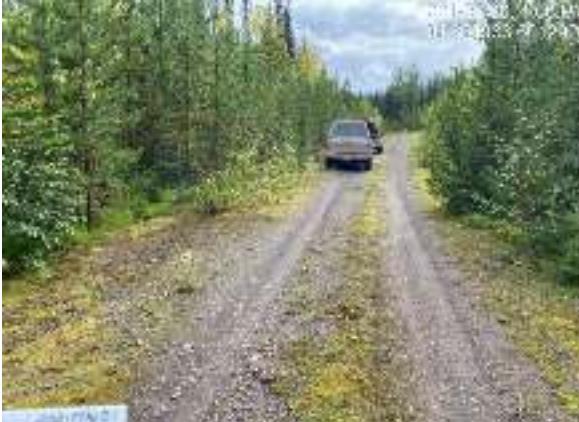
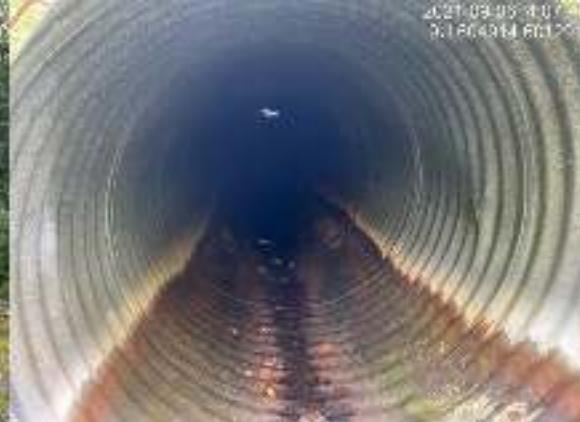
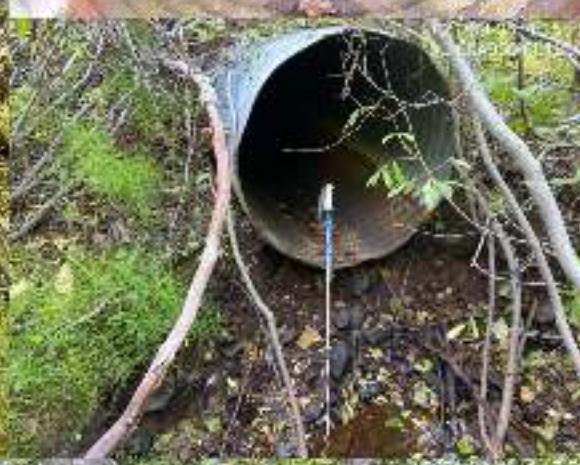
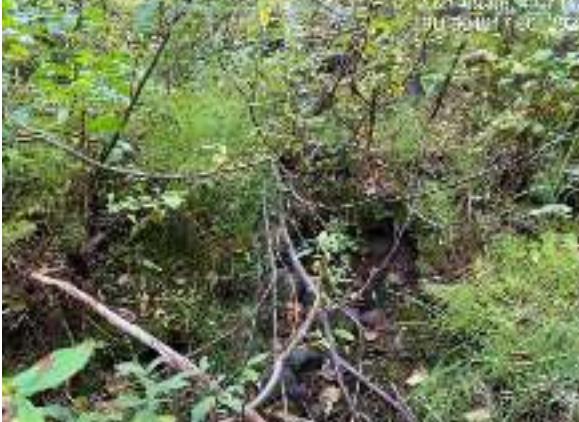
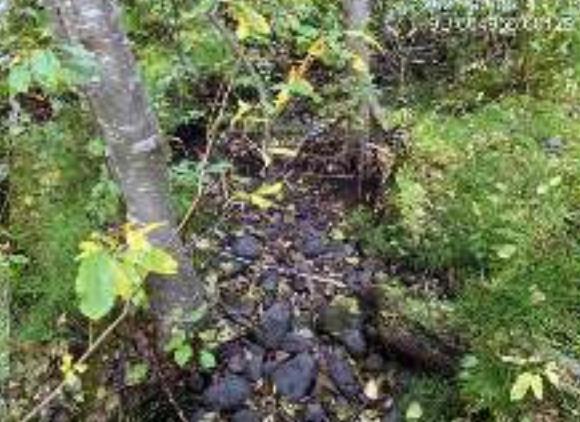
Photos: PSCIS ID 198051. From top left clockwise: Road/Site Card, Barrel, Outlet, Downstream, Upstream, Inlet.

Location and Stream Data		Crossing Characteristics	
Date	2021-09-06	Crossing Sub Type	Round Culvert
PSCIS ID	198051	Diameter (m)	0.6
External ID	14001409	Length (m)	11
Crew	AI	Embedded	No
UTM Zone	9	Depth Embedded (m)	—
Easting	604621.6	Resemble Channel	No
Northing	6012796	Backwatered	No
Stream	Tributary to Thault River	Percent Backwatered	—
Road	Spur	Fill Depth (m)	1
Road Tenure	Canfor R04078	Outlet Drop (m)	0
Channel Width (m)	1.3	Outlet Pool Depth (m)	0
Stream Slope (%)	1	Inlet Drop	No
Beaver Activity	No	Slope (%)	4
Habitat Value	Low	Valley Fill	Deep Fill
Final score	26	Barrier Result	Barrier
Fix type	Replace Structure with Streambed Simulation CBS	Fix Span / Diameter	3

Location and Stream Data	•	Crossing Characteristics	-
Comments: Dry, difficult to find the channel upstream. 16:30

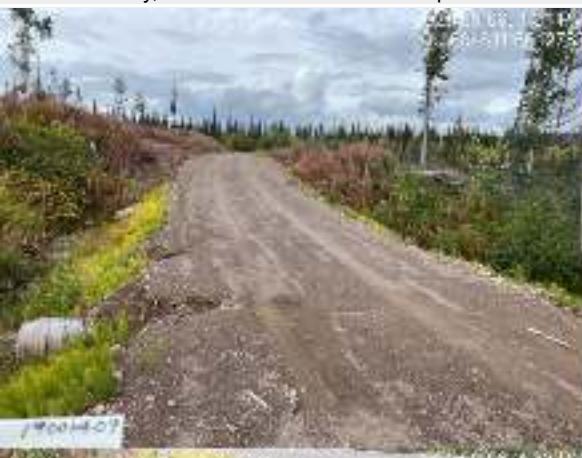
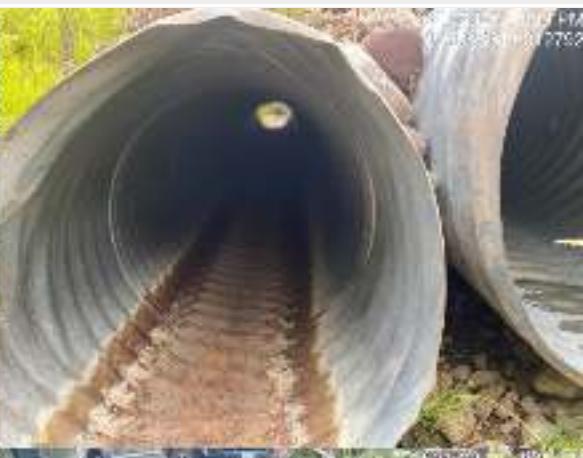
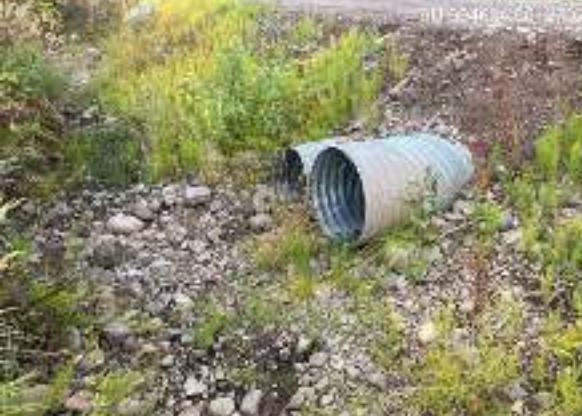
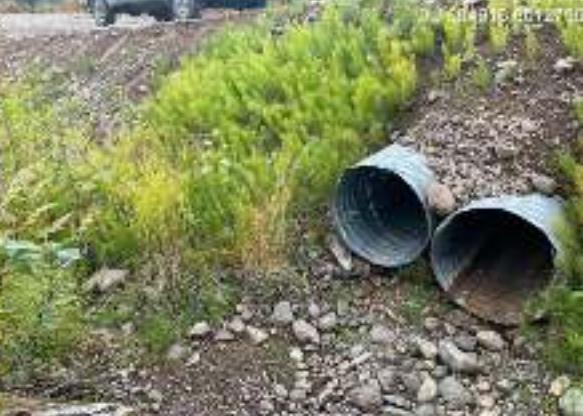
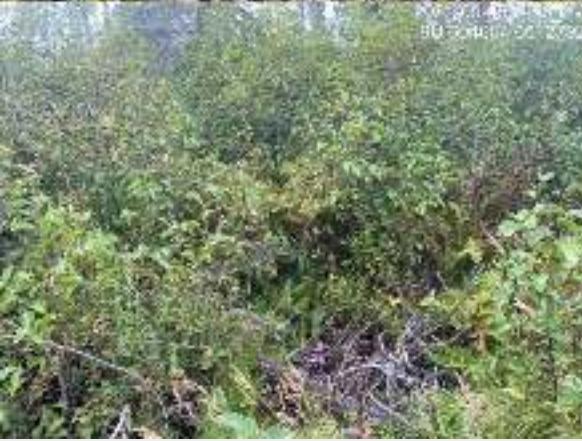
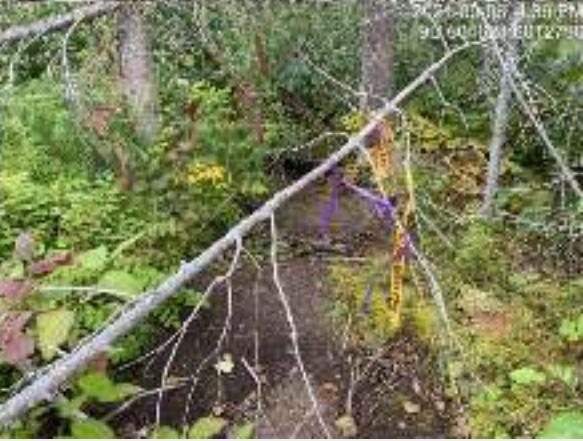
Photos: PSCIS ID 198052. From top left clockwise: Road/Site Card, Barrel, Outlet, Downstream, Upstream, Inlet.

Location and Stream Data		Crossing Characteristics	
Date	2021-09-06	Crossing Sub Type	Round Culvert
PSCIS ID	198052	Diameter (m)	0.4
External ID	14001468	Length (m)	12
Crew	AI	Embedded	No
UTM Zone	9	Depth Embedded (m)	—
Easting	604616.4	Resemble Channel	No
Northing	6010547	Backwatered	No
Stream	Tributary to Thault River	Percent Backwatered	—
Road	Spur	Fill Depth (m)	1
Road Tenure	Unclassified	Outlet Drop (m)	0
Channel Width (m)	0.5	Outlet Pool Depth (m)	0
Stream Slope (%)	0	Inlet Drop	No
Beaver Activity	No	Slope (%)	4
Habitat Value	Low	Valley Fill	Deep Fill
Final score	23	Barrier Result	Barrier
Fix type	Replace Structure with Streambed Simulation CBS	Fix Span / Diameter	3

Location and Stream Data	•	Crossing Characteristics	-
Comments: Cannot locate outlet. Not likely fish habitat. Seasonal wetland. 17:00

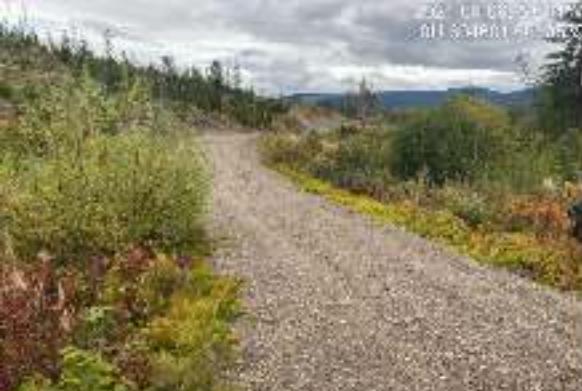
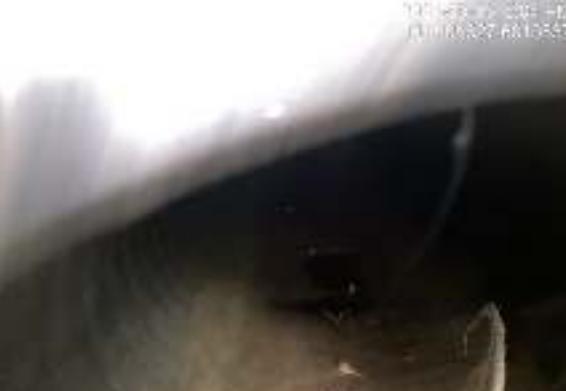
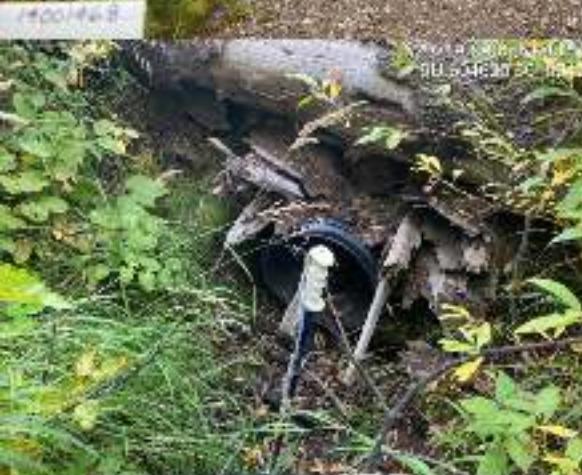
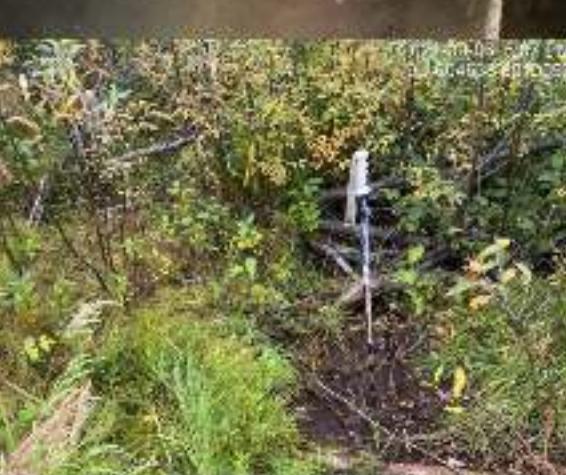
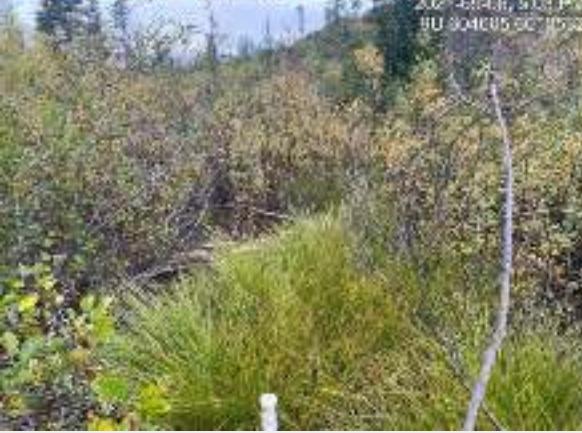
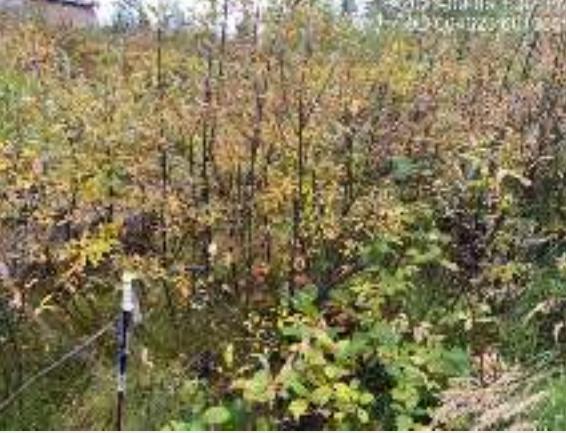
Photos: PSCIS ID 198053. From top left clockwise: Road/Site Card, Barrel, Outlet, Downstream, Upstream, Inlet.

Location and Stream Data	•	Crossing Characteristics	-
Comments: Bridge. 13:22

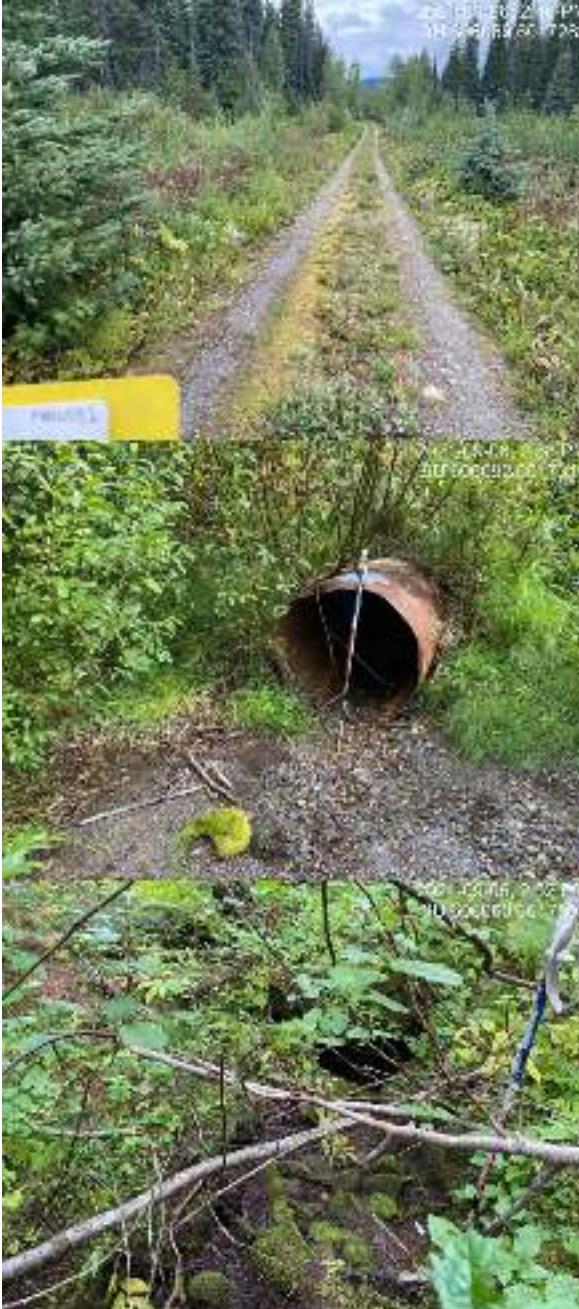
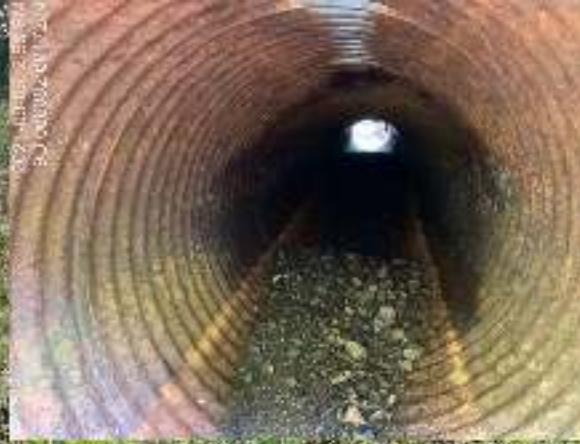
Photos: PSCIS ID 198056. From top left clockwise: Road/Site Card, Barrel, Outlet, Downstream, Upstream, Inlet.

Location and Stream Data	*	Crossing Characteristics	-
Date	2021-09-06	Crossing Sub Type	Oval Culvert
PSCIS ID	198056	Diameter (m)	0.6
External ID	14000389	Length (m)	25
Crew	AI VJ TP	Embedded	No
UTM Zone	9	Depth Embedded (m)	-
Easting	604962.1	Resemble Channel	No
Northing	6015050	Backwatered	No
Stream	Tributary to Thautil River	Percent Backwatered	-
Road	Thautil FSR	Fill Depth (m)	4.5
Road Tenure	West Fraser R03753	Outlet Drop (m)	1.2
Channel Width (m)	1.8	Outlet Pool Depth (m)	0.45
Stream Slope (%)	9	Inlet Drop	No
Beaver Activity	No	Slope (%)	4
Habitat Value	Low	Valley Fill	Deep Fill
Final score	39	Barrier Result	Barrier
Fix type	Replace Structure with Streambed Simulation CBS	Fix Span / Diameter	3

Location and Stream Data	•	Crossing Characteristics	-
Comments: Small stream. Minimal flow - not dry. Steep downstream of culvert. 80cm steps, good gravels. 15:22
