Appendix - Phase 1 Fish Passage Assessment Data and Photos

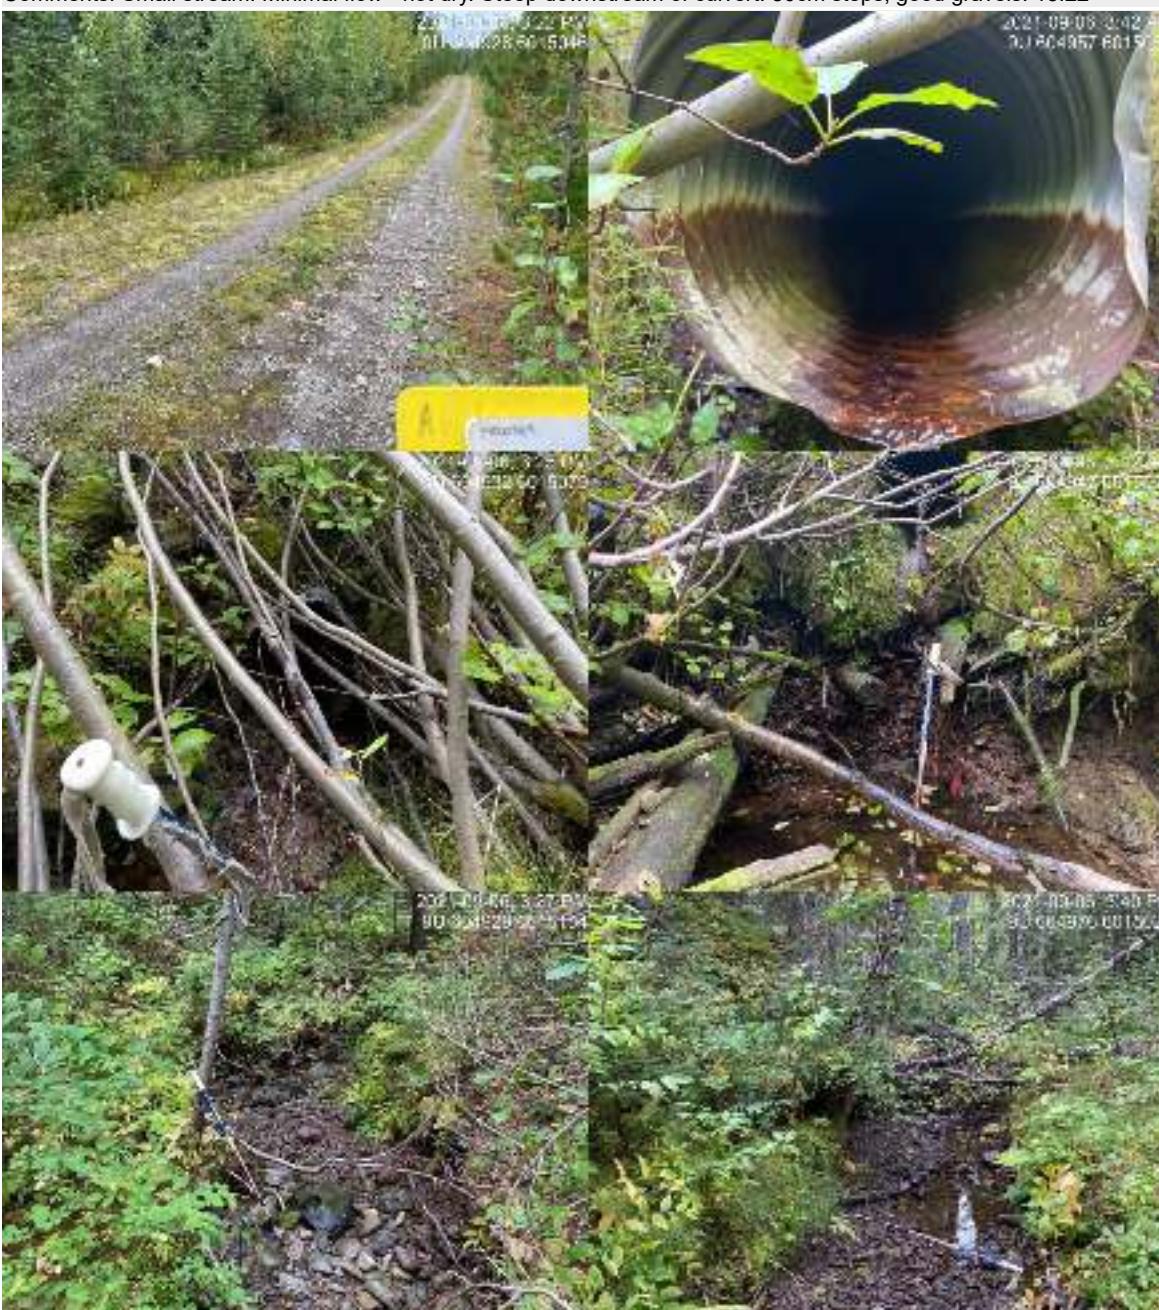
Photos: PSCIS ID 198057. From top left clockwise: Road/Site Card, Barrel, Outlet, Downstream, Upstream, Inlet.

Location and Stream Data		Crossing Characteristics –	
Date	2021-09-06	Crossing Sub Type	Round Culvert
PSCIS ID	198057	Diameter (m)	1.4
External ID	14000383	Length (m)	18
Crew	AI KP VJ TP	Embedded	No
UTM Zone	9	Depth Embedded (m)	—
Easting	605307.1	Resemble Channel	No
Northing	6023040	Backwatered	No
Stream	Tributary to Gabriel Creek	Percent Backwatered	—
Road	Thautil FSR	Fill Depth (m)	3
Road Tenure	West Fraser R03753	Outlet Drop (m)	0
Channel Width (m)	3	Outlet Pool Depth (m)	0.75
Stream Slope (%)	3.5	Inlet Drop	No
Beaver Activity	No	Slope (%)	3
Habitat Value	Medium	Valley Fill	Deep Fill
Final score	29	Barrier Result	Barrier
Fix type	Replace with New Open Bottom Structure	Fix Span / Diameter	10

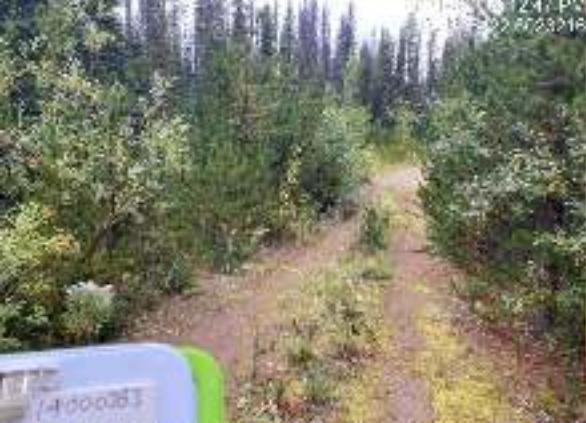
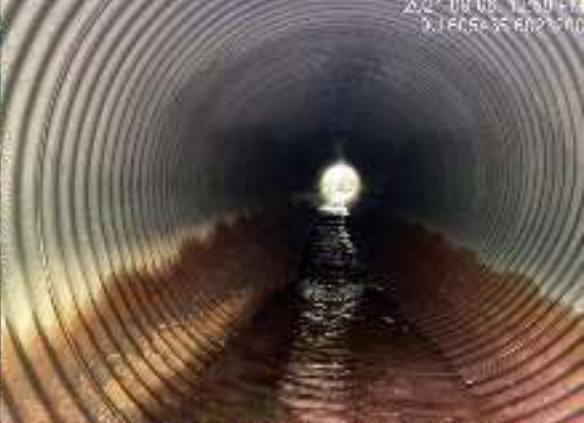
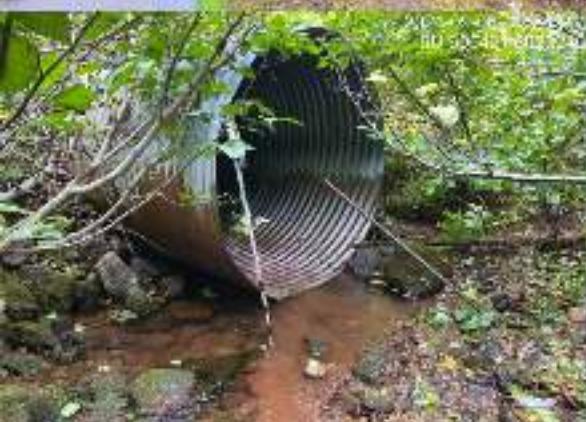
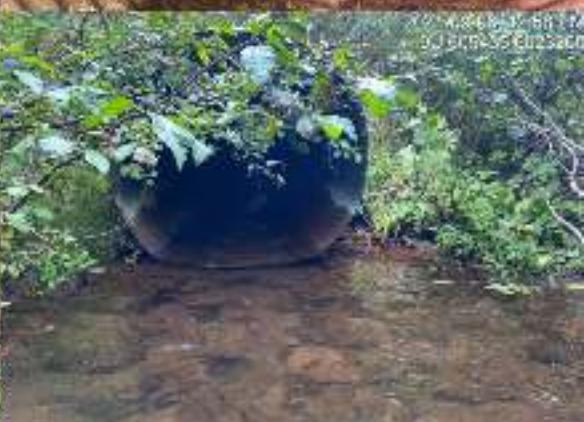
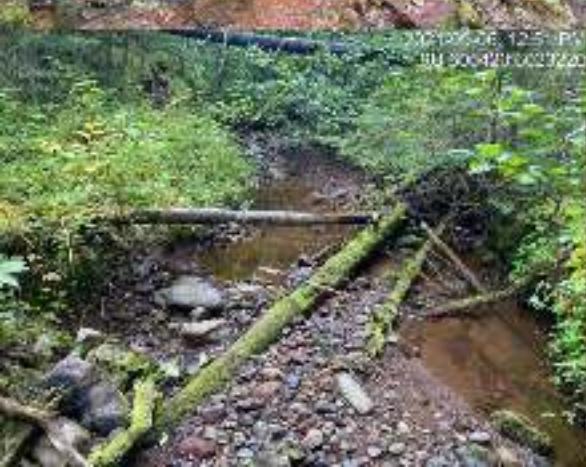
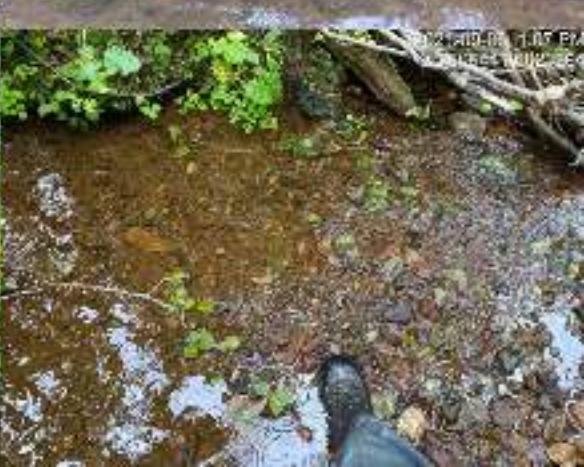
Photos: PSCIS ID 198058. From top left clockwise: Road/Site Card, Barrel, Outlet, Downstream, Upstream, Inlet.

Location and Stream Data		Crossing Characteristics	
Date	2021-09-06	Crossing Sub Type	Round Culvert
PSCIS ID	198058	Diameter (m)	1
External ID	14000390	Length (m)	14
Crew	AI VJ TP	Embedded	No
UTM Zone	9	Depth Embedded (m)	—
Easting	605778.6	Resemble Channel	No
Northing	6021673	Backwatered	No
Stream	Tributary to Gabriel Creek	Percent Backwatered	—
Road	Thautil FSR	Fill Depth (m)	1
Road Tenure	West Fraser R03753	Outlet Drop (m)	0.3
Channel Width (m)	1.5	Outlet Pool Depth (m)	0.2
Stream Slope (%)	7	Inlet Drop	No
Beaver Activity	No	Slope (%)	5
Habitat Value	Low	Valley Fill	Deep Fill
Final score	36	Barrier Result	Barrier
Fix type	Replace Structure with Streambed Simulation CBS	Fix Span / Diameter	3

Location and Stream Data	•	Crossing Characteristics	-
Comments: Very small amount of flow. Some good gravels. Multiple FISS sites downstream with velocity barrier noted. Non-fish? 13:54

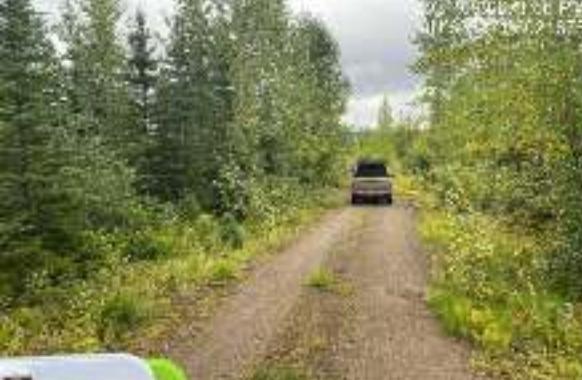
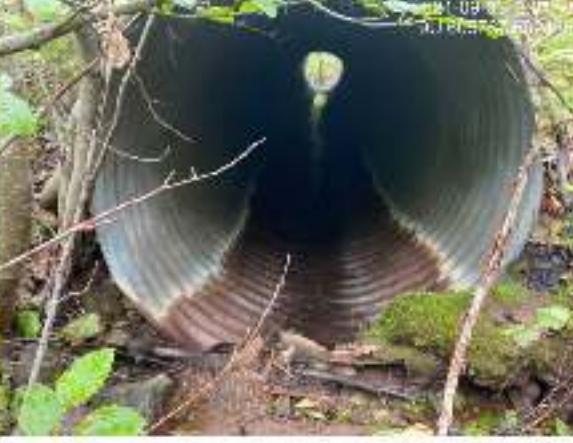
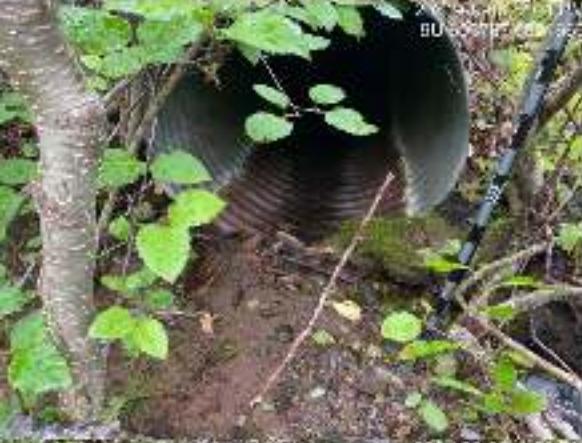
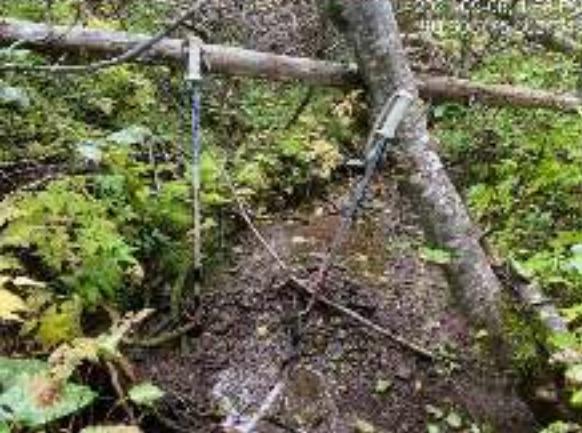
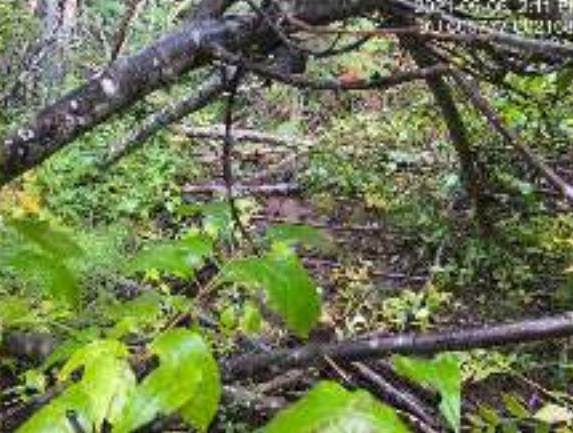
Photos: PSCIS ID 198059. From top left clockwise: Road/Site Card, Barrel, Outlet, Downstream, Upstream, Inlet.

Location and Stream Data		Crossing Characteristics	
Date	2021-09-06	Crossing Sub Type	Round Culvert
PSCIS ID	198059	Diameter (m)	0.6
External ID	14000392	Length (m)	12
Crew	AI KP	Embedded	No
UTM Zone	9	Depth Embedded (m)	—
Easting	605753.6	Resemble Channel	No
Northing	6023618	Backwatered	No
Stream	Tributary to Gabriel Creek	Percent Backwatered	—
Road	Thautil FSR	Fill Depth (m)	1.5
Road Tenure	West Fraser R03753	Outlet Drop (m)	0.62
Channel Width (m)	1.5	Outlet Pool Depth (m)	0.82
Stream Slope (%)	4	Inlet Drop	No
Beaver Activity	No	Slope (%)	2
Habitat Value	Medium	Valley Fill	Deep Fill
Final score	31	Barrier Result	Barrier
Fix type	Replace Structure with Streambed Simulation CBS	Fix Span / Diameter	3

Location and Stream Data	•	Crossing Characteristics	-
Comments: Nice gravels. Some flow at this dry time of year. Small system with Dolly Varden noted downstream. 12:26

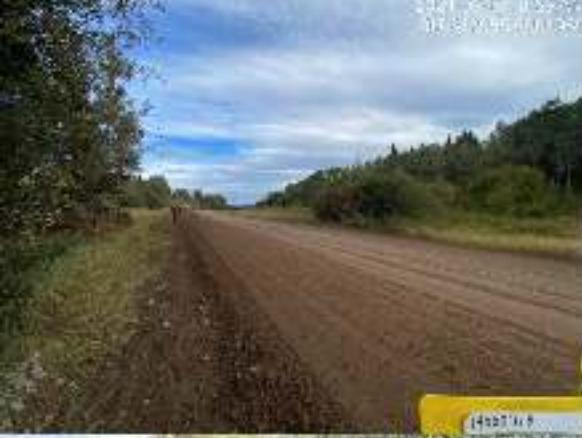
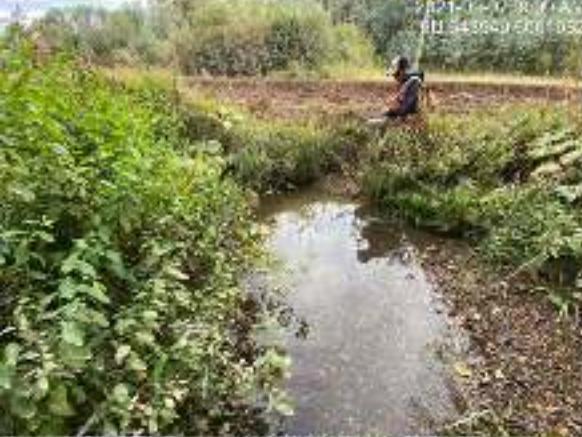
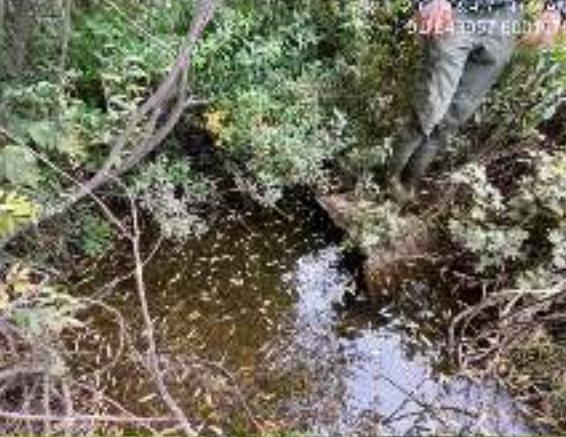
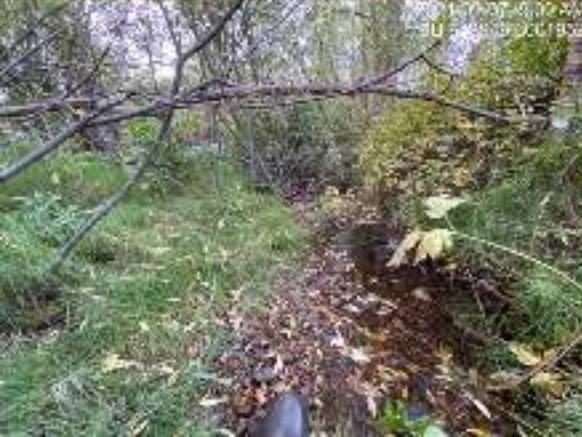
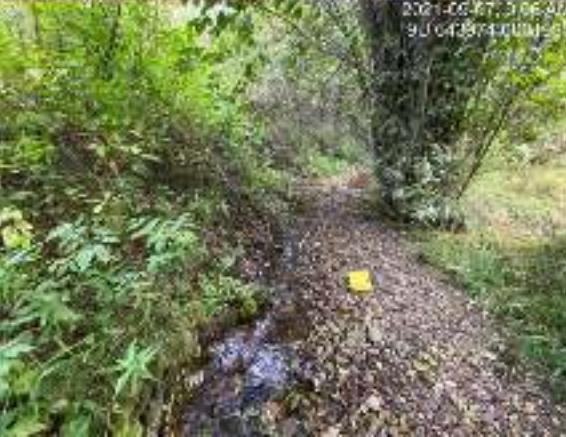
Photos: PSCIS ID 198060. From top left clockwise: Road/Site Card, Barrel, Outlet, Downstream, Upstream, Inlet.

Location and Stream Data		Crossing Characteristics –	
Date	2021-09-07	Crossing Sub Type	Round Culvert
PSCIS ID	198060	Diameter (m)	0.6
External ID	14000718	Length (m)	16
Crew	AI	Embedded	No
UTM Zone	9	Depth Embedded (m)	–
Easting	643962	Resemble Channel	No
Northing	6001978	Backwatered	Yes
Stream	Tributary to Owen Creek	Percent Backwatered	100
Road	Morice-Owen FSR	Fill Depth (m)	0.7
Road Tenure	Unknown	Outlet Drop (m)	0
Channel Width (m)	2	Outlet Pool Depth (m)	0.36
Stream Slope (%)	3	Inlet Drop	No
Beaver Activity	No	Slope (%)	0.5
Habitat Value	Medium	Valley Fill	Deep Fill
Final score	19	Barrier Result	Potential
Fix type	Replace with New Open Bottom Structure	Fix Span / Diameter	10

Location and Stream Data	•	Crossing Characteristics	-
Comments: Very nice gravels. Some flow. Passable currently but may by higher velocity at higher flows. 8:59

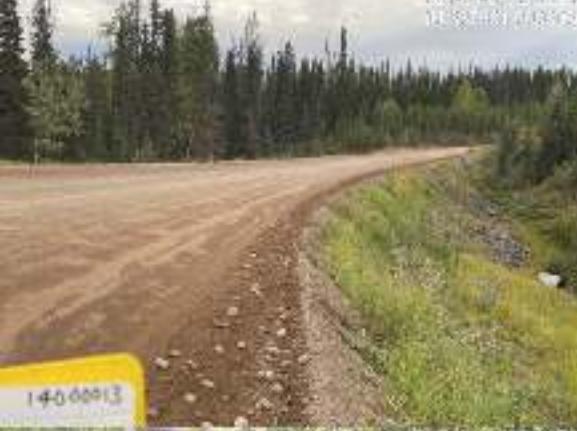
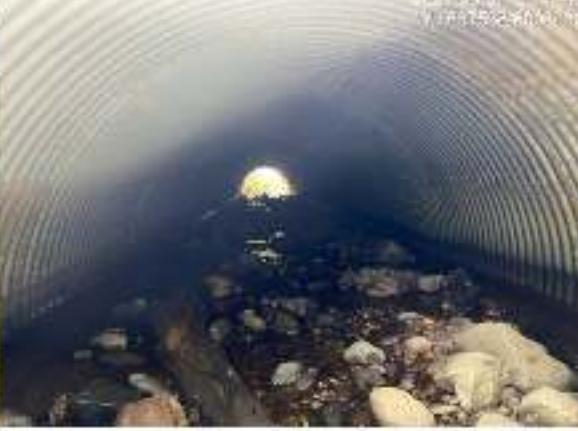
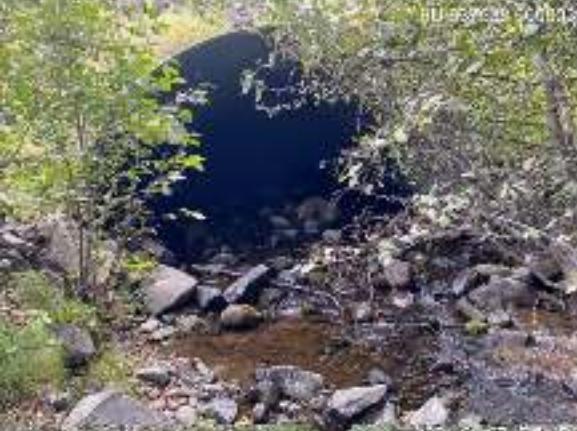
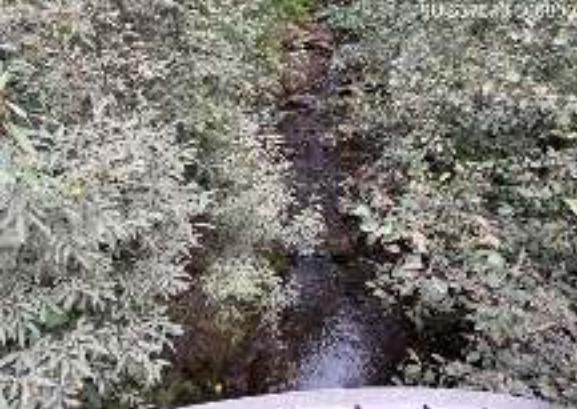
Photos: PSCIS ID 198061. From top left clockwise: Road/Site Card, Barrel, Outlet, Downstream, Upstream, Inlet.

Location and Stream Data	Crossing Characteristics
Comments: Pipe arch. Mis-labelled as 14000013 (upstream modelled crossing) which has been removed. 17:39

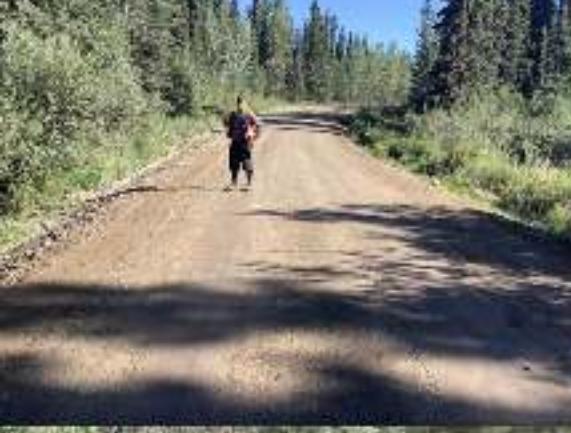
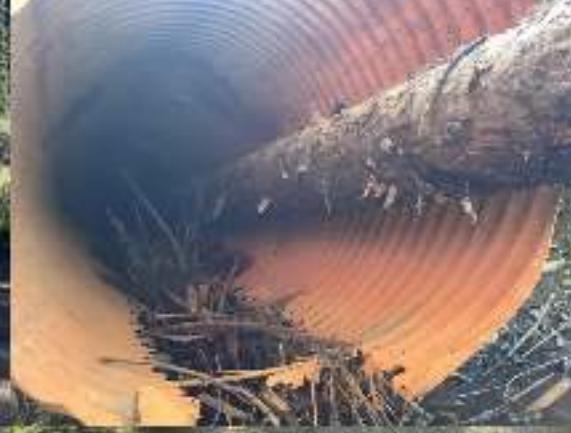
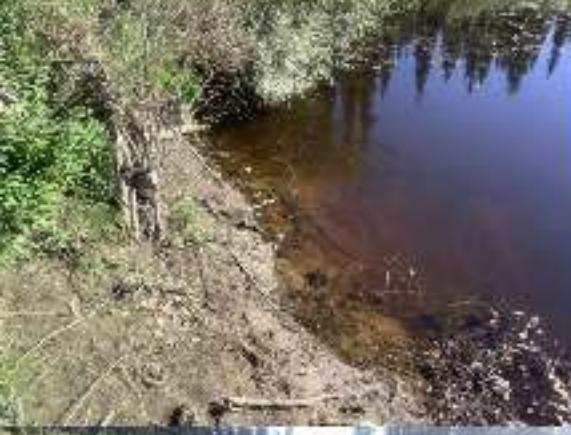
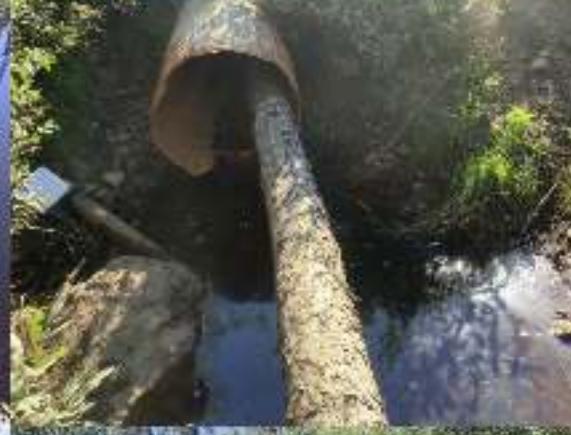
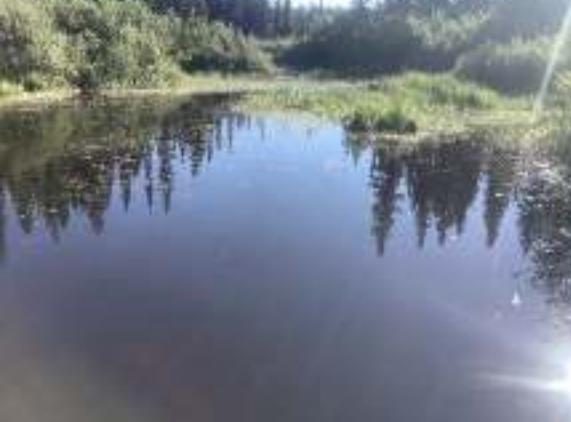
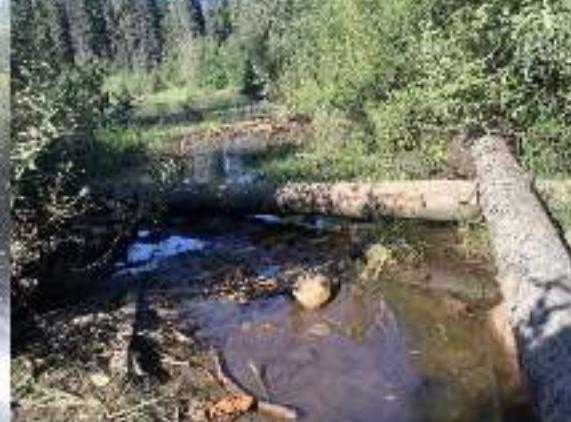
Location and Stream Data	• Crossing Characteristics	-
Comments: Upstream wetland appears shallow. Flown with drone. Could not locate inlet. Culvert damaged with 24cm tree lodged in it. Slope estimated as black barrel. 17:30

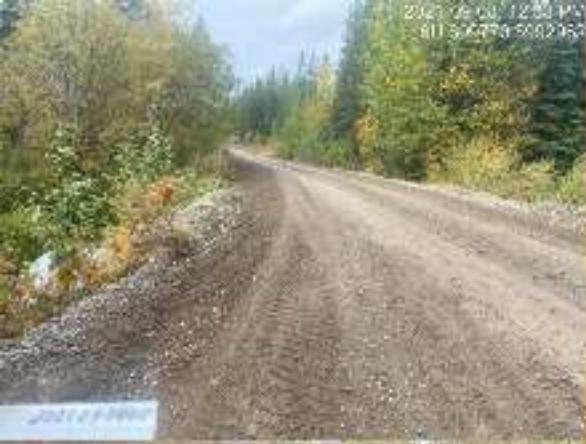
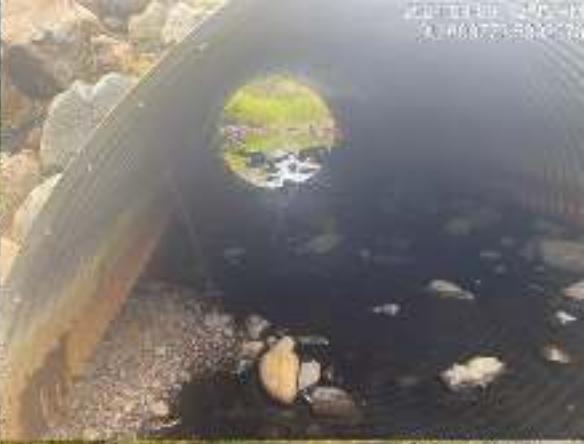
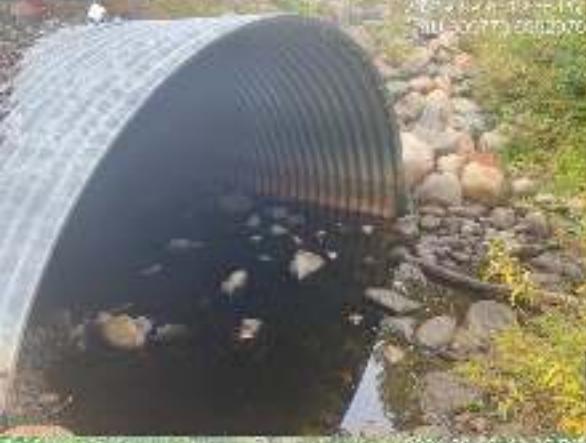
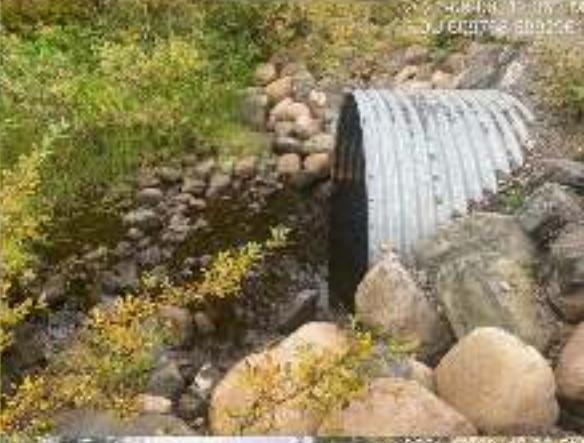
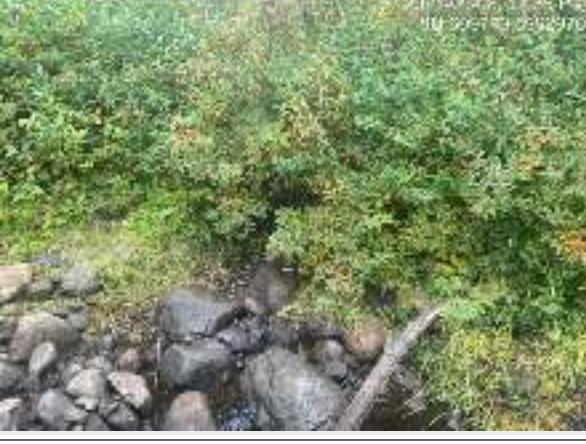
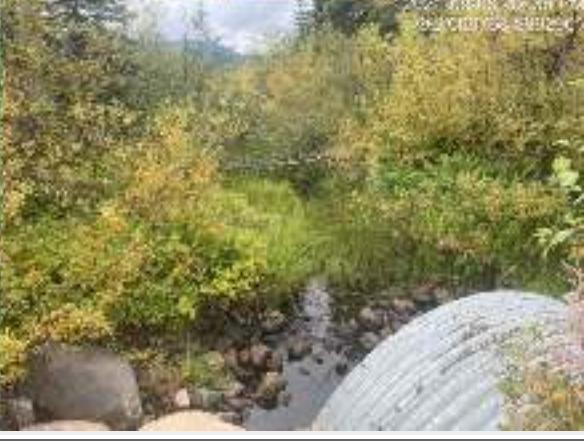
Photos: PSCIS ID 198063. From top left clockwise: Road/Site Card, Barrel, Outlet, Downstream, Upstream, Inlet.

Location and Stream Data	•	Crossing Characteristics	-
Comments: Pipe arch. 12:33

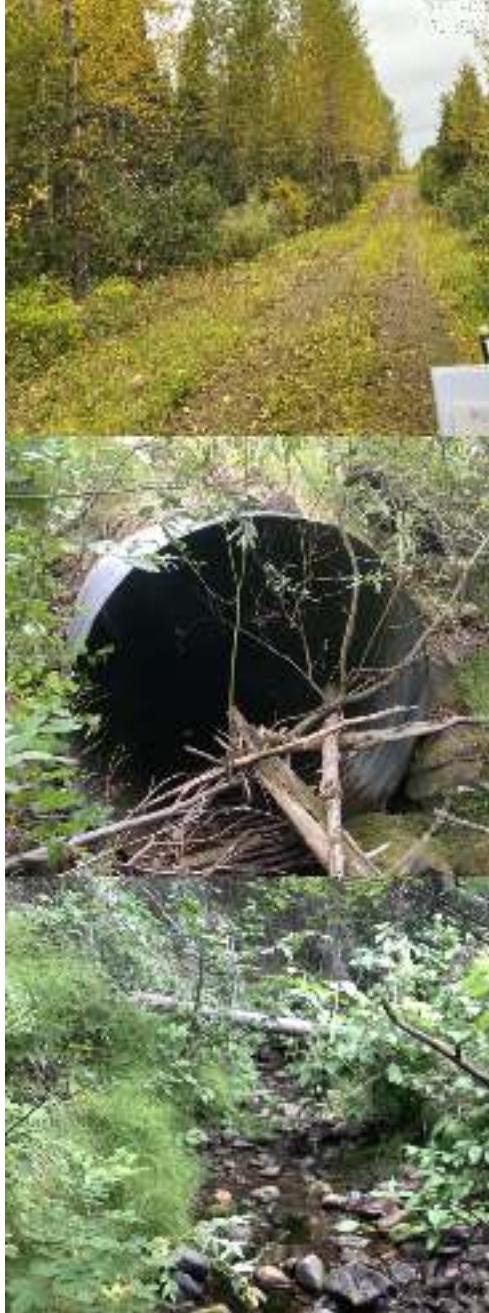
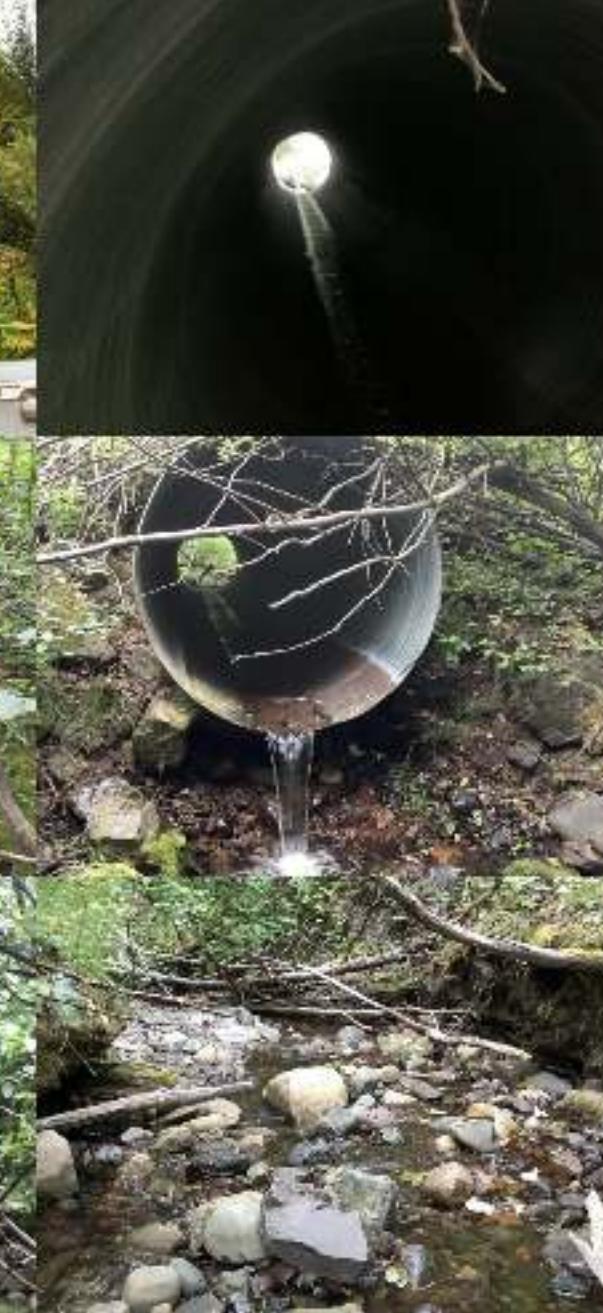
Photos: PSCIS ID 198064. From top left clockwise: Road/Site Card, Barrel, Outlet, Downstream, Upstream, Inlet.

Location and Stream Data		Crossing Characteristics –	
Date	2021-09-08	Crossing Sub Type	Round Culvert
PSCIS ID	198064	Diameter (m)	1.6
External ID	14001094	Length (m)	14
Crew	KP AI TP VJ	Embedded	No
UTM Zone	9	Depth Embedded (m)	—
Easting	623369	Resemble Channel	No
Northing	6000283	Backwatered	No
Stream	Tributary to Lamprey Creek	Percent Backwatered	—
Road	Spur	Fill Depth (m)	1
Road Tenure	Canfor R05233	Outlet Drop (m)	0.54
Channel Width (m)	2.56	Outlet Pool Depth (m)	0.6
Stream Slope (%)	4.5	Inlet Drop	No
Beaver Activity	No	Slope (%)	5
Habitat Value	Medium	Valley Fill	Deep Fill
Final score	36	Barrier Result	Barrier
Fix type	Replace with New Open Bottom Structure	Fix Span / Diameter	10

Location and Stream Data	• Crossing Characteristics	-
Comments: Habitat confirmation conducted. Fish observed (150mm). Good flows when compared to many other streams. 9.25

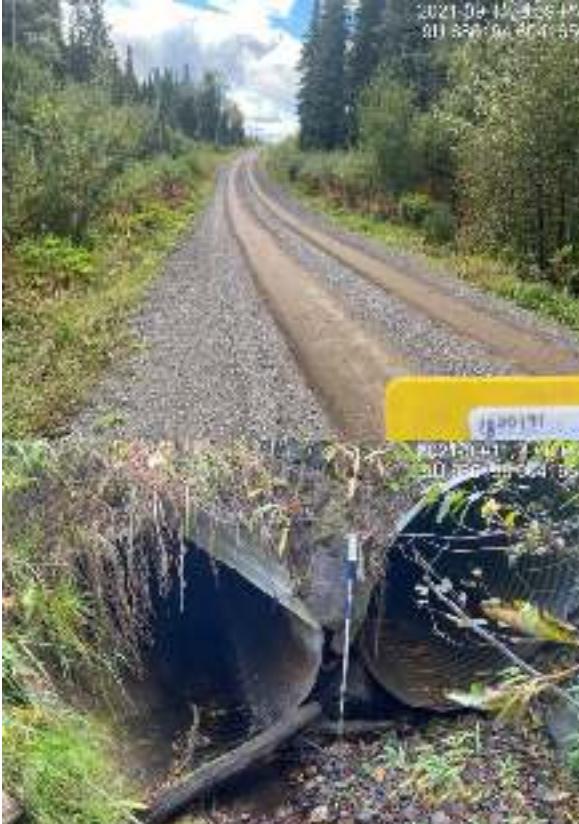
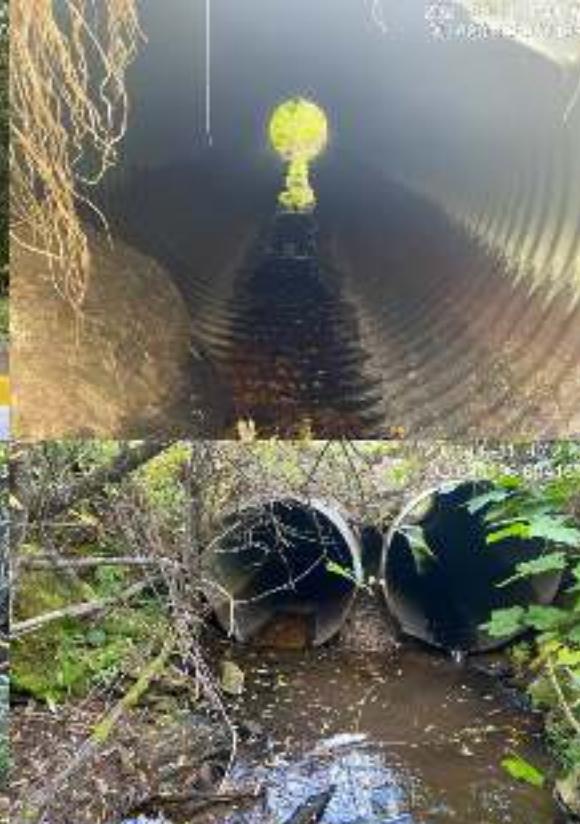
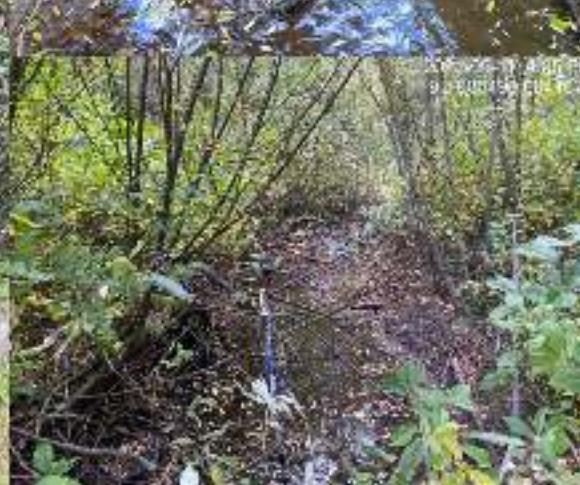
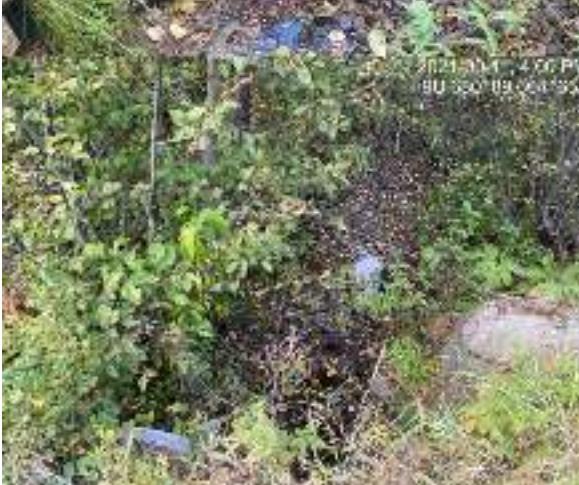
Photos: PSCIS ID 198065. From top left clockwise: Road/Site Card, Barrel, Outlet, Downstream, Upstream, Inlet.

Location and Stream Data		Crossing Characteristics –	
Date	2021-09-11	Crossing Sub Type	Round Culvert
PSCIS ID	198065	Diameter (m)	1.2
External ID	1800191	Length (m)	10
Crew	AI	Embedded	No
UTM Zone	9	Depth Embedded (m)	—
Easting	680197	Resemble Channel	No
Northing	6041647	Backwatered	No
Stream	Watson Creek	Percent Backwatered	—
Road	Montgomery Road	Fill Depth (m)	0.7
Road Tenure	MoTi Local	Outlet Drop (m)	0.13
Channel Width (m)	3	Outlet Pool Depth (m)	0.1
Stream Slope (%)	1	Inlet Drop	No
Beaver Activity	No	Slope (%)	1
Habitat Value	Medium	Valley Fill	Deep Fill
Final score	21	Barrier Result	Barrier
Fix type	Replace with New Open Bottom Structure	Fix Span / Diameter	10

Location and Stream Data	•	Crossing Characteristics	-
Comments: Very low flow but channel is mostly watered. Abundant gravels and excellent vegetation cover. 15:58

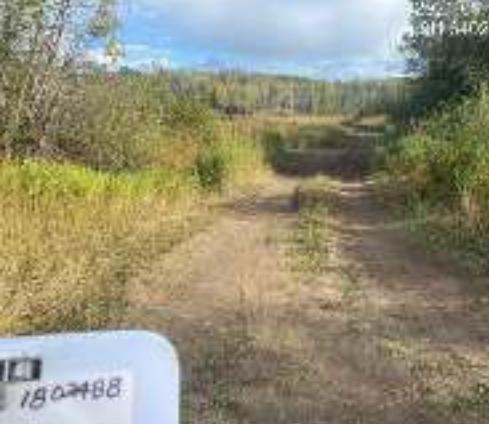
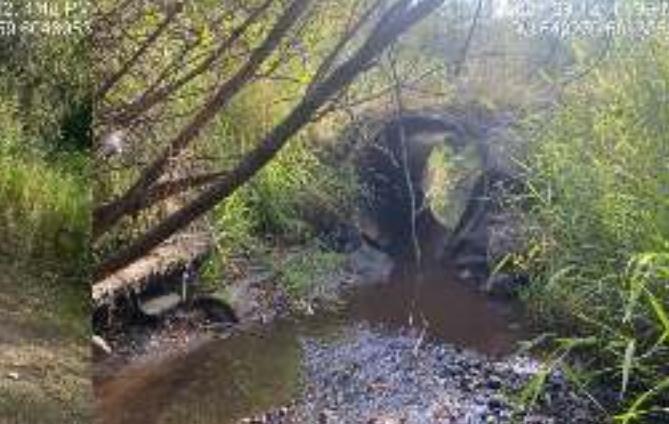
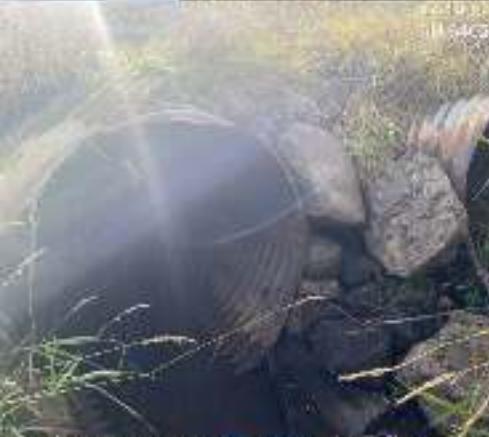
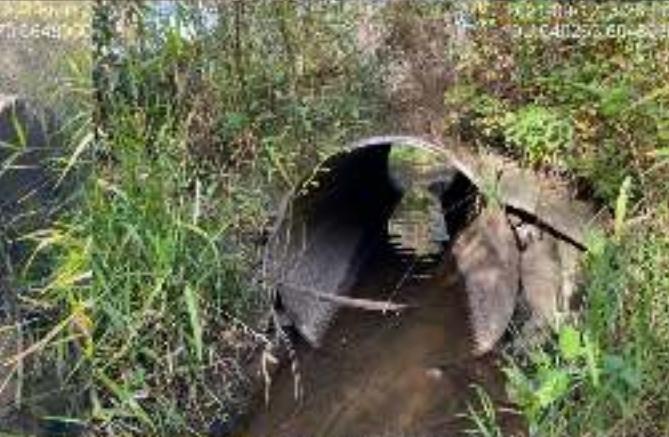
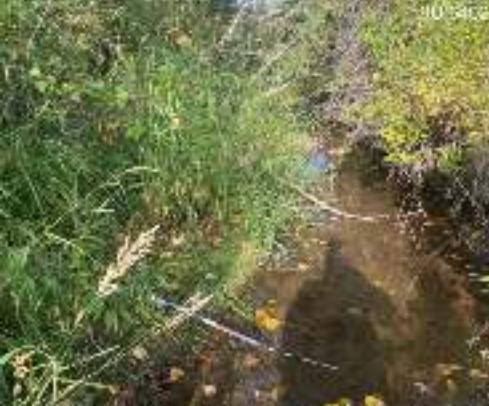
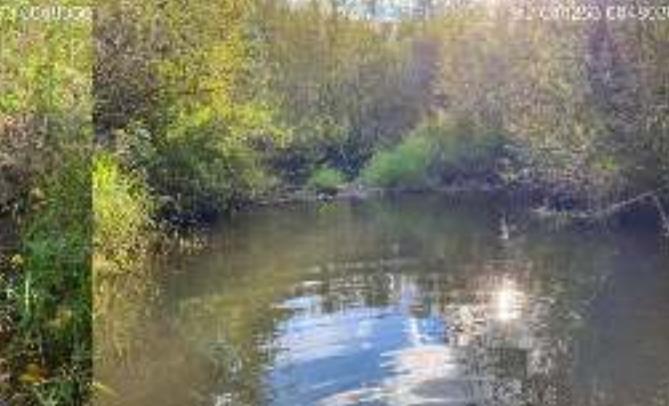
Photos: PSCIS ID 198066. From top left clockwise: Road/Site Card, Barrel, Outlet, Downstream, Upstream, Inlet.

Location and Stream Data		Crossing Characteristics –	
Date	2021-09-12	Crossing Sub Type	Round Culvert
PSCIS ID	198066	Diameter (m)	1.3
External ID	1802488	Length (m)	6
Crew	AI	Embedded	No
UTM Zone	9	Depth Embedded (m)	–
Easting	640243.9	Resemble Channel	No
Northing	6048061	Backwatered	Yes
Stream	Thompson Creek	Percent Backwatered	95
Road	Private Road	Fill Depth (m)	0.2
Road Tenure	Unclassified	Outlet Drop (m)	0
Channel Width (m)	2.77	Outlet Pool Depth (m)	0.1
Stream Slope (%)	0.5	Inlet Drop	No
Beaver Activity	No	Slope (%)	0.4
Habitat Value	High	Valley Fill	Deep Fill
Final score	16	Barrier Result	Potential
Fix type	Replace with New Open Bottom Structure	Fix Span / Diameter	10

Location and Stream Data	• Crossing Characteristics
<p>Comments: Udder View Farm. Currently appears passable for all life stages and species but may present slight barrier at time of year when flow are high. Large outlet pool indicates that culvert is undersized. Landowners adjacent to the stream report that the channel was historically relocated through the fields near the river and they would like to work together to relocate. 16:48</p>

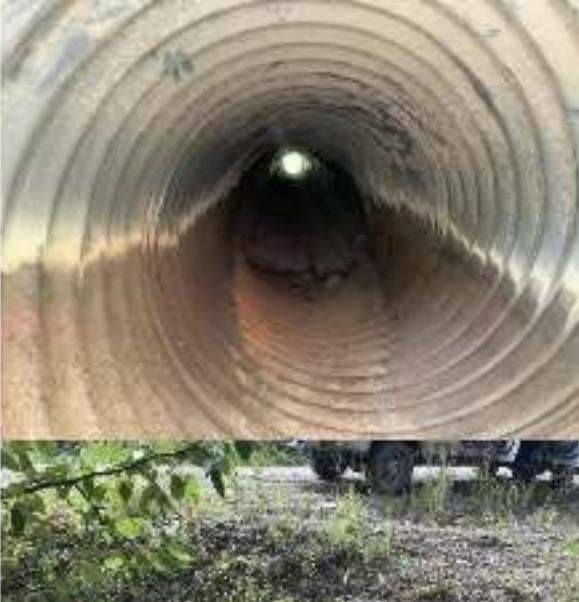
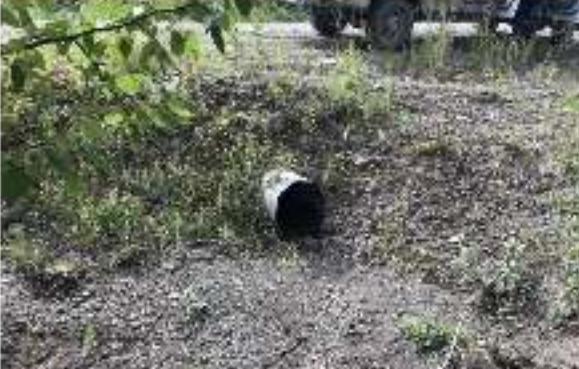
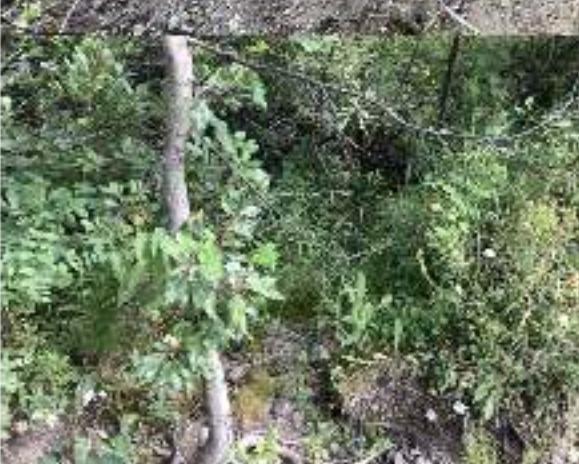
Photos: PSCIS ID 198068. From top left clockwise: Road/Site Card, Barrel, Outlet, Downstream, Upstream, Inlet.

Location and Stream Data		Crossing Characteristics	
Date	2021-08-09	Crossing Sub Type	Round Culvert
PSCIS ID	198068	Diameter (m)	0.5
External ID	14000815	Length (m)	13
Crew	LRH DM	Embedded	No
UTM Zone	9	Depth Embedded (m)	–
Easting	619989	Resemble Channel	No
Northing	5998259	Backwatered	No
Stream	Tributary to Lamprey Creek	Percent Backwatered	–
Road	Morice R FSR	Fill Depth (m)	0.3
Road Tenure	FLNR DND 4656	Outlet Drop (m)	0.4
Channel Width (m)	0.8	Outlet Pool Depth (m)	0.5
Stream Slope (%)	2	Inlet Drop	Yes
Beaver Activity	No	Slope (%)	2
Habitat Value	Low	Valley Fill	Deep Fill
Final score	31	Barrier Result	Barrier
Fix type	Replace Structure with Streambed Simulation CBS	Fix Span / Diameter	3

Location and Stream Data	•	Crossing Characteristics	-
Comments: down stream channel follows ditch line, dry channel.			
NO IMAGE AVAILABLE	•

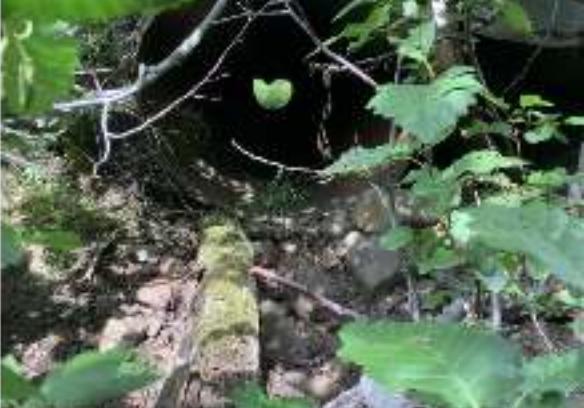
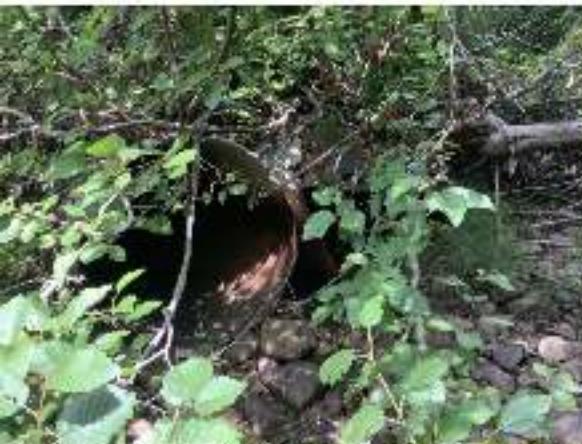
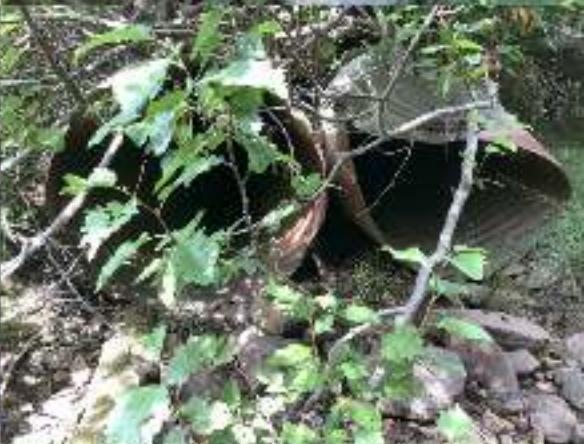
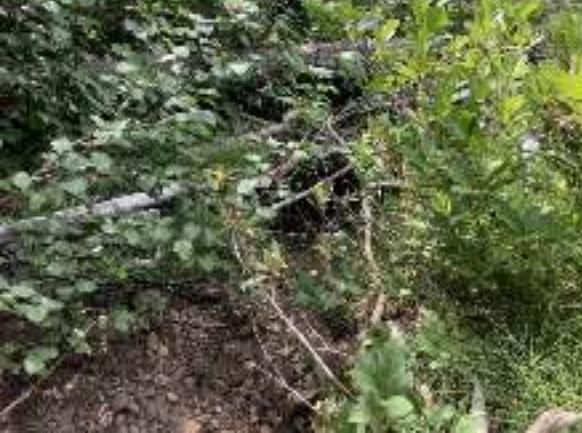
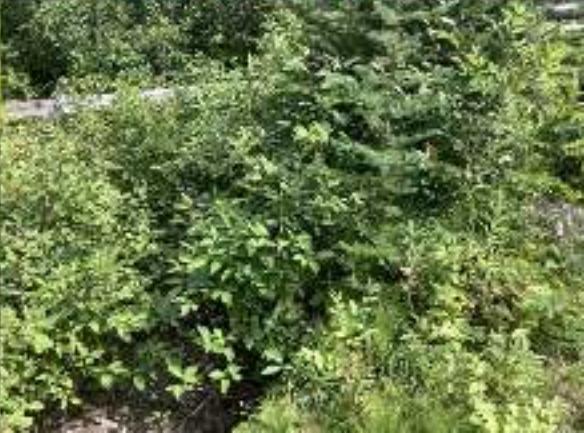
Photos: PSCIS ID 198069. From top left clockwise: Road/Site Card, Barrel, Outlet, Downstream, Upstream, Inlet.

Location and Stream Data		Crossing Characteristics –	
Date	2021-08-09	Crossing Sub Type	Round Culvert
PSCIS ID	198069	Diameter (m)	0.8
External ID	14000256	Length (m)	9
Crew	LRH DM	Embedded	No
UTM Zone	9	Depth Embedded (m)	—
Easting	616234.1	Resemble Channel	No
Northing	5998376	Backwatered	No
Stream	Tributary to Collins Lake	Percent Backwatered	—
Road	Morice Nado	Fill Depth (m)	0.3
Road Tenure	Unclassified	Outlet Drop (m)	0.05
Channel Width (m)	2.5	Outlet Pool Depth (m)	0.5
Stream Slope (%)	2	Inlet Drop	No
Beaver Activity	No	Slope (%)	1
Habitat Value	Medium	Valley Fill	Deep Fill
Final score	21	Barrier Result	Barrier
Fix type	Replace with New Open Bottom Structure	Fix Span / Diameter	10

Location and Stream Data	•	Crossing Characteristics	-
Comments: channel dry, old overgrown road, pooled after observed upslope of culvert			
NO IMAGE AVAILABLE

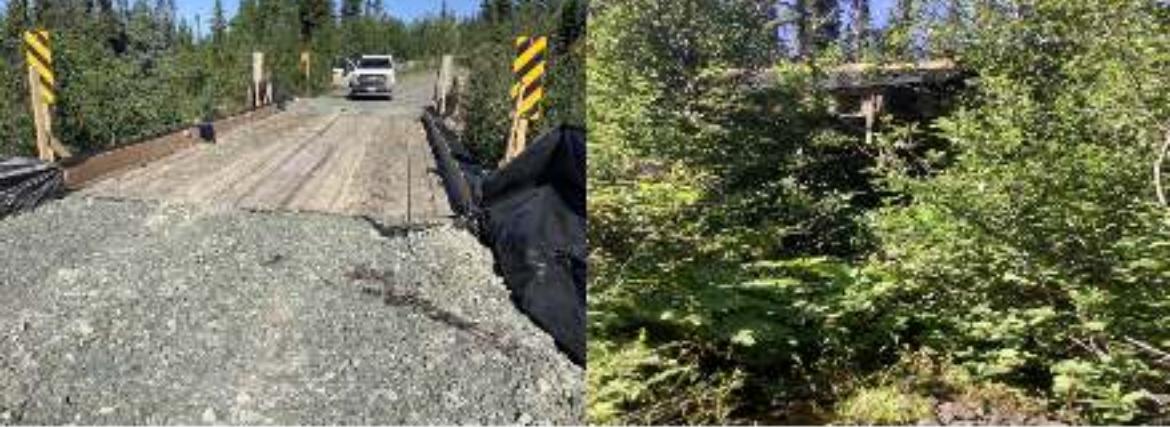
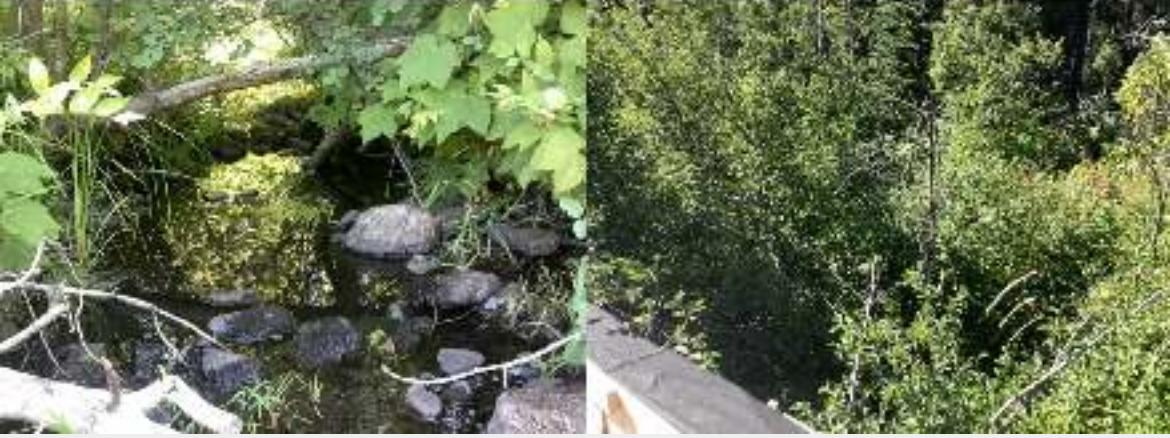
Photos: PSCIS ID 198070. From top left clockwise: Road/Site Card, Barrel, Outlet, Downstream, Upstream, Inlet.

Location and Stream Data	•	Crossing Characteristics	-
Comments: Bridge, 2 layers of sediment/erosion control cloth on and adjacent to bridge - installation by pipeline company

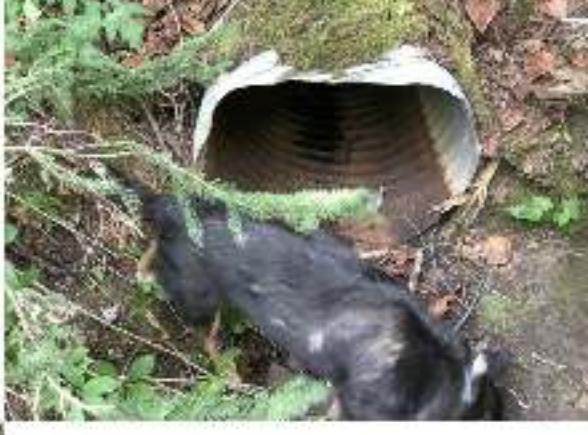
Photos: PSCIS ID 198071. From top left clockwise: Road/Site Card, Barrel, Outlet, Downstream, Upstream, Inlet.

Location and Stream Data		Crossing Characteristics	
Date	2021-08-09	Crossing Sub Type	Round Culvert
PSCIS ID	198071	Diameter (m)	0.8
External ID	14000022	Length (m)	6
Crew	LRH DM	Embedded	No
UTM Zone	9	Depth Embedded (m)	—
Easting	616801	Resemble Channel	No
Northing	5998662	Backwatered	No
Stream	Tributary to Collins Lake	Percent Backwatered	—
Road	spur Morice Nado	Fill Depth (m)	1
Road Tenure	Unclassified	Outlet Drop (m)	0
Channel Width (m)	2	Outlet Pool Depth (m)	0
Stream Slope (%)	1	Inlet Drop	No
Beaver Activity	No	Slope (%)	1
Habitat Value	Medium	Valley Fill	Deep Fill
Final score	21	Barrier Result	Barrier
Fix type	Replace Structure with Streambed Simulation CBS	Fix Span / Diameter	3

Location and Stream Data	• Crossing Characteristics	-
Comments: stream diverted onto road for approximately 500m - between 'modelled crossing Ids' 1014000022 and 1014000256, remove structure and restore to original channel, old pre-code logging		
NO IMAGE AVAILABLE

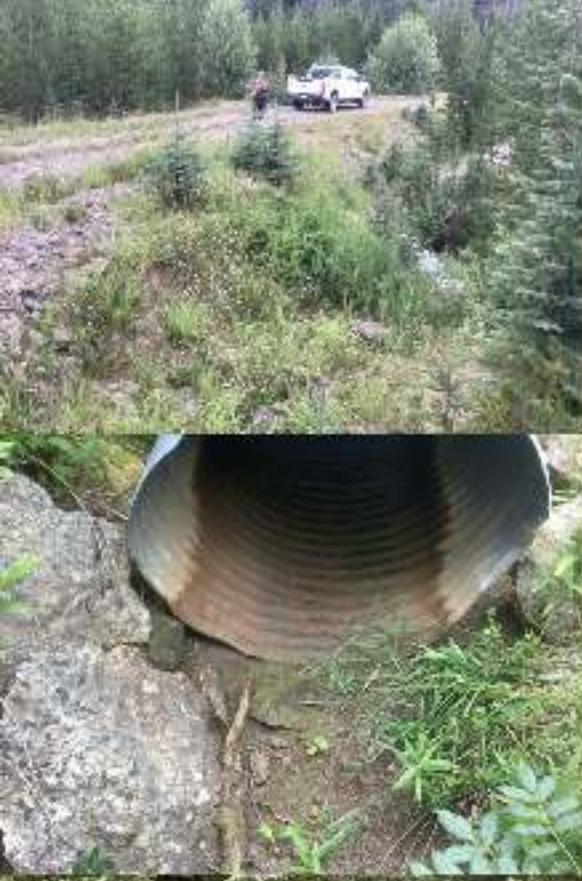
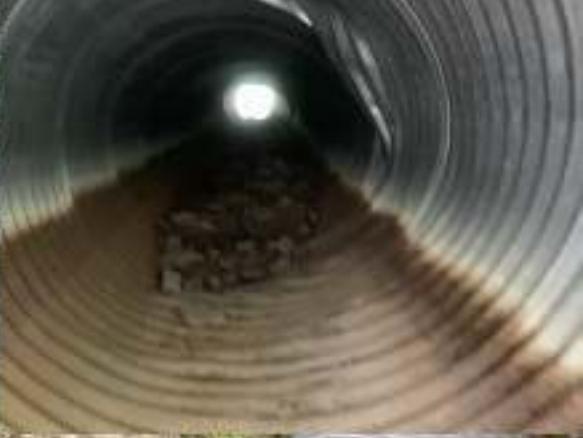
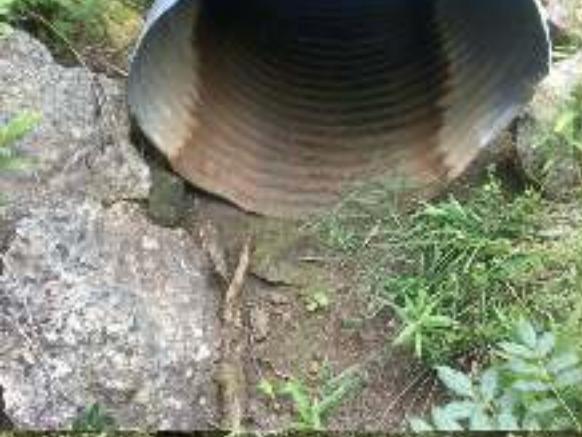
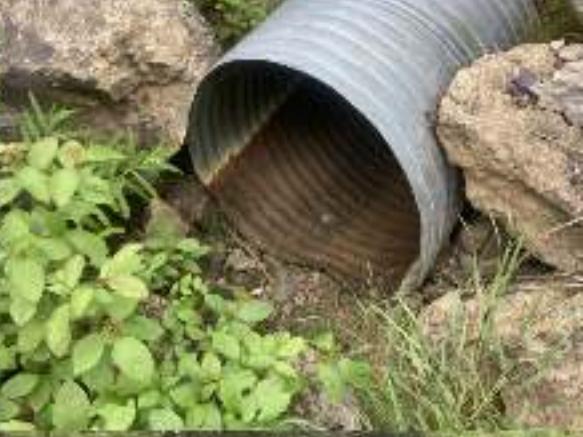
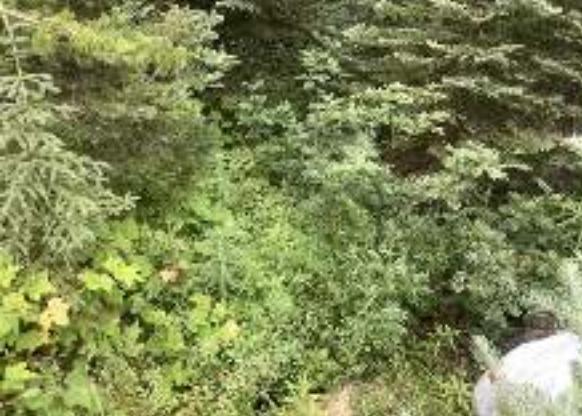
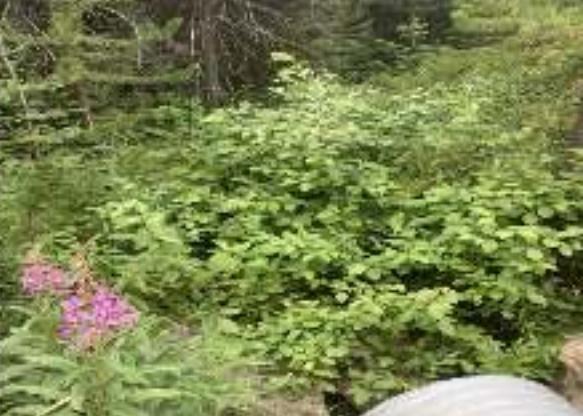
Photos: PSCIS ID 198072. From top left clockwise: Road/Site Card, Barrel, Outlet, Downstream, Upstream, Inlet.

Location and Stream Data		Crossing Characteristics	
Date	2021-08-10	Crossing Sub Type	Round Culvert
PSCIS ID	198072	Diameter (m)	0.9
External ID	14000892	Length (m)	16
Crew	LRH DM	Embedded	No
UTM Zone	9	Depth Embedded (m)	–
Easting	620392.1	Resemble Channel	No
Northing	5991273	Backwatered	No
Stream	Tributary to Lamprey Creek	Percent Backwatered	–
Road	Spur	Fill Depth (m)	2
Road Tenure	Canfor R10987	Outlet Drop (m)	0
Channel Width (m)	1	Outlet Pool Depth (m)	0
Stream Slope (%)	4	Inlet Drop	No
Beaver Activity	No	Slope (%)	0
Habitat Value	Low	Valley Fill	Deep Fill
Final score	16	Barrier Result	Potential
Fix type	Replace Structure with Streambed Simulation CBS	Fix Span / Diameter	3

Location and Stream Data	•	Crossing Characteristics	-
Comments: Dry channel, Post Code
