Appendix - Phase 1 Fish Passage Assessment Data and Photos

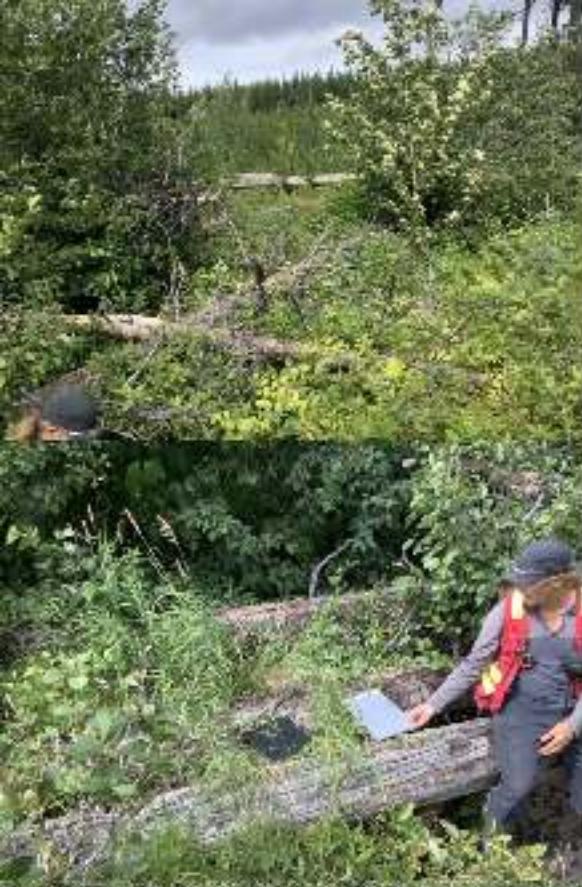
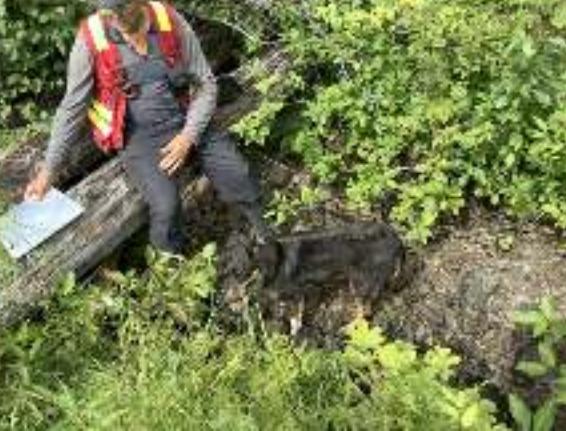
Photos: PSCIS ID 198073. From top left clockwise: Road/Site Card, Barrel, Outlet, Downstream, Upstream, Inlet.

Location and Stream Data	.	Crossing Characteristics	-
Comments: Deactivated road - no structure.

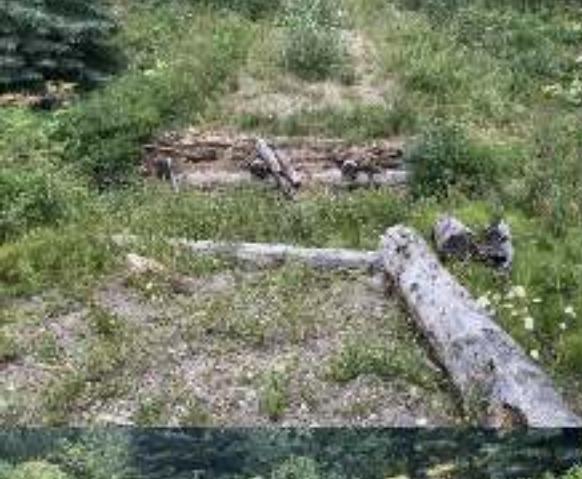
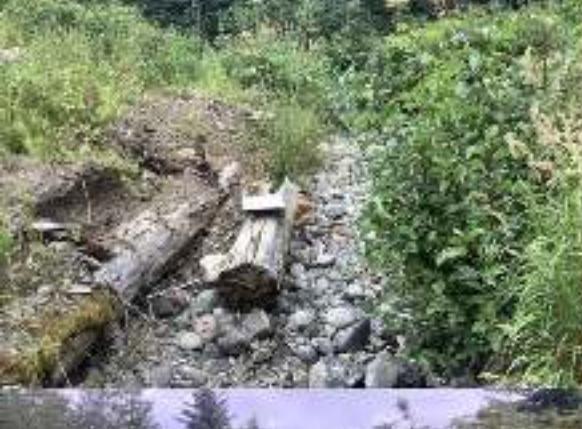
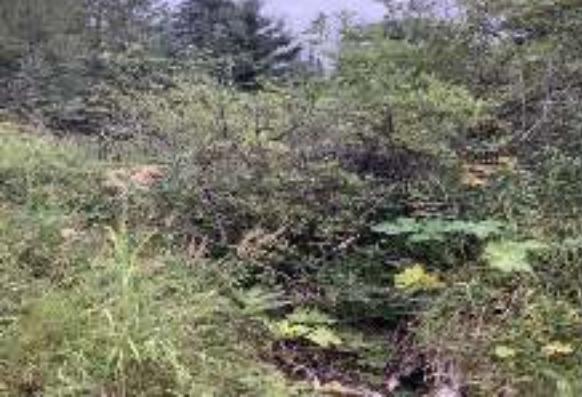
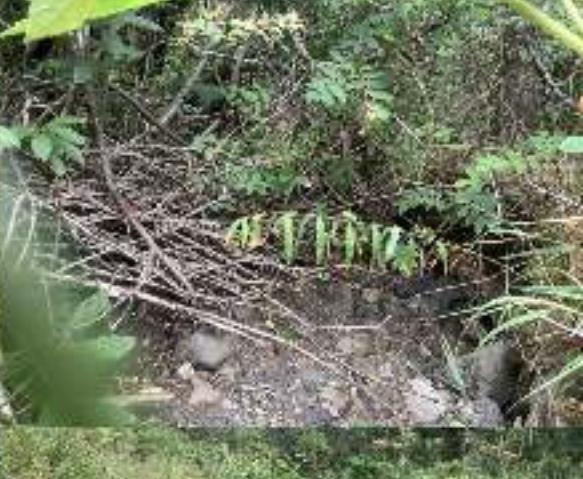
Photos: PSCIS ID 198074. From top left clockwise: Road/Site Card, Barrel, Outlet, Downstream, Upstream, Inlet.

Location and Stream Data	•	Crossing Characteristics	-
Comments: dry channel, post code. Width estimated.

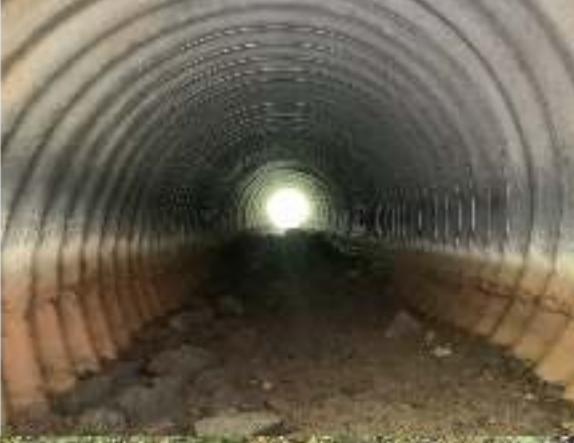
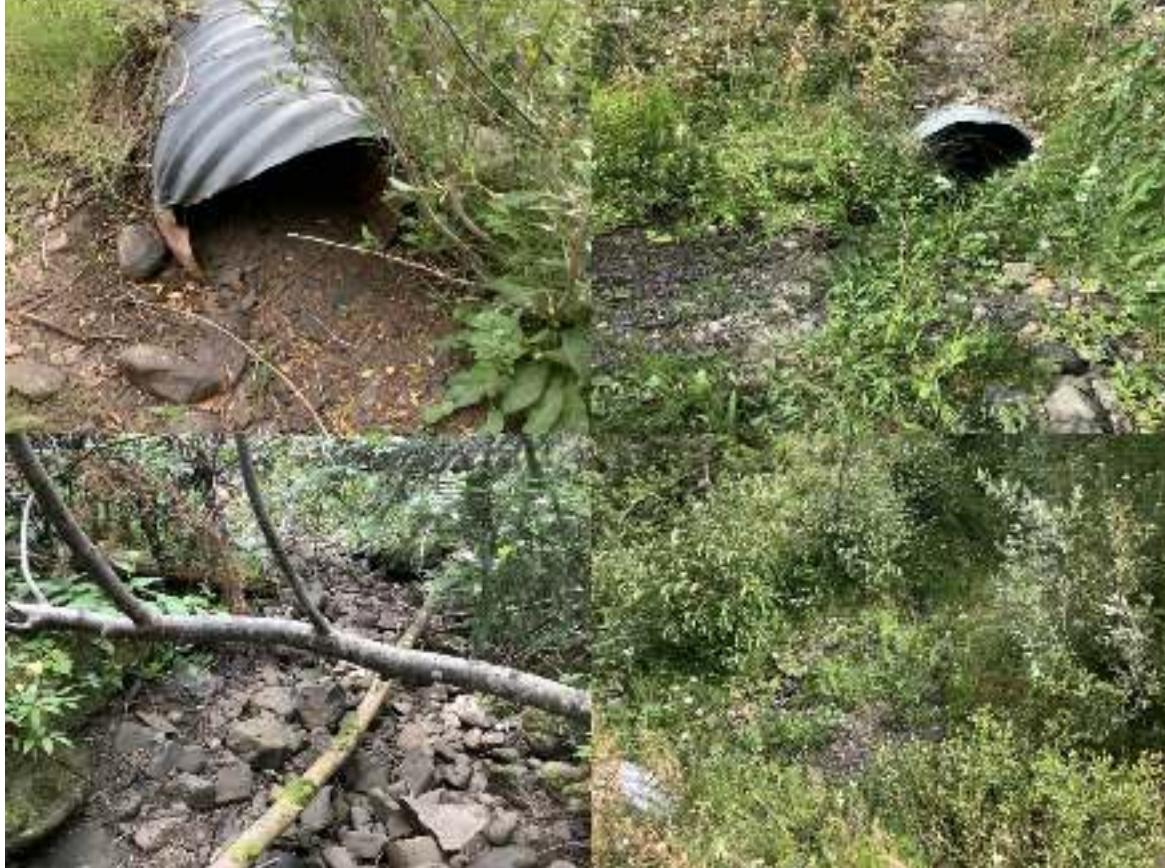
Photos: PSCIS ID 198075. From top left clockwise: Road/Site Card, Barrel, Outlet, Downstream, Upstream, Inlet.

Location and Stream Data		Crossing Characteristics	
	•		-
Date	2021-08-09	Crossing Sub Type	Round Culvert
PSCIS ID	198075	Diameter (m)	0.6
External ID	14001624	Length (m)	9
Crew	LRH DM	Embedded	No
UTM Zone	9	Depth Embedded (m)	0.05
Easting	618396.2	Resemble Channel	Yes
Northing	5996675	Backwatered	Yes
Stream	Tributary to Collins Lake	Percent Backwatered	50
Road	Spur	Fill Depth (m)	1
Road Tenure	Resource	Outlet Drop (m)	0
Channel Width (m)	0.65	Outlet Pool Depth (m)	0
Stream Slope (%)	10	Inlet Drop	Yes
Beaver Activity	No	Slope (%)	2
Habitat Value	Low	Valley Fill	Deep Fill
Final score	18	Barrier Result	Potential
Fix type	Replace Structure with Streambed Simulation CBS	Fix Span / Diameter	3

Location and Stream Data	•	Crossing Characteristics	-
Comments: dry channel, crossing takes the ditch line flow as well resulting in downstream channel being larger than upstream, post-code logging			
NO IMAGE AVAILABLE

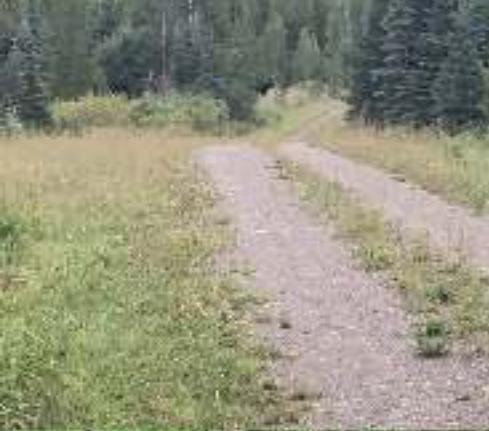
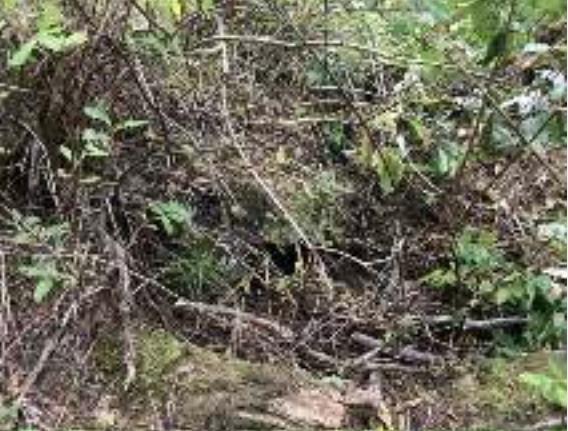
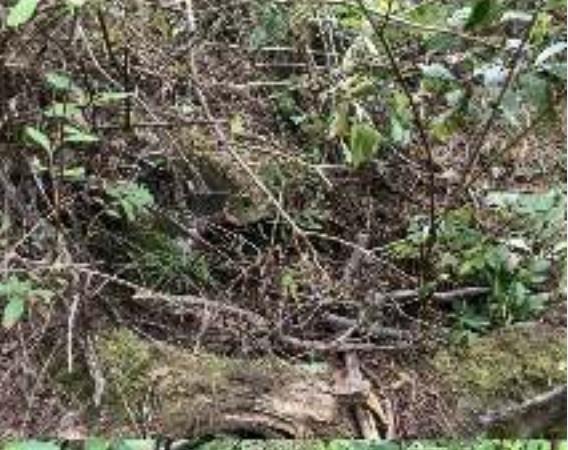
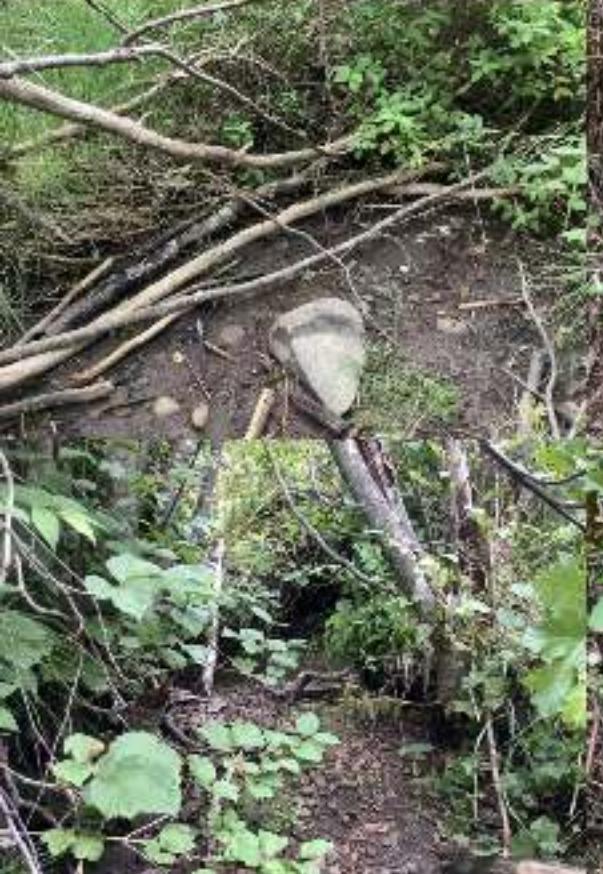
Photos: PSCIS ID 198076. From top left clockwise: Road/Site Card, Barrel, Outlet, Downstream, Upstream, Inlet.

Location and Stream Data	•	Crossing Characteristics	-
Comments: Upstream channel contains some pooled water, up stream the stream is diverted down ditch line and over tops road 30m from old crossing. Pre Code logging. Span estimated.

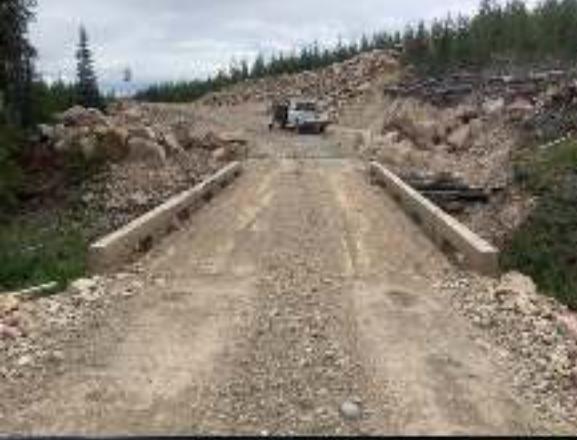
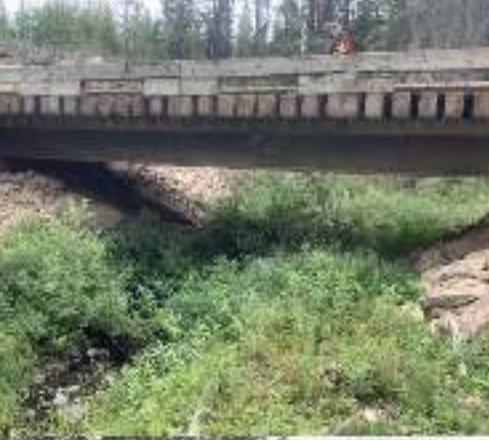
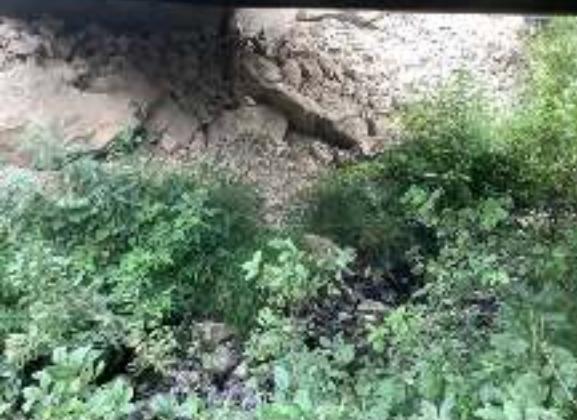
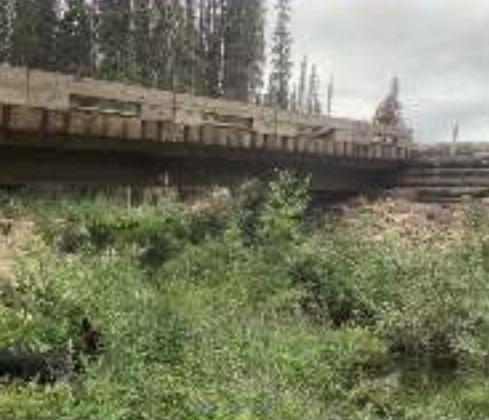
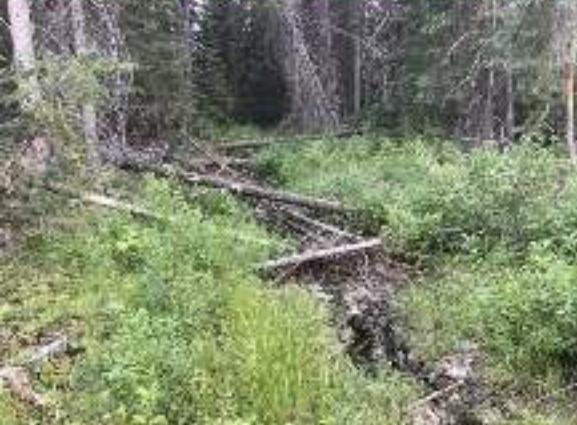
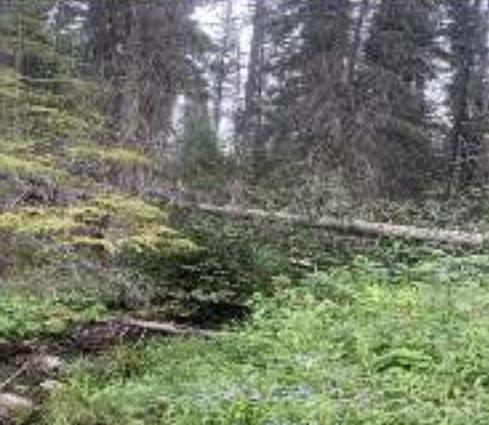
Photos: PSCIS ID 198077. From top left clockwise: Road/Site Card, Barrel, Outlet, Downstream, Upstream, Inlet.

Location and Stream Data	•	Crossing Characteristics	-
Comments: AI #03, post code recent build

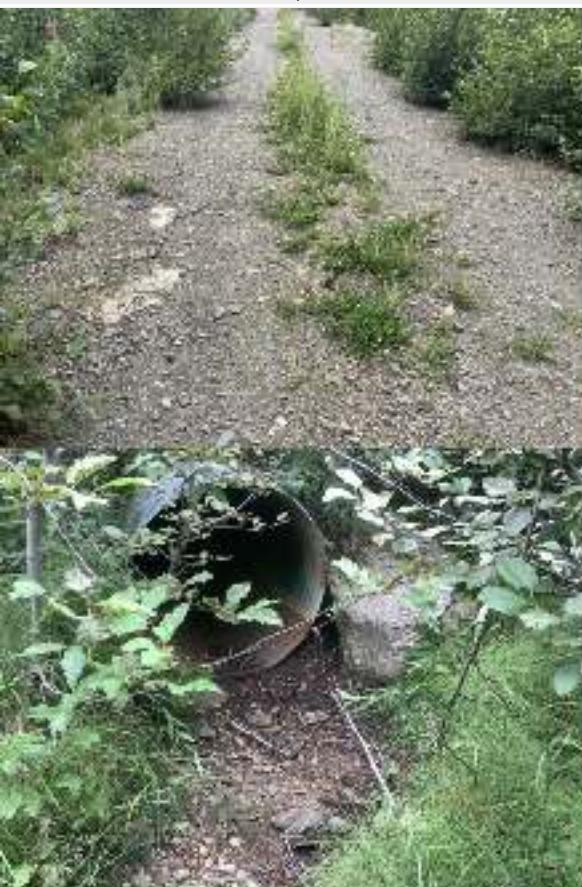
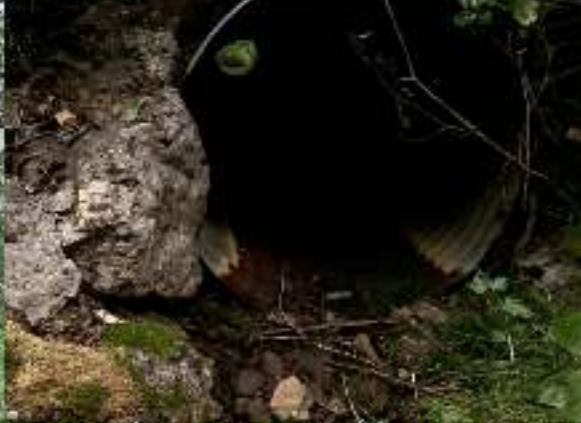
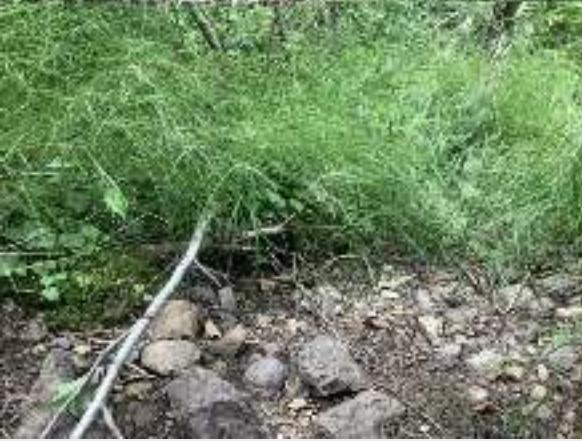
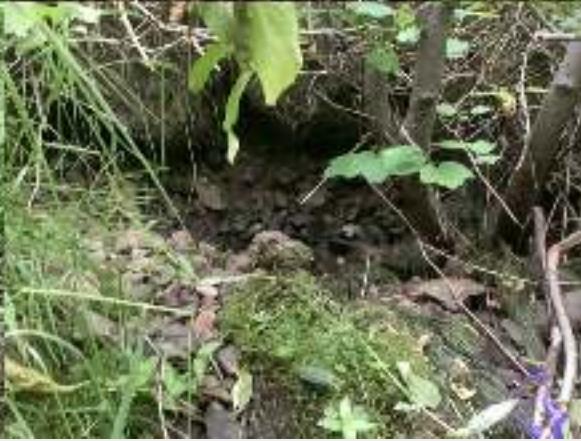
Photos: PSCIS ID 198079. From top left clockwise: Road/Site Card, Barrel, Outlet, Downstream, Upstream, Inlet.

Location and Stream Data		Crossing Characteristics	
Date	2021-08-10	Crossing Sub Type	Round Culvert
PSCIS ID	198079	Diameter (m)	1
External ID	14000890	Length (m)	13
Crew	LRH DM	Embedded	No
UTM Zone	9	Depth Embedded (m)	–
Easting	620641.4	Resemble Channel	No
Northing	5990771	Backwatered	Yes
Stream	Tributary to Lamprey Creek	Percent Backwatered	50
Road	Spur	Fill Depth (m)	1.5
Road Tenure	Canfor R10987	Outlet Drop (m)	0
Channel Width (m)	0.9	Outlet Pool Depth (m)	0
Stream Slope (%)	2	Inlet Drop	No
Beaver Activity	No	Slope (%)	3
Habitat Value	Medium	Valley Fill	Deep Fill
Final score	20	Barrier Result	Barrier
Fix type	Replace Structure with Streambed Simulation CBS	Fix Span / Diameter	3

Location and Stream Data	•	Crossing Characteristics	-
Comments: Confirm fish value, small intermittent streams with high habitat values? Post Code

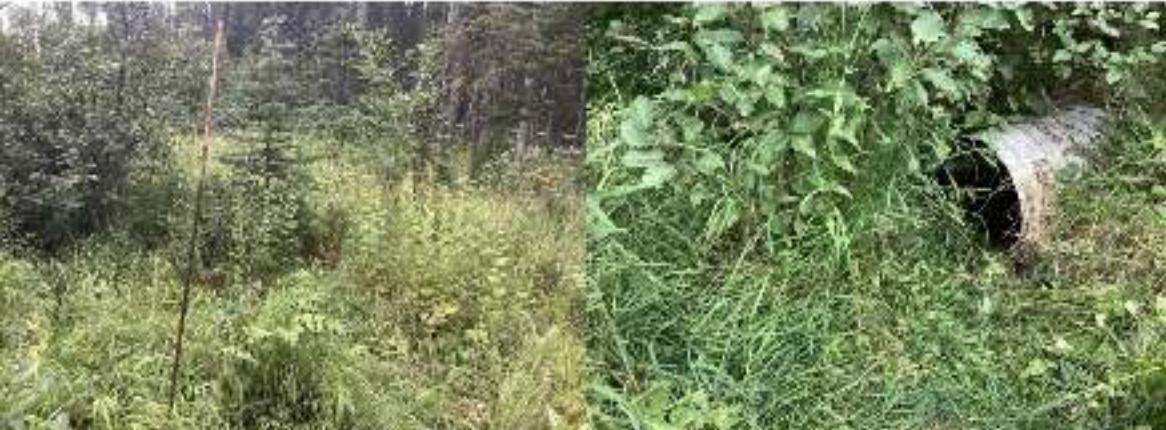
Photos: PSCIS ID 198080. From top left clockwise: Road/Site Card, Barrel, Outlet, Downstream, Upstream, Inlet.

Location and Stream Data		Crossing Characteristics	
Date	2021-08-10	Crossing Sub Type	Round Culvert
PSCIS ID	198080	Diameter (m)	0.5
External ID	14000894	Length (m)	10
Crew	LRH DM	Embedded	No
UTM Zone	9	Depth Embedded (m)	–
Easting	620681.5	Resemble Channel	No
Northing	5990583	Backwatered	No
Stream	Tributary to Lamprey Creek	Percent Backwatered	–
Road	Spur	Fill Depth (m)	1
Road Tenure	Canfor R10987	Outlet Drop (m)	0
Channel Width (m)	0.6	Outlet Pool Depth (m)	0.2
Stream Slope (%)	3	Inlet Drop	No
Beaver Activity	No	Slope (%)	4
Habitat Value	Medium	Valley Fill	Deep Fill
Final score	23	Barrier Result	Barrier
Fix type	Replace Structure with Streambed Simulation CBS	Fix Span / Diameter	3

Location and Stream Data	•	Crossing Characteristics	-
Comments: Channel has ponded water/wetland up and down stream - Post Code			
NO IMAGE AVAILABLE		NO IMAGE AVAILABLE	
NO IMAGE AVAILABLE		NO IMAGE AVAILABLE

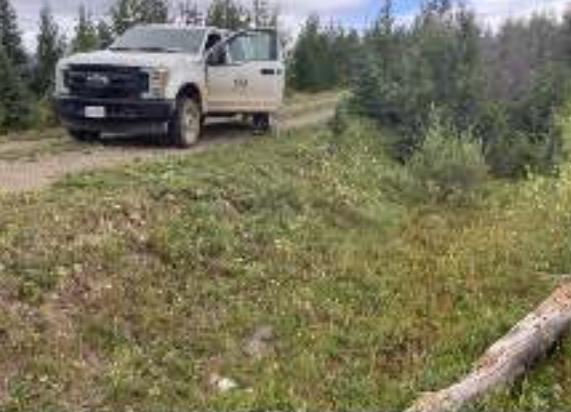
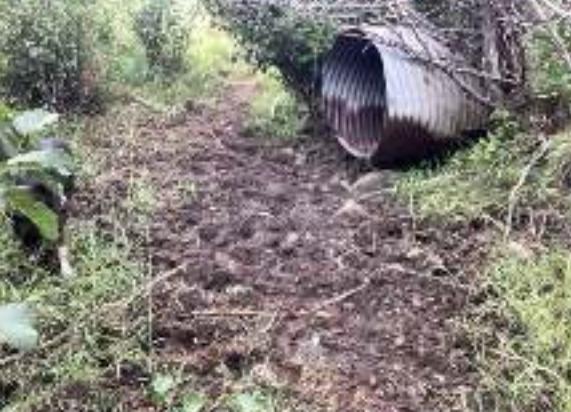
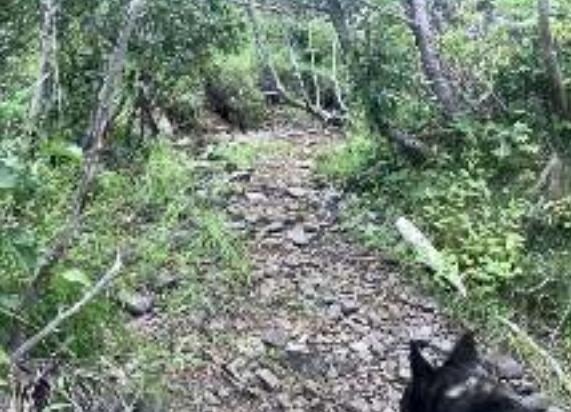
Photos: PSCIS ID 198081. From top left clockwise: Road/Site Card, Barrel, Outlet, Downstream, Upstream, Inlet.

Location and Stream Data		Crossing Characteristics	
Date	2021-08-10	Crossing Sub Type	Round Culvert
PSCIS ID	198081	Diameter (m)	1
External ID	14000592	Length (m)	13
Crew	LRH DM	Embedded	No
UTM Zone	9	Depth Embedded (m)	–
Easting	620084.6	Resemble Channel	No
Northing	5994112	Backwatered	No
Stream	Tributary to Lamprey Creek	Percent Backwatered	–
Road	07 Road	Fill Depth (m)	1
Road Tenure	Resource	Outlet Drop (m)	0.3
Channel Width (m)	1.6	Outlet Pool Depth (m)	0.55
Stream Slope (%)	5	Inlet Drop	No
Beaver Activity	No	Slope (%)	2
Habitat Value	Low	Valley Fill	Deep Fill
Final score	31	Barrier Result	Barrier
Fix type	Replace Structure with Streambed Simulation CBS	Fix Span / Diameter	3

Location and Stream Data	Crossing Characteristics
Comments: Inlet 35cm above channel, inlet and outlet damaged by cows, Post Code

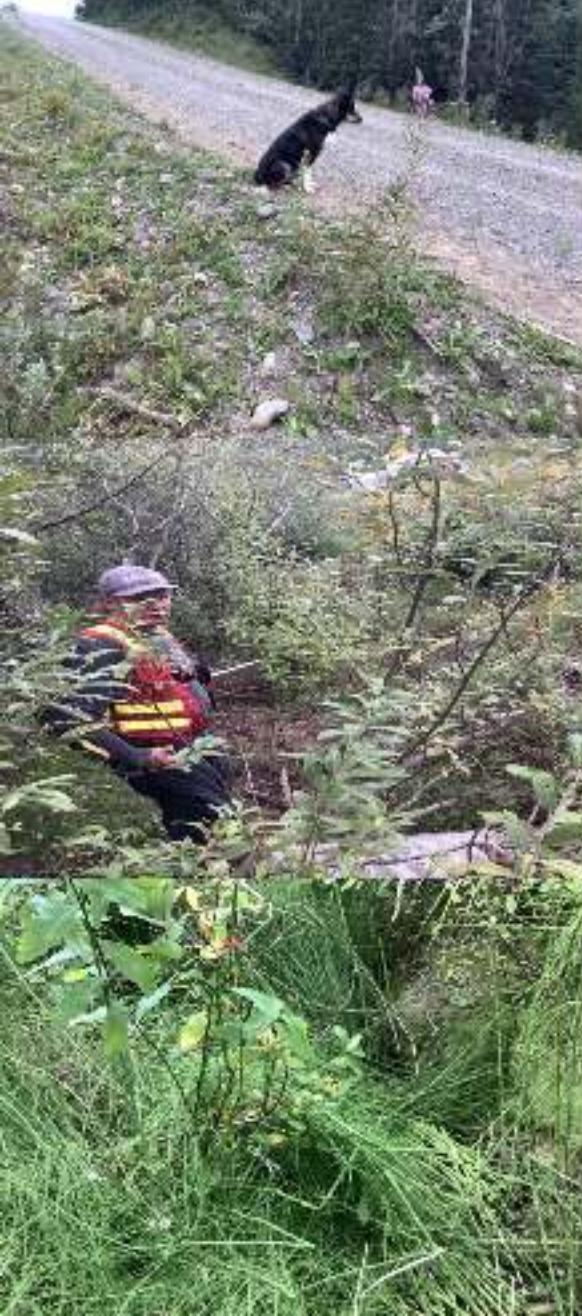
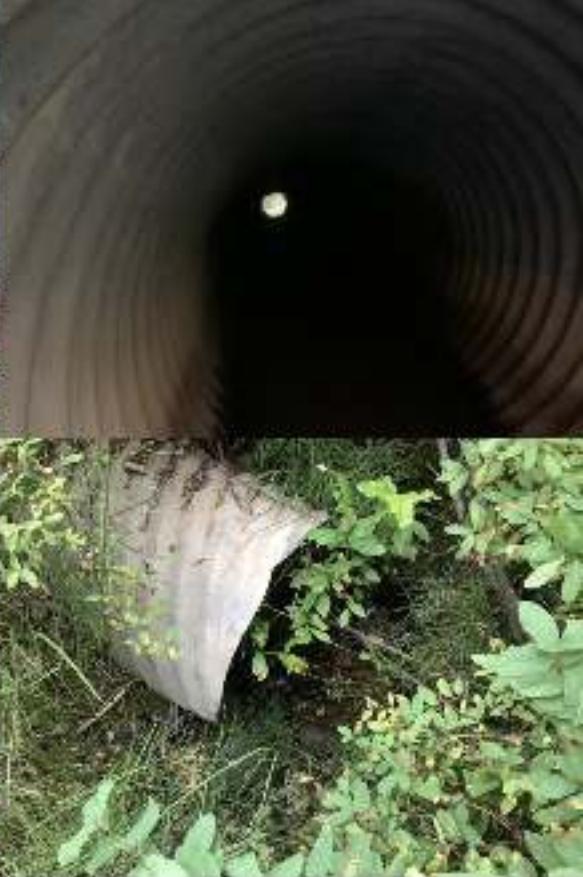
Photos: PSCIS ID 198082. From top left clockwise: Road/Site Card, Barrel, Outlet, Downstream, Upstream, Inlet.

Location and Stream Data		Crossing Characteristics	
Date	2021-08-10	Crossing Sub Type	Round Culvert
PSCIS ID	198082	Diameter (m)	0.6
External ID	14001062	Length (m)	15
Crew	LRH DM	Embedded	No
UTM Zone	9	Depth Embedded (m)	–
Easting	622408	Resemble Channel	No
Northing	5997287	Backwatered	No
Stream	Tributary to Lamprey Creek	Percent Backwatered	–
Road	Bill Nye	Fill Depth (m)	1.5
Road Tenure	Canfor R05233	Outlet Drop (m)	0.1
Channel Width (m)	0.6	Outlet Pool Depth (m)	0.15
Stream Slope (%)	1	Inlet Drop	No
Beaver Activity	No	Slope (%)	3
Habitat Value	Medium	Valley Fill	Deep Fill
Final score	26	Barrier Result	Barrier
Fix type	Replace Structure with Streambed Simulation CBS	Fix Span / Diameter	3

Location and Stream Data	•	Crossing Characteristics	-
Comments: pooled water above crossing, pre code road, post code culvert

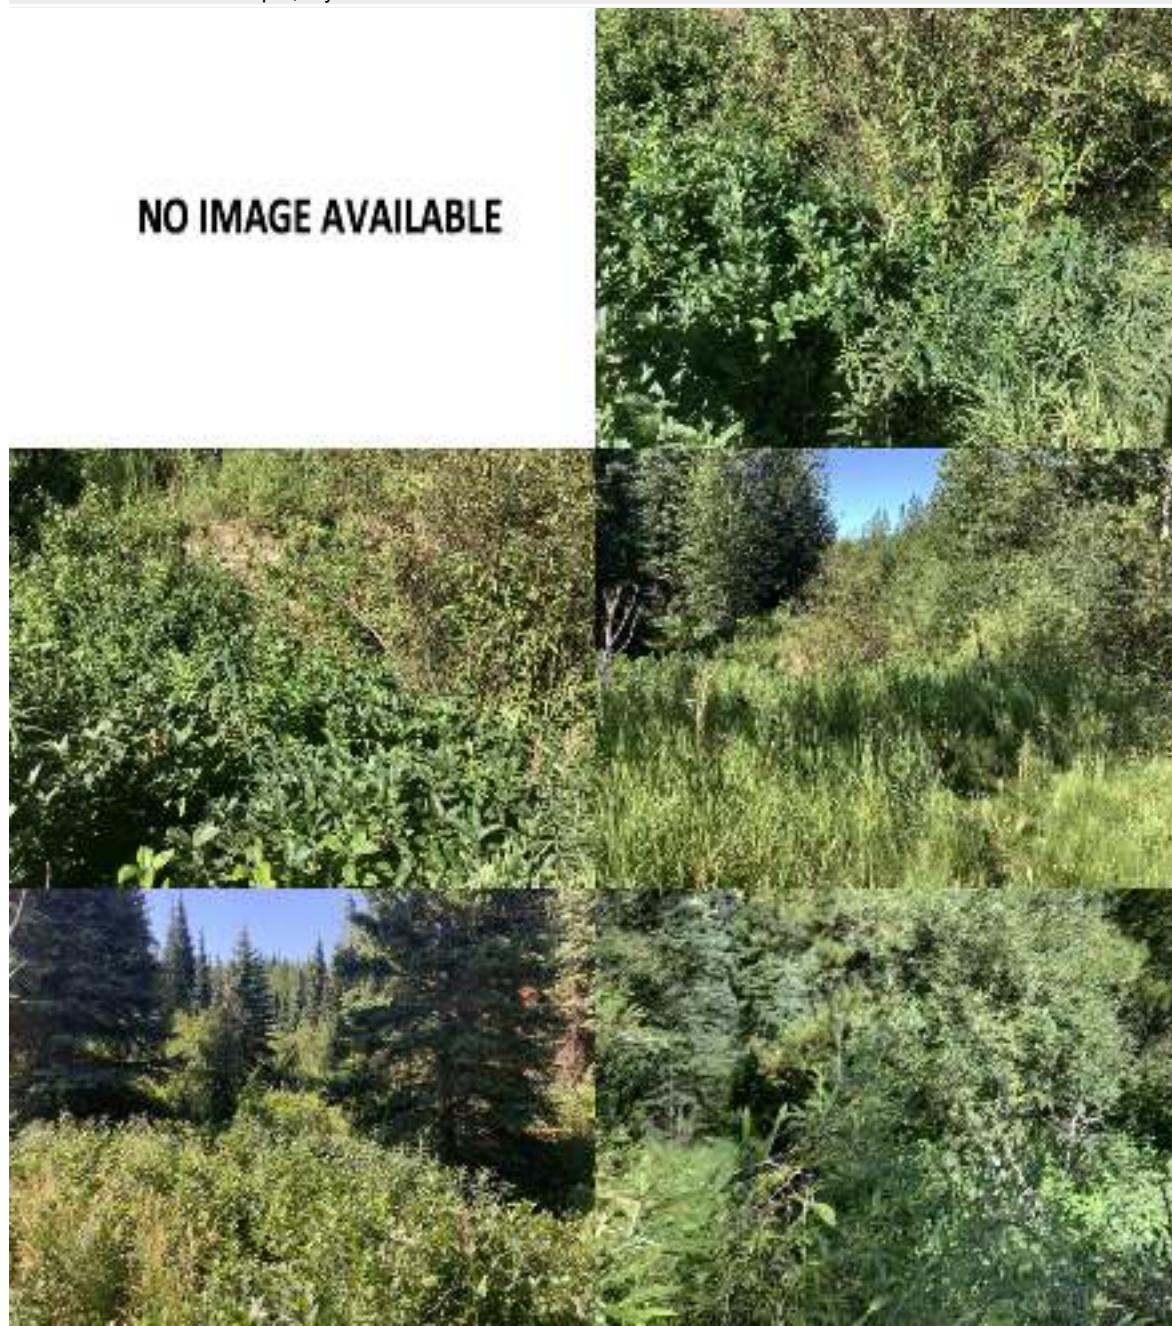
Photos: PSCIS ID 198083. From top left clockwise: Road/Site Card, Barrel, Outlet, Downstream, Upstream, Inlet.

Location and Stream Data	•	Crossing Characteristics	-
Comments: Deactivated spur, dry channel			
<p>NO IMAGE AVAILABLE</p>

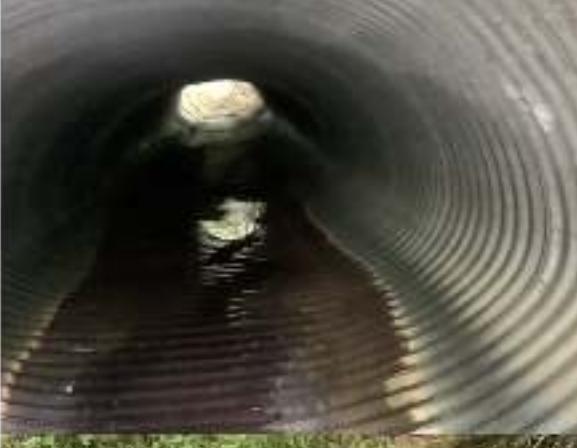
Photos: PSCIS ID 198084. From top left clockwise: Road/Site Card, Barrel, Outlet, Downstream, Upstream, Inlet.

Location and Stream Data	*	Crossing Characteristics	-
Date	2021-08-10	Crossing Sub Type	Oval Culvert
PSCIS ID	198084	Diameter (m)	1.5
External ID	14000968	Length (m)	14
Crew	LRH DM	Embedded	No
UTM Zone	9	Depth Embedded (m)	-
Easting	623986	Resemble Channel	No
Northing	6001191	Backwatered	No
Stream	Tributary to Lamprey Creek	Percent Backwatered	-
Road	Spur	Fill Depth (m)	1
Road Tenure	Canfor R05233	Outlet Drop (m)	0.15
Channel Width (m)	0.9	Outlet Pool Depth (m)	0.18
Stream Slope (%)	9	Inlet Drop	No
Beaver Activity	No	Slope (%)	7
Habitat Value	Medium	Valley Fill	Deep Fill
Final score	25	Barrier Result	Barrier
Fix type	Replace Structure with Streambed Simulation CBS	Fix Span / Diameter	3

Location and Stream Data	•	Crossing Characteristics	-
Comments: Water in channel (pooled) above and below, Post Code			
NO IMAGE AVAILABLE

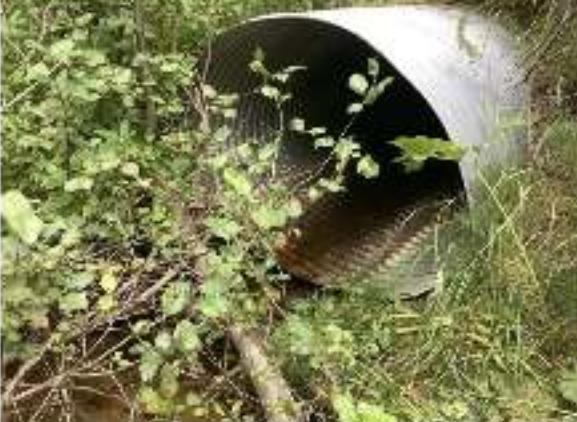
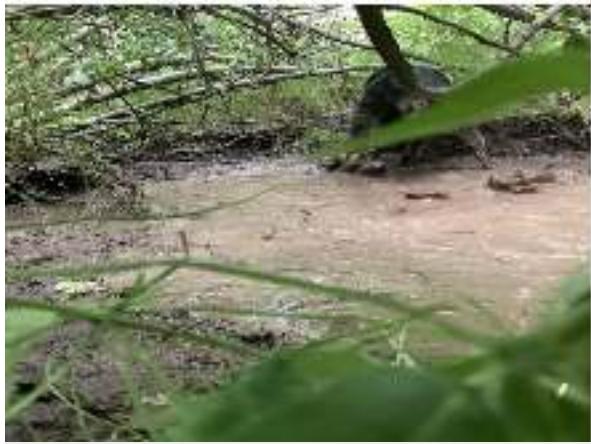
Location and Stream Data		Crossing Characteristics	
Date	2021-08-11	Crossing Sub Type	Round Culvert
PSCIS ID	198085	Diameter (m)	0.9
External ID	14000799	Length (m)	13
Crew	LRH DM	Embedded	No
UTM Zone	9	Depth Embedded (m)	—
Easting	623422	Resemble Channel	No
Northing	6001388	Backwatered	No
Stream	Tributary to Lamprey Creek	Percent Backwatered	—
Road	Morice FSR	Fill Depth (m)	1
Road Tenure	FLNR DND 4656	Outlet Drop (m)	1.6
Channel Width (m)	1.4	Outlet Pool Depth (m)	0.3
Stream Slope (%)	8	Inlet Drop	Yes
Beaver Activity	No	Slope (%)	5
Habitat Value	Medium	Valley Fill	Deep Fill
Final score	36	Barrier Result	Barrier
Fix type	Replace Structure with Streambed Simulation CBS	Fix Span / Diameter	3

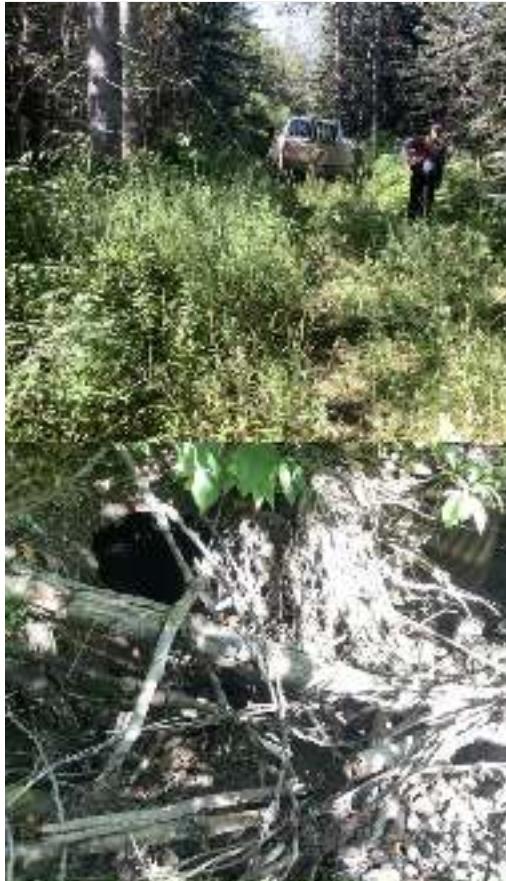
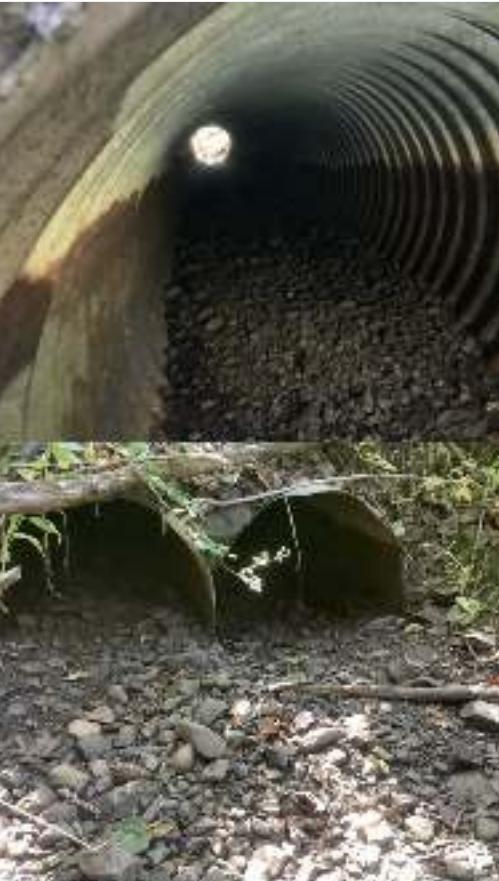
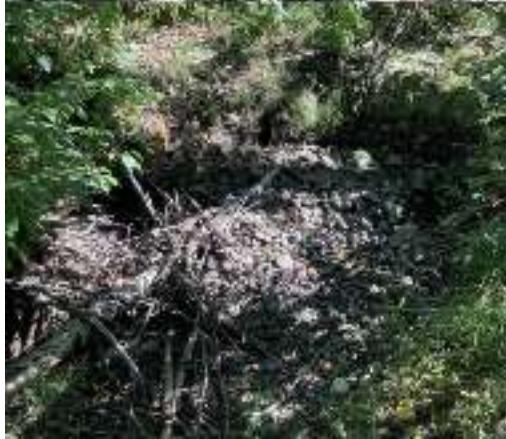
Photos: PSCIS ID 198087. From top left clockwise: Road/Site Card, Barrel, Outlet, Downstream, Upstream, Inlet.

Location and Stream Data		Crossing Characteristics	
Date	2021-09-02	Crossing Sub Type	Round Culvert
PSCIS ID	198087	Diameter (m)	2
External ID	14000453	Length (m)	25
Crew	AI	Embedded	No
UTM Zone	9	Depth Embedded (m)	–
Easting	649728	Resemble Channel	No
Northing	6029328	Backwatered	No
Stream	Tributary to Nanika River	Percent Backwatered	–
Road	Cutthroat 1	Fill Depth (m)	1.5
Road Tenure	Houston Highway	Outlet Drop (m)	0.41
Channel Width (m)	1.9	Outlet Pool Depth (m)	0.6
Stream Slope (%)	6	Inlet Drop	Yes
Beaver Activity	No	Slope (%)	7
Habitat Value	Low	Valley Fill	Deep Fill
Final score	33	Barrier Result	Barrier
Fix type	Replace Structure with Streambed Simulation CBS	Fix Span / Diameter	3

Location and Stream Data	•	Crossing Characteristics	-
Comments: At modelled crossing location but no map label. Dry. 15:25

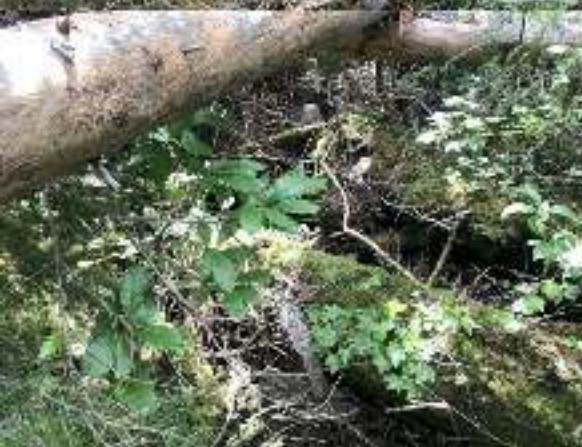
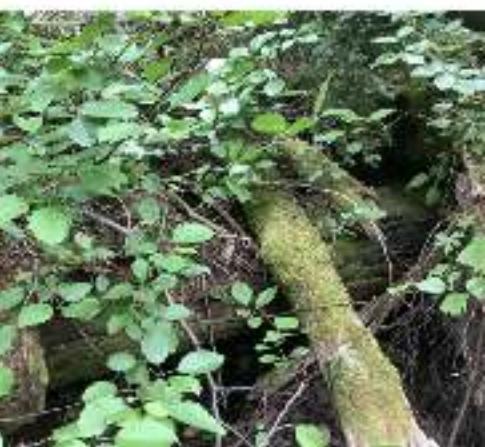
Photos: PSCIS ID 198089. From top left clockwise: Road/Site Card, Barrel, Outlet, Downstream, Upstream, Inlet.

Location and Stream Data	• Crossing Characteristics	-
Comments: Overgrown road, wood box culvert complete blockage, access required to deactivate/restore channel

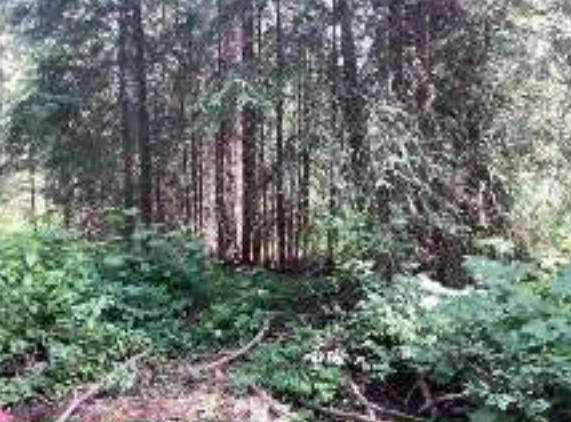
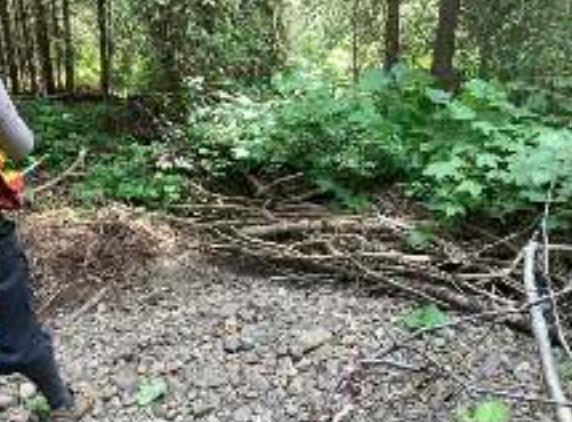
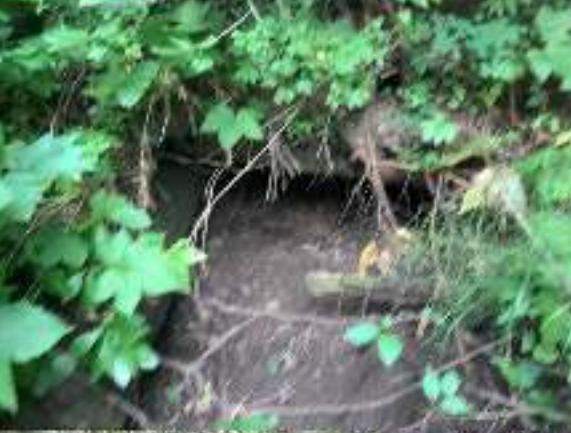
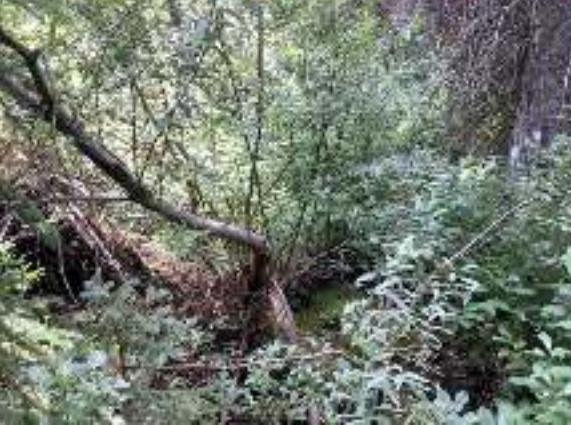
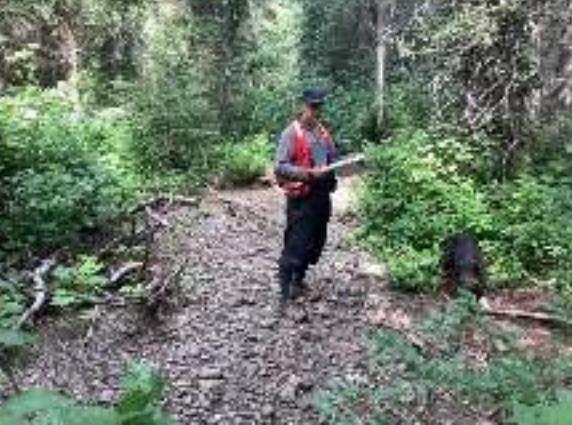
Photos: PSCIS ID 198090. From top left clockwise: Road/Site Card, Barrel, Outlet, Downstream, Upstream, Inlet.

Location and Stream Data	•	Crossing Characteristics	-
<p>Comments: No crossing actually exists in the field however site entered as a placeholder because there should be connection between Bulkley and Cesford at this location. Survey found no culvert and landowner reported none present. 11:22</p>
