## **Bulkley River and Morice River Watershed Groups Fish Passage Restoration Planning 2021**

**Prepared for  
Habitat Conservation Trust Foundation - CAT22-6-288  
BC Fish Passage Remediation Program  
Canadian Wildlife Federation**

**Prepared by  
Al Irvine, B.Sc., R.P.Bio.  
New Graph Environment Ltd.  
on behalf of  
Society for Ecosystem Restoration in Northern British Columbia**

**Version 0.1.9 2025-06-02**

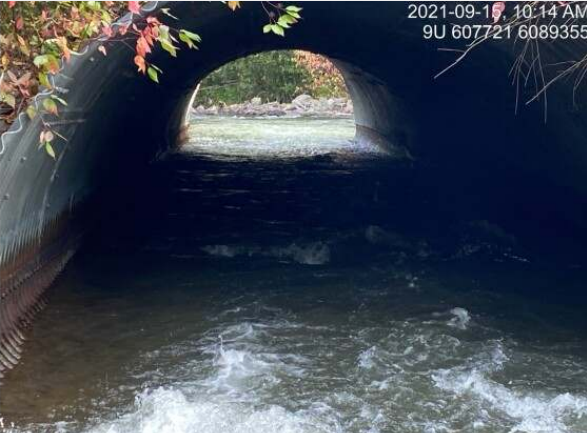
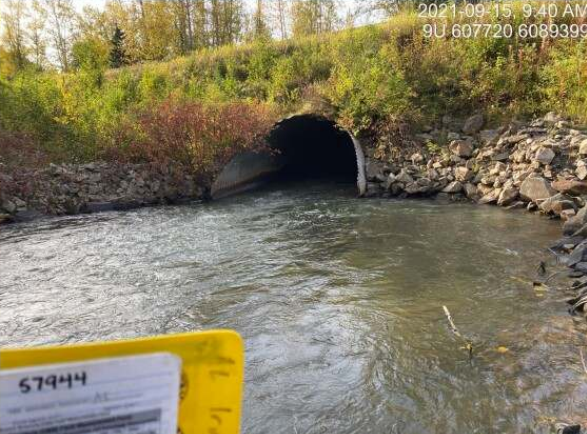
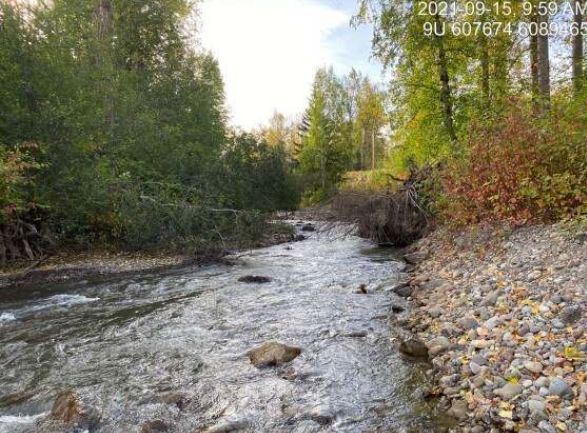
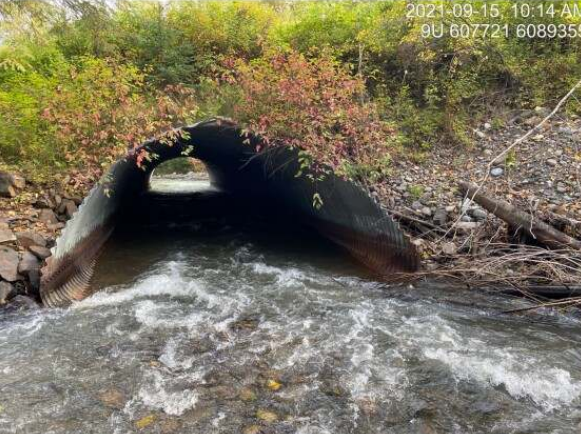
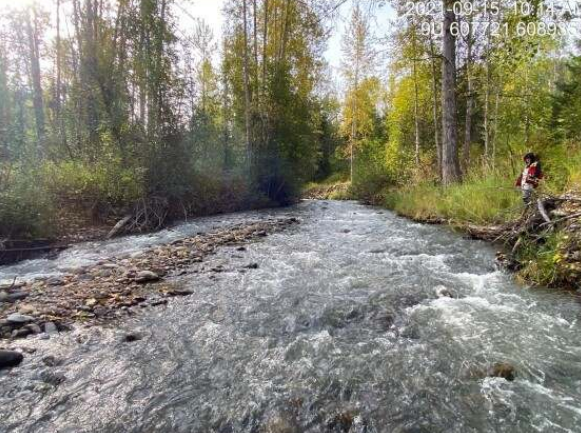
| Location and Stream Data | Crossing Characteristics |
|---|---|
| <p>Comments: Oval culvert. 9:34</p> <p>Photos: From top left clockwise: Road/Site Card, Barrel, Outlet, Downstream, Upstream, Inlet.</p> | |

| Location and Stream Data | | Crossing Characteristics | |
|---|---|---|---|
| Fix type | Replace with New Open Bottom Structure | Fix Span / Diameter | 13.5 |

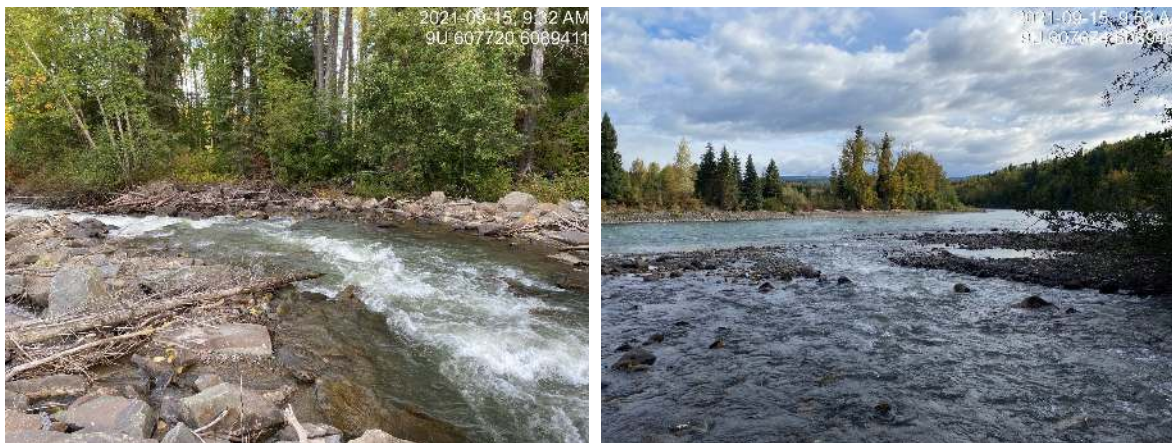
The stream was surveyed downstream from crossing 57944 for 140m to the confluence with the Bulkley River (Figure 5.1). Total cover amount was rated as moderate with undercut banks dominant. Cover was also present as small woody debris, large woody debris, boulders, and overhanging vegetation. The average channel width was 13.9m, the average wetted width was 6.7m and the average gradient was 5.5%. The dominant substrate was cobbles with boulders subdominant. Although rated as an important migration corridor, the habitat was rated as medium value for salmonid rearing and spawning.

Figure 5.1: Left: Typical habitat downstream of PSCIS crossing 57944. Right: Typical habitat downstream of PSCIS crossing 57944.

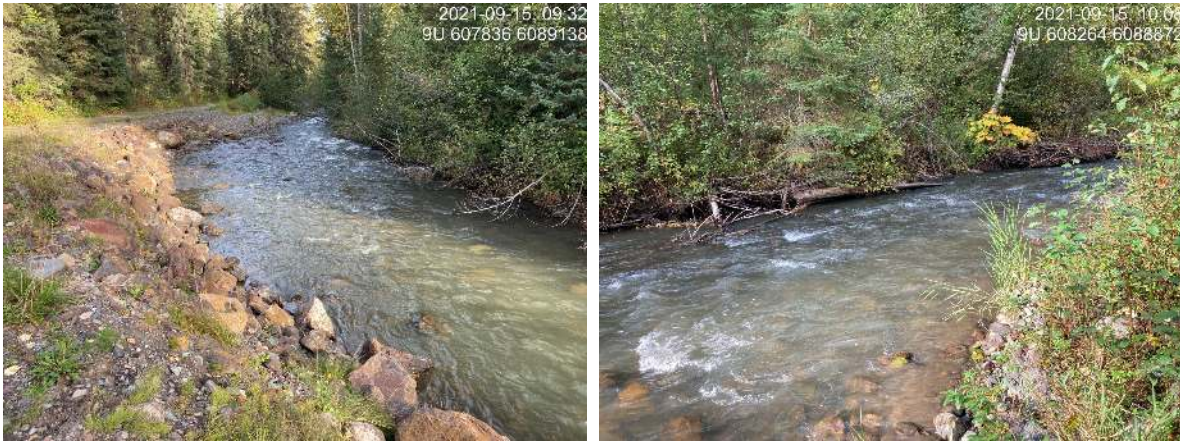
The stream was surveyed upstream from crossing 57944 for 880m (Figure 5.2). Total cover amount was rated as moderate with large woody debris dominant. Cover was also present as small woody debris and boulders. Total cover amount was rated as moderate with overhanging vegetation dominant. Cover was also present as small woody debris and boulders. The average channel width was 8.5m, the average wetted width was 6.7m and the average gradient was 2.1%. The dominant substrate was cobbles with gravels subdominant. The first 50 - 100m upstream of crossing channel and banks were noted as armoured with riprap. Abundant gravels suitable for resident and anadromous salmonids were noted throughout. The habitat was rated as high value as an important migration corridor containing suitable spawning habitat and having moderate rearing potential.

Figure 5.2: Left: Typical habitat upstream of PSCIS crossing 57944. Right: Typical habitat upstream of PSCIS crossing 57944.

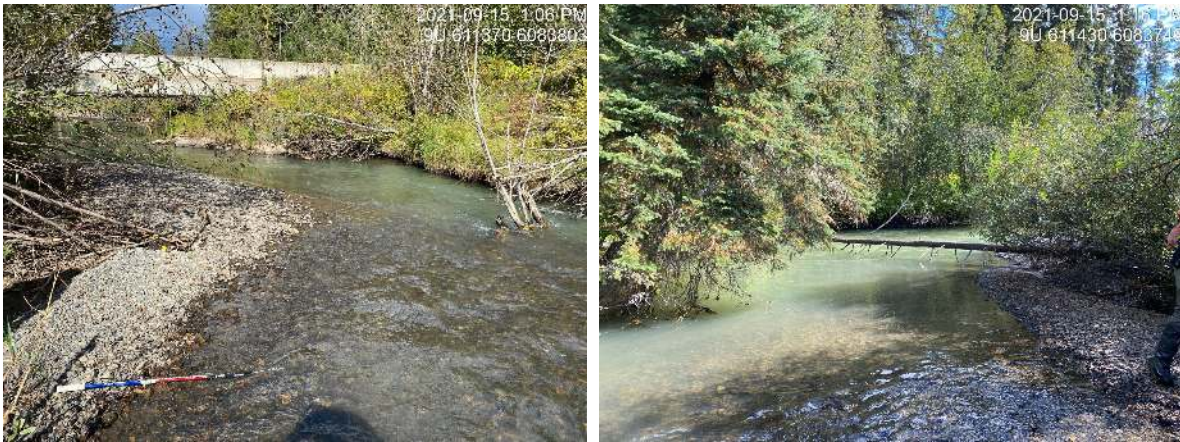
The stream was also surveyed at a second location upstream of the hatchery adjacent to the Owen Road bridge for 150m (Figure 5.3). Total cover amount was rated as abundant with deep pools dominant. Cover was also present as small woody debris, undercut banks, and overhanging vegetation. The average channel width was 12.6m, the average wetted width was 10.5m and the average gradient was 0.5%. The dominant substrate was gravels with fines subdominant. The habitat was rated as high value for salmon rearing and spawning.

Figure 5.3: Left: Typical habitat upstream of PSCIS crossing 57944. Right: Typical habitat upstream of PSCIS crossing 57944.

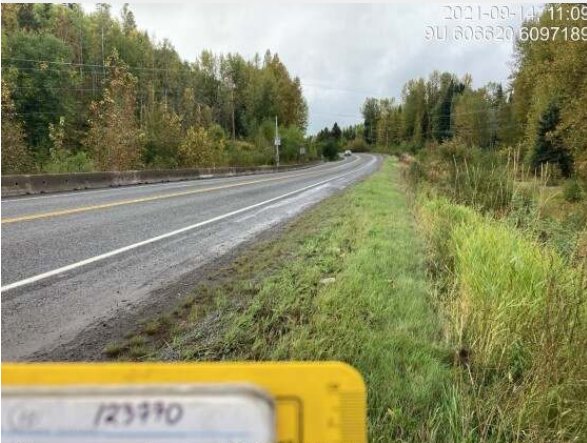
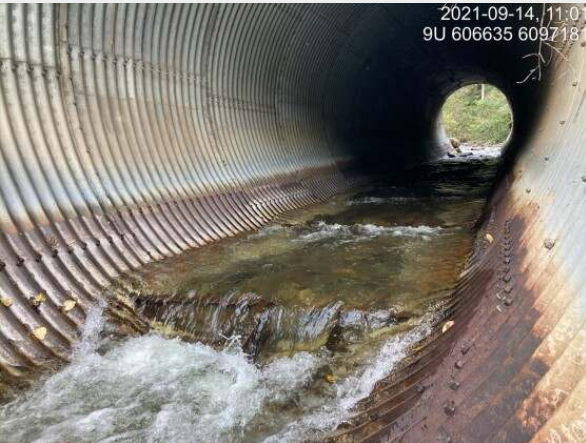
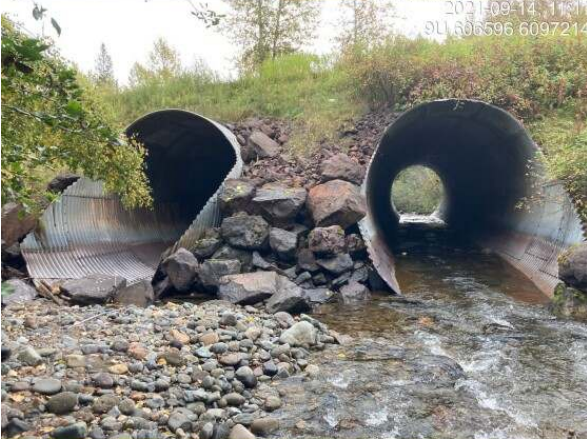
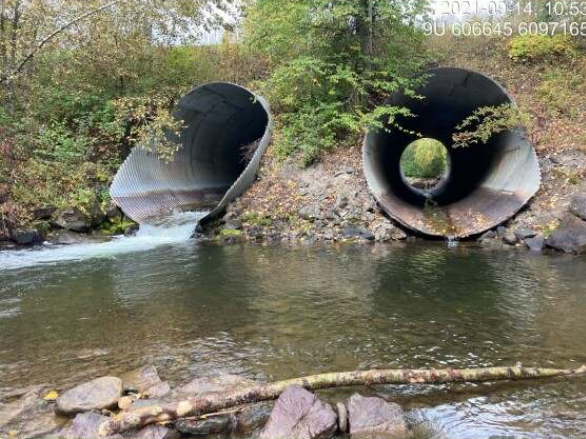
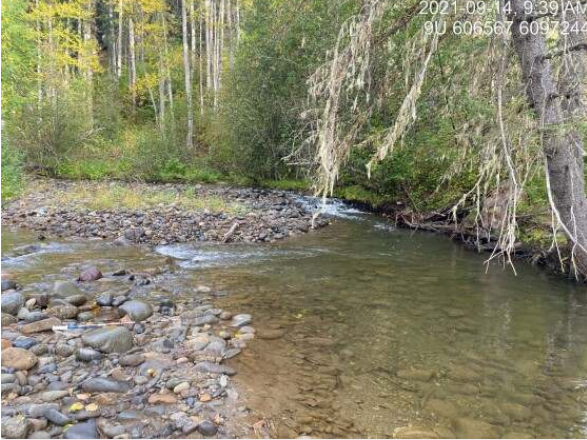
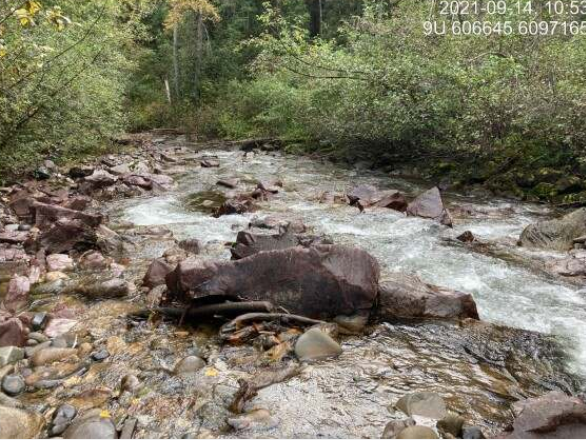
| Location and Stream Data | Crossing Characteristics |
|---|---|
| <p>Comments: Both pipes have outlet drop and water flowing through. Water depth in left pipe is 0.01m, left pipe no embedment. Inlet drop only on right one. Also has baffling with substrate but baffling not in place for downstream ~3m, so not continuous. Estimated pool depth. 10:52</p> <p>Photos: From top left clockwise: Road/Site Card, Barrel, Outlet, Downstream, Upstream, Inlet.</p> | |

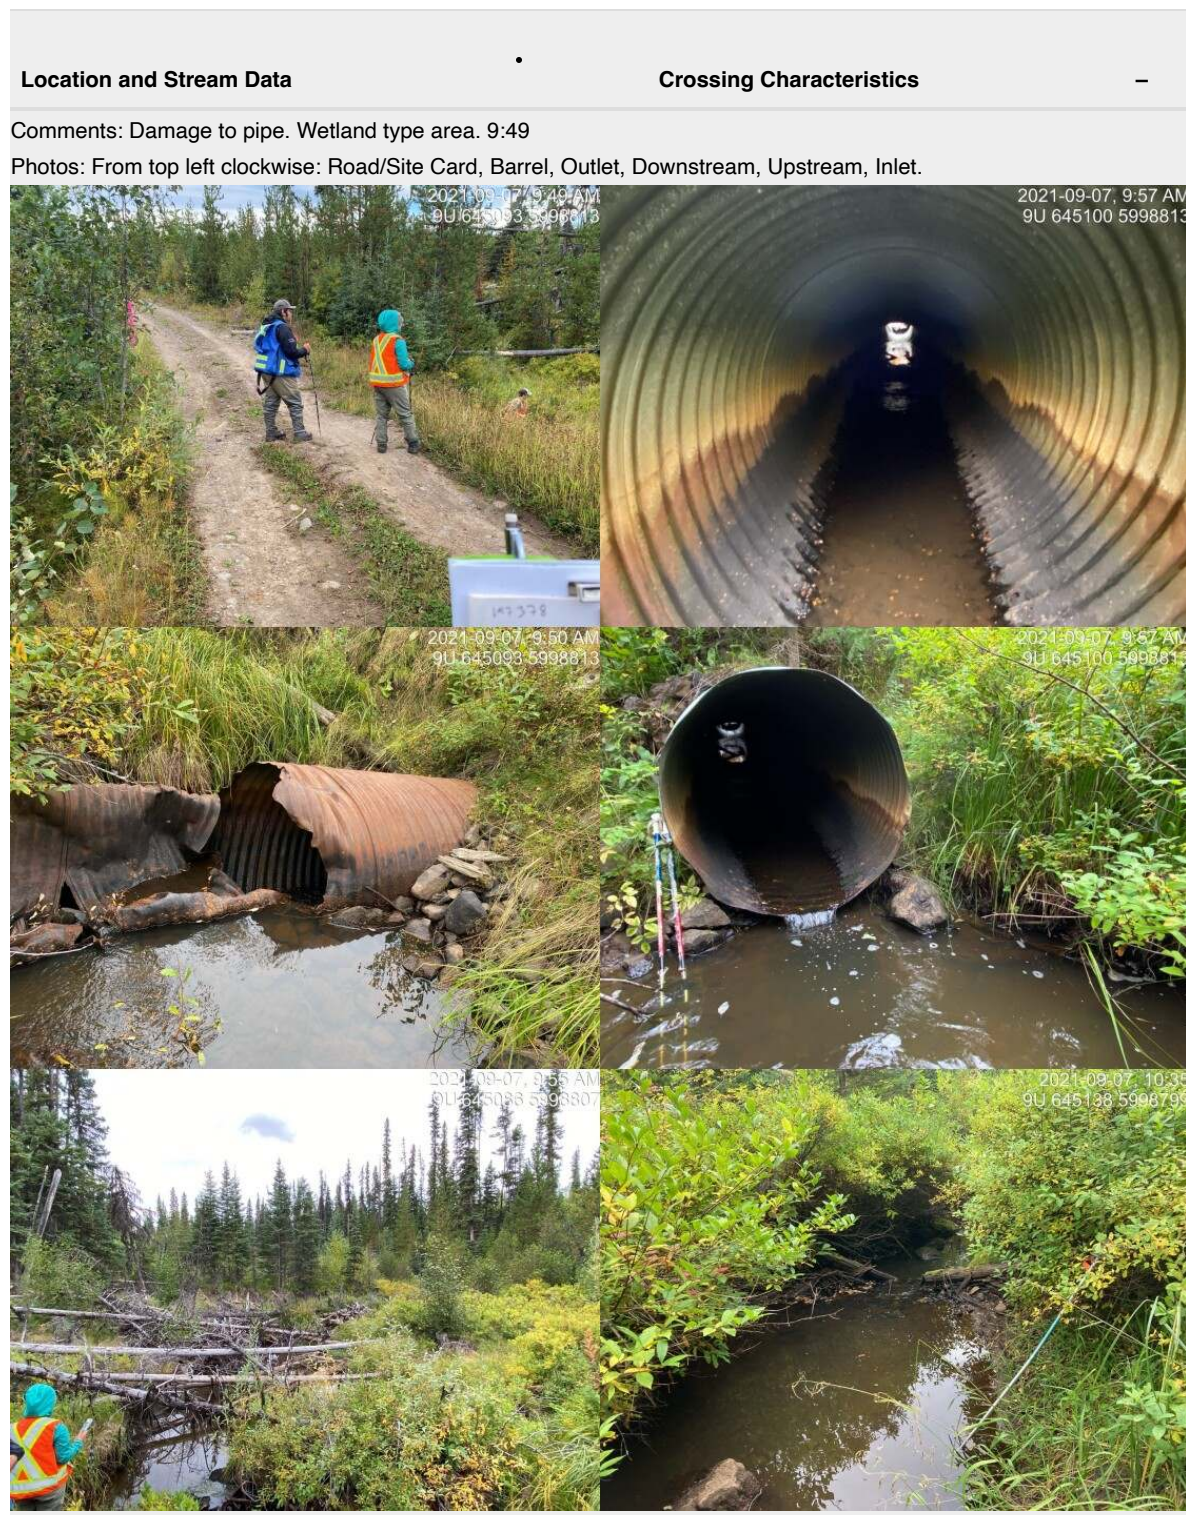
At the time of the survey, PSCIS crossing 197378 was un-embedded, non-backwatered and ranked as a barrier to upstream fish passage according to the provincial protocol (MoE 2011b) (Table 5.25). The pipe was in very rough condition and had collapsed and separated in half which effected water flow into the barrel. The water temperature was 11°C, pH was 7.6 and conductivity was 84uS/cm.

Should restoration/maintenance activities proceed, replacement of PSCIS crossing 197378 with a bridge (10m span) is recommended. The cost of the work is estimated at \$300,000 for a cost benefit of 1.9 linear m/\$1000 and 3.4 m<sup>2</sup>/\$1000.

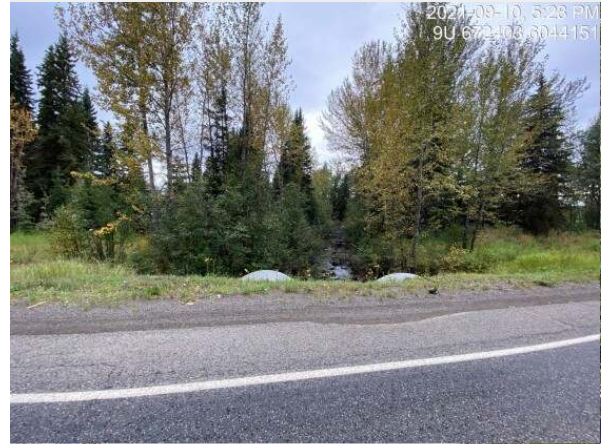
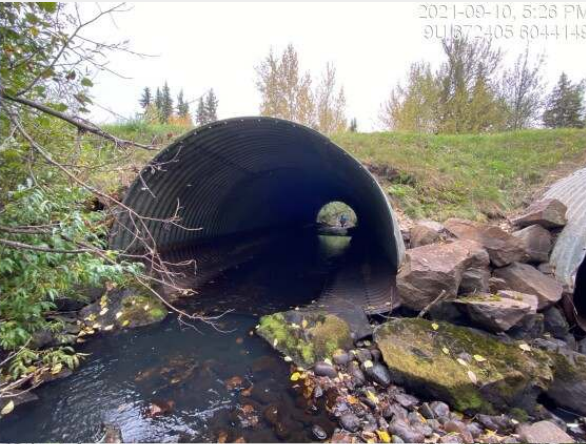
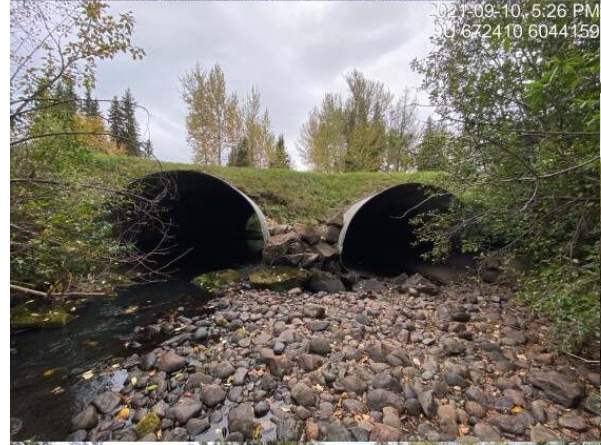
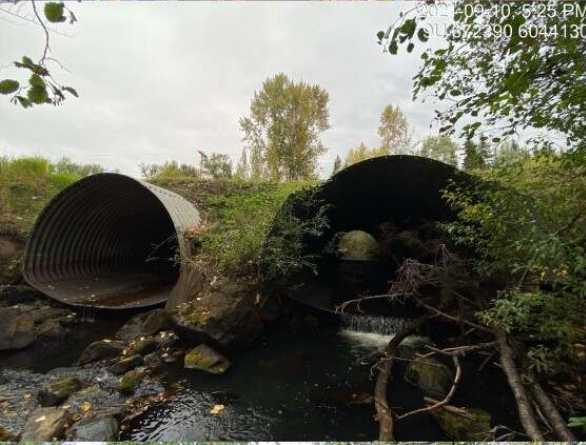
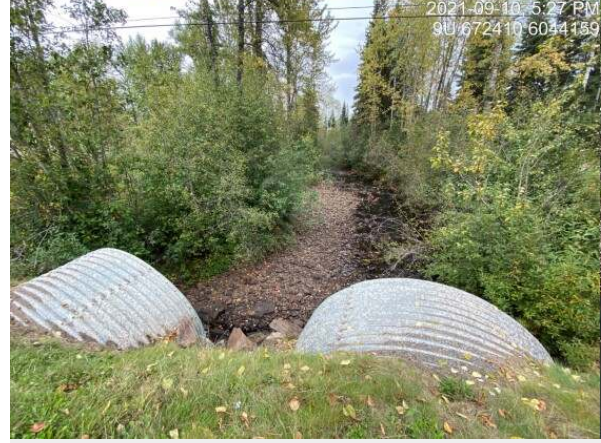
| Location and Stream Data | Crossing Characteristics |
|---|---|
| <p>Comments: Culvert and habitat measurements taken in 2020. Multipass closed site electrofishing conducted in 2021 upstream and downstream of highway. 17:25</p> <p>Photos: From top left clockwise: Road/Site Card, Barrel, Outlet, Downstream, Upstream, Inlet.</p> | |

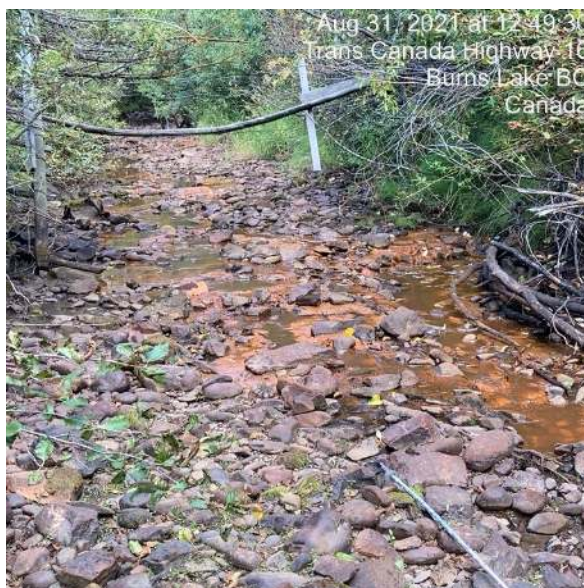
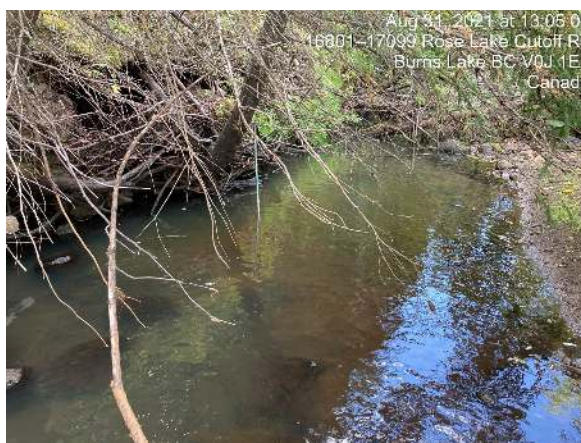
The stream was surveyed downstream from crossing 197967 for 375m to the bridge (PSCIS 197966) located on Ross Lake Cutoff Rd (Figure 5.38). The dominant substrate was cobbles with fines sub-dominant. Total cover amount was rated as trace with overhanging vegetation dominant. Cover was also present as deep pools and instream vegetation. The average channel width was 5.7m, the average wetted width was 3.1m, and the average gradient was 2.5%. The site was noted as having significant amounts of thick red colored algae for the majority of survey. Flow was very low with uncommon pools. Fence material was noted in or across channel in two locations and riparian vegetation had been removed where an agricultural field and fence line were close. Although considered an important migration corridor, the habitat was rated as medium value for salmonid rearing and spawning due to limited complexity resulting from adjacent agricultural activities.

Figure 5.38: Left: Habitat downstream of PSCIS crossing 197967. Right: Habitat downstream of PSCIS crossing 197967.

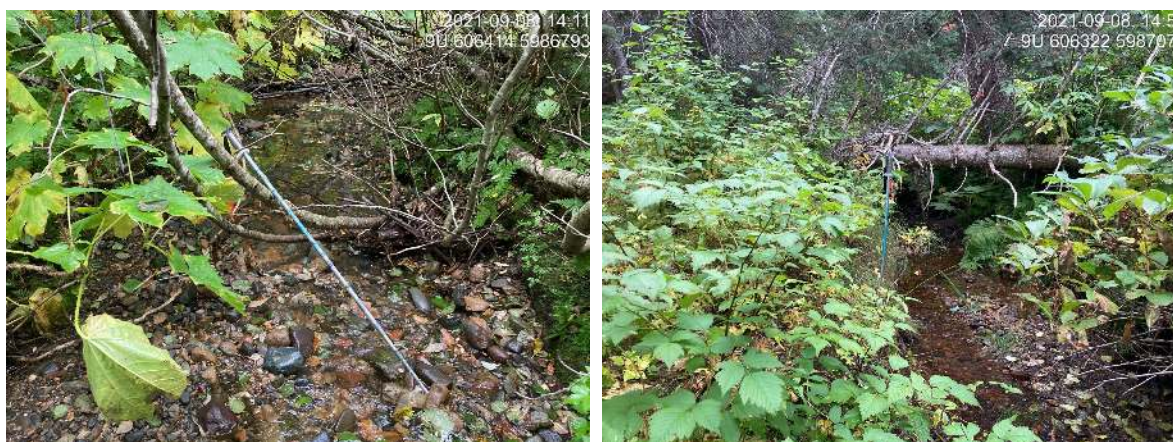
The stream was surveyed downstream from crossing 198008 for 400m (Figure [5.47](#)). The dominant substrate was gravels with fines sub-dominant. The average channel width was 2.3m, the average wetted width was 1.3m, and the average gradient was 5.2%. Total cover amount was rated as abundant with overhanging vegetation dominant. Cover was also present as small woody debris, large woody debris, and undercut banks. This was a small stream with low, consistent flows and shallow pools. There were few undercut banks but abundant overhanging vegetation. Gravels were present throughout with fines near the bottom half of the survey and more cobbles near the top. The gradient was steeper in the top half of the survey and decreased further downstream. A few functional large woody debris clusters created drops up to 0.6m high. Overall, the habitat was rated as medium value for salmonid rearing and spawning.

Figure 5.47: Left: Typical habitat downstream of PSCIS crossing 198008. Right: Typical habitat downstream of PSCIS crossing 198008.

Should restoration/maintenance activities proceed, replacement of PSCIS crossing 198008 with a bridge (3m span) is recommended. The cost of the work is estimated at \$100,000 for a cost benefit of 0 linear m/\$1000 and 0 m<sup>2</sup>/\$1000.

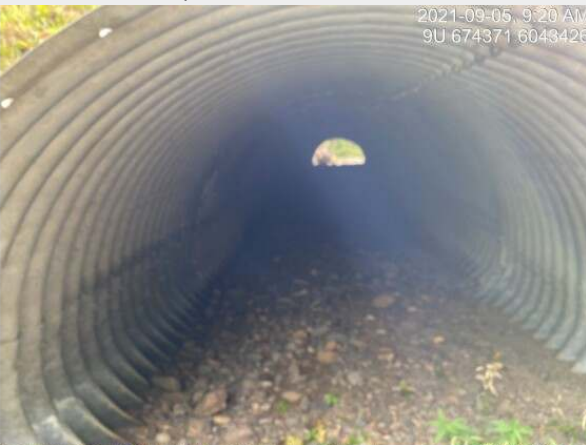
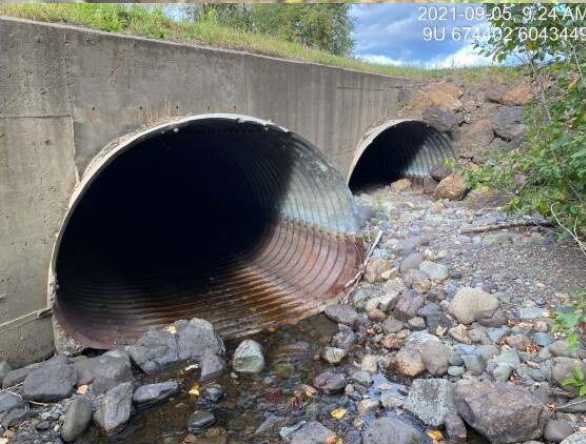
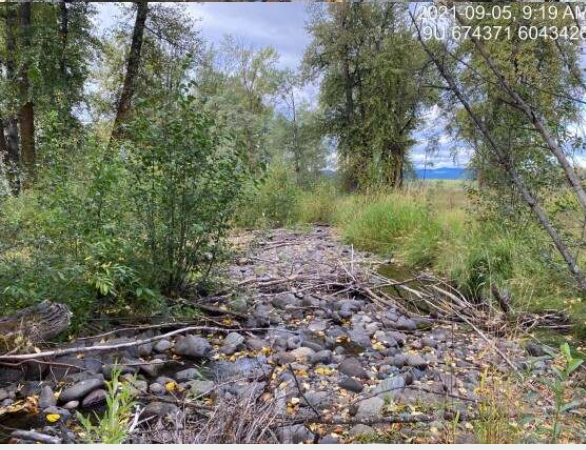
| Location and Stream Data | Crossing Characteristics |
|---|---|
| <p>Comments: Habitat confirmation conducted. Two pipes (2.5m x 2.5m). Culvert slope measured with lazel level. Fish observed. Could not locate downstream crossing on railway. Garmin backroads mapbook shows stream connecting with side channel of the Bulkley. 9:17</p> <p>Photos: From top left clockwise: Road/Site Card, Barrel, Outlet, Downstream, Upstream, Inlet.</p> | |

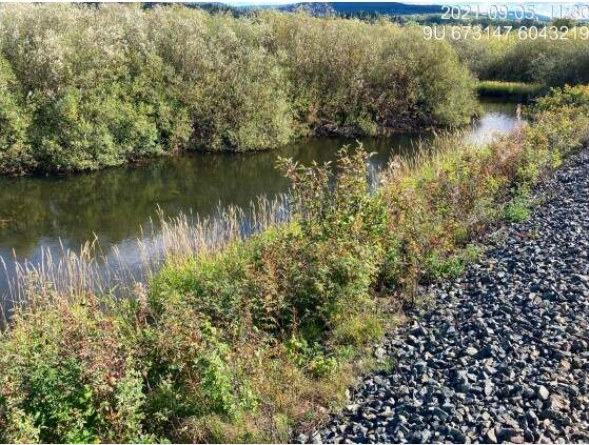
| Location and Stream Data | Crossing Characteristics |
|---|---|
| <p>Comments: No crossing actually exists in the field however site entered as a placeholder because there should be connection between Bulkley and Cesford at this location. Survey found no culvert and landowner reported none present. Large man-made ditch through adjacent field may be draining some water. Lower section of stream dry at time of survey. 11:22</p> <p>Photos: From top left clockwise: Road/Site Card, Barrel, Outlet, Downstream, Upstream, Inlet.</p> | |

For PSCIS crossing 198090 it is recommended some sort of fish passable structure be installed under the railway to reconnect Cesford Creek with the Bulkley River. The cost of the work is roughly estimated at \$9,000,000.
