## **Bulkley River and Morice River Watershed Groups Fish Passage Restoration Planning 2021**

**Prepared for  
Habitat Conservation Trust Foundation - CAT22-6-288  
BC Fish Passage Remediation Program  
Canadian Wildlife Federation**

**Prepared by  
Al Irvine, B.Sc., R.P.Bio.  
New Graph Environment Ltd.  
on behalf of  
Society for Ecosystem Restoration in Northern British Columbia**

**Version 0.1.9 2025-06-02**

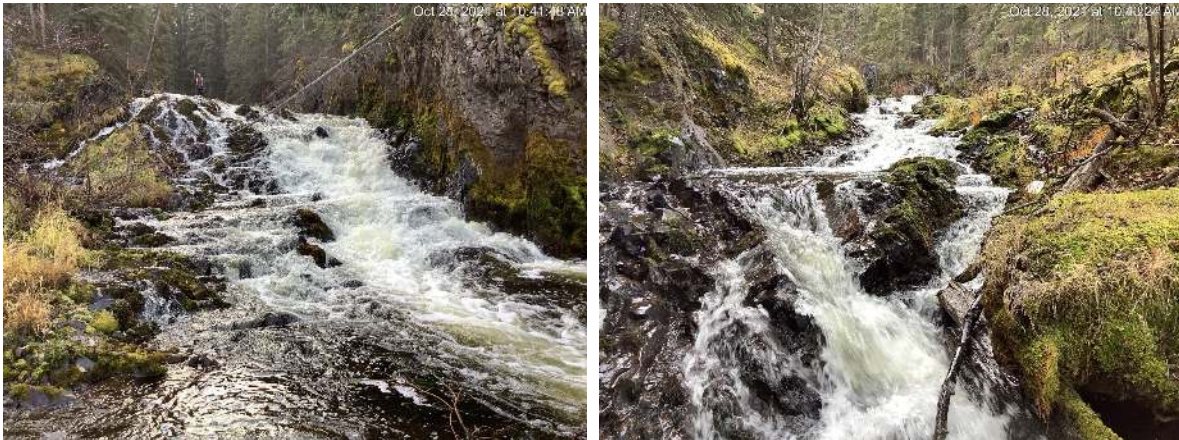
Dyson (1949) and Stokes (1956) report substantial use of habitat above Bulkley Falls by steelhead, chinook, coho and sockeye utilization in the past (pre-1950) based on spawning reports. Both authors concluded that the Bulkley Falls pose a partial obstruction to migrating fish based on flow levels. Chinook, which migrate early in the summer when water levels are high, have been noted as able to ascend the falls in normal to high water years and in high water years it was thought that coho and steelhead could ascend. A. Gottesfeld and Rabnett (2007) report that the falls are almost completely impassable to all salmon during low water flows. Stokes (1956) reports that there was high value spawning habitat located within the first 3km of the Bulkley River from the outlet of Bulkley Lake.

Figure 4.1: Left: Bulkley Falls main channel. Right: Bulkley Falls side channel.

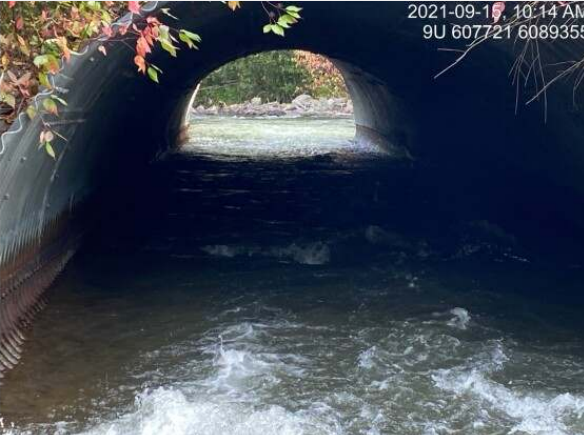
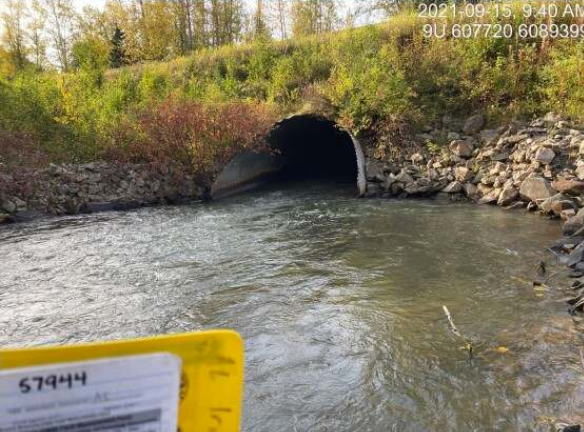
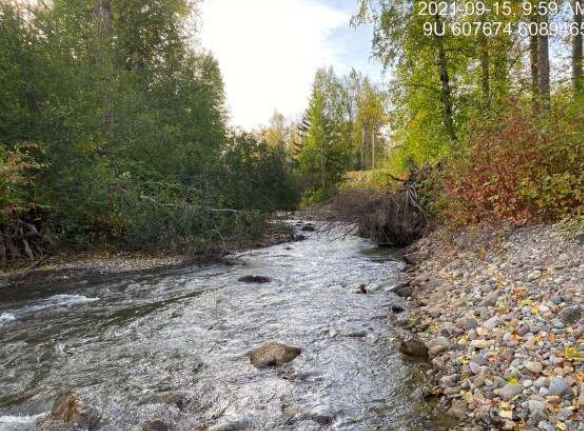
| Location and Stream Data | Crossing Characteristics |
|---|---|
| <p>Comments: Oval culvert. 9:34</p> <p>Photos: From top left clockwise: Road/Site Card, Barrel, Outlet, Downstream, Upstream, Inlet.</p> | |

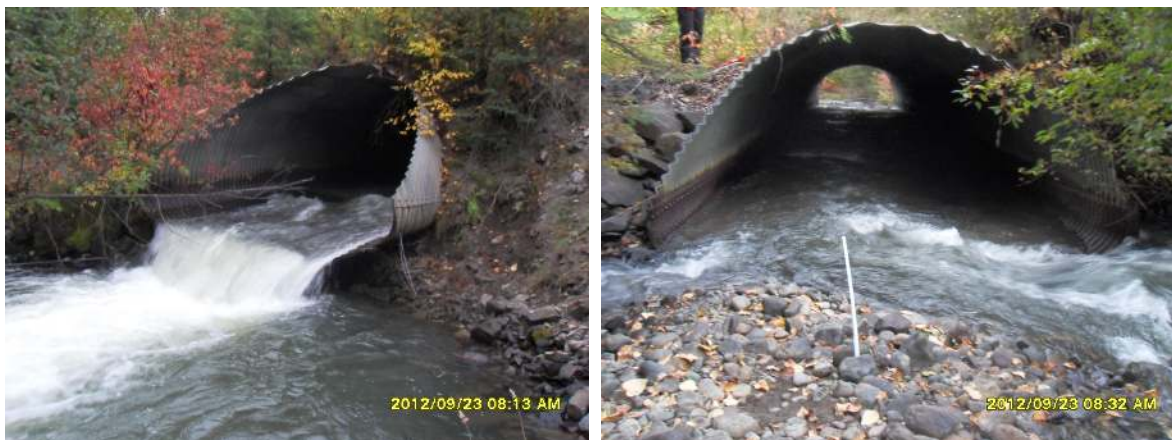
Figure 5.4: Left: Outlet of PSCIS crossing 57944 in 2012. Photo from PSCIS. Right: Inlet of PSCIS crossing 57944 in 2012. Photo from PSCIS.

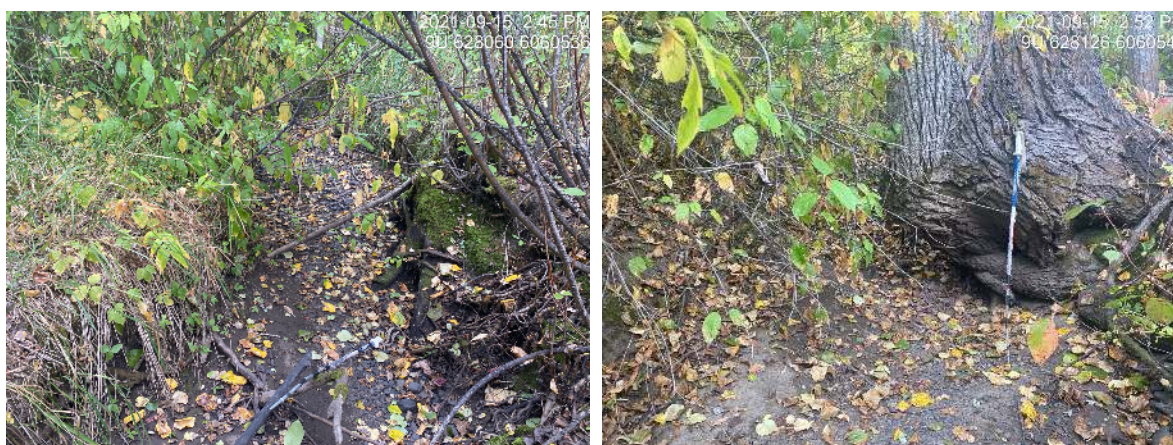
The stream was surveyed downstream from crossing 123544 for 300m (Figure [5.5](#)). Total cover amount was rated as abundant with undercut banks dominant. Cover was also present as small woody debris, large woody debris, boulders, deep pools, and overhanging vegetation. The dominant substrate was gravels with fines sub-dominant. The average channel width was 2.6m, and the average gradient was 2%. Although dry, the channel was well defined with frequent gravels throughout. The undercut banks were deeply cut and riparian vegetation was comprised of thick red-osier dogwood understory and open mature cottonwood forest. Habitat was rated as low value for salmonid rearing and spawning.

Figure 5.5: Left: Habitat downstream of PSCIS crossing 123544. Right: Habitat downstream of PSCIS crossing 123544.

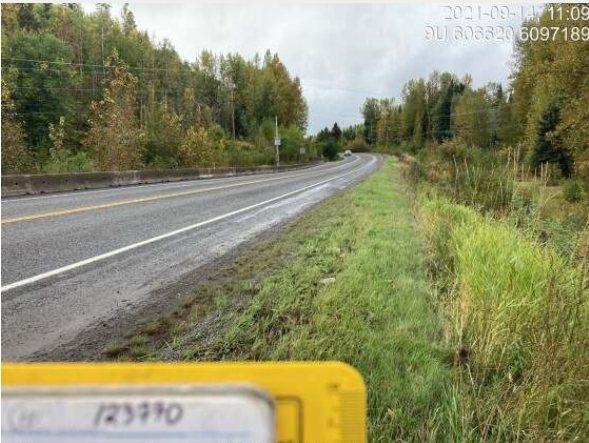
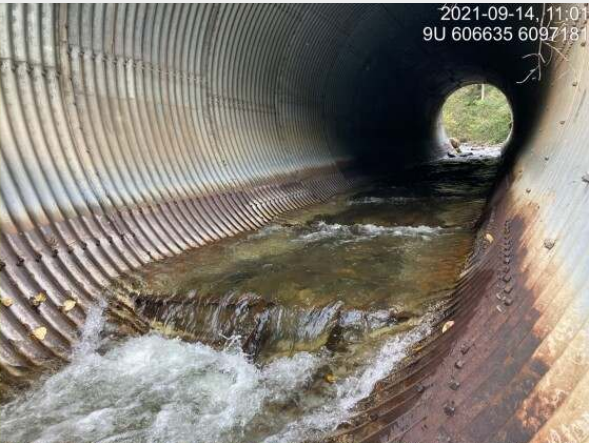
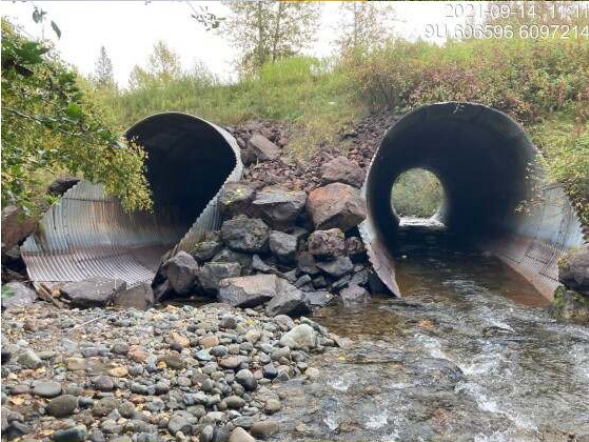
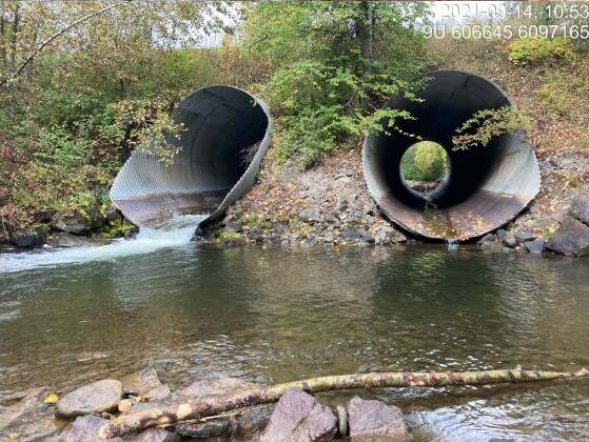
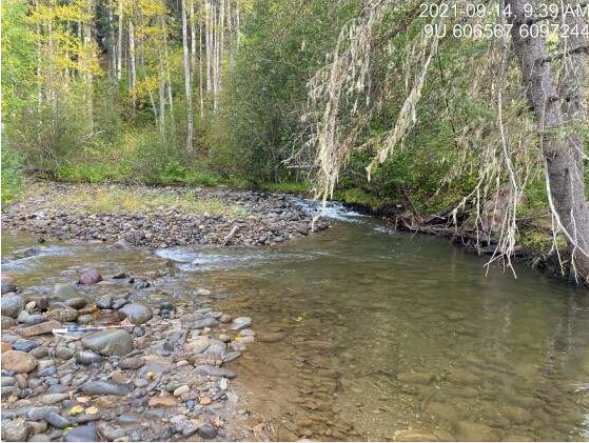
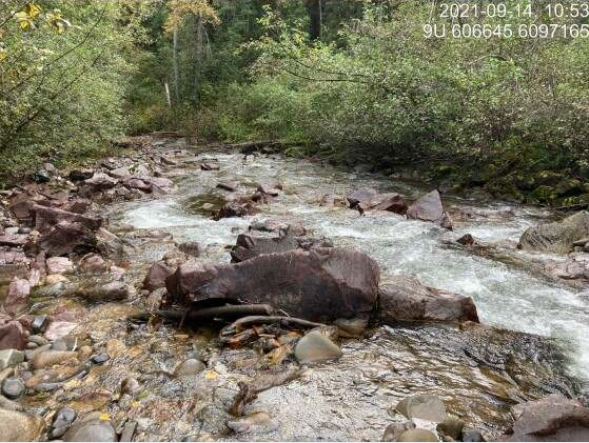
| Location and Stream Data | Crossing Characteristics |
|---|---|
| <p>Comments: Both pipes have outlet drop and water flowing through. Water depth in left pipe is 0.01m, left pipe no embedment. Inlet drop only on right one. Also has baffling with substrate but baffling not in place for downstream ~3m, so not continuous. Estimated pool depth. 10:52</p> <p>Photos: From top left clockwise: Road/Site Card, Barrel, Outlet, Downstream, Upstream, Inlet.</p> | |

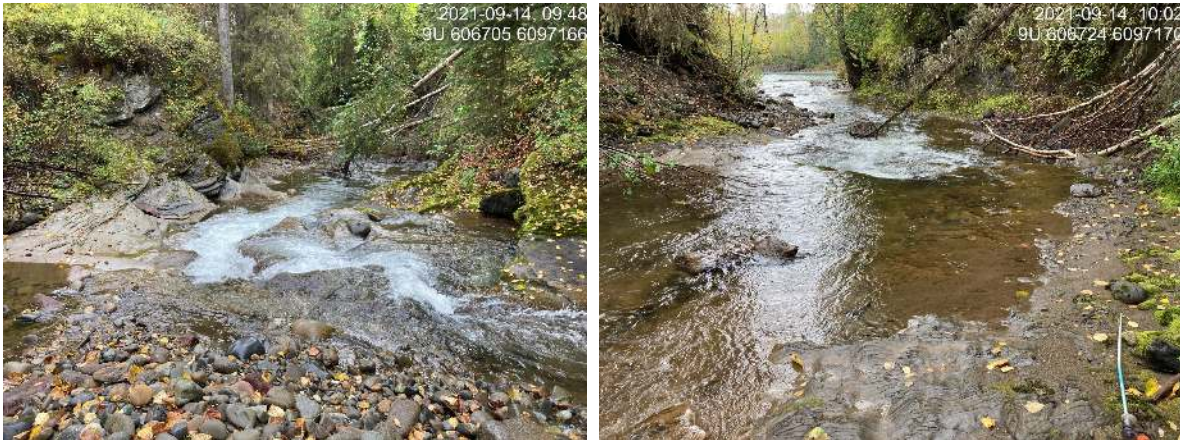
The stream was surveyed downstream from crossing 123770 for 230m to the confluence with the Bulkley River (Figure [5.9](#)). Total cover amount was rated as moderate with boulders dominant. Cover was also present as deep pools and overhanging vegetation. The average channel width was 13.6m, the average wetted width was 8.3m and the average gradient was 4.1%. The dominant substrate was large rock/bedrock with cobbles subdominant. Although rated as an important migration corridor, the habitat was rated as medium value for salmonid rearing and spawning with high flows and limited complexity. Several dead pink salmon were noted on the fan at the confluence with the Bulkley River.

Figure 5.9: Left: Typical habitat downstream of PSCIS crossing 123770. Right: Typical habitat downstream of PSCIS crossing 123770.

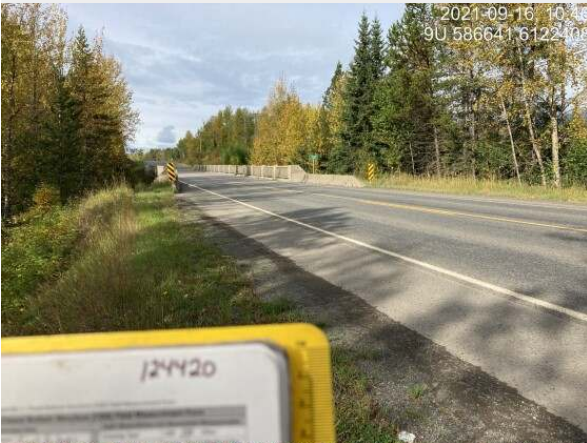
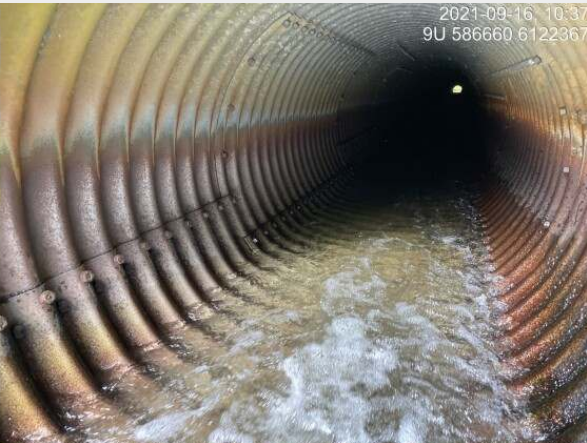
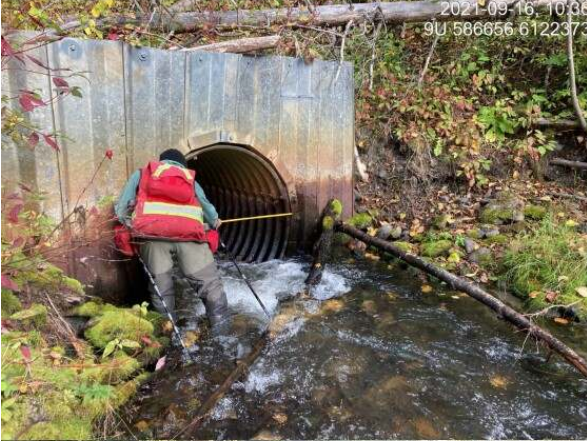
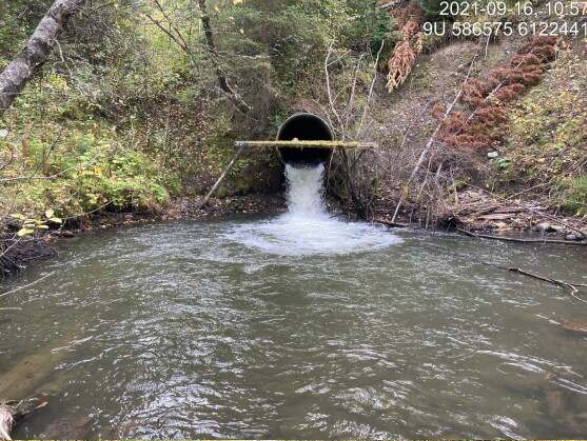
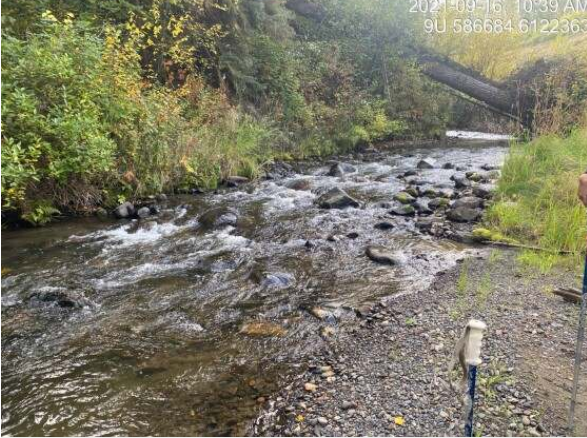
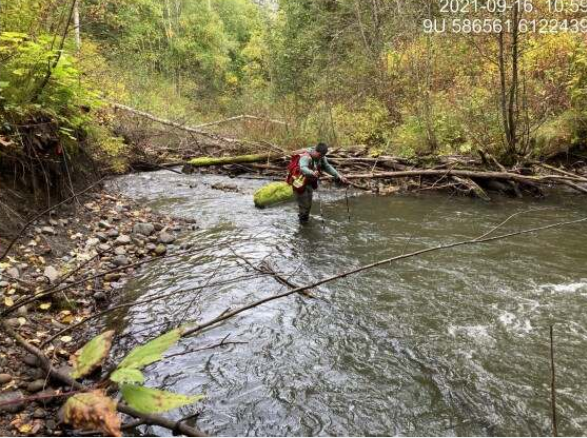
| Location and Stream Data | Crossing Characteristics |
|---|---|
| <p>Comments: Majority of culvert is ~3% however last 5 m steepens to 6-7%, appears to be because exposed section is bending from weight of water. Fill depth ~24m. Huge pool appears it would require a lot of material to backwater and build up. 10:30</p> <p>Photos: From top left clockwise: Road/Site Card, Barrel, Outlet, Downstream, Upstream, Inlet.</p> | |

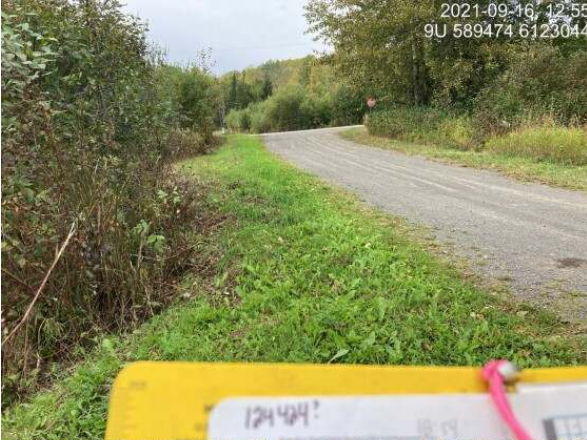
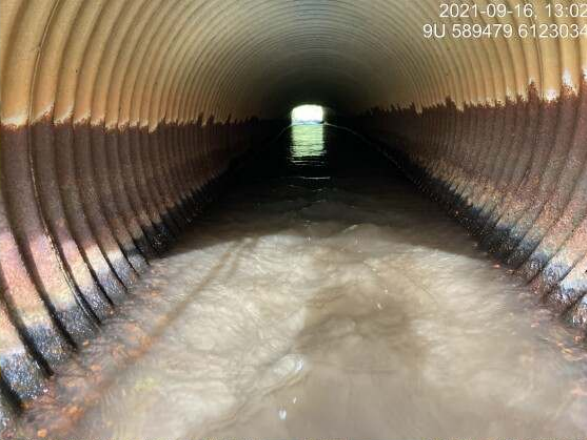
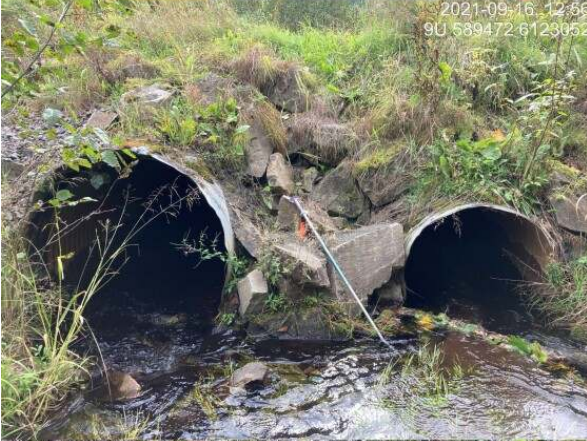
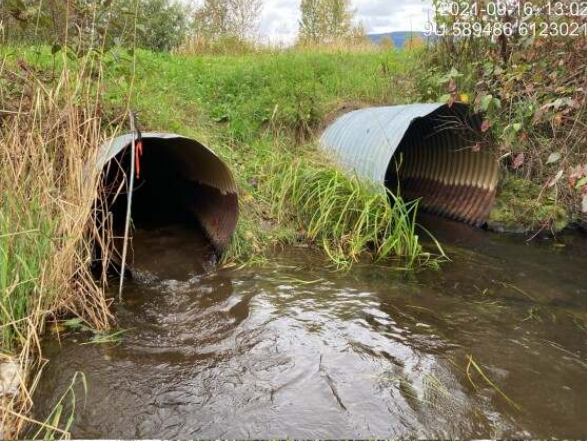
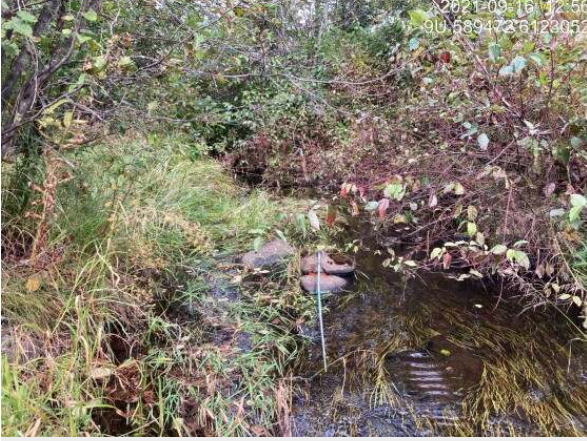
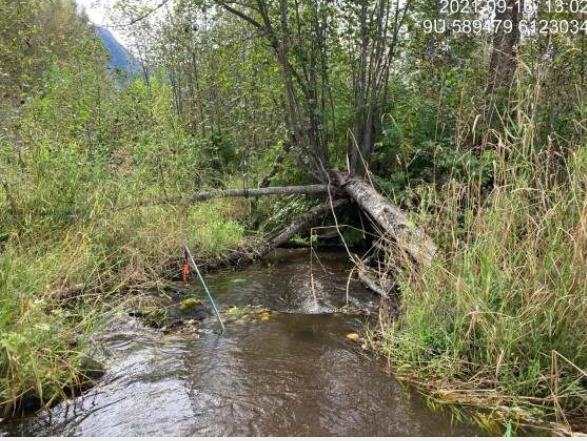
| Location and Stream Data | Crossing Characteristics |
|---|---|
| <p>Comments: Bent in middle from road weight. Inlet drop of 0.10 for both pipes. Slow steady flow almost wetland habitat above and below. Water is high. 12:54</p> | |

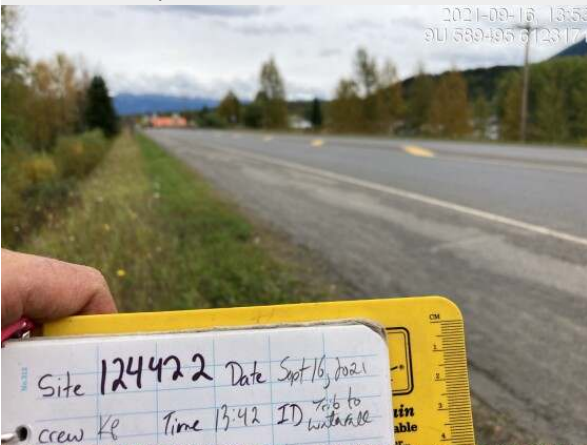
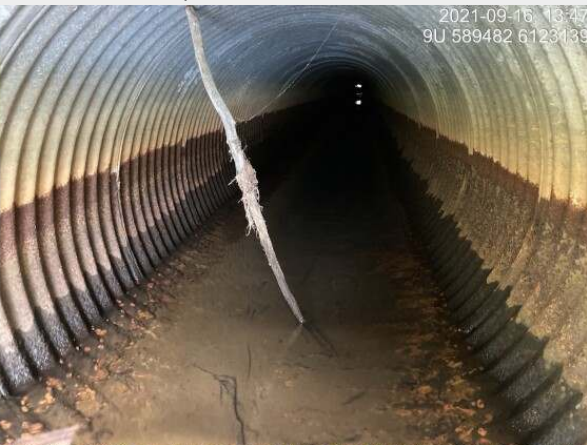
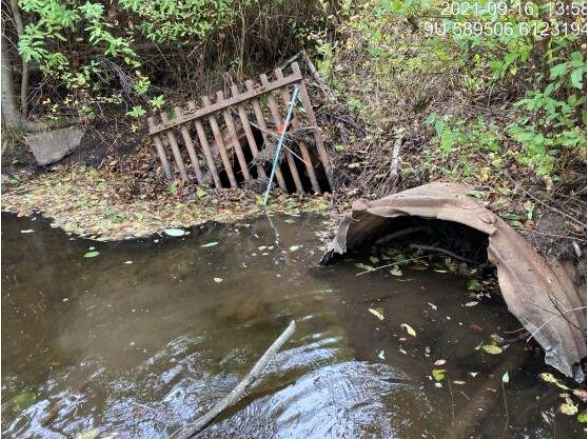
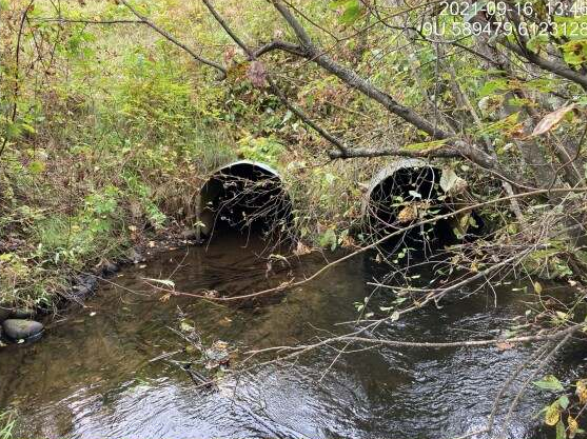
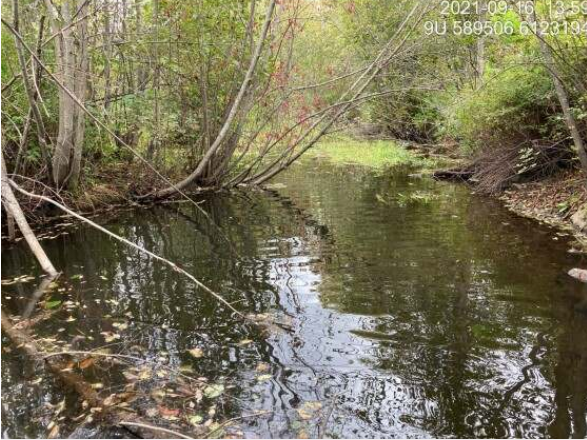
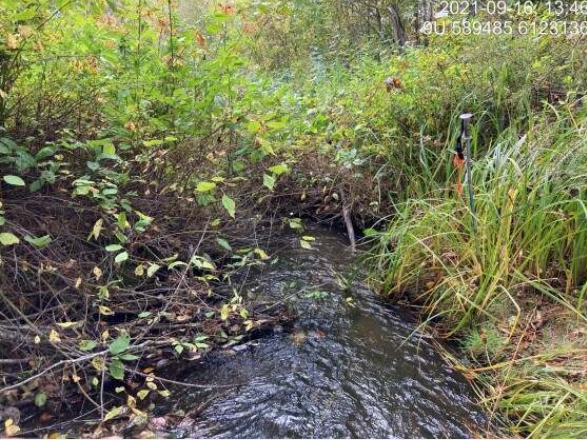
Table 5.21: Summary of fish passage assessment for PSCIS crossing 124422.

| Location and Stream Data | Crossing Characteristics |
|---|---|
| <p>Comments: 2 pipes. Both have water, left bank one is flowing. Assessment comments indicate right bank pipe is backwatered 100% but changed to 25% based on photos and past PSCIS data and photos which also indicated not backwatered. Suspect blockage due to debris. Outlet water depth, fish sighted in outlet of right barrel. 13:42</p> <p>Photos: From top left clockwise: Road/Site Card, Barrel, Outlet, Downstream, Upstream, Inlet.</p> | |

| Location and Stream Data | | Crossing Characteristics | |
|---|---|---|---|
| Fix type | Replace with New Open Bottom Structure | Fix Span / Diameter | 19 |

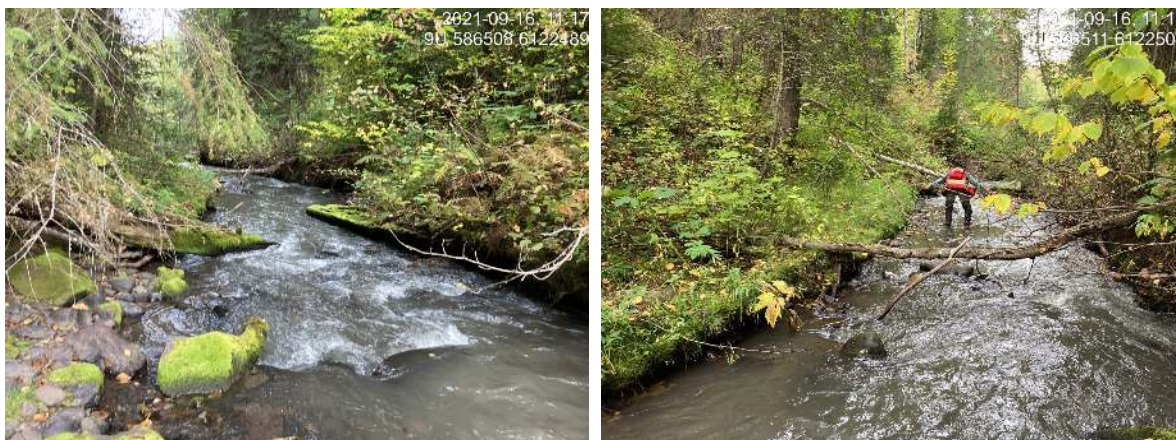
Figure 5.13: Left: Typical habitat downstream of PSCIS crossing 124420. Right: Typical habitat downstream of PSCIS crossing 124420.

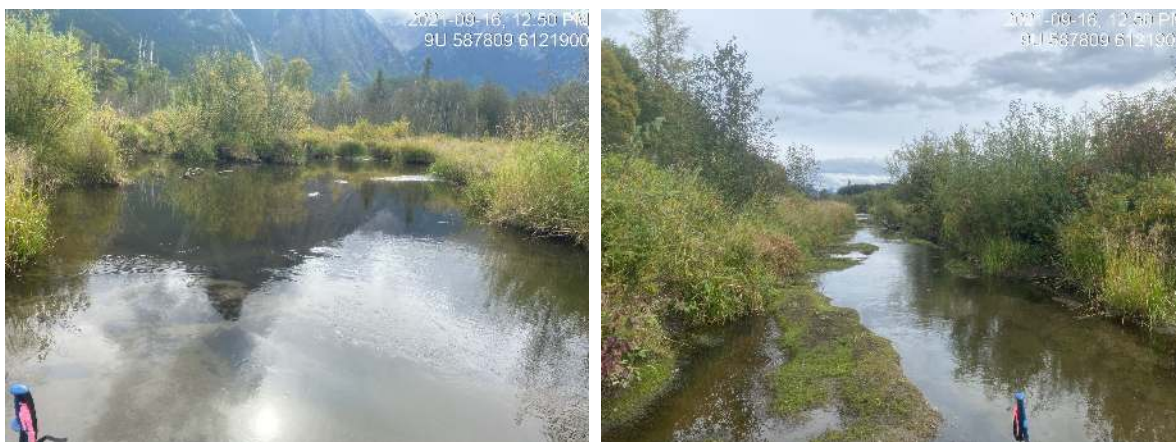
At approximately 1200m upstream of Highway 16, Waterfall Creek enters into station Creek. In addition to the survey via drone, Waterfall Creek was assessed immediately upstream of the confluence with Station Creek for 430m (Figure 5.15) The dominant substrate was fines with gravels sub-dominant. The average channel width was 6.2m, the average wetted width was 5.5m, and the average gradient was 0.5%. Total cover amount was rated as abundant with instream vegetation dominant. Cover was also present as undercut banks, deep pools, and overhanging vegetation. The area assessed included slow flowing wetland type habitat with generally shallow glide type habitat and significant quantities of instream vascular vegetation. Habitat value for areas surveyed was rated as high value as the area could provide significant amounts of rearing habitat for juvenile rainbow and coho.

Figure 5.15: Left: Habitat upstream of PSCIS crossing 124420. Right: Habitat upstream of PSCIS crossing 124420 within Waterfall Creek.

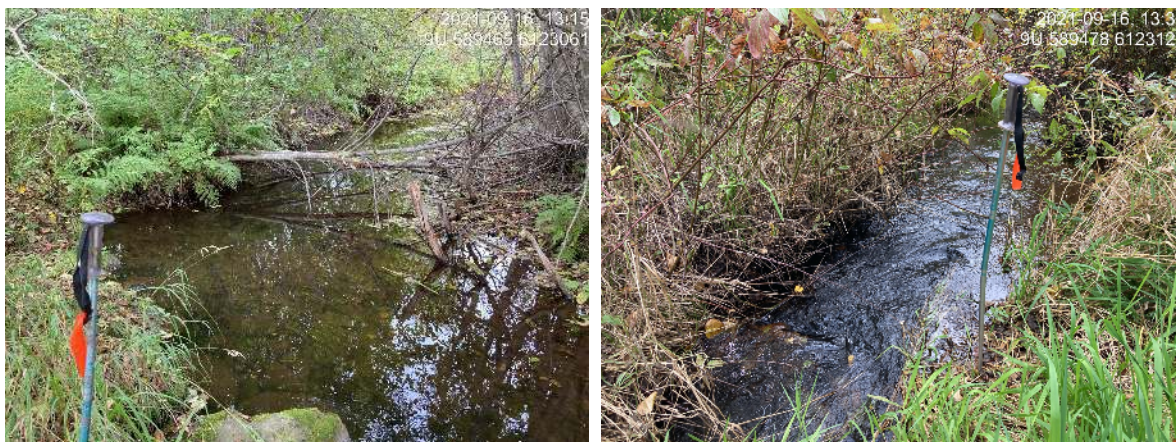
The stream was surveyed upstream from crossing 124421 for 120m to 124422 (Figure 5.16). The average channel width was 2.6m, the average wetted width was 2.5m, and the average gradient was 1%. Total cover amount was rated as abundant with instream vegetation dominant. Cover was also present as small woody debris, undercut banks, and overhanging vegetation. The dominant substrate was fines with gravels sub-dominant. Survey notes indicate a slow moving wetland like stream with deep glides throughout. Instream vegetation was abundant with somewhat stagnant water often smelling of sulfur. Near top of the survey, the gradient increased slightly and the substrate transitioned from primarily fines to small gravel. Within the riparian area shrubs and

Figure 5.16: Left: Typical habitat upstream of PSCIS crossing 124420. Right: Typical habitat upstream of PSCIS crossing 124420.

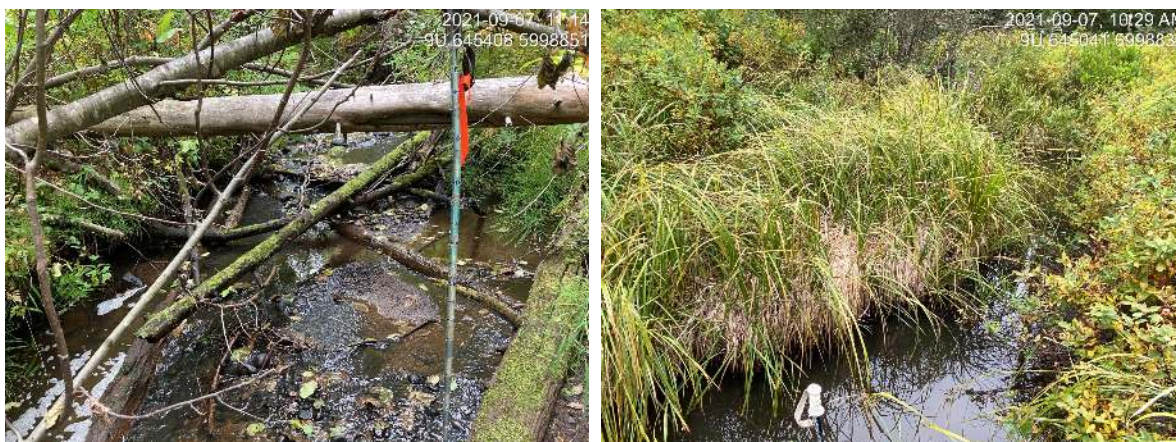
The stream was surveyed downstream from crossing 197378 for 450m (Figure [5.20](#)). Total cover amount was rated as abundant with overhanging vegetation dominant. Cover was also present as small woody debris and undercut banks. The average channel width was 2.4m, the average wetted width was 1.9m, and the average gradient was 2.5%. The dominant substrate was gravels with fines sub-dominant. There was a high percentage of crown closure, with riparian shrubs but a thin, coniferous forest further upland. There was an numerous pockets of gravels suitable for rainbow and dolly varden spawning. The stream appeared to have stable flows with no notable erosion. Overall, the habitat was rated as medium value for salmonid rearing and spawning.

Figure 5.20: Left: Typical habitat downstream of PSCIS crossing 197378. Right: Typical habitat upstream of PSCIS crossing 197378.

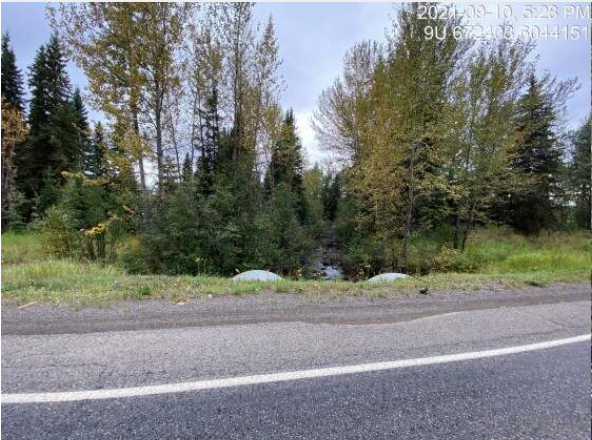
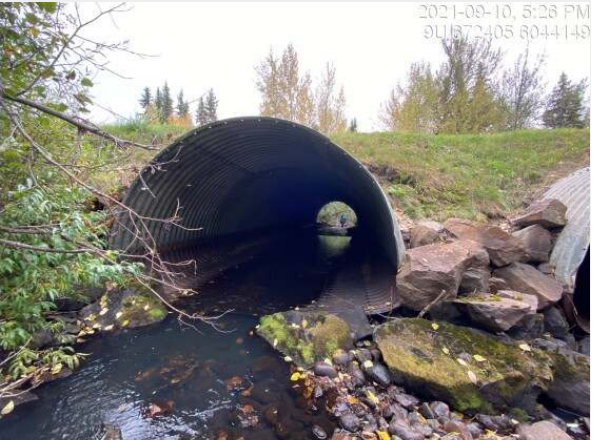
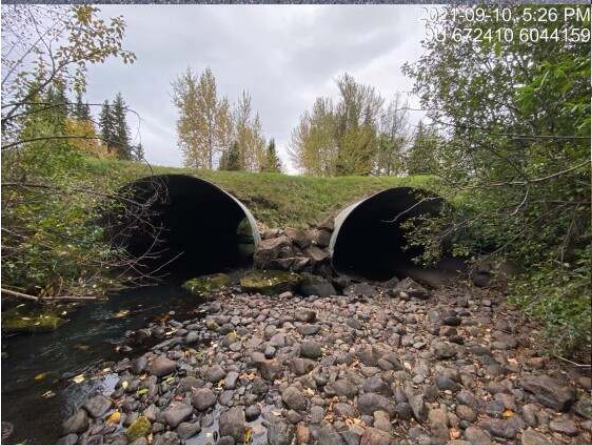
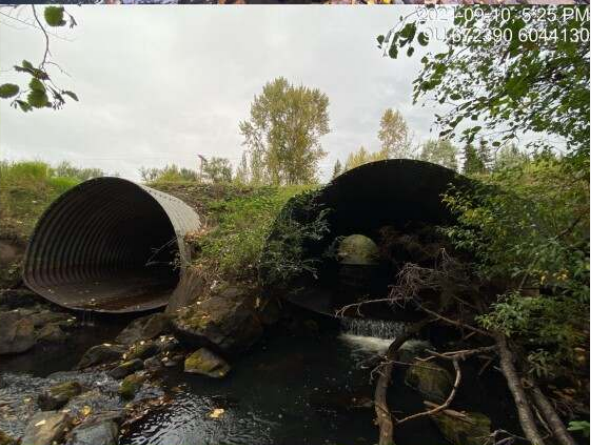
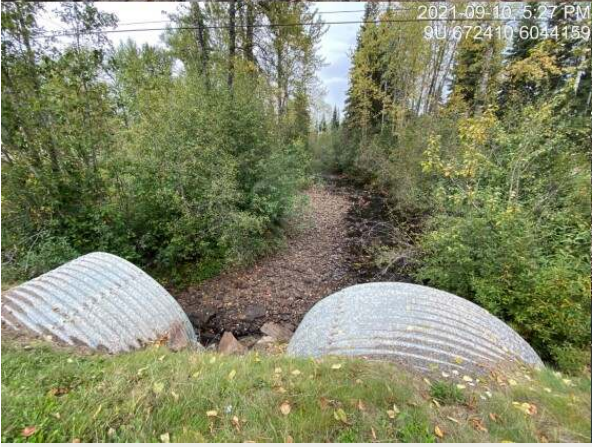
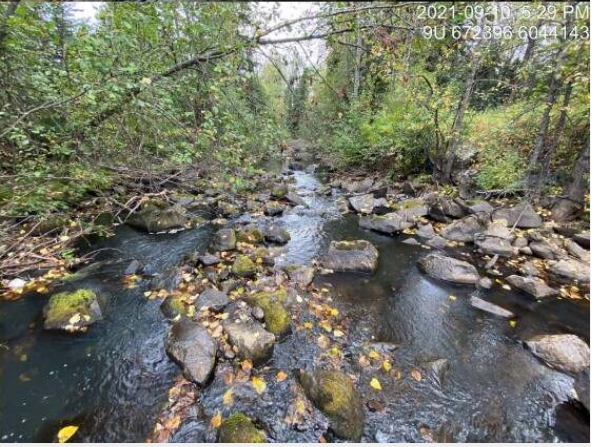
| Location and Stream Data | Crossing Characteristics |
|---|---|
| <p>Comments: Culvert and habitat measurements taken in 2020. Multipass closed site electrofishing conducted in 2021 upstream and downstream of highway. 17:25</p> <p>Photos: From top left clockwise: Road/Site Card, Barrel, Outlet, Downstream, Upstream, Inlet.</p> | |

| Location and Stream Data | | Crossing Characteristics | |
|---|---|---|---|
| Fix type | Replace with New Open Bottom Structure | Fix Span / Diameter | 16.5 |

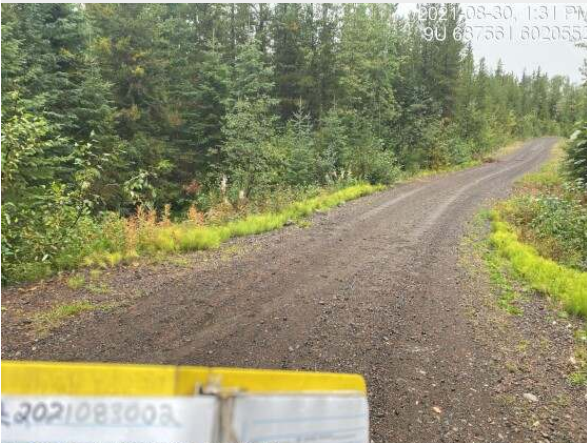
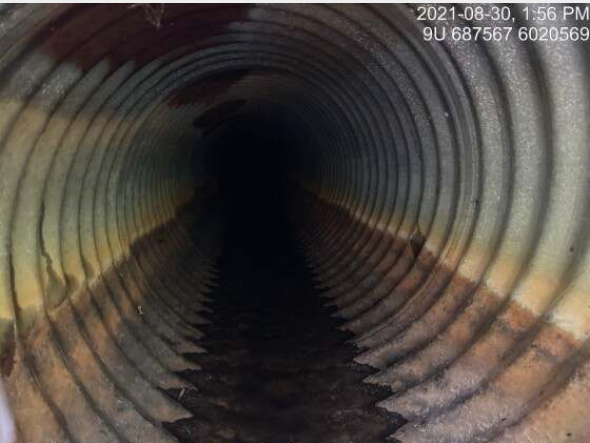
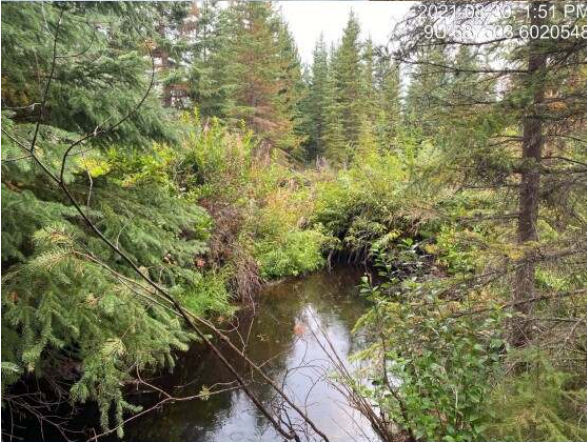
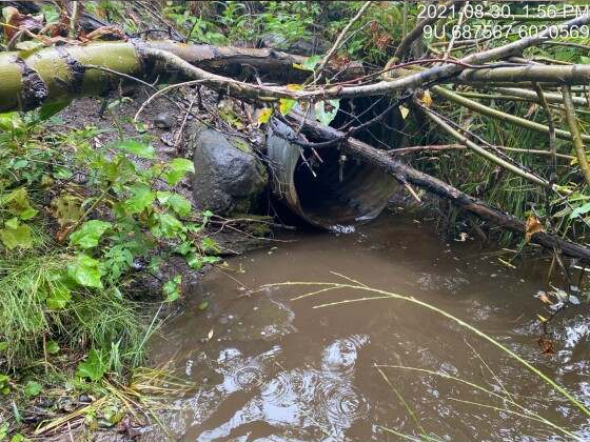
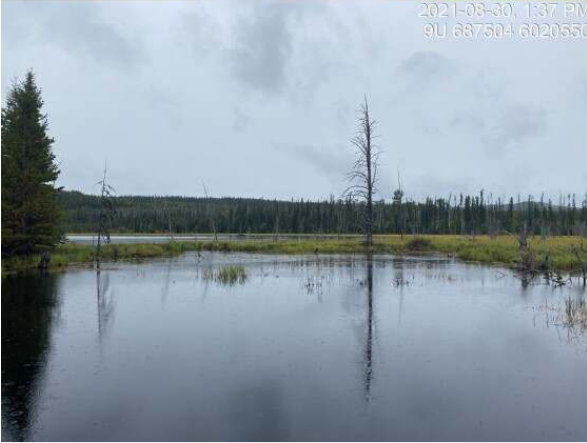
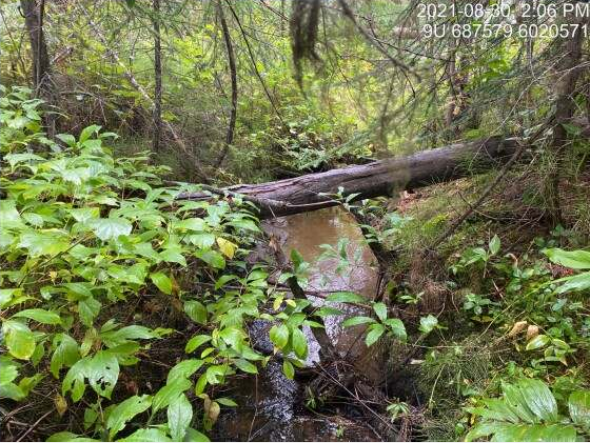
| Location and Stream Data | Crossing Characteristics |
|---|---|
| <p>Comments: Habitat value is low to medium. Large beaver influenced lake upstream with two dams ~1.5m high at 10m and 30m upstream. Inlet blocked. Water at inlet is level with the top of the culvert. At 4m downstream is a 1m high beaver dam. 13:23</p> <p>Photos: From top left clockwise: Road/Site Card, Barrel, Outlet, Downstream, Upstream, Inlet.</p> | |

| Location and Stream Data | | Crossing Characteristics | |
|---|---|---|---|
| Fix type | Replace Structure with Streambed Simulation CBS | Fix Span / Diameter | 3 |

Should restoration/maintenance activities proceed at the site, replacement of PSCIS crossing 197909 with a clear span bridge is recommended. The cost of the work is estimated at \$100,000 for a cost benefit of 2.2 linear m/\$1000 and 2.9 m<sup>2</sup>/\$1000.

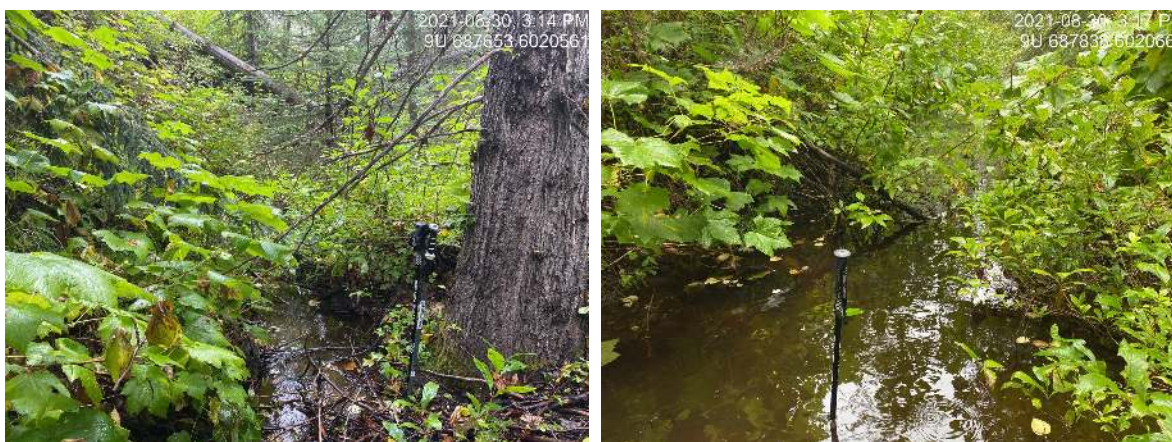
The stream was surveyed downstream from crossing 197909 for 400m (Figure [5.25](#)). Total cover amount was rated as moderate with overhanging vegetation dominant. Cover was also present as undercut banks. The average channel width was 1.3m, the average wetted width was 1.3m, and the average gradient was 3.2%. Substrate was composed of fines. At approximately 300m downstream of the culvert the stream became wider with glide habitat to ~50cm in depth resulting from sediments deposited by a failure on the steep north canyon wall. Habitat was rated as low value for salmonid rearing and spawning due to the small size of the stream, low flows and fine substrate.

Figure 5.25: Left: Habitat downstream of PSCIS crossing 197909. Right: Habitat downstream of PSCIS crossing 197909.

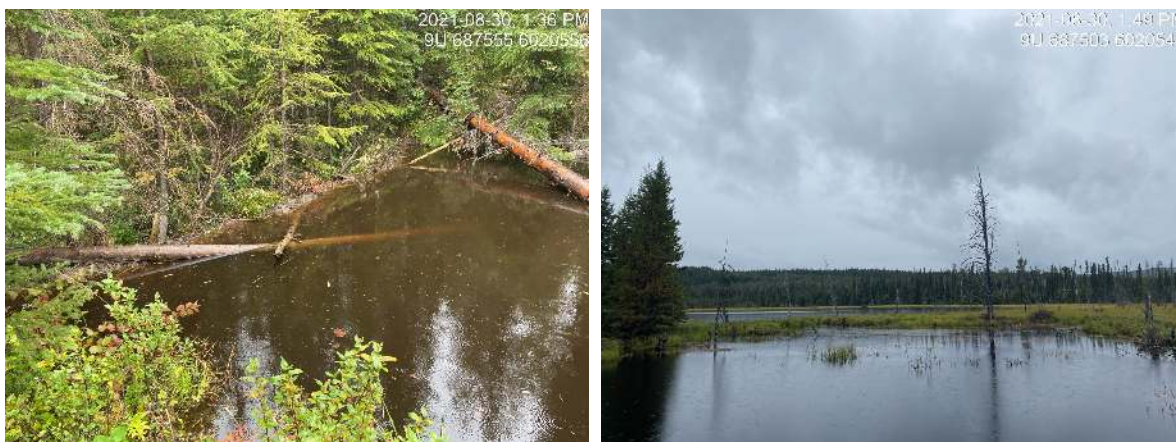
Figure 5.26: Left: Habitat upstream of PSCIS crossing 197909. Right: Habitat upstream of PSCIS crossing 197909.

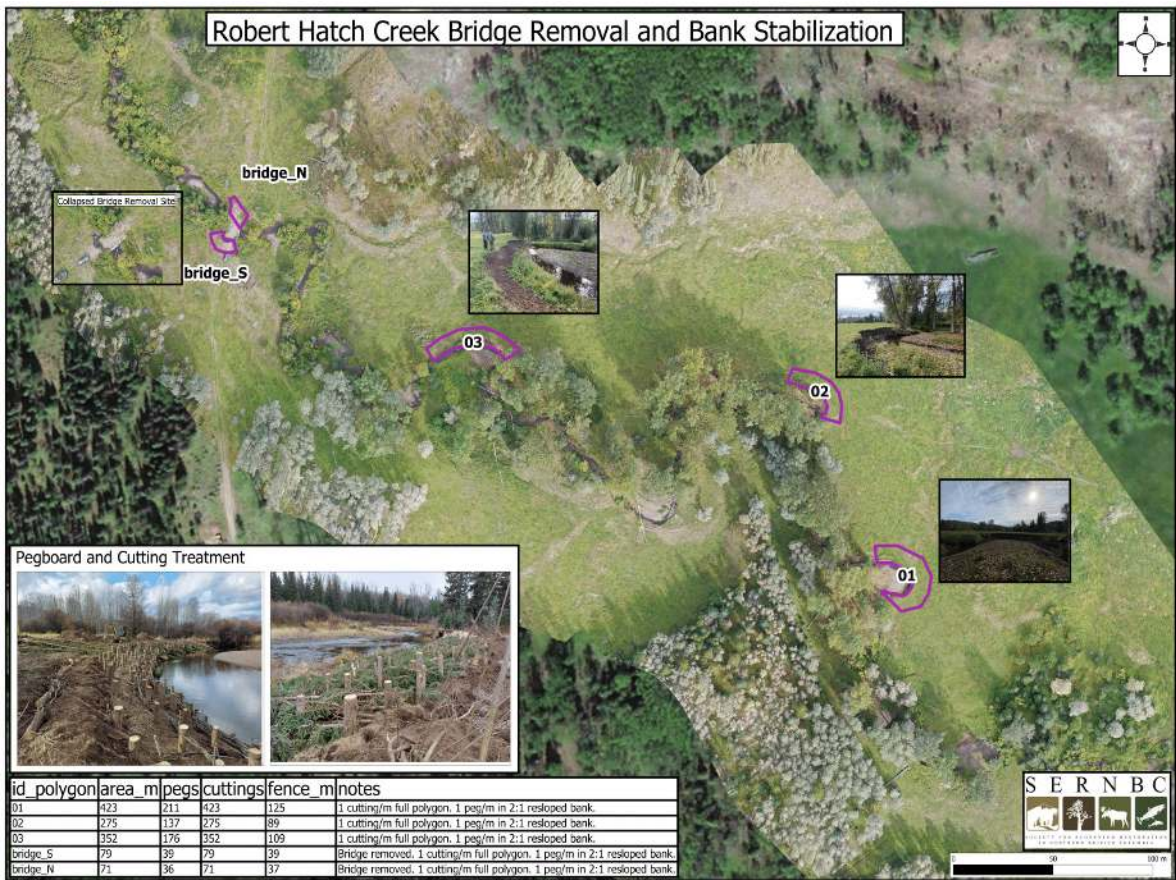
Figure 5.27: Restoration plan for Robert Hatch Creek including removal of collapsed bridge, resloping of banks and the installation of live cuttings/pegboarding

Should restoration/maintenance activities proceed at the site, removal of PSCIS crossing 197912 is recommended. In addition to removal of the collapsed bridge, resloping of banks and the installation of live cuttings/pegboarding is recommended in three areas downstream where cattle trampling is resulting in significant erosion. A map of the erosion areas and associated prescriptions for rehabilitation of the downstream corners is provided as Figure [5.27](#). The cost of the work is estimated at \$30,000 for a cost benefit of 924 linear m/\$1000 and 3973.2 m<sup>2</sup>/\$1000.

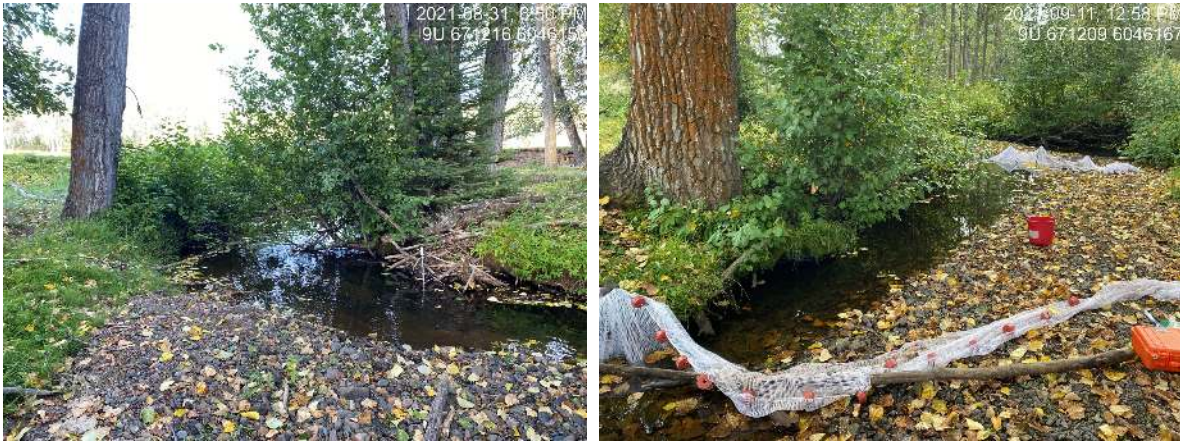
Figure 5.29: Left: Typical habitat downstream of PSCIS crossing 197912. Right: Typical habitat downstream of PSCIS crossing 197912.

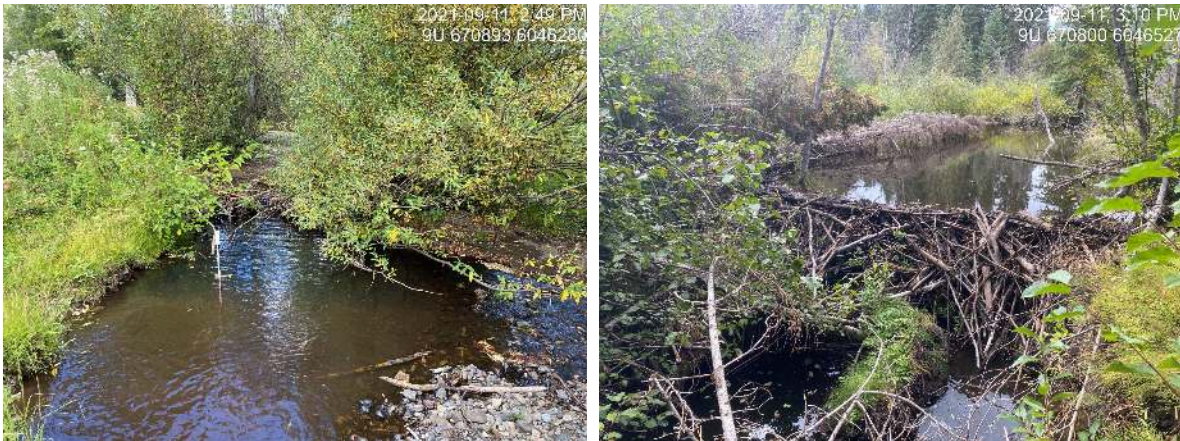
Figure 5.30: Left: Typical habitat upstream of PSCIS crossing 197912. Right: Typical habitat upstream of PSCIS crossing 197912.

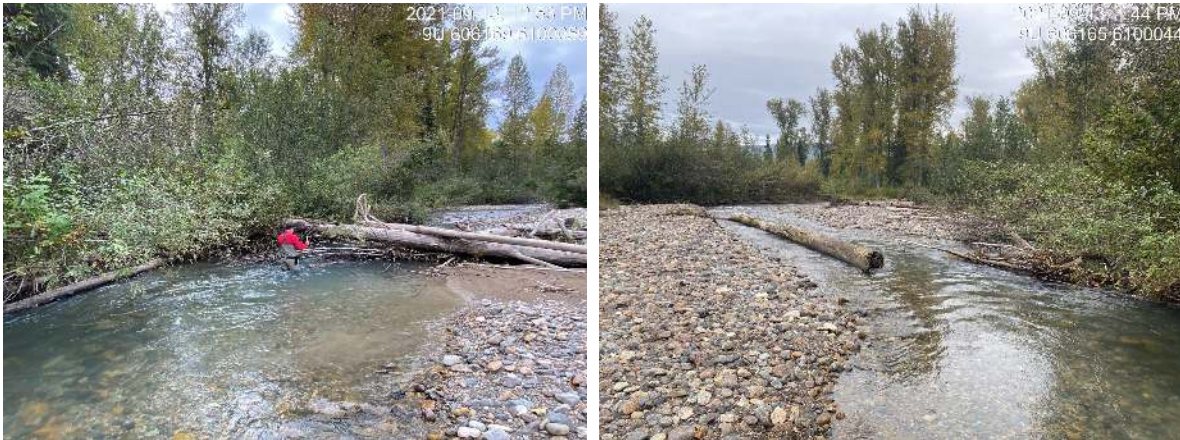
The stream was surveyed downstream from crossing 197960 for 450m (Figure [5.32](#)). Total cover amount was rated as moderate with overhanging vegetation dominant. Cover was also present as small woody debris, large woody debris, undercut banks, and deep pools. The average channel width was 25.4m, the average wetted width was 8.9m and the average gradient was 1.7%. The dominant substrate was cobbles with gravels subdominant. The stream was moderately turbid due to glacial flour with abundant quantities of gravels suitably sized for trout and salmon species present. The stream channel was noted as riffle dominated with a lack of complexity due to adjacent riparian clearing and dyke installation. The habitat was rated as medium value for salmonid rearing and spawning.

Figure 5.32: Left: Typical habitat downstream of PSCIS crossing 197960. Right: Typical habitat downstream of PSCIS crossing 197960.

Should restoration/maintenance activities proceed, replacement of PSCIS crossing 197960 with a bridge (23m span) is recommended. The cost of the work is estimated at \$20,700,000 for a cost benefit of 0.5 linear m/\$1000 and 8.7 m<sup>2</sup>/\$1000.

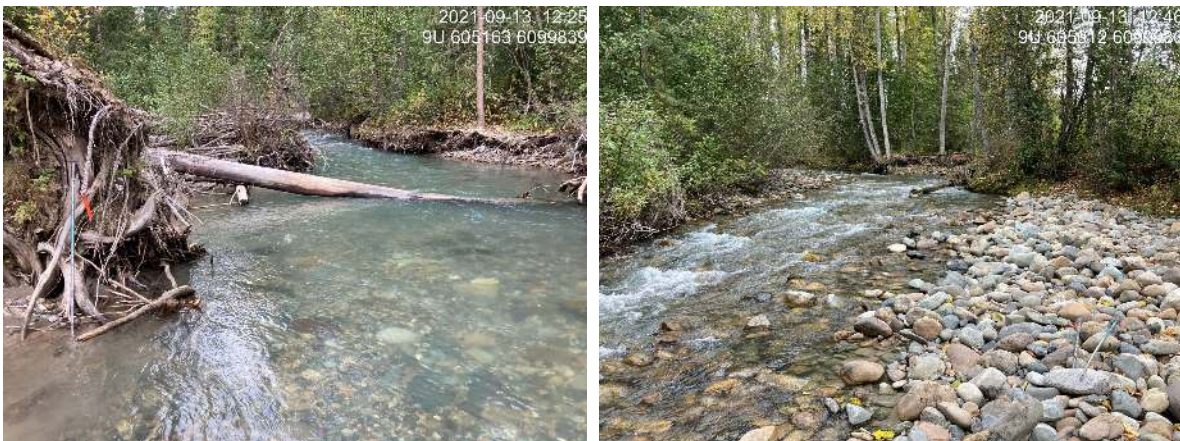
The stream was surveyed upstream from crossing 197960 for 1000m (Figure [5.33](#)). Total cover amount was rated as moderate with overhanging vegetation dominant. Cover was also present as small woody debris, large woody debris, boulders, and undercut banks. The average channel width was 18m, the average wetted width was 8.9m and the average gradient was 2.8%. The dominant substrate was cobbles with gravels subdominant. The first 50 - 100m upstream of crossing channel and banks were noted as armoured with riprap. Abundant gravels suitable for resident and anadromous salmonids were noted throughout. The habitat was rated as medium value as an important migration corridor containing suitable spawning habitat and having moderate rearing potential.

Figure 5.33: Left: Typical habitat upstream of PSCIS crossing 197960. Right: Typical habitat upstream of PSCIS crossing 197960.
