## **Bulkley River and Morice River Watershed Groups Fish Passage Restoration Planning 2021**

**Prepared for  
Habitat Conservation Trust Foundation - CAT22-6-288  
BC Fish Passage Remediation Program  
Canadian Wildlife Federation**

**Prepared by  
Al Irvine, B.Sc., R.P.Bio.  
New Graph Environment Ltd.  
on behalf of  
Society for Ecosystem Restoration in Northern British Columbia**

**Version 0.1.9 2025-06-02**

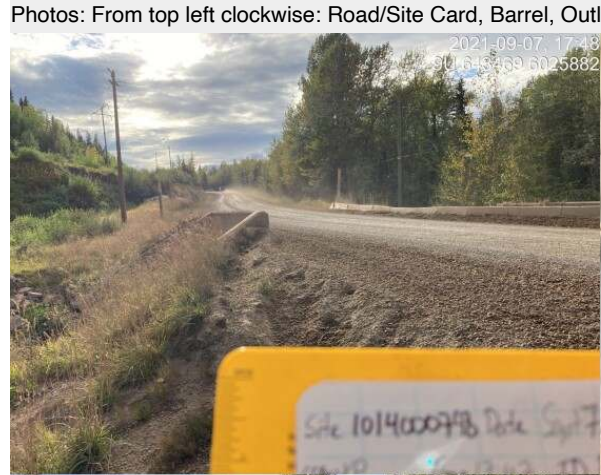
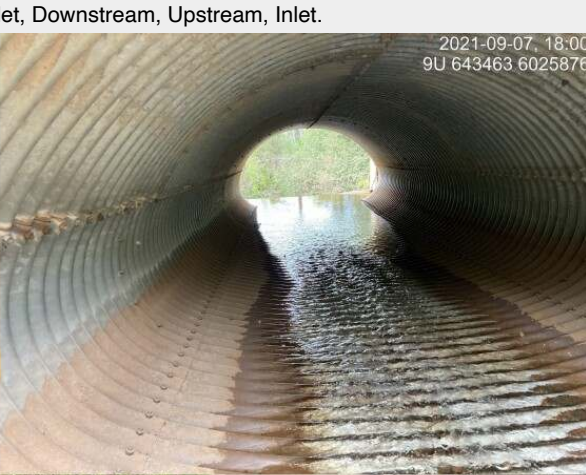
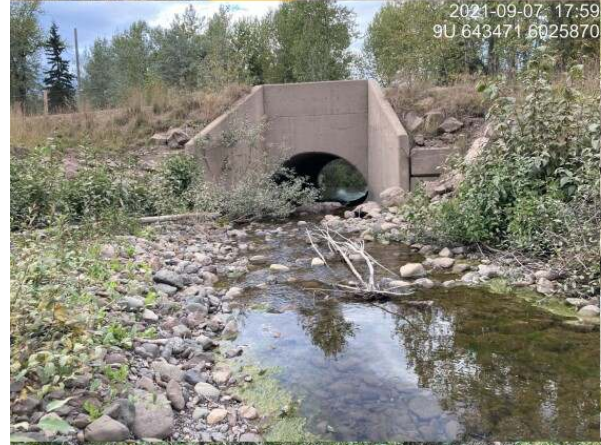
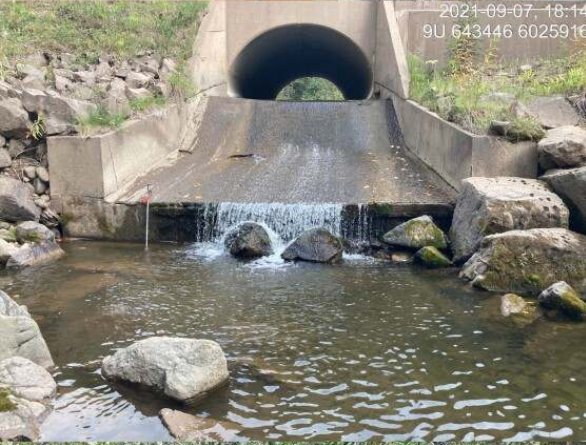
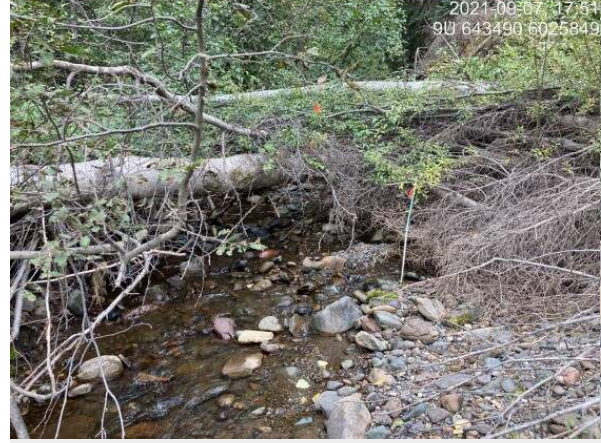
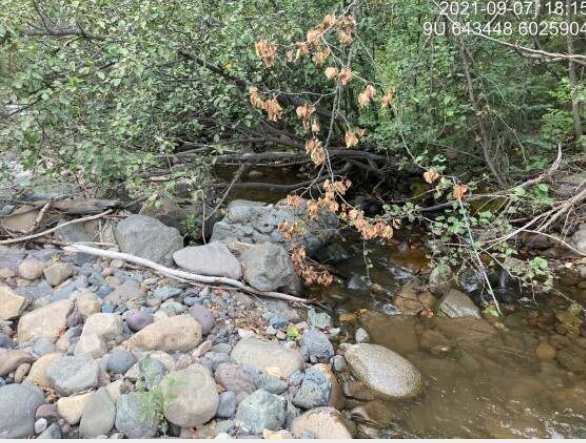
| Location and Stream Data | Crossing Characteristics |
|---|---|
| <p>Comments: Partial inlet drop of varying height due to large woody debris and boulders. Side channel dry, must be seasonal use only. 17:47</p> <p>Photos: From top left clockwise: Road/Site Card, Barrel, Outlet, Downstream, Upstream, Inlet.</p> | |

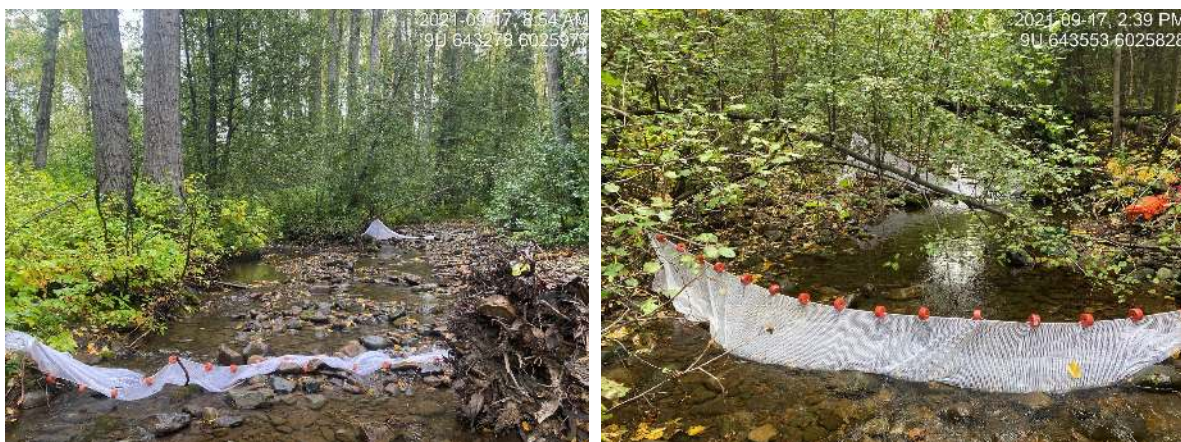
Figure 5.35: Left: Closed electrofishing site downstream of PSCIS crossing 197962. Right: Closed electrofishing site upstream of PSCIS crossing 197962.

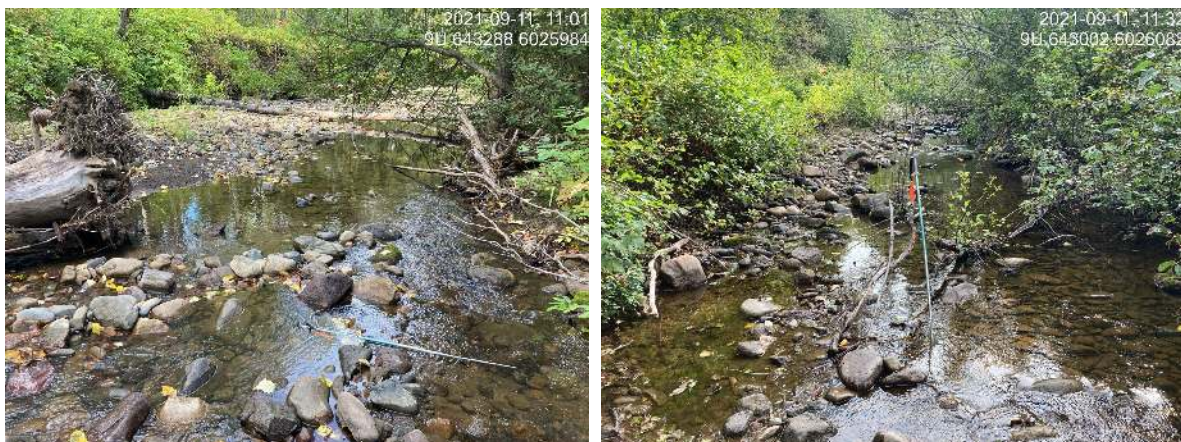
Figure 5.36: Left: Habitat downstream of PSCIS crossing 197962. Right: Habitat downstream of PSCIS crossing 197962.

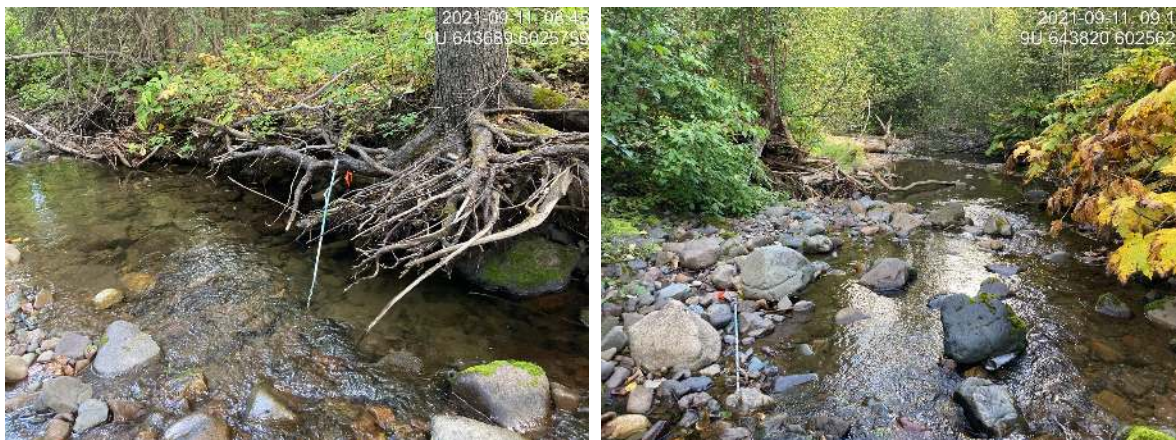
Figure 5.37: Left: Habitat upstream of PSCIS crossing 197962. Right: Habitat upstream of PSCIS crossing 197962.

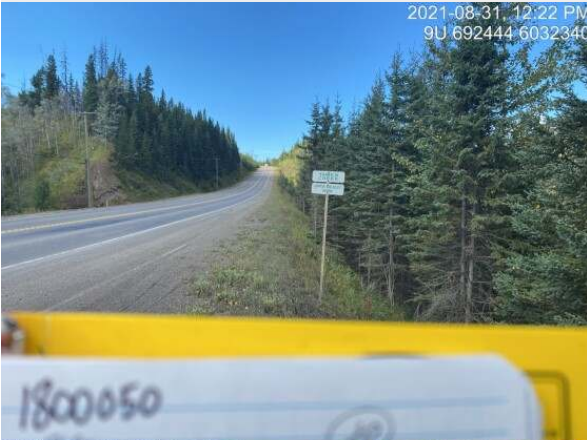
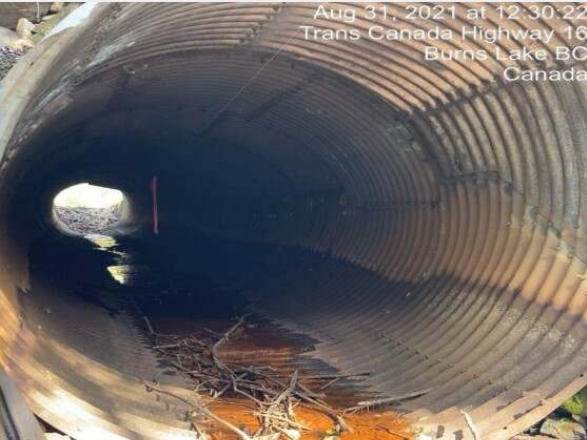
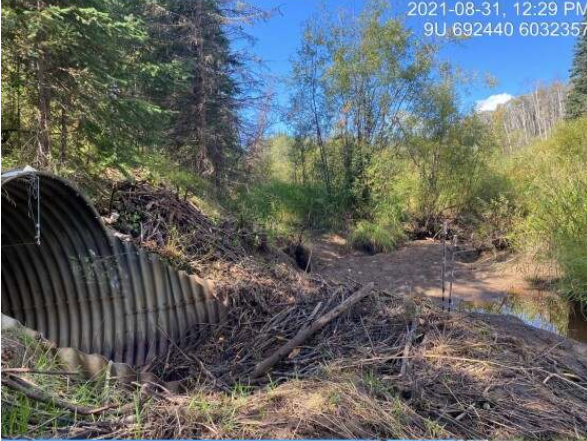
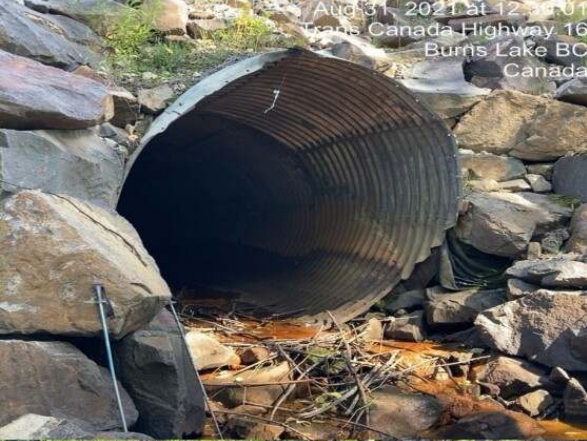
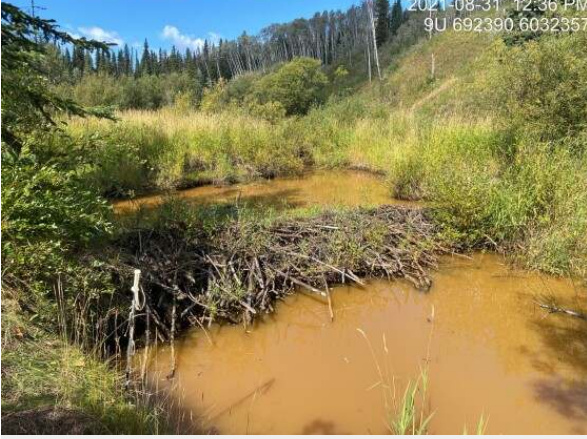
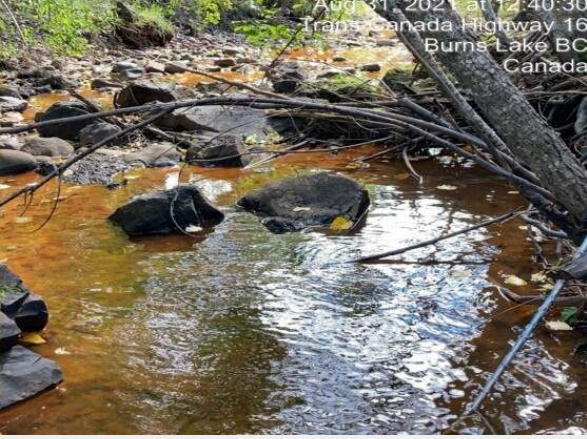
| Location and Stream Data | Crossing Characteristics |
|---|---|
| <p>Comments: Beaver dam at inlet ~1.5m high. Rocks placed at outlet reducing drop to 0, rocks about long, and have staggered drop of 0.7m. 12:20</p> | |

Should restoration/maintenance activities proceed, replacement of PSCIS crossing 197967 with a bridge (31m span) is recommended. The cost of the work is estimated at \$27,900,000 for a cost benefit of 1.9 linear m/\$1000 and 9.9 m<sup>2</sup>/ \$1000.

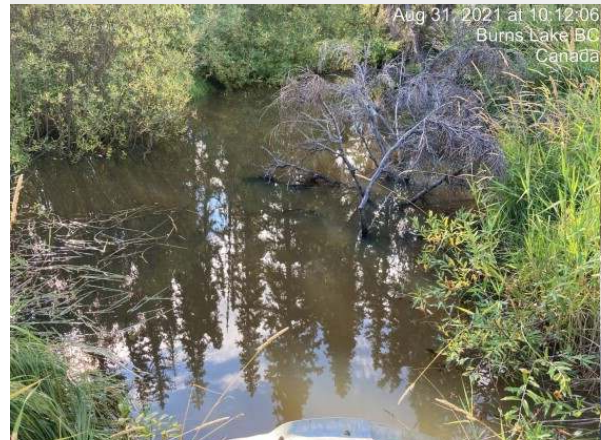
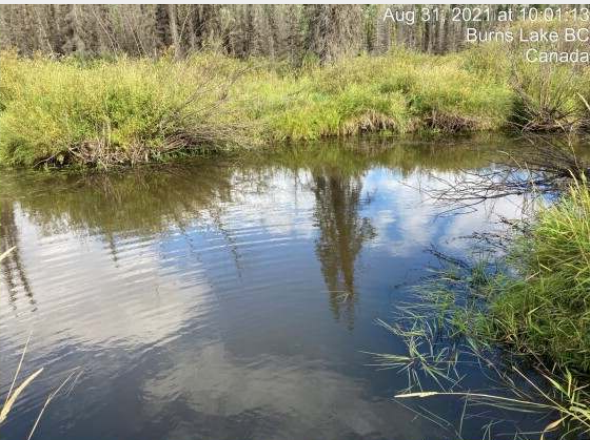
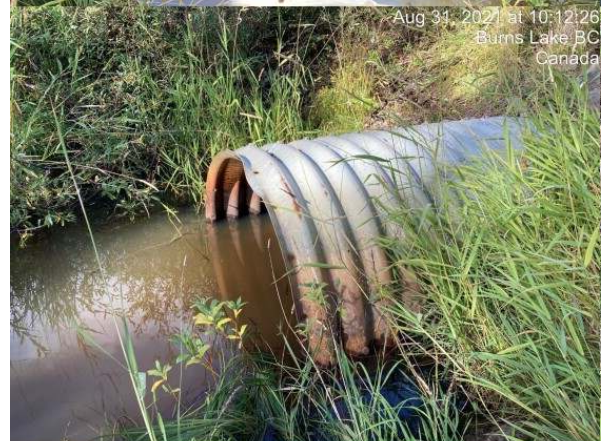
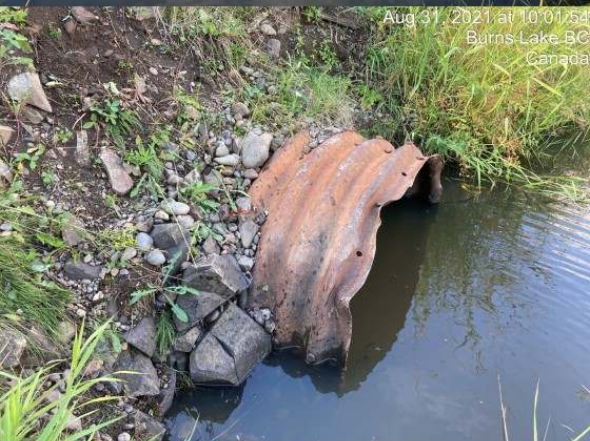
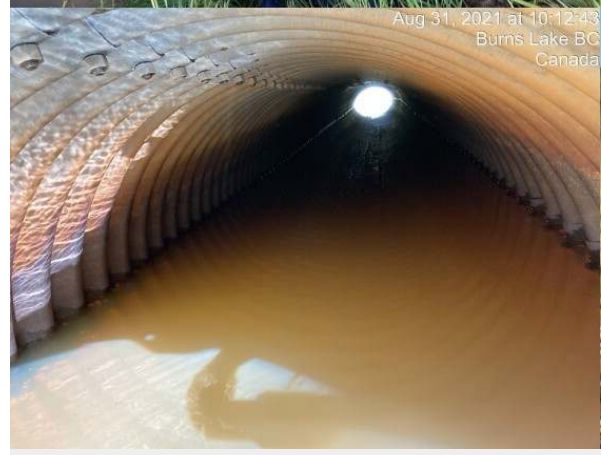
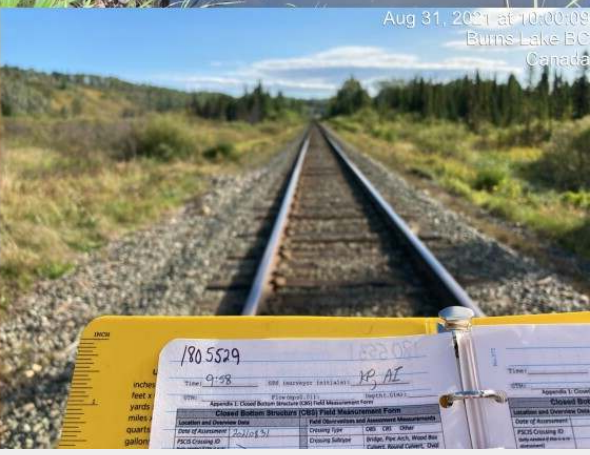
| Location and Stream Data | Crossing Characteristics |
|---|---|
| <p>Comments: Backwatered fully, appears fully passable. Fish sighted at outlet. Distance from water surface to top of culvert is 70cm. 9:58</p> | |

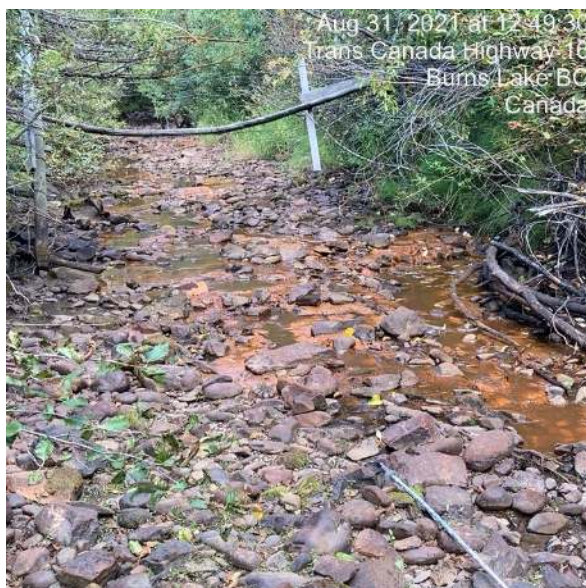
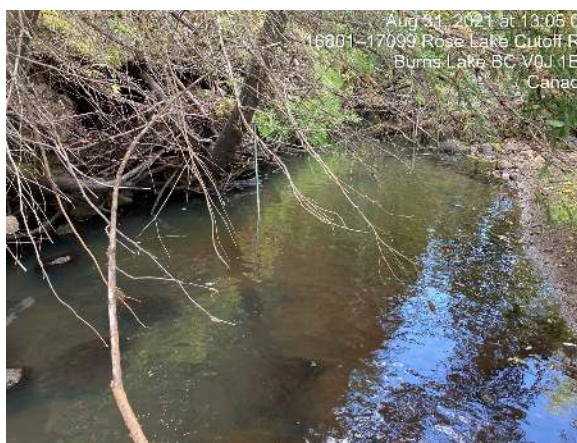
The stream was surveyed downstream from crossing 197967 for 375m to the bridge (PSCIS 197966) located on Ross Lake Cutoff Rd (Figure 5.38). Total cover amount was rated as trace with overhanging vegetation dominant. Cover was also present as deep pools and instream vegetation. The average channel width was 5.7m, the average wetted width was 3.1m, and the average gradient was 2.5%. The dominant substrate was cobbles with fines sub-dominant. The site was noted as having significant amounts of thick red colored algae for the majority of survey. Flow was very low with uncommon pools. Fence material was noted in or across channel in two locations and riparian vegetation had been removed where an agricultural field and fence line were close. Although considered an important migration corridor, the habitat was rated as medium value for salmonid rearing and spawning due to limited complexity resulting from adjacent agricultural activities.

Figure 5.38: Left: Habitat downstream of PSCIS crossing 197967. Right: Habitat downstream of PSCIS crossing 197967.

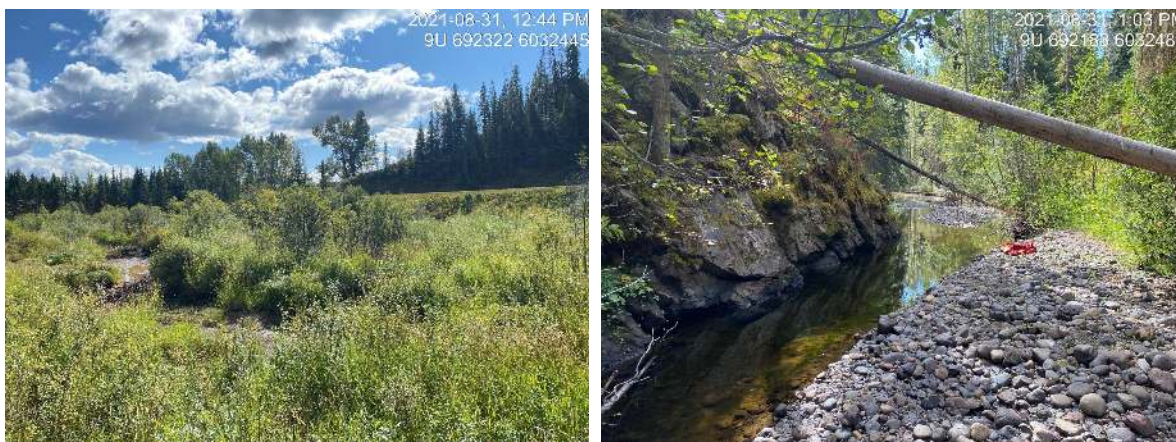
The stream was surveyed upstream from crossing 197967 for 800m (Figure [5.39](#)). The average channel width was 5.3m, the average wetted width was 2.3m, and the average gradient was 1.7%. The dominant substrate was gravels with cobbles sub-dominant. Total cover amount was rated as moderate with deep pools dominant. Cover was also present as large woody debris and overhanging vegetation. The first ~250m of channel upstream of the highway were noted as beaver influenced wetland with extensive dry sections at the time of the survey. Frequent pockets of gravels and small cobbles suitable for rainbow trout and coho salmon spawning were noted throughout the area surveyed. A canyon section of stream was located upstream of the crossing approximately 300m contained deep bedrock pools with small fish present and no large woody debris. One deep pool upstream of the canyon section contained likely 2-3 year old juveniles (coloring indicated rainbow trout, unverified). The habitat was rated as medium value as an important migration corridor containing suitable spawning habitat and having moderate rearing potential.

Figure 5.39: Left: Habitat upstream of PSCIS crossing 197967. Right: Habitat upstream of PSCIS crossing 197967.

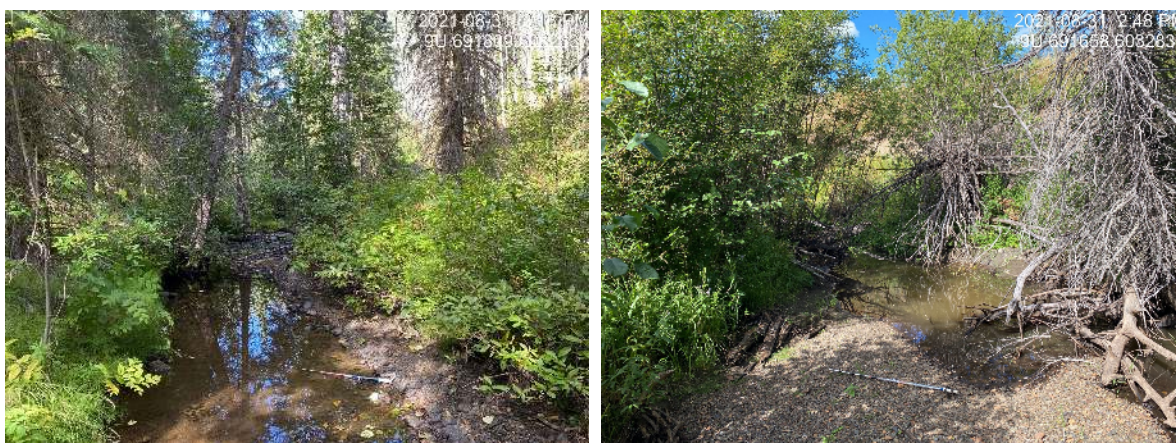
Taman Creek was surveyed for 400m above where it joins the Bulkley River mainstem upstream of PSCIS crossing 197967 (Figure [5.40](#)). The average channel width was 3.8m, the average wetted width was 2.2m, and the average gradient was 1.5%. Total cover amount was rated as moderate with deep pools dominant. Cover was also present as small woody debris, large woody debris, undercut banks, and overhanging vegetation. The dominant substrate was gravels with cobbles sub-dominant. The water in Taman Creek during the survey was noted as turbid with numerous salmonid fry present at the downstream end of the site. Algae was abundant throughout the system and eroding banks were common. Abundant gravels suitable for resident rainbow trout and coho salmon spawning were present and habitat was rated as medium value for salmon rearing and spawning.

Figure 5.40: Left: Habitat upstream of PSCIS crossing 197967. Right: Habitat upstream of PSCIS crossing 197967.

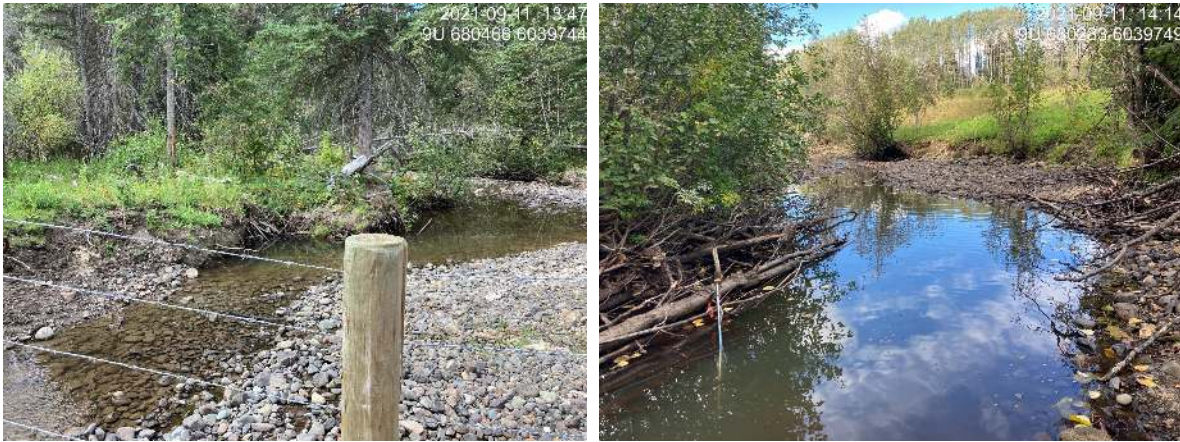
The stream was surveyed downstream from crossing 197976 for 575m (Figure [5.42](#)). The dominant substrate was cobbles with gravels sub-dominant. Total cover amount was rated as moderate with deep pools dominant. Cover was also present as small woody debris, undercut banks, overhanging vegetation, and instream vegetation. The average channel width was 7.7m, the average wetted width was 3.5m, and the average gradient was 1%. Although side channels continued to flow throughout the area surveyed, approximately 160m downstream of the crossing the main channel was dewatered below the location of a beaver dam. Areas of riparian and bank degradation from cattle trampling were noted throughout the area surveyed and there was fencing spanning the channel. Large deposits of substrate and clumped large woody debris piles were observed within widened channel areas indicating disturbance and high flow events. There were abundant gravels present suitable for spawning resident and anadromous salmonids. Habitat was rated as high value for salmonid rearing and spawning with numerous fish observed and numerous deep pools to 0.95m deep.

Figure 5.42: Left: Typical habitat downstream of PSCIS crossing 197976. Right: Typical habitat downstream of PSCIS crossing 197976.

Should restoration/maintenance activities proceed, replacement of PSCIS crossing 197976 with a bridge (12.5m span) is recommended. The cost of the work is estimated at \$11,250,000 for a cost benefit of 2.2 linear m/\$1000 and 18.1 m<sup>2</sup>/\$1000. As the crossing partially backwaters naturally, a plan to backwater the crossing could also be of consideration in the short term with a rough cost estimate to complete of \$25,000.

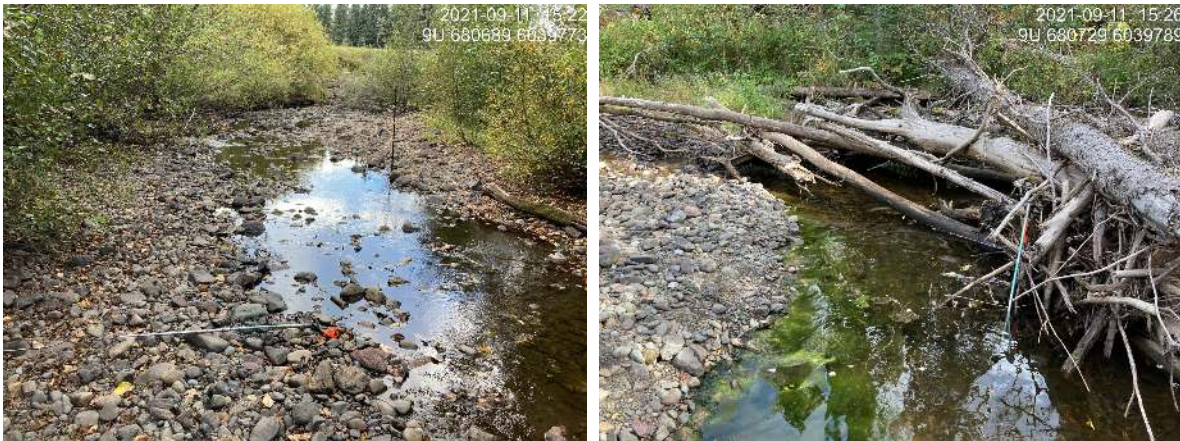
The stream was surveyed upstream from crossing 197976 for 345m (Figure [5.43](#)). The average channel width was 8.1m, the average wetted width was 4.2m, and the average gradient was 2.2%. The dominant substrate was cobbles with gravels sub-dominant. Total cover amount was rated as moderate with deep pools dominant. Cover was also present as small woody debris, undercut banks, and overhanging vegetation. Fish were observed throughout the area surveyed and extensive algae growth was present on stream substrates. Large woody debris was rare and riparian/bank damage due to livestock was minimal and located at what appeared to be watering sites. Fencing was located across the stream in multiple locations. Patches of gravels suitable for spawning were present. Habitat value was rated as medium as the surveyed area was considered an important migration corridor containing suitable spawning habitat and having moderate rearing potential.

Figure 5.43: Left: Typical habitat upstream of PSCIS crossing 197976. Right: Typical habitat upstream of PSCIS crossing 197976.

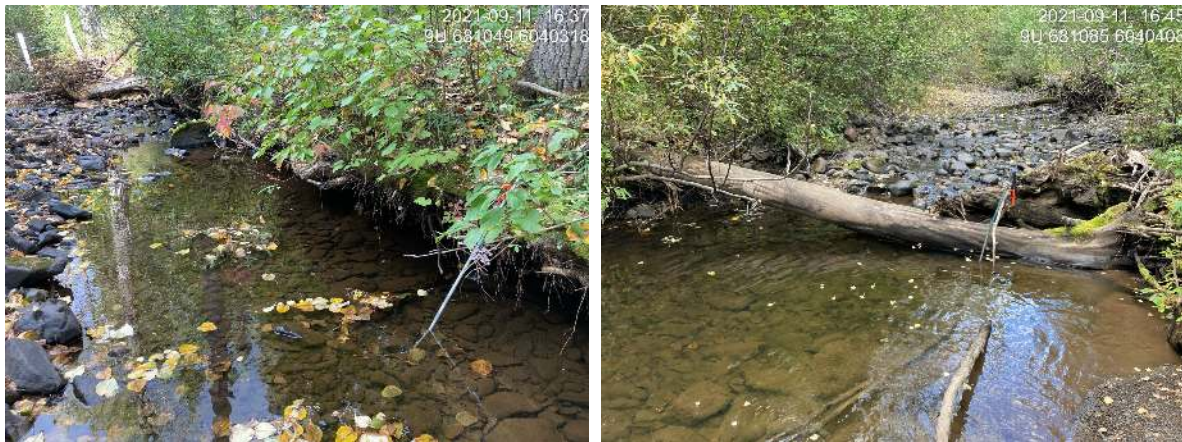
The stream was surveyed upstream from crossing 197975 for 550m (Figure [5.44](#)). Total cover amount was rated as moderate with deep pools dominant. Cover was also present as small woody debris, boulders, undercut banks, and overhanging vegetation. The average channel width was 7.7m, the average wetted width was 3.5m, and the average gradient was 3%. The dominant substrate was cobbles with gravels sub-dominant. Immediately upstream of the crossing for ~80m, extensive anthropogenic damage was noted due to dredging of the channel. Heavy cattle grazing was also observed on the left bank. Juvenile salmonids were observed occasionally throughout the area surveyed. Fencing was located across the stream approximately 250m upstream of the culvert. Patches of gravels suitable for spawning were present. Habitat value was rated as medium as the surveyed area was considered an important migration corridor containing suitable spawning habitat and having moderate rearing potential.

Figure 5.44: Left: Typical habitat upstream of PSCIS crossing 197975. Right: Typical habitat upstream of PSCIS crossing 197975.

Should restoration/maintenance activities proceed, replacement of PSCIS crossing 197975 with a bridge (11.5m span) is recommended. The cost of the work is estimated at \$345,000 for a cost benefit of 71.6 linear m/\$1000 and 551.1 m<sup>2</sup>/\$1000. Relocation of the driveway accessing the private land from the other side of the stream and removal of the crossing could also be considered.

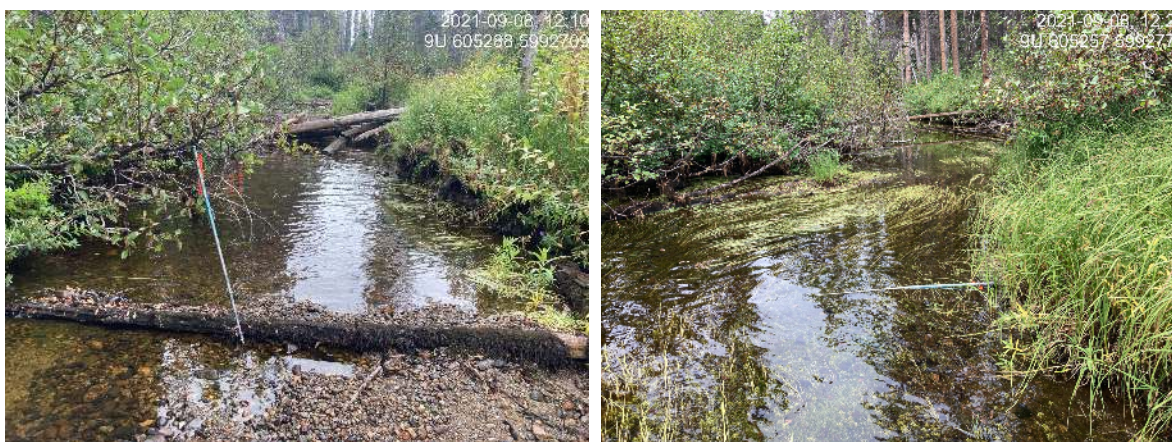
The stream was surveyed downstream from the culvert for 300m (Figure [5.45](#)). Total cover amount was rated as with instream vegetation dominant. Cover was also present as small woody debris, large woody debris, and overhanging vegetation (Table [5.73](#)). The average channel width was 6.2m, the average wetted width was 5.1m and the average gradient was 1.2%. The dominant substrate was gravels with cobbles subdominant. The habitat was rated as high value for salmonid rearing and spawning.

Figure 5.45: Left: Typical habitat downstream of PSCIS crossing 198000. Right: Typical habitat downstream of PSCIS crossing 198000.

Should restoration/maintenance activities proceed at the site, replacement of PSCIS crossing 198000 with a bridge (14m span) is recommended.

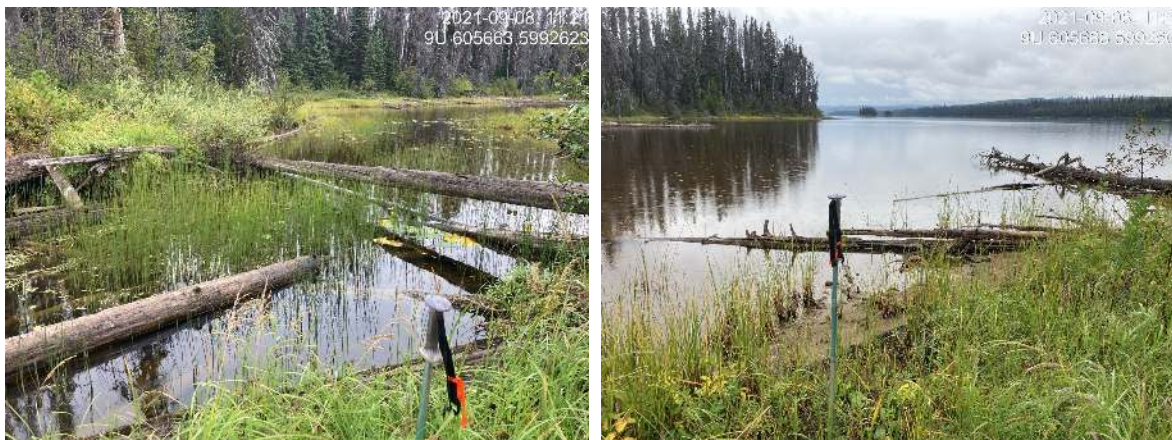
Figure 5.46: Left: Typical habitat upstream of PSCIS crossing 198000. Right: Typical habitat upstream of PSCIS crossing 198000.

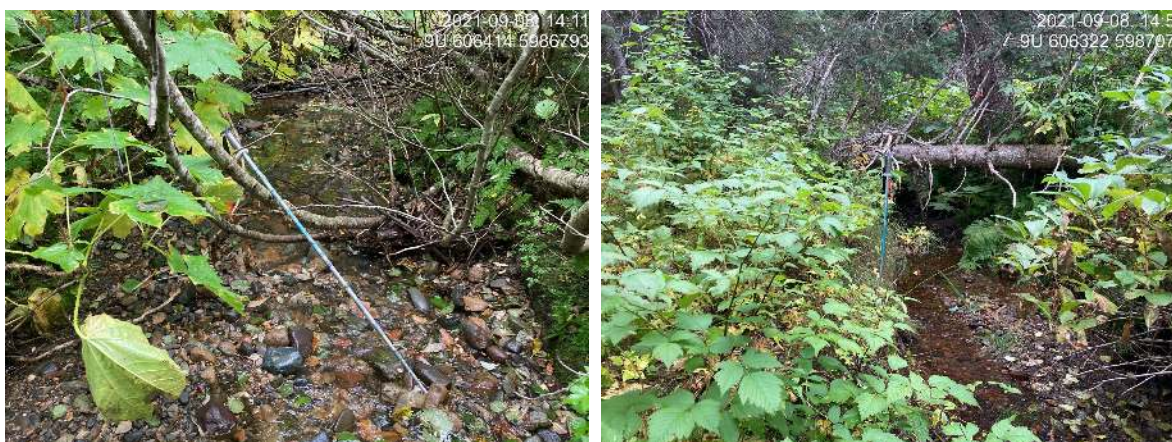
The stream was surveyed downstream from crossing 198008 for 400m (Figure [5.47](#)). Total cover amount was rated as abundant with overhanging vegetation dominant. Cover was also present as small woody debris, large woody debris, and undercut banks. The dominant substrate was gravels with fines sub-dominant. The average channel width was 2.3m, the average wetted width was 1.3m, and the average gradient was 5.2%. This was a small stream with low, consistent flows and shallow pools. There were few undercut banks but abundant overhanging vegetation. Gravels were present throughout with fines near the bottom half of the survey and more cobbles near the top. The gradient was steeper in the top half of the survey and decreased further downstream. A few functional large woody debris clusters created drops up to 0.6m high. Overall, the habitat was rated as medium value for salmonid rearing and spawning.

Figure 5.47: Left: Typical habitat downstream of PSCIS crossing 198008. Right: Typical habitat downstream of PSCIS crossing 198008.

Should restoration/maintenance activities proceed, replacement of PSCIS crossing 198008 with a bridge (3m span) is recommended. The cost of the work is estimated at \$100,000 for a cost benefit of 0 linear m/\$1000 and 0 m<sup>2</sup>/\$1000.

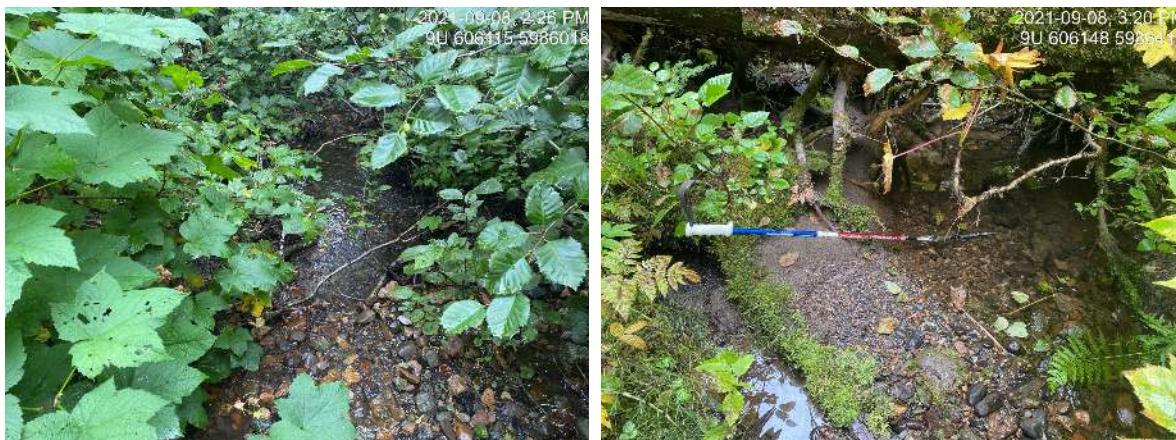
Figure 5.48: Left: Typical habitat upstream of PSCIS crossing 198008. Right: Typical habitat upstream of PSCIS crossing 198008.

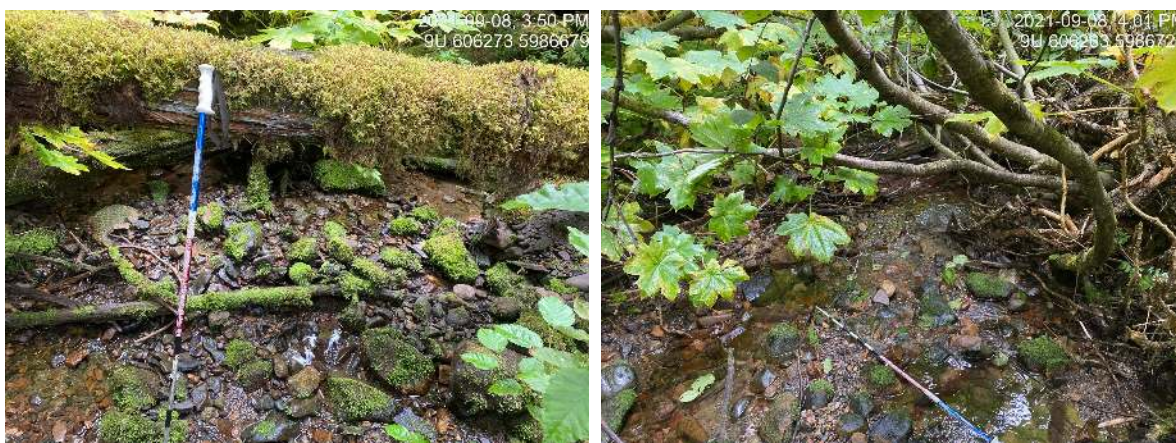
Figure 5.49: Left: Typical habitat upstream of PSCIS crossing 198008. Right: Typical habitat upstream of PSCIS crossing 198008.

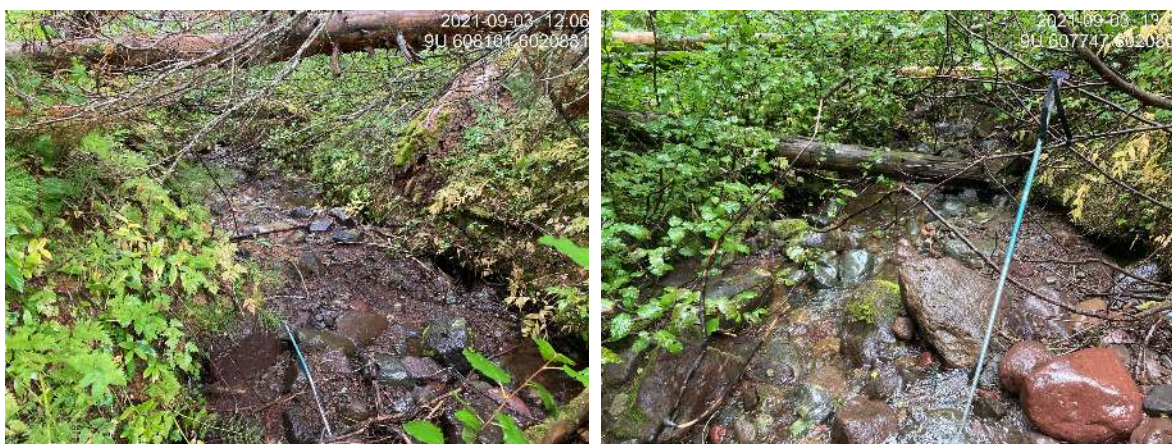
The stream was surveyed downstream from crossing 198016 for 700m (Figure [5.50](#)). Total cover amount was rated as moderate with large woody debris dominant. Cover was also present as small woody debris, undercut banks, and overhanging vegetation. The dominant substrate was cobbles with gravels sub-dominant. The average channel width was 2m, the average wetted width was 1.2m, and the average gradient was 9%. Fish were sighted downstream during the assessment. There was abundant and functional large woody debris, creating cover and deep pools. The gradient increased near the confluence, with large woody debris jams up to 1m in height forming pools approximately 0.45m deep. There appeared to be abundant rearing habitat with suitable overwintering areas. There were patches of gravel found throughout the length surveyed, but the gradient was always greater than 5%, which is not ideal for spawning. Overall, the habitat was rated as medium value for salmonid rearing and spawning.

Figure 5.50: Left: Typical habitat downstream of PSCIS crossing 198016. Right: Typical habitat downstream of PSCIS crossing 198016.

Should restoration/maintenance activities proceed, replacement of PSCIS crossing 198016 with a streambed simulation (embedded pipe) (3m diameter) is recommended. The cost of the work is estimated at \$100,000 for a cost benefit of 12 linear m/\$1000 and 22.8 m<sup>2</sup>/\$1000.

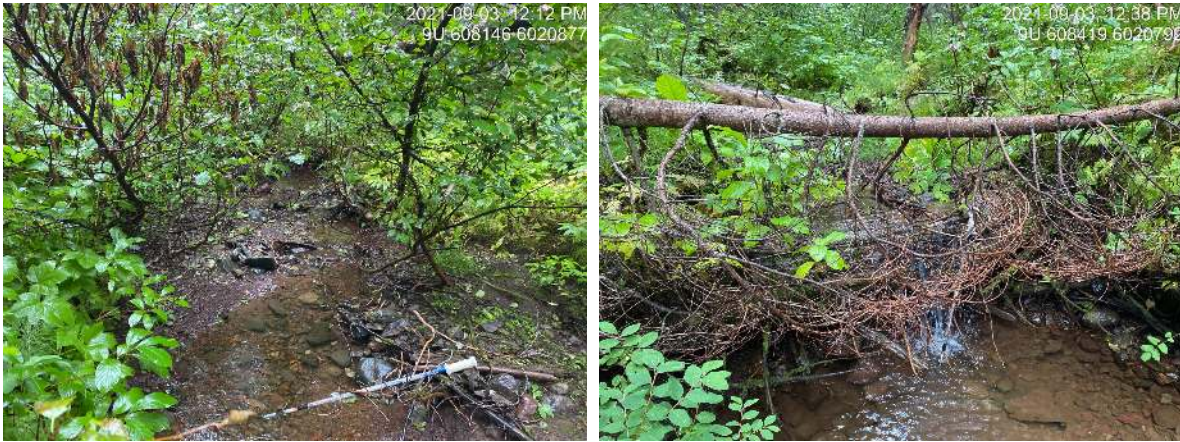
Figure 5.51: Left: Typical habitat upstream of PSCIS crossing 198016. Right: Typical habitat upstream of PSCIS crossing 198016.

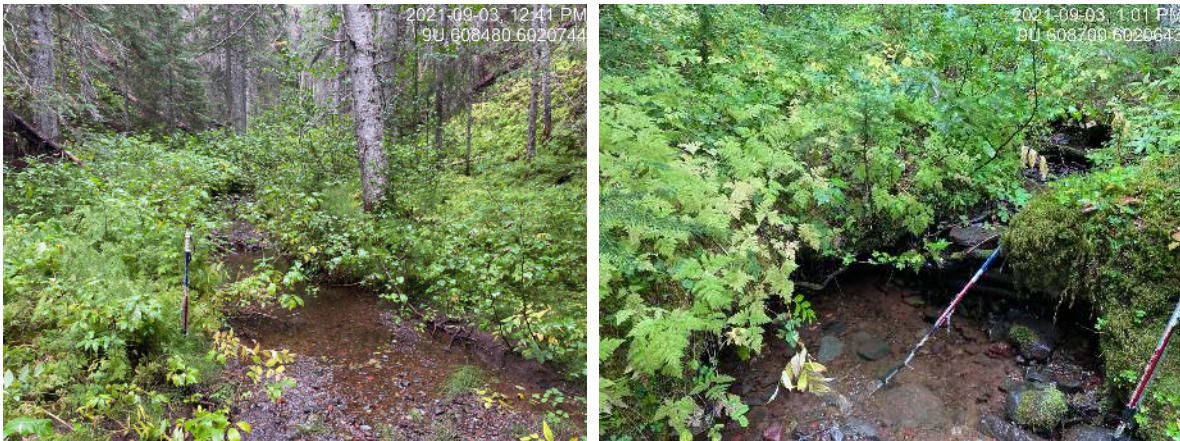
Figure 5.52: Left: Typical habitat upstream of PSCIS crossing 198016. Right: Typical habitat upstream of PSCIS crossing 198016.

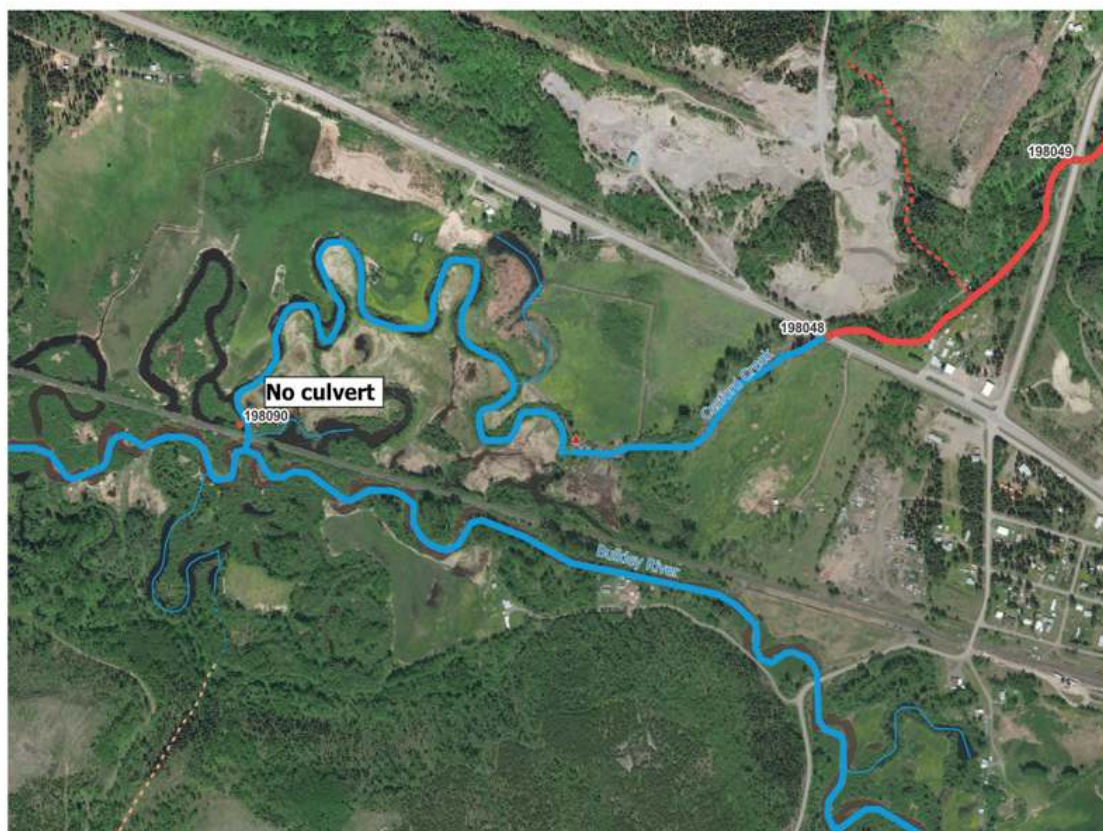
Figure 5.53: Location of potential location of crossing 198090 which was not present in the field.

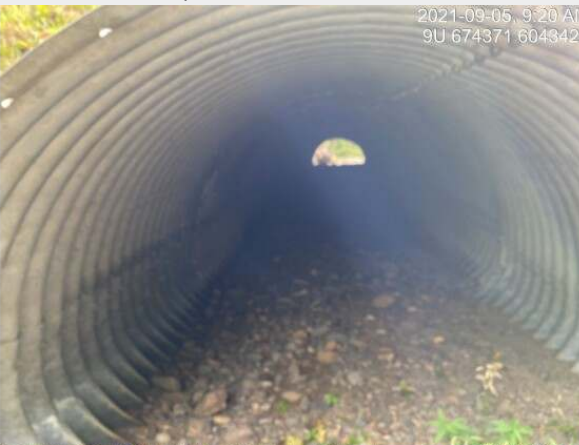
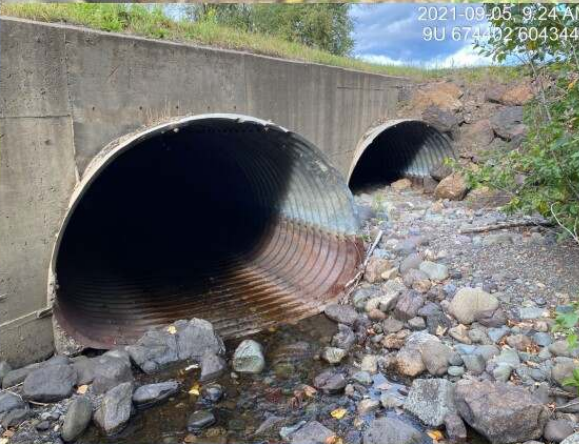
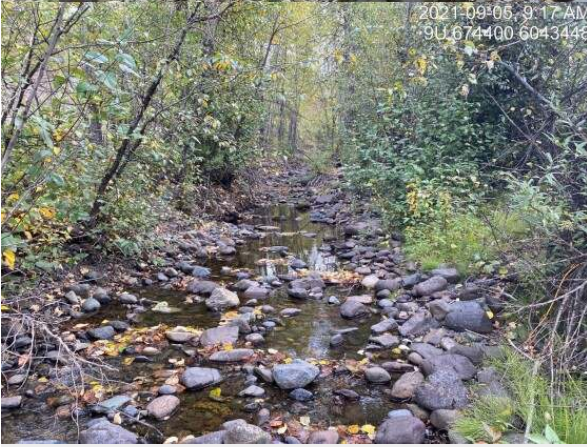
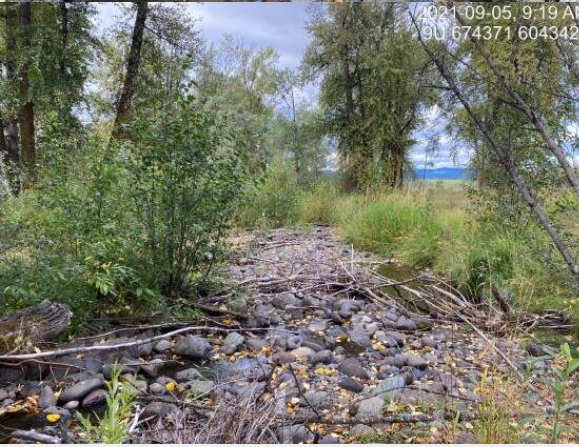
| Location and Stream Data | Crossing Characteristics |
|---|---|
| <p>Comments: Habitat confirmation conducted. Two pipes (2.5m x 2.5m). Culvert slope measured with lazel level. Fish observed. Could not locate downstream crossing on railway. Garmin backroads mapbook shows stream connecting with side channel of the Bulkley. 9:17</p> <p>Photos: From top left clockwise: Road/Site Card, Barrel, Outlet, Downstream, Upstream, Inlet.</p> | |

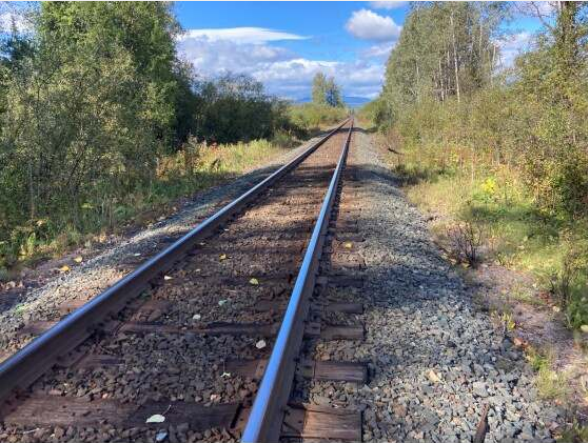
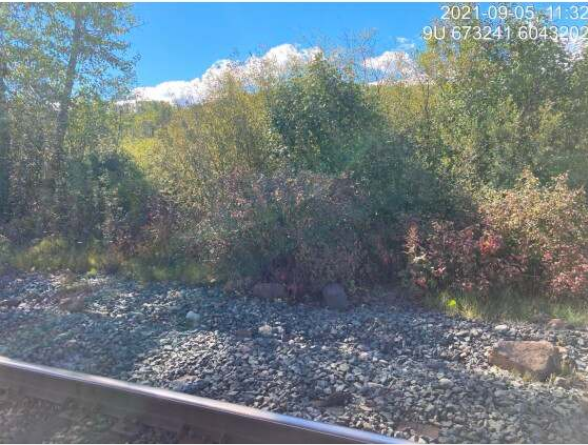
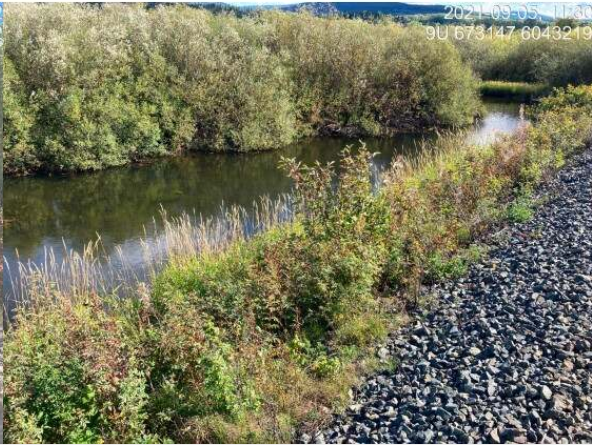
| Location and Stream Data | Crossing Characteristics |
|---|---|
| <p>Comments: No crossing actually exists in the field however site entered as a placeholder because there should be connection between Bulkley and Cesford at this location. Survey found no culvert and landowner reported none present. Large man-made ditch through adjacent field may be draining some water. Lower section of stream dry at time of survey. 11:22</p> <p>Photos: From top left clockwise: Road/Site Card, Barrel, Outlet, Downstream, Upstream, Inlet.</p> | |

For PSCIS crossing 198090 it is recommended some sort of fish passable structure be installed under the railway to reconnect Cesford Creek with the Bulkley River. The cost of the work is roughly estimated at \$9,000,000.

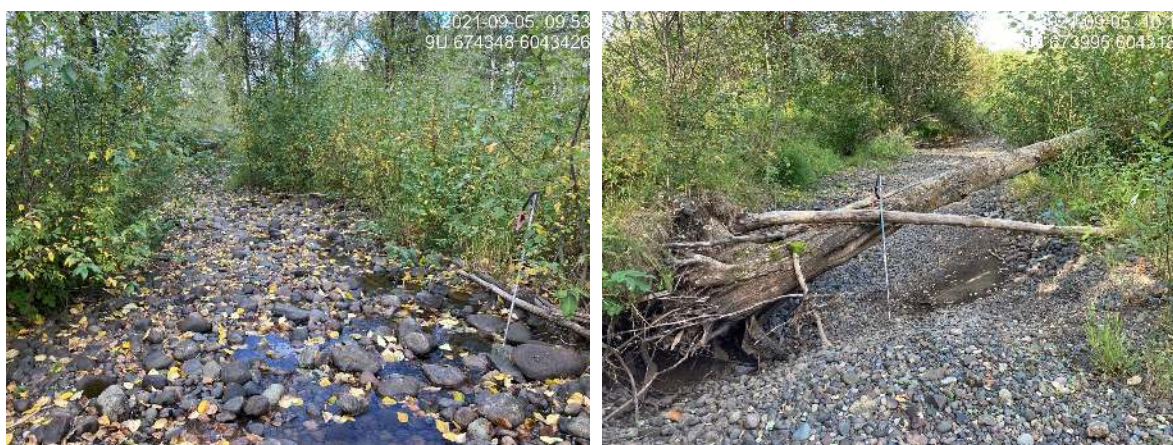
The stream was surveyed downstream from crossing 198048 at Highway 16 for 1400m to the mainstem of the Bulkley River (Figure [5.54](#)). Total cover amount was rated as with overhanging vegetation dominant. Cover was also present as small woody debris and undercut banks (Table [5.86](#)). The average channel width was 5.5m, the average wetted width was 1.5m and the average gradient was 3.5%. The dominant substrate was cobbles with gravels subdominant. The habitat was rated as medium value for salmonid rearing and spawning.

Figure 5.54: Left: Typical habitat downstream of PSCIS crossing 198048. Right: Typical habitat downstream of PSCIS crossing 198048.

Should restoration/maintenance activities proceed, replacement of PSCIS crossing 198048 with a bridge (10m span) is recommended. The cost of the work is estimated at \$9,000,000 for a cost benefit of 1.2 linear m/\$1000 and 6.1 m<sup>2</sup>/\$1000.

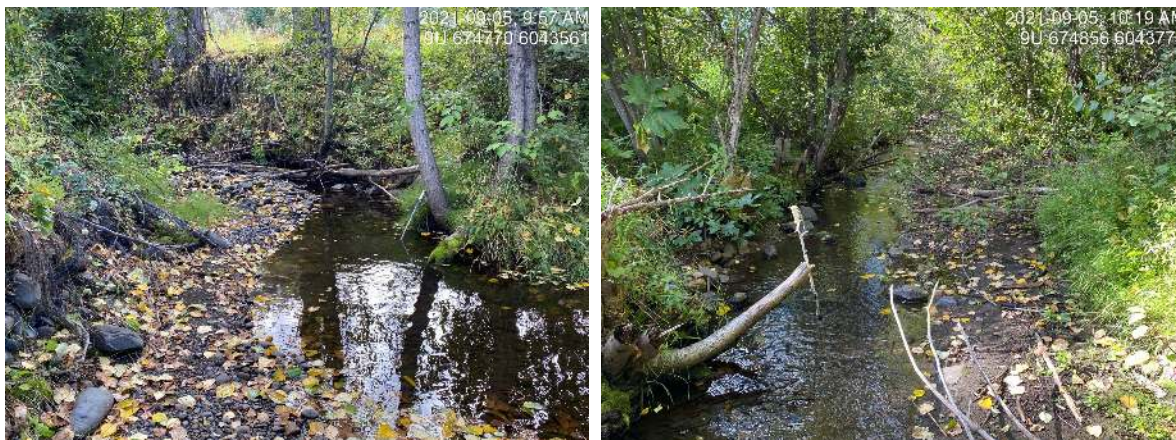
Figure 5.55: Left: Typical habitat upstream of PSCIS crossing 198048. Right: Typical habitat upstream of PSCIS crossing 198048.

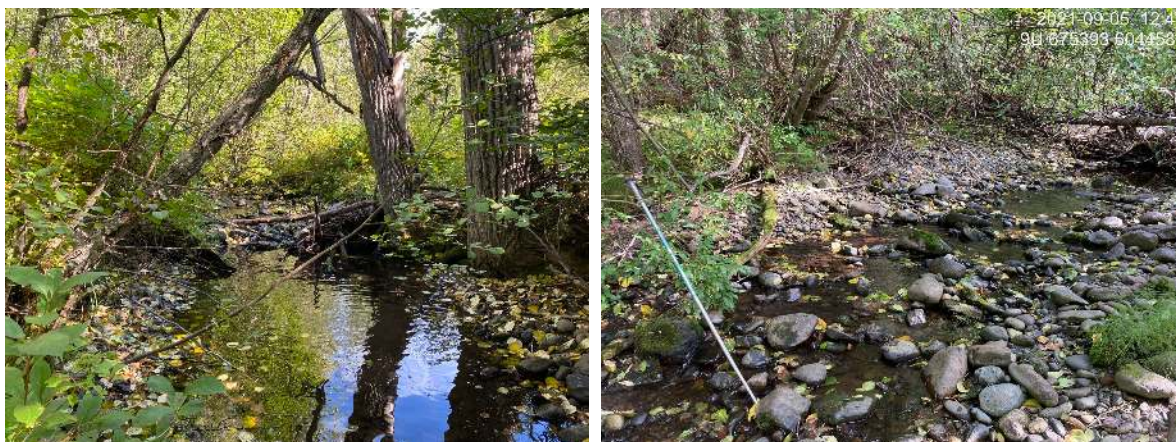
The stream was surveyed upstream from crossing 198049 for 600m (Figure [5.56](#)). The dominant substrate was cobbles with boulders sub-dominant. The average channel width was 5m, the average wetted width was 2.8m, and the average gradient was 2.1%. Total cover amount was rated as moderate with dominant. Cover was also present as . The stream had good flow and moderate complexity due to mature cottonwood riparian and frequent large woody debris. Occasional pool and frequent gravel sections were also noted. Habitat value was rated as medium as the surveyed area was considered an important migration corridor containing suitable spawning habitat and having moderate rearing potential.

Figure 5.56: Left: Habitat upstream of PSCIS crossing 198049. Right: Habitat upstream of PSCIS crossing 198049.

Should restoration/maintenance activities proceed, replacement of PSCIS crossing 198049 with a bridge (10m span) is recommended. The cost of the work is estimated at \$9,000,000 for a cost benefit of 1.1 linear m/\$1000 and 5.6 m<sup>2</sup>/\$1000. Relocation of the driveway accessing the private land from the other side of the stream and removal of the crossing could also be considered.
