## **Bulkley River and Morice River Watershed Groups Fish Passage Restoration Planning 2021**

**Prepared for  
Habitat Conservation Trust Foundation - CAT22-6-288  
BC Fish Passage Remediation Program  
Canadian Wildlife Federation**

**Prepared by  
Al Irvine, B.Sc., R.P.Bio.  
New Graph Environment Ltd.  
on behalf of  
Society for Ecosystem Restoration in Northern British Columbia**

**Version 0.1.9 2025-06-02**

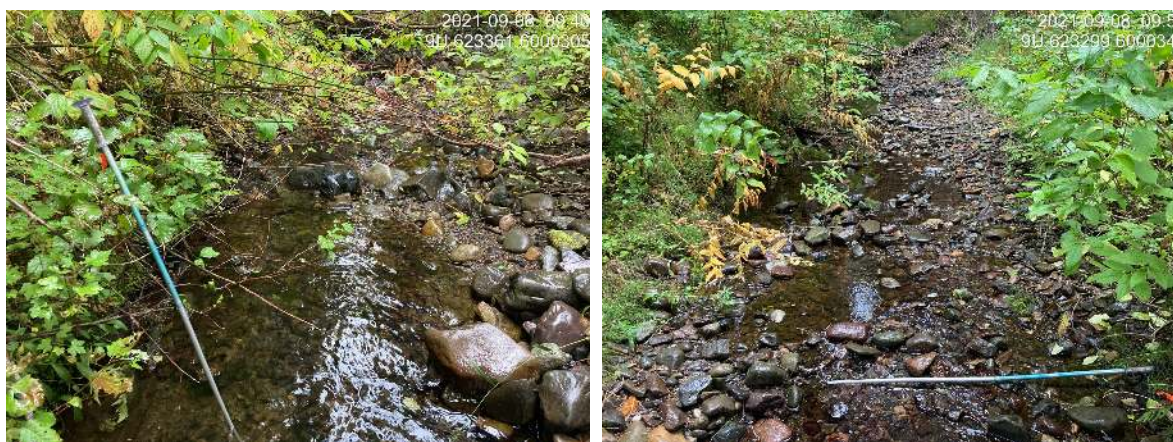
The stream was surveyed downstream from crossing 198064 for 150m (Figure [5.57](#)). The average channel width was 2.4m, the average wetted width was 1.4m, and the average gradient was 4.5%. The dominant substrate was cobbles with gravels sub-dominant. Total cover amount was rated as moderate with small woody debris dominant. Cover was also present as large woody debris, undercut banks, and overhanging vegetation. Abundant undercut banks were present, but few deep pools. Water flowed beneath the substrate approximately 5m from the confluence with Lamprey creek. The habitat was rated as medium value for salmonid rearing and spawning.

Figure 5.57: Left: Typical habitat downstream of PSCIS crossing 198064. Right: Typical habitat downstream of PSCIS crossing 198064.

Should restoration/maintenance activities proceed, replacement of PSCIS crossing 198064 with a bridge (10m span) is recommended. The cost of the work is estimated at \$300,000 for a cost benefit of 6 linear m/\$1000 and 16.8 m<sup>2</sup>/\$1000.

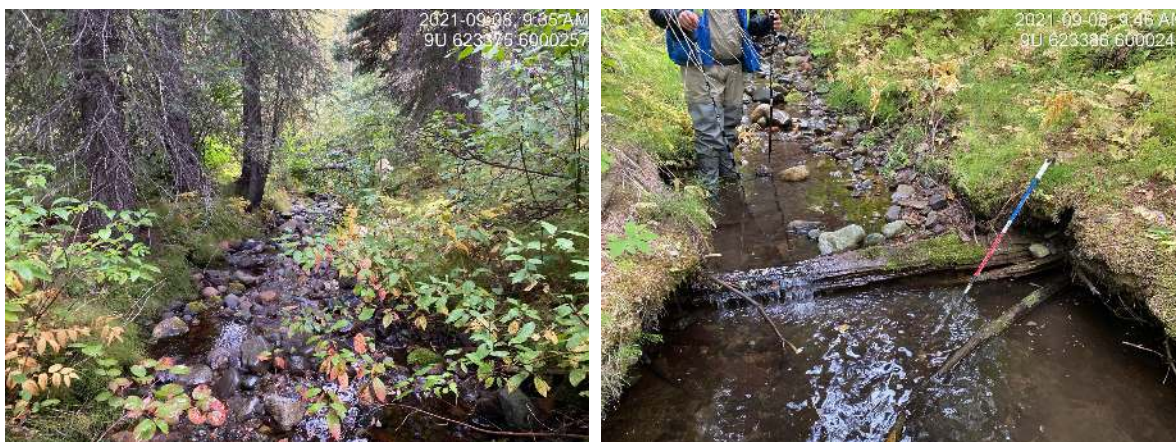
Figure 5.58: Left: Typical habitat upstream of PSCIS crossing 198064. Right: Typical habitat upstream of PSCIS crossing 198064.

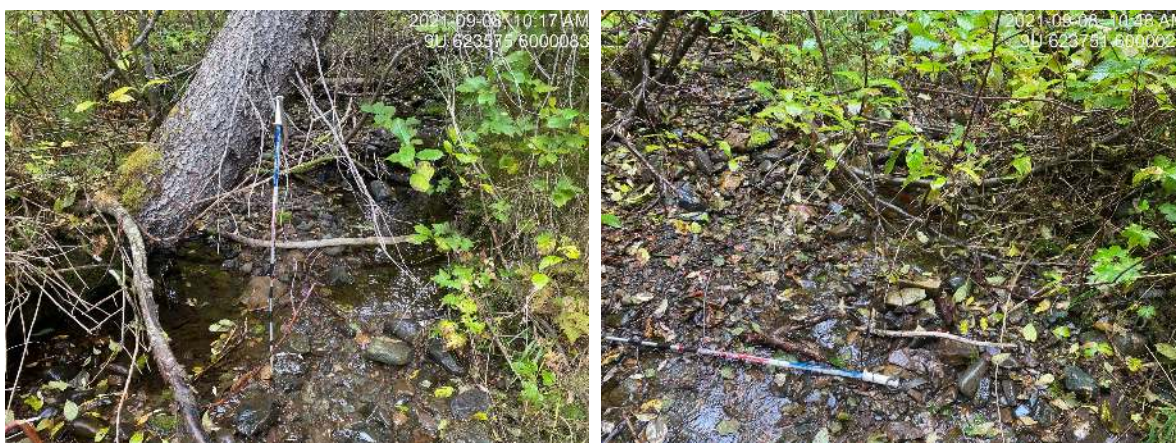
Figure 5.59: Left: Typical habitat upstream of PSCIS crossing 198064. Right: Typical habitat upstream of PSCIS crossing 198064.

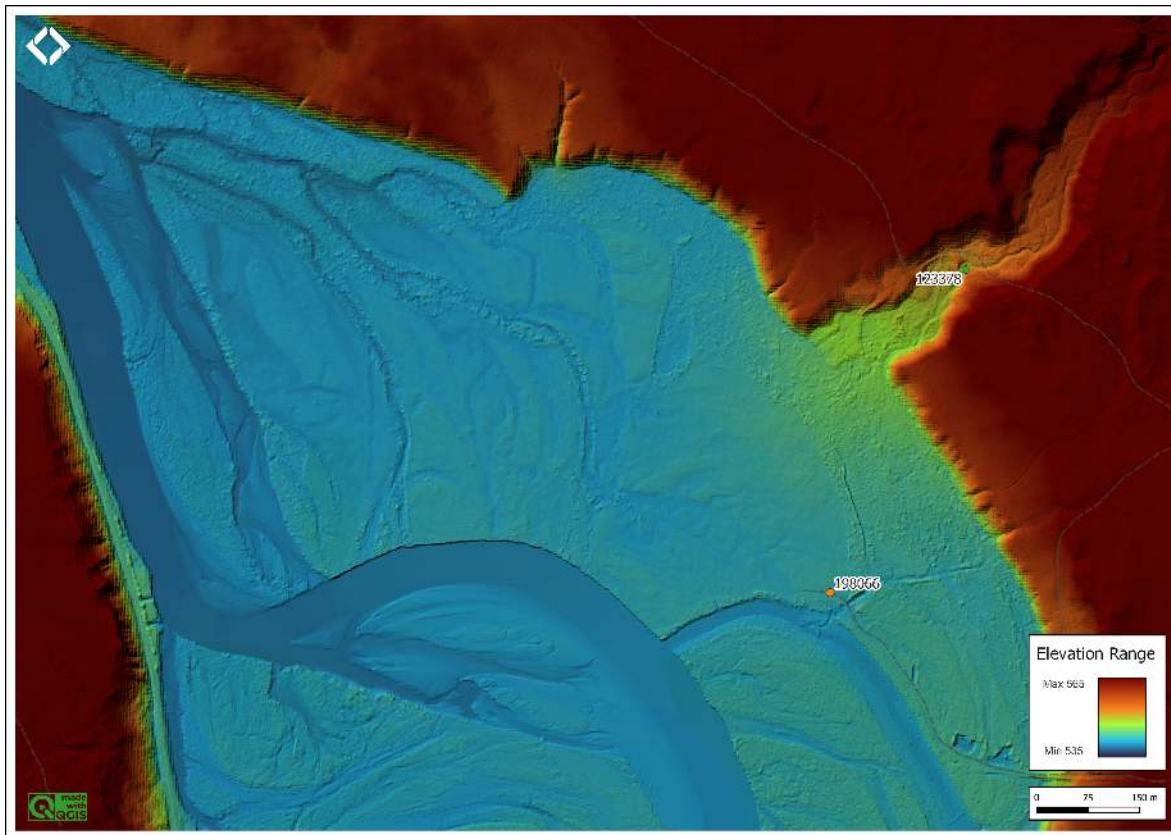
Figure 5.60: Digital elevation model showing Thompson Creek and the Bulkley River floodplain. Note the anthropogenic trenching of areas adjacent to the hay fields just west of PSCIS 198066 and the general descending slope of the height of land from south to north and from east to west from the outlet of the Thompson Creek valley.

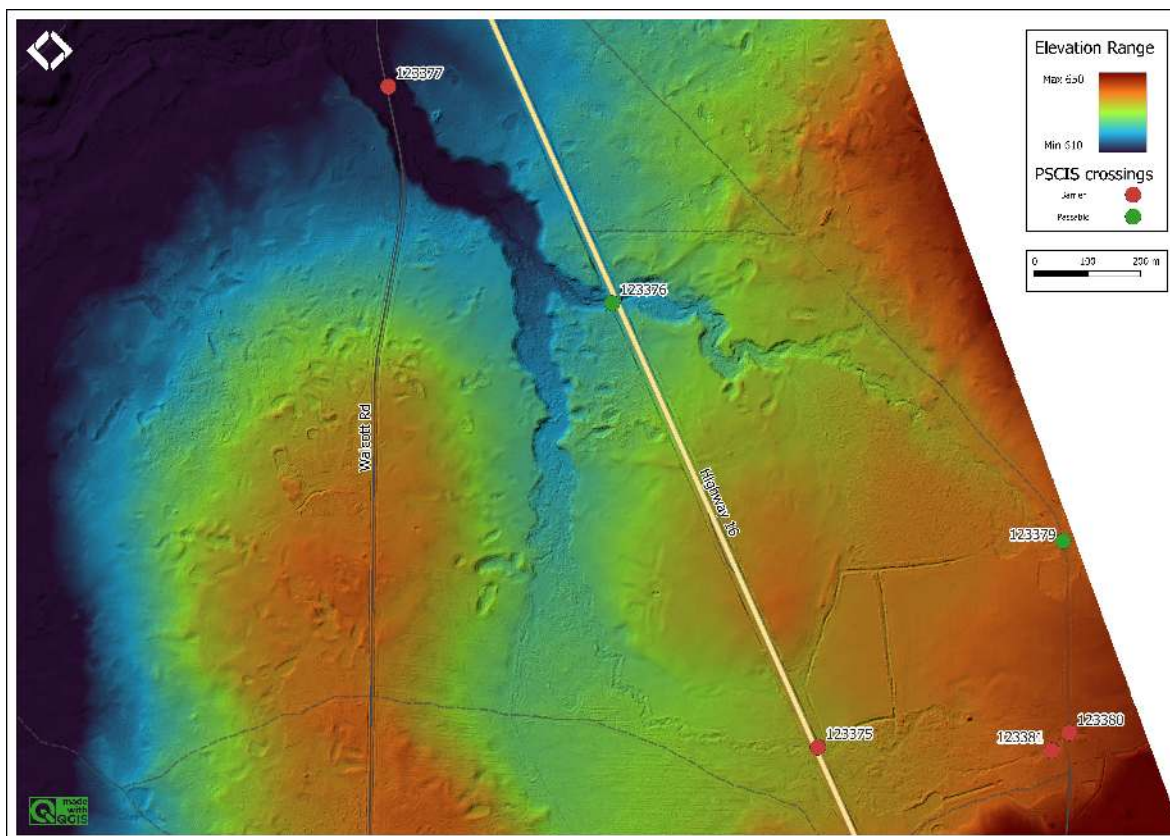
Figure 5.61: Digital elevation model of Thompson Creek upstream of Walcott Road and Highway 16. Note that the majority of discharge for the system flows under Highway 16 at an open bottom structure (PSCIS 123376) located approximately 925m to the north of where the main channel is incorrectly mapped in the freshwater atlas (PSCIS 123375). Also, note the extensive excavation of ditches draining the areas east of the highway adjacent to 123375.

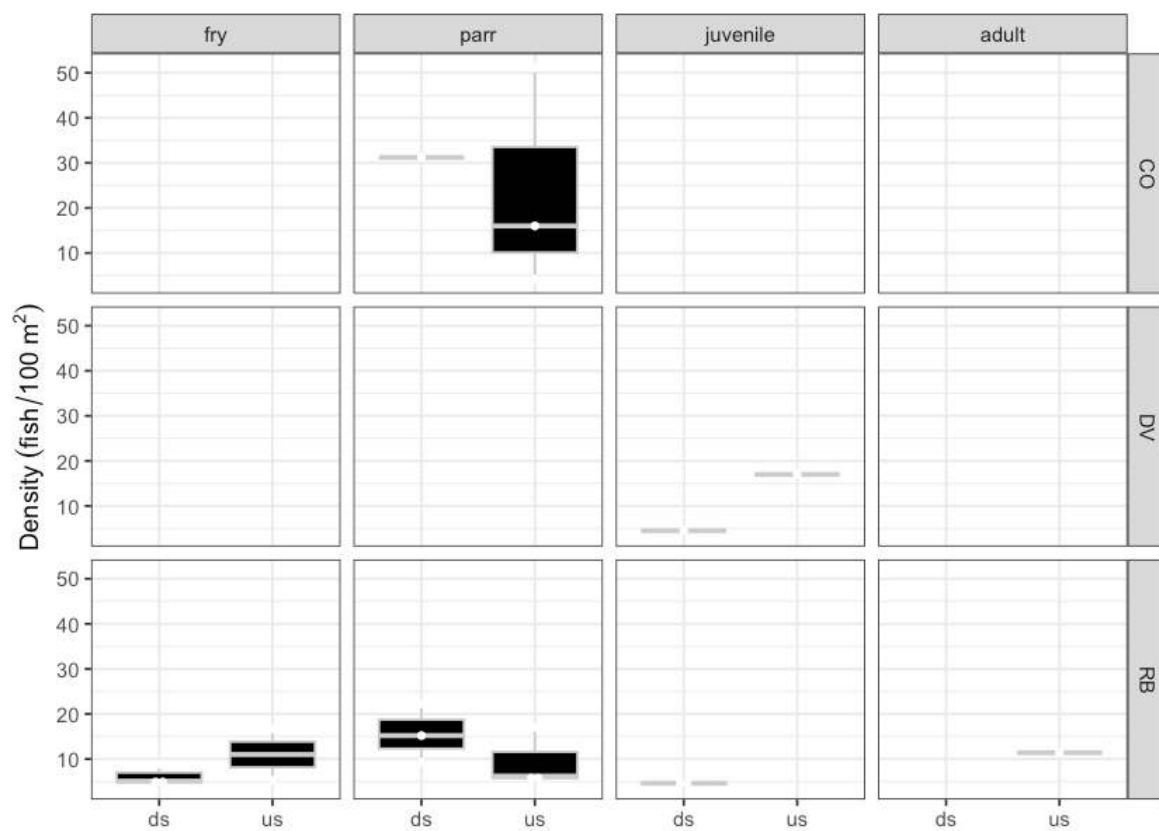
As noted above - following recommendations from the 2022 survey, crossing 123377 was revisited on September 14, 2023 and electrofishing was conducted with results summarised in Tables [5.97](#) - [5.98](#) and Figure [5.62](#). A total of 35 fish were captured upstream, and 24 fish were captured downstream. Species caught included coho, rainbow trout, and dolly varden (Figures [5.67](#)). All fish captured with a fork length greater than 60mm were tagged with Passive Integrated Transponders (PIT tags) with data stored [here](#).

Figure 5.62: Densities of fish (fish/100m2) captured upstream and downstream of PSCIS crossing 123377.

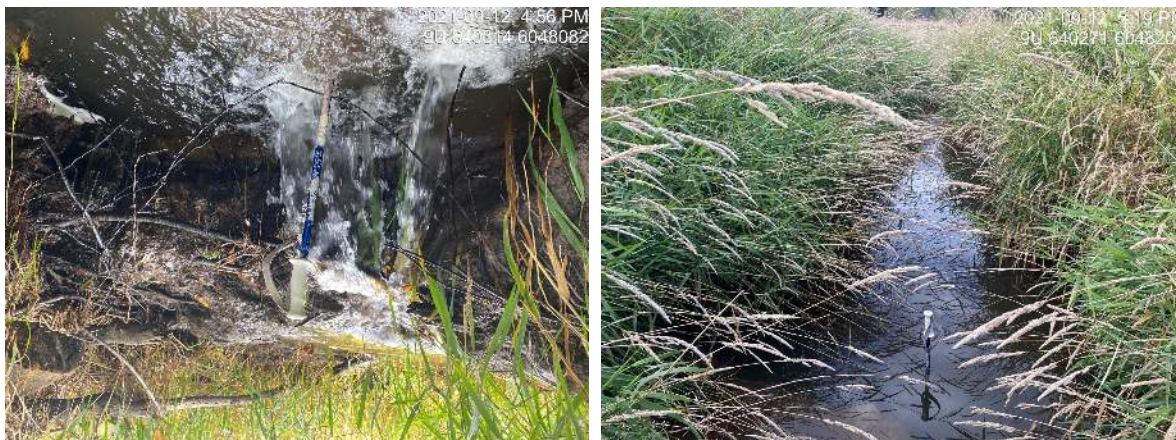
Although PSCIS culvert 198066 on the private Udder View Dairy farm road ranks as a potential barrier according to the conservative provincial metric it was considered passable to all life stages and species at the time of surveying in 2021. Additionally, although velocities within the pipe may prevent passage at some times of year it is recommended that options to remove the culvert completely be explored before replacement is considered. As review of lidar data indicates there is appropriate elevation relief for the stream to travel naturally in a northern direction where the Thompson Creek valley meets the Bulkley River floodplain (as has been reported as historically occurring), it seems feasible that regulators, First Nations and other organizations could work with the landowner to develop a plan to redirect some or all stream discharge to the north and infill the drainage ditches east of the culvert. It is also recommended that as part of that plan, agricultural area could be removed from sections of the Bulkley River floodplain to allow for retention of water within wetland complexes and the regeneration of riparian shrub and forest communities adjacent to Thompson Creek and the Bulkley River. The feasibility of providing financial incentives for the landowner to reduce the area of agriculture and increase wetland assets on the property could be explored. Regardless, for now, hardening of the road/culvert infrastructure at PSCIS culvert 198066 and the anthropogenic drainage network upstream of the private road should not be pursued as this section of stream at the time of the survey was not in a healthy state and this will not be addressed through those actions. Investigation of fish presence upstream near Walcott Road (discussed in more detail below) would give a good indication of whether the situation on the floodplain is preventing anadromous species such as coho from accessing further up in the watershed.

Figure 5.63: Left: Small drop (50cm high) located ~20m upstream of PSCIS crossing 198066. Right: Habitat immediately upstream of PSCIS crossing 198066 that flows through a hay field within an excavated trench for approximately 350m.

As crossing 198066 did not appear to be a significant barrier to fish passage at the time of the survey, and because of anthropogenic alterations upstream (dredging and ditching) - replacement of the culvert on the private Udder View Dairy farm road was not recommended at least until a plan to improve watershed health in the agricultural area immediately upstream was devised.

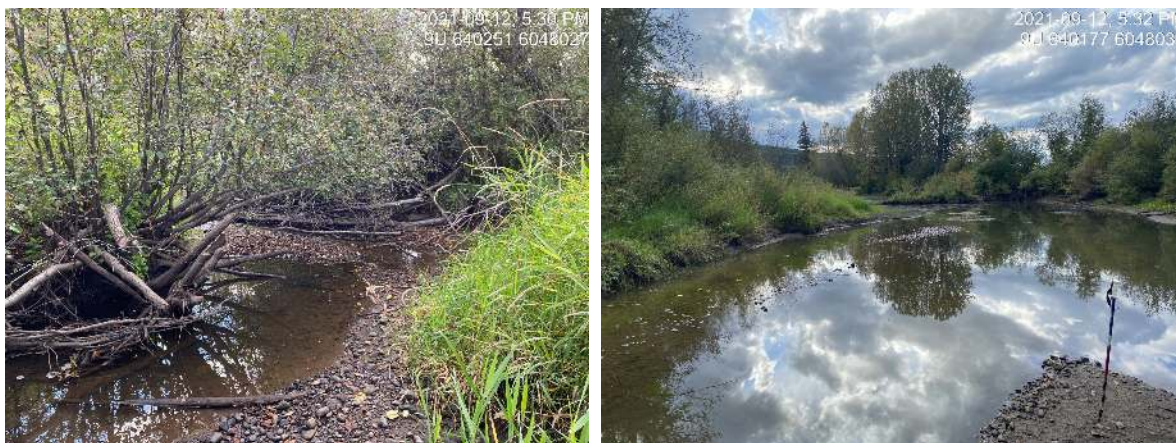
The stream was surveyed downstream from the private road for 100m to the confluence with the Bulkley River side channel (Figure [5.64](#)). Total cover amount was rated as moderate with overhanging vegetation dominant (Table [5.96](#)). The average channel width was 3.4m, the average wetted width was 2.5m and the average gradient was 1.8%. The dominant substrate was gravels with fines subdominant. The habitat was rated as high value for salmonid rearing and spawning. This area is an important migration corridor, a likely area of refuge during high flows and valuable juvenile rearing area that connects Thompson Creek to a side channel of the Bulkley River. Hundreds of fish were spotted that ranged from 40 - 80mm in length.

Figure 5.64: Left: Typical habitat downstream of PSCIS crossing 198066. Right: Habitat on side channel of Bulkley River downstream of crossing 198066.

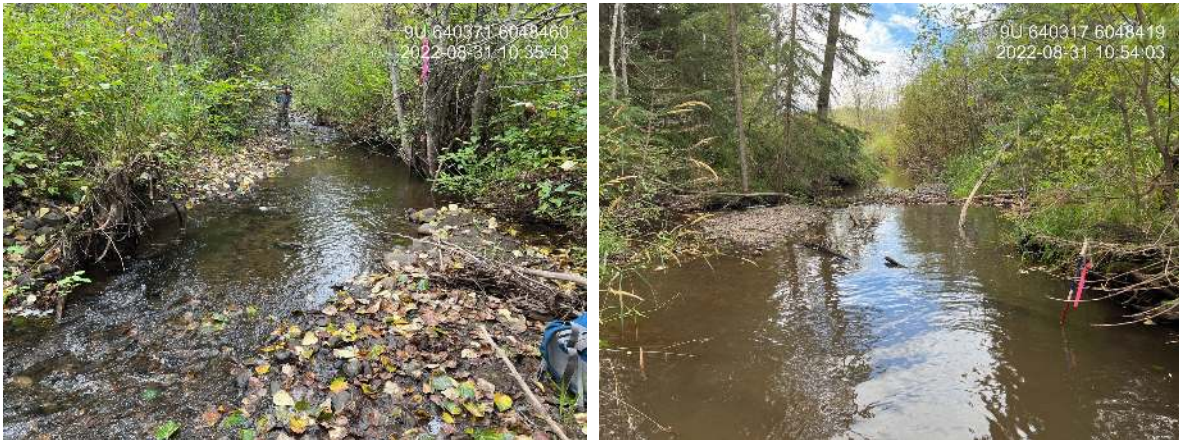
Figure 5.65: Left: Habitat upstream of PSCIS crossing 198066 and downstream of PSCIS crossing 123378. Right: Habitat upstream of PSCIS crossing 198066 and downstream of PSCIS crossing 123378.

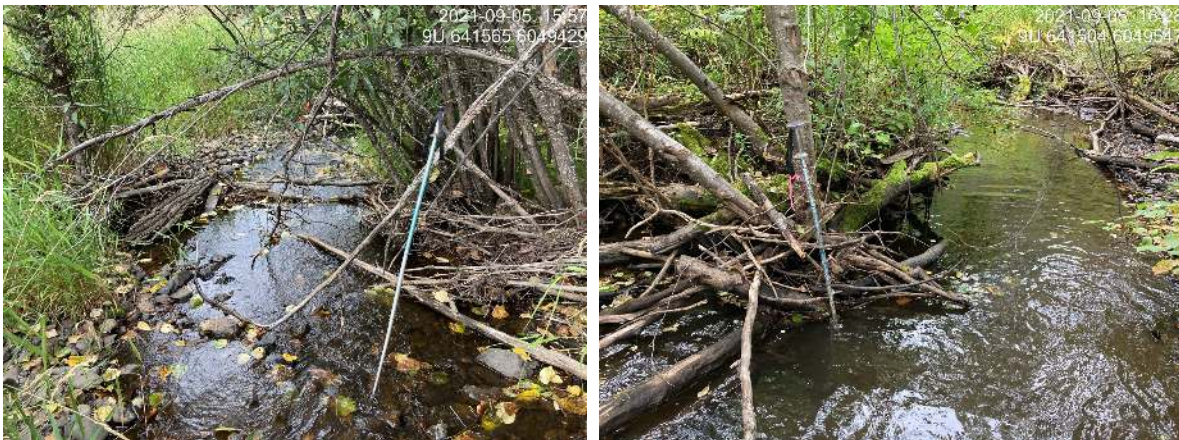
Figure 5.66: Left: Habitat downstream of PSCIS crossing 123377. Right: Habitat downstream of PSCIS crossing 123377.

Replacement of PSCIS crossing 123377 on Walcott Road with a bridge (10m span) is recommended with the cost of the work is estimated at \$2,400,000 for a cost benefit of 5.1 linear m/\$1000 and 24.6 m<sup>2</sup>/ \$1000.

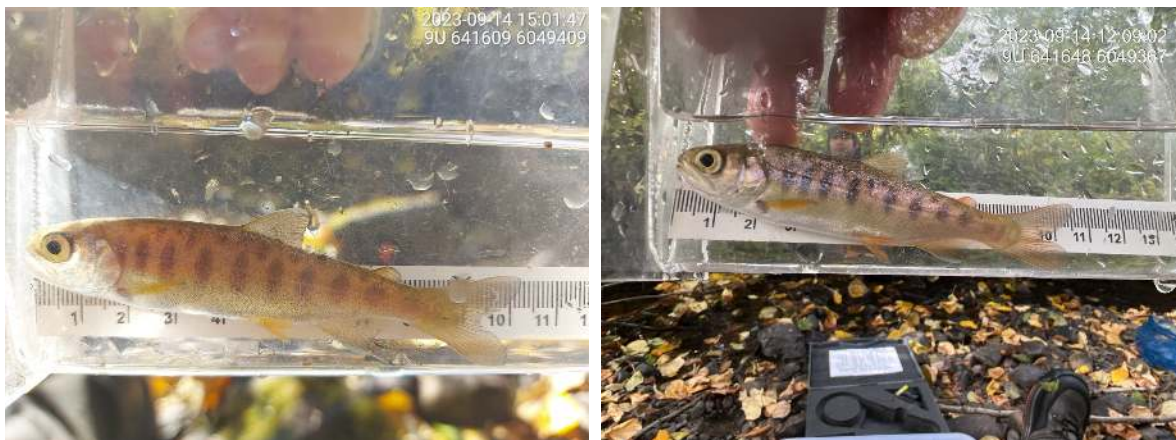
Figure 5.67: Left: Coho caught downstream of crossing 123377. Right: Coho caught upstream of crossing 123377.

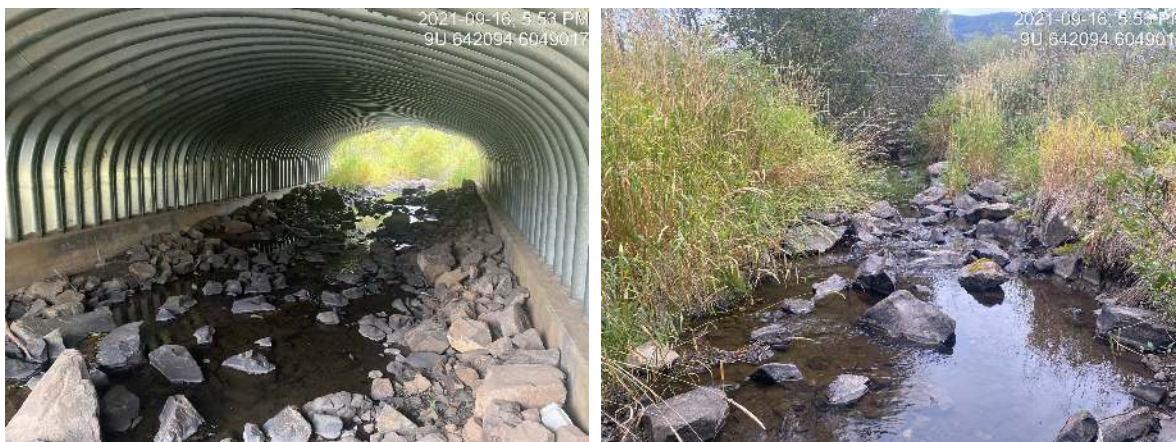
PSCIS crossing 123376 on Highway 16 was assessed by M. C. Gollner, Cain, and Russell (2013) in 2013. This is an open bottom structure (pipe arch) located approximately 600m upstream of Walcott Road and 925m north of PSCIS crossing 123375 on Highway 16. As noted, the majority of discharge within the Thompson Creek watershed flows through this crossing with the freshwater atlas not capturing the connectivity between this area and the mainstem mapped to the east of the Highway closed bottom structure (PSCIS 123375 and MojTi ID 2076608). This open bottom structure appears to have been installed within the last 15 years and was considered passable to all life stages at the time of both the 2013 and 2021 surveys. The structure was 7m in diameter and 24m in length. The site at crossing 123376 was revisited in 2021, with photos shown in Figure [5.68](#). A digital elevation model of the area surrounding crossings 123377 and 123376 is presented in Figure [5.61](#). Note that this imagery was taken from the LiDAR BC open data portal [here](#) and there was no lidar available for areas of the Thompson Creek watershed located south east of crossing 123380 on Highway 16. Review of this lidar imagery for areas between Walcott Road to areas upstream of highway 16 show extensive anthropogenic excavations upstream of 123375 likely draining large areas of low lying wetlands to accommodate agricultural fields.

Figure 5.68: Left: Open bottom structure on Highway 16 (PSCIS crossing 123376). Right: Habitat immediately upstream of PSCIS crossing 123376.

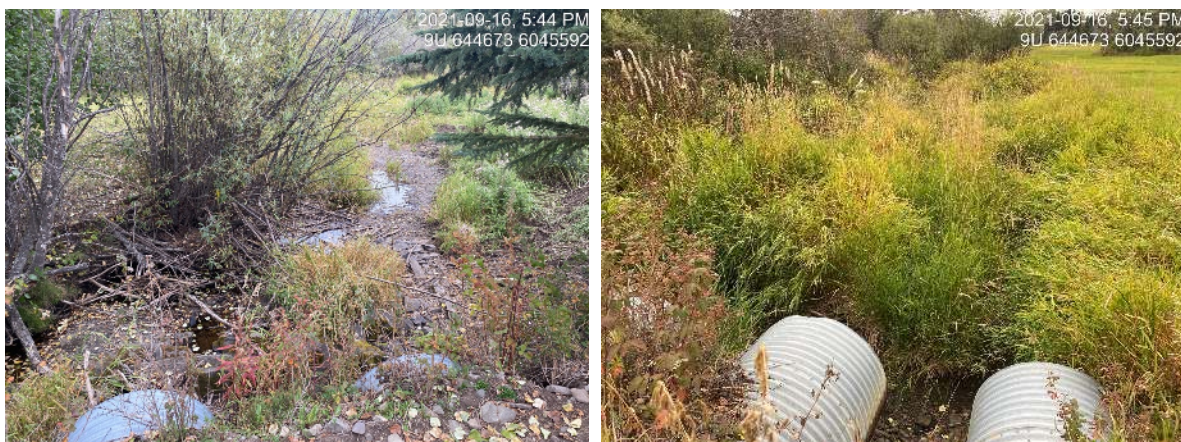
Figure 5.69: Left: Downstream view of PSCIS crossing 123382 on McNeil Road. Right: Upstream view of PSCIS crossing 123382 on McNeil Road.
