STURAA TEST

500,000 MILE BUS

PROTERRA, INC.

MODEL BE-35

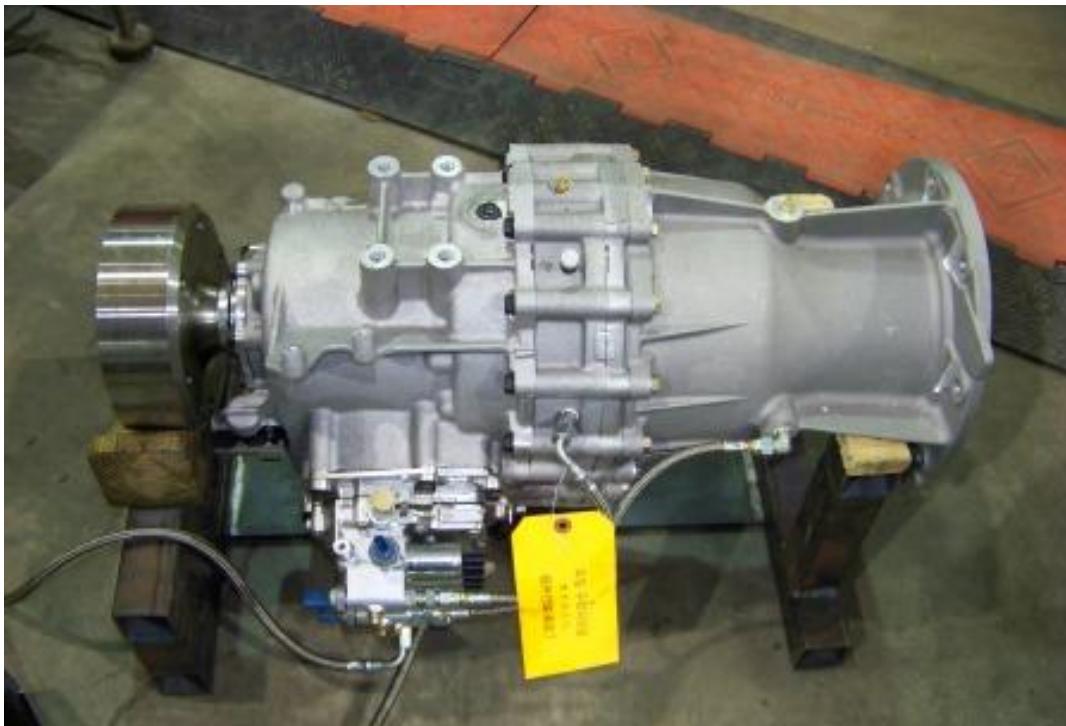
**TRANSMISSION REMOVAL AND REPLACEMENT
(8.00 MAN HOURS)**

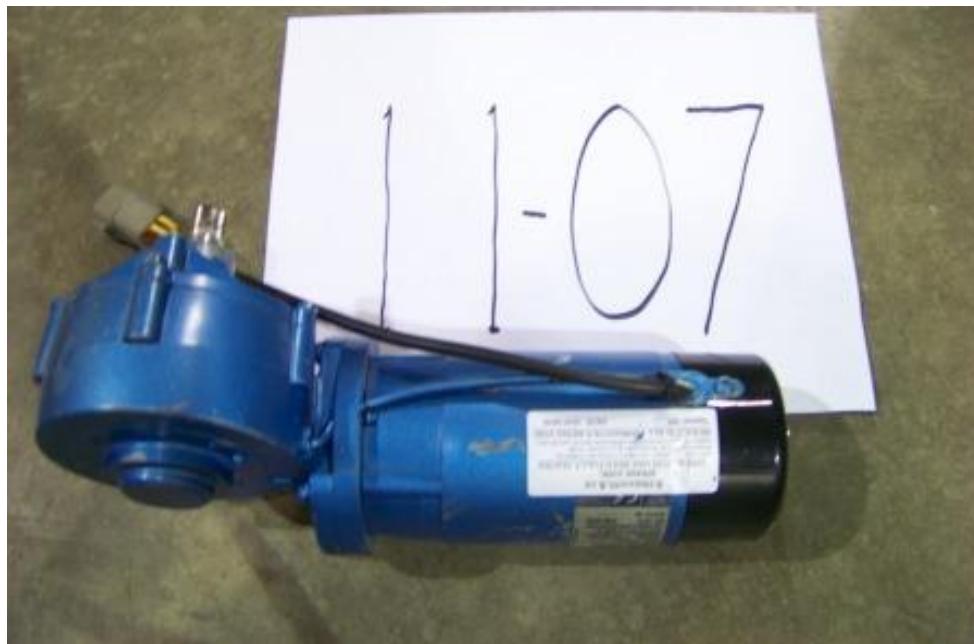
**WIPER MOTOR REMOVAL AND REPLACEMENT
(2.00 MAN HOURS)**

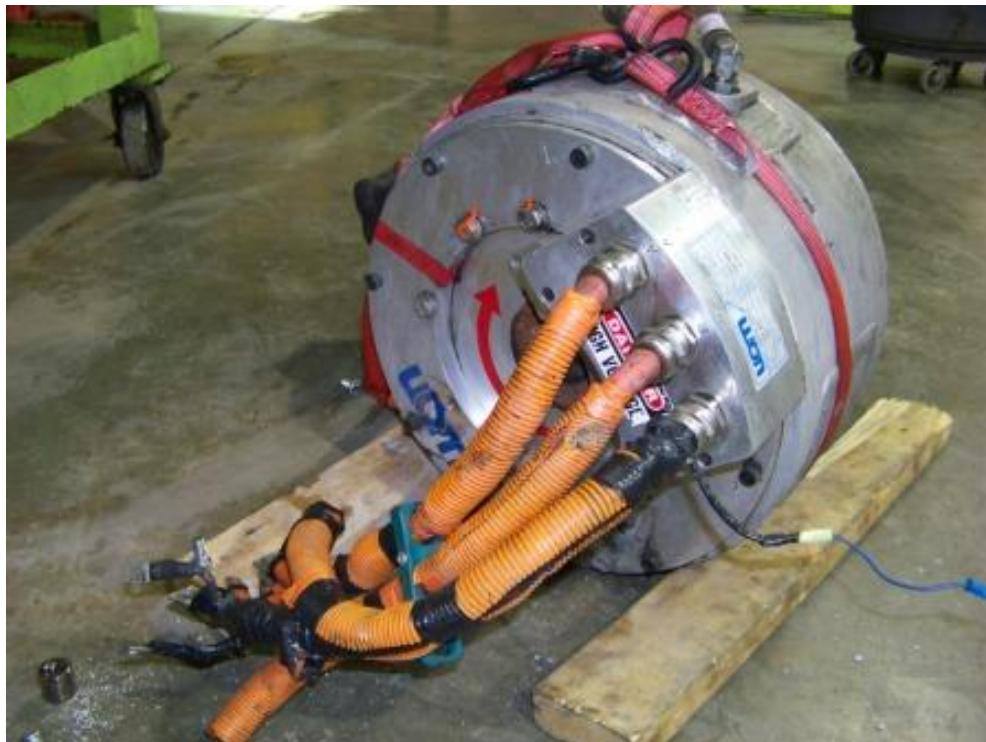
DRIVE MOTOR REMOVAL AND REPLACEMENT (4.00 MAN HOURS)

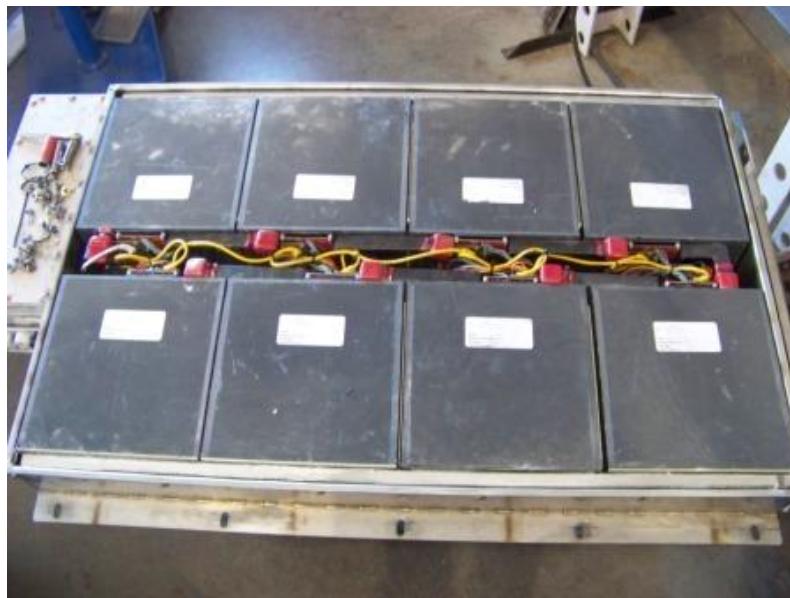
STORAGE BATTERY PACK REMOVAL AND REPLACEMENT (0.50 MAN HOURS)

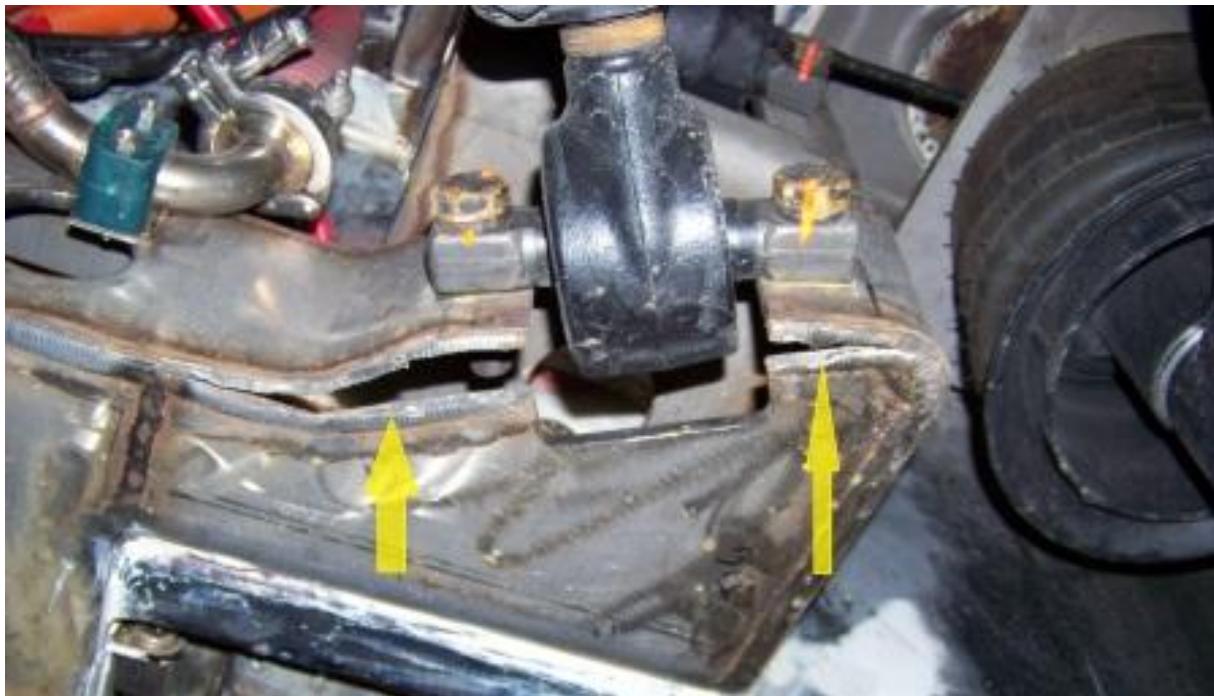
**BROKEN REAR UPPER RADIUS ROD MOUNT
(197 TEST MILES)**

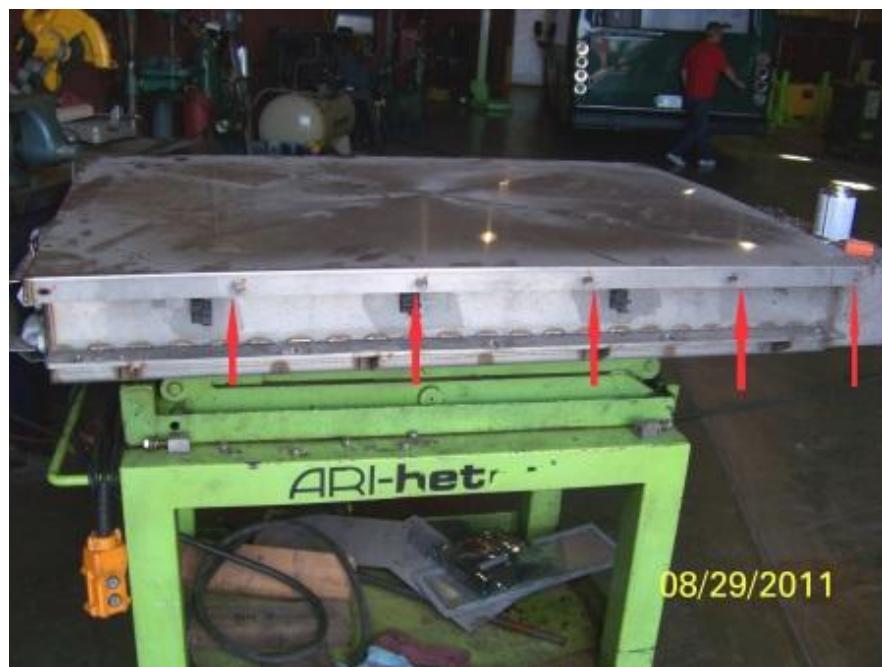
**5 BROKEN NUTSERTS IN FIRST
RIGHT SIDE BATTERY PACK
(2,007 TEST MILES)**

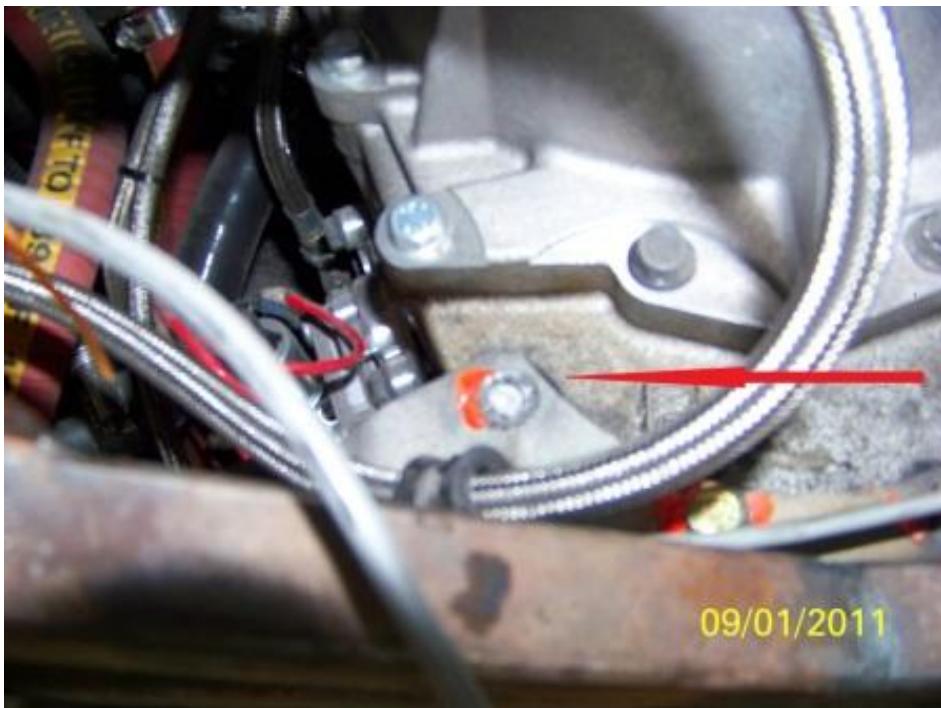
**BROKEN TRANSMISSION MOUNTING BOLT
(2,167 TEST MILES)**

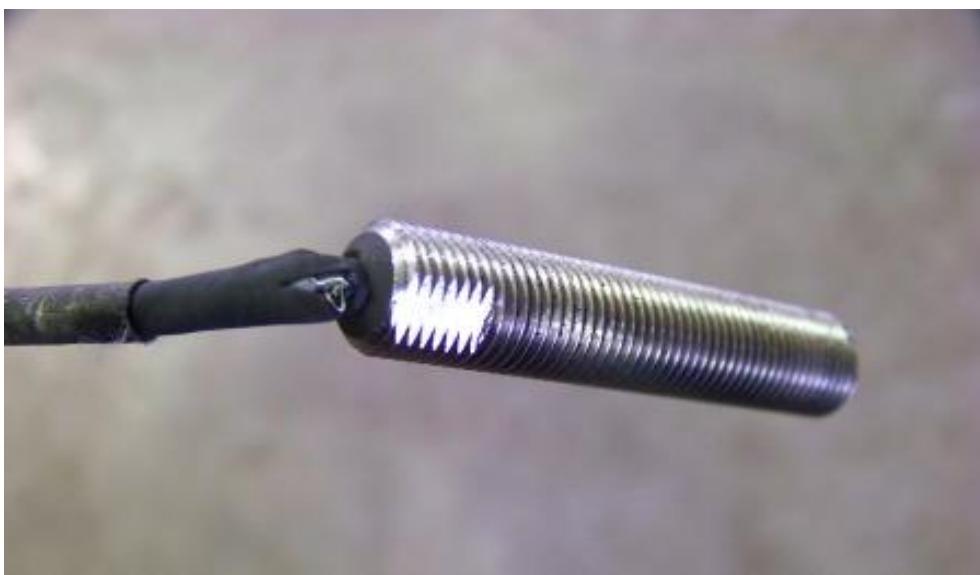
**DAMAGED TRANSMISSION CLUTCH SPEED SENSOR
(2,219 TEST MILES)**

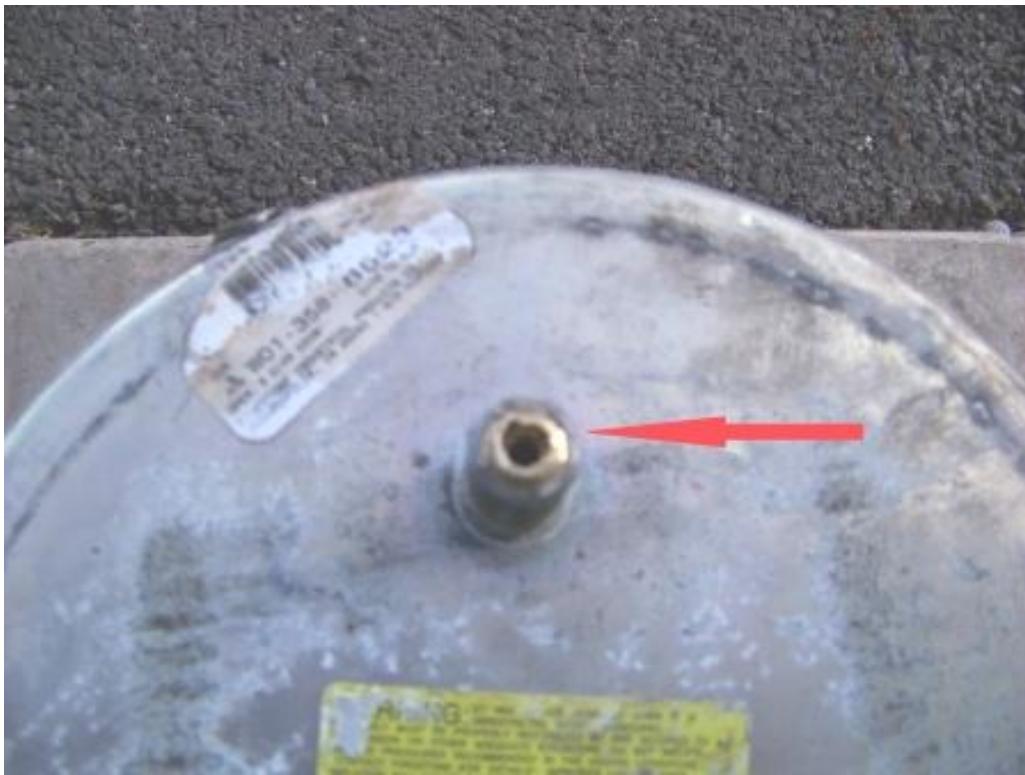
**BROKEN BRASS AIR FITTING ON RIGHT FRONT AIR
BAG
(3,141 TEST MILES)**

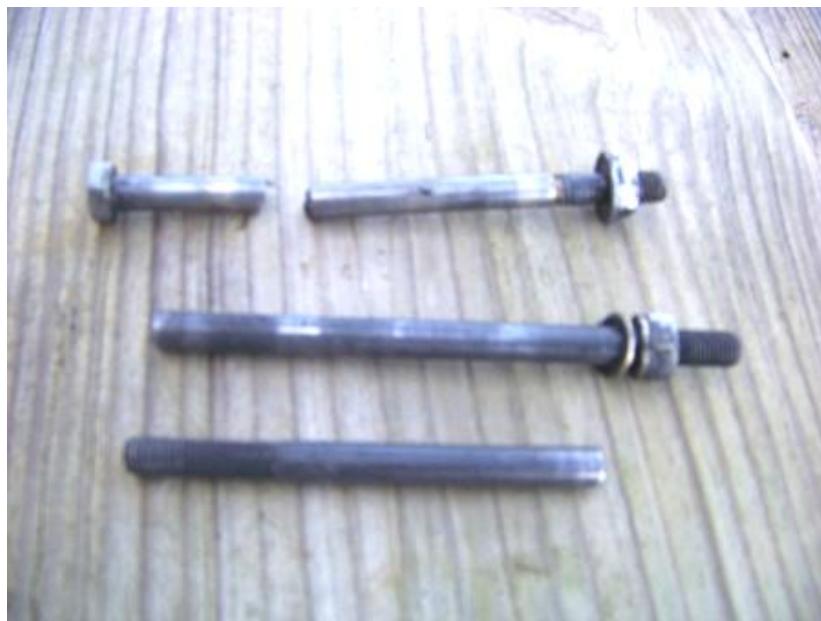
**THREE BROKEN TRANSMISSION CASE BOLTS
(3,141 TEST MILES)**

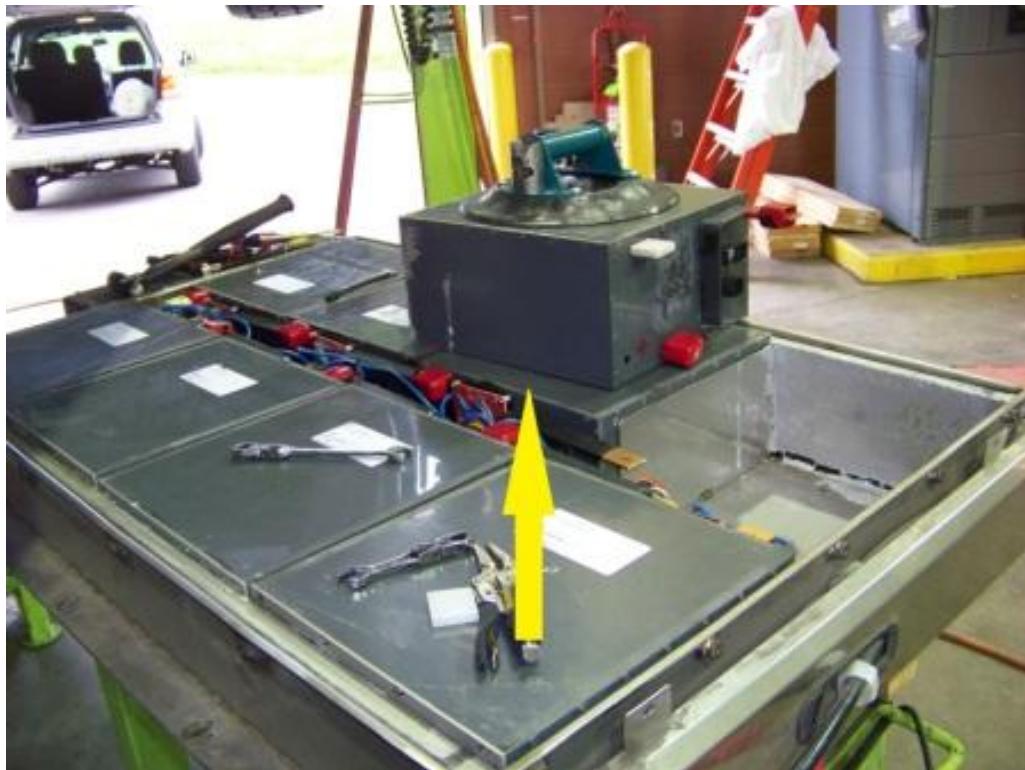
**FAILED BATTERY PACK
(3,644 TEST MILES)**

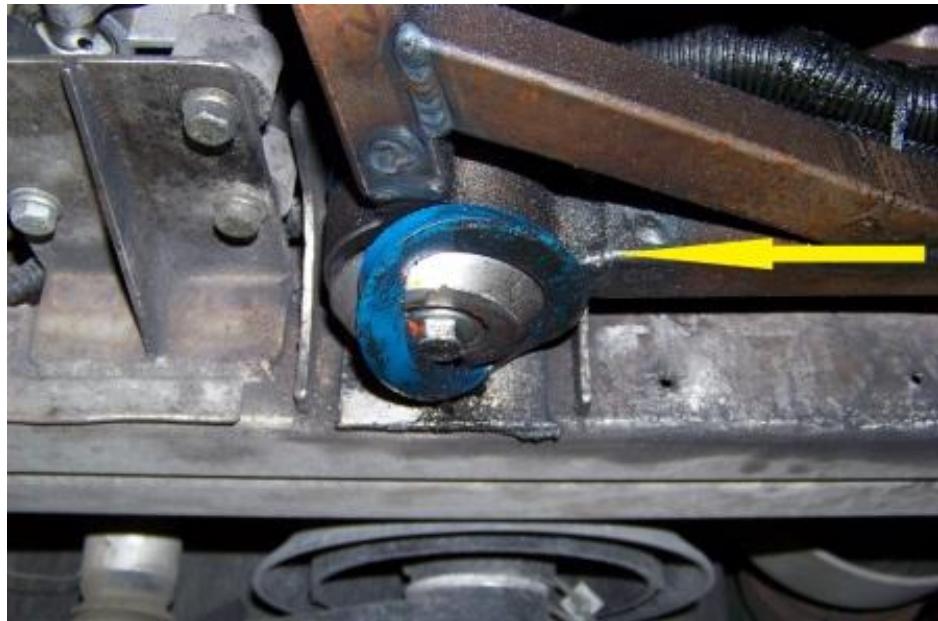
**FAILED LEFT FRONT TRANSMISSION
CROSSMEMBER BUSHING
(3,644 TEST MILES)**

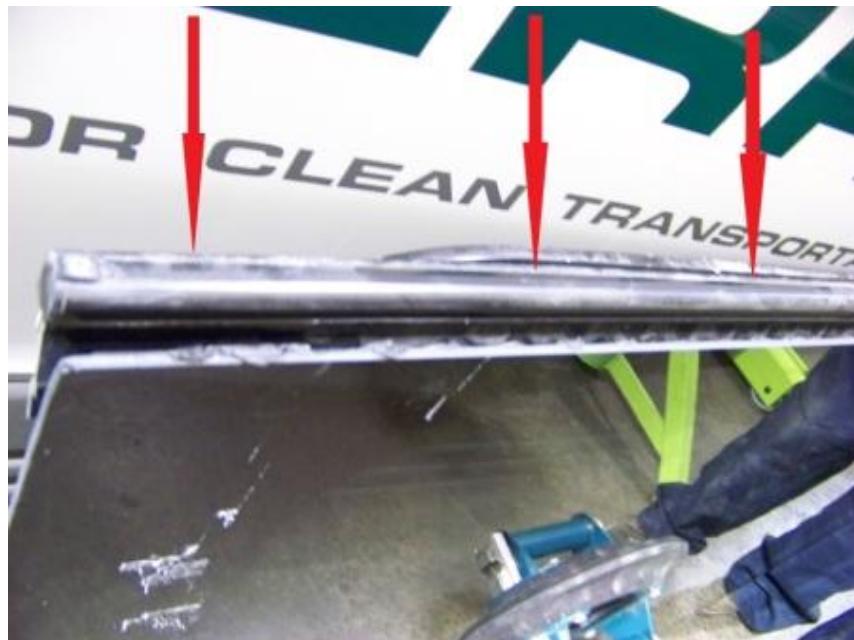
**ADHESIVE FAILURE AT 5TH
PASSENGER WINDOW, LEFT SIDE
(3,989 TEST MILES)**

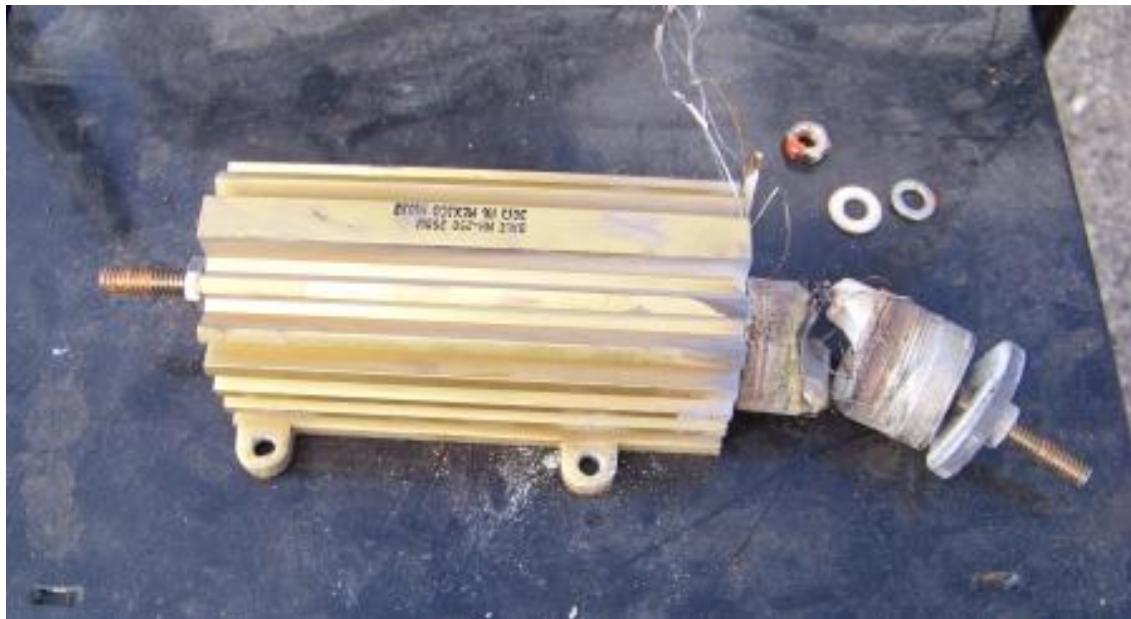
**FAILED TRACTION MOTOR RESISTOR
(6,019 TEST MILES)**

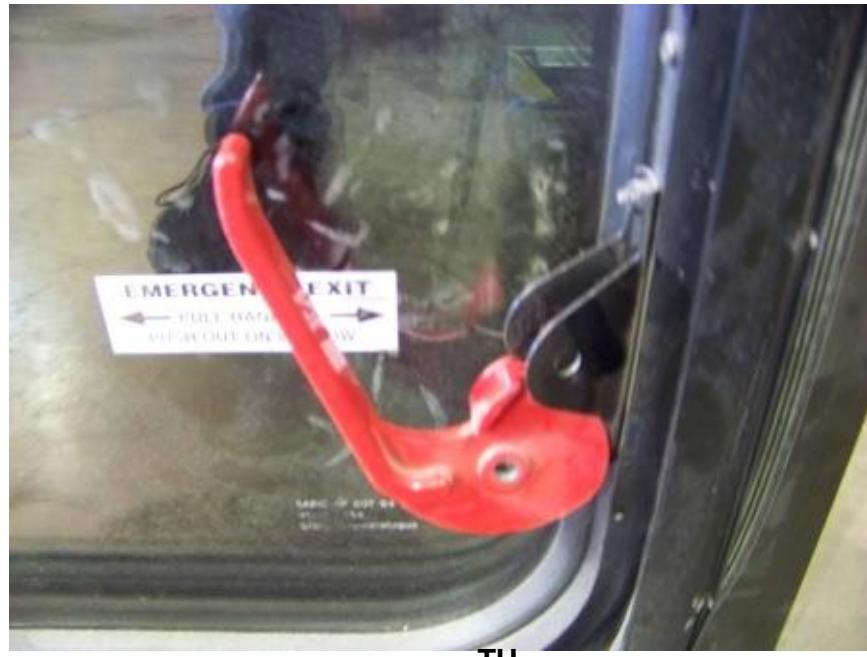
**FAILED SAFTEY LATCH, 6TH WINDOW, LEFT SIDE
(6,669 TEST MILES)**

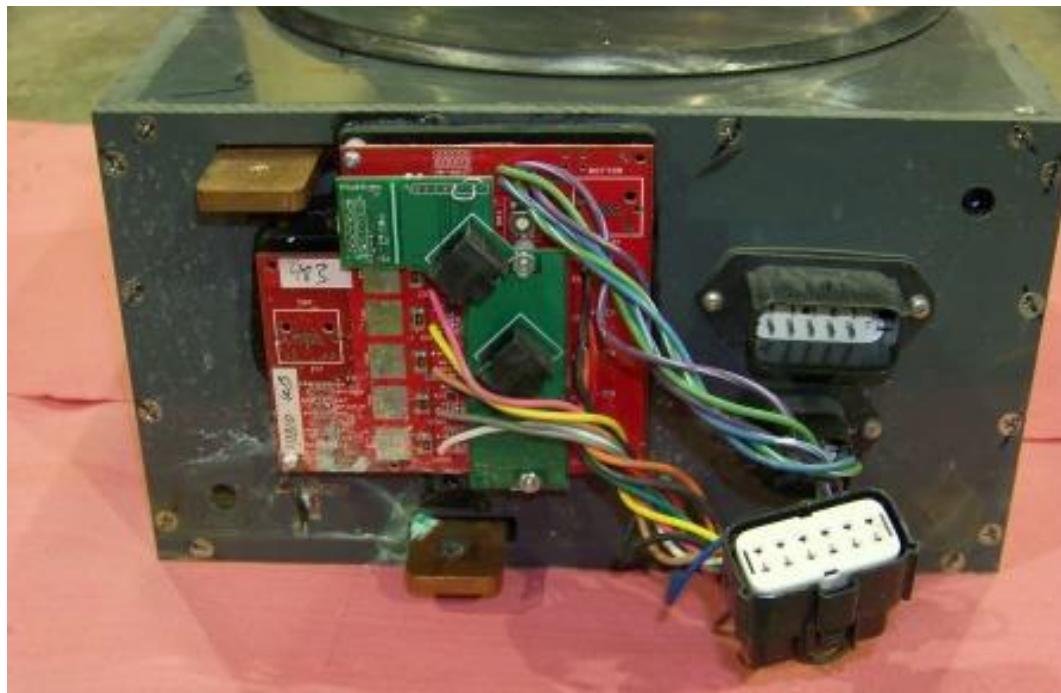
**MOISTURE FOUND IN BATTERY PACK CIRCUIT
BOARD
(13,604 TEST MILES)**

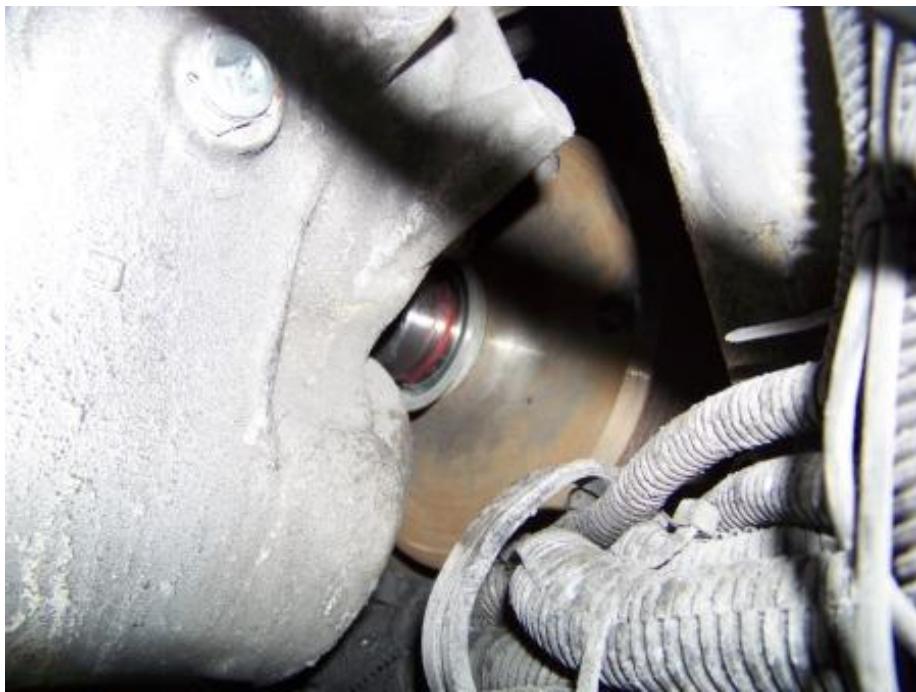
02-10-12	13,977	The output shaft in the transmission is broken.	Removed transmission and separated drive motor.	12.00	4.00
02-13-12	13,977	Replacement transmission arrived.	Manufacturer representative installed new drive motor/transmission assembly.	28.50	72.00
02-23-12	15,000	Loss of throttle and "Hot Transmission" warning light is on. The electric drive motor failed.	Manufacturer replaced the electric drive motor.	6.00	24.00

**BROKEN TRANSMISSION OUTPUT SHAFT
(13,977 TEST MILES)**

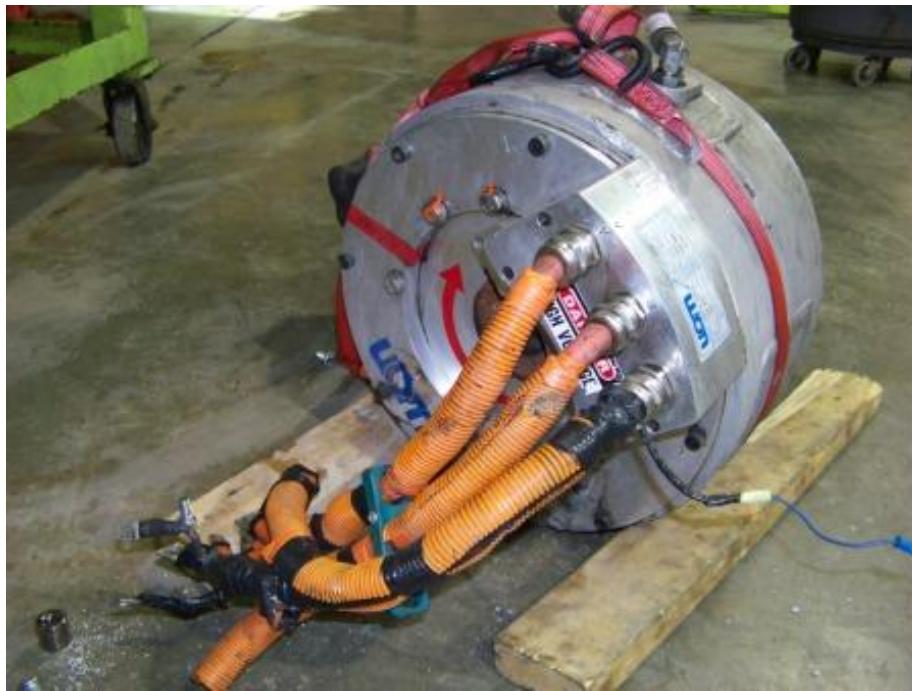
**FAILED ELECTRIC DRIVE MOTOR
(15,000 TEST MILES)**
