Diagnosis for FL01

Categorization of measurements

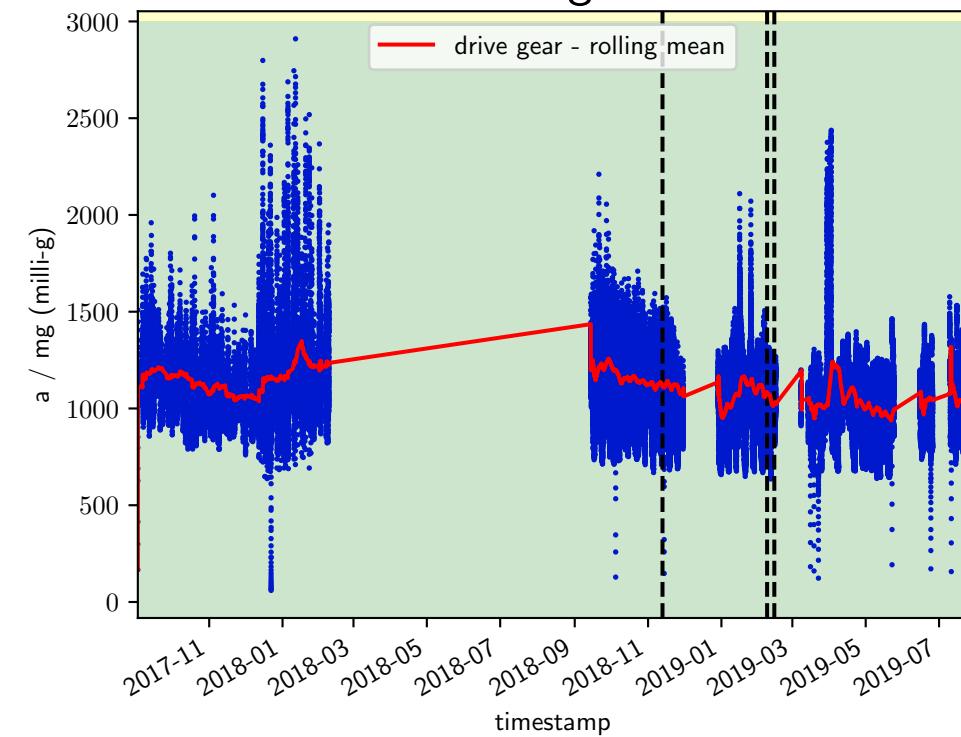
drive gear

Good: 110061/110061 = 100%
Satisfactory: 0/110061 = 0%
Unsatisfactory: 0/110061 = 0%
Unacceptable: 0/110061 = 0%

Good

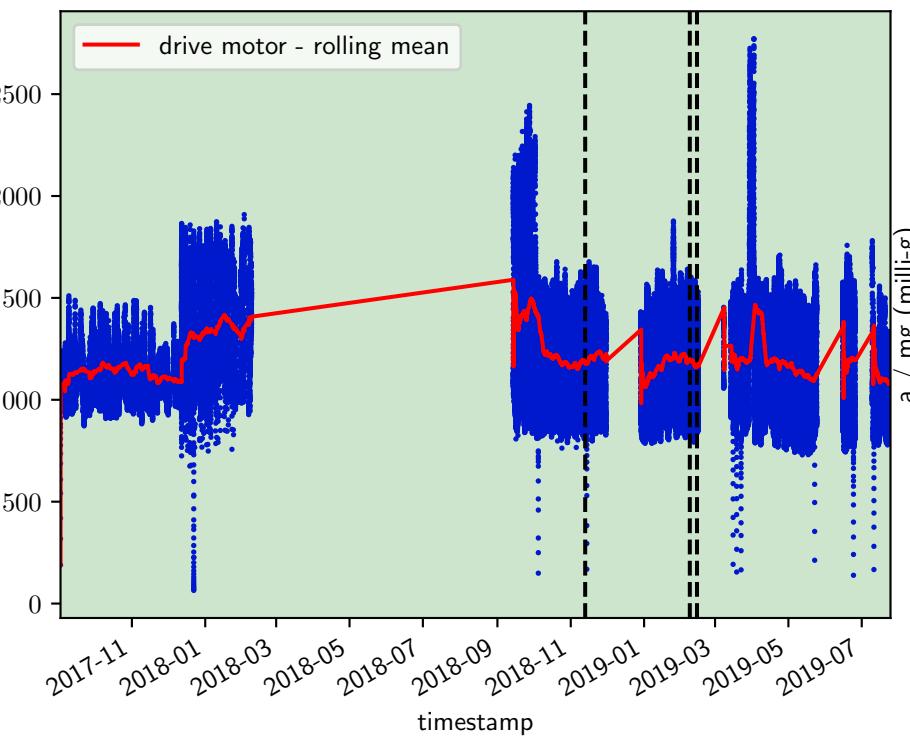
drive motor

Good: 110059/110059 = 100%
Satisfactory: 0/110059 = 0%
Unsatisfactory: 0/110059 = 0%
Unacceptable: 0/110059 = 0%

Good

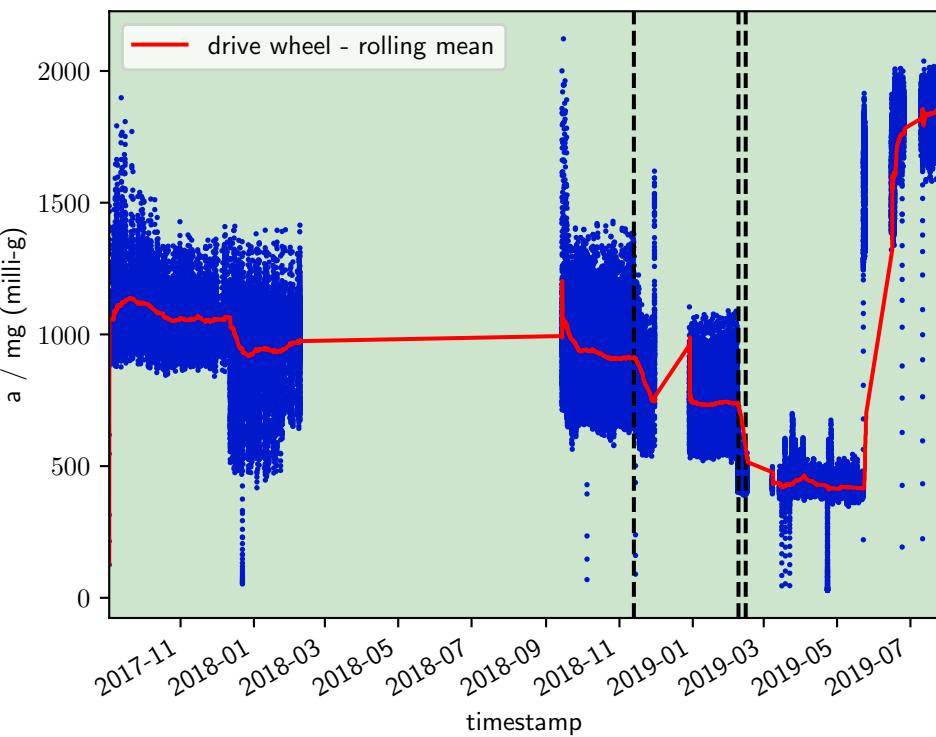
drive wheel

Good: 110180/110180 = 100%
Satisfactory: 0/110180 = 0%
Unsatisfactory: 0/110180 = 0%
Unacceptable: 0/110180 = 0%

Good

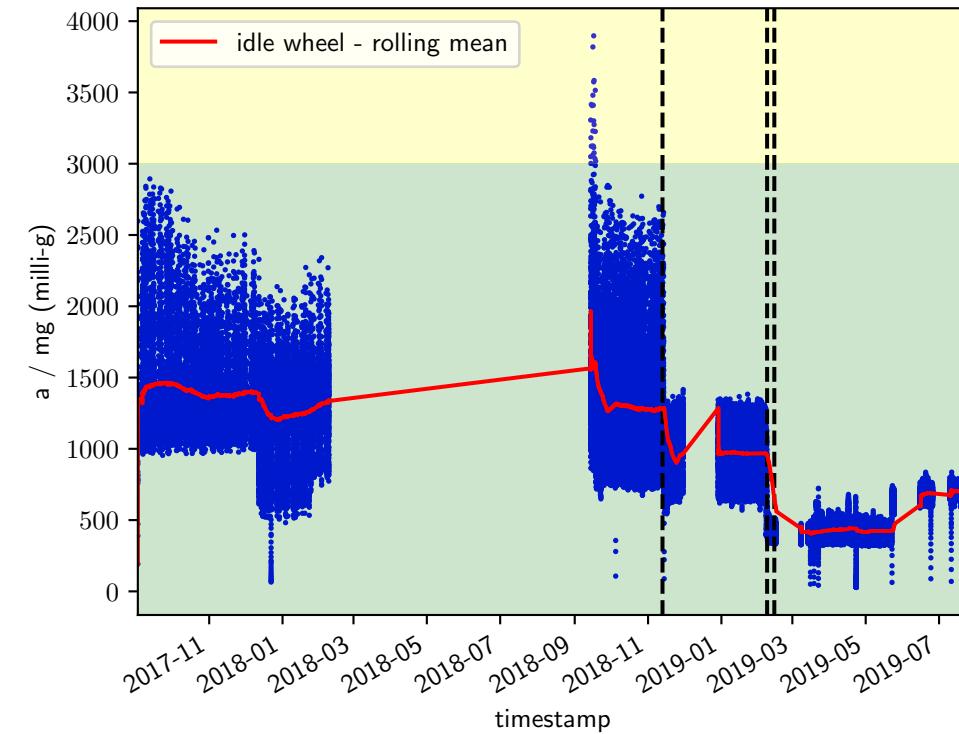
idle wheel

Good: 110152/110177 = 100%
 Satisfactory: 25/110177 = 0%
 Unsatisfactory: 0/110177 = 0%
 Unacceptable: 0/110177 = 0%

Satisfactory

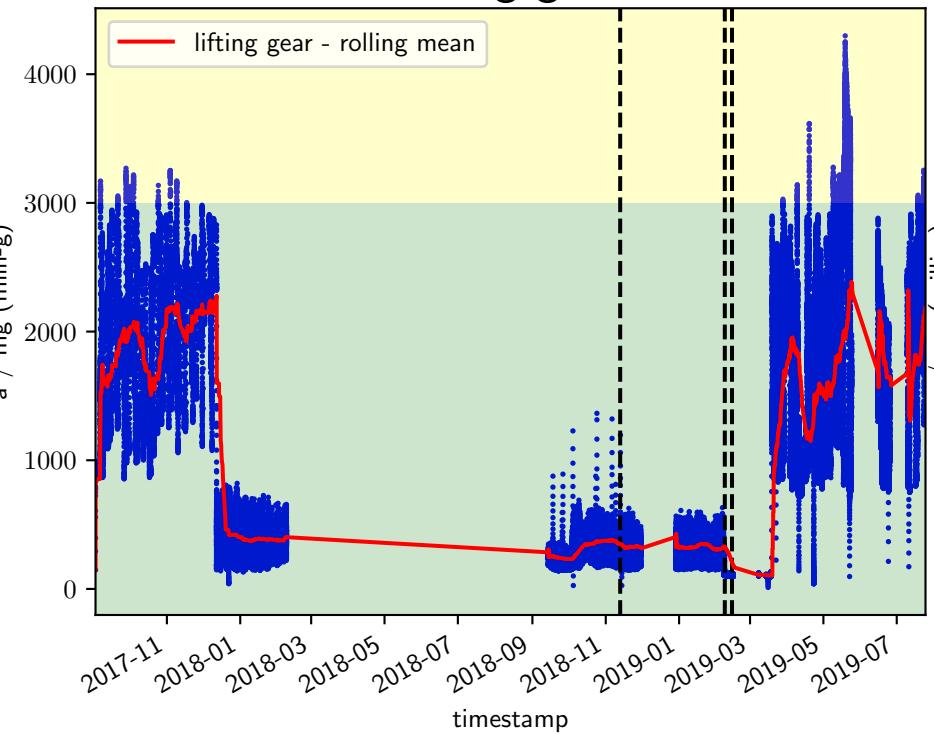
lifting gear

Good: 119218/121014 = 99%
 Satisfactory: 1796/121014 = 1%
 Unsatisfactory: 0/121014 = 0%
 Unacceptable: 0/121014 = 0%

Satisfactory

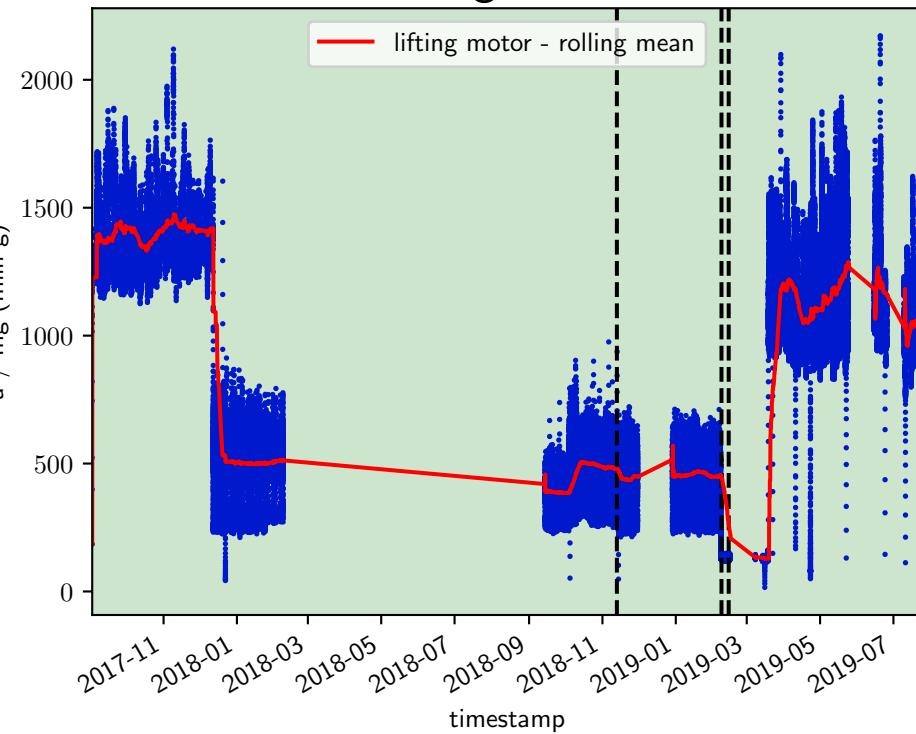
lifting motor

Good: 121012/121012 = 100%
 Satisfactory: 0/121012 = 0%
 Unsatisfactory: 0/121012 = 0%
 Unacceptable: 0/121012 = 0%

Good

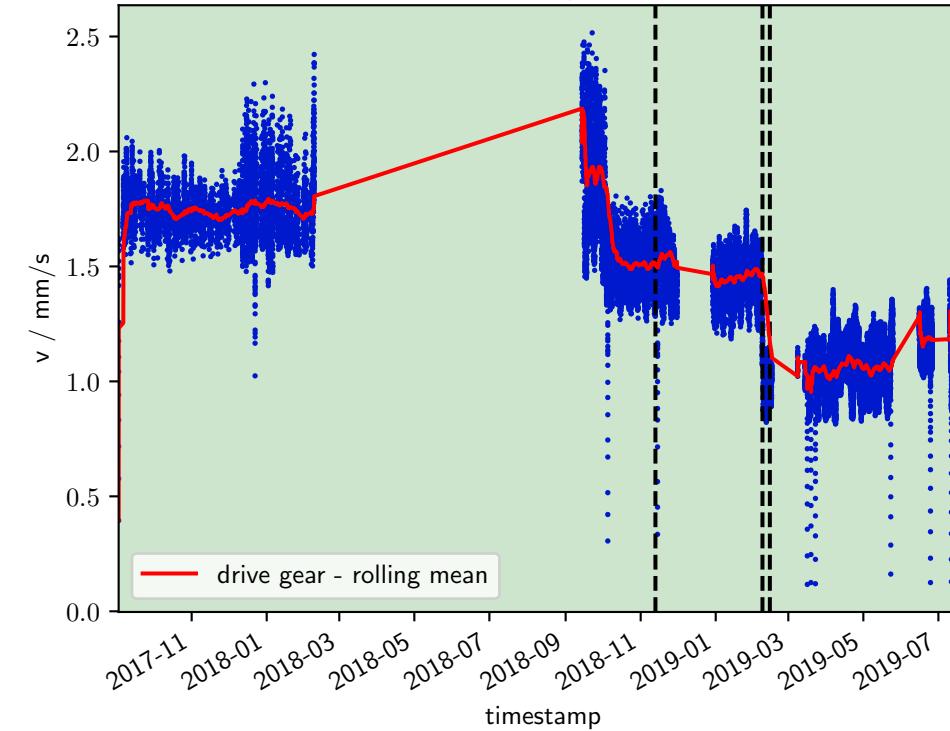
drive gear

Good: 32554/32554 = 100%
 Satisfactory: 0/32554 = 0%
 Unsatisfactory: 0/32554 = 0%
 Unacceptable: 0/32554 = 0%

Good

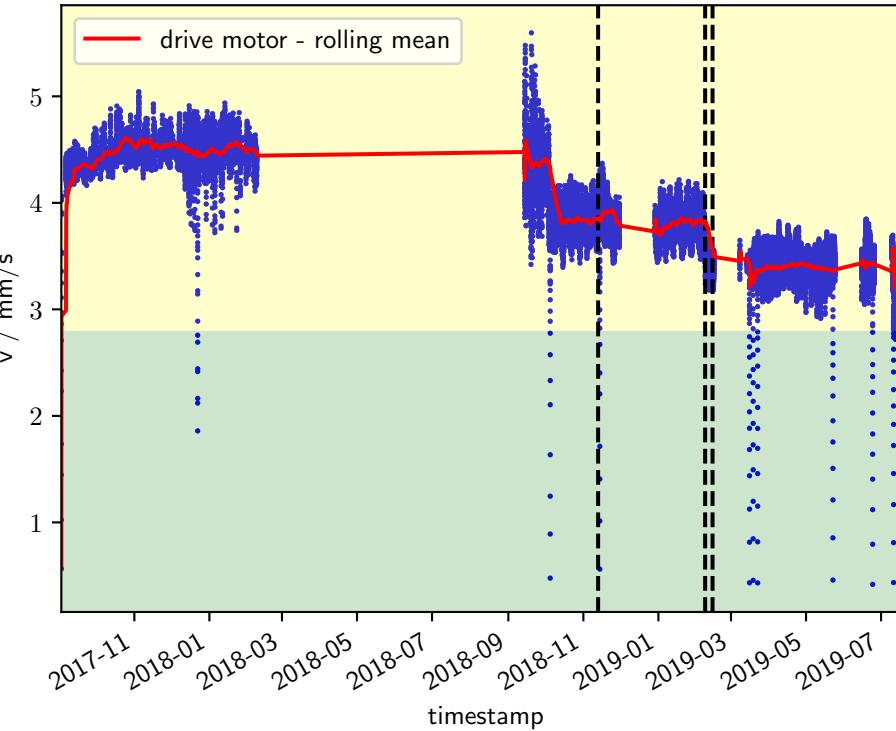
drive motor

Good: 141/33940 = 0%
 Satisfactory: 33799/33940 = 100%
 Unsatisfactory: 0/33940 = 0%
 Unacceptable: 0/33940 = 0%

Satisfactory

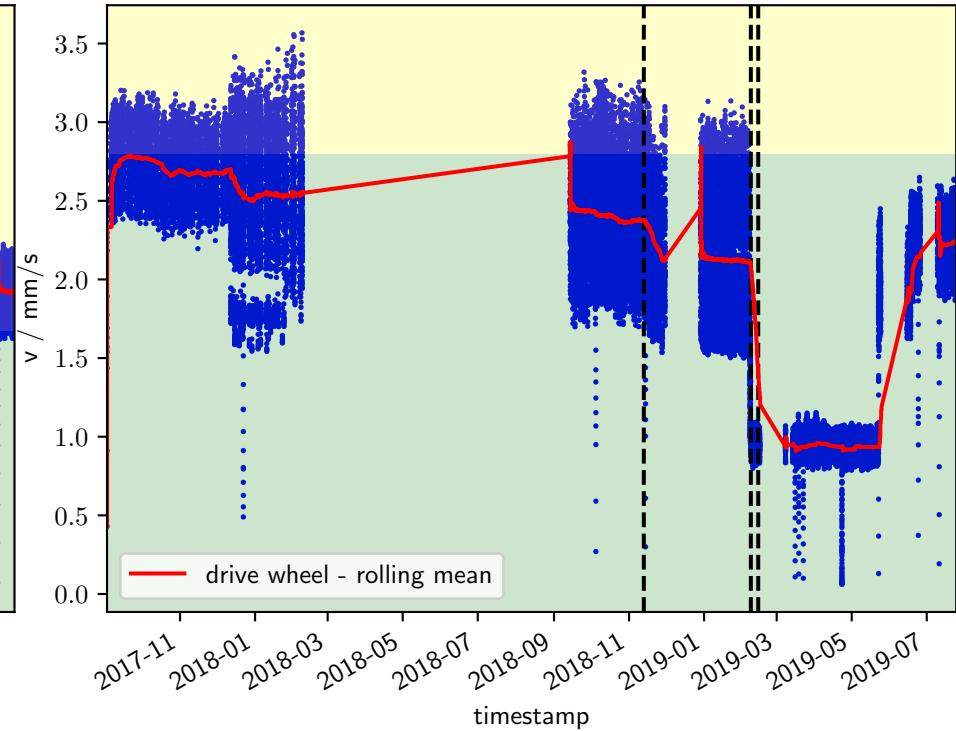
drive wheel

Good: 46261/51461 = 90%
 Satisfactory: 5200/51461 = 10%
 Unsatisfactory: 0/51461 = 0%
 Unacceptable: 0/51461 = 0%

Satisfactory

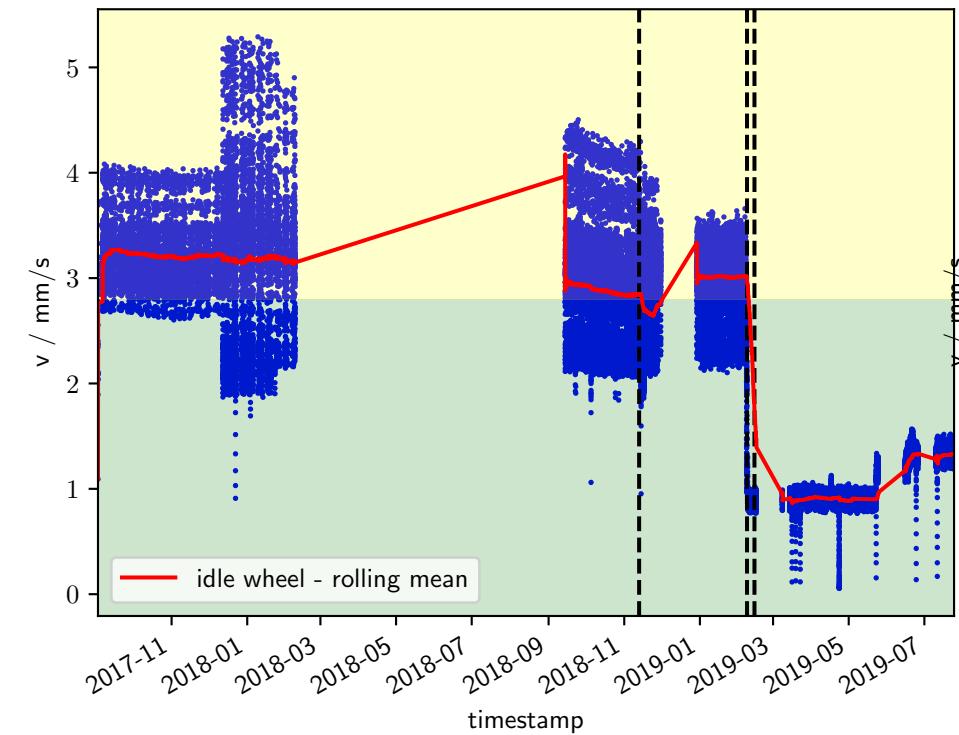
idle wheel

Good: 28222/50188 = 56%
 Satisfactory: 21966/50188 = 44%
 Unsatisfactory: 0/50188 = 0%
 Unacceptable: 0/50188 = 0%

Satisfactory

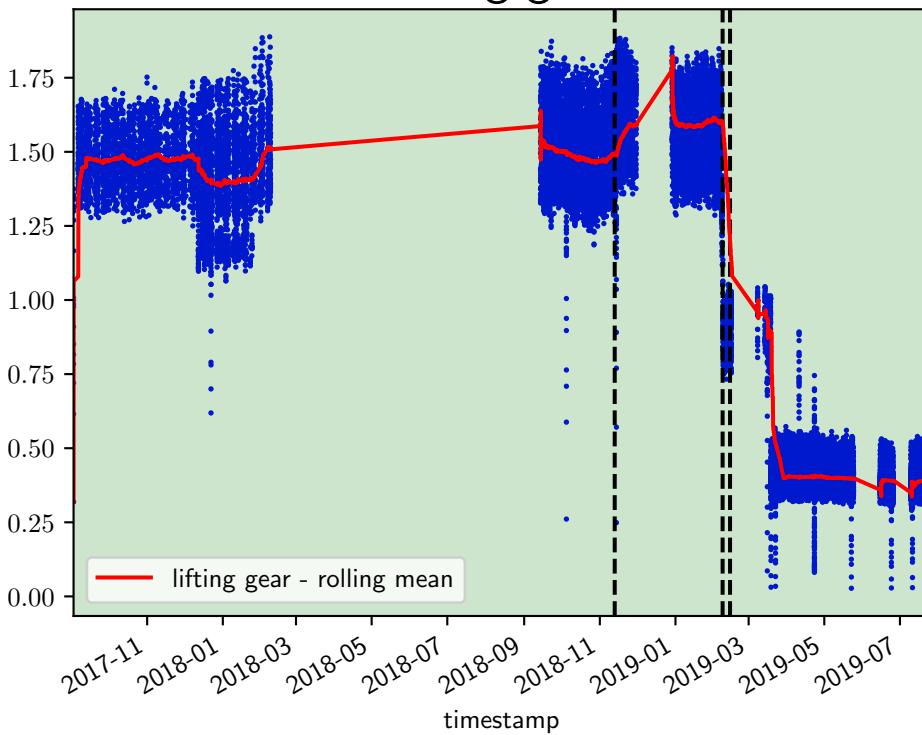
lifting gear

Good: 38446/38446 = 100%
 Satisfactory: 0/38446 = 0%
 Unsatisfactory: 0/38446 = 0%
 Unacceptable: 0/38446 = 0%

Good

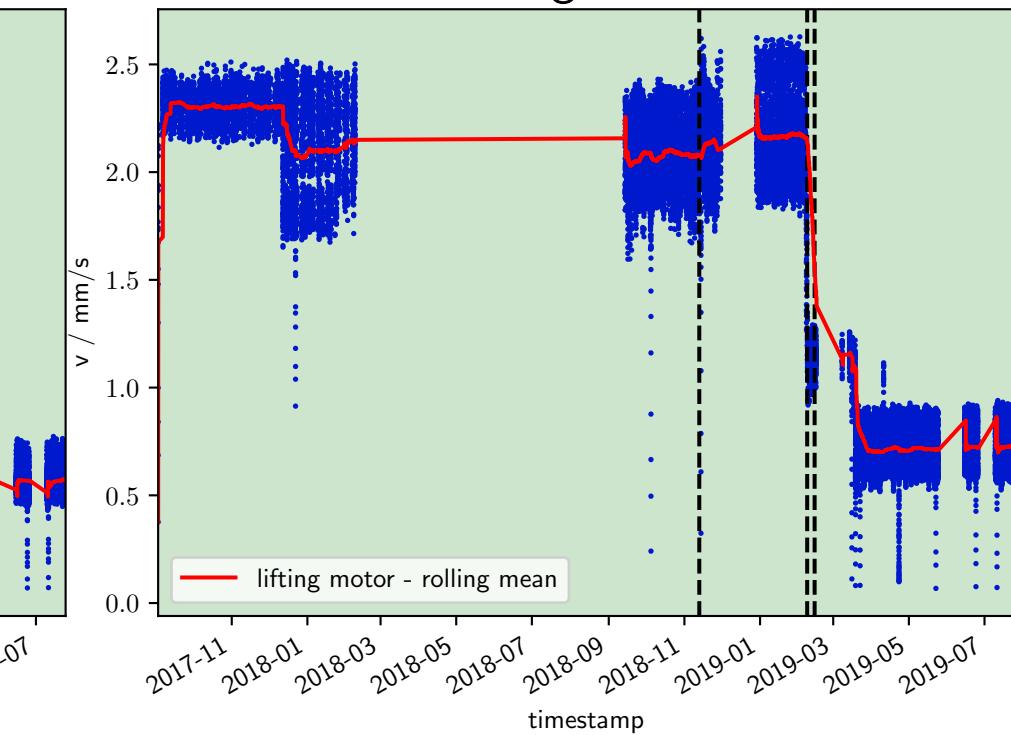
lifting motor

Good: 39163/39163 = 100%
 Satisfactory: 0/39163 = 0%
 Unsatisfactory: 0/39163 = 0%
 Unacceptable: 0/39163 = 0%

Good
