GARAGE REPLACEMENT / DESIGN REVIEW

Existing building / floor plan

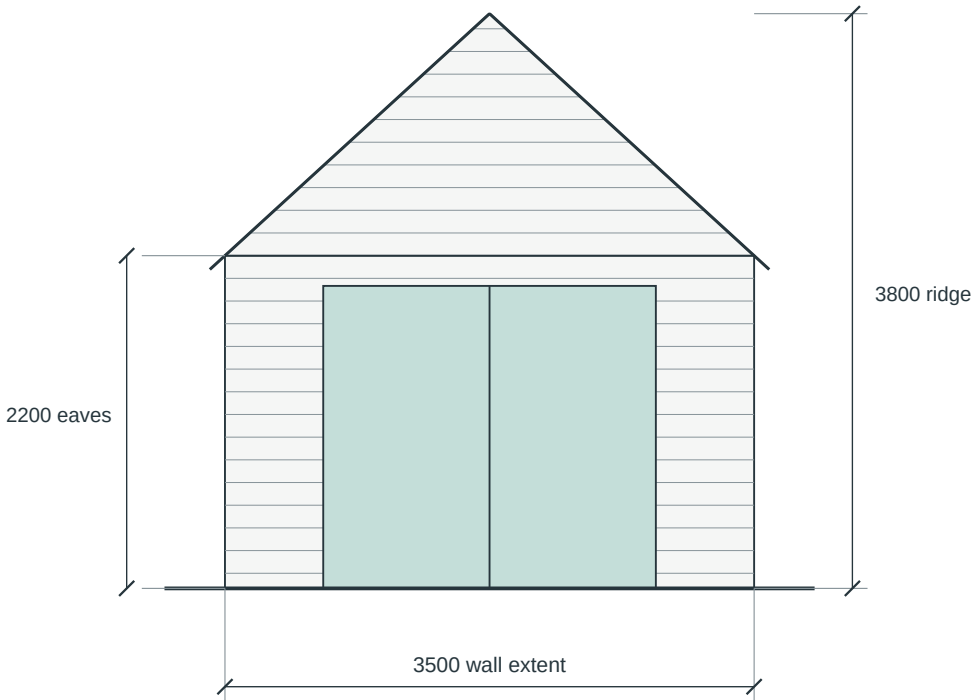
Existing building / front elevation

Door width/position schematic; verify 1100 label.  
Door height 2000 from reference.

Photo S5: weathered timber and blue-green doors; roof covering still to be verified.  
S2 labels roof corrugated; photograph appears tiled - confirm covering.  
Front doors schematic; rear reference indicates no openings.

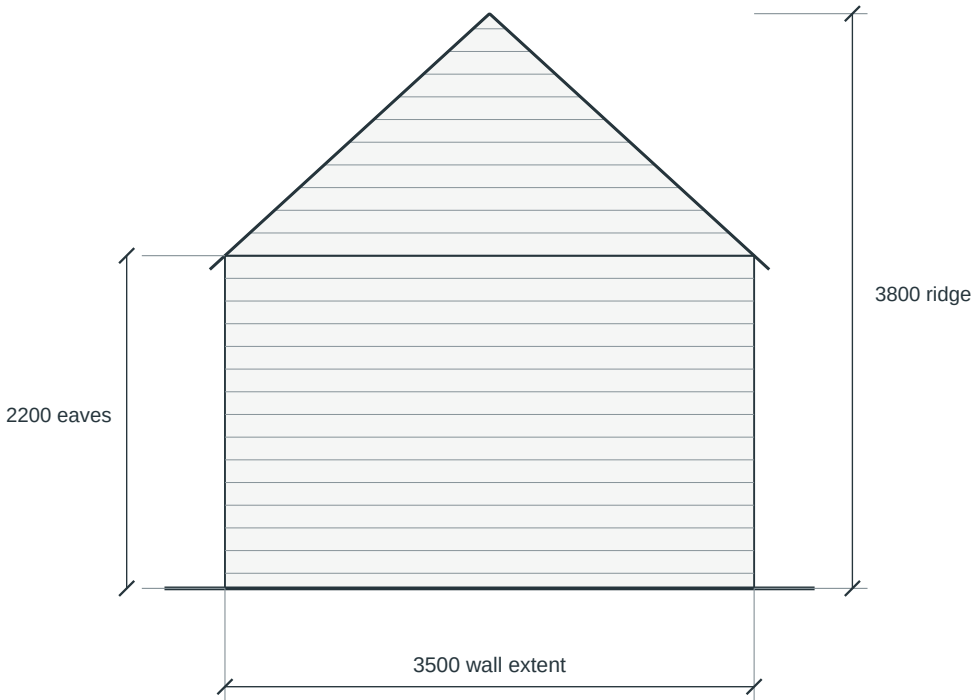
Existing building / rear elevation

Photo S5: weathered timber and blue-green doors; roof covering still to be verified.  
S2 labels roof corrugated; photograph appears tiled - confirm covering.  
Front doors schematic; rear reference indicates no openings.

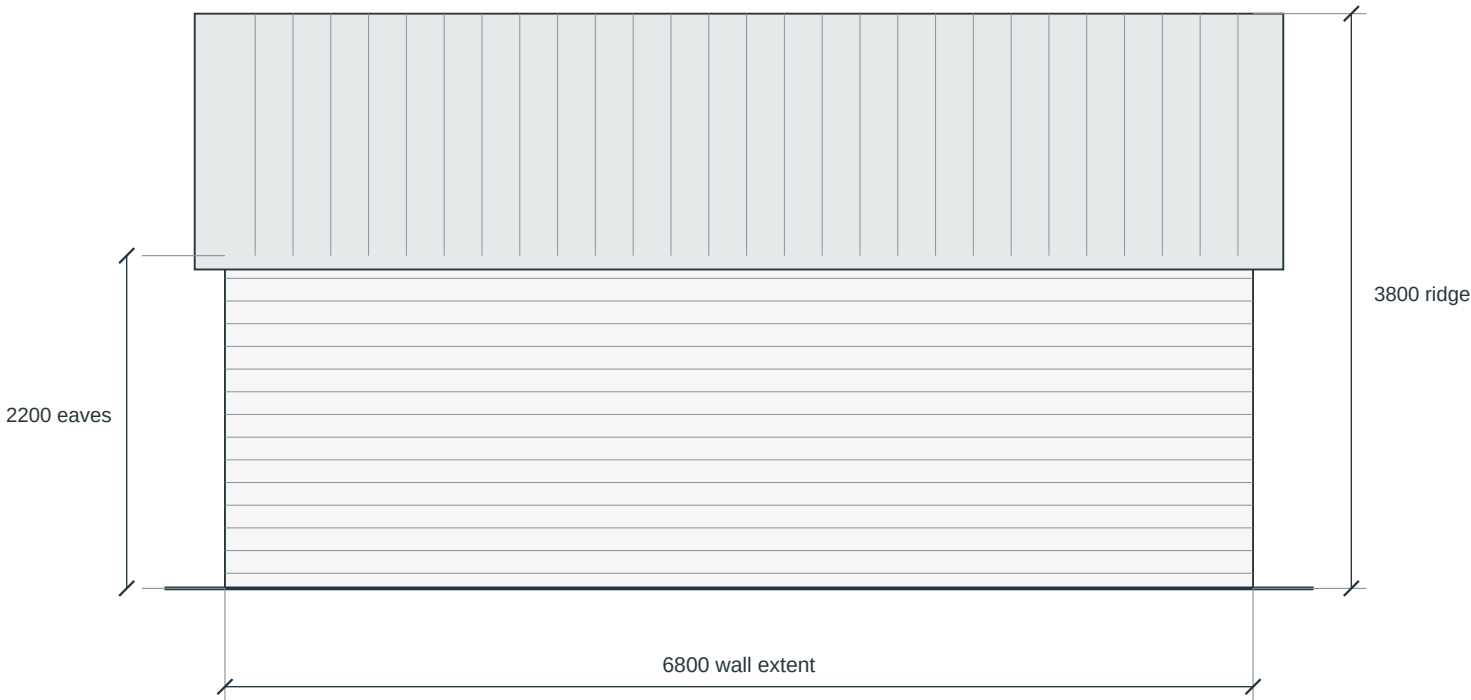
Existing building / left elevation

Photo S5: weathered timber and blue-green doors; roof covering still to be verified.  
S2 labels roof corrugated; photograph appears tiled - confirm covering.  
Side openings unresolved where original image is cropped.

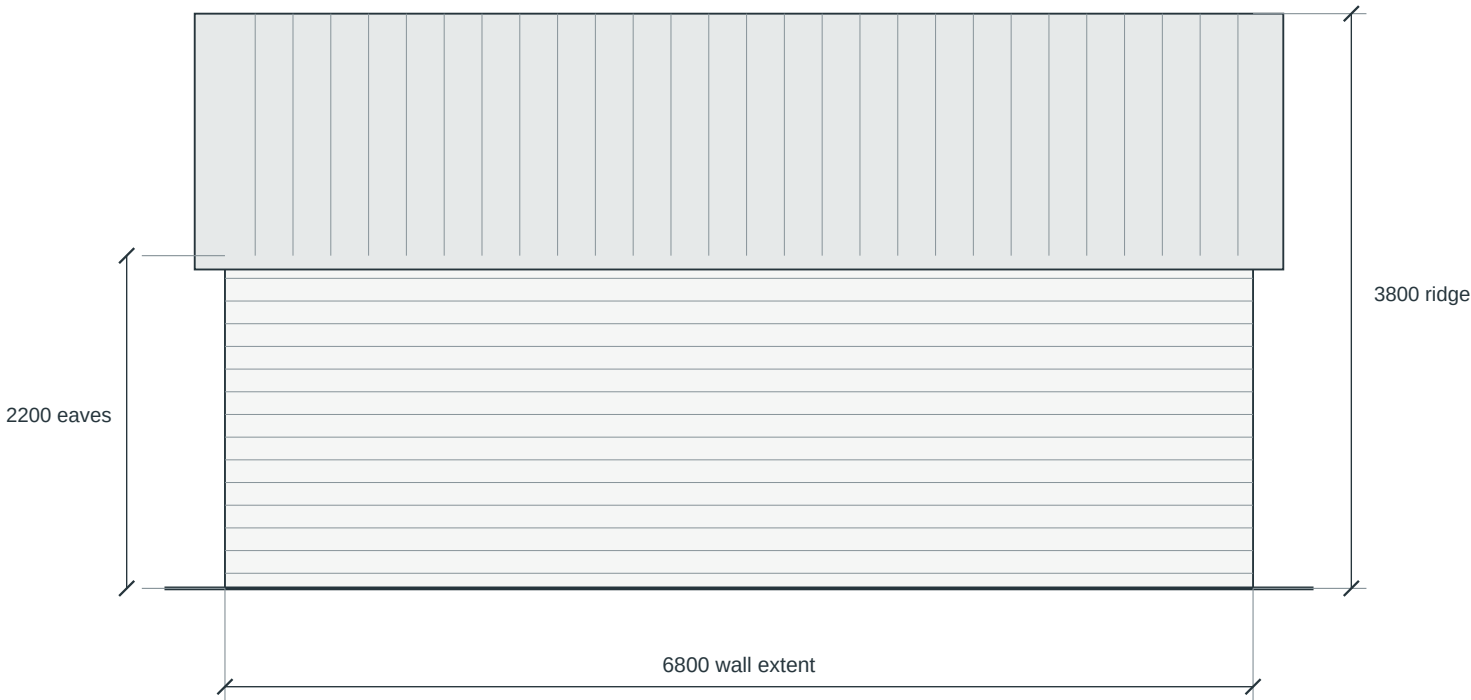
Existing building / right elevation

Photo S5: weathered timber and blue-green doors; roof covering still to be verified.  
S2 labels roof corrugated; photograph appears tiled - confirm covering.  
Side openings unresolved where original image is cropped.

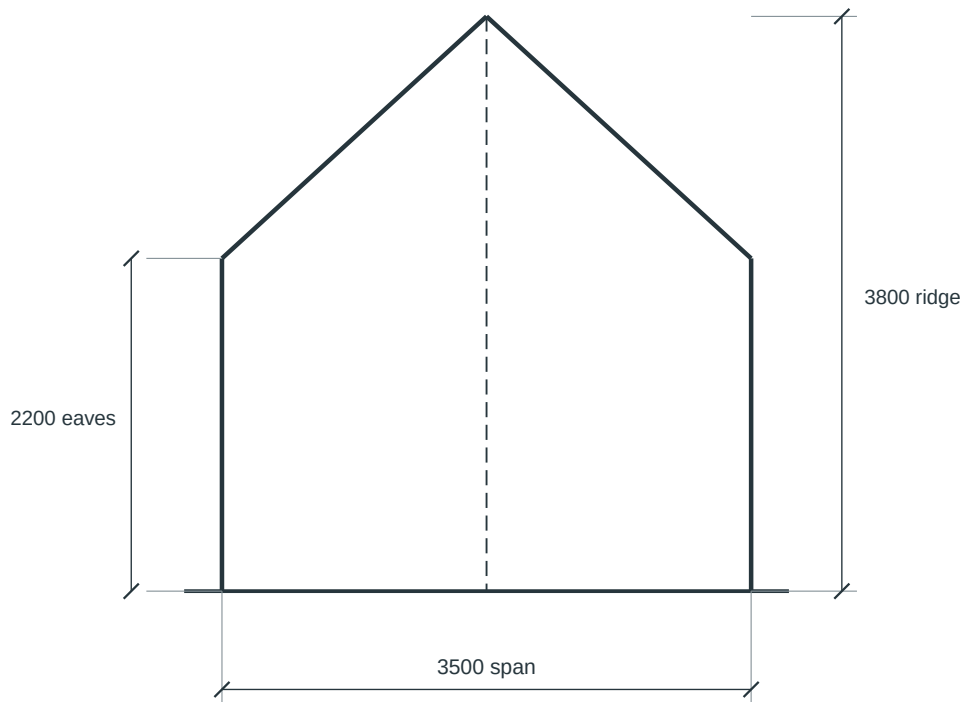
Existing building / schematic roof section

Reference roof length 7200 versus wall length 6800.

Model assumes 200 mm overhang at each end; distribution unverified.

Eave overhang 100 mm is a visual assumption.

Verify heights and ground levels.
