GARAGE REPLACEMENT / DESIGN REVIEW

Existing building / floor plan

EXISTING GARAGE / DEMOLITION

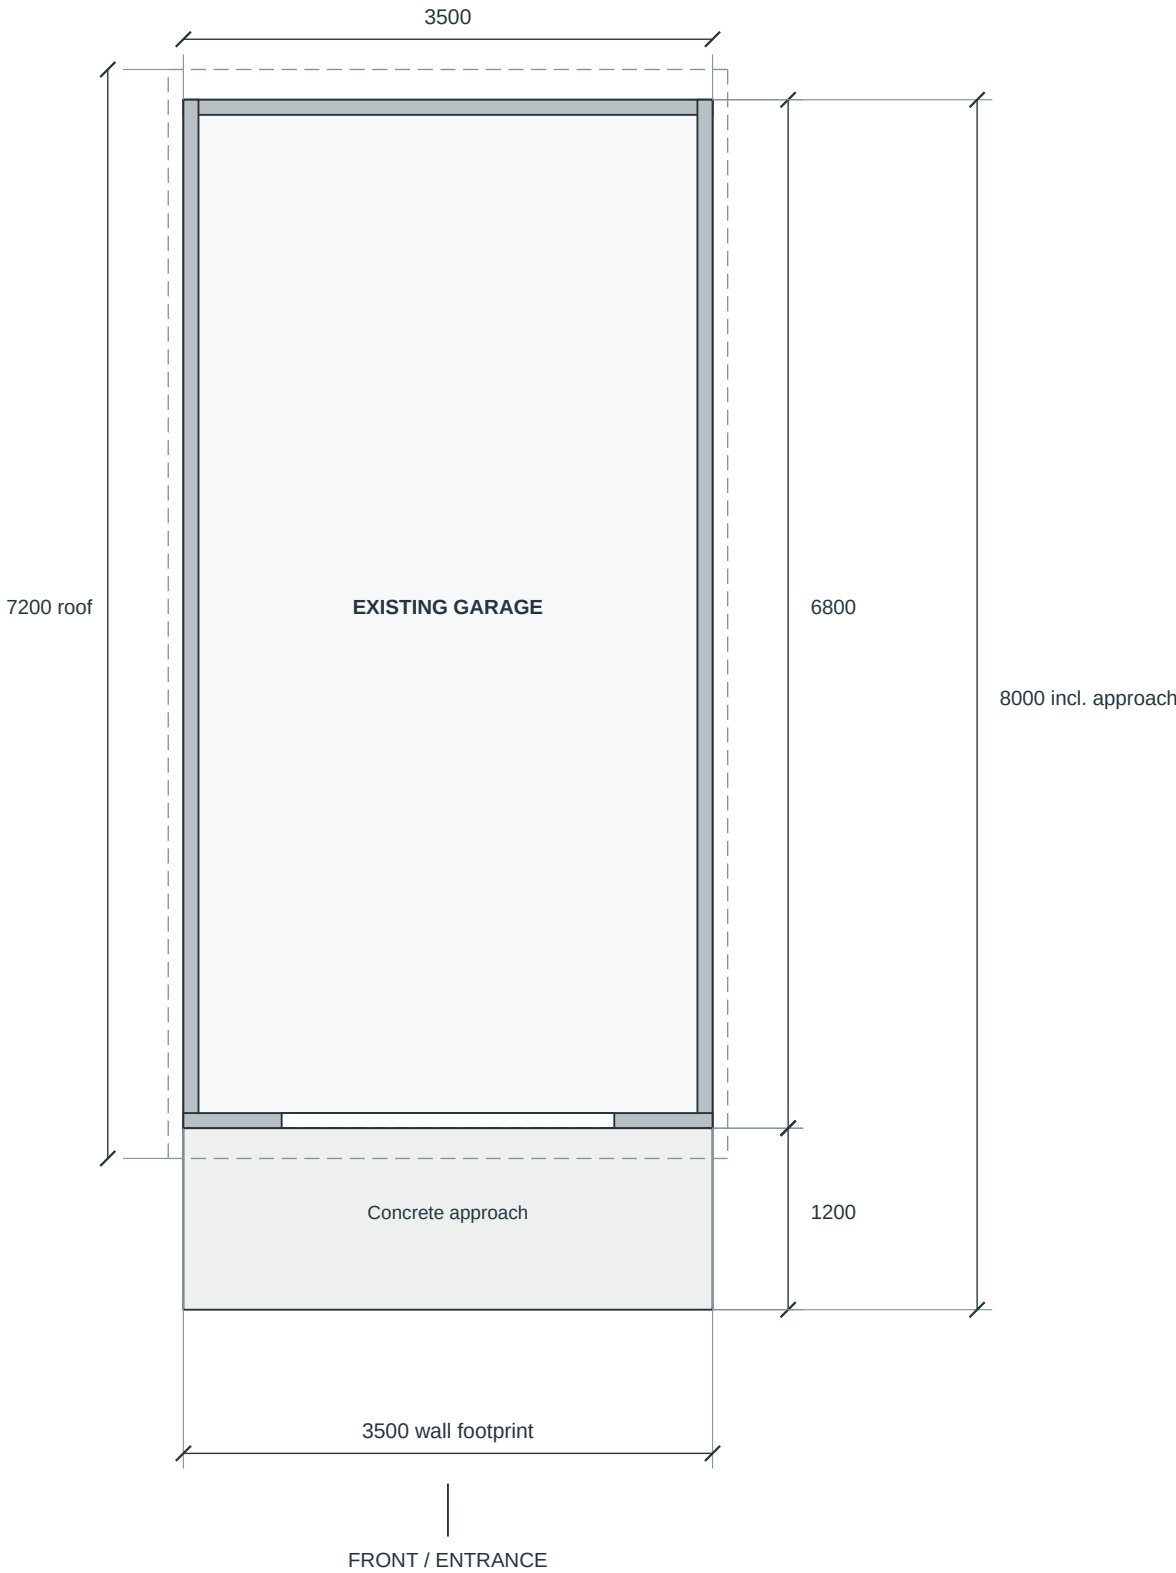
Building footprint: 6800 x 3500.  
Roof length annotation: 7200.  
Approach: 1200 beyond entrance.

Door width is unresolved.  
Dashed entrance is schematic only.  
1100 source label may describe one leaf.

Side elevations are partly cropped.  
Additional openings are not established.  
100 mm wall thickness is schematic.

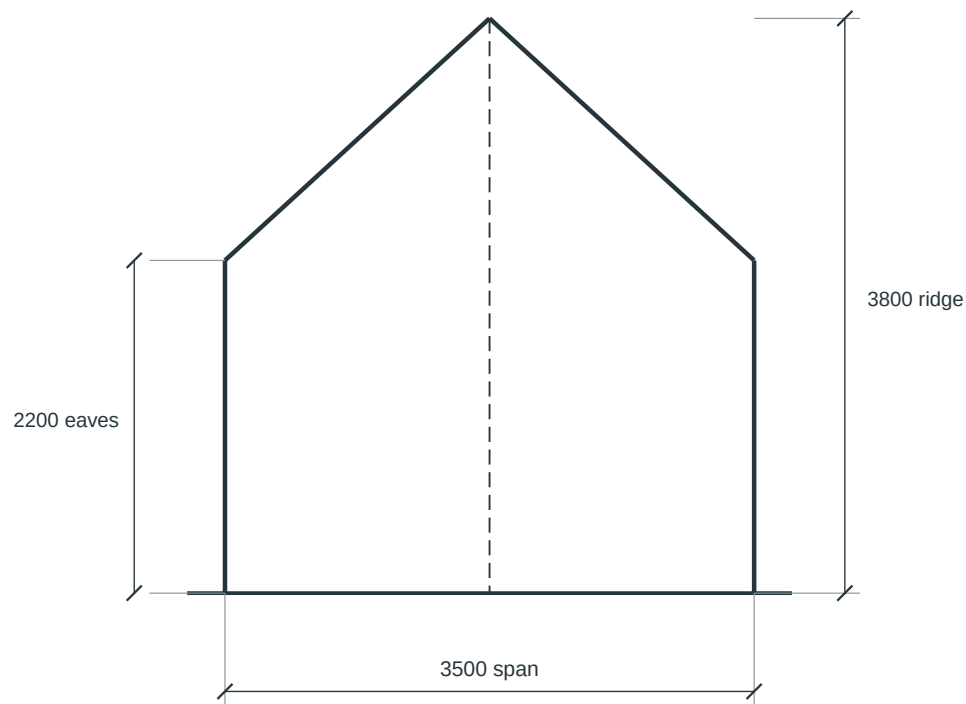
Existing building / schematic roof section

Geometric section | pitch 42.44 deg

Reference roof length 7200 versus wall length 6800.  
Model assumes 200 mm overhang at each end; distribution unverified.  
Eave overhang 100 mm is a visual assumption.  
Section cuts across 3500 width; length/approach shown separately on plan.

Section is geometric, not structural.  
Verify heights and ground levels.
