# FIRST PRODUCTION REVIEW

# FLUIDFLOW 2.0 M Art. FZ1985

PT. Hwaseung Indonesia Jepara, November 17<sup>th</sup>, 2021

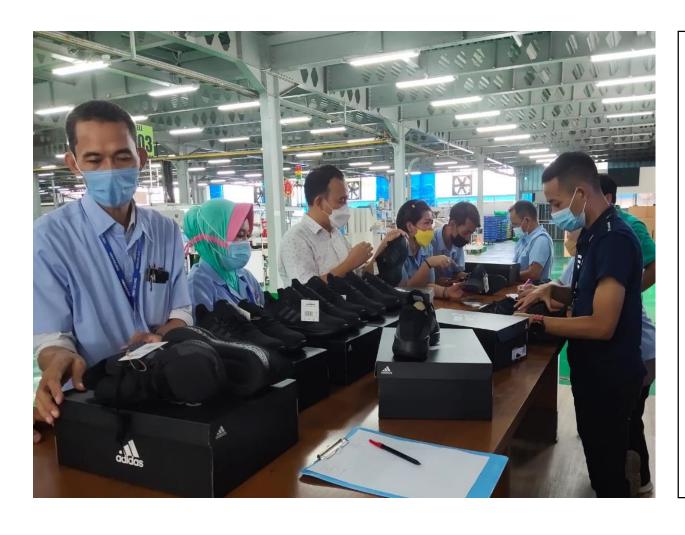
Result : Pass rate : 64% (32 from 50 pairs OK)

LO Comment : Go Ahead Production

( with note : the first production must

be repacked 100% issue dirty outsole)

Defect:

1. Dirty Outsole

2. Dirty Upper

3. Thread End

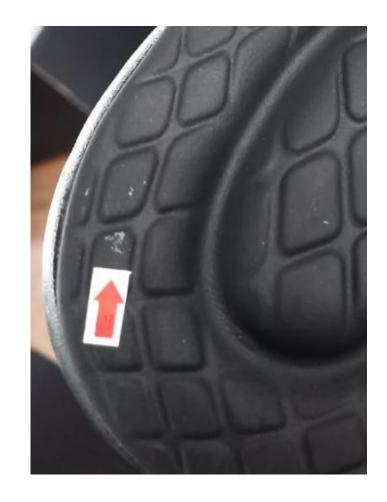
DIRTY OUTSOLE DIRTY UPPER THREAD END

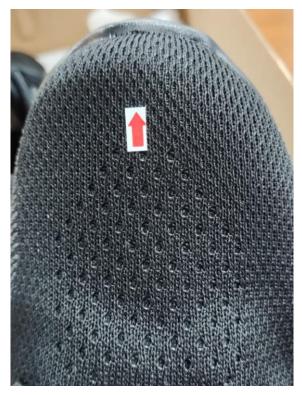
TOE OFF CENTER

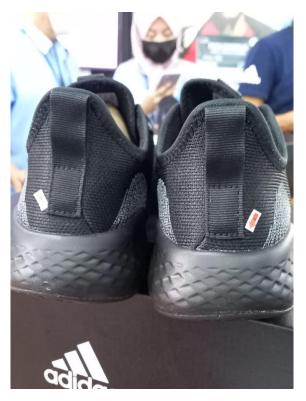
LINE UP HEEL WEBBING

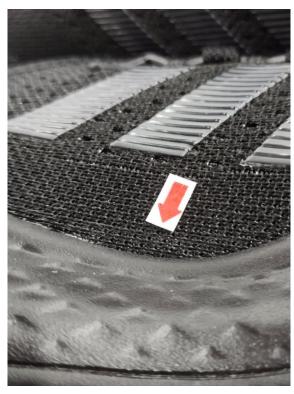
**OVERCEMENT**

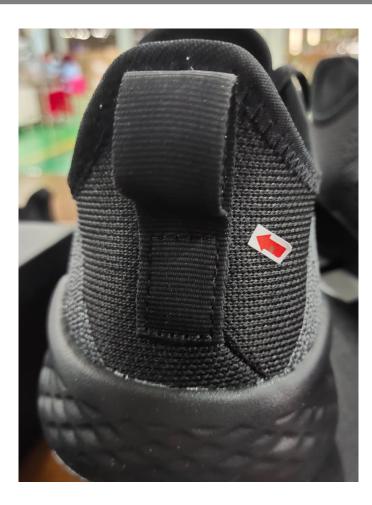
POOR SHAPE HEEL WEBBING
