Stewardship for South Fork

Lead Steward: Andrew

2023-12-18

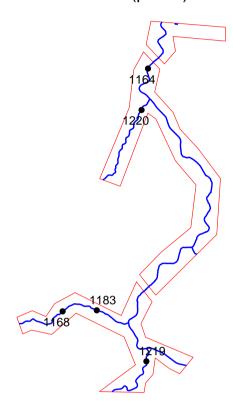
Channel Issues (points)

OBJECTID	Year	Subtype	Issue	Description	Treatment	TreatDate	Resolved
1057	2023	Channel Stability/Erosion	ErosionScour				No
1058	2023	Channel Stability/Erosion		Needs livestakes			No
1124	2023	Needs Livestakes					No
1125	2023	Channel Stability/Erosion					No
1164	2023	Failed Structure					No
1168	2023	Failed Structure					No
1183	2023	Failed Structure		Rock sill piping			No
1219	2023	Failed Structure					No
1220	2023	Failed Structure	Erosion/Scoured				No
888	2022	Channel Stability/Erosion		Sills failing	Sill fixes	01/2022	Yes
889	2022	Channel Stability/Erosion		Sills failing			No
890	2022	Channel Stability/Erosion	ErosionScour	Sills failing			No

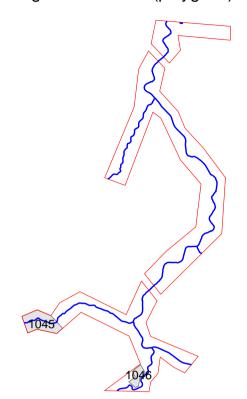
Vegetation Issues (polygons)

OBJECTID	Year	Issue	Description	Treatment	TreatDate	Resolved
1046	2023	Bare Areas, Low Stem Vigor/Height and Density	Small area of poor tree growth	planted thirty 1 gallon container trees	08/2023	No
1045	2023		Low Stem Density	Planted eighty 1 gallon container trees	02/2023	No

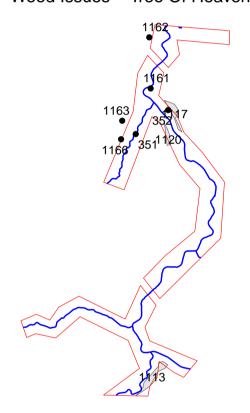
Weed Issues – Tree Of Heaven

OBJECTID	Year	Species1	Species2	Issue	Treatment	Method	${\bf TreatDate}$	Resolved
1114	2023	Blackberry	Sweet Gum					No
1115	2023	Blackberry						No
1160	2023	Blackberry	Multiflora Rose					No
1118	2023	Chinese Privet	Japanese Honeysuckle					No
1119	2023	Chinese Privet	Japanese Honeysuckle					No
1155	2023	Chinese Privet						No
1158	2023	Chinese Privet	Multiflora Rose					No
1116	2023	Japanese Honeysuckle	Chinese Privet		TOH/Privet Cut Stump	Cut Stump	06/2023	No
1157	2023	Japanese Honeysuckle						No
1159	2023	Japanese Honeysuckle	Blackberry					No
1156	2023	Multiflora Rose		Rose creeping in from outside easement				No
1493	2023	Princess Tree		Princess Tree patch	Cut stump	Cut Stump	07/2023	No
1252	2023	Sweet Gum		Thick Sweet Gum	Cut Stump Sweet Gums	Cut Stump	06/2023	Yes
1120	2023	Tree Of Heaven	Japanese Honeysuckle	TOH seedlings	TOH cut stump	Cut Stump	06/2023	No
1113	2023	Tree Of Heaven			Small re-sprouts of TOH	Cut Stump	07/2023	No

1113	2023	Tree Of Heaven			Cutstump Princess Tree/TOH	Cut Stump	07/2023	No
1117	2023	Tree Of Heaven			TOH and Privet	Cut Stump	07/2023	No
1161	2023	Tree Of Heaven	Chinese Privet					No
1162	2023	Tree Of Heaven		TOH - several stems, 1-4" DBH				No
1163	2023	Tree Of Heaven		TOH 50 stems				No
1166	2023	Tree Of Heaven		One mature, 10-20 seedlings				No
1127	2023							No
352	2022	Tree Of Heaven			Cut Stump	Cut Stump	06/2023	No
351	2022	Tree Of Heaven	Princess Tree	Three medium sized trees				No
337	2021	Multiflora Rose	Blackberry		Weedwhack Blackberries	Other	12/2021	No
547	2021			Murdania in riffles				No
183	2020	Chinese Privet			Cut Stump		12/2021	No
186	2019	Chinese Privet	Japanese Honeysuckle		Cut Stump	Cut Stump	12/2021	No
185	2019	Chinese Privet	Princess Tree	Chinese privet - small to large stems	Cut Stump	Cut Stump	12/2021	No
