Disk / Hub corrosion

Loose wheel retaining bolts

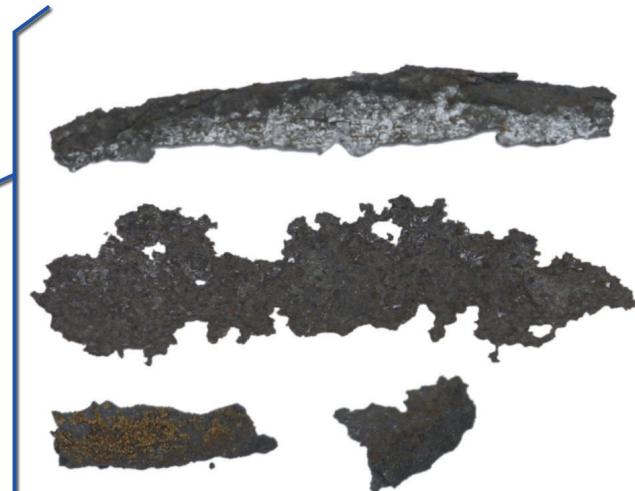
The reason identified for this problem is corrosion between the disc and hub mounting faces. Although when securing the road wheel retaining bolts to the correct torque, the bolts can loosen during vehicle use.

This is because corrosion present between the hub/disc mounting faces will gradually be converted to dust, thus resulting in a clearance, reducing the initial wheel bolt torque applied and allowing the bolt to loosen.

Magnified rust pieces

To prevent this always ensure the mounting faces of both disc and hub are clean and free from corrosion. If there is any doubt in the suitability for continued service of any component always replace with new guaranteed parts, where necessary in axle sets.
