MINING DEALER BEST PRACTICE

# Cooling System Performance for LWL 994

**August 2013**  
**1212-1.01-1303**

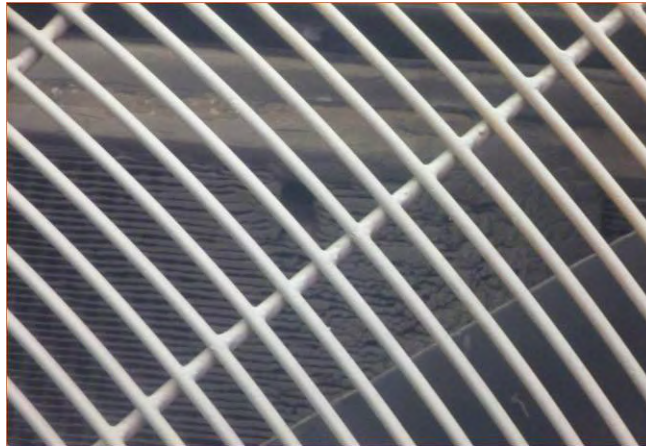
Image 1- Exterior clogging of the implement's core

The data analysis compared to previous experiences may indicate that less air amount is going through the radiator, impacting directly on the cooling system performance.

Repair actions, such as cleanliness, parts replacement, etc. can be generated depending on the analysis.
