MINING DEALER BEST PRACTICE

# Cooling System Thermal Inspection

**January 2015  
1411-1.01-1359**

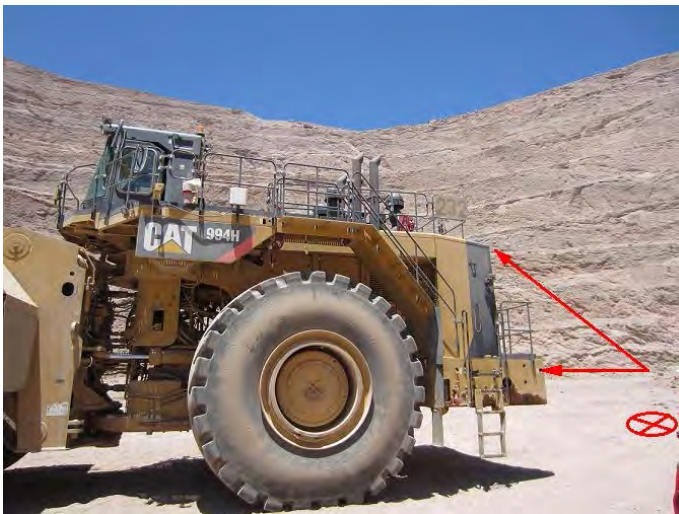
**Fig1.** Location to register thermal image

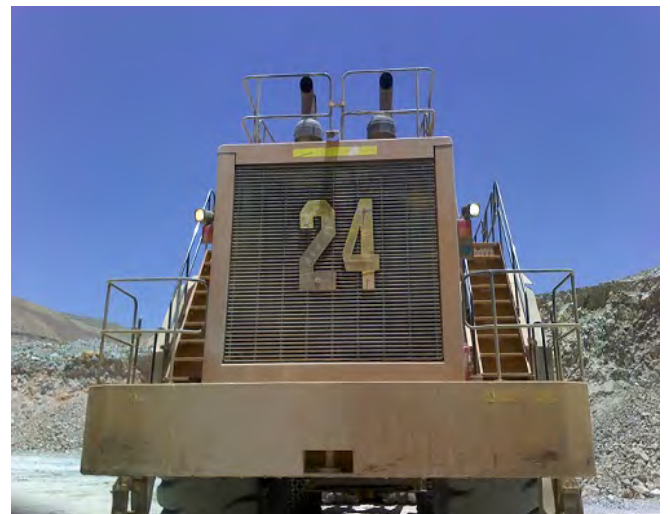
**Fig2.** All radiator must be captured completely on the thermal image area
