BEST PRACTICE SERIES

# Wheel Loader Lubricated Pin Inspection

NUMBER  
0909-1.01-1183

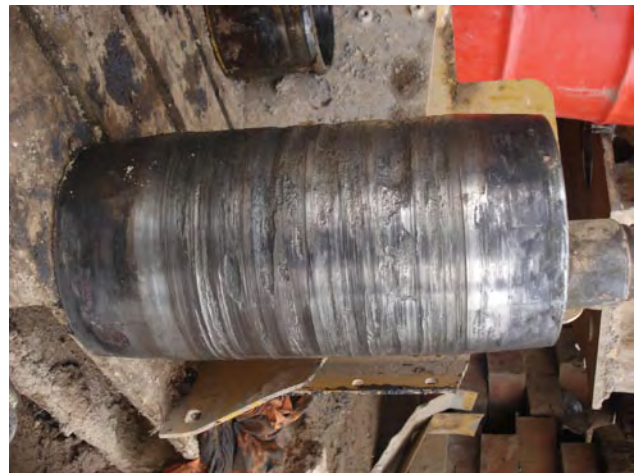
These pictures show the effects of uncontrolled wear and lubrication problems.
