DEALER BEST PRACTICE SERIES

Failure Analysis Report

| Failure Analysis Report | DATE<br>1/13/2015 | CHG<br>NO<br>01 | NUMBER<br>0911-1.04-1226 |

## Sample Report

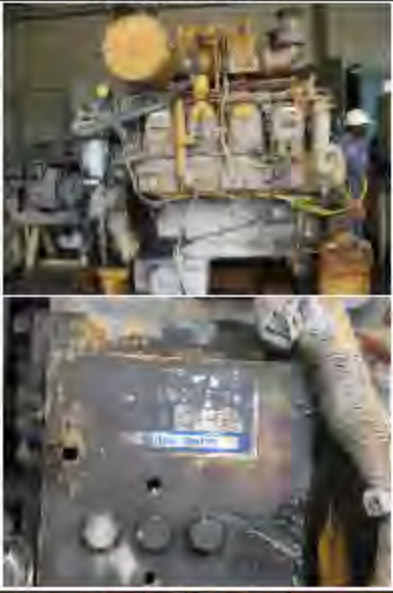
| <h2 style="text-align: center;">FAILURE ANALYSIS REPORT</h2> | |
|---|---|
| Engine condition during received at KKCRC. | |

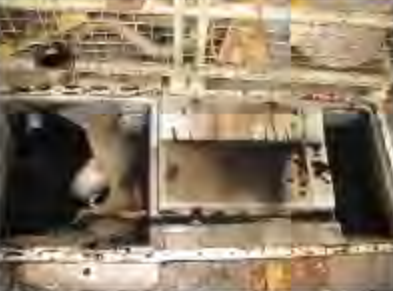
| <h2 style="text-align: center;">FAILURE ANALYSIS REPORT</h2> | |
|---|---|
| Oil pan after been removed. We found two pieces of thrust washer inside this oil pan which later identified coming from rear idler gear for PTO | |

The copper found in the oil filter came from broken thrust washer P/N 7N-3006 at the PTO idler gear rear. Further inspection on broken face of thrust washer found different appearance, one side is dark rough and the other is smooth bright. The thrust washer has been cracked first before it fully broken.

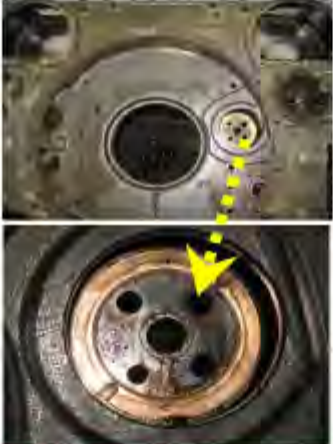
| <p>The opposite thrust washer toward the front of engine still attach on the flywheel housing. This mean the broken thrust washer is on the side toward the rear of the engine</p> | |

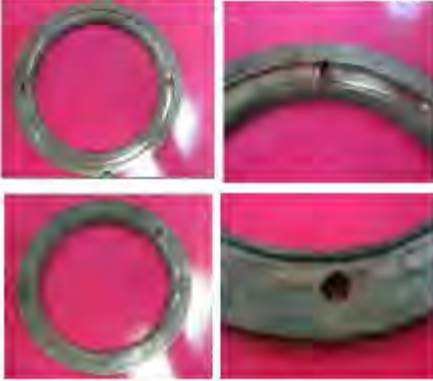
| <p>Complete picture of above thrust washer. The face toward the flywheel housing is worn out as deep groove due to rotating and rubbed by the dowel. While the face toward the gear has deep worn out as in friction with the gear. These happened after the opposite thrust washer broken and drop down causing increase of clearance/end play</p> | |
