## DEALER BEST PRACTICE SERIES

# Contamination Control Covers During Components Removal and Installation

NUMBER  
1106-3.04-1235

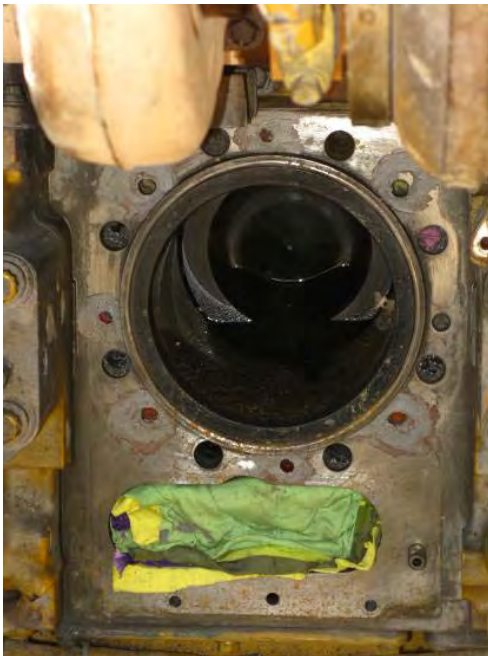
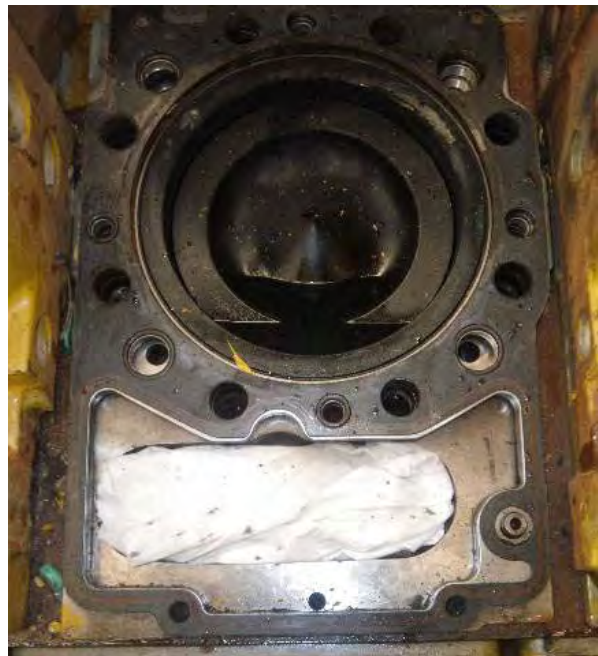
### Case 1: Cylinder Block Protection Cover

The picture shows the cylinder area exposed to the contamination during cylinder head removal and installation. The camshaft area is plugged with a wad of cloth that can cause the component to be exposed to additional contamination.

Considering continuous improvement and aiming at the contamination control of the work done at mine site, the use of a protector (acrylic) for the equipment repairs has been implemented. The cover protects the exposed area when the component is removed, improving the working conditions (reducing the risk of equipment damage).
