## DEALER BEST PRACTICE SERIES

# Tool to Repair Damaged OHT Exhaust Pipe

**June 2011**  
**1011-1.04-1218**

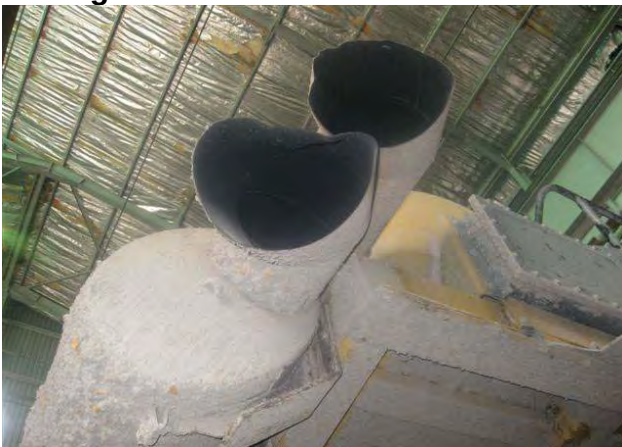
### Damaged exhaust on LOHT:

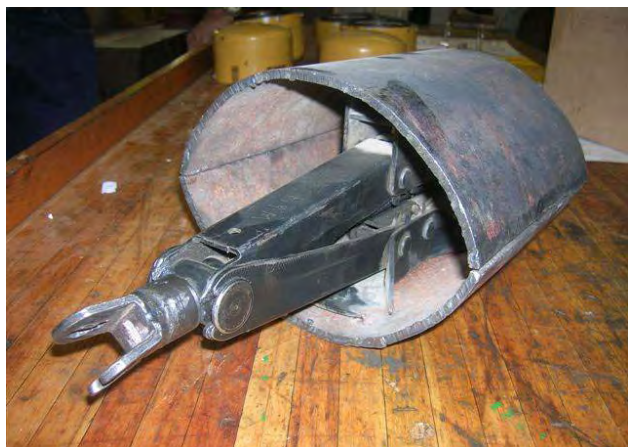
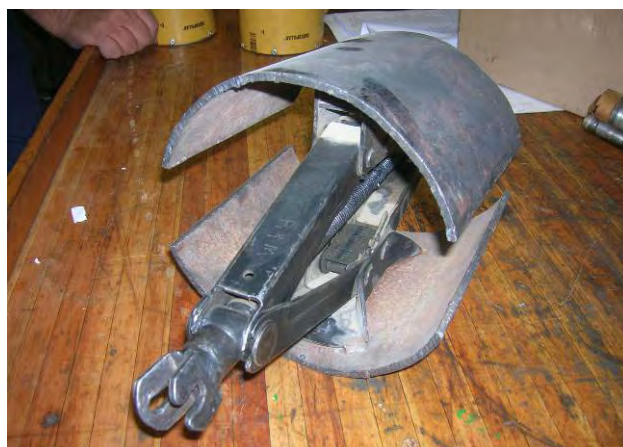
Scissor-jack tool with plates welded to jack.

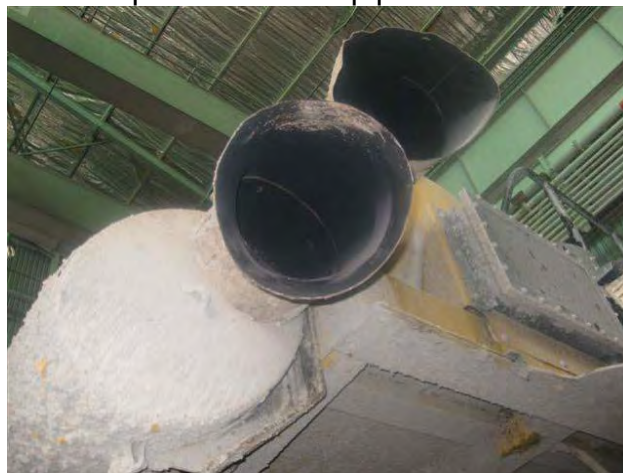
Install tool in exhaust and extend to straighten. Photo of repaired exhaust pipe.
