MINING DEALER BEST PRACTICE

# Changing the Position of the Jack Sensor Box – MD6640

**February 2022**  
**1.10-220218-1**

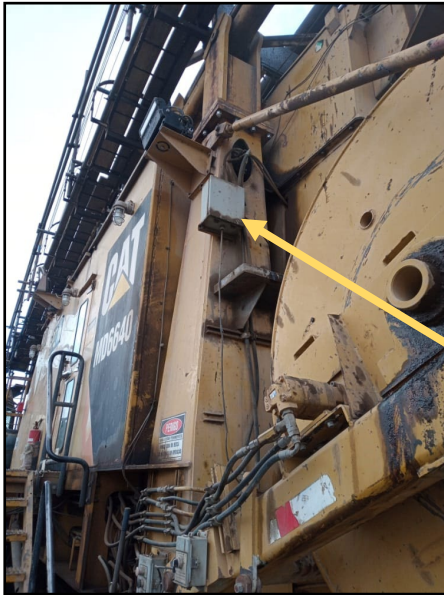
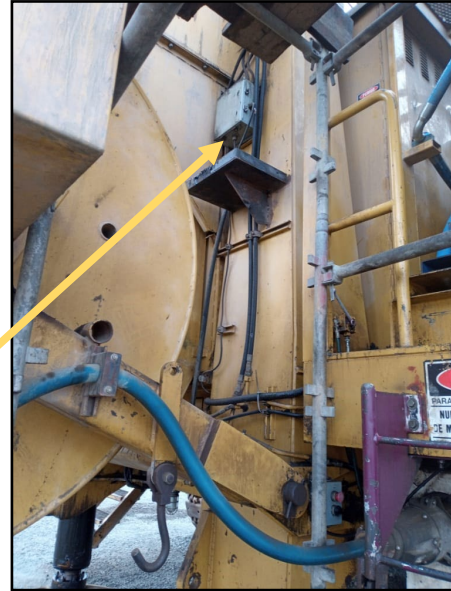
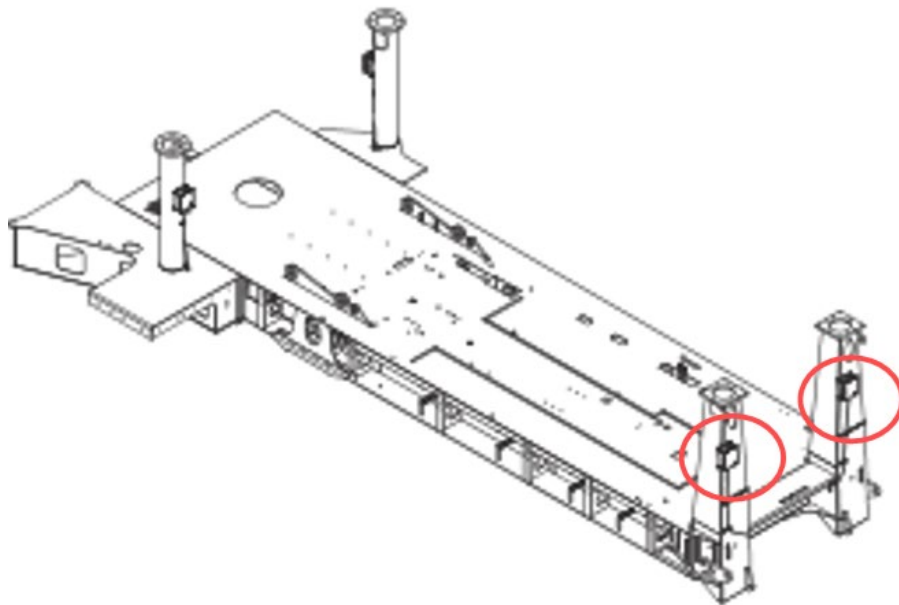
The maintenance and repair of the sensors of the front jacks to the activity in the MD6640 is done at a height of approximately 3 meters in a condition of difficult access, without a fixed anchor point, without a support base appropriate, exposing the technician to a high risk of falling during the execution of the activity.

Jack sensor box  
factory default position
