# Spreader Bar Protection

**Maintenance and  
Repair**

| THE INFORMATION HEREIN MAY NOT BE COPIED OR TRANSMITTED TO OTHERS WITHOUT THE WRITTEN PERMISSION OF CATERPILLAR | | | |
|---|---|---|---|
| | 7/10/2015 | 00 | 1505-1.10-1378 |

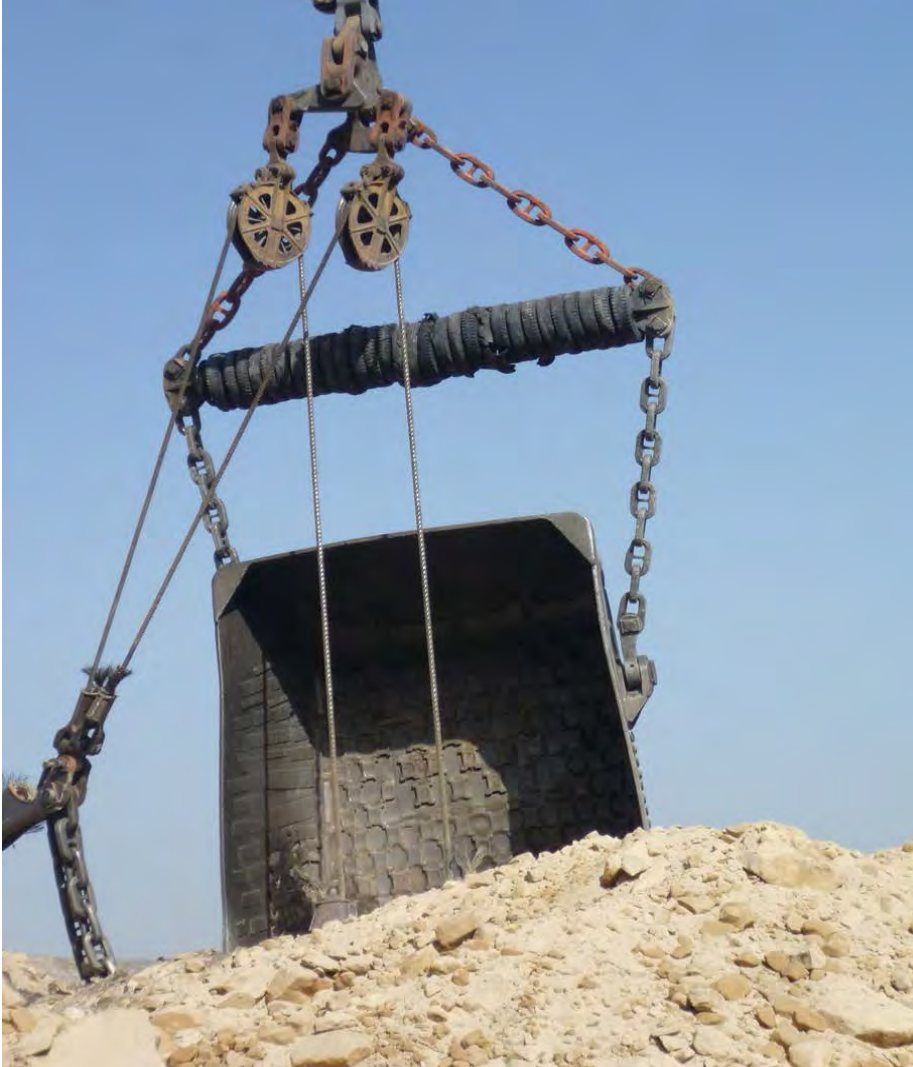
The dragline uses hoist chains to lift the bucket up and lower it down. Hoist chains are on both sides of the bucket. A spreader bar is between the upper hoist chain and lower hoist chain and it is used to prevent the hoist chains rubbing on the bucket. See below picture.

**Figure 1 Spread bar with rubber protection**

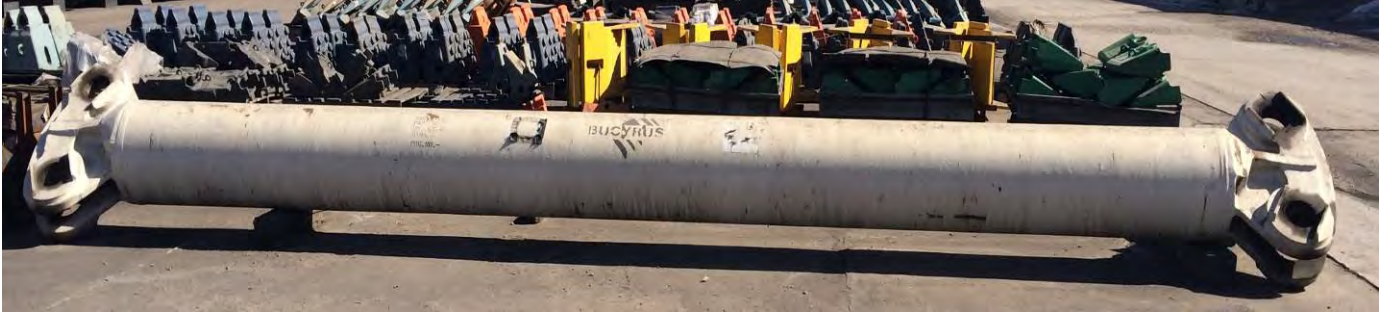
Figure 2 New spreader bar

The dimensions of a new spreader bar will vary depending upon the size of the bucket.

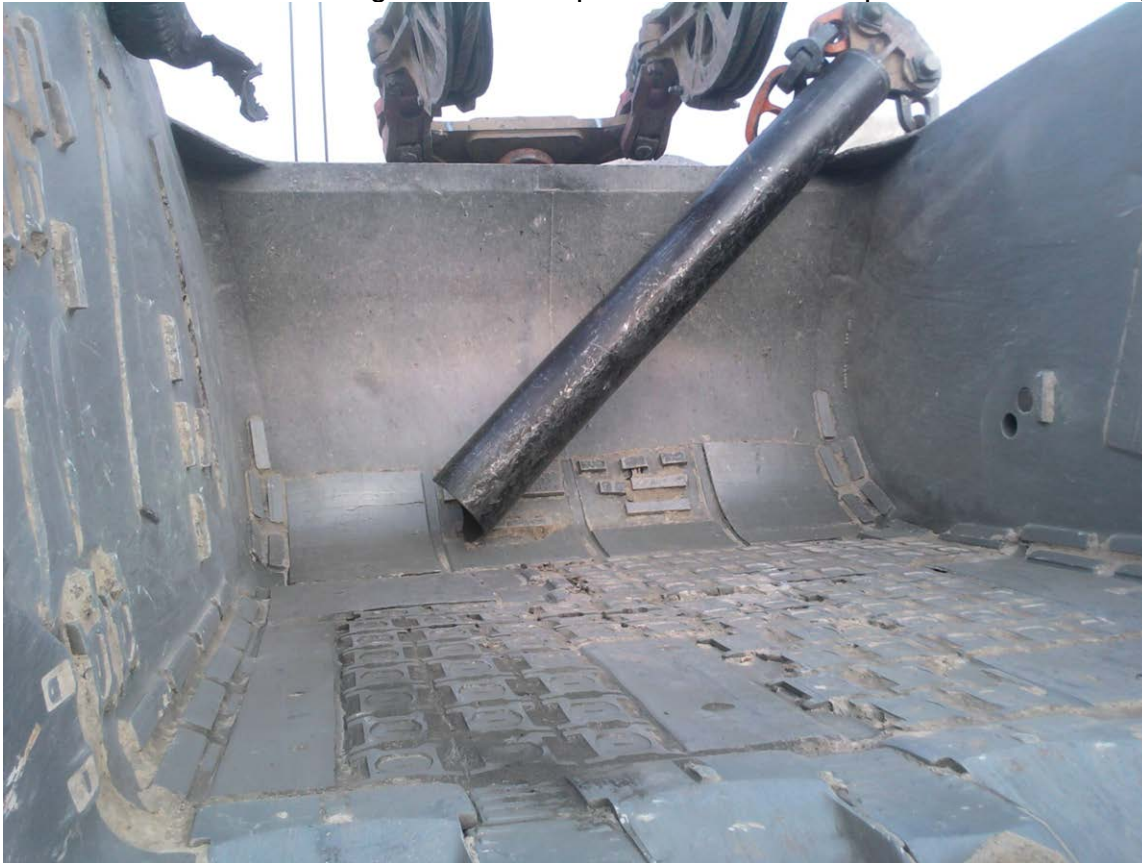
For initial operation of the dragline, especially for new operators, the service life of the spreader bar is very short, about two months. Sometimes even shorter to about a few hours depending on the operator's skills. Once it was broken, maintenance people must rush to the site, a crane must be used to restore the dragline back to operation as soon as possible, even at night shift.

Figure 3 Broken spreader bar

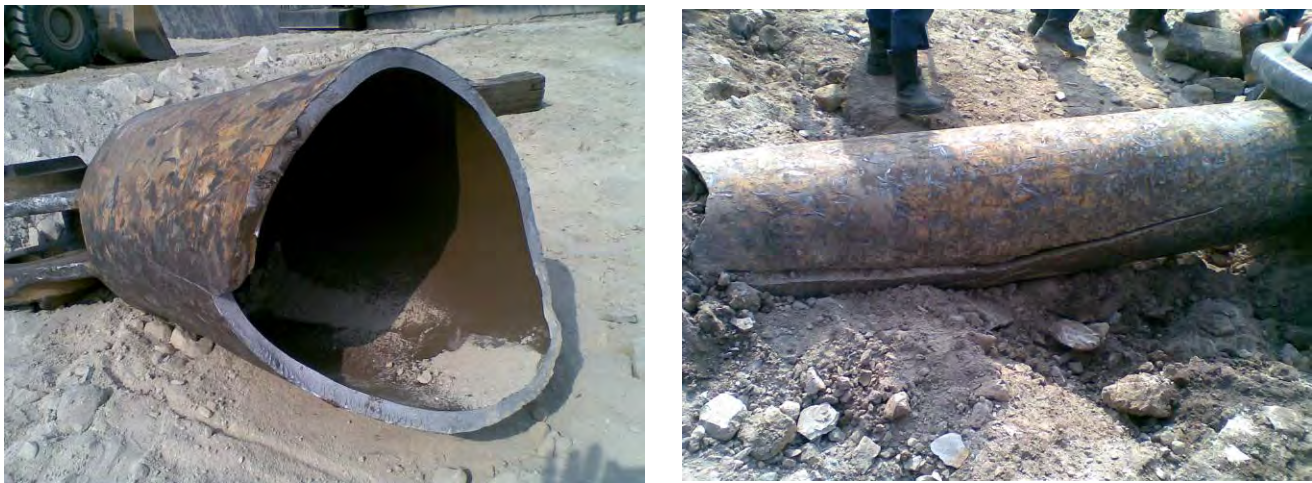
Figure 4 Typical Failures

Most of spreader bars were broken by hitting the top of the bucket. The key to prolong the service life of the spreader bar is to prevent it from hitting on the bucket, which seems impossible. Given they cannot completely avoid the spreader bar hitting against bucket, a method to reduce the hitting force was created. Used rubber tires are put on the spreader bar to reduce direct impact to spreader bar. It has been proven this works effectively. See Pic 5 and Pic 6 below.

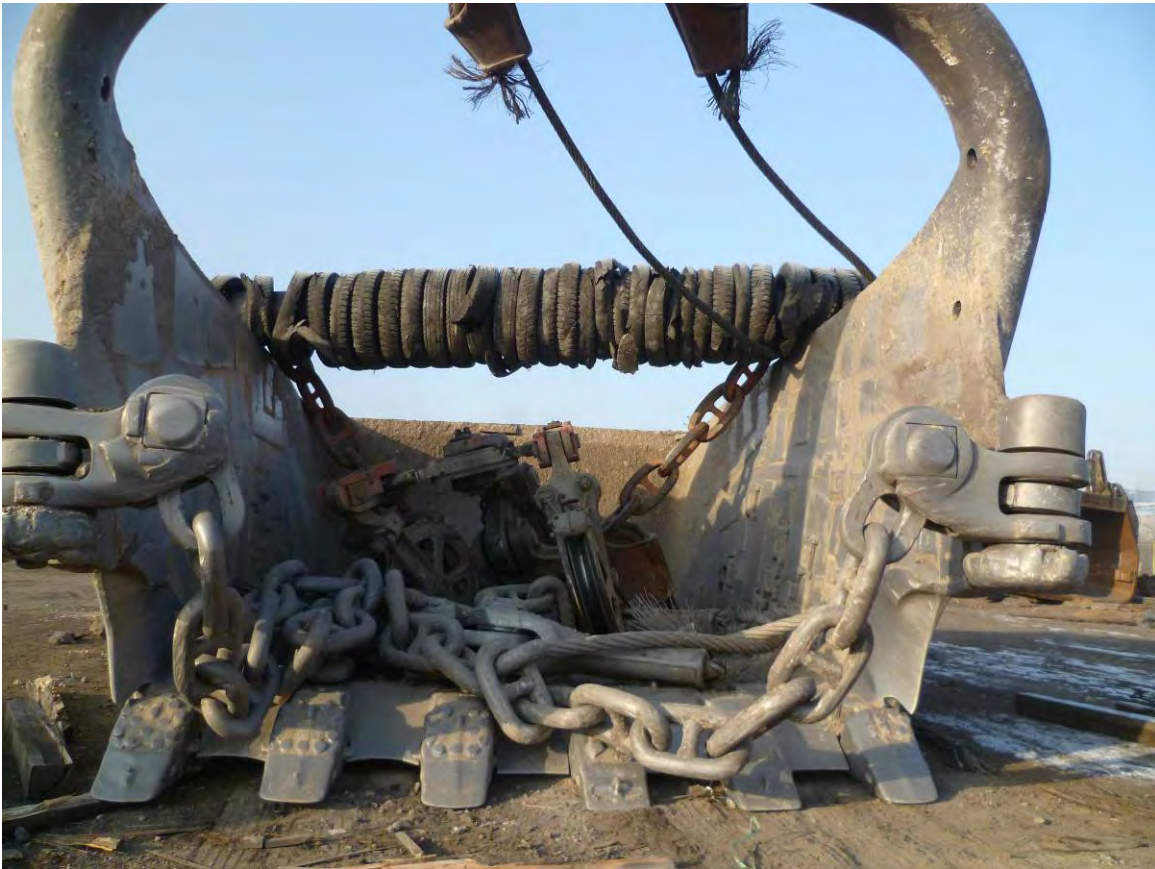
Figure 6 Spreader bar with rubber protection

Find and collect the old useless rubber tires, make sure the inner hole diameter is over 20 inches and the outer diameter is roughly the same. Put them on the spreader bar one by one closely.

Depending on the tube size and length of the spreader bar, the quantity and size of the rubber tires used on the spreader bar will vary accordingly.
