# Improving the Hydraulic Fluid Cleanliness of 794AC Fleet

Maintenance and  
Repair

November 2021  
3.03-211105-1

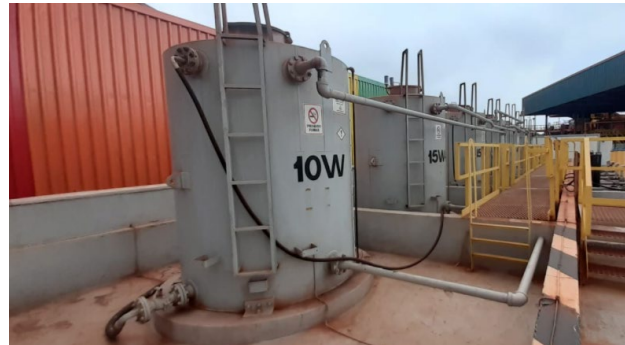
One of Sotreq's largest customers encountered the following SAE 10W SOS results out of specification in the hydraulic systems of their 794AC Fleet and bulk storage tanks.

**Source/Picture 1:** Customer/Dealer SOS Results and SAE10W at oil tank in site

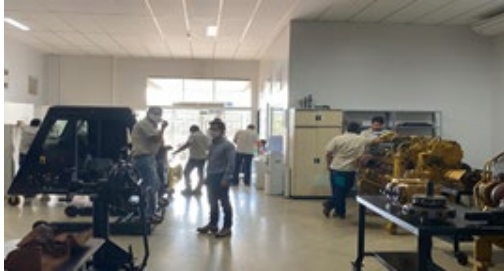
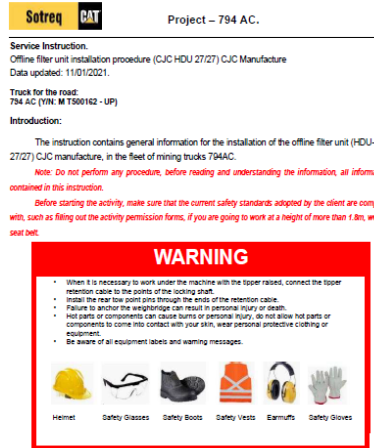
**Pictures 7 – Service Training, On-board Filtration Guideline, Risk Assessment, Unit at Upper Platform**

Training of the technician on both the operations and maintenance of the on-board filtration system was conducted through use of the documentation and in practice. All the safety aspects were identified, mapped, and mitigated during a risk assessment.
