MINING DEALER BEST PRACTICE

# 3500 Engine Exhaust Manifold Salvage

**August 2024**  
**4.02-240819-1**

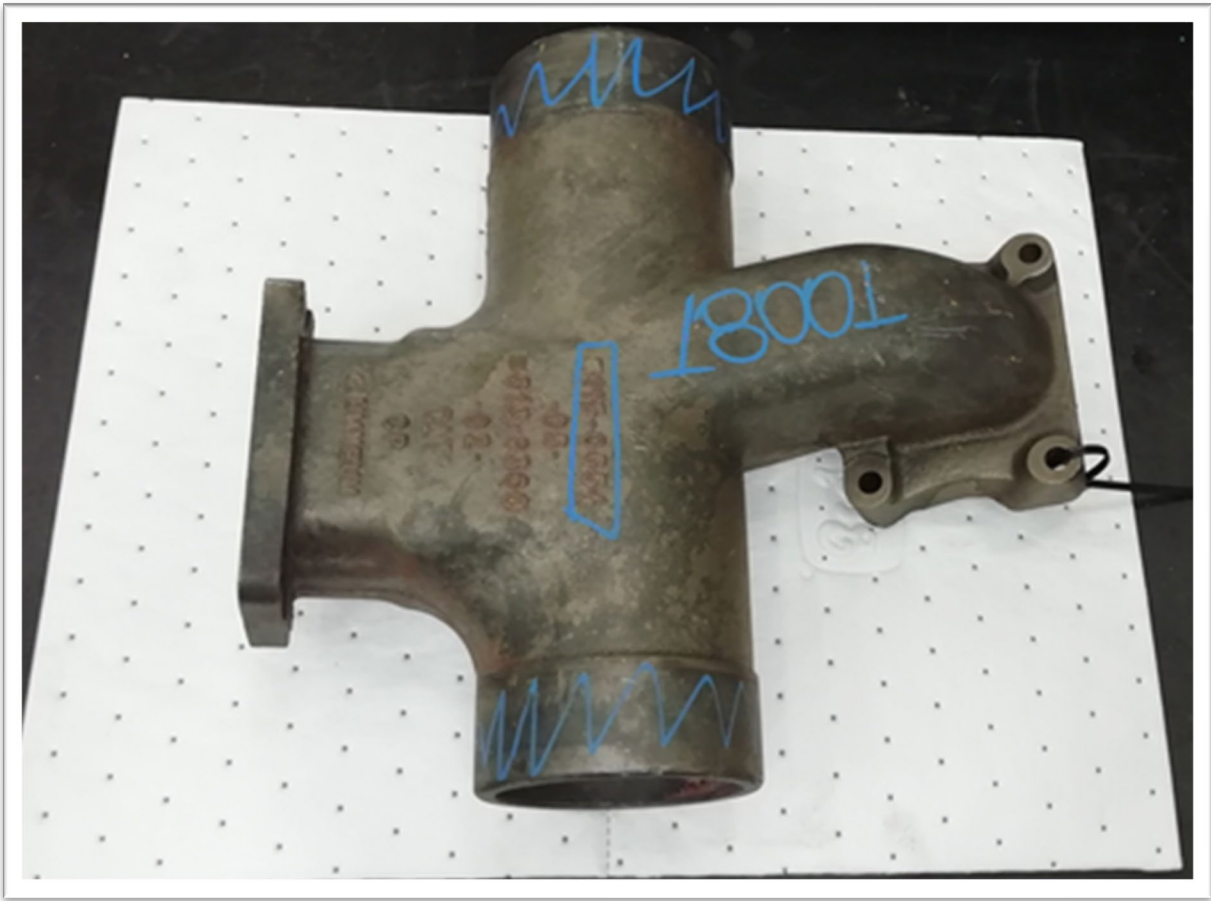
Figure 1. Typical 3500 Exhaust Manifold

This new process has been developed at MATCO machine shop to salvage the 3500 exhaust manifold ends when fretting and pitting exists. The salvage procedure is an alternative that is more durable than a machined sleeve.

The salvage procedure consists of pre-machining the exhaust manifold to remove the damage, thread cutting the surface to be salvaged, metal spraying the surface, and finally machining the outside diameter.
