MINING DEALER BEST PRACTICE

# C175 Main Oil Gallery - D&A Debris Protection

May 2016  
1605-4.01-1432

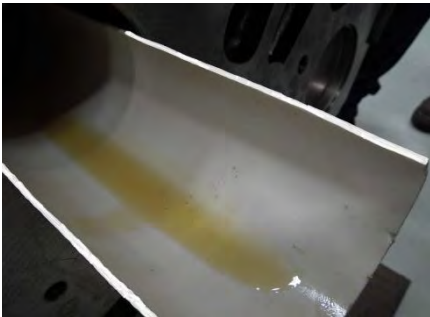
In this example, 75mm PVC tubing has been cut in half lengthwise, and cut to block length, and inserted into the main oil gallery of a C175 engine. As the camshaft bearings are pressed into the block, any small metal shavings that are generated during installation will fall into the main gallery and be caught by the tube (tube has been slid out partly for illustration purposes).

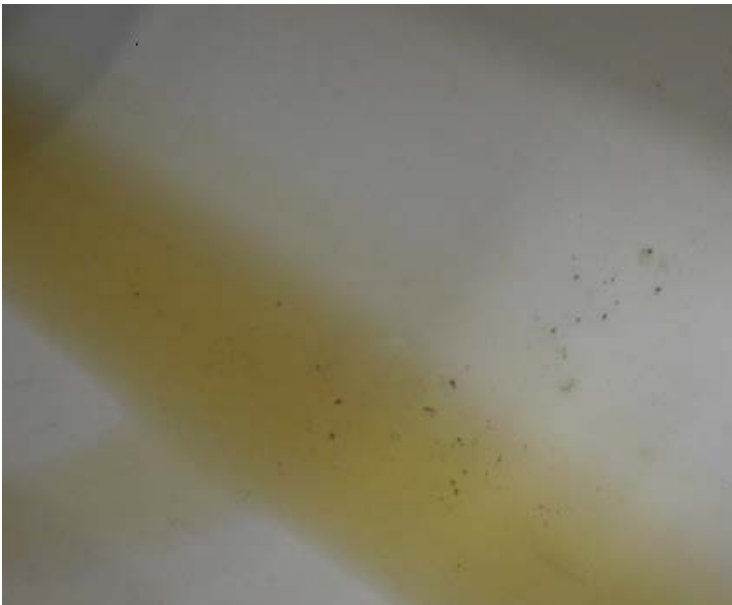
Here is a close-up of bearing filings that were caught in the tube from one bearing.
