## MINING DEALER BEST PRACTICE SERIES

# 3500 Engine Series Water Lines Group Parts Salvage

March 2013  
1210-4.02.1294

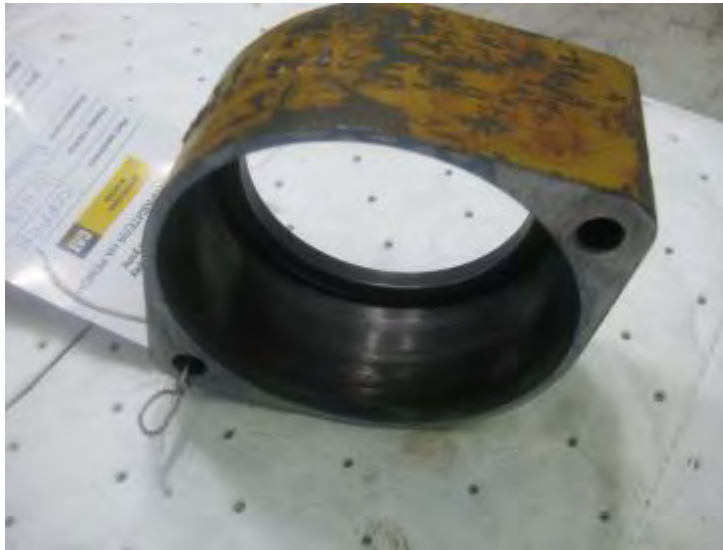
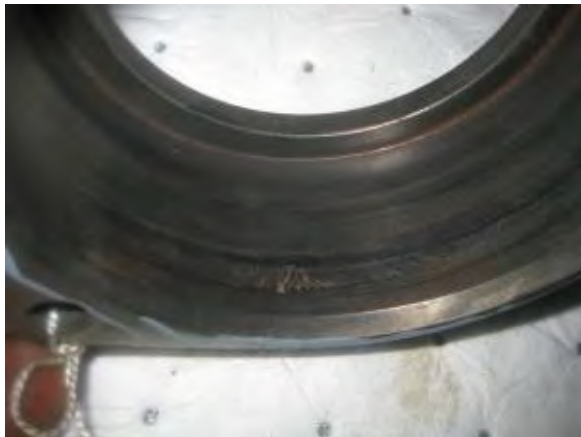
The parts of water line groups, such as flanges, bonnets and elbow tubes, usually have damaged connecting areas. The damaged areas are machined down and fabricated sleeves are installed to enable reusing the parts.

*Damage component –Flange 146-7383*

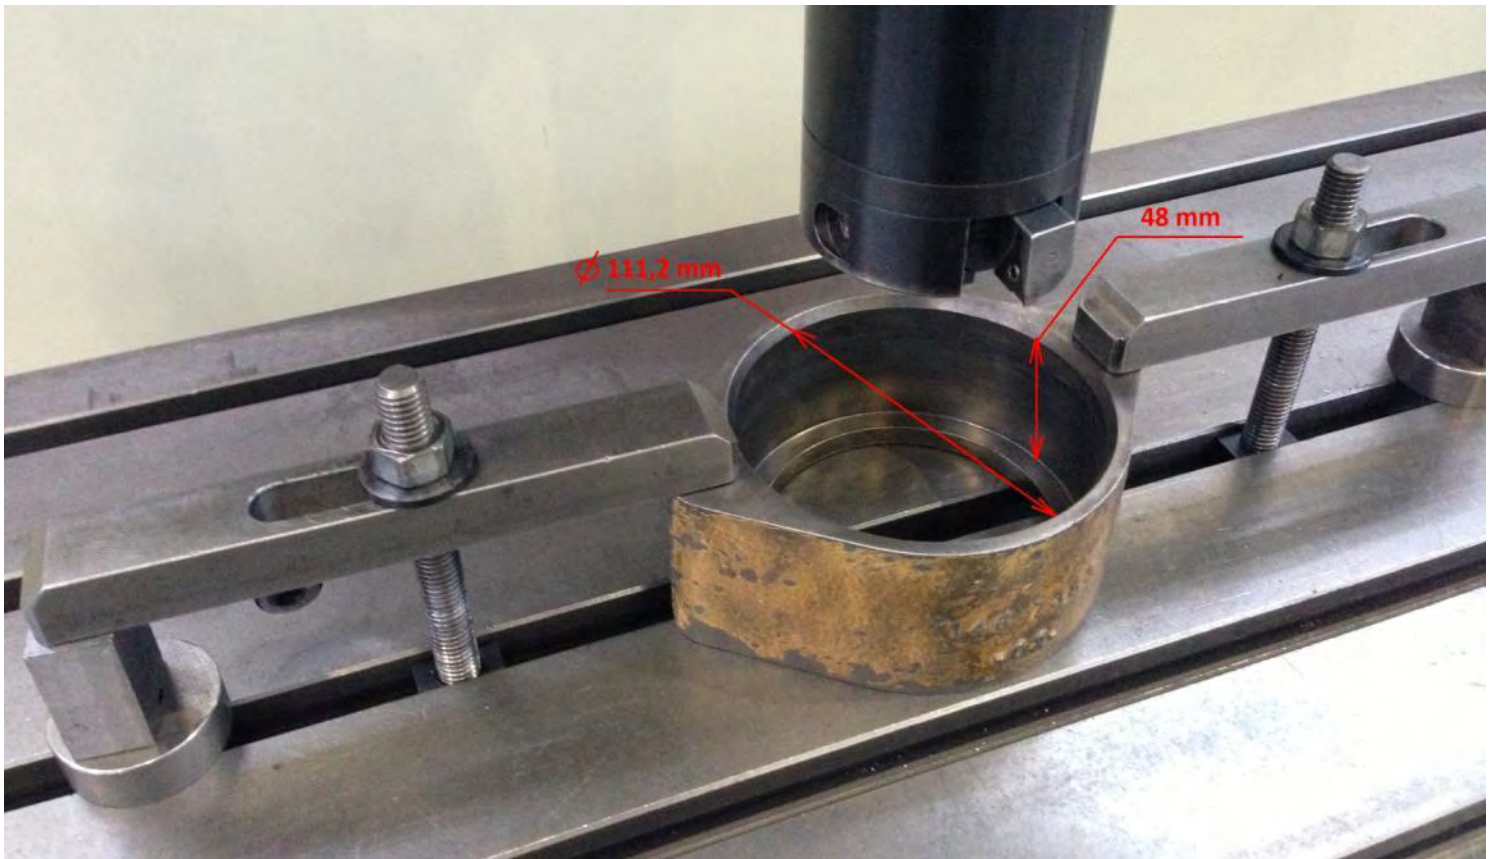
*Machining the Flange 146-7383*

- Make sure the part has been properly cleaned before beginning of the repair
- Inspect the part for cracks. If there is a crack, salvage of the component is not recommended.
- Machine the bore of the flange 146-7383 to 111.2 mm ID; and depth of 48 mm.

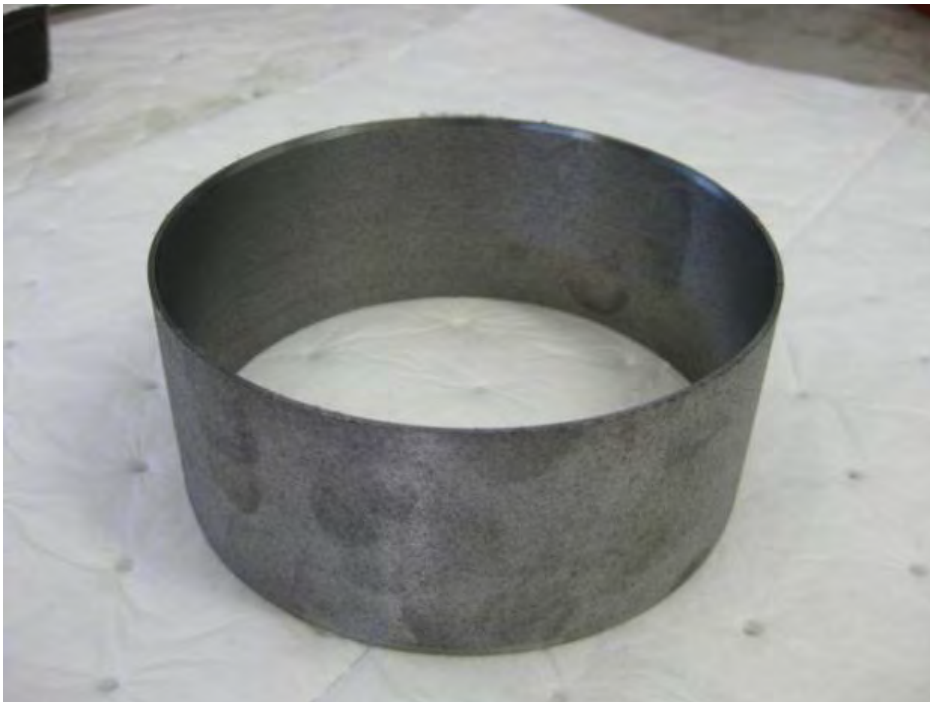
*A fabricated sleeve*

- Fabricate a sleeve using ASTM A48 -30B (Gray Iron). Detailed dimensions are given below.

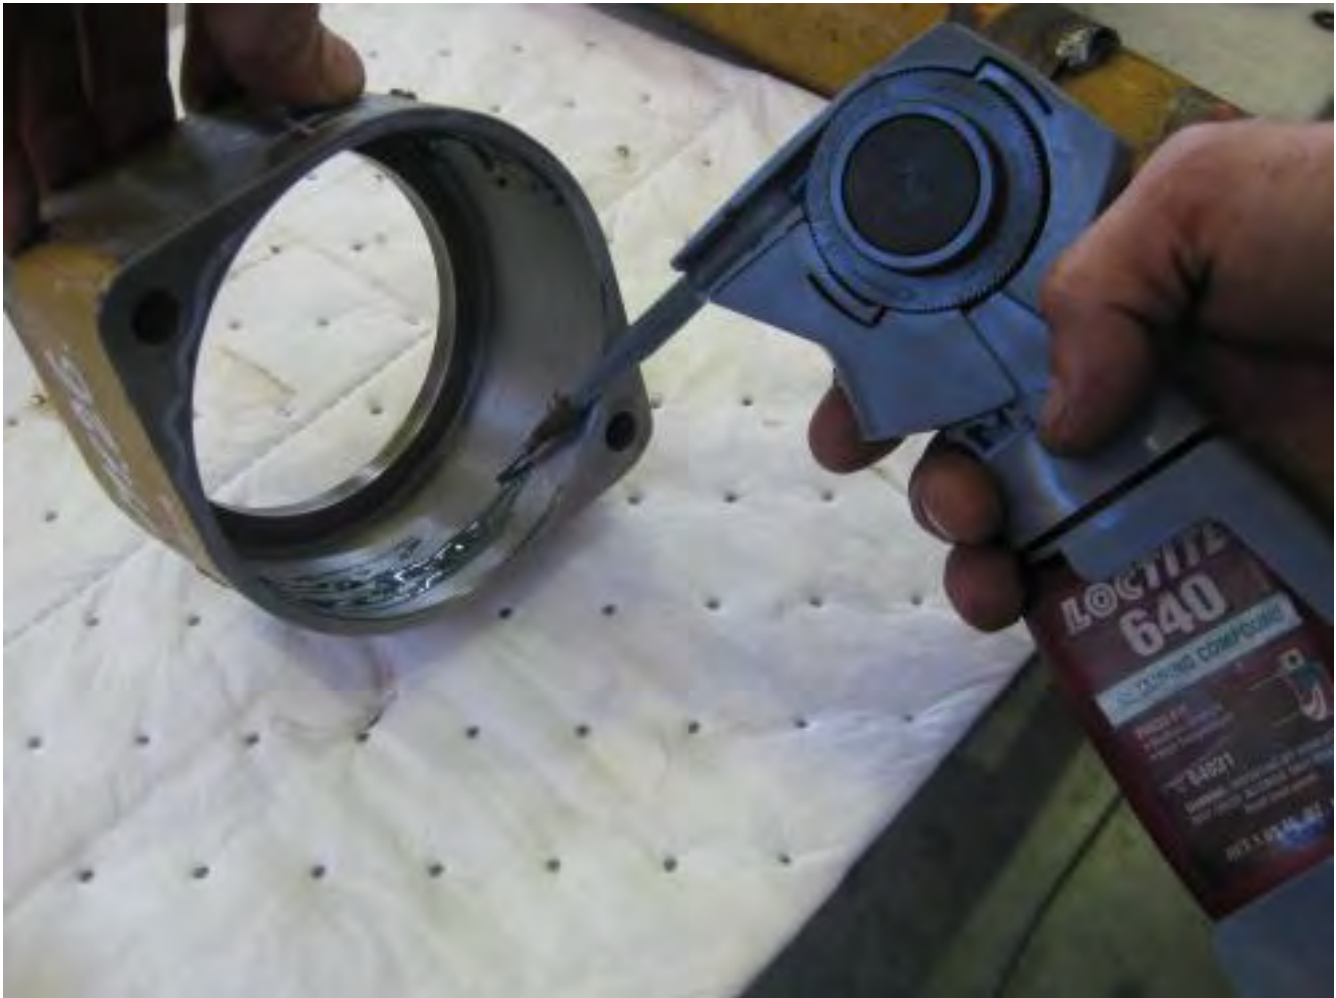
*Application of the retaining compound*

- Cool down the sleeve to -45 degrees C (-50 degrees F) for 2 hours.
- Apply LOCTITE 640 on the machined surface of the part.

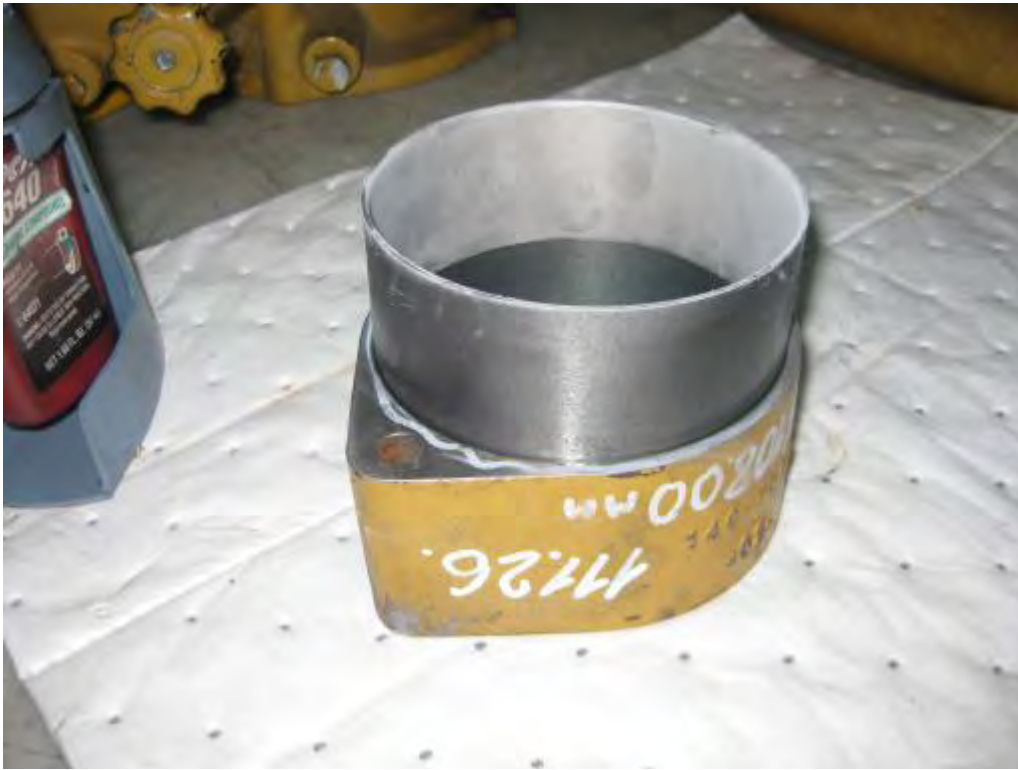
*Installation of the sleeve*

- Install the cooled sleeve into the machined bore using proper driver adapter.

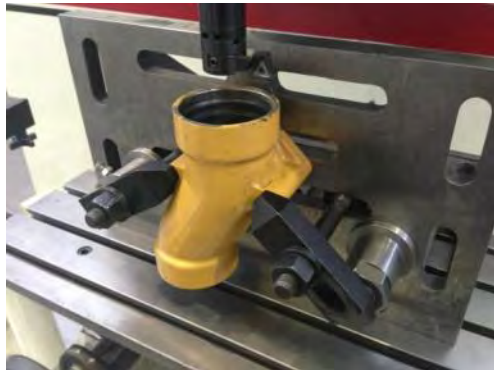
| Parts | | Dimensions | | | | | Sleeve Material | |
|---|---|---|---|---|---|---|---|---|
| 4W-6077 Elbow | | 84.45 | 88.04 ± .02 | 88 | 25 | 3X30 <sup>0</sup> | 2.5X10 <sup>0</sup> | ASTM A48 - 30B |

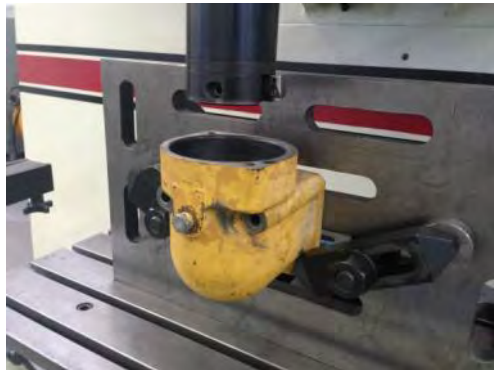
| Parts | | Dimensions | | | | | Sleeve Material | |
|---|---|---|---|---|---|---|---|---|
| 7E-9584 Elbow | | 97.5 | 101.04 ± .02 | 101 | 30 | 3X30 <sup>0</sup> | 2.5X10 <sup>0</sup> | ASTM A48 - 30B |

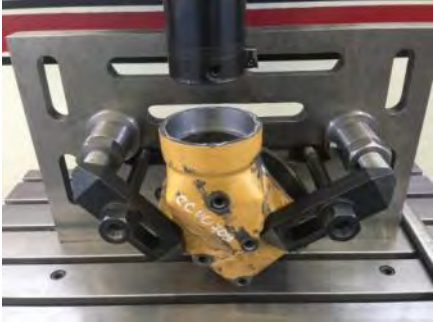
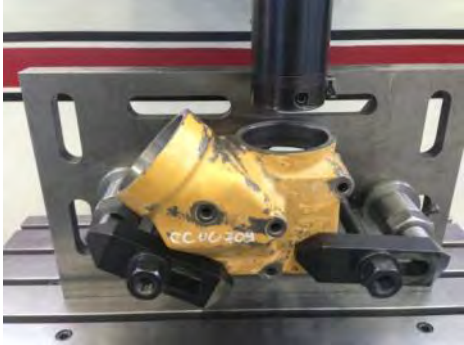
| <p>4W-9625 Bonnet</p> | | <p>1)<br/>84.45</p> <p>2)<br/>85.90</p> | <p>1) 88.04 ± .02</p> <p>2) 90.04 ± .02</p> | <p>1) 88</p> <p>2) 90</p> | <p>25</p> | <p>3X30°</p> | <p>2.5X10°</p> | <p>ASTM A48 - 30B</p> |

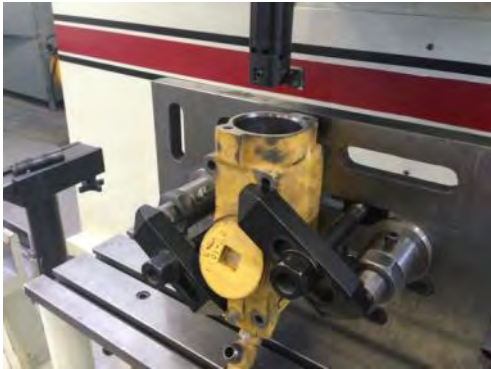
| <p>2W-1055 Elbow</p> | | <p>65.40</p> | <p>69.04 ± .02</p> | <p>69</p> | <p>30</p> | <p>2.5X30°</p> | <p>2 X10°</p> | <p>ASTM A48 - 30B</p> |

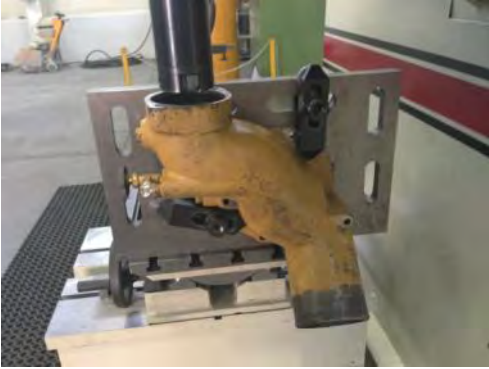
| 4P-5752 Elbow | | 97.15 | 101.04 ± .02 | 101 | 30 | 3X30 <sup>0</sup> | 2.5X10 <sup>0</sup> | ASTM A48 - 30B |
