MINING DEALER BEST PRACTICE

# Connection Bypass on Main Cooling for 3500 Engine Test

June 2016  
1605-4.03-1434

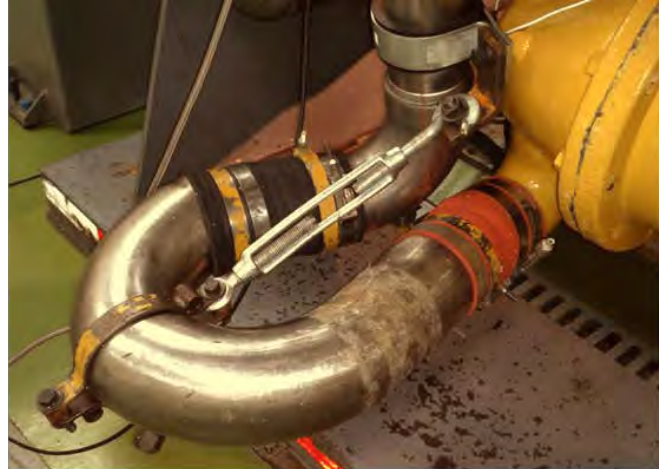
Fig. 1.

To Conduct the tests on the dynamometer which prefixes are ATY and FDB (793C / D), the hydraulic oil cooler circuit on the engine block needs to be shut down. Since the SISWEB does not provide an immediate or direct connection between these two points, a horseshoe-shaped tube has been designed to meet this requirement. The problem is that once the device was disconnected a large amount of hot water was leaked during the test creating the risk of burning the components around it and even causing injuries to the technicians. A tension gripping system was designed for the same device in order to hold it more securely, but some problems came up because the vibrations of engine. (See Fig. 1.)
