# 777, 785, 789 and 793 OHT Disc Frictions Protection during Pre-washing

Maintenance and  
Repair

| THE INFORMATION HEREIN MAY NOT BE COPIED OR TRANSMITTED TO OTHERS WITHOUT THE WRITTEN PERMISSION OF CATERPILLAR | | | |
|---|---|---|---|
| Protection of the Brake Pack During Washing | DATE<br>2/19/2015 | CHG<br>NO<br>00 | NUMBER<br>1306-4.03-1317 |

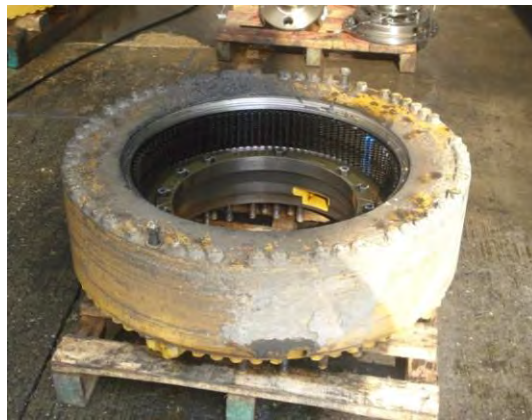
Friction discs, which are part of the brake packs, can be reused under the conditions that are referenced in the guide of reusability SEBF8095-06 Service Brakes for Off-Highway Trucks and Tractors. The guide notes that friction discs that are exposed to water can be damaged and must be replaced, so it is necessary to protect them from water in the pre-wash area.

Figure 1. Brake group exposed.

This Best Practice suggests the use of a brake group protection tool for trucks during the pre-wash process.

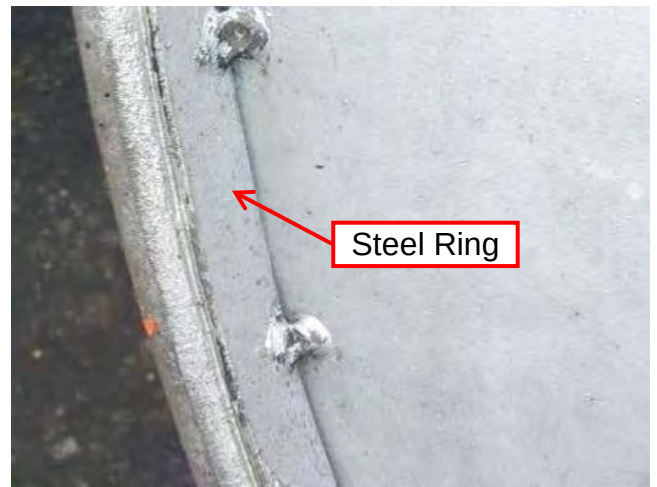
Figure 4. Reinforced duo-cone seal.

The protective cover includes a circular sheet, steel ring, duo-cone seal and O-ring. The plate is jointed to the circular sheet by welding points and sealed using epoxy (Figures 4 and 5). Between the seal and plate, it is also epoxied. The O-ring ensures the cover is sealed (See Figure 7).

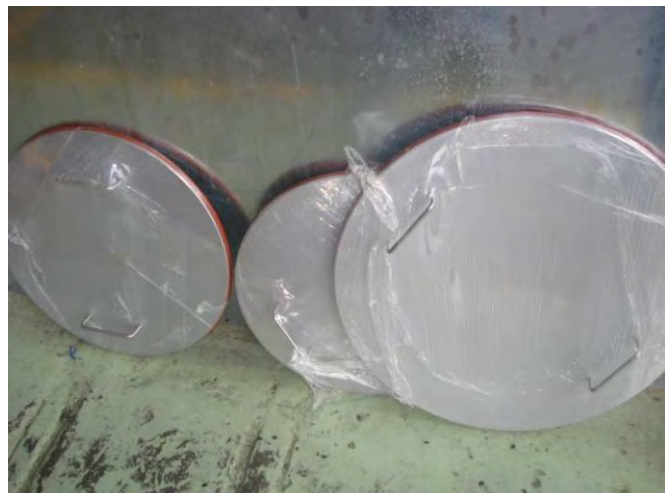
Figure 6. Different size protective covers.

There are three sizes currently in operation (depending on the brake package to be washed) but the design can be adapted to other components using the duo-cone seal respective (Figure 6).
